# BETHEL RECREATION FACILITY MASTER PLAN

Town of Bethel, Vermont

March 2013

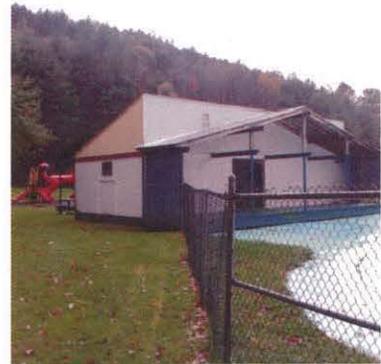
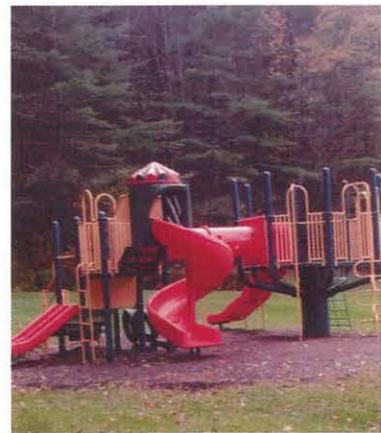
The Facilities at the Bethel Recreation Center were developed over thirty years ago, and they are showing their age. Cracked paving at the tennis courts, parking and walks, poor drainage, water damage to the building, mildew on the building, and deferred maintenance all contribute to a sense of general disrepair. The architectural style of the building is also outdated.

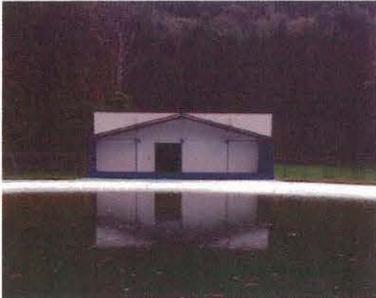
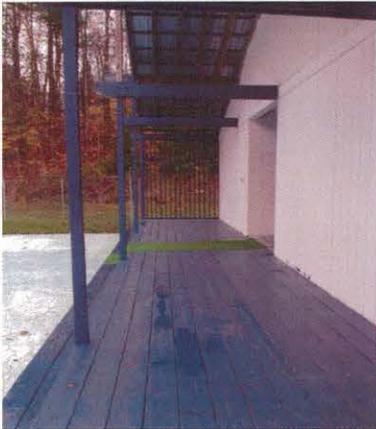
The existing pool deck, pool house and attached picnic deck were built in the mid 1970's (probably 1974) per drawings prepared by Donald F. McKnight AIA in April 1974. It consist of "boy's toilet & dressing room", "girl's toilet & dressing room", a mechanical room, and an office. The current building is substantially the same design built in 1974 with several notable changes. A gable roof was added to the pool deck area, a shed roof was installed over the picnic deck area, and a ramp was built up to the entry area of the pool house. It is not clear when these additions and alterations were made although a hand drawn sketch of the roof over the pool deck exists from 2004. As a result of these alterations the building has lost any sense of architectural integrity it may have had with the original design.

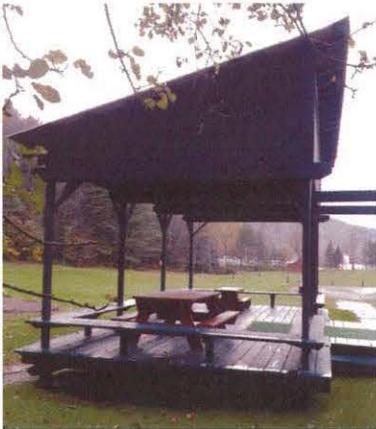
While ad-hoc provisions have been made for accessibility these improvements do not meet contemporary standards. There are many examples of this including not having a ramp from the pool house down to the pool, the hill slope up to the pool house being greater than the 1:20 allowed with no handrail, and the lack of accessible toilet stalls.

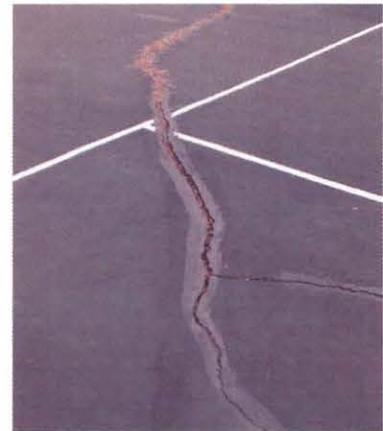
The tennis courts are in need of repair. Their are large surface cracks and an uneven playing surfafce. There are also accessibility issues with regards to the grading of the site.

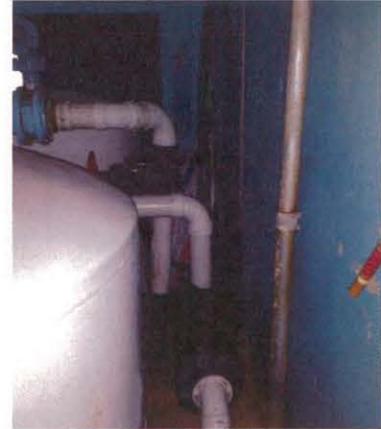
The existing building is fitted with plumbing systems that support bathroom functions, pool filter drainage, and exterior shower unit. The existing plumbing system is fitted with a 1 1/2" galvanized steel domestic water main fed from an underground municipal water feed. There were two municipal water curb stops due North of the pool, we are assuming that one curb stop supported the water fill to the pool and the second curb stop supported the building plumbing fixtures. The male bathroom is fitted with (1) urinal, (1) water closet, (2) lavatories, (1) hose bib, and (1) floor drain. The female bathroom is fitted with (2) water closets, (2) lavatories, (1) hose bib, and (1) floor drain. The pool filtration system is fitted with a back flush drainage system. The exterior is fitted with a shower unit that is no longer fitted with a shower valve, but is used as a drain pan. The domestic hot water is generated in a 30 gallon electric water heater fitted with a 4500 watt electric resistance element.

The existing water entrances are not fitted with backflow prevention devices which are required by the State of Vermont in order to protect the municipal water supply. The required reduced pressure zone backflow preventers will require drains to the exterior or pool filter drain to accommodate full flow in the event of a preventer failure. Additional space will be required to accommodate the backflow preventers.

We recommend replacing the existing domestic water heater with a hybrid 80 gallon electric water heater that is coupled with a solar domestic water heating system. This will allow near utility free domestic hot water for the facility. We would recommend using (2) 119 gallon water heaters linked to (5) solar collectors to provide baseline domestic hot water.

We would recommend replacing the existing water closets with new 1.1 gallon per flush technology to update the existing facility. We recommend replacing the urinal with a new waterless urinal unit. We recommend refitting the existing lavatories with automatic faucets (spring loaded or electronic) that are fitted with 0.75 gallon per minute aerators. We recommend installing insulation kits on the existing lavatory piping services to be consistent with ADA requirements.
