Performance of Buildings and Nonstructural Components in the 2014 South Napa Earthquake

FEMA P-1024 / February 2015

APPLIED TECHNOLOGY COUNCIL
201 Redwood Shores Parkway, Suite 240
Redwood City, California 94065
<http://www.atcouncil.org/>

FEDERAL EMERGENCY MANAGEMENT AGENCY
Michael Mahoney, Project Officer
Washington, D.C.

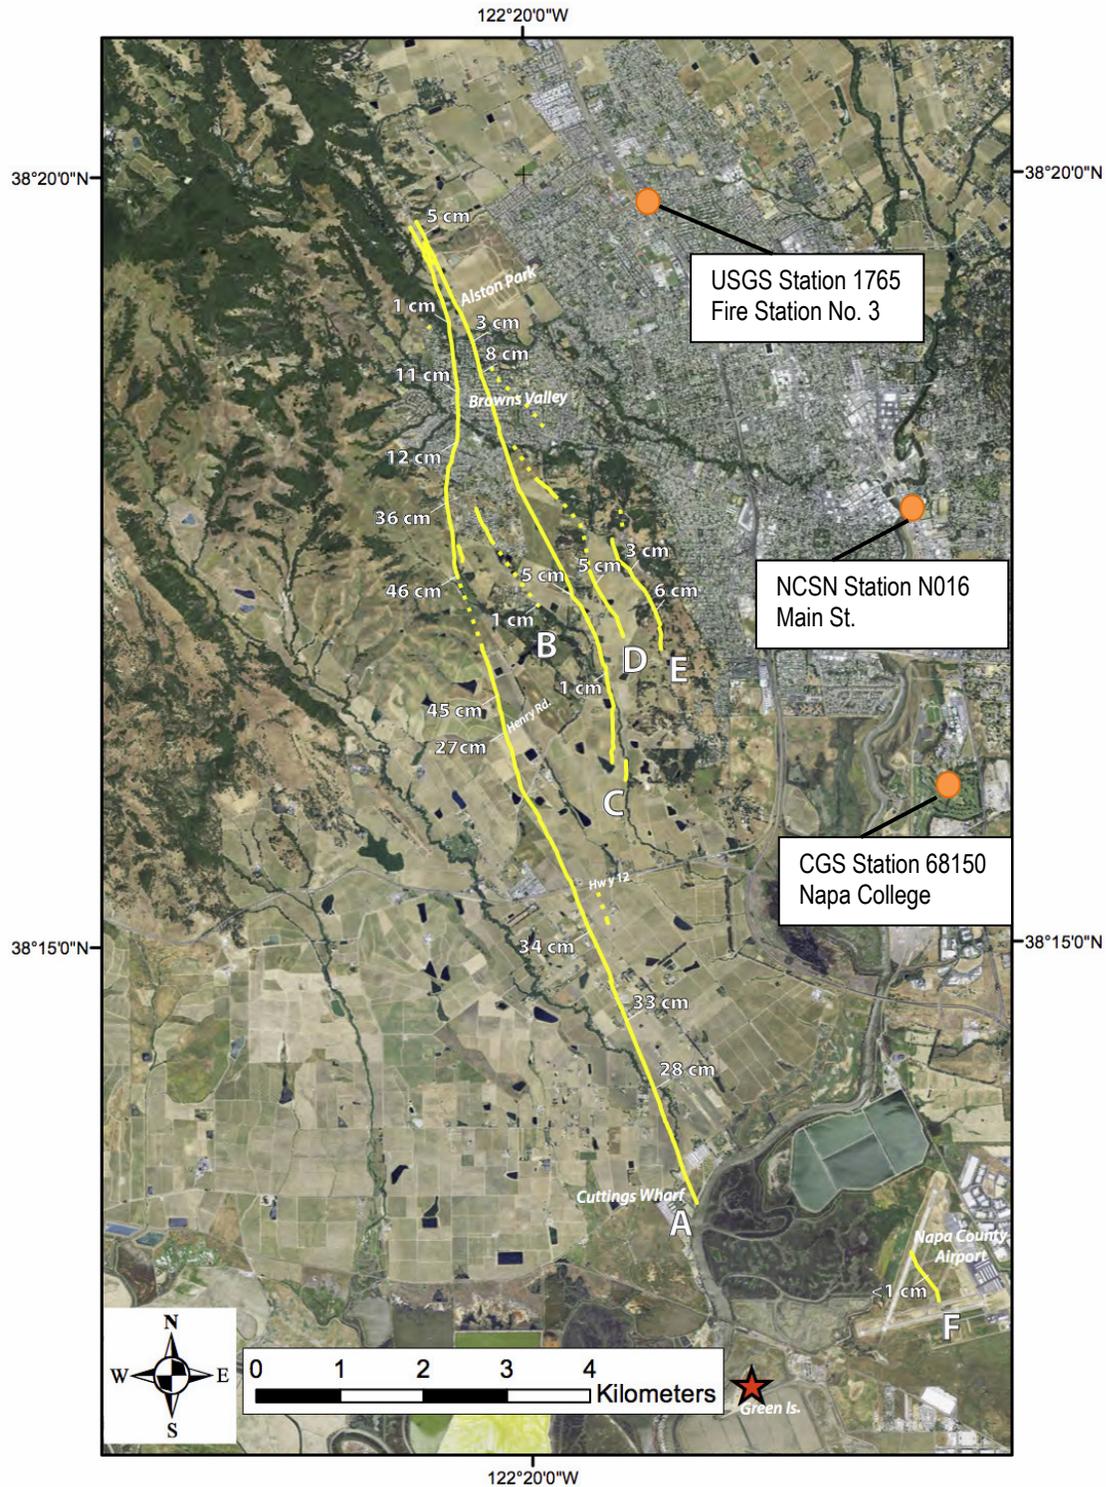
Figure 2-3 Surface faulting (yellow lines) produced by the August 24, 2014 South Napa earthquake (USGS, 2014). Numbers show maximum measured right-lateral offset at selected sites, rounded to the nearest cm; includes both coseismic, as well as measured afterslip as of November 17, 2014. Red star shows the location of earthquake epicenter, orange circles show the location of three ground-motion recording instrument stations.

The earthquake produced more than 14 km of surface rupture from the Napa River at Cuttings Wharf in the south, through Browns Valley to Alston Park, within the City of Napa, as shown in Figure 2-3. This amount of fault slip is considered unusual for a magnitude-6.0 earthquake.

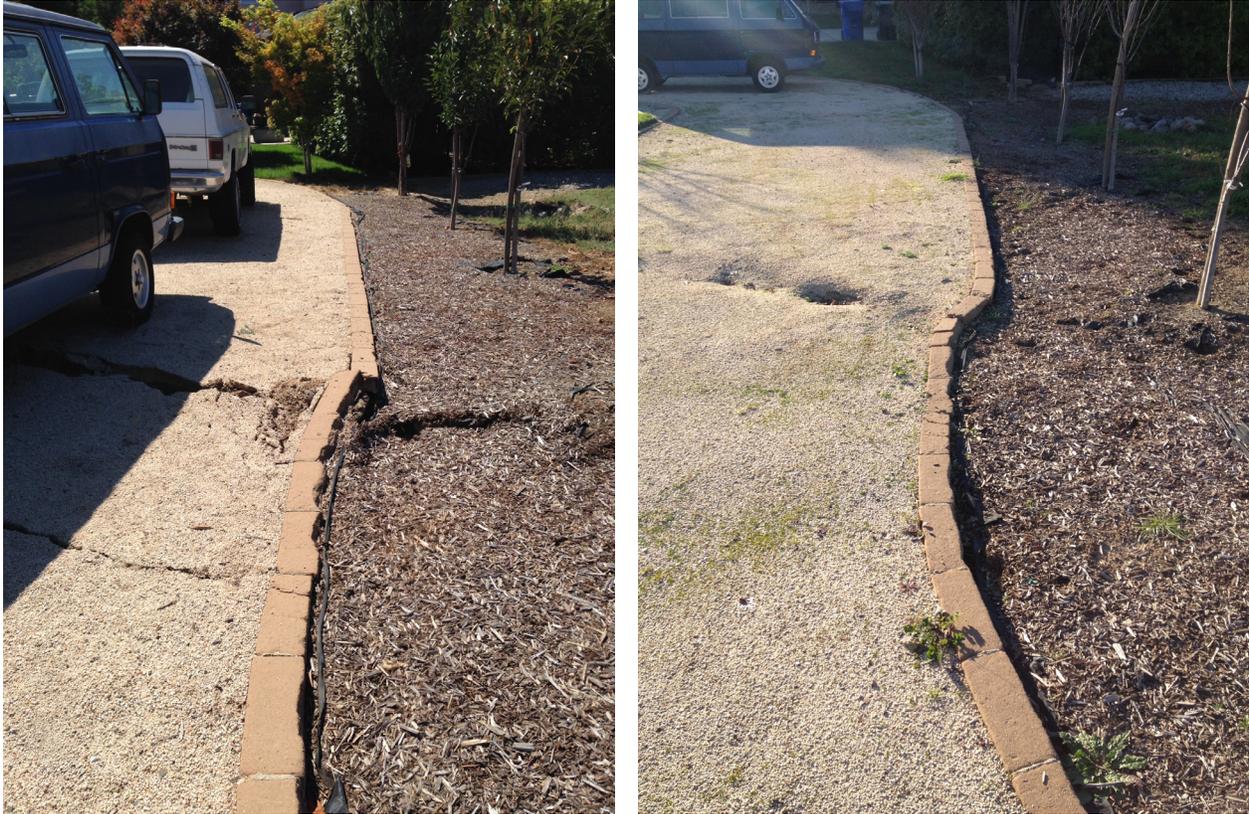
Figure 2-9 shows the same location 11 hours after the earthquake on August 24, 2014 and on January 12, 2015, over four months after the earthquake. According to the USGS, 11 hours after the earthquake (Figure 2-9a), the slip was observed to be several inches, and 135 days later on January 12, 2015 (Figure 2-9b), the slip was measured as 15 inches. Even though the creep rate several months after the earthquake is barely perceptible, the West Napa Fault Zone main strand at this location (and in the south, near Highway 12 crossing) is still creeping faster than the San Andreas fault's creeping section. However, the creep rate is slowing down and is expected to drop down to lower than the San Andreas creep rate in the coming months.

Figure 2-9 Observation of afterslip at Leaning Oak Drive following the South Napa earthquake: (a) 11 hours after the earthquake (photo from Alex Morelan); (b) 4 months after the earthquake (photo from Kenneth Hudnut, USGS).

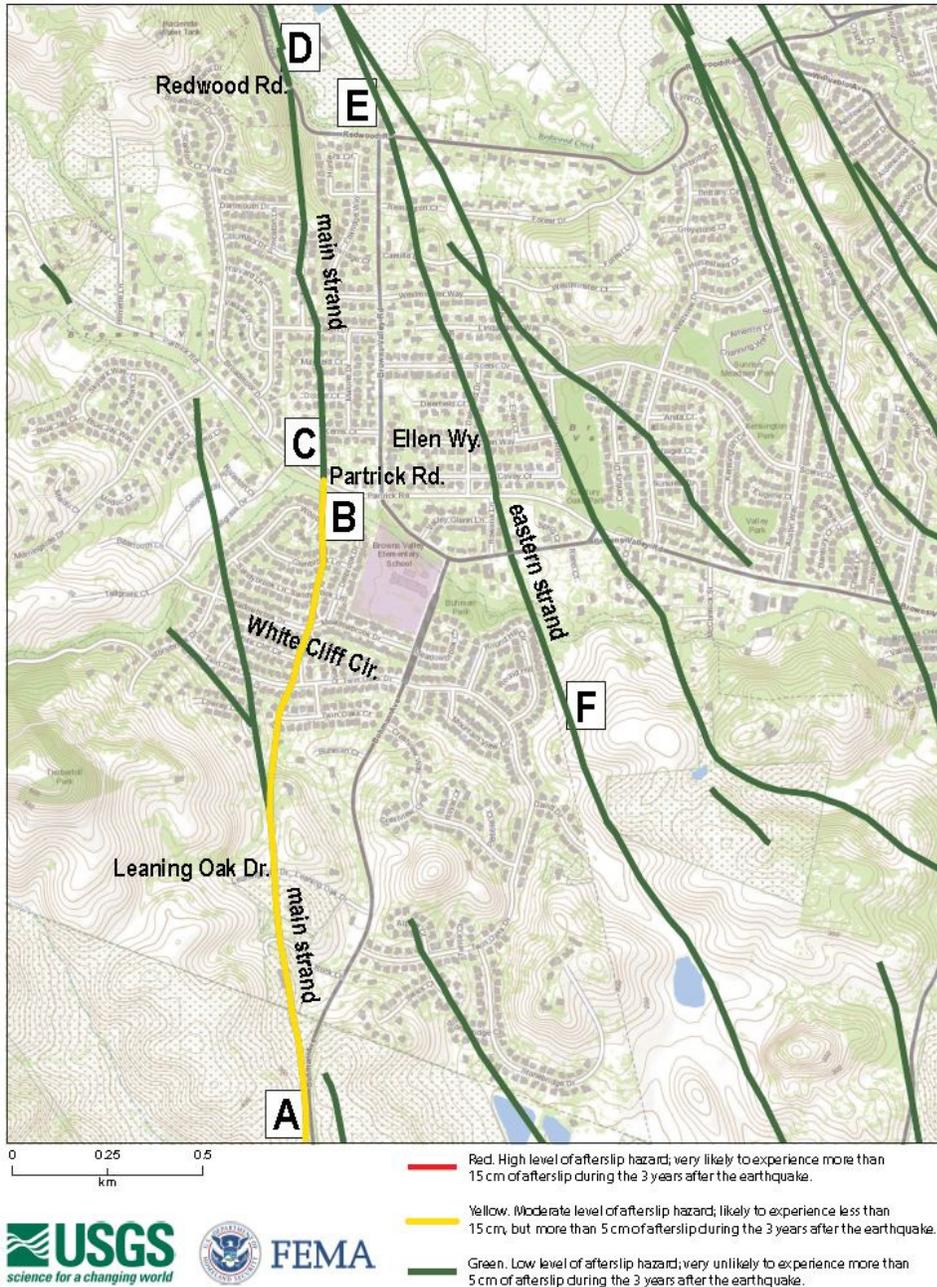
- The yellow fault trace means a moderate level of afterslip hazard; likely to experience less than 15 cm, but more than 5 cm, of afterslip during the three years after the earthquake.
- The green fault trace means a low level of afterslip hazard; very unlikely to experience more than 5 cm of afterslip during the three years after the earthquake.

Figure 2-10 Afterslip map (USGS, 2014). Note that there are no red lines in the figure.

According to the USGS, for all levels of afterslip hazard, the afterslip amount that is measured 90 days after the earthquake may double within 10 years after the earthquake, although lower levels of afterslip are also possible. The afterslip and associated hazard decreases exponentially with time, posing a moderate hazard. The southern part of the main strand of the West Napa fault within Browns Valley, from south of Leaning Oak Drive up to Partrick Road (A to B on Figure 2-10), is shown in yellow on the map and poses an

The northern part of the main strand of the West Napa fault within Browns Valley, north of Partrick Road (C to D on Figure 2-10), has experienced no significant afterslip; low afterslip hazard exists on this part of the main strand of the West Napa fault system. The newly named “eastern strand” of the West Napa fault system (E to F on Figure 2-10) has experienced no afterslip; low afterslip hazard exists on this part of the eastern strand. Other fault strands shown in green on the figure also have low afterslip hazard.

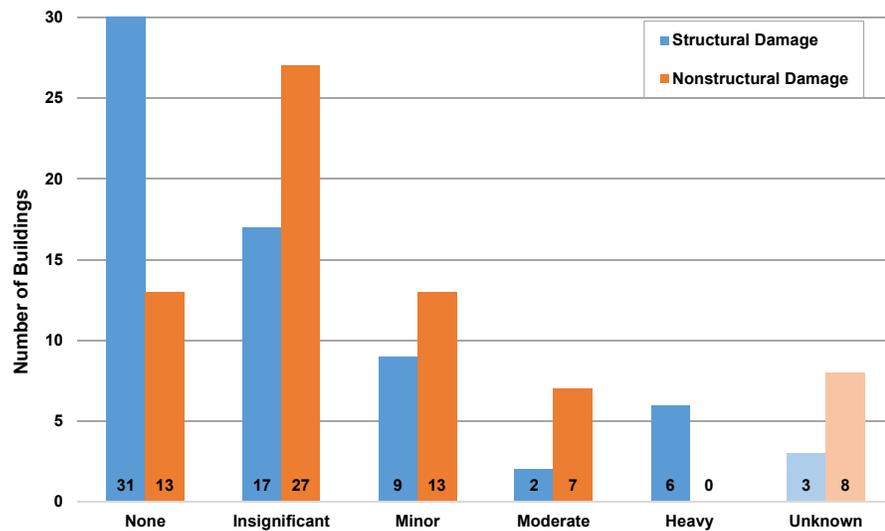
Distribution of building damage by General Damage Classification is shown in Figure 3-6. Overall, nonstructural damage was more common than structural damage: 80% of buildings were observed to have some degree of nonstructural damage, while 54% were observed to have some degree of structural damage. However, the most severe damage classification “Heavy” was only observed for structural systems; classifications of nonstructural damage were limited to “insignificant” (40%), “minor” (19%), and “moderate” (10%). However, it is noted that UNSAFE placards limited access to observation of nonstructural damage, so these buildings with greater levels of structural damage may well have also had greater amounts of nonstructural damage, but because this could not be verified, they have been categorized under “Unknown.”

Figure 3-6 Distribution of building damage according to general damage classification.

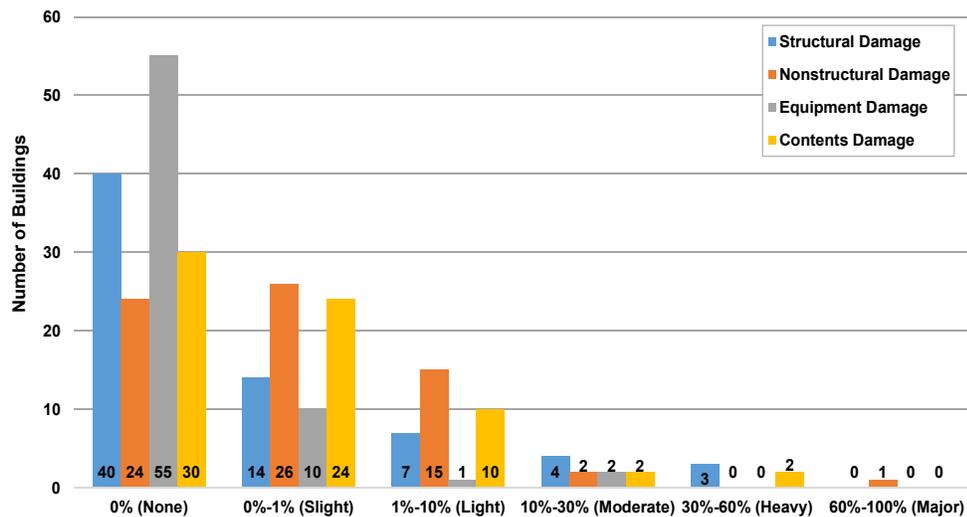
Distribution of building damage by ATC-13 Damage State is shown in Figure 3-7. The data for these assessments show a similar pattern for nonstructural and structural components as that observed in Section 3.8.1. More buildings were assessed to have some degree of nonstructural damage than structural damage, although nonstructural damage was clustered in the less severe states: “slight,” “light,” and “moderate.” Three buildings were

Figure 3-7 Distribution of building damage according to ATC-13 damage states.

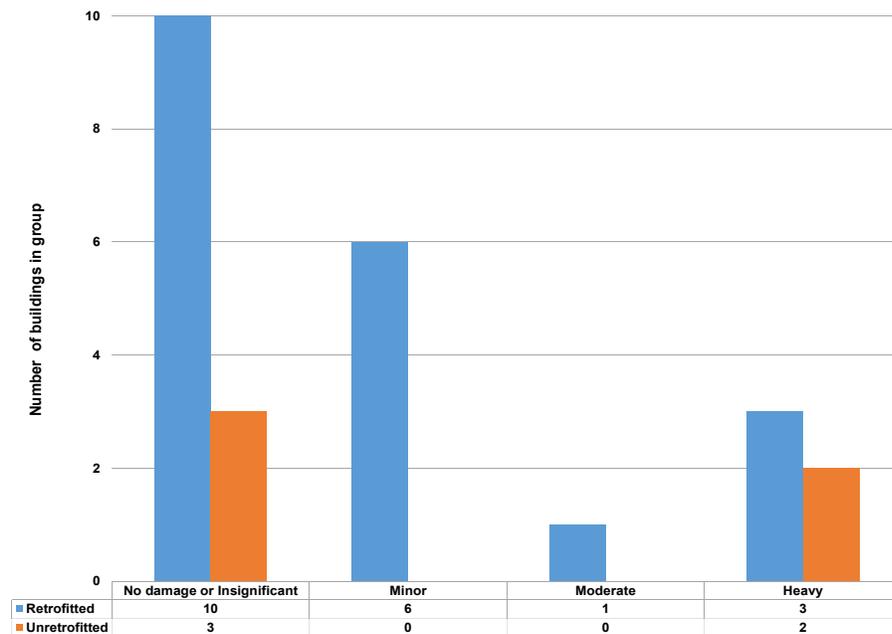
Among the 20 retrofitted URM buildings, 10 buildings sustained no structural damage or the damage was deemed insignificant; six buildings suffered minor damage, one building moderate damage, and three were heavily damaged. No buildings collapsed. Among the buildings sustaining minor damage, two showed minor cracking of URM walls, and one building that was retrofitted with a combination of steel braced and moment frames sustained localized yielding and buckling in some of the steel elements. One of the two heavily damaged buildings is a two-story commercial structure that suffered extensive cracking to the URM walls, including X-cracking of slender URM piers. Damage to decorative terra-cotta elements was also significant. The other heavily damaged building, also a two-story structure, was reported to have sustained a wall anchorage failure.

A number of different approaches were used to retrofit URMs, and partial retrofits of URM buildings were less successful in limiting damage compared to those that received more comprehensive upgrades. Stone masonry walls and parapets were more likely to sustain damage compared to those of brick masonry. Overall, based on the performance of the URM buildings within 1,000 feet of Station N016, it was observed that the hazard mitigation efforts in Napa were successful in reducing damage and the risk to life safety due to URM construction: Only 20% of the retrofitted URM buildings were posted UNSAFE (one additional building was posted UNSAFE due to damage to an adjacent structure), compared to over 70% of the unretrofitted buildings.

Figure 3-8 Damage comparison between unretrofitted and retrofitted URM buildings.

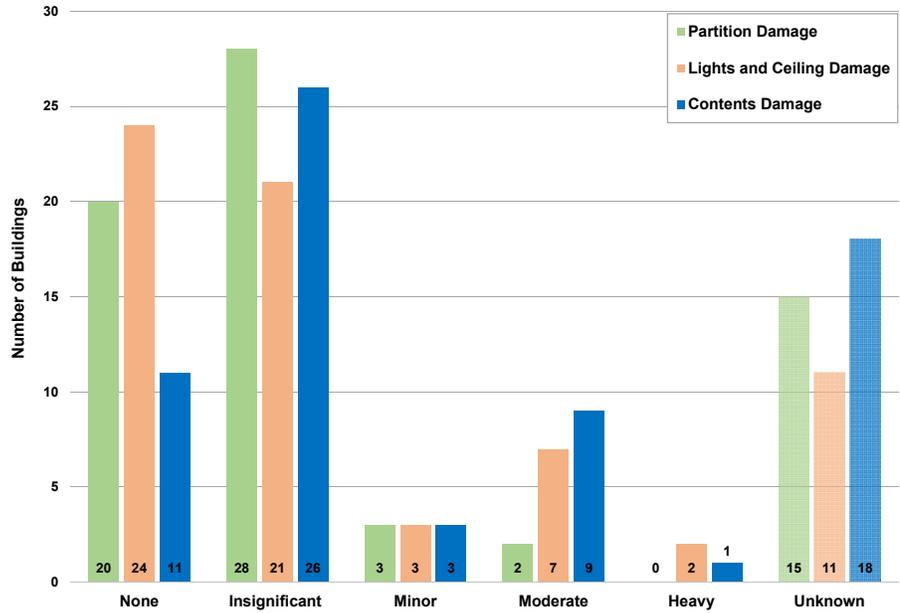
Although a majority of the buildings sustained damage in each of these three categories, the observable damage was mostly assessed as “insignificant.”

Damage to contents was the most common of the three, with 24% experiencing a significant level of loss (“minor”, “moderate,” or “heavy”). Damage to lights and ceilings was the next most common, with 16%. Damage to partitions was sustained by the fewest buildings (8%).

Figure 3-9 Number of buildings where select types of nonstructural damage was observed.

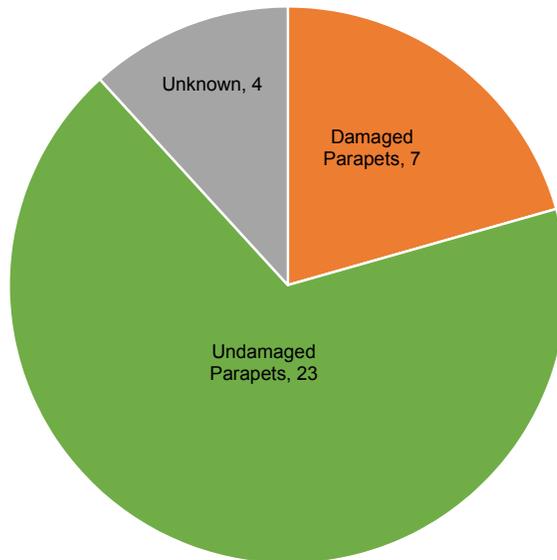
The performance of parapets is summarized in Figure 3-10. Of the subset of buildings with parapets, 21% had observed damage.

Figure 3-10 Distribution of parapet performance.

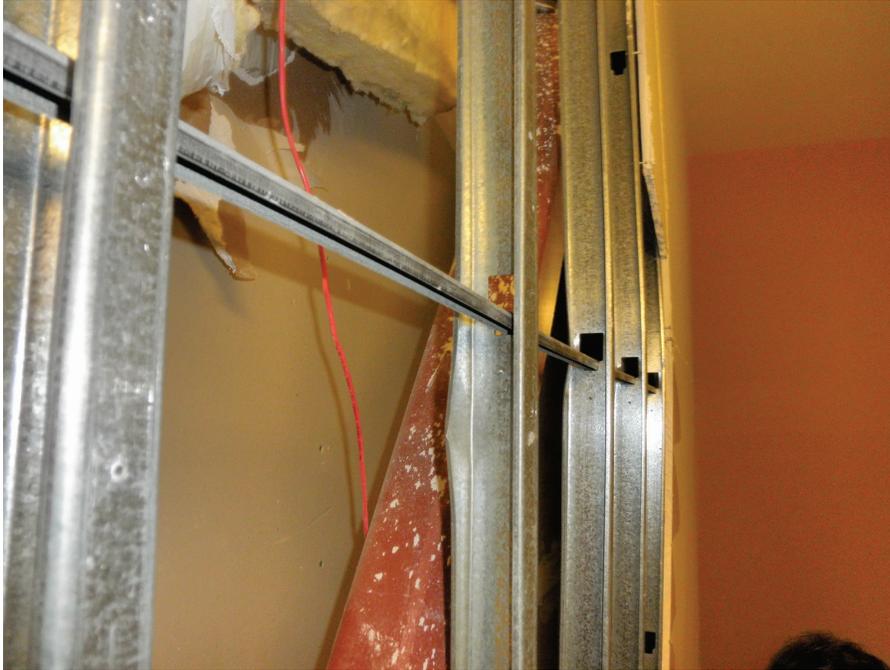
- **Structural Performance:** No significant damage was observed. A brace on the north side of the building buckled elastically out-of-plane, causing some damage to the light-frame furring wall (Figure 4-4).

Figure 4-4 Damage to steel studs due to out-of-plane buckling of brace.

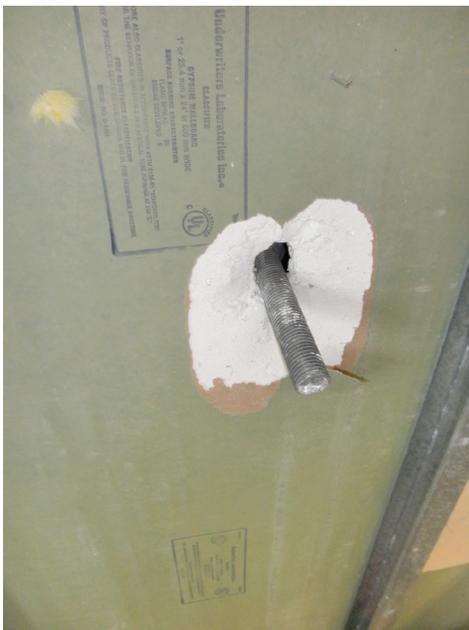
- **Nonstructural Performance:** In general, very little nonstructural damage to the building was observed. There was almost no drywall damage observed on the first floor, and no ceiling damage reported. As noted above, there was damage to the light-frame furring at the third floor north wall, in the vicinity of one brace. Along the north wall, damage to the exterior wall occurred when the out-of-plane wall anchors of the adjacent building struck the drywall (Figure 4-5). No damage to equipment or piping, including the fire sprinkler system, was reported.

Figure 4-5 Out-of-plane wall anchor of adjacent building penetrated drywall.

damaged the wall of the adjacent building (Building L1) (Figures 4-5 and 4-70).

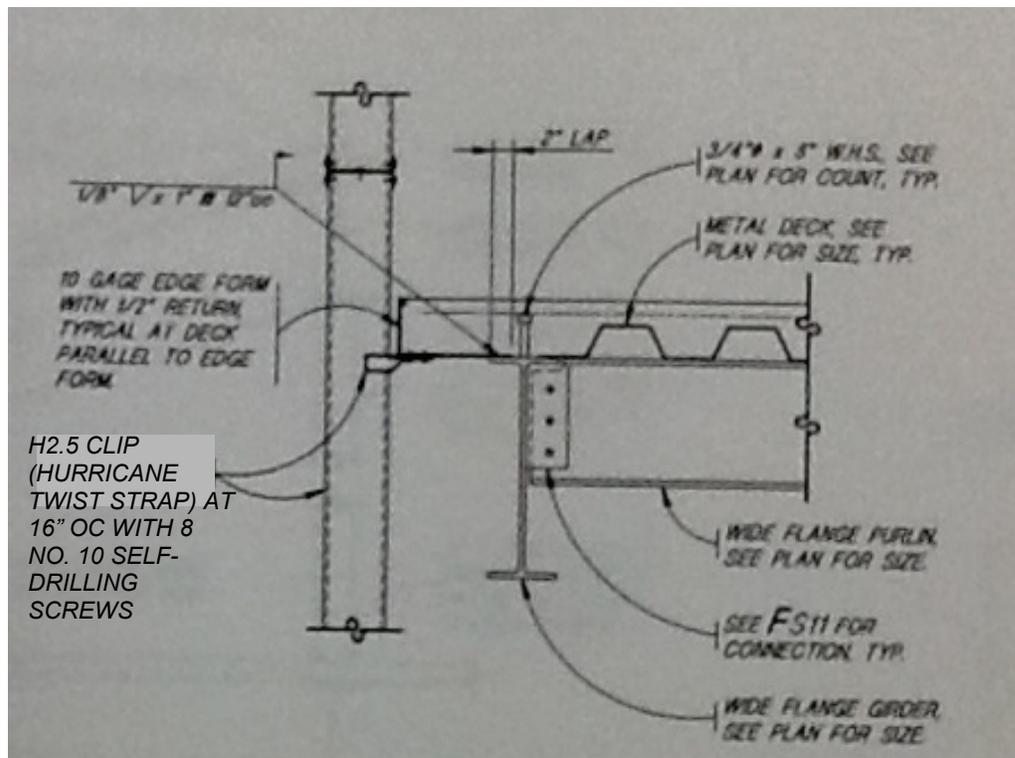
- **Occupancy Type:** Office.
- **Posting Placard:** The building was posted UNSAFE immediately after the earthquake, but at the time of the field investigation, the building was posted INSPECTED.
- **Structural Performance:** There was no reported structural damage. One RBS connection was exposed for examination approximately six weeks after the earthquake. No damage was observed at the connection.
- **Nonstructural Performance:** The south exterior wall of the building, which contains large sections of solid wall, suffered the most significant damage (Figures 4-7 and 4-8). The wall, constructed with metal studs sheathed on the exterior with 5/8 inch gypsum fire-rated wallboard and approximately 1 1/4 inch of cement plaster (Figure 4-9), does not appear to have been detailed to accommodate story drift through a sliding or

Figure 4-9 Detail from original drawings showing connection of exterior wall to each floor.

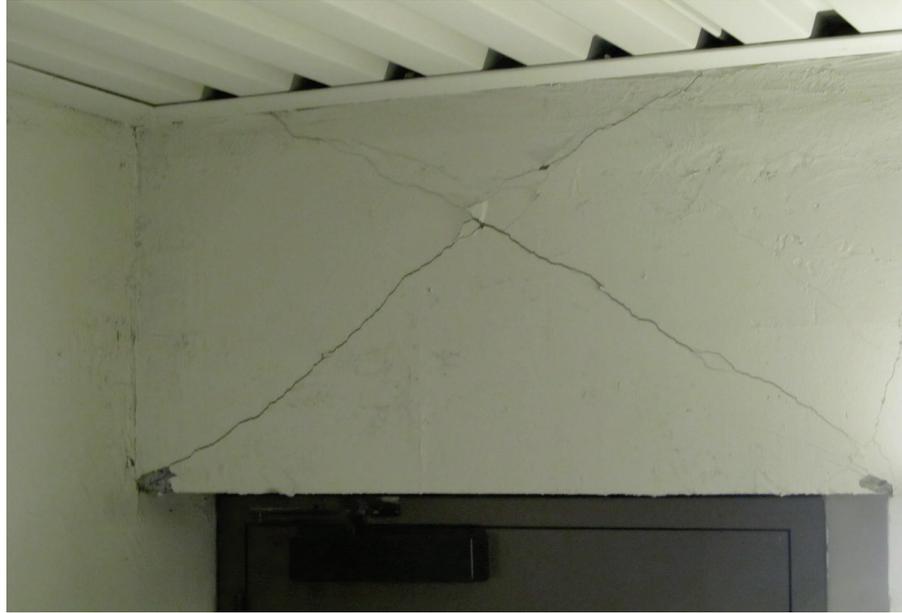
Figure 4-14 Cracking in spandrel in concrete stair core.

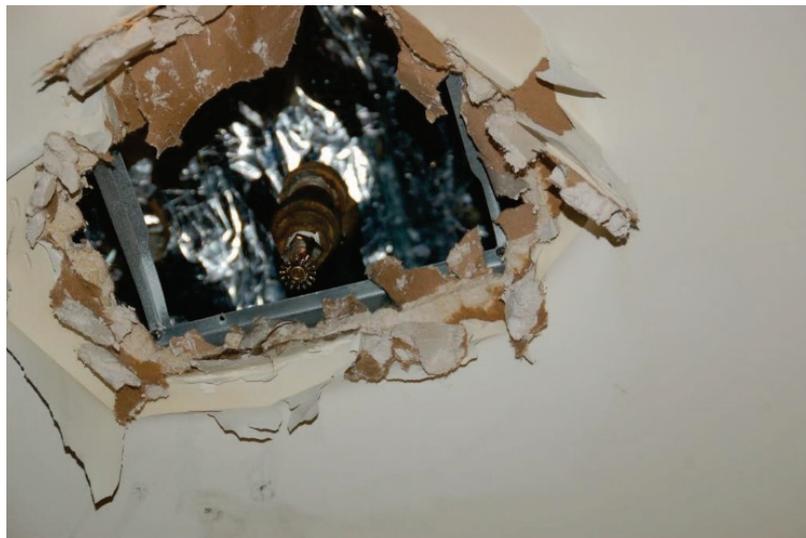
The most significant damage was caused in the restaurant area by a single sprinkler head that impacted an adjacent beam and was triggered. This released water onto both wood and marble flooring (Figure 4-18) for several hours, causing enough damage that required the floor to be completely replaced.

Figure 4-18 Sprinkler impacted HVAC components and discharged.

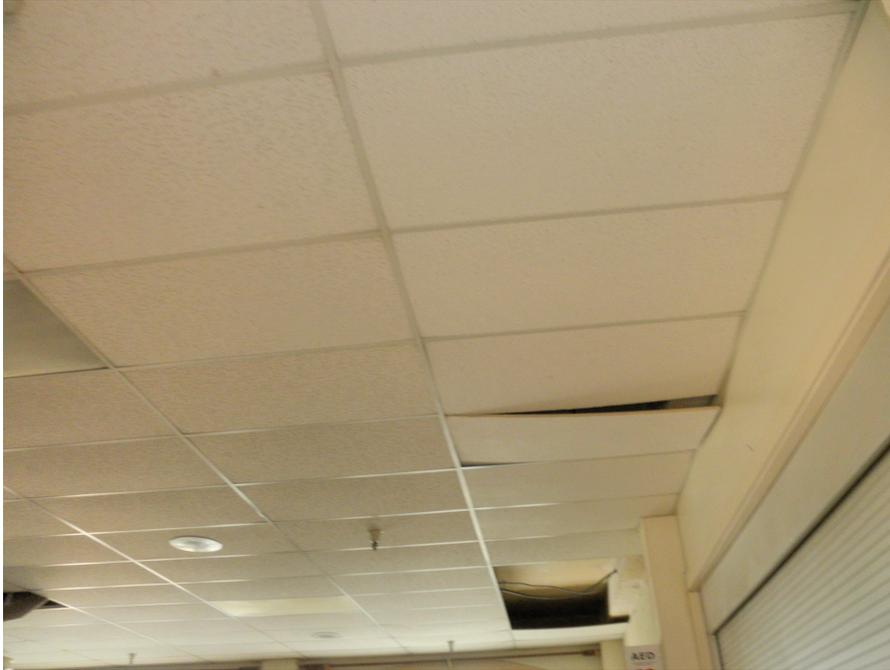
- **Nonstructural Performance:** A few bricks fell from the façade, penetrating the cold-formed steel canopy over the sidewalk (Figure 4-20). About 30% of the windows in the first floor storefront were damaged. Damage to lath and plaster wall finishes was widespread. There was minor damage to suspended ceilings in some areas (Figure 4-21). A support leg of a commercial convection oven failed (Figure 4-22). Unanchored and marginally anchored rooftop equipment displaced but did not fail. No damage to the fire sprinkler system was reported.
- **Time until Full Occupancy:** Portions of the building were inaccessible to the public following the earthquake due to fallen debris. At the time of the field investigation, some of the retail establishments on the ground floor were open. The use of the upper floor spaces was restricted due to nonstructural damage.

Figure 4-21 Minor damage to suspended ceilings.

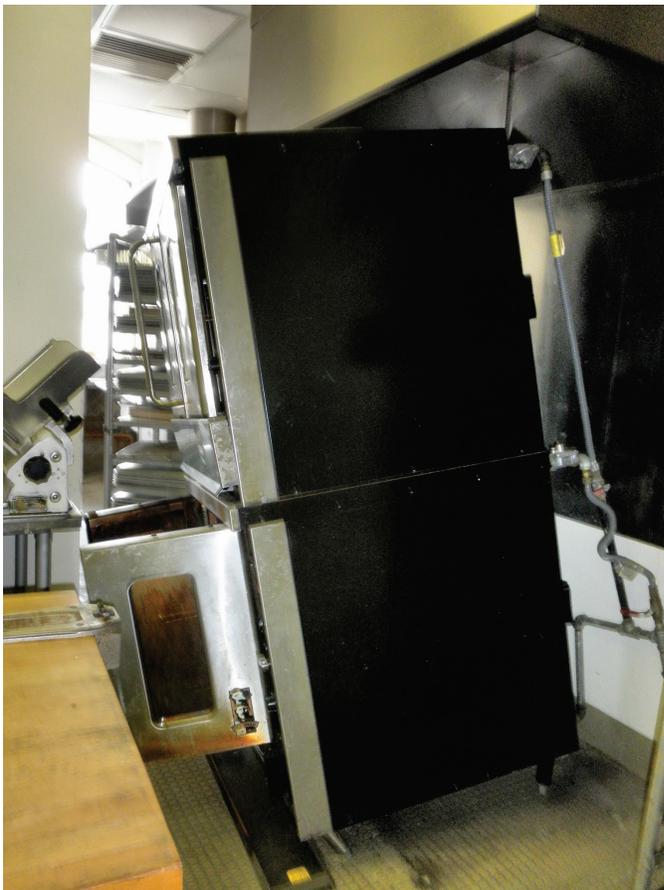
Figure 4-22 Convection oven with failed support leg.

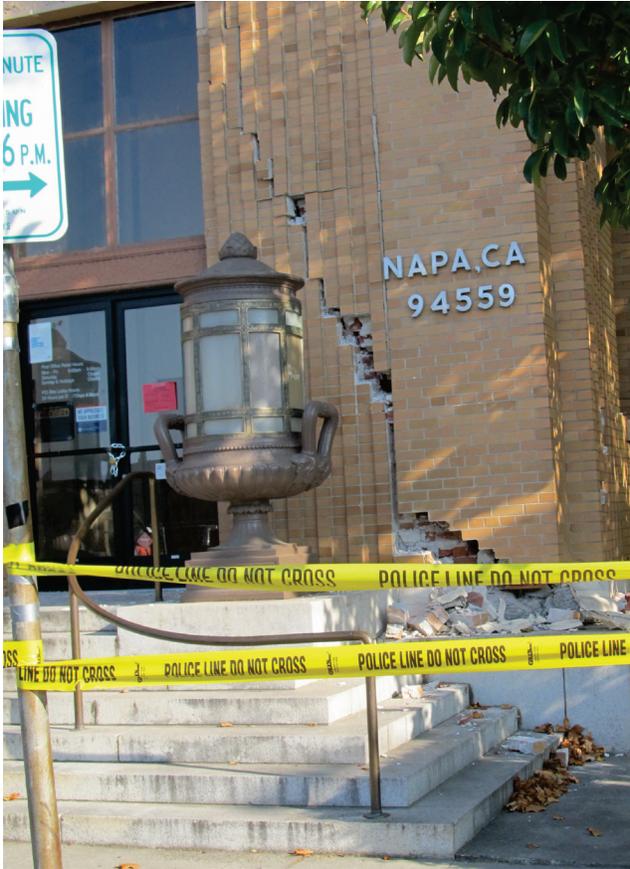
- **Occupancy Type:** United States post office.
- **Posting Placard:** At the time of the field investigation, the building was posted UNSAFE.
- **Structural Performance:** Masonry piers sustained heavy damage on all elevations, but worse on front and rear sides. Corner piers sustained major inclined cracking two inches or more in width, rear elevation piers had cracking in excess of 1/2 inch (Figure 4-24). Some other piers shifted laterally at the sill line (Figure 4-25). Short segments of exposed corner columns indicate that they may be bowed or no longer plumb. No damage was reported in the basement.

Figure 4-24 Damage to corner pier.

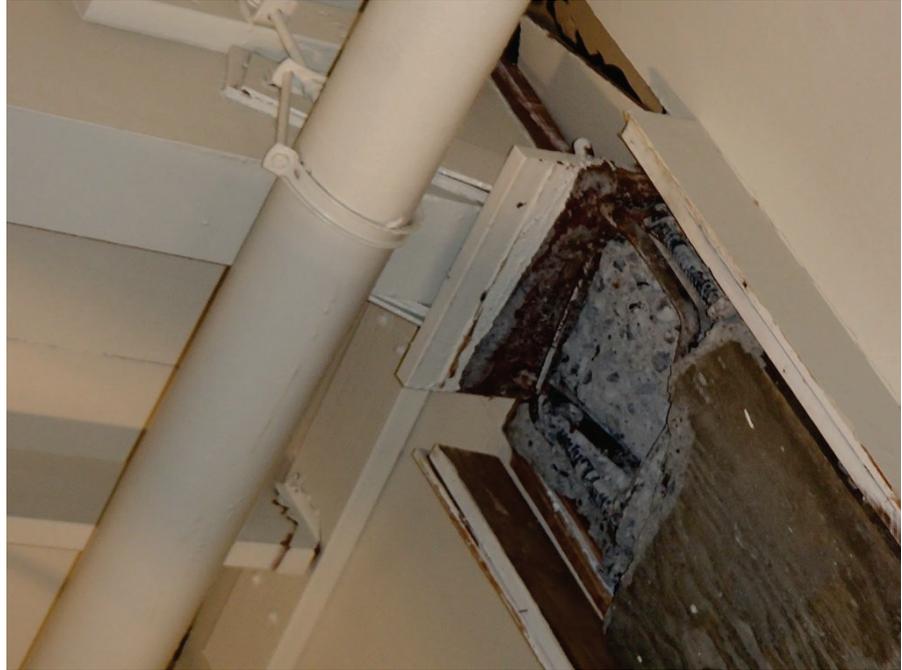
- **Structural Performance:** Five glulam beam-to-pilaster connections on the north wall of the building suffered damage at the pilaster connection (Figure 4-28). The top of the pilaster spalled or cracked around the anchor bolts. One mezzanine support beam experienced some damage at its connection to the rear wall.
- **Nonstructural Performance:** One unbraced sprinkler line broke (Figure 4-29), and water ran for several hours. The lightly strapped hot water heater overturned breaking a water line but not the gas line, which had a flexible connection. There was damage to refrigeration equipment. The suspended acoustic tile ceiling was severely damaged, including substantial loss of tiles and failures in the grid, requiring replacement of

Figure 4-28 Damaged pilaster-to-roof beam connection.

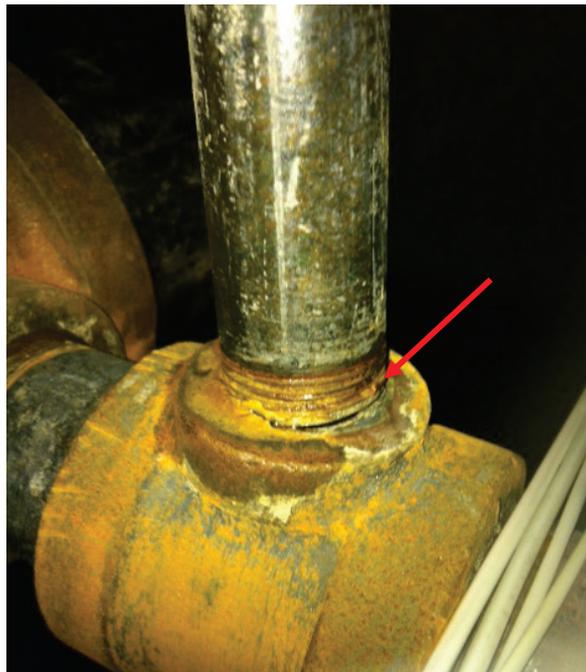
Figure 4-29 Cracked sprinkler pipe.

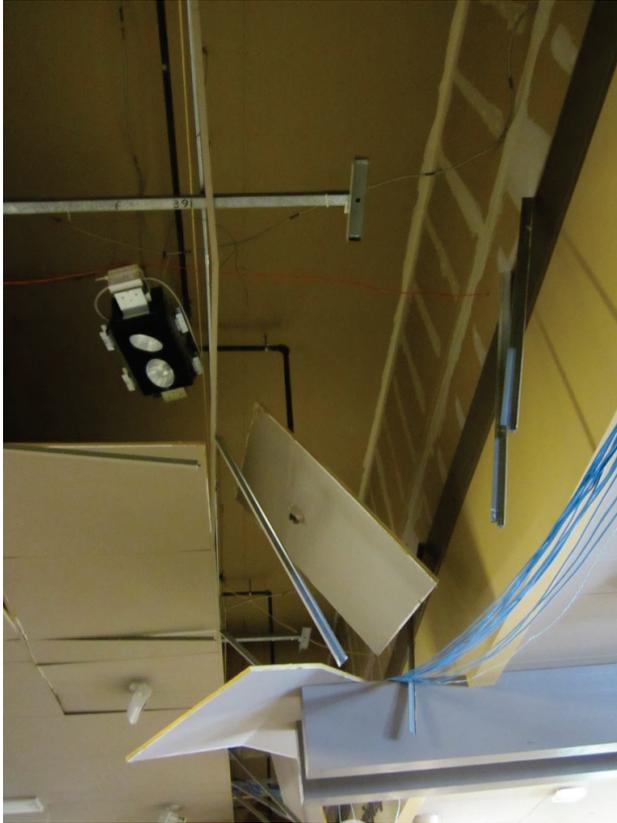
the entire ceiling (Figure 4-30). Some light fixtures were dislodged at their connections to the struts supporting them. Some unanchored store fixtures shifted or overturned. At one aisle, all of the fixtures along one side overturned into the aisle; there was substantial loss of contents from shelves, and virtually all the product was lost (Figure 4-31).

Figure 4-30 Suspended ceiling damage.

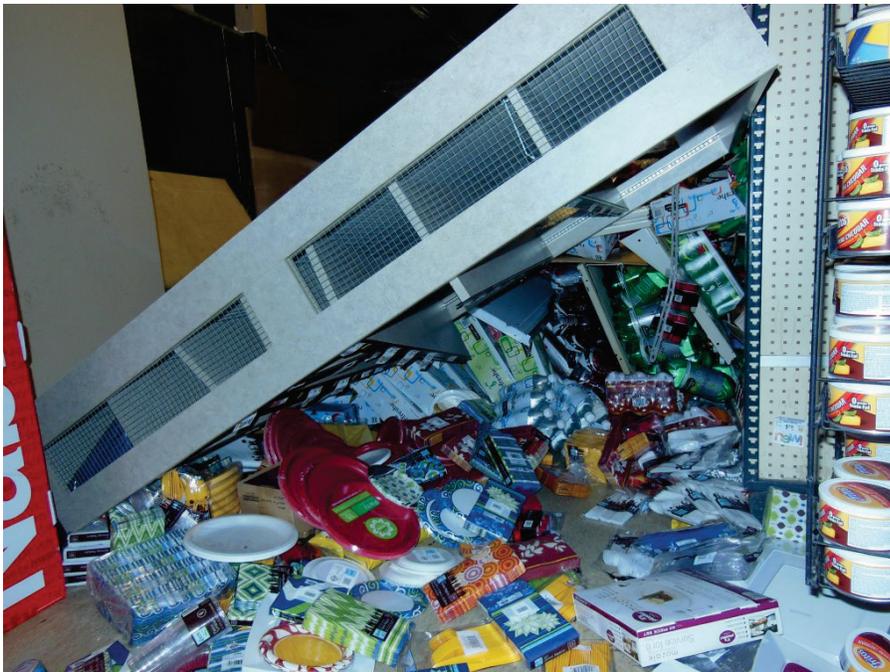
Figure 4-31 Overturned store fixture, loss of contents.

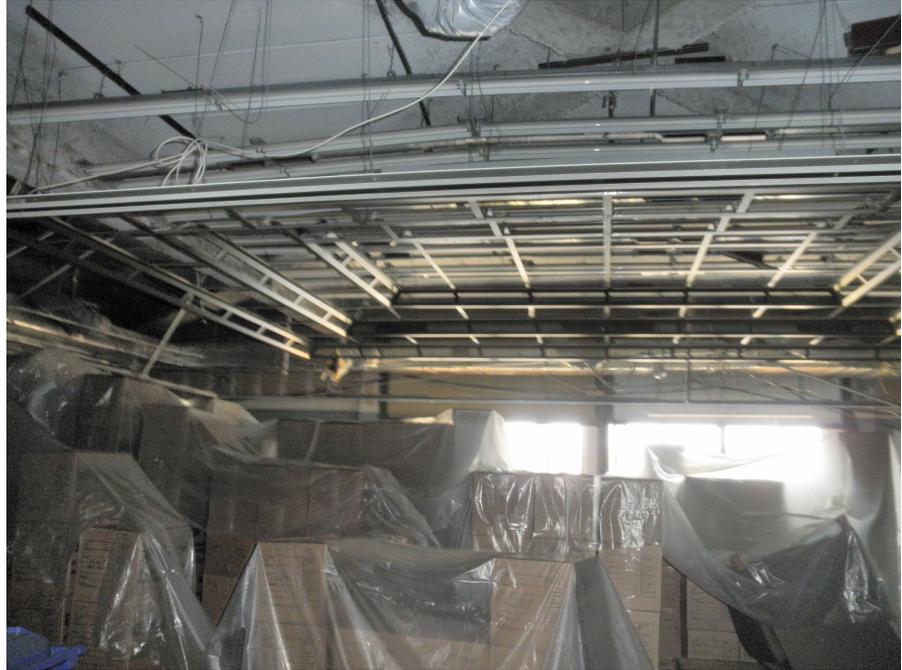
There was extensive ceiling damage in some rooms of the third floor (Figure 4-34), with progressively less ceiling damage at each floor lower. At the third floor, about 20% of the grid was damaged, including some light fixtures that detached from the grid, although safety wires kept them from falling. In some areas, ducts disconnected from independently supported in-line HVAC components (Figure 4-33).

Figure 4-34 Ceiling removed due to water damage, third floor.

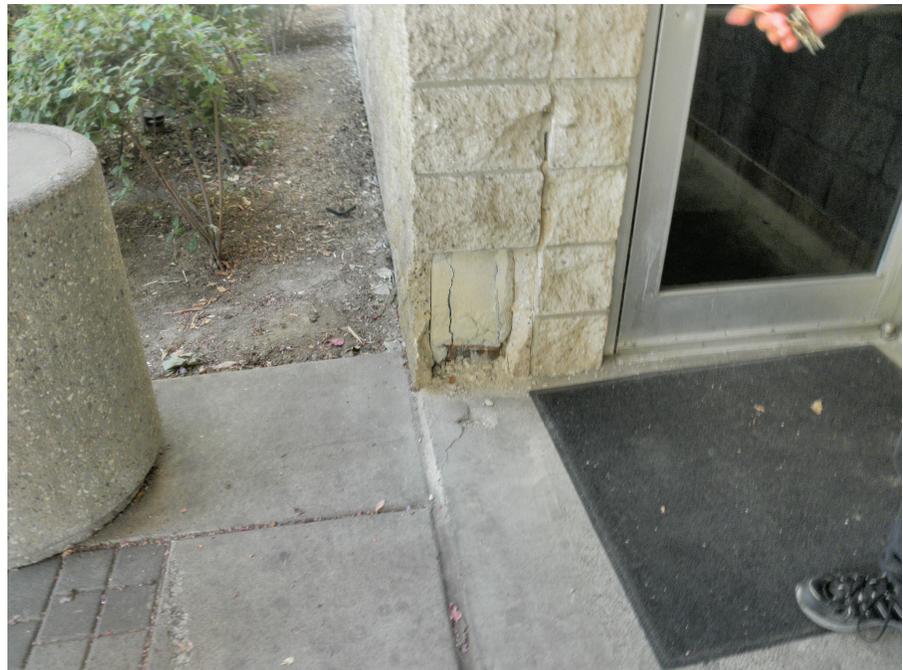
Figure 4-38 CMU face shell spalling, typical at base of walls.

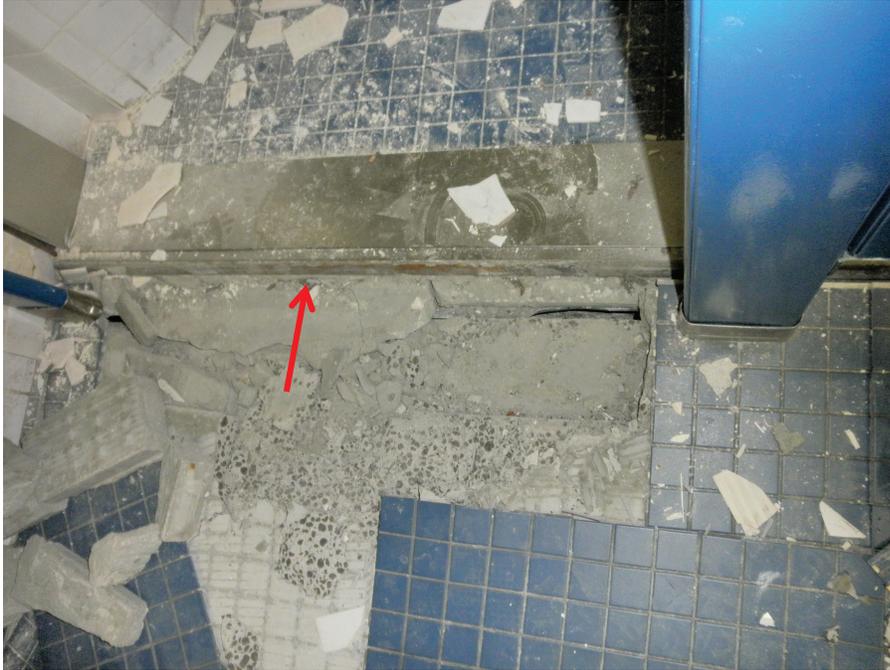
Figure 4-39 Floor finish damage due to pounding at the seismic joint indicated by the arrow.

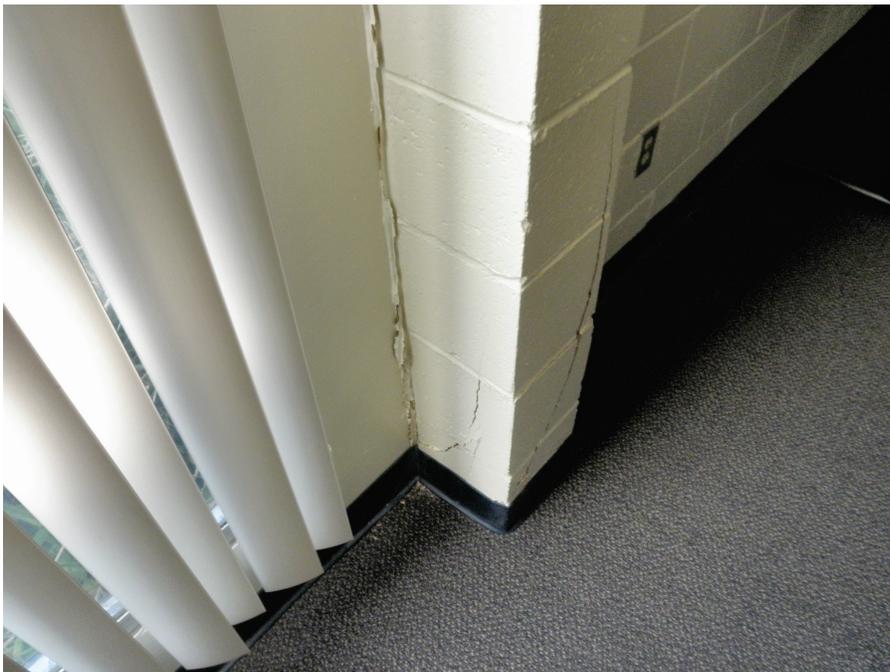
- **Occupancy Type:** Correctional facility and offices.
- **Posting Placard:** At the time of the field investigation, the building was posted RESTRICTED USE. The City of Napa website reported visible damage in the court tunnel, and impairment of the domestic water system.
- **Structural Performance:** Minor X-cracking in the first floor CMU shear walls was observed, along with minor spalling of the CMU face shells at the ends of the walls (Figure 4-38). Pounding damage was observed between the 1974 and 1989 wings (Figure 4-39). In the 1974 wing, some damage was noted in the vicinity of the precast concrete panels containing the windows (Figure 4-40). These units are integrated into the CMU walls, without any allowance for isolating the panel from

Figure 4-40 CMU damage at precast concrete panels containing the window.

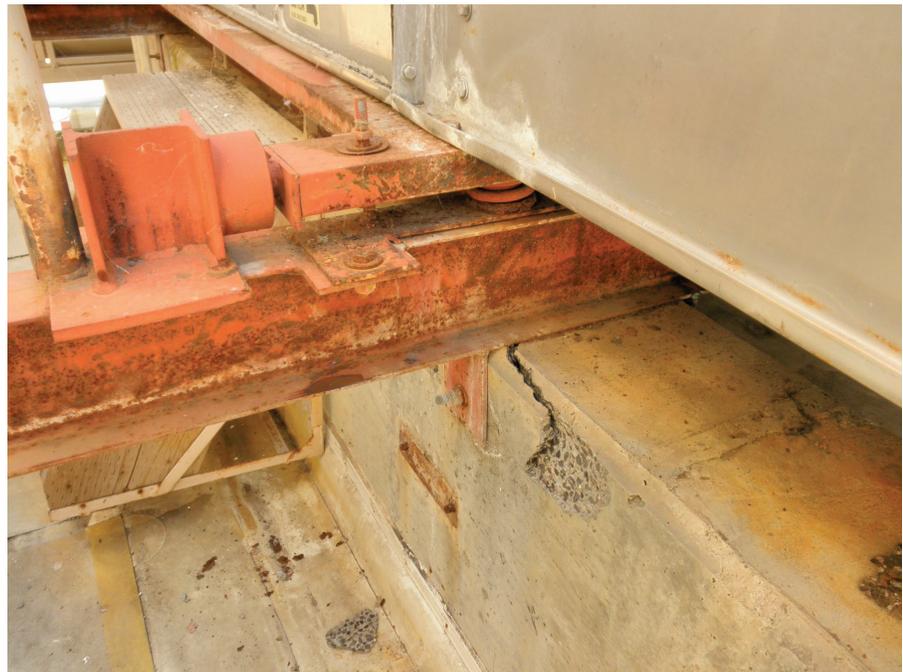
- **Nonstructural Performance:** Significant nonstructural damage was noted in the 1974 wing penthouse. Nearly all vibration-isolated components in the penthouse failed (Figure 4-41). Many failures were associated with splitting of the unreinforced concrete housekeeping slabs

Figure 4-41 Anchor failure, rooftop cooling tower 1974 wing.

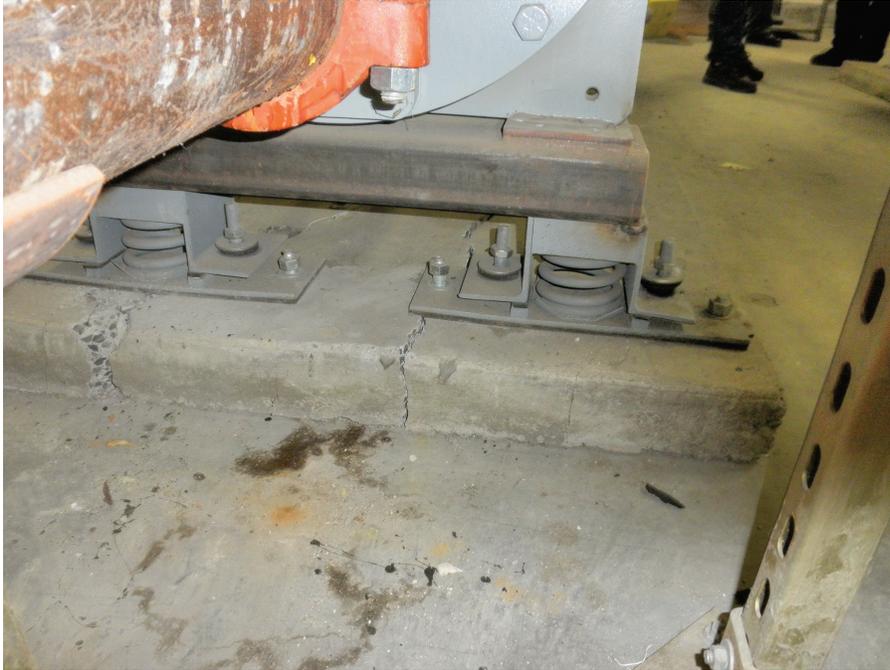
(Figure 4-42), resulting in anchorage failures. The gas-fired emergency generator, which suffered vibration isolator failures, fell from its mounts and displaced laterally, but continued to function. The unbraced batteries for the generator slid but remained functional. A motor control center displaced several feet, but the conduits entering the unit at the top kept it from toppling. It was reported that four of the ten duct drops in the penthouse failed, but the nature of the failure could not be confirmed. Unbraced vibration isolated axial flow fans in-line with the ducts broke free from the ducts but did not fall. A mushroom fan on the roof toppled. Pumps failed their isolator mounts and were restrained by the pipe drops, and one pump pounded against an adjacent partition wall. Ducts and conduit crossing the seismic joint between the wings were not provided with flexible connections and some failed. Damage to suspended ceilings was noted (Figure 4-43), but no general failures of the grid were observed. On the third floor, some of the damage to the ceilings was associated with failure of brazed/soldered piping connections to coils in the ductwork. Damage to gypsum wallboard partitions due to story drift was generally minor. Some disruption to the hydraulic elevators due to buckled gypsum wallboard in the shafts was reported.

Figure 4-42 Housekeeping slab failure, chiller in 1974 wing penthouse.

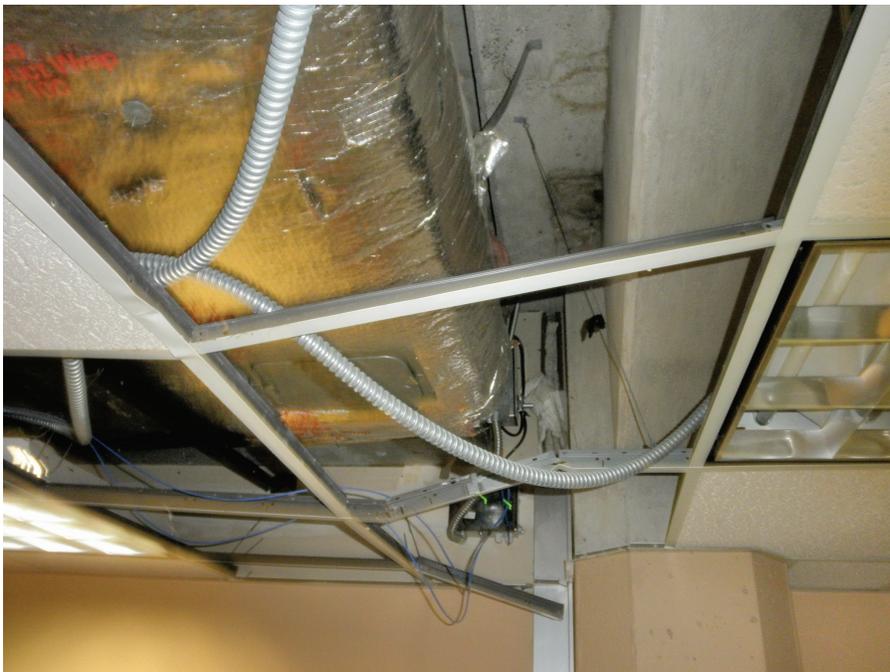
Figure 4-43 Ceiling damage at seismic joint.

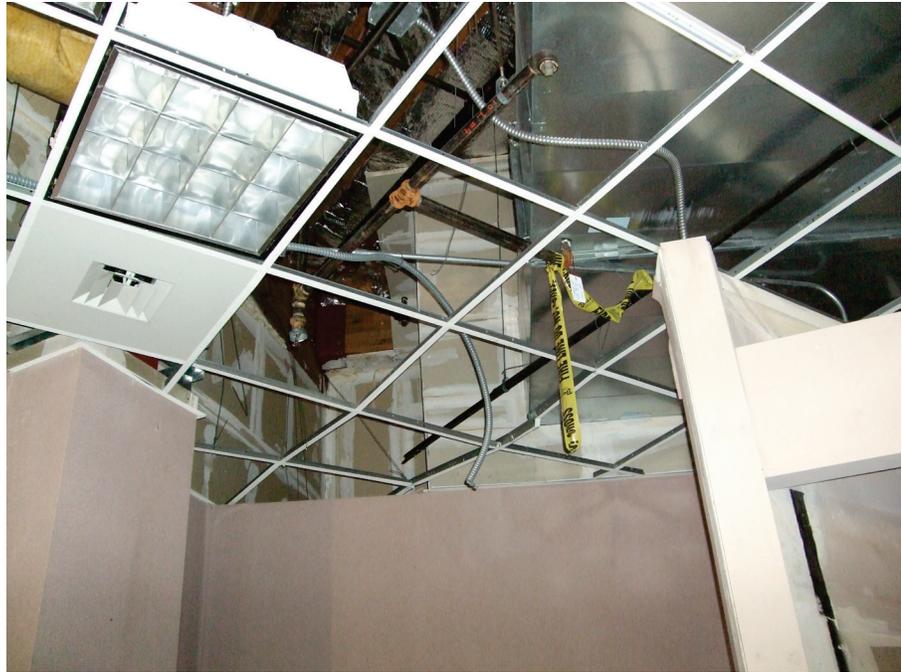
Figure 4-46 Damaged sprinkler pipe. Damage believed to have been caused by interaction with adjacent air handler.

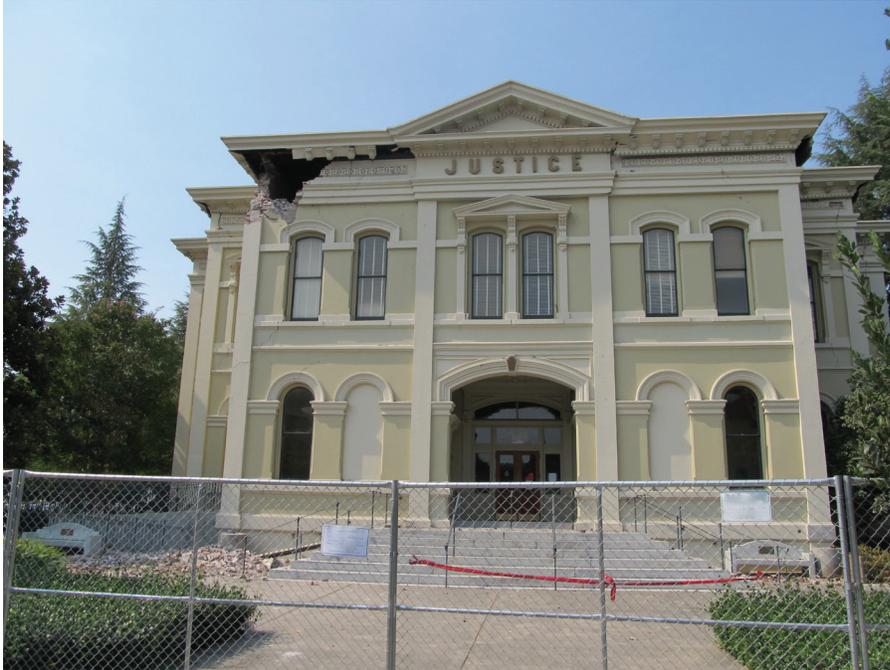
Figure 4-47 East façade of historic URM courthouse. Note fallen bricks below the damaged portion at the top of the wall.

- **Structural Performance:** No structural damage was reported in the west (1916) and central (1977) portions of the structure. The east (1856) URM structure suffered extensive diagonal cracking to spandrels on the north-south façade, especially at the roof level, with heavier damage concentrated in masonry above the second floor and in the corner piers (Figure 4-48). There was partial collapse of the four-wythe brick attic wall at the southeast corner just below the roof. It was observed that roof-to-wall ties were no longer connected to the walls. Some minor damage was visible where the URM structure meets the CMU structure.
