Performance of Buildings and Nonstructural Components in the 2014 South Napa Earthquake

FEMA P-1024 / February 2015

APPLIED TECHNOLOGY COUNCIL
201 Redwood Shores Parkway, Suite 240
Redwood City, California 94065
<http://www.atcouncil.org/>

FEDERAL EMERGENCY MANAGEMENT AGENCY
Michael Mahoney, Project Officer
Washington, D.C.

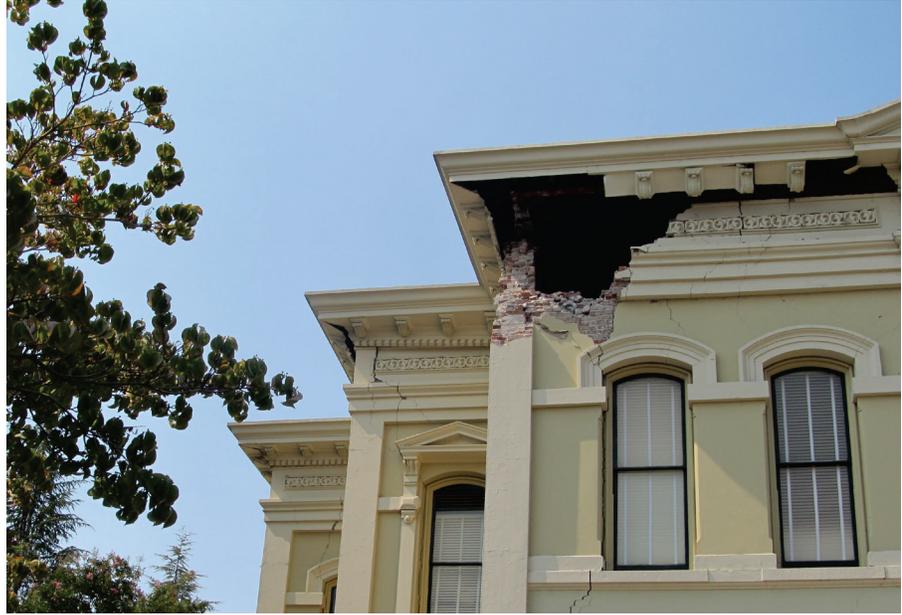
- **Structural Performance:** No structural damage was reported in the west (1916) and central (1977) portions of the structure. The east (1856) URM structure suffered extensive diagonal cracking to spandrels on the north-south façade, especially at the roof level, with heavier damage concentrated in masonry above the second floor and in the corner piers (Figure 4-48). There was partial collapse of the four-wythe brick attic wall at the southeast corner just below the roof. It was observed that roof-to-wall ties were no longer connected to the walls. Some minor damage was visible where the URM structure meets the CMU structure.

Figure 4-48 Close-up of damage at top of the wall.

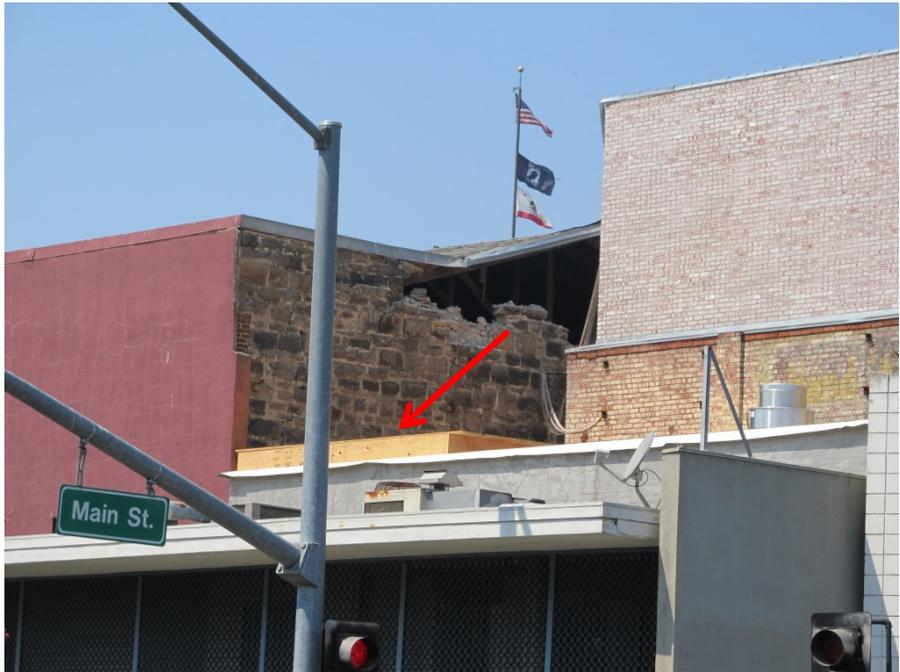
- **Structural Performance:** The masonry wall on the south side of the building separated from the structure and portions of it fell into the neighboring parking lot, striking an unoccupied, parked car (Figure 4-49). Stones fell off the back of the building into the alleyway that separates the building from several retrofitted URMs (Figure 4-51). Large parapet stones fell into the attic space, which was used for storage. A large X-crack was observed in the north masonry wall.

Figure 4-51 Failure of stone masonry east wall. Red arrow indicates wood barrier protecting adjacent property from falling stones.

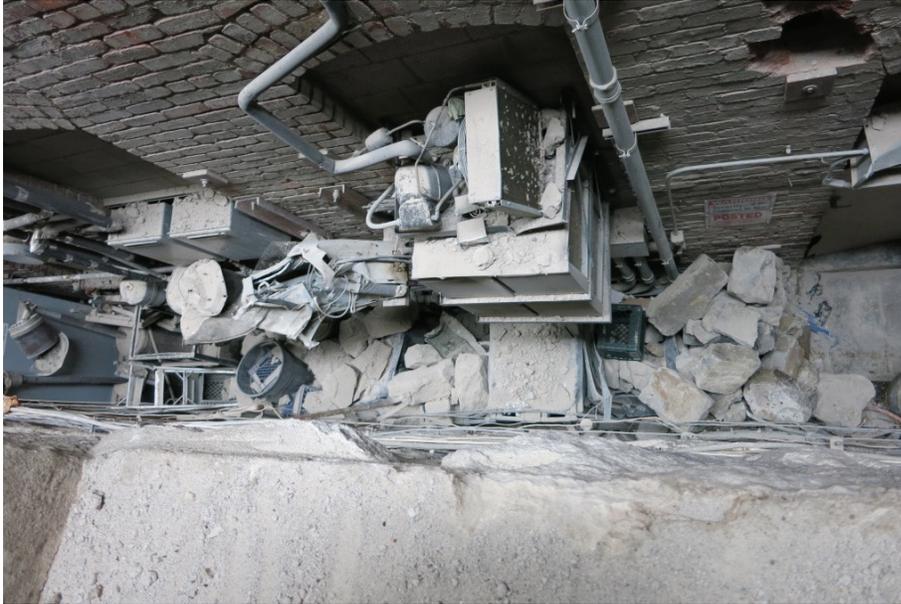
- **Nonstructural Performance:** Cracking of the plaster wall and ceiling finishes was observed. HVAC equipment was damaged by falling stone masonry (Figure 4-52).

Figure 4-52 HVAC equipment damaged by falling stones.

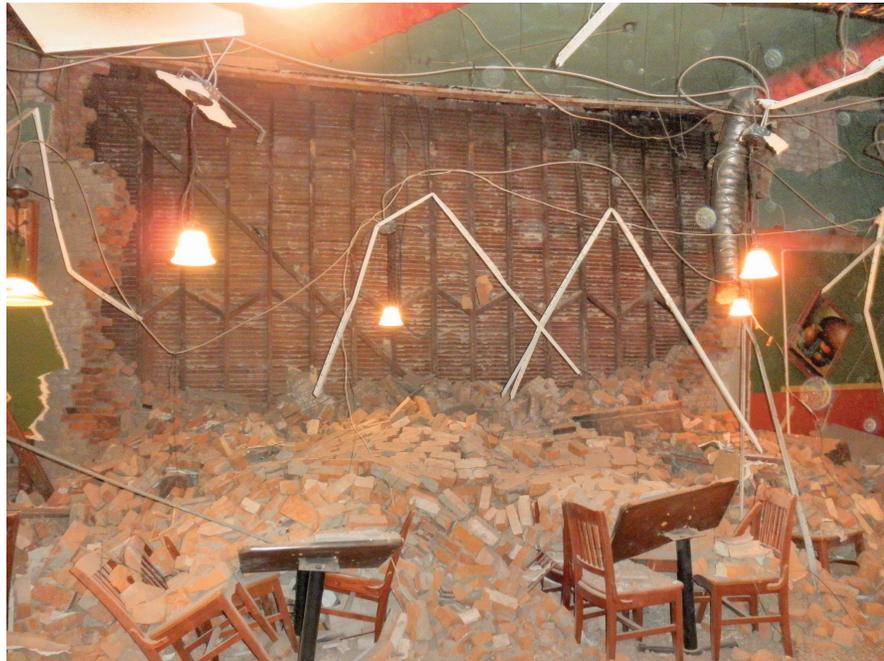
- **Posting Placard:** At the time of the field investigation, the building was posted UNSAFE due to the collapse of a URM wall on the east side of the buildings, and collapse of the ceiling in the dining area.
- **Structural Performance:** The building shares a common URM wall with the structure to the east (Building B3, located to the left of the roof drain in Figure 4-53, with the green awning). This wall collapsed into the dining area, striking about six tables (Figure 4-54). This is another example indicated that the time of the earthquake prevented increased numbers of injuries and fatalities. It was reported that a portion of the east URM wall above at the roof level that had not collapsed, being supported by a beam, was deemed a falling hazard. The parapet at the front of the building appeared to have displaced. No damage to the CMU walls was noted.

Figure 4-54 Collapsed URM wall and ceiling in dining area.

- **Nonstructural Performance:** The plaster ceiling in the dining area collapsed. Moderate cracking in interior wall finishes and exterior stucco was observed. No damage to equipment was noted.
- **Time until Full Occupancy:** The building was closed for repairs at the time this report was being developed.

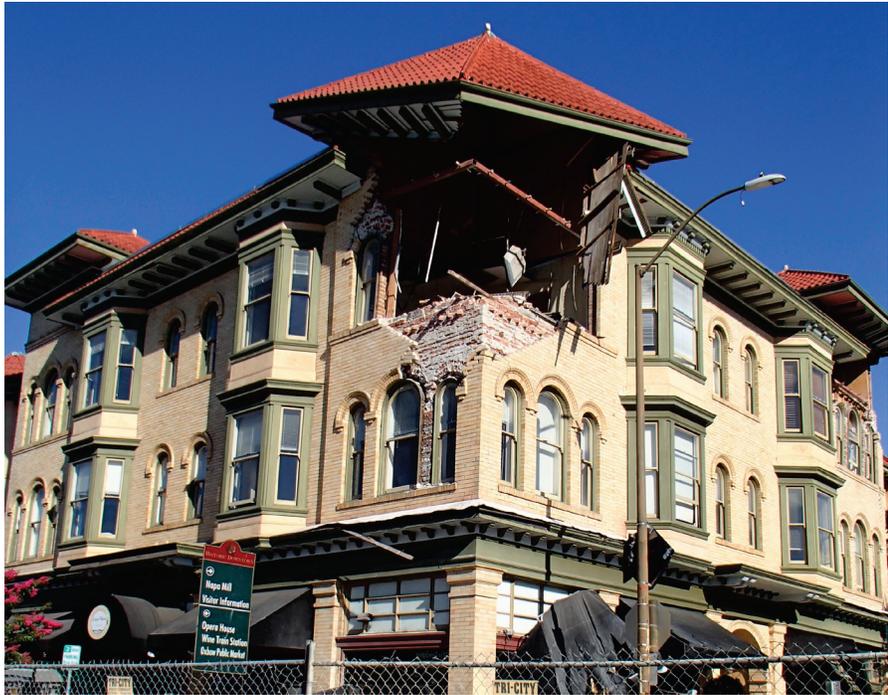
- **Structural Performance:** The building sustained a collapse of the top floor URM walls at the northwest and southwest corners (Figures 4-55b, 4-56, and 4-57). The horizontal tube steel strongback was not effective at preventing the wall from collapsing out-of-plane. It was observed that the anchor bolts were straight and did not appear embedded through all brick wall wythes (Figure 4-58). The soffits of the roof cupola were several feet higher than the horizontal tube steel braces. The wall also reduced in thickness by at least one wythe above the horizontal braces. This resulted in a thinner, unbraced wall section, several feet high, spanning between the braces and soffits of the roof cupola. The collapse of the walls resulted in a loss of support to the wood-framed roof cupolas at the building corners, which were at incipient collapse following the earthquake. The other portions of the building sustained minor structural damage.

Figure 4-55 Photographs of building: (a) circa 1910 and (b) 2014.

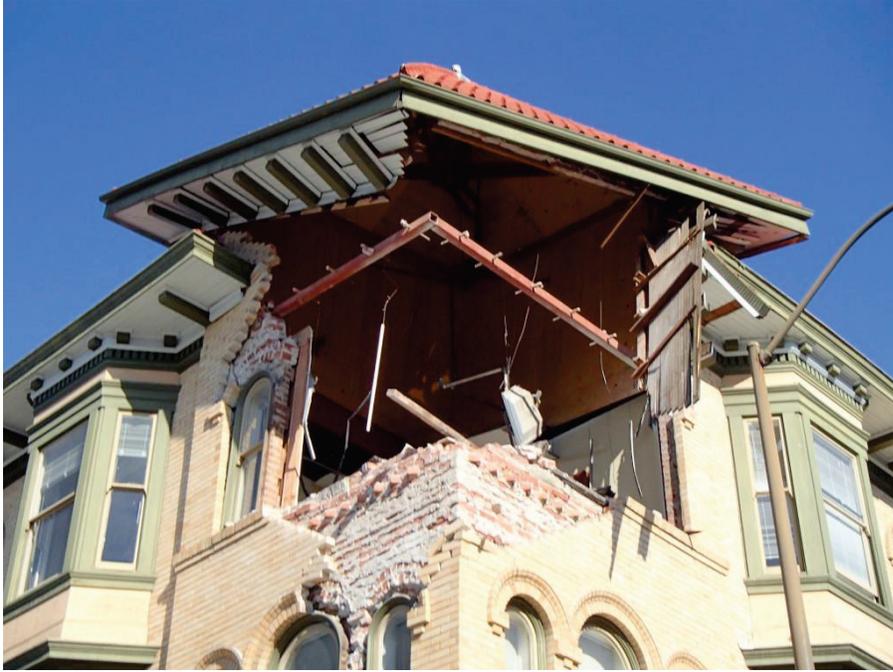
Figure 4-56 Collapse of URM walls supporting a corner cupola.

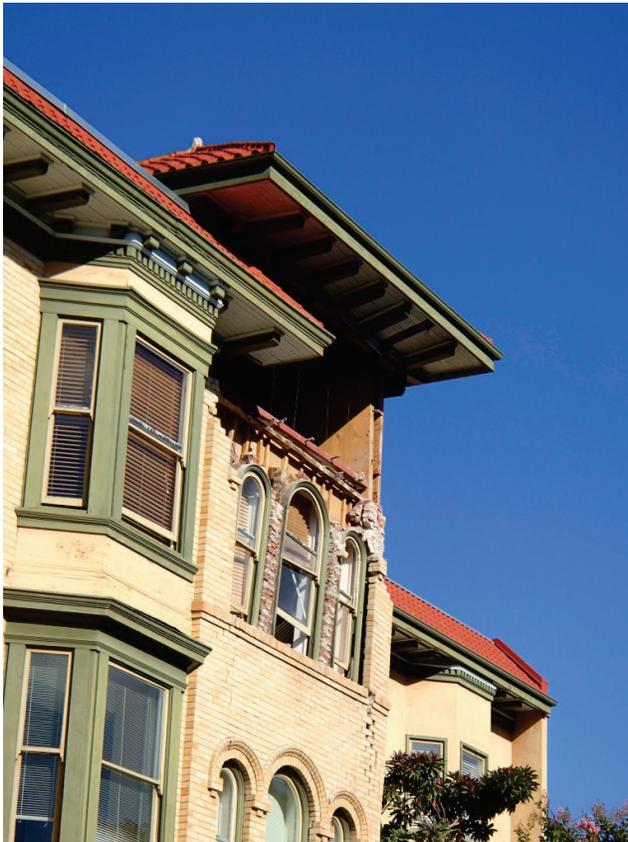
Figure 4-57 Collapse of the URM wall at a corner cupola.

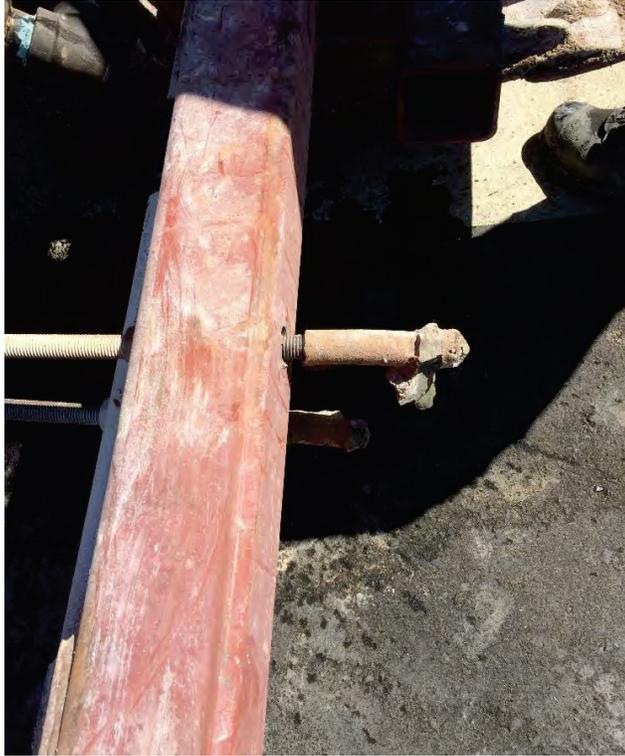
Figure 4-58 Close-up of steel tube and masonry anchor at corner cupola.

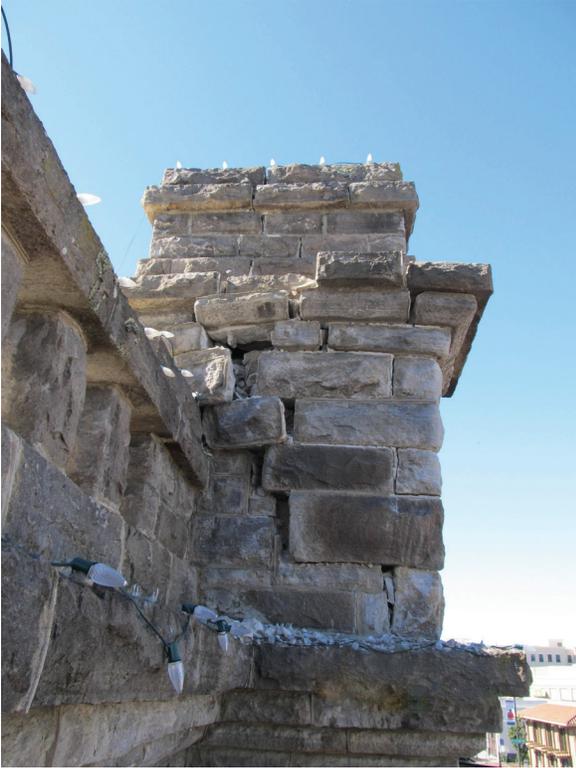
- **Structural Performance:** Damage included cracking of the stone perimeter façade pier near the roof level, typically through mortar joints, corner damage at all four corners with out-of-plumb movement of approximately 2 inches at the northwest and northeast corners and 4 to 6 inches at the southwest corner. At the northwest corner, the masonry just below the cornice had shifted outward up to 3/4 inches. There were small fallen stones on the east façade, light cracking above the roof at the

parapets at the southwest and southeast corners, and very significant damage to the front façade stone tower feature at the roof level that included fallen stone and shifting of the stone on mortar joints. See Figures 4-60 and 4-61 for damage at the front façade and tower feature.

Figure 4-60 Cracking on east side of the tower feature.

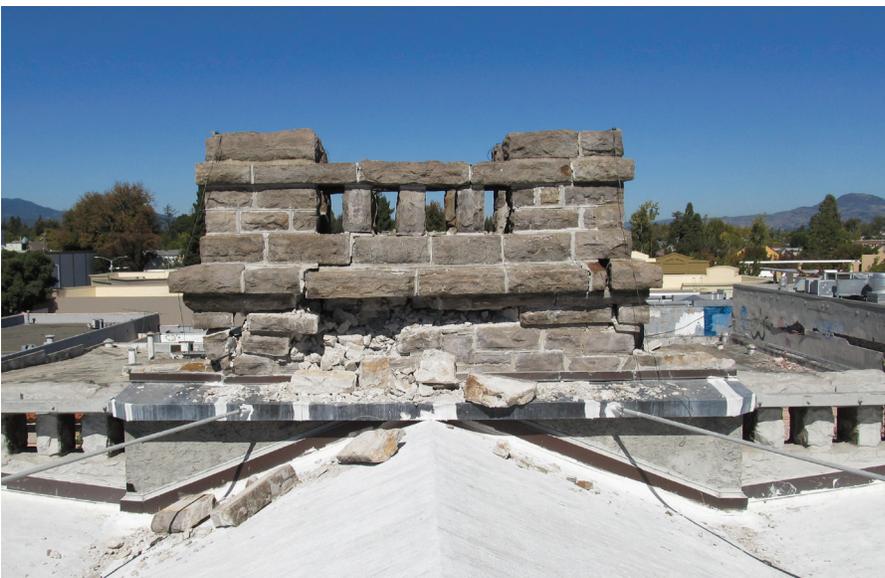
Figure 4-61 Top of concrete shear wall at roof level behind the tower feature.

The concrete backing at the front façade stopped at the roof level and did not continue up the remaining height of the tower feature. The most significant damage began at about this level. The tower feature also did not have any parapet bracing or capstone ties like the other parapets. Reportedly, historic preservation concerns limited the extent of retrofit work that was implemented at the tower feature.

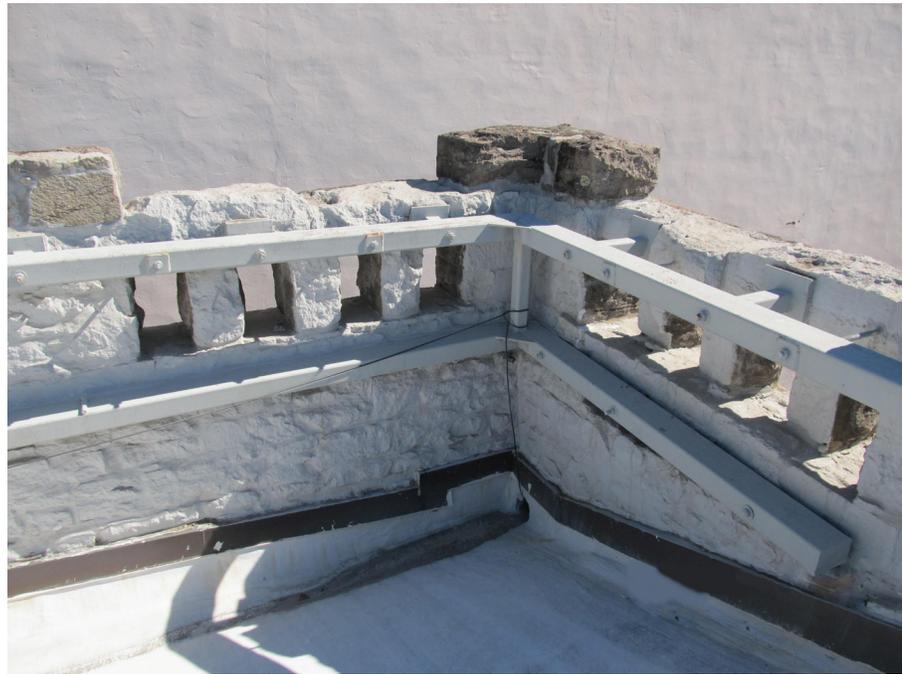
Figure 4-62 Steel tube bracing at parapet.

The steel tubes at the roof extended around the corners and held the top of the wall and parapets together as did the second floor diaphragm-to-wall ties. The outward wall movement occurred below the cornice level that was approximately between the roof and second story ceiling levels.

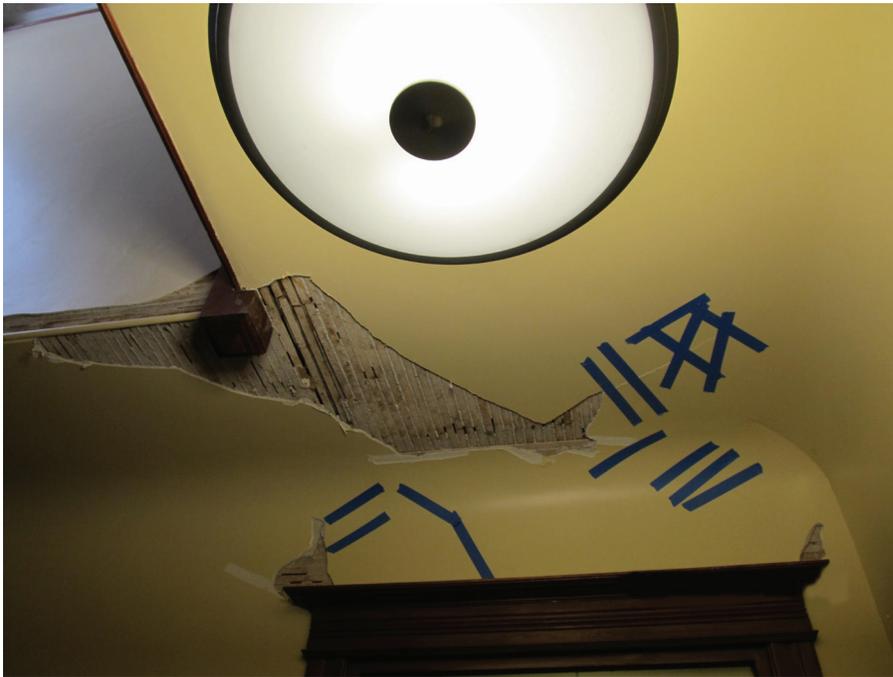
- **Nonstructural Performance:** Lath and plaster at the walls and ceiling cracked and pieces fell (see Figure 4-63), there was movement at the second story ceiling, and many books fell from bookshelves in the library (the shelves were bolted to the floor). During a site visit on September 9, 2014, the elevator was not functioning. The cab had descended to the

Figure 4-63 Lath and plaster ceiling damage and temporary taping at cracks and spalls.

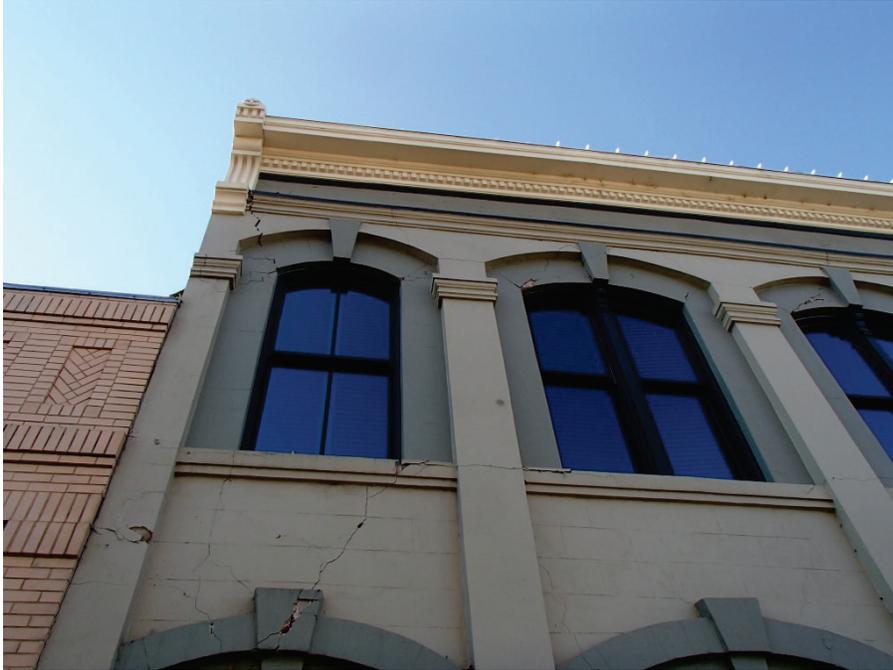
- **Structural Performance:** There was in-plane damage at the south façade (Figure 4-65) due to “bookend effect” (the two adjacent unretrofitted URM structures to the west had no lateral force-resisting systems). Out-of-plan punching shear failure of URM wall was observed at the second floor anchors of the south wall (Figure 4-66). The building suffered moderate to severe diagonal shear of URM at north and west walls. The floor-to-wall diaphragm connections for the north and west walls had only straight anchors to resist tension (not inclined at 22.5 degrees), and many were pulled out.

Figure 4-65 Cracking in URM on south façade.

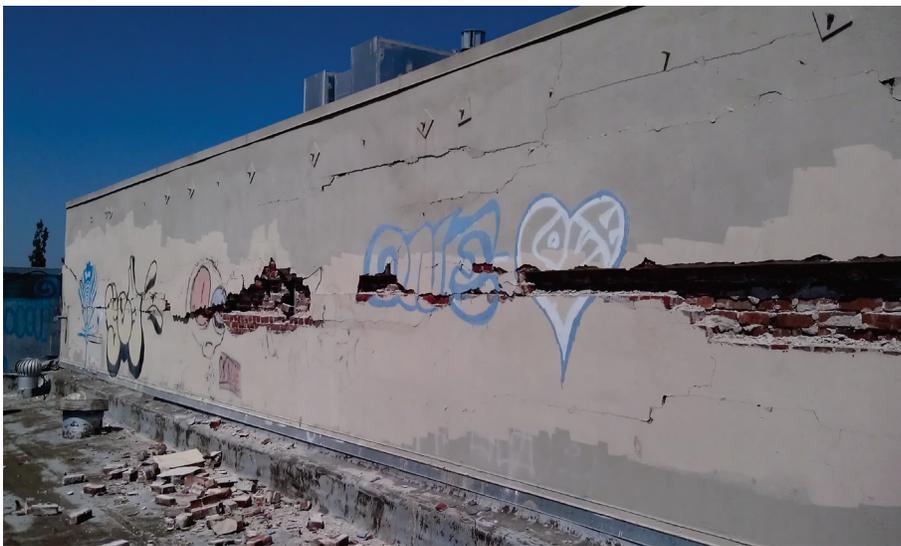
Figure 4-66 URM damage, west elevation (photo from Chris Jonas, ZFA Structural Engineers).

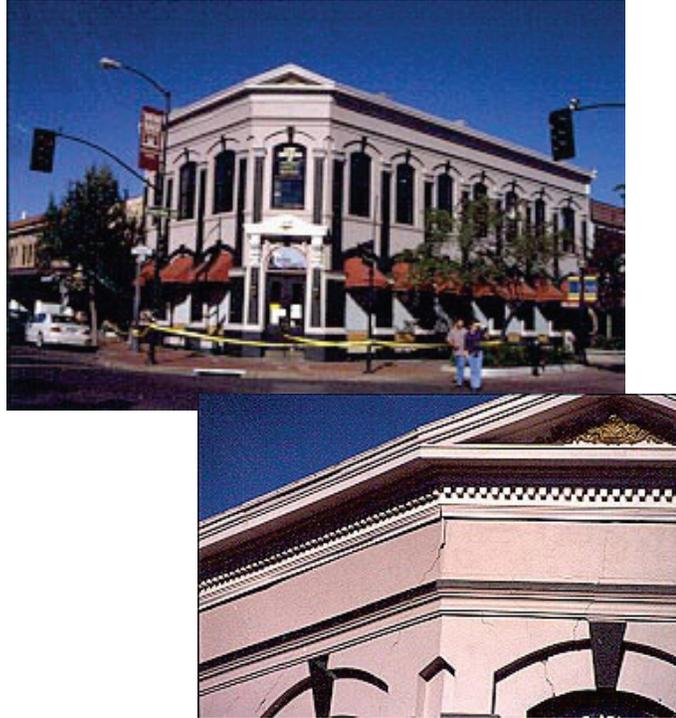
- **Other Notes:** The building suffered damage in the 2000 Yountville earthquake. Observed damage included cracking of spandrels along south façade and over the corner diagonal entry at southeast corner of the building (Figure 4-67).

Figure 4-67 Photo of Building J4 and detail of damage after the 2000 Yountville earthquake (PEER, 2000).

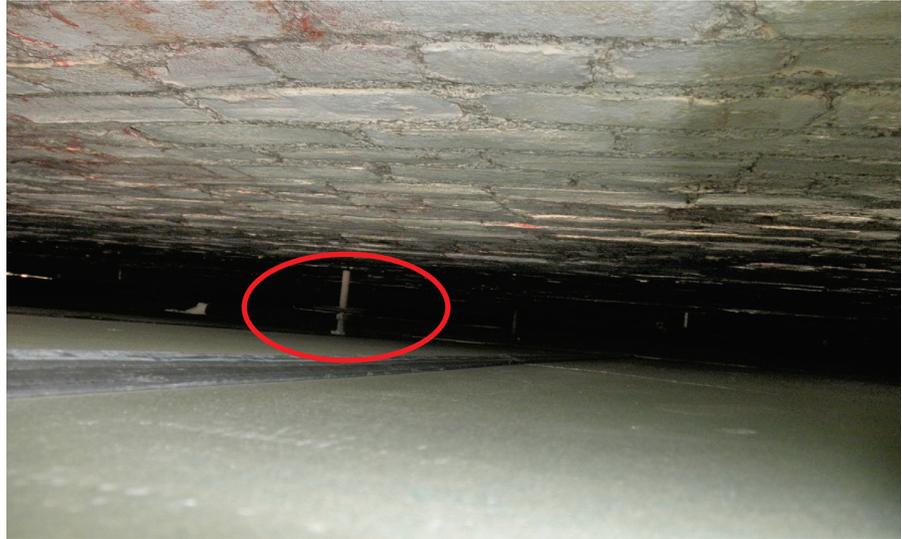
- **Structural Performance:** The building did not sustain significant structural damage. There is evidence of pounding with the structure to the south (Building L1). Some of the wall anchors on the south side of the building appear to have loosened, and these wall anchor bolts

damaged the wall of the adjacent building (Building L1) (Figures 4-5 and 4-70).

Figure 4-70 Loosened wall anchors on south wall, looking down.

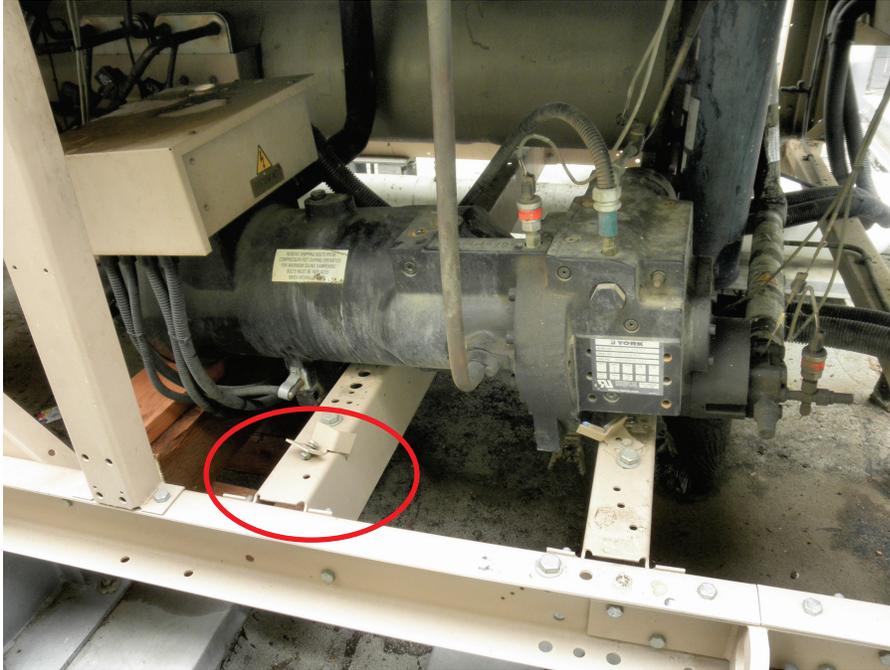
Figure 4-71 Connection failure at compressor.

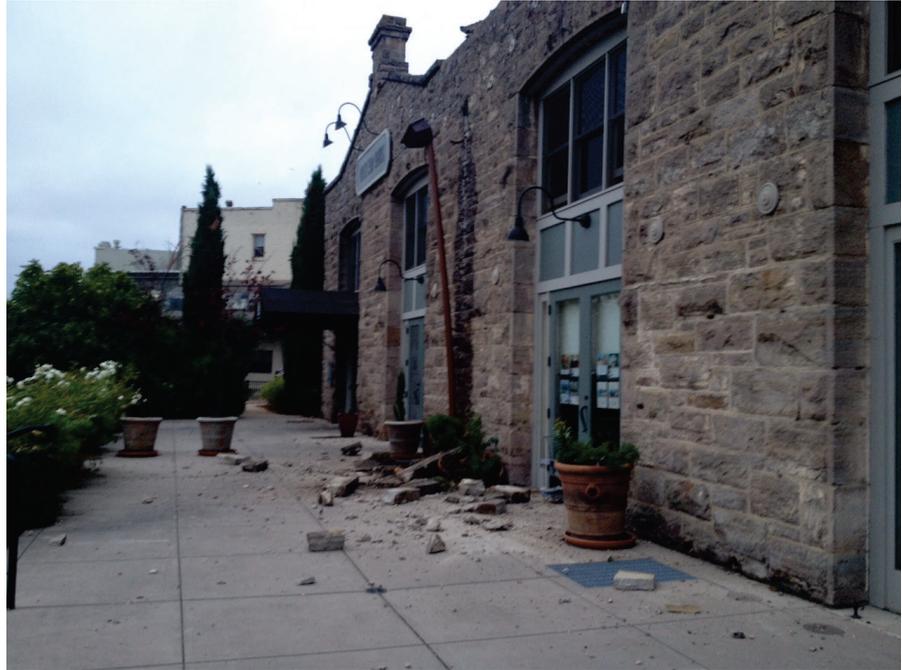
- **Structural Performance:** With the exception of the parapets (see Nonstructural Performance, below) the observed damage was generally minor (Figure 4-72). Minor to moderate cracking was observed at parts of the rear wall (Figure 4-73), specifically: at corners (stair stepped through bed joints) and inter-tenancy walls (both stair stepped through bed joints and through stone masonry units). It was unclear from visual

Figure 4-72 Exterior wall on day of earthquake.

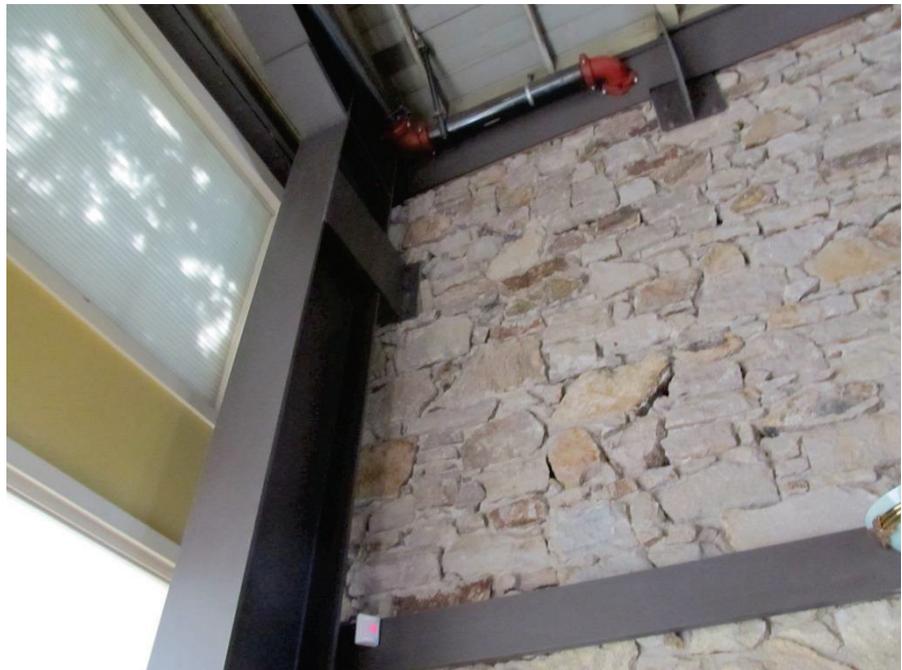
observation as to how or whether these crack patterns related to the shotcrete overlays on the interior face of the wall.

Figure 4-73 Diagonal cracks in stone wall.

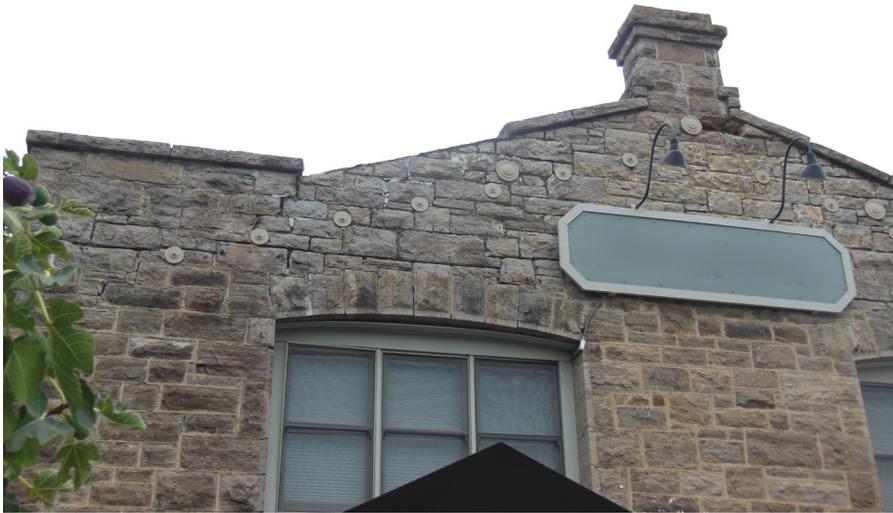
- **Nonstructural Performance:** Stones were dislodged from the stone masonry parapets along the front and rear walls, with the majority of damage appearing to be on interior face of the parapet (Figures 4-74,

4-75, and 4-76). Some capstones were dislodged from the low-height parapet along the rear. Stone masonry chimneys at rear appeared essentially undamaged. It is unknown how or if these chimneys were retrofitted. Some glazing in the mezzanine broke, and there was minor loss of contents.

Figure 4-74 Exterior face of parapet wall.

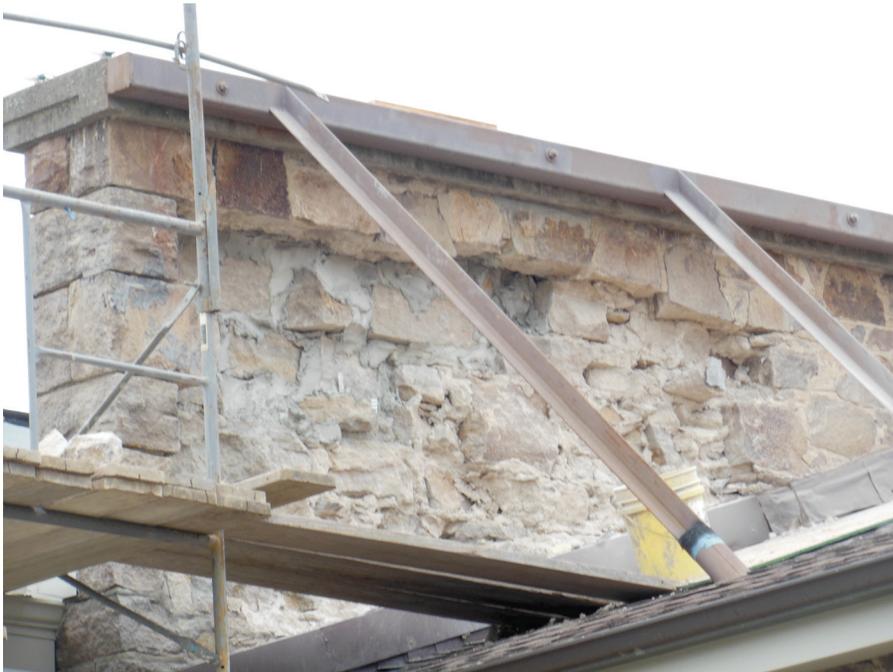
Figure 4-75 Close up of dislodged stone on inside face of parapet.

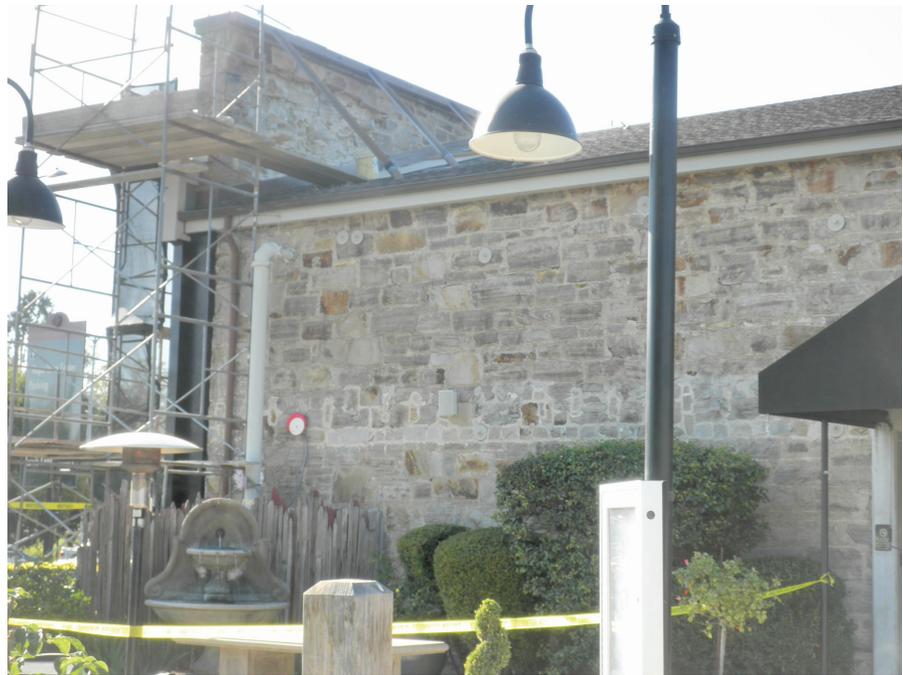
Figure 4-76 URM parapet bracing, loss of stonework.

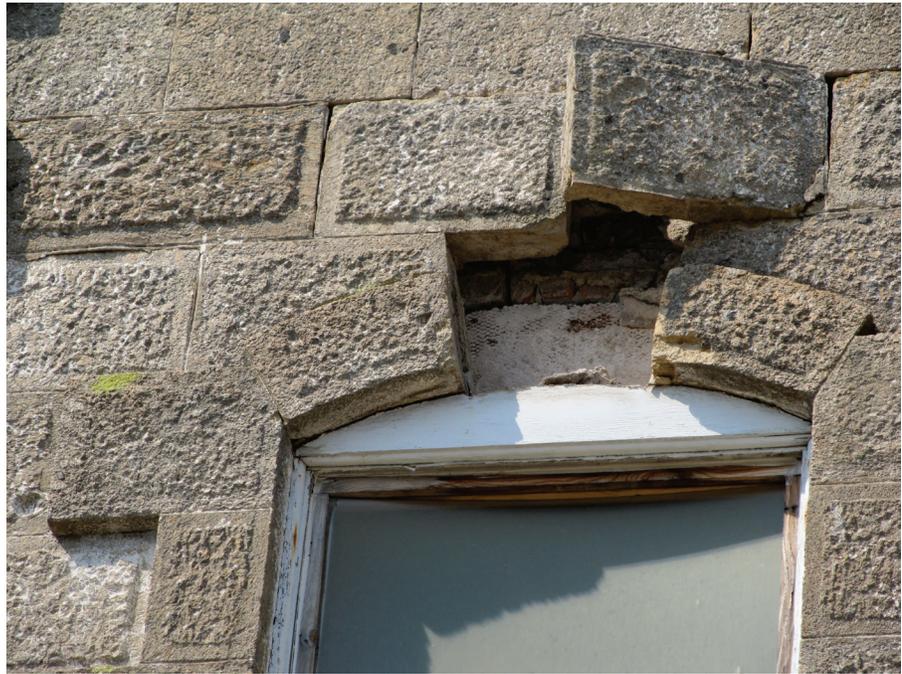
Figure 4-78 Loose stone cladding over window at front façade.

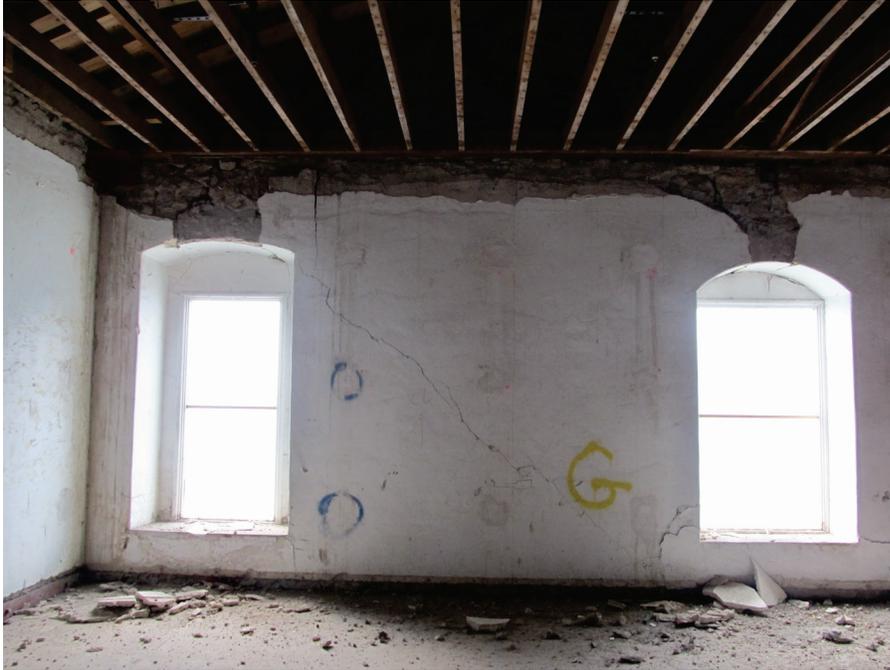
Figure 4-79 Diagonal cracking at inside face of second story pier at front façade.

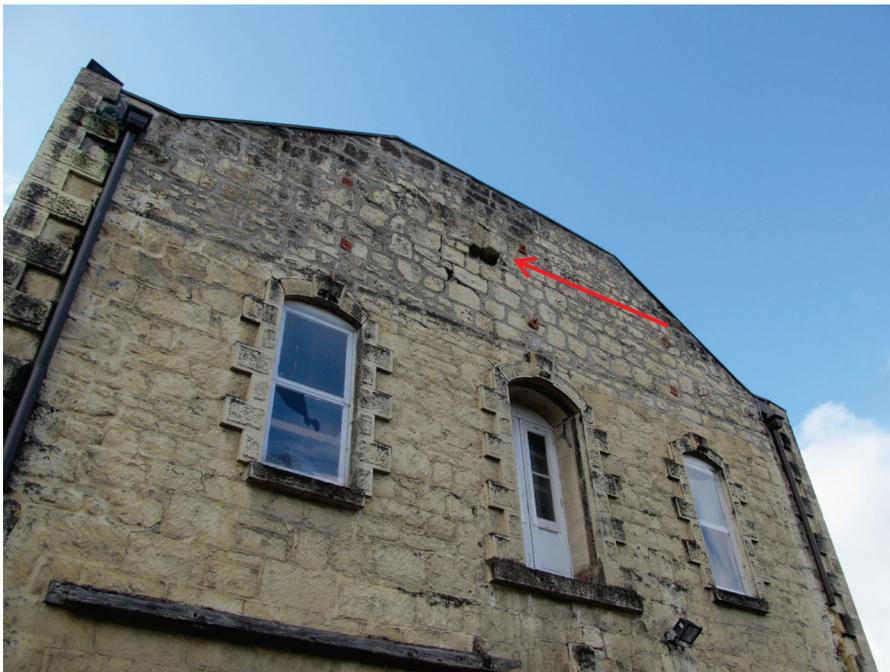
Figure 4-80 Rear façade elevation. Red arrow points to the location where the stone fell at the center of the gable.

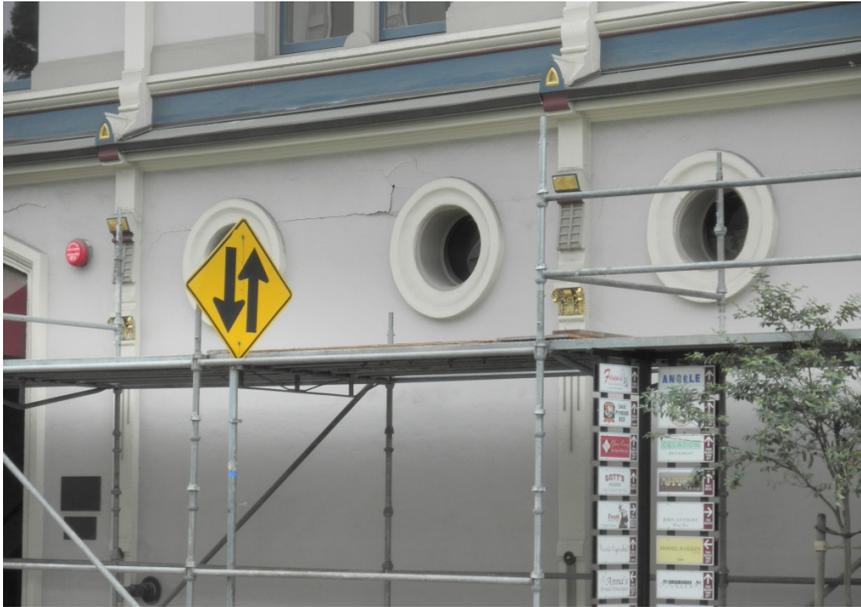
Figure 4-82 Minor cracking in URM wall, north elevation.

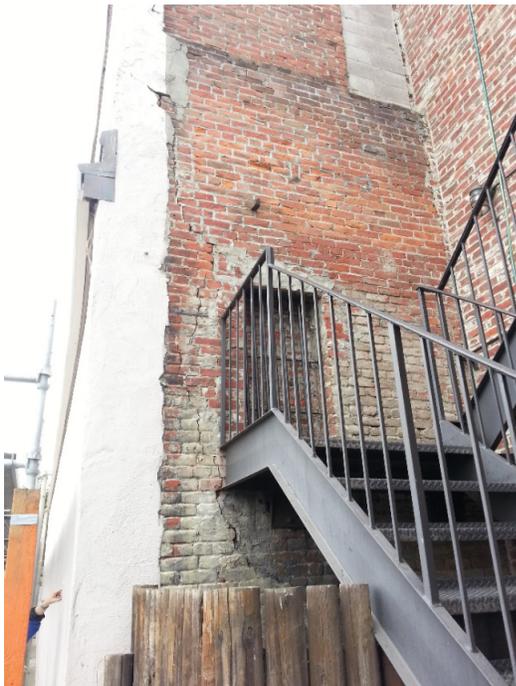
floor of adjacent building, is supported at the mid-height landing from the URM wall. The stair was rigidly attached to the URM wall, the adjacent building at the second floor, and at grade. The stair stringers appear to have acted as braces, inducing out-of-plane demands on the URM wall, which resulted in localized out-of-plane wall failure (Figure 4-83). The upper stair stringer also buckled.

Figure 4-83 Southeast corner, damage to URM wall due to interaction with steel stair.

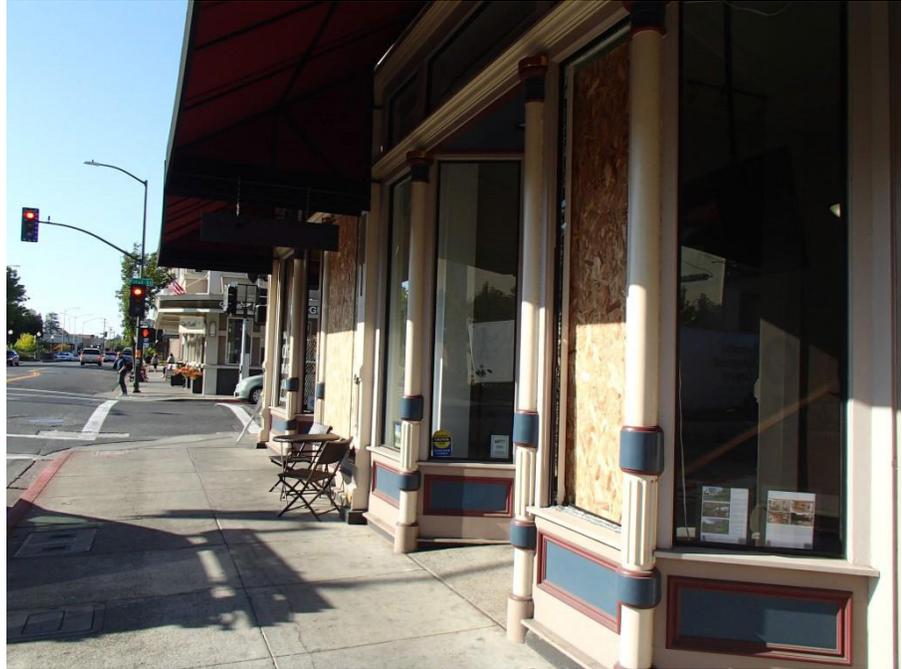
- **Nonstructural Performance:** About 50% of the glazing on the ground floor and 10% of the glazing on the second floor were damaged (Figure 4-84). Minor cracking of the plaster wall and ceiling finishes was observed. No damage to the mechanical and electrical systems was reported.

Figure 4-84 Damage to glazing, west elevation.

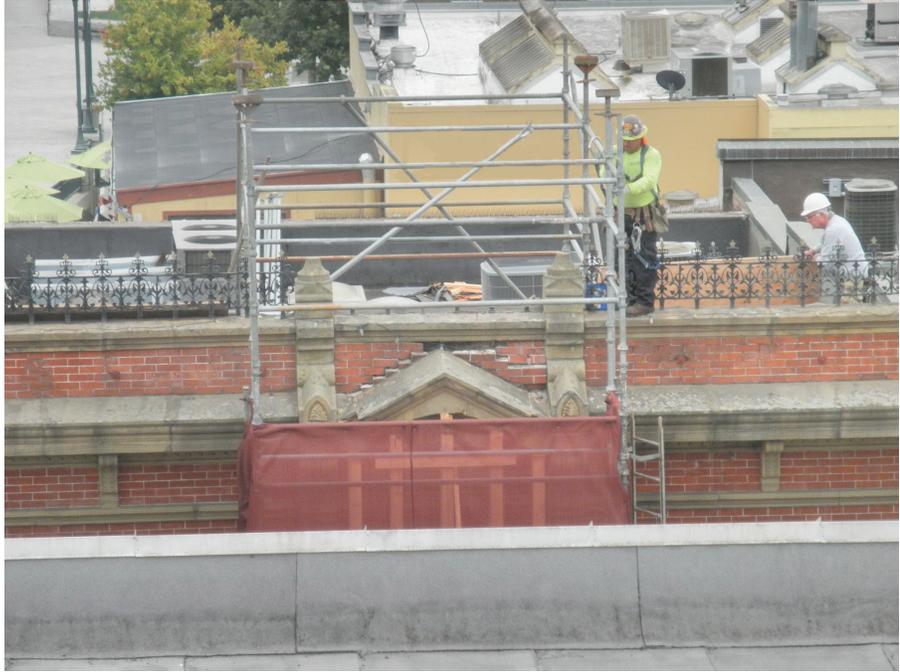
- **Structural Performance:** Minor damage (hairline cracking) was observed at the interior CMU retrofit wall.
- **Nonstructural Performance:** The stonework parapet above the front entrance of the building dislodged (Figure 4-86). Anchorage failure at the parapet braces was observed, which may be due to poor adhesive installation of anchor bolts (Figure 4-87). One rooftop air conditioning unit failed at its base connection and slid slightly on the wood sleeper (Figure 4-88). The exterior steel framed stair at rear of building interacted with common/party-wall of the building to the west (Building A1) and caused out-of-plane wall failure (Figure 4-83).

Figure 4-86 Damage to stonework above main entrance.

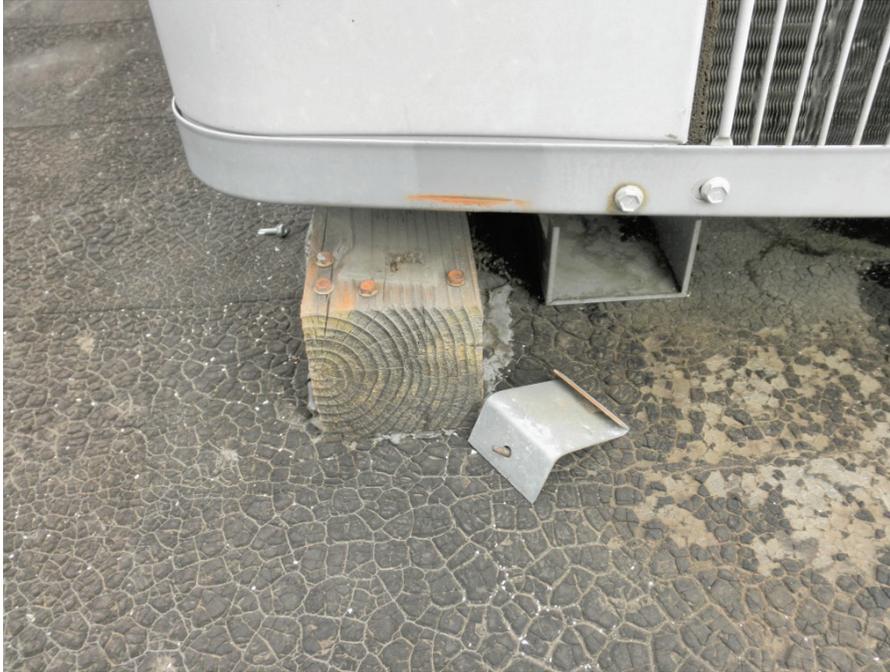
Figure 4-88 Failure of air handler unit anchor, screws pulled out of sleeper.

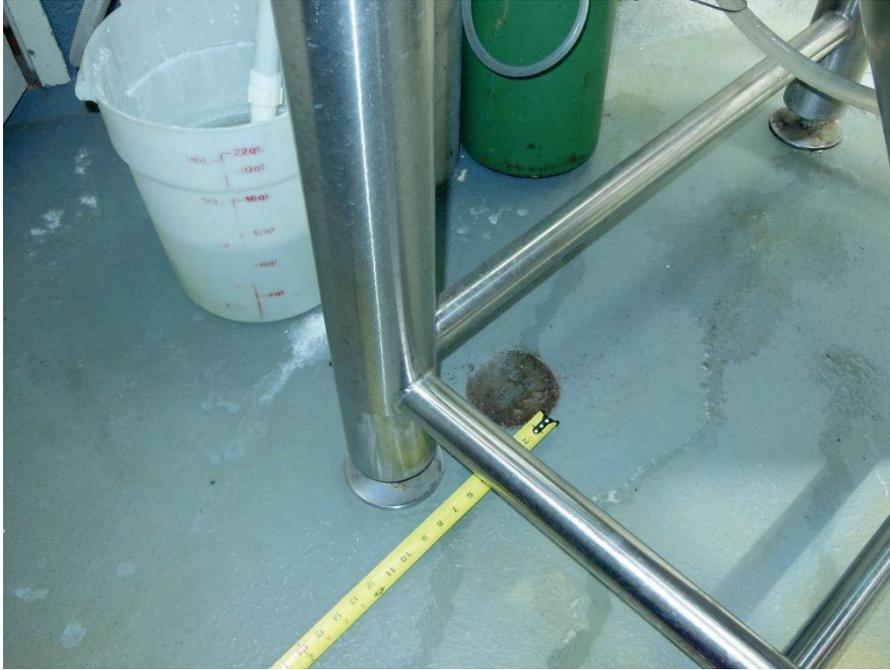
- **Nonstructural Performance:** The building contains beer tanks, kettles, and other equipment related to brewing operations. The only reported nonstructural damage was reported as: bottles and crockery falling, and an unanchored fermentation tank that slid 8 inches (Figure 4-90). The tank had flexible pipe connections which remained intact. Minor cracking of interior wall and ceiling finishes.
- **Time until Full Occupancy:** Aside from clean-up of broken bottles and dishes, the restaurant was open and serving food on the day of the earthquake.
- **Other Notes:** Station N016 is located in the crawlspace of the building, mounted to the top of the footing (Figure 4-91). Drawings of the seismic retrofit were available for review. The rear of the building is located immediately adjacent to the riverfront.

Figure 4-90 Unanchored tank shifted approximately 8 inches.

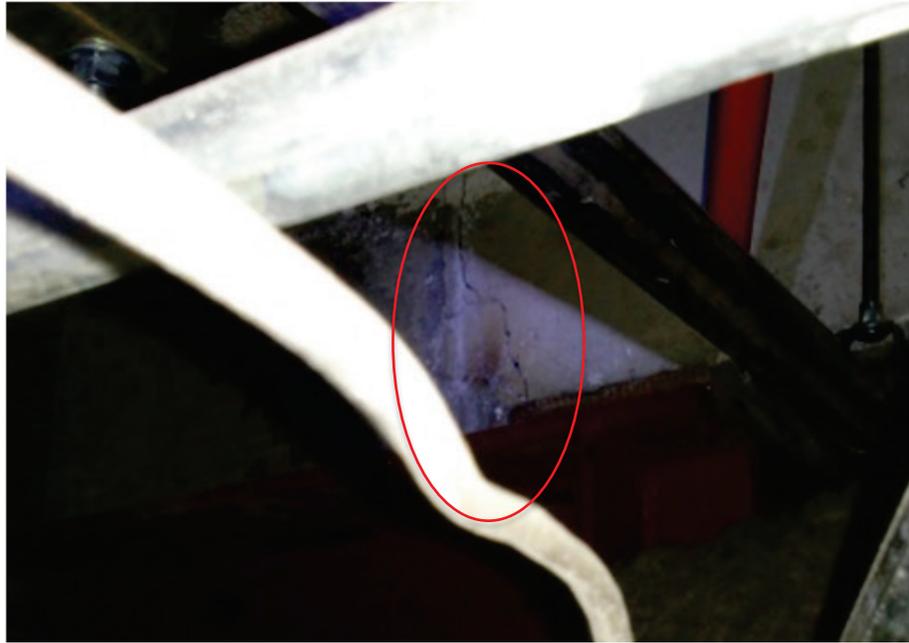
- Structural Performance:** Some structural damage was observed. A crack in a precast beam (Figure 5-3) in the Main Hospital (BLD-01650), a three-story structure constructed in 1957, led investigators to post the the room below the beam RESTRICTED USE pending further analysis. Other minor concrete cracking was also identified in this building

Figure 5-3 Damaged concrete beam at the third floor of BLD-01650.

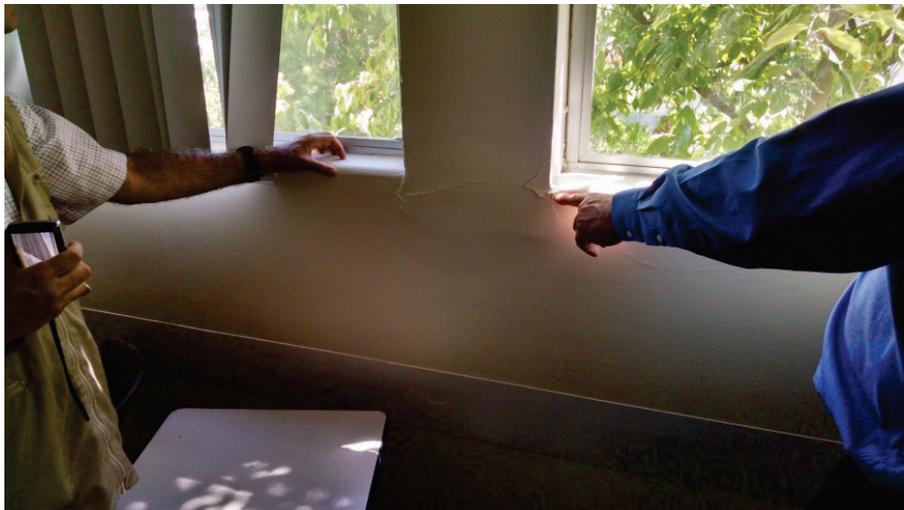
Figure 5-4 Cracked concrete wall piers in BLD-01650.

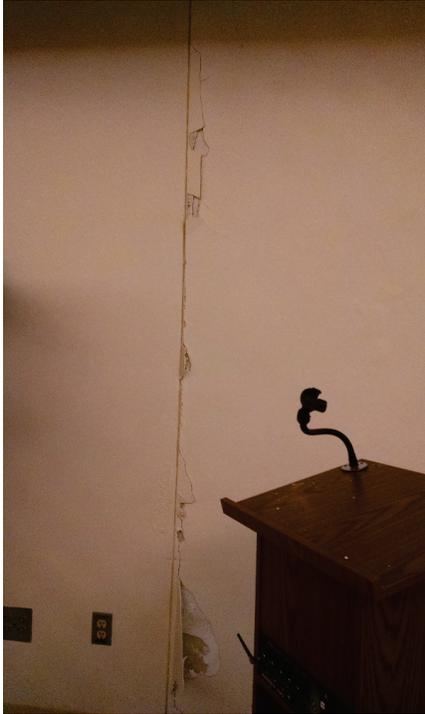
(Figure 5-4). Minor cracking and spalling in a precast panel in the Conference Addition (BLD-01653) was noted (Figure 5-5); the building was posted INSPECTED.

Figure 5-5 Cracked precast concrete panel in BLD-01653.

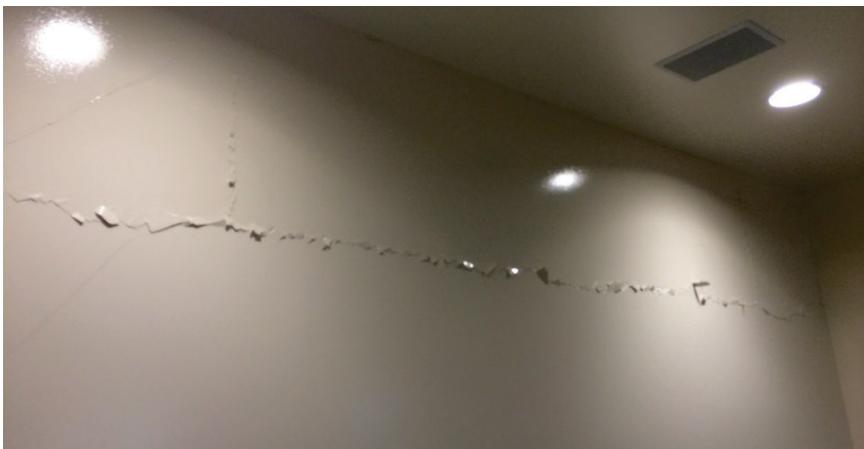
Figure 5-6 Cracked gypsum board wall in BLD-05309.

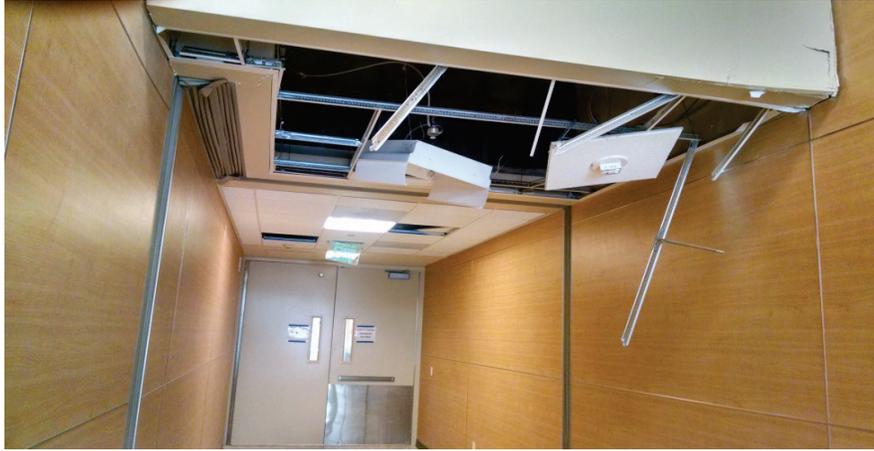
Figure 5-7 Third floor ceiling damage in BLD-05323 corridor link.
