Performance of Buildings and Nonstructural Components in the 2014 South Napa Earthquake

FEMA P-1024 / February 2015

APPLIED TECHNOLOGY COUNCIL
201 Redwood Shores Parkway, Suite 240
Redwood City, California 94065
<http://www.atcouncil.org/>

FEDERAL EMERGENCY MANAGEMENT AGENCY
Michael Mahoney, Project Officer
Washington, D.C.

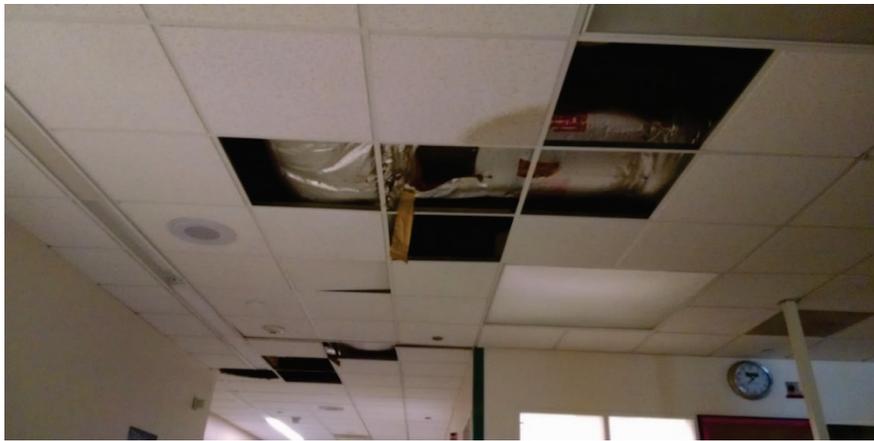
Figure 5-8 Third floor ceiling damage in BLD-01656.

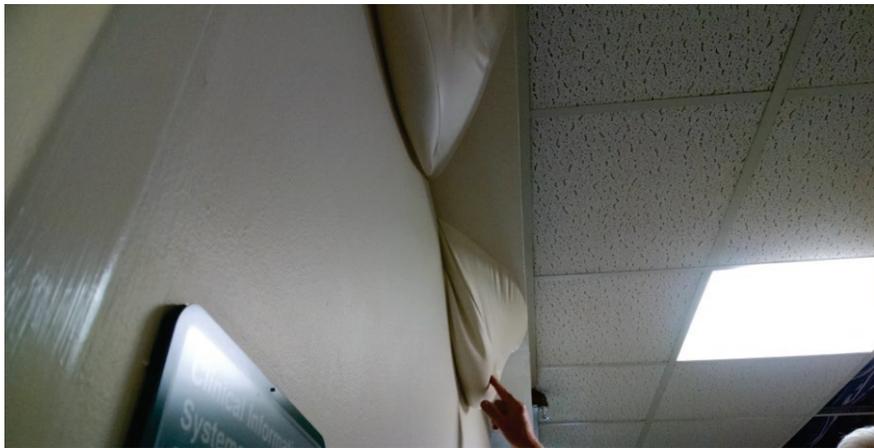
Figure 5-9 Evidence of water leak in corridor of BLD-01650 (paint stretched to contain water).

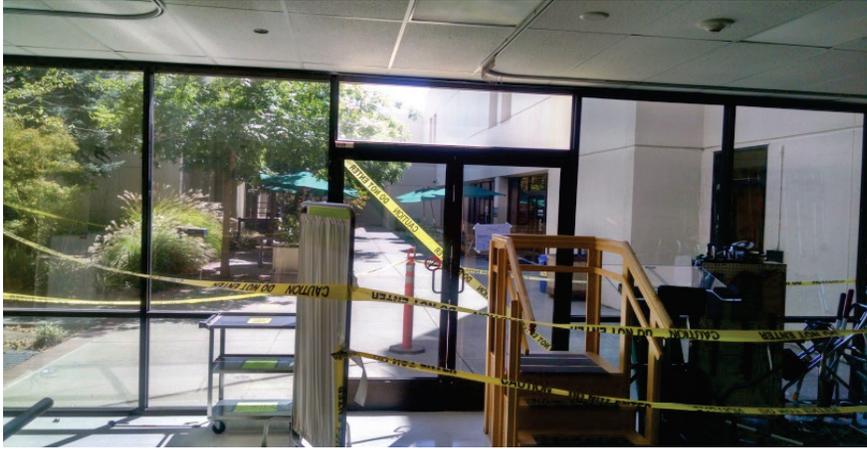
Figure 5-10 South Nursing Wing storefront glazing damage leading to entrance posted RESTRICTED USE at BLD-01656.

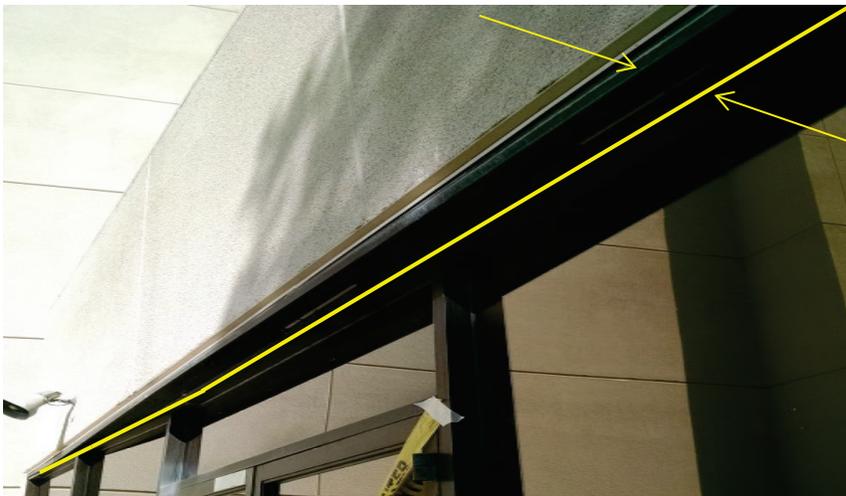
Figure 5-11 South Nursing Wing storefront glazing damage leading to RESTRICTED USE posting at BLD-01656. Yellow line indicates amount of movement in the top track.

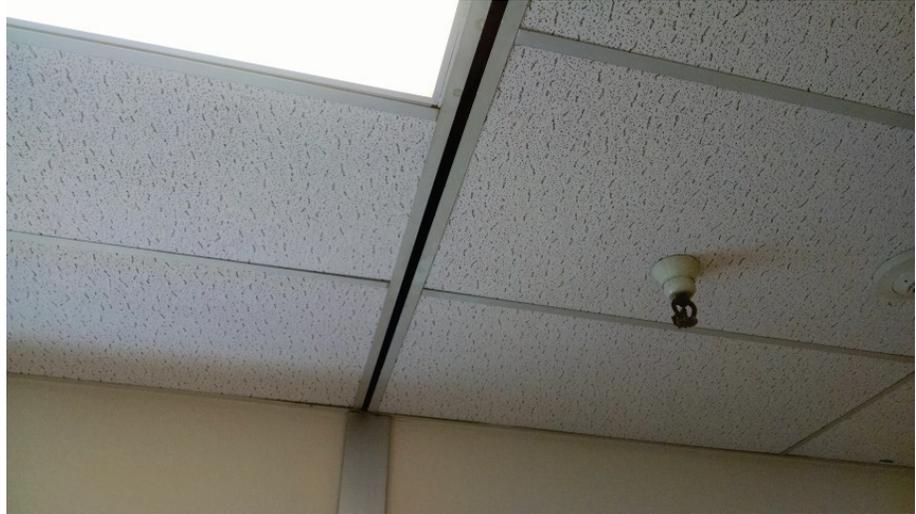
Figure 5-12 Movement at seismic joint between BLD-01652 and BLD-01650 Main Hospital.

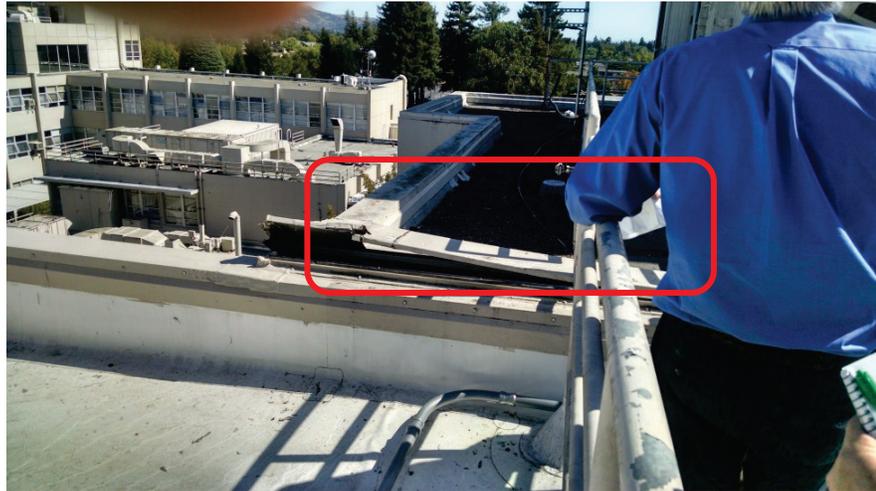
Figure 5-13 Damage to seismic joint flashing between BLD-01654 and BLD-01655.

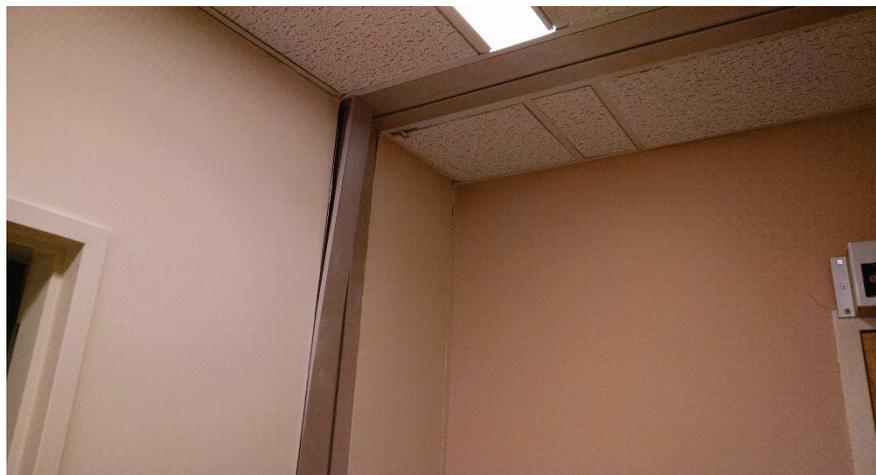
Figure 5-14 Damage to seismic joint cover at second floor of BLD-01659.

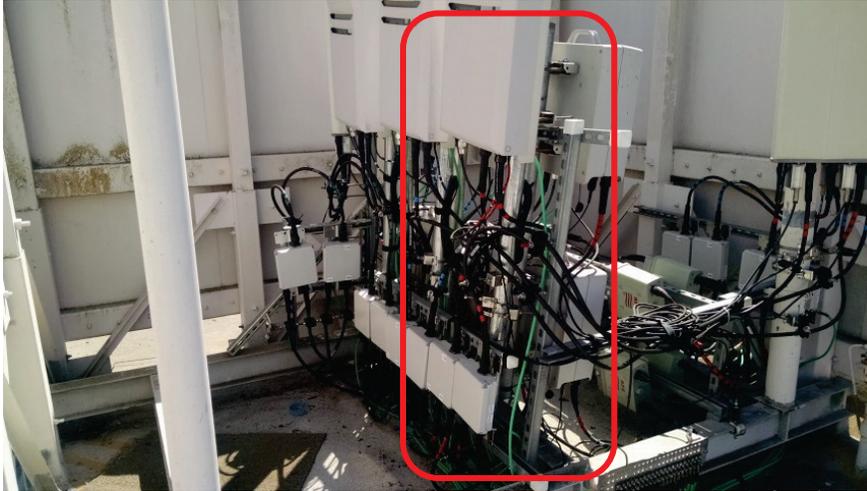
Figure 5-15 Telephone rack on cantilevered supporting frame at roof of BLD-01650 severely out of plumb.

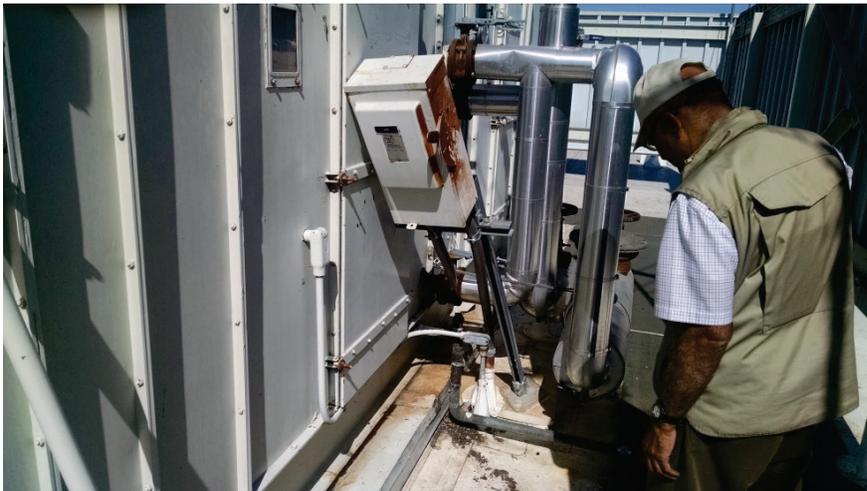
Figure 5-16 Electrical panel on cantilevered supports damaged at roof of BLD-01656.

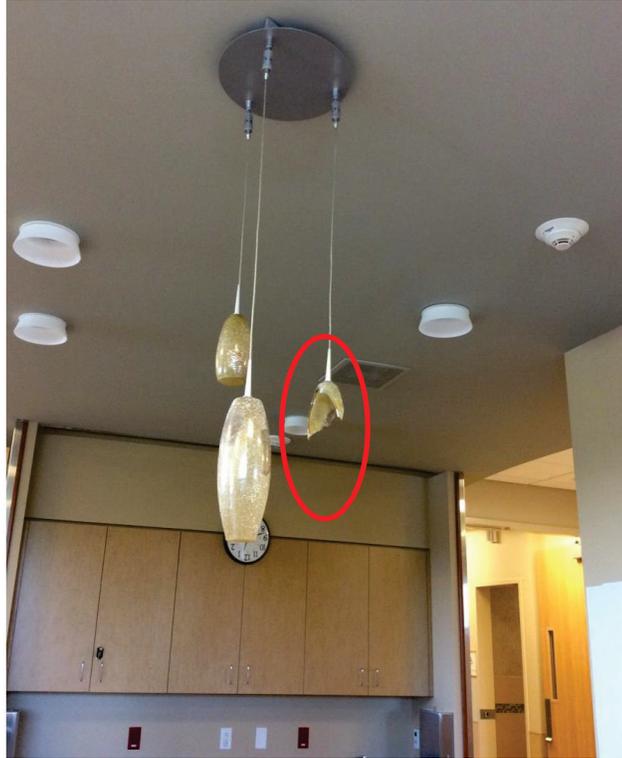
Suspended light fixtures were damaged when they struck one another (Figure 5-17). Content damage also occurred, including overturned office equipment, book cases, loss of contents off of shelving, and other items (Figures 5-18 to 5-20).

Figure 5-17 Damaged light fixture in BLD-05309.

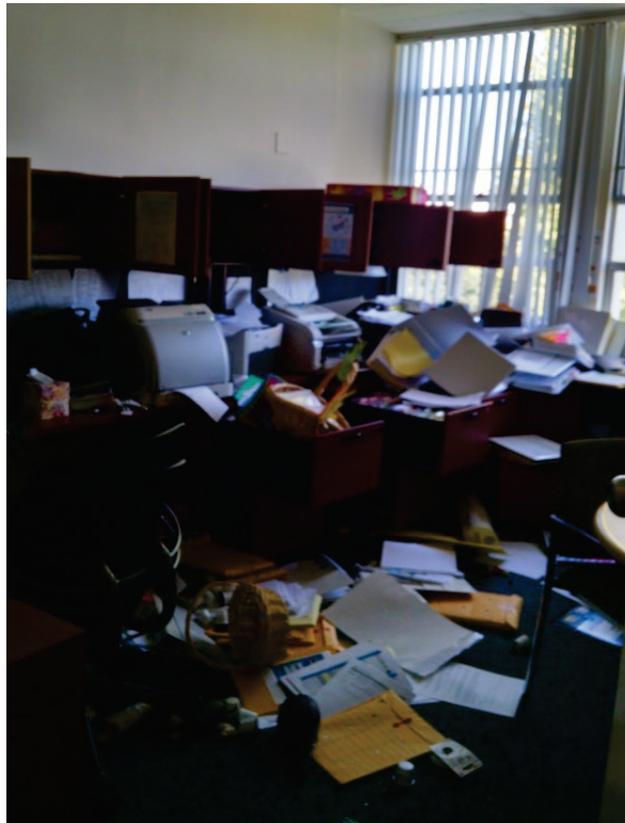
Figure 5-18 Contents damage in BLD-01650.

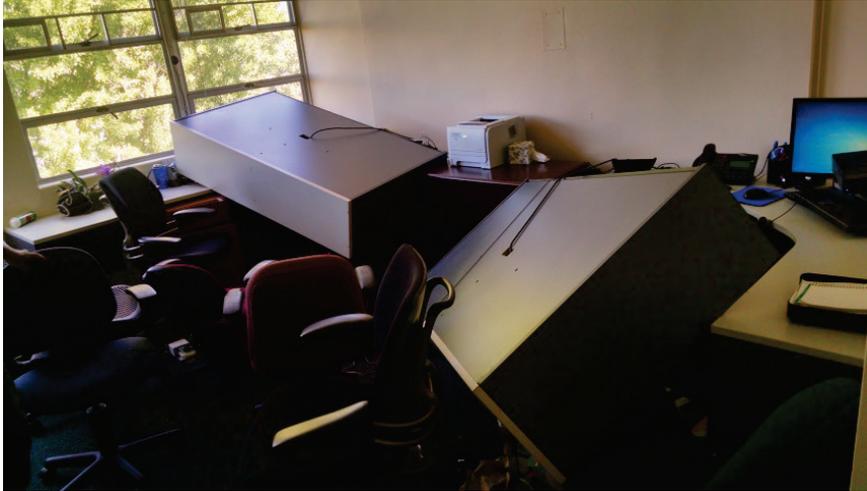
Figure 5-19 Contents damage in BLD-01650.

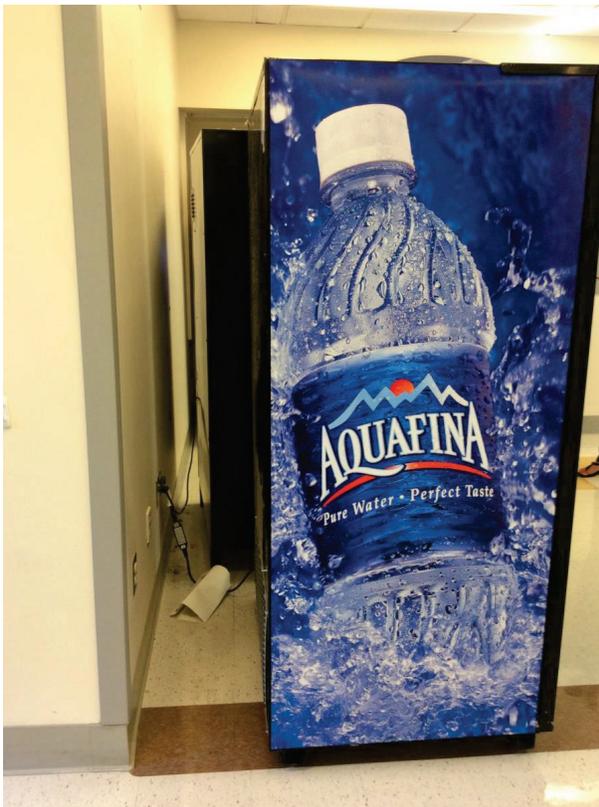
Figure 5-20 Unanchored vending machine in BLD-01656 shifted over 12 inches.

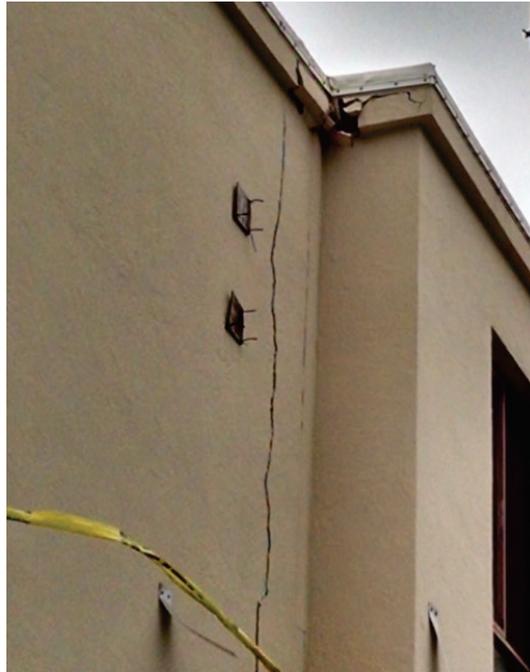
Figure 5-26 Cracking along the separation joint between BLD-01666 and BLD-01667 at the roof penthouse.

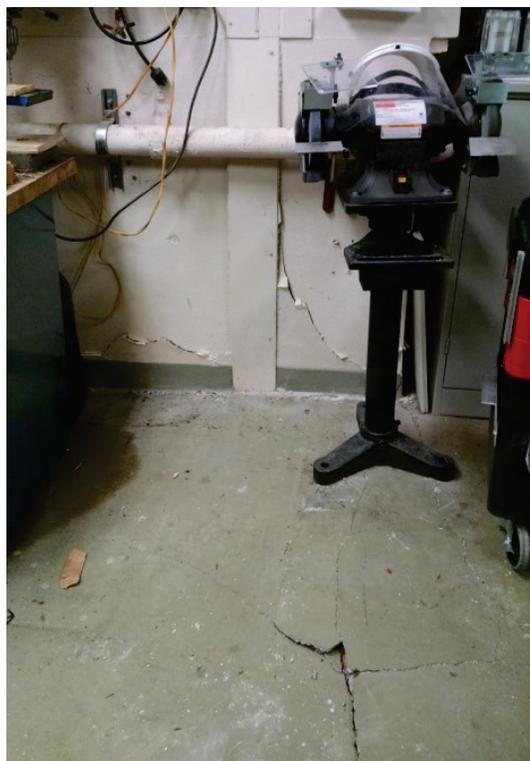
Figure 5-27 Cracking of the 1/2 inch to 1 inch thick topping slab over original roof slab inside the roof penthouse along the separation joint.

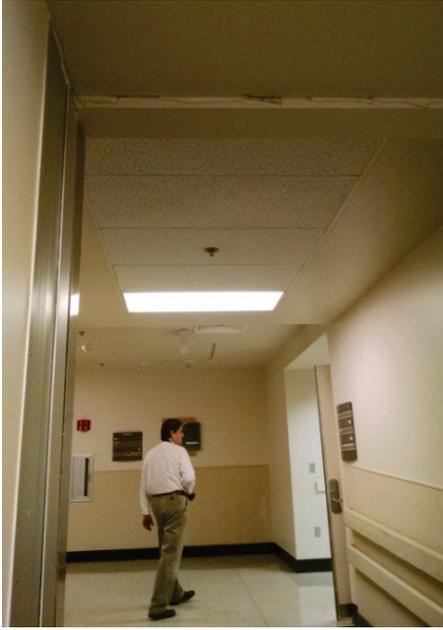
Figure 5-28 Evidence of movement along the separation joint at the fourth floor between BLD-01668 and BLD-01666.

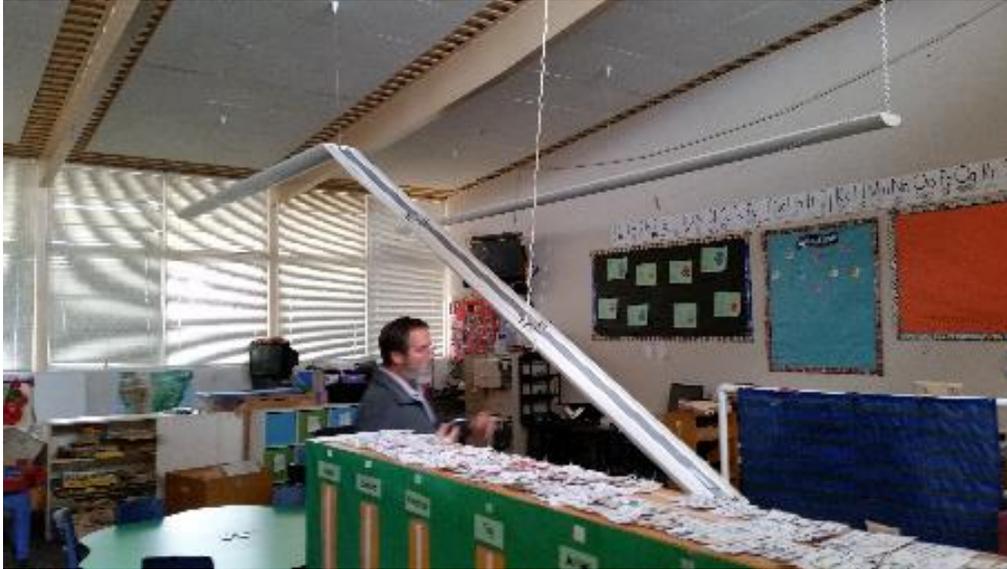
- The aircraft cable supporting the fixture slipped from the gripping connection (Figures 6-2 and 6-3)
- The connection of the aircraft cable to the fixture failed at the fixture (Figures 6-4 through 6-6). Figure 6-7 shows an undamaged connection.
- The bracing wire pulled out of its support (Figure 6-8)
- The lens cover dislodged (Figure 6-9)
- The bulbs dislodged and fell (Figure 6-10)

Figure 6-4 Damaged light fixtures in Irene M. Snow Elementary School (photo by Quattrocchi Kwok Architects).

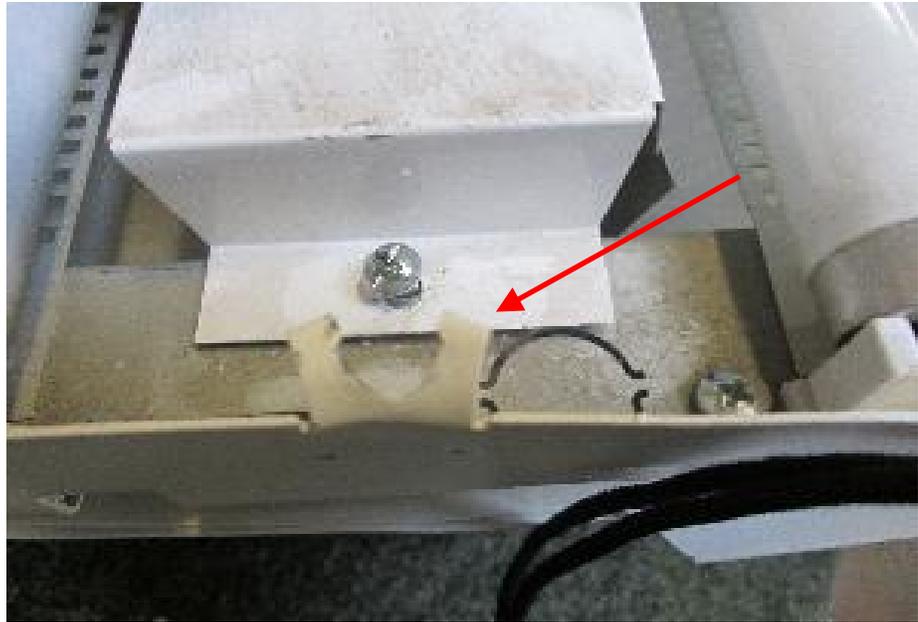
Figure 6-6 Failed connection at light fixture in Napa Valley Language Academy (photo by Quattrocchi Kwok Architects).

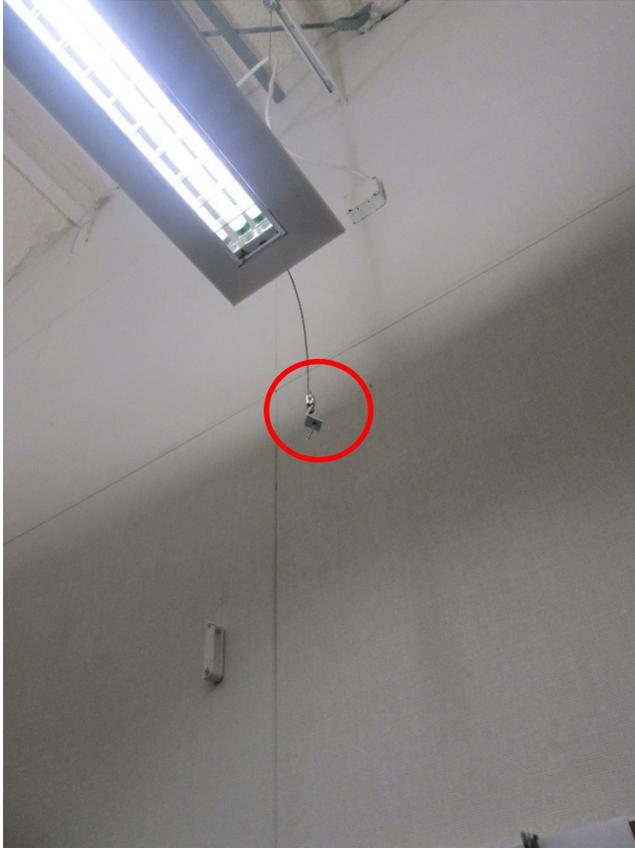
Figure 6-8 Bracing wire pulled out of wall at Harvest Middle School (photo by Quattrocchi Kwok Architects).

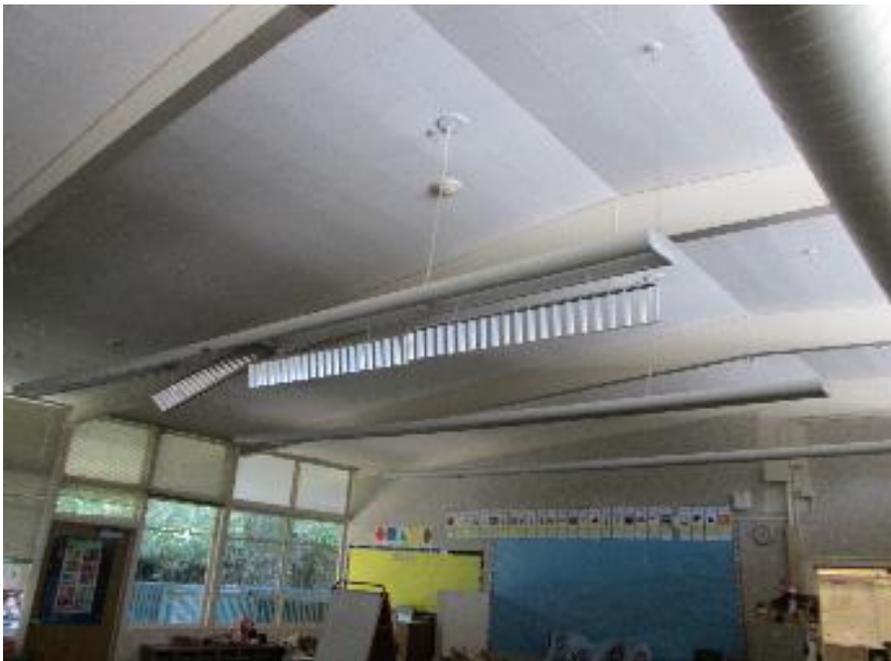
Figure 6-9 Open lens covers at Shearer Elementary School (photo by Quattrocchi Kwok Architects).

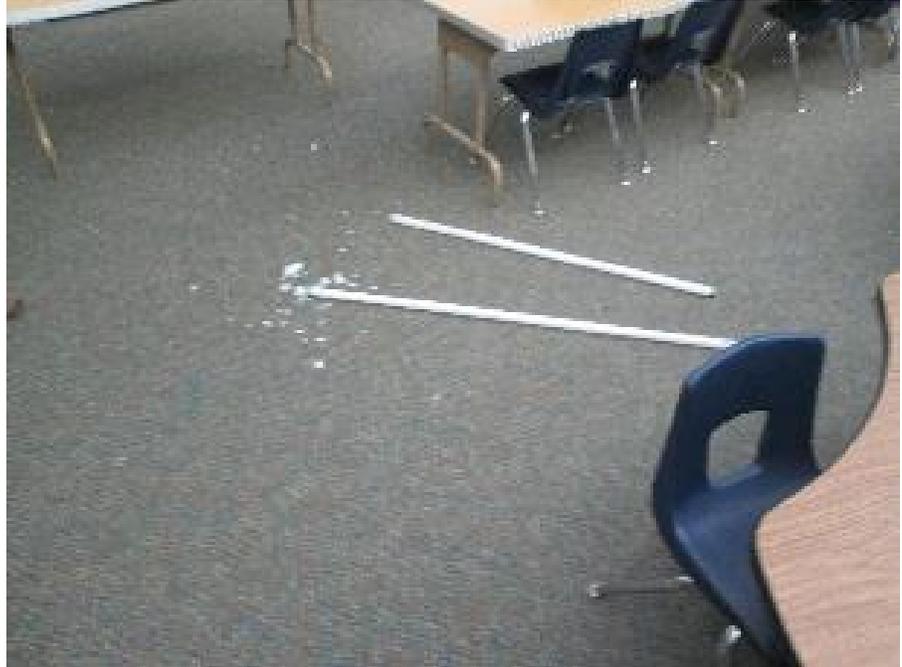
Figure 6-10 Dislodged fluorescent bulbs at Shearer Elementary School (photo by Quattrocchi Kwok Architects).

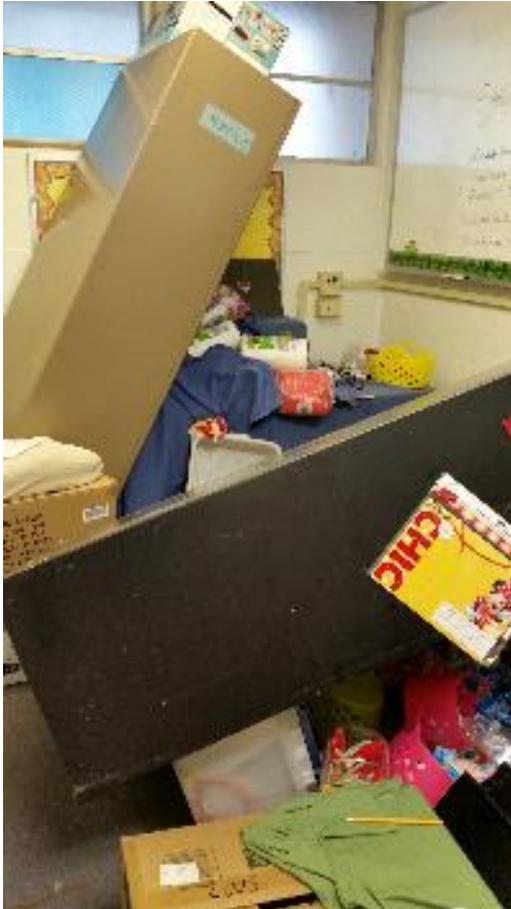
no visible measures in place to prevent such movement. Figures 6-11 through 6-15 illustrate examples where overturned furniture created a safety risk. In cases where furniture did not overturn or move, contents were shed, sometimes posing a potential safety hazard as well (Figures 6-16 and 6-17).

Figure 6-11 Overturned cabinets in Irene M. Snow Elementary School (photo by Quattrocchi Kwok Architects).

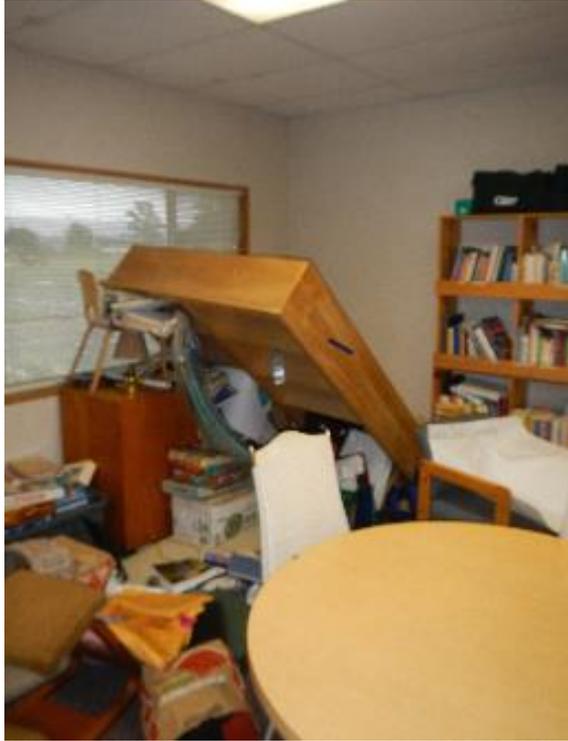
Figure 6-12 Overturned bookcase in Stone Bridge School (photo by Quattrocchi Kwok Architects).

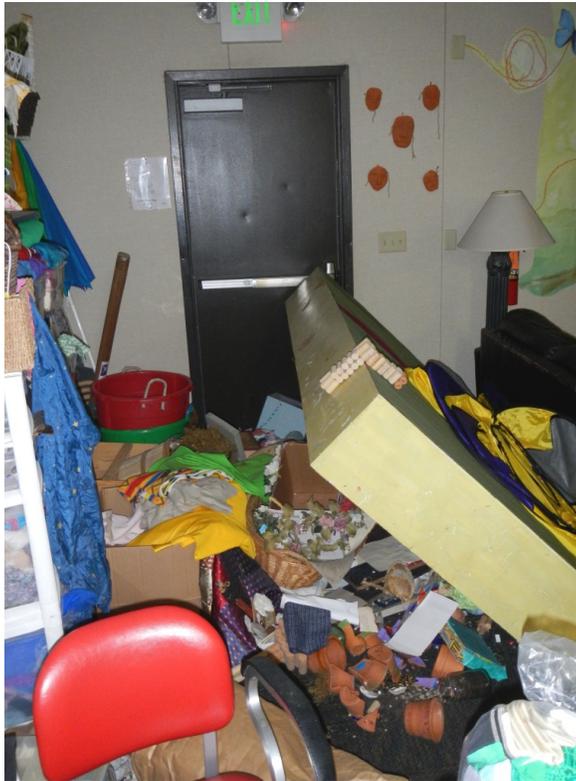
Figure 6-13 Overturned bookcase blocking exit in Stone Bridge School (photo by Quattrocchi Kwok Architects).

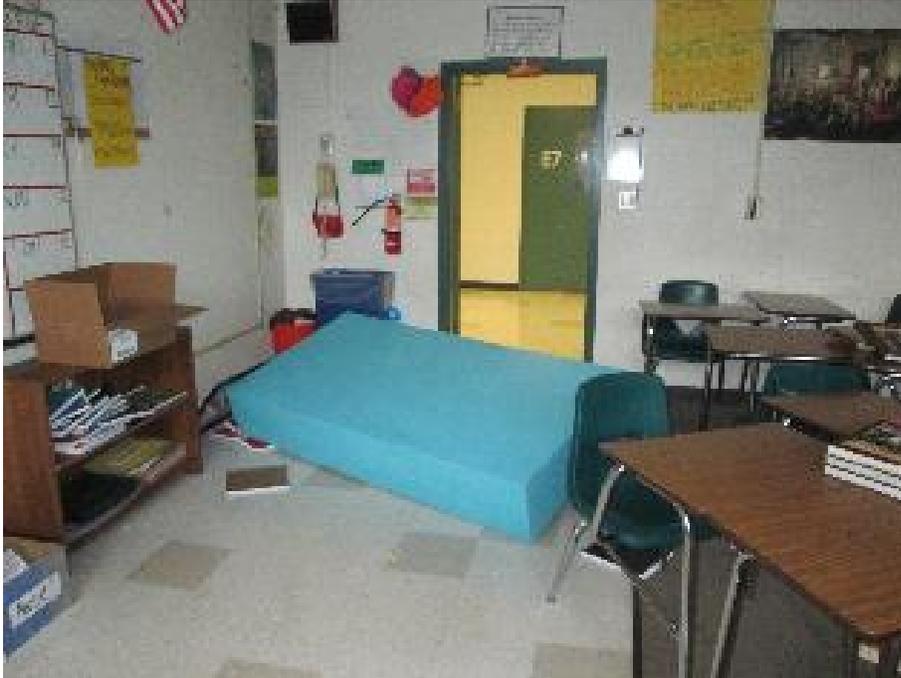
Figure 6-14 Overturned bookcase at doorway in Harvest Middle School (photo by Quattrocchi Kwok Architects).

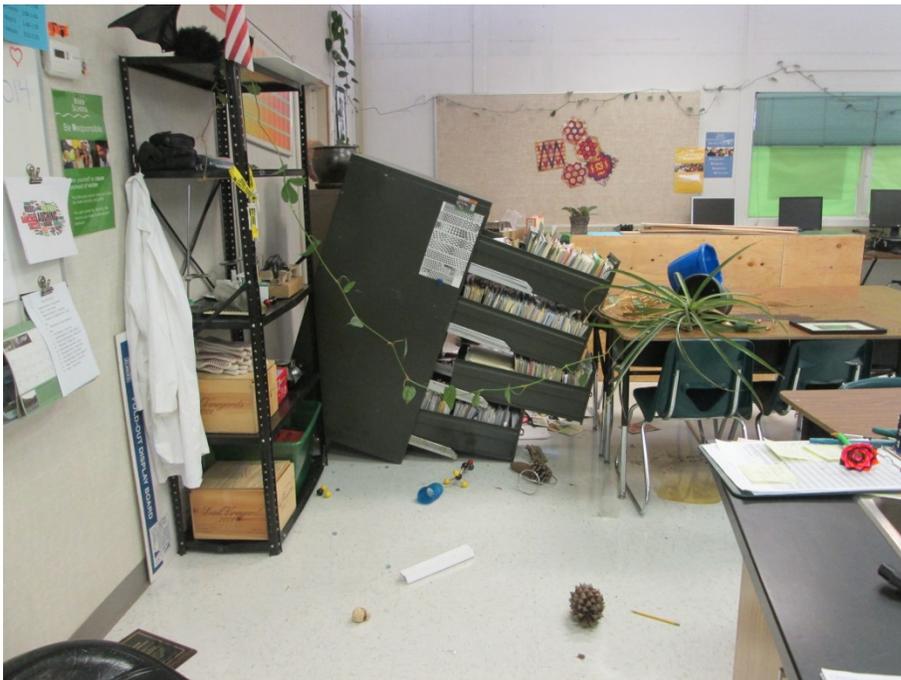
Figure 6-15 Overturned file cabinet in Harvest Middle School (photo by Quattrocchi Kwok Architects).

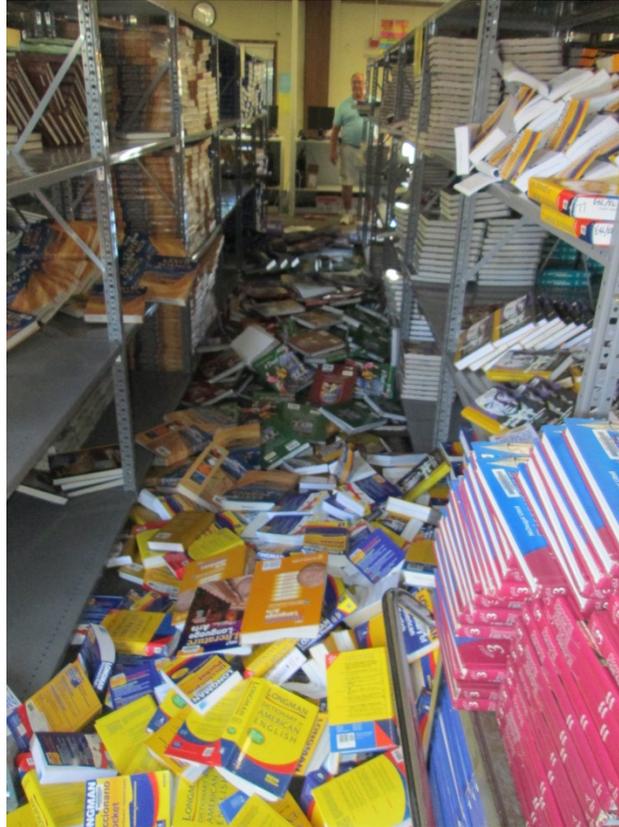
Figure 6-16 Dislodged books in Napa High School (photo by Quattrocchi Kwok Architects).

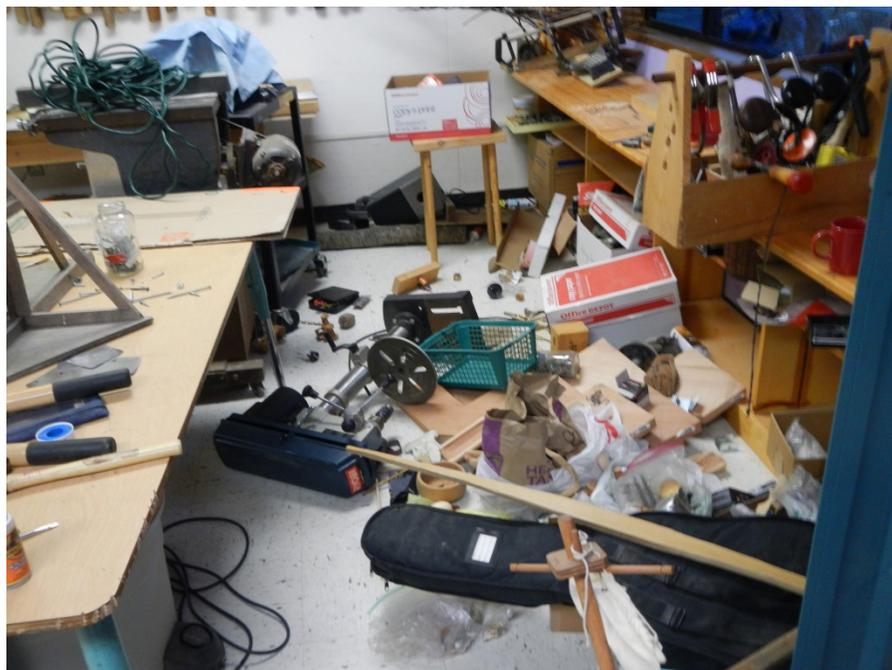
Figure 6-17 Contents dislodged from counters in Stone Bridge School wood shop (note drill press on floor) (photo by Quattrocchi Kwok Architects).

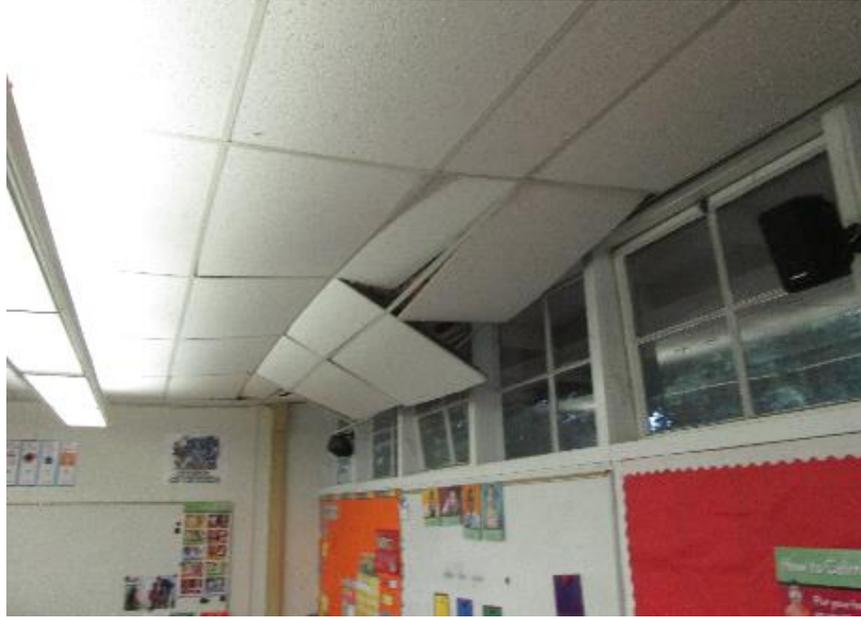
Figure 6-19 Damage to suspended acoustic tile ceiling in Napa Junction Elementary School (photo by Quattrocchi Kwok Architects).

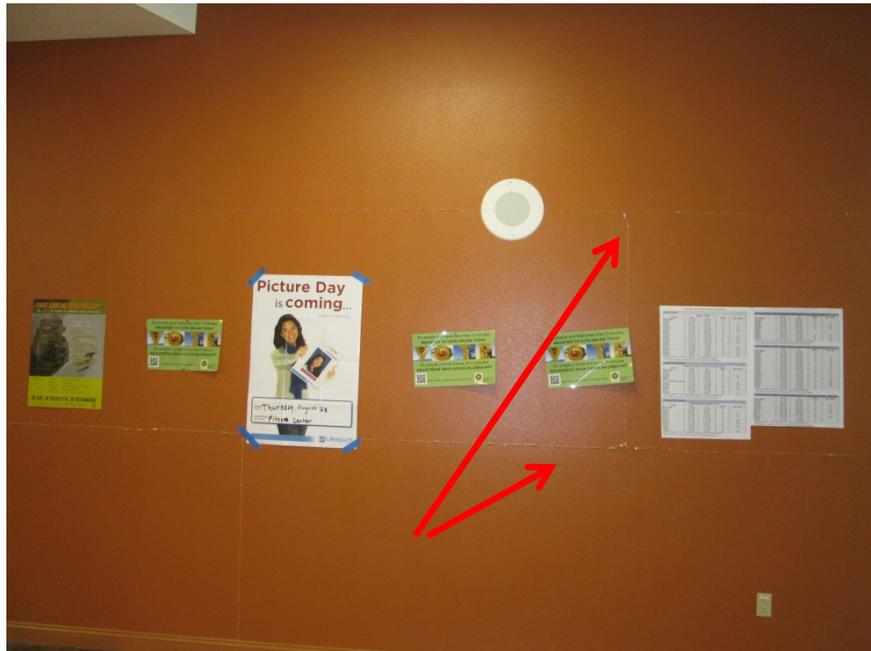
Interior partitions observed typically consisted of full height wood or metal studs with gypsum wallboard or plaster sheathing. Reported damage was limited to minor cracking (Figures 6-20). In one school small areas of adhered ceramic tiles were dislodged (Figure 6-21).

Figure 6-20 Gypsum wallboard cracking in New Technology High School (photo by Quattrocchi Kwok Architects).

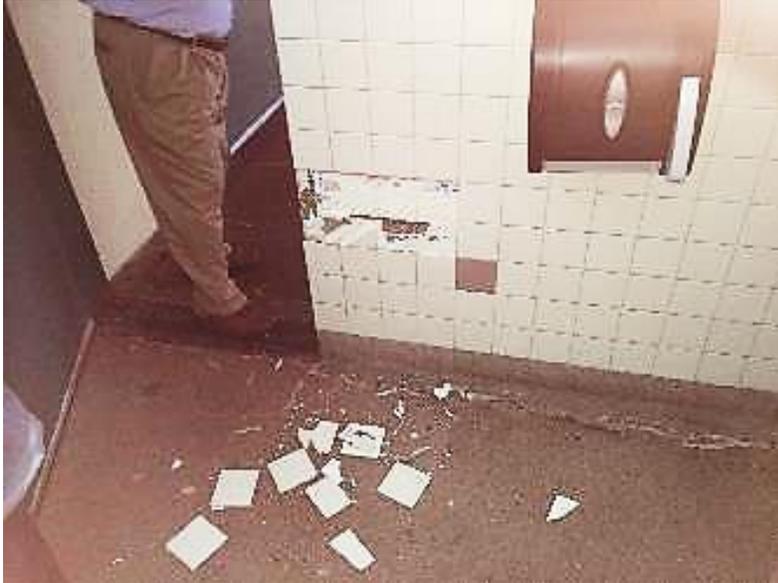
Figure 6-21 Dislodged adhered tile in Harvest Middle School (photo by Quattrocchi Kwok Architects).

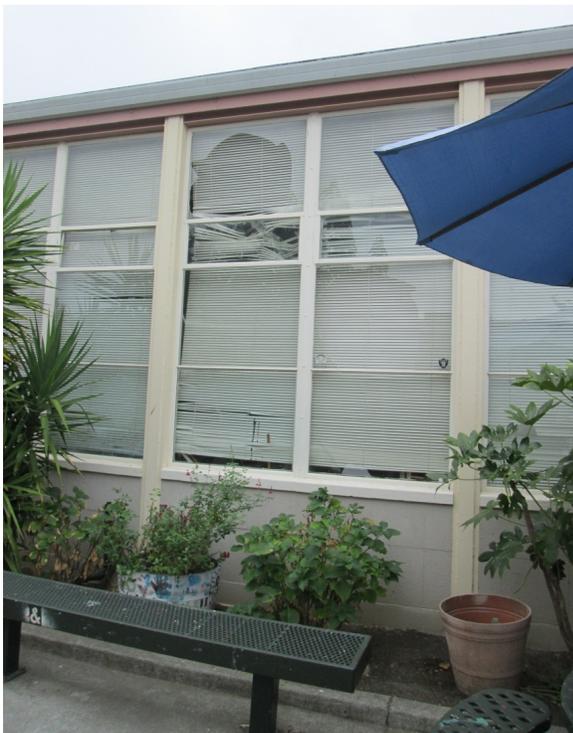
Damage to glazing was limited. Broken windows were reported at three schools, but only one window was damaged at each school (Figure 6-22). Some schools experienced minor movement in the window framing system.

Figure 6-22 Broken window at Harvest Middle School (photo by Quattrocchi Kwok Architects).

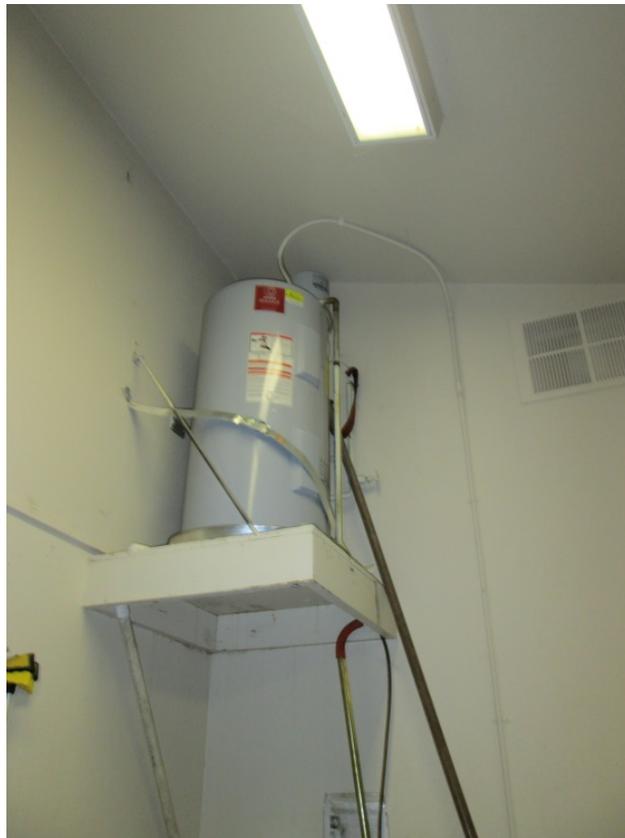
In general, there was limited damage to mechanical and plumbing systems in schools. The earthquake restraint straps on two water heaters failed, but the tanks did not topple (Figures 6-23 and 6-24). A water main broke at Stone Bridge School, and a 28,000-gallon water tank was damaged at New Technology High School. The tank, which was anchored to a concrete foundation, was damaged at the connection between anchor brackets and the tank wall, causing ruptures in the tank wall and water release. There was also local buckling of the tank wall near the base.

Figure 6-23 Failed earthquake restraining strap on water heater (photo by Quattrocchi Kwok Architects).

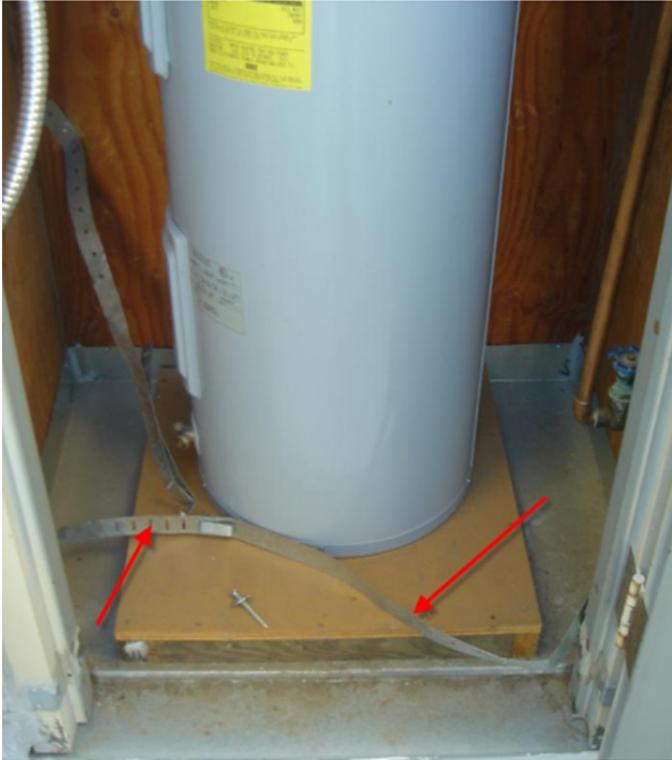
Figure 6-24 Failed earthquake restraining strap at Shearer Elementary School (photo by Quattrocchi Kwok Architects).

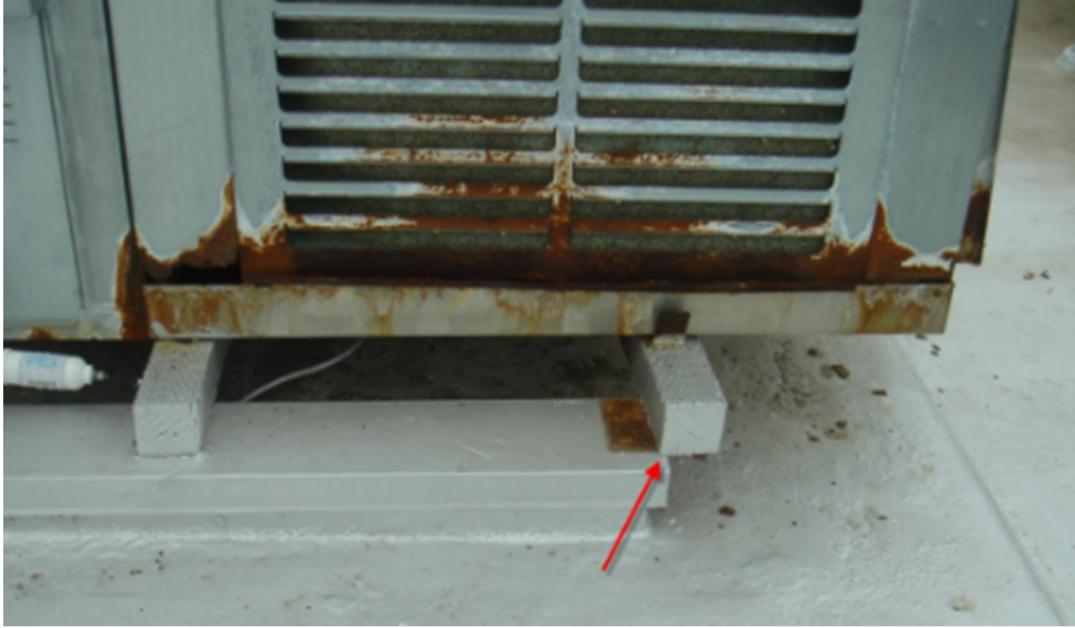
The rooftops of most schools support piping and equipment on wood sleepers. In many instances, the sleepers are unanchored. The South Napa Earthquake caused movement of piping, conduit, and equipment; however there was no loss of function reported for any of the rooftop equipment. Examples of the damage to rooftop equipment are shown in Figures 6-25 to 6-29.

Figure 6-26 Shifted rooftop make-up air unit at Napa High School (photo by Quattrocchi Kwok Architects).

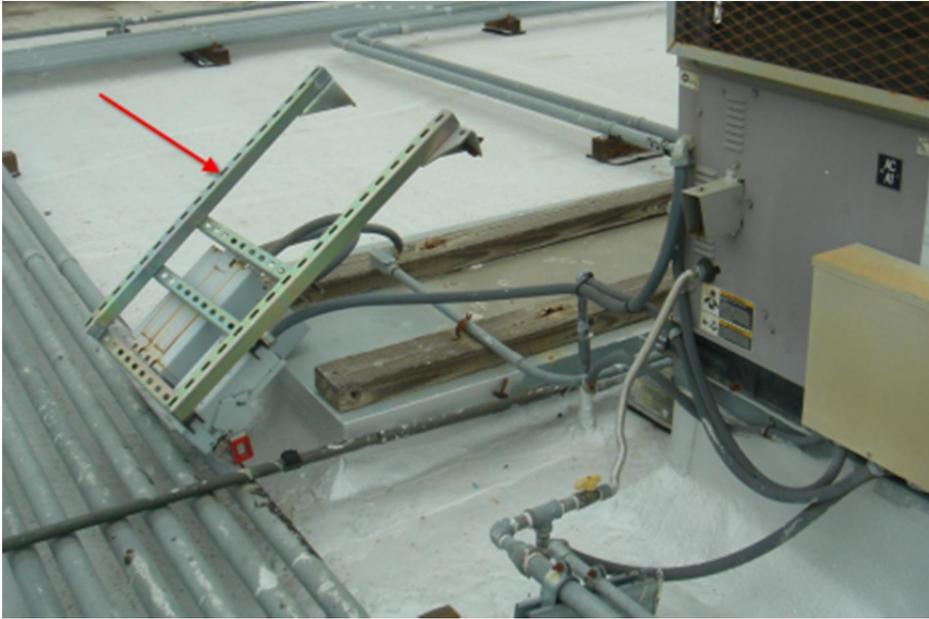
Figure 6-28 Toppled disconnect for rooftop air handler at Napa High School (photo by Quattrocchi Kwok Architects).

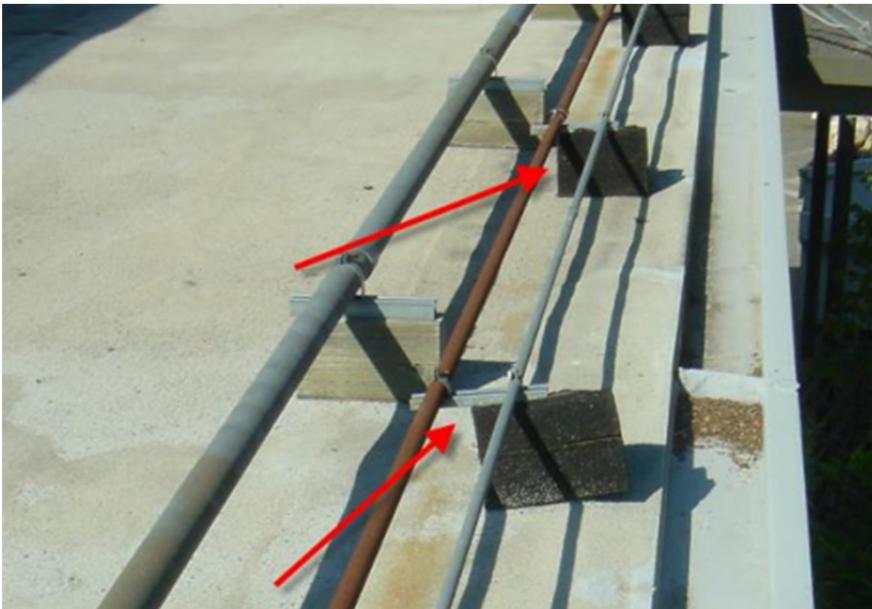
Figure 6-29 Shifted rooftop pipe supports at Silverado Middle School (photo by Quattrocchi Kwok Architects).

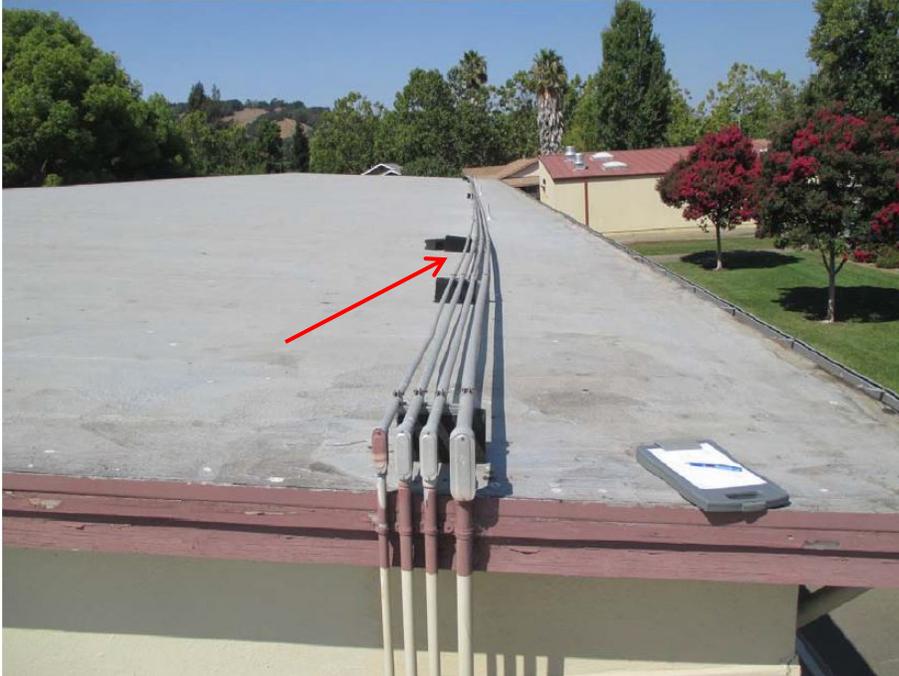
Figure 6-32 Shifted conduit at Napa Valley Language Academy (photo by Quattrocchi Kwok Architects).

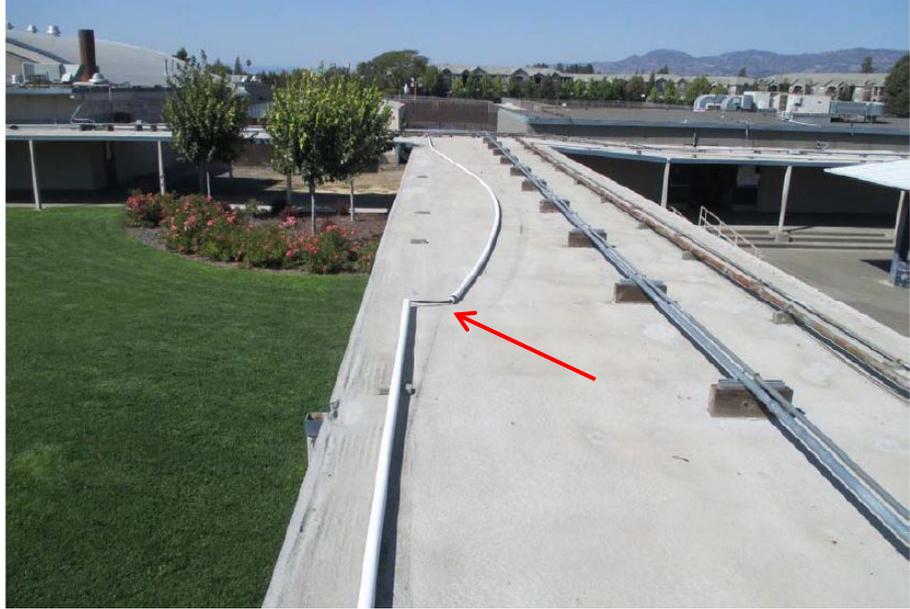
Figure 6-34 Broken PVC conduit at Redwood Middle School (photo by Quattrocchi Kwok Architects).

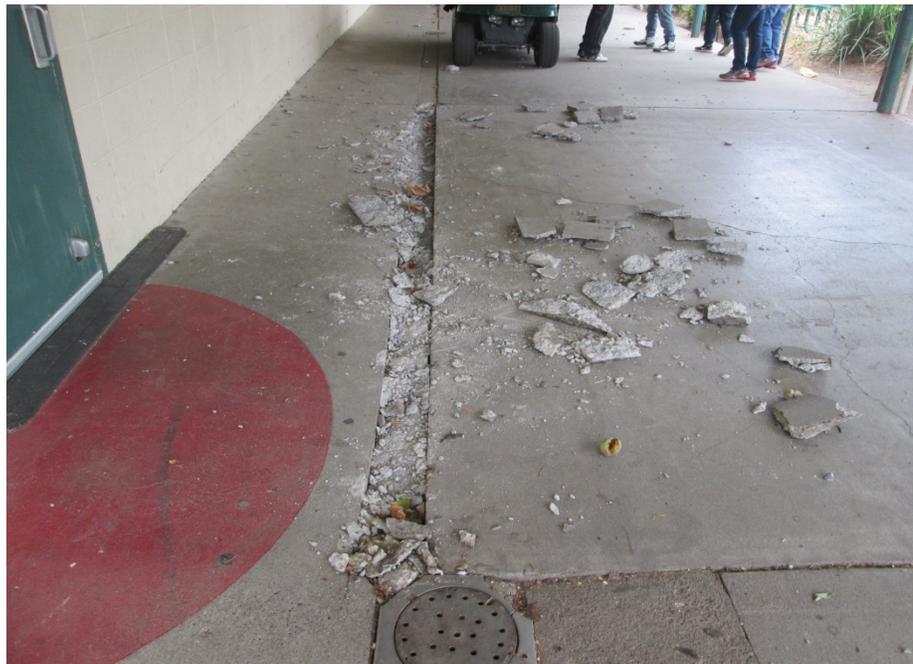
Several schools reported damage to concrete slabs-on-grade and one school reported damage to the asphalt parking lot, due to ongoing afterslip (see Chapter 2). The slab cracking generally occurred at existing slab construction joints.

Figure 6-35 Cracking at slab joint in walkway at Harvest Middle School (photo by Quattrocchi Kwok Architects).

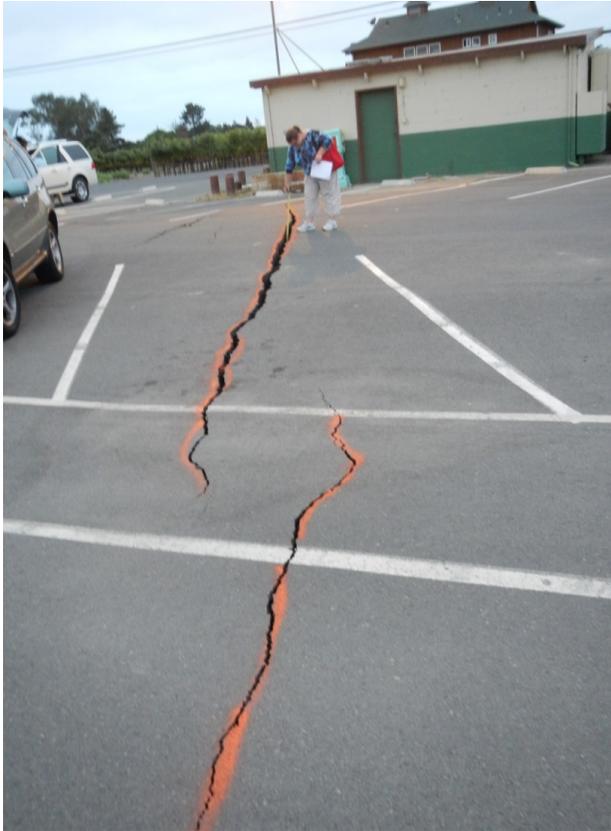
Figure 6-36 Cracks in asphalt parking lot at Stone Bridge School (photo by Quattrocchi Kwok Architects).

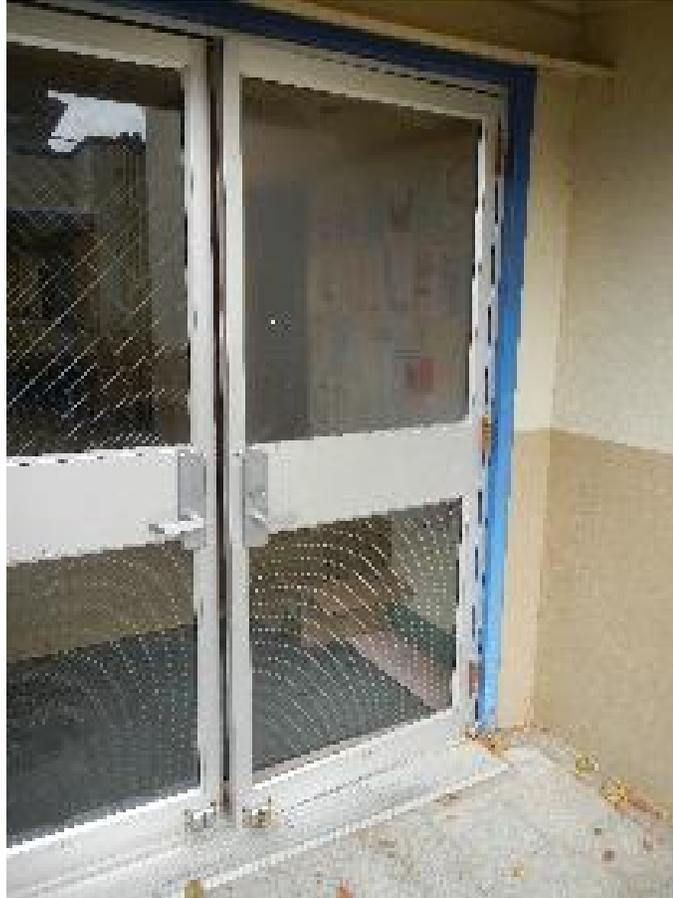
At several schools, some doors were reported to be hard to open or binding after the earthquake. In some cases, the cause appears to have been movement of the building and in others the cause appears to be related to ground movement. All doors were operable, but with stronger shaking, it is possible that means of egress could have been compromised.

Figure 6-37 Damaged door at Browns Valley Elementary School (photo by Quattrocchi Kwok Architects).
