Performance of Buildings and Nonstructural Components in the 2014 South Napa Earthquake

FEMA P-1024 / February 2015

APPLIED TECHNOLOGY COUNCIL
201 Redwood Shores Parkway, Suite 240
Redwood City, California 94065
<http://www.atcouncil.org/>

FEDERAL EMERGENCY MANAGEMENT AGENCY
Michael Mahoney, Project Officer
Washington, D.C.

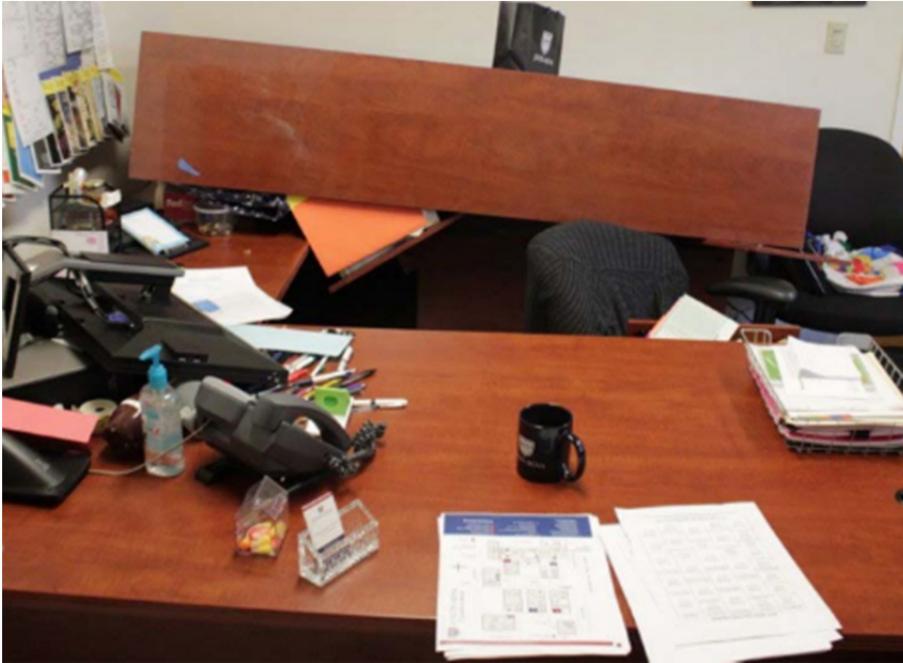
Justin Siena, a parochial high school in Napa, 10 miles north-northwest from the epicenter, sustained nearly \$60,000 in losses. Damage included broken windows, broken water mains, cracked wall finishes, damaged light fixtures, shifted equipment, toppled bookcases and furniture, loss of supplies, and damaged statuary (Figures 6-38 through 6-40).

Figure 6-38 Unrestrained bookshelf overturned in office (photo by Quattrocchi Kwok Architects).

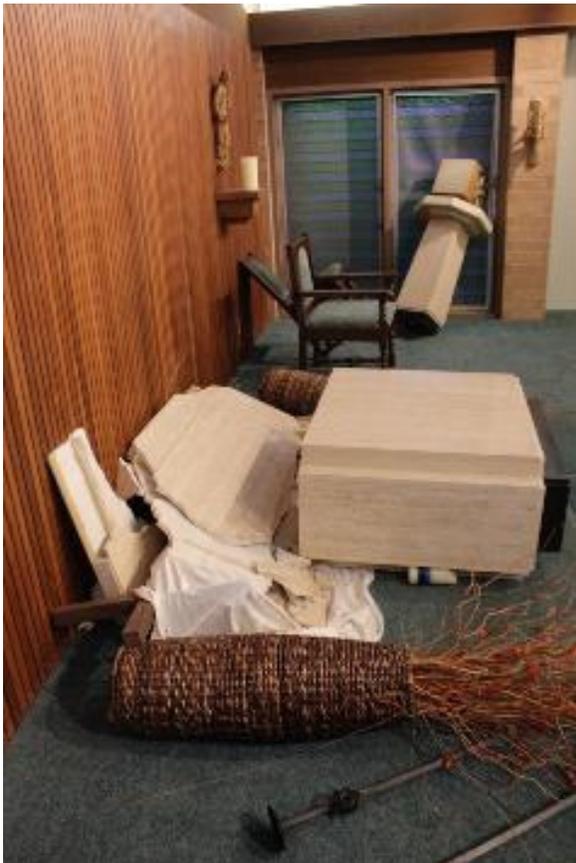
Figure 6-39 Toppled altar and statuary (photo by Quattrocchi Kwok Architects).

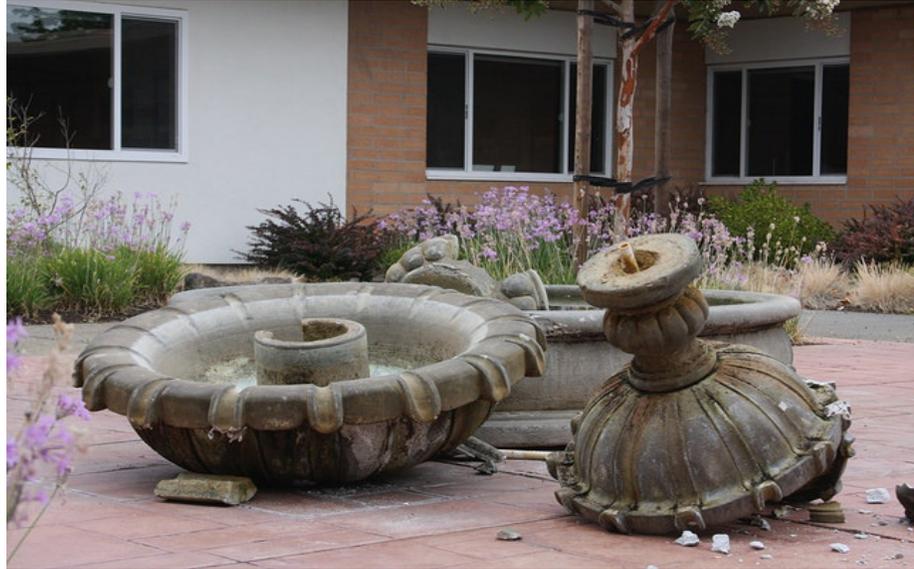
Figure 6-40 Toppled landscape statuary (photo by Quattrocchi Kwok Architects).

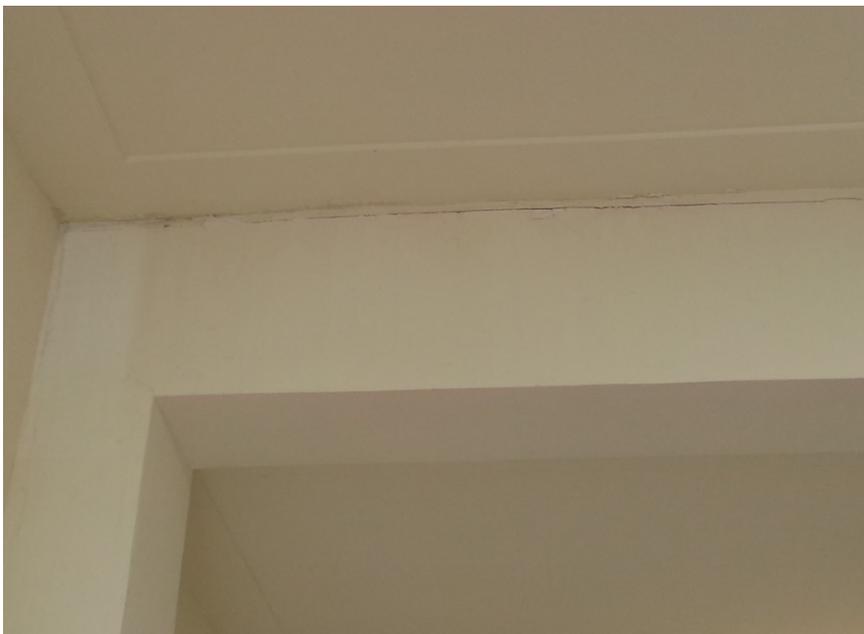
In the 2014 earthquake, the only damage was minor wall cracking around a beam added as part of the retrofit (Figure 6-42). One exterior fire sprinkler head under the front portico that broke and discharged on the outside of the building.

Figure 6-42 Minor wall cracking.

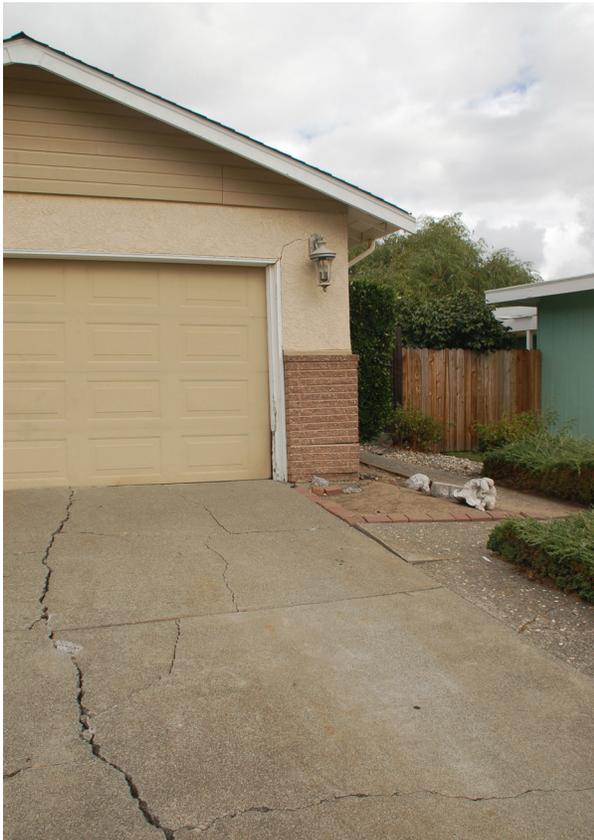
This one-story, single-family residence is located in the Browns Valley neighborhood, and was built circa 1960 on a slab-on-grade. The building was posted UNSAFE at the time of the field investigation. Accordingly, the inspection was limited to exterior only. This house was co-located with the surface feature of the fault rupture. The rupture can be followed from the asphalt on the street (Figure 7-2), to the driveway leading up to the garage (Figure 7-3), and around the garage (Figure 7-4). The crack running up the middle of the driveway is presumed to continue through the house. A fallen brick chimney (Figure 7-5) was also observed. This house is located immediately to the south of Browns Valley House No. 2.

Figure 7-3 Crack running through the street and up the driveway.

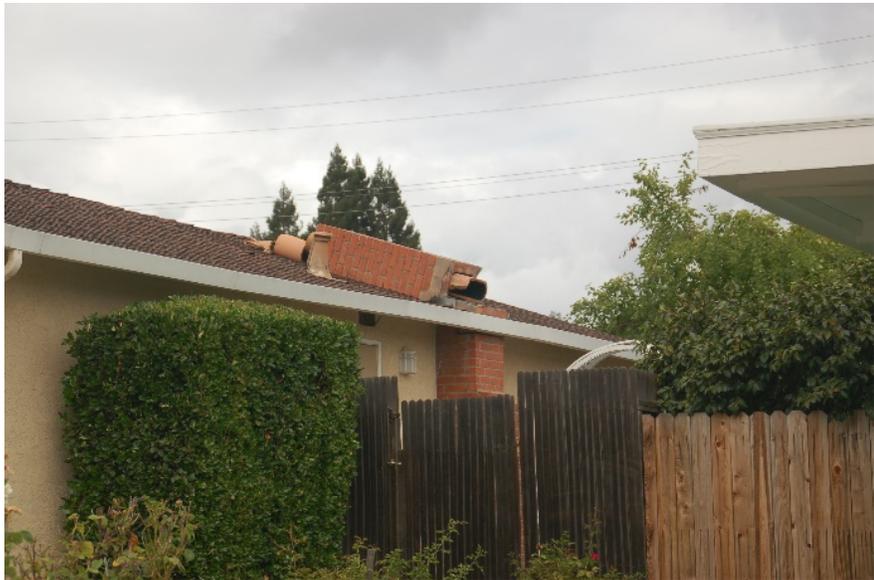
Figure 7-5 Brick chimney collapse on to the roof.

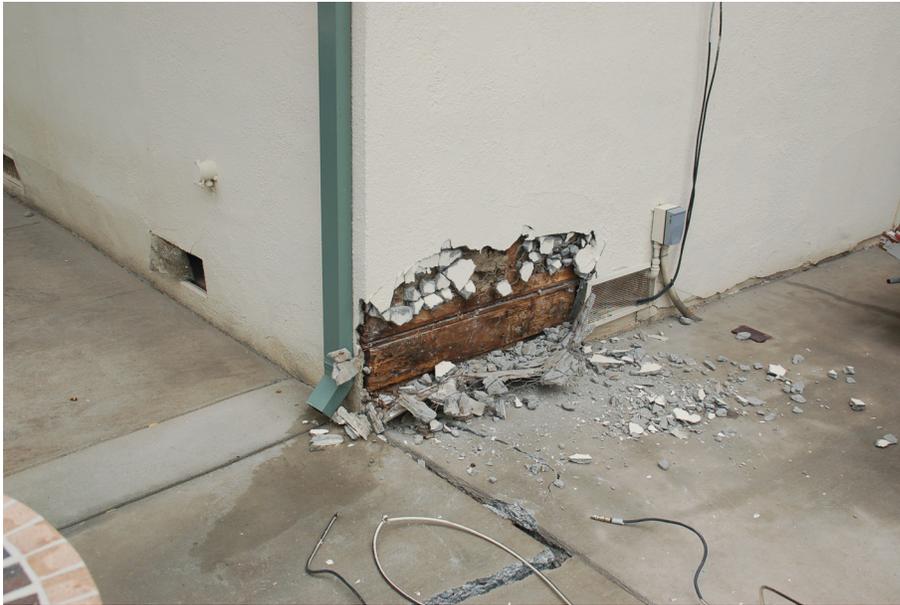
Owners were available on site, and both exterior and interior inspections were performed. It was reported that the brick chimney collapsed, and was demolished prior to the site visit. Cracks running from the south end of the property (Figure 7-6), i.e., adjoining to Browns Valley House No. 1, through the house (Figure 7-7) to the front of the house (Figure 7-8) and street (Figure 7-9) were observed. Inside the house, large cracks (Figure 7-7) and buckled floors were observed. The water heater, which had been seismically braced, was undamaged. Rooftop solar panels were also undamaged.

Figure 7-6 Cracks in the pavement of the backyard and damage to stucco wall.

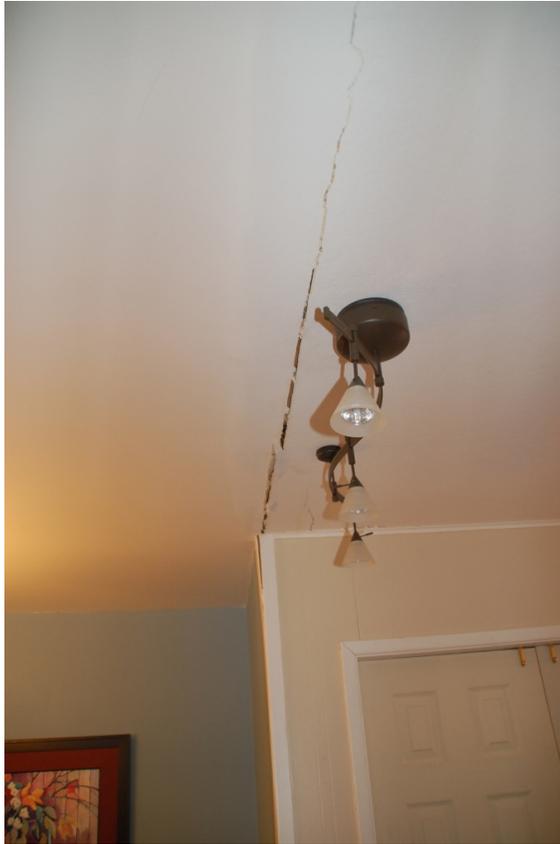
Figure 7-7 Ceiling crack.

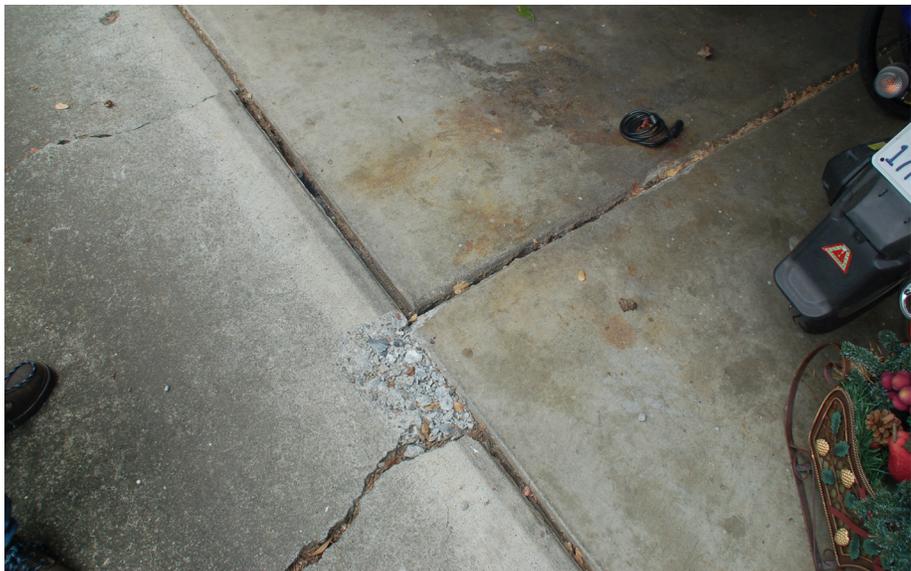
Figure 7-8 Damage caused due to differential movement of floor slabs in garage and driveway pavement.

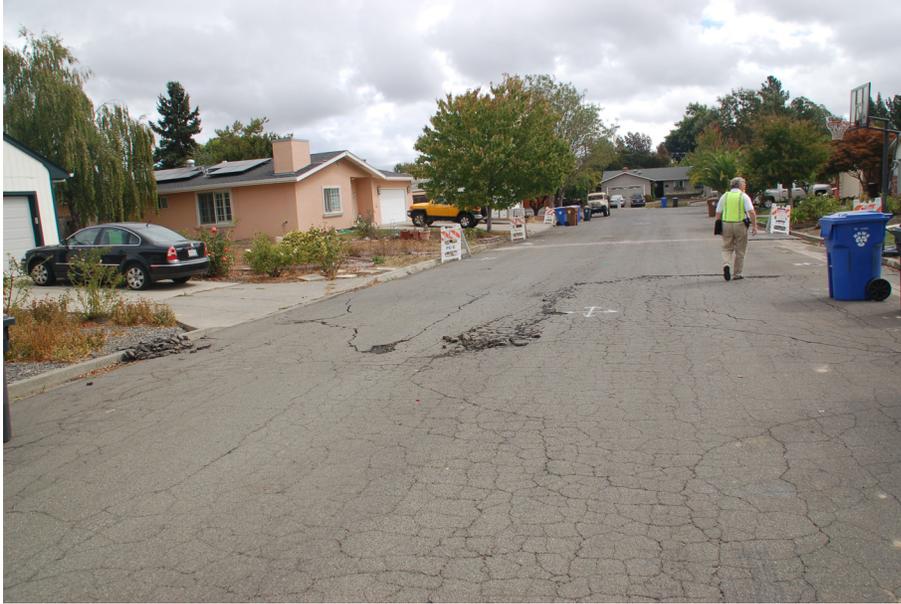
Figure 7-9 Surface rupture observed on street.

The damage to Browns Valley House No. 2 highlights the risks of fault rupture. The home, which did not have an unbraced cripple wall, would have been expected to perform well in an earthquake. However, it was not able to withstand the fault rupture that traced directly through the house footprint, and damage (although not collapse) was experienced and occupants had to evacuate. The issue of afterslip is covered in Chapter 2; its greatest impact was to residential structures in the Browns Valley neighborhood.

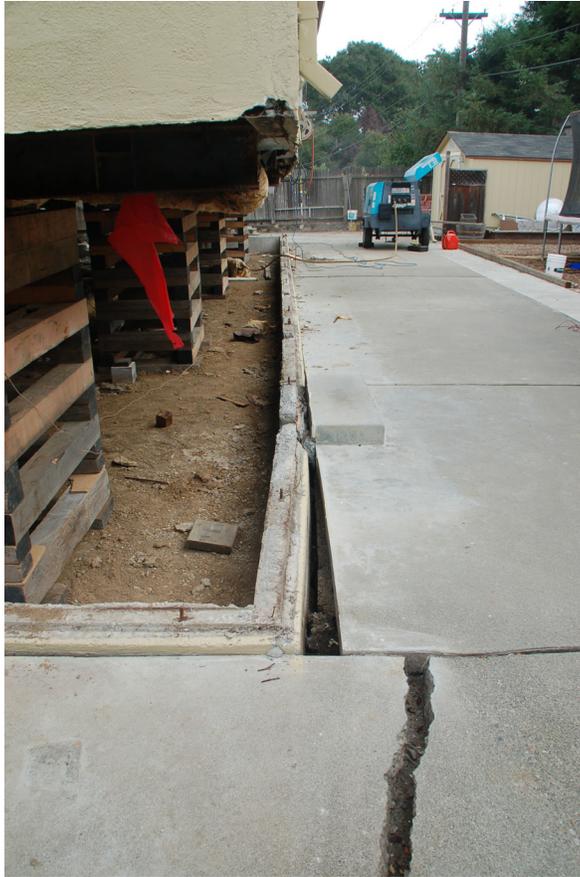
This L-shaped, one-story, single-family residence was built circa 1965. An exterior inspection was performed. The residence was posted UNSAFE following the earthquake. The brick chimney collapsed, and was demolished prior to the site visit. Fault rupture caused the building to twist. Damage was concentrated at the reentrant corner by the main door, buckling the floors. At the time of the site visit, the building was being professionally repaired, and had been lifted off the concrete perimeter wall (Figures 7-10 and 7-11). The contractor was interviewed on site and stated that the plan was to completely remove the existing perimeter foundation and interior piers and replace with a similar foundation system but one using better concrete with deeper embedment lengths. This retrofit is considered far superior to other “patch and paint” foundation repairs observed at other sites.

Figure 7-10 Photo showing demolished perimeter foundation and cracks in pavement.

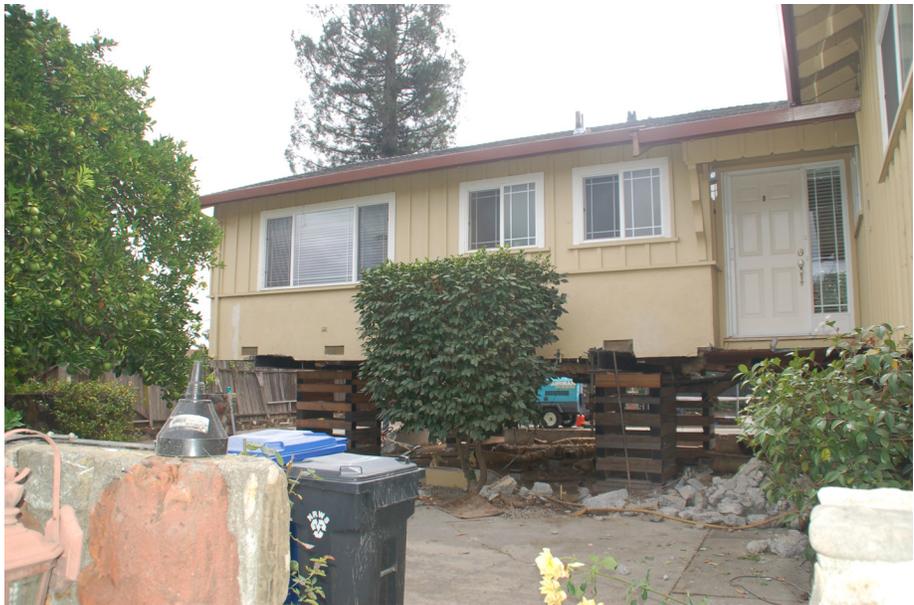
Figure 7-11 Structure raised for foundation repair.

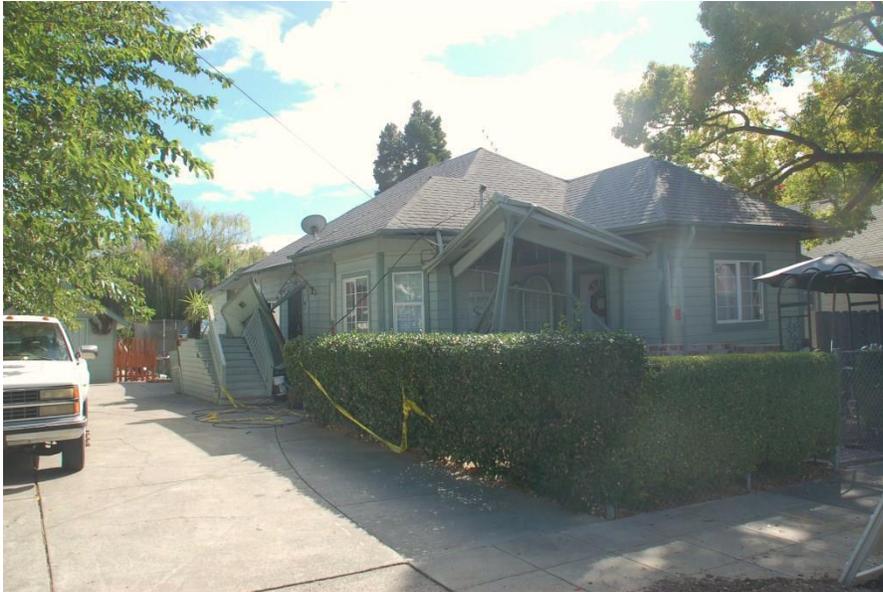
This one-story, duplex residence was built circa 1910. An exterior inspection was performed. The residence was posted UNSAFE following the earthquake. The brick chimney collapsed. The cripple wall supporting the building, which was approximately 5 feet tall, collapsed (Figure 7-12), causing the house to fall into the adjoining property (Figure 7-13). As a result of the cripple wall failure, the side porch roof collapsed (Figure 7-14).

Figure 7-12 Home with collapsed cripple wall.

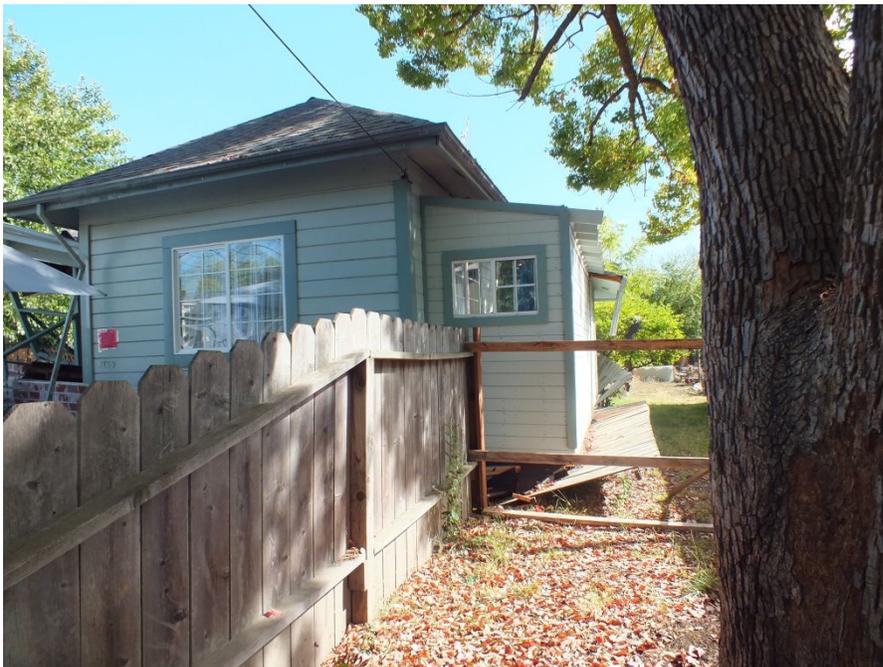
Figure 7-13 Building fell into adjoining property.

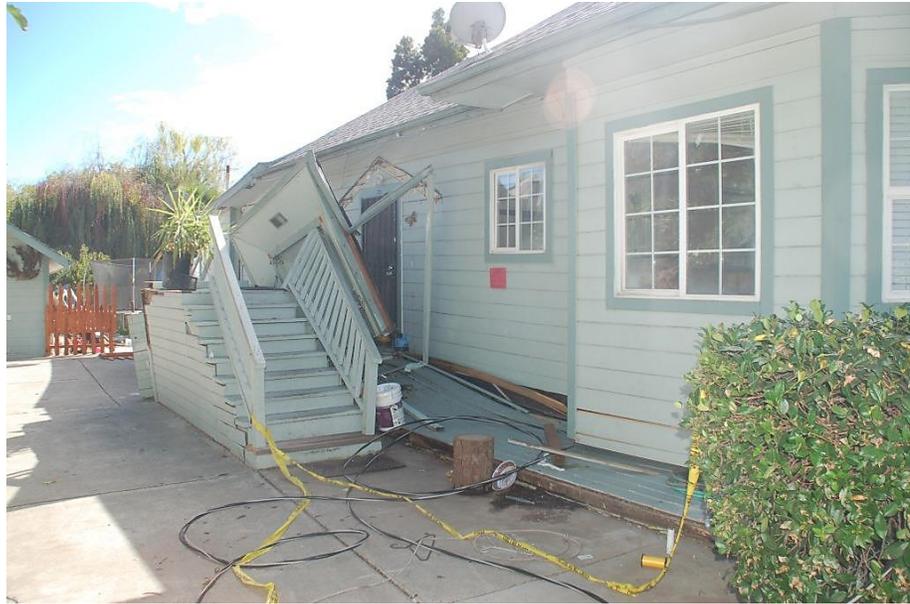
Figure 7-14 Failure of porch due to cripple wall collapse .

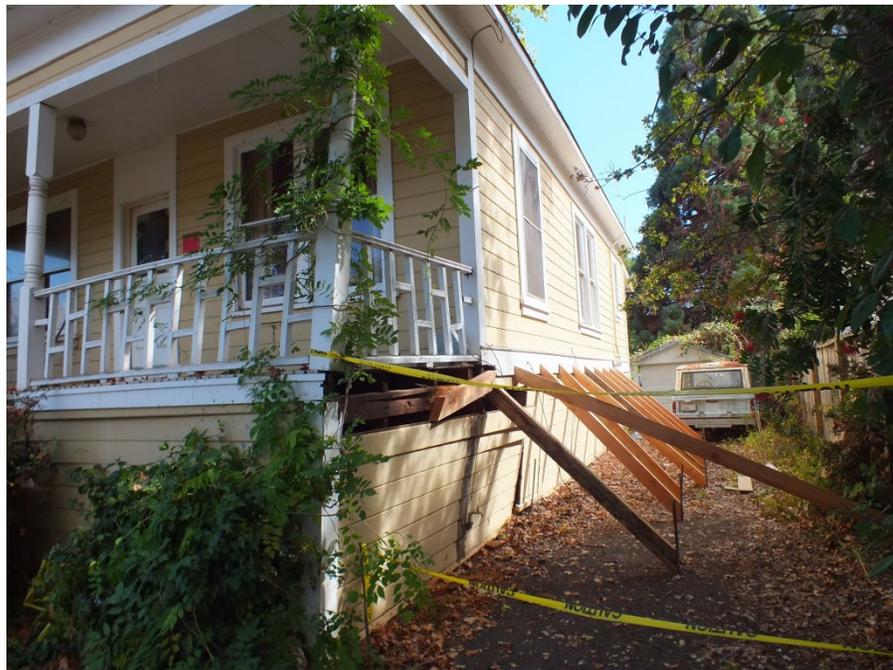
This one-story, single-family home was built circa 1910. An exterior inspection was performed. The residence was posted UNSAFE following the failure of the approximately five foot tall cripple wall (Figure 7-15). The house shifted laterally but did not collapse (Figure 7-16).

Figure 7-15 Temporary lateral bracing at cripple wall.

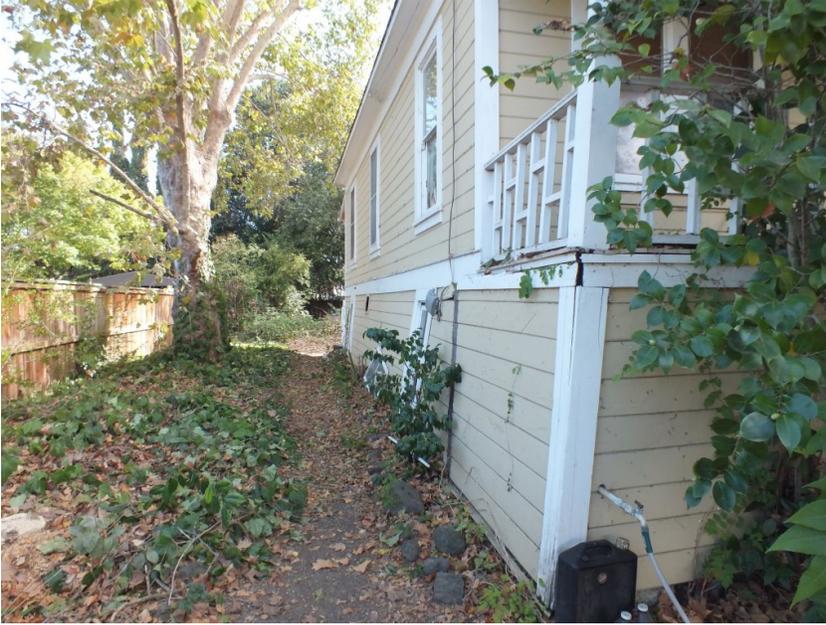
Figure 7-16 House shifted lateral at damaged cripple wall.

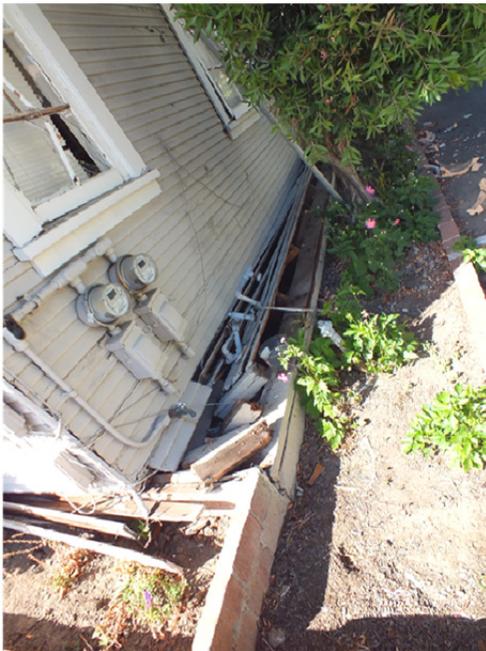
This one-story, duplex residence was built circa 1925. An exterior inspection was performed. The residence was posted UNSAFE following the earthquake after the 3 foot tall cripple wall supporting the building collapsed (Figure 7-17). As a result of the cripple wall failure, the front porch roof collapsed (Figure 7-18).

Figure 7-17 Collapsed cripple wall.

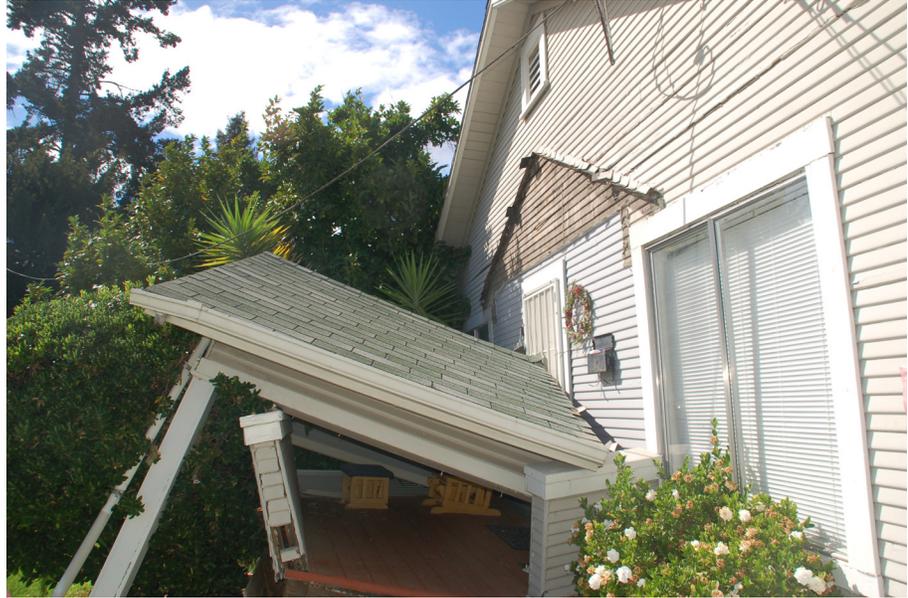
Figure 7-18 Failure of porch due to cripple wall collapse.

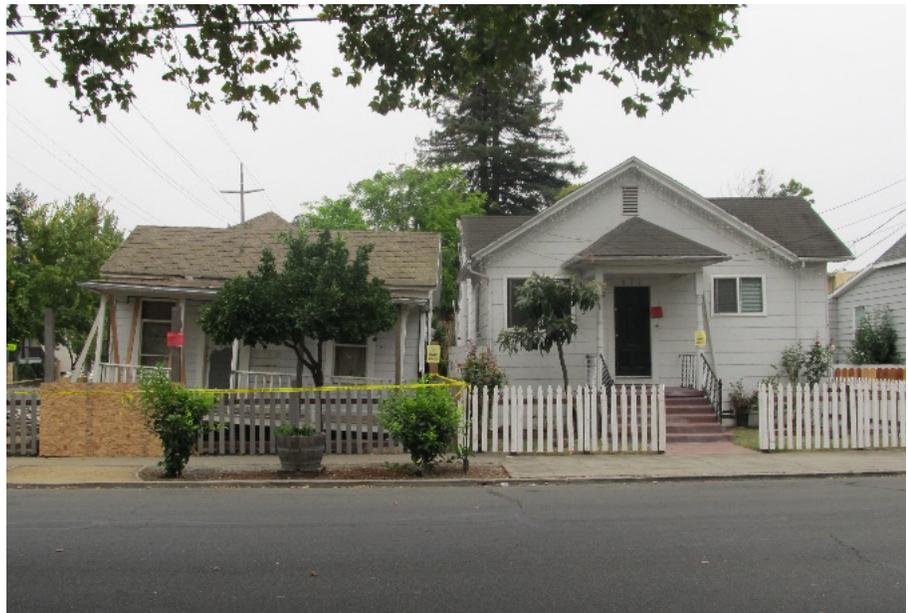
This one-story, single-family residence was built circa 1900 (white building on the right of photo in Figure 7-19). An exterior investigation was performed. The house was initially posted INSPECTED following the earthquake, but was subsequently posted UNSAFE due to the imminent hazard posed by the adjacent residence, which had suffered a cripple wall failure and severe racking.

Figure 7-19 Undamaged residence on the right was posted UNSAFE due to risk posed by damaged residence on the left.

The earthquake highlighted the possibility that residents could find their homes unavailable after an earthquake due to damage in adjacent buildings. Napa House No. 4 performed well and was initially posted INSPECTED, allowing the residents to return home. However, its proximity to the poorly performing home next door resulted in Napa House No. 4 being posted UNSAFE, forcing the residents out.

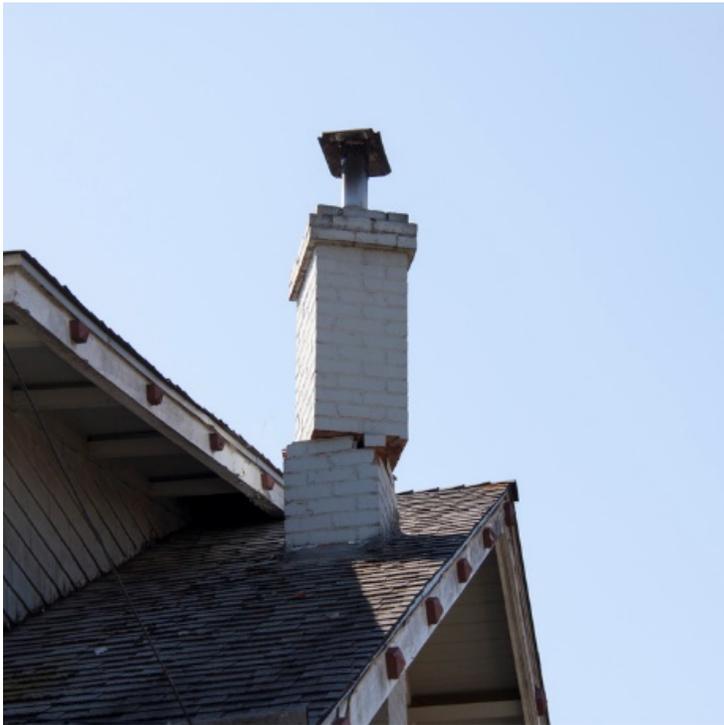
Unreinforced masonry chimneys performed poorly with many observed failures in the form of significant damage (Figure 7-22) or collapse (Figures 7-23 and 7-24). In many cases, chimneys fell out onto exterior areas, endangering adjacent homes, passersby on sidewalks, and parked cars. In other cases, chimneys fell into homes, endangering occupants. In one instance, a teenage boy who was asleep in the living room, was struck and injured by falling bricks from a collapsed fireplace (Figure 7-25). This was

Figure 7-22 Dislodged unreinforced masonry chimney (photo from Janiele Maffei).

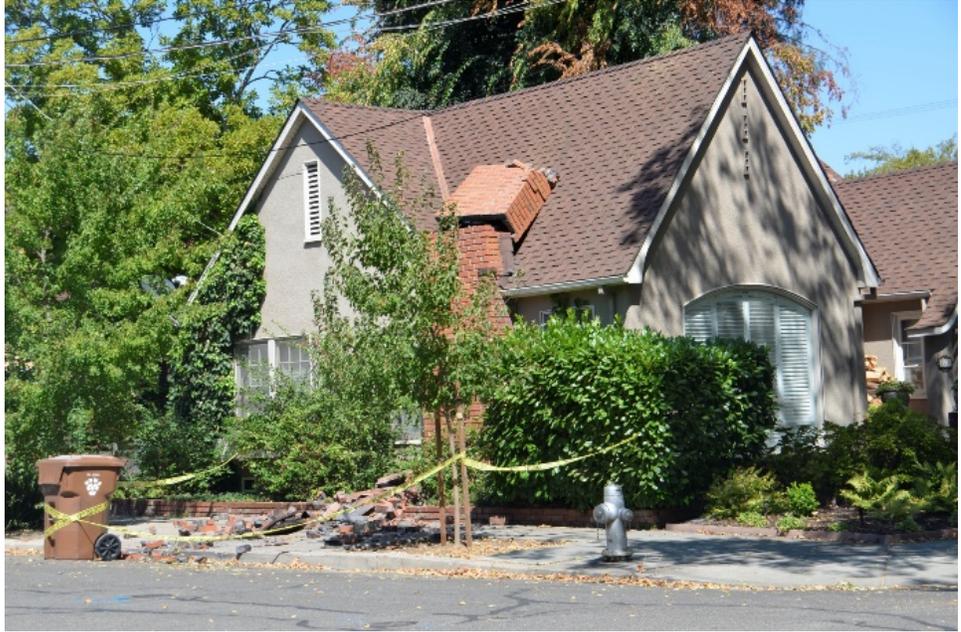
Figure 7-23 Photo of damaged chimney (photo from Janiele Maffei)

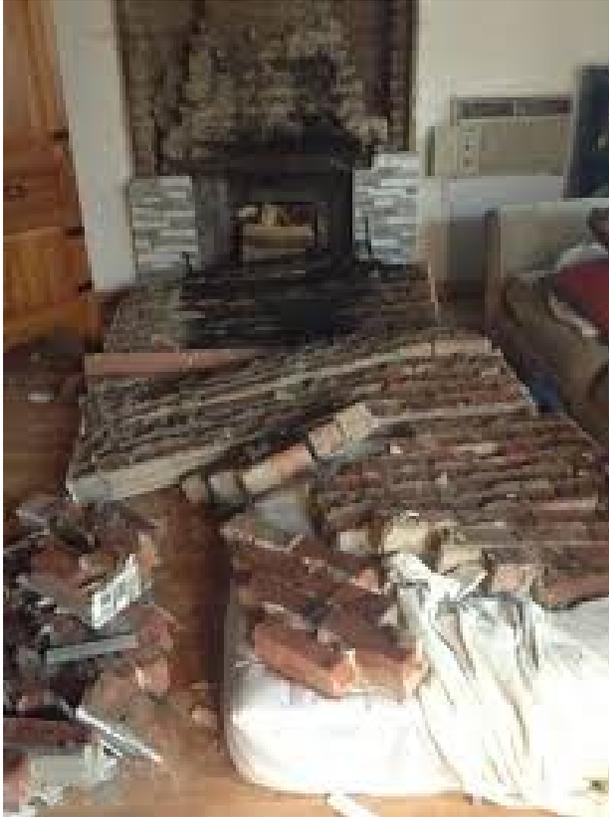
one of the most serious injuries caused by the earthquake. It was reported that some reinforced masonry chimneys also failed, likely due to insufficient reinforcement. Lightweight metal flue chimneys performed much better and caused no injuries. The City of Napa had issued a construction information handout *Retro Fitting Masonry Fireplace with Factory Built Metal Chimney* (City of Napa, 2000), but the guidance was not readily implemented. In response to the damage sustained to masonry chimneys in the 2014 South Napa earthquake, FEMA funded the development of a Recovery Advisory on *Repair of Earthquake-Damaged Masonry Fireplace Chimneys*. This Recovery Advisory is provided in its entirety in Appendix B.

Figure 7-25 Photo of interior chimney collapse (photo from Janiele Maffei).

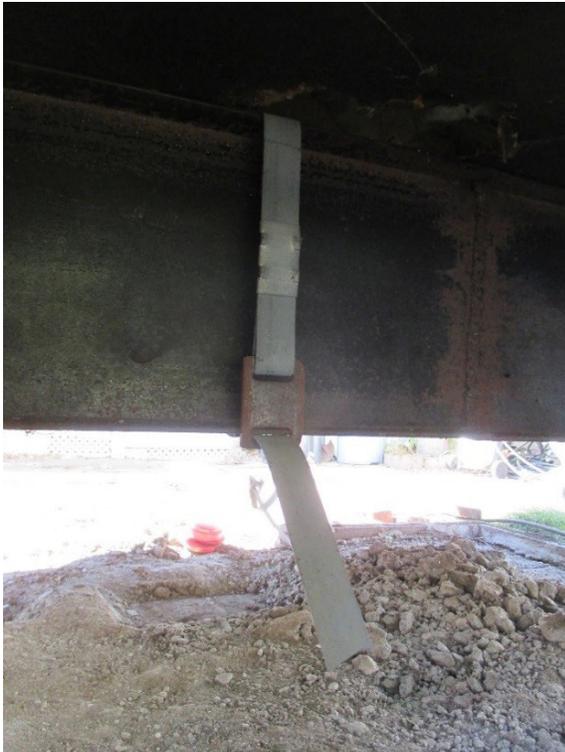
homes are permitted to be used (supplemented with gravity support along the chassis), none were observed in the surveyed Napa manufactured homes. Early ETS used a set of steel straps looped over the chassis beams and attached to helical soil anchors. Figures 8-5 and 8-6 show such a system, with the strap cut to allow relocation of the home. HCD representatives indicated that this type of ETS is seldom used anymore, replaced by other approved systems. Straps were only seen in two of the homes where support systems were observed.

Figure 8-5 ETS strap connected to a home chassis beam, cut to allow home to be relocated.

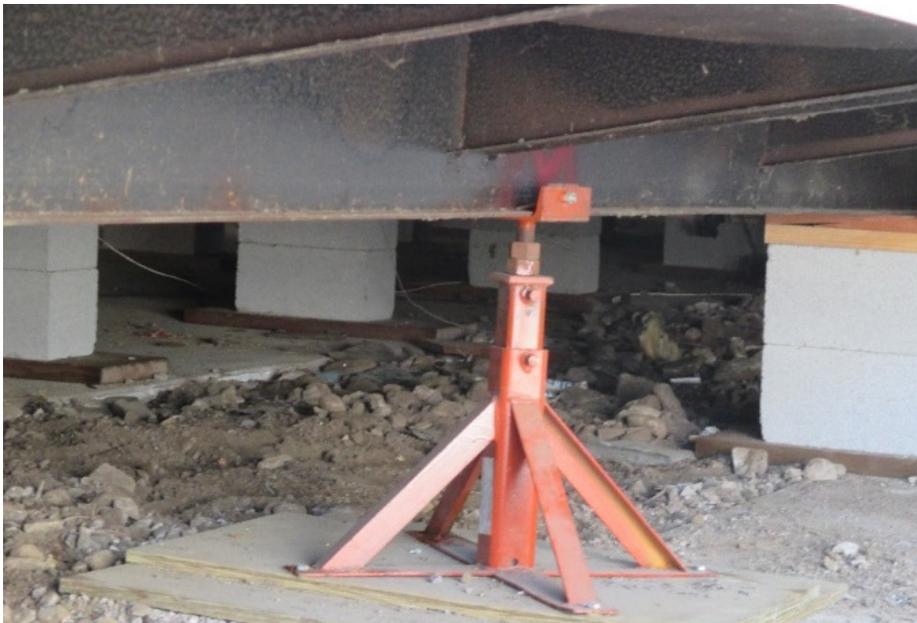
Many of these “cantilevered” piers did not have holes in the pier base that would allow installation of fasteners between the pier base and the supporting wood board, nor was the wood board anchored to or embedded in the supporting soil, thus some of these “cantilevered” steel piers appeared to have slid or toppled over, allowing the home to drop. Similar “cantilevered” piers being installed new in postearthquake reinstalls were observed to have screw connections between the pier base and the supporting wood boards (Figure 8-9), but continued to lack connection of the wood board to the supporting soils.

Figure 8-9 New “cantilevered” pier, anchored to supporting plywood panels.

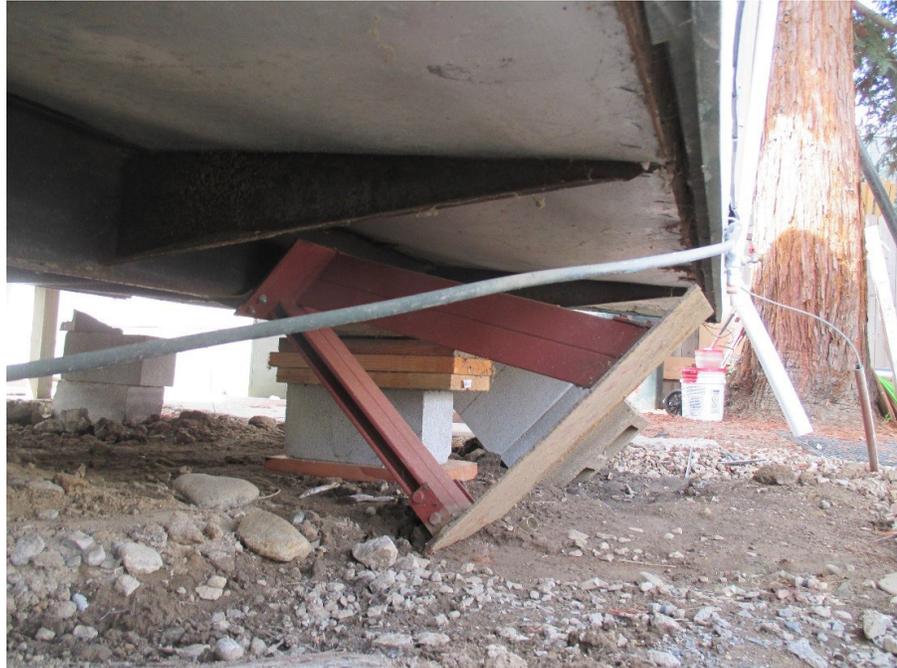
approved as an ETS or ERBS; further, many systems utilize the same supports in different numbers and configurations making the exact determination of system (ETS, ERBS, or other) extremely difficult to an untrained observer. Figure 8-10 shows another type of “cantilevered” pier, also without anchorage to the ground, which rocked and toppled over, allowing the home to drop.

Figure 8-10 “Cantilevered” steel pier on home requiring reinstallation.

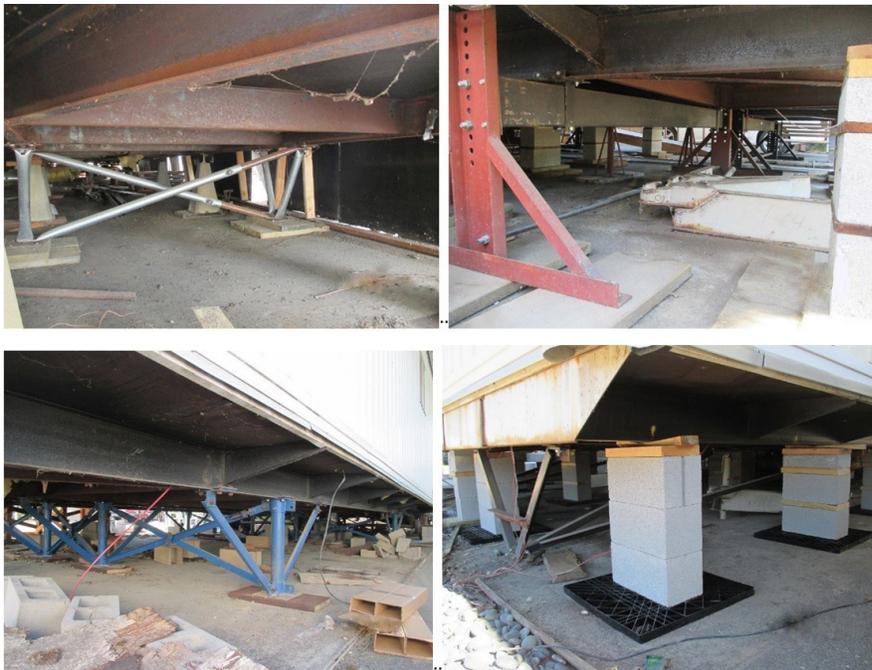
A number of homes were found to have identifiable ERBS at the time of the earthquake. These are designated as “diagonally braced” ERBS in this report, because they often had diagonal bracing members that engage more than one chassis beam. Dates of installation of ERBS were in some cases identified by residents to be the early 1980s, while others were more recently installed. Figure 8-11 illustrates some of these systems. These systems were typically seated on wood plates sitting on the ground, similar to the gravity piers and “cantilevered” pier systems. Unlike the “cantilevered” steel piers that were vulnerable to rolling over, these “diagonally braced” ERBS were observed to stay upright while the homes slid horizontally from a few inches to more than a foot. The “diagonally braced” ERBS appeared to be much more inherently stable under earthquake loading than the “cantilevered” piers.

Figure 8-11 “Diagonally braced” ERBS on homes requiring reinstallation.

Some homes with “diagonally braced” ERBS (Figure 8-11) were reported by the owners to not have moved at all or only moved a few inches; however, multiple homes with the “diagonally braced” ERBS installed were observed to have slid significantly during the earthquake, but not fallen or dropped appreciably. Figures 8-21 and 8-22 show significant sliding in one home with an ERBS. The gravity piers on this home are believed to have tipped and been reset upright for temporary support until the home can be moved back to its pre-earthquake position. Table 8-2 provides information on four homes with “diagonally braced” ERBS for which measurements or estimates of sliding were made. This extent of sliding was surprising, as significant horizontal movement in

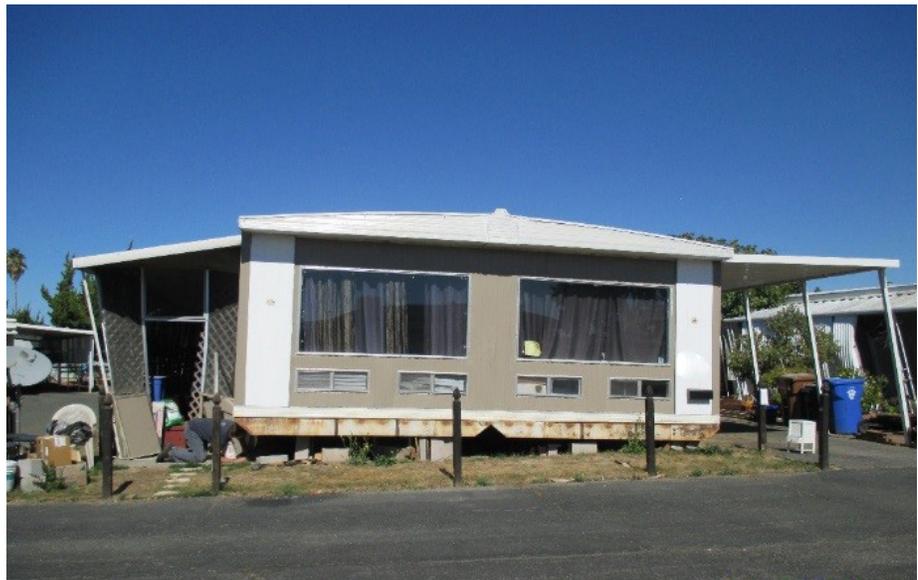
- Homes toppled off of support piers, as shown in Figures 8-13 and 8-14. Most often the home itself was not damaged; however, occasionally steel support piers punched through the floor as the home dropped. When the home falls off the supports, the outward swinging doors are often blocked, as occurred in the home shown in Figure 8-15. This damage can impede safe egress of occupants, requires reinstallation of the home, including lifting and placement back onto supports, and repair or replacement of damaged components. In addition, reinstallation of any

Figure 8-13 Home dropped from masonry gravity pier supports.

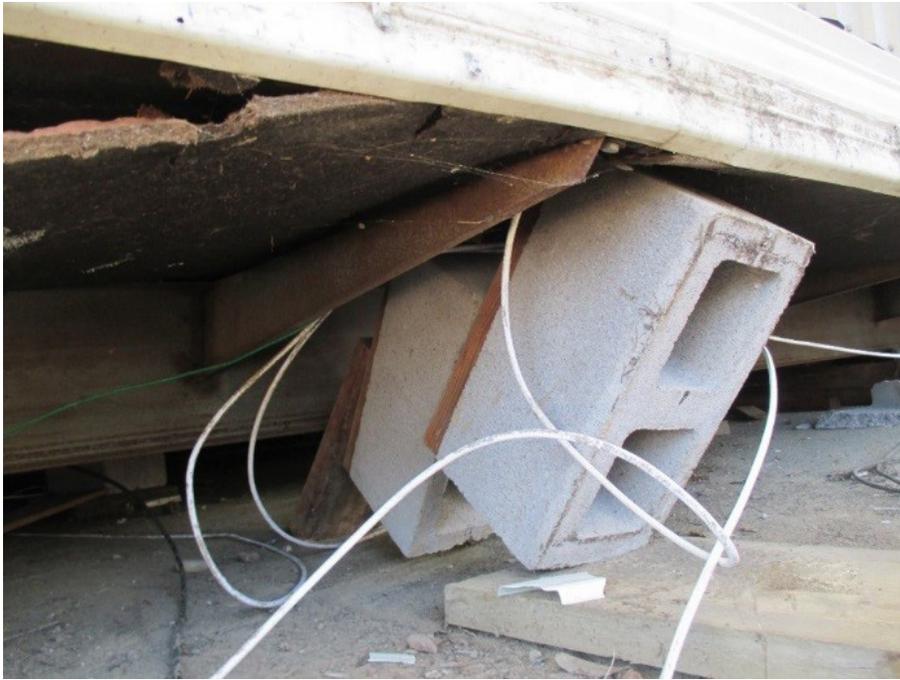
Figure 8-14 Close-up of toppled masonry gravity pier.

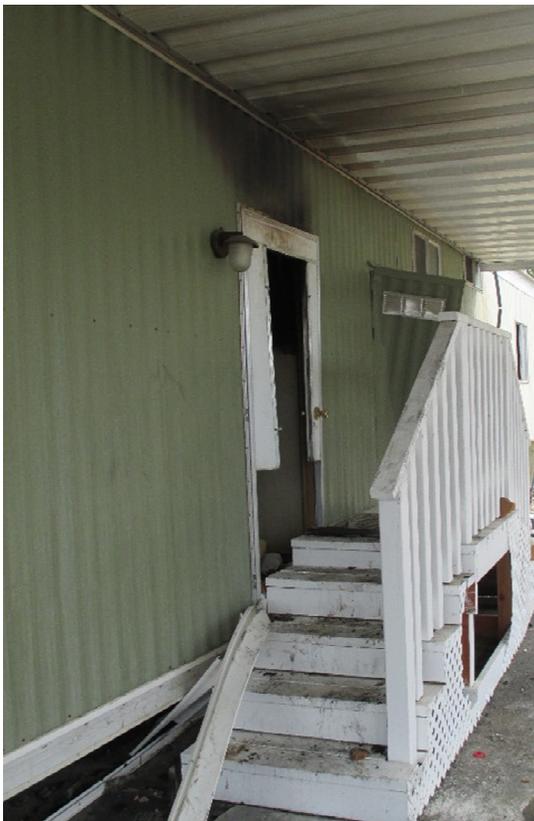
Figure 8-15 This door was blocked when the home dropped off of the gravity supports and had to be broken open by fire fighters.

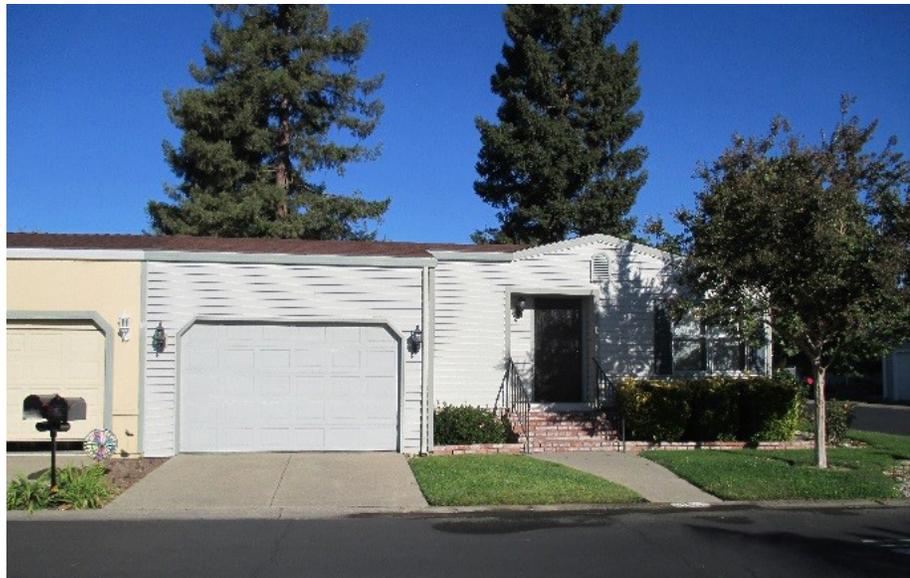
No homes in Oaktree Vineyard MHP (MHP 1 on Figure 8-17) were reported by HCD to require reinstallation following the earthquake. Homes in this park were installed over an approximate four year period in the 1980s. The homes in Oaktree Vineyard MHP are unique in a number of ways: (1) all of the homes are of the newer type; (2) each home, in addition to a porch, has an attached site-built enclosed garage (Figure 8-18) instead of a carport that is common in other MHPs; (3) the home siding appears to have been installed on site and is continuous with the garage and porch siding; (4) the roofing appears to have been installed on site, and the roofing is continuous between the homes and garages. In addition, the homes are most often installed in pairs, as is common for two-family dwellings in residential developments.

Figure 8-18 Oaktree Vineyard MHP typical home configuration.

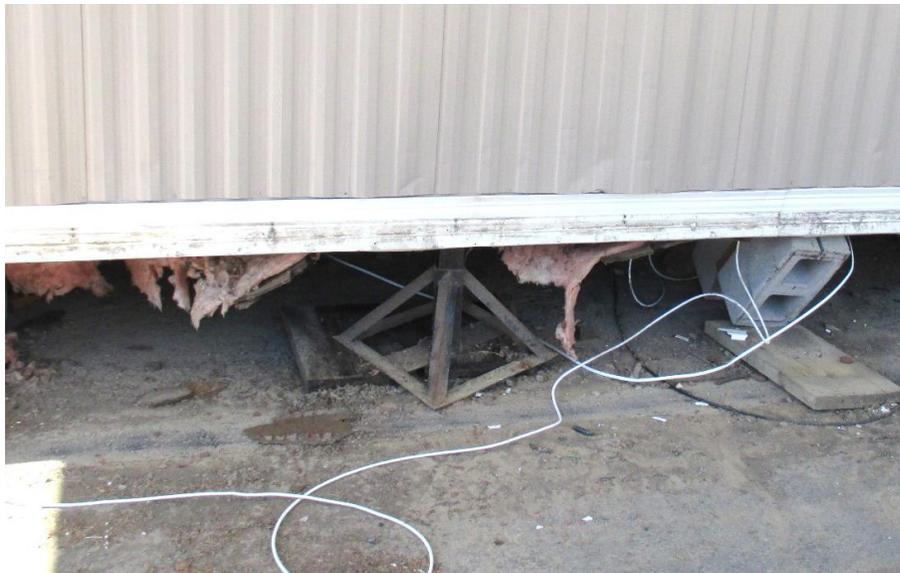
reinstallation prior to the site visits. The primary mode of behavior observed was rocking or sliding of the “cantilevered” piers (Figure 8-20), which were often not connected to the supporting wood boards. Some occurrences of the top of these piers punching through the home floor above were also observed.

Figure 8-20 “Cantilevered” pier system that slid, adjacent to a masonry pier that has rolled over.

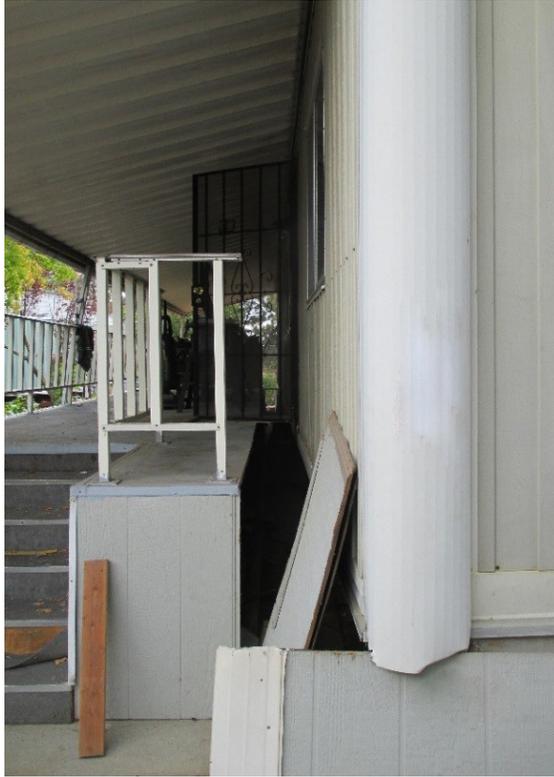
Figure 8-21 Gap between front porch and home on home with ERBS that slid a significant distance.

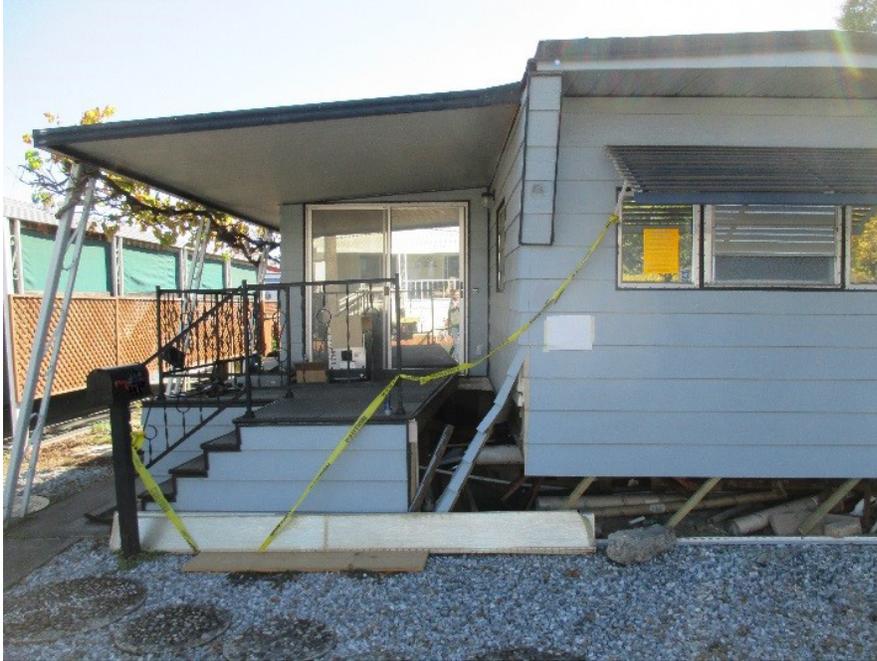
Similar to Salvador Mobile Estates, a number of homes at the Napa Valley MHP (MHP No. 5 in Figure 8-17) were observed to have very visible damage. Like in Salvador Mobile Estates, a notable number of units at the west end of the park were damaged and had moved, whether sliding or dropping, in a predominantly westerly direction (Figure 8-24). A handful of homes, however, were observed to be predominantly displaced in an easterly direction, and also experienced significant damage (Figures 8-25 and 8-26). It is possible that a ground displacement pulse is responsible for the damage in both the west and east directions.

Figure 8-24 Napa Valley MHP home displaced significantly to the west.

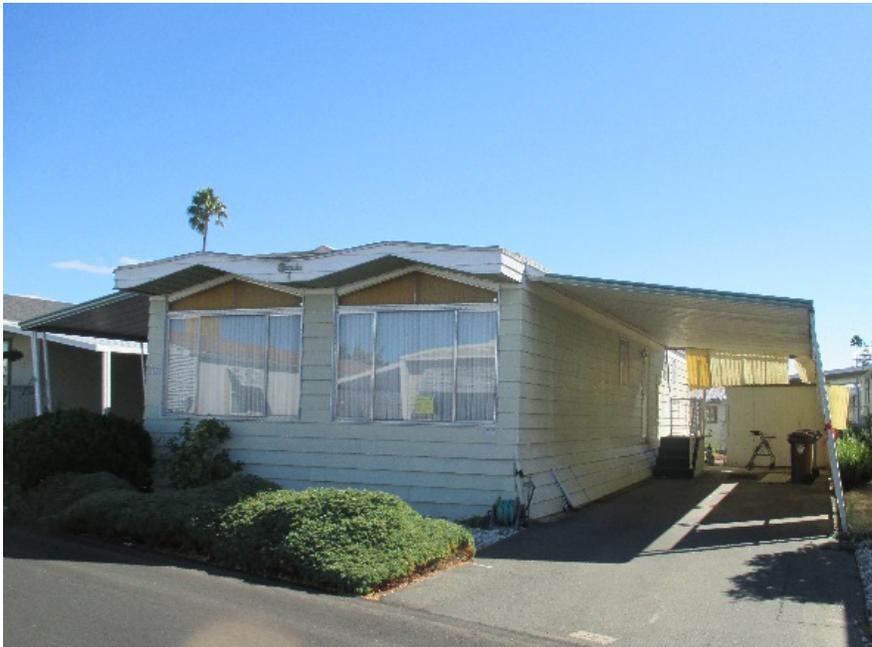
Figure 8-25 Napa Valley MHP home displaced significantly to the east.
