Performance of Buildings and Nonstructural Components in the 2014 South Napa Earthquake

FEMA P-1024 / February 2015

APPLIED TECHNOLOGY COUNCIL
201 Redwood Shores Parkway, Suite 240
Redwood City, California 94065
<http://www.atcouncil.org/>

FEDERAL EMERGENCY MANAGEMENT AGENCY
Michael Mahoney, Project Officer
Washington, D.C.

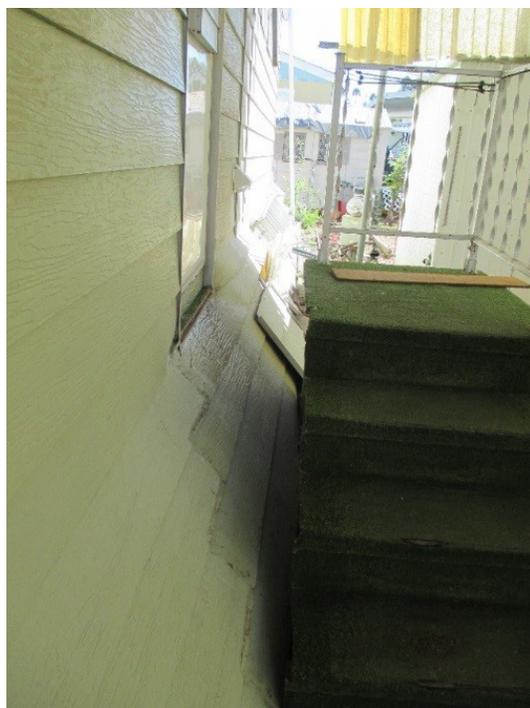
Figure 8-26 Entry stairs at Napa Valley MHP home that displaced significantly to the east.

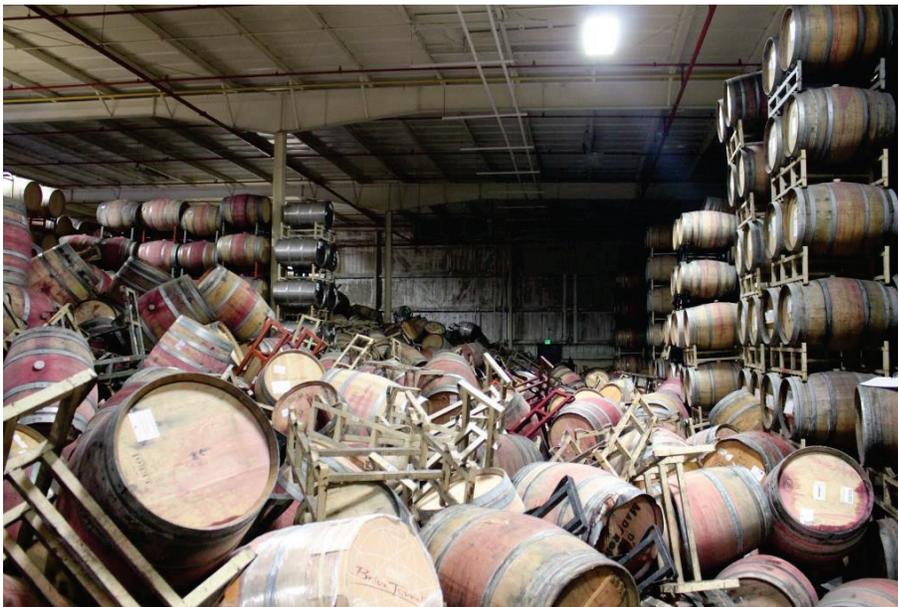
Production facility disruption was attributed to collapse of wine barrel stacks (Figure 9-1) and limited damage to full stainless steel wine tanks. The recovery efforts for the wine barrel stacks were very dangerous and time consuming. The piles of barrels were unstable and the threat of aftershocks resulted in a life safety risk to the employees engaged in the recovery operations.

Figure 9-1 Collapsed barrel stacks.

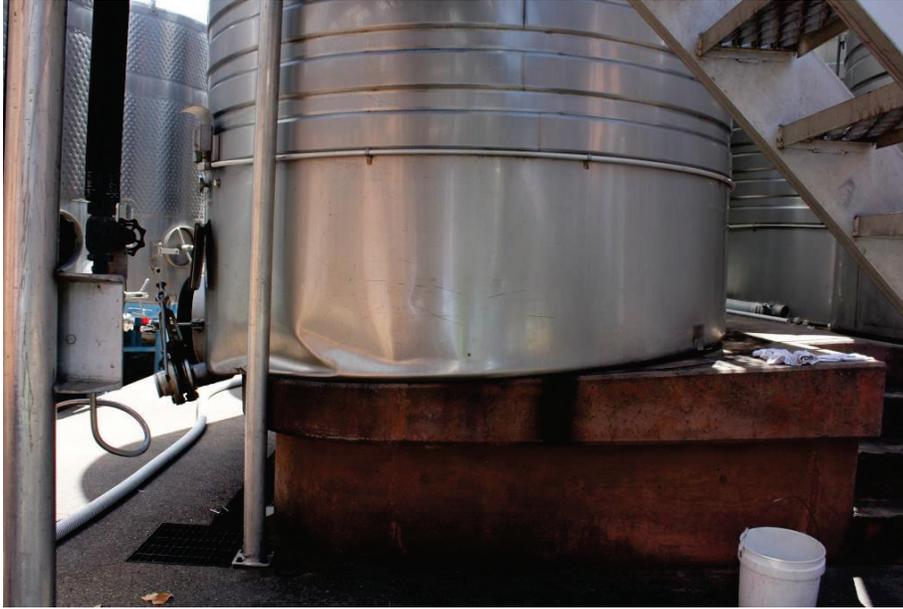
Tank anchorage appeared to play a part in the overall performance. Tanks with appropriately sized and spaced anchors performed well. Damage was limited to minor deformation of the bottom course of stainless steel in the structural wall. Tanks without anchorage shifted on the cellar floor or shifted on concrete pedestals (Figure 9-2). The movement of the tanks resulted in rupture of fixed glycol cooling lines and tank-supported catwalks. One tank-supported catwalk collapsed when the tank shifted off its concrete pedestal. Poorly anchored tanks had the worst performance. Some tanks with poorly-designed anchorage and limited number of anchorage points suffered failure of the tank wall at the anchorage. Wine was lost through the resulting hole in the tank wall on four 5,000 gallon tanks in the Oakville region. The tanks were anchored using a 1/4 inch weld, 4 inches long, between four steel embed plates in the concrete pedestal and the base of the tank.

Figure 9-2 Anchorage failure allowed tank to shift on pedestal.

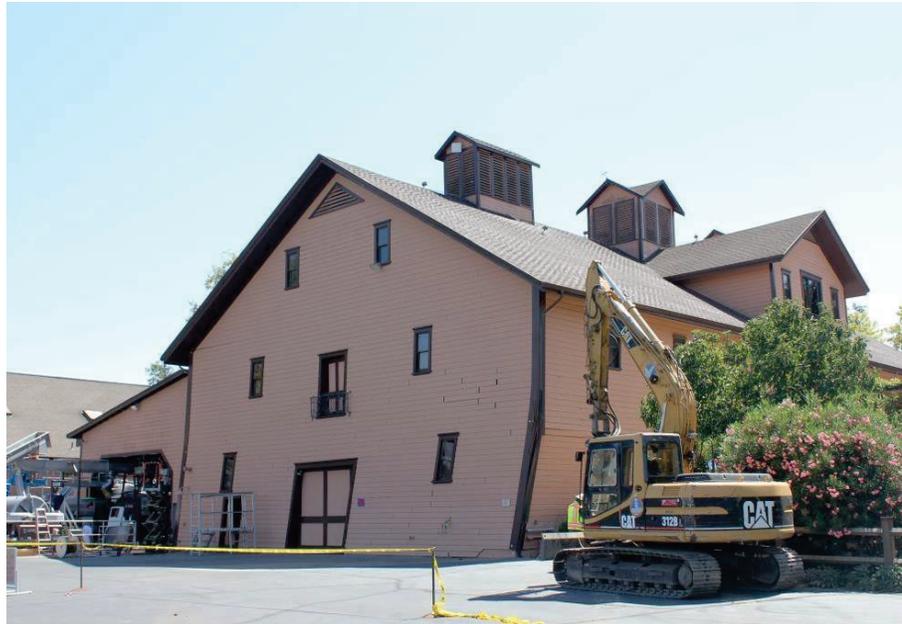
The three-story timber-frame winery building, built in 1886 sustained significant structural damage. The building was posted UNSAFE and will be repaired and returned to service. Full wine barrels, stacked on portable steel barrel racks (three levels tall), were stored on the second floor level. The mass of the barrels contributed to the shear failure of the exterior lap siding. Residual interstory drift at the first story was approximately 15%, with virtually no permanent drift at the second and third stories (Figure 9-3).

Figure 9-3 Historic timber-framed winery building with large residual drift at the ground floor.

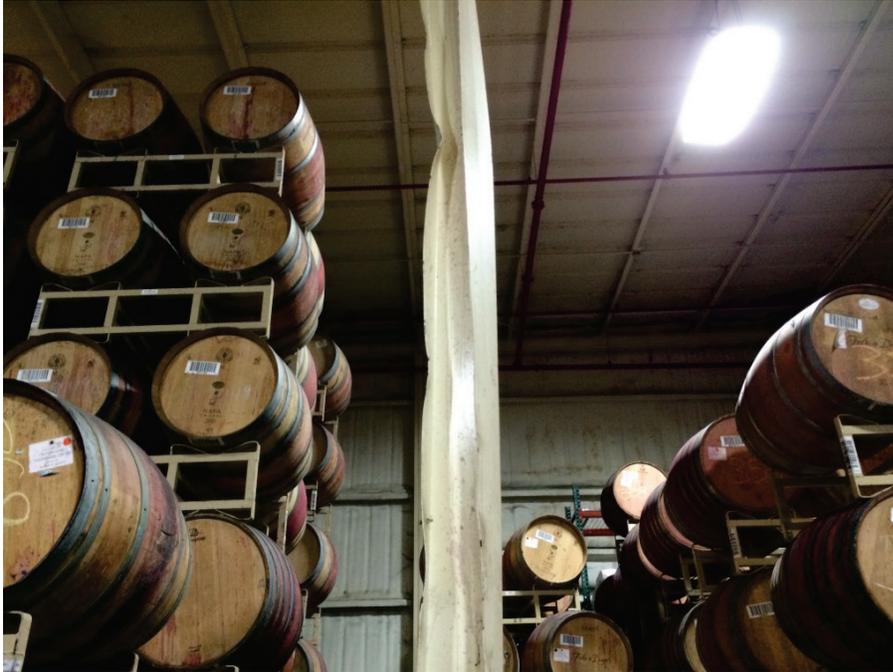
The facility sustained significant damage to the interior structural steel columns due to impact with toppling wine barrel stacks (Figure 9-4). The building was constructed circa 1970 and is a one-story, pre-fabricated metal structure. Damage was sufficient to require replacement of one third of the columns. No other structural damage was noted.

Figure 9-4 Steel columns damaged by impact of barrels.

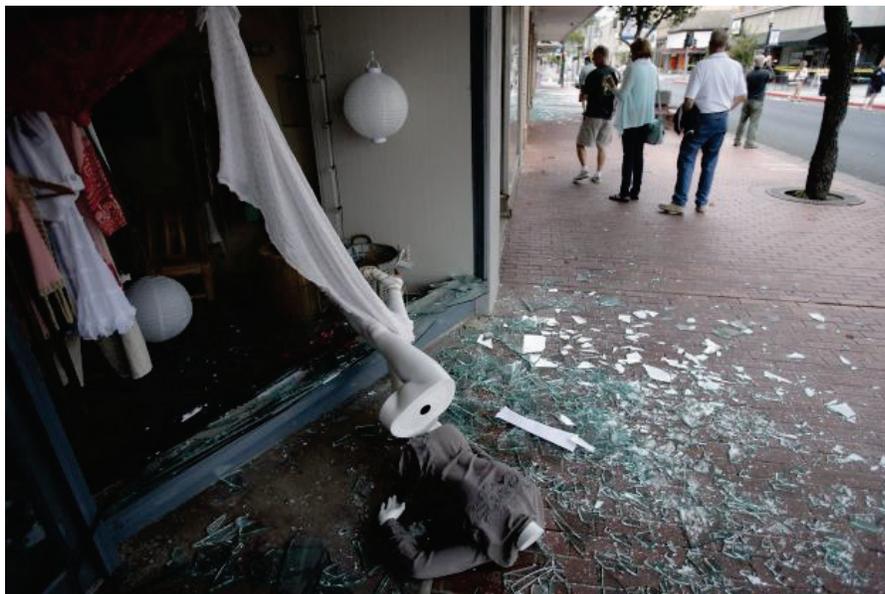
One-story unreinforced masonry buildings with open storefronts within the 1,000 foot radius sustained losses of up to 60% of the storefront glazing (Figure 10-1). In retrofitted unreinforced masonry buildings, glazed storefront damage was more pronounced on building elevations where lateral resistance was provided by moment frames, compared to buildings with stiffer lateral force-resisting systems. The building in Figure 10-2 was retrofitted with a steel moment frame along the front. The stiffness of the steel frame appears to have been insufficient to limit drift sufficiently to protect the glazing.

Figure 10-1 Broken glass at open storefront on an unreinforced masonry building.

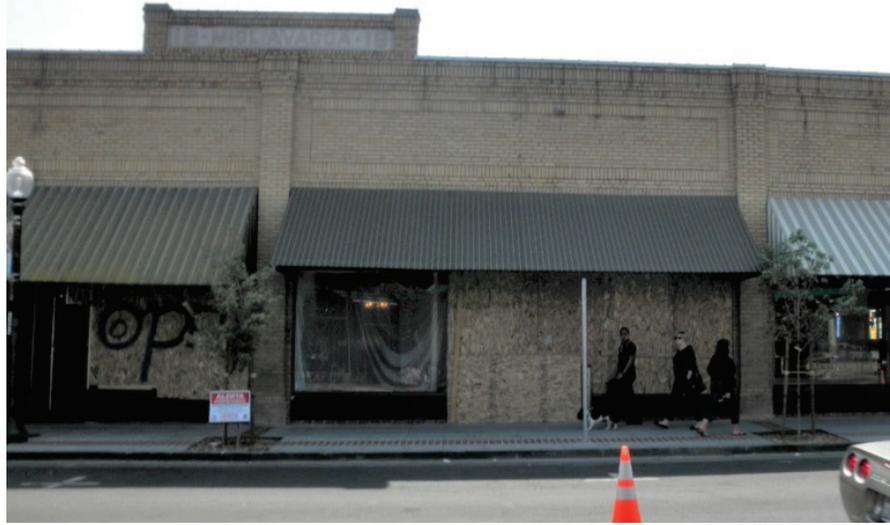
Figure 10-2 Typical condition showing temporary plywood barricades and plastic over openings where storefront glazing was damaged.

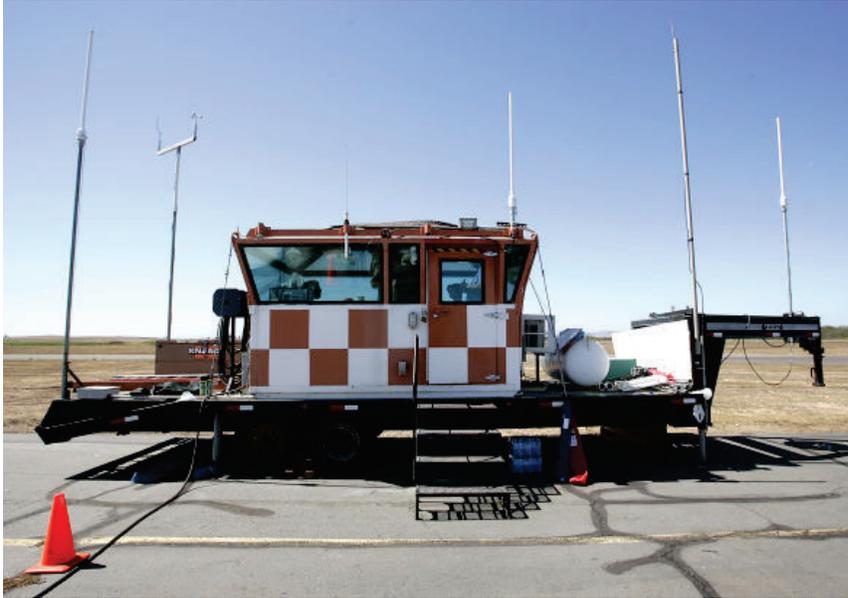
Nine of the ten plate-glass windows in the Napa County air traffic control tower, each 3/4” thick, were shattered during the earthquake (Figure 10-3). No employees were present during the earthquake, because the Napa tower operates only between 7 a.m. and 8 p.m. Consequently, there were no injuries. No structural damage was reported. A temporary tower was brought to the site to allow for continued use of the airport (Figure 10-4).

Figure 10-4 Temporary air traffic control tower.

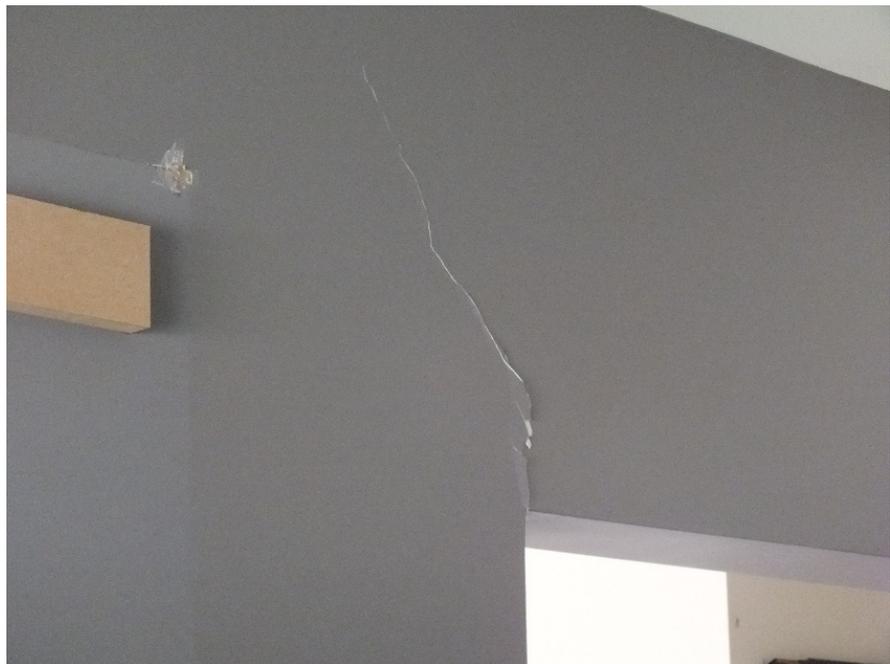
Within 1,000 feet of Station N016, the interiors of 40 buildings were observed. Partition damage was described as “insignificant” or “none” in 91% of the buildings with interiors observed. Damage was reported as “minor” in 6% of the buildings. Two buildings were reported with “moderate” damage and none was described as “heavy.” The buildings with moderate partition damage also suffered consequential damage due to damaged sprinkler piping, which released water for an extended period. As a result of water damage, large areas of gypsum wallboard sheathing required removal and replacement in these buildings (Figure 10-7). In virtually all other cases, repair could be accomplished with local patching and painting (Figure 10-8 and 10-9).

Figure 10-8 Typical damage to gypsum wallboard.

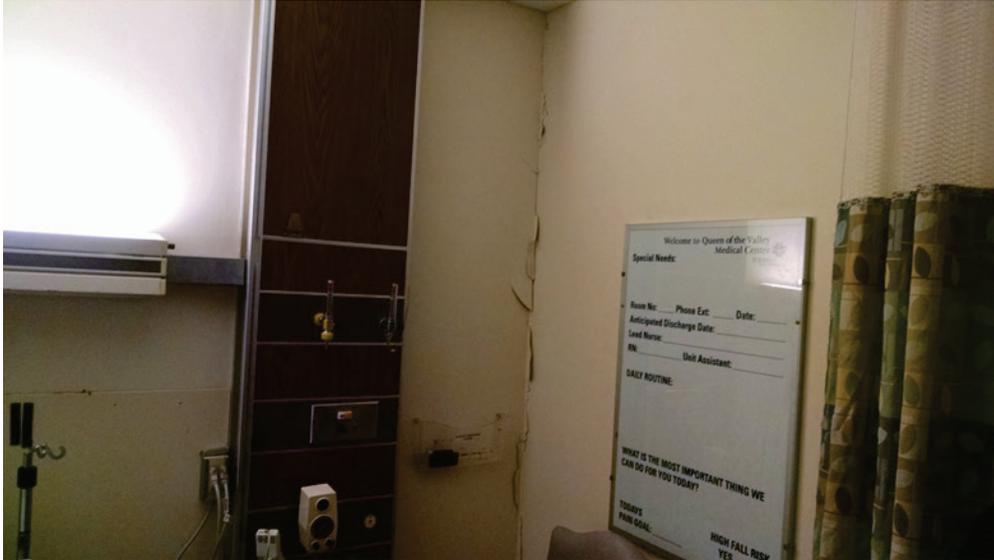
Figure 10-9 Damage to gypsum wallboard at corner (photo from OSHPD).

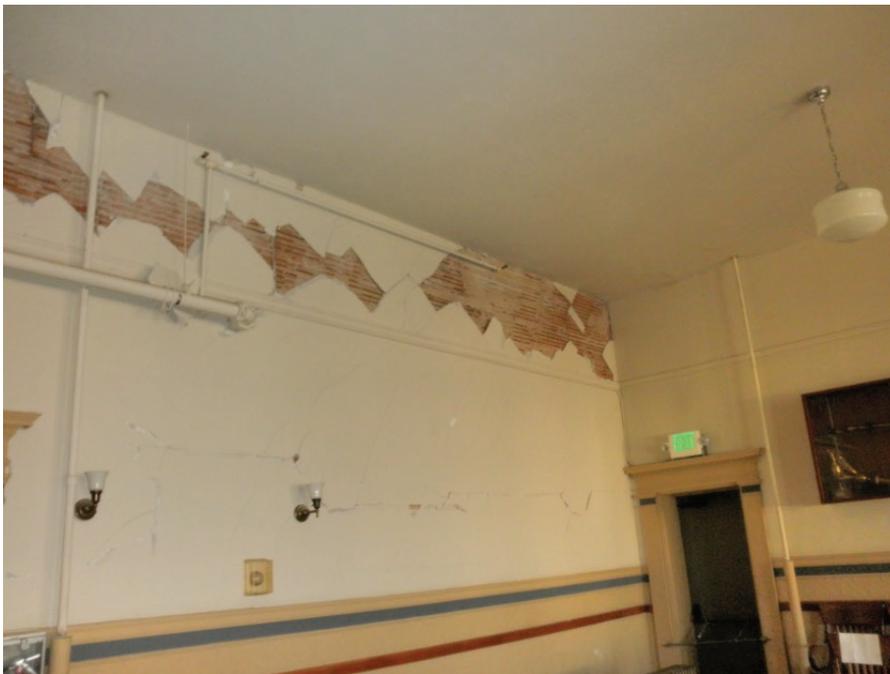
Older buildings with lath and plaster wall finishes sustained more significant damage in the form of cracking and spalling (Figure 10-10).

Figure 10-10 Cracked and spalled plaster on lath and plaster wall.

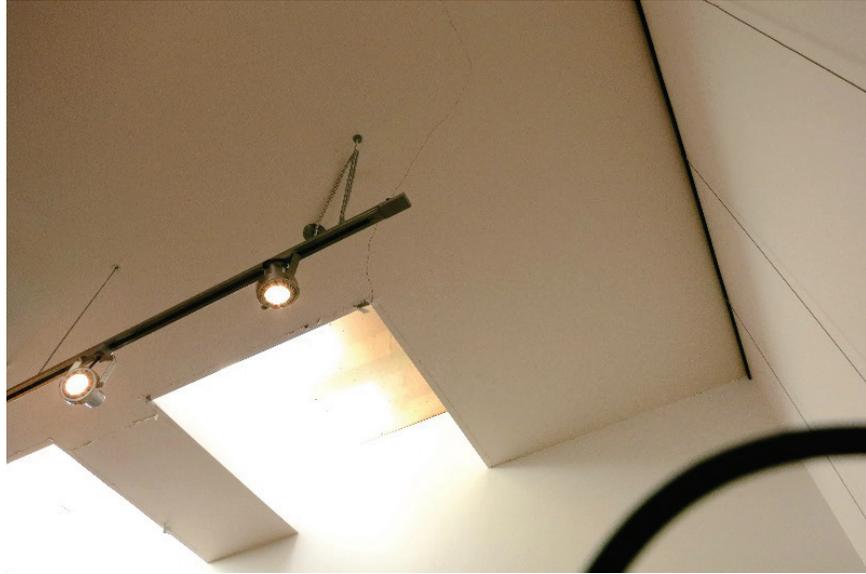
Gypsum wallboard ceilings fastened directly to structural framing generally performed well. Minor cracking was observed at some locations (Figure 10-11). Older plaster ceilings did not perform as well as gypsum ceilings. Spalling and cracking of these ceilings were observed in multiple buildings (Figure 10-12 and Figure 10-13).

Figure 10-11 Cracking of gypsum wallboard ceiling.

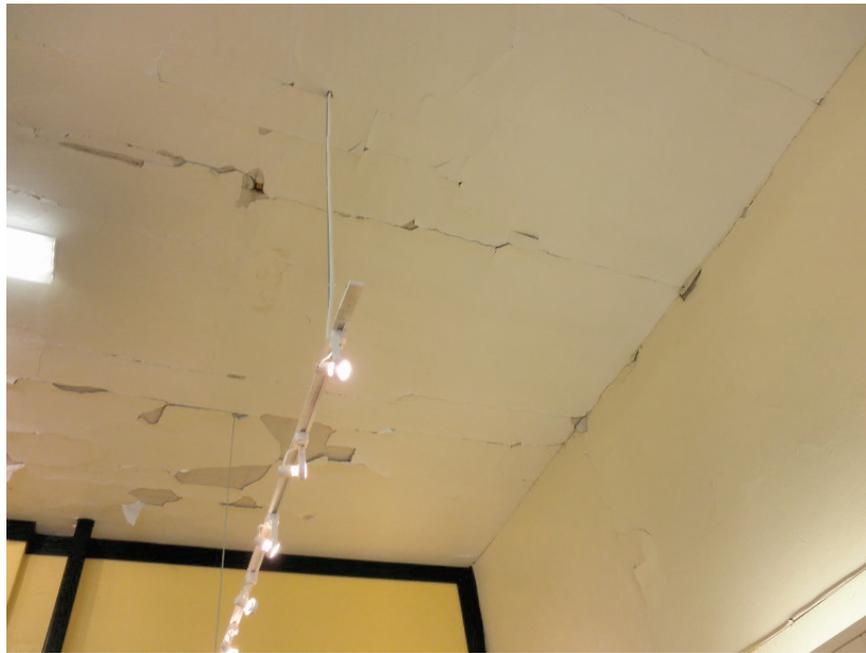
Figure 10-12 Cracking and spalling of a plaster ceiling in an older masonry building in downtown Napa.

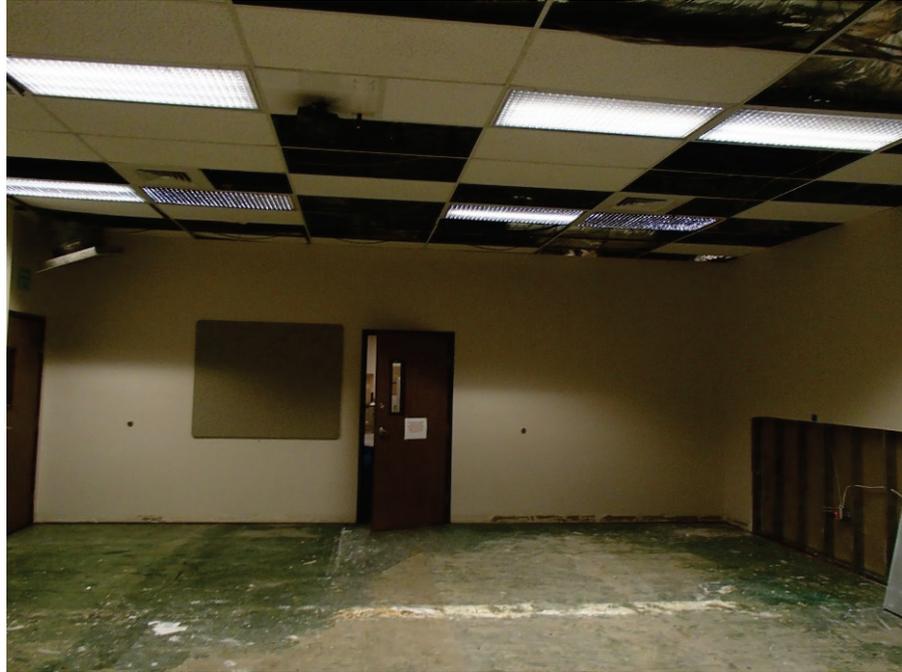
The most commonly observed form of damage to suspended acoustic tile ceilings was fallen tiles (Figure 10-14). Failure of splices in the ceiling grid members, as well as damage at the “fixed” and “free” ends of the ceiling grid, were observed in several buildings. Figures 10-15 through 10-17 illustrate a ceiling estimated to be 20 years old that included diagonal wire bracing without compression posts. Although reinstalling or replacing tiles occurred quickly, failure of the grid itself required an extended period to restore. In extreme cases of damage, removal and replacement of the entire ceiling was required.

Figure 10-14 Acoustic ceiling where tiles fell in an office building.

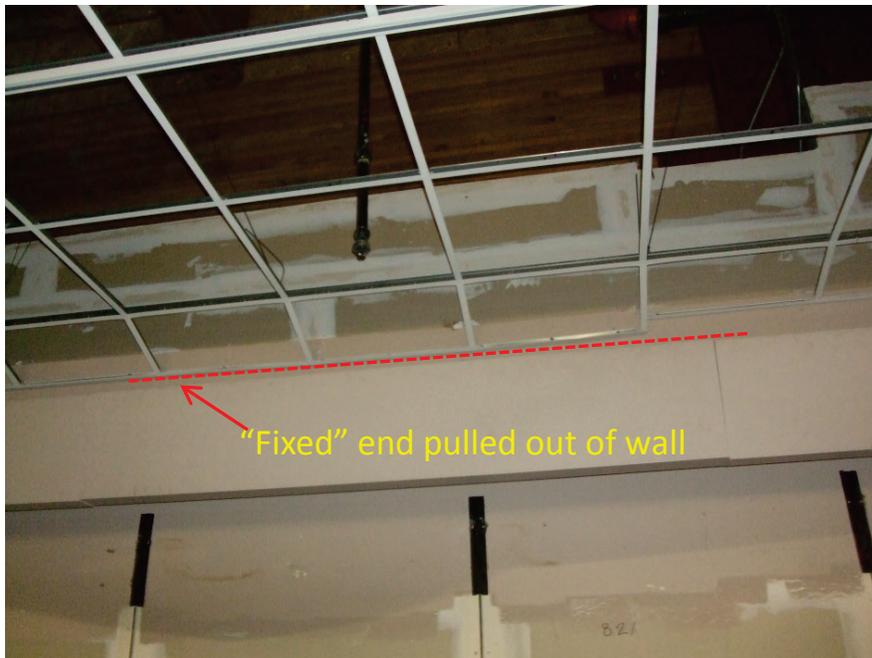
Figure 10-16 Failure of “fixed” end support of the acoustical tile ceiling grid in a two-story retail store in downtown Napa.

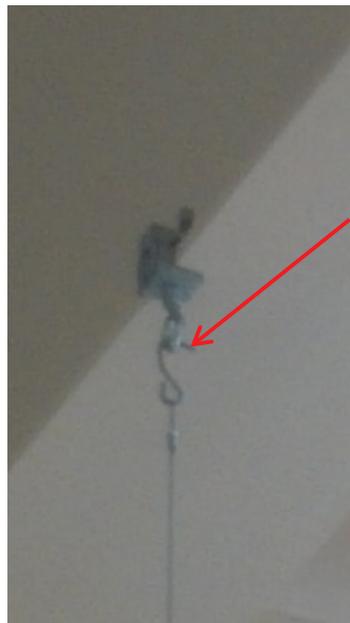
At a grocery store on Trancas Avenue, Napa, the primary lighting in the store, which was constructed within the past ten years, consisted of pendant fixtures suspended over the aisles. The 1 foot by 4 feet fixtures were connected end-to-end and mounted directly to struts that were in turn connected via aircraft cable to an “S” hook that connected to an eyebolt fastened to the structure. Approximately 10% of the fixtures fell because the “S” hook opened up under the combined forces due to seismic loads and the weight of the lights (Figure 10-18). The connection detail is shown in Figure 10-19.

Figure 10-18 “S” hook opened during earthquake and caused fixtures to drop.

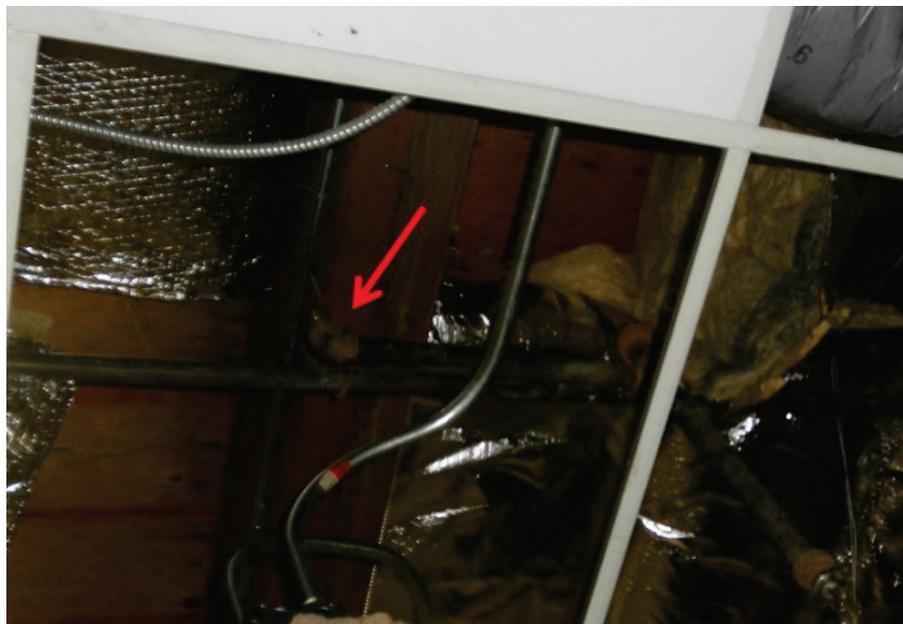
The county office building on 1st Street, Napa (Building C4) is a two-story concrete shear wall structure with a mezzanine. This building sustained extensive damage when a single sprinkler head on third floor above the ceiling began discharging water after it impacted either a U-hanger for the branch line or an adjacent wood beam (Figure 10-20). The sprinkler system could not be shut off, and the sprinkler ran for five hours. All partition walls and floor coverings sustained extensive water damage. The building was expected to be out-of-service for several months.

Figure 10-20 Sprinkler head interaction with adjacent components resulted in extensive flooding.

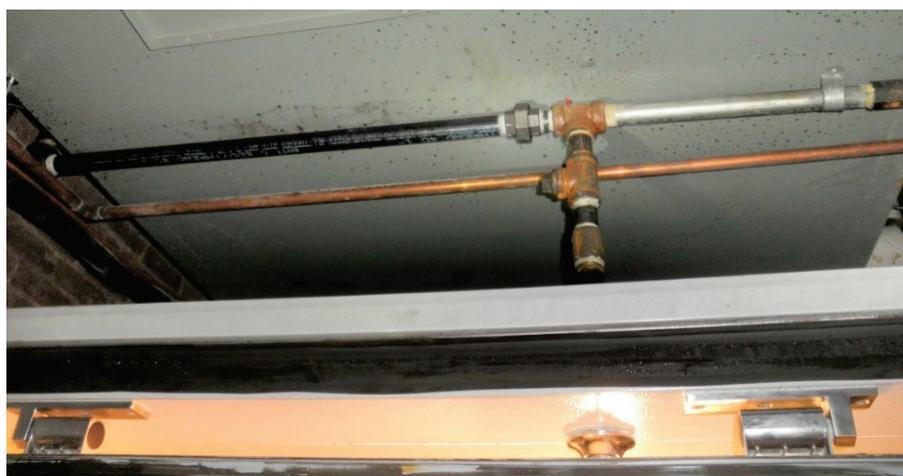
A single sprinkler line failed at a threaded fitting and flooded the first floor of a three-story theater building on Main Street in Napa (Building L2) (Figure 10-21). The water to the fire sprinkler system could not be shut off because the valve was locked in the open position. The fire pump activated and continued to run, and the flooding continued for about nine hours. The hardwood floor in the first floor warped and in some areas buckled. In addition, some of the partition finishes were damaged by the water and had to be replaced. The building was closed for a week to dry out the flooring and repair water damage.

Figure 10-21 Repaired condition of a failed pipe at threaded connection that resulted in flooding of the first floor restaurant.

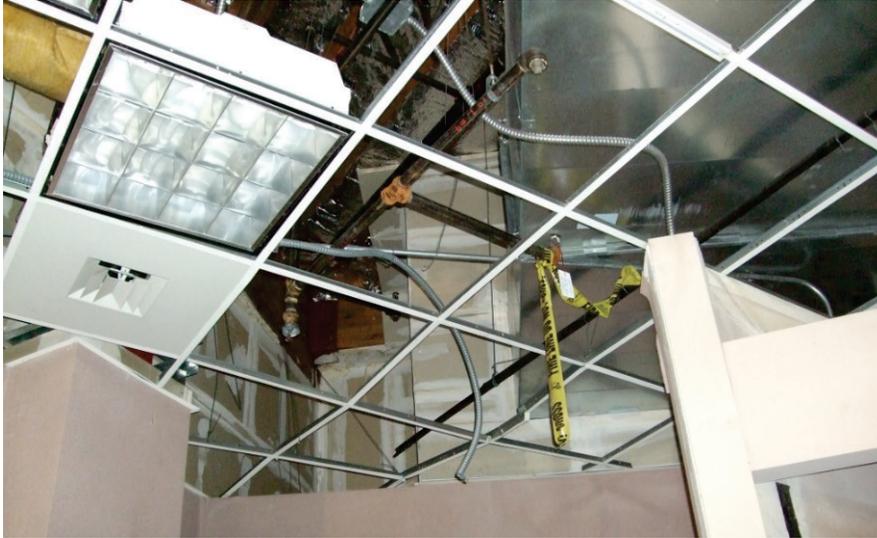
Five sprinkler lines suspended from the roof of a two-story retail building in the Napa Town Center reportedly broke and remained on for several hours. The sprinkler piping had threaded connections and damage appears to have been related to swaying and interaction with adjacent HVAC components (Figures 10-22 and 10-23). The elevator and escalator pits were flooded and both systems required repair. Contents were damaged as a result of the water; and considerable amounts of gypsum wallboard were damaged and required removal.

Figure 10-22 Sprinkler piping in close proximity to HVAC components.

- The interaction of fire sprinkler piping with other MEP components warrants further study. The current practice of using unbraced sprinkler drops and armovers may be contributing to adverse interactions, as well as failure to specify adequate clearance between piping and other components. The role of bracing or other means to prevent damaging interactions should be explored. Also, the importance of maintaining clearances with other obstructions is critical and standard requirements need to be maintained.

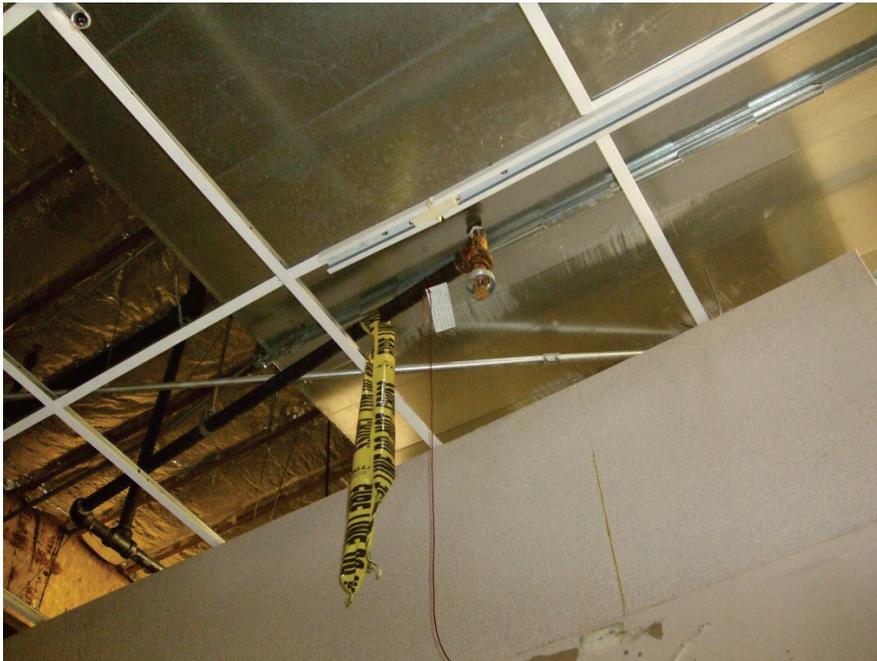
Figure 10-23 Sprinkler armover in close proximity to HVAC components.

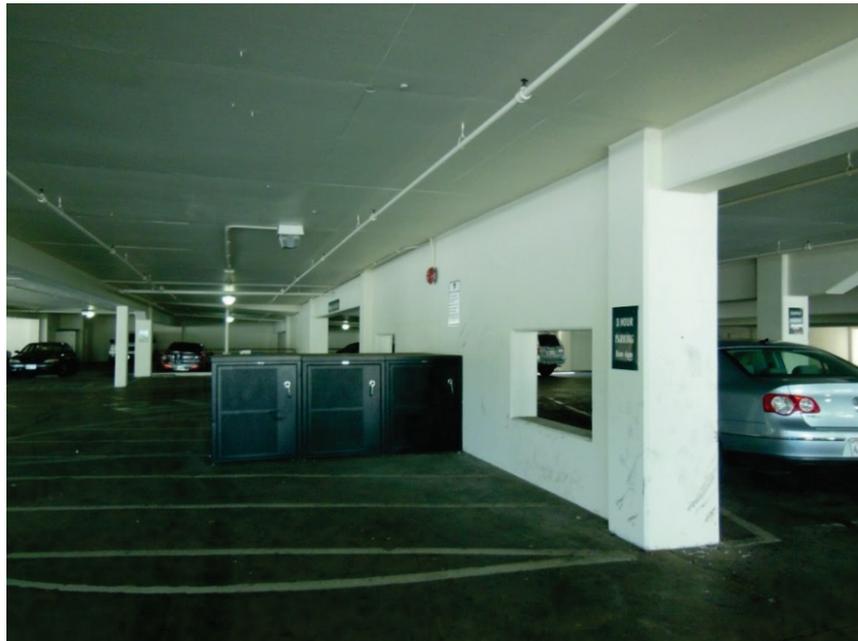
Unbraced sprinkler pipes in a parking garage in downtown Napa supported with threaded rods and powder driven fasteners sustained several types of damage including permanently bent threaded rod hangers and pullout or failure of powder driven fasteners (Figures 10-24 and 10-25). No water release was reported. This type of fastener is no longer permitted by the building code and the city is not allowing its use for repairs.

Figure 10-24 Sprinkler installation in parking garage.

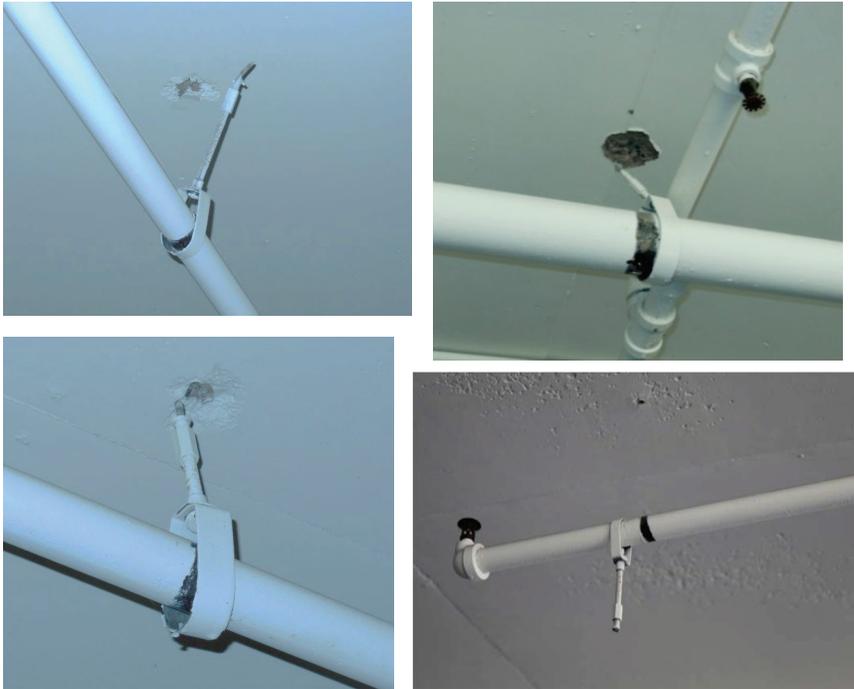
Figure 10-25 Failures of powder driven fasteners. Bottom right photo is from PEER (2014).

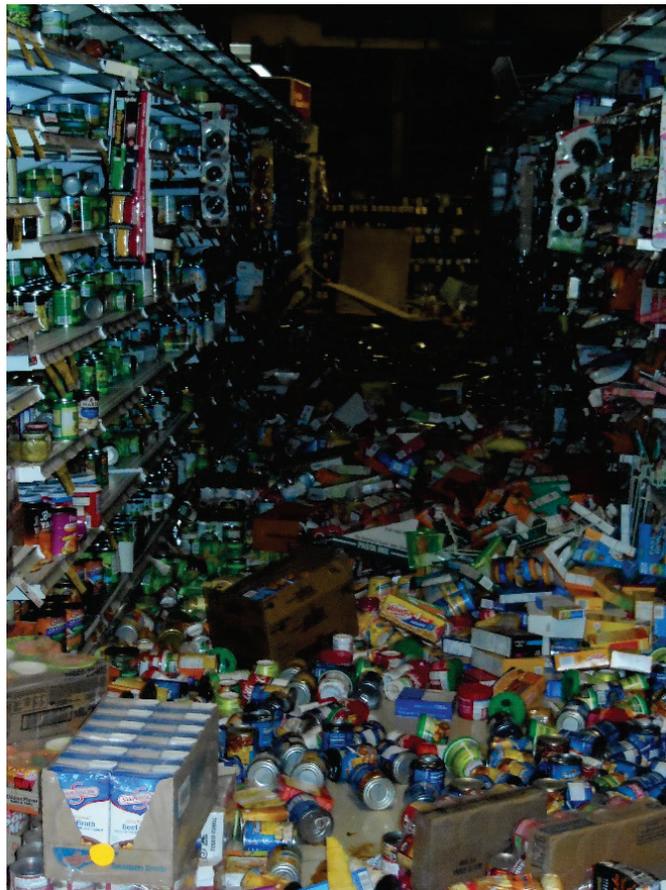
- The majority of retail stores, including wine and olive oil shops, and restaurants, experienced loss of product from shelving (Figures 10-26 and 10-27). An example of a wine storage rack in a retail store where no bottles were lost is shown in Figure 10-28.
- In some stores, unanchored shelving racks or storage units overturned into aisles (Figure 10-29)
- Some office furnishings overturned or shifted, posing a life-safety hazard had the spaces been occupied at the time of the earthquake (Figure 10-30)

Figure 10-26 Contents dislodged from grocery store shelves.

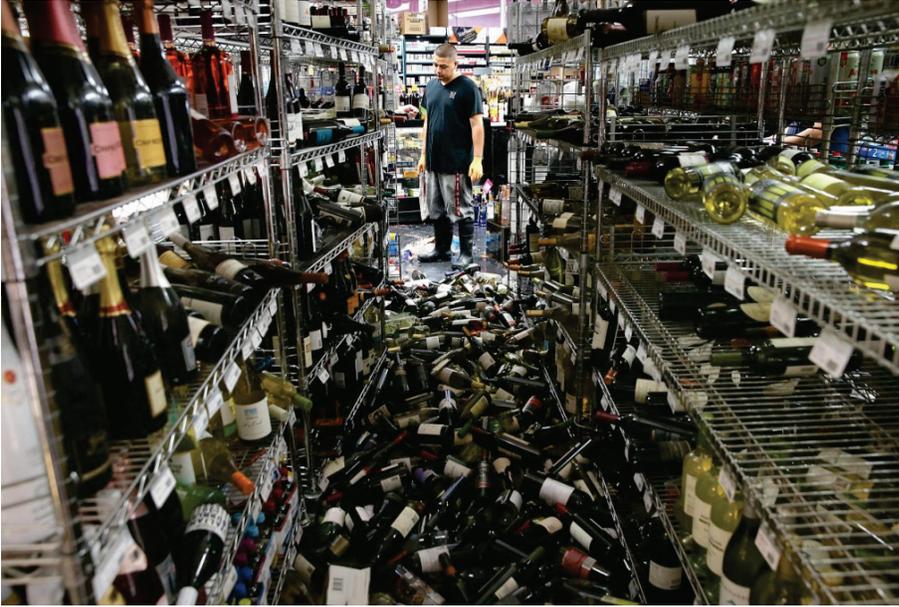
Figure 10-27 Loss of products from shelves.

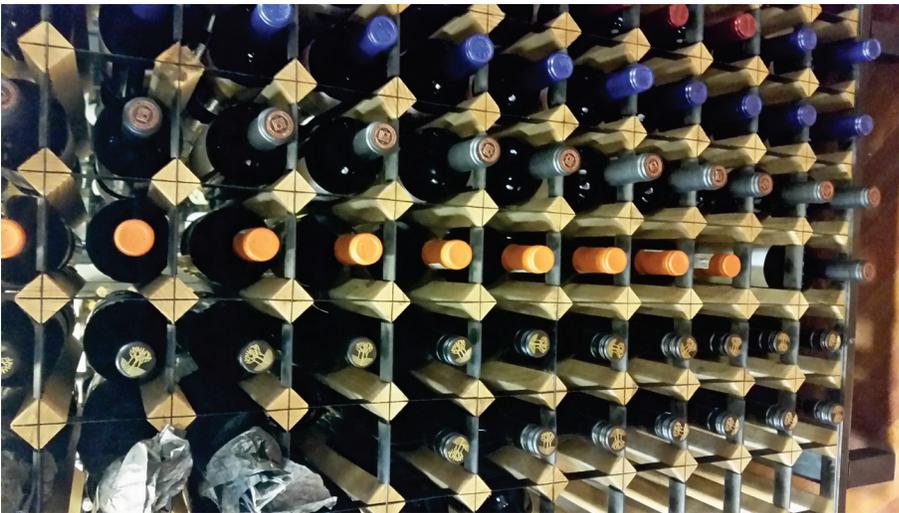
Figure 10-28 Wine storage rack in retail store that did not lose a single bottle of wine in the earthquake. The storage racks were modular units of interlocking wood and metal slats. The wine bottles sat on two metal slats, one supporting the lower bottle body and a front one supporting the bottle neck. The bottle shoulder sat below the front slat that kept the bottles from sliding out.

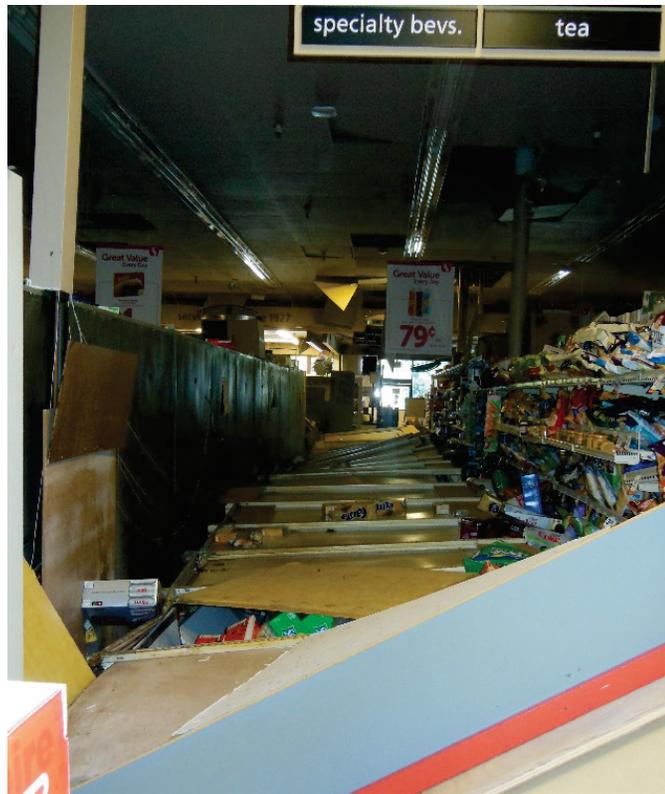
Figure 10-29 Unanchored fixtures overturned in aisle.

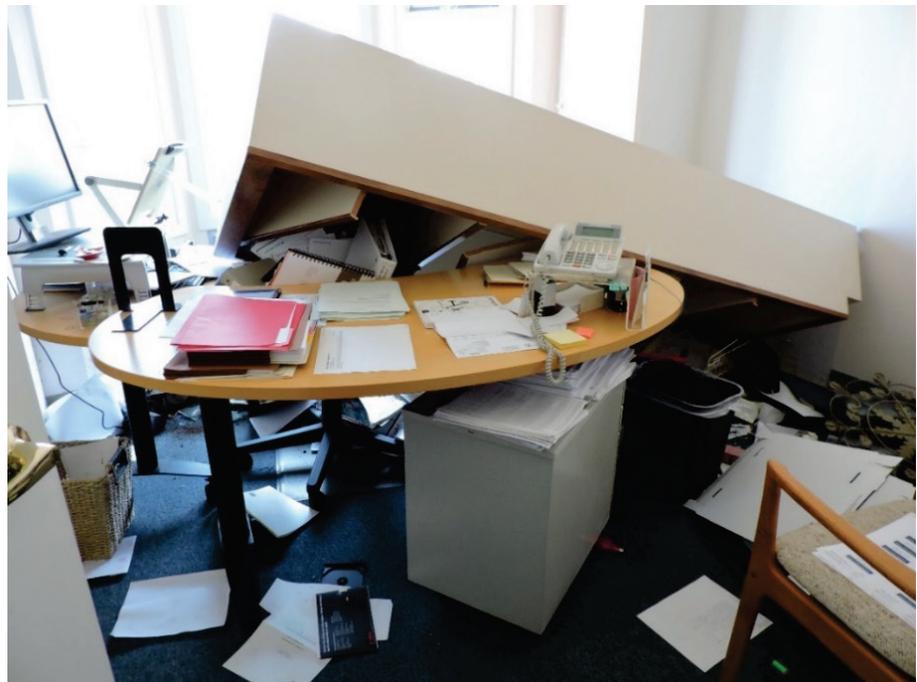
Figure 10-30 Overturned unanchored bookshelf.

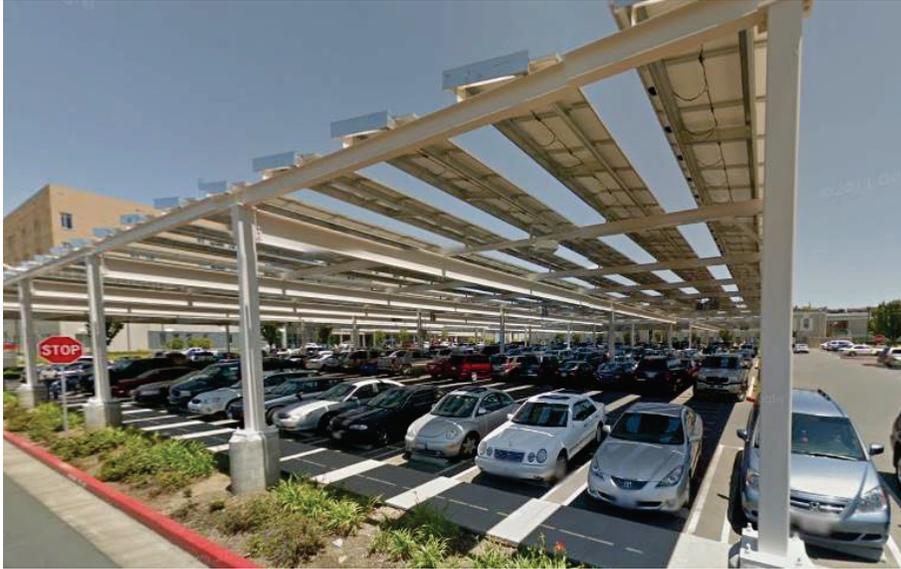
This array was mounted on a steel framework over a parking lot (Figure 10-33). Steel tube columns were anchored to cylindrical concrete pedestals that extend approximately three feet above grade. Wide-flange girders frame into columns and wide-flange beams run across the top of columns and girders. Rows of solar panels are located on the top of the beams. The lateral force-resisting system appears to be either an ordinary steel moment frame or a cantilever column system. There was no reported interruption in power from this array or damage to the supporting system.

Figure 10-33 Ground-mounted solar canopy over parking lot (photo from Google Street View). No damage reported.

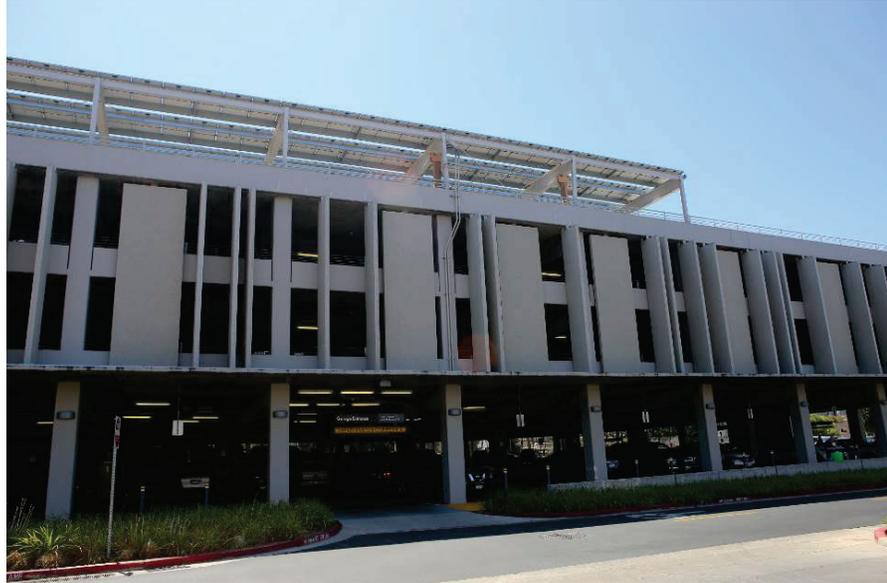
Site personnel reported that the top level of the parking garage was posted RESTRICTED USE because of damage to the array, and power from the array was shut down. The company that owns and operates the array through a power-purchase agreement obtained a permit from the City of Vallejo and performed repairs approximately two weeks after the earthquake.

Figure 10-34 Parking garage with solar canopy structure on roof (photo by Jiun-Wei Lai).

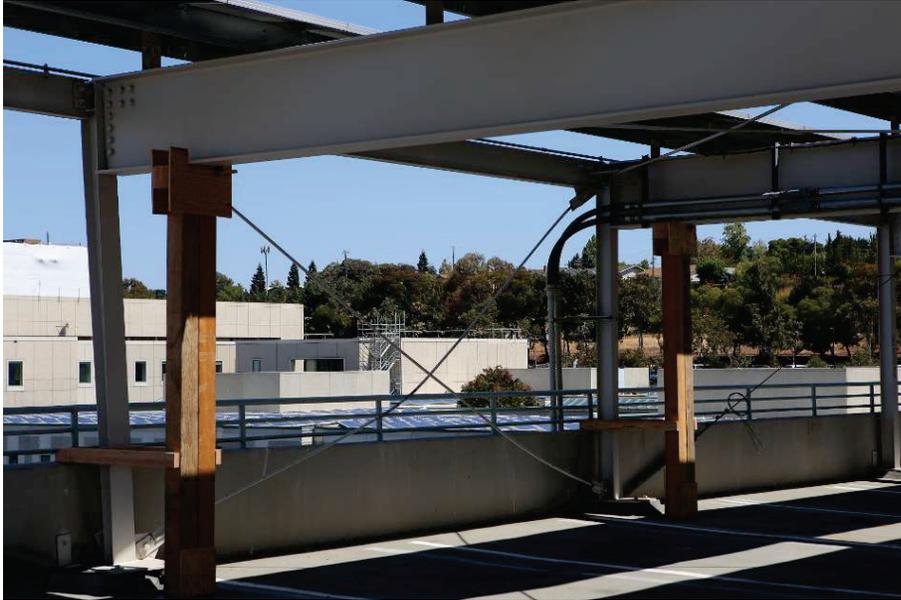
The earthquake caused elongation of steel X-bracing rods (Figure 10-36), and breakout or crushing of grout around column anchor bolts under column base plates (Figures 10-37 and 10-38). The configuration of the baseplates and anchor bolts was eccentric with respect to X-bracing rods, amplifying the shear demands on the anchor bolts.

Figure 10-36 Elongated steel X-bracing rods. Note residual drift in the shored column to the left (photo by Jiun-Wei Lai).

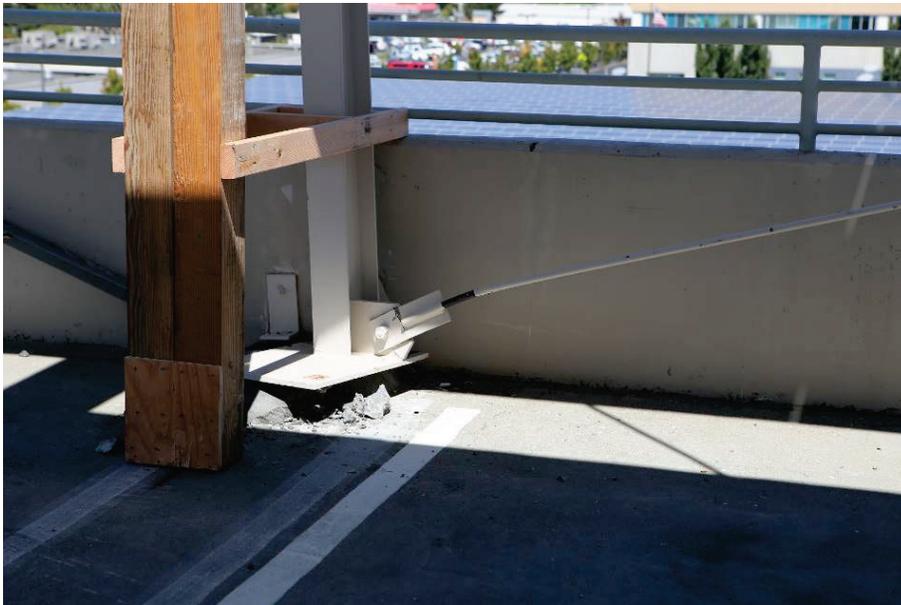
Figure 10-37 Possible plastic strain of steel rod X-bracing adjacent to gusset plate. Column has twisted due to eccentric configuration of rod bracing and anchor bolts. Anchor bolt breakout or grout crushing occurred beneath column baseplate (photo by Jiun-Wei Lai).

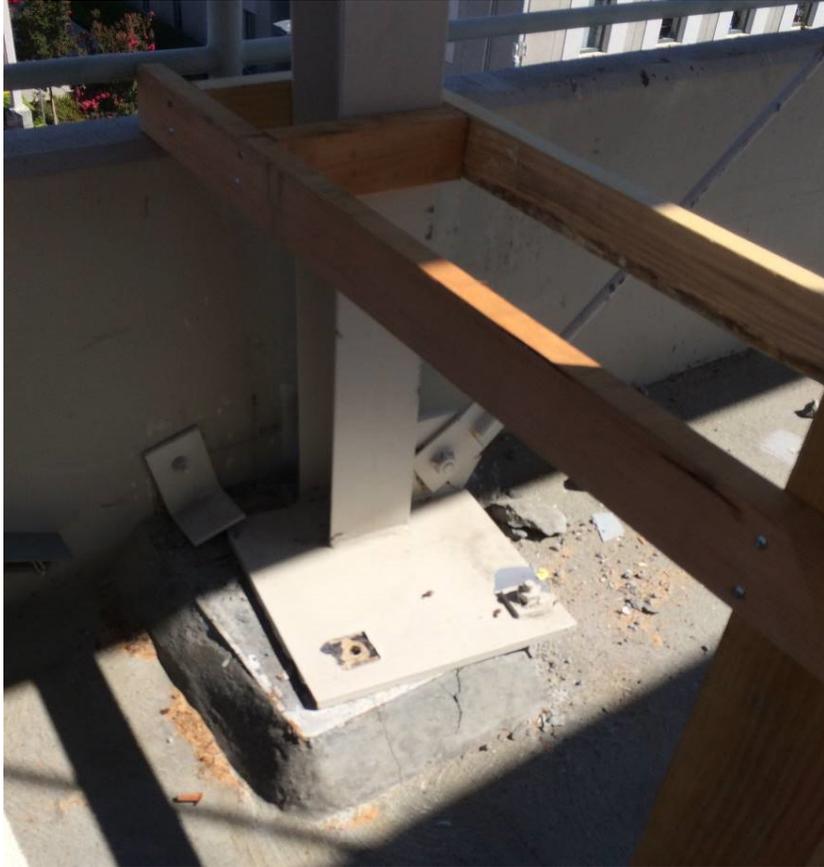
Figure 10-38 Clip angle is anchored to the concrete wall but not attached to column baseplate. Note eccentricity between the X-bracing rod and the column anchor bolts (photo by John Silva).

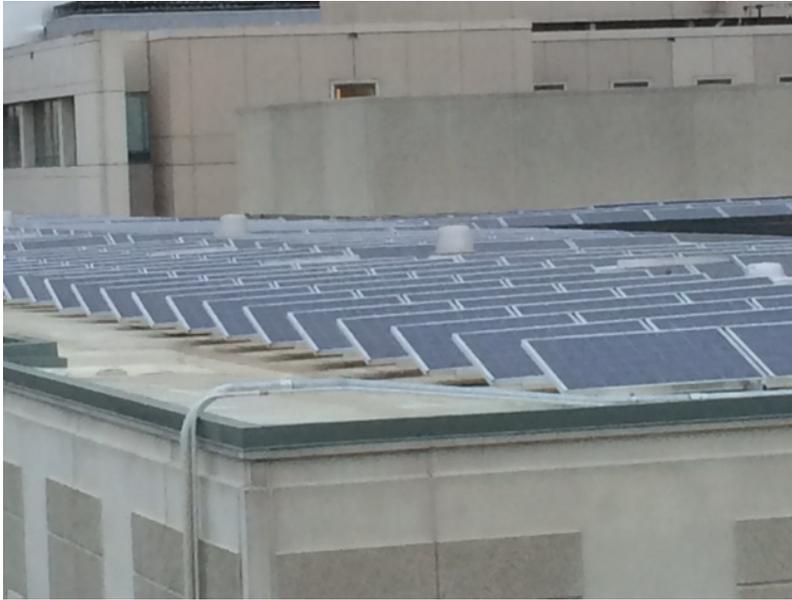
It is reported that the rooftop array did not displace. No interruption in power production from this array was reported. The building itself was reported to suffer minor nonstructural damage (some drywall cracking, falling ceiling tiles, and damage to sprinkler escutcheons were reported). No structural damage to the building was reported.

Figure 10-39 Low-profile unattached (ballast-only) solar array on roof of medical office building (photo from Kaiser Permanente). No damage was reported.

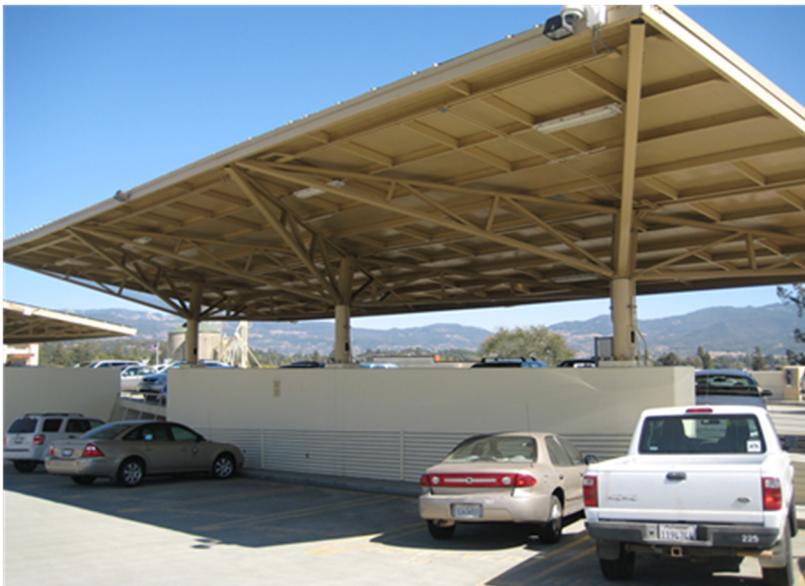
This rooftop array on top of the parking structure on 5th Street in Napa is supported on a steel framework constructed with round HSS steel cantilever columns (Figure 10-40). Columns have baseplates with anchor bolts into the top of a concrete wall that is part of the building structure. There was no observed or reported damage and no apparent loss of power.

Figure 10-40 Roof-mounted solar canopy on top of parking garage structure. No damage was reported.

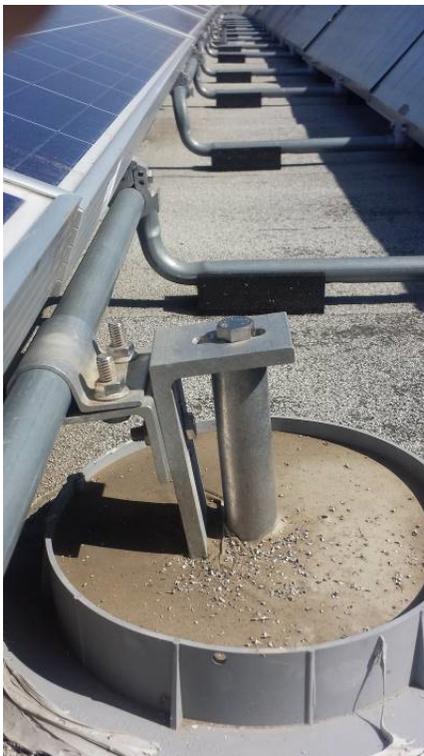
Figure 10-43 Mechanical attachment of solar array on the roof of an office/warehouse building two miles east of earthquake epicenter (photo from PanelClaw, Inc.). Array includes ballast and mechanical attachments to the building roof at selected locations. Mechanical attachments are evenly distributed throughout the array and typically showed similar evidence of possible movement.
