Performance of Buildings and Nonstructural Components in the 2014 South Napa Earthquake

FEMA P-1024 / February 2015

APPLIED TECHNOLOGY COUNCIL
201 Redwood Shores Parkway, Suite 240
Redwood City, California 94065
<http://www.atcouncil.org/>

FEDERAL EMERGENCY MANAGEMENT AGENCY
Michael Mahoney, Project Officer
Washington, D.C.

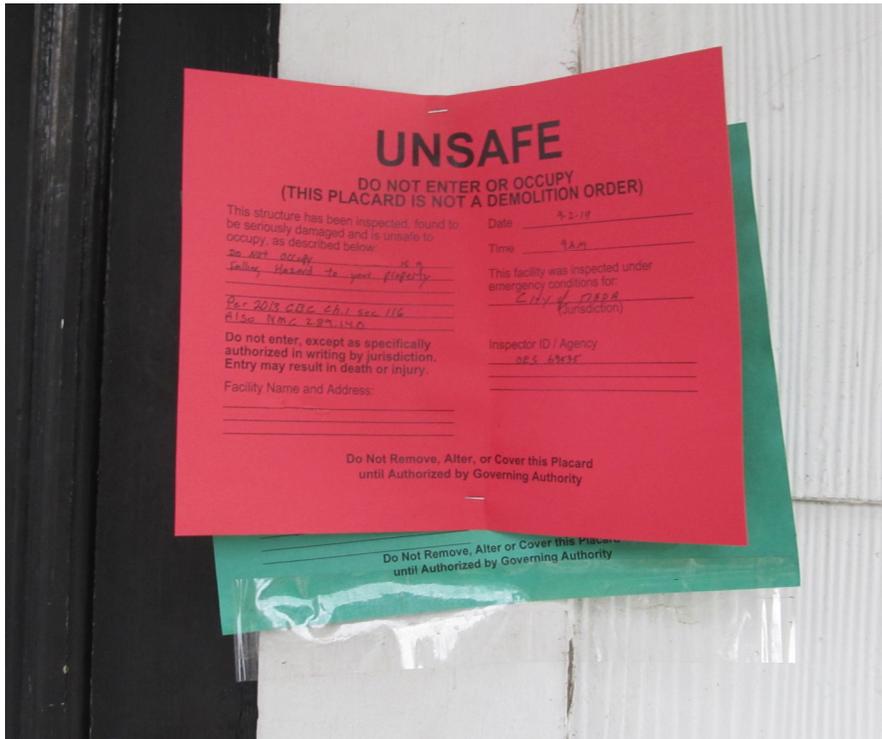
Many buildings in Napa received follow-up evaluations and the buildings were reposted with a different placard. However, in some cases, the superseded placard was not removed. Figure 11-1 shows an example of an UNSAFE placard placed over an INSPECTED placard. The INSPECTED placard had the City of Napa logo; the UNSAFE placard which came later did not.

Figure 11-1 A building with multiple placards.

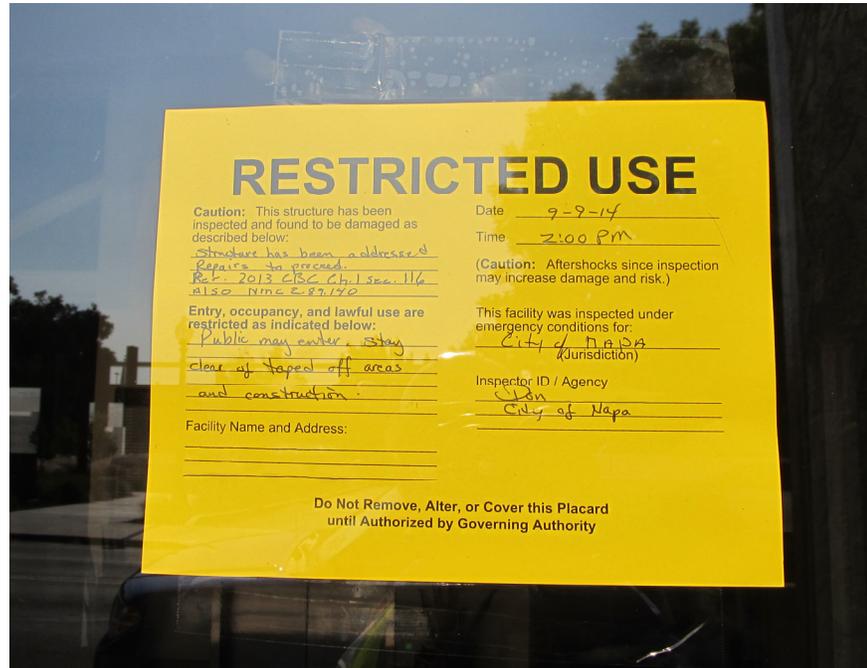
The purpose of the RESTRICTED USE placard is to restrict use to local areas of the building with significant damage. The restrictions need to be documented on the placard so that building occupants understand the limitations. Figure 11-2 shows an example of a proper use of the RESTRICTED USE placard at a building where an area with falling hazards had been taped off and access was restricted to selected entrances.

Figure 11-2 A RESTRICTED USE tag with restrictions noted as “Public may enter. Stay clear of taped off areas and construction.”

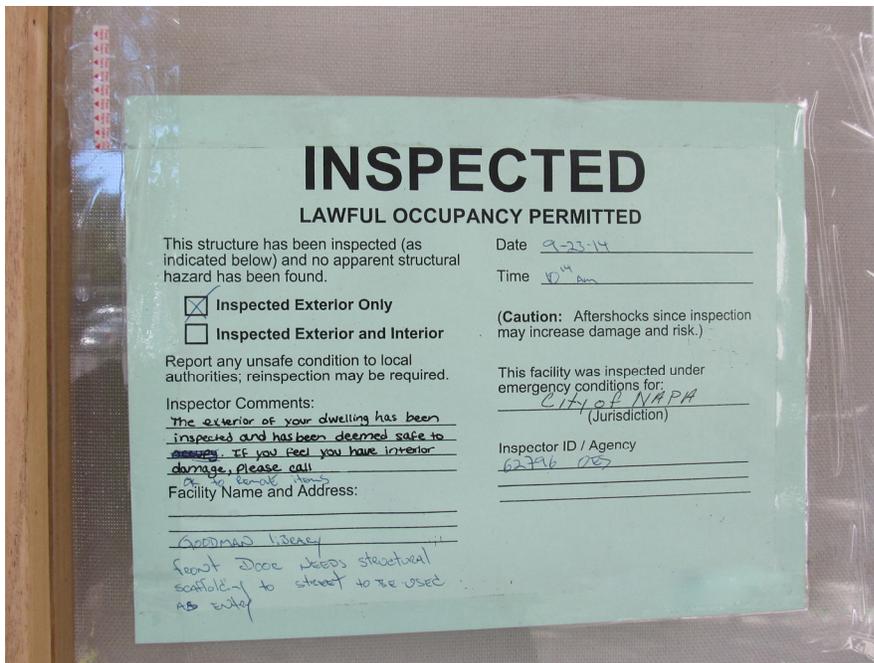
Figure 11-4 shows an INSPECTED placard that was placed on the rear entrance of a building where access to the front entrance was restricted due to a significant falling hazard. A RESTRICTED USE placard should have been placed at both entrances clearly identifying the restrictions.

Figure 11-4 An INSPECTED placard on a building with another exit that is still restricted. A RESTRICTED USE placard should have been used.

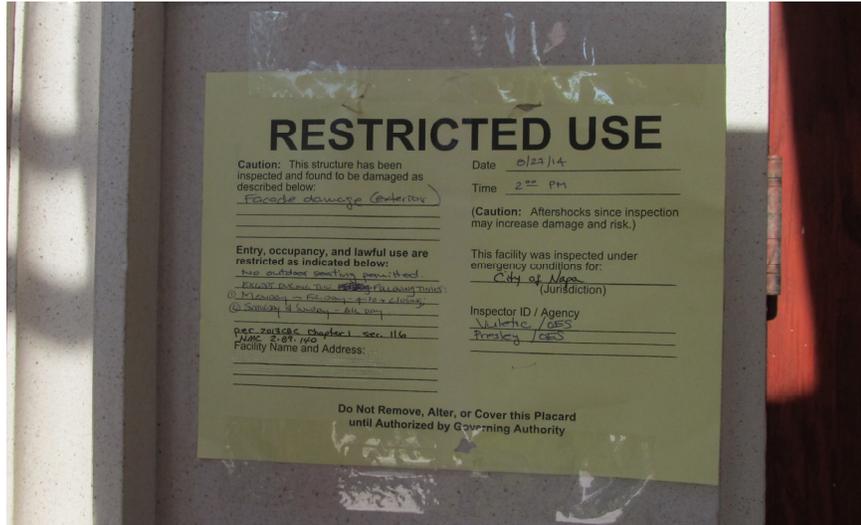
Figure 11-5 shows a RESTRICTED USE placard on a restaurant with falling hazards. Outdoor seating adjacent to the placards was restricted, “except during the following times: (1) Monday – Friday, 4:30pm to closing, (2) Saturday to Sunday – All Day.” The restrictions should never relate to when the restaurant is open, but rather to the hazard itself. Placing exceptions for

specific times is inappropriate and in this case potentially endangers patrons during the busier times.

Figure 11-5 A RESTRICTED USE placard with exemptions permitting access while the restaurant is open.

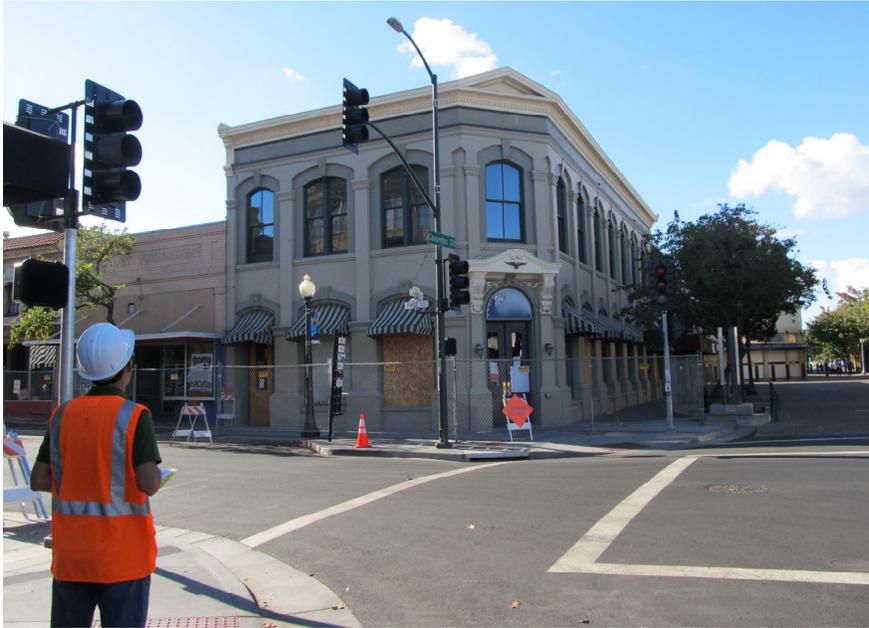
In some cases, it was observed that initial barricades were inadequately spaced from damaged buildings. Figure 12-1 shows an unreinforced masonry (URM) building with an UNSAFE placard and significantly damaged masonry façades, with a fence only several feet from the building (much less than the 1.5 times the vertical height), with the street allowed to remain in full operation.

Figure 12-1 A building with an UNSAFE placard where the fence setback was much less than a 1.5H:1V setback distance.

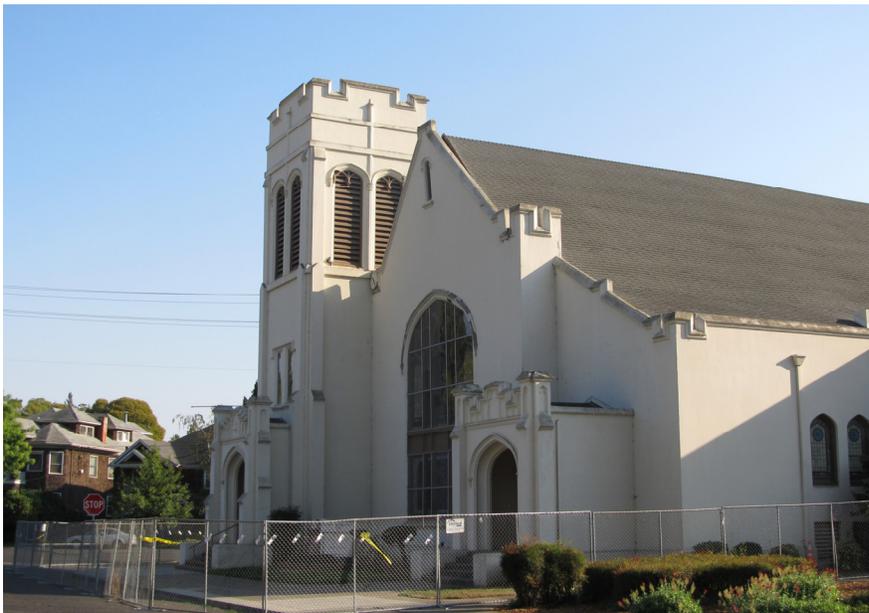
Figure 12-2 shows a church with a gable wall separated from the roof diaphragm where the fence was set back some distance into the street, but less than the 1.5H:1V setback threshold.

Figure 12-2 Church with damaged gable façade where the fence setback was less than a 1.5H:1V set back distance.

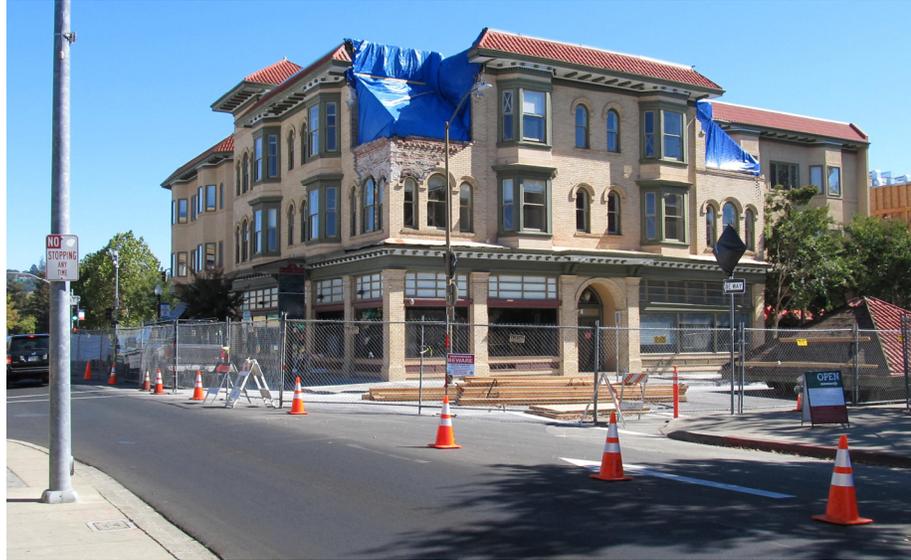
There were some streets that were closed in downtown Napa due to the falling hazards from damaged buildings, but typically only the sidewalks and portions of the street were fenced off, usually at a distance of much less than 1.5 times the height of the falling hazard. Figure 12-3 shows a street that was

partially closed due to damage of the adjacent building. Prior to removal of the damaged roof over the cupolas, the entire street had been closed.

Figure 12-3 Partial street closure. Prior to removal of the damaged roof cupola, the entire street was closed.

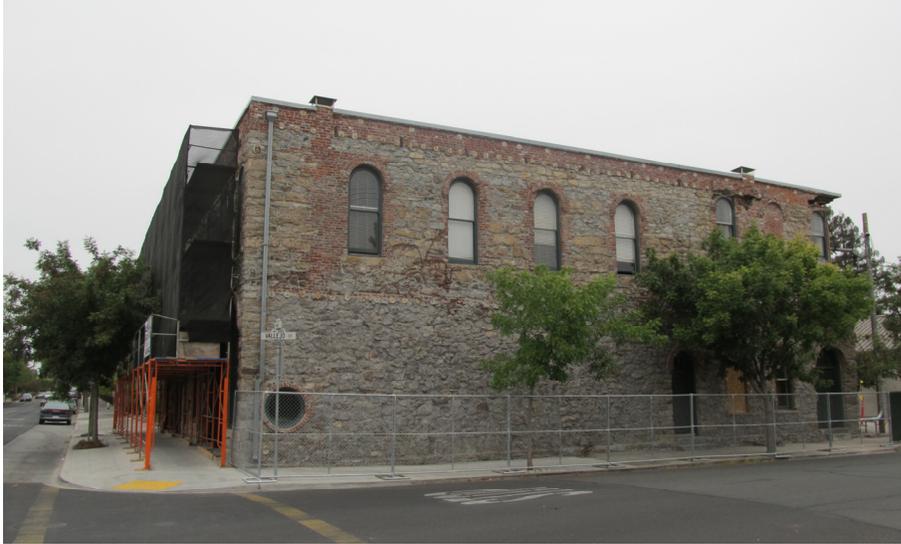
As time passed and damage could be better evaluated, the barricades and fencing strategies evolved. A common approach while repairs were being made was to install scaffolding in front of the damaged building façades. To limit the visual impact, plastic fencing was usually part of the installed scaffolding (Figure 12-4). Reportedly, scaffolding was not engineered and not anchored or attached to the building it was barricading. Although it is likely that the scaffolding and screening would stop small pieces of masonry and other cladding materials from falling outward, given the relative mass of many of the damaged structures with URM façades, it is not obvious that the scaffolding would be effective in preventing a failing wall from falling on the sidewalk or street.

Figure 12-4 Scaffolding used as a barricade on damaged URM building.

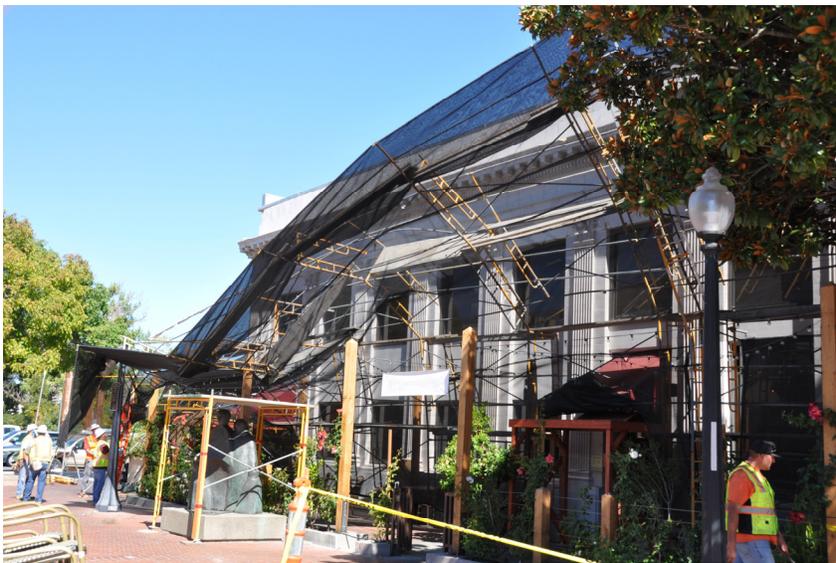
In at least one case, a windstorm damaged a lightweight scaffolding system placed adjacent to a damaged URM side wall (Figures 12-5 and 12-6). The lightweight system was later replaced with a more robust scaffolding system (Turner, 2014).

Figure 12-5 Scaffolding used as a barricade damaged in a windstorm (photo by Fred Turner).

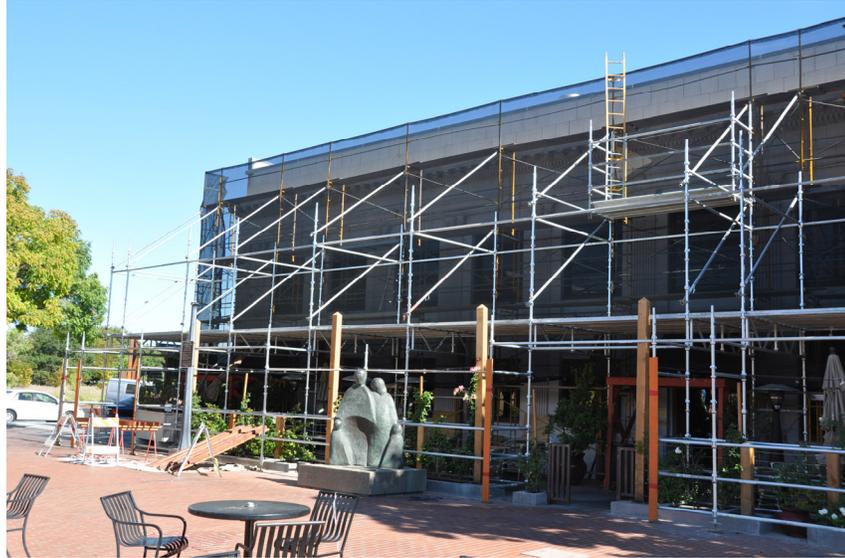
Figure 12-6 Replacement scaffolding following the windstorm (photo by Fred Turner).

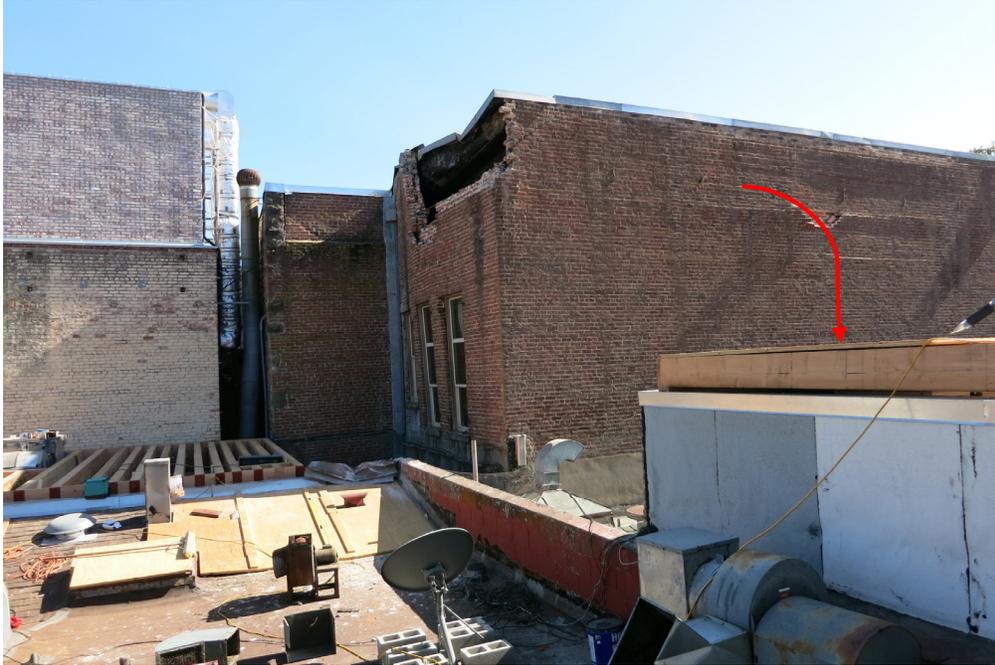
In one instance, an unretrofitted URM building was severely damaged and posted UNSAFE as a result of damage to brick walls. There were four shorter undamaged buildings immediately adjacent to it that were also posted UNSAFE due to risk of collapsing masonry walls striking their rooftops (Refer to Section 4.4.1). In order to allow occupancy in the adjacent buildings, the City of Napa required barriers to be constructed over the adjacent rooftops to prevent any falling bricks from penetrating the roofs and posing a safety risk to building occupants (Figure 12-7). With the protective barriers in place, the adjacent buildings were reposted INSPECTED and were opened for business.

Figure 12-7 Protective barrier constructed over the rooftops of buildings to protect from falling brick.

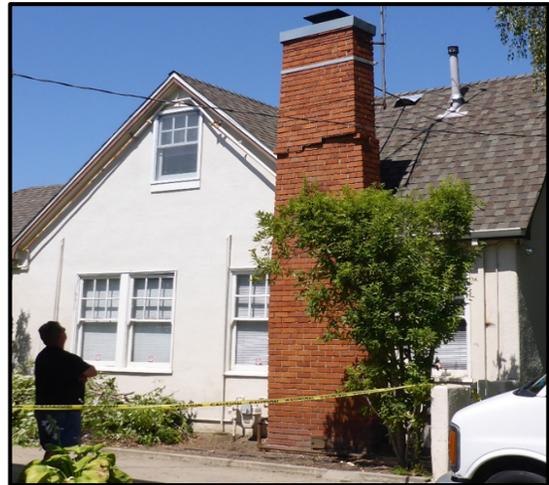
The August 24, 2014 South Napa Earthquake has again served as a reminder that masonry chimneys in wood-frame dwellings are extremely vulnerable to earthquake shaking. FEMA assessment teams observed over 100 brick masonry chimneys damaged in the South Napa Earthquake (Figures 1 and 2). Older, unreinforced masonry chimneys with degraded mortar are most vulnerable, but even masonry chimneys constructed according to modern standards are susceptible to significant damage. Collapses of previously damaged and reconstructed chimneys were also observed.

Figure 1: Chimney damaged in the South Napa Earthquake. Photo Credit: Exponent.

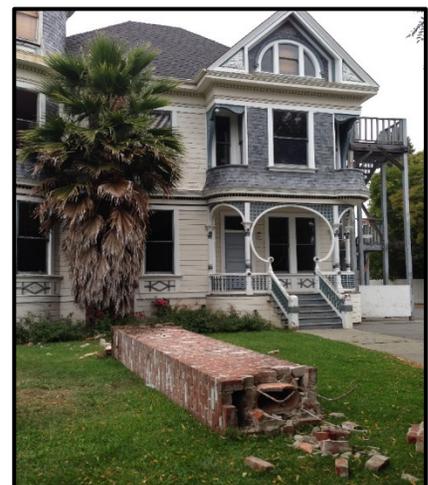
Figure 2: Chimney damaged in the South Napa Earthquake. Photo Credit: Janiele Maffei, CEA

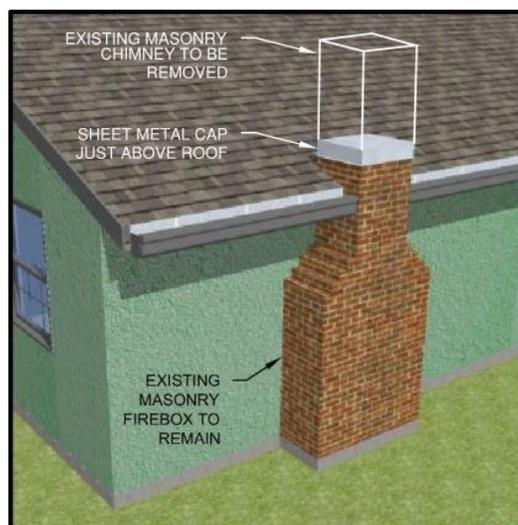
Figure 3: Dwelling with a chimney capped at the roof line.

The interior of the firebox will need to be closed off to prevent any possible use of the fireplace. For least impact on interior appearance, plywood can be installed across the fireplace opening, set back into the fireplace, and painted to match interior finishes.

Although capping eliminates the hazard associated with the most vulnerable portion of the chimney (above the roof), there is still risk of damage or collapse of the remaining masonry in future earthquakes.

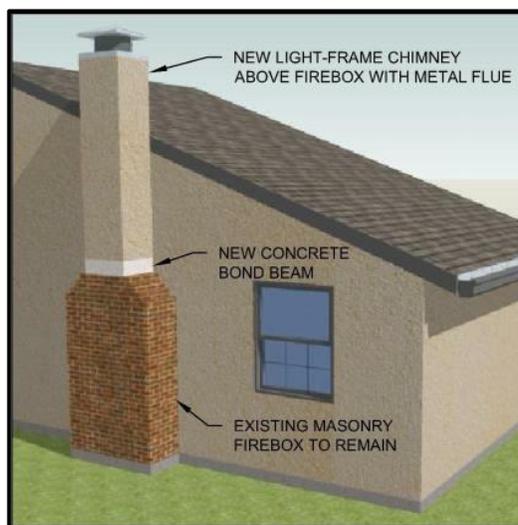
Figure 4: Dwelling with chimney reconstructed from the firebox up.

Alternative B permits continued use of an undamaged firebox in combination with a new chimney. Instead of using a conventional masonry chimney with a clay flue liner, the new chimney is constructed using a lightweight metal flue contained in a cold-formed steel stud chimney enclosure, as shown in Figure 4. This lightweight, flexible construction is much more resistant to damage in future earthquakes. Although the remaining masonry firebox could be damaged in a future earthquake, the firebox is much less vulnerable to damage than the original masonry chimney. As a result, the risk of collapse and the associated risk to life safety are greatly reduced when this reconstruction alternative is implemented.

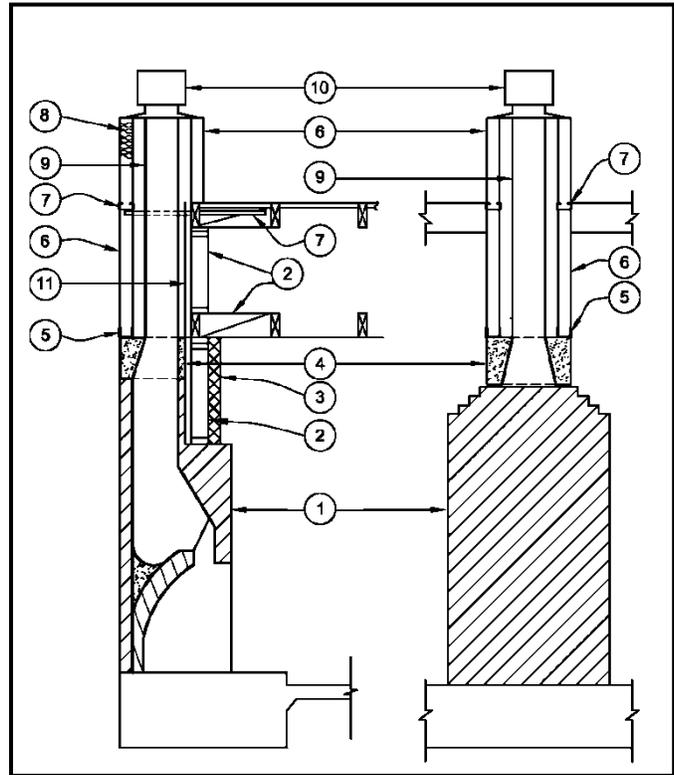
Figure 5: Components of a masonry firebox in combination with lightweight metal flue and chimney (Alternative B).

The primary components of Alternative B construction are listed below, illustrated in Figure 5. Additional details of construction are provided in Figures 6 and 7.

1. **Masonry firebox.** Inspect the firebox to verify that it is in good condition prior to start of repair work.
2. **Existing framing.** To remain as is except for roof blocking as detailed in Figure 7 and Item 7 below.
3. **Masonry veneer.** Verify support and anchorage of existing veneer where it occurs above and surrounding the fireplace.

4. **Firebox to flue transition.** *The transition from the masonry firebox to the metal flue includes: anchorage to masonry, concrete bond beam, steel adapter cone, and anchor plate. This detail is critical to the safe performance of this reconstruction alternative. See Figure 6 for more information.*

5. **Cold-formed steel track.** *Anchor track to concrete beam per Figure 6.*
6. **Cold-formed steel stud wall.** *Provide full height studs.*
7. **Chimney connection to dwelling.** *Provide stud blocking and steel strap connection to existing dwelling framing at upper floor, ceiling, and roof framing.*

9. **Metal flue.** *Provide UL Standard 103 listed metal flue, installed in accordance with manufacturer's instructions. Provide as large a flue as can be installed in available space while still meeting minimum clear distances.*

10. **Flue cap.** *Install flue cap supplied by flue manufacturer as part of the flue assembly.*
11. **Fire blocking.** *Provide fire blocking between chimney chase and attic as required by the building code.*

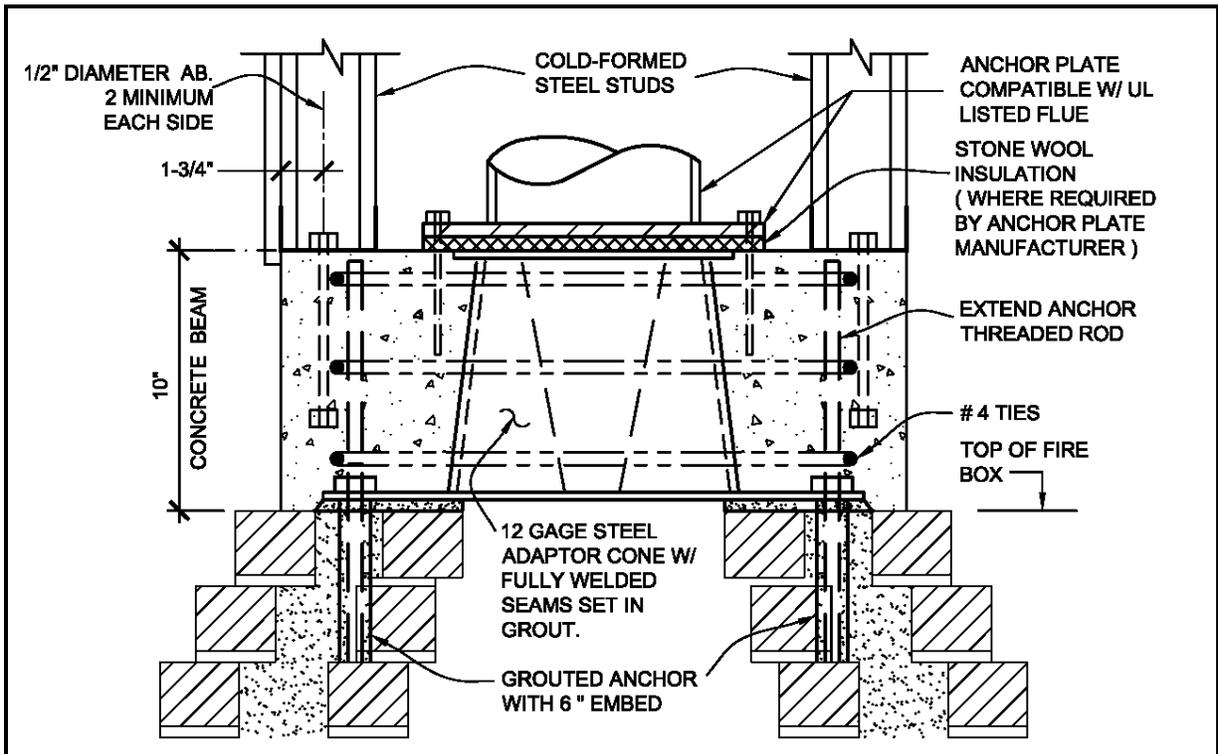
Figure 6: Example of detail at masonry firebox transition to metal flue and light-frame chimney (Alternative B, similar detail for Alternative C).

Figure 6 provides details for the transition from the masonry firebox to the metal flue and stud wall chimney chase. The components of this transition include the following:

- Fabricate a 12 gage (97 mil) minimum sheet steel adaptor cone as shown in Figure 6. The adaptor cone is to have minimum 12 gage (97 mil) sheet steel top and bottom plates as shown. This will likely need to be custom fabricated by a sheet metal shop for each chimney. All seams are to be fully welded. The adaptor cone is intended to provide a smooth-surfaced transition between the flue opening at the top of the firebox and the anchor plate and metal flue. The base plate geometry is to match the opening geometry at the top of the firebox, and the top plate geometry is to be coordinated with the anchor plate. The adaptor cone will also serve to minimize movement of heated gas through cracks that might form in the surrounding concrete beam. The adaptor cone is to be set in cementitious grout.

- Provide not less than four 1/2-inch diameter threaded rod anchors anchoring the adaptor cone base plate to the firebox masonry, as shown in Figure 6. Extend the threaded rods to one inch below the top of the concrete beam. Where the existing masonry is fully grouted at anchor locations, drill one-inch diameter holes six inches deep and set in high-strength grout. Where the existing masonry is not fully grouted, place threaded rods in cavity and grout the entire cavity.

- When required by anchor plate manufacturer, install stone wool (basalt) insulation board on top of the transition cone top plate as shown in Figure 6.

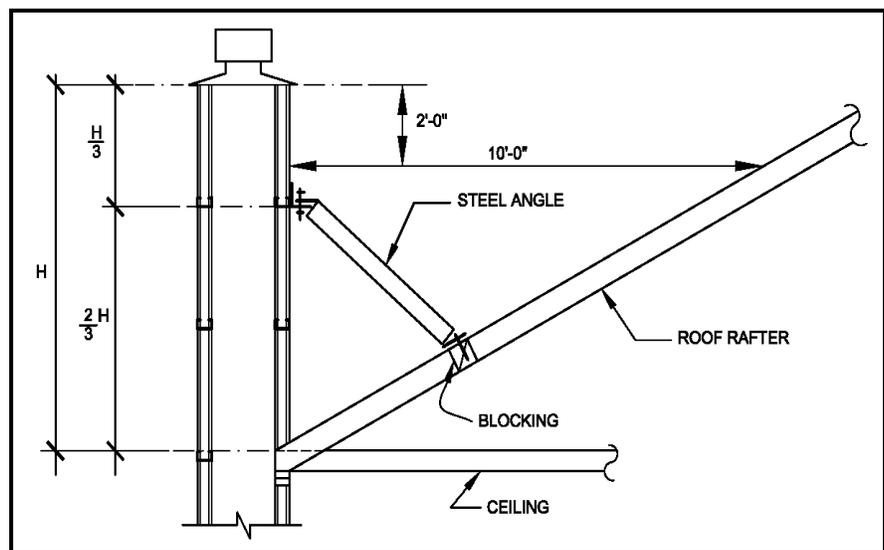
Figure 7: Bracing of light-frame chimney chase to roof (Alternatives B and C).

IRC and CRC requirements for the height of the chimney require that the top of the chimney extend three feet above the roof and not less than two feet above the elevation of the roof or other construction within a ten foot radius, as illustrated in Figure 7. This often requires that the chimney extend a significant distance above the roof line. Where this occurs, it is necessary to provide bracing of the chimney down to the roof. Such bracing should be provided in the upper third of the chimney clear height above the roof (H), as shown in Figure 7. Chimney bracing may also be required in Alternative C.

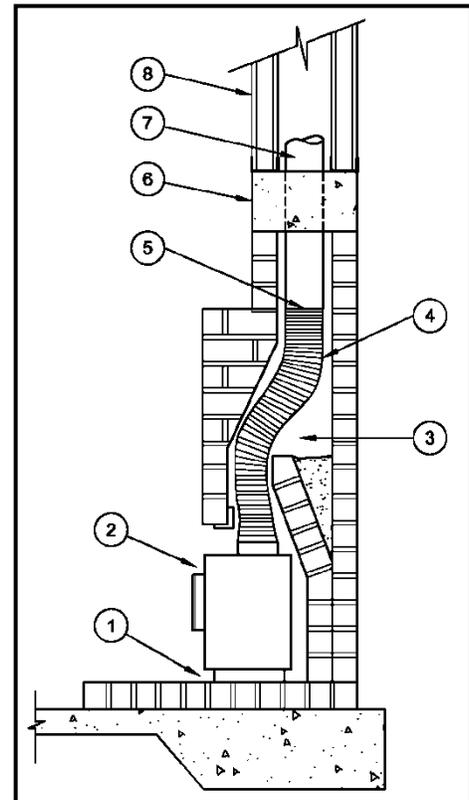
Figure 9: Components of a Factory-built Fireplace Insert (Alternative C).

The primary components of the installation of a fireplace insert into an existing masonry fireplace are listed below and illustrated in Figure 9. Items not noted are similar to information shown in Figure 5.

1. **Bottom connection.** *Secure bottom of fireplace insert.*
2. **Fireplace insert.** *Provide UL Standard 127 listed fireplace insert.*
3. **Damper and draft stop.** *Remove as required to install flue.*
4. **Flexible flue transition from insert to chimney.** *Install transition supplied as part of UL listed flue.*
5. **Metal flue connections.** *Install flue connections supplied as part of UL listed assembly.*
6. **Firebox to flue transition.** *Provide transition similar to that shown in Figure 6.*
7. **Metal chimney.** *Provide UL listed metal chimney.*
8. **Cold-formed steel stud wall.** *Provide chimney enclosure as described for Alternative B.*

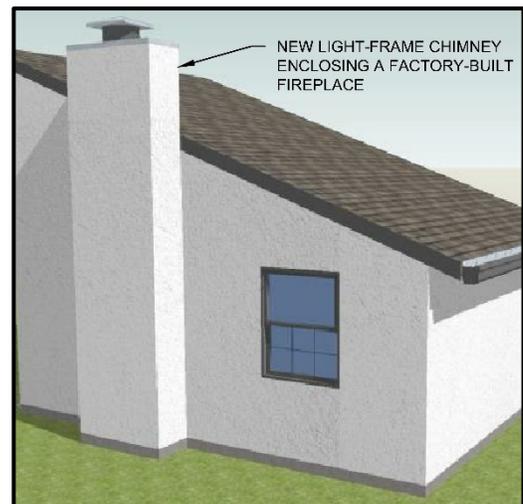
Figure 10: Replacement of entire firebox and chimney with light-frame construction.

If earthquake damage extends below the shoulder of the firebox or if complete removal of all masonry is preferred, the entire firebox and chimney can be replaced from the top of foundation up. This involves installing a factory-built fireplace and metal flue inside a cold-formed steel stud chimney chase, as seen in Figure 10. This type of lighter and more flexible construction avoids many of the issues that have made masonry fireplaces and chimneys vulnerable to damage in past earthquakes. If preserving the architectural aesthetic of masonry is important, adhered masonry veneer can be used.

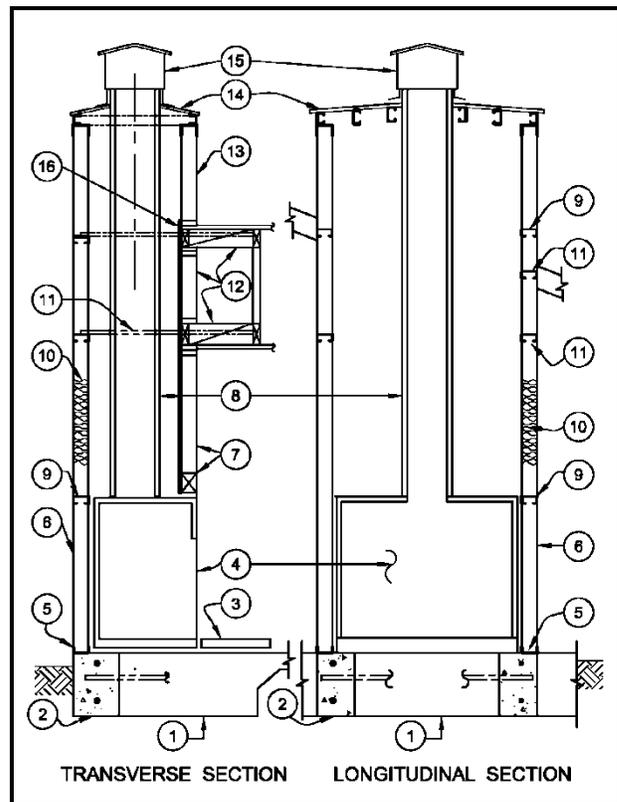
Figure 11: Components of a factory-built fireplace in light-frame chimney chase (Alternative D).

12. **Existing framing.** To remain.
13. **Light-frame wall.** From roof up.
14. **Chimney cap.** Provide framed chimney cap on chimney chase.
15. **Flue cap.** Install flue cap supplied by flue manufacturer.

16. **Fire blocking.** Provide fire blocking between chimney chase and attic.
