Building Envelope Performance

5.1 Sheathing on the Underside of Elevated Buildings

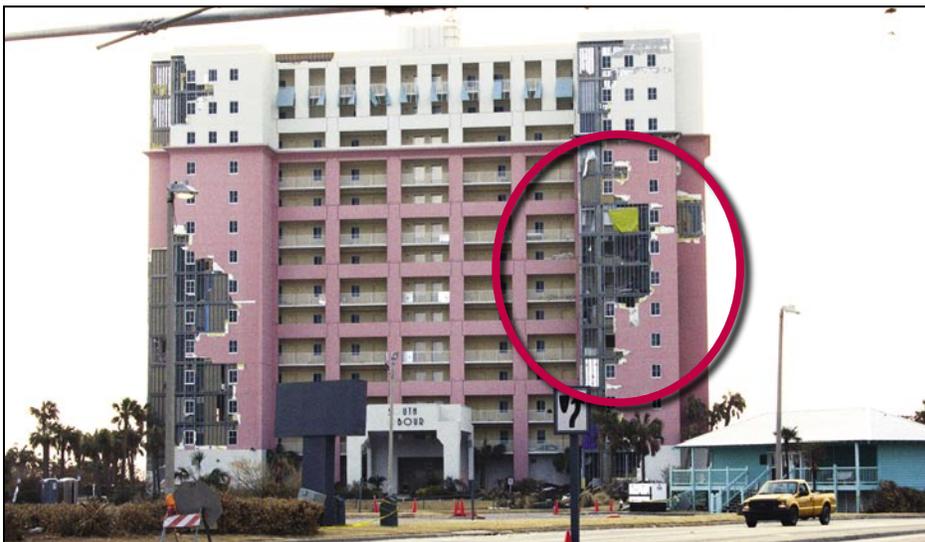
Figure 5-14 shows extensive damage to non-load-bearing EIFS walls on a multi-story building. Hurricane Ivan inflicted large areas of EIFS failure on many multi-story buildings.

Figure 5-14.
Multi-story building showing severe EIFS damage. The gypsum board typically detached from the studs. See Figure 7-11 for a close-up of the circled area.

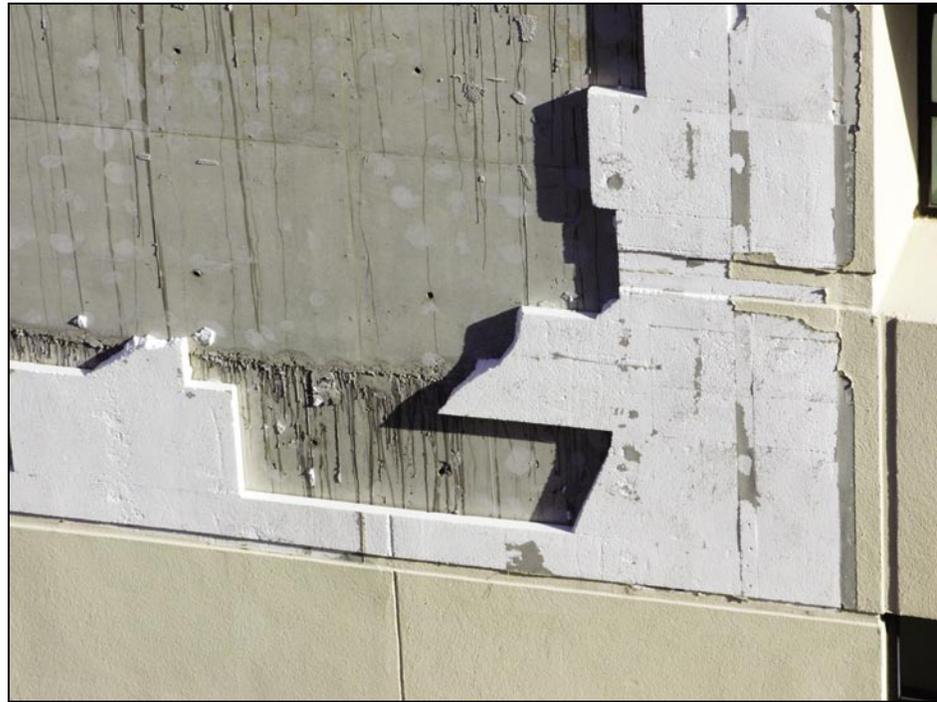
Most of the EIFS damage caused by Hurricane Ivan occurred over metal or wood stud walls. However, some damaged EIFS occurred over concrete walls, as shown in Figures 5-20 and 5-21.

Figure 5-21.
Close-up of Figure 5-20.
The light colored round marks indicate where adhesive had been applied. The adhesive did not make a good bond with the concrete and it should have been continuously applied.

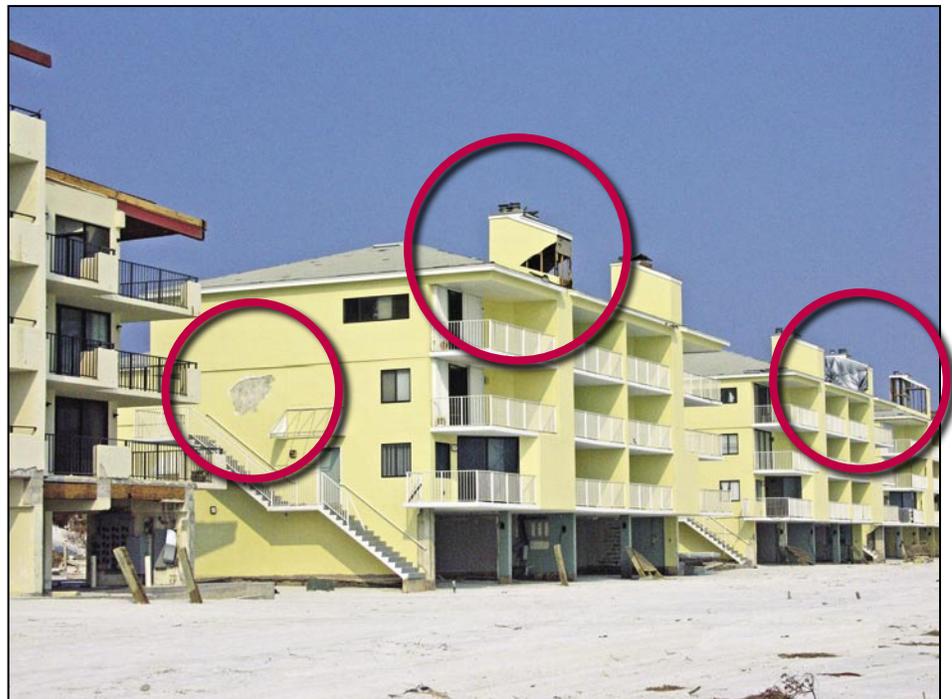
Figure 5-25.
At the end wall of the center building, stucco blew off the concrete substrate. Some of the chimney walls made of stucco over gypsum board over wood studs were also blown away.

As with EIFS assemblies, attention to attachment of studs to the building, attachment of gypsum board to the studs, and attachment of the lath are critical in achieving good wind performance.

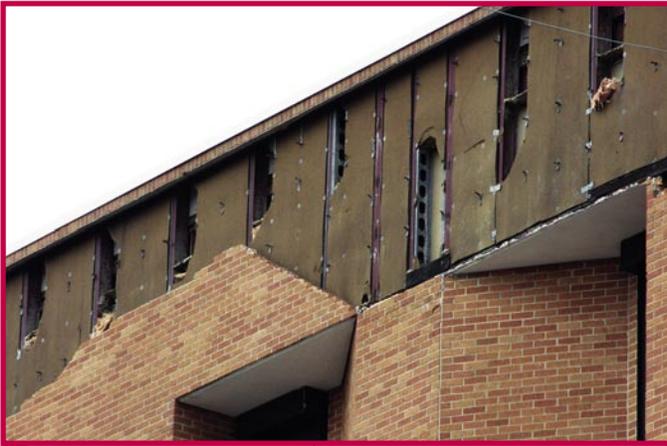
Several buildings with brick veneer were observed. Figure 5-26 shows failure on an office building. The majority of the corrugated ties remained attached to the steel studs. The ties were spaced approximately 18 inches on center vertically and 16 inches on center horizontally. According to another investigation team that had access to the building, the primary mode of failure was tension failure of the ties due to severe corrosion. Based on the Brick Industry Association's (BIA) *Technical Notes 28B – Brick Veneer/Steel Stud Walls*, “corrugated ties are not permitted when brick veneer is supported by steel stud backing.” In part, this provision is based on the greater corrosion susceptibility of corrugated ties versus round ties (i.e., water is more likely to remain for a longer period of time on the flat surface of corrugated ties). The tie spacings were closer than the maximum recommended in *Technical Notes 28B*, which is 18 inches on center vertically and 32 inches on center horizontally, yet still failed due to corrosion.

Figure 5-26.
Brick veneer failure on an office building
(Pensacola).

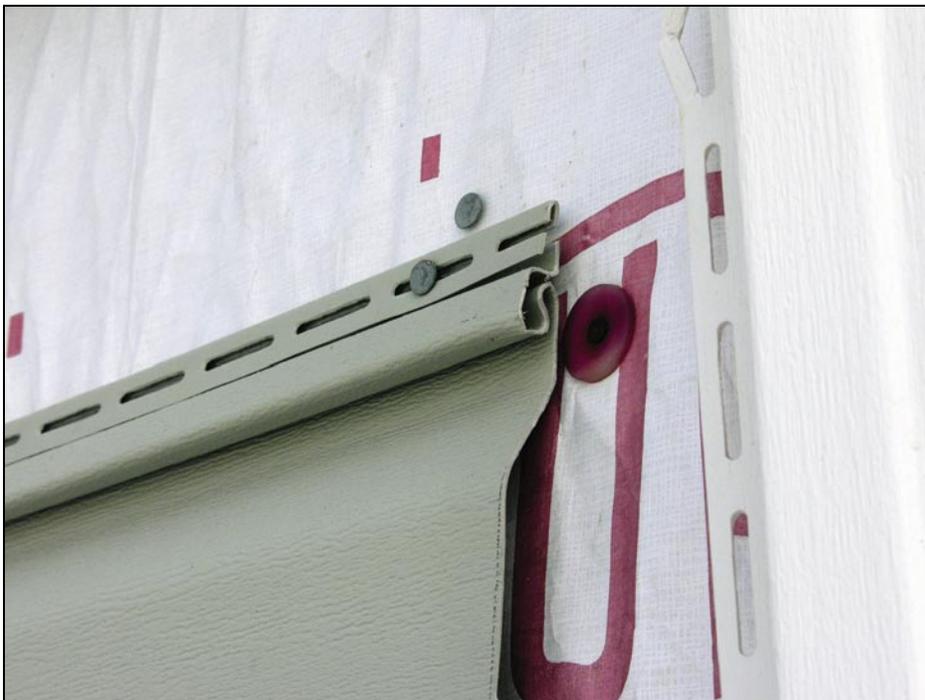
Vinyl siding manufactured for high-wind areas is available, but was observed on only one building (Figure 5-31). With high-wind siding, the nailing flange is folded over, so there is a double thickness of vinyl at the fastener points (Figure 5-32).

Figure 5-32. A double thickness of vinyl occurred at the nailing flange. This provided greater fastener pull-over resistance. However, many of the panels pulled over the nail heads.

Vinyl siding that was blown off typically tore around the fastener points. Staples were used to attach the siding on some residences, but large headed nails were typically used. The 2003 IBC requires a maximum fastener spacing of 16". ASTM D 4756, *Standard Practice for Installation of Rigid Poly (Vinyl Chloride) (PVC) Siding and Soffit* also specifies a maximum spacing of 16". The 2001 FBC does not specify a maximum limit.

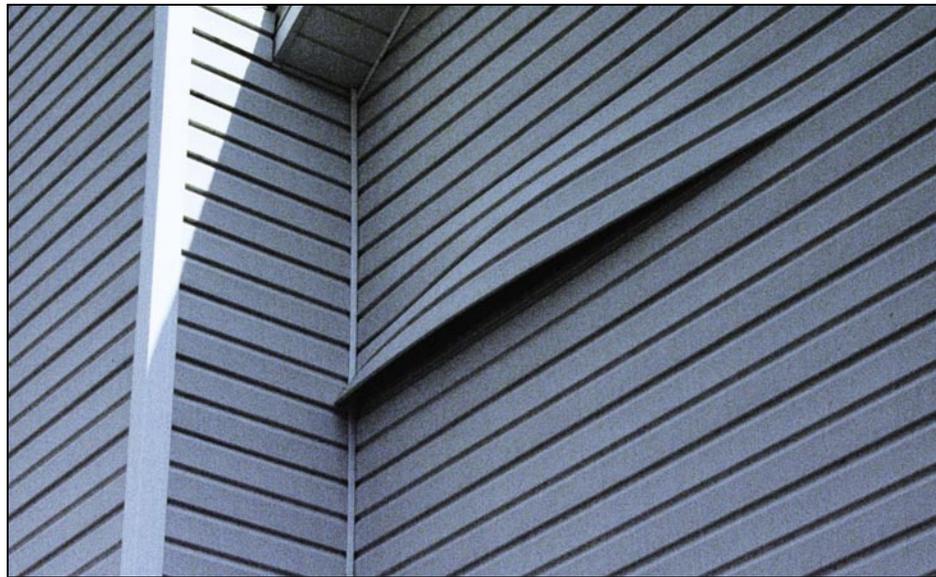
In some cases, the MAT believes that the blow-off was triggered by unlatching of the buttlock, which is the bottom portion of the panel (see Figures 5-33 and 5-68). Once the panel unlatches from the retainer slot just below the nailing flange, the panel is free to rotate outward where it can be caught by the wind and blow off. The magnitude of the unlatching issue, compared to the strength of the nailing flange and fastener spacing, is unknown. When unlatched, panels are very susceptible to blow-off.

Figure 5-33.
When a panel becomes unlatched, it becomes very susceptible to blow-off.

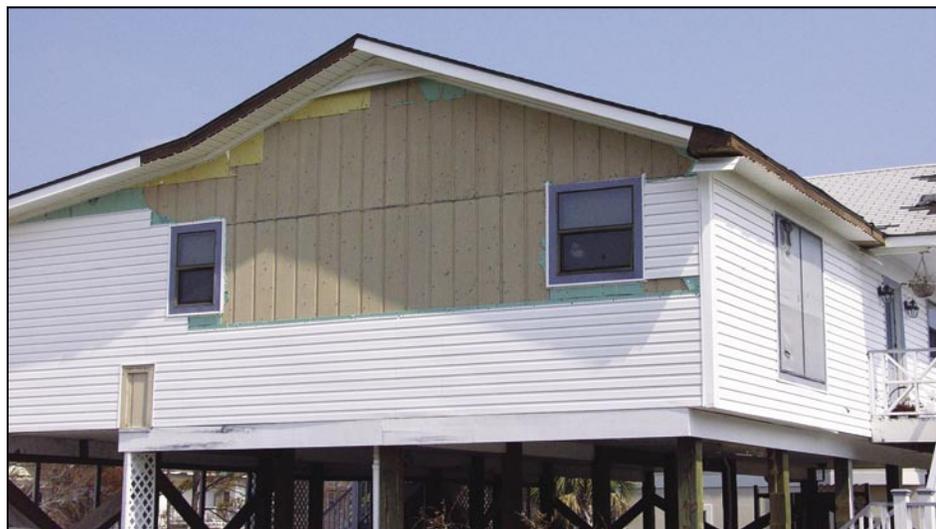
Several residences had wood siding, either textured plywood or boards. The wind performance of wood siding was typically very good. Although there were several instances of failure of wood-framed exterior walls, such as that shown in Figure 5-34, loss of just the plywood wall siding was very rare (see Figure 5-35). Loss of board siding was also rare. There were instances where failure of other elements, such as decks or walls resulted in some progressive failure of board siding.

Figure 5-35.
Vinyl siding had been installed over textured plywood siding. Although a large area of vinyl blew off, the plywood was not damaged, leaving the building envelope intact. This scenario was observed on several buildings.

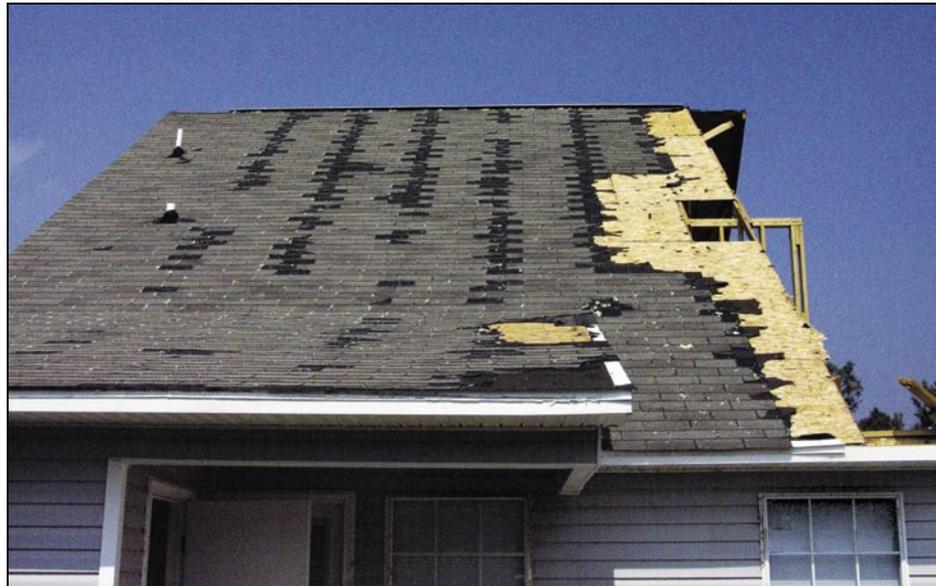
One notable difference between the Hurricane Charley and Ivan observations was shingle damage associated with raking. With the raking installation method, shingles are installed from eave to ridge in bands about 6-feet wide. Where the bands join one another, at every other course, a shingle from the previous row needs to be lifted up to install the end nail of the new band shingle. Sometimes installers do not install the end nail – in these applications, the shingles are vulnerable to unzipping at the band lines, as shown in Figure 5-36. The National Roofing Contractors Association recommends that the raking method not be used. Rather, starting at the eave, shingles should be laid one course at a time from rake to rake.

Figure 5-36.
The vertical lines of missing shingle tabs are indicative of installation via the raking method. When raked, end nails are frequently not installed.

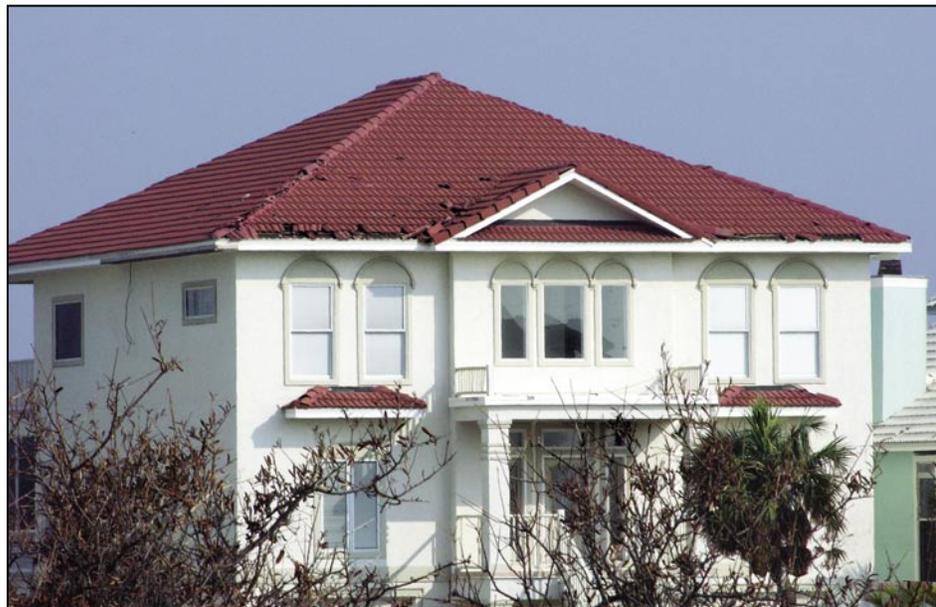
Figure 5-39 illustrates typical tile damage in areas that experienced modest wind speeds. Eave, hip, ridge, and rake tile failures were common. In areas with higher wind speeds or on higher elevation roofs, large areas of tiles were blown away, such as shown in Figure 5-40, 5-43, and 5-46.

Figure 5-39.
This roof is indicative of tile failure at modest wind speeds, wherein failure of eave, hip, and rake tiles were most common.

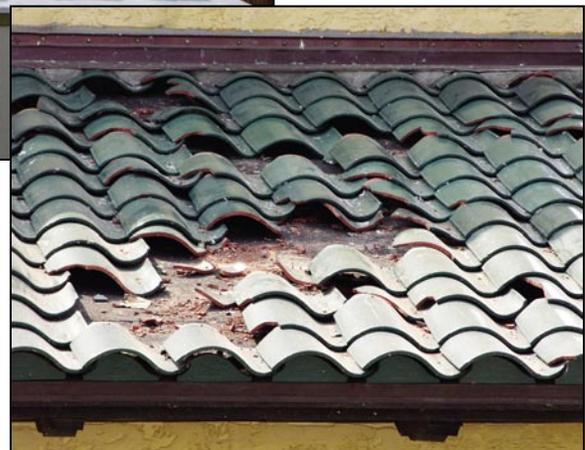
Figure 5-40 shows a direct-to-deck mechanically attached clay tile roof that experienced large blow-off areas. The tiles were attached with two nails per tile; however, both nails were located in one corner (Figure 5-41). A clip near the end of the tile occurred along the eave row. However, the clips were ineffective. Many of the tiles were displaced by wind pressure, but much of the tile damage was caused by tiles or tile fragments impacting other tiles. The hip tiles were nailed with a single nail to a ridge board and set in mortar. However, similar to Figure 5-51, this attachment method was ineffective.

Figure 5-40. Direct-to-deck mechanically attached clay tile. The tiles were attached with two nails per tile. The nails typically remained in the deck. See Figure 5-41.

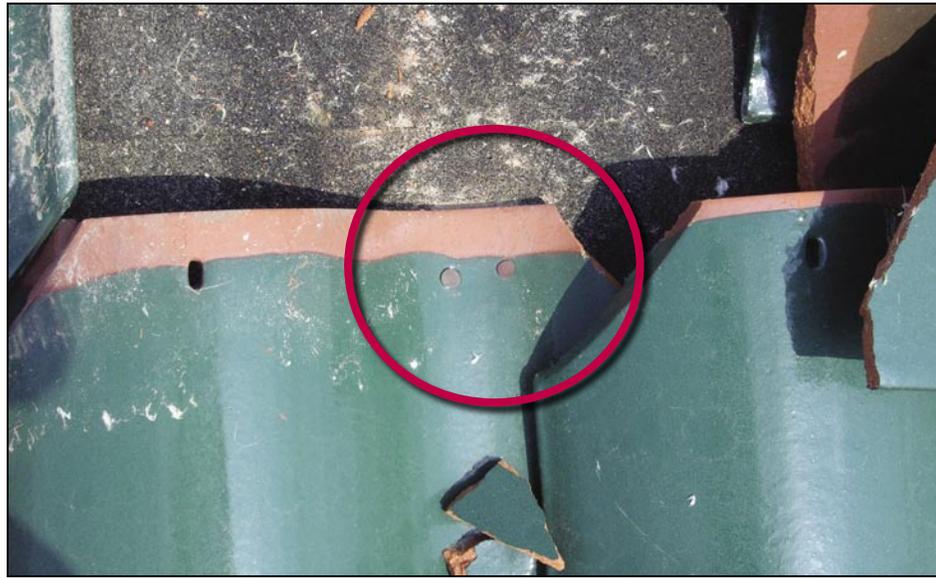
Figure 5-41.
Both nails were located in the right corner. Better load distribution would have been achieved by placing one of the nails in the far left nail hole.

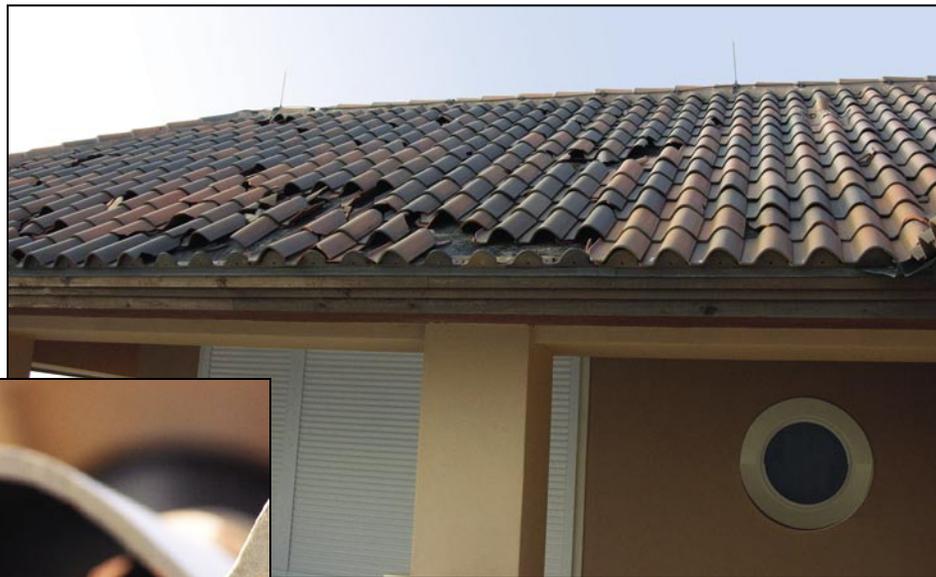
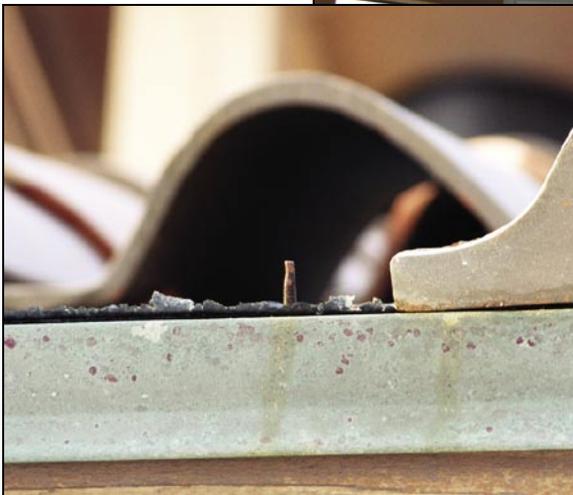
Another direct-to-deck roof is shown in Figure 5-42. This six-year-old residence was adjacent to the ocean. Several of the fastener heads had corroded off, thus allowing the tiles to lift over the fasteners.

Figure 5-42.
The fastener heads on this direct-to-deck mechanically attached tile roof had corroded. The six-year old house sat near the ocean.

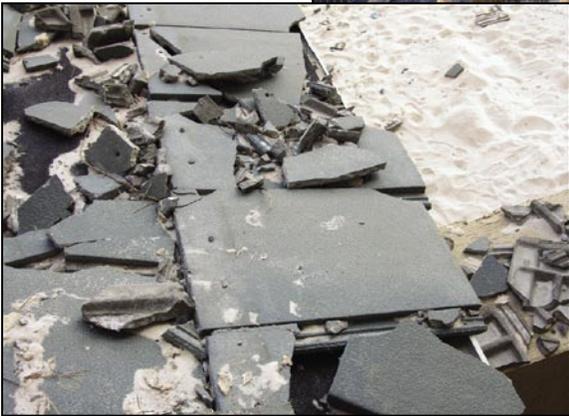
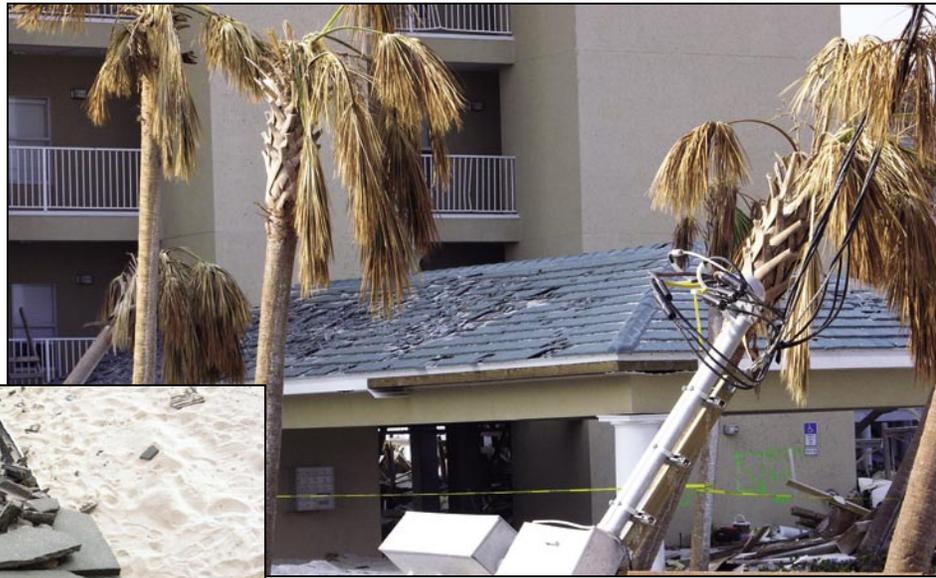
The tiles shown in Figure 5-44 were partially shielded from wind by nearby buildings. Hence, while some of the tiles were damaged by wind pressure, the majority were damaged by windborne debris (which included tile fragments from this roof). The field tiles were attached with a single 2 ½" long screw. The row of tiles along the eave were attached with two screws per tile.

Figure 5-44. Although some of these batten-attached tiles were damaged by wind pressure, the majority were damaged by windborne debris (which included tile fragments).

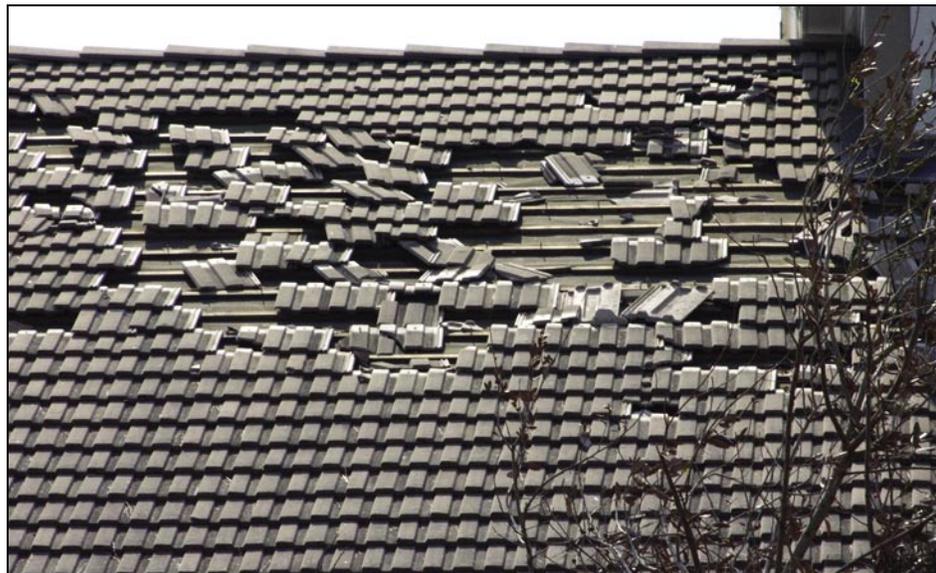
The batten-attached tile damage shown in Figure 5-45 was due to increased wind pressure associated with turbulence created by the building projection at the upper right of the photograph. Elsewhere on this roof, there was intermittent damage to field tiles from windborne debris, likely consisting of tiles that were missing from the upper level roof and/or tiles blown from the area shown in Figure 5-45.

Figure 5-45. The majority of these batten-attached tiles were displaced by wind pressure. The fasteners typically remained in the battens.

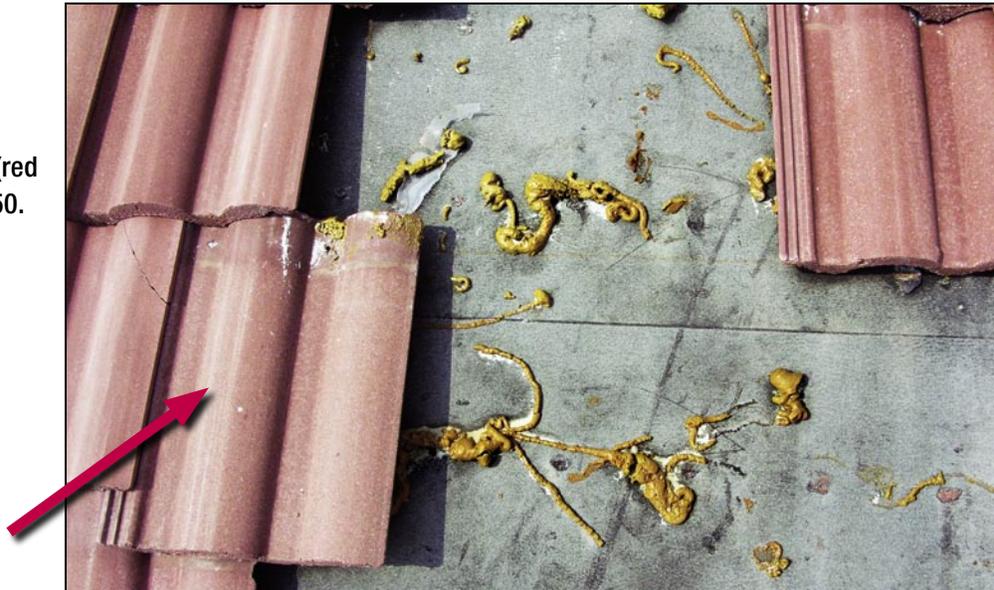
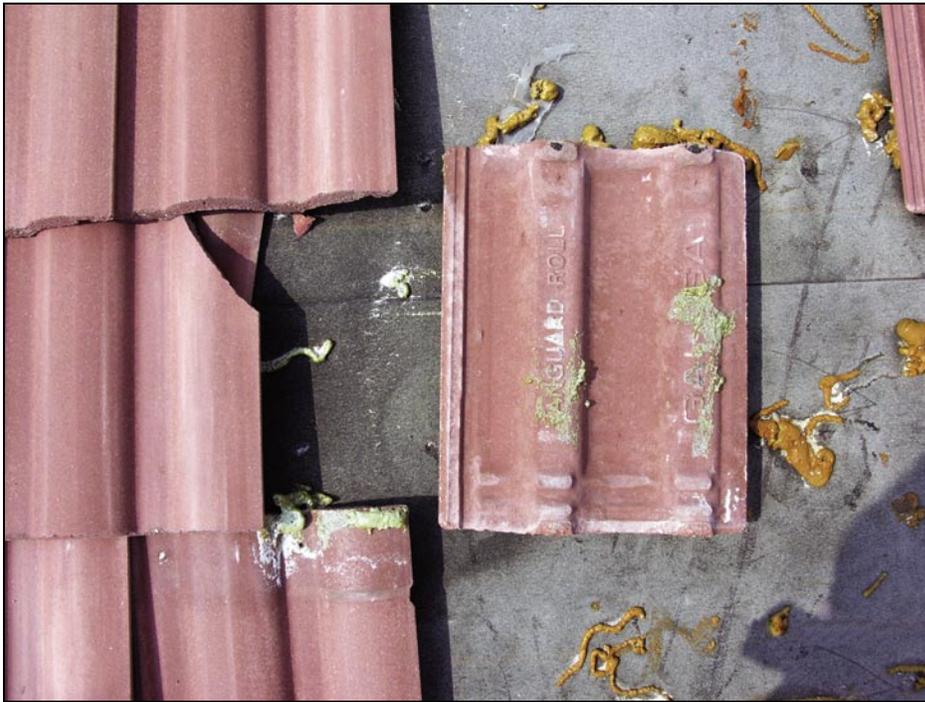
Tiles were blown off of several areas of the roof shown in Figure 5-48. These failures were caused by significant workmanship errors, wherein too little adhesive was applied (Figures 5-49 and 5-50).

Figure 5-50.
View of the underside of the tile that slid in Figure 5-49. Note the very limited amount of foam on the underside of the tile and underlayment.

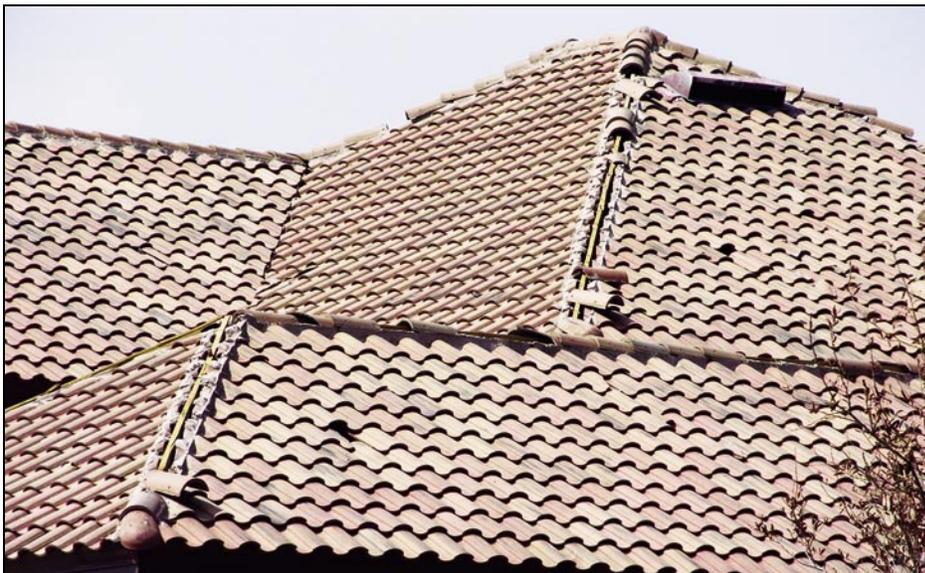
As observed in Hurricanes Charley and Frances, blow-off of hip and ridge tiles was very common, even when the trim tiles were nailed to a ridge board and set in mortar (Figure 5-51). On one of the observed roofs, the hip tiles were foam-set, but failure also occurred with this attachment method (Figure 5-52). Hurricane Recovery Advisory Number 3 (see Appendix D) provides recommendations for enhancing attachment of hip and ridge tiles.

Figure 5-51.
Significant loss of hip and ridge tiles. The trim tiles were set in mortar and were attached to a ridge board with a single nail near the head of the trim tile.

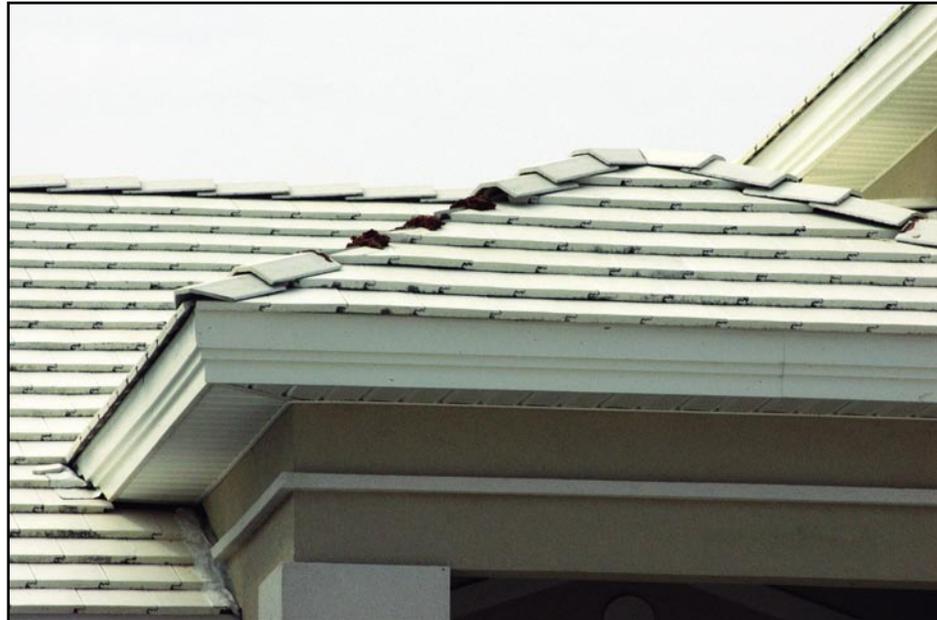
Figure 5-52.
These hip and ridge tiles
were foam-set.

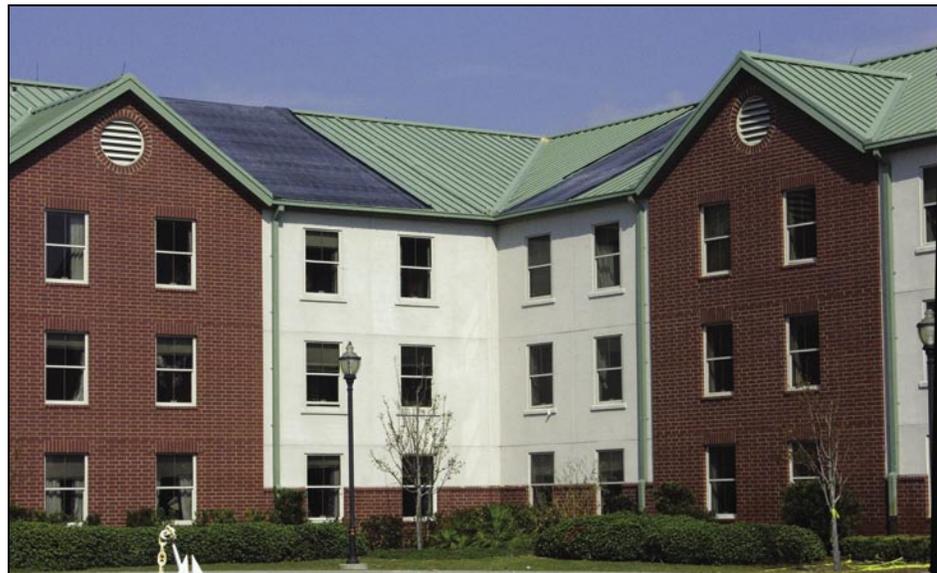
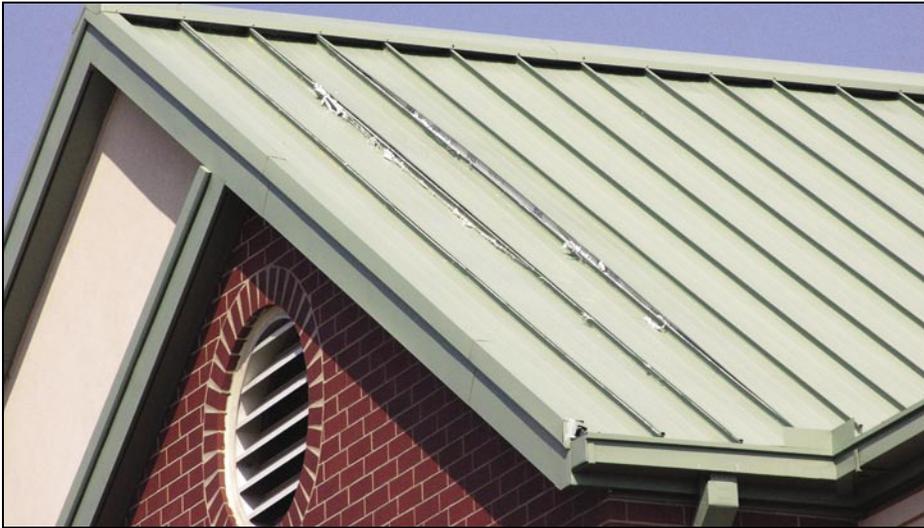
A variety of standing seam and exposed fastener panel systems was observed, as well as metal shingles. The observations of the Hurricane Ivan MAT were similar and consistent with the observations of the Hurricane Charley MAT. The performance of metal roofing varied greatly. Figure 5-53 shows a complex that lost several standing seam panels. At one area the panels remained on the roof, but a few of the seams opened up (Figure 5-54). In the opened condition, the panels were very susceptible to progressive failure, and they were no longer in a watertight condition.

Figure 5-53.
Loss of standing seam
metal panels. See Figure
5-54. (Pensacola)

Figure 5-54. These panels nearly blew away. The seams on three of the panels opened up. (Pensacola)

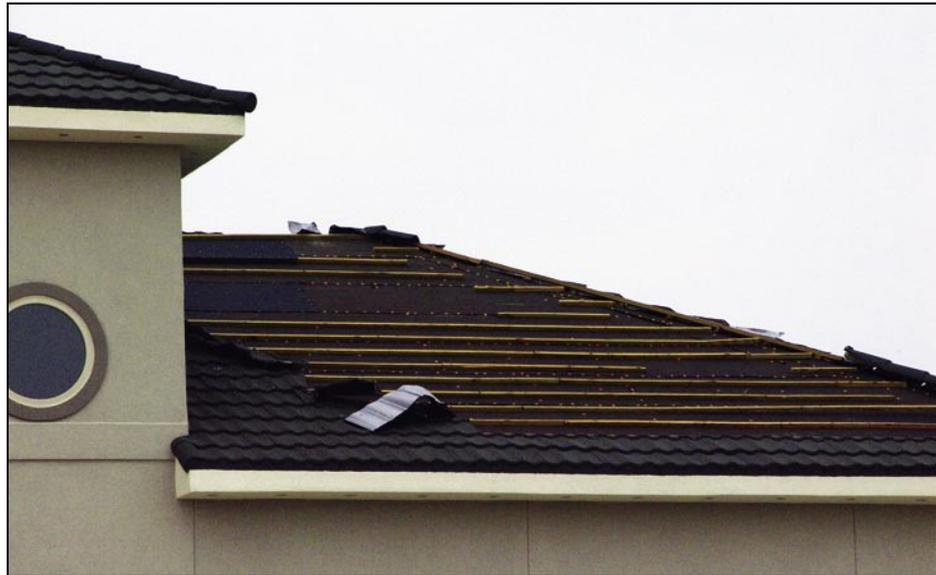
More metal shingles were observed in the area impacted by Hurricane Ivan than in the area impacted by Hurricane Charley. Several batten-attached metal shingles that simulated the appearance of tile were observed. While some of the metal shingles performed well, many failures similar to Figure 5-56 were observed. As with other types of roof coverings, attention to connections (including attachment of the battens for batten-attached systems) is important with metal shingles.

Figure 5-56.
This residence had metal shingles that simulated the appearance of tile. The shingles typically blew off the battens, but some of the battens were also blown away.

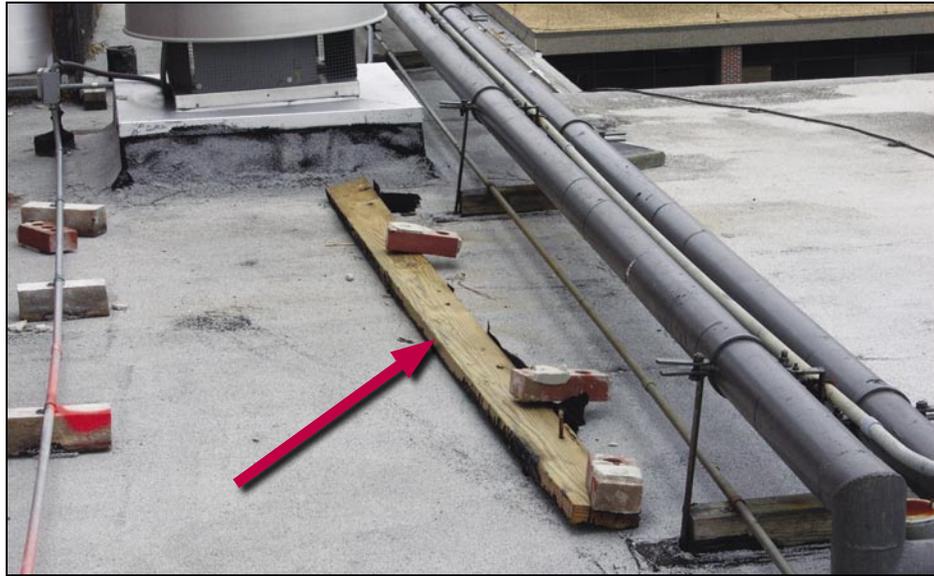
Another type of edge failure is shown in Figure 5-58. At this hospital, the wooden nailer at the roof edge was bolted to a brick wall, but because of an inadequate load path, the bricks lifted up with the nailer. The nailer failure resulted in progressive lifting and peeling of the roof membrane. Nailer lifting may have also initiated the failure on the hospital roof shown in Figure 6-3, although as discussed in Section 6.2.2, that failure may have been initiated by lifting and peeling of the edge flashing or by debonding of the insulation from the concrete roof deck. The 4' x 8' polyisocyanurate insulation boards had been attached to the deck with hot asphalt. This attachment method can be very effective, but it requires good contact between the boards and asphalt, which can be difficult to achieve if the deck surface is not a relatively flat plane. The use of 4' x 4' versus 4' x 8' boards facilitates conformance to irregular substrates. Use of relatively thin boards (e.g., 1 ½" thick) also facilitates conformance.

Figure 5-58.
The edge nailer on top of an old brick wall was inadequately attached to the wall. Failure of the nailer caused a progressive lifting and peeling failure of the roof membrane. (Pensacola)

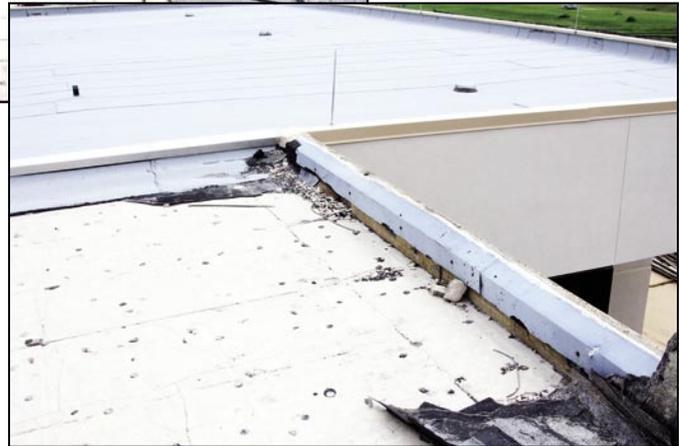
Figure 5-60. Minor base flashing displacement on a new hospital roof (Gulf Breeze)

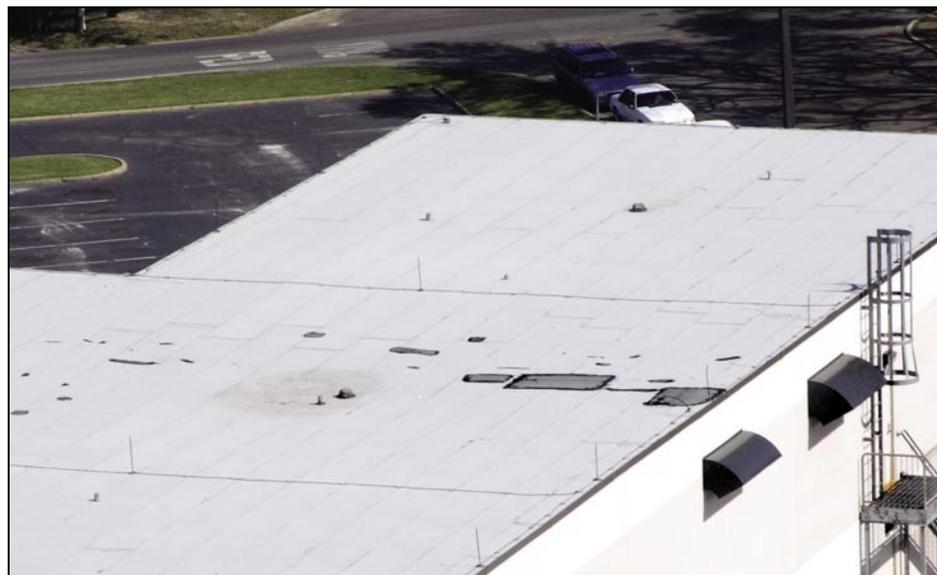
Figure 5-62.
This hospital roof had
been punctured in
several locations by
windborne debris. When
punctured, a secondary
membrane, as discussed
in FEMA 424, is needed
to avoid water infiltration.
(Pensacola)

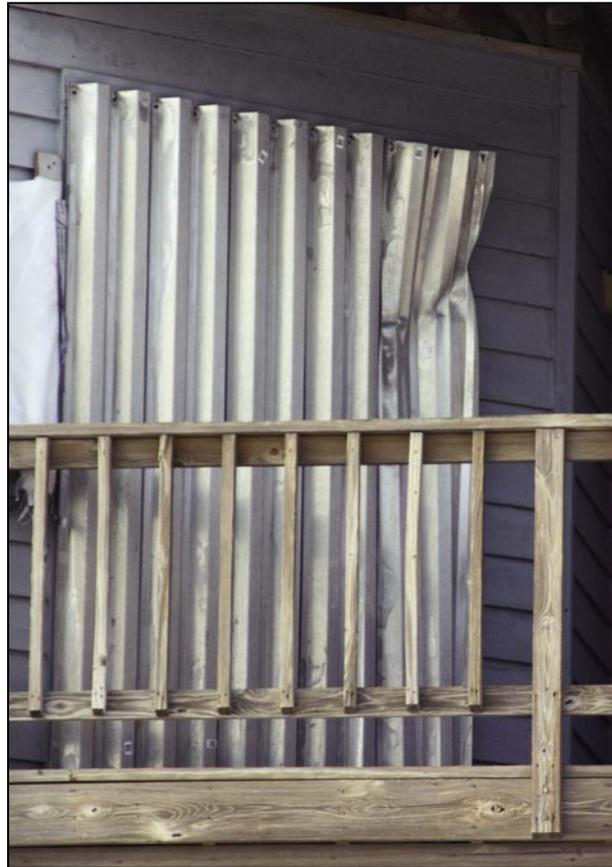
The MAT did not observe any laminated glass that had been impacted by debris, other than a skylight as discussed in Section 5.5.3. However, a variety of shutters were observed. They were made of wood sheathing, metal panels, or plastic panels of various designs. The MAT observed a few cases where shutters were impacted by debris and were effective in preventing glass breakage (Figure 5-65).

Figure 5-65.
This shutter was impacted by high-energy debris.

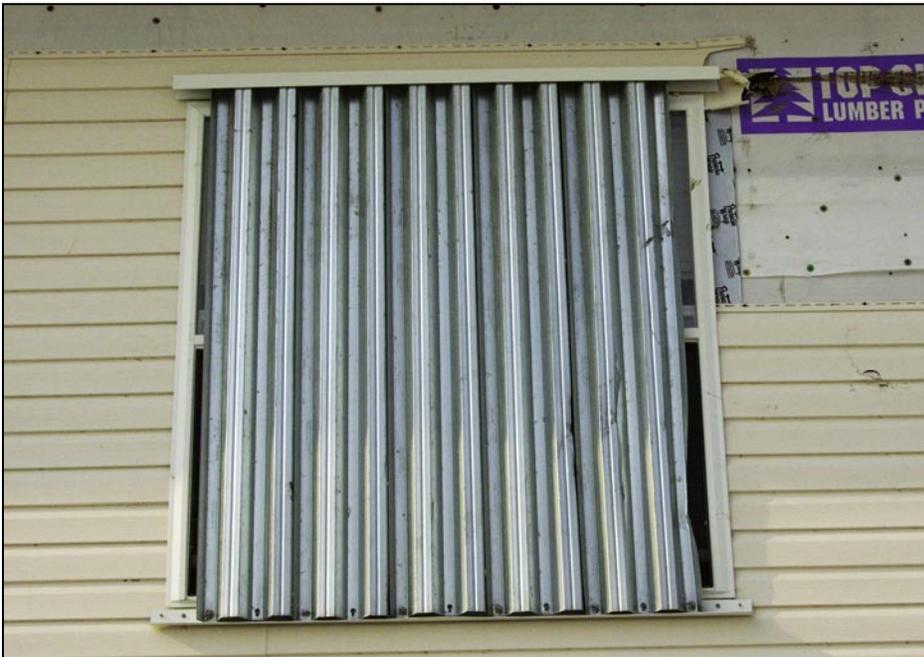
Figure 5-66.

A few problems were observed with shutters. At the school shown in Figure 5-66, shutters had been retrofitted. However, shutters were not placed over the windows above and below window air conditioners or over the glazed entrance doors. Although the shutters that were installed decreased the amount of exposed glass and, as a result, reduced the probability of glazing damage, a shuttering project should protect all exterior glazing. Another problem is illustrated by Figure 5-67, wherein metal panels did not completely cover the glazing. Also, at that shutter, wing-nuts were installed at only every other fastener stud. Installation of nuts on every other stud was observed on several different buildings. When all of the nuts are not installed, shutters are more susceptible of being blown away.

Shutters had been retrofitted on this school, but the glazing above and below the window air conditioners and the glass entry doors were not protected. (Pensacola)

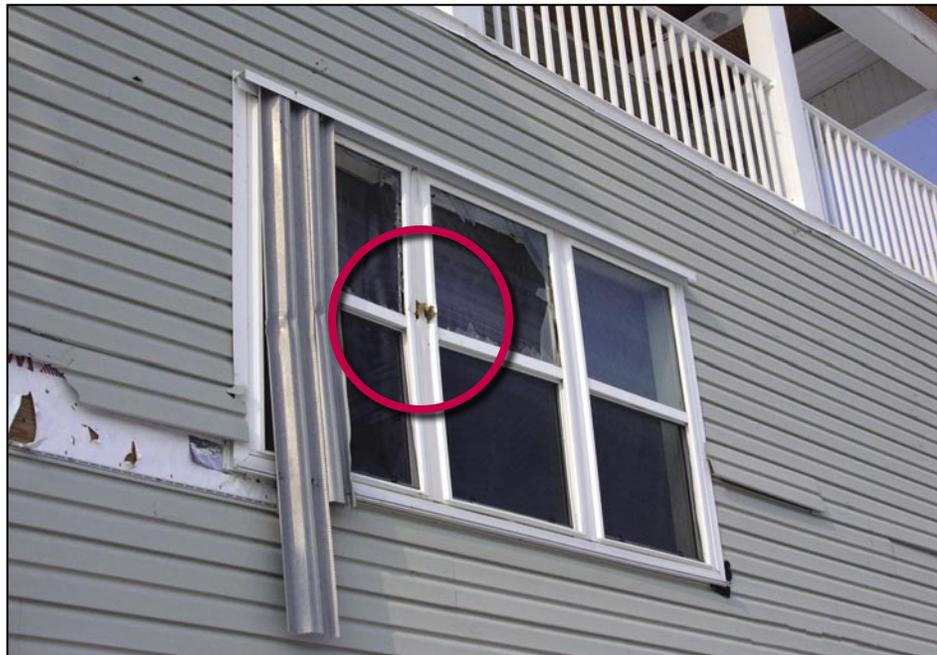
Two of the panes in the window unit shown in Figure 5-68 were broken because the window unit was not fully protected. It was unclear whether some of the shutter panels blew away or were never installed. At the lower shutter track, rather than employ fixed fastener studs, the studs were slid into the track at the track ends. This type of stud connector relies on friction to keep the studs from moving sideways. If the nuts are not snug, the panels can drift sideways and be blown from the track. It was clear that one of the panels had not been fabricated for this unit. This illustrates a potential problem with panel shutters. When shutter panels are removed from storage for installation, it is important for the panels to have been labeled so that the proper panels go over the intended windows.

Figure 5-68.
It was unclear whether some panels blew away, or the glazing was not fully protected. Note the debris embedded in the window mullion.

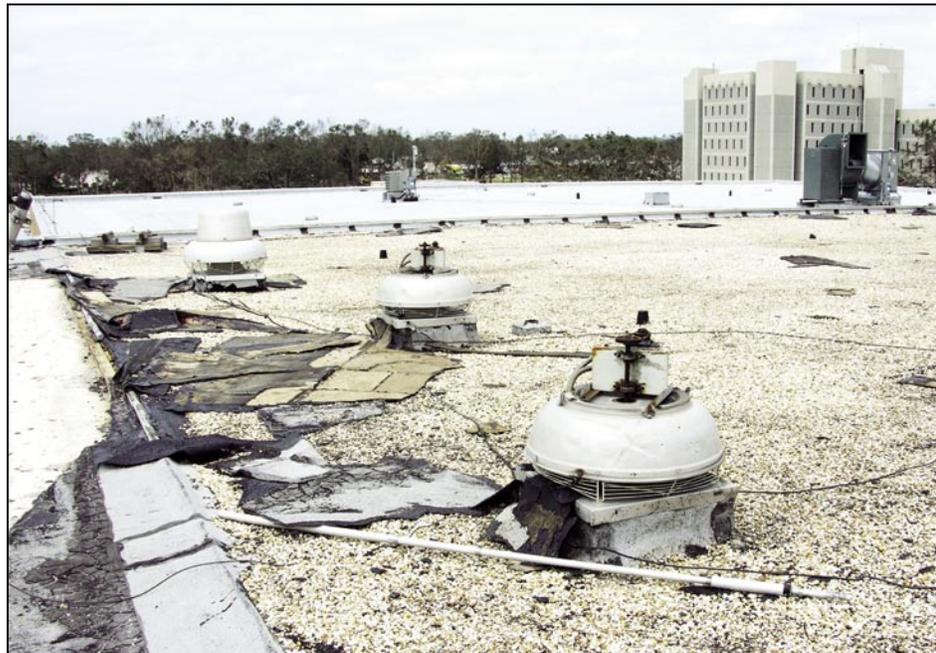
As frequently observed following previous hurricanes, many fan units were damaged. In some cases, the fans were blown off the curbs because too few screws were used to attach the fans to the curbs. In other cases, the fans remained attached to their curbs, but the cowlings were blown away (Figure 5-70). (FEMA 424 *Design Guide for Improving School Safety in Earthquakes, Floods, and High Winds* provides guidance for job-site strengthening of cowlings.) Figure 5-71 shows loss of a hood over a relief air vent. The connectors attaching the hood had insufficient strength to resist the wind loads. Although the opening through the roof was small, a substantial quantity of rainwater was able to enter the school. Because of widespread damage in the Pensacola area, this opening remained unprotected for several days after the storm.

Figure 5-70.
Loss of two fan cowlings on an EOC. Blown-off cowlings can tear roof membranes and break glazing. (Pensacola)

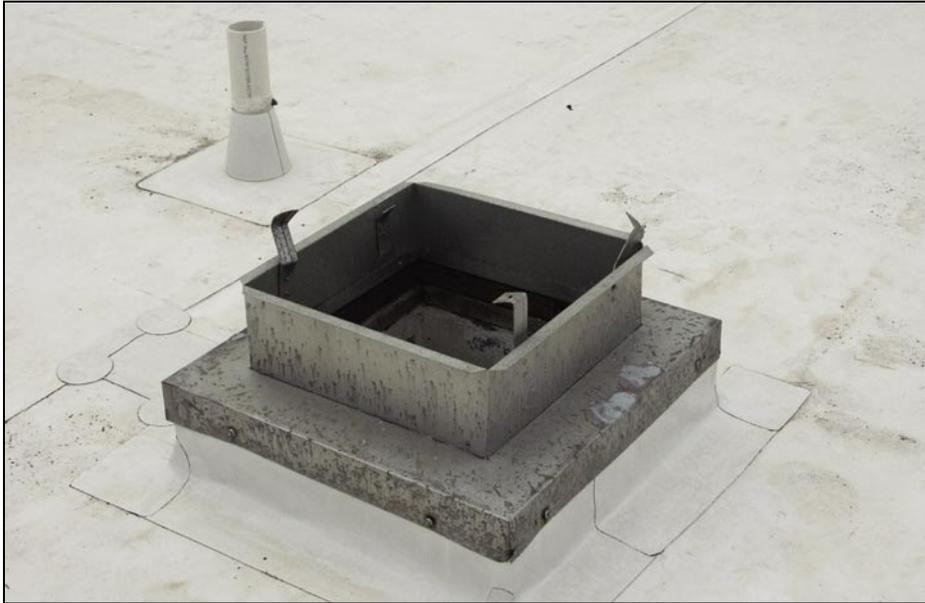
Figure 5-71.
Loss of the hood at this relief air vent allowed rainwater to directly enter the school. (Pensacola)

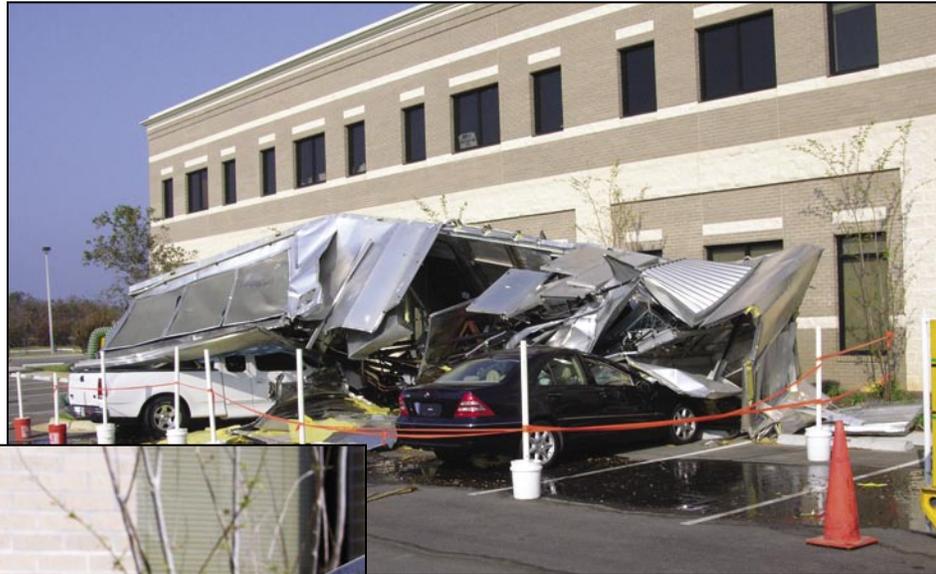
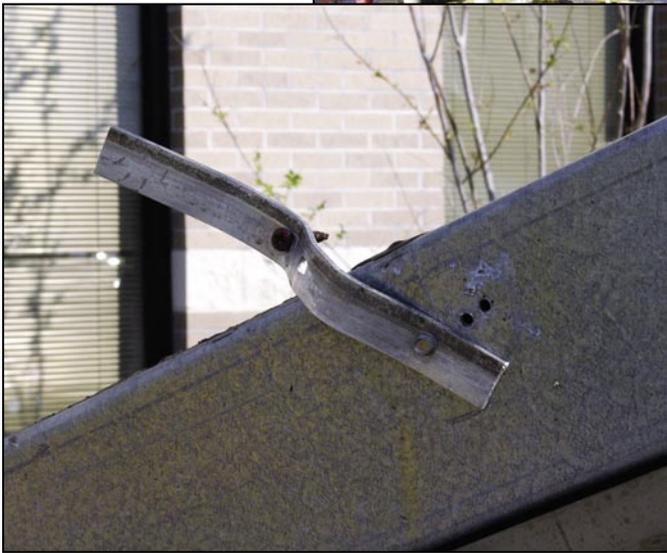
Figure 5-73 shows that even large HVAC units are susceptible to damage at moderate wind speeds (winds were estimated to be 85 to 95 mph in this area). This unit reportedly weighed 18,000 pounds. It was 30' long, 10' wide, and 8' high. It was attached to a wooden curb with sixteen 1" x 1/8" thick straps. Each strap had a single screw into the unit and a single 1 3/4" long #14 screw into the curb. The majority of the

screws pulled out of the curb, although some may have failed in shear. The unit was located approximately 20 feet from the edge of the building. After lifting off the curb, the unit hit and cut the roof membrane in several areas and then fell off the building and crushed two unoccupied vehicles. It was reported that approximately 2" of water collected on the second floor. The building was less than one year old.

Figure 5-73.
This large HVAC unit blew off a new medical office building. It was attached with 16 straps (see inset). (Gulf Breeze)

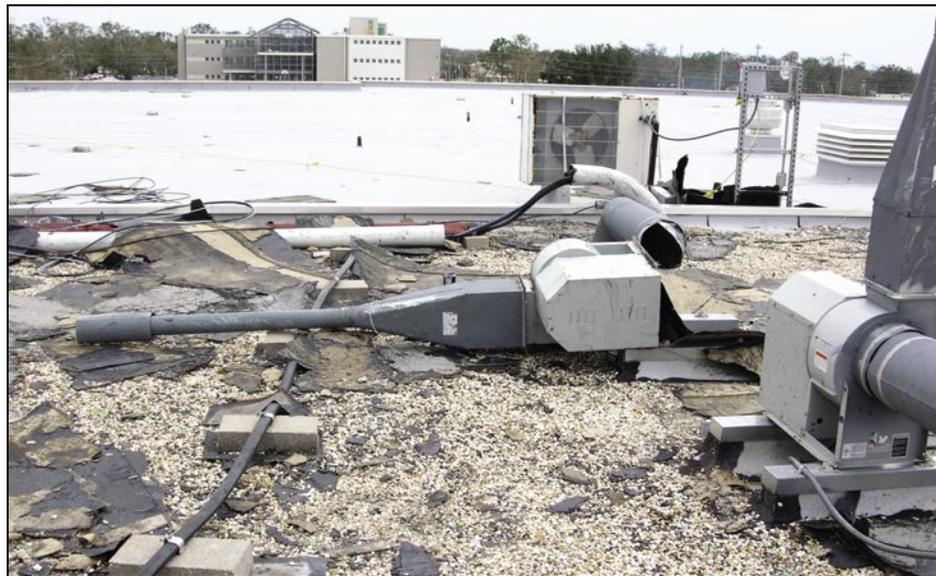
Figure 5-77.
Damaged ductwork at
an EOC. This damage
was likely caused by roof
membrane debris that
blew off a nearby area.
(Pensacola)
