Building Envelope Performance

5.1 Sheathing on the Underside of Elevated Buildings

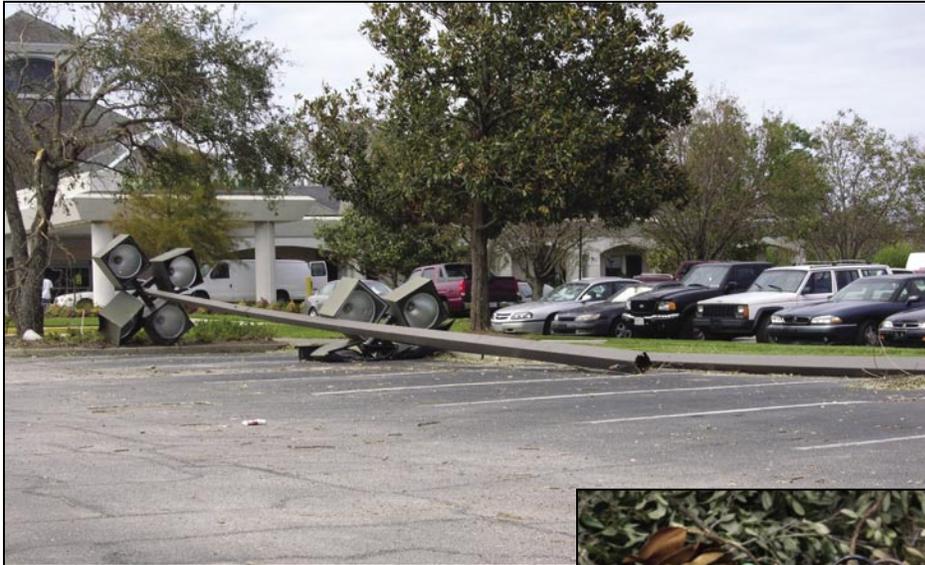
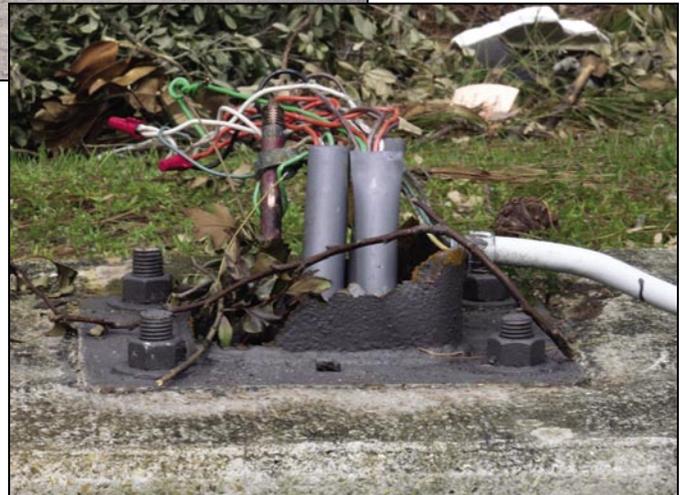
Figure 5-82 shows collapsed light fixtures. These failures were caused by severe corrosion.

Figure 5-82.
Collapsed light fixtures
at a hospital. The bottom
of the tube was severely
corroded (see inset).
(Pensacola)
