Structural Systems Performance

4.1 Flood

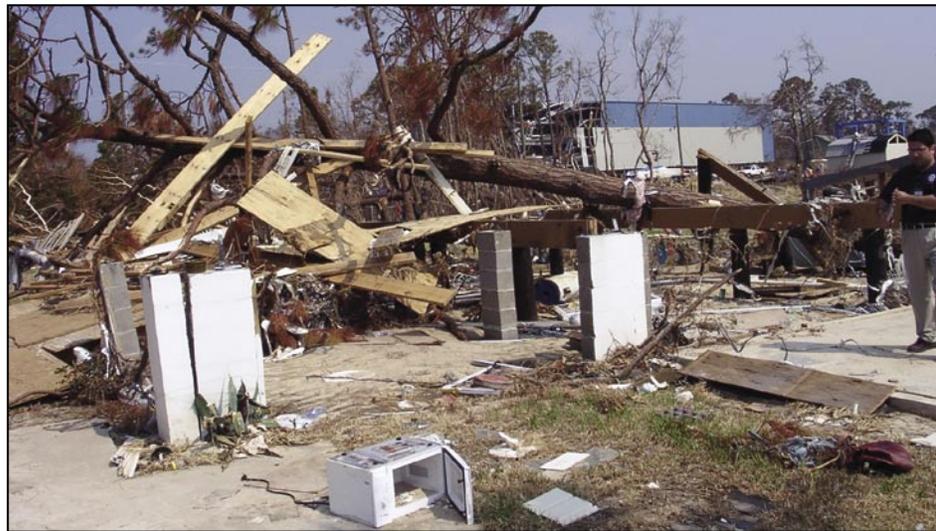
Figure 4-18. This photo shows the destroyed building adjacent to the house in Figure 4-17. It was destroyed (knocked off the masonry pier foundation) by some combination of storm surge, wave and debris impacts, and wind. (Big Lagoon)

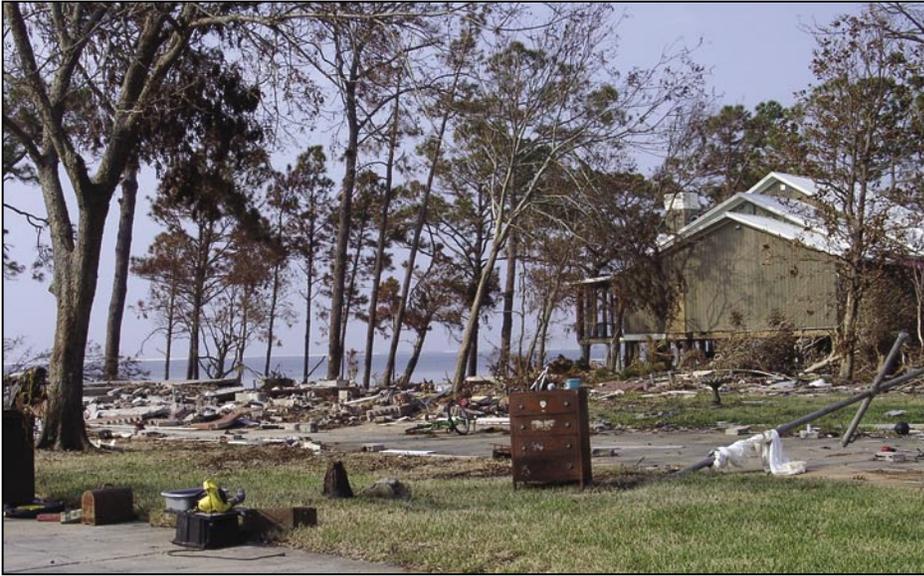
Figure 4-19. The pre-FIRM building constructed on a slab foundation (foreground) was completely destroyed, yet the adjacent building constructed on piles at a higher elevation remained intact and suffered relatively little damage. (Big Lagoon)

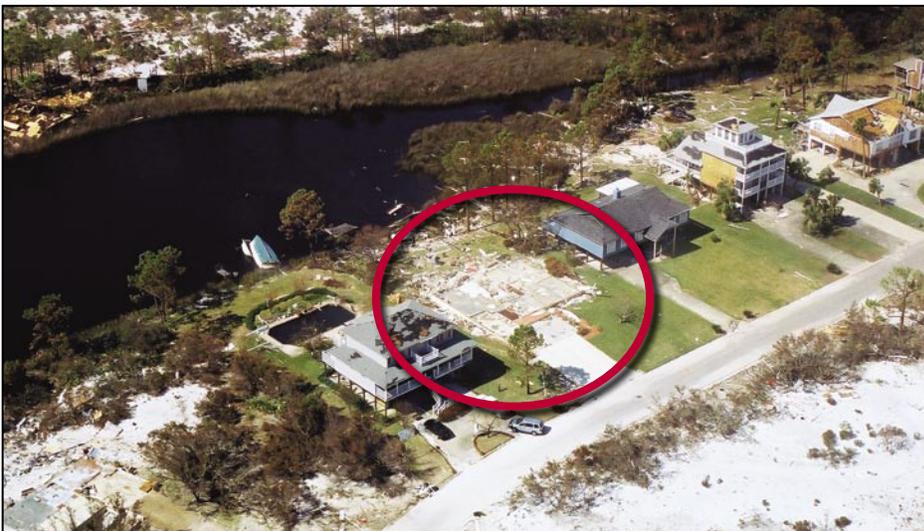
Figure 4-20. Destruction of slab-on-grade house (circled) in the Grande Lagoon neighborhood. Adjacent houses elevated on piles above the BFE sustained destruction of ground level enclosures and some wind damage, but survived. (Big Lagoon)

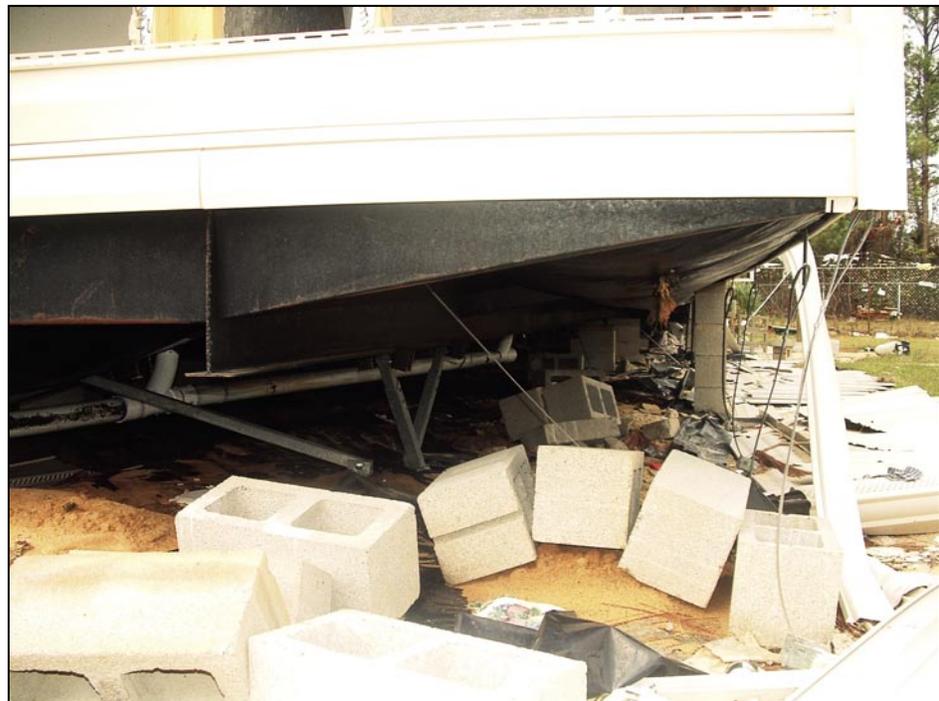
Manufactured houses placed on unreinforced, dry-stacked block piers were observed to shift in some cases due to the storm surge and wave action effects. Figures 4-30 through 4-32 provide several examples of piers shifting under manufactured houses. These types of piers are not suitable for coastal areas.

Figure 4-32.
Dry-stacked pier failure
(Orange Beach)

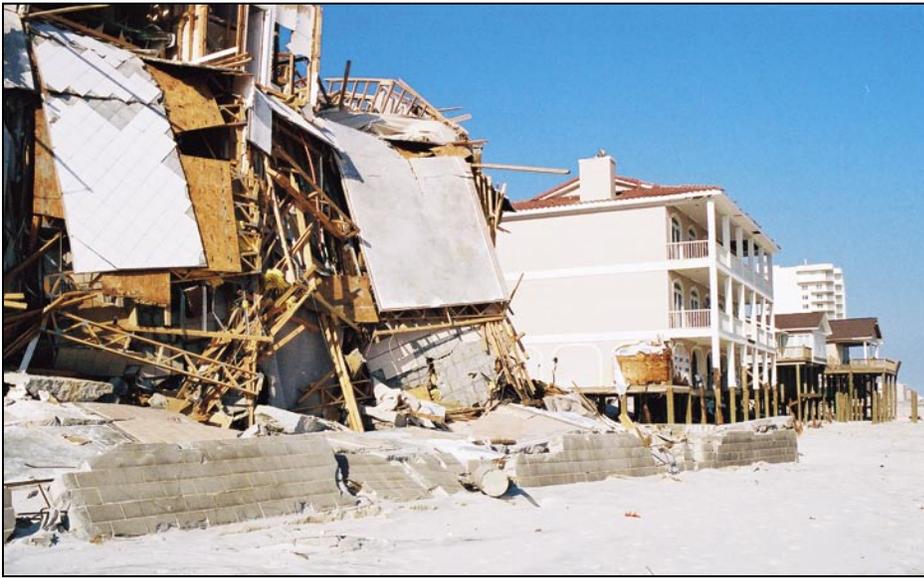
Figure 4-35. Shallow foundation failure. Note success of pile support structures in the background. (Orange Beach - Perdido Key)

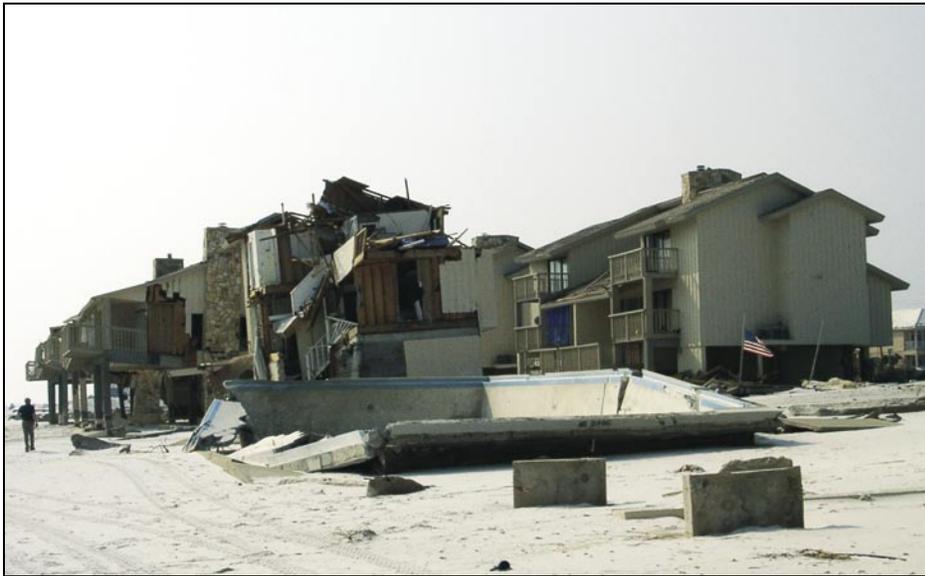
Figure 4-50.
Typical pool failure
(Pensacola Beach)

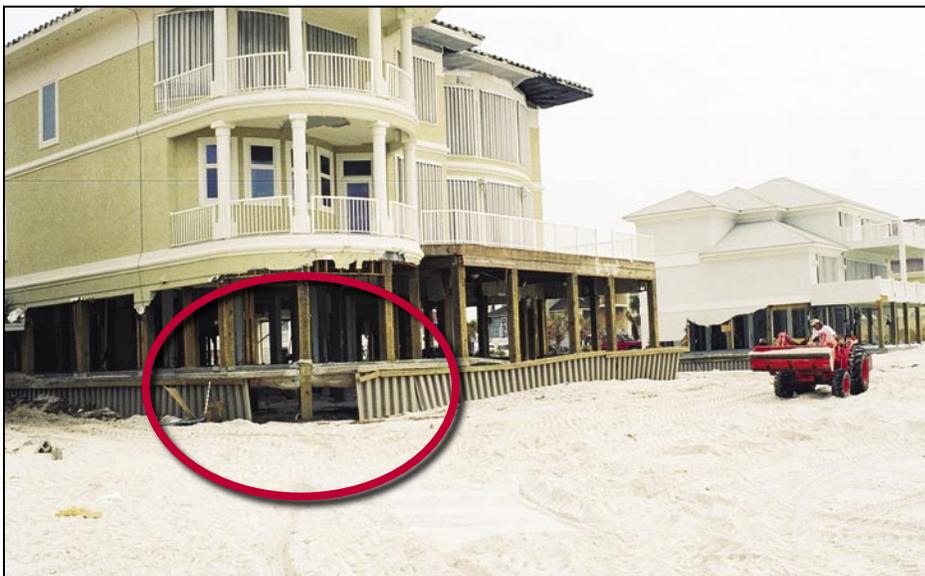
Figure 4-51.
Retaining wall failure
(Gulf Shores)

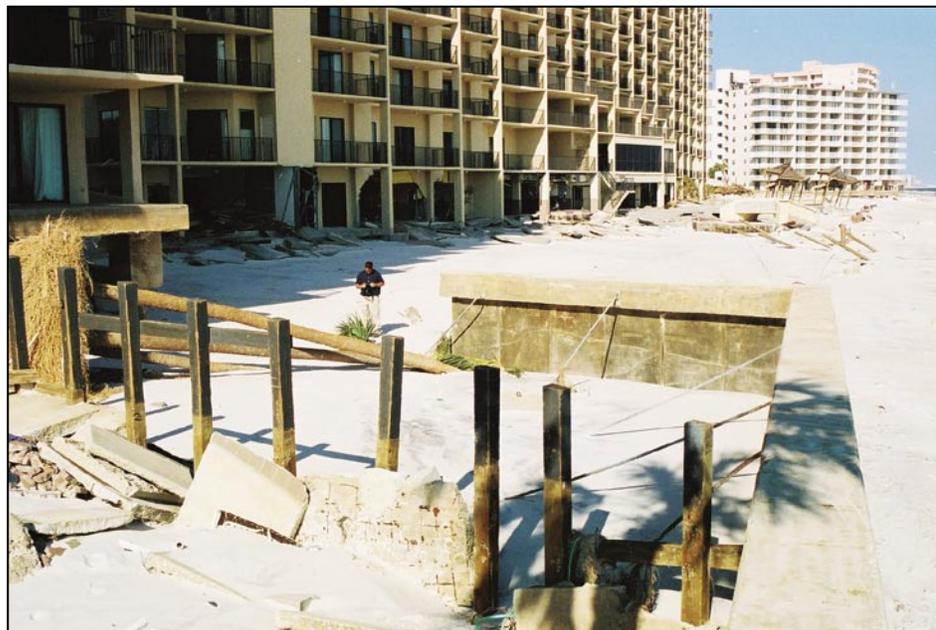
Figure 4-54. Bulkhead shown in Figure 4-53 remained in-place, but surge and wave overtopping, coupled with erosion at the short return wall, led to deck and retaining wall failure. (Orange Beach)

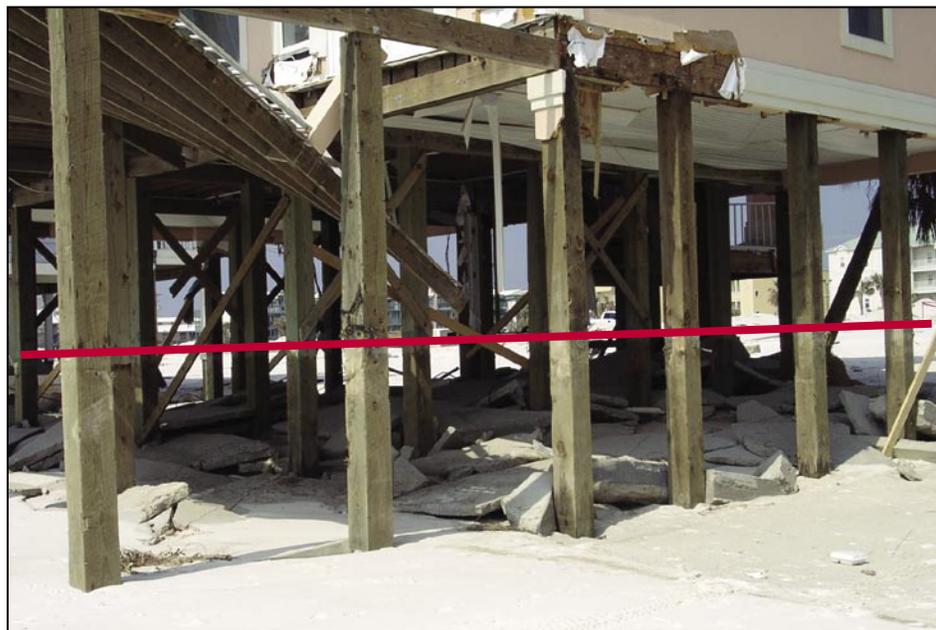
Figure 4-58. This slab failed but did not break into small pieces due to the reinforcing steel. The incomplete slab failure might have transferred flood forces to the foundation and contributed to the pile failure (piles in background were partially pulled out of the ground and are leaning). (Orange Beach)

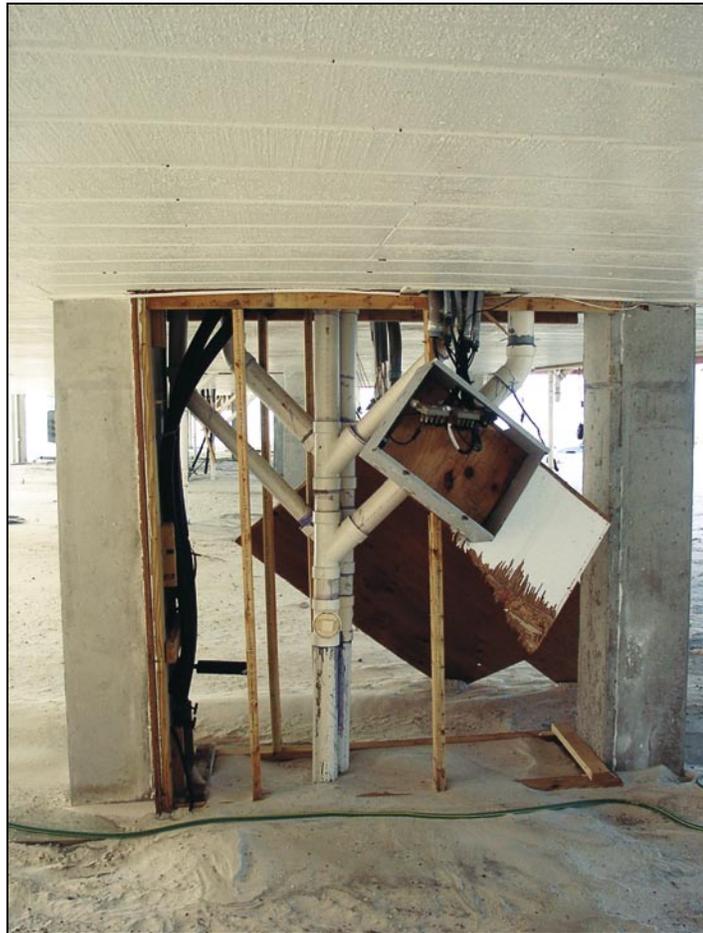
Figure 4-71.

Drain lines constructed between interior piles (which helped to protect them from flood forces), although electrical box was connected to plywood panel and was destroyed (Pensacola Beach)

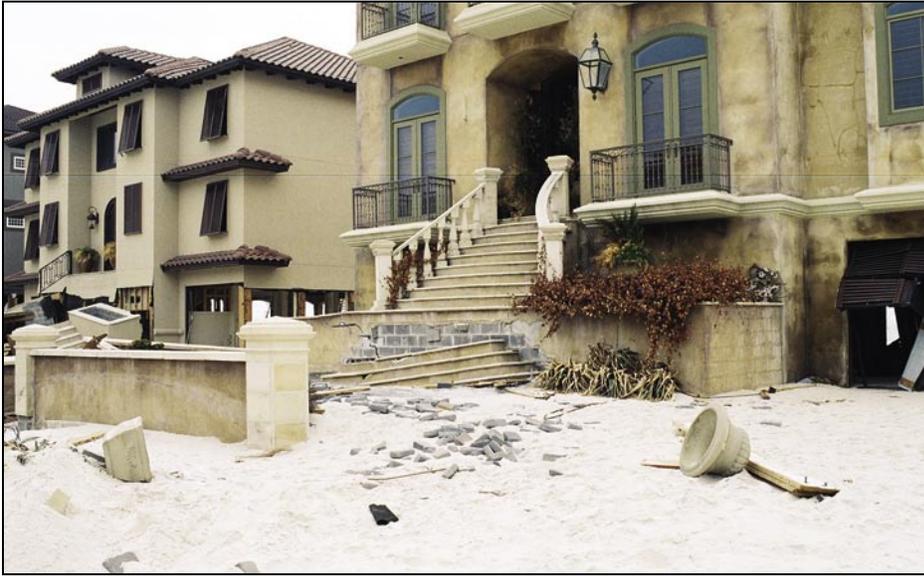
Figure 4-72. Massive stairs that will obstruct flows could deflect waves and debris into the elevated building. This type of stair structure is a violation of the V-Zone free-of-obstruction requirement. (Gulf Shores)

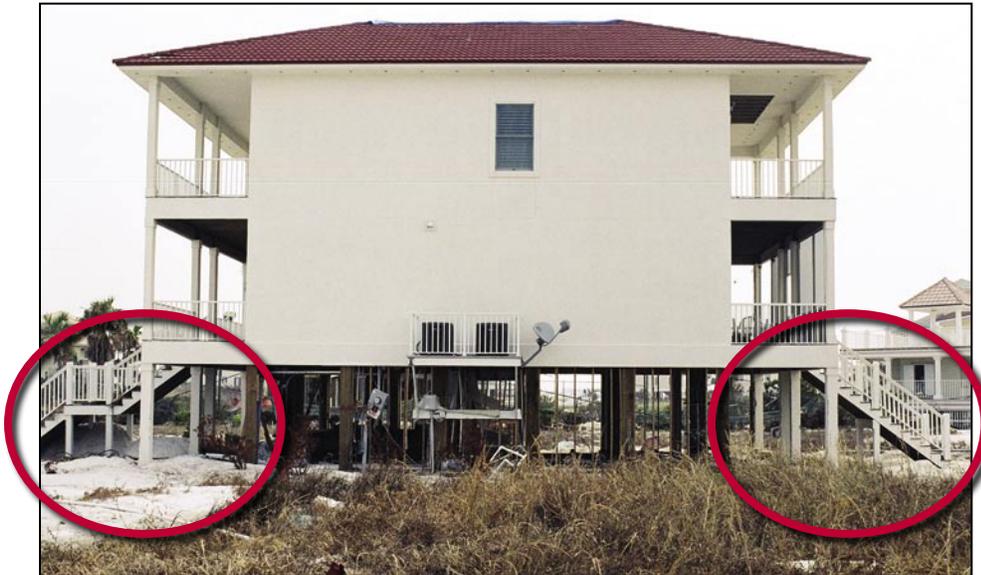
Figure 4-73. Stairway structures (circled) that will minimize obstructions to flow and potential adverse effects on the elevated building (Gulf Shores)

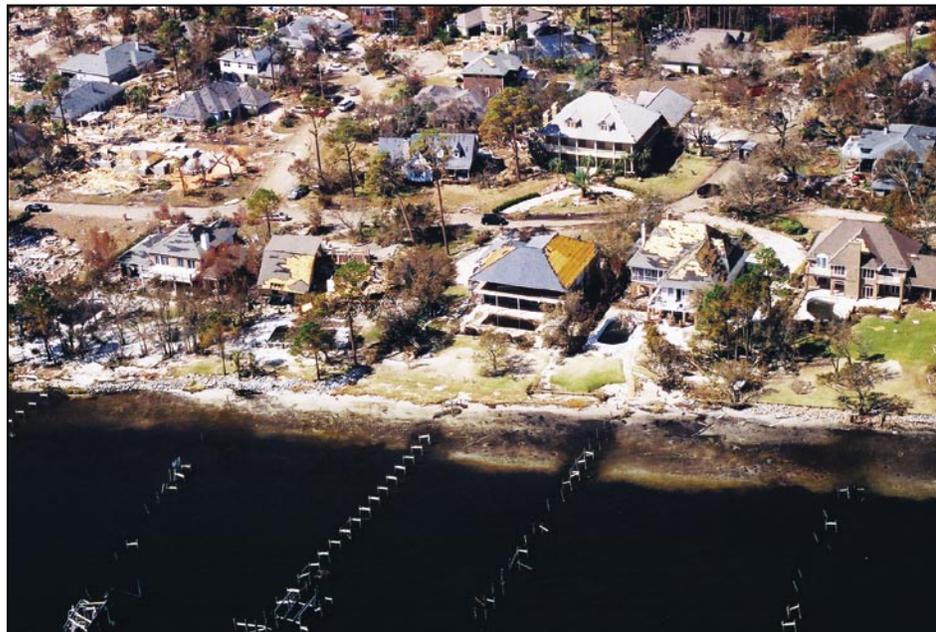
Figure 4-79.
Typical view of destroyed docks contributing to floodborne debris (Big Lagoon)

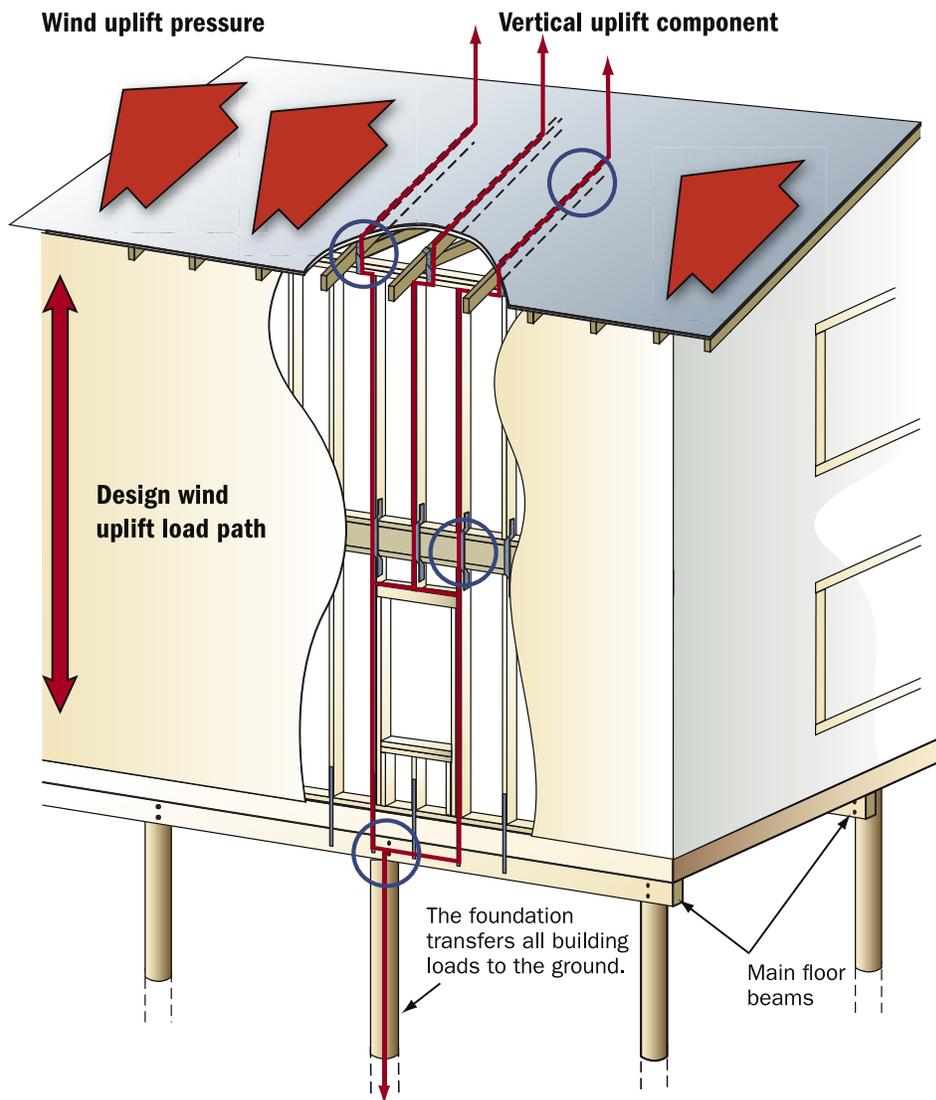
Figure 4-82. Load path of a two-story building with a primary wood-framing system: walls, roof diaphragm, and a floor diaphragm

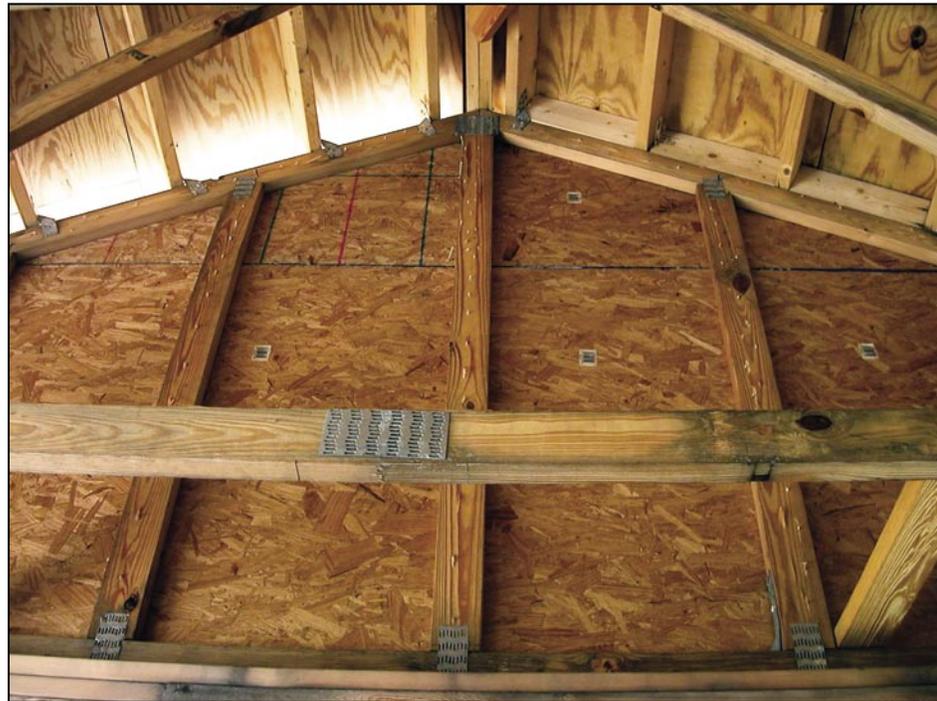
Another common failure point was wood-frame gable end walls. These are commonly under designed or improperly constructed. Often, a typical roof truss is the only support element behind the wall covering of the gable as shown in Figure 4-85. Trusses are constructed with the weak dimension of the lumber turned normal to the plane of the truss. This means that when a typical truss is used alone as the wall framing for the gable end wall, the truss members must resist the wall's wind forces in their weak direction. On larger buildings, the height of the gable end wall from the plane of the ceiling up to the peak of the gable is often taller than the story heights below. In these cases, even wall studs would have to be strengthened in order to be adequate. The truss members are typically not capable of carrying the bending forces in this manner. In cases where adequate wall stud framing is present in the gables, the problem is typically the absence of adequate bracing where the gable end wall sits on top of the wall below. This point is a hinge and must be braced by framing to transfer the wind loads into the lateral load resisting system. Figure 4-85 illustrates the arrangement of these structural members in typical light-frame construction. The framing shown in Figure 4-86 shows a truss resisting the wind loads with its weak axis. This was in an upscale house under construction, so the problem is still not being addressed in all cases. The condominium building shown in Figure 4-87 had no evidence of any bracing at the hinge point in its gable end wall framing.

Figure 4-87.
Gable end wall failure
due to lack of bracing at
hinge point in wall (see
arrow) (Perdido Key)

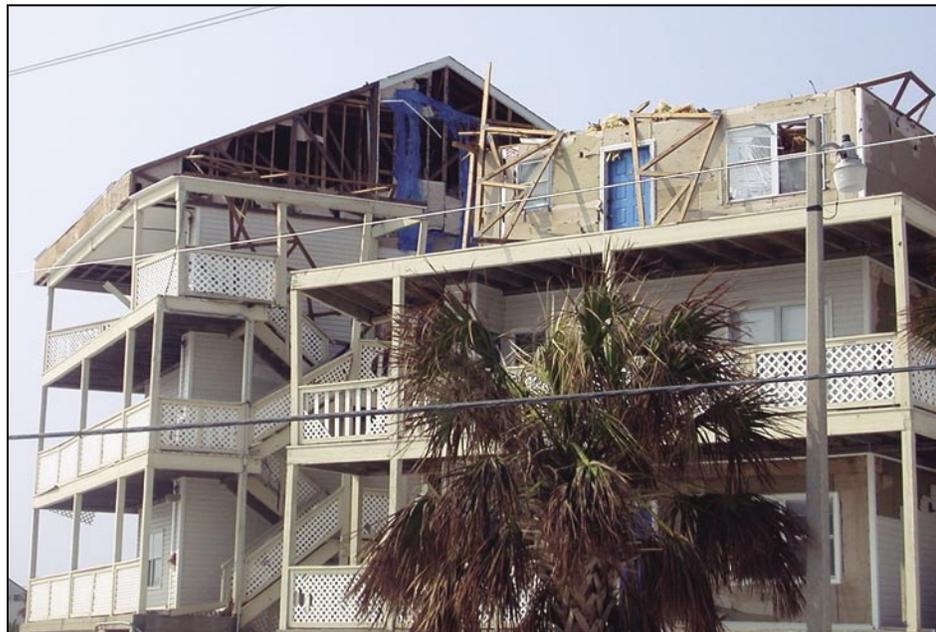
complete the load paths, as illustrated in Figure 4-82, was the cause of damage. The MAT observed several buildings such as the ones shown in Figures 4-88, 4-89, and 4-90, which suffered the total loss of the roof framing due to improper anchorage of the roof framing to the walls.

Figure 4-89.
Roof framing damage due
to lack of connections
from roof to wall
(Pensacola Beach)

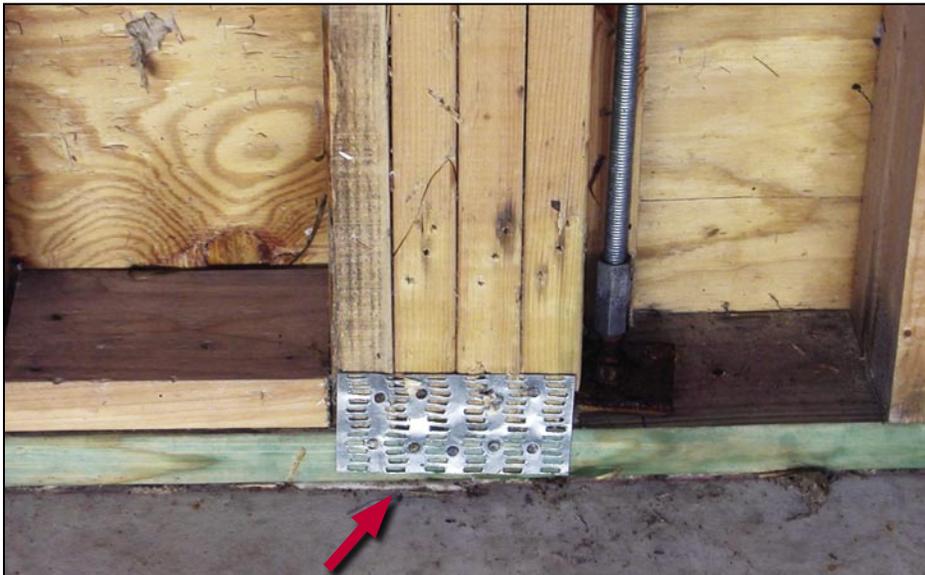
Figure 4-91.
Improper use of a wood truss press plate connector to substitute for stud hold-downs (Oriole Beach)

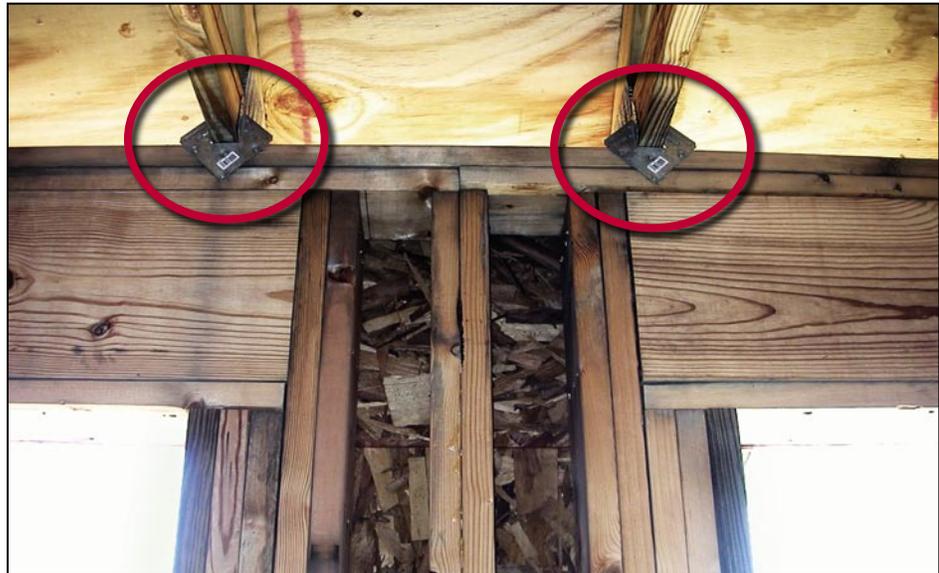
Figure 4-93.
Improper strapping
(Ono Island)

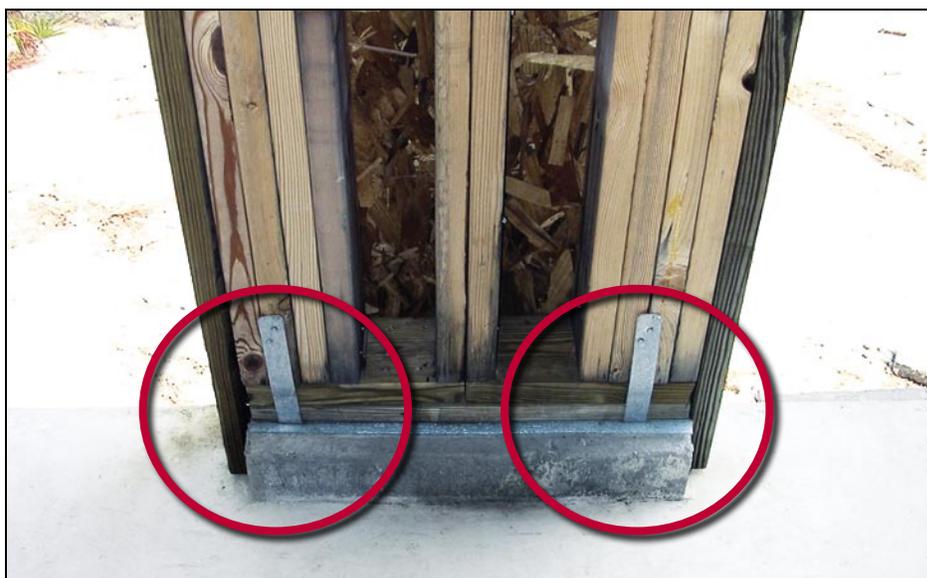
Figure 4-94.
Wall studs between
garage doors with
inadequate hold-downs
(Ono Island)
