Appendix A

History of Antiseep Collars

Conduits through Embankment Dams

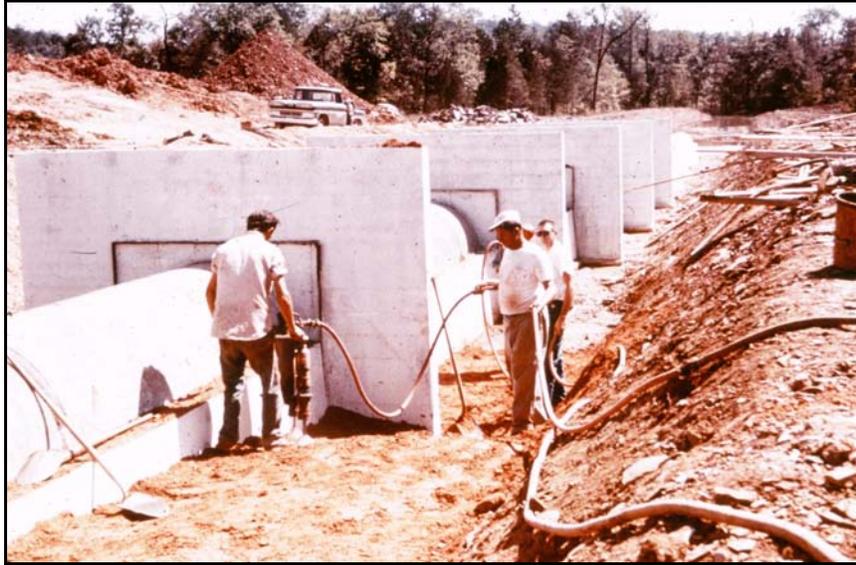
Figure A-1.—Hand tamping embankment material next to an antiseep collar.

The cause of the failure was likely the combination of the dispersive clay embankment material, hydraulic fracture, antiseep collars (figure B-3) around the conduit that required the use of hand tampers (figure B-4), “flowable” backfill for conduit support in lieu of a continuous concrete conduit support, and lack of a filter and drain around the outlet conduit in the downstream portion of the embankment dam. Cold air flowed through the conduit during the winter preceding the failure. This caused lenses of frozen material in the conduit’s backfill. These lenses may have provided a path for concentrated leakage when they were thawed by the initial flow of water in the conduit during the runoff.

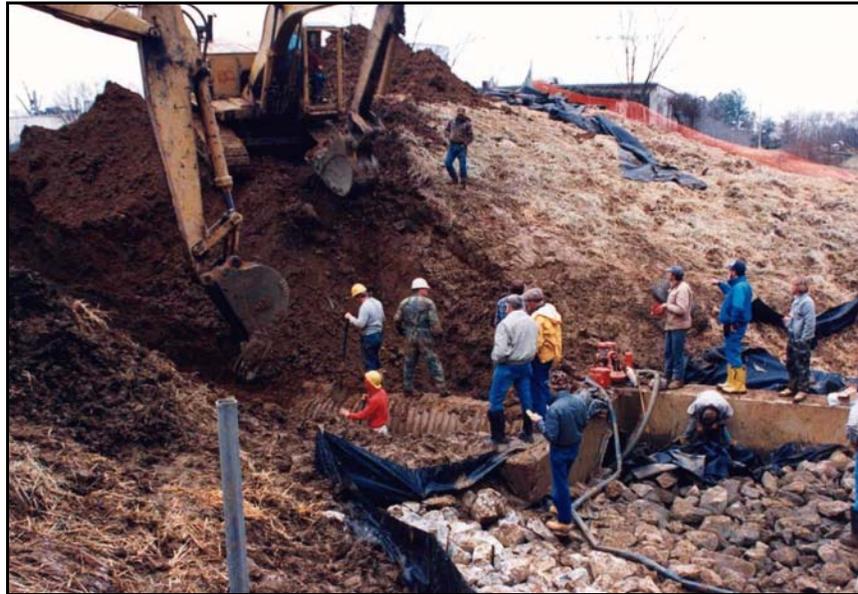
The forensic investigation confirmed that the CMP was installed in a trench with near vertical sides. In addition, it appeared that the trench may have been overexcavated and backfilled with poorly compacted fill material, which was quickly eroded away by flow along the outside of the conduit and/or into open joints. Loss of soil support would have caused additional conduit deformation, further opening the joints, resulting in an ever-increasing cycle of leakage and loss of earthfill by internal erosion. Figure B-10 shows the presence of undisturbed foundation soils

Figure B-7.—The spillway conduit and portions of the embankment soils were carefully removed and documented during a forensic investigation about 2 weeks after the failure.

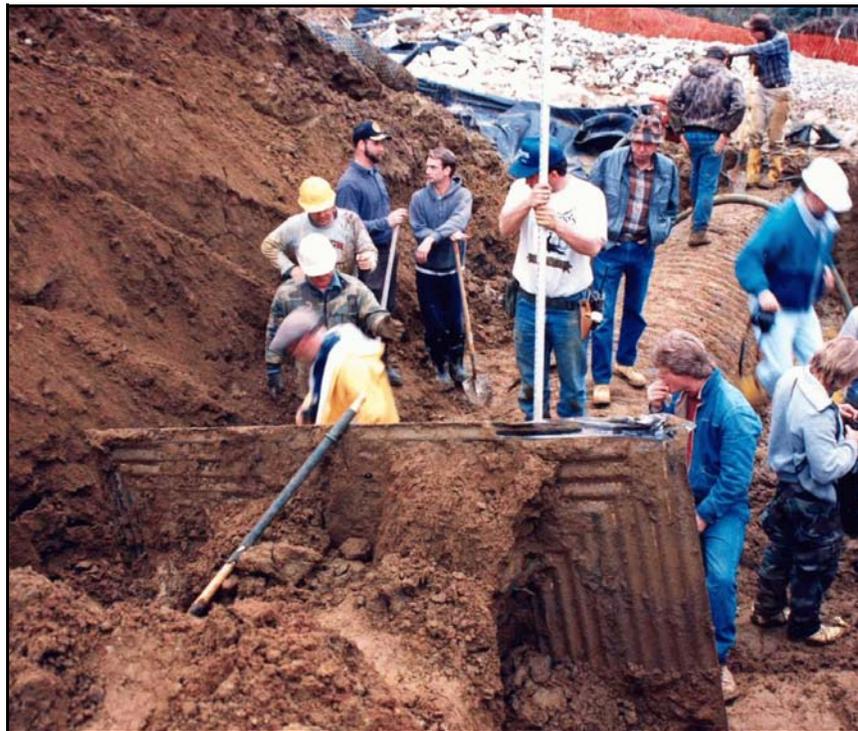
Figure B-8.—Starting at the downstream end of the conduit, two large excavators removed the majority of the earthfill under the watchful eyes of State and local officials, geotechnical engineers, surveyors, lawyers and the pipe manufacture.

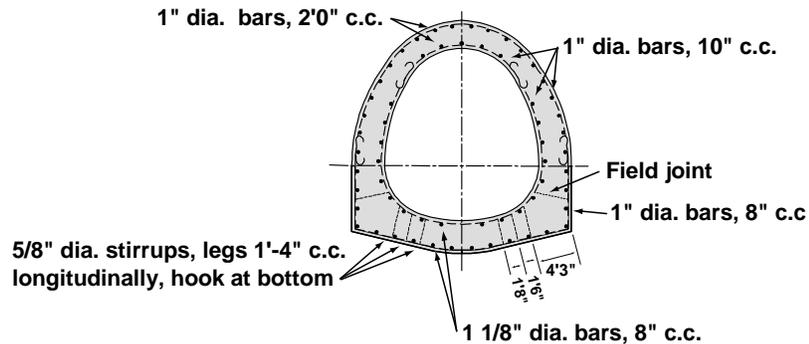
waterstops in the joints of the conduit be designed and installed properly. Unfortunately, this did not happen. There is no written record why this error was not discovered sooner. A cross section of the outlet works conduit is shown in figure B-13. The designers intended that the lower one-third of the conduit be constructed as one continuous monolith. Above the field joint shown in figure B-13, the conduit was designed to be cast in 25-foot long monoliths.

The above background provides an introduction to the problem experienced in the fall of 2003. While in the conduit to replace the filler in the outer dove-tail portion of the joints, joint 6-7 broke lose and started to make sand at a significant rate ($\frac{2}{3}$ cubic yard in 1 hour). Even though it has been known since construction that there were no waterstops in the lower portion of the conduit, it was thought that the joints

Figure B-13.—Cross section of the outlet works conduit.

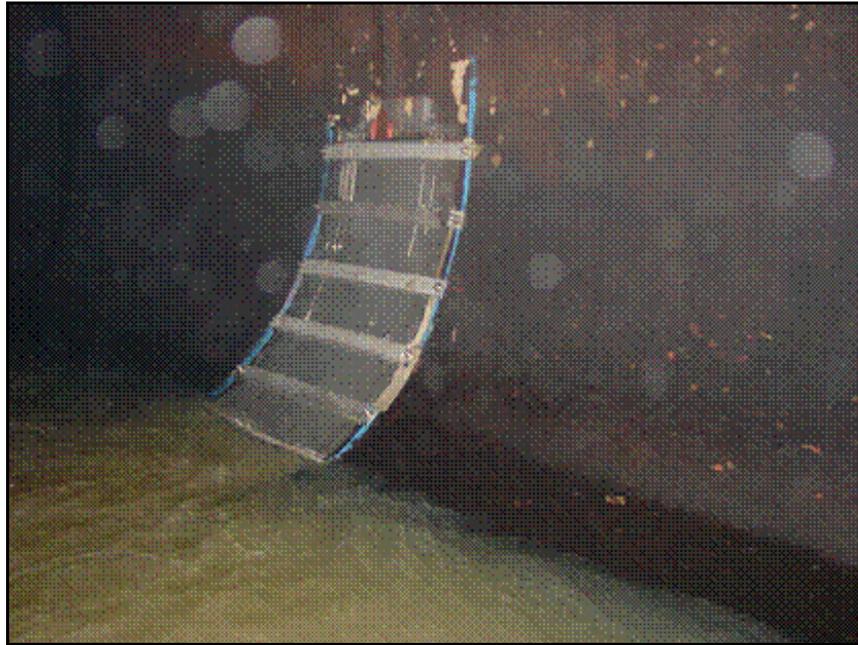
Figure B-14.—Metal plate bolted across the joint.

had been satisfactorily sealed with grout and that periodic grouting with chemical grout would keep the conduit watertight. However, since joint 6-7 broke loose suddenly and flowed sand at a significant rate, the conduit could no longer be considered safe for static loading and definitely could not be considered safe for earthquake loadings. Therefore, a team was formed to determine what should or could be done to ensure the continued safety of the conduit. The team solicited advice from personnel throughout the USACE. The consensus felt that the obvious solution was to line the conduit with a steel liner. However, the team recognized that this would be very expensive and would require bypassing outflow. Also, going through the design process, review process, and budgeting process would take several years. Therefore, the team elected to experiment with an interim measure that may or may not be the final solution. The team felt that if a plate were bolted across the joint with gasket material beneath it to prevent sand from exiting from the joint, then this would solve the problem. However, no one had any experience in doing this, and there was no assurance that the plate would stay in place. Therefore, the USACE elected to experiment with two joints during the time that the structure was unwatered for the 5-year formal inspection. A metal plate was bolted across joints 5-6 and 6-7 during a shutdown of the outlet works (figure B-14).

- *Cement mortar.*—Cement mortar was used to smooth the surface across the joint. This mortar was from 1.8 inches thick to 1 inch thick (had this much differential settlement at one joint).
- *Steel plate.*—Twenty-two feet of stainless steel plate was installed along the bottom of the joint. At a distance of about 10.5 feet from the centerline of the conduit, a 1.25-inch diameter hole was drilled in the side of the conduit to the existing waterstop (about 21 inches).

- *Waterstop.*—A waterstop was formed in this hole using backer rod saturated with chemical grout.
- *Chemical grout.*—After chemical grout in the backer rod had hardened, chemical grout was pumped through a tube that had been installed to the bottom of the hole. Grout was pumped under pressure to fill any voids and try to get a good contact with the rubber waterstop.

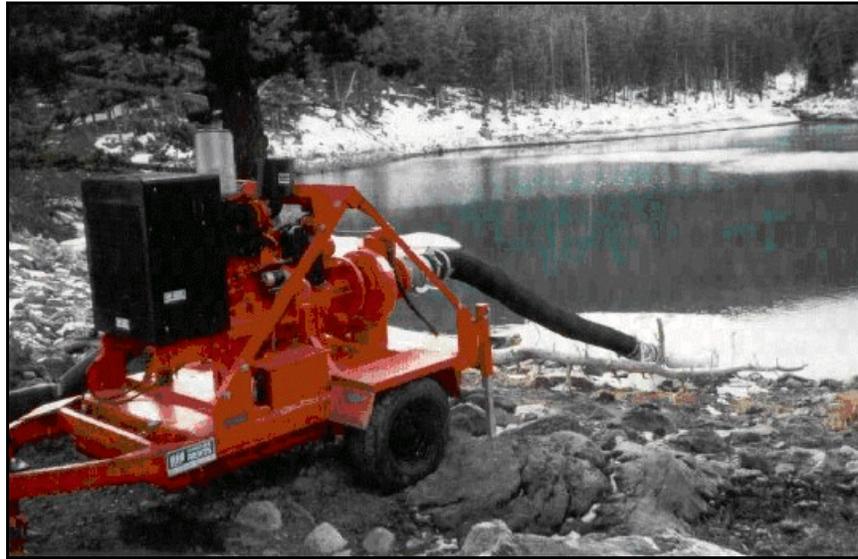
On November 15, 1996, a portable 3,000 gal/min pump (figure B-17) was delivered to the site. The pump was set up adjacent to the spillway and placed into operation. The pump was operated continuously for 3 days, and the water surface level of the reservoir was lowered to approximately 8 feet below the spillway crest. At this point, the excavation to breach the embankment dam was commenced. A Caterpillar 330 track-mounted excavator was used to perform the excavation. The area of the sinkhole and the upstream slope were first excavated as far into the reservoir as the excavator could reach, and then the embankment dam crest was benched down approximately 4 feet on either side of the breach. The breach was excavated on both sides at a slope of 1.5H:1V down to the water surface level. Rocks of varying sizes were placed in the bottom of the excavation and down the downstream slope of the embankment dam to help control erosion. Then, a small amount of the embankment dam was removed from the breach entrance, and water was allowed to flow through the breached section. Some minor slope erosion occurred, but no backcutting of the channel into the embankment dam was observed.

Figure B-17.—Portable pump used to initiate draining of the reservoir.

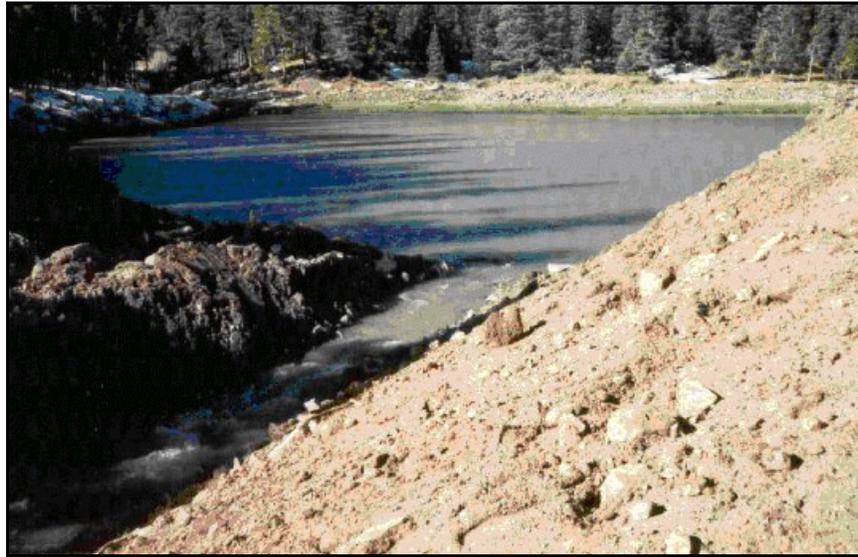
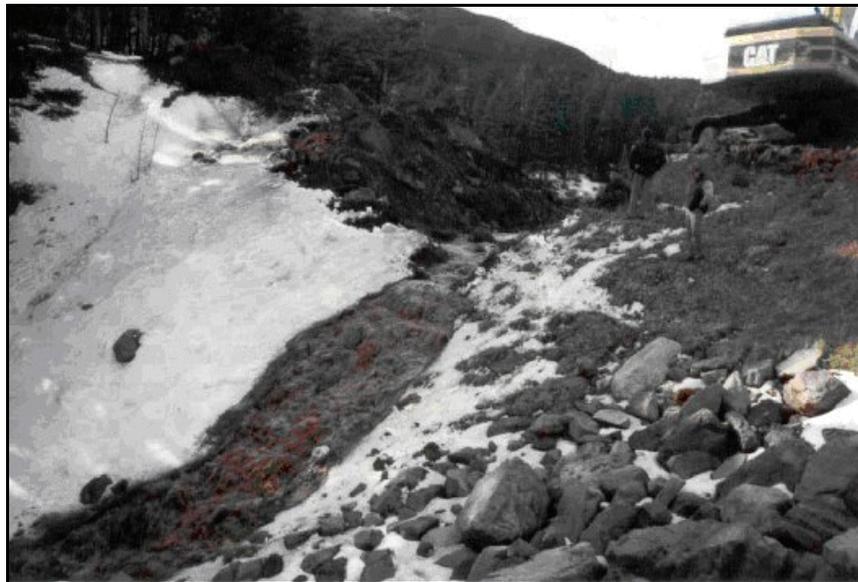
The initial flow of water through the breach (figures B-18 and B-19) was allowed to stabilize and diminish, and then the process was repeated to remove another small portion of the embankment dam. The excavation of the embankment material was kept at a minimal amount to limit the quantity of water discharging through the breach section. This process was repeated, and each time the water flowing through the breach was allowed to flow out and stabilize before removing additional embankment material. The partial breaching of the embankment dam was completed over 2 days. The final dimensions of the breach obtained consisted of an 8-foot wide bottom, a 65-foot top width, a depth of 20 feet, and side slopes of 1.5H:1V. The bottom of the breach section was provided with rock riprap erosion protection. The embankment dam was not completely breached to allow for a small reservoir with a depth of 8 feet to remain for the purpose of controlling silt deposits in the reservoir and to maintain a fish habitat. With the partial breaching of the embankment dam, the dam was considered to no longer pose a safety hazard to the general public.

Figure B-18.—Initialization of the breach in the embankment dam near the left abutment.

Figure B-19.—Discharge of water through partially breached section and down the downstream slope of the embankment dam.

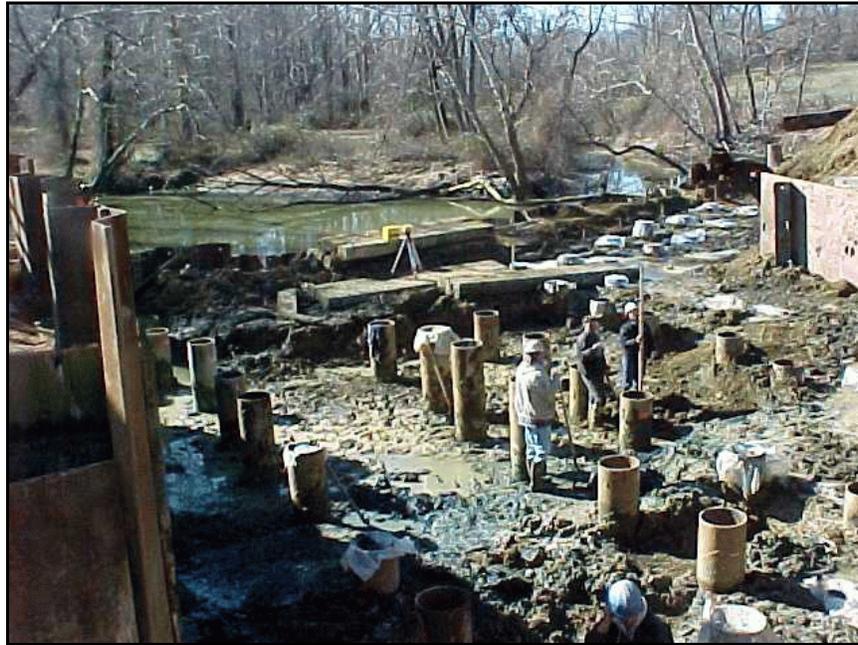
Figure B-24.—Because of soft foundation soils, numerous 60-foot long pipe piles were installed in winter 2001 to support a new reinforced cast-in-place concrete spillway structure.

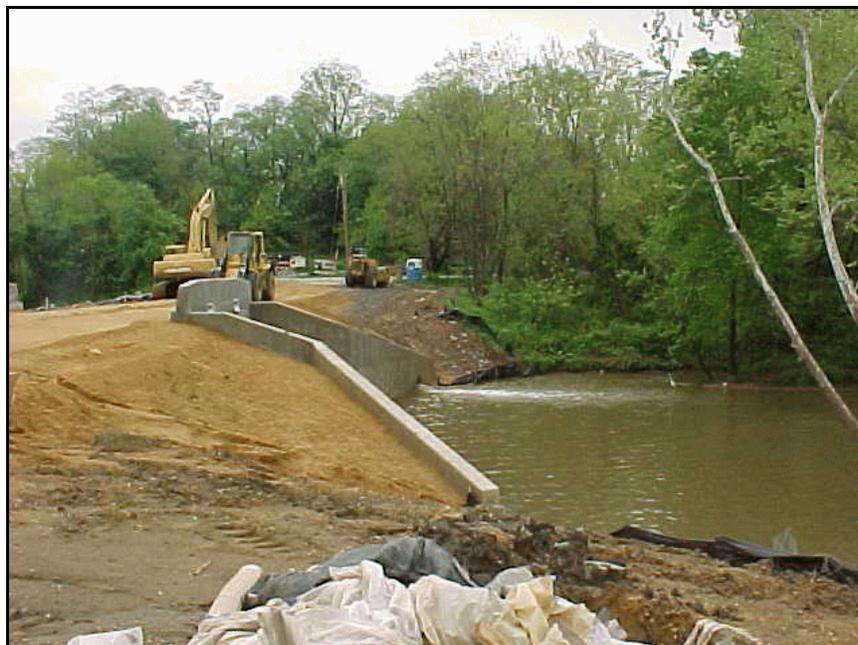
Figure B-25.—This the downstream end of the spillway at the end of construction in 2002.

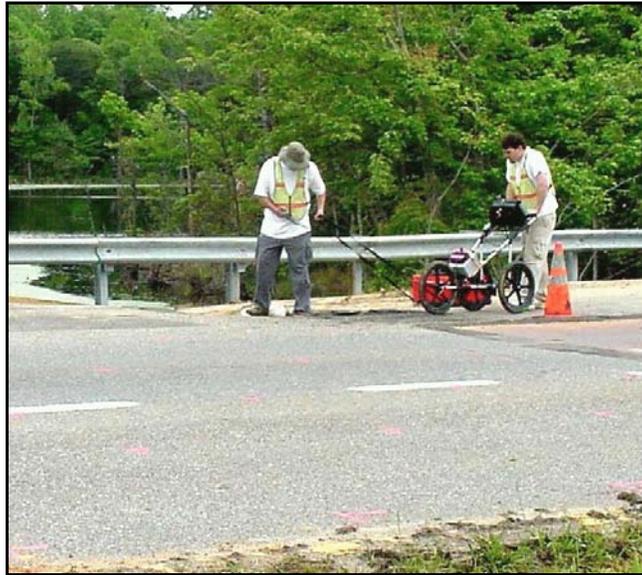
Figure B-30.—Ground penetrating radar investigations were performed from the embankment dam crest.

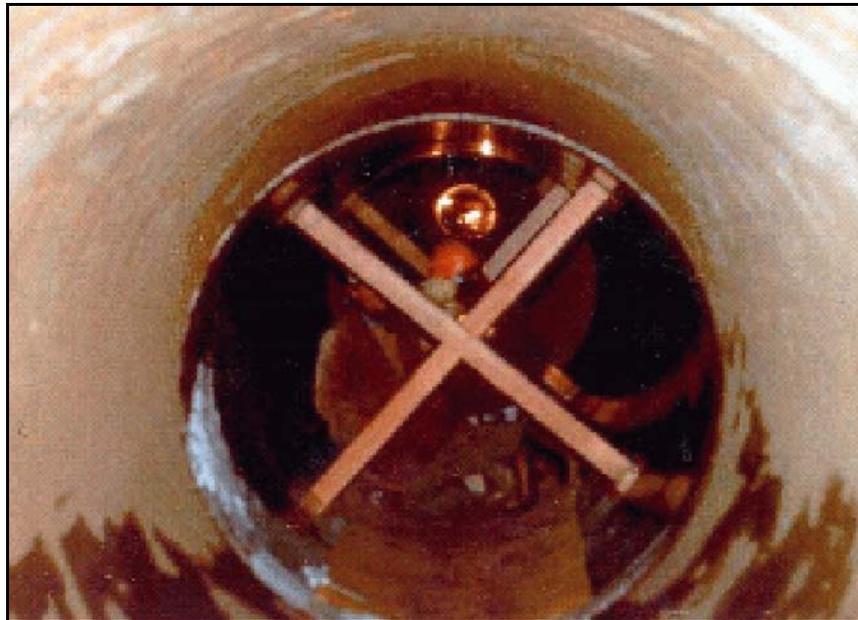
Figure B-34.—Installing the steel pipe slipliner within the existing outlet works conduit.

entire conduit with a steel pipe slipliner. This steel pipe slipliner would provide additional structural stability and a good flow surface, prevent seepage through the concrete, and could be placed in an expeditious manner to allow reservoir operation in the spring of 1993.

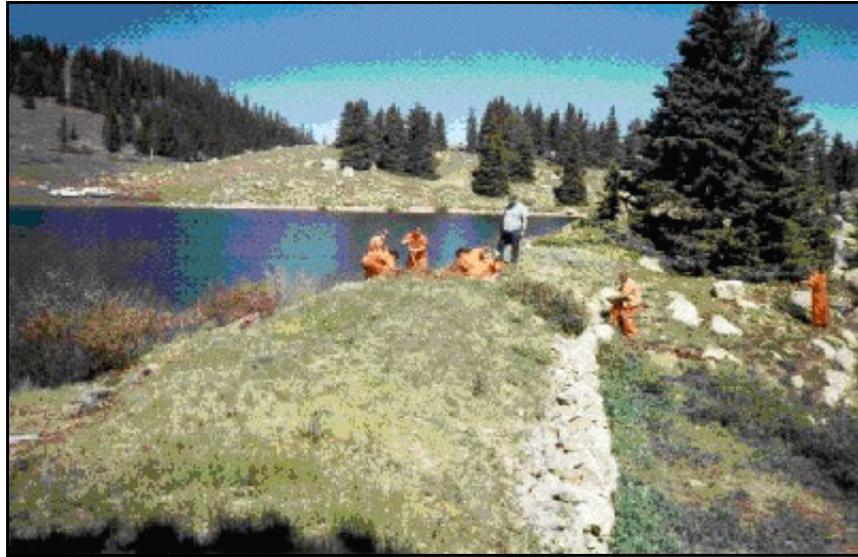
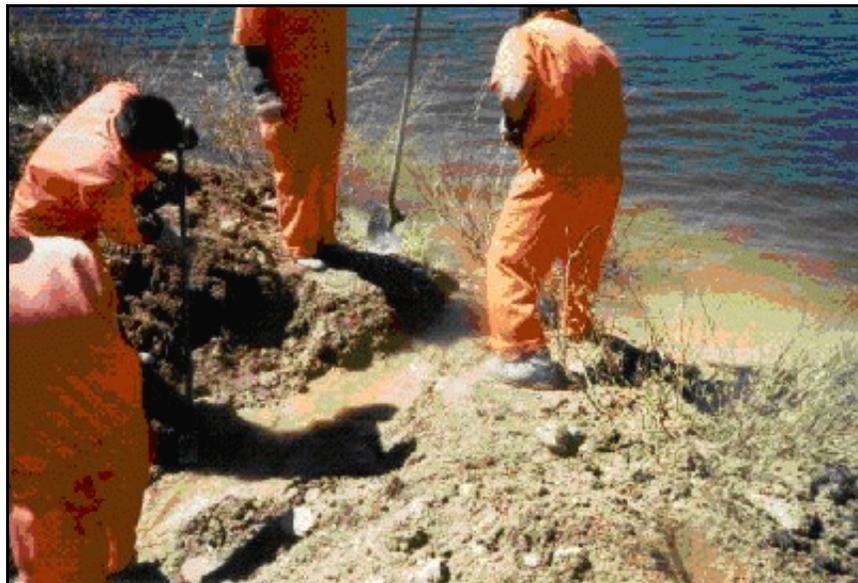
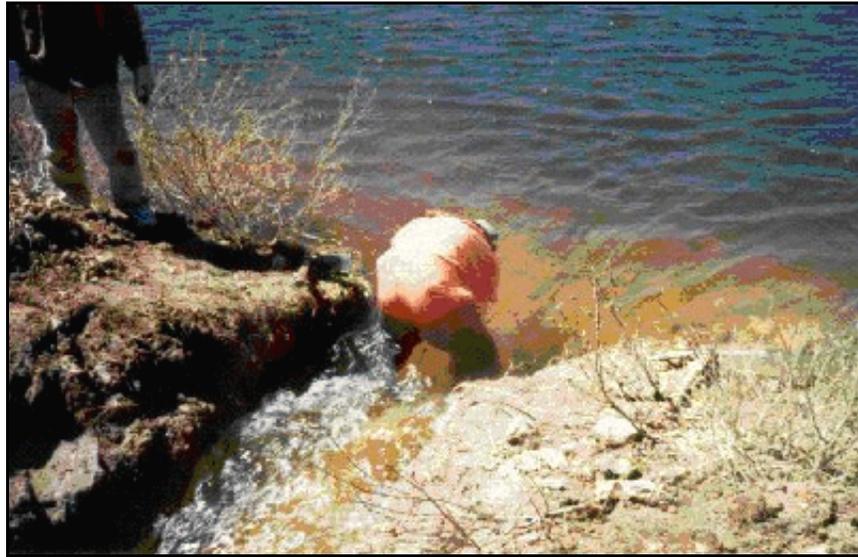
hauled in by hand. The final cut would be made through the embankment dam, allowing the reservoir to be drained in a controlled manner. The bottom and sides of the breach were excavated and lined with a graded rock riprap (figure B-38).

Figure B-38.—Excavation of the controlled breach in the embankment dam.

Figure B-39.—Completion of the initialization of the breach in the embankment dam.

Figure B-40.—Deepening of the initial breach channel.

B-40). However, the control section, where the flow transitions from subcritical to supercritical flow, was located in the breach channel, where backcutting could occur and cause a large uncontrolled release. The reservoir basin upstream of the breach would have to be excavated in order to move the control section back into the reservoir. The inmates donned hip-waders and began the arduous task of excavating underwater, and after an hour's effort, the control section was safely located several feet back into the reservoir. Empire Dam was completely breached by July 2, and the reservoir drained in a very efficient and cost-effective manner.

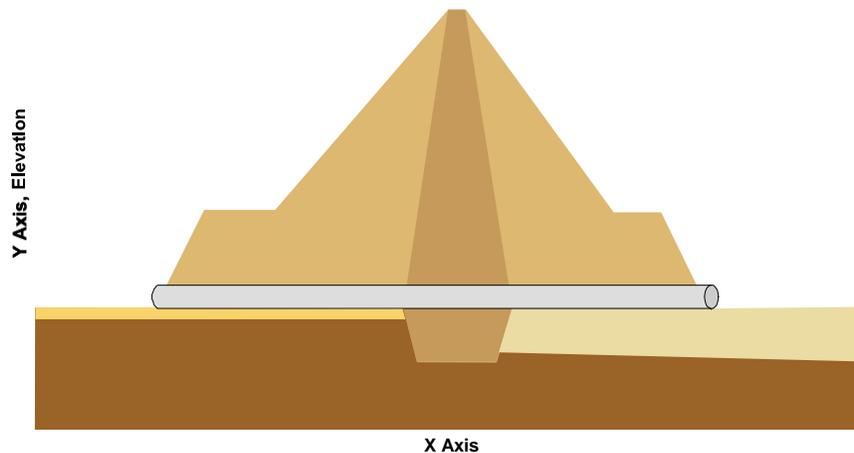
The outlet conduit was installed on variable thicknesses of compressible material. The first 50 feet of the outlet conduit at the upstream toe of the embankment dam is chert bedrock. From this point to the upstream edge of the core trench, a layer of gravel backfill above chert bedrock serves as foundation for the outlet conduit. The gravel thickness varies from 1 foot at its upstream end to 3 feet at the edge of the core trench. In the core section, the outlet conduit bridges above 20 feet of compacted clay backfill, which is in the underlying cutoff trench. Downstream from the core, the bedrock dips steeply, and the outlet conduit is founded on streambed gravels in the upper zones, grading to gravelly clays in the lower levels above bedrock. The depth of the alluvium to bedrock was 24 feet prior to the embankment dam foundation excavation. The outlet conduit was constructed in the

Figure B-41.—Idealized cross section of Hernandez Dam.

trench condition under the upstream shell and the first half of the downstream shell; it was constructed in the positive projecting condition in the sections under the core and second half of the downstream shell. The impervious core backfill in the key trench was brought up to $\frac{1}{2}$ foot above grade; the earthfill was then excavated down to grade prior to the installation of the outlet conduit.

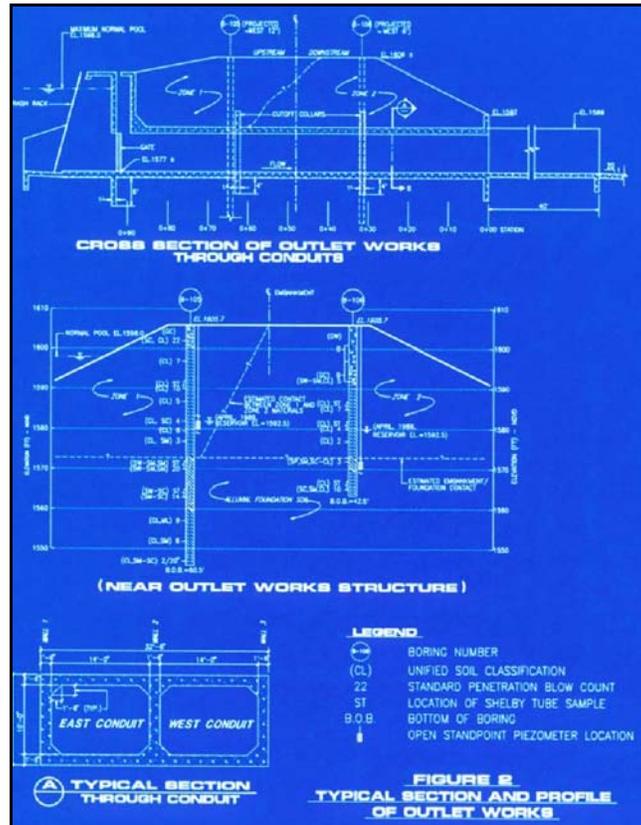
Figure B-44.—A cross section with a profile of the outlet works and design cross section of Lake Darling Dam.

embankment dam. The original design and construction did not include any control joints with waterstops in the conduits. The alluvial foundation materials beneath the conduits consist of up to 80 feet of sands, silts, and clays, some of which have moderate compressibility.

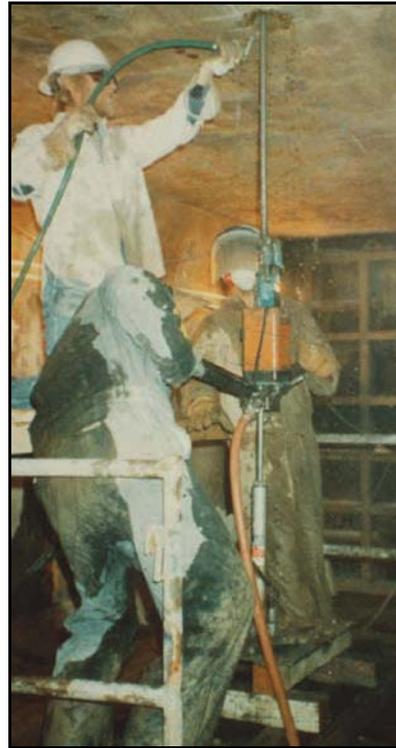
Figure B-45.—Grouting operations within the conduit.

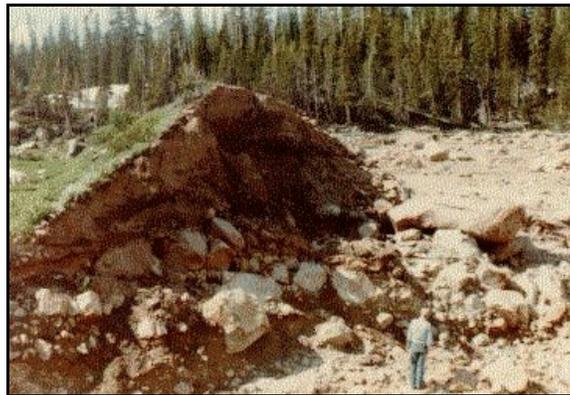
The embankment dam failure occurred when a large leak developed in a pressurized outlet conduit. Flow from the leak quickly eroded the surrounding low plasticity embankment soils. The probable cause of the defect in the outlet conduit system that led to the embankment dam failure was deterioration of the lead caulking at the joint between the steel outlet conduit and the gate valve used to control releases through the conduit. The opening at this juncture in the conduit allowed pressurized water to escape the conduit, because the gate valve was closed, and the reservoir was full.

Figure B-47.—Right side of the breached Lawn Lake Dam.

The embankment dam was constructed of low plasticity soils susceptible to backward erosion piping, and the failure could have occurred from this mechanism. The high seepage pressures caused by the conduit leak would have been sufficient to initiate backward erosion piping, and the exit face for the seepage was not protected by an adequate filter. Another possibility is that the pressurized leakage hydraulically fractured the earthfill surrounding the conduit and the failure occurred from the mechanism of internal erosion. Probably, a combination of these mechanisms was responsible for the earthfill erosion. Regardless of the mechanism, the failure demonstrated the dangers of a pressurized conduit that develops a defect allowing full reservoir head to be imposed on soil that is not protected by filters.

If possible, construction of fully pressurized conduits beneath embankment dams should be avoided. When pressurized conduits are constructed within embankment dams, the joints in the conduit should be properly designed to assure watertightness under all loading conditions.

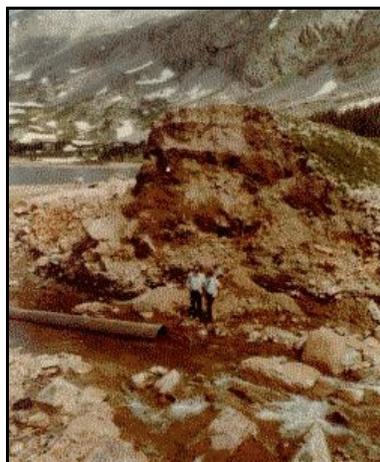
Figure B-48.—Left side of the breached Lawn Lake Dam.
