HURRICANE

Katrina

IN THE GULF COAST

5. Building Envelope Performance

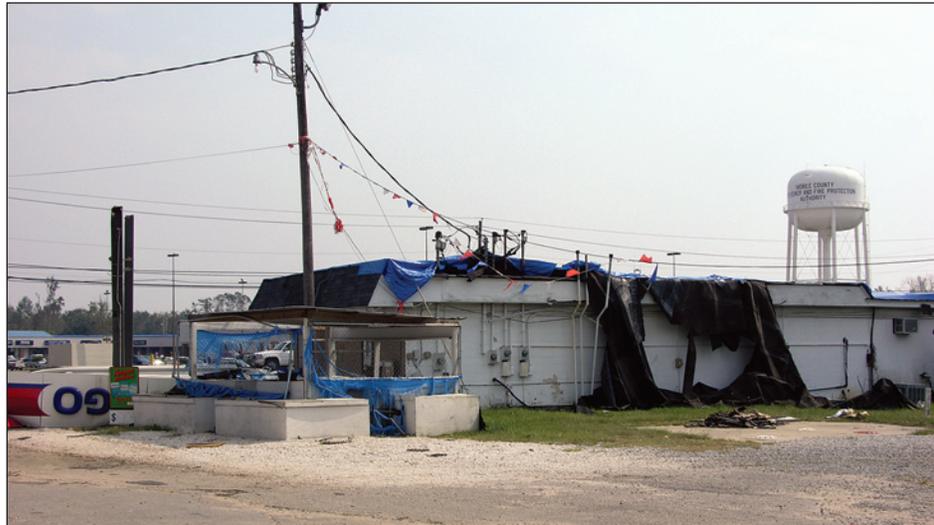
Figure 5-1.
Blow-off of a modified bitumen roof membrane at a service station. Note: The cantilevered canopy over the pumps was flipped upside down (estimated wind speed: 85 mph. Mobile, Alabama¹).

¹ Estimated speeds given in this chapter are based on Figure 1-13. These are for a 3-second gust at a 10-meter elevation for Exposure C. Unless otherwise noted, the buildings for which estimated speeds are given are located in Exposure B. See Table 1-4 for the estimated speed conversion for buildings located in Exposure B. For example, the 85-mph Exposure C speed given for Figure 5-1 is equivalent to 70 mph in Exposure B.

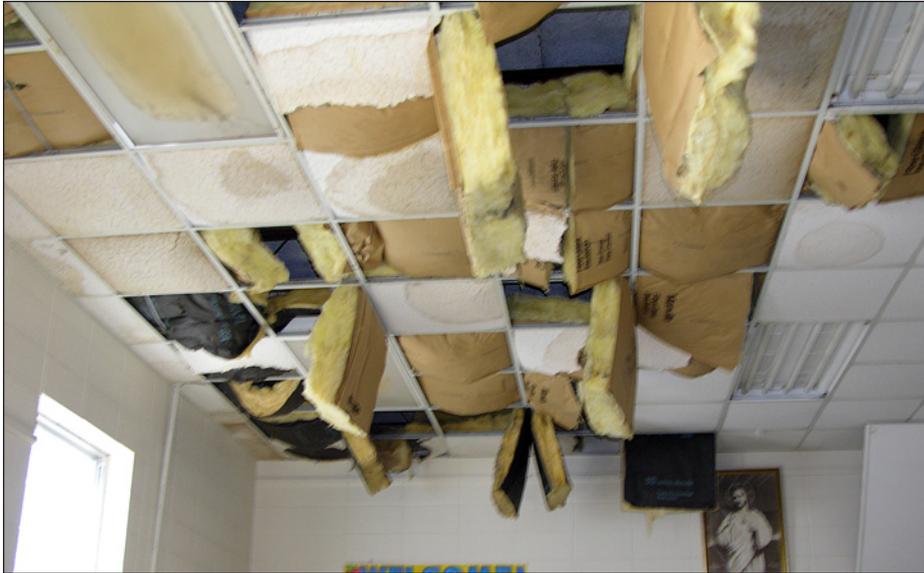
Figure 5-2. After the roof membrane blew off this school, water saturated the fiberglass insulation and ceiling boards, and several of the ceiling boards collapsed (estimated wind speed: 120 mph. Biloxi, Mississippi).

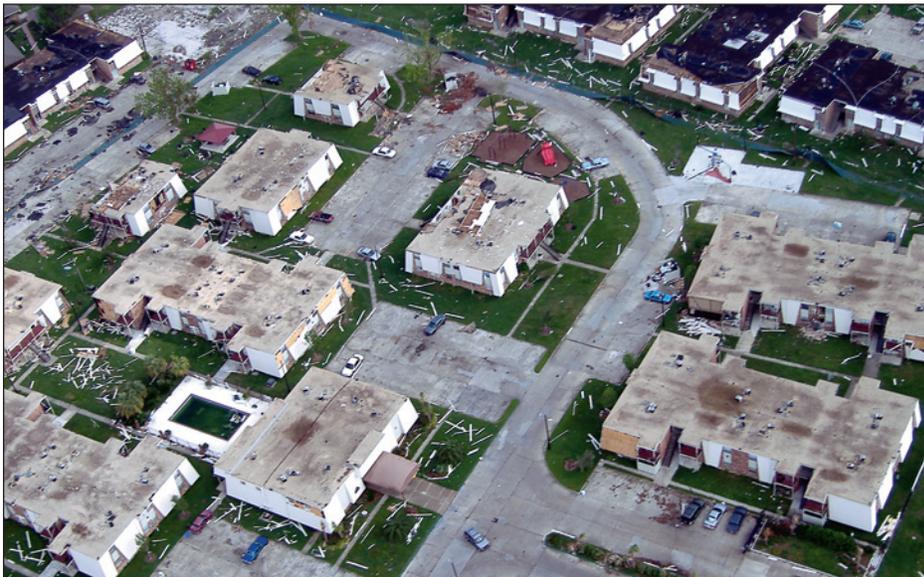
Figure 5-3. A substantial amount of siding (the white lines scattered around the ground) blew off this housing complex (estimated wind speed: 105 mph. Harvey, Louisiana area).

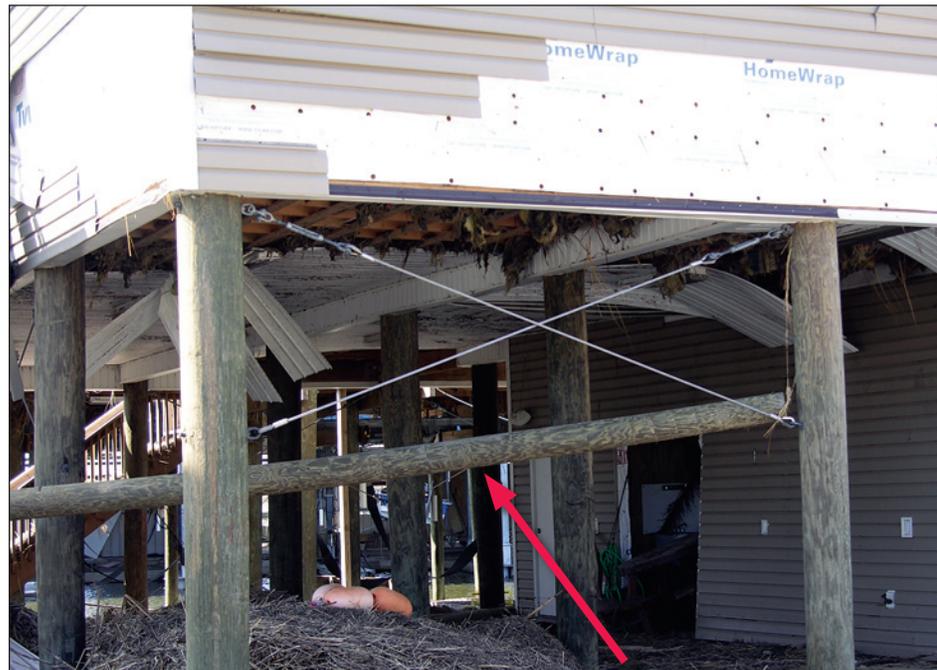
Figure 5-4. Loss of vinyl siding from the underside of an elevated residence in Exposure C. Note the large floodborne pole debris near the steel cable "x" brace (estimated wind speed: 130 mph. St. Bernard Parish, Louisiana).

Fast-moving floodwater and breaking waves can cause sheathing loss and floodborne debris can cause gouging. However, the loss of the fiber-cement sheathing appeared to be caused by wind accelerating as it passed beneath the elevated building. Neither ASCE 7, IBC, or IRC provide guidance for determining design wind loads for sheathing on the underside of elevated buildings. Therefore, professional judgment in specifying attachment is needed.

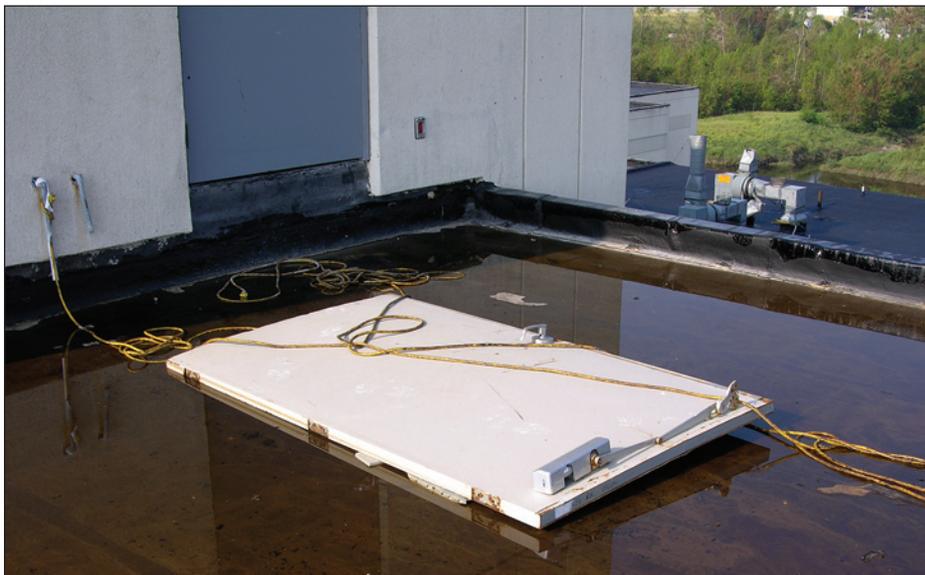
Personnel door damage was observed on a limited number of buildings. Observed damage included door frames that detached from the building (likely caused by inadequate fastening to the building) and doors that blew from their hinges (likely caused by use of inadequately sized screws) as illustrated by Figure 5-5. One door on a new residence under construction blew off when the hinges detached from the frame. The door/frame was a pre-hung assembly that used very short screws to attach the hinges to the frame (otherwise, the screws would have projected from the frame and been a potential safety hazard during installation). After the frame was installed in accordance with most manufacturers' instructions, the short screws should have been replaced with stronger permanent screws.

A penthouse door on this hospital blew off its hinges. Blown-off doors allow entrance of rain, and tumbling doors can puncture roof membranes (estimated wind speed: 130 mph. Gulfport, Mississippi).

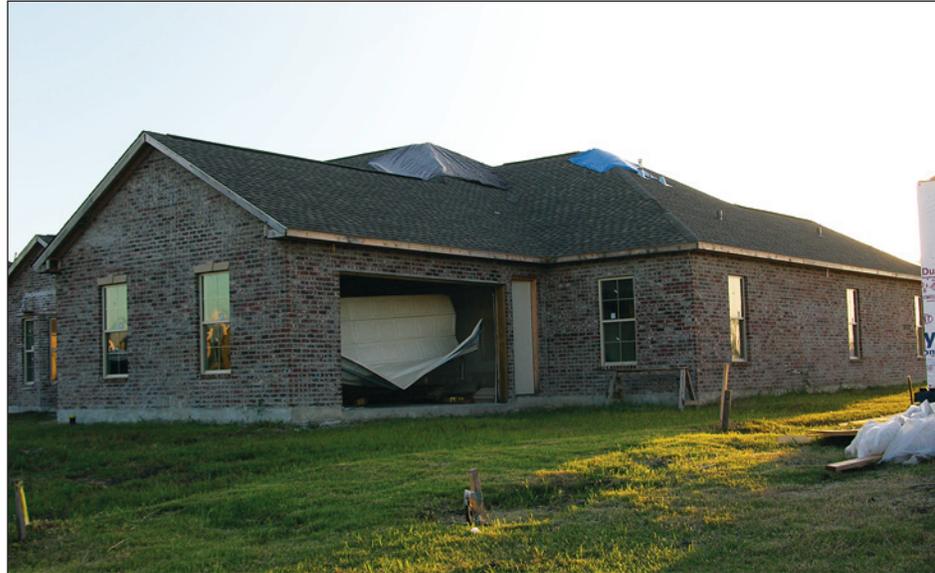
Several damaged residential garage doors were observed, some of which were damaged by floodwater, while others were damaged by wind. Figure 5-6 shows wind-induced damage at a house under construction. Damaged doors were typically displaced from their tracks, but in some

Figure 5-6.
Positive pressure blew this garage door from its tracks. At some other residences, negative pressure blew doors outward. Note the damage to the asphalt shingles (estimated wind speed: 110 mph. Belle Chase, Louisiana).

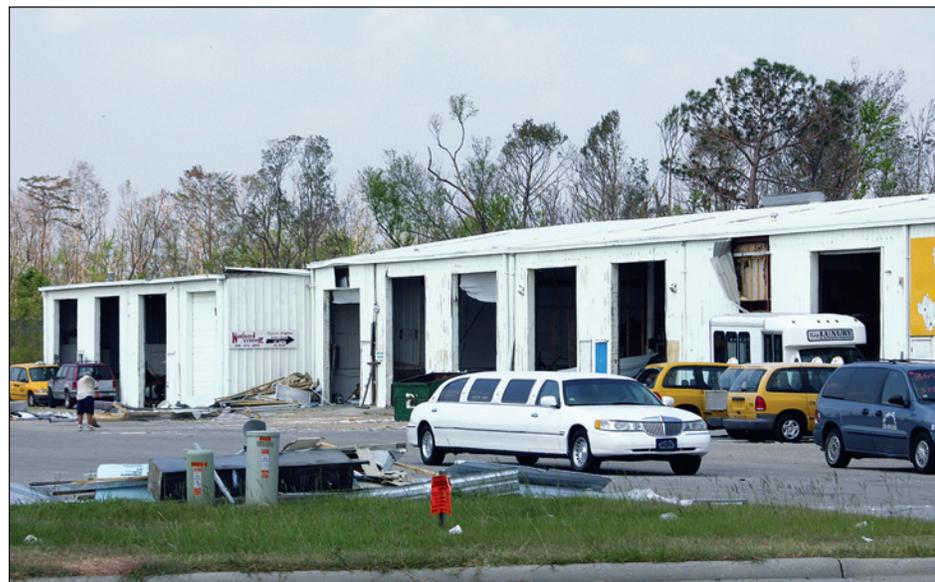
Water- and wind-induced damage to rolling and sectional doors (e.g., service garage doors, loading dock doors, and fire station apparatus bay doors) was observed (see Figure 5-7). In some cases, the doors were dislodged from their tracks, while in others the tracks pulled away from the wall. At a fire station in Gulfport (constructed in 1977), all three windward (eastern) doors were blown in (see Figure 7-8). One of the doors pulled from its tracks, but at the other

Figure 5-7.
Wind-induced damage to several roll-up doors (estimated wind speed: 130 mph. Gulfport, Mississippi)

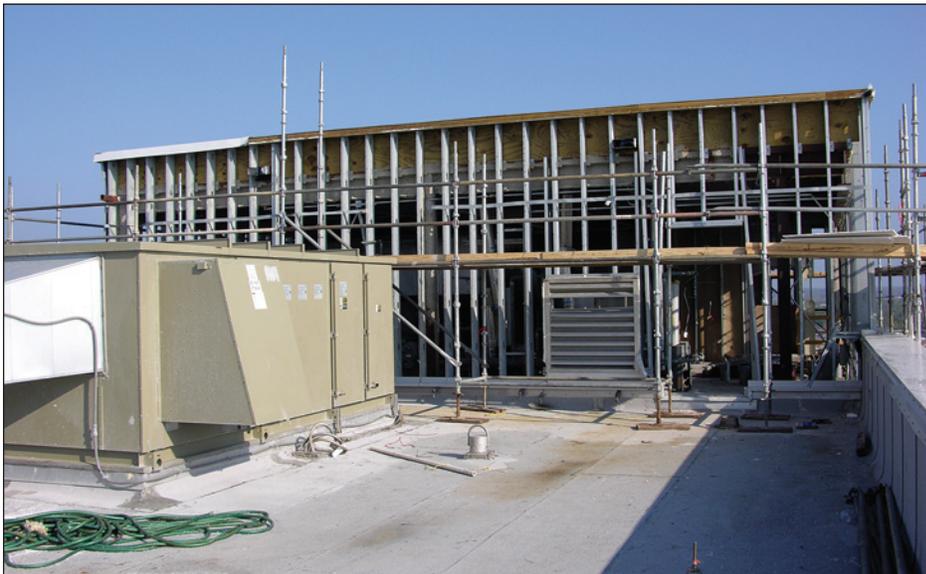
Figure 5-10 shows loss of EIFS on a penthouse on a new 13-story building (there was also extensive loss at the main walls). The gypsum board detached from the 8-inch-deep steel studs spaced 16 inches on center. The gypsum board was attached with screws that were irregularly spaced. Along one stud near the corner, the screws were spaced at 8, 25-1/2, and 12-1/2 inches. Along another stud in the corner region, the screws were spaced at 14, 12, and 21-1/2 inches. Away from the corner region, the screws along one stud were spaced at 12, 10-1/2, 12-1/2, and

10-1/4 inches. Along another nearby stud, the screws were spaced at 10, 12, 8-1/4, 4-3/4, and 11 inches. Surprisingly, the screws were typically spaced farther apart in the corner region (where the wind loads are the highest). Away from the corners, the screws should have been spaced in the range of a maximum of 6 inches on center. In the corner areas, the screws should have been spaced in the range of a maximum of 4 inches on center and the studs should have been at a maximum of 12 inches on center. Because contract documents were not available, it is unknown whether the spacing deficiencies were due to design or workmanship errors.

Figure 5-10. Loss of EIFS on penthouse of a new 13-story building in Exposure C. The gypsum board was attached with irregularly spaced screws and detached from the steel studs (estimated wind speed: 120 mph. Biloxi, Mississippi).

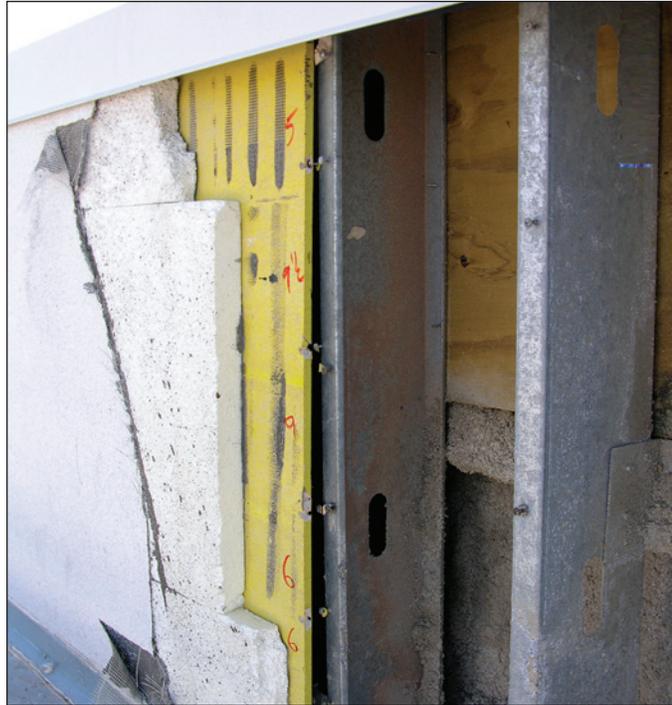
Figure 5-11.

Along another wall of the penthouse in an area outside of the corner region, the screws along the end of a gypsum board panel were spaced at 5, 9-1/2, 6, 6, 4, and 4-1/2 inches. Along the next stud, the intermediate row was spaced at 21-1/2, 10, and 13 inches. As shown in Figure 5-11, in one area the molded expanded polystyrene (MEPS) insulation detached from the gypsum board. The MEPS had been adhered with vertical lines of adhesive. Adhesive should have been continuously applied throughout the entire board area.

The MEPS had been set in rows of adhesive rather than in a continuous layer of adhesive. Note the inadequate edge distance of the fasteners along the end joint. The building was located in Exposure C (estimated wind speed: 120 mph. Biloxi, Mississippi).

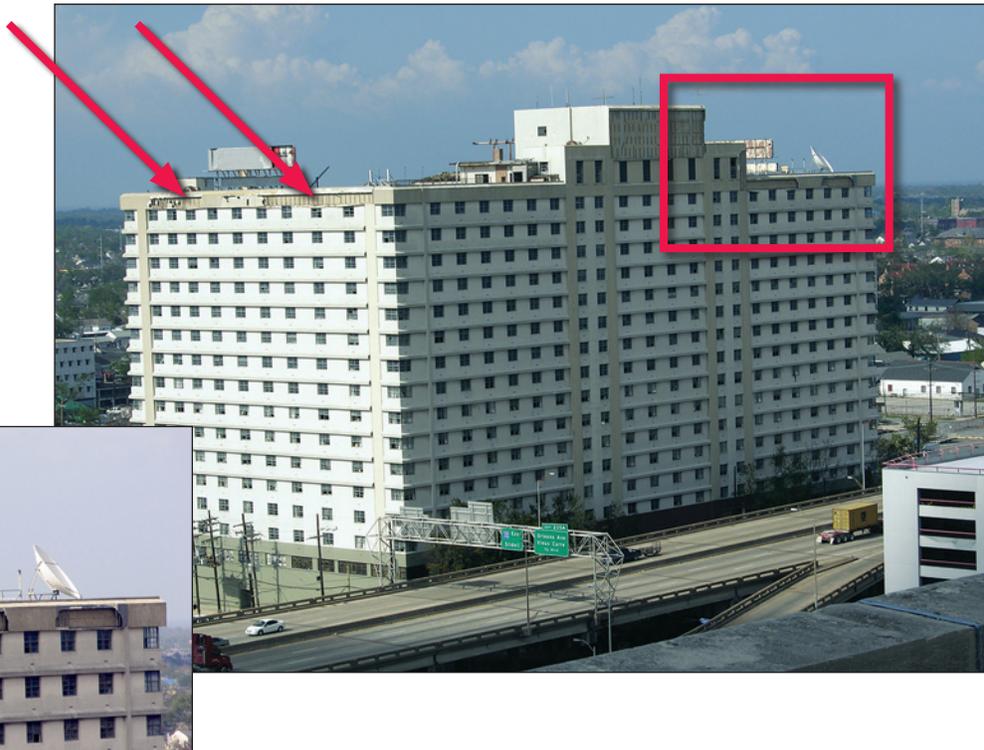
Figure 5-12.

Figure 5-12 shows a building that had been re-skinned with EIFS (new metal framing had been installed over the original walls). In some areas, the gypsum board blew off the new metal framing, but in other areas the metal framing was blown away because it was inadequately attached to the building.

This building had been re-skinned with EIFS. In some areas, the gypsum board blew off the studs (arrows). In other areas, the metal framing was blown away (square/inset) (estimated wind speed: 105 mph. New Orleans, Louisiana).

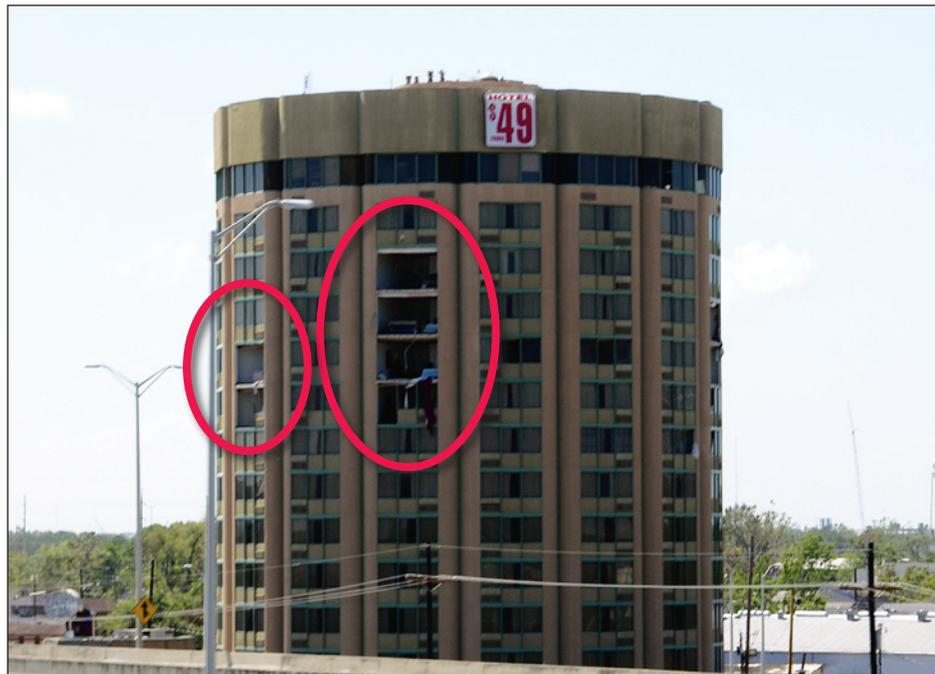
Figure 5-13 shows collapsed wall panels. The tracks at the top of the panels were inadequately anchored to the concrete floor slabs. Figure 5-14 shows collapse of non-load-bearing walls at a hotel. These types of failures can be avoided by designing and constructing the wall panels and their connections to the structure to resist the design wind loads.

Figure 5-14.
Collapse of non-load-bearing walls at a hotel (estimated wind speed: 105 mph. New Orleans, Louisiana)

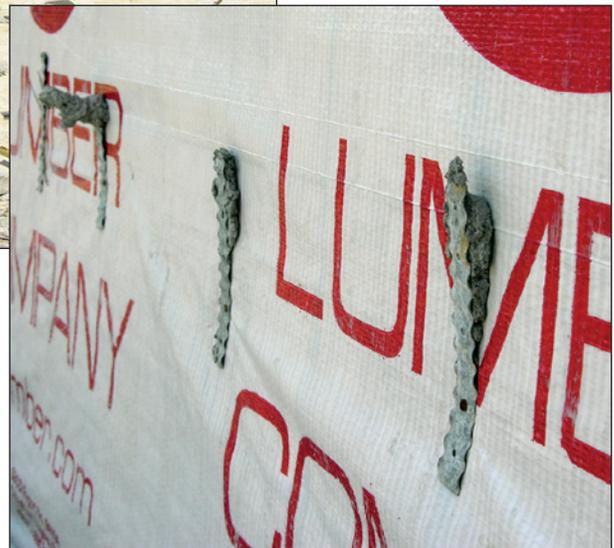
Several buildings with failed brick veneer were observed. The majority of the failed brick veneers were applied over wood stud framing; however, some of the failed veneers were applied over CMU (in some instances, the CMU also failed). Figure 5-15 shows failed brick at a house that was under construction. The ties were typically spaced at 16 inches on center horizontally. Vertical spacing varied. The first row was 19 and 21 inches above the footer. The second row was 22 and 24 inches above the first row, and the third row was 18 inches above the second row. Some of the smooth-shank tie nails pulled from the studs. Many of the ties had never been embedded into the mortar joints, which was a major workmanship error.

Figure 5-15. Collapsed brick veneer wall that was under construction. Several of the ties had not been embedded into the mortar joints (square/inset) (estimated wind speed: 125 mph. Waveland, Mississippi).

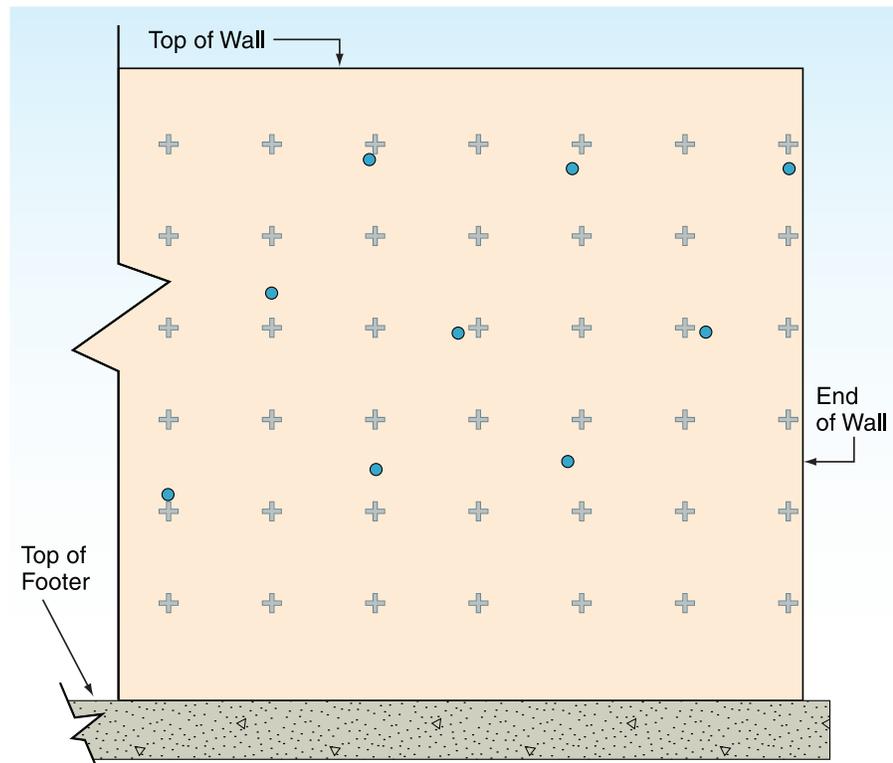
At a house under construction in Ocean Springs, Mississippi, brick had not been installed, but the corrugated ties had been placed. At a narrow strip of wall between a door and window, the ties were spaced 16 inches apart along one row. A tie along the first row was up 22 inches from the footer. The next row was up 41-1/4 and 42-1/4 inches from the footer. Along another wall, the first row was up 35 inches from the footer. The first tie along this row was 34 inches from the corner. A tie along the second row was up 54 inches from the footer. Ties along this row were 30 and 37 inches apart. The first tie was about 14 inches from the corner. A tie along the third row was up 78 inches from the footer and another was up 80-1/4 inches. These ties were 32 and 31 inches apart. The first tie was about 2 inches from the corner. Figure 5-16 illustrates the layout of ties at this wall.

The ties at this house did not comply with the vertical or horizontal spacing specified in *Technical Notes 28*. This house is located in an area with a basic wind speed of 140 mph; ACI 530-02 does not provide prescriptive tie spacings for this speed. The FEMA Hurricane Katrina Recovery Advisory *Attachment of Brick Veneer in High-Wind Regions* (Appendix E) recommends a maximum horizontal tie spacing of 16 inches and a maximum vertical spacing of 13.7 inches for a 140-mph design wind speed. Figure 5-16 also illustrates location of ties as recommended in the advisory.

Figure 5-16.
Brick ties at house under construction in Ocean Springs, Mississippi. At this wall, nine ties were installed (blue circles); however, 42 ties ("+" symbol) are needed to comply with the advisory.

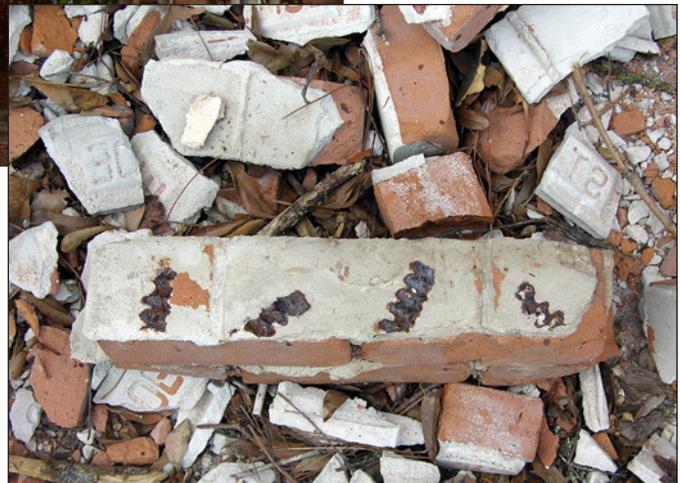
Figure 5-17. Partial collapse of brick veneer at an apartment building; the ties were corroded (inset) (estimated wind speed: 115 mph. Slidell, Louisiana).

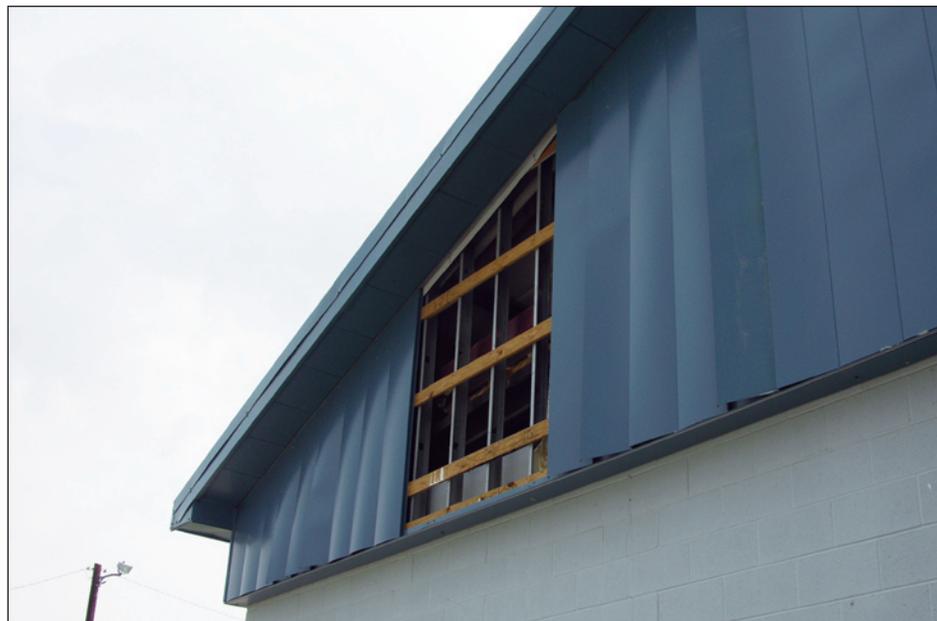
Figure 5-22 shows panels at a police station that unlatched and were blown away. The panels were attached with concealed staples to 1x wood nailers.

Figure 5-22.
Loss of metal panels at a police station. In addition to generating windborne debris, loss of panels allowed rainwater infiltration (estimated wind speed: 130 mph. Long Beach, Mississippi).

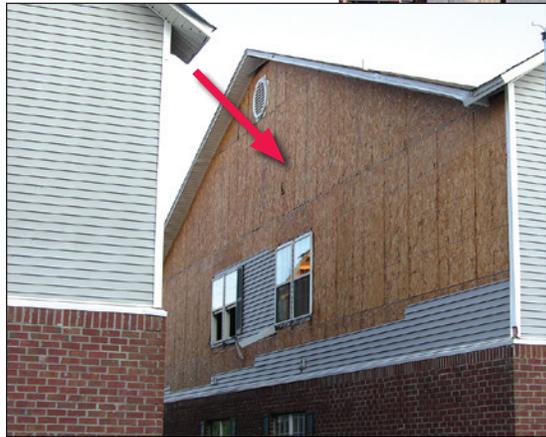
Vinyl was the predominant siding and soffit material observed on residences in the areas investigated by the MAT. Performance of the siding and soffit was extremely poor (see Figure 5-26) and there were numerous significant failures on both new and old buildings. When vinyl siding was blown off, the underlayment (either asphalt-saturated felt or housewrap) was also often blown away. With loss of the siding and underlayment, wind-driven rainwater was then able to enter the wall cavity, causing water damage and initiating mold growth. Vinyl siding and soffits that became windborne debris were capable of breaking unprotected glazing.

Figure 5-26. Many of the buildings in this apartment complex lost a substantial amount of vinyl siding (arrows) and asphalt shingles (circles). Underlayment had not been installed underneath the siding (estimated wind speed: 120 mph. D'Iberville, Mississippi).

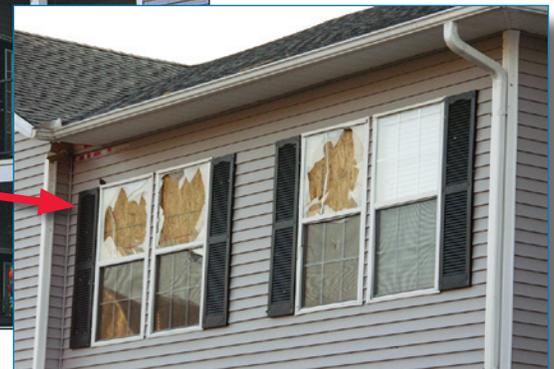
Many of the windows in the apartment complex shown in Figure 5-26 were broken (see Figure 5-27), which is not surprising considering the large amount of vinyl siding, vinyl soffit, and asphalt shingles that were blown off of these buildings.

Figure 5-27. These windows were broken by windborne debris (inset and arrows). Note the missing vinyl siding and soffit (estimated wind speed: 120 mph. D'Iberville, Mississippi).

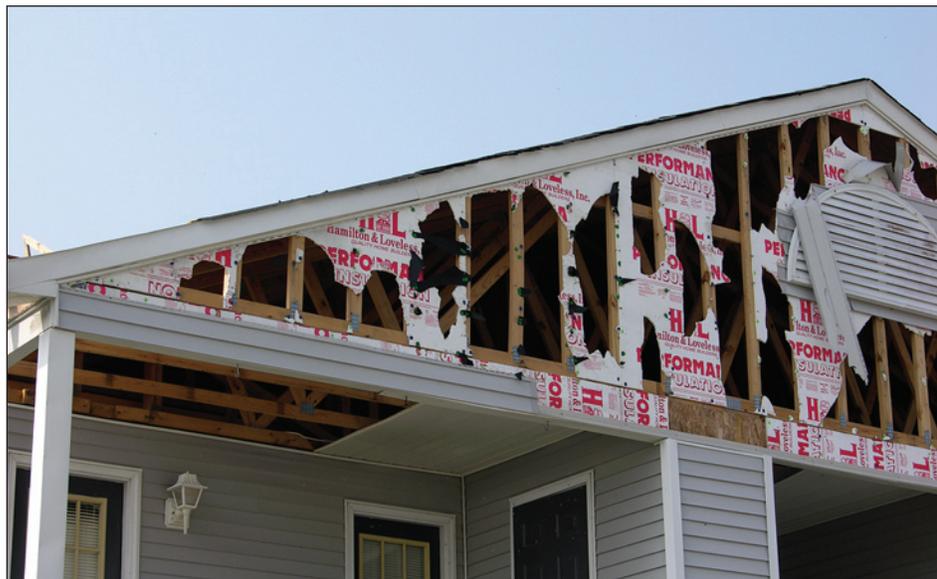
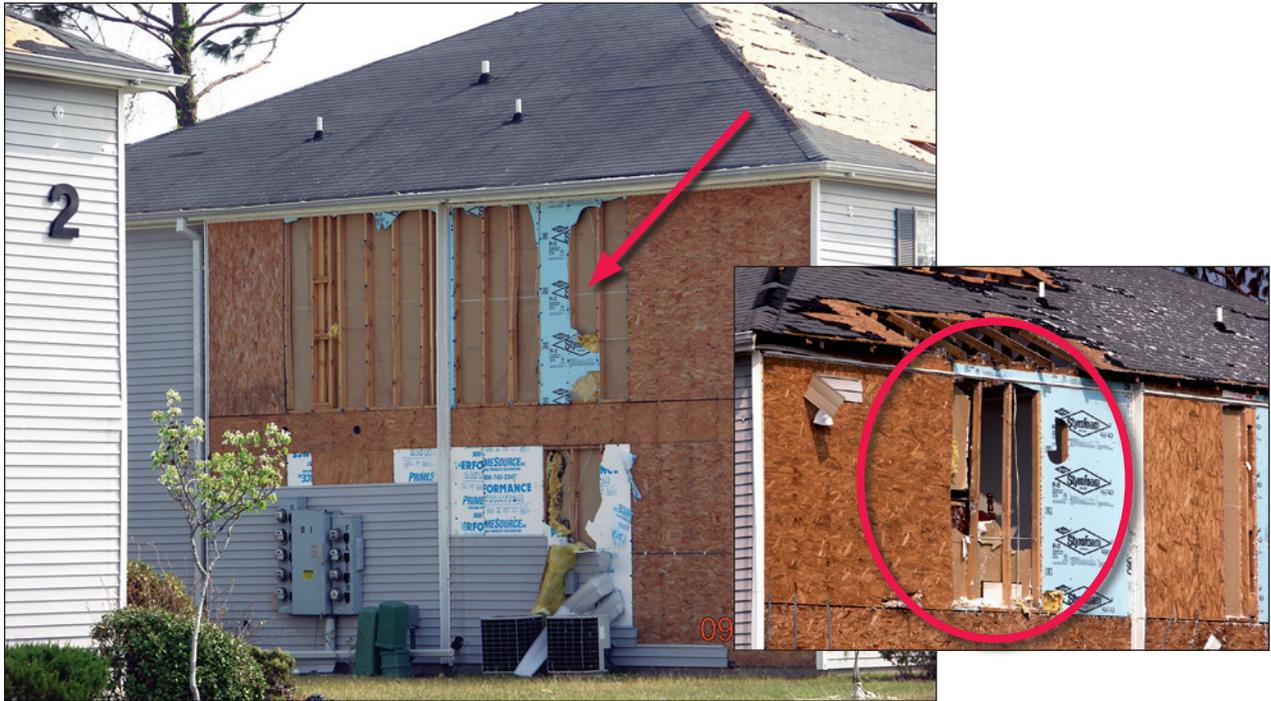
Figure 5-28.
Loss of vinyl siding and foam insulation at a gable end wall. Note the missing vinyl soffit (estimated wind speed: 130 mph. Long Beach, Mississippi).

The fastener spacing was measured at a few buildings. The spacings on each of the buildings were quite variable. At the complex shown in Figures 5-28 and 5-29, along one of the siding panels, the nails were located 4 inches from the end of the panel, then 29, 14, 18, 31, and 17 inches. At another building in this complex, along one of the panels the nails were located 20 inches from the end of the panel, then 37 and 39 inches (this last fastener was 9 inches from the end of the panel).

OSB was installed at the corner areas, but only foam insulation was present over the studs in the field of the wall. Most of the foam was blown away at this end wall (arrow). At some areas in this complex, the gypsum board on the interior side of the studs was also blown away (circle) (estimated wind speed: 130 mph. Long Beach, Mississippi).

Underlayment had not been installed at all on some residences (see Figures 5-26, 5-28, and 5-29). Not installing underlayment is a poor practice because vinyl siding (like many other types of wall coverings) does not prevent rainwater from getting behind the siding. Underlayment should always be installed to intercept the leakage and drain it out of the wall. ASTM D 4756 does not currently require underlayment underneath vinyl siding; however, the 2003 IBC does require underlayment.

Some vinyl siding was damaged by windborne debris, and some vinyl soffit damage was observed (see Figures 5-27 and 5-28). Where soffits were blown away, a significant amount of water was often driven into the attics and ultimately into living spaces. (Debris damage and soffit failure was more commonly observed by the MAT that investigated Hurricane Charley. Further discussion

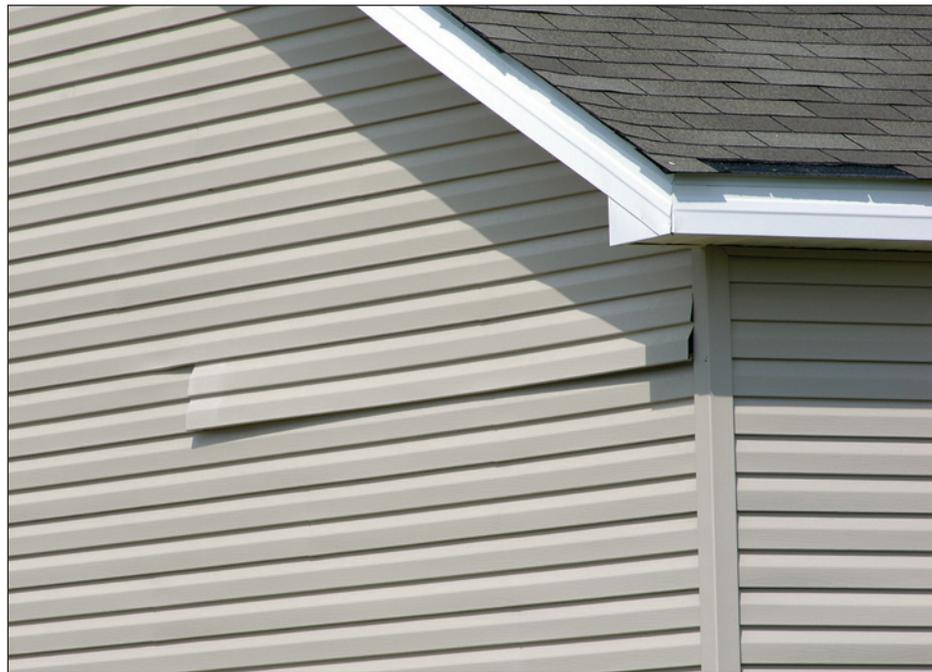
ASTM D 4756 specifies that the fasteners are to be driven into framing or furring members, rather than just into plywood or OSB. Most of the fasteners that were investigated by the MAT were merely driven into sheathing. Although this practice did not comply with ASTM D 4756, no fastener pull-out problems were observed. In some cases, the MAT believes that the blow-off was triggered by unlatching of the buttlock, which is the bottom portion of the panel (see Figure 5-30). Once the panel unlatches from the retainer slot just below the nailing flange, the panel is free to rotate outward where it can be caught by the wind and blown off. The magnitude of the unlatching issue, compared to the strength of the nailing flange and fastener spacing, is unknown. When unlatched, panels are very susceptible to blow-off.

Figure 5-30.
When a panel becomes unlatched, it becomes very susceptible to blow-off (estimated wind speed: 120 mph. Ocean Springs, Mississippi).

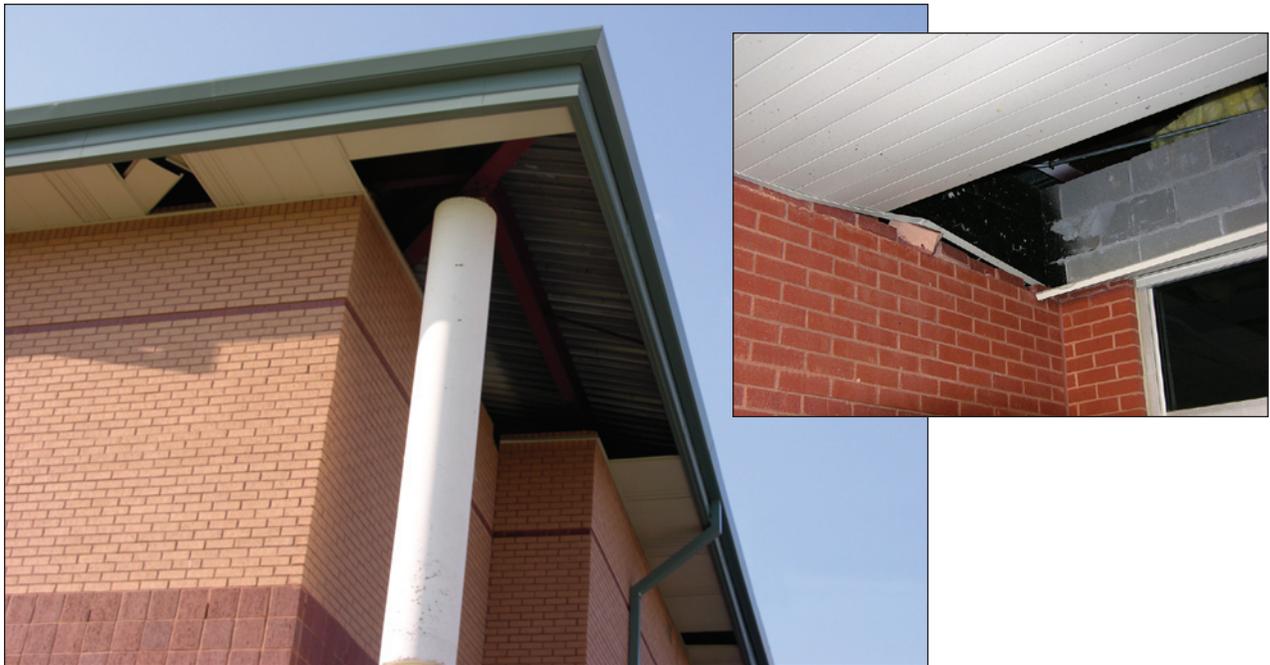
Figure 5-31.

Vinyl soffits were discussed in the vinyl siding section, and damaged soffits were shown in Figures 5-27 and 5-28. Figure 5-31 shows loss of metal soffit at a school that was completed in 1997. Some of the soffit panels were perforated. In one area, the soffit support angle was attached to the top row of brick veneer (inset in Figure 5-31). Wind created positive (i.e., upward-acting) pressure on the soffit panels. This load was transferred to the support angle and then to the bricks, which lacked sufficient strength to carry the uplift load. This failure illustrates the importance of soffits being designed and constructed to carry positive and negative pressures, and the importance of load-path continuity. With loss of the soffit, wind-driven rainwater was able to enter the ceiling space, whereupon several ceiling boards became saturated and collapsed. Soffit failure can also increase the magnitude of positive pressure within attics and exert more load on the roof structure and coverings (see Section 10.2.3.1 for further discussion).

Loss of metal soffit at a school. At the area shown in the inset, the soffit support angle was inadequately anchored (estimated wind speed: 130 mph. Gulfport, Mississippi).

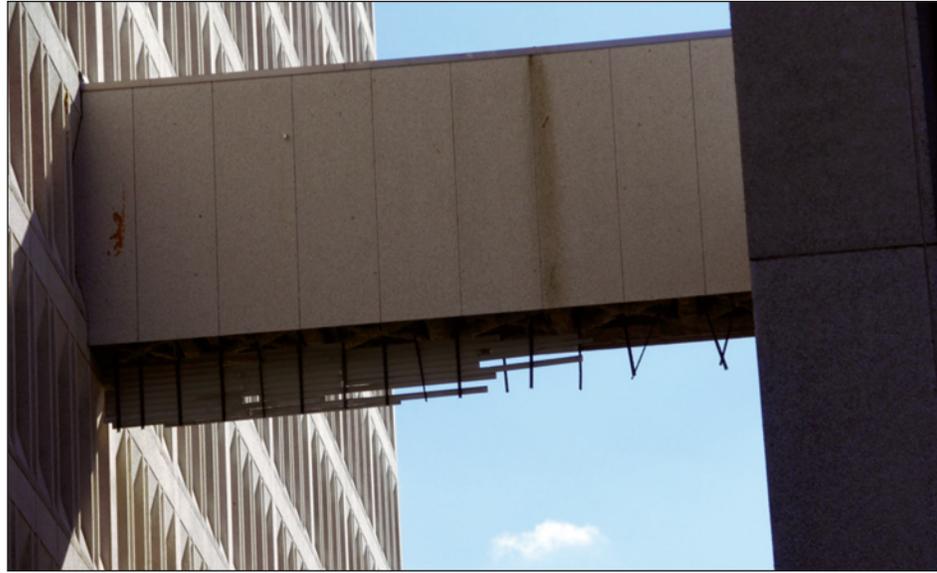
Figure 5-32 shows loss of metal soffit from an elevated walkway at a courthouse in downtown New Orleans. Figure 5-33 shows loss of soffit boards from a suspended grid system. The grid system did not have compression struts to resist positive pressure. In addition to the soffit damage itself, windblown soffit panels can break windows.

Figure 5-32.
Loss of metal soffit from
an elevated walkway
(estimated wind speed:
105 mph. New Orleans,
Louisiana)

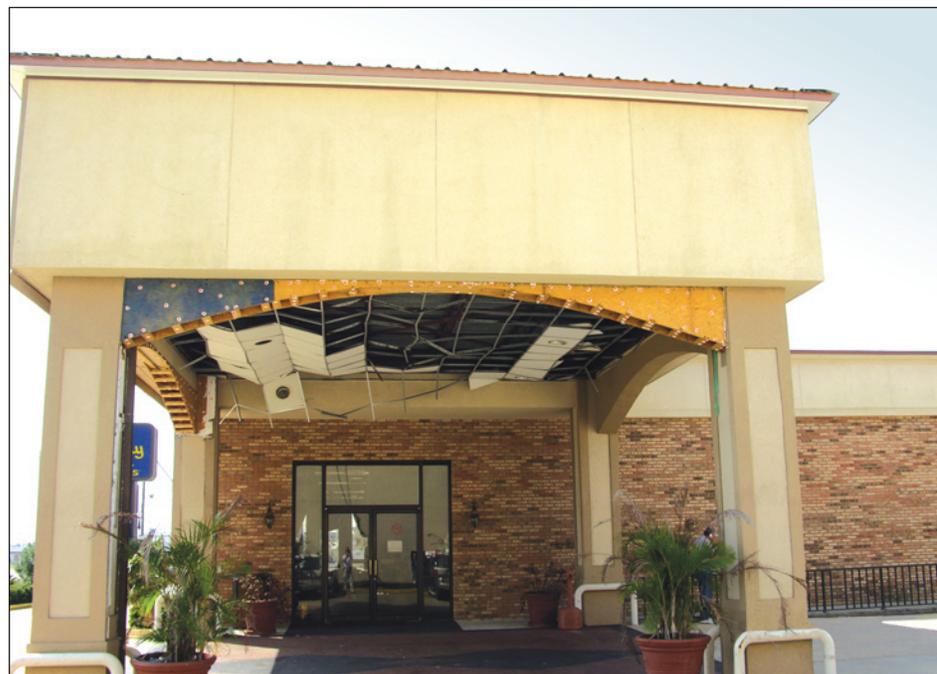
Figure 5-33.
Loss of soffit at canopy.
The grid support did
not have compression
struts (estimated wind
speed: 130 mph. Gulfport,
Mississippi).

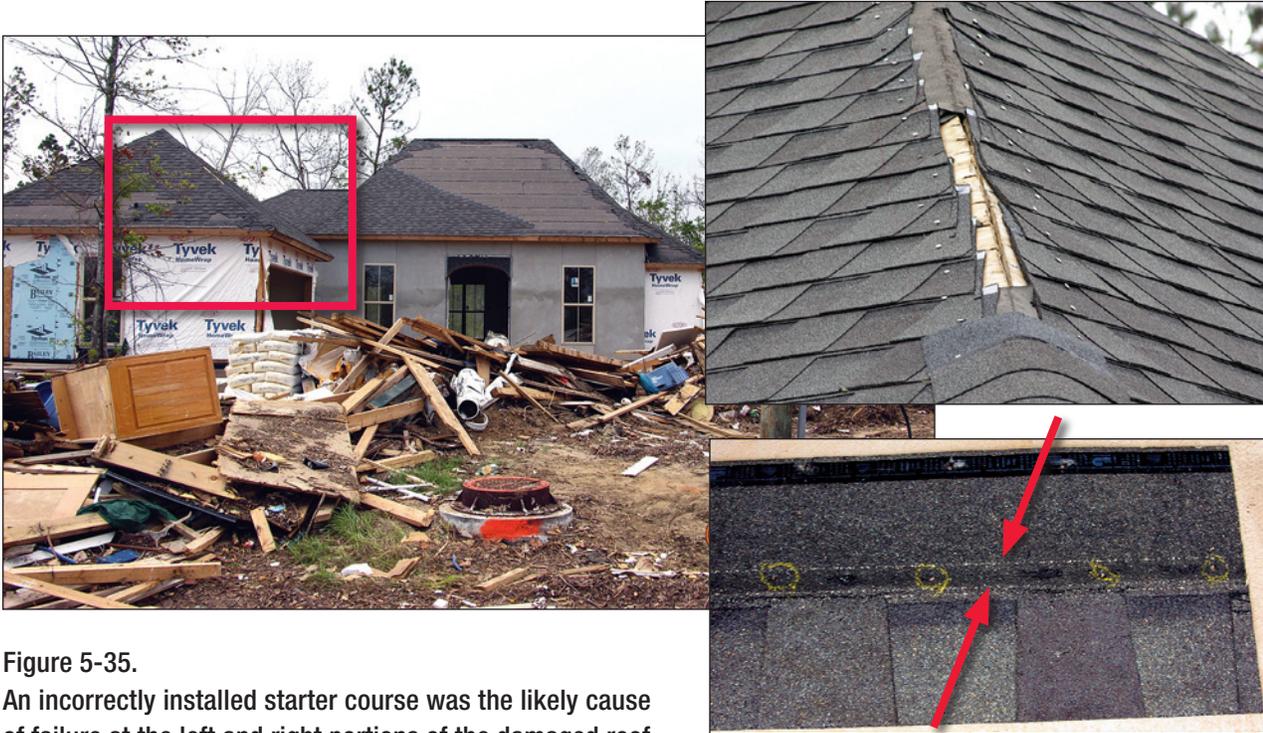
Figure 5-35.

A large number of relatively new shingle roofs (including several houses still under construction) experienced shingle damage. Figure 5-35 shows a new house that lost many shingles. The starter course was incorrectly installed (as discussed later) and there was no metal drip edge. Some of the shingles were superficially bonded to one another, underlayment was not lapped over a portion of the hip, the underlayment along the hip was cut in several locations (apparently while the shingles were being trimmed), the hip nails were incorrectly located, and several of the hip shingles did not bond, or were only superficially bonded, to one another. These shingles had a 1-1/2-inch-wide nailing strip and the majority of the nails were placed within the strip. The end nails were too far from the end (ranging from about 2 to 4 inches rather than 1 inch from the end). The field nails were somewhat uniformly distributed between the end nails; however, the manufacturer's literature indicates a different nailing pattern. These shingles had a Miami-Dade County (Florida) product approval label.

An incorrectly installed starter course was the likely cause of failure at the left and right portions of the damaged roof. Water was able to leak into the building where the underlayment was not lapped over a portion of the hip (estimated wind speed: 130 mph. Long Beach, Mississippi).

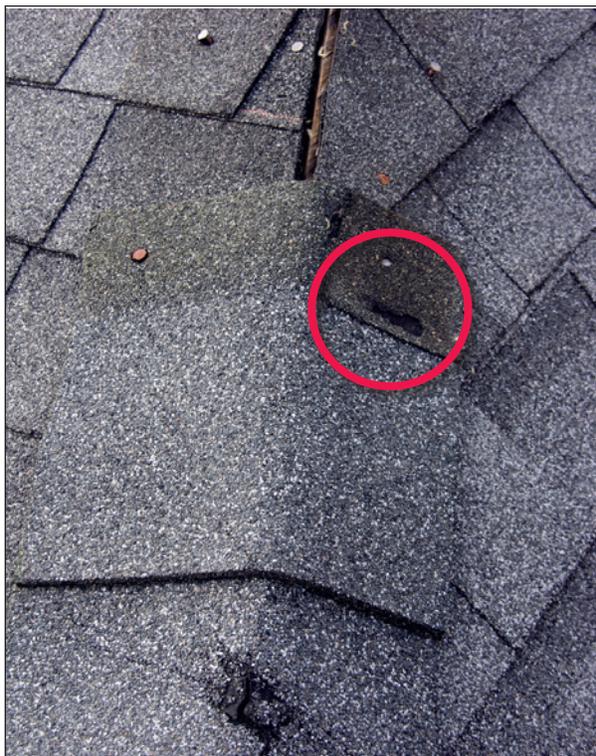
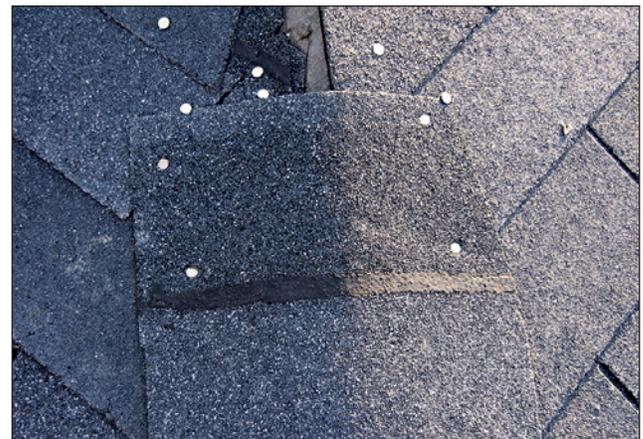
as recommended by the industry. However, the hip and ridge shingles were blown off because of lack of bonding of the adhesive. Sometimes a limited amount of bonding occurred, but frequently none of the adhesive had bonded (Figure 5-37). Lack of bonding of hip and ridge shingles is common due to substrate irregularity along the hip/ridge line. Use of asphalt roof cement, as recommended in Technical Fact Sheet No. 20 in FEMA 499, ensures bonding.

Figure 5-37. At the hip on the left, the self-seal adhesive only made contact at a small area on the right side of the hip (red circle). At the hip at the right, no adhesive bonding occurred. The nails at both of these hips were above, rather than below, the adhesive line (estimated wind speed: 105 and 130 mph. Pascagoula and Gulfport, Mississippi, respectively).

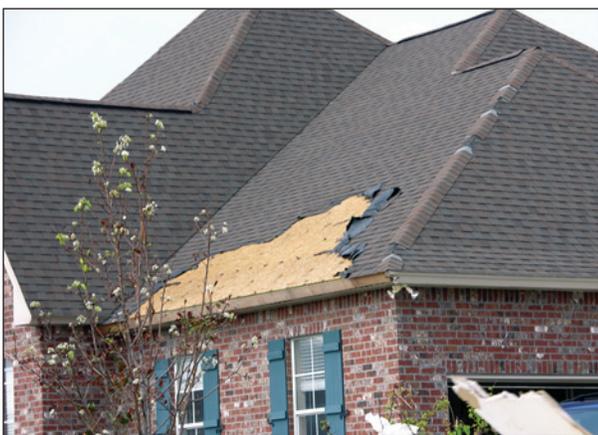
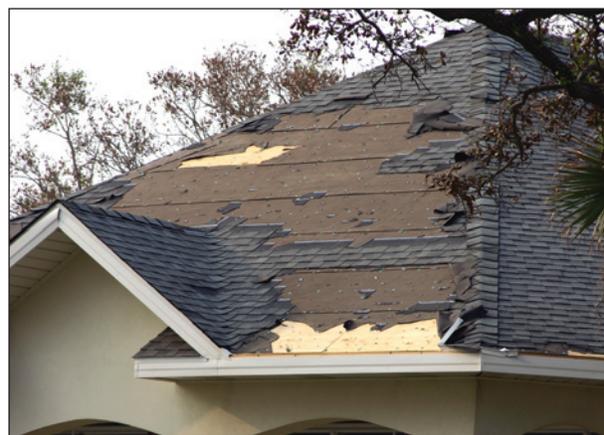
Figure 5-39. These two failures likely initiated at the eave due to an incorrectly installed starter course. Note that, at both roofs, a portion of the underlayment and some of the hip shingles were blown away (estimated wind speed: 115 and 105 mph. Slidell, Louisiana, and Pascagoula, Mississippi, respectively).

In addition to correctly installing the starter, use of asphalt roof cement to ensure bonding along the eave is recommended in Technical Fact Sheet No. 20 of FEMA 499. Due to substrate irregularities along the eave line, even when the starter is correctly installed, insufficient tab bonding can occur unless asphalt roof cement is applied.

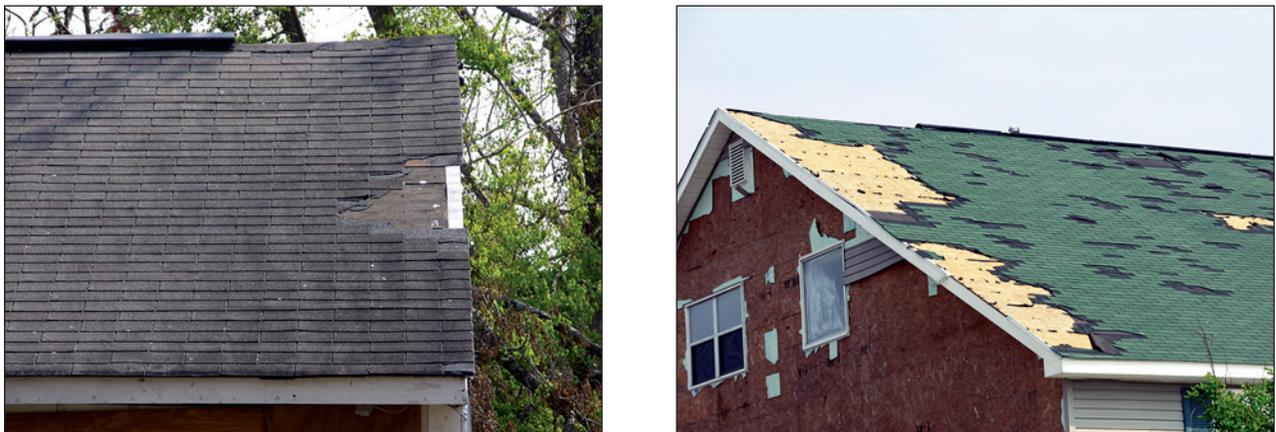
As with eaves, lifting and peeling failure often initiates at rakes and propagates into the field of the roof, as shown in Figure 5-40. Rakes are susceptible to failure due to the additional load exerted on the overhanging shingles (thus it is important to minimize the overhang as discussed above) and the configuration of the self-sealing adhesive. Along the long dimension of the shingle (i.e., parallel to the eave), the tab is sealed with self-sealing adhesive that is either continuous or nearly so. But along the rake, the ends of the tab are only sealed at the self-seal lines; therefore, the tabs are typically sealed at about 5 inches on center. Therefore, under high-wind loading, the adhesive at the rake end is stressed higher than the adhesive farther down along the tab. With sufficient wind loading, the corner of the tab at the rake can begin to lift up and progressively peel.

These shingle blow-offs likely were initiated by lifting and peeling of shingles along the rake. Note the loss of vinyl siding at the right photograph (estimated wind speed: 130 and 115 mph respectively. Long Beach, Mississippi, and Slidell, Louisiana, respectively).

On several damaged roofs, including the one shown on the left side of Figure 5-40, bleeder strips had been installed. Bleeder strips are shingles that are applied along the rake, similar to the starter course at the eave, as shown at Figure 5-41. A bleeder provides an extended straight edge that can be used as a guide for terminating the rake shingles. At first glance, it might be believed that a bleeder enhances wind resistance along the rake. However, it does not significantly enhance resistance because the concealed portion of the overlying rake shingle is the only portion that makes contact with the self-seal adhesive on the bleeder. As can be seen in Figure 5-42, the tab does not make contact with the bleeder. Hence, if the tab lifts, the shingle is placed in a peel mode, which can easily break the bond with the bleeder. Also, if the tabs are not cut from the bleeder and the cut edge placed along the rake edge (which was seldom done on the observed roofs), the bleeder's adhesive is too far inward to be of value.

To enhance the wind resistance of shingles along the rake, Technical Fact Sheet No. 20 in FEMA 499 recommends application of asphalt roof cement along the rake. By adding dabs of cement, as shown in Technical Fact Sheet No. 20 (and Figure 5-41), uplift load across the ends of the rake

shingles is distributed to the cement as well as the self-seal adhesive, thus minimizing the possibility of tab uplift and progressive peeling failure.

If bleeder strips are installed for alignment purposes, use of asphalt roof cement, as shown in Technical Fact Sheet No. 20 of FEMA 499, is still recommended.

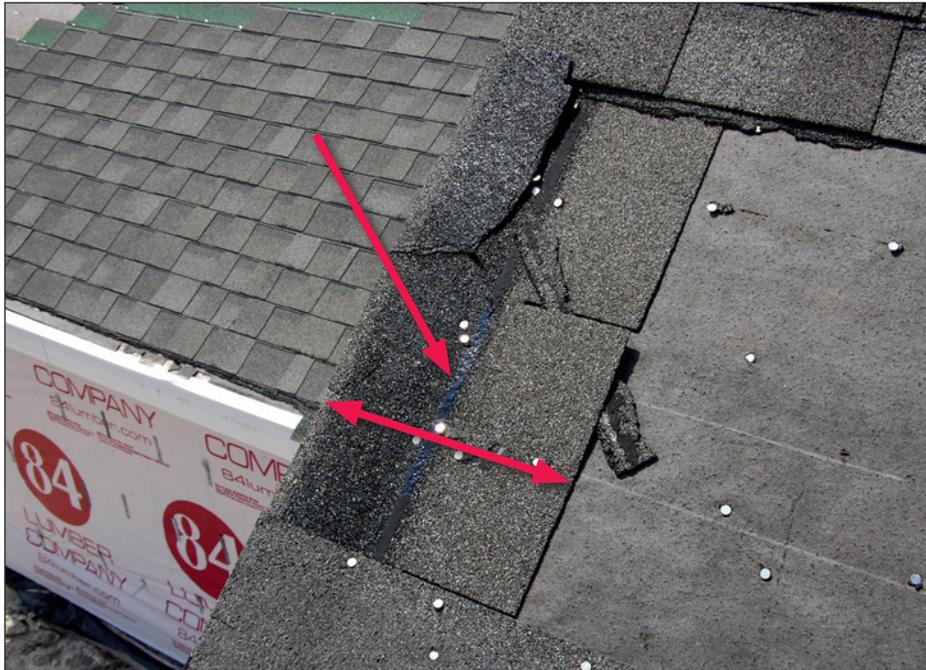
Figure 5-42. Blow-off of shingles at a new house under construction. A bleeder strip (double-arrow) was used along the rake. Note that the tab of the overlying shingle cannot make contact with the bleeder's self-seal adhesive (upper arrow) (estimated wind speed: 125 mph. Waveland, Mississippi).
