HURRICANE

Katrina

IN THE GULF COAST

5. Building Envelope Performance

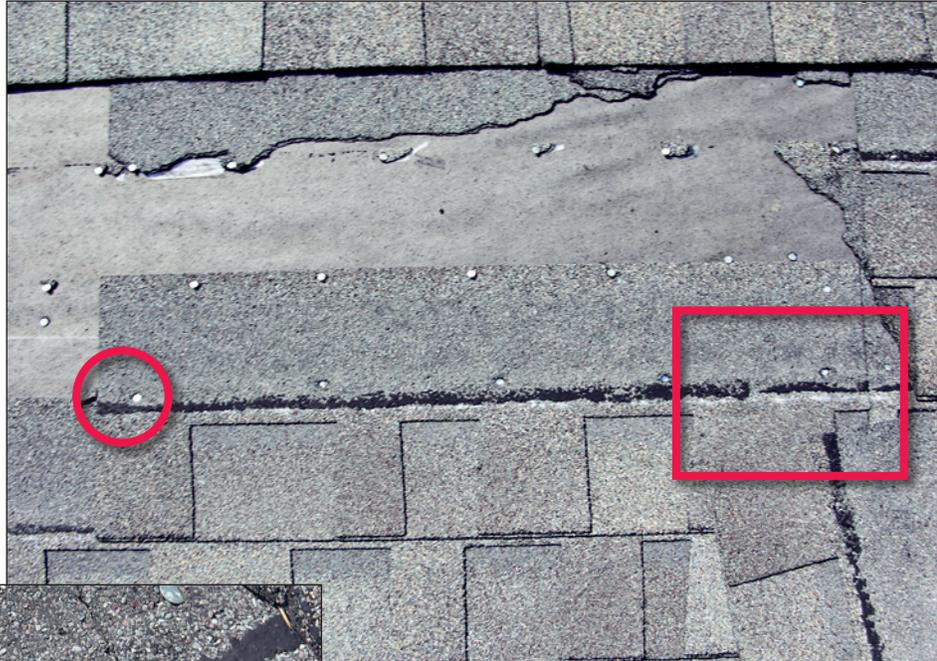
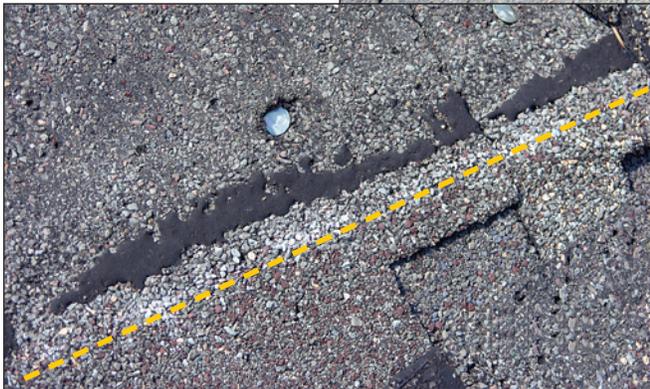
Figure 5-43.

Significant fastener mislocation occurred on nearly all of the damaged roofs observed (see Figures 5-43 and 5-44). Fasteners were typically located 1 to 2 inches above the nailing line (i.e., the line printed on the shingle by the manufacturer). End fasteners were often 2 to 3 inches from the end, rather than the industry-recommended 1 inch. Minor deviations from intended fastener locations should be expected; however, the deviations on nearly all of the damaged roofs were excessive.

When nails are too high above the nail line, they can miss the underlying shingle headlap or have inadequate edge distance as shown by the nail that is right of the circle in Figure 5-43 and illustrated in Figure 5-45. When using laminated shingles, high nailing may miss the overlap of laminated shingles; if the overlap is missed, the nail pull-through resistance is reduced (see Figure 5-46). High nailing may also influence integrity of the self-seal adhesive bond by allowing excessive deformation (ballooning) in the vicinity of the adhesive.

The nails at this house under construction were too far above the nailing line (underscored by dotted yellow line in inset) and too far from the ends (circle). They were also over-driven (square and inset) (estimated wind speed: 125 mph. Waveland, Mississippi).

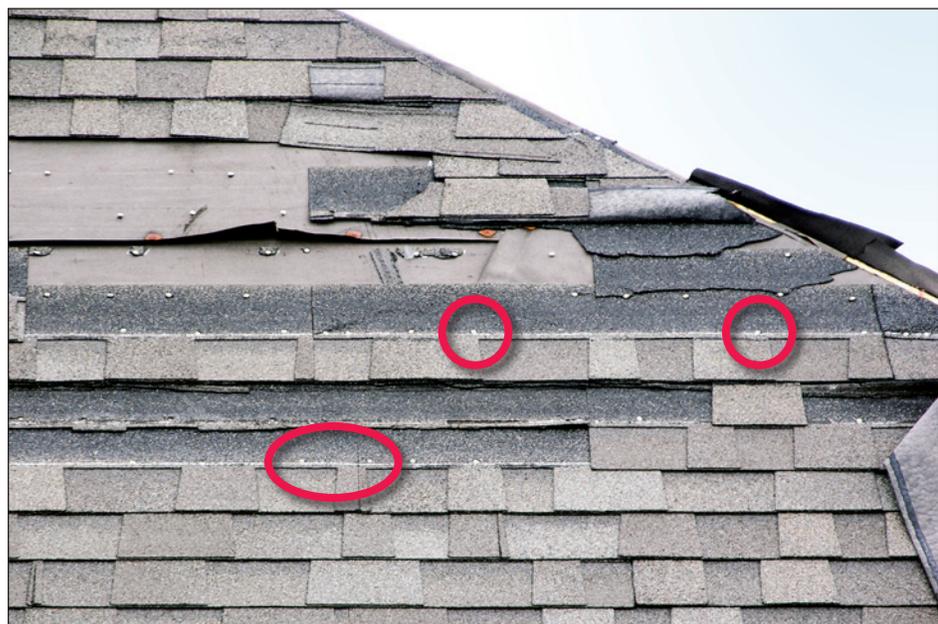
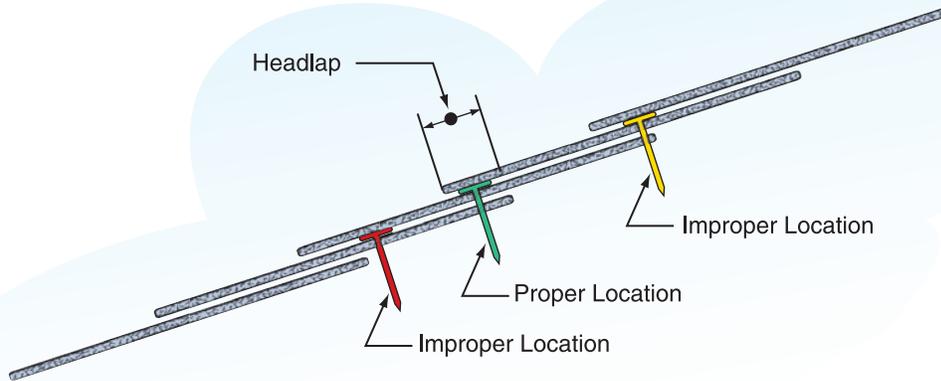
Figure 5-44.

The nails at this house under construction were placed quite close to the nailing line. However, some of the end nails were too far inward (the nail in the oval was several inches from the end). Distribution along the nail line was also a problem (the nails in the circles were much too far apart) (estimated wind speed: 115 mph. Slidell, Louisiana).

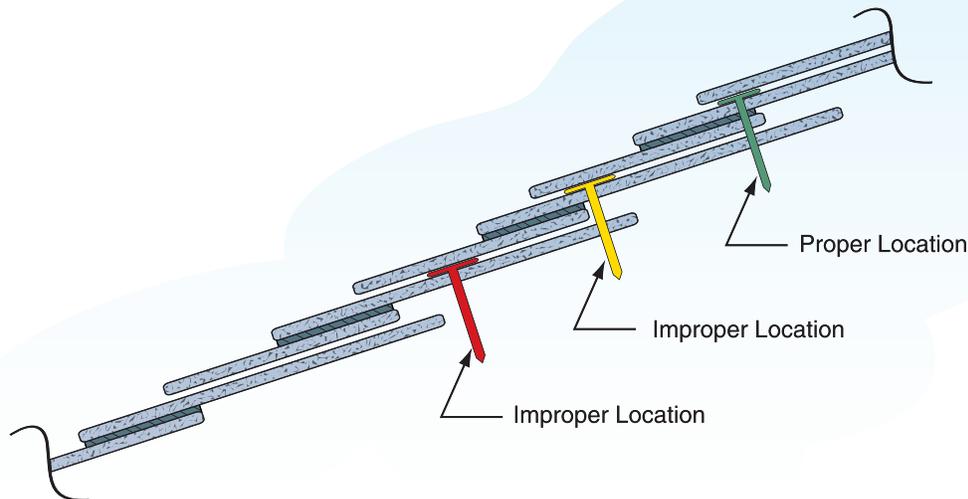
Figure 5-45.

When properly located, the nail engages the underlying shingle in the headlap area (green nail). When too high, the nail misses the underlying shingle (red arrow) or is too close to the edge of the underlying shingle (yellow nail).

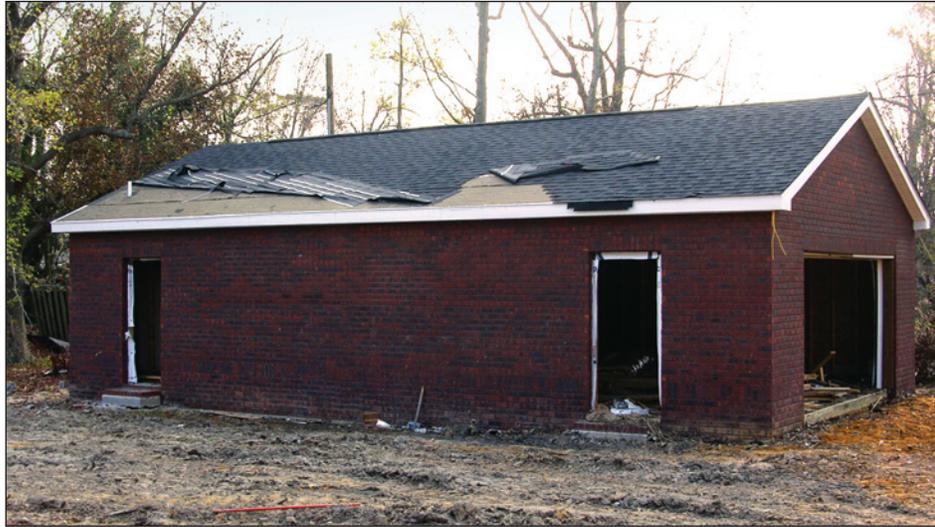
Figure 5-47.

The number of nails (i.e., four versus six) and their location likely plays little role in wind performance, as long as the shingles remain bonded. However, if they are unbonded prior to a storm, or debonded during a storm, the number and location of nails and the shingles' nail pull-through resistance likely play an important role in the magnitude of progressive damage, as illustrated by Figure 5-47.²

The starter course was incorrectly installed at this recently completed roof. The starter course and eave course lifted. A progressive peeling occurred because there was inadequate nailing attachment to resist the peel forces (estimated wind speed: 105 mph. Pascagoula, Mississippi).

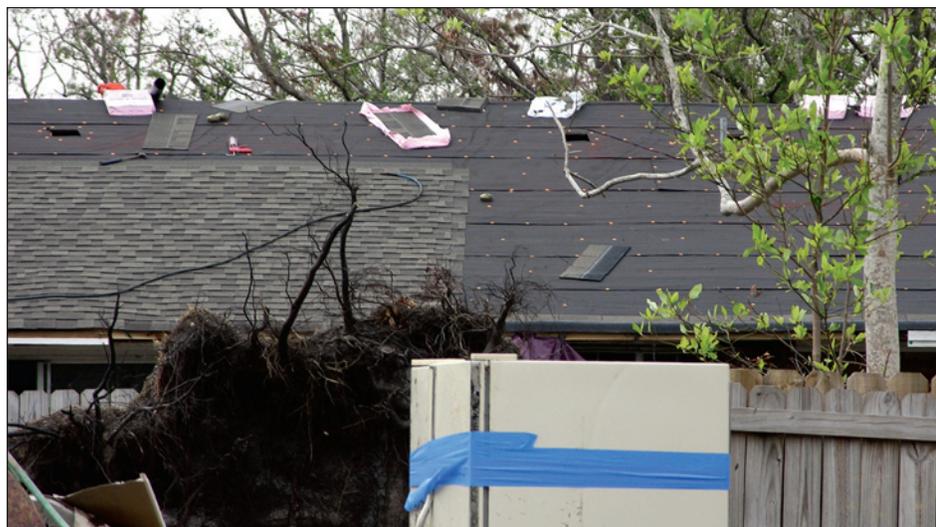
Figure 5-48.

Several of the damaged roofs were installed with the raking installation method. With this method, shingles are installed from eave to ridge in bands about 6-feet wide (see Figure 5-48). Where the bands join one another, at every other course, a shingle from the previous row needs to be lifted up to install the end nail of the new band shingle. Sometimes installers do not install the end nail; in these applications, the shingles are vulnerable to unzipping at the band lines, as shown in Figure 5-49. At a nursing home in Gulfport, Mississippi, a limited amount of spot checking found three shingles that were missing the right end nail (see Figure 5-50). Blown-off shingles broke some of the windows in the nursing home (see Figure 5-51), and were the likely cause of glazing damage at a building across the street.

This house was being re-roofed after the hurricane using the raking method. The starter course was incorrectly installed (estimated wind speed: 130 mph. Long Beach, Mississippi).

The National Roofing Contractors Association (NRCA) recommends that the raking method not be used and that shingles should be laid one course at a time from rake to rake starting at the eave.

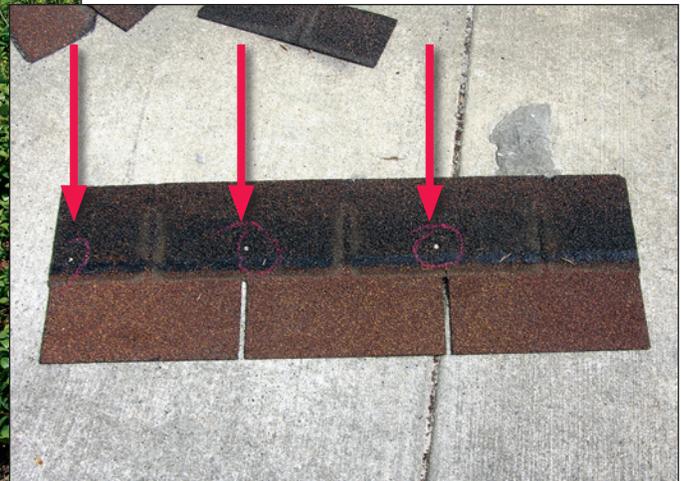
Figure 5-50.
Many shingles were blown from a nursing home. Limited checking found three shingles that were missing the right end nail (see inset for one of these). The nails that were installed were placed very high (red arrows); many missed or just nicked the underlying headlap (estimated wind speed: 130 mph. Gulfport, Mississippi).

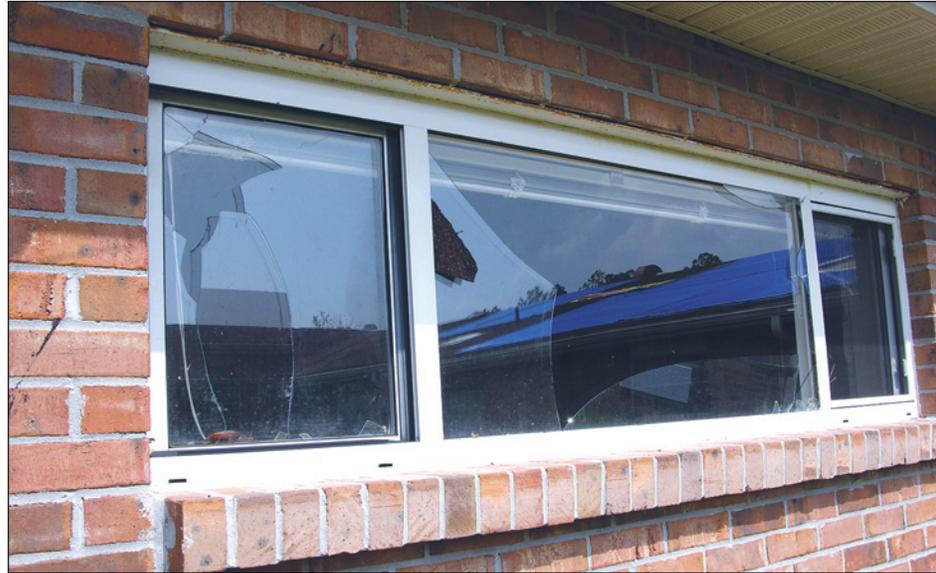
Figure 5-51.
Windborne asphalt shingle debris broke several windows in this nursing home. A piece of shingle debris is embedded in the frame (estimated wind speed: 130 mph. Gulfport, Mississippi).

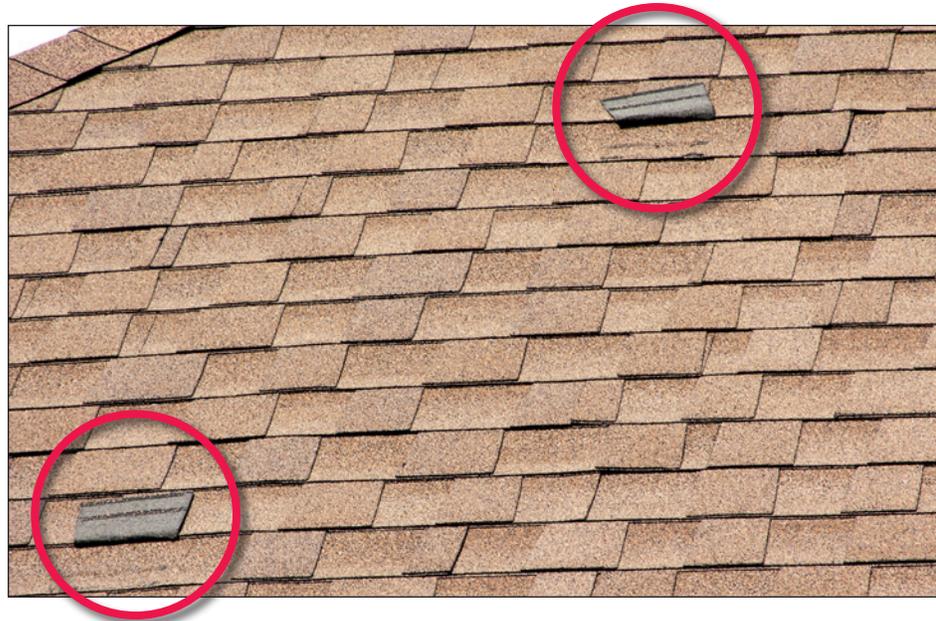
On a few roofs with architectural shingles, instances of blow-off of laminated tabs were observed (see Figure 5-52). This type of failure was due to an inadequate amount and/or strength of adhesive used in the manufacturing of the shingles.

Figure 5-52.
Two laminated tabs were lifted (circles) at a house under construction (estimated wind speed: 120 mph. Ocean Springs, Mississippi).

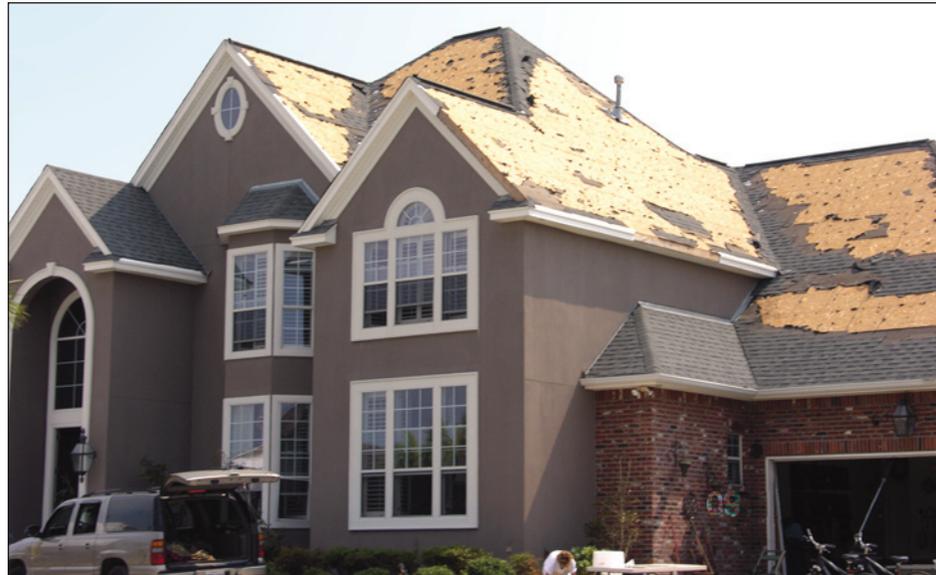
Figure 5-54.
Widespread loss of underlayment. With loss of underlayment, water is free to leak into the building and cause extensive interior damage (estimated wind speed: 115 mph. Slidell, Louisiana).

Technical Fact Sheet No. 19 in FEMA 499 provides recommended practices for underlayments on roofs in high-wind areas.

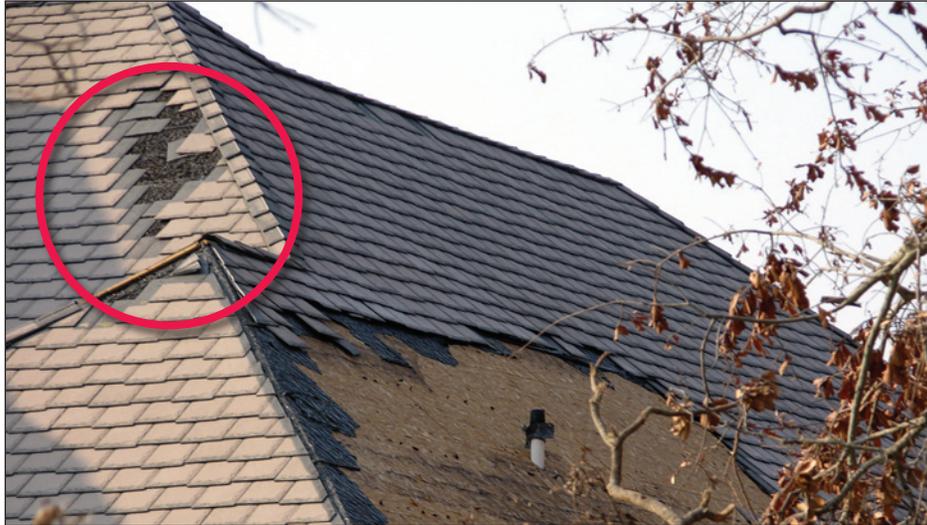
Fiber-cement and slate roof coverings have very limited market shares in the southeastern United States and there is limited information in the literature on the wind performance of these products. The MAT observed one roof with fiber-cement that simulated slate and one slate roof. Figure 5-55 shows the fiber-cement roof. It experienced damage in several areas, including many of the hip lines. The simulated slates were attached with two nails. The manufacturer's literature states the nails are to be placed between 1/2 and 1-1/2 inches above the exposure so that the nail penetrates the underlying simulated slate in the headlap area. However, the nails were typically placed a few inches above the exposure and they missed the headlap. Some of the nails pulled out of the deck, but many remained in place. In several instances, the simulated slates broke at the nail line.

In 2004, the manufacturer issued high-wind attachment recommendations, which consisted of placing 1-1/2x3/8 inch beads of adhesive over the nail heads. Adhesive was not used on the roof shown in Figure 5-55; however, that roof may have been installed prior to distribution of the 2004 recommendations.

Figure 5-55. Fiber-cement simulating slate. Note the loss of underlayment and the simulated slates broken at the nail line (circle). This house was located in Exposure C (estimated wind speed: 105 mph. Pascagoula, Mississippi).

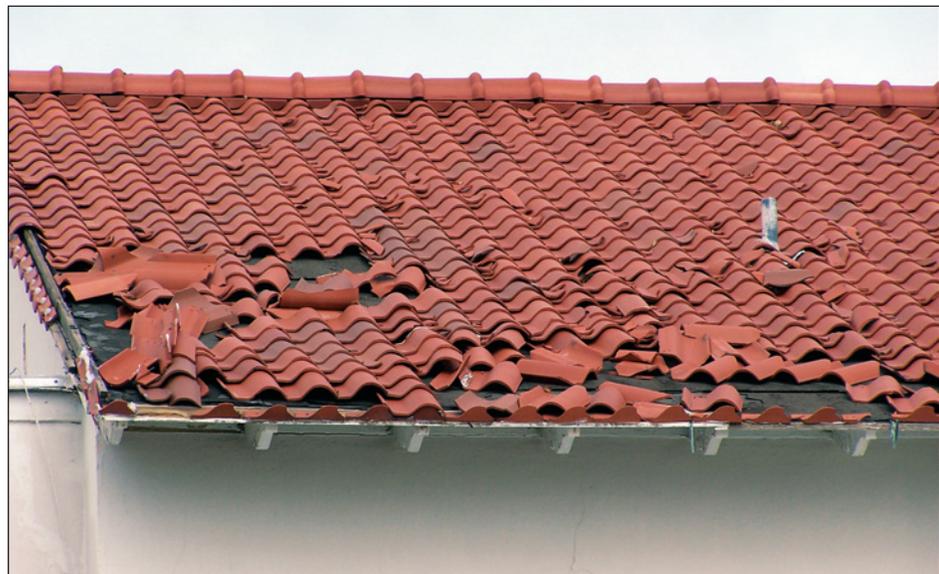
Figure 5-57.
Damaged tiles at roof perimeter (estimated wind speed: 120 mph. VA Hospital Chapel, Biloxi, Mississippi)

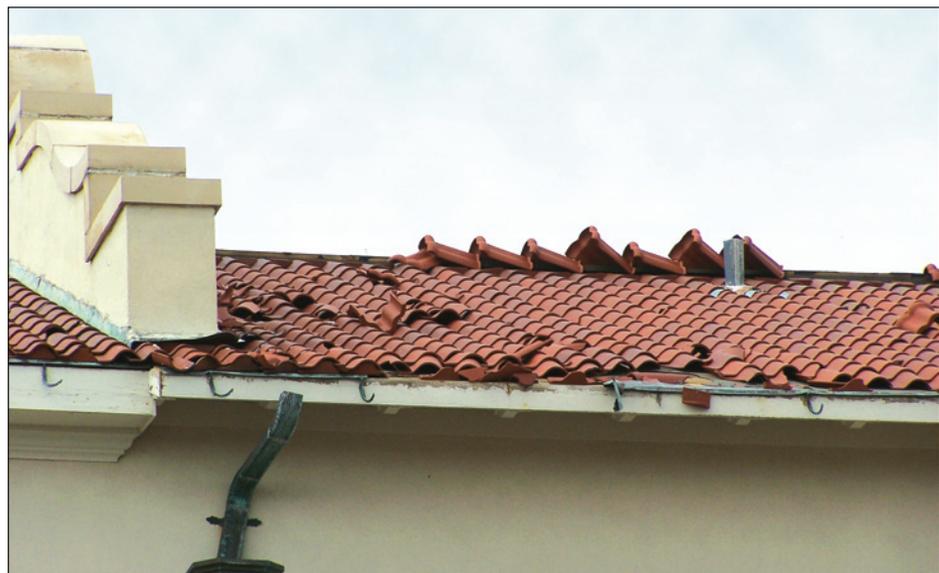
Figure 5-58.
Wind turbulence behind parapet resulted in uplift of ridge tiles. Tile was also damaged along the eave (estimated wind speed: 120 mph. VA Hospital Patient Building, Biloxi, Mississippi).

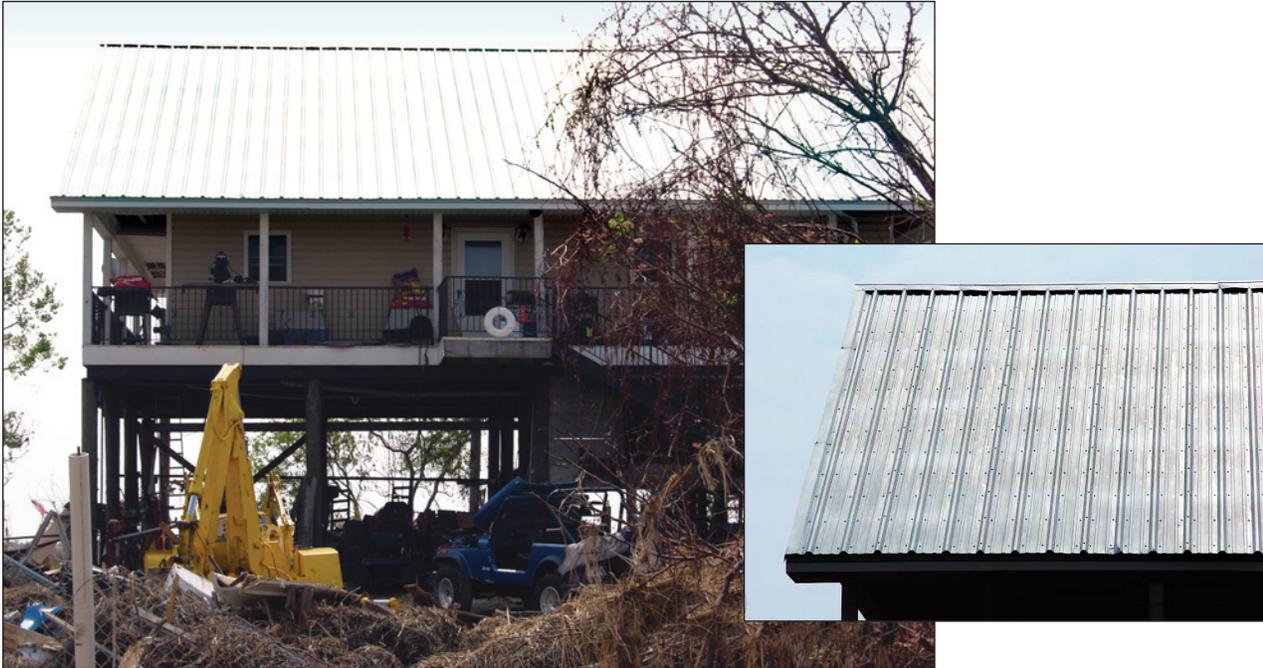
Figure 5-60.

Success or failure of exposed fastener panels was likely dependent upon fastener spacing (see Figure 5-60) and type, and whether or not the substrate lifted, as discussed later. Panel gauge may have also had some influence. Screws provided greater pull-out resistance than ring-shank nails, and were more resistant to dynamic loading. Another key element of good performance is the spacing of fasteners along the eave and at hip and ridge flashings. Close spacing at the flashings and eave is important to keep the flashings and panel ends from billowing during high winds.

The R-panel roof on this house located in Exposure C was very well attached. The screws were closely spaced horizontally and vertically, and at the panel side laps. The flashing fasteners were too far apart (12 inches on center), but the attachment was sufficient for these winds (estimated wind speed: 115 mph. Slidell, Louisiana).

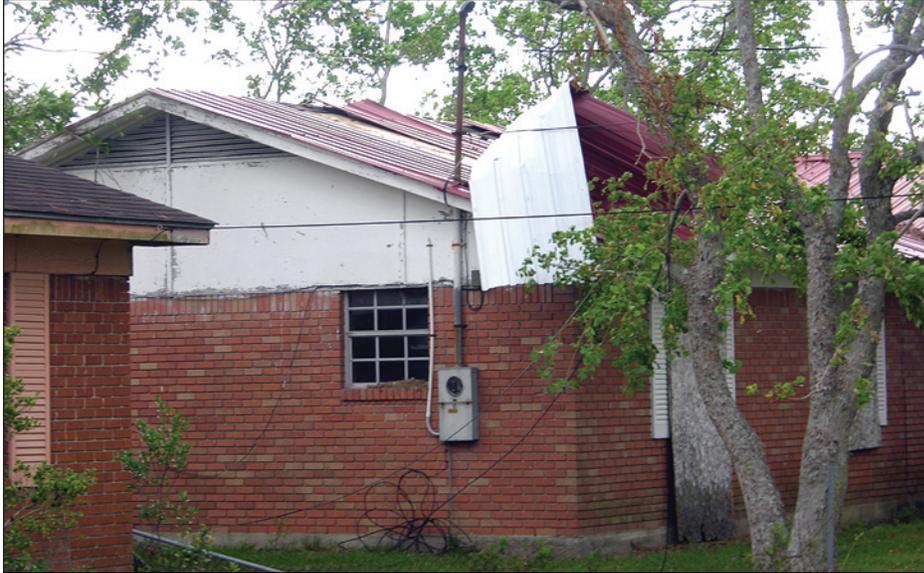
Several of the R-panel failures were caused by failure of the substrate to which the panels were attached. The panels on the house shown in Figure 5-61 were likely a reroofing application. The panels were installed over underlayment over plywood. On the backside of the house, one or more plywood panels were blown off from along two locations at the eave. The decking blow-off resulted in a progressive lifting and peeling failure of the panels. At the house shown in Figure 5-62, 2x4 nailers had been attached to the plywood decking and then the R-panels were attached to the nailers. The right half of the third nailer from the eave was blown away. Inadequate nailer attachment was the likely cause of this failure. Nailer failure also caused R-panels to be blown away on a few residences where nailers had been installed over existing asphalt shingles. The panels were screwed to the nailers at 12 inches on center, but the nailers were nailed to the sheathing at spacings that exceeded 12 inches. Therefore, the nailer attachment was the weak link in the load path.

Figure 5-61.
Blow-off of decking caused these panels to progressively fail (estimated wind speed: 105 mph. Pascagoula, Mississippi).

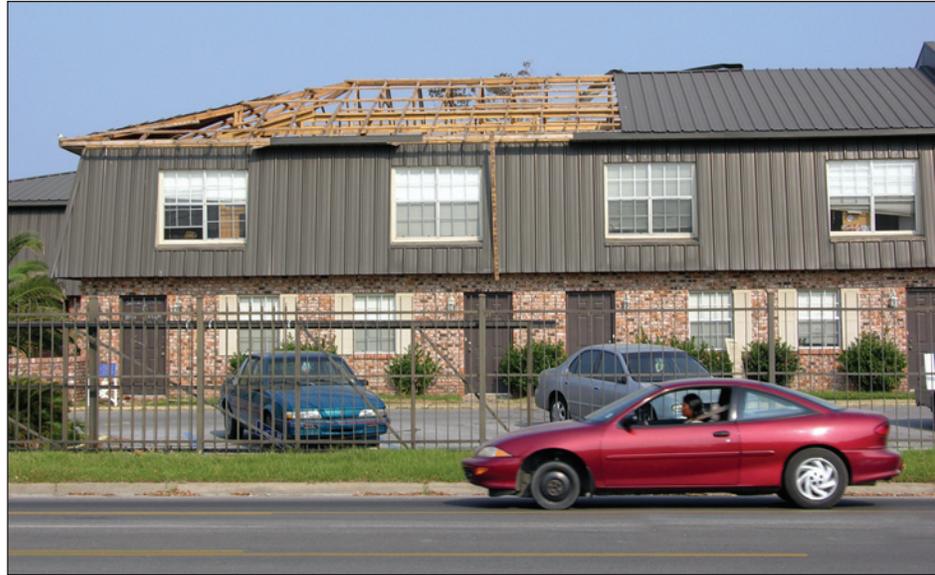
Figure 5-63 shows an apartment complex that did not incorporate roof decking. The trusses had 2x4 nailers installed directly over them. Several of the nailers were blown away, which resulted in a progressive failure of the R-panels. Since there was no roof decking, it was not possible to install underlayment. Thus with loss of the metal panels, the living units were exposed to massive rainwater infiltration.

Figure 5-63.
Blow-off of nailers caused these panels to progressively fail. The nailers were installed directly over the trusses and, with loss of the panels, rainwater was free to enter the building (estimated wind speed: 105 mph. Pascagoula, Mississippi).

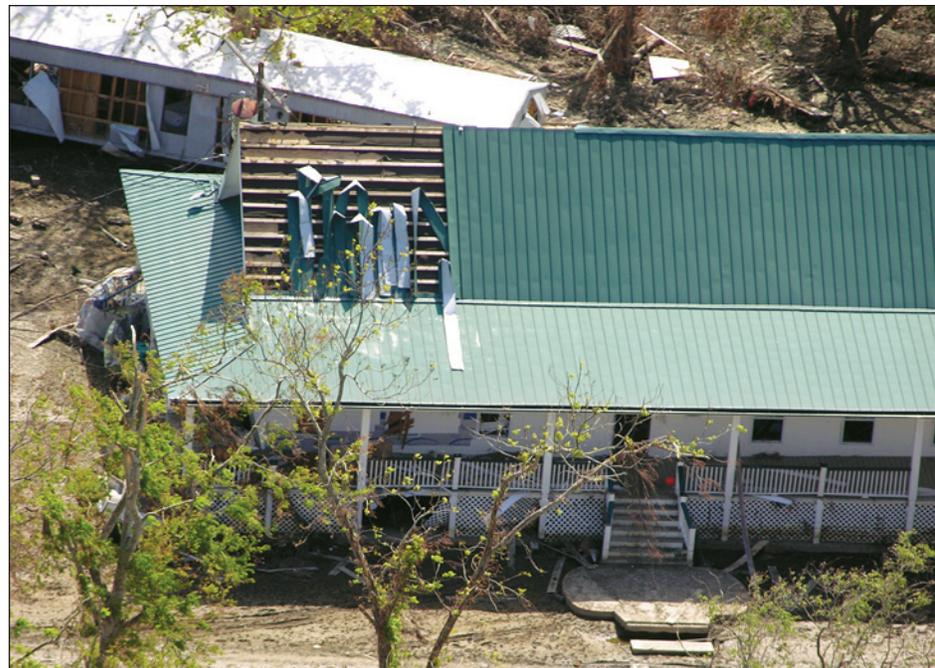
A variety of architectural and structural standing seam panels was also observed. As with the exposed fastener panels, some of the roofs were undamaged, others lost hip or ridge flashings, and others lost a large number of panels (see Figure 5-64). Performance of standing seam panels is a function of the strength of the panels and their interlock with the clips, clip spacing and attachment, and strength of the flashing attachments. Some of the failed hip and ridge flashings were attached with cleats rather than exposed fasteners. Cleat attachment is not as reliable as exposed fasteners.

Figure 5-64.
Loss of architectural standing seam panels. The panels were installed over 2x4 nailers over underlayment and wood sheathing panels. Much of the exposed underlayment was blown away, thereby allowing rainwater infiltration (estimated wind speed: 130 mph. Buras, Louisiana).

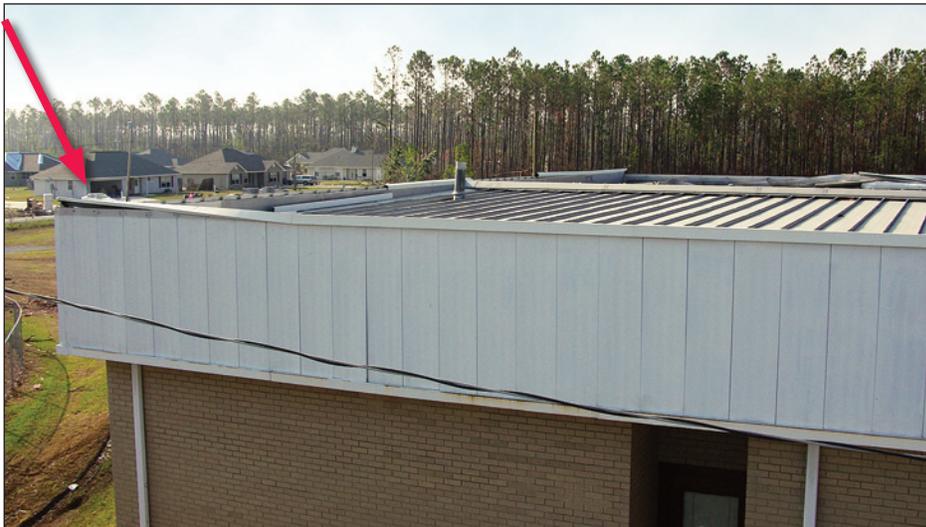
Two unusual installation practices were observed. At the school shown in Figure 5-65, the standing seams were not continuously seamed together. Rather, they were crimped at an erratic spacing (in one area, it was about 4 feet between 6-inch-long crimps). Lack of continuous seaming reduces uplift resistance of the panels and makes them susceptible to leakage. Some of the copings were blown off, and several suspended ceiling boards collapsed after becoming saturated from roof leakage.

Figure 5-65.
The architectural standing seam panels on this school were not continuously seamed. Note the coping damage. This portion of the school was completed in 1988 (estimated wind speed: 125 mph. Waveland, Mississippi).

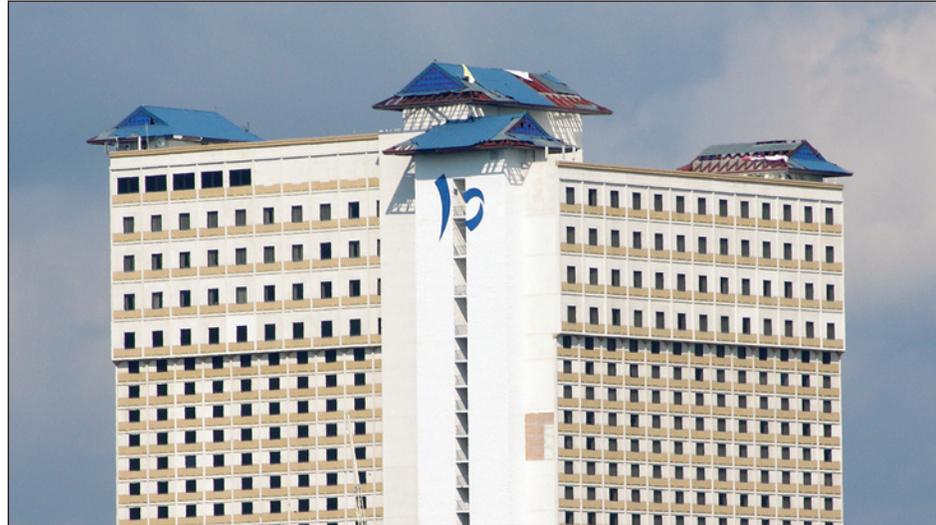
When metal panels or hip/ridge flashings blow off (see Figure 5-67), they can become high-energy windborne debris that can damage buildings and other property and cause injury. These types of windborne debris can travel a considerable distance.

Figure 5-67.
The steep-slope roof coverings on this high-rise building appear to be tile; however, they actually were metal panels that simulated tile. Several panels were blown off (estimated wind speed: 120 mph. Biloxi, Mississippi).

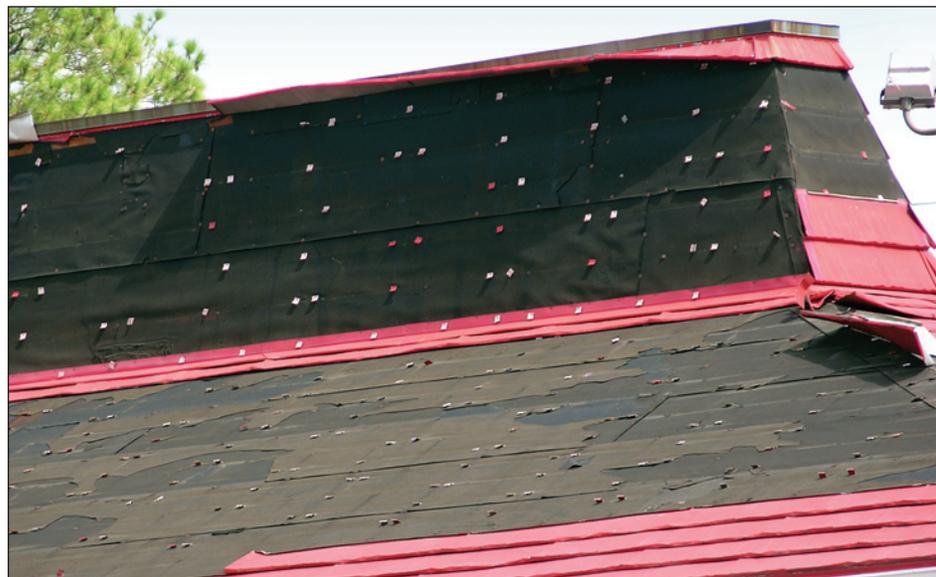
A limited number of metal shingles were observed. Figure 5-68 shows an aluminum shingle that has been used on many fast-food restaurants throughout the United States. These shingles are attached with two stainless steel clips per shingle. Because these shingles are quite flexible, they deformed and lost engagement with the clip. Poor performance with this type of shingle has been observed in several previous hurricanes, dating back to Hurricane Hugo in 1989. Another aluminum shingle of somewhat similar design to that shown in Figure 5-64 also deformed and lost engagement with its clips. Some batten-attached metal shingles were also observed, but detailed investigations were not performed to determine the failure mode.

Figure 5-68.
These aluminum shingles disengaged from their clips (estimated wind speed: 115 mph. Slidell, Louisiana).

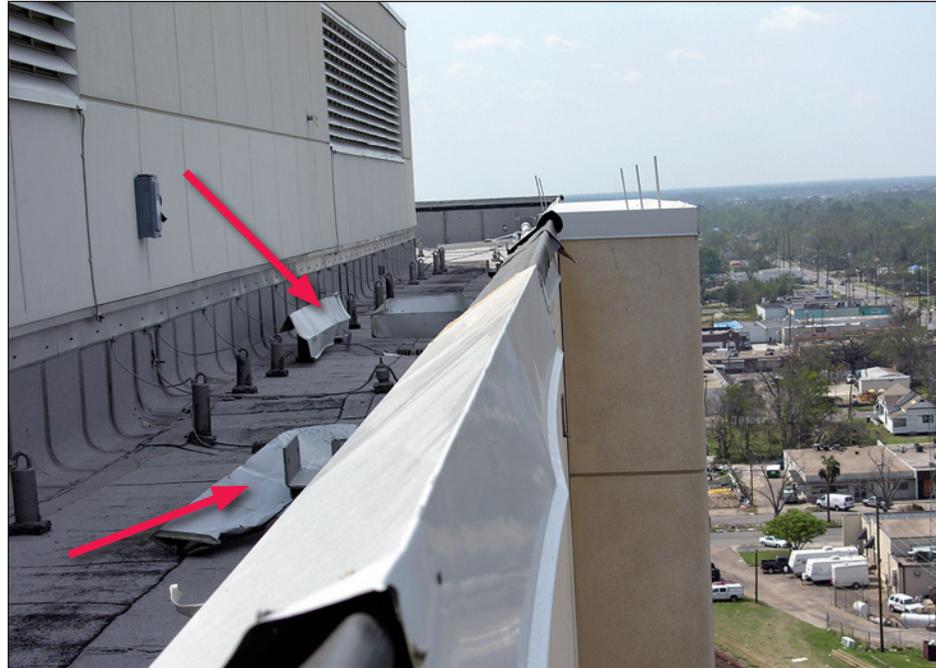
At the Federal courthouse shown in Figure 5-69, the coping had a 6-1/2-inch vertical face, but the hem on the continuous cleat was only 7/16 inch long.⁴ High-wind loads caused deformation of the coping and cleat. Because of the limited engagement with the cleat, the outer face of the coping unlatched from the cleat. At several areas, the unlatched coping lifted, but remained attached to the parapet; however, some of the sections of coping were blown from the parapet. The courthouse was completed in 2003.

⁴ The 2001 edition of *The NRCA Roofing and Waterproofing Manual* recommends a 3/4-inch long hem.

Figure 5-69.
This coping unlatched from the cleat because the cleat hem was too short. Two sections of detached coping are resting on the roof (red arrows) (estimated wind speed: 130 mph. Gulfport, Mississippi).

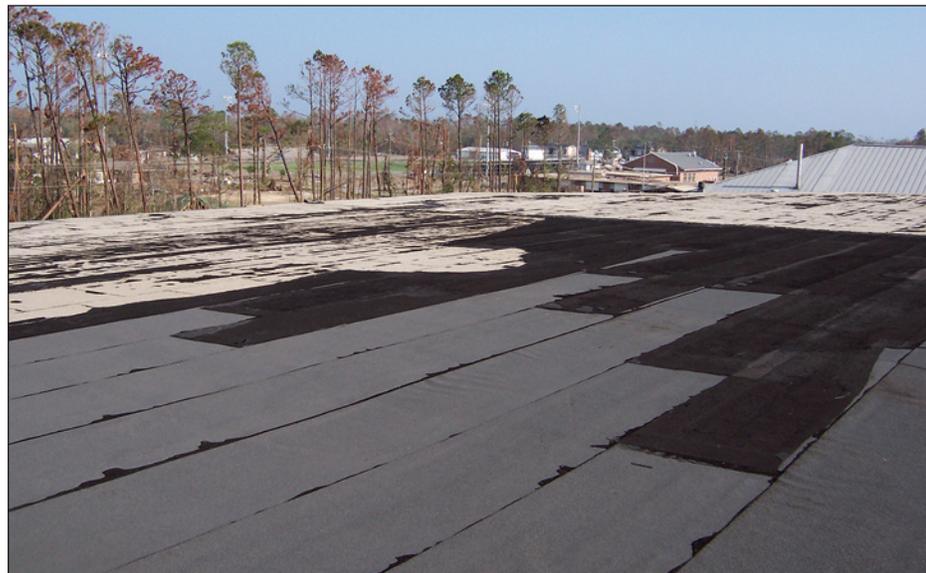
At the school gym roof shown in Figure 5-70, the modified bitumen membrane was set in hot asphalt over 4x4-foot perlite set in hot asphalt over mechanically attached polyisocyanurate insulation and glass mat gypsum roof board over metal deck. The membrane peeling was caused by failure of the edge flashing nailers. Rather than stacking continuous 2x nailers, a 2x nailer about 12 inches long was attached to the deck, followed by another 2x nailer of the same length on top of it. The upper nailer was attached with two power-driven fasteners. These discontinuous stacks were spaced at 4 feet 7 inches on center. A continuous top nailer was then attached to the stacks. The continuous top nailer lifted with the metal edge flashing and caused the membrane to lift and peel. This school was completed in 1998.

Figure 5-70.
The modified bitumen membrane failure at this school was caused by lifting of the edge nailer (estimated wind speed: 130 mph. Pass Christian, Mississippi).

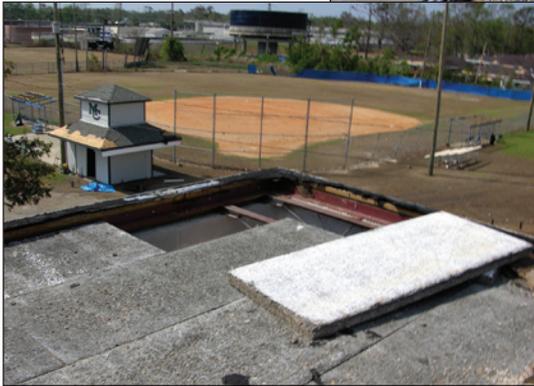
Figure 5-72.
The BUR on this school was blown off after one of the cementitious wood-fiber deck panels detached from the joists. Older cementitious wood-fiber deck attachments typically offered limited uplift resistance (estimated wind speed: 120 mph. Biloxi, Mississippi).

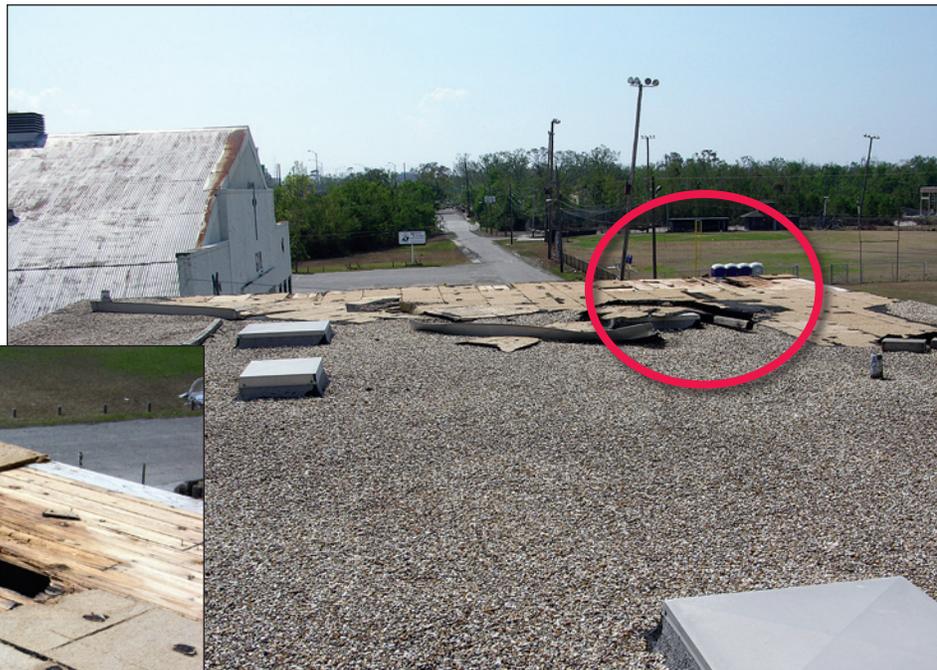
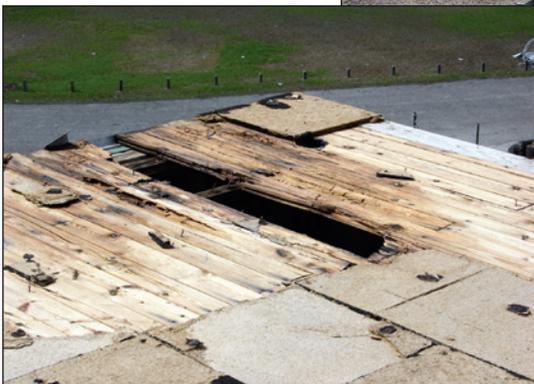
Failure of the roof deck or the roof deck support structure sometimes occurs, particularly with buildings designed when the building code did not account for increased uplift loads at the roof perimeter and corners. Deck failure can be caused by inadequate attachment of the deck to the deck support structure, as shown in Figures 3-48 and 5-72. Deck failure can also be caused by corrosion or dry rot, as shown in Figure 5-73.

Figure 5-73.
The BUR on this school was blown off after a few of the rotted wood planks detached from the joists (estimated wind speed: 120 mph. Biloxi, Mississippi).

When buildings in hurricane-prone regions are reroofed, it is prudent to tear off the existing roof system down to the deck, so that the entire deck surface can be checked for attachment and deterioration. If inadequately attached or deteriorated decking is discovered, remedial action should then be taken as part of the reroofing project. By doing so, future wind damage associated with deck deficiencies can be avoided.

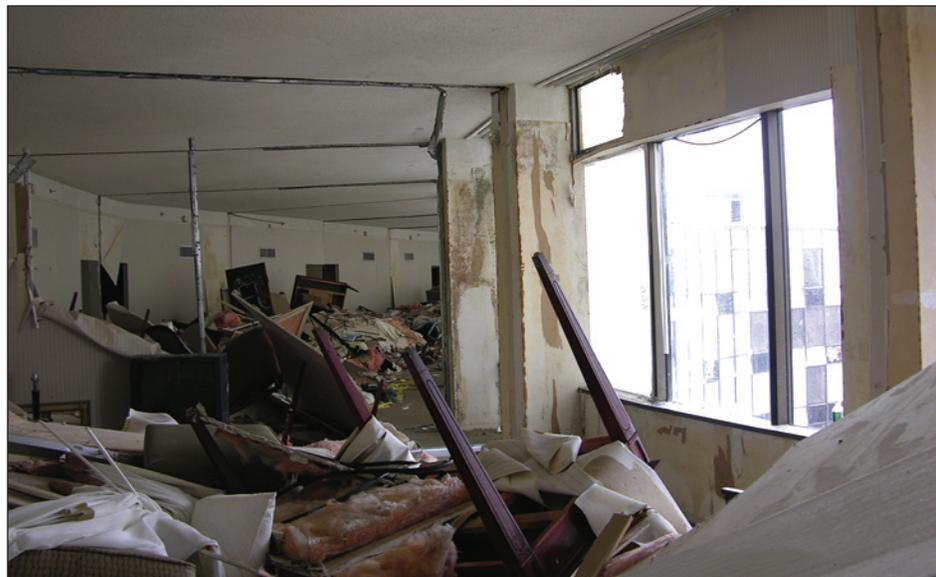
Figure 5-75.
Interior view of the hotel shown in Figures 3-47 and 5-82. After the exterior glazing broke, wind knocked down the partitions between the guest rooms and water entered the building (estimated wind speed: 105 mph. New Orleans, Louisiana).

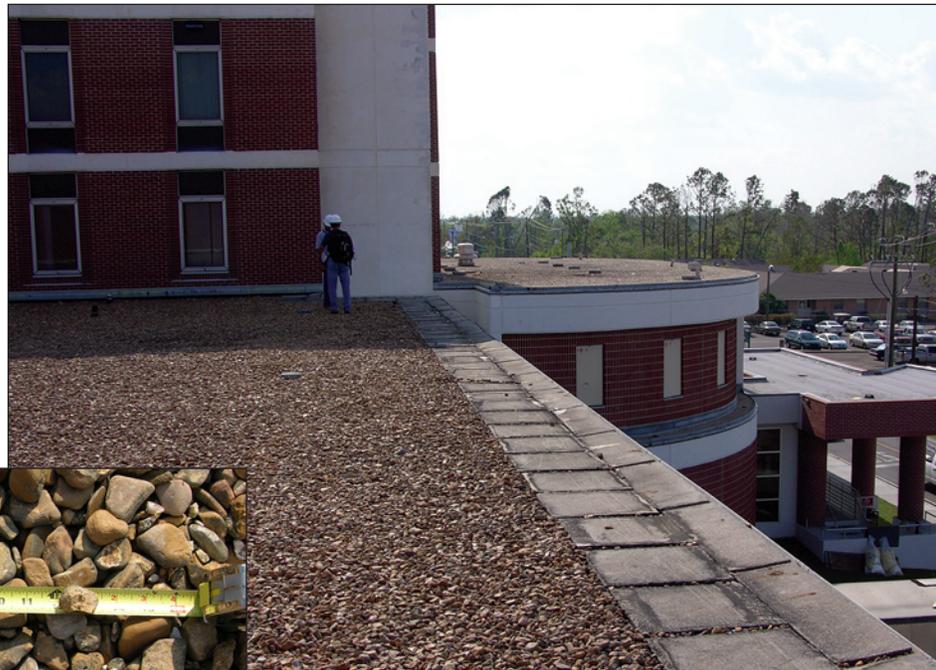
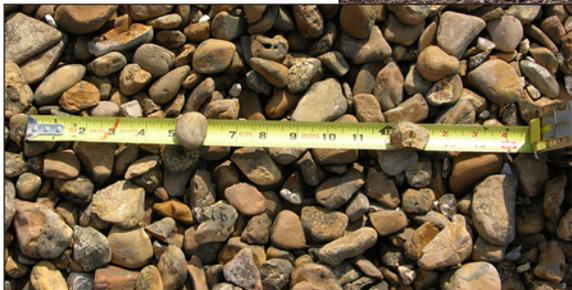
Figure 5-77.
Aggregate from this ballasted single-ply broke several of the windows in the wall beyond. The concrete pavers at the perimeter were not displaced. The aggregate (inset) does not comply with RP-4 requirements (estimated wind speed: 130 mph. Gulfport,

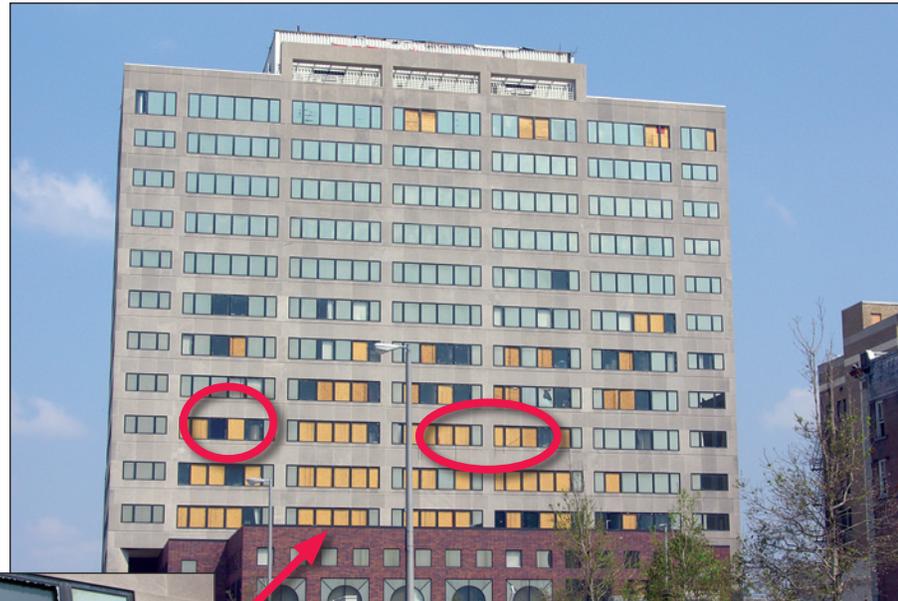
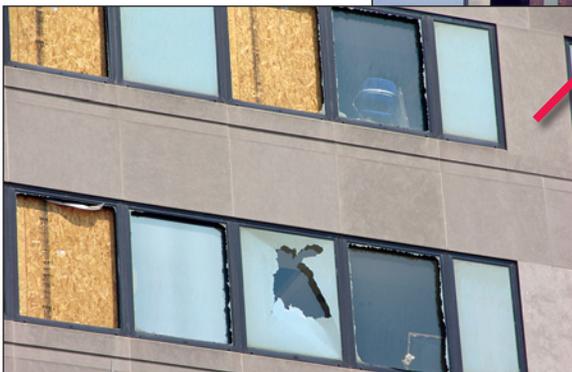
The tower windows were double glazed. Tempered glass was used for the outer pane. At some windows, only the outer panes were broken (the windows in Figure 5-79 that appear black and those that appear white [due to window blinds] are where the outer panes broke and the inner panes are still in place). However, at most of the broken windows, both the outer and inner panes were broken (at these windows, the openings were covered with OSB after the storm). With loss of both panes of glass, wind and water were able to enter the building. Ceiling boards were blown from their support grid and there was significant water damage to interior finishes and furnishings.

At the 15th (top floor), the outer pane at the west end broke, and the inner and outer panes broke at seven other windows as shown at Figure 5-79. As discussed in the ASCE 7 Commentary, during its flight, aggregate blown from roofs can be lifted 30 feet above the roof from which it blew. The 15th floor windows are well above the penthouse roof on the seven-story building “D”; therefore, it is unlikely that the 15th floor windows were broken by aggregate from roofs “A” - “D.” The main roof on the tower was also aggregate surfaced. The parapet around this roof was 30 inches high; therefore, aggregate was likely blown from this roof.

Aggregate blown from a roof can be blown back toward the leeward side of the building and cause glazing damage. However, it did not appear that sufficiently strong winds blew from the north to cause glazing damage on the south facade. Some of the 15th floor windows may have been weakened by scratches and failed when over-stressed by wind pressure, which would have been greatest at the top floor.

Another view of the tower shown in Figure 5-78. Roof "A" is shown by the arrow. At the black and white (circled) window areas, the outer pane broke. Temporary OSB enclosures were installed where the inner and outer panes broke (see inset) (estimated wind speed: 130 mph. Gulfport, Mississippi).

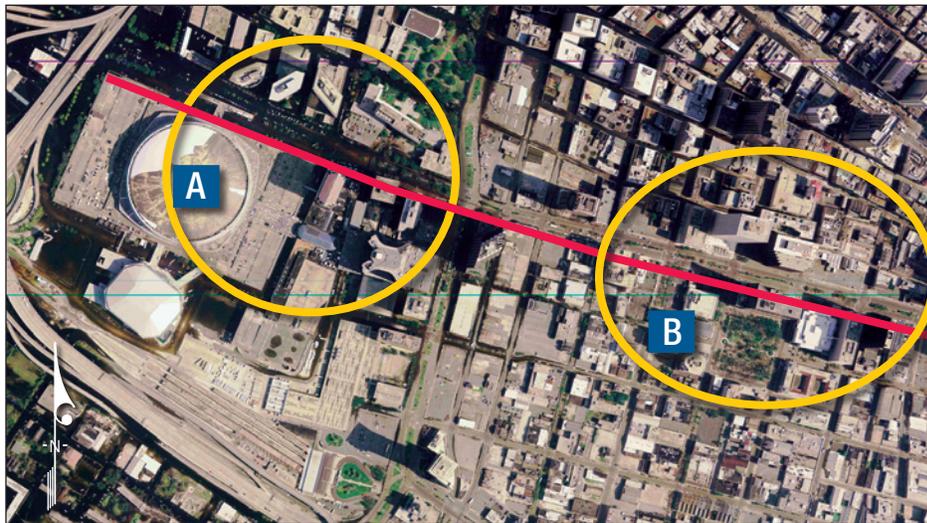
Cluster A: The buildings in circle A in Figure 5-80 are shown in Figure 5-81. Wind in this area blew from two primary directions, from the north and west. Buildings T1 - T4 and S4 experienced extensive glazing damage. Buildings T1, T2, and S4 are office buildings; T3 is a hotel;

Figure 5-80. General locations of buildings (highlighted by yellow circles) along Poydras Street (highlighted in red) with extensive glazing damage. The Superdome is at the left of the figure. (estimated wind speed: 105 mph. New Orleans, Louisiana.)

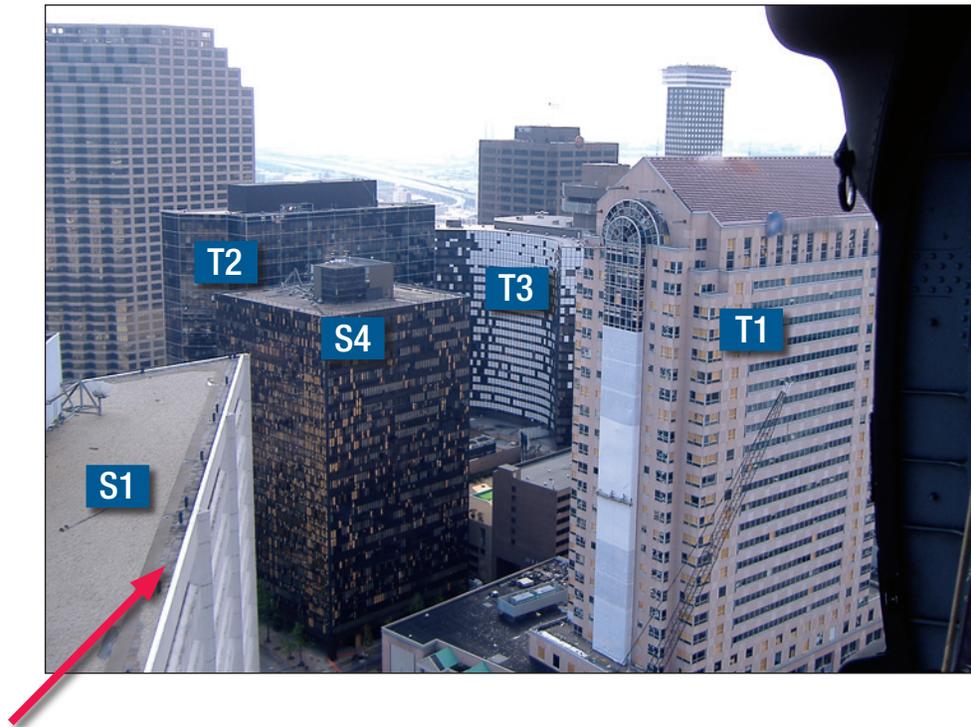
Figure 5-82.
View of glazing damage
at T1 - T3 and S4.
Building S1 had an
aggregate ballasted roof
membrane; aggregate
from this roof was one
of the likely sources of
debris (estimated wind
speed: 105 mph. New
Orleans, Louisiana).

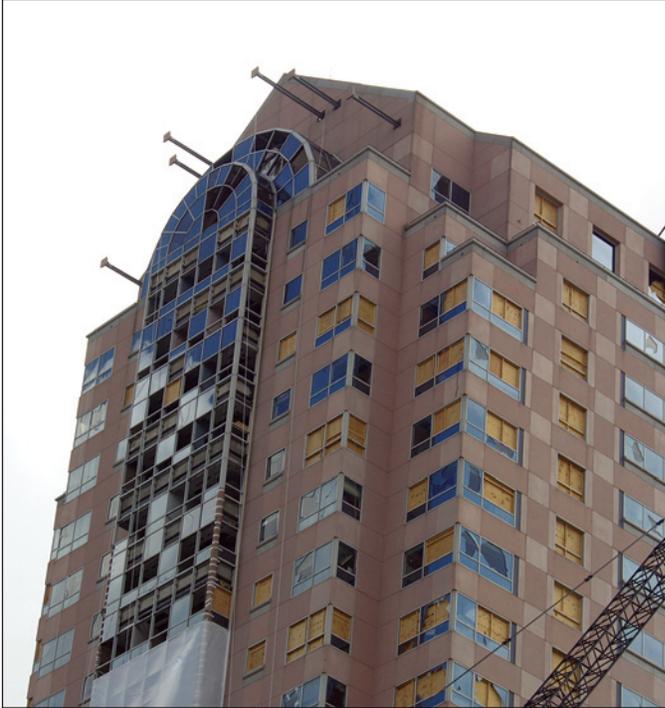
Figure 5-83.
Closeup view of T1 (estimated wind speed: 105 mph. New Orleans, Louisiana).

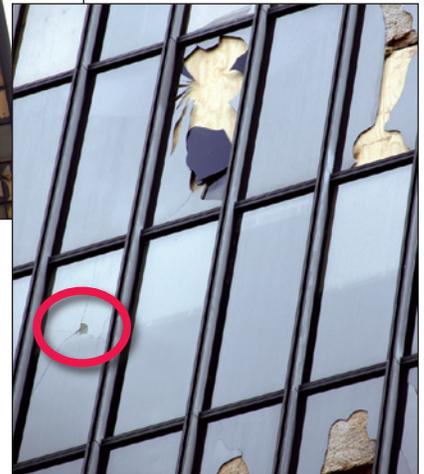
Figure 5-84.
Closeup view of the north façade of S4. The inset (west façade) shows broken windows and spandrel panels. The broken glass at the circle is indicative of impact by a large piece of aggregate (estimated wind speed: 105 mph. New Orleans, Louisiana).

Building S4: This was an aggregate surfaced BUR with a parapet that appeared to be about 18 to 24 inches high. This building is about the same height as the 27-story hotel (T3). Virtually all of the main roof was scoured and it appeared that a substantial amount of aggregate blew off. Aggregate was ramped along the south parapet (see Figure 5-88). The roof on the penthouse (red arrow in Figure 5-88) did not have a parapet. It appeared that all of the loose aggregate was blown from the penthouse roof. Equipment screen wall panels were blown toward the south (yellow arrow in Figure 5-88) and east. The north and east support structure for the screen walls collapsed. Two exhaust fan cowlings were also blown away.
