HURRICANE

Katrina

IN THE GULF COAST

5. Building Envelope Performance

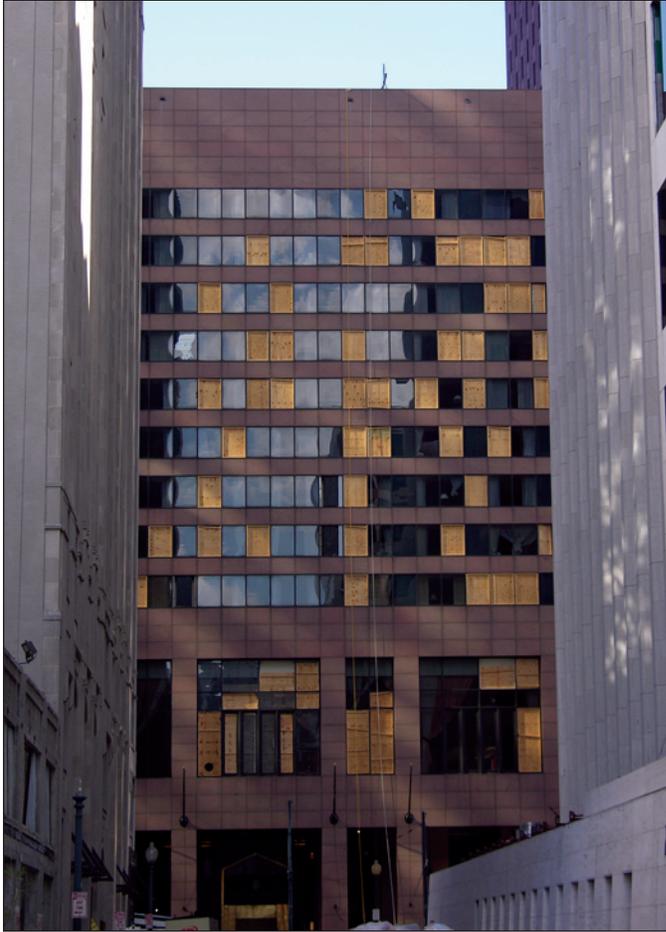
Figure 5-91.

Building T5: Several windows on the west façade of this 11-story building were broken (see Figure 5-91). A few isolated breaks occurred on the north and east façades. BURs occurred in the vicinity, but a likely source of aggregate debris was not definitively determined.

View of the west façade of T5. The tallest building in New Orleans is at the right (estimated wind speed: 105 mph. New Orleans, Louisiana).

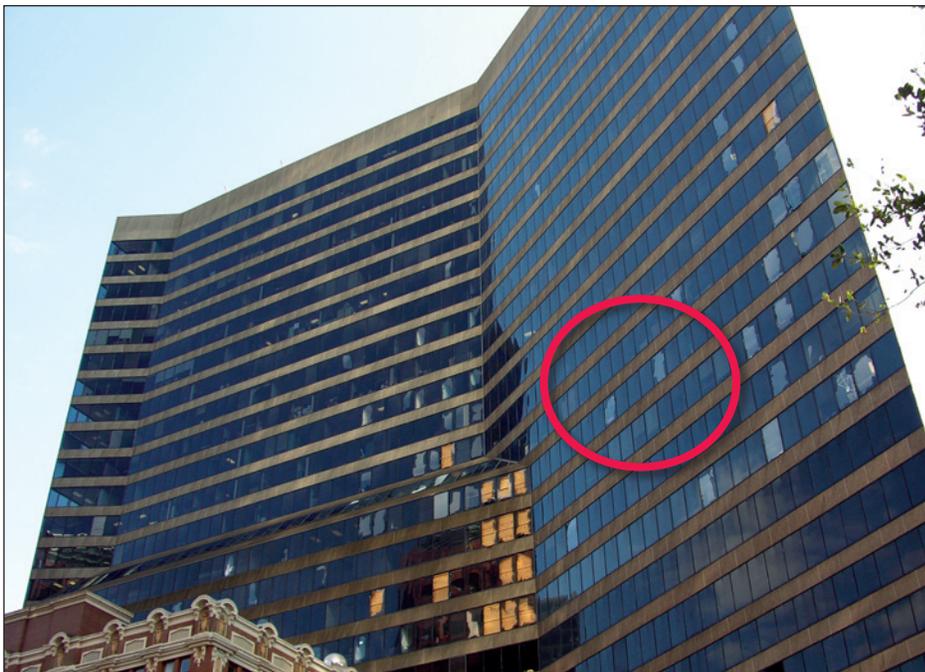
Figure 5-92.

Building T6: Several windows were broken on the north façade (see Figure 5-92). The likely sources of debris were the aggregate surfaced roofs on S6, which is directly across the street from T6 (see Figure 5-93). The narrow stair-stepped roofs (see Figure 5-94) appeared to be aggregate ballasted single-ply membranes. Metal roof panels were also blown from S6 and may have caused some of

the glazing damage. At least 20 windows on the west façade of T6 were also broken (in most cases, only the outer pane broke). The debris source for the west façade was not determined.

General view of T6. Plywood had been placed where the inner and outer panes had been broken. At most of the broken windows, only the outer pane broke (red circle). The building at the lower left did not have an aggregate roof surface (estimated wind speed: 105 mph. New Orleans, Louisiana).

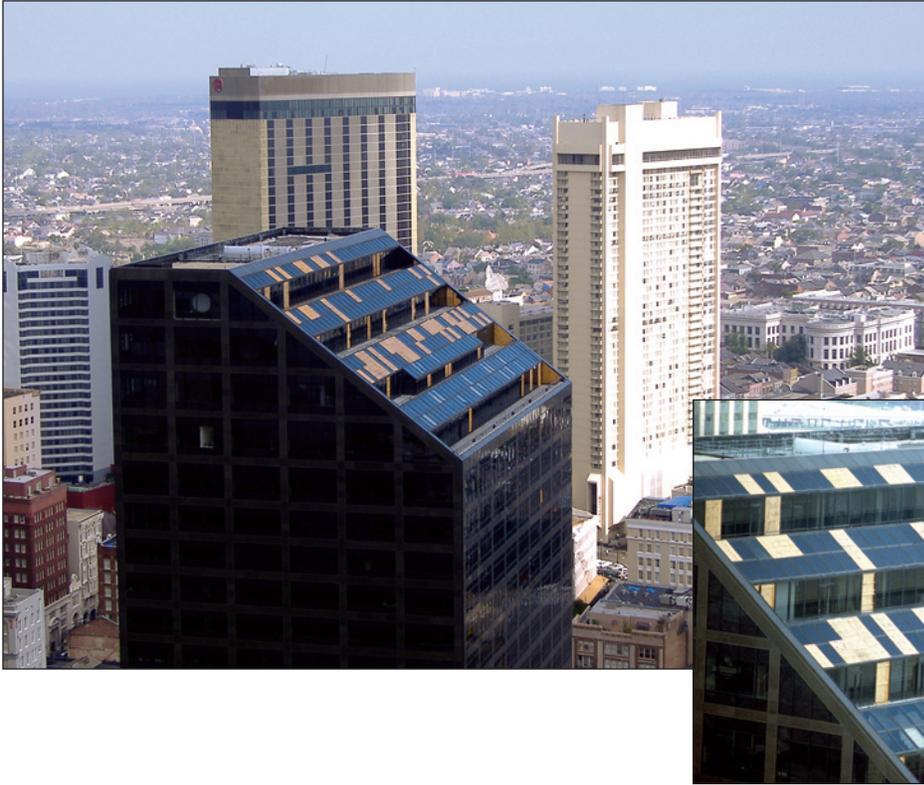
Building T7: This high-rise building is shown in Figure 5-93. It had sloped glazing that was sloped to the east (see Figure 5-95). Several of the outer panes of the sloped glazing were broken. Inner panes may have also been broken where plywood was installed after the hurricane. Several of the vertical windows adjacent to the sloped glazing were broken as well as a few windows on the east façade of the tower. A few windows were also broken on the north and south façades. The main roof and one of the stair-stepped roofs had ballasted single-ply membranes. A stone-protection mat occurred between the aggregate and membrane. Some aggregate was ramped against a portion of the west parapet. A substantial amount of aggregate was scoured and blown from the main roof (see Figure 5-96). The parapet appeared to be about 3 feet high. Aggregate from the main roof was the likely source of debris that broke the sloped glazing and nearby windows.

Figure 5-95. Aggregate ballast from the main roof of T7 was the likely source of debris that broke the sloped glazing and nearby windows (estimated wind speed: 105 mph. New Orleans, Louisiana).

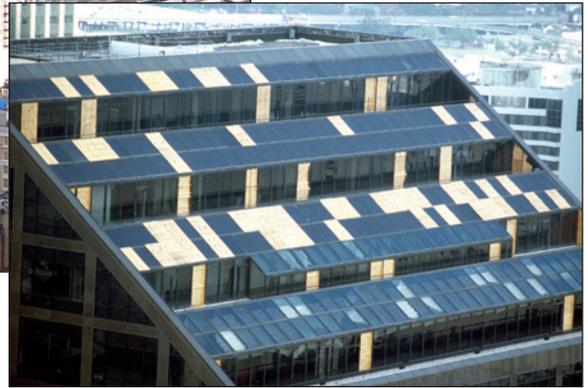
Figure 5-96. Aggregate ballast was scoured and blown from a large portion of the T7 roof. Aggregate also occurred at one, but not all of the stair-stepped roofs (yellow arrow) (estimated wind speed: 105 mph. New Orleans, Louisiana).

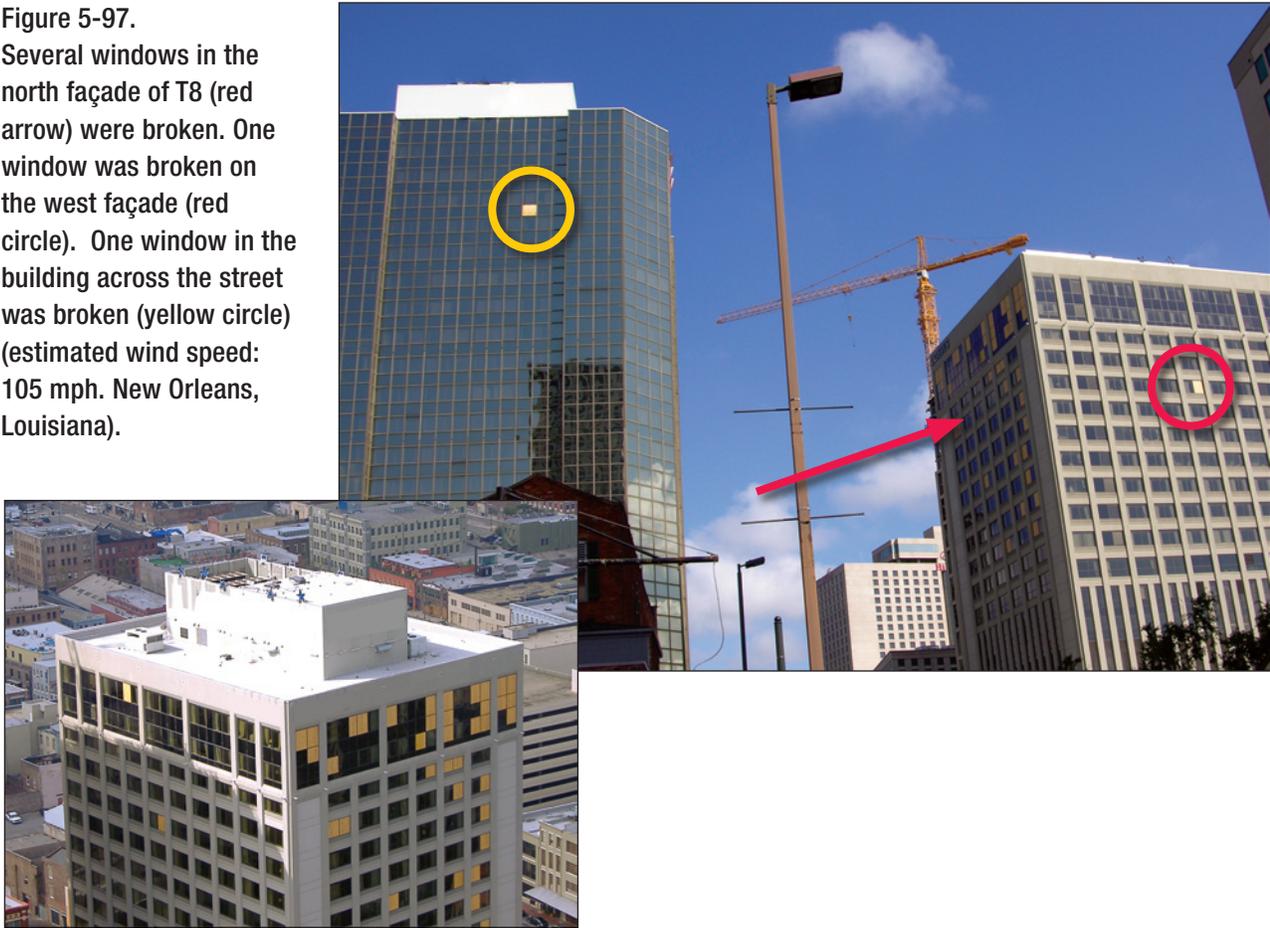
Building T8: Several windows were broken on the north façade (see Figure 5-97). The debris source was not determined. One window was broken on the west façade and a few were broken on the east façade. The roof of this building was not aggregate surfaced.

Figure 5-97. Several windows in the north façade of T8 (red arrow) were broken. One window was broken on the west façade (red circle). One window in the building across the street was broken (yellow circle) (estimated wind speed: 105 mph. New Orleans, Louisiana).

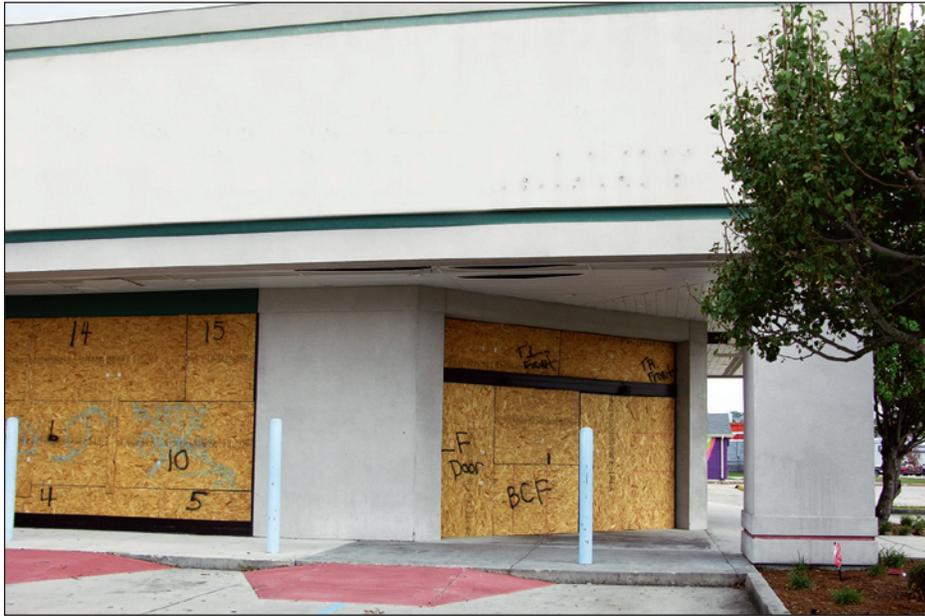
A variety of shutters were observed. They were made of wood sheathing, metal panels, polycarbonate, or plastic panels of various designs. Figure 5-98 shows the use of inexpensive pre-cut OSB shutters to protect storefront glazing. Because wood sheathing shutters are not pre-engineered, it is important that they be adequately anchored to avoid blow-off. Prescriptive anchoring requirements are provided in the IBC. Other examples of shutters are shown in Chapter 9.

Figure 5-98.
Pre-cut OSB shutters
(estimated wind speed:
115 mph. Slidell,
Louisiana)

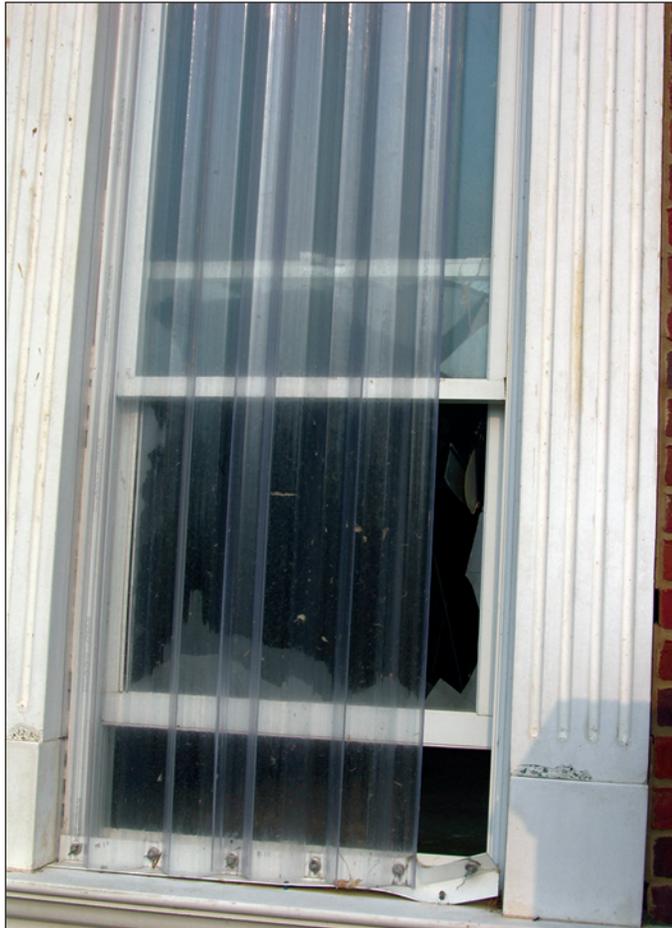
Figure 5-100.
This plastic shutter did not completely cover the
window. The lower window was broken (estimated
wind speed: 105 mph. Pascagoula, Mississippi).

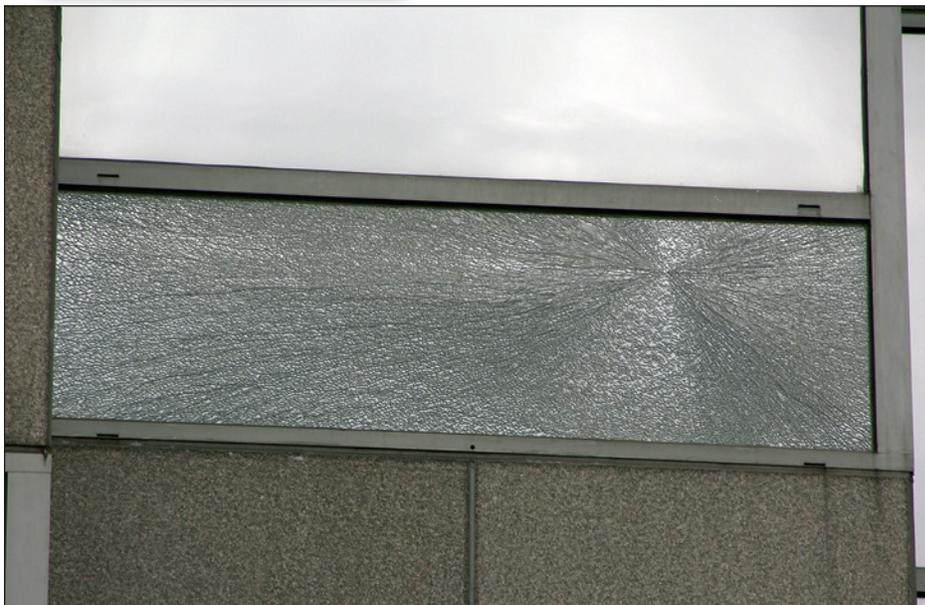
The MAT observed some laminated glass that had been impacted by debris. Except for the window shown in Figure 5-102, this glazing occurred in skylights as discussed in Section 5.5.5. When laminated glass breaks, the glass remains bonded to the plastic film between the panes, and the glazing remains in the frame. Although the glass will need to be replaced, costly interior water and wind damage is avoided.

Figure 5-102. The laminated glass broke, but remained in the frame and continued to provide wind and water protection (estimated wind speed: 105 mph. New Orleans, Louisiana).

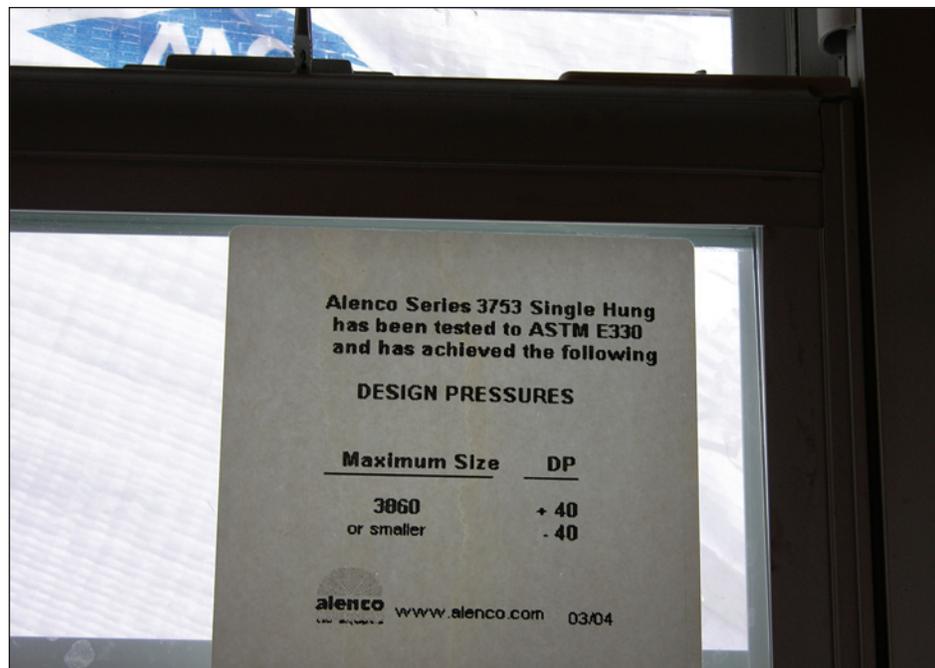
Figure 5-103. View of a wind pressure rating label at a house under construction. The windows on most of the houses observed did not have pressure labels (estimated wind speed: 120 mph. Ocean Springs, Mississippi).

The MAT commonly observed window installation problems at houses under construction. The problems pertained to attachment and flashing. For example, at the house that had the windows with the pressure rating labels (see Figure 5-103), the manufacturer recommended attaching the nailing flange at 12 inches on center maximum. For one of the windows that was investigated, this would have required five nails at the head and sill, and six nails at each jamb. However, only two nails were installed at the head (siding prevented observation of the sill nailing) and only five were installed at the jambs. At another house, nails were spaced 21-1/2 inches apart at one area (a 12-inch spacing was likely the recommended maximum). At still another house, staples were used to attach the nailing flange even though the manufacturer recommends nails.

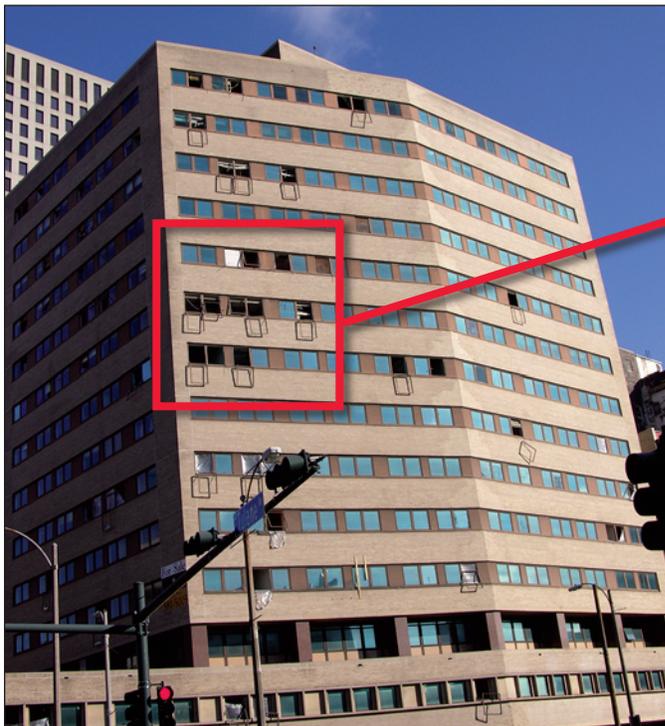
Frame failure due to wind pressure caused the loss of several windows in the office building shown in Figure 5-105.

Figure 5-105. Wind pressure caused frame failure at several windows in this building (estimated wind speed: 105 mph. New Orleans, Louisiana).

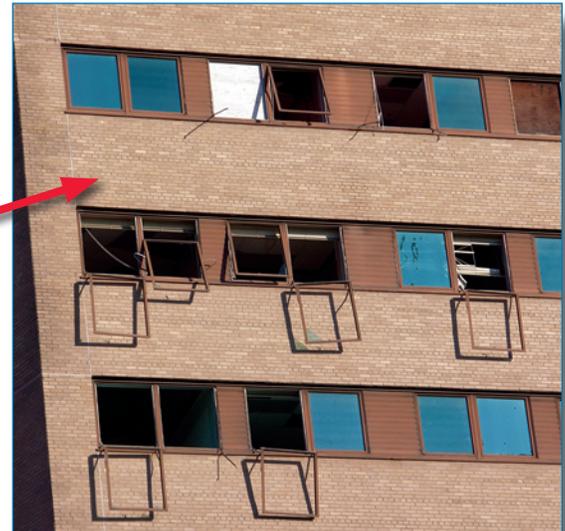
An unusual glazing failure is shown in Figure 5-106. This older brick building had been re-skinned with a curtain wall system. As part of the re-skinning, wood nailers had been attached

to the brick to provide anchorage for the curtain wall. A large number of spandrel panels were blown away. Several of the nailers had detached from the brick at the areas shown by the yellow circle and arrow. At the other missing spandrels, the panels had detached from the nailers.

Several spandrel panels detached from their wood nailers. In some areas, the nailers detached (red rectangle and arrow). The glazing at the yellow circles was likely broken by debris (estimated wind speed: 105 mph. New Orleans, Louisiana).

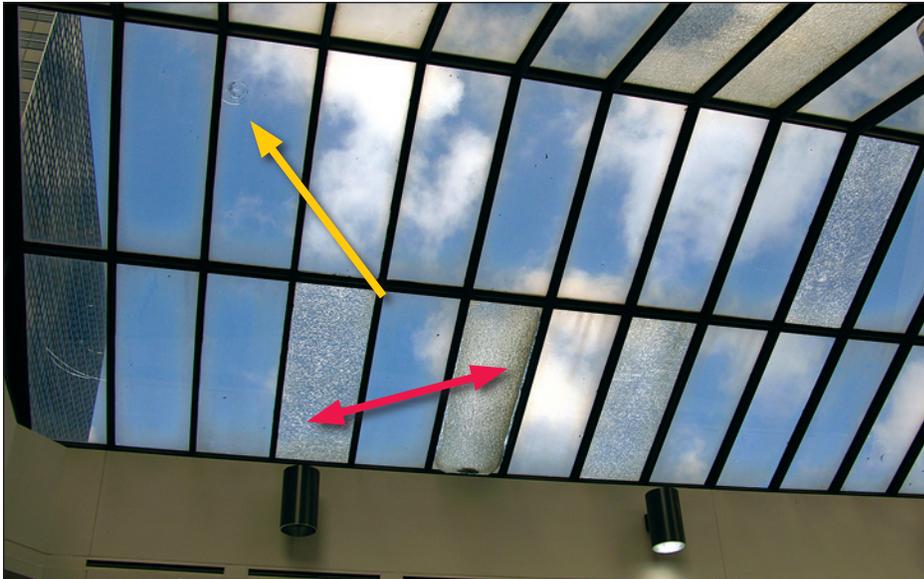
A few skylights with glass panes were observed, including the large skylight shown in Figure 5-86. These skylights were double-glazed. The outer panes were normal glass and the inner panes were laminated glass. Laminated glass is used for the inner panes in skylights to avoid occupant injury in the event the glazing breaks. Figure 5-107 shows a skylight in the vicinity of the skylight shown in Figure 5-86. At least six of the laminated panes were broken. Three other windows were broken, but these breaks appeared to be in the outer panes.

Figure 5-107. Six of the inner laminated panes were broken (two of them are shown by the red arrow). Three other breaks appeared to be at the outer panes (one of these is shown by the yellow arrow) (estimated wind speed: 105 mph. New Orleans, Louisiana).

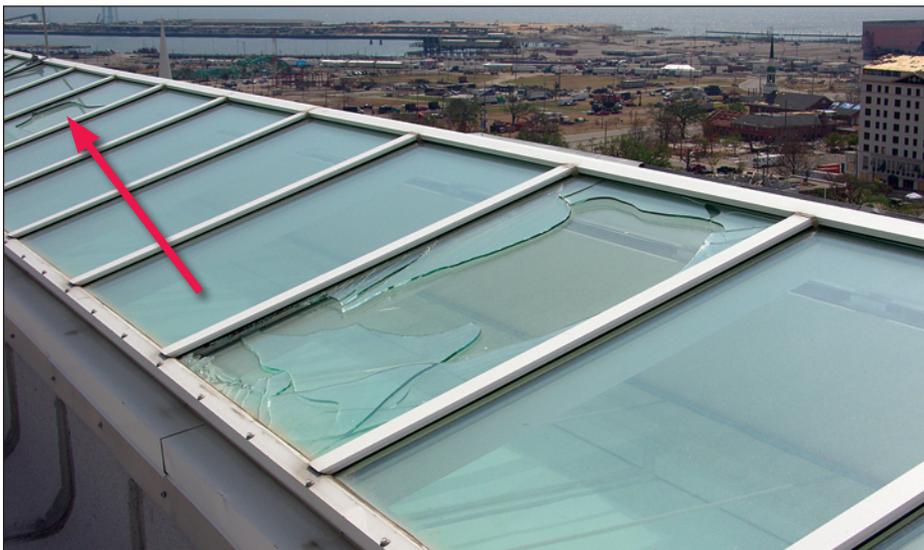
As discussed in Section 5.5.2, although the inner and outer panes were broken, the laminated glass avoided costly interior water and wind damage. However, unless the outer panes are also laminated, if the outer panes are broken, the shards become windblown debris (see Figure 5-108).

Figure 5-108. Skylight on a new eight-story Federal courthouse. Two of the outer panes were broken. Windborne shards can cause injury and damage buildings and vehicles (estimated wind speed: 130 mph. Gulfport, Mississippi).

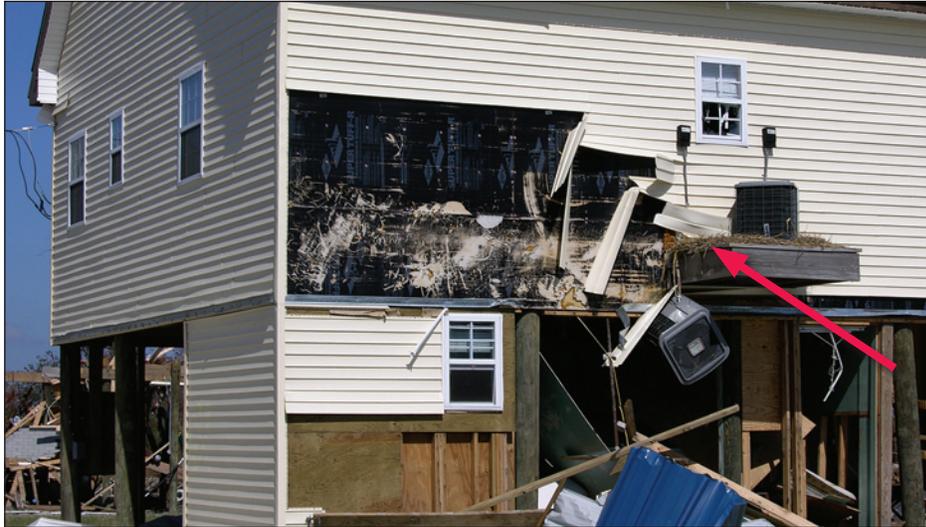
Condensers should be elevated in floodprone areas. Condensers at many residences observed by the MAT were supported on cantilevered platforms as shown in Figures 9-18 and 5-109. As discussed in Section 9.5.1, cantilevered platforms are preferable over knee-braced or pile-supported platforms. Several condensers were blown from their platforms because they were not anchored or had insufficient anchorage. Cantilevered platforms are preferred because they are less susceptible to damage from floodborne debris impacts than are pile or knee-braced supported platforms.

Figure 5-109.
One of the condensers was blown off this cantilevered platform (estimated wind speed: 120 mph. Shell Beach, Louisiana).

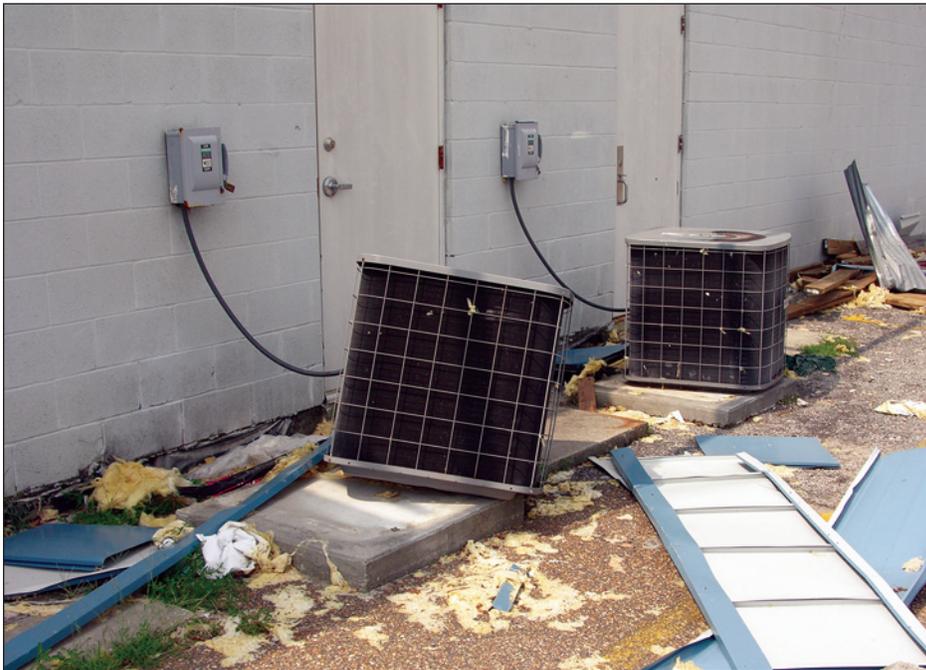
Outside of flood-prone areas, condensers are normally mounted at grade or on rooftops. Both grade- and roof-mounted condensers were typically not anchored or were insufficiently anchored as shown in Figures 5-110 and 5-111. Figure 5-112 shows one of the few buildings

Figure 5-110.
Inadequately attached condenser at the police station shown in Figure 3-54 (estimated wind speed: 130 mph. Long Beach, Mississippi).

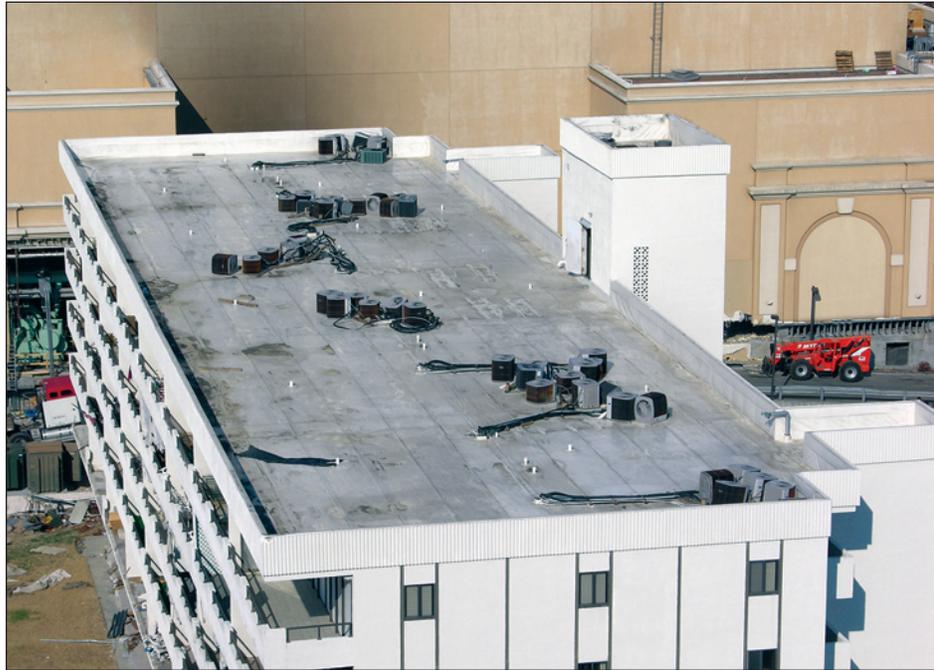
Figure 5-111. These displaced condensers had been placed on wood sleepers that rested on the roof membrane. Sleepers do not provide resistance to uplift or lateral wind loads (estimated wind speed: 120 mph. Biloxi, Mississippi).

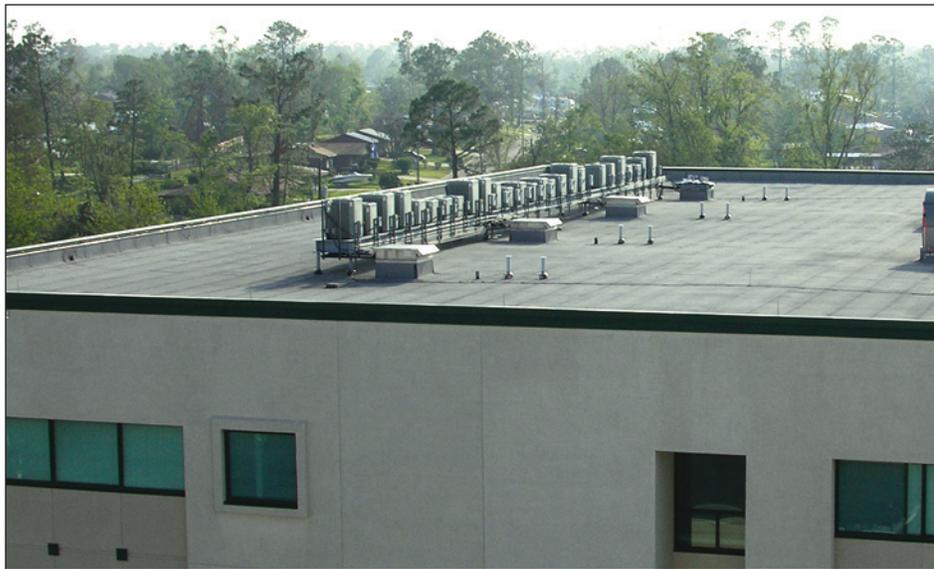
observed by the MAT where special attention had been given to condenser attachment. These condensers remained attached to the structural steel equipment support stands, thereby avoiding damage to the condensers and the roof membrane.

Figure 5-112. The condensers on this new medical office building were anchored to structural steel equipment support stands (estimated wind speed: 130 mph. Gulfport, Mississippi).

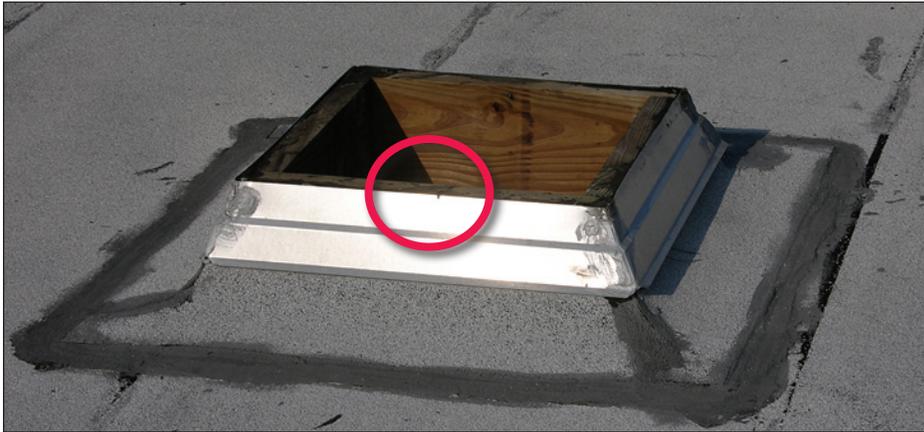
As frequently observed following previous hurricanes, many fan and HVAC units were damaged. In several cases, the units were blown off the curbs because too few fasteners were used to attach the units to the curbs. The blown-off exhaust fan on the school in Figure 5-113 had been attached with only two screws. Had the fan been attached in accordance with the guidance in the Hurricane Katrina Recovery Advisory, *Attachment of Rooftop Equipment in High-Wind Regions* (Appendix E), there would have been five screws per side. Although the opening through the roof was small, a substantial quantity of rainwater was able to enter the school. Because of Katrina's widespread damage, this opening remained unprotected for more than a month after the storm.

Figure 5-113. The missing exhaust fan was attached with only two screws, one of which just grazed the top of the nailer (red circle). The screw that engaged the nailer was sheared off (estimated wind speed: 125 mph. Waveland, Mississippi).

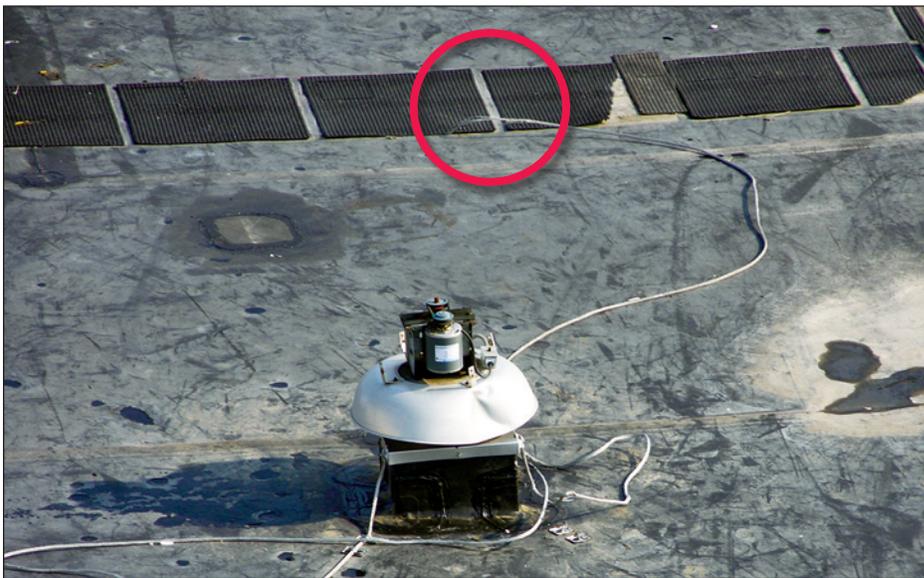
In many other cases, the fans remained attached to their curbs, but the cowlings were blown away (see Figure 5-114). The Hurricane Katrina Recovery Advisory, *Attachment of Rooftop Equipment in High-Wind Regions* (Appendix E), provides guidance for jobsite strengthening of cowlings. Another fan near the one shown in Figure 5-114 was struck and damaged by windborne debris (see Figure 7-18). At least for critical and essential facilities, this illustrates the benefits of placing rooftop mechanical equipment in penthouses so that the equipment is protected from debris and remains operational.

Figure 5-114. At this hospital, the cowling was blown off the exhaust fan. Note also the loose LPS conductors (red circle, Figure 5-123) and missing walkway pads (estimated wind speed: 130 mph. Gulfport, Mississippi).

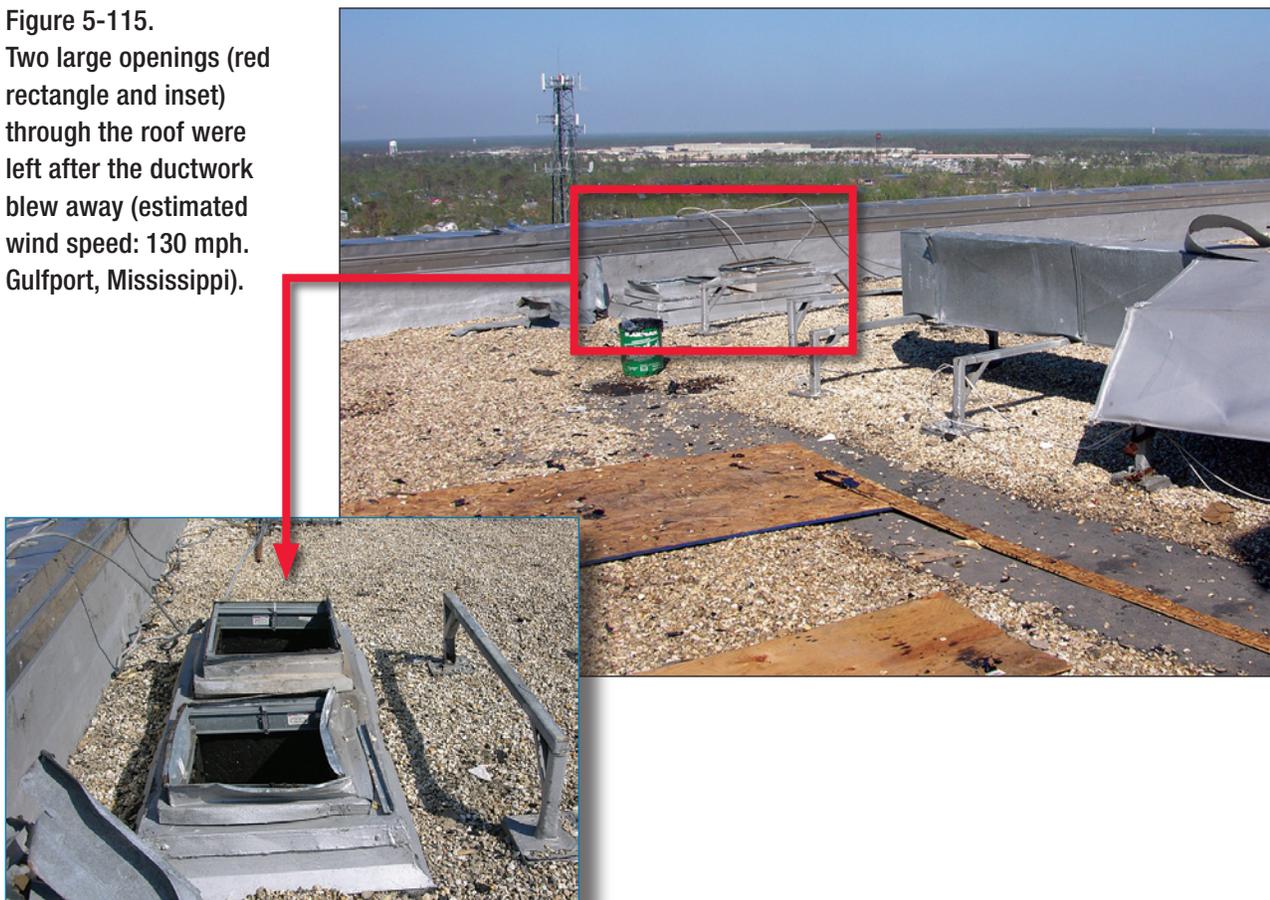
Rooftop-mounted ductwork was observed on a few buildings. At the building shown in Figure 5-79, portions of the ductwork were blown away as shown in Figure 5-115. The ducts rested on top of steel support channels. At the time of the MAT's observation, the openings through the roof had been unprotected for nearly a month after the storm.

Figure 5-115.
Two large openings (red rectangle and inset) through the roof were left after the ductwork blew away (estimated wind speed: 130 mph. Gulfport, Mississippi).

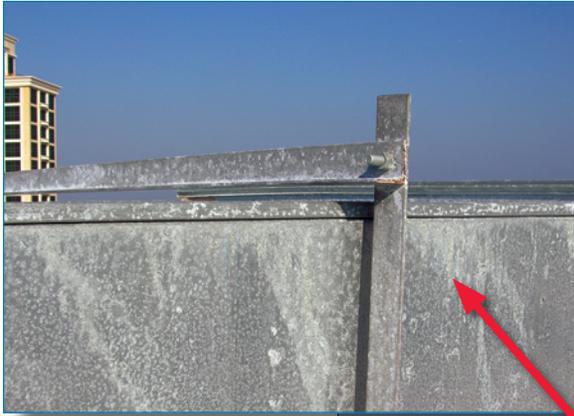
At the recently constructed 13-story building shown in Figure 3-44, the main duct runs were not damaged during this hurricane (see Figure 5-116). However, ducting on either side of a fan was blown away (see Figure 5-117). The main duct support frames were spaced at 8 feet on center. The frames were made from 1-1/2 x 1-1/2 x 1/8-inch thick angles. The frames were bolted together. The top horizontal angle was about 7/8 inch above the ducts.

Figure 5-116. These ducts were supported on steel angles (yellow arrow). A steel angle also occurred above the ducts (red rectangle and inset). The building was located in Exposure C (estimated wind speed: 120 mph. Biloxi, Mississippi).

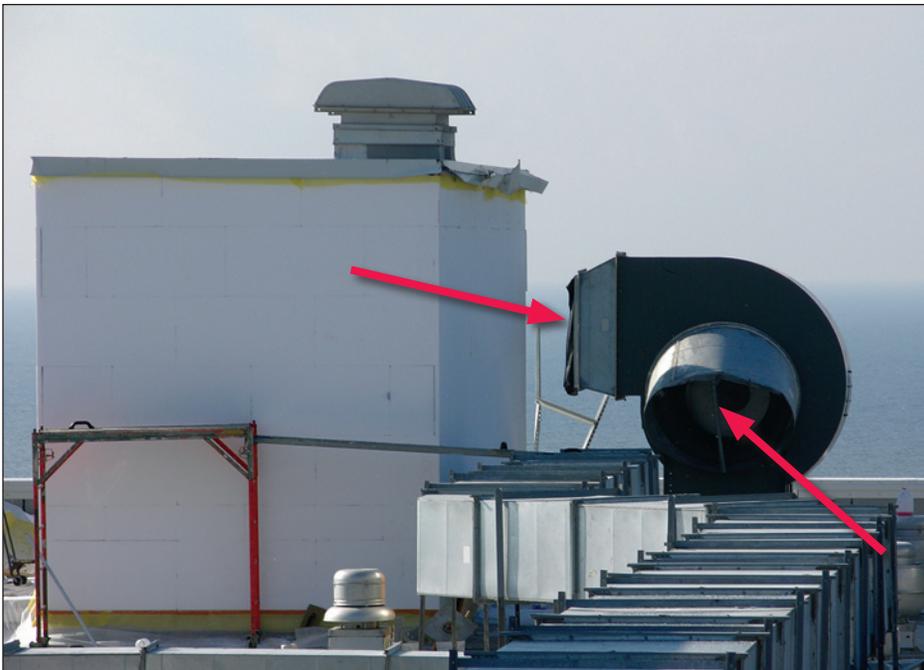
Figure 5-117. Opposite view of Figure 5-116. The ducting on either side of the fan was blown away (red arrows) (estimated wind speed: 120 mph. Biloxi, Mississippi).

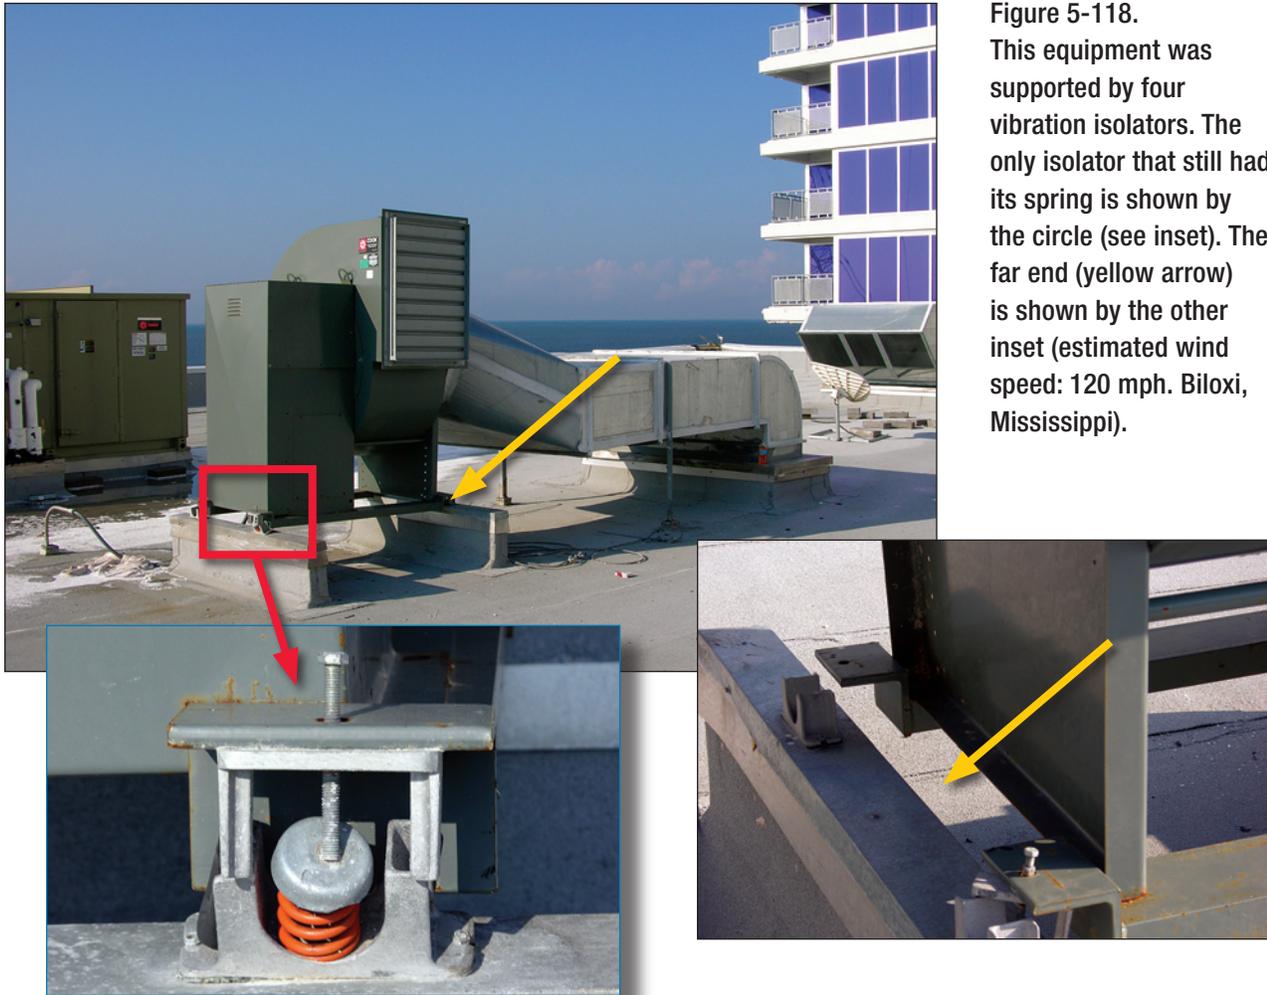
A particular type of vibration isolator was observed on a few new buildings. The isolator’s design provided lateral resistance, but no uplift resistance. Because of the lack of uplift resistance, the equipment shown in Figure 3-61 was lifted up and blown away. Rainwater was able to enter the building at the duct openings through the roof. This same vibration isolator design was used on a lower roof of the building shown in Figure 5-116. At the equipment shown in Figure 5-118, the equipment was not blown away, but it was lifted up and three of the four springs were blown away. When equipment is mounted on vibration isolators, the isolator design needs to provide both lateral and uplift resistance, or an alternative means to accommodate lateral and uplift loads needs to be provided.

Figure 5-118. This equipment was supported by four vibration isolators. The only isolator that still had its spring is shown by the circle (see inset). The far end (yellow arrow) is shown by the other inset (estimated wind speed: 120 mph. Biloxi, Mississippi).

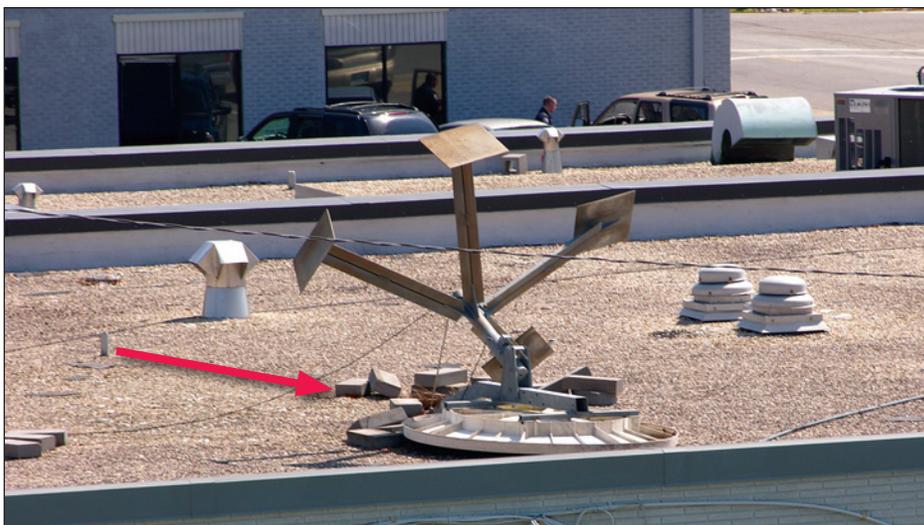
The MAT observed several satellite dishes that were blown over. Failed satellite dishes did not have positive connections to the roof structure. Rather, the dish support simply rested on the roof and was weighted down with concrete pavers (see Figure 5-120). Blown over satellite dishes can puncture roof membranes, and if blown from the roof can damage other buildings or vehicles.

Figure 5-120.
This satellite dish was held down only with concrete pavers (estimated wind speed: 130 mph. Gulfport, Mississippi).

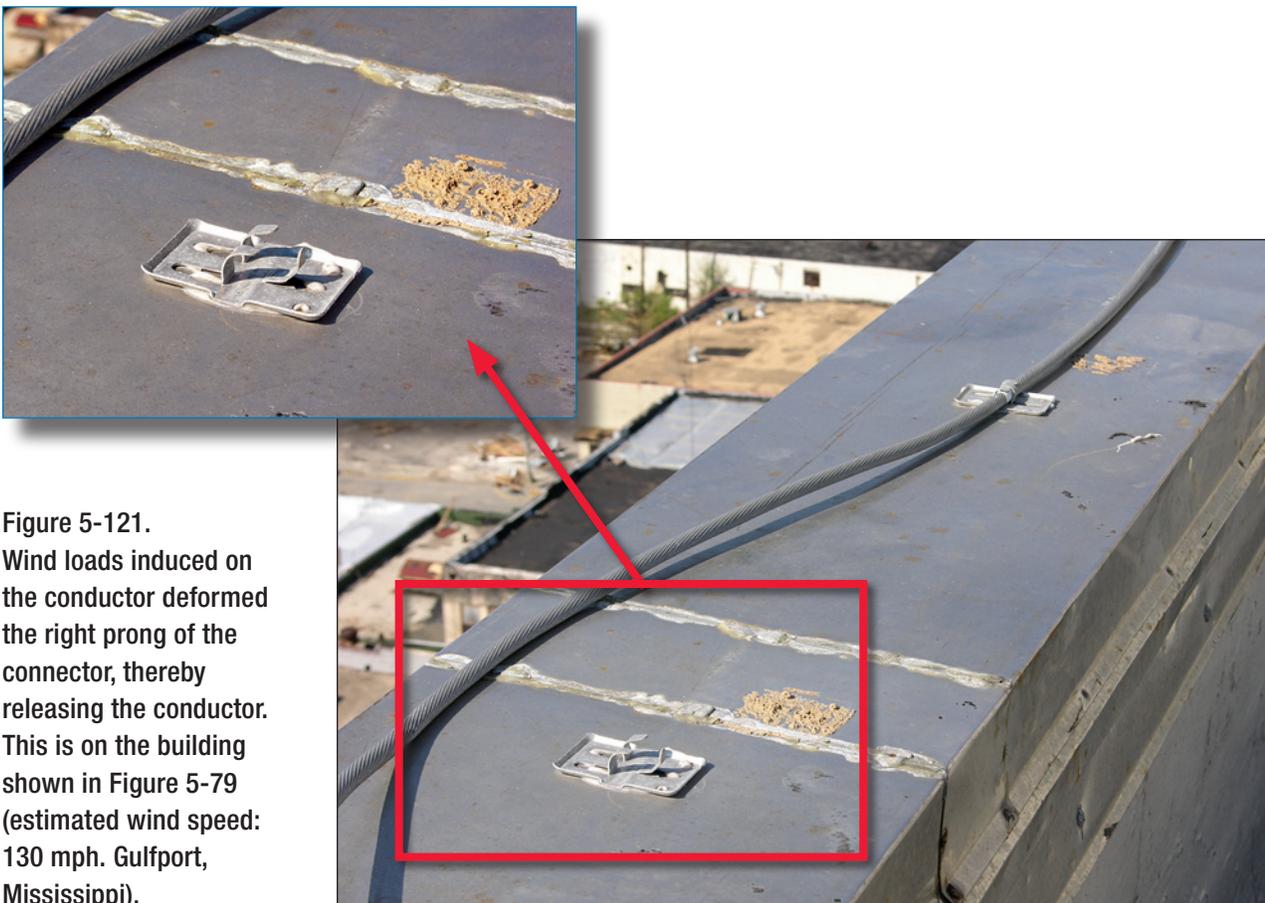
LPS failures were typically the result of poorly anchored systems. Connectors often fail by opening up and releasing the conductor cable (see Figure 5-121) or they debond from the roof (see Figure 5-122). When conductors detach, the conductor ends can whip around and puncture and tear the roof membrane. At the hospital shown in Figures 5-122 and 5-123, several punctures had been patched after the hurricane. Some of the punctures were likely caused by loose conductors. At another hospital, a loose conductor whipped the exterior wall and punctured the EIFS in several locations (see Figure 5-124).

Figure 5-121. Wind loads induced on the conductor deformed the right prong of the connector, thereby releasing the conductor. This is on the building shown in Figure 5-79 (estimated wind speed: 130 mph. Gulfport, Mississippi).

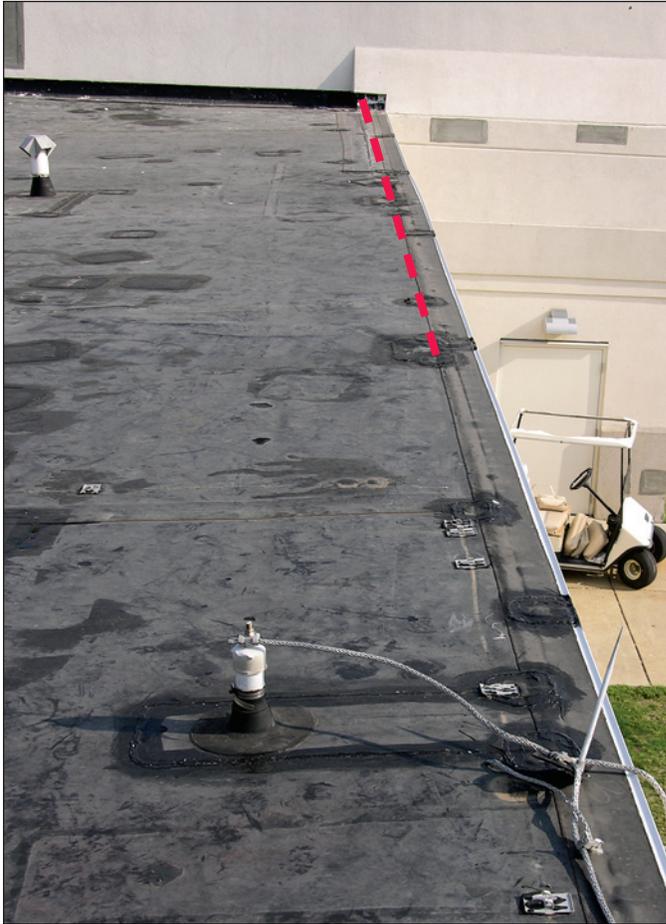
Figure 5-122.

At this hospital, in the area of the dashed line the conductor connectors debonded from the roof membrane. In the foreground, the connectors are attached to the roof, but the conductor pulled from the prongs (estimated wind speed: 130 mph. Gulfport, Mississippi).

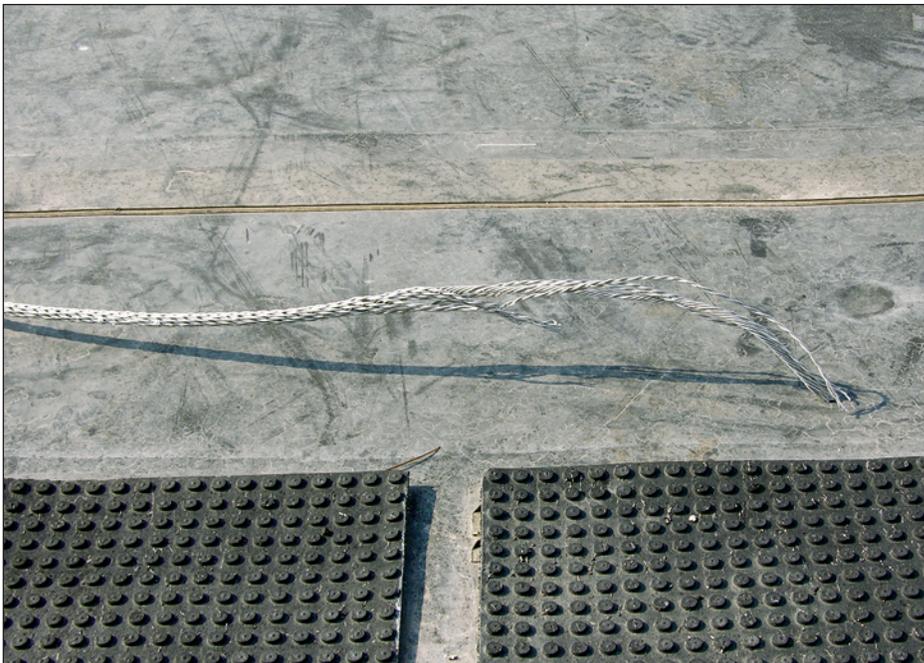
Figure 5-123.

View of an abraded end of a conductor that became detached at the hospital shown in Figures 5-114 and 5-122 (estimated wind speed: 130 mph. Gulfport, Mississippi).

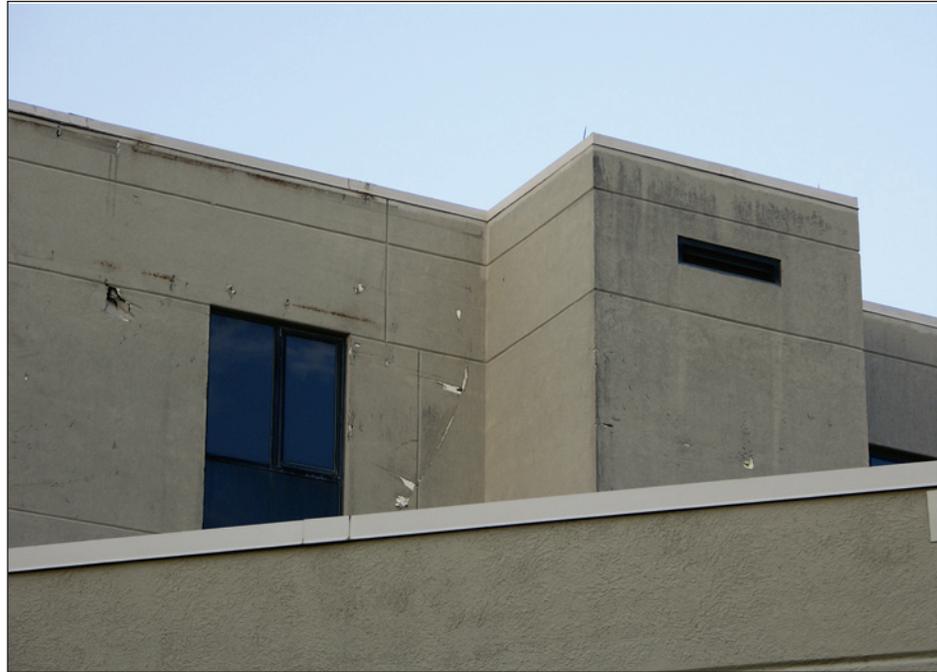
Figure 5-124.
A loose LPS conductor
whipped the exterior
wall and punctured the
EIFS in several locations
(estimated wind speed:
115 mph. Slidell,
Louisiana).

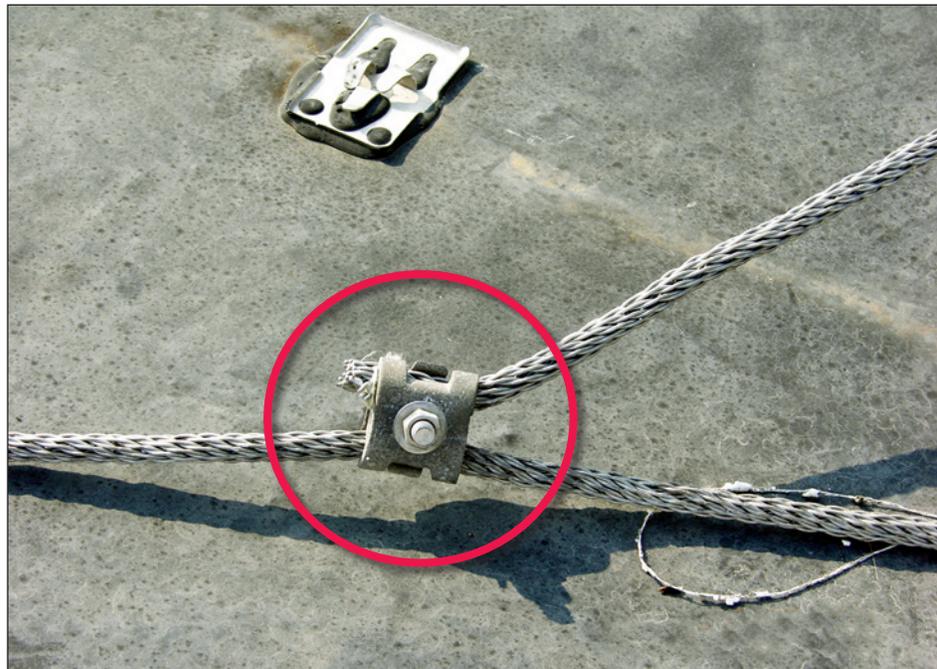
Two prudent practices were observed. At the hospital shown in Figure 5-122, bolted splice connectors were used (see Figure 5-125). Pronged splice connectors are approved for heights up to 75 feet. Above that height, bolted splice connectors are required. However, regardless of height, bolted connectors are prudent in hurricane-prone regions because they are less likely to pull apart if the conductor becomes detached. If detached conductors remain connected together, that minimizes the number of free ends whipping about.

Figure 5-125.
A bolted splice connector
was used in lieu of a
pronged splice connector
(estimated wind speed:
130 mph. Gulfport,
Mississippi).
