HURRICANE

Katrina

IN THE GULF COAST

5. Building Envelope Performance

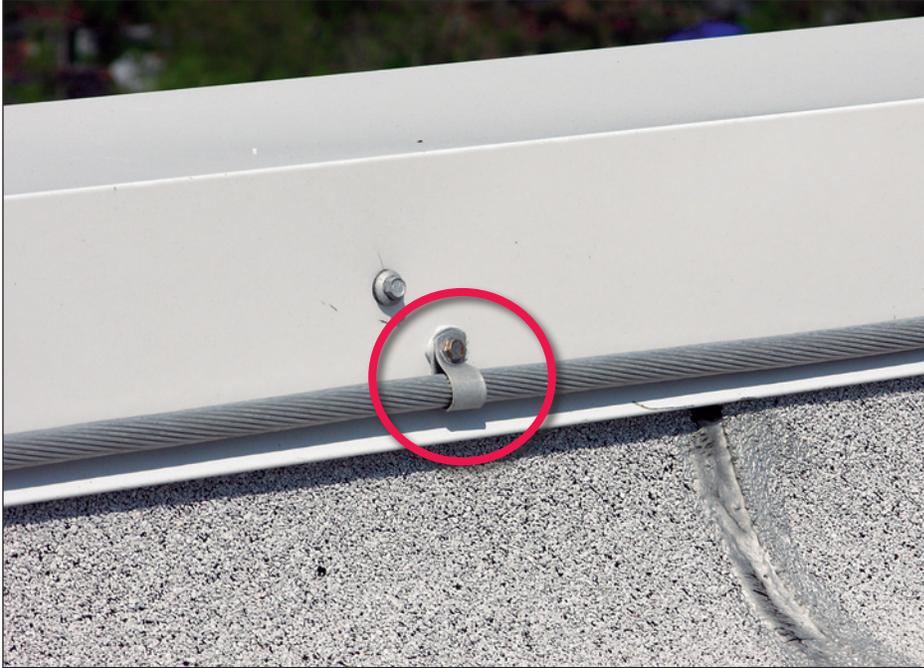
The other prudent practice was the use of mechanically attached looped connectors to attach the conductor to the coping (see Figure 5-126). A looped connector does not have prongs; therefore, this is a reliable connector (provided sufficiently long screws are used).

Figure 5-126. Screw-attached looped connectors were used to anchor this conductor (estimated wind speed: 130 mph. Gulfport, Mississippi).
