HURRICANE

Katrina

IN THE GULF COAST

6. Historic Buildings

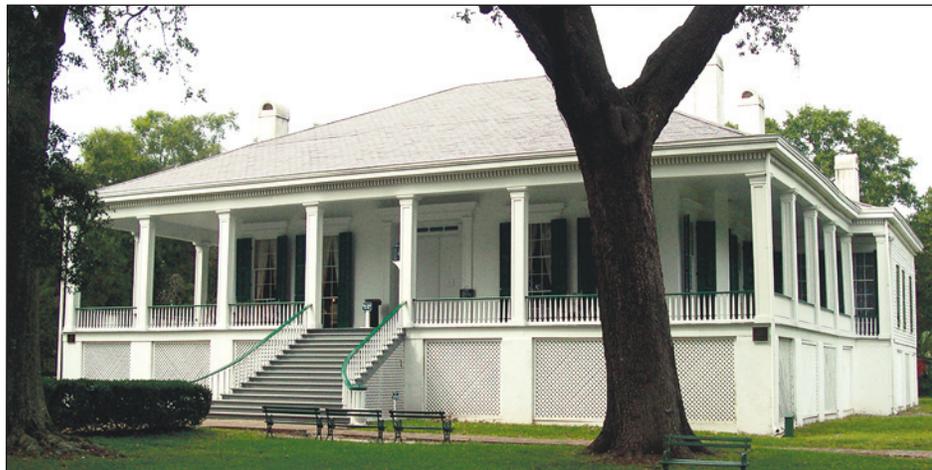
Built in 1848, Beauvoir (see Figure 6-4) and the surrounding structures sustained serious flood (velocity flow) damage from Hurricane Katrina. Approximately 75 percent of the main house still stands, except for the front, side, and rear porches (see Figures 6-5 and 6-6). Many windows, doors, and columns are also gone.

Figure 6-4. Front elevation of Beauvoir before Hurricane Katrina (Biloxi, Mississippi)

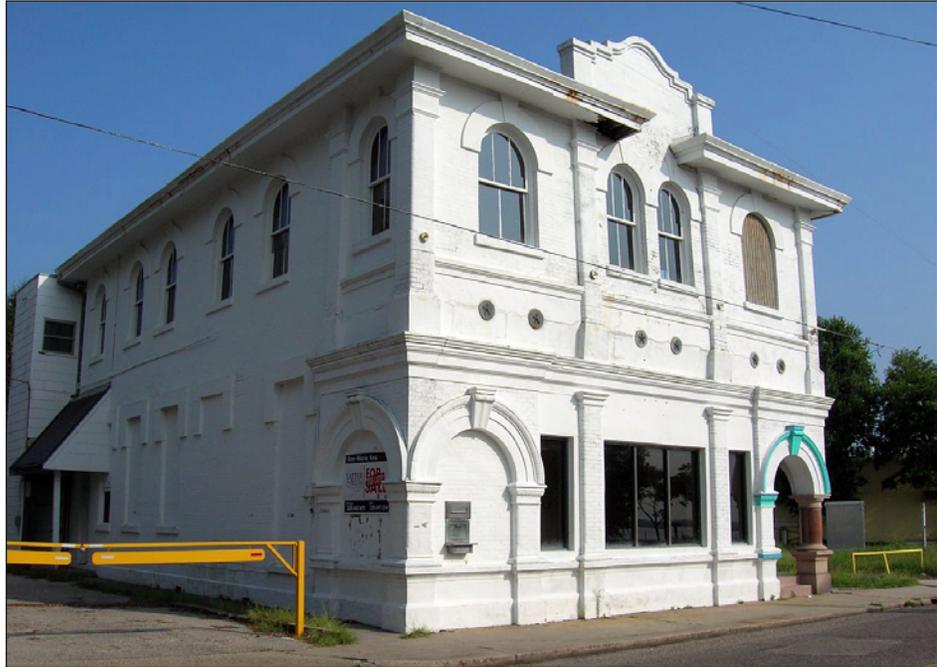
The "before" picture of this empty bank building (see Figure 6-11) was taken 2 weeks before Hurricane Katrina. Surge waters moved through the front windows and door, collapsing the side elevation and part of the second floor (see Figure 6-12).

Figure 6-11.
View of front elevation
of bank before Hurricane
Katrina (Bay St. Louis,
Mississippi)
