HURRICANE

*Katrina*

IN THE GULF COAST

## 7. Performance of Critical and Essential Facilities

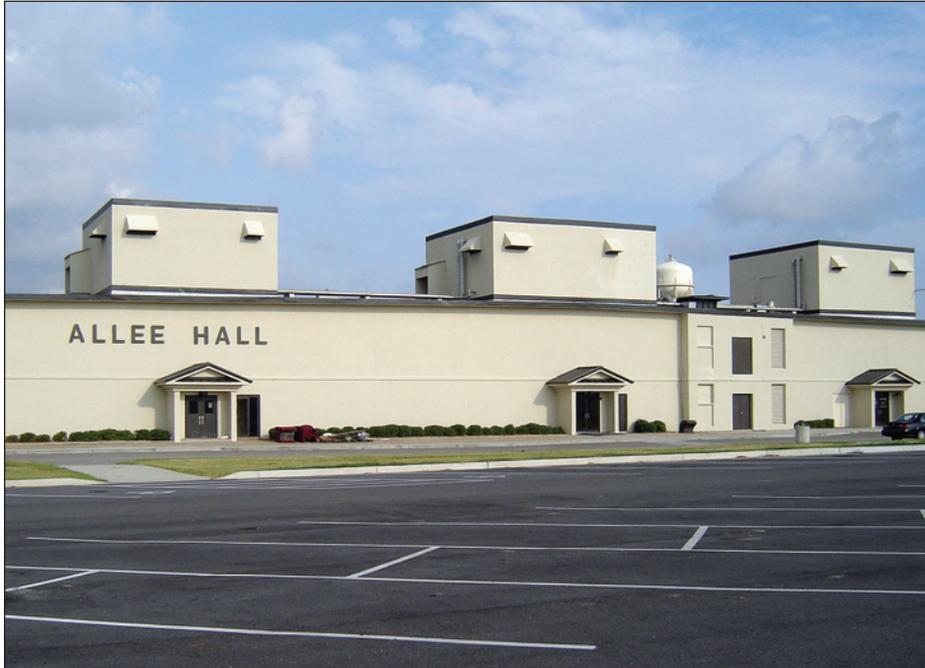
Most personnel were evacuated from the base prior to Hurricane Katrina. However, about 350 essential personnel remained and took shelter in Allee and Wolfe Halls (see Figure 7-27). During the storm, large portions of the roof covering blew off, resulting in major water leaks inside the building, and great anxiety for the building occupants.

**Figure 7-27.**  
Allee Hall, place of refuge for base essential personnel during the storm (estimated wind speed: 120 mph. Biloxi, Mississippi)

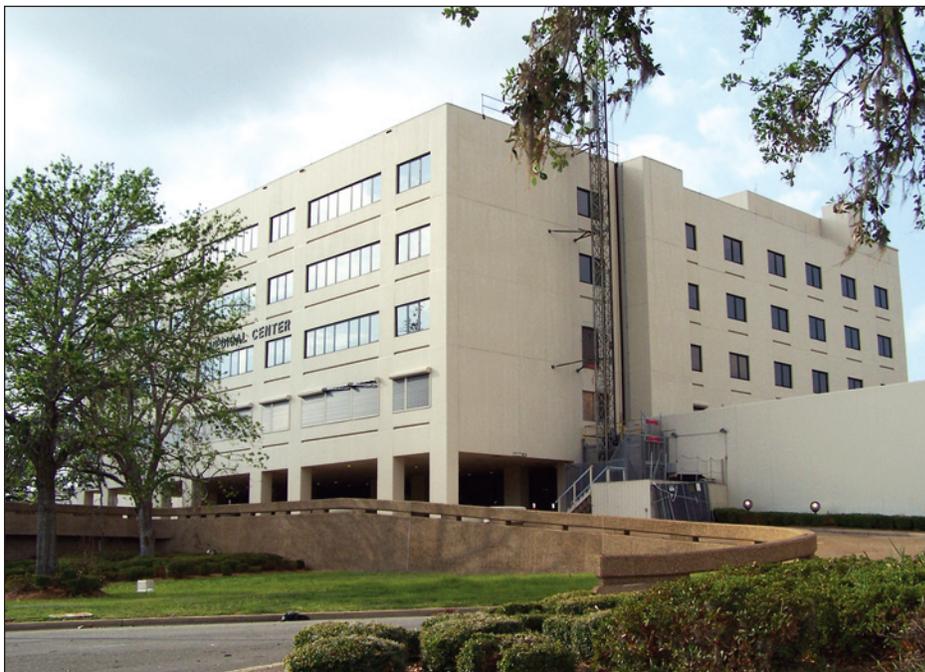
The Keesler Medical Center (see Figure 7-28), which is used annually by 56,000 military retirees and active duty personnel, was flooded during the storm, with surge spilling into the basement

of the building and inundating the emergency generators. The medical center was not expected (at the time of this report) to be fully operational until later in 2006. The hospital was not in a mapped floodplain (Zone C).

**Figure 7-28.**  
Keesler AFB Medical Center (estimated wind speed: 120 mph. Biloxi, Mississippi)
