4 Performance of Critical Facilities

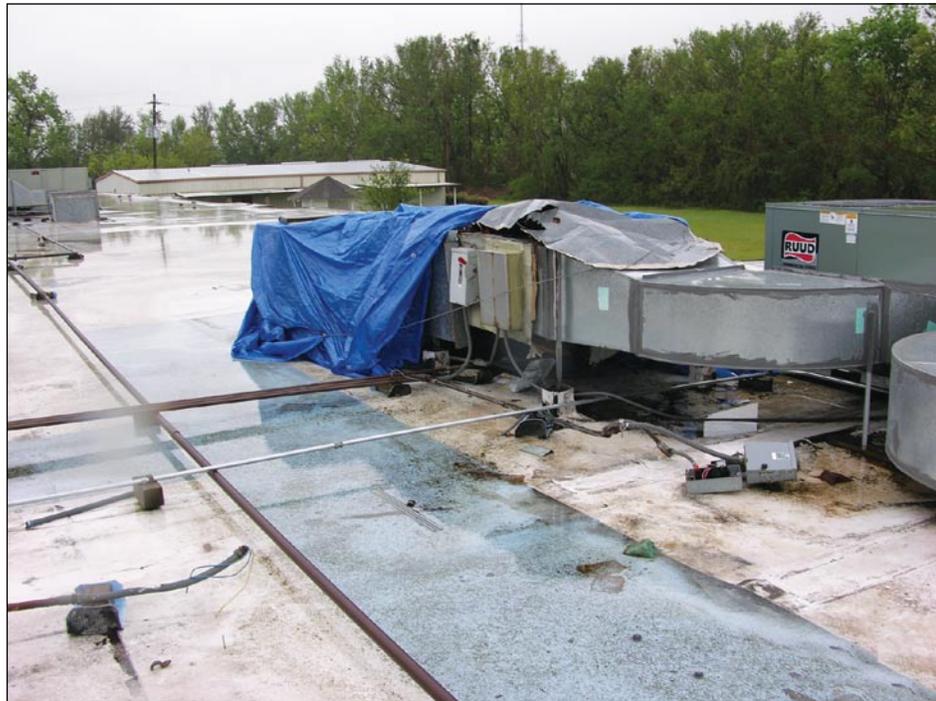
Numerous pieces of HVAC equipment were on the roof. Many condensers toppled, but apparently none punctured the single-ply roof membrane. However, water entered the building where some rooftop ductwork blew away (Figure 4-20). Access panels were blown away at a piece of equipment and the communications tower collapsed (both shown in Figure 4-21).

Figure 4-21.
Collapsed communications tower and blown-away access panels (red circle)

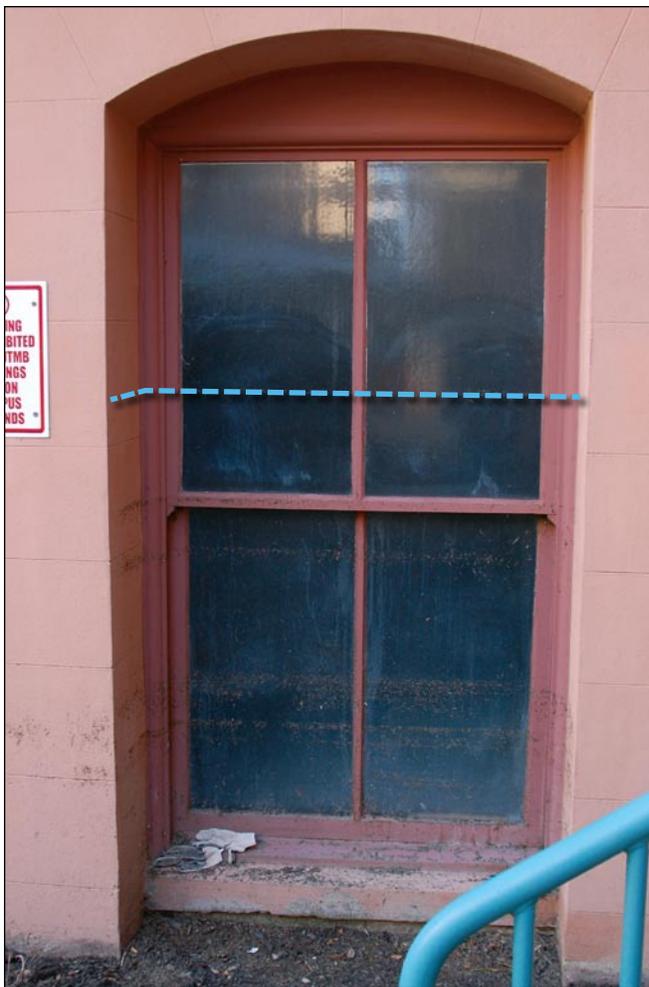
Figure 4-23.

Figures 4-23 through 4-26 show some of the water marks remaining and flood clean-up underway during the MAT visit on October 20, 2008. Flooding damaged utility lines and equipment, generators, HVAC equipment, pumps and controls, gas piping for hospital and operating rooms, the morgue, offices, laboratories, and classrooms.

High water mark (dashed blue line) shown from the outside of UTMB Building 1. The mark was measured by the MAT and found to be approximately 69 inches above the floor of the basement area inside the building.

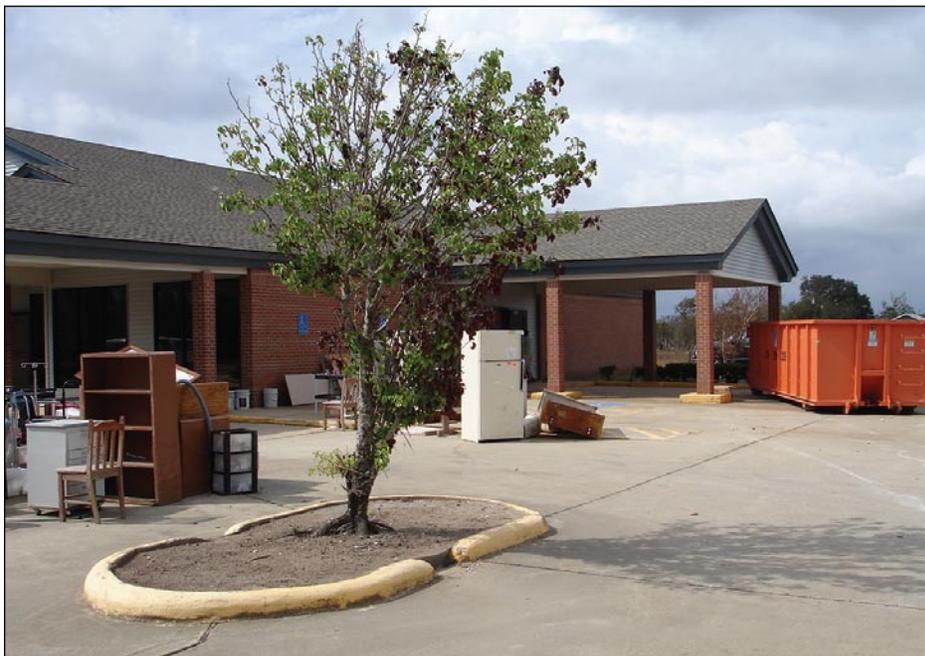
Figure 4-36.
Hackberry Rural Medical
Clinic

The Hackberry Rural Medical Clinic at Hackberry, LA, is located approximately 15 miles north of the Gulf of Mexico shoreline (Figure 4-36). The medical facility received significant flooding damage from Hurricane Ike. This facility was also flooded during Hurricane Rita and the damages had been repaired.

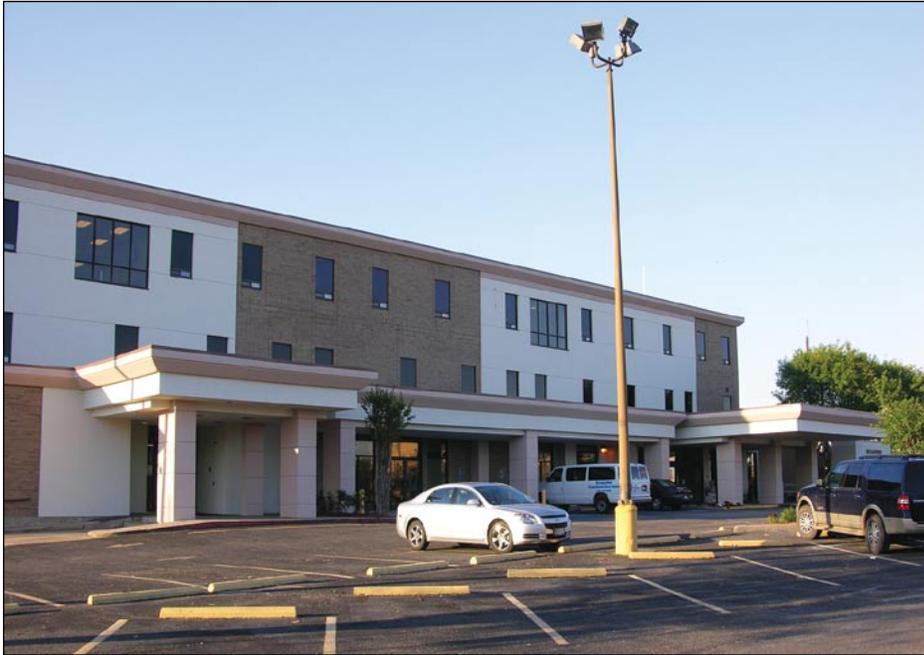
General Wind Damage. The canopy roofs and a portion of the upper roof had a low parapet. The remainder of the upper roof had metal edge flashing. The coping blew off a portion of one of the canopies and a portion of the main roof. Exposed fasteners were used to attach the inner leg of the copings. In one area, the fasteners were 3 feet 2 inches on center, which is very excessive spacing. Had the winds been stronger, roof blow-off associated with coping failure would have been likely.

Figure 4-38.
General view of
Oceanview Transitional
Care Center

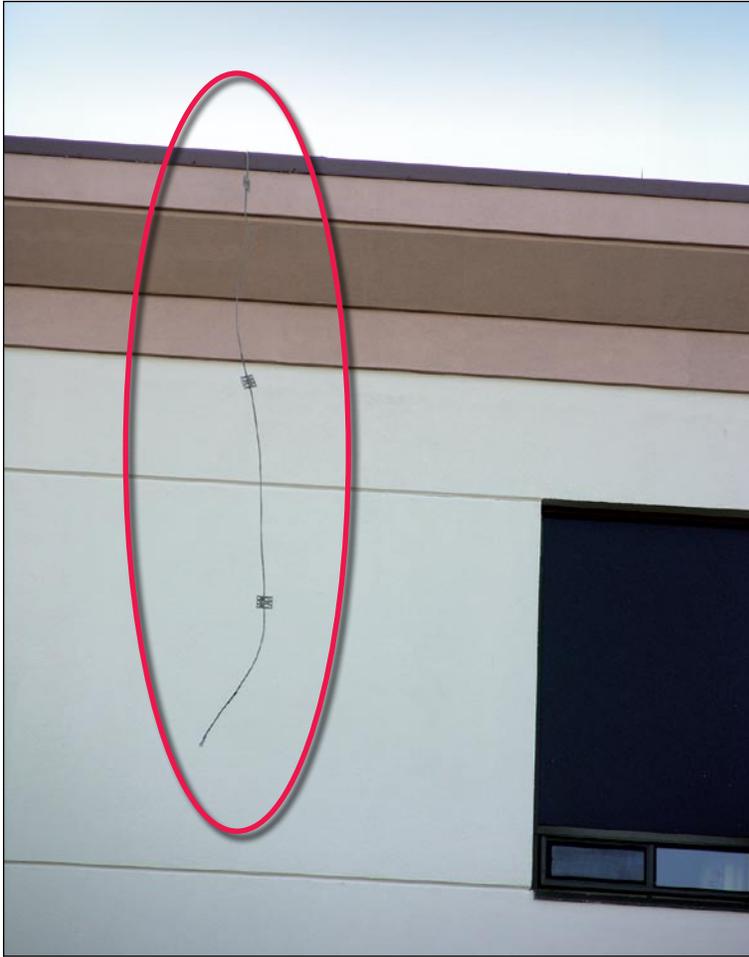
The LPS became detached from several areas of the main roof. Portions of the conductors were dangling over the front and back walls (Figure 4-40). In addition to loss of lightning protection, the detached conductors had the potential to break glazing.

Figure 4-40.
Detached LPS conductor

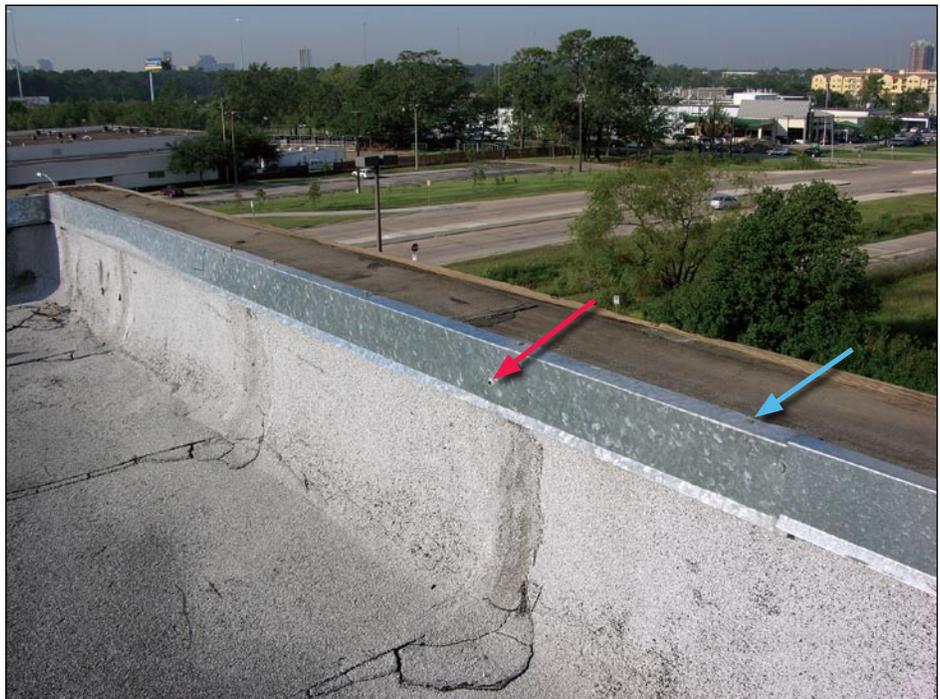
Figures 4-43 and 4-44 show pieces of coping that landed elsewhere on the roof. Windborne coping can easily puncture roof membranes, including tough membranes like the modified bitumen membrane on this roof (inset at Figure 4-43).

Figure 4-43.
Coping debris (red arrow);
the membrane was
gouged (blue arrow) by
coping debris (an ink pen
shows the scale)

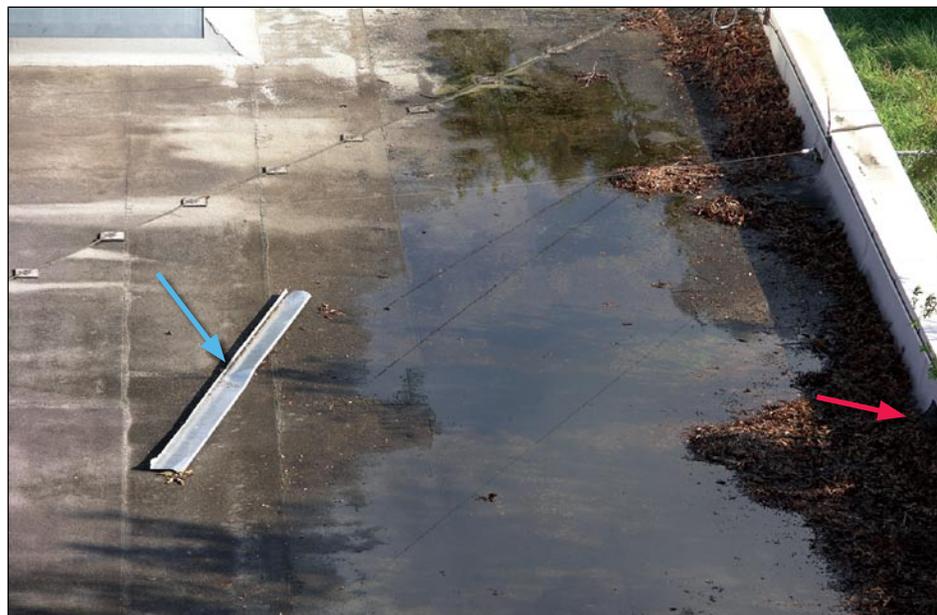
A substantial amount of leaf debris was observed in the vicinity of scuppers on a lower roof (Figure 4-44). During hurricanes, heavy leaf loss and accumulation on roofs has the potential to block roof drains and overflow drains and scuppers. Increasing the size of scuppers and downspouts minimizes the potential for scupper/downspout blockage.

Figure 4-44.
Coping debris (blue arrow)
on a lower roof; note leaf
debris near the scupper
(red arrow)

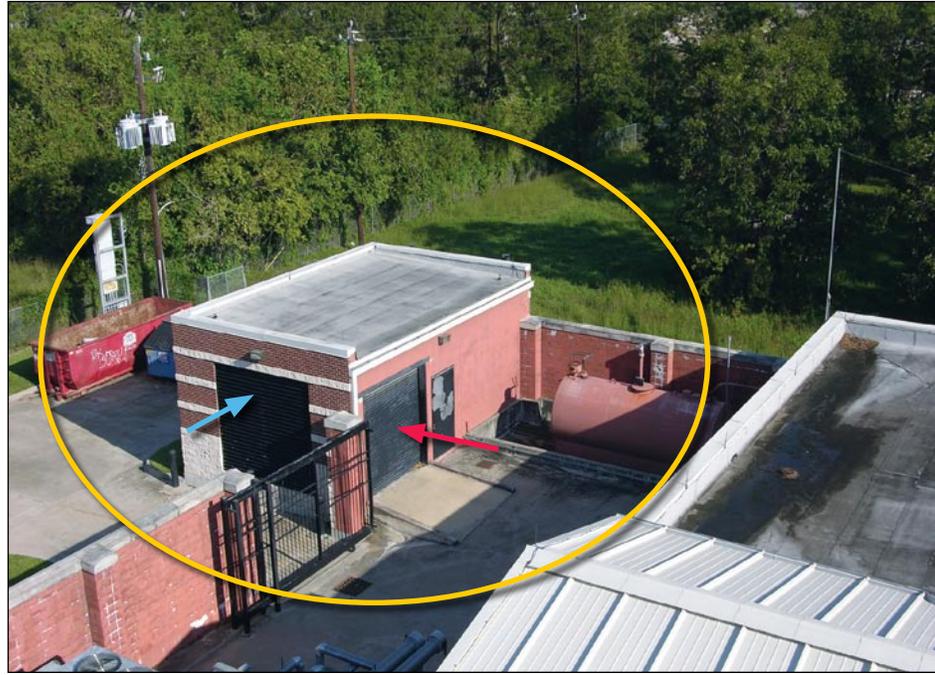
Under the right wind conditions, the emergency generator could also have been damaged because of inadequate building envelope protection. The facility's one emergency generator is housed in a separate building, shown in Figure 4-46. The coiling doors shown by the red arrow in Figure 4-46 appeared to possess little wind resistance. In addition, the louver shown by the blue arrow was not resistant to large windborne debris (which could penetrate the louver and damage the generator). Considering the importance of this facility, it would be prudent to: 1) add a back-up generator and a cam locking box (to facilitate rapid connection of a portable generator); 2) replace the coiling door with a new door rated for the design wind load and

Figure 4-46.
The emergency generator is housed in the circled building; the coiling door (red arrow) and the louver (blue arrow) appeared to provide inadequate protection for the generator

capable of resisting test missile E as specified in ASTM E 1996; and 3) replace the louver with one capable of resisting test missile E, or provide a debris-resistant shield in front of the louver. Recommendations pertaining to all three of these items are provided in FEMA 543.

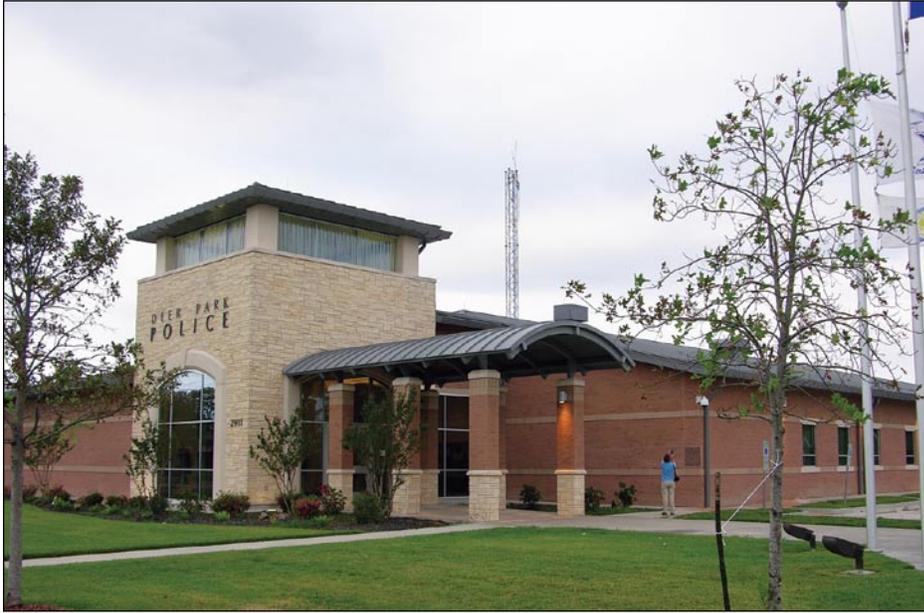
Figure 4-47.
General view of Deer Park
Police Station

The Deer Park Police Station (Figure 4-47), constructed in 2004, received wind-driven rain damage as a result of Hurricane Ike. According to ASCE 7-05, the basic wind speed for this location is approximately 112 mph. The estimated maximum wind speed during Hurricane Ike was approximately 95 mph. Shutter mitigation work was conducted after the building was constructed.

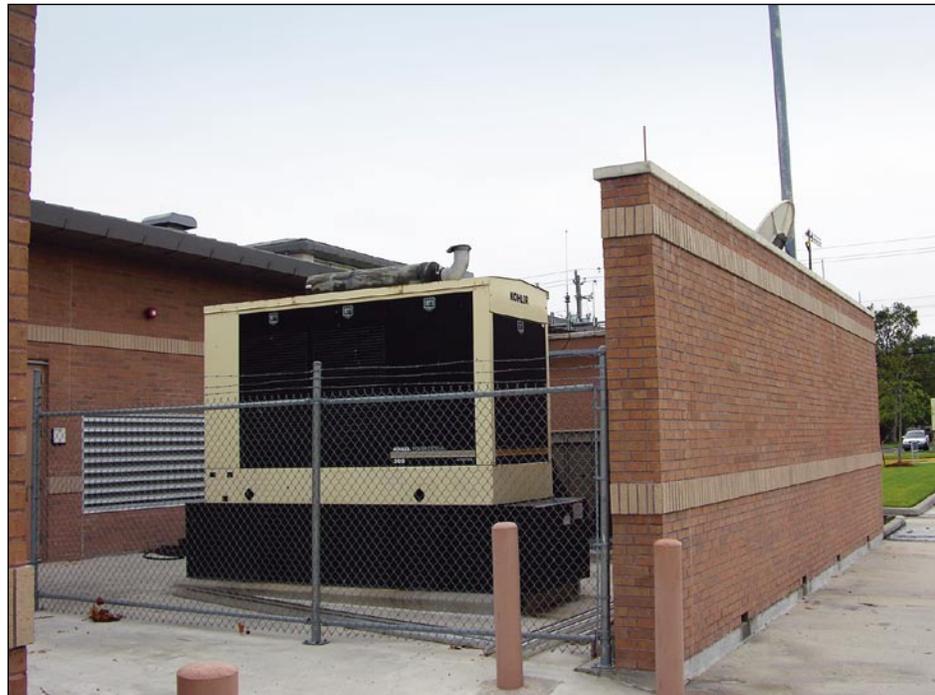
The emergency generator is shown in Figure 4-49. Although the enclosure has walls around three sides, it does not provide sufficient wind and windborne debris protection. Had the generator failed to function during the storm, lack of protection would have inhibited maintenance efforts to get the generator back online. FEMA 543 recommends providing a wind- and windborne-debris-resistant enclosure all around and over the generator.

Figure 4-49.
The emergency generator is inadequately protected from wind and windborne debris

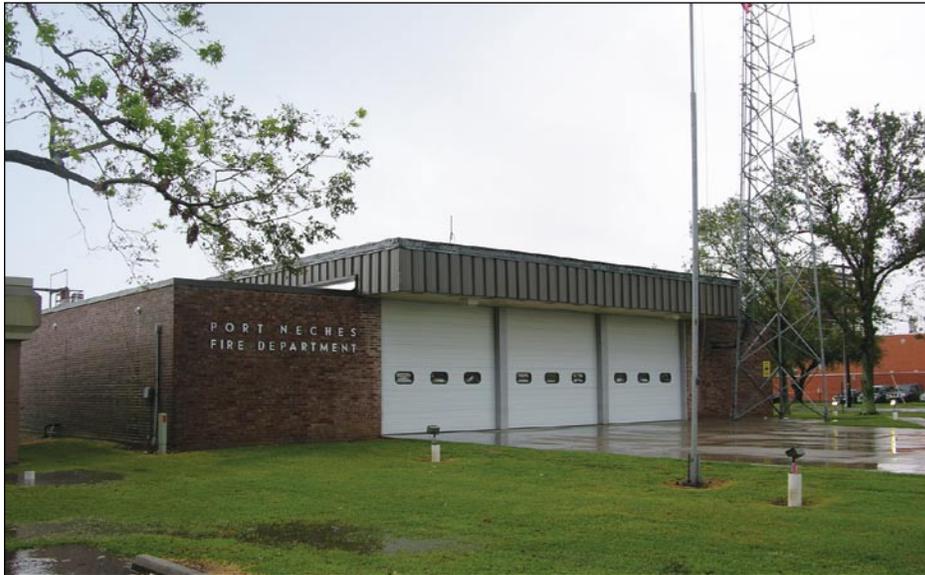
Figure 4-50.
General view of Port
Neches Fire Station

The Port Neches Fire Station (Figure 4-50) was constructed in 1972. In the aftermath of Hurricane Rita (2005) and at the time that Hurricane Ike struck, this building was being mitigated using HMGP funds. The mitigation work consisted of replacing all six apparatus bay sectional doors, adding window and door shutters (Figure 4-51), and installing a new modified bitumen roof system. At the time of Hurricane Ike, all the work had been completed except installation of some of the metal edge flashing. According to ASCE 7-05, the basic wind speed for this location is approximately 116 mph. The estimated maximum wind speed during Hurricane Ike was approximately 90 mph.

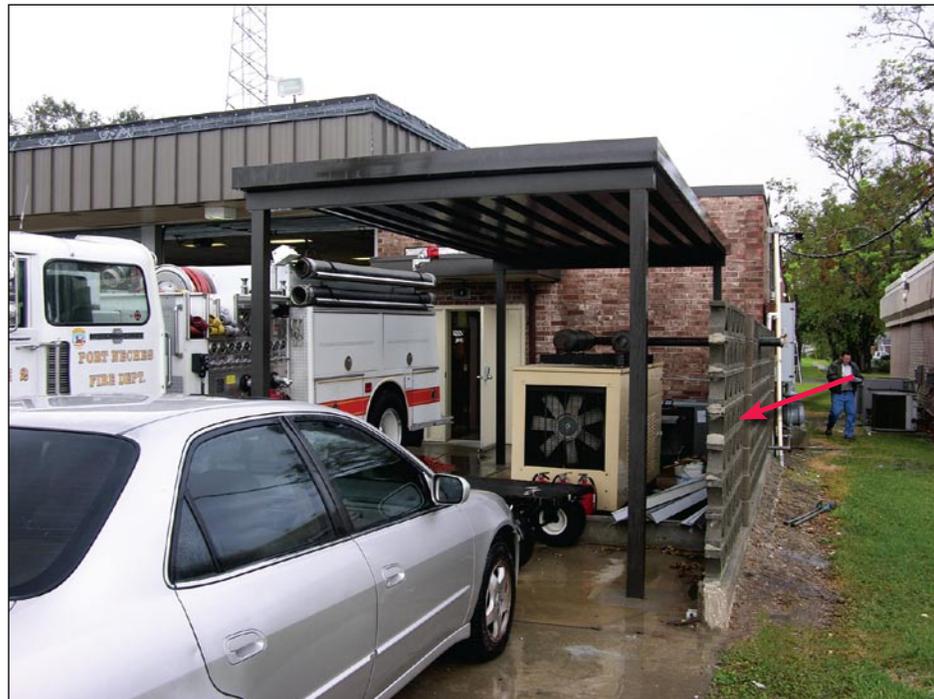
The emergency generator is not located in a protected enclosure (Figure 4-52). The nearby non-reinforced masonry screen wall (red arrow) could collapse on the generator, and the generator could be damaged by windborne debris. Had the generator failed to function during the storm, lack of protection would have inhibited maintenance efforts to get the generator back online. As part of a comprehensive mitigation project, providing a wind- and windborne-debris-resistant enclosure all around and over the generator as recommended in FEMA 543 would have been prudent.

Figure 4-52.
The emergency generator is susceptible to windborne debris and damage caused by collapse of the masonry screen wall

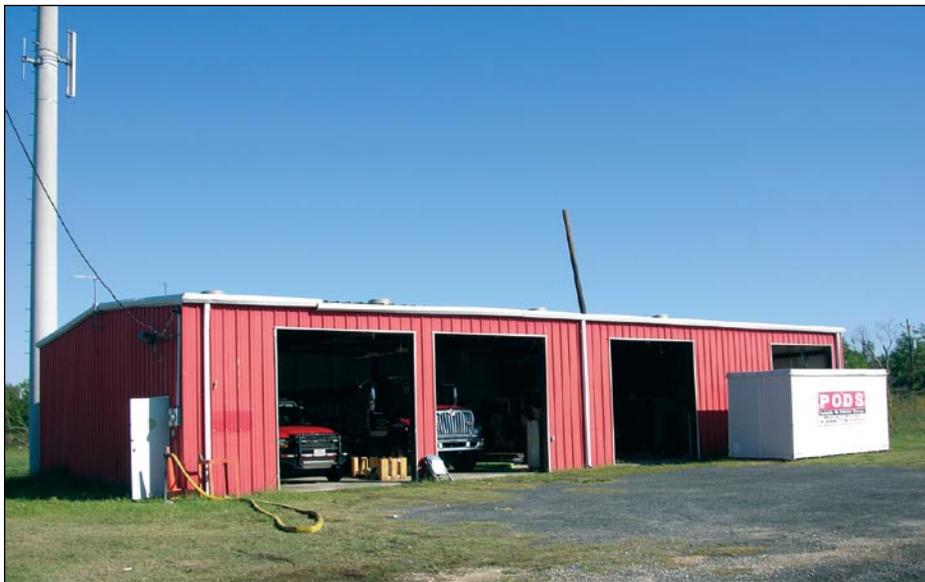
Figure 4-53.
General view of High
Island Fire Station

The High Island Fire Station is an older pre-engineered metal building (Figure 4-53). The facility received wind damage during Ike. According to ASCE 7-05, the basic wind speed for this location is approximately 131 mph. The estimated maximum wind speed during Hurricane Ike was approximately 110 mph.

General Wind Damage. All four apparatus bay doors blew away when the door rollers disengaged from the tracks (Figure 4-53).

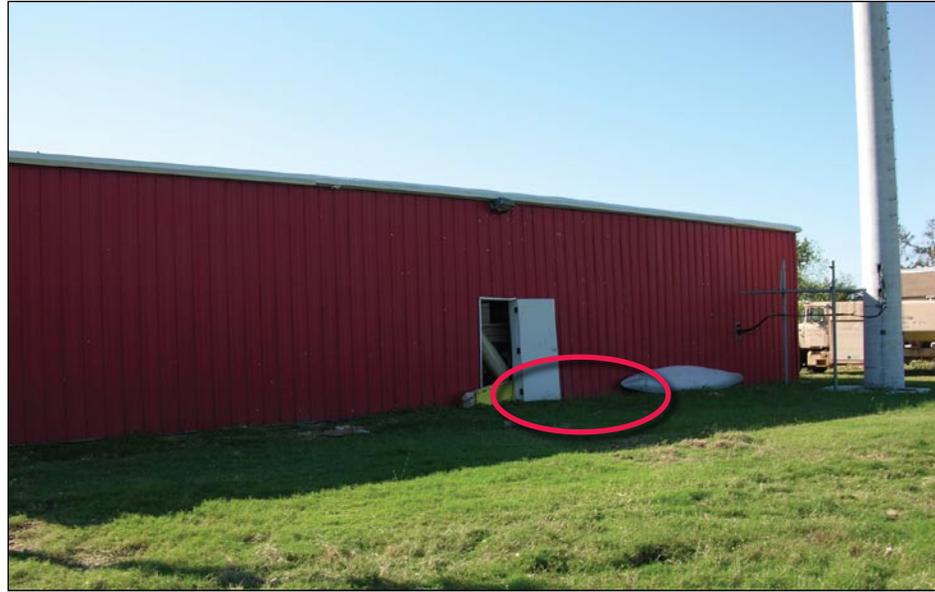
At the back of the building, the bottom of the wall blew outward (Figure 4-54). The metal walls were attached to an angle that was poorly attached to the concrete slab. The angle was attached at the door jamb, but there was a 10-foot gap to the next adjacent fastener. Some wall insulation near the door was also blown away. In addition, some of the metal wall panels peeled back at a corner of the building.

Figure 4-54.
The metal wall at the red oval area was pushed outward because of inadequate attachment of the wall angle to the slab

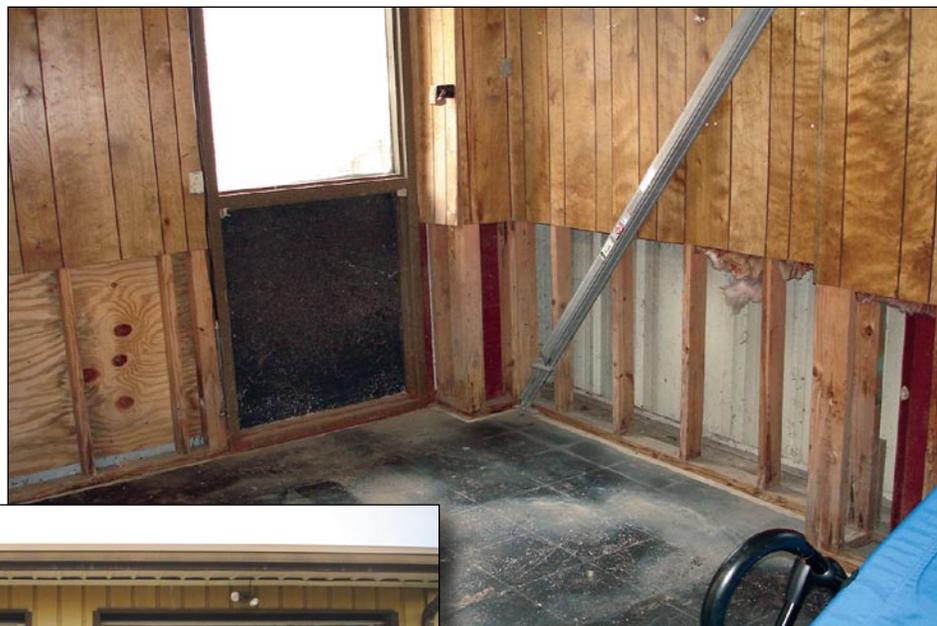
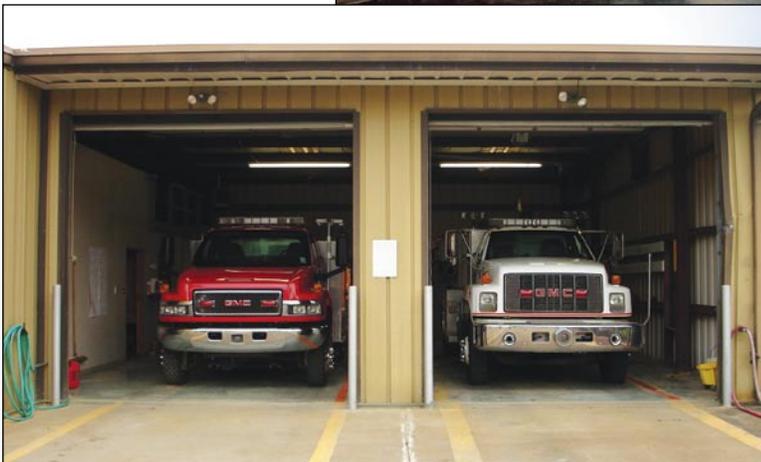
Figure 4-57.
7th Ward Fire District No.1
Fire Station; wall repairs
were in progress during
MAT inspection

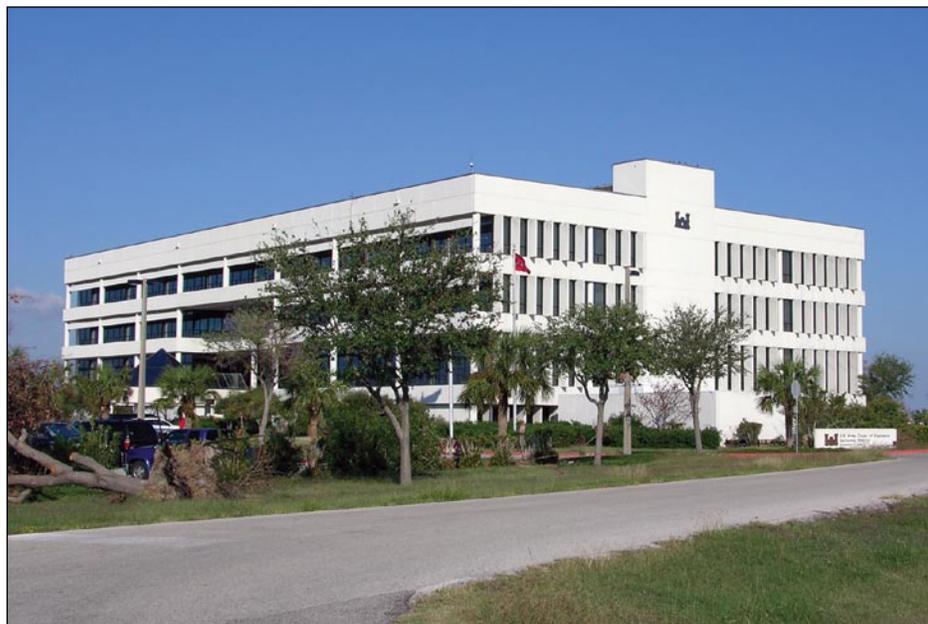
Figure 4-60.
General view of the USACE
Administration Building in
Galveston, TX

The USACE Administration Building (Figure 4-60), constructed in 1991, is located in Galveston, TX. Although the building was not damaged by flooding, floodwater surrounded the building during Hurricane Ike. Had the water been a few inches higher, it would have wetted the first (lobby) floor. The building experienced wind damage from Hurricane Ike. The exterior walls are precast concrete. According to ASCE 7-05, the basic wind speed for this location is approximately 132 mph. The estimated maximum wind speed during Hurricane Ike was approximately 108 mph.

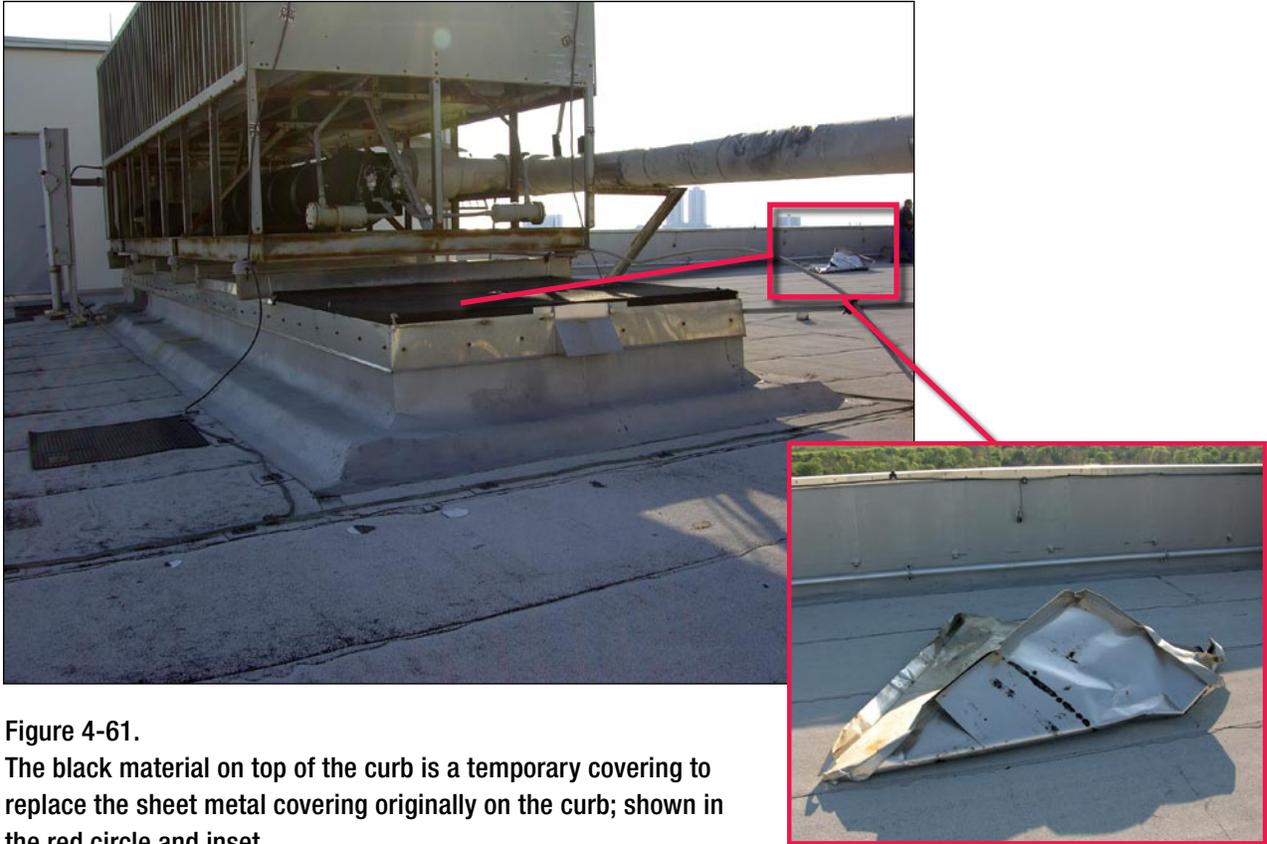
Figure 4-61.

General Wind Damage. Some minor leakage occurred at a few windows; facility staff reported that minor leakage had also occurred during previous thunderstorms. Additionally, some fan cowlings and louvers at condensers were blown off, and some of the LPS conductors detached from the roof membrane. A sheet metal cover over a curb was blown off (Figure 4-61). The presence of the 3-foot 2-inch high parapet was the likely reason the sheet metal was not blown from the roof. The roof membrane is a mineral-surface modified bitumen membrane (which is relatively tough and one of the membrane types recommended in FEMA 543). Although the sheet metal scuffed the roof, the membrane was not punctured or torn.

The black material on top of the curb is a temporary covering to replace the sheet metal covering originally on the curb; shown in the red circle and inset

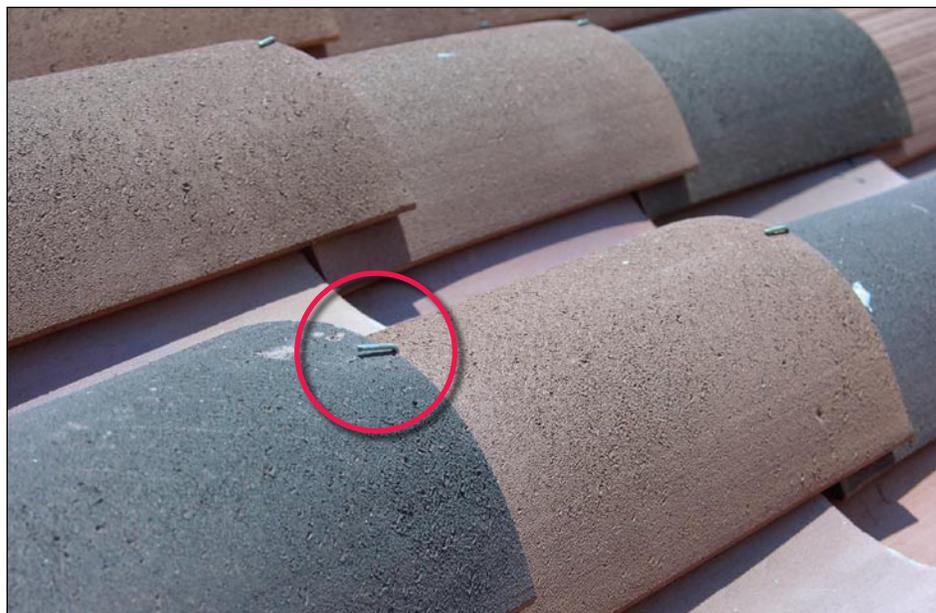
approximately 107 mph. The upper level roof is composed of two types. The steep-slope portion is tile. All of the tails of the tiles are hooked (red circle in Figure 4-63). The sloped roofs surround a low-slope area that has a mineral-surface modified bitumen membrane.

Figure 4-63. All of the tile tails were hooked

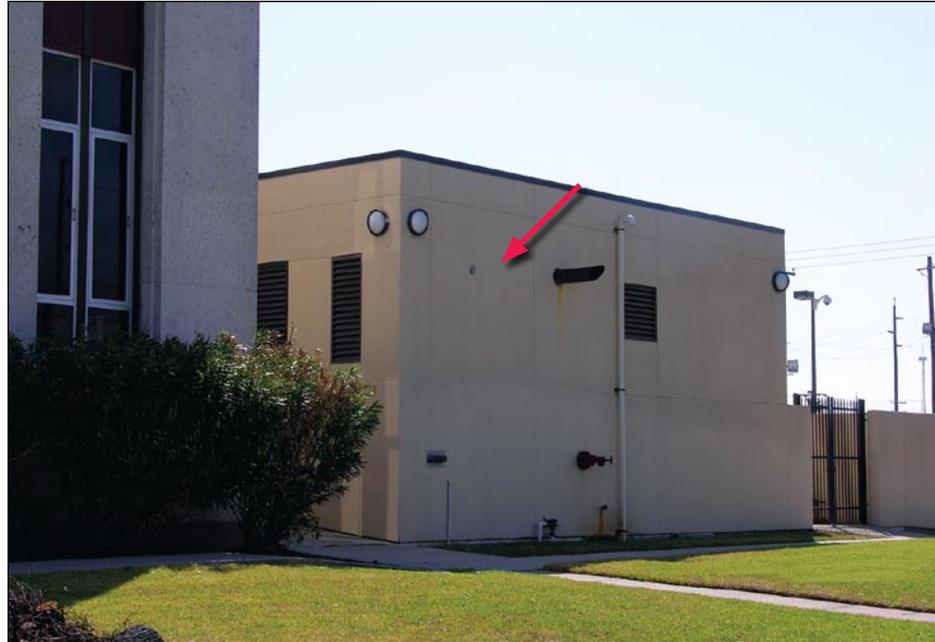
Vulnerabilities and Other Observations. A good practice observed at this facility is the location of the emergency generator in a wind- and windborne-debris-resistant building and elevation above the floodwater level (Figure 4-65). Hence, although flooding damaged the switchgear in the basement, the emergency generator was functional and, therefore, able to be reconfigured to power portable equipment used to dry the interior of the building.

Figure 4-65.
The emergency generator is housed in a separate wind- and windborne-debris-resistant building (red arrow)

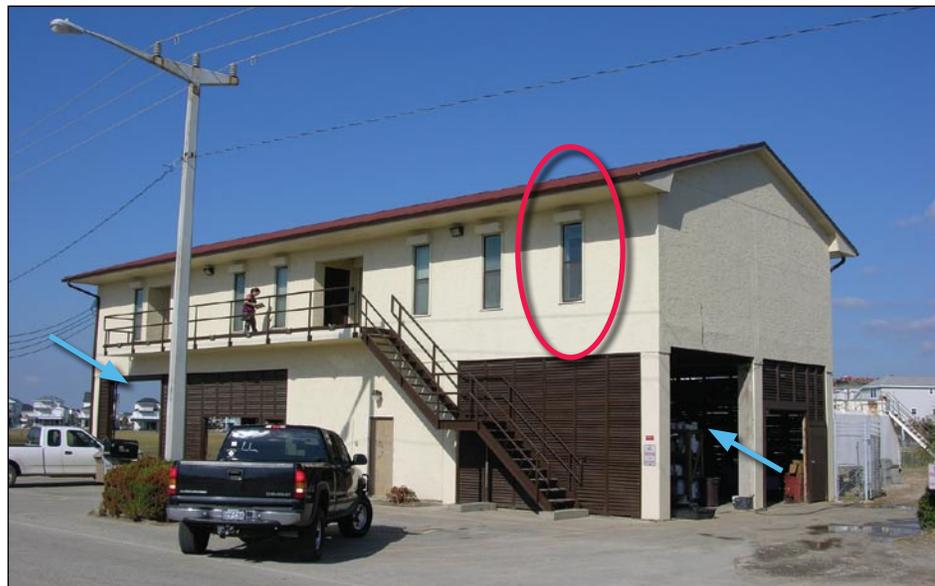
General Wind Damage. A portion of the ridge flashing was blown off the metal roof (Figure 4-67). Leakage did not occur, so the roof underlayment was apparently correctly lapped over the ridge. However, loss of flashing can make roof panels more susceptible to blow-off.

Figure 4-67.
The oval shows where
ridge flashing blew away

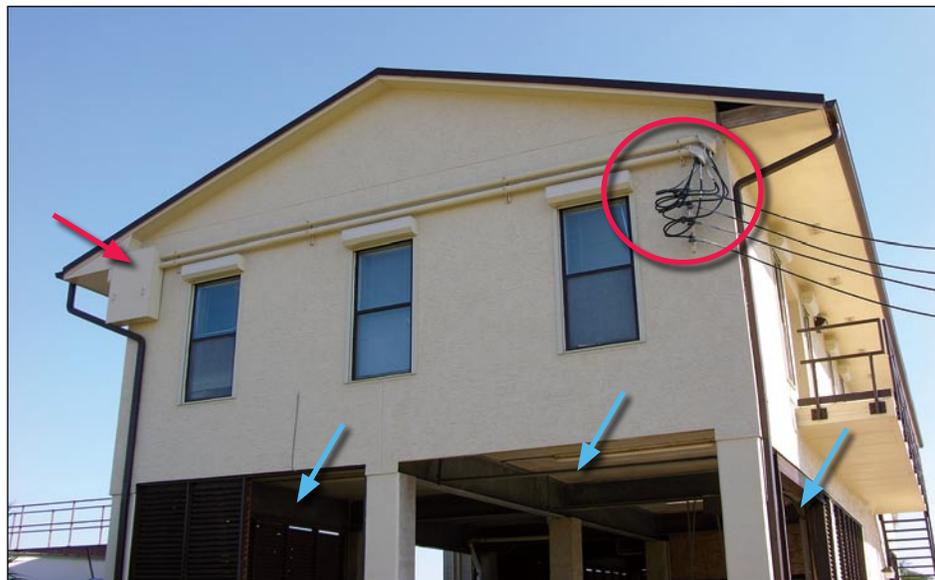
General Flood Damage. Breakaway walls failed under flood forces and ground level space was inundated (blue arrows in Figures 4-66 and 4-68).

Vulnerabilities and Other Observations. The building design incorporated a very sound practice regarding entrance of electrical service. Normally when power is provided by overhead lines (as is the case with this building), the lines come into a weatherhead that penetrates the roof. If nearby power poles collapse or move significantly, the power lines pull the weatherhead, which often tears the roof and allows leakage. However, at this building, the conduit from the weatherhead (circled in Figure 4-68) runs along the wall and then enters the building through the wall (red arrow). With this installation, movement of the power lines may have caused some damage at the wall penetration had the power lines moved significantly; but if wall damage had occurred, leakage would have been much less problematic than if the conduit penetrated the roof.

Figure 4-68.
The electrical service entered through the wall rather than the roof; the blue arrows indicate missing breakaway walls

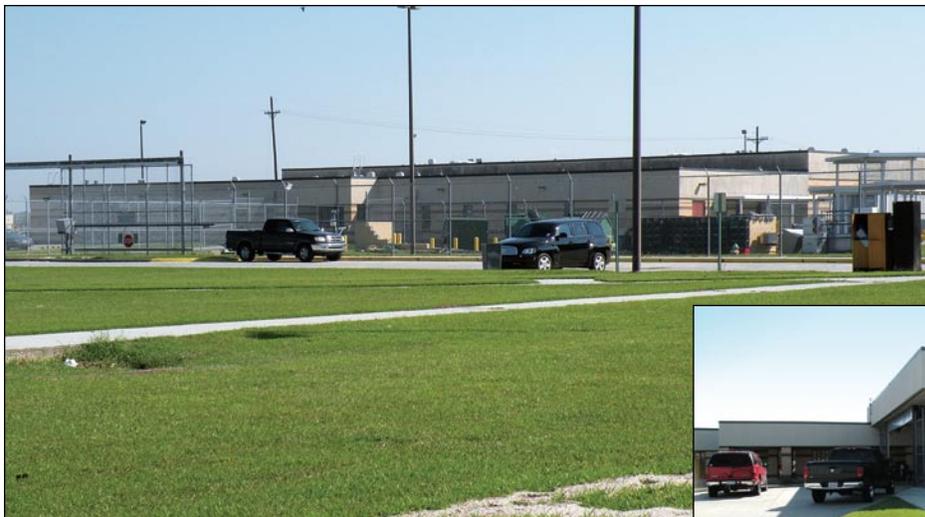
The Terrebonne Parish Criminal Justice Complex located in Houma, LA, houses approximately 600 inmates. It is a relatively new facility but received approximately 18 to 24 inches of flooding due to Hurricane Ike (Figure 4-69).

General Flood Damage. Utility service, which runs beneath the slab foundation, was damaged and disrupted by Ike's flooding. In addition to the inundation problems, the facility became unusable because controls were either damaged or inoperable (virtually all of the functions of the prison are operated by electric switches, relays, and motors, including the communications, prison monitors, lights, and cell doors). Parish records also indicate that the criminal complex electronic security system was damaged by Hurricane Rita and required repair and replacement in 2006.

Functional Loss. Flooding damaged essential equipment and required that prisoners be relocated to a State corrections facility.

Figure 4-69.
Terrebonne Parish
Criminal Justice Complex
