HURRICANE  
**IKE**  
& IN TEXAS  
& LOUISIANA

# 6 Conclusions

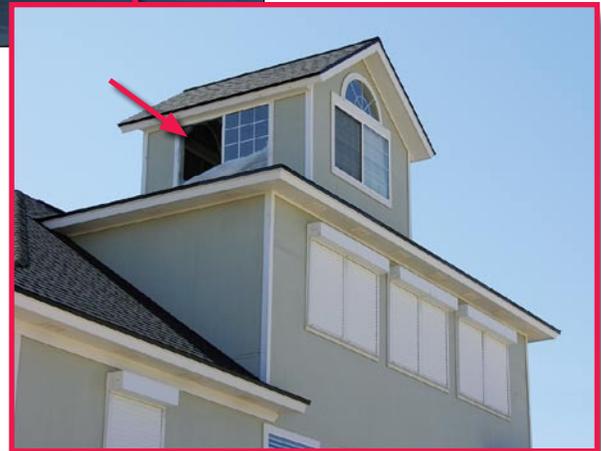
**Doors, Windows, and Shutters.** Few impact-resistant glazed window units were observed by the MAT. Most houses observed by the MAT had some form of shutter to provide debris impact protection. The shutter type varied from simple plywood to expensive roll-down shutters. The MAT observed numerous instances where plywood shutters were not properly anchored to the building structure, but rather to window frames and wall cladding. Though few debris impacts were observed, it appeared that most shuttering was effective in this less-than-design wind event. It was further observed that some homeowners chose not to shutter all windows (Figure 6-2). In some instances, shutters were only placed on the seaward facing windows, and the unshuttered north facing windows left vulnerable to Ike's backside winds.

**Figure 6-2.**  
The upper windows on this Seabrook, TX, residence were not shuttered and were vulnerable to windborne damage
