Mitigation Assessment Team Report on

Hurricane Ike

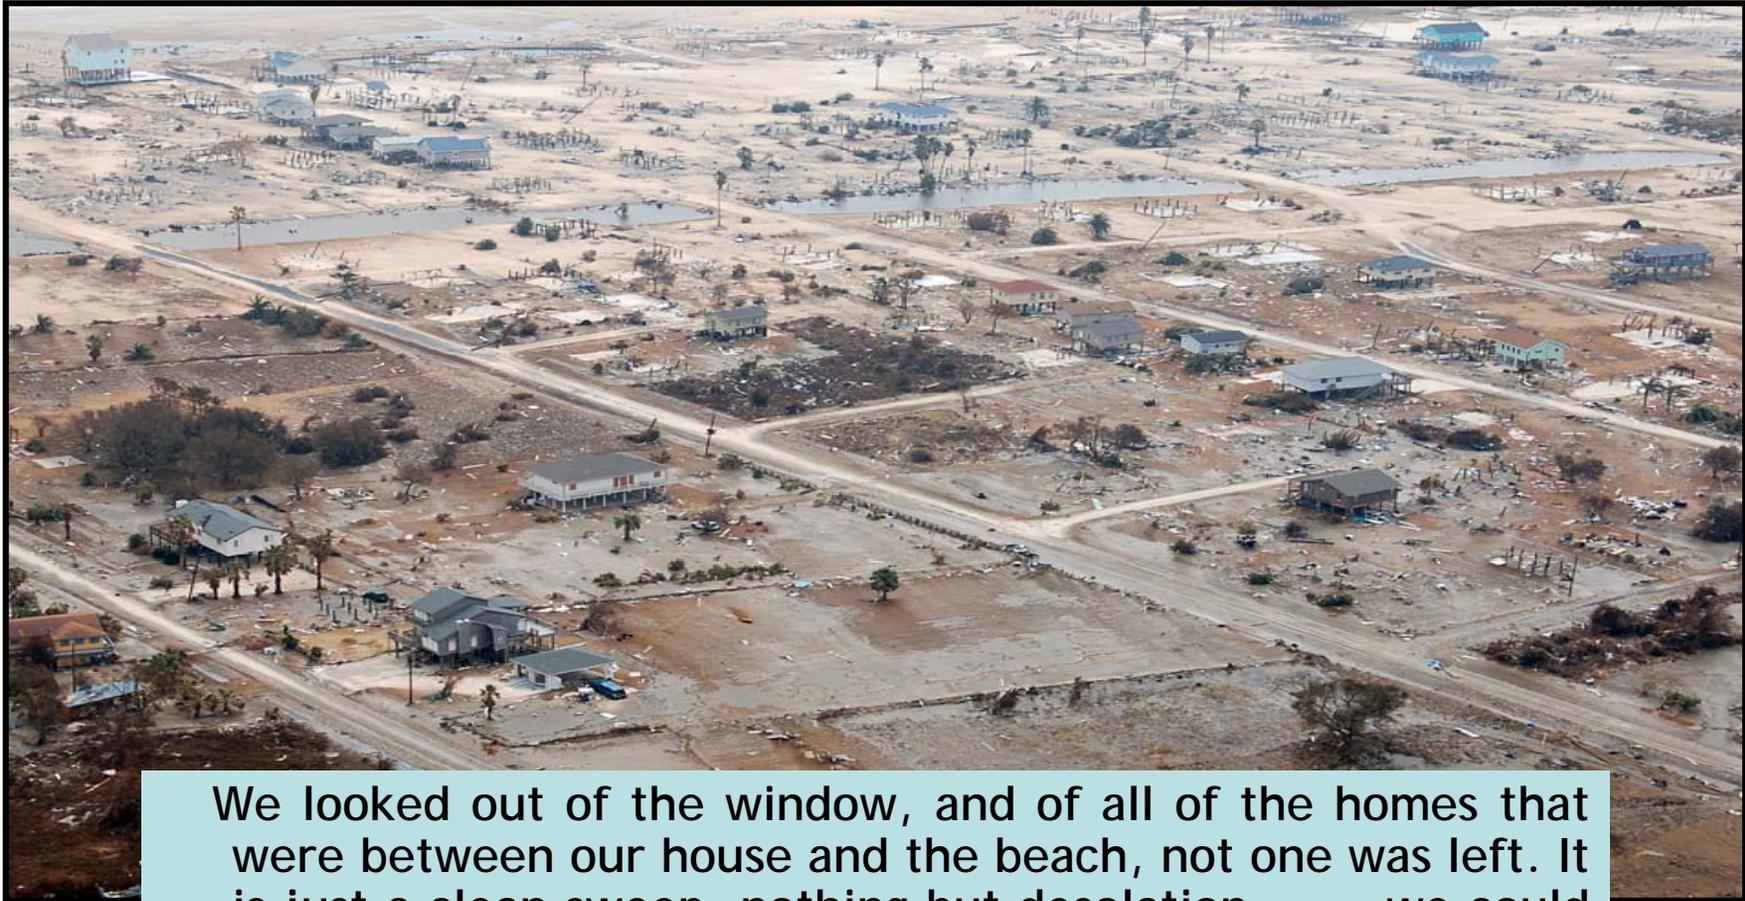
Hurricane Ike damage—Seen again and again

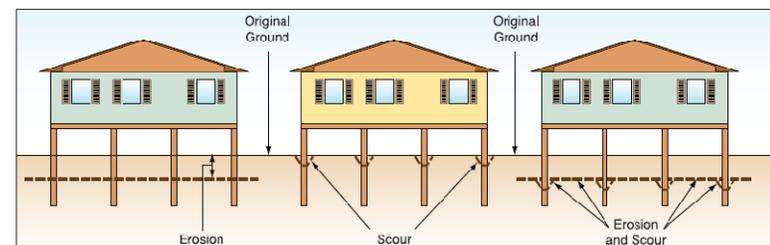
Figure 1. Distinguishing between coastal erosion and scour. A building may be subject to either or both, depending on the building location, soil characteristics, and flood conditions.
