## MIDWEST FLOODS of 2008 & IN IOWA & WISCONSIN

# 6 Conclusions

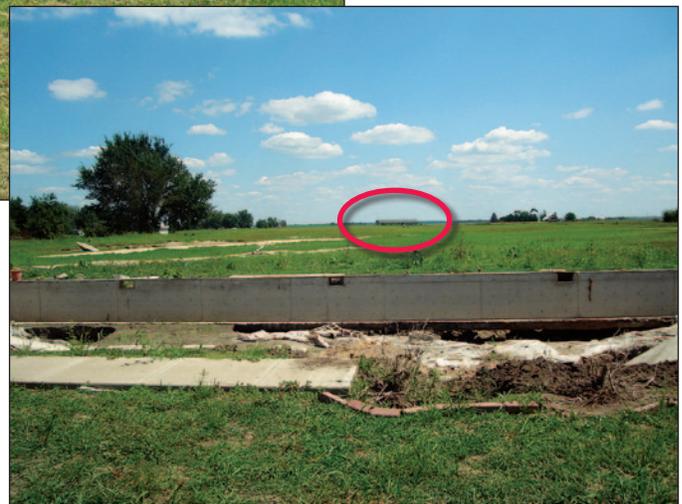
Throughout the field visits, the MAT observed a lack of openings in foundation walls, openings that were too high above grade, and openings that were obstructed. Because foundation walls can sustain damage or collapse due to hydrostatic loads, NFIP regulations require that enclosure walls contain openings that allow for the automatic entry and exit of floodwater. These openings are intended to allow floodwater to reach equal levels on each side of the wall, thereby lessening the probability of damage caused by a difference in hydrostatic loads on opposite sides of the wall. In some cases, openings that were designed in compliance with the NFIP and FEMA TB 1, *Openings in Foundation Walls and Walls of Enclosures*, became non-compliant during construction due to the addition of insulation, as shown in Figure 6-3.

Figure 6-3. Example of a riverfront property with foundation vent openings; the openings in the garage were clear but those around the house were blocked by insulation, eliminating the effectiveness of the openings (Iowa City, Iowa).
