# MIDWEST FLOODS of 2008

& IN IOWA  
 & WISCONSIN

## 4 Critical and Essential Facilities

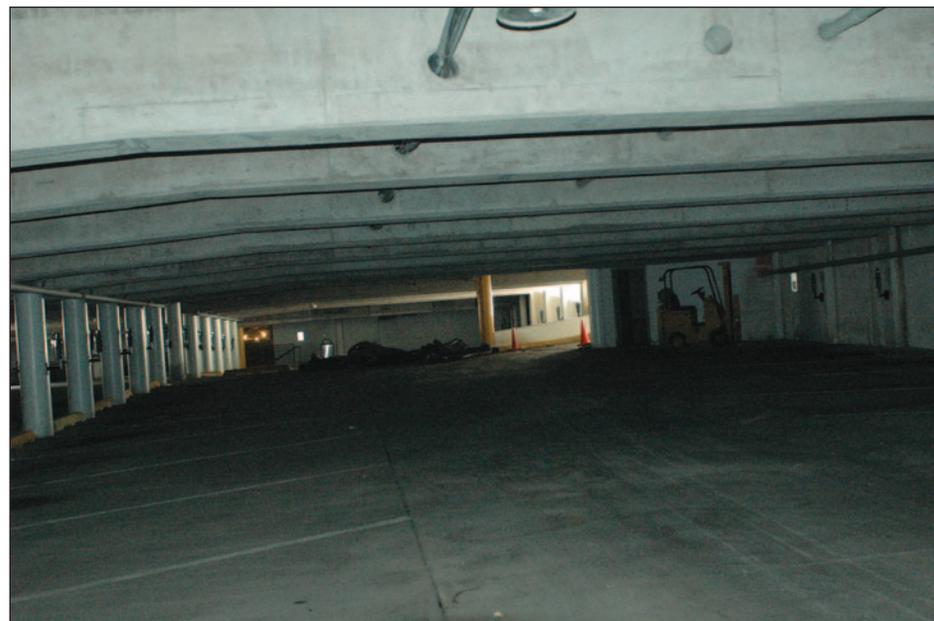
Figure 4-4.  
The Mays Island  
underground parking  
structure connects to  
City Hall and the County  
Courthouse and was a  
major source of floodwater  
intrusion into both buildings  
(Cedar Rapids, Iowa).

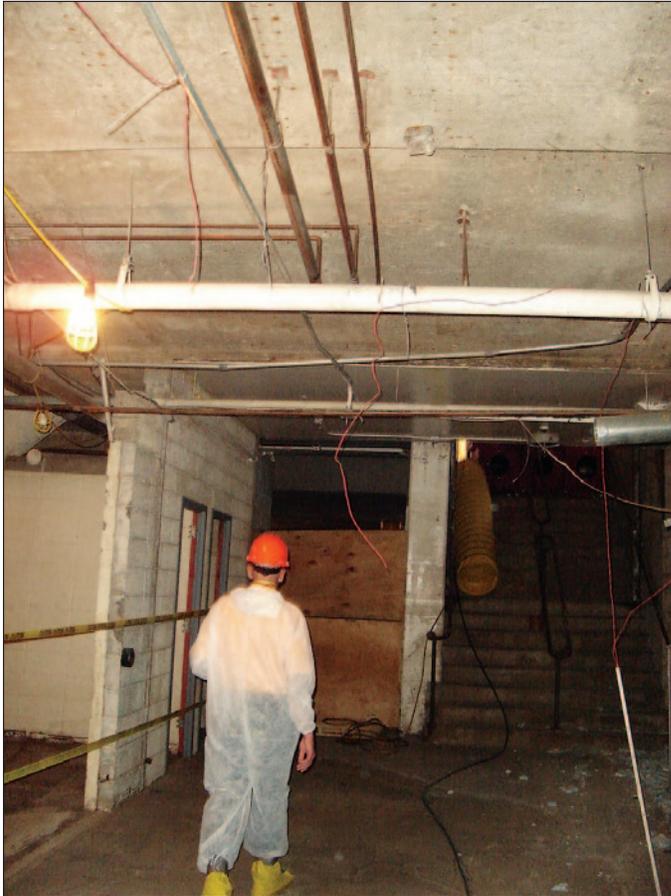
Figure 4-5.

The tunnel and stairs into City Hall from the underground parking structure were a source of flooding in the basement (Cedar Rapids, Iowa).

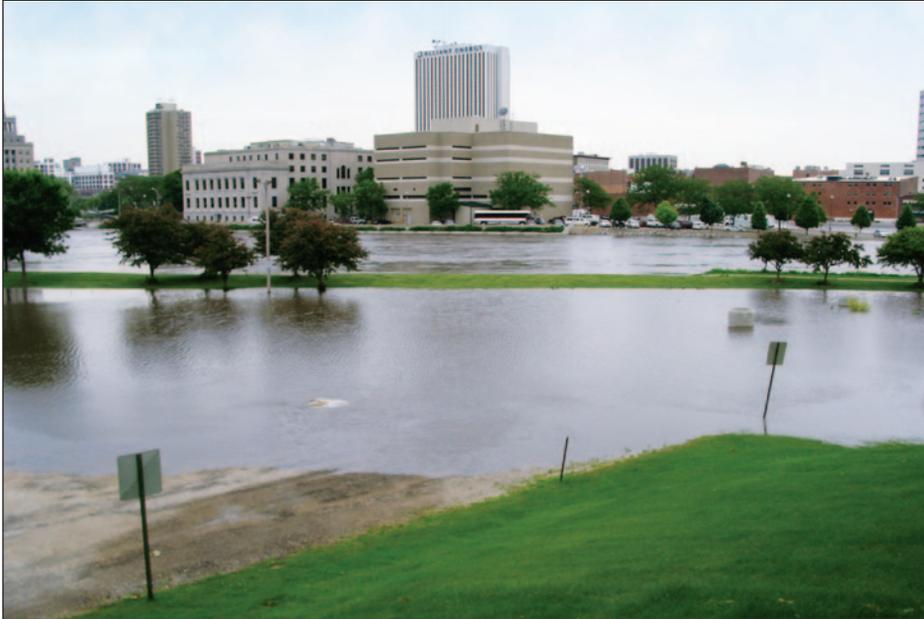
**Overview:** The Linn County Detention Center was built in 1984 and is a cast-in-place and pre-cast concrete, six-story building located on Mays Island in the Cedar River (Figure 4-7). The building is connected to the Linn County Courthouse via an underground access tunnel (Figure 4-8). The jail has an operating capacity of 450 inmates; at the time of the flood, there were between 350 and 400 inmates in custody. The building experienced significant flooding of the basement level and 2 feet of flooding on the ground floor. As the water entered the building, an emergency evacuation was ordered.

**Figure 4-7.**  
The Linn County Detention Center is on Mays Island in the Cedar River (Cedar Rapids, Iowa).

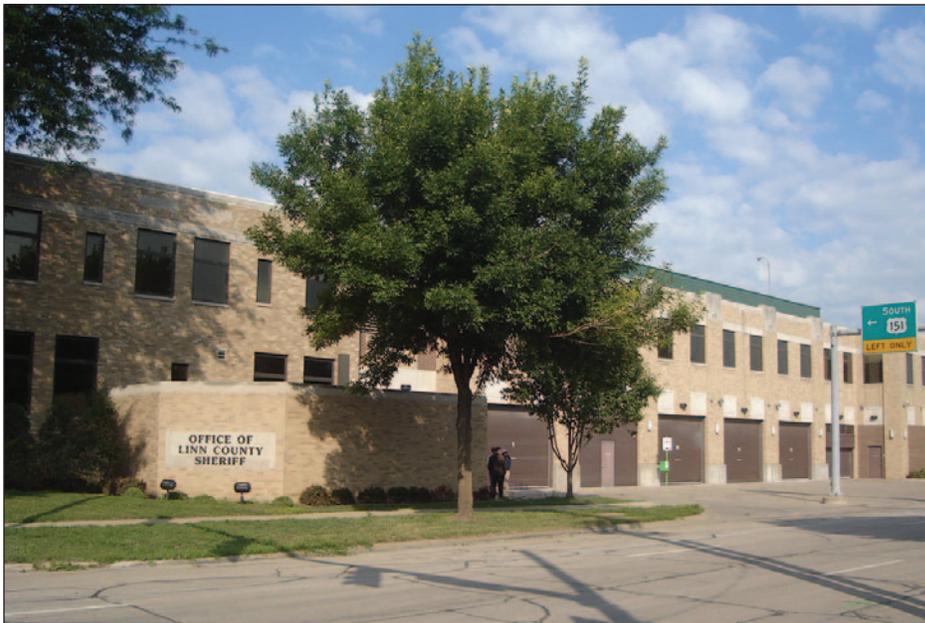
**Overview:** The Linn County Sheriff's Department (Figure 4-13) was built in 1921. In 2001, a slab-on-grade garage was added onto the original structure. The building is located in the 0.2-percent-annual-chance floodplain (Figure 4-1). The basement and first floor of the original section were flooded to their full heights, and the second floor was flooded to 2 feet.

Figure 4-13. Linn County Sheriff's Department (Cedar Rapids, Iowa)

**Summary of Damages:** Several overhead garage doors were damaged. In addition, the emergency generator, which was kept in an outdoor enclosure, was completely submerged (Figure 4-14). The Sheriff's Department also lost significant equipment, including the electrical and mechanical distribution systems, and communications and data systems. There was also damage to interior architectural finishes.

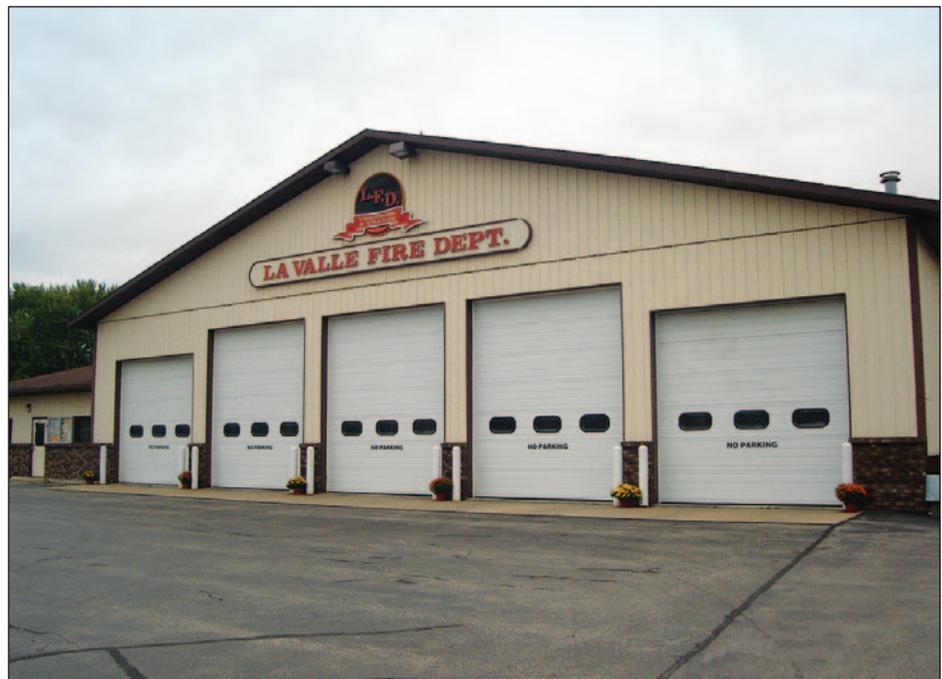
Figure 4-19.  
La Valle Fire Department  
(La Valle, Wisconsin)

**Summary of Damages:** There was some damage to interior wall finishes, and the drywall in the office and meeting areas was torn out and replaced to 4 feet above the floor. The gas meter was also damaged.

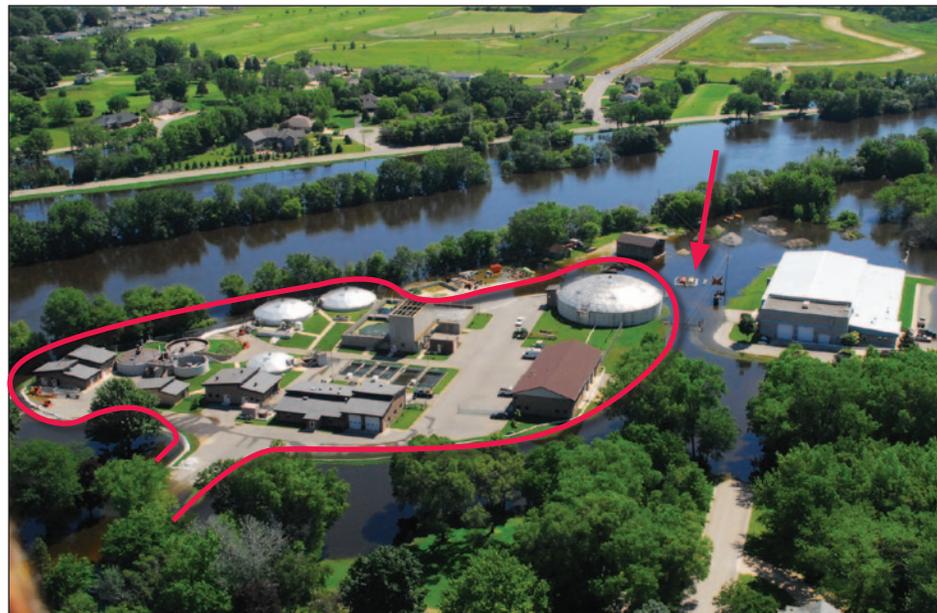
The city’s fuel station quickly flooded (Figure 4-33) and fuel supply for WWTF equipment became a primary concern to keep the facility operating. Operators were able to obtain fuel from a local gas station and have more fuel delivered to the facility on regular intervals throughout the remainder of the storm event.

**Figure 4-33.**  
The Jefferson WWTF is protected by a berm, outlined in red. The fuel station, shown by the arrow, is not protected and was flooded (Jefferson, Wisconsin).

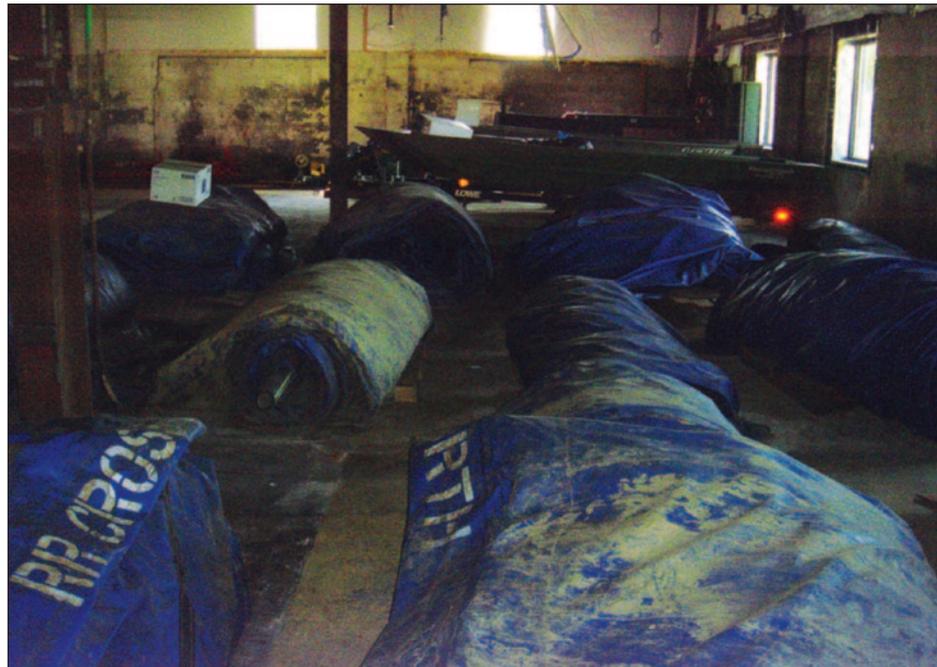
**Figure 4-35.** Inflatable bladders are stored on site and deployed when a flood threat is perceived. The Cedar Falls Utility Plant maintained hourly monitoring of the latest flood levels to determine deployment of barrier systems (Cedar Falls, Iowa).

In the days leading up to the 2008 floods, plant staff had been tracking reports and anticipated river crests. Water-filled bladder systems were prepared and assembled to protect against the anticipated flood levels. However, just before the floods began, river crest predictions rose by 3 feet. Though they had the capability to raise the protection level, plant staff did not have enough time to fill additional bladders and construct the additional bracing necessary to hold them in place. Actual flood levels were 1 to 2 feet above the floodwalls, and, as a result, the facility was inundated (Figure 4-36).

Future mitigation plans for the Cedar Falls utility plant call for protection to the 0.2-percent-annual-chance flood elevation plus 3 feet.

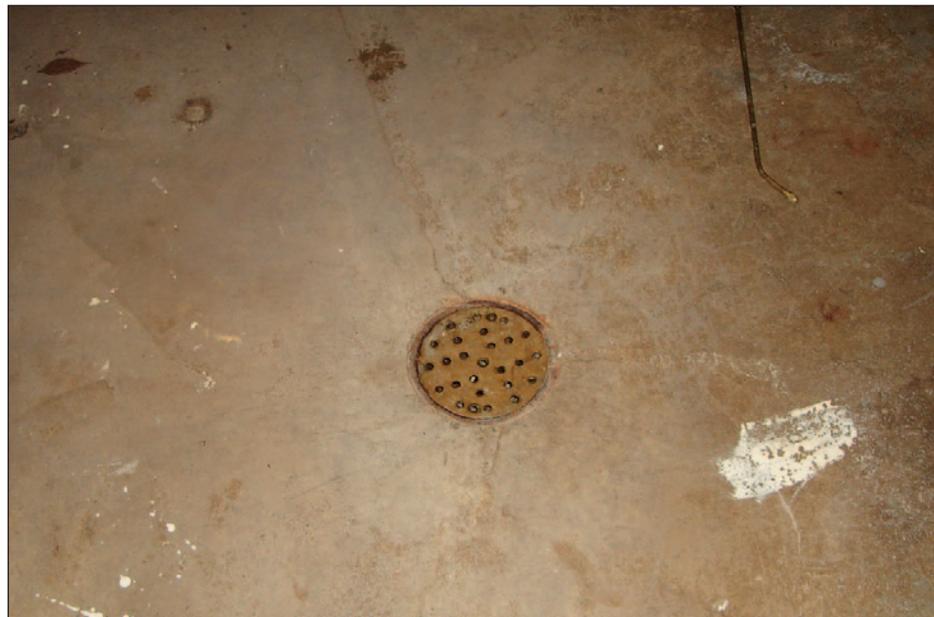
**Overview:** South School, which was built in 1937, is in a residential area of Reedsburg. The school is not in the SFHA (Figure 4-39). Flooding inside the building was the result of storm sewer backup, which allowed water to enter through floor drains (Figure 4-40). The school had about 2 feet of standing water in the basement, which houses the kitchen, a cafeteria/multi-purpose room, and storage areas. In addition, the sub-basement was totally flooded.

Figure 4-40. Flooding in South School was due to backup through floor drains such as the one shown in this photo (Reedsburg, Wisconsin).

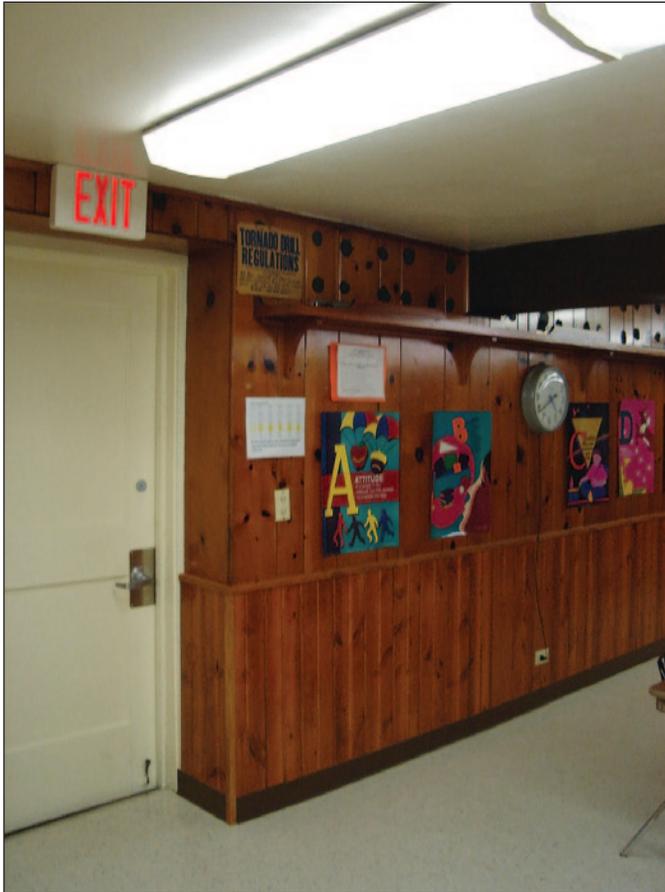
Figure 4-41.

**Summary of Damages:** The flooding resulted in the loss of two boilers and kitchen equipment, including a freezer, cooler, and stove. There was also damage to the interior wall and floor finishes in the cafeteria (Figure 4-41). The school district refurbished an air compressor and the main electrical panel, which were also damaged.

Damaged paneling in the Pine Room, South School's cafeteria and multi-purpose room, was refurbished to maintain the room's character (Reedsburg, Wisconsin).

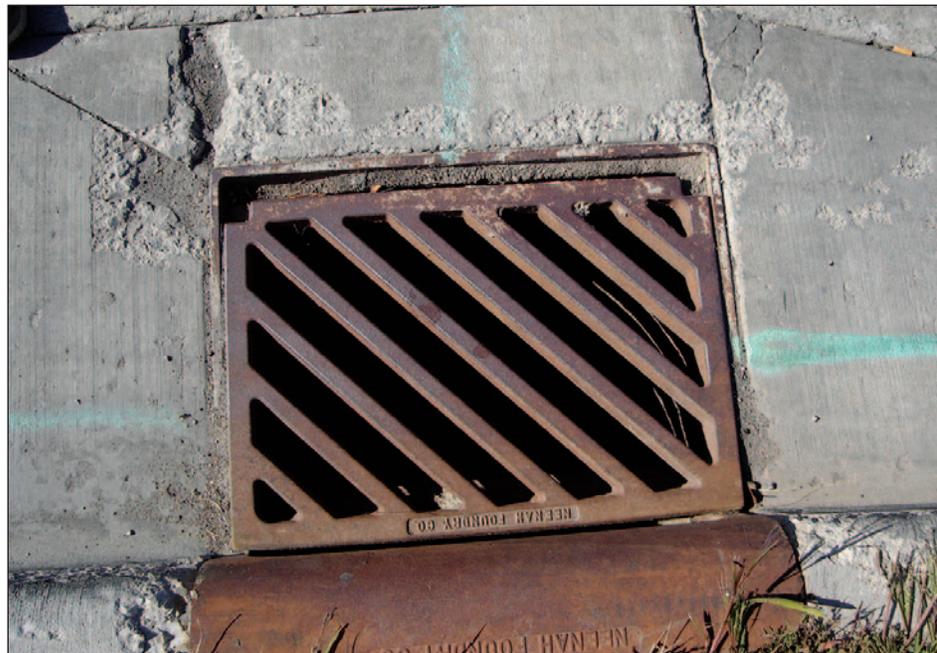
The school is located near the Fox River (Figure 4-42), although river water was not the cause of flooding on campus. Flooding in university facilities was the result of backup in city-owned storm sewers (Figure 4-43), which allowed water to infiltrate buildings such as the Nursing & Education Building, the Clow Social Science Center, Swart Hall, and Oviatt House through utility tunnels. In most cases, standing water inside buildings was limited to a few inches. Massive flooding at the River Center, discussed in Section 4.4.4, led to a campus-wide power loss.

Figure 4-43. City-owned storm drains contributed to flooding at UW Oshkosh, but this vulnerability was not considered prior to the 2008 floods (Oshkosh, Wisconsin).

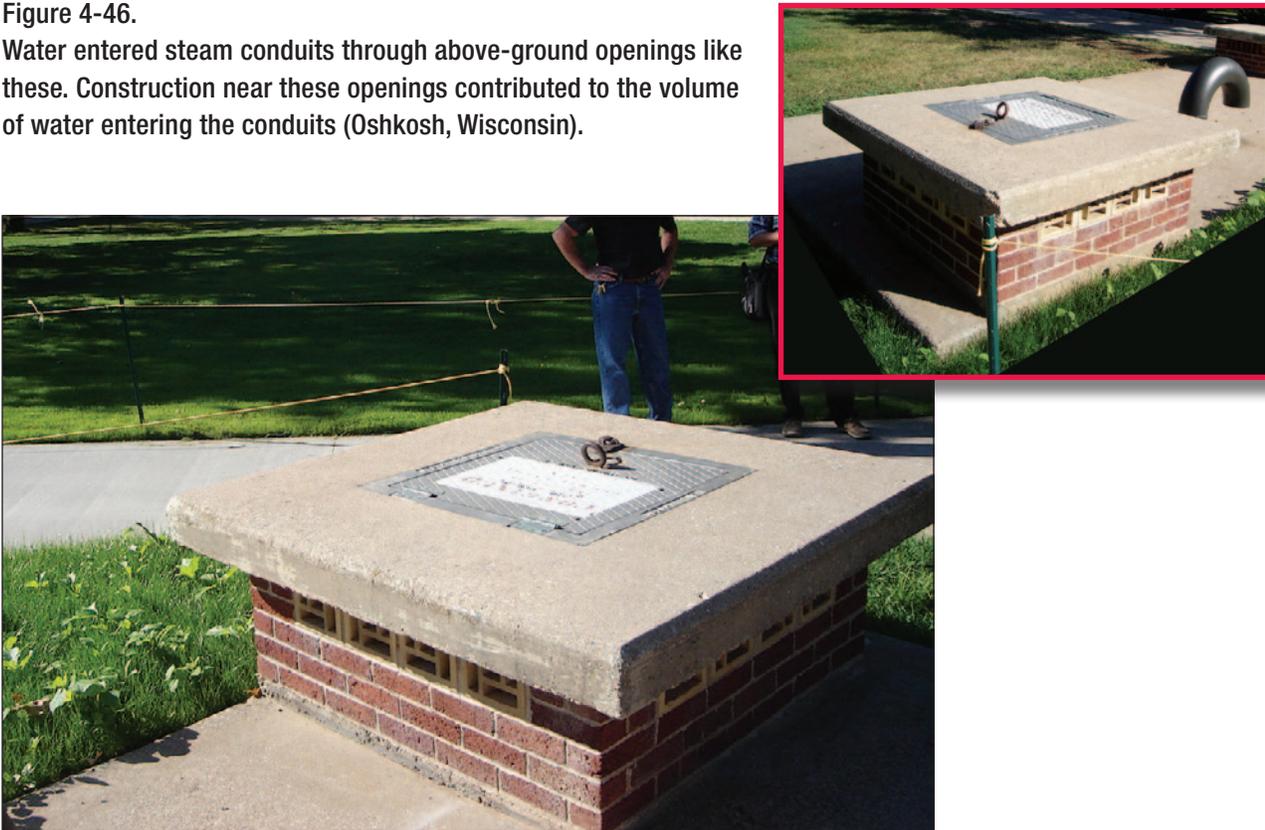
**Summary of Damages:** Temporary changes in grading for construction allowed surface water to collect behind Oviatt House. The flooding in the academic buildings resulted from surface storm water entering the steam tunnels behind Oviatt House (Figures 4-46 and 4-47). The tunnels, which connect to several buildings including those mentioned above, allowed floodwater to enter academic and mechanical areas in several basements. In one case, staff attempted to contain water in a mechanical room by placing a wooden plank in the doorway. As water flowed in through the tunnel, it was stopped from entering into the hallway and academic area.

**Figure 4-46.** Water entered steam conduits through above-ground openings like these. Construction near these openings contributed to the volume of water entering the conduits (Oshkosh, Wisconsin).

Damages incurred in the academic buildings included loss of carpeting, electrical floor outlets, drywall, and wall finishes. Following the floods, damaged basement finishes were replaced with flood damage-resistant materials:

- Carpeting and damaged tile were replaced with vinyl sheet flooring.
- Drywall was removed to 4 feet above the ground and replaced with mold-resistant cement board.
- Rather than installing floor-to-ceiling drywall, staff installed a strip of pressure treated lumber at floor level, left an air gap above it, and then installed cement board in order to prevent wicking in future flood events (similar to the technique shown in Figure 4-48).

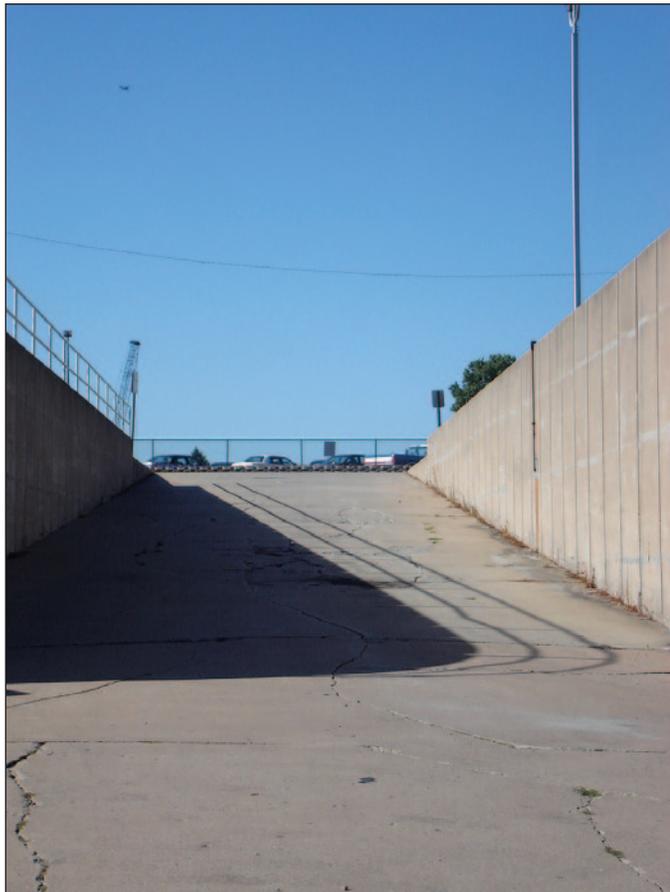
**Overview:** The River Center is a two-story structure that served as a cafeteria prior to the flood (see Figure 4-42). Storm sewer backup allowed water to flow from street level down a steep driveway into the River Center’s loading dock, and led to 8 feet of standing water in the basement (Figure 4-49). Loss of a transformer at the River Center triggered a campus-wide power loss. Though campus power was restored within hours, the River Center was not restored before the 2008–2009 academic year; it was without power for at least two months after the flood.

**Figure 4-49.**  
The steep driveway leads from street level to the loading dock at River Center’s basement (Oshkosh, Wisconsin).

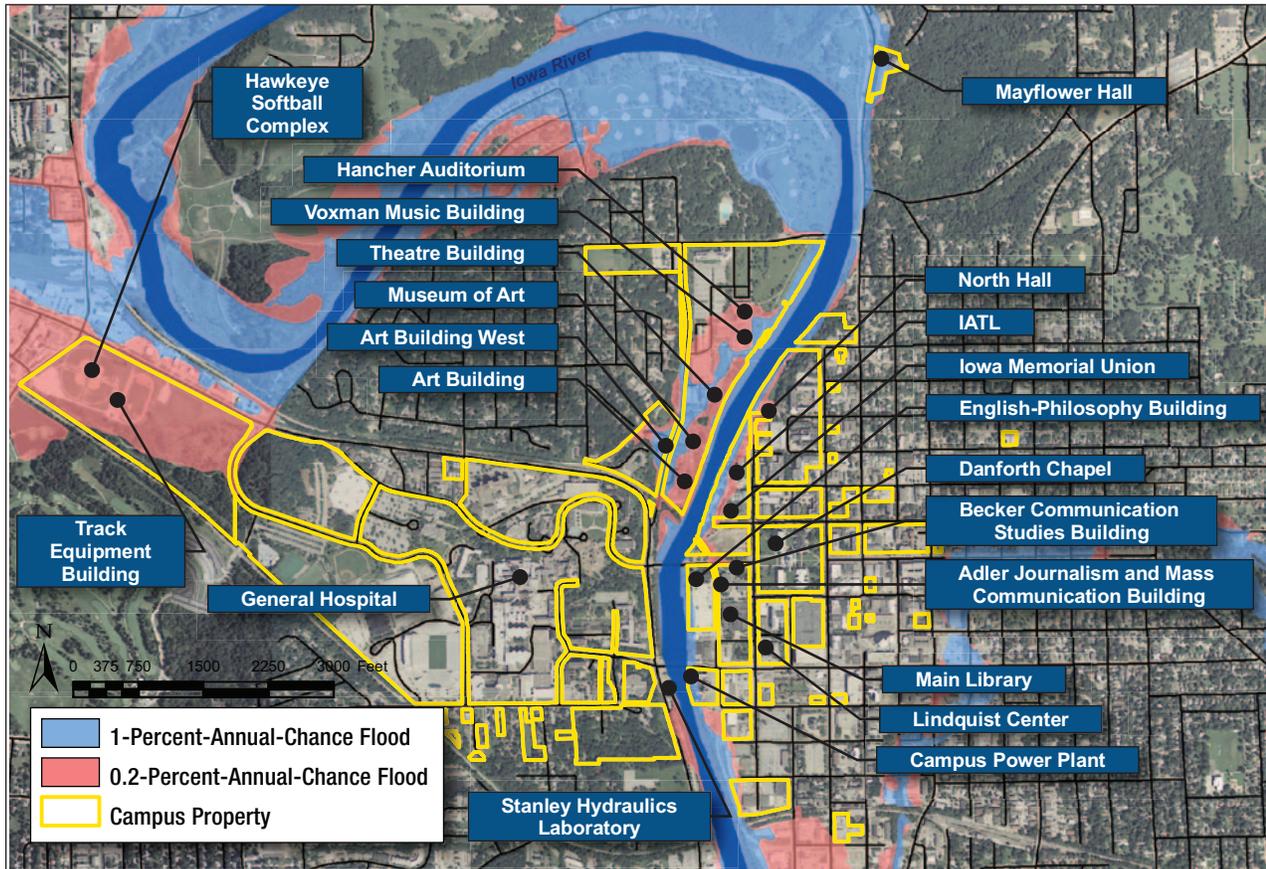
Figure 4-51. Flood zones and inundated buildings for the University of Iowa (Iowa City, Iowa)

Although most of the buildings were directly flooded by river water, Adler Journalism Building, Becker Hall, and the Power Plant were significantly damaged by water entering from the utility tunnels. Access to Iowa City, the campus, and the University Hospital was severely limited. Medical personnel had to be flown in by helicopter to meet manpower needs. Power was lost throughout the campus. Temporary power generation plants were brought onto campus and restored power within three days of the flooding. The hospital, which had limited power from an operational substation on the west side of the river, had a temporary boiler system installed to provide the hot water necessary to continue emergency services.

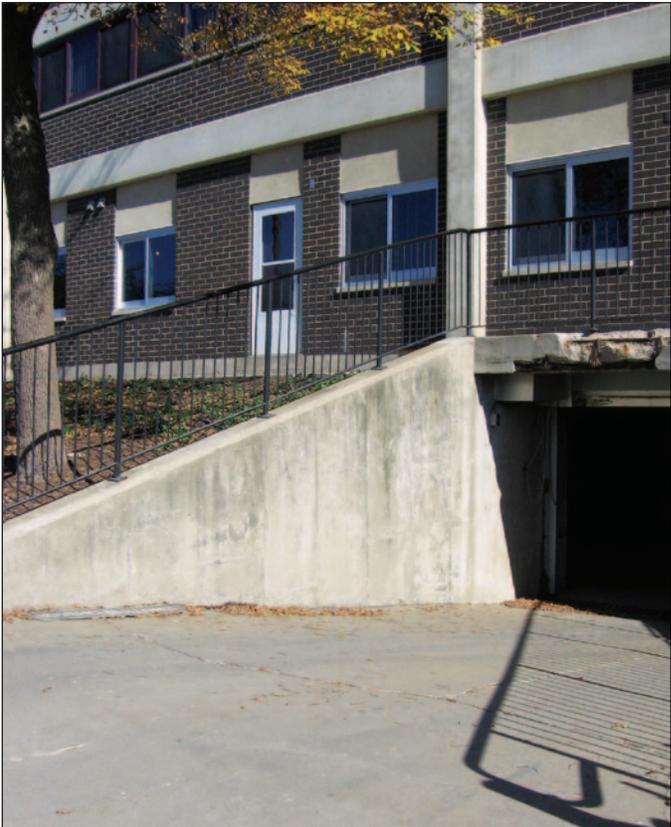
**Mayflower Residence Hall:** Built in 1968 and acquired by the University in 1983, this building is a medium rise, eight-story dormitory. It is located upstream of the main campus and in the SFHA. The building, which sits on top of a two-story, below-grade parking structure, had 2 inches of water on the first floor. The parking structure, which housed electrical and mechanical systems, was completely flooded (Figure 4-56). Although the parking structure had not been used for parking in several years, the electrical and mechanical equipment were severely damaged. The first floor

sustained damage to wooden doors and frames, drywall partitions, appliances, casework, electrical wiring and devices, mechanical ductwork, and floor finishes in the housing areas. The Food Services area sustained major damage to interior architectural finishes and food service equipment. The building was repaired and reoccupied in time for the 2008–2009 academic year.

**Figure 4-56.** Entrance to the parking garage beneath the Mayflower Residence Hall (Iowa City, Iowa)

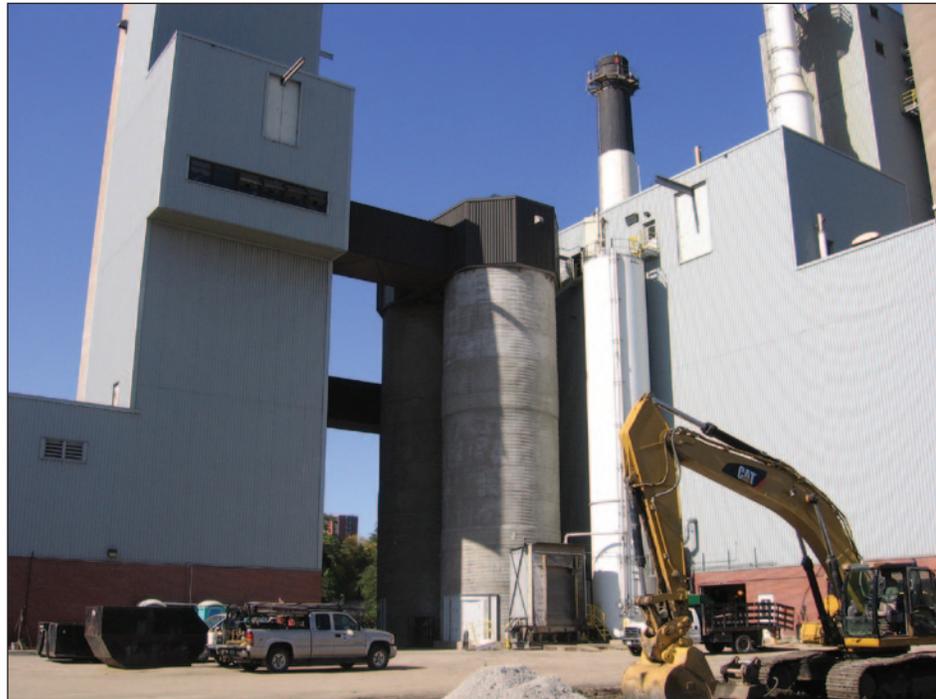
**Power Plant:** A portion of the Power Plant is located in the 0.2-percent-annual-chance floodplain along the Iowa River. This building had major flooding in the basement, which housed the power, processing, pumping, and controls of the steam generation equipment for the entire campus. The controls were completely submerged, and, as a result, they needed extensive repairs. In October 2008, the building was under evaluation for structural damage; the basement floor was estimated to have incurred damage of over \$25 million, primarily to the main steam generation equipment (Figure 4-57).

**Figure 4-57.**  
Power plant site repairs  
(Iowa City, Iowa)

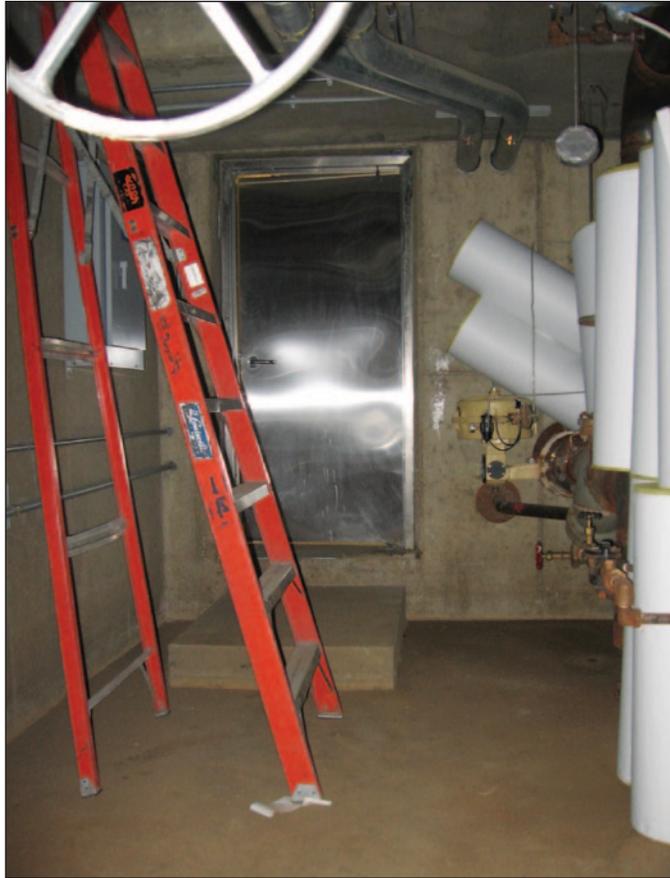
**Utility Tunnels:** Water entered campus utility tunnels through access hatches and tunnel vents, and through tunnel openings in the Power Plant. The utility tunnels, which run from the Power Plant carrying steam and water piping and communication lines throughout the campus, were flooded in the following locations:

The tunnels incurred damages to steam pipe insulation, valves, pipe penetrations, ductwork, and building entrances (Figures 4-58 and 4-59).

Figure 4-59.  
Repair to tunnel entrance to Alder Journalism and  
Mass Communications Building (Iowa City, Iowa)
