TORNADO OUTBREAK *of* **2011**

IN ALABAMA, GEORGIA, MISSISSIPPI,
TENNESSEE, AND MISSOURI

5 Observations on Commercial and Industrial Building Performance

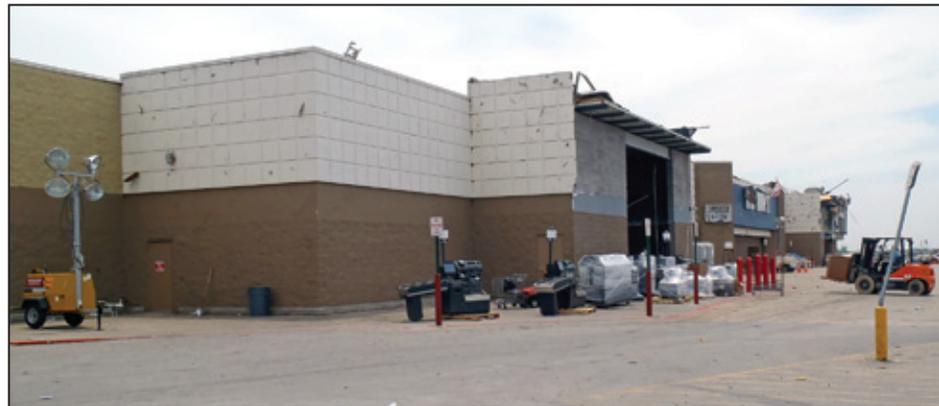
General Wind Damage: The north portion of the Walmart building remained standing (Figure 5-32) with the majority of its roof structure in place. The south portion of the building lost its roof structure and some of the exterior walls collapsed. At the time the MAT visited, site cleanup of the interior space had been in progress for several days and most of the store contents had been removed.

Figure 5-32:
The relatively undamaged west elevation of Walmart after the May 22, 2011 tornado (Joplin, MO)

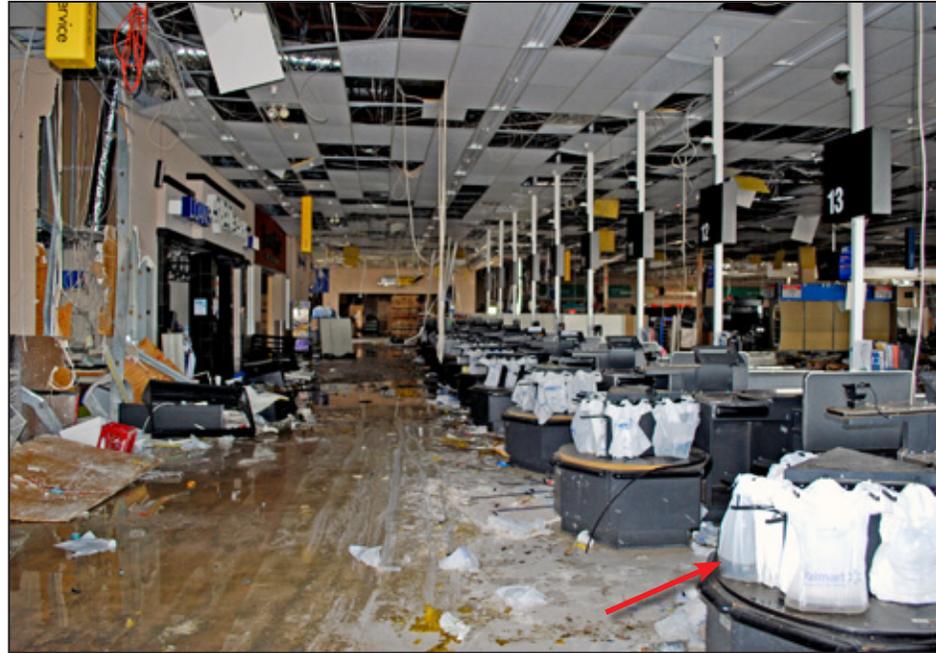
The east side of the building within the north half was compromised. The east wall and roof were destroyed beginning at approximately the loading docks on the east side (Figures 5-33 and 5-34). The failures resulted in significant water infiltration. Figure 5-35 is looking north inside the space; note the water level inside the Walmart bag in the lower right corner of the photograph.

Figure 5-35:
Interior of the north half
of building showing water
infiltration collected in bags
(red arrow) (Joplin, MO)

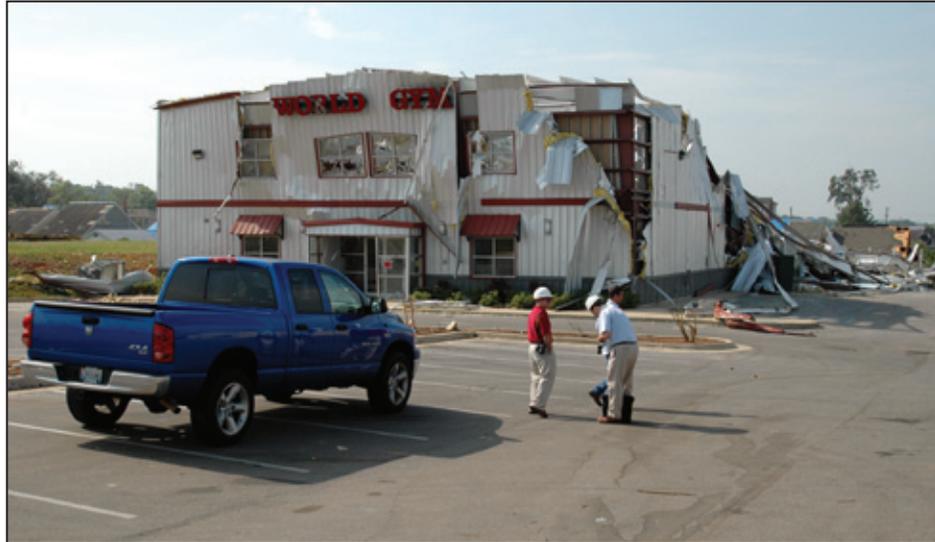
General Wind Damage: The southern part of the building was completely destroyed, while some of the northern part of the building was left standing (Figure 5-47). The failures observed were due to a breach of the building envelope from inflow winds that then resulted in excessive wind pressures being exerted on the MWFRS.

Figure 5-47:
Front (north side) of fitness center building
(Tuscaloosa, AL)

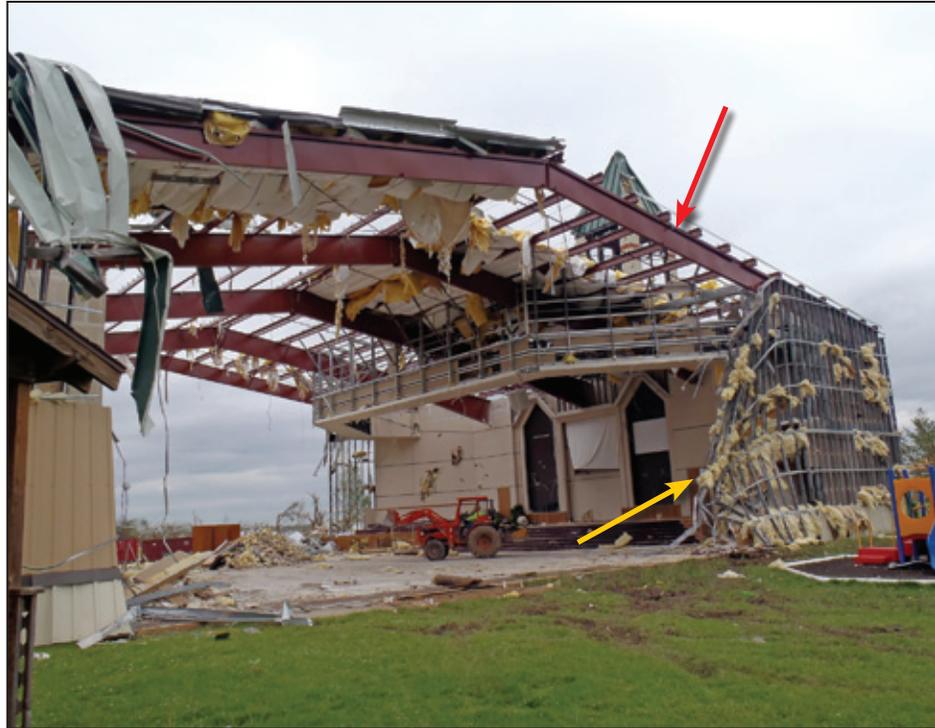
resulted in a failure of these secondary elements relieving the internal wind pressure from the MWFRS (Figure 5-52). The primary main column frames and their anchorage to the foundation performed very well (Figure 5-53).

Figure 5-53:
Secondary framing (light gage infill walls) failed (yellow arrow) while the main frames survived (red arrow) (Joplin, MO)

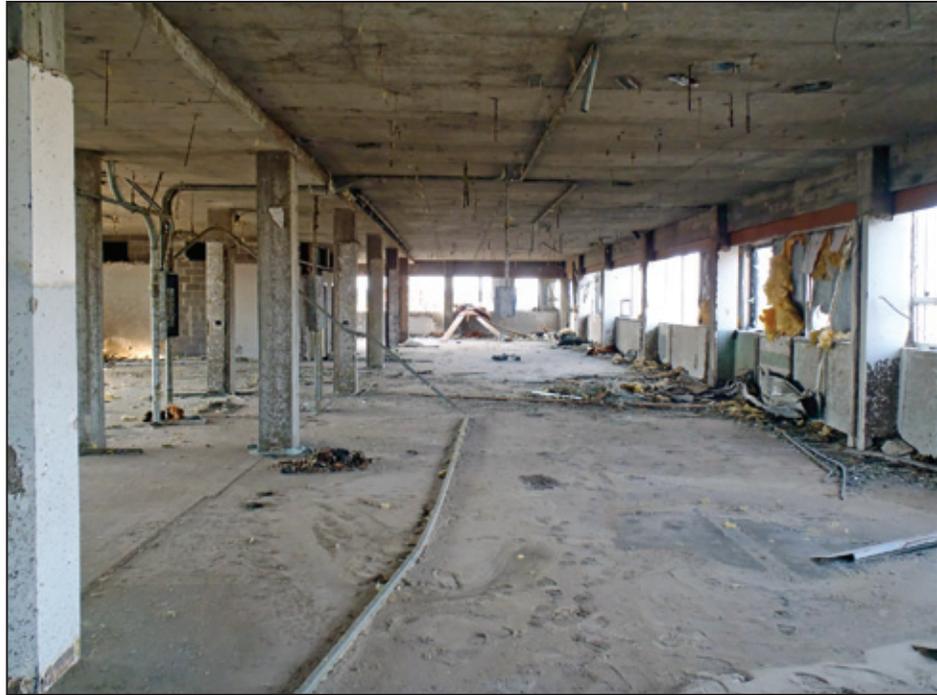
The Ozark Center is a three-story main building that has a two-story extension on the east side (Figure 5-56). Figure 5-57 shows the typical interior layout of the main building with a perimeter beam and column system. There are two rows of center columns in the two-story extension. The slab is thickened between the rows of center of columns at each level. The remainder of the building is cast-in-place concrete.

Figure 5-57:
Two-story extension on east side of building shown in Figure 5-56; view shows typical interior layout (Joplin, MO)

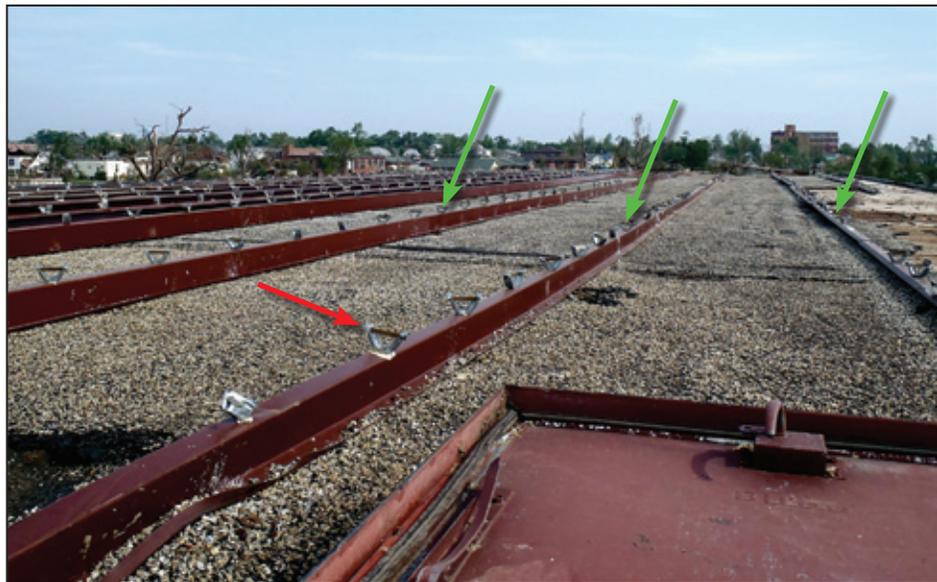
The roof system on the main building consists of a poured-in-place concrete roof deck that was subsequently covered over by adding steel purlins attached to the roof deck at approximately 5 feet on center. The original concrete roof deck was undamaged. The MAT observed clips in place that would accept new roof material, most likely a metal roof deck system. The connection of the roof material to the purlins had failed and the roof material was not observed at the site (Figure 5-58).

Figure 5-58:
Roof of the third-story main building. The roof overbuild purlins are shown with green arrows while the roof clips that unlatched are shown by red arrow (Joplin, MO).
