TORNADO OUTBREAK *of* **2011**

IN ALABAMA, GEORGIA, MISSISSIPPI,
TENNESSEE, AND MISSOURI

Observations on Tornado Refuge Areas, Hardened Areas, and Safe Rooms

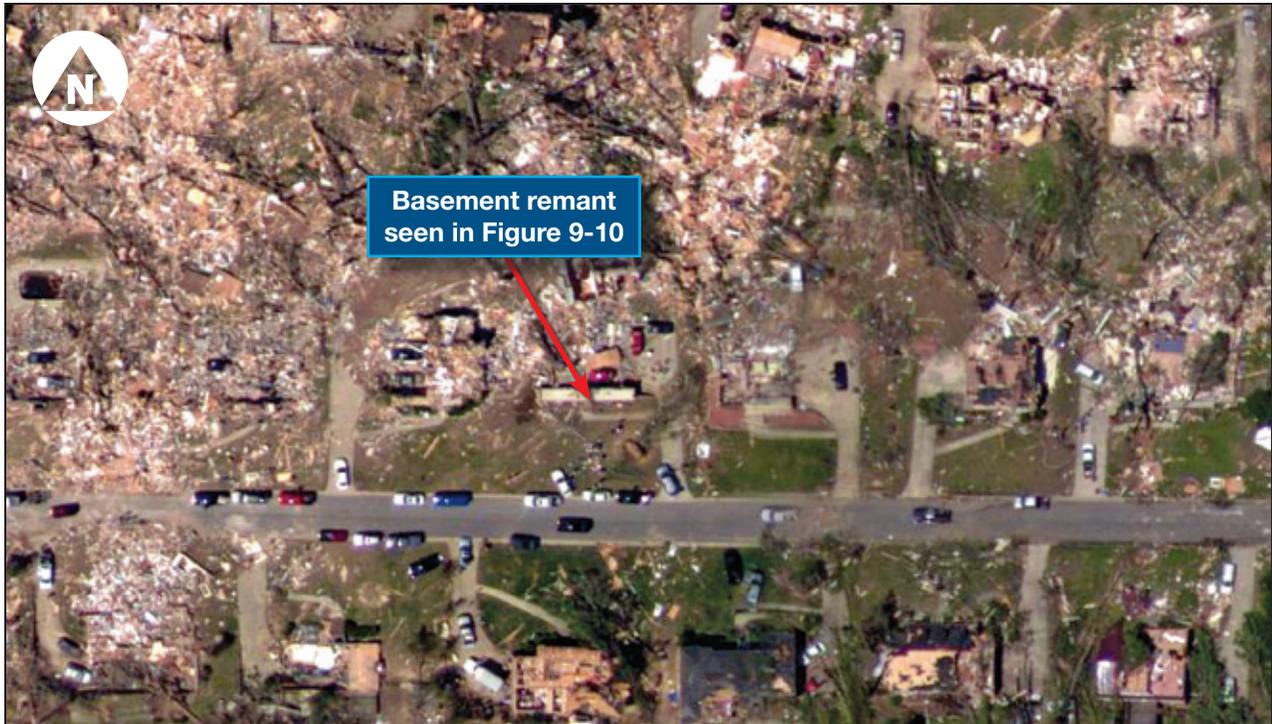
The Pleasant Grove neighborhood outside Birmingham, AL, was directly struck by a tornado (Figure 9-9). The NWS rated the center of the tornado circulation as EF4 in this portion of its track. Many homes in this neighborhood were destroyed, resulting in several fatalities.⁴ In several of the destroyed homes, residents sought refuge in their basements, but they were not always safe.

Figure 9-9: Aerial view of the Pleasant Grove, AL, neighborhood.
NOTE: TRACK DAMAGE CENTERLINE IS NOT IN THE FRAME SHOWN HERE.

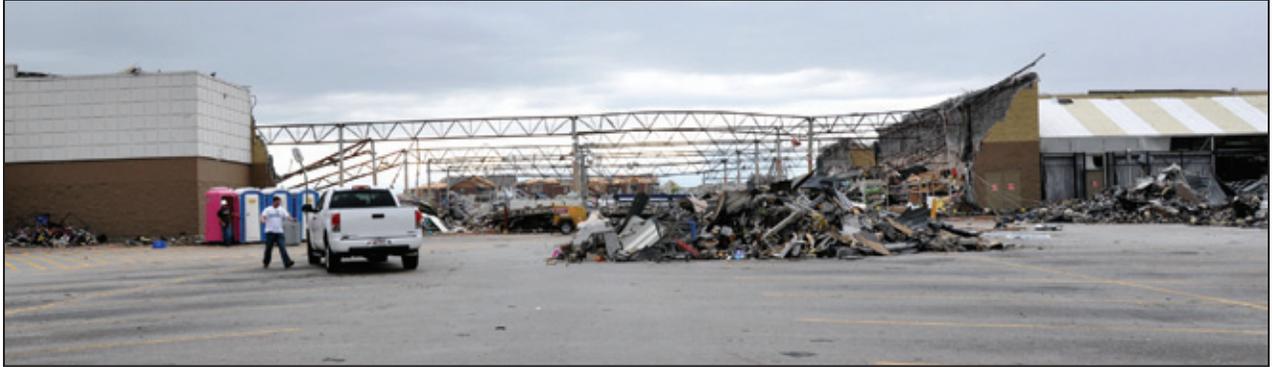
Figure 9-12: Walmart store in Joplin, MO

Although not a public shelter or designated community tornado refuge area, a Walmart store in Joplin, MO, had a disaster plan that provided guidance on where to take refuge during a tornado. Over 200 people sought refuge inside the store during the May 22, 2011 tornado. The damage swath centerline of the tornado that devastated Joplin was located just a few hundred feet from the building (Figures 9-12 and 9-13). The NWS rated the center of the tornado circulation as EF4 in this portion of its track. Employees gathered everyone inside the store in break rooms, rest rooms, and

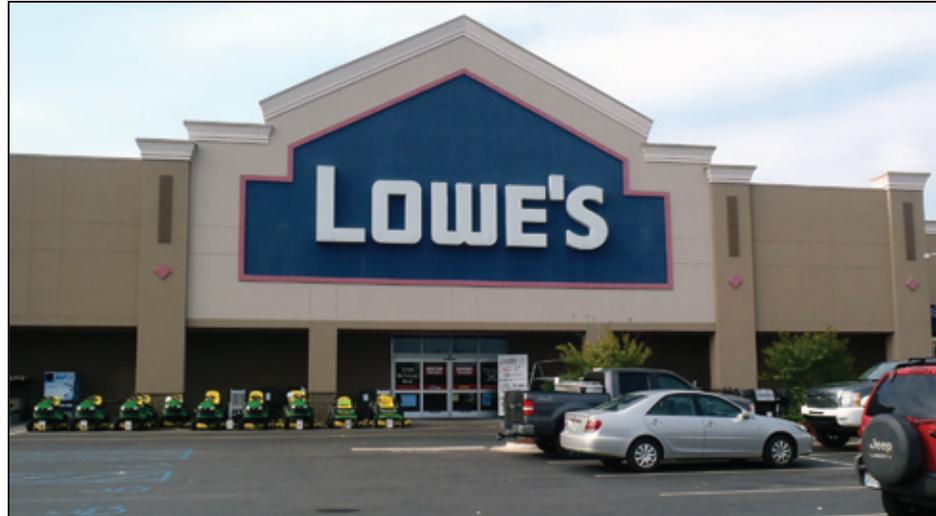
The Lowe's Home Improvement store in Tuscaloosa, AL (Figure 9-14), was a site where individuals who heard the tornado warning gathered to seek refuge. Although it was not impacted by a tornado, the MAT visited the site. The Lowe's store had an emergency response flipchart that clearly described the action to be taken by store employees during an emergency, including tornadoes (Figure 9-15). The tornado procedure included what to do for a tornado watch, tornado warning, response procedure, and post-tornado procedures.

Figure 9-14:
Lowe's Home Improvement
building (Tuscaloosa, AL)

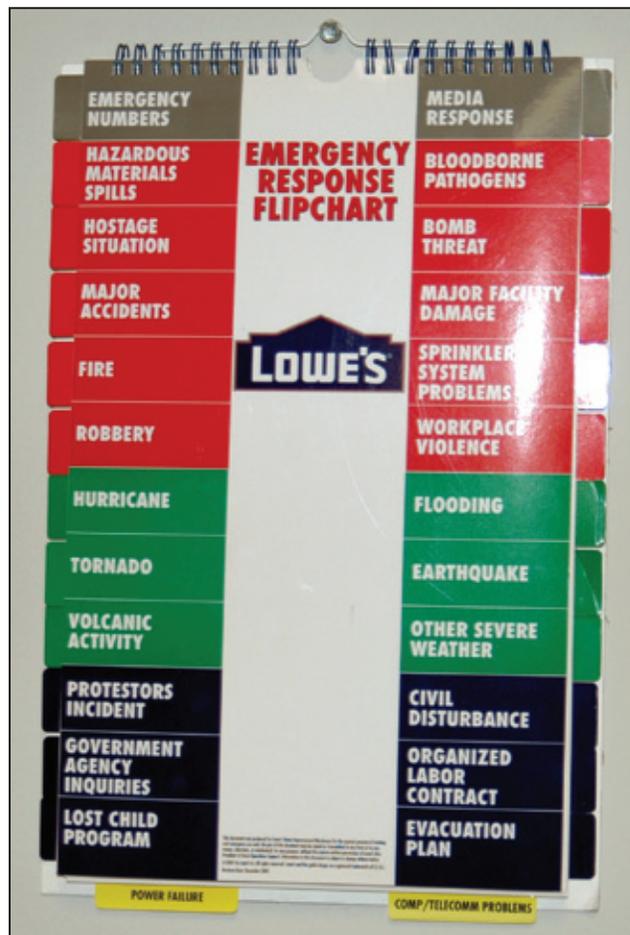
Figure 9-15:
Lowe's Emergency Response
Flipchart (Tuscaloosa, AL)

The store manager had been advised of an updated procedure recently issued by Lowe's corporate officials after a tornado struck a Lowe's store in North Carolina just weeks before. The response plan originally called for customers inside the store to be moved to the center aisles of the building, away from exterior walls and windows. In the updated plan, employees were instructed to move everyone to the front of the store into areas with multiple walls defining the space. At this store location, the front of the store was identified in the updated response plan as the designated area for use during tornado events. These smaller rooms were identified in the hopes they would provide better protection for employees and patrons based on similar areas of the North Carolina store performing better during a tornado. This part of the store was primarily unreinforced CMU construction and drop ceiling. The MAT could not determine if this portion of the building had been assessed for use as a tornado refuge area or evaluated to be a best available refuge area.

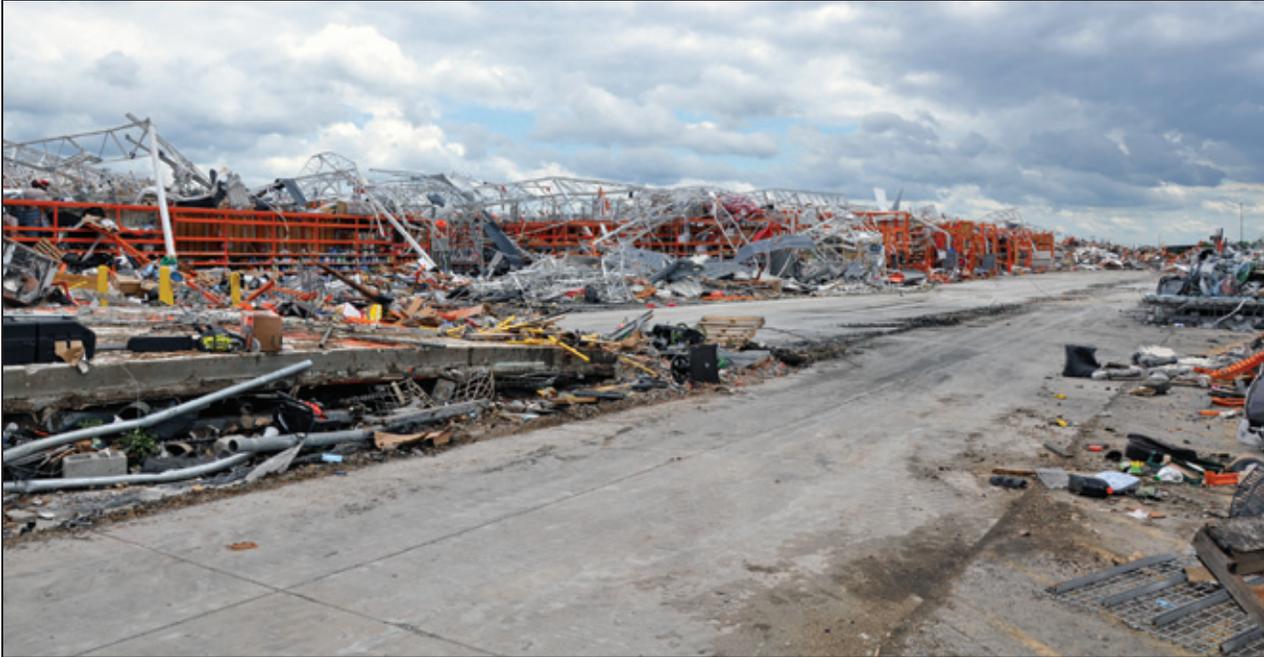
The Home Depot in Joplin, MO, was struck by a direct hit from a very intense tornado on May 22, 2011 (Figure 9-16). The NWS rated the center of the tornado circulation as EF4 to EF5 in the vicinity of this building. Individuals in the area who heard the tornado warning attempted to seek refuge at this store. As discussed in Section 5.1.3 of this report, the roof of the store was torn off and the building's massive concrete tilt-up panels collapsed, resulting in seven fatalities in different locations in the store.

Employees listened to the weather radio and followed the standard emergency plan put in place by the company. As part of the emergency plan, all doors in the store were locked in an attempt to secure the building and reduce the risk of inflow of air, which could compromise the roof system of the building by causing uplift. There were two fatalities at the front of the store. People from the

Figure 9-16: Home Depot after the May 22, 2011 tornado (Joplin, MO)

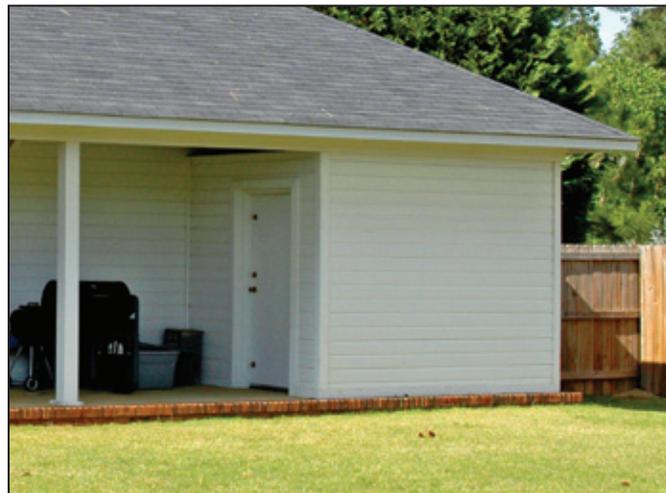
Figure 9-24 shows an above-ground safe room that was added to the exterior of an existing home in Tuscaloosa, AL. This home was not in the path of the tornado that struck Tuscaloosa, but the safe room was used by the resident during the storms. The safe room was placed at-grade on the back porch of the home and matched the existing siding and aesthetics of the home. This particular design was chosen because the homeowner's mother had limited mobility and would not be able to access a below-ground safe room in the event of an emergency. This safe room was constructed with FEMA funds.

Figure 9-24:
Above-ground safe room
that matches the aesthetics
of the home (outside
Tuscaloosa, AL)

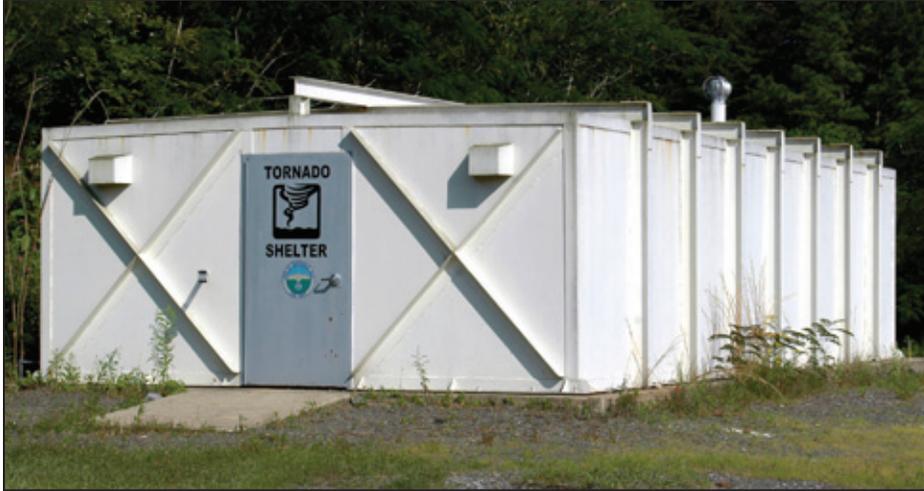
Figure 9-25 shows an above-ground community storm shelter in Graysville, AL. The structure is adjacent to a church and available for residents of the surrounding area to use in the event of a tornado.

Figure 9-25:
Above-ground community
storm shelter (Graysville, AL)

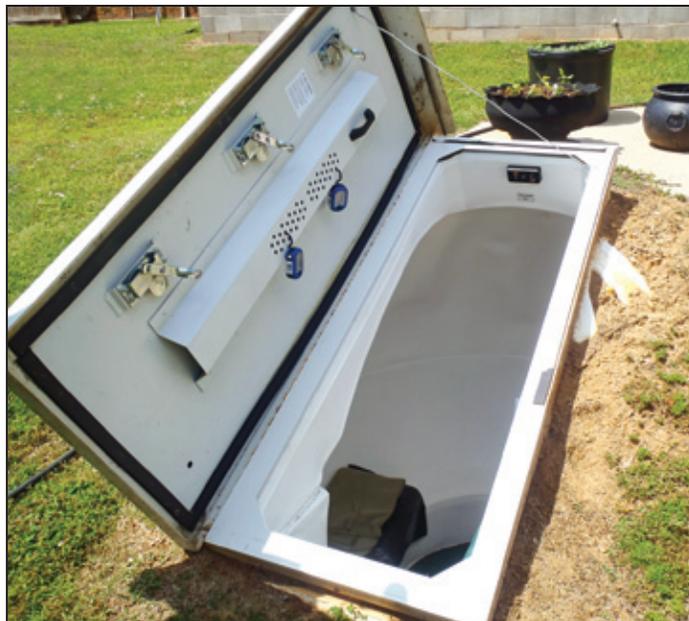
A common safe room design is a stand-alone residential safe room installed below the ground surface outside a house or building. Small stand-alone safe rooms can be constructed to accommodate the occupants of one house, a few houses, or a small apartment building. Building a stand-alone safe room underground can be desirable because it does not take up any additional space within the home or building, and the grade of the surrounding land may lend itself favorably to this design. Figure 9-26 is an example of a below-ground safe room built into the side slope of the back yard of a home in Tuscaloosa, AL. This safe room, constructed in 2008 and funded in part through FEMA grant programs, was placed about 20 feet away from the home and could be reached quickly during a storm. This particular model is large enough to accommodate 10 people comfortably. It is a prefabricated unit, and the door and portions of the safe room that are above ground were tested to show compliance with FEMA 320 criteria. This safe room was occupied during the April 25–28, 2011 tornado outbreak, but this site was not struck by a tornado.

Figure 9-26:
Below-ground FEMA-
funded residential safe room
(Tuscaloosa, AL)

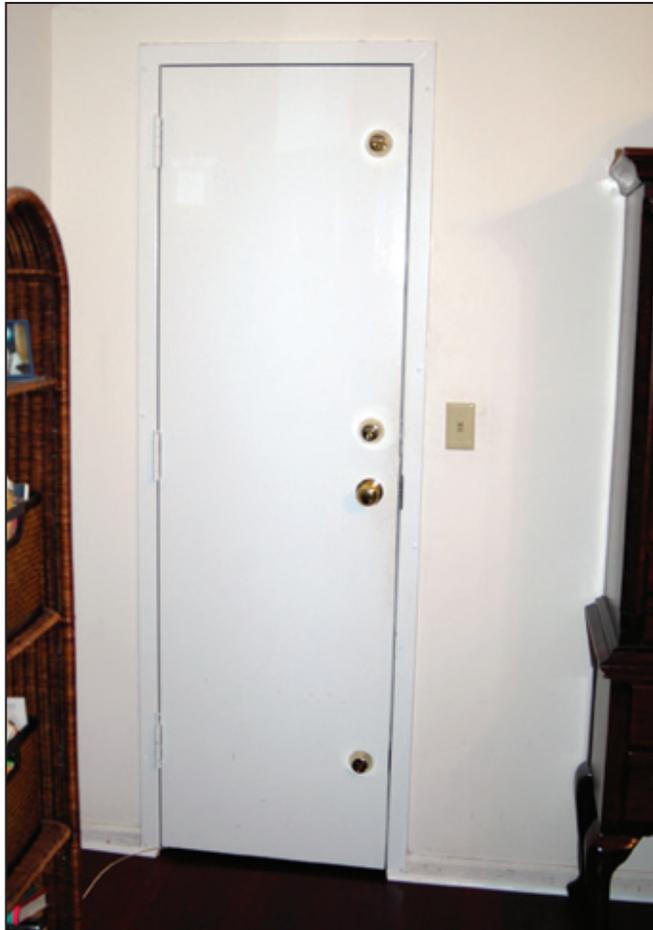
Safe rooms and storm shelters can be prefabricated or site-built, depending on the needs of the owner and the specific site limitations. If constructed correctly to FEMA or ICC criteria, both types can provide life-safety protection. Safe rooms built within existing homes or as part of new construction projects tend to be site-built because there is usually limited access to position a prefabricated safe room or storm shelter. Figure 9-27 is an example of a residential site-built safe room constructed in the master bedroom closet of an existing home in Tuscaloosa, AL, using one of the designs presented in FEMA 320. The above-ground, wood-frame safe room with steel sheathing was used (see Drawing No. AG-06, sheet 11 of 18 [FEMA 1999b]). This safe room was constructed in 2002, funded in part through FEMA grant programs. The safe room was completely contained by the existing structure and very well concealed. The residents of this home used the safe room during the April 25–28, 2011 tornado outbreak, but this site was not struck by a tornado.

Figure 9-27:
Site-built FEMA-funded
residential safe room
(Tuscaloosa, AL)

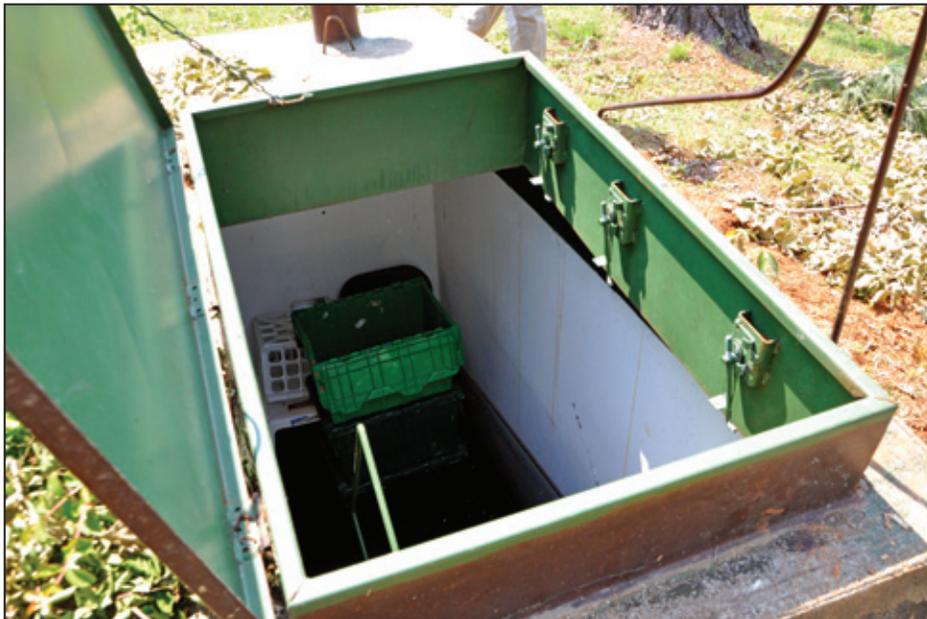
In Tuscaloosa, AL, four people survived an EF2 tornado (as rated by the NWS) in the below-ground FEMA-funded safe room shown in Figure 9-28. The grab bar to the right of the safe room was bent by a fallen tree that trapped the family in the safe room until a neighbor cut the tree away from the door. This safe room was installed in 2001 and complies with the FEMA 320 criteria for residential safe rooms in place at the time.

Figure 9-28:
Below-ground FEMA-
funded residential safe room
(Tuscaloosa, AL)

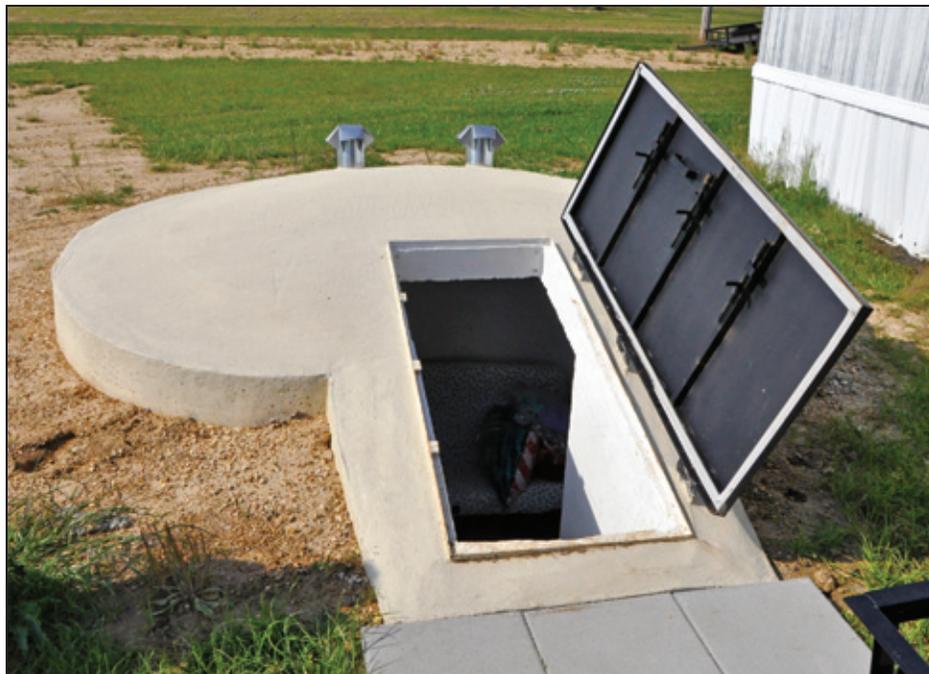
The concrete below-ground safe room shown in Figure 9-29 was in a rural area outside of Smithville, MS, and provided shelter for the occupants of a manufactured home. On April 27, 2011 the homeowner and nine other family members and neighbors, as well as one dog and two cats, took shelter in this FEMA-funded safe room. The shelter had a tested door assembly. Though the area was not struck by the storm, the occupants were comforted and protected by their safe room.

Figure 9-29:
FEMA-funded residential
safe room (Smithville, MS)

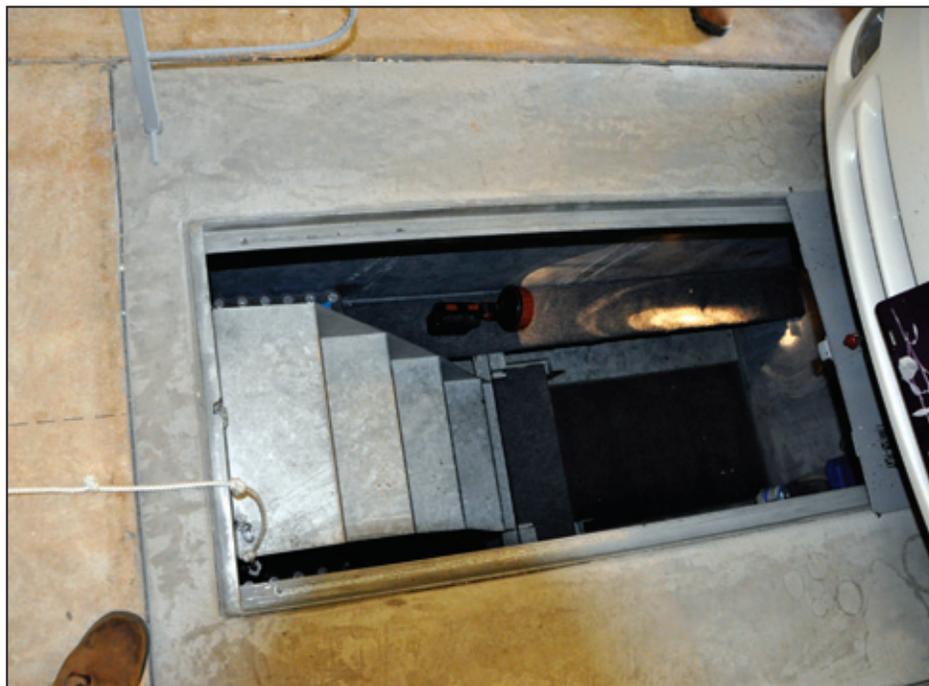
The MAT observed the below-ground garage storm shelter shown in Figure 9-30 in Huntsville, AL. This area of Huntsville was placed under two separate tornado warnings on April 27. The homeowner and his wife retreated to their storm shelter on both occasions. This house was not ultimately affected by the tornadoes, though it sustained damage when a tree fell on it as a result of the strong winds from the storm. Though not a FEMA-funded safe room, the shelter is ICC 500-compliant and

Figure 9-30:
Below-ground garage shelter
(Huntsville, AL)

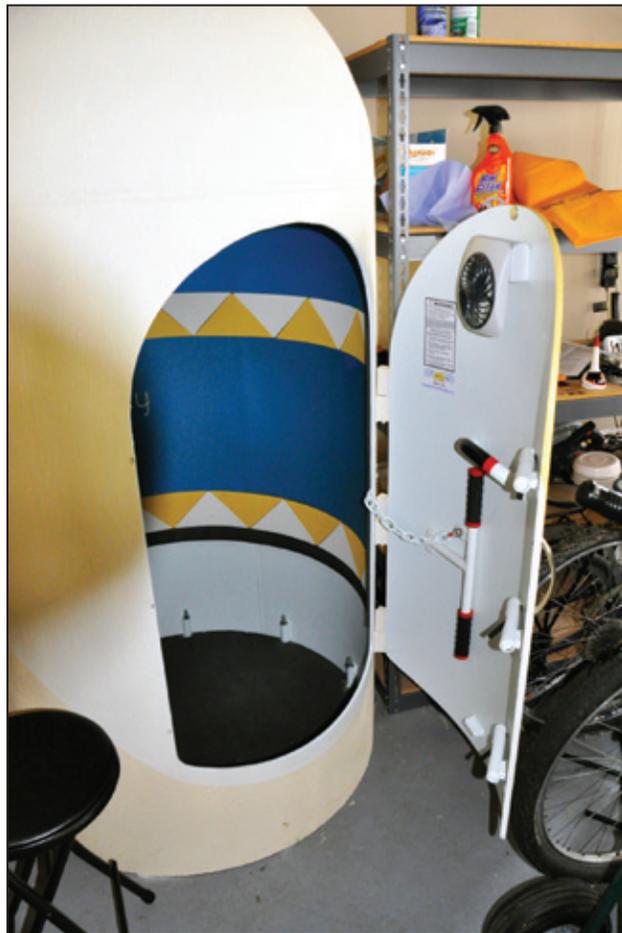
In the Village of Providence in Huntsville, AL, the MAT found the small and unique above-ground storm shelter shown in Figure 9-31. The shelter was not funded by FEMA, but was ICC 500-compliant and was constructed and installed by an NSSA member company. A husband and wife sought shelter here during both tornado warnings issued on April 27, 2011 for the Huntsville area.

Figure 9-31:
ICC 500-compliant storm
shelter (Huntsville, AL)

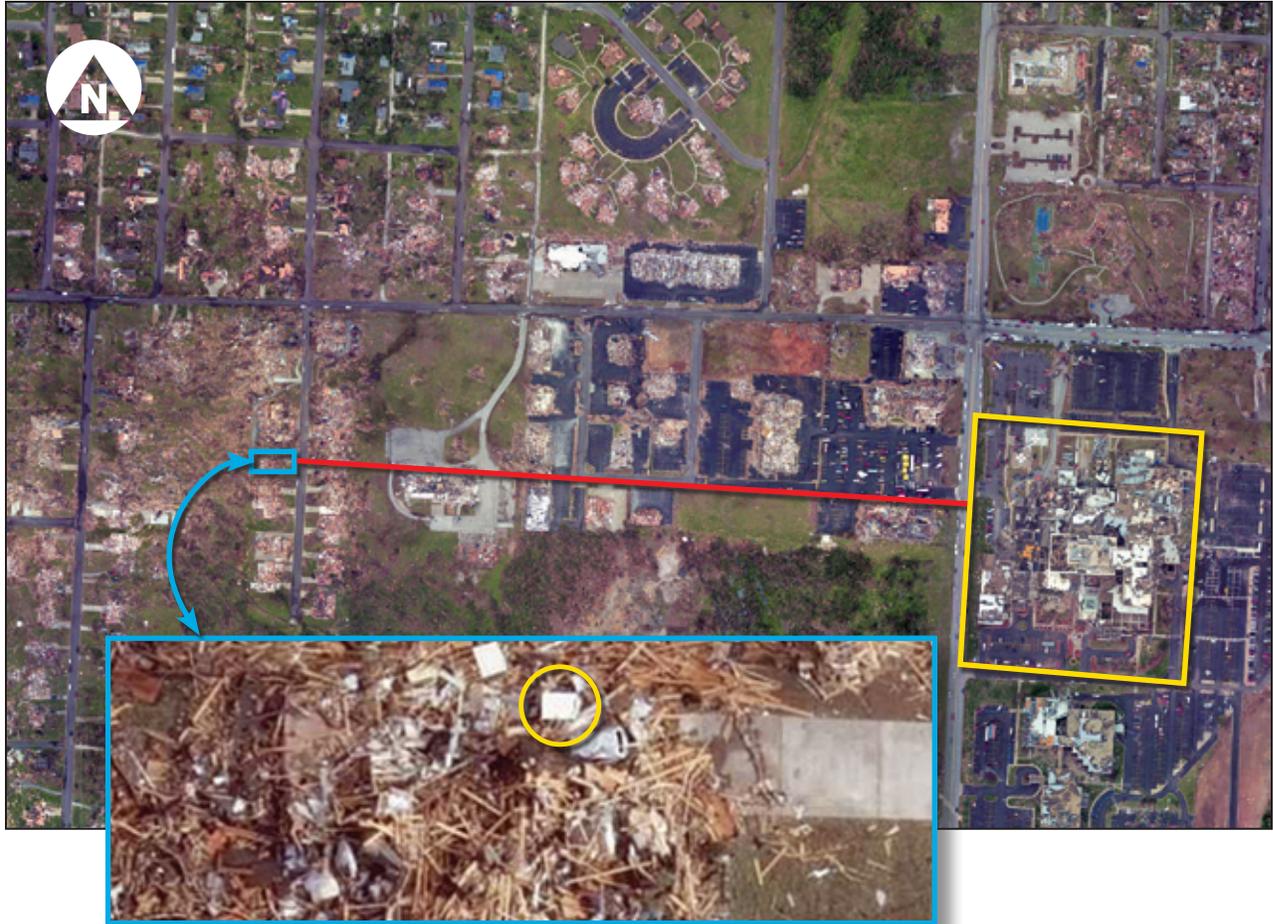
Amidst the massive destruction of the violent tornado that struck Joplin, MO, on May 22, 2011 the MAT discovered the safe room shown in Figure 9-32; its location is shown in Figure 9-33. A family of two walked out of their safe room, only to find their home and their neighborhood totally destroyed. The safe room was anchored to the concrete slab where the garage once stood. The safe room door was locked with multiple locking points and used four hinges. This shelter design was tested at TTU. Installed with no FEMA or Federal funding assistance, the safe room effectively protected the occupants during the historic May 22, 2011 Joplin, MO, EF4 tornado event.

Figure 9-33: Proximity of the residential safe room shown in Figure 9-32 (circled in yellow in the inset) to the approximate centerline of the Joplin, MO, tornado damage swath (red line). The safe room was located 0.5 mile west of the heavily damaged St. John's Medical Center (shown by yellow box and described in Section 7.1.4.)

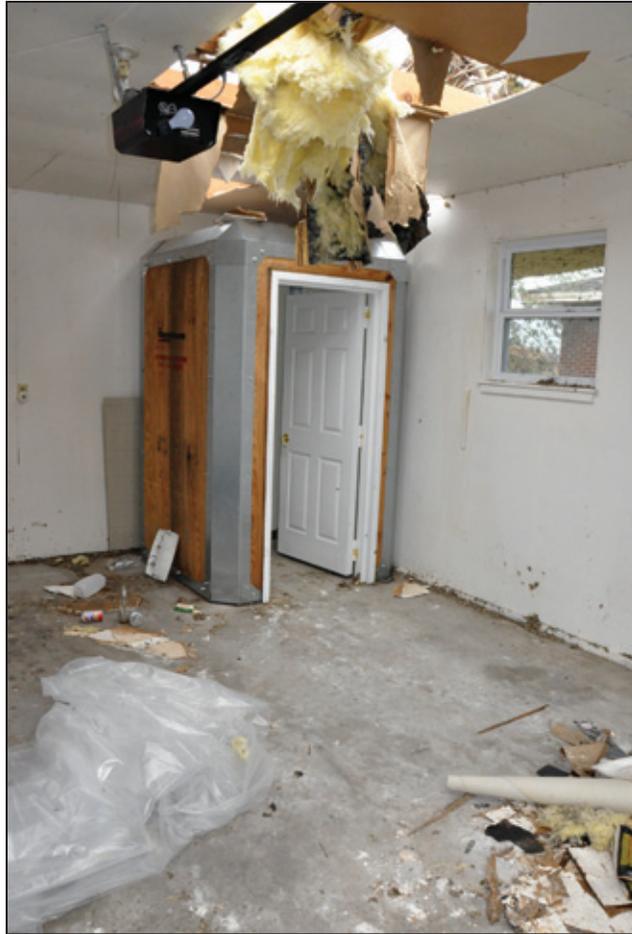
TTU assisted the manufacturer of the in-residence safe room shown in Figure 9-34 in researching and developing its design and performed all the debris impact testing to meet the residential safe room criteria set forth in FEMA 320 and FEMA 361. The home and its safe room were on the periphery of the violent May 22, 2011 Joplin, MO, tornado. The NWS rated the center of the tornado circulation in the vicinity of this home as EF2. The roof structure of the home was lifted up and glazing damage occurred.

Figure 9-34:
Residential safe room
(Joplin, MO)

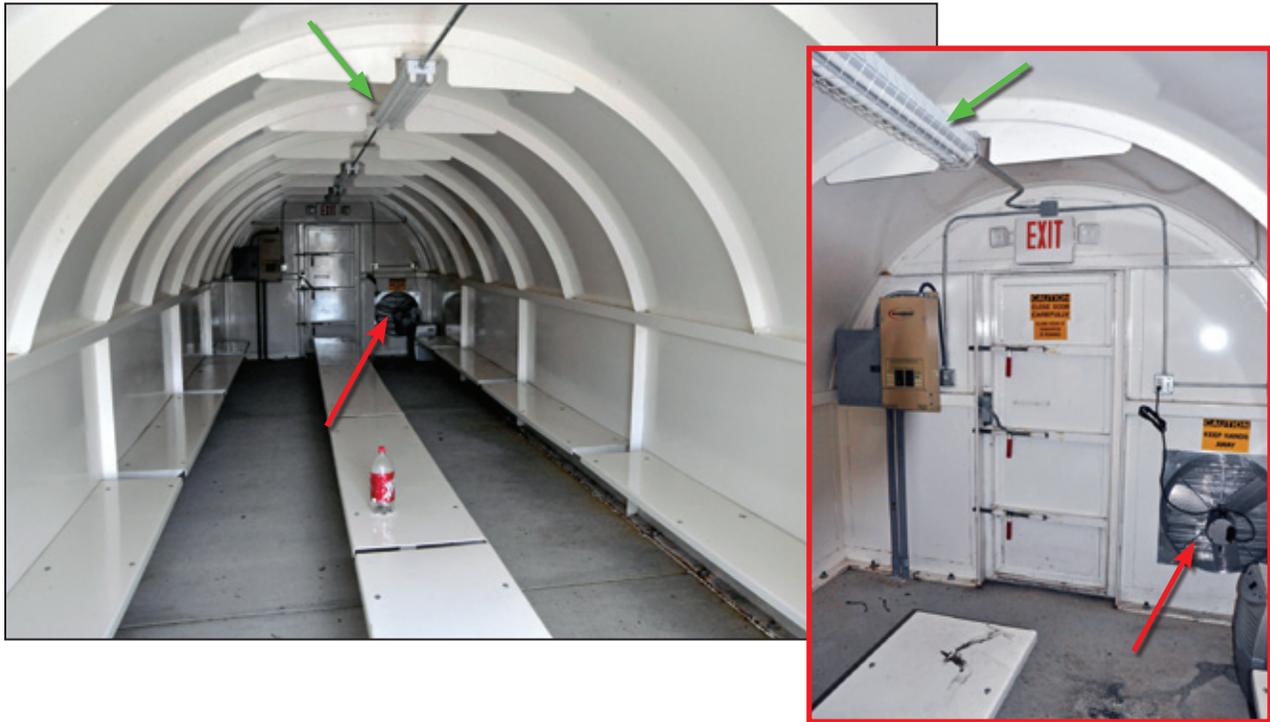
The community of Phil Campbell, AL, was struck by a violent tornado on April 27, 2011. The NWS rated the center of the tornado circulation for this tornado as EF4. Hundreds of homes were damaged or destroyed, and 27 lives were lost according to a local representative. On top of a hill, away from most of the devastation, was Phil Campbell's FEMA-funded community safe room (Figure 9-36), which housed 60 residents on the day of the storm. The safe room door and panel system was tested in the Debris Impact Test Facility at TTU and meets FEMA 361 debris impact guidelines. The safe room and door is heavy gauge steel and the shelter is partially buried into the hill. An emergency generator (located in the box outside the door of the safe room) supplies electricity for lighting and the mechanical ventilation system. The generator is protected by an impact-resistant enclosure, and the ventilation system is protected from debris impacts with heavy steel shrouds. Figure 9-37 shows the inside of the safe room and the seating arrangement.

Figure 9-37: Interior of the community safe room shown in Figure 9-36 featuring seating, emergency lighting (green arrows), and ventilation (red arrows); inset is a close-up of the entrance door (Phil Campbell, AL)

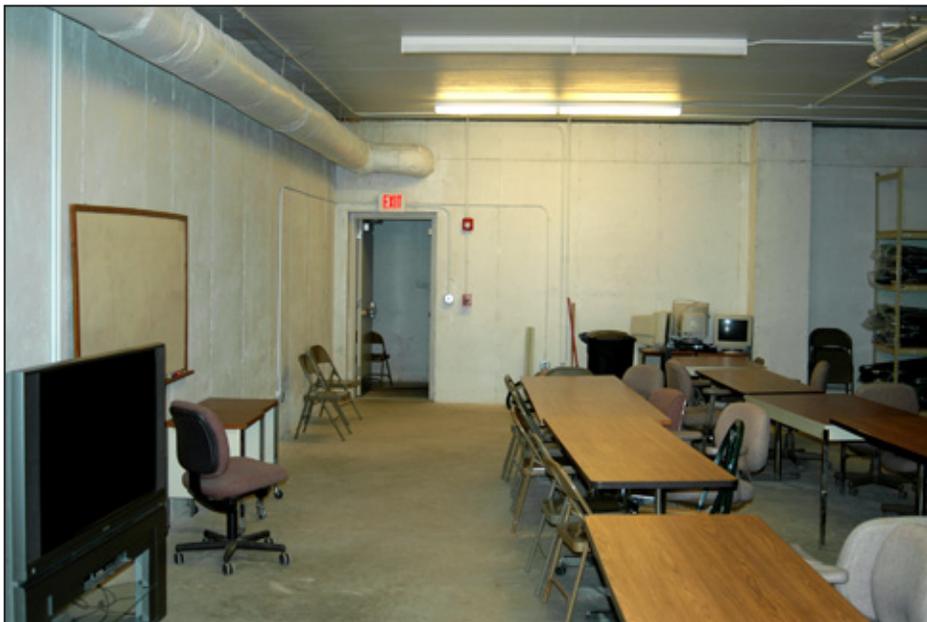
Figure 9-39:
Interior view of the well-furnished community safe room shown in Figure 9-38 (Brookside, AL)

There are two entrances to the safe room, one of which has a lift so disabled occupants can access it. The structure can shelter over 300 occupants. The safe room has tools, equipment, bedding, and other support elements in adequate supply for the safe room occupants. Although an emergency generator is on site for backup power, it is not protected from wind-borne debris (red arrow in Figure 9-38). Figure 9-39 shows the interior of the safe room.

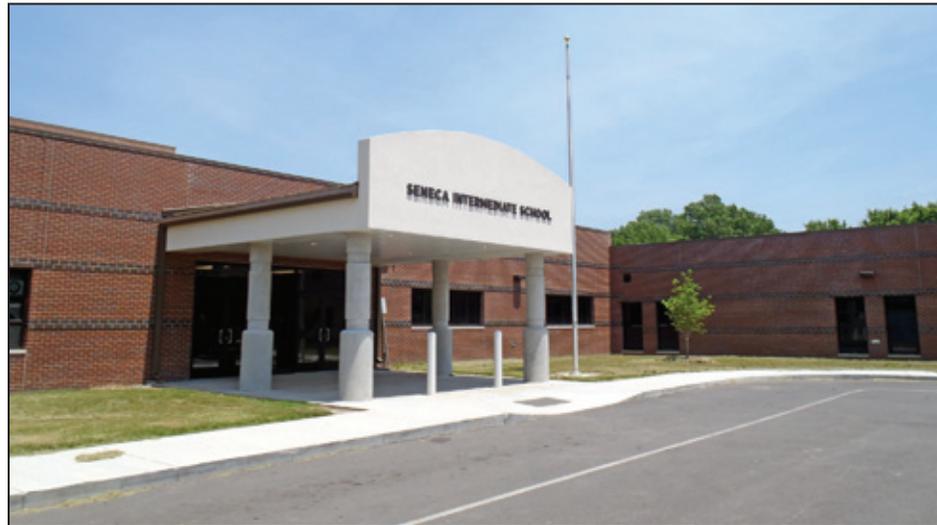
After suffering damage from a tornado in May of 2008, the City of Seneca, MO, built a new Intermediate School (Figure 9-40). Using FEMA HMGP funding, the school designed the cafeteria and gymnasium as a FEMA 361 community safe room (Figures 9-41 and 9-42). This safe room was also constructed to comply with the new ICC 500 storm shelter standard; it was the only safe room visited by the MAT designed to both criteria.

Figure 9-40:
Seneca Intermediate School
(Seneca, MO)

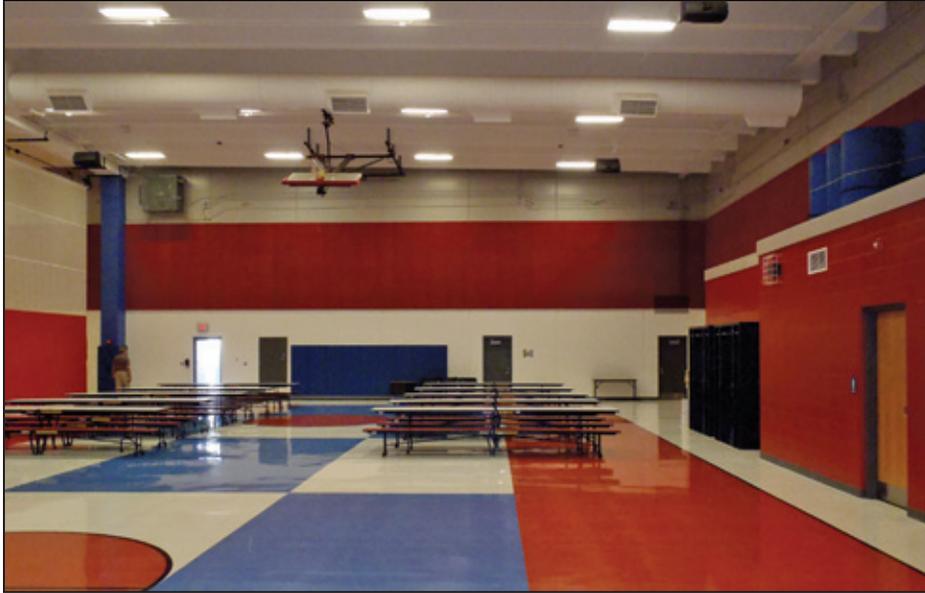
Figure 9-41:
Seneca Intermediate School
safe room in the cafeteria

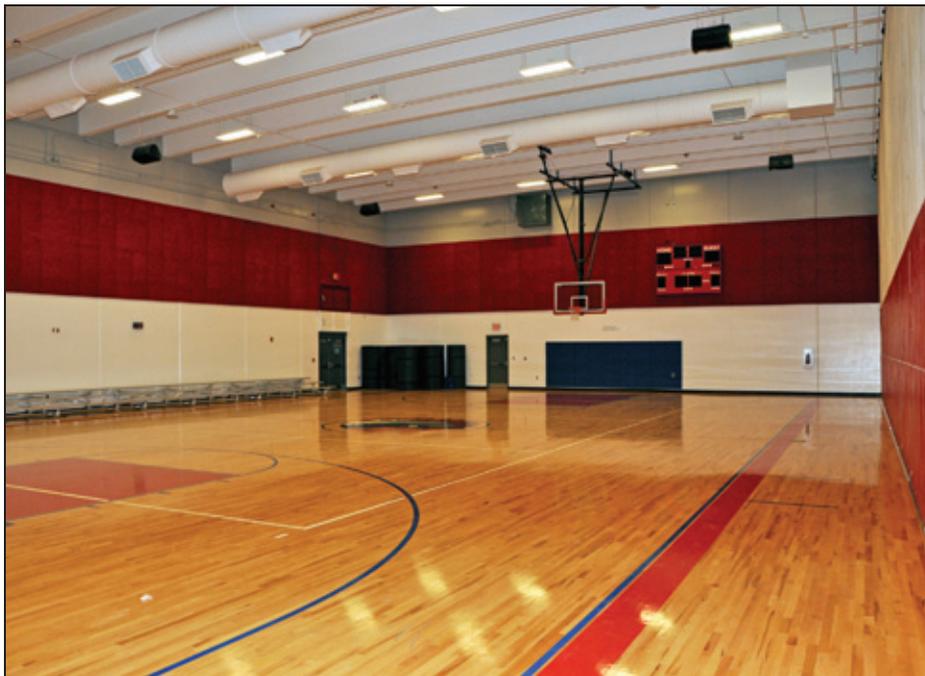
- + The walls are constructed from pre-cast, insulated concrete panels and the roof structure is constructed from precast concrete double tee's (Figure 9-42)
- + All doors are tested FEMA 361 assemblies (Figure 9-43) and the louvers above doors are protected by alcove entries (Figure 9-44)

Figure 9-42:
Seneca Intermediate School
gymnasium safe room

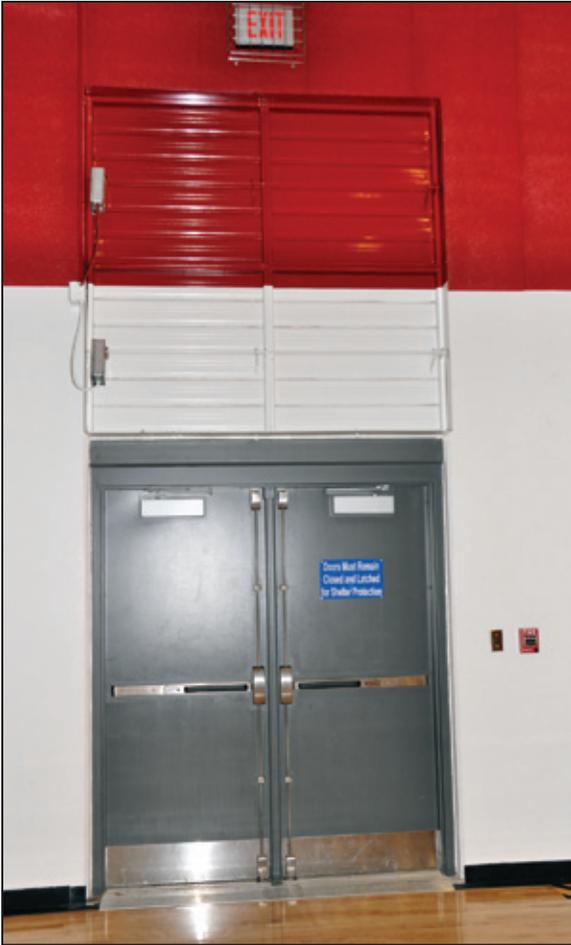
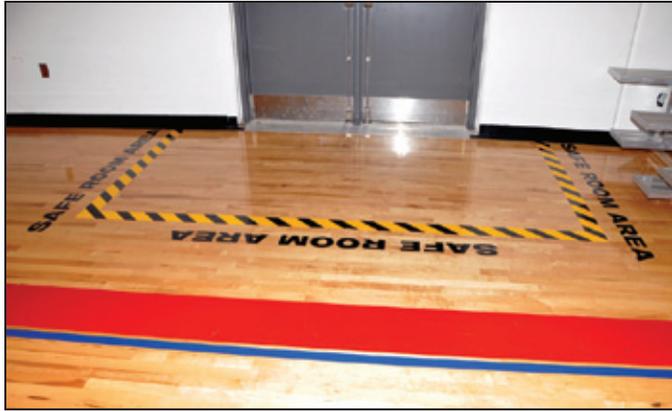
Figure 9-43:
Doors and ventilation louvers in Seneca Intermediate School community safe room

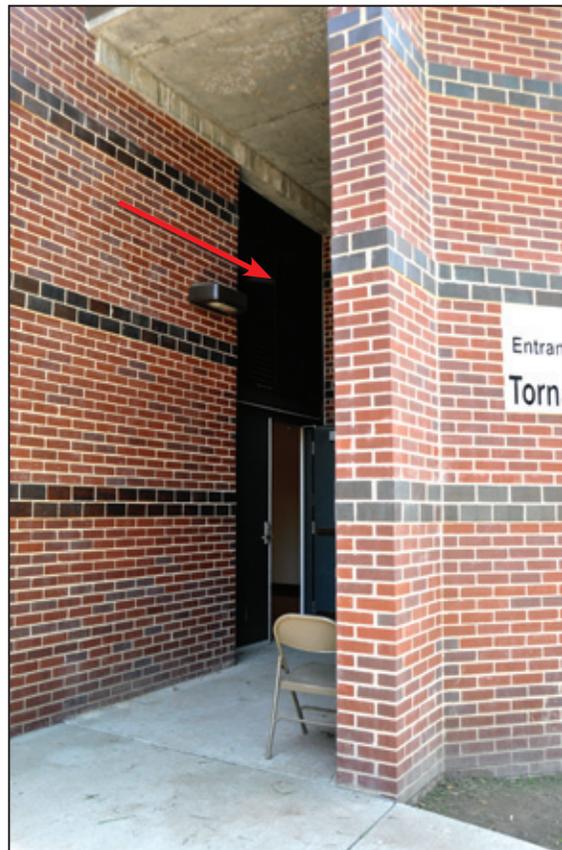
Figure 9-44:
Outside doors and louvers (red arrow) protected by alcoves at the Seneca Intermediate School community safe room

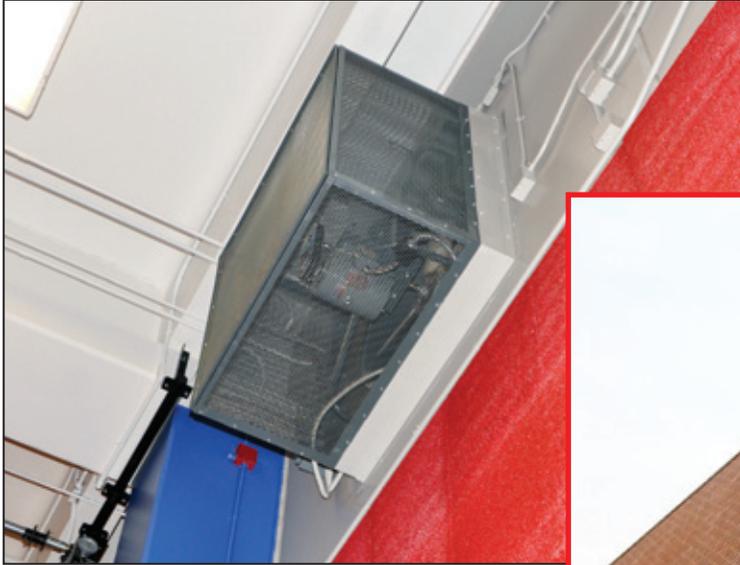
- + Elevated ventilation units are protected on the outside wall with heavy steel shrouds (Figure 9-45)
- + The generator building was similarly constructed with heavy wall and roof construction, tested doors, and steel shrouds over ventilation openings (Figure 9-46)

Figure 9-45:
Elevated ventilator in the Seneca
Intermediate School community safe room.
Inset shows the exterior shroud.

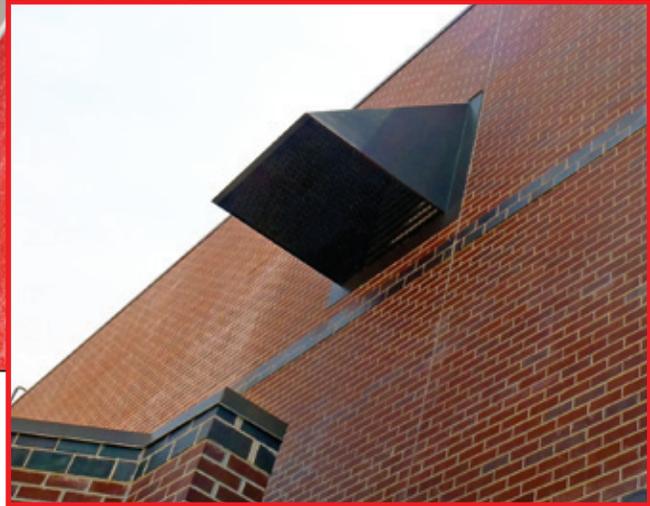
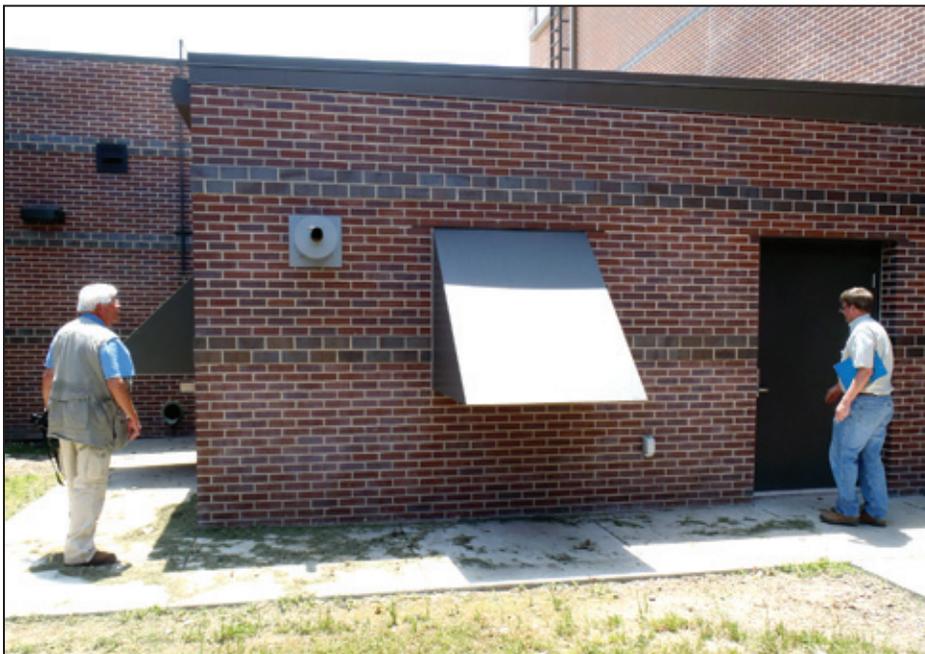
Figure 9-46:
Emergency generator
building for the community
safe room at the Seneca
Intermediate School
