# FEMA Mitigation Assessment Team Report on Hurricane Ivan

Bill Coulbourne, P.E.

June 2, 2005

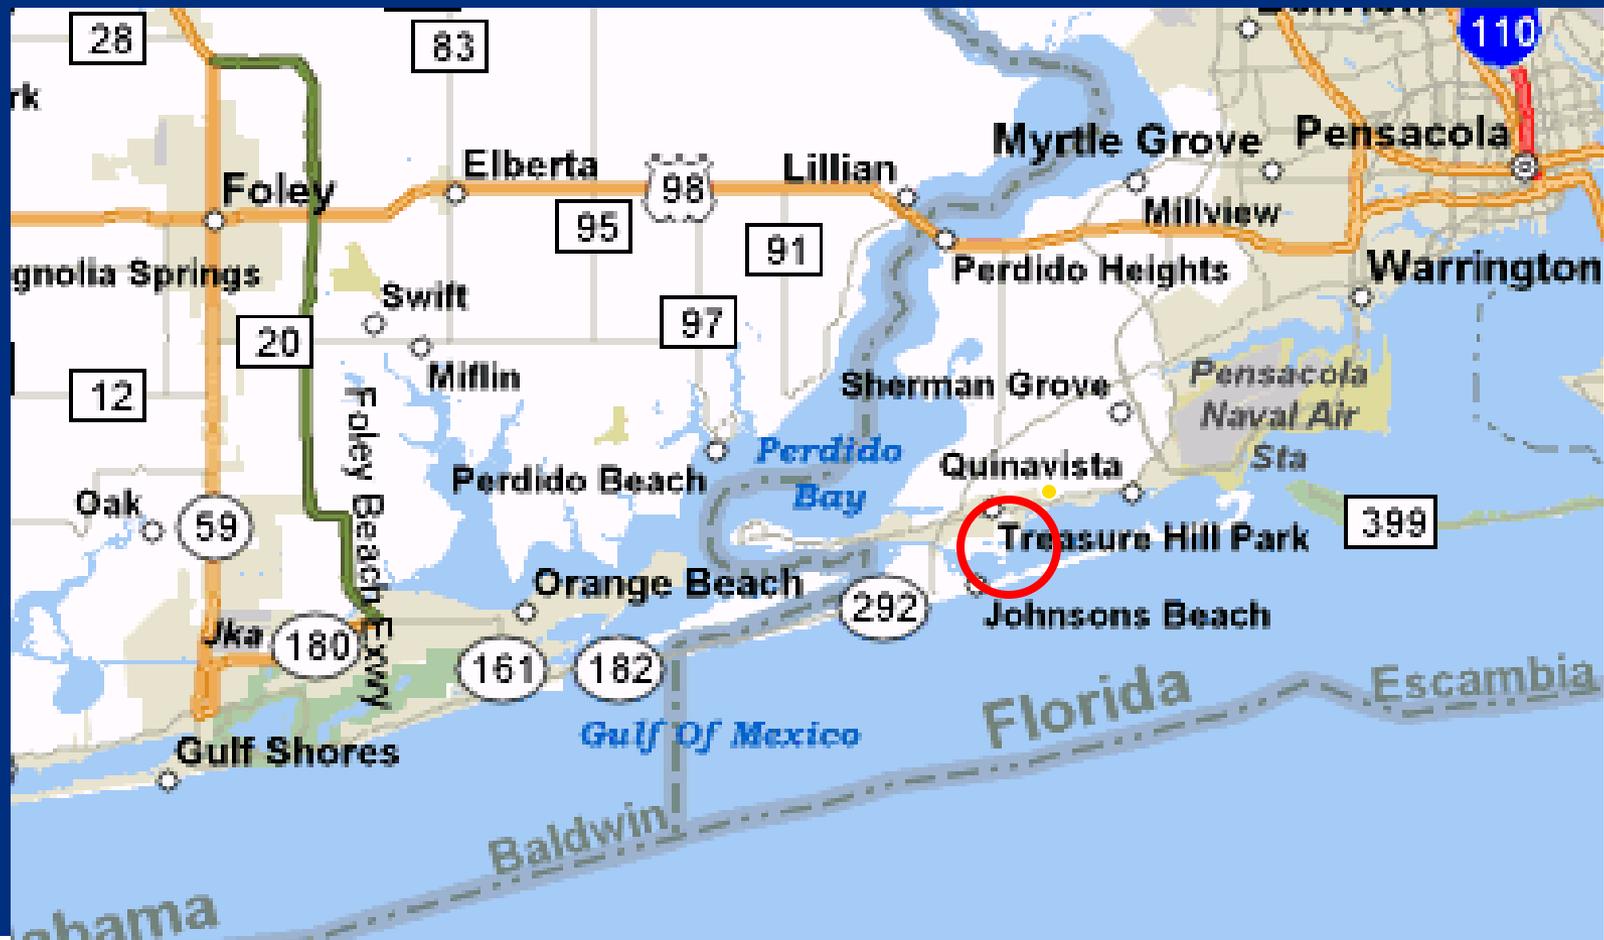
## Grand Lagoon Neighborhood

# Flood Damage – Bayfront Homes

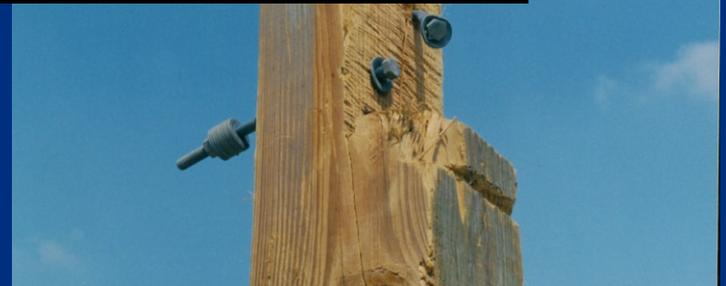
- *pile-supported*, home **~OK** (enclosures lost) = **9**
- *pile-supported*, home **damaged** = **7**
- *pile-supported*, home **detached & destroyed** = **10**
- *masonry column* supported, home **destroyed** = **1**
- *slab*, **swept away** = **5**
