Mitigation Assessment Team Report

Hurricane Isaac in Louisiana

Building Performance Observations,
Recommendations, and Technical Guidance

FEMA P-938 / March 2013

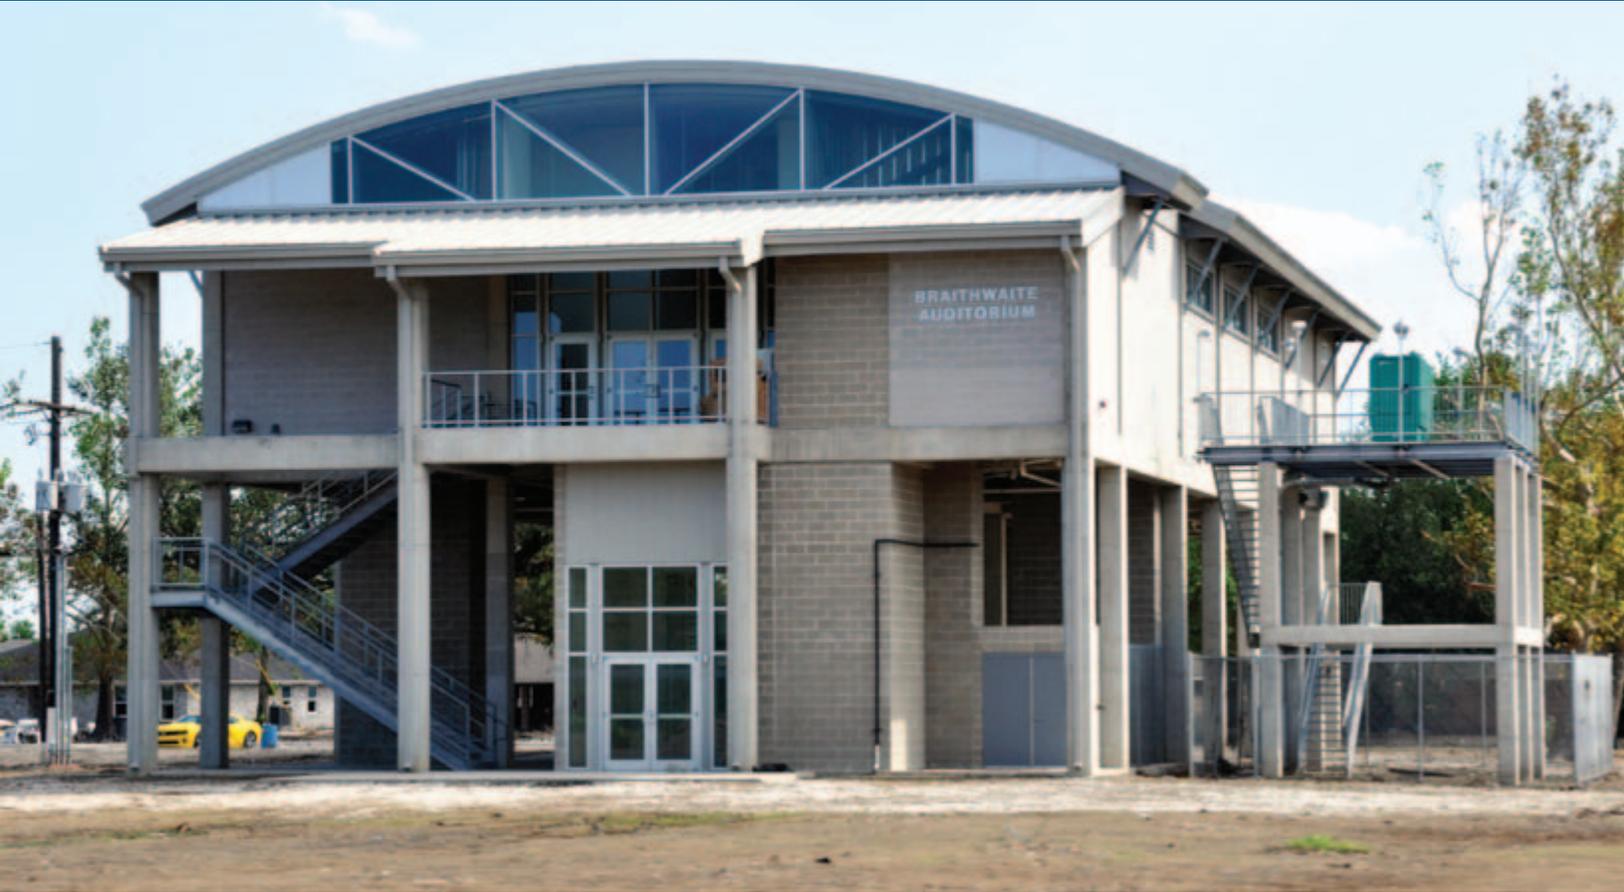
The Braithwaite Auditorium was rebuilt after it was damaged by Hurricane Katrina. The facility was built based on the preliminary Flood Insurance Rate Map base flood elevation (VE 21) and sustained minimal damage during Hurricane Isaac.

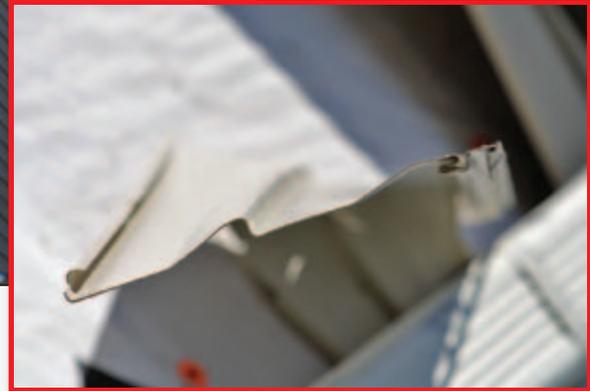
Figure 3-6: Loss of standard vinyl siding to recently elevated residential building; use and/or damage of high-wind siding was not observed by the MAT (Plaquemines Parish, LA).

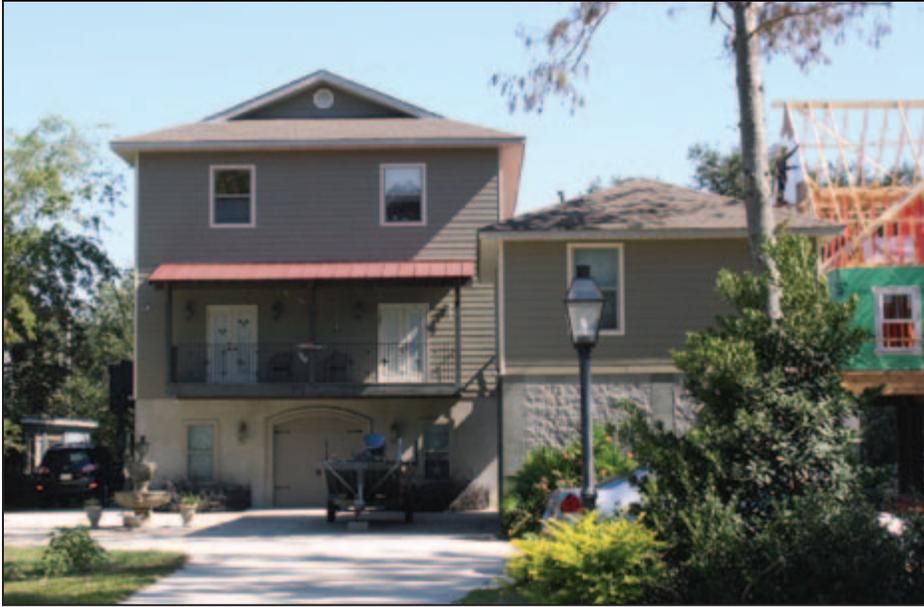
Figure 3-8:
Pilot Mitigation
Reconstruction Program
project; no observed wind
damage (Mandeville, LA).

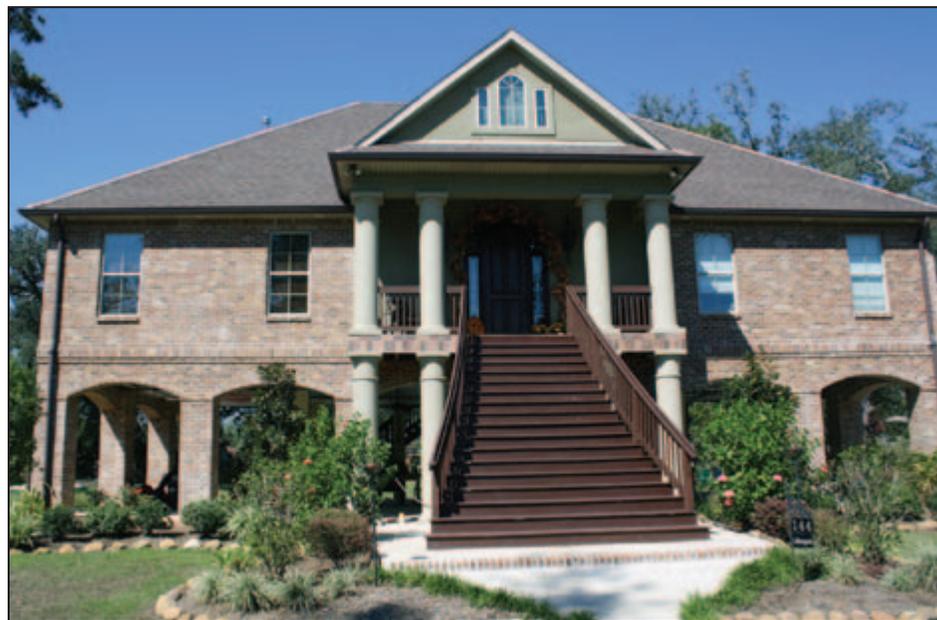
Figure 3-10:
House elevated as part of
the HMGP Pilot Mitigation
Reconstruction Program
(Mandeville, LA).

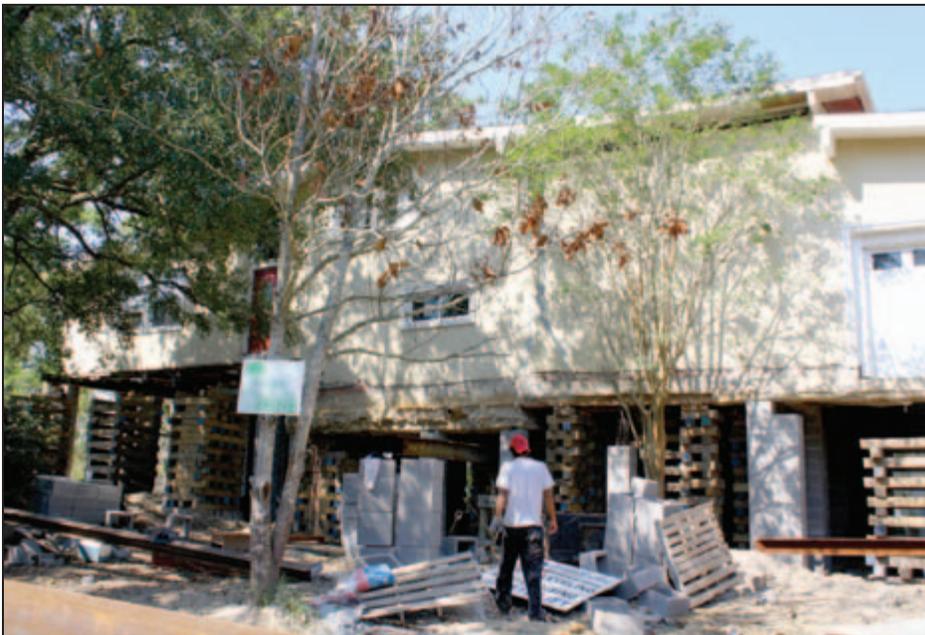
Figure 3-12:
Slab-on-grade elevation in
progress (Slidell, LA).

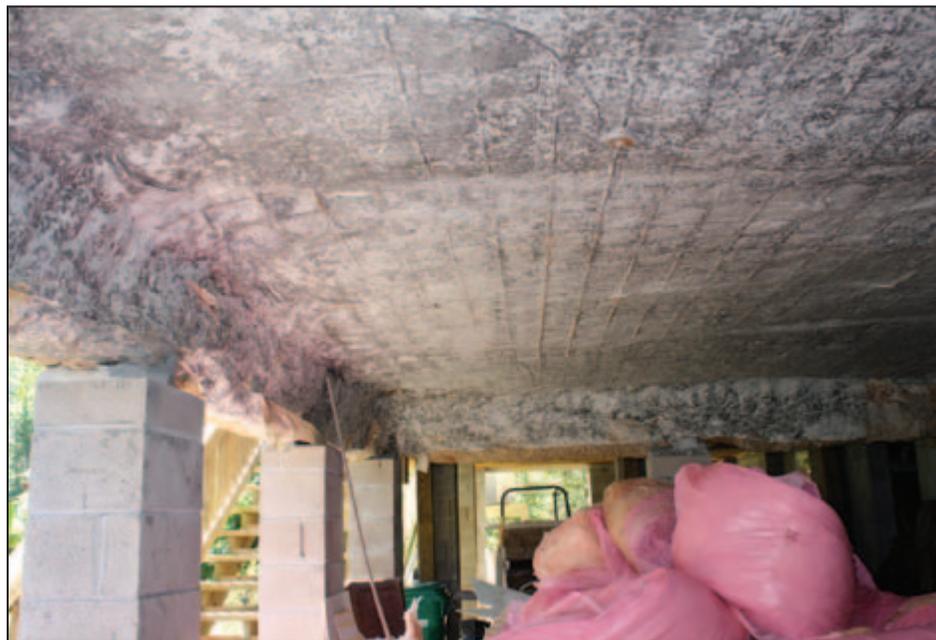
- + **Insufficient slab reinforcement/thickness:** Elevated concrete slabs were often found to be of minimal thickness with limited wire mesh steel reinforcement and/or insufficient concrete cover of the wire mesh, as shown in Figure 3-13. This was also observed in ongoing residential building slab elevation projects with attached garages.

Figure 3-13:
Elevated slab with
insufficient steel cover
(Slidell, LA).

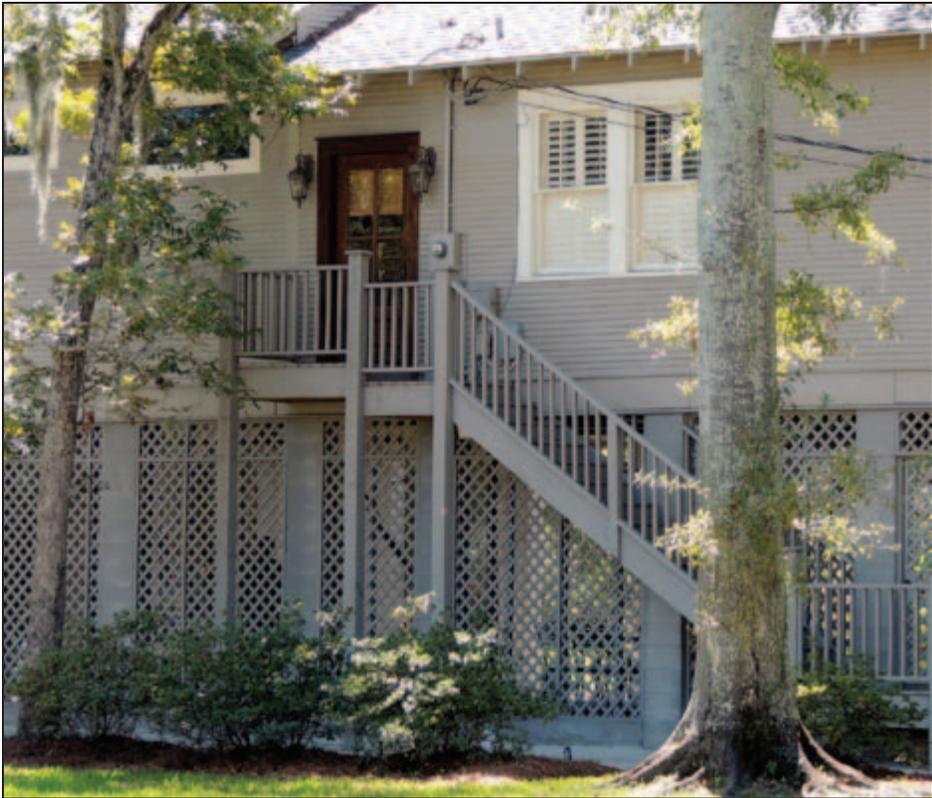
Proper elevation of equipment involves installing it above design flood levels and maintaining access for utility workers and first responders. Figure 3-16 shows an example of elevated electrical service components.

Figure 3-16:
Residential building with electric meter installed adjacent to side entrance (Mandeville, LA).

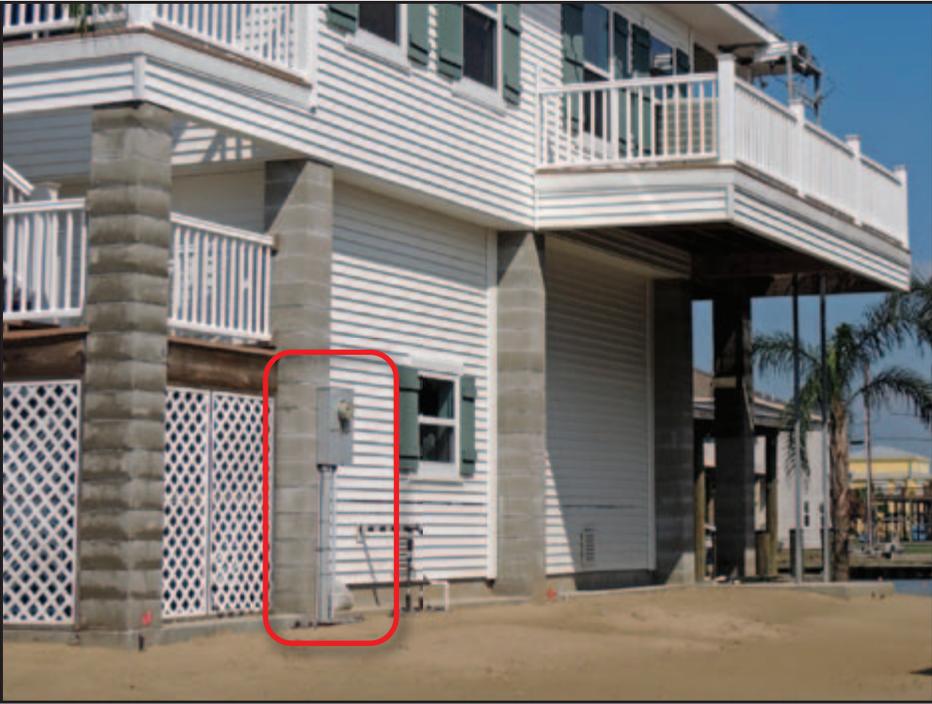
When conditions or local utility company requirements limit elevation of electrical meters and they must be situated below design flood levels, it is critical not to attach utilities to breakaway walls or other building components not designed to resist flood loads. Figure 3-17 shows an example of a home where the utilities are attached to foundation piers. See the *Minimizing Flood Damage to Electrical Service Components Recovery Advisory* in Appendix D for more details on recommended practices for utility placement.

Figure 3-17:
Electric meter attached to foundation pier (Plaquemines Parish, LA).

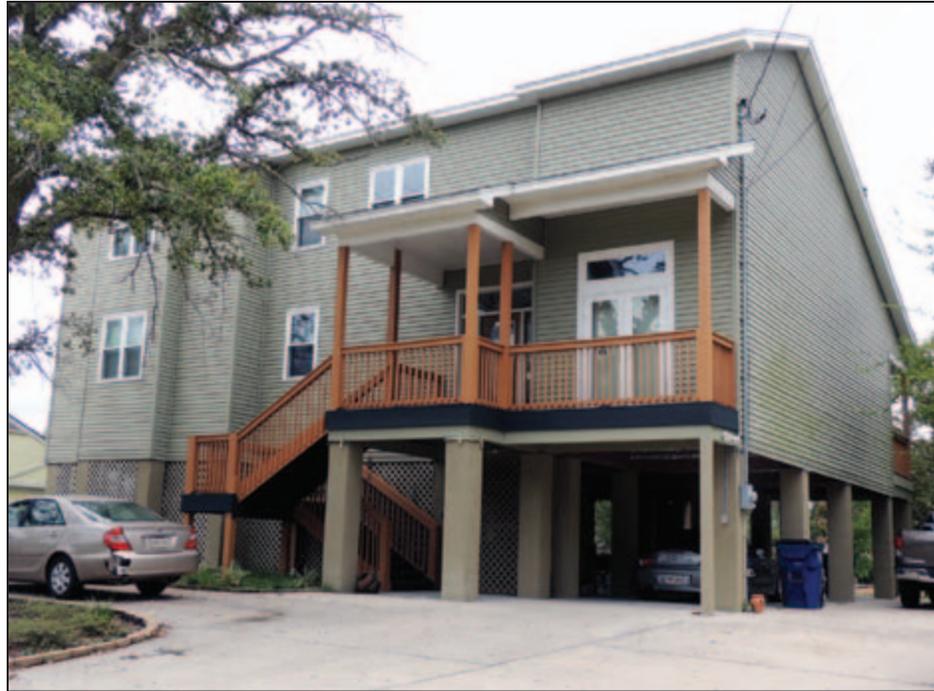
A service drop is an overhead electrical line running from a utility pole to a home. Traditionally, the lines enter residential buildings through a weatherhead that penetrates the roof (see Figure 3-18). The MAT observed service drops along rooftops and along the sides of the houses. At times, vertical clearance requirements constrain the service drop location to rooftops, but in most circumstances there is some flexibility in where the connection is installed. When the service drop was attached to the roof, the MAT observed some instances where a utility pole collapsed or wind-borne debris struck it, causing the weatherhead to shift in a way that tore the roof and allowed water to penetrate. This was less likely when the service drop was installed on the side of the house. Overhead clearance requirements or the locations of the utility pole and the electrical meter may dictate whether a weatherhead is attached to the roof or the side of the house.

Figure 3-18:
Post-Katrina residential
reconstruction with
service drop attached to
the side of house
(Slidell, LA).

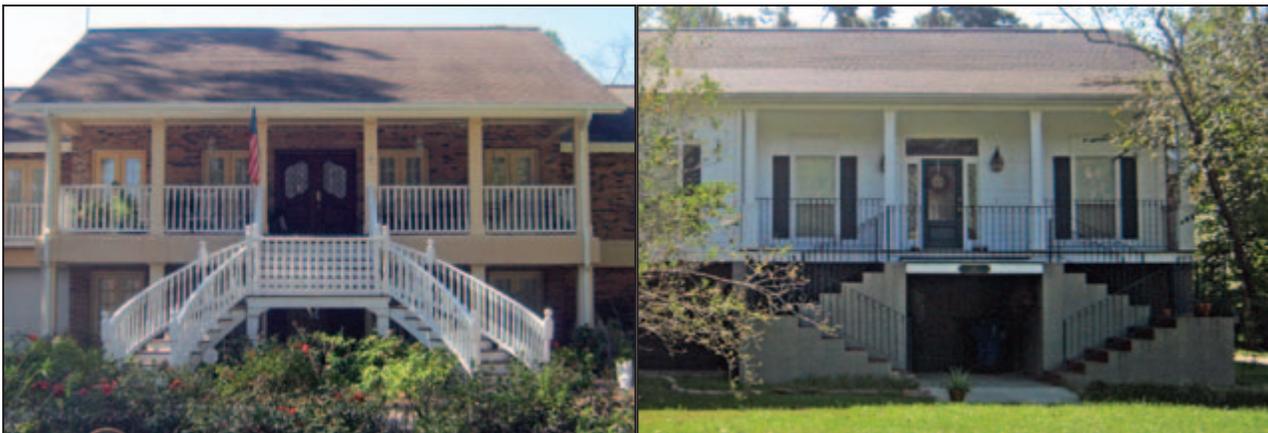
Figure 3-19: Curved and split stair configurations for elevated residential buildings (Mandeville, LA).

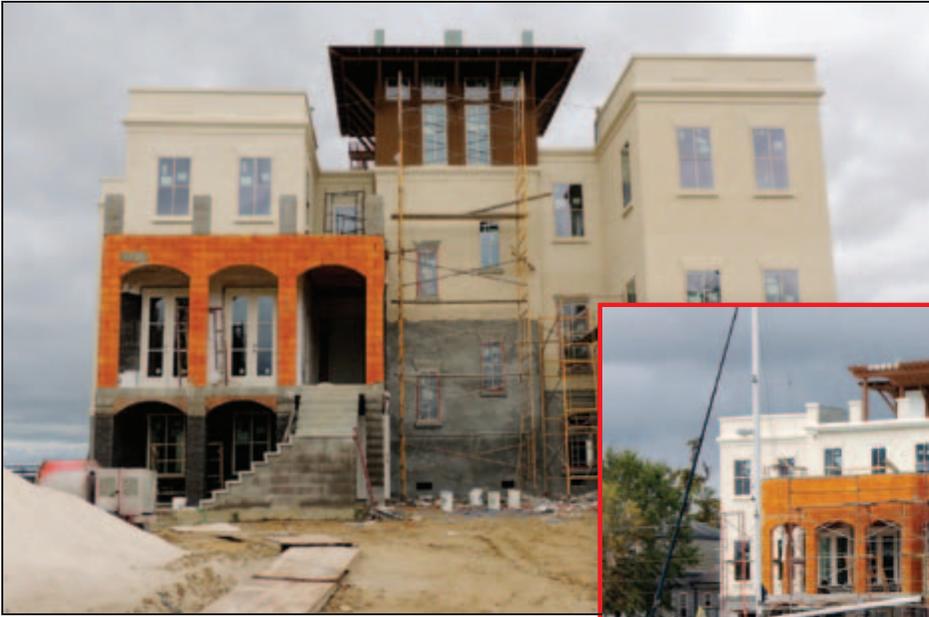
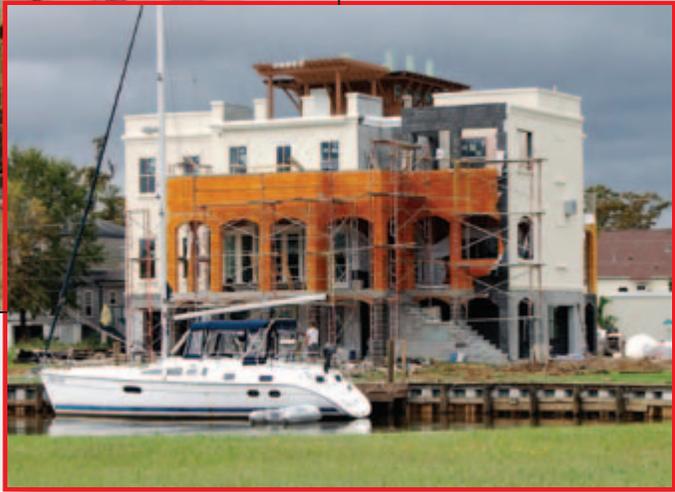
Figure 3-21: Residential building under construction with a partially enclosed area—front closed/rear open with effective BFE of A13 (EL12), Katrina ABFE of Zone AE (EL13), and preliminary FIRM of Zone VE (EL14) (Madisonville, LA).

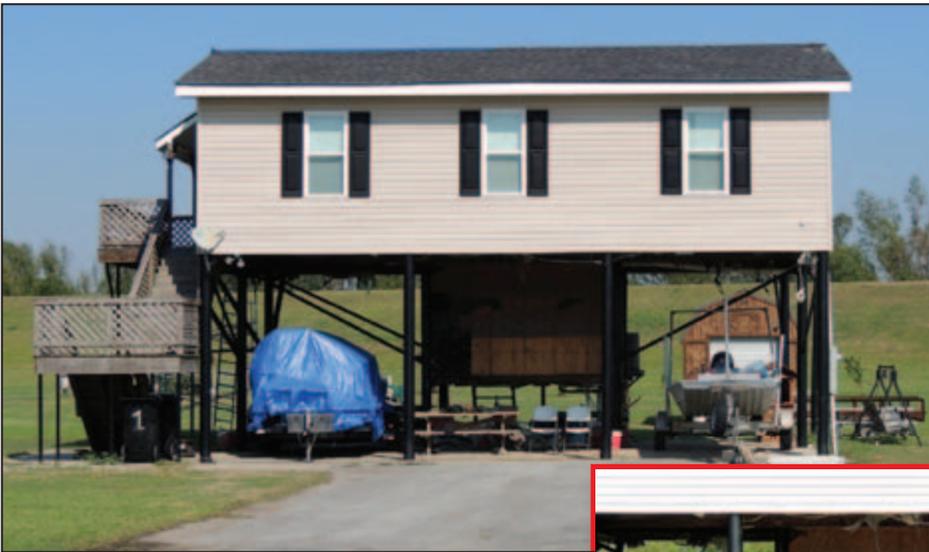
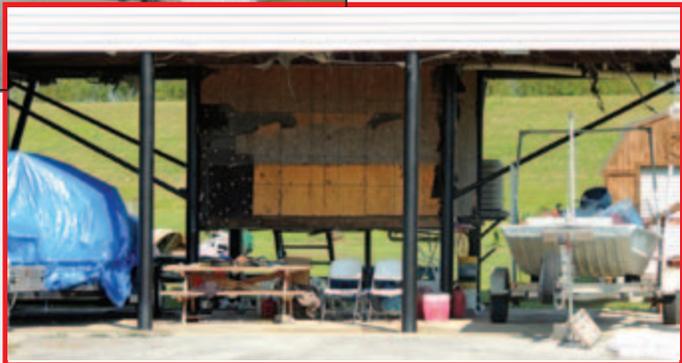
Figure 3-22: Example of above-grade enclosure below elevated residence (Plaquemines Parish, LA).

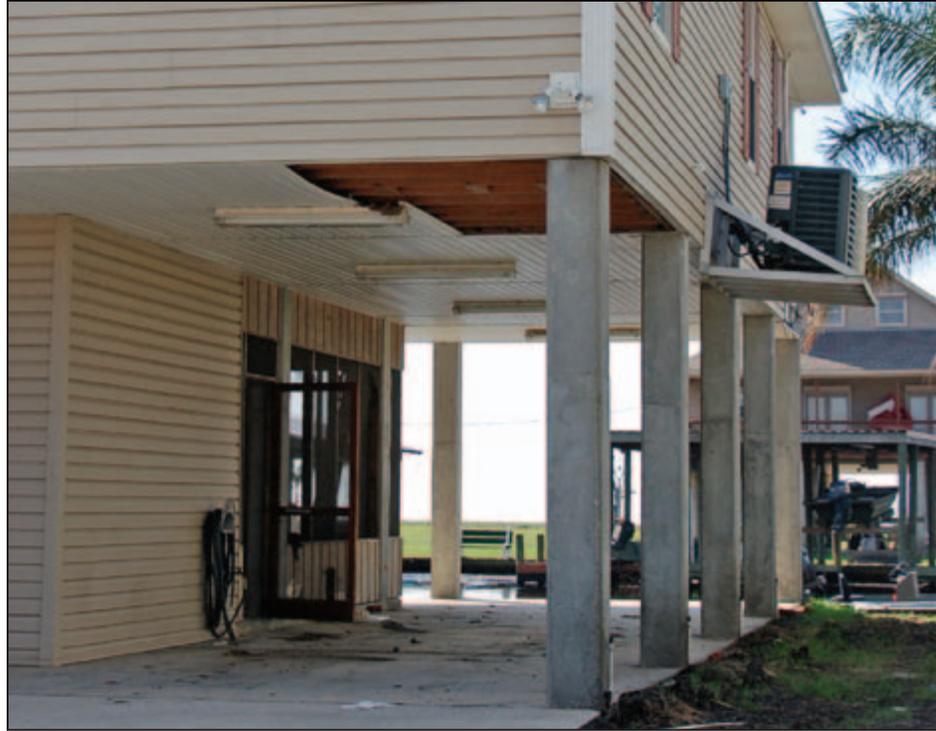
The MAT observed hurricane wind damage to paneling and sheathing on the underside of several elevated homes in Plaquemines Parish. Paneling torn completely away became a source of wind-borne debris with the potential to damage neighboring buildings, and the loss of this layer of protection allowed water infiltration. Figure 3-24 shows an example of a residential building that experienced a loss of sheathing underneath the elevated first floor.

Figure 3-24:
Loss of the sheathing from the underside of an elevated building due to wind gusts (reported to exceed 80 mph) that exceeded the capacity of the vinyl siding (Plaquemines Parish, LA).

Although the wind loads underneath a building are significantly less than those on the roof system, the potential loads imposed on the sheathing system should be calculated to determine the fastener size and spacing required to adequately attach the material. The MAT team observed that, in many instances, vinyl paneling material used to cover the underside of elevated buildings frequently tore at the connection point or failed because fasteners pulled out. Less damage was observed at elevated buildings where the covering material was wood that was properly fastened to the framing above. The use of wood or more rigid materials may not eliminate all damage during high-wind events, but it will minimize the damage. See the *Minimizing Wind and Water Intrusion by Covering the Underside of Elevated Buildings* Recovery Advisory in Appendix D for more details on recommended practices.

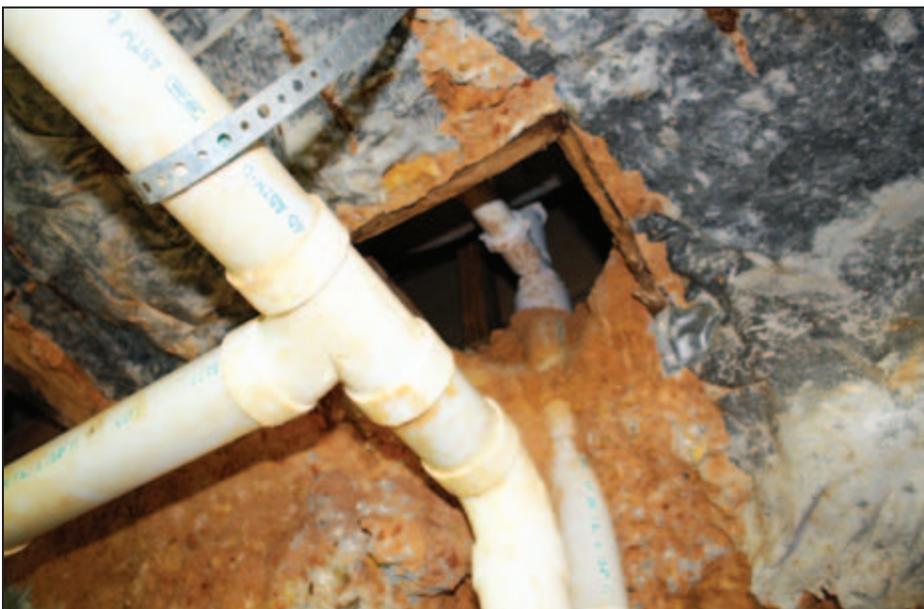
Such conduits, as shown in Figure 3-26, would allow fire beneath the slab to enter the structure. The elevated structure should be constructed in accordance with the IRC or IBC. The 2012 IRC Table R302.6 requires not less than 5/8-inch Type X gypsum board or equivalent for habitable rooms above a garage. See the *Minimizing Wind and Water Intrusion by Covering the Underside of Elevated Buildings* Recovery Advisory in Appendix D for more detail on fire-resistant assemblies in elevated structures.

Figure 3-26:
Elevated house with open space to interior of the home that would allow fire to spread (Mandeville, LA).

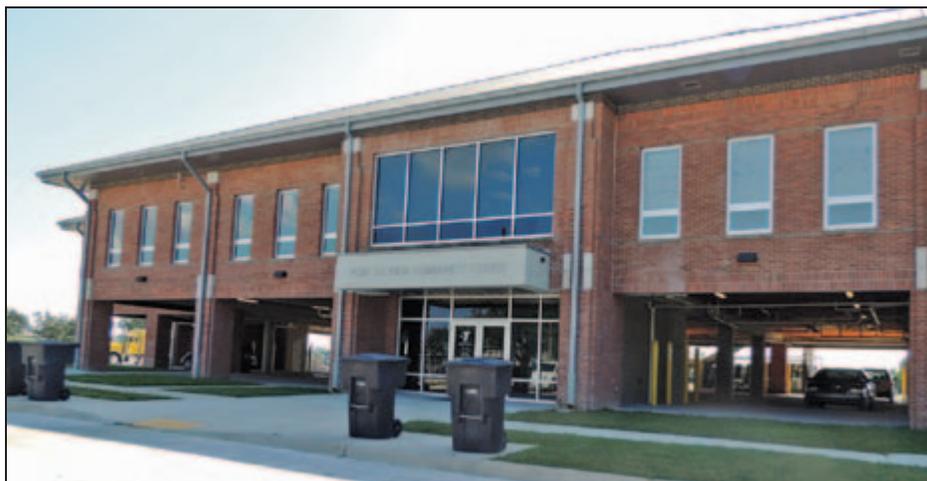
As part of Hurricane Katrina recovery, the Port Sulphur Community Center was constructed in 2010 with FEMA Public Assistance funding (see Figure 4-7). Plaquemines Parish consolidated 10 existing facilities into four community centers with similar construction to the Braithwaite Auditorium. These new centers were built to preliminary FIRM BFE (Zone VE [EL13]) rather than the Hurricane Katrina ABFE (Zone AE [EL 10]). No damage was observed by or reported to the MAT for the Port Sulphur Community Center; there was no flooding in this area.

Figure 4-7:
Recently constructed Port Sulphur Community Center; no damage was observed or reported for the elevated facility (Port Sulphur [West Bank] – Plaquemines Parish, LA).

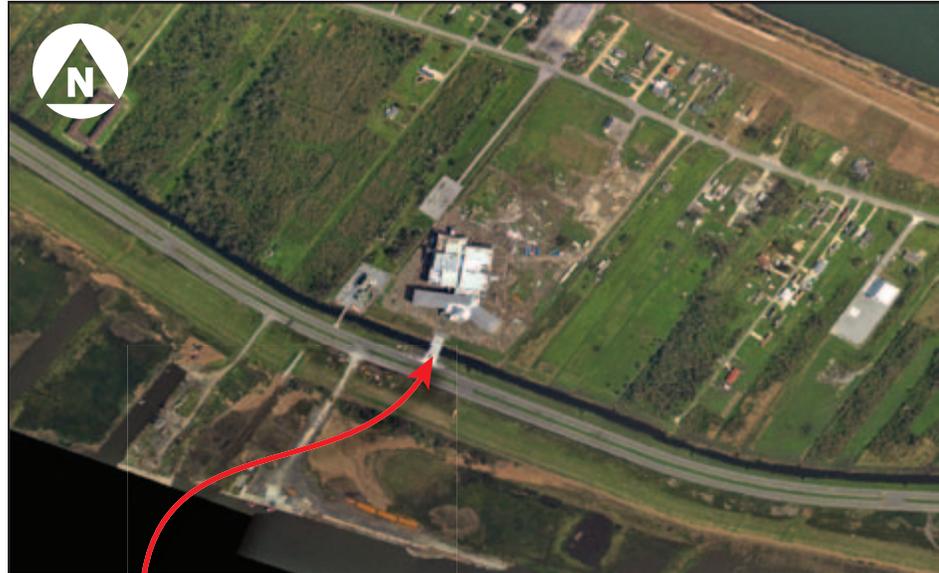
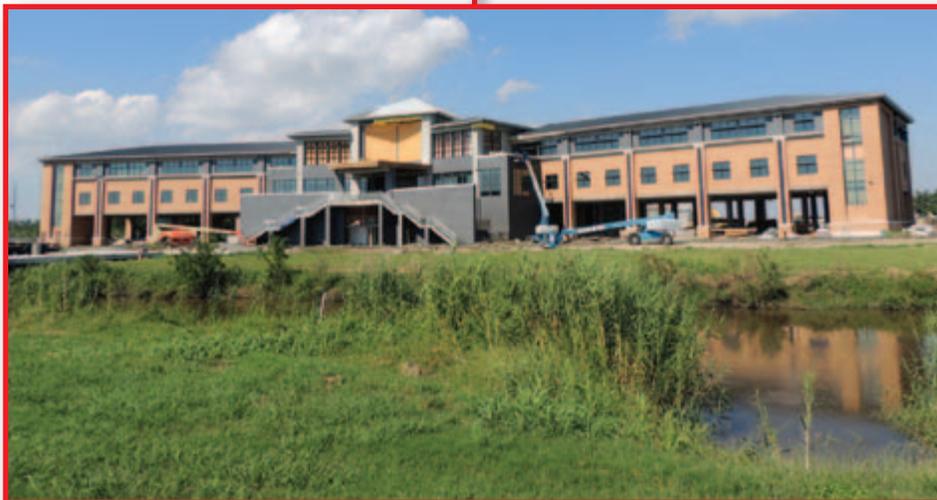
Figure 4-11:
South Plaquemines High School under construction;
the preliminary BFE at this site is Zone VE (EL 15)
(Boothville [West Bank] –
Plaquemines Parish, LA).

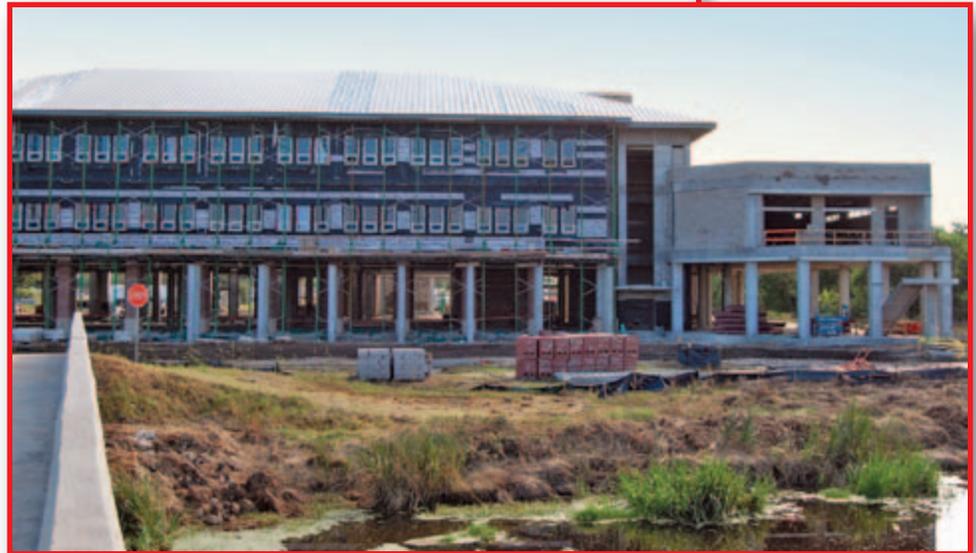
Figure 4-12:
The Phoenix Pre-K-12
School under construction;
the preliminary BFE at this
site is Zone AE (EL 17)
(Phoenix [East Bank] –
Plaquemines Parish, LA).

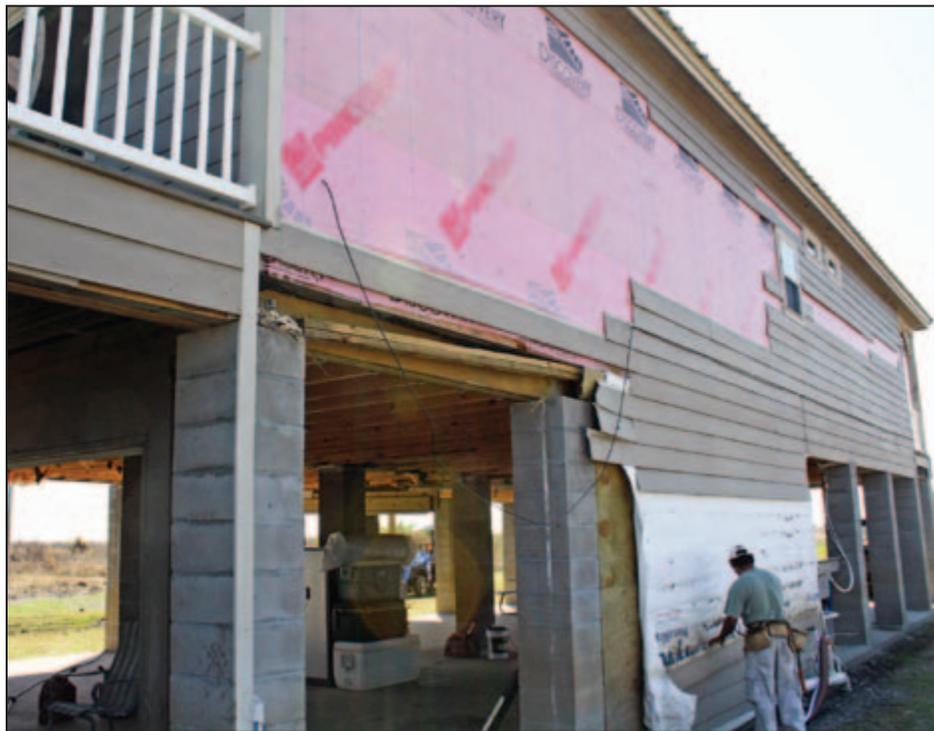
Figure 5-8:
Exterior damage (wood siding) to the elevated house (Plaquemines Parish, LA).

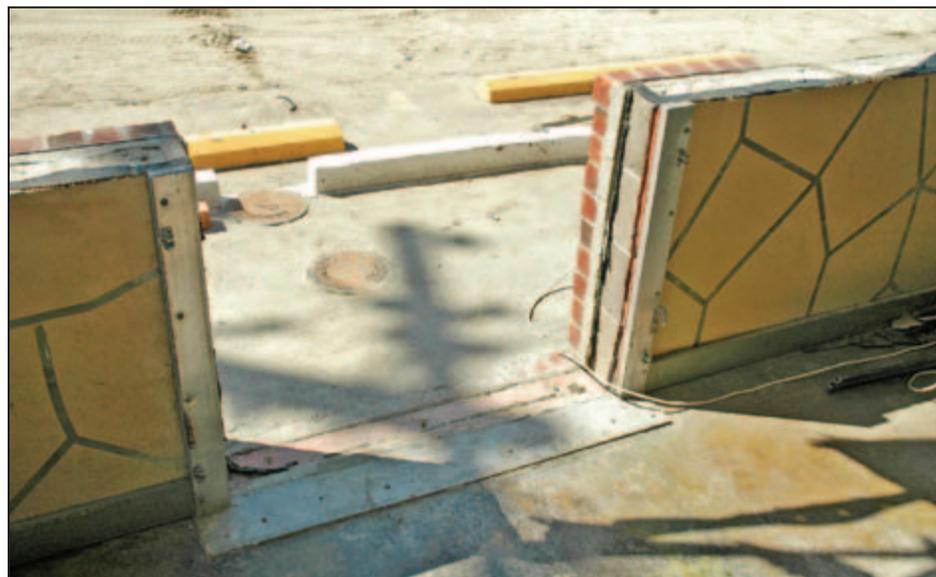
A nonresidential building along Lakeshore Drive in Mandeville was floodproofed 2 to 3 feet above ground level prior to Hurricane Katrina but experienced flooding of 7 feet that overtopped the floodproofed elevation by 4 feet (see Figures 5-11 through 5-13). After being Substantially Damaged by Hurricane Katrina, the building was reconstructed on an open foundation (see Figure 5-14). The building was not inundated during Hurricane Isaac. See Table 5-3 for a comparison of estimated damages. The property is located within the SFHA (effective FIRM – Zone VE [EL12] 05/16/2012; Katrina ABFE – Zone VE [EL15]).

Figure 5-12:
Entrance to nonresidential building on Lakeshore Drive in Mandeville post-Hurricane Katrina (Mandeville, LA).

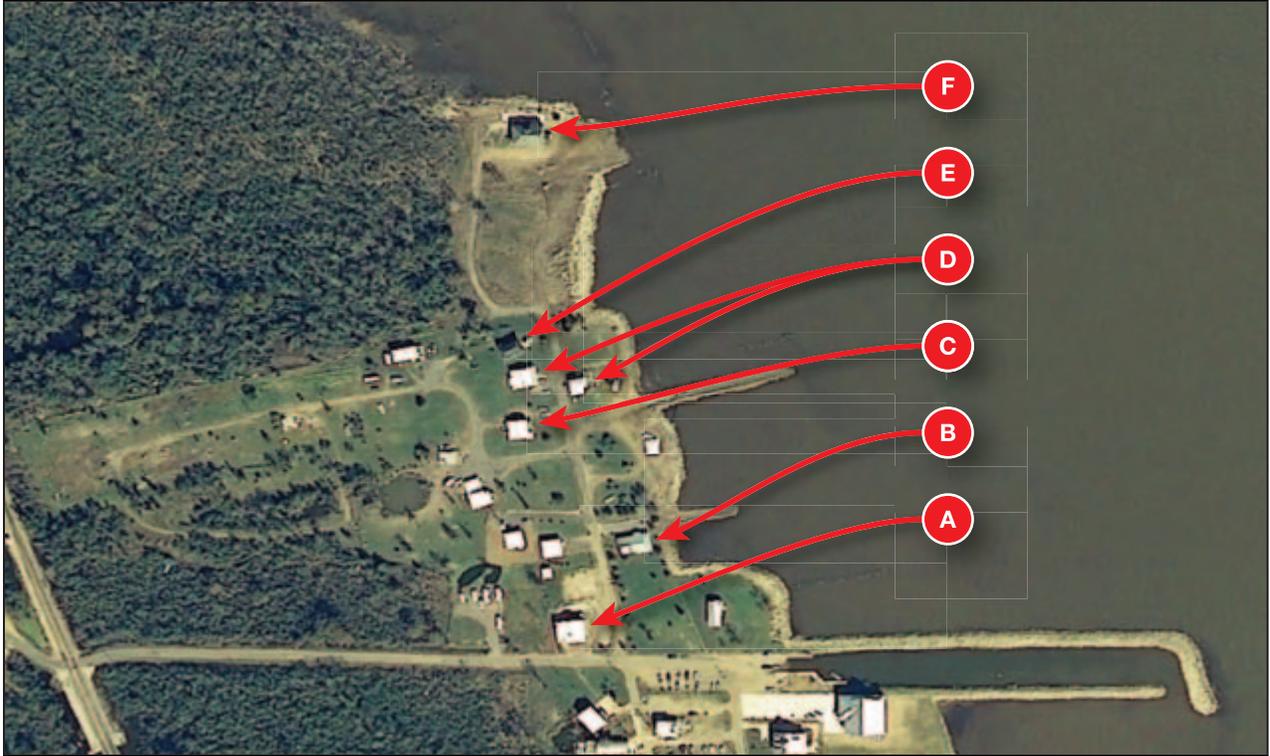
The MAT visited the Frenier Fishing Village, a small community along the west bank of Lake Pontchartrain, with estimated building ages ranging from less than 5 years to more than 30 years old. The entire community is located in the Coastal High Hazard Area (effective FIRM – Zone VE [EL16] 11/04/2010; Katrina ABFE – N/A; Historic FIRM – Zone VI6 [EL16]) and consists of about a dozen residential and nonresidential buildings. All buildings were constructed on an open foundation; however, the first floor elevations vary from approximately 1 to 12 feet above grade. As a result, the magnitude of flood damage from Isaac varied from collapse/failure to no damage (see Figures 5-18 through 5-25). See Table 5-5 for a comparison of estimated damage.

Figure 5-18: 2008 aerial of the Frenier Fishing Village (St. John the Baptist Parish, LA).

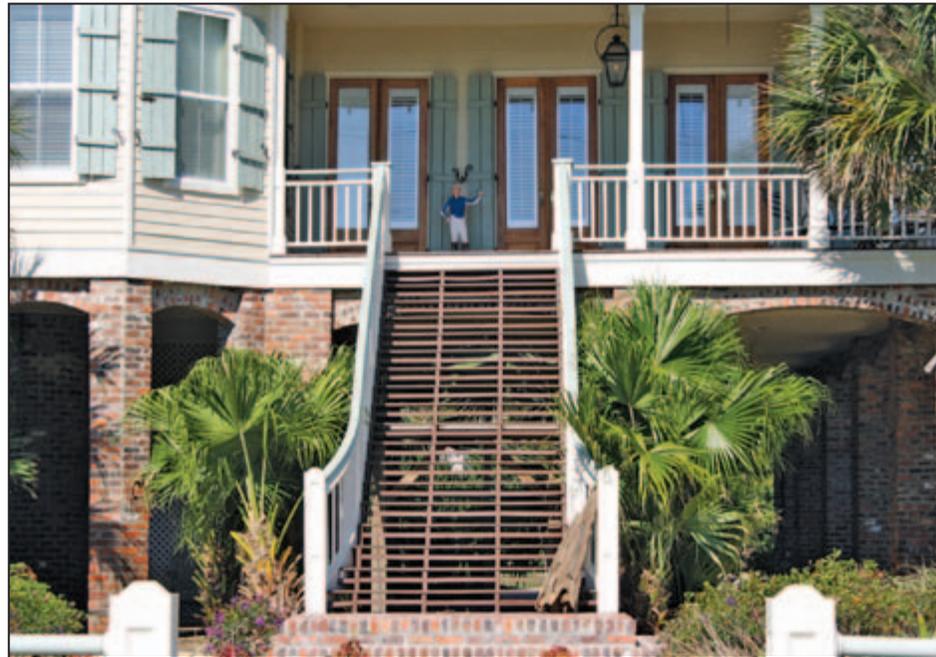
Figure 6-1:
Residential stairs with
partially open risers to
reduce potential flood
damage (Mandeville, LA).

for adequate performance. For residential buildings, stairs should be constructed with partially open risers in accordance with building code requirements and should be oriented perpendicular to the direction of flood flow to reduce flood damage, as shown in Figure 6-1. Constructing these stairs with open risers will reduce the forces incurred by the stair structure and thus reduce the likelihood that they will fail during a flood. If constructing stairs with open risers is not possible, construct stairs such that there are intermediate landings with supports that can resist flood forces.

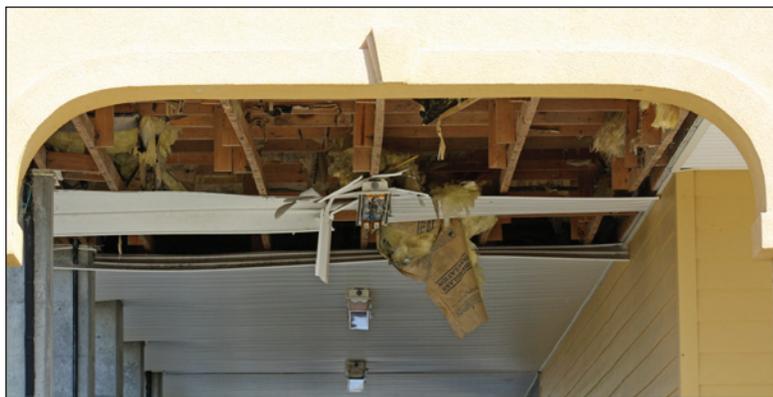
The purpose of this Hurricane Recovery Advisory is to describe practices for minimizing damage to the underside of elevated buildings (see Figure 1) resulting from high-wind events. The undersides of elevated coastal buildings are typically covered with paneling (vinyl or aluminum soffit sheeting) or sheathing (plywood) to protect the insulation and metal connectors used for the floor system. These undersides are often damaged by high winds during hurricanes, allowing water to be driven into the building.

Figure 1. Loss of the covering from the underside of an elevated building due to high winds (Plaquemines Parish, LA, Hurricane Isaac)

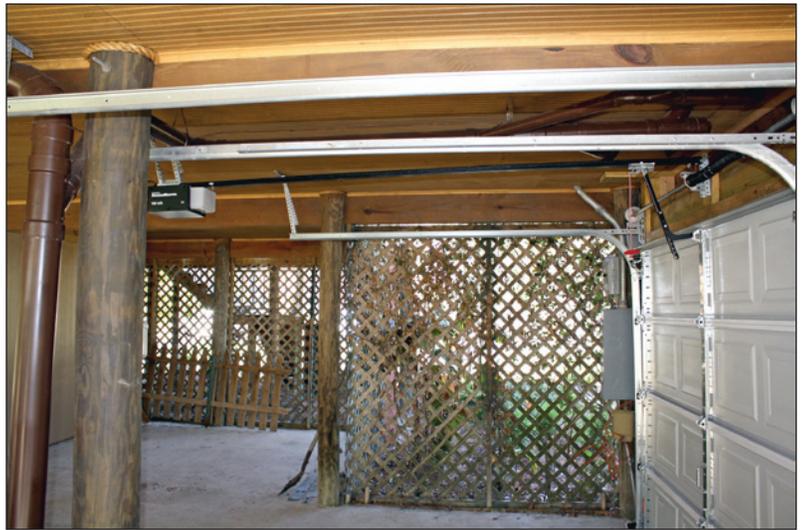
- Floodplain management regulations restrict the use of building space below the base flood elevation to vehicle parking, building access, and storage (see Figure 2).
- Local regulations may require parking/garage areas to be separated from the living space with a fire-resistant-rated floor assembly.

Figure 2. Space under an elevated building used as a parking area (St. Tammany Parish, LA, Hurricane Isaac)

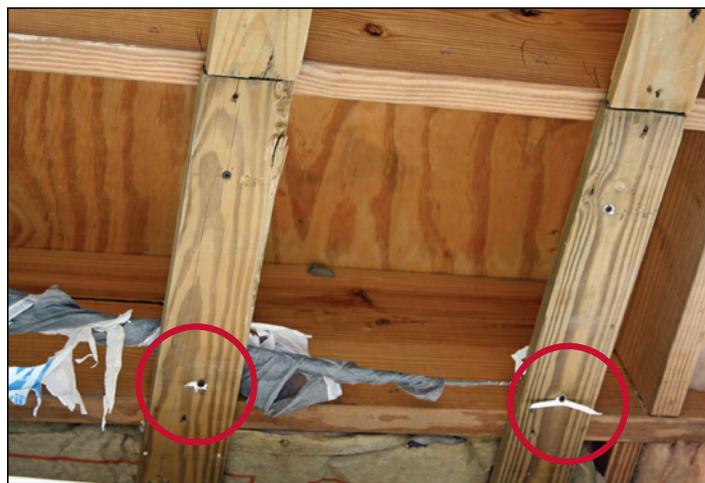
FEMA post-disaster assessments have observed that vinyl siding or soffit paneling material used to cover the underside of elevated buildings frequently fails, usually as a result of the vinyl tearing or fasteners pulling out (see Figure 3). FEMA has observed less damage to underside coverings from high-wind events where the covering material is wood (typically plywood sheathing). The use of wood or more rigid materials may not eliminate all damage during high-wind events, but it will minimize damage to the underside covering material from tear out around fasteners or buckling (see Figure 4).

Figure 3. Covering under an elevated building was lost when the vinyl soffit paneling tore around fastener heads during high winds (Plaquemines Parish, LA, Hurricane Isaac)

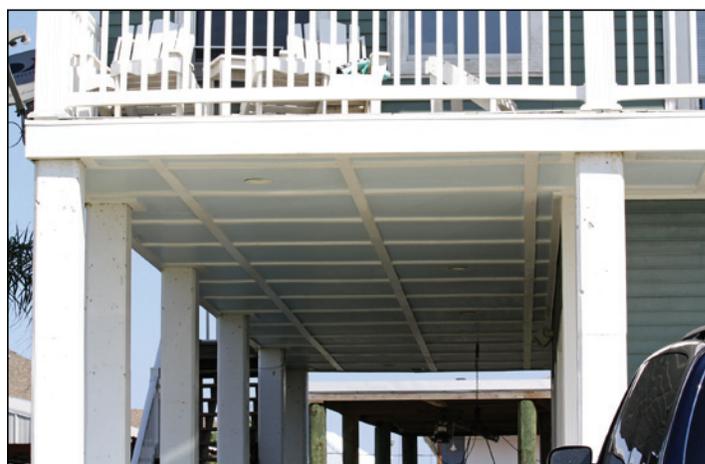
Figure 4. Wood sheathing under a house near the one shown in Figure 3 did not fail; this is not a fire-resistant-rated assembly (Plaquemines Parish, LA, Hurricane Isaac)

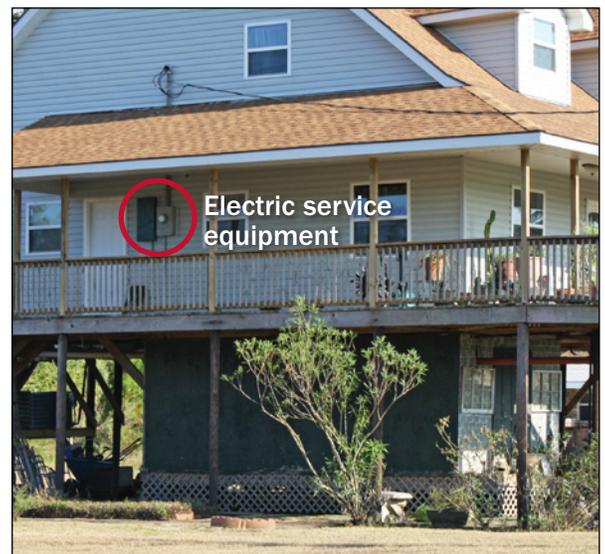
Figure 3 shows a house where the electrical meter and all other electrical service components are all located above the elevated lowest floor. For floods that do not rise above the level of the elevated lowest floor, service equipment will not be damaged by flood waters (with the possible exception of an easily repairable grounding conductor that bonds the meter enclosure and service panel to a ground rod below). Workers can easily access the electrical meter from the stairs and elevated deck to read the meter or remove it to shut off power to the home.

Figure 3. Example of the preferred method of elevating all electrical components (St. Tammany Parish, LA)

Although the NFIP does not regulate equipment owned by utilities, such as electric meters, FEMA recommends that electrical services be designed so that all equipment is elevated above flood levels to prevent flood damage (Figure 3) or that most of the electric service equipment be placed above flood levels to minimize flood damage (Figure 4).

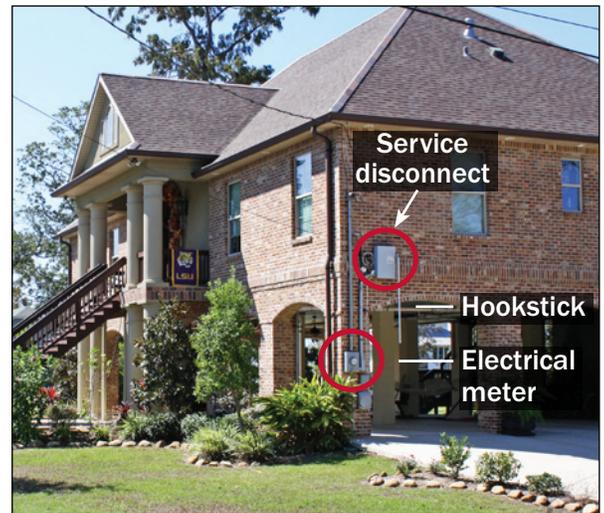
In some situations, elevating the meter may not be possible, but all other electrical service components may be elevated (see Figure 4). Because there are no stairs or elevated decks to provide access for an elevated meter, the utility meter is located within 4 to 6 feet of grade and remains vulnerable to flooding, but can be repaired or replaced after floodwaters recede. Flood risks to the electrical equipment, while not eliminated, are greatly reduced at this home. The service disconnecting means is mounted nearly 10 feet above grade; it is equipped with a hookstick that allows remote operation. The electrical service panel (located inside opposite the service disconnect) is also elevated and protected from flooding.

Figure 4. Other than the electrical meter, all the electrical components are elevated and protected from flooding at this home. The system incorporates an electrical service disconnect that is remotely operable with a hookstick (St. Tammany Parish, LA).
