HURRICANE

Katrina

8. Overview of Hurricane Katrina in the New Orleans Area

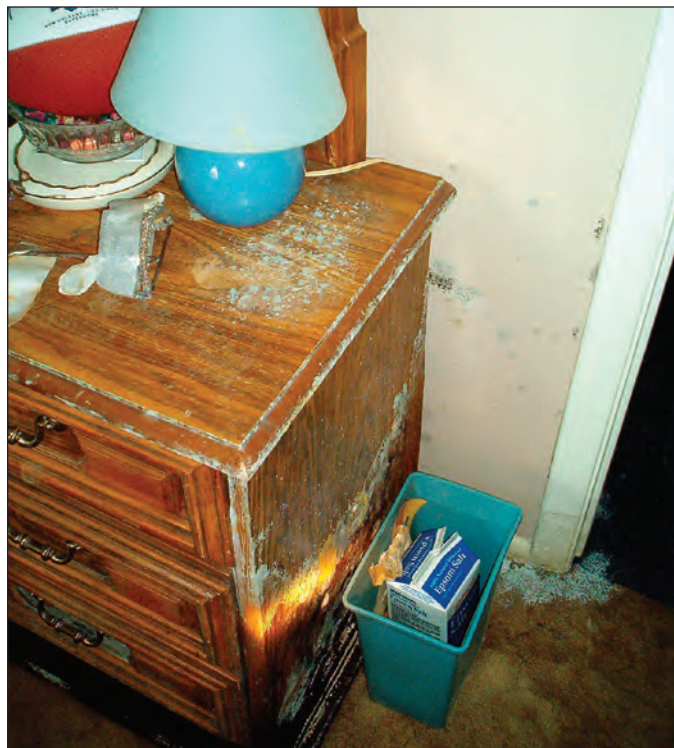
Figure 8-17.

Bacterial growth appeared to be inhibited by fungal growth in numerous areas. Rampant fungal growth on the damp carpet and wallpaper in the living room of the Savoie Court residence may well account for the fact that bacteria were not detected in those areas (see Table 8-4). Bacterial levels were also very low in the samples of visible fungal growth that were scraped from the carpet and a dresser leg in the Savoie Court residence (samples 6379-18, 6379-19, 6379-24, and 6379-25) (see Figure 8-17).

Bacteria levels were frequently found to be significantly lower in areas with rampant fungal growth. This pattern held true at the residence on Savoie Court, where fungal levels were extensive on the dresser and carpet near the door frame while the bacteria levels were negligible at these same locations.
