HURRICANE

Katrina

IN THE GULF COAST

7. Performance of Critical and Essential Facilities

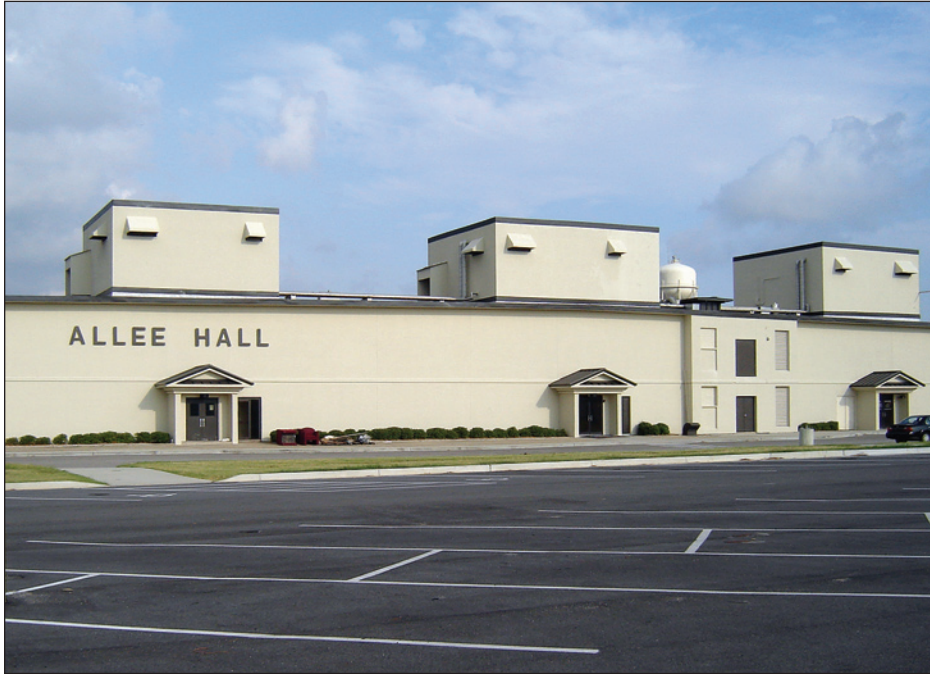
Most personnel were evacuated from the base prior to Hurricane Katrina. However, about 350 essential personnel remained and took shelter in Allee and Wolfe Halls (see Figure 7-27). During the storm, large portions of the roof covering blew off, resulting in major water leaks inside the building, and great anxiety for the building occupants.

Figure 7-27.
Allee Hall, place of
refuge for base essential
personnel during the
storm (estimated wind
speed: 120 mph. Biloxi,
Mississippi)

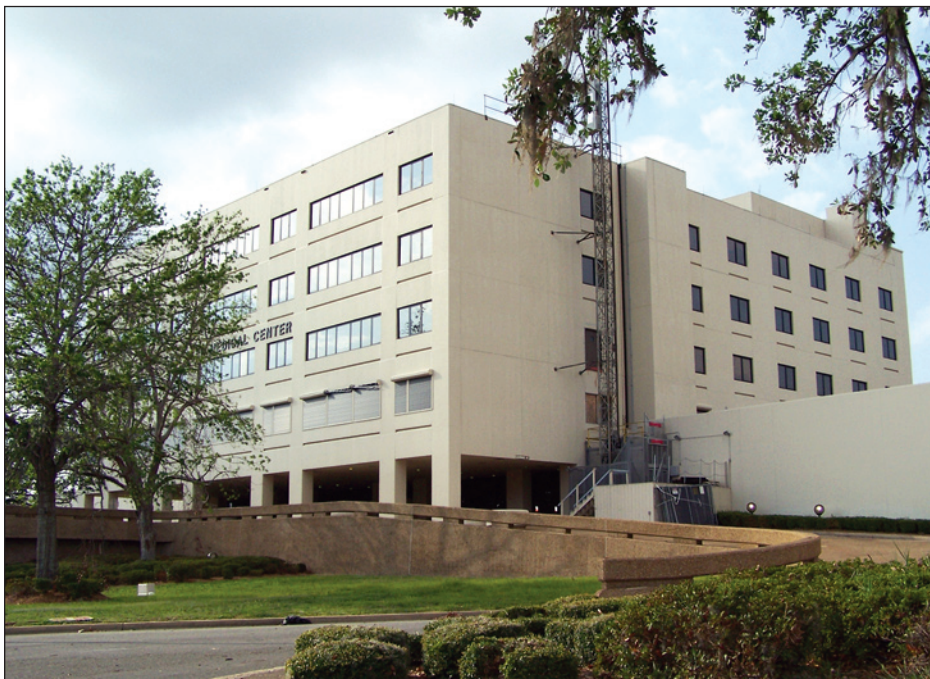
The Keesler Medical Center (see Figure 7-28), which is used annually by 56,000 military retirees and active duty personnel, was flooded during the storm, with surge spilling into the basement

of the building and inundating the emergency generators. The medical center was not expected (at the time of this report) to be fully operational until later in 2006. The hospital was not in a mapped floodplain (Zone C).

Figure 7-28.
Keesler AFB Medical
Center (estimated wind
speed: 120 mph. Biloxi,
Mississippi)
