**BUILDING PERFORMANCE ASSESSMENT REPORT**

# *Midwest Tornadoes of May 3, 1999*

**OBSERVATIONS, RECOMMENDATIONS,  
AND TECHNICAL GUIDANCE**

**FEDERAL EMERGENCY MANAGEMENT AGENCY**

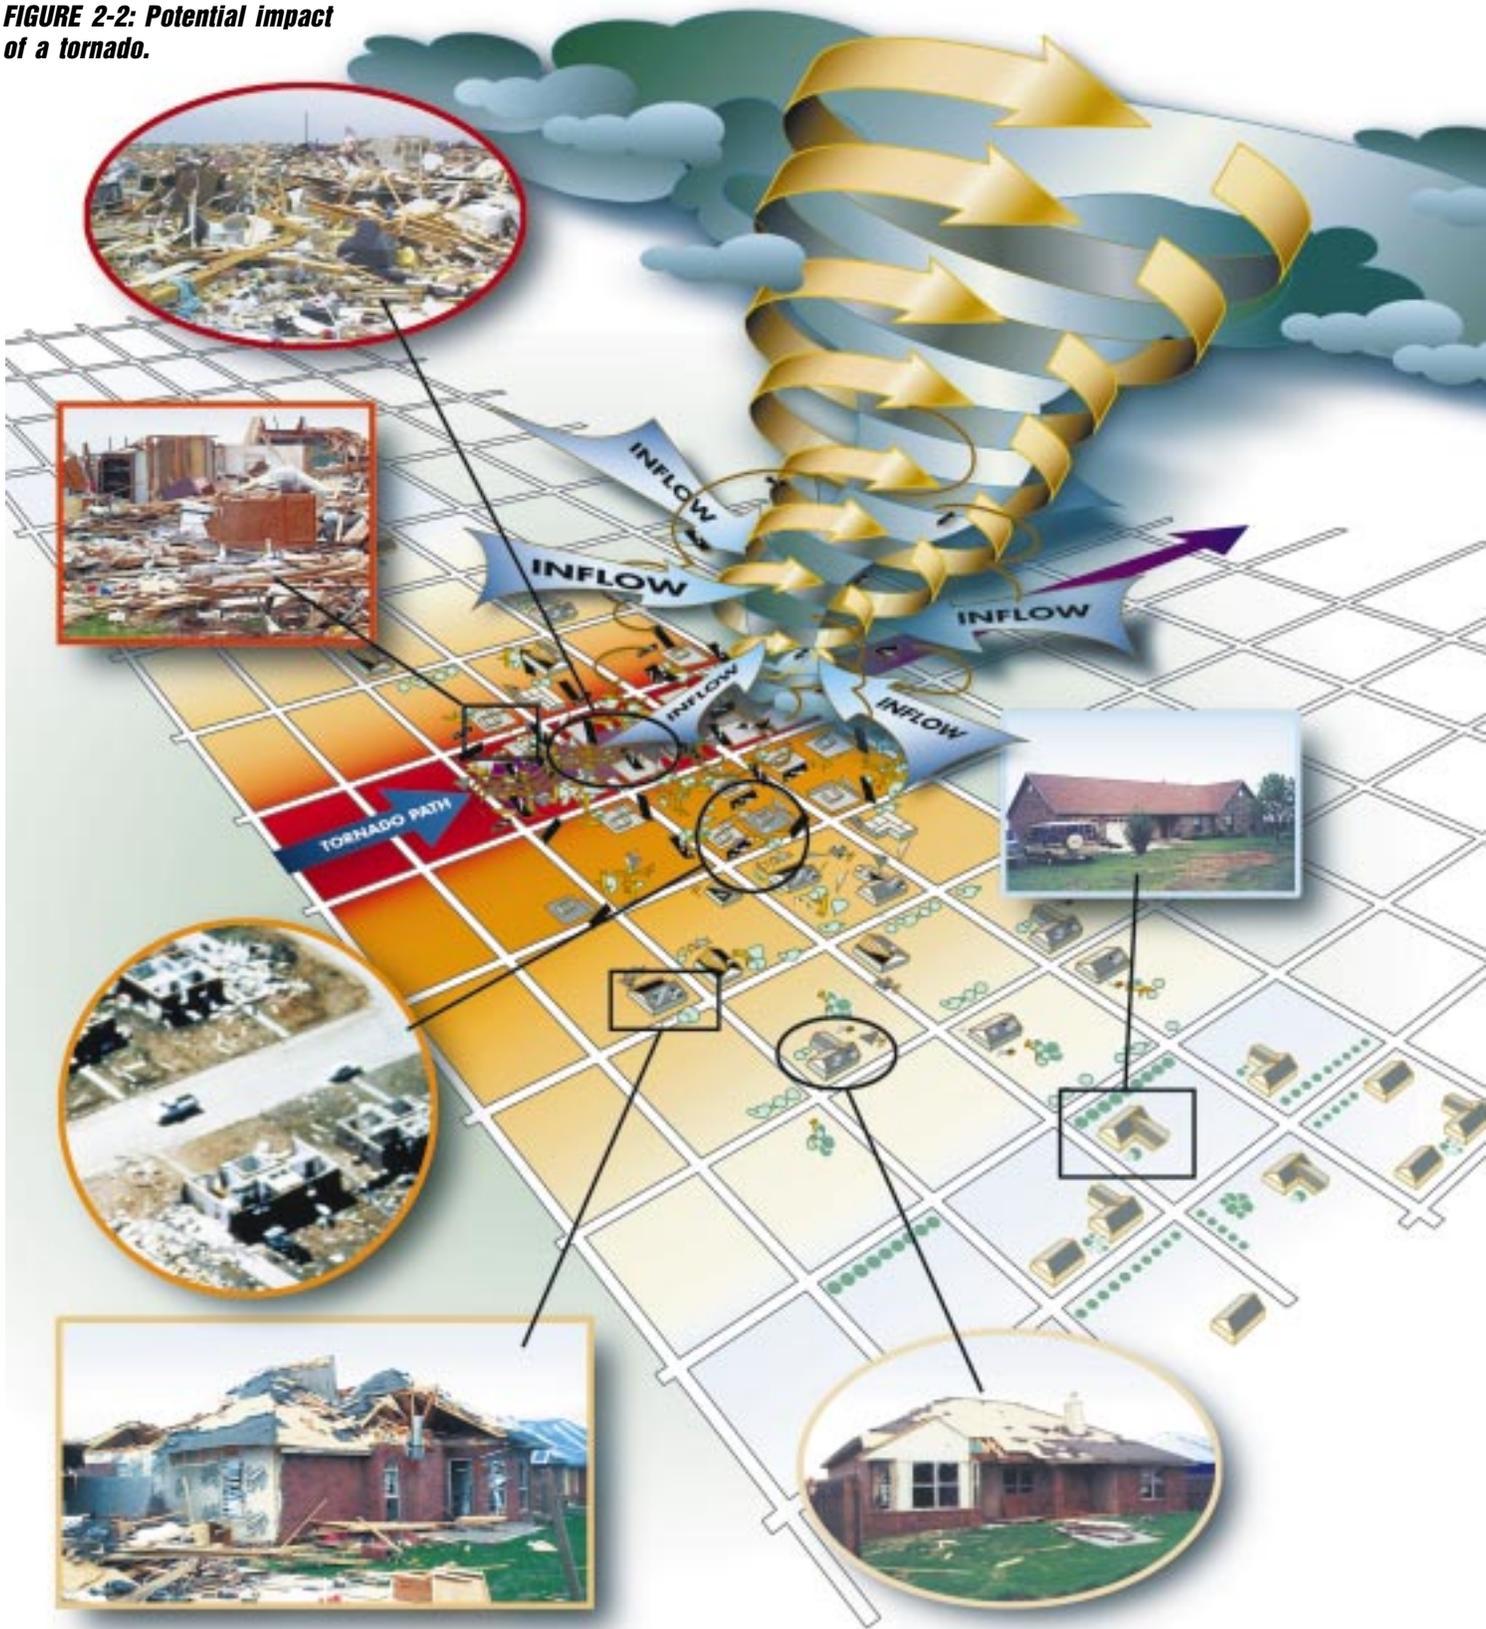
**FIGURE 2-2: Potential impact of a tornado.**

In a violent tornado, the most severe damage occurs in the area directly affected by the vortex (the area shaded dark red in Figure 2-2). Typically, in this area, all buildings are destroyed and trees are uprooted, debarked, and splintered. In the immediately adjacent area, shaded orange in the figure, buildings may also be destroyed, but others may suffer less severe damage, such as the loss of exterior walls, the roof structure, or both. Even when buildings in this area lose their exterior walls and roofs, interior rooms may survive. In the outer portion of this area, further from the vortex, damage to buildings affects primarily roofs and windows. Roof damage ranges from loss of the entire roof structure to the loss of all or part of the roof sheathing or roof coverings. Typically, most or all of the windows in buildings in this area will be broken by windborne debris. In the area shaded yellow, damage is again primarily to roof coverings and windows. However, roof damage is lighter, and although windborne debris damage still occurs here, not all windows are broken. Damage to buildings in the outer fringe of this area is even lighter. Beyond this area, where the figure shows blue shading, buildings typically suffer no damage.

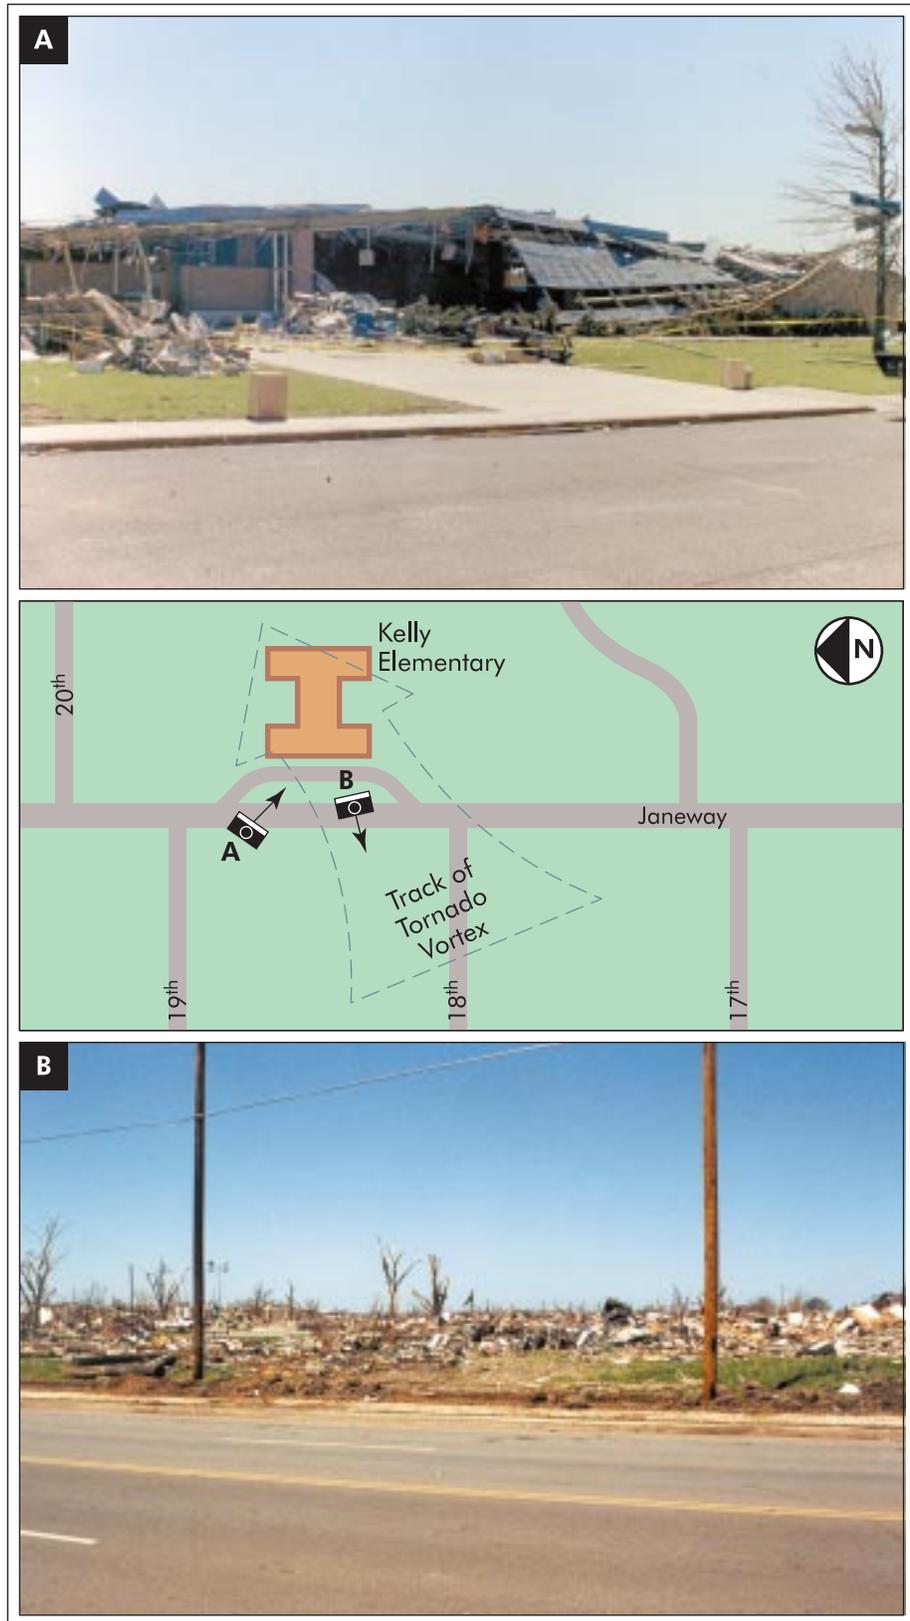
Site visits in both Oklahoma and Kansas of wind-induced damage to residential and commercial buildings indicated that internal pressurization due to breach of the building envelope (i.e., broken windows and doors, failed garage doors, partial roof failures, etc.) was a major contributor to poor building performance under severe wind loading conditions. It is recognized that maintaining the exterior envelope of a building has a large effect on the

**FIGURE 3-1: Differences in the performance of non-residential (engineered) buildings and residential buildings. The violent tornado that passed through Moore, Oklahoma, severely damaged the Kelly Elementary School (Figure 3-1, photo A) but left some elements standing. By contrast the neighborhood directly across the street, (Figure 3-1, photo B) was reduced to rubble. Note: The utility poles in photo B were replaced after the tornado, original poles are on the ground on the left side of the photo,**

performance of the elements of the structural system. In spite of loss of a portion of the exterior envelope, the construction must provide a continuous load path in order to increase survivability of the building in events that marginally exceed the design winds.

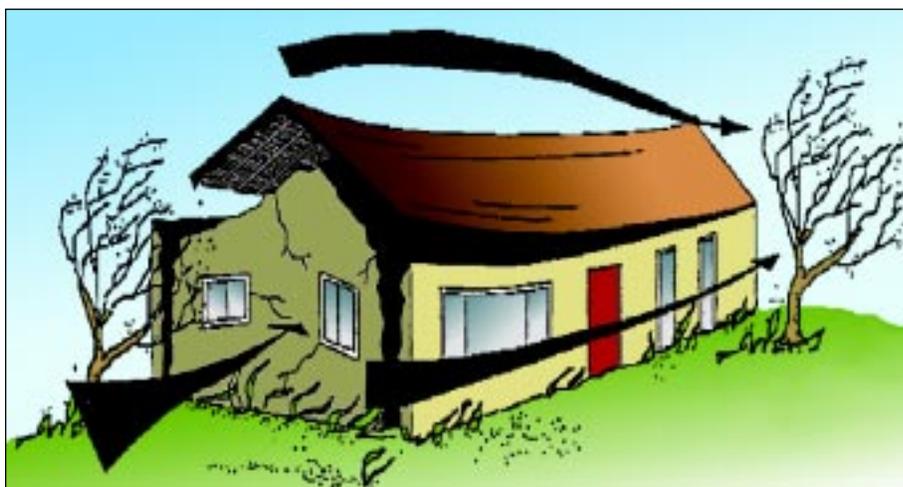
**FIGURE 3-4:** This building failure is the result of inward wind forces and uplift wind forces acting on a building during a high wind event.

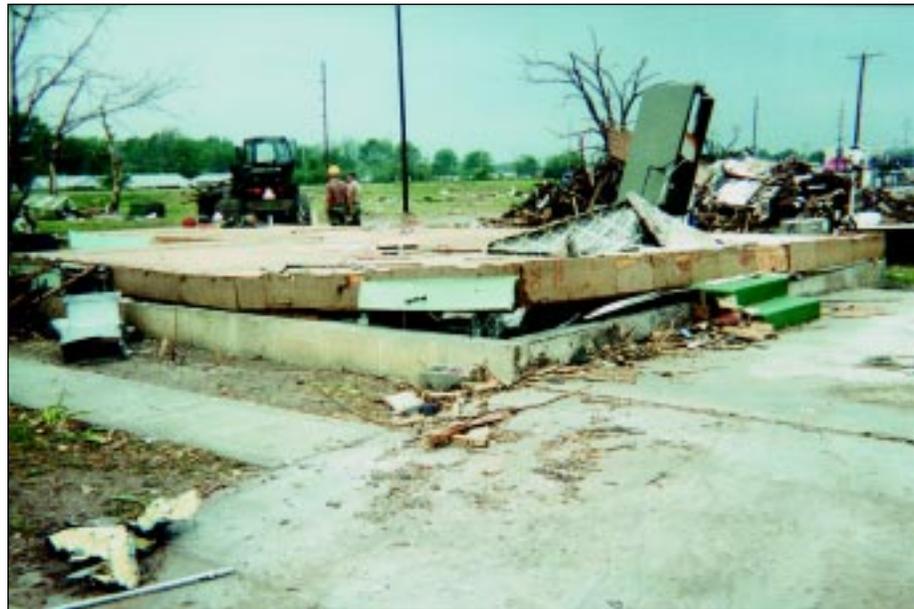
Winds moving around a building or structure will create uplift, overturning, and sliding forces that act on buildings (Figure 3-3). Uplift is the force caused by the wind accelerating around and over buildings and other structures (Figure 3-4). An example of uplift strong enough to move a house off its foundation is presented in Figure 3-5. This house was separated from its foundation when it experienced winds associated with a strong tornado that passed through the city of Haysville, Kansas. Although anchor bolts extended from the concrete foundation into the wood floor framing, nuts and washers were not attached to the bolts to provide a continuous load path at the connection points. The use of nuts and washers in combination with anchor bolts is essential for this connection to provide a continuous load path that would have resisted the uplift forces. This type of deficiency was observed at more than just this one house.

**FIGURE 3-5: Wind uplift acting on this house in Haysville, Kansas, resulted in this corner of the building being lifted off its foundation.**

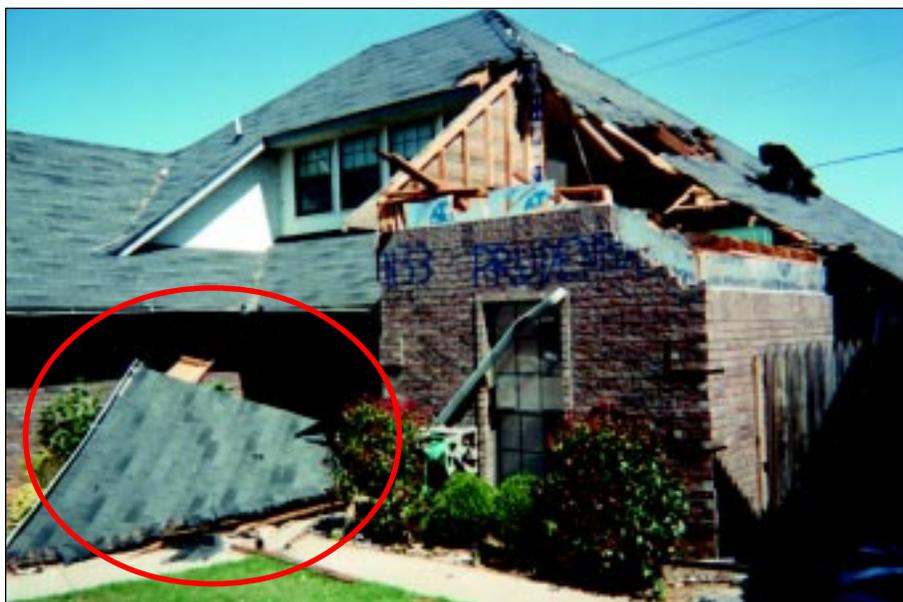
Failures due to combined internal pressures and leeward roof pressures, failure due to leeward suction pressures only, and failures due to internal pressurization only are presented in Figures 3-7, 3-8, and 3-9, respectively. These failures were typical of wind induced failures observed along the inflow wind areas of violent and strong tornadoes.

**FIGURE 3-7:** Failure of hip roof due to internal pressures and leeward roof (uplift) wind forces acting together. This house, which was exposed to inflow winds on the periphery of a violent tornado, is located in a suburb of Oklahoma City, Oklahoma.

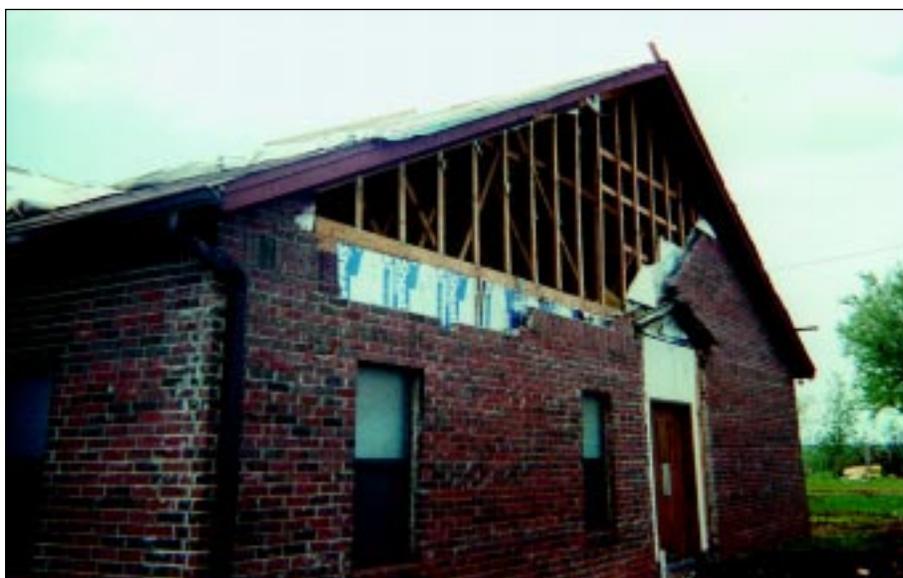
**FIGURE 3-8:** Failure of this gable wall section was due to wind suction forces on the leeward wall. This church was on the outer edge of a violent tornado path.

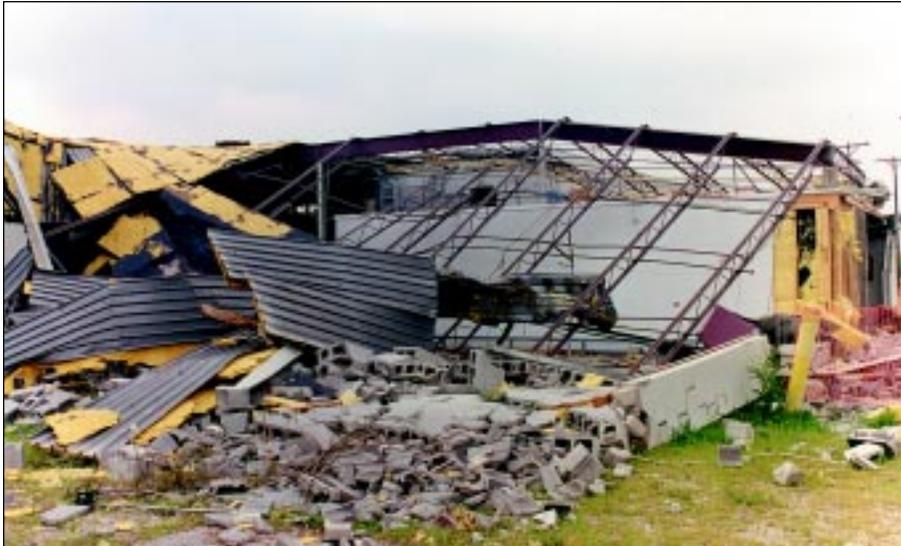
**FIGURE 3-11:** *This un-reinforced masonry (URM) wall failed when inflow winds from a strong tornado acted on this building in Wichita, Kansas.*

breached. Figure 3-11 was a building with load bearing masonry walls and a steel joist roof system. Figure 3-12 is a steel frame building with masonry infill walls.

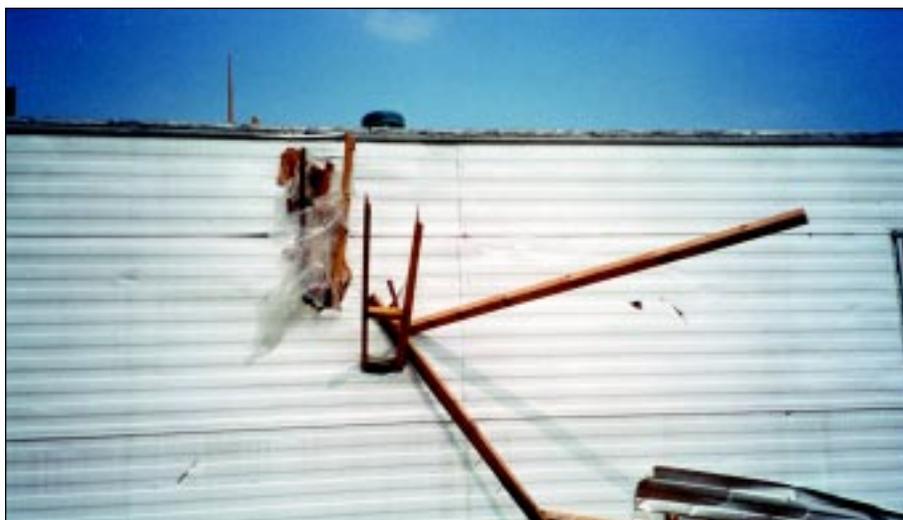
**FIGURE 3-14:** *These medium sized missiles struck and remained embedded within this manufactured home in Wichita, Kansas.*

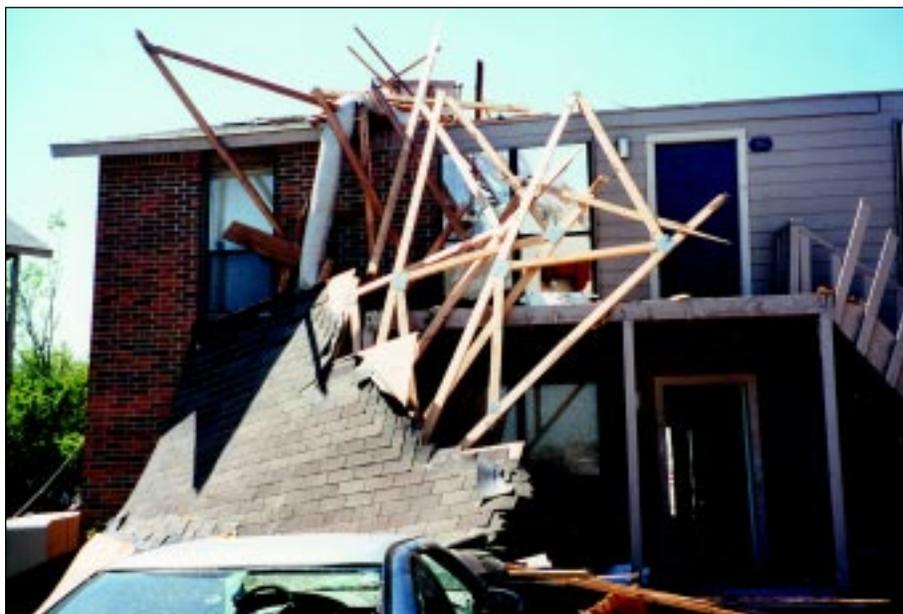
**FIGURE 3-15:** *These trusses and roof covering (still attached to the roof sheathing) were displaced by the winds of a violent tornado and are capable of becoming large, windborne missiles. These trusses were originally attached to this apartment building.*

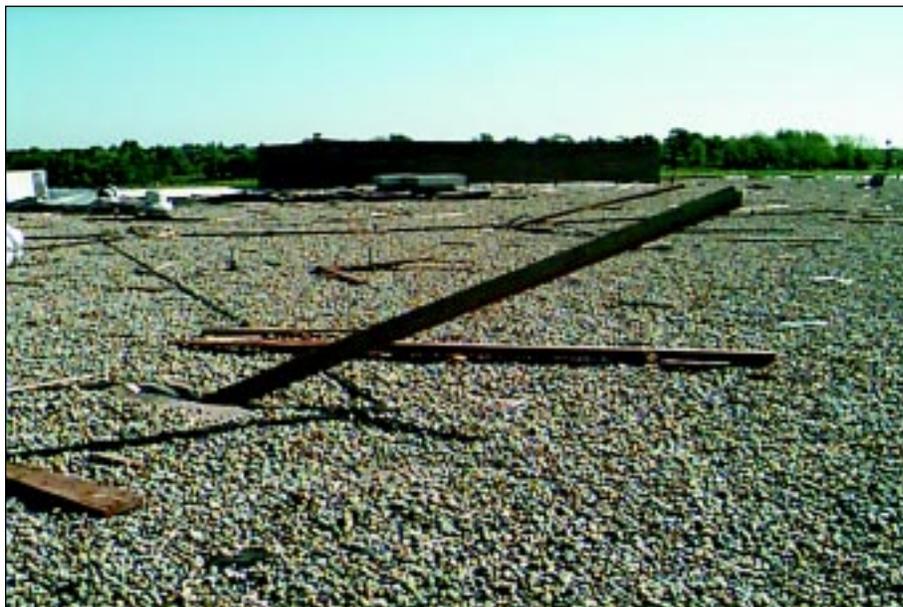
Figure 3-16 shows missile impacts on the roof of Westmoore High School in Moore, Oklahoma. The missile sticking out of the roof surface in the foreground is a double 2-in by 6-in. The portion sticking out of the roof is 13 feet long. It penetrated a ballasted ethylene propylene diene monomer (EPDM) membrane, approximately 3-in of polyisocyanurate roof insulation and the steel roof deck. The missile laying on the roof just beyond it is a 2-in by 10-in wood member that is 16 feet long. The missile in the background that penetrated the roof deck is a 2-in by 6-in that had a total length of 16 feet. The source of missiles was not determined, hence the distance to their origin is unknown. However, because this school building was located within 100 yards of a violent tornado, it is likely that they traveled at least a few hundred feet from a subdivision of wood-frame houses that were in the direct path of the tornado.

**FIGURE 3-16:** *Medium and small missiles through and on Westmoore High School's roof, Moore, Oklahoma*

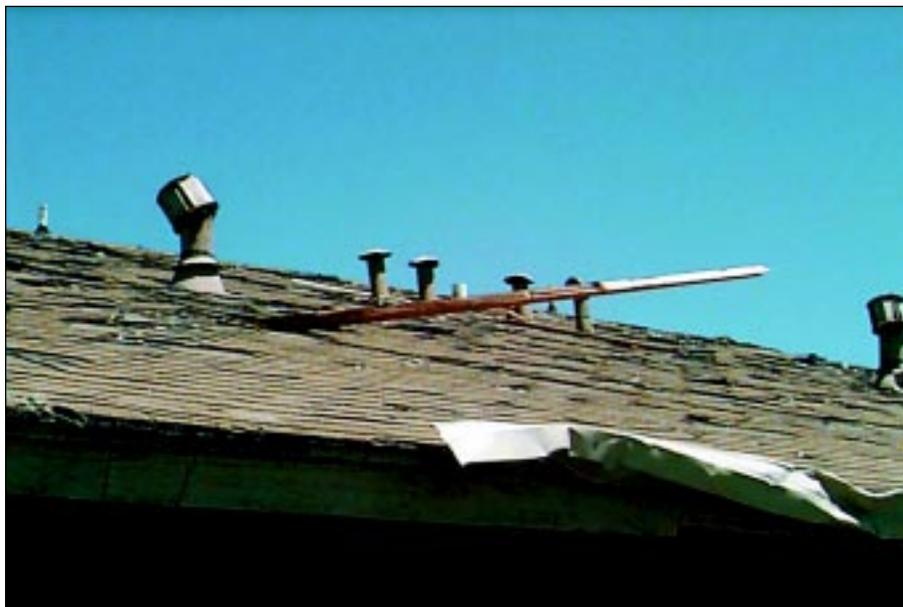
Figures 3-17 and 3-18 show board missiles that struck and remained embedded in the roofs of homes that were located on the periphery of tornado tracks. Figure 3-19 shows a 2-in by 6-in missile completely penetrating the brick veneer of a home. Figure 3-20 shows a 2-in by 6-in missile penetrating several inches into the freezer compartment of a refrigerator located in a home that was on the periphery of a violent tornado track. The portion that is visible is 4-ft, 8-in long.

**FIGURE 3-17:** *This missile struck a house located in Moore, Oklahoma.*

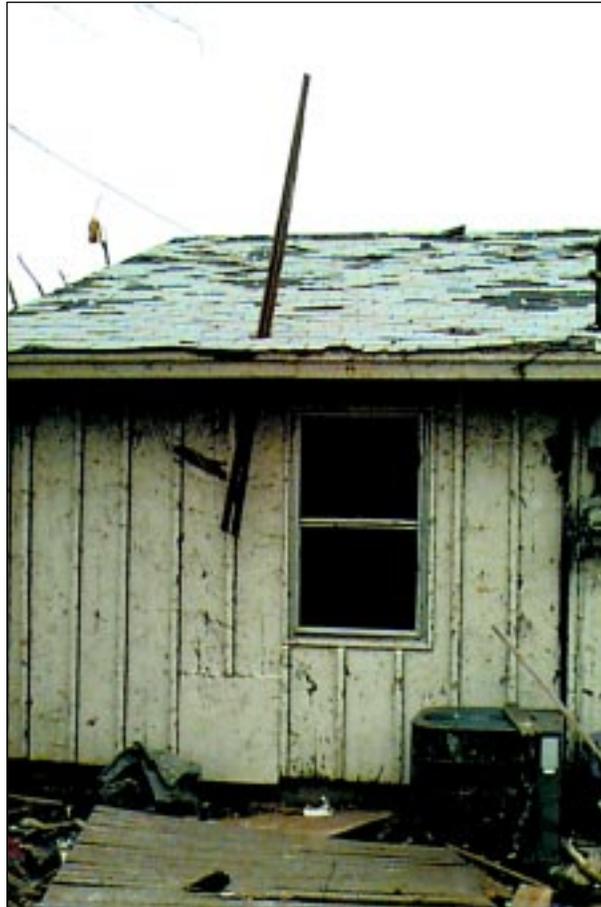
**FIGURE 3-18:** *This missile fell nearly vertical, illustrating the importance of a strong cover over the top of a tornado shelter to protect against free-falling debris. This home was located in Midwest City,*

**FIGURE 3-19:** *A 2-in by 6-in missile can be seen completely penetrating the brick veneer of a home in Moore, Oklahoma.*

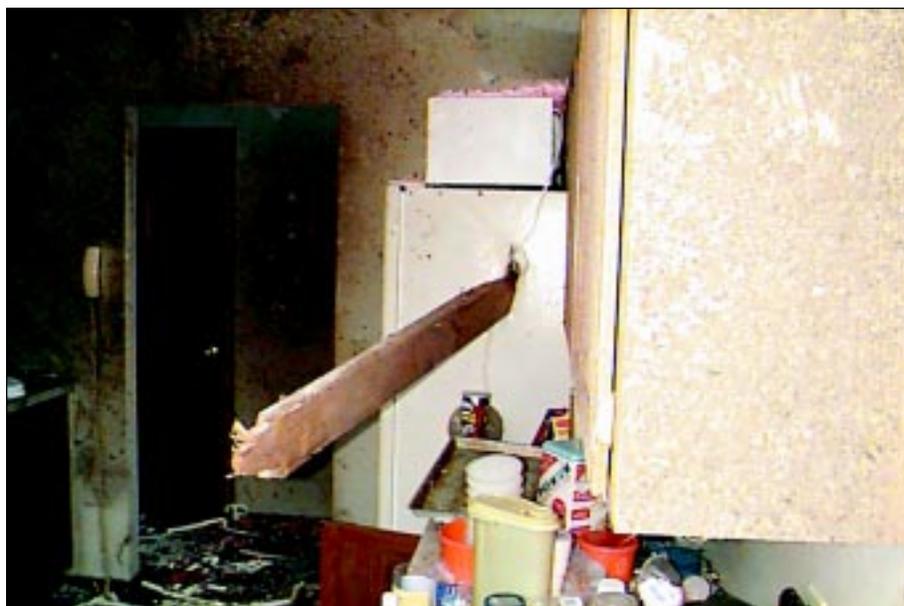
**FIGURE 3-20:** A 2-in by 6-in missile penetrating a refrigerator located inside a home in the Country Place subdivision outside Oklahoma City, Oklahoma.

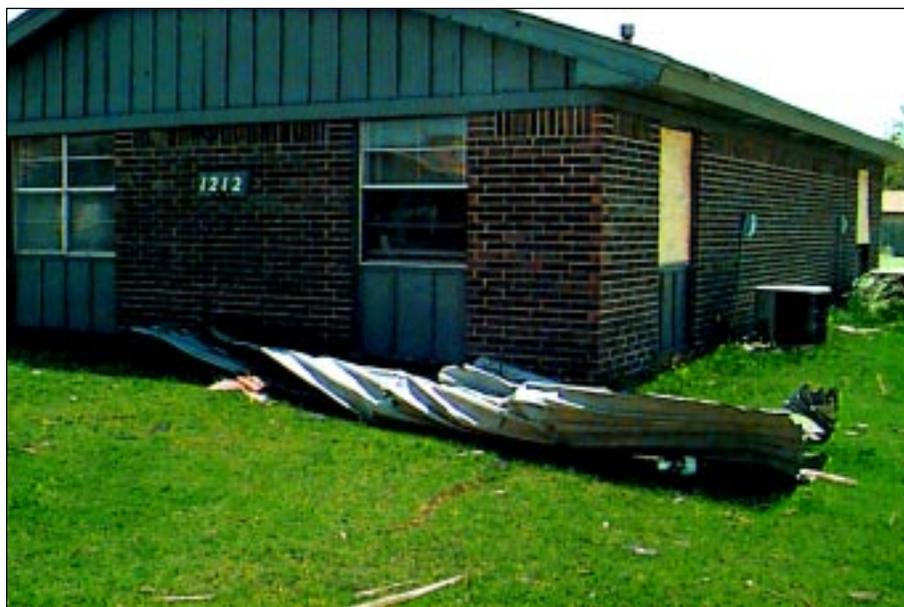
**FIGURE 3-21:** This piece of steel deck landed at the periphery of a violent tornado damage area in Moore, Oklahoma. The building it likely came off of was a few hundred feet away.

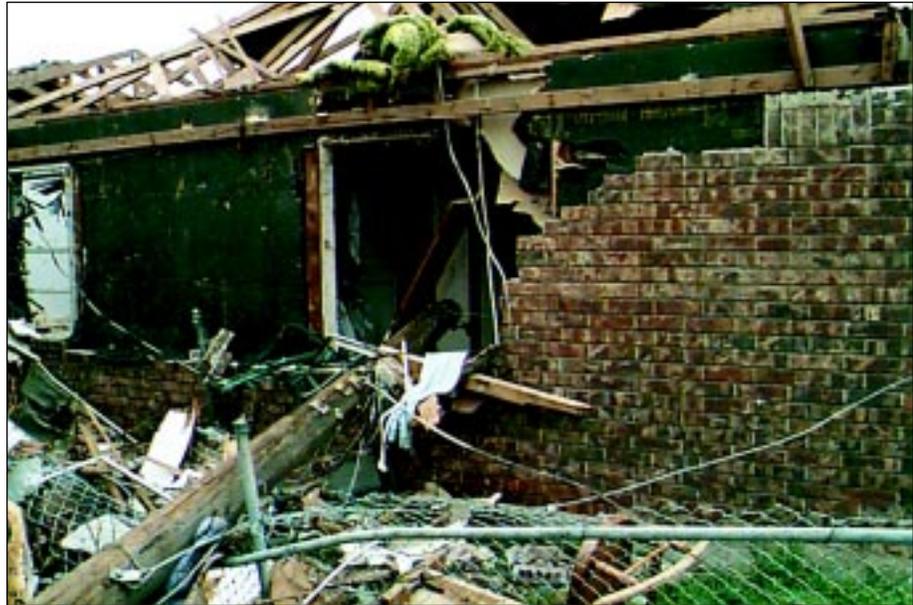
**FIGURE 3-22:** This power pole penetrated a window and extended several feet into the house after traveling approximately 40 feet from its original location. This home was located in Moore, Oklahoma, along the track of a violent tornado.

roughly 40 feet to the original location of the pole from the window. Manufactured home chassis, a large propane tank (Figure 3-23), pre-cast concrete hollow core panels (see Chapter 5), steel dumpsters, a steel deck (Figure 3-21), and trees (Figure 3-24) were among other large missiles observed by the BPAT. Automobiles were observed to have been significantly displaced and destroyed in areas under the vortex of and in the inflow wind field near the vortex of violent tornadoes.

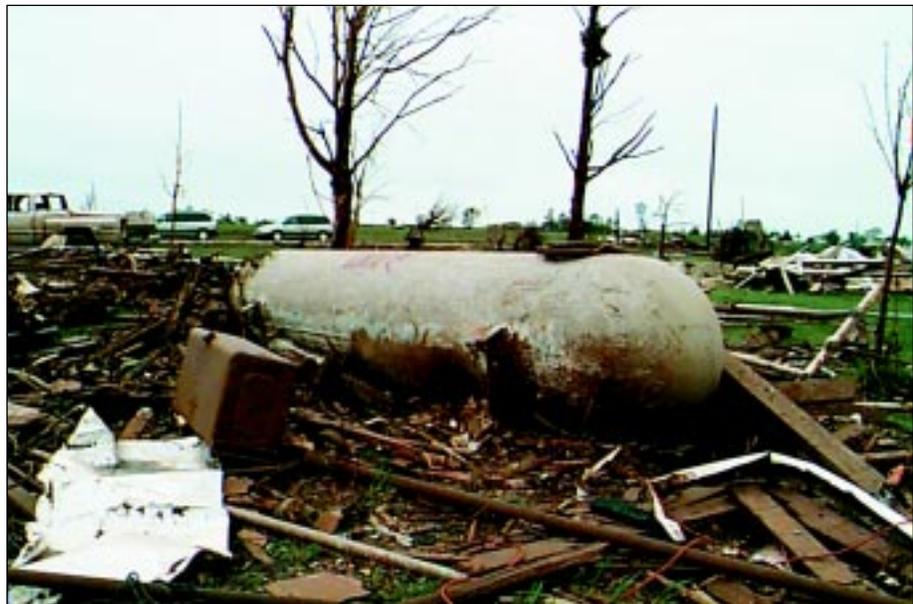
**FIGURE 3-23:** Wind displaced this very large propane tank in Bridge Creek, Oklahoma; its original location could not be determined. This area was hit by the vortex of a violent tornado.

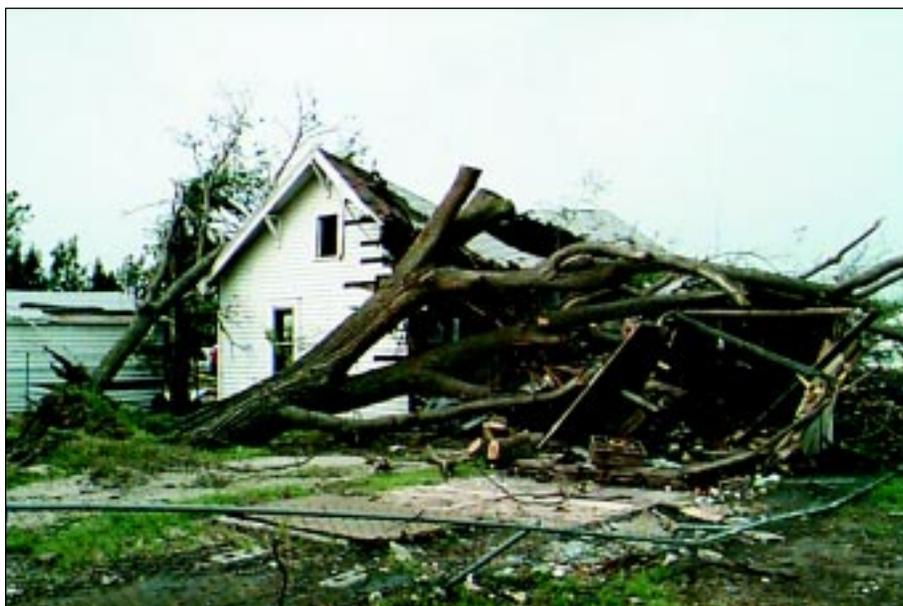
**FIGURE 3-24:** This building was on the periphery of a violent tornado damage area in Haysville, Kansas. One large tree fell near the corner of the house and collapsed a large portion of the roof and the corner walls. A smaller tree caused minor damage on the other corner of the house.

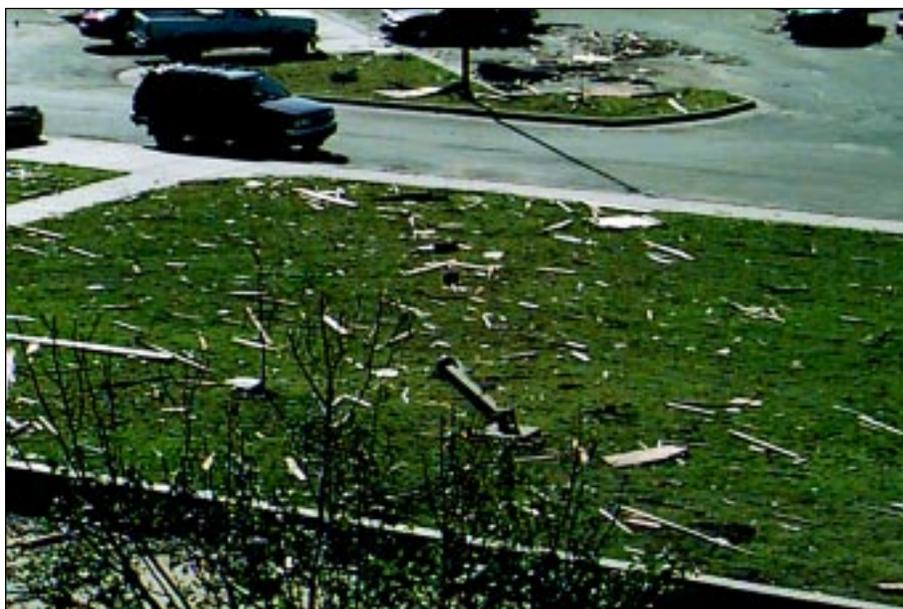
In areas where buildings were totally or nearly totally destroyed by a violent tornado, missiles were in such great quantity (Figure 3-25) that they often made a layer of rubble that completely covered the ground (Figure 3-26). In many houses, the floors were covered with small tree branches and fragments of broken framing members. Figures 3-26 through 3-30 give some idea of the number of missiles that were flying during the storm.

**FIGURE 3-25:** Wood framing members and plywood sheathing near the periphery of a violent tornado damage area in Moore, Oklahoma, displaying quantity of flying debris.

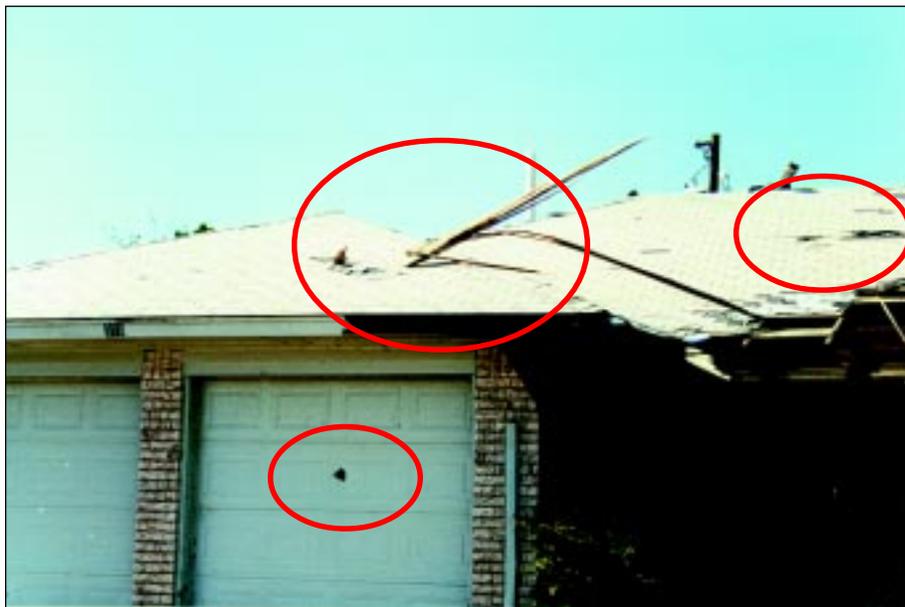
**FIGURE 3-28:** This house was on the periphery of a violent tornado damage area in Moore, Oklahoma. Two medium missiles are embedded this area of the roof and additional holes due to windborne missiles are also visible.

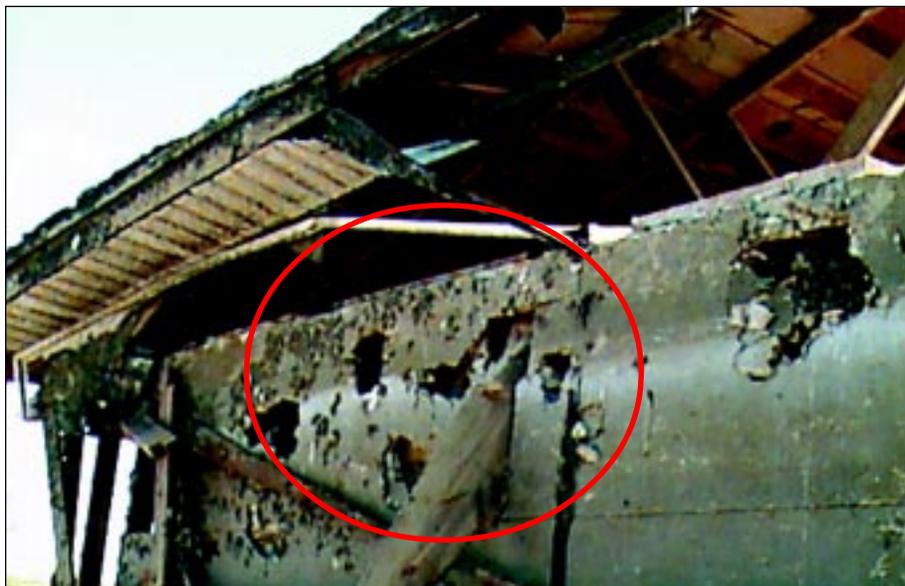
**FIGURE 3-29:** Several missiles struck the wall of this house in Del City, Oklahoma, including a medium sized piece of debris in the center of the photo.

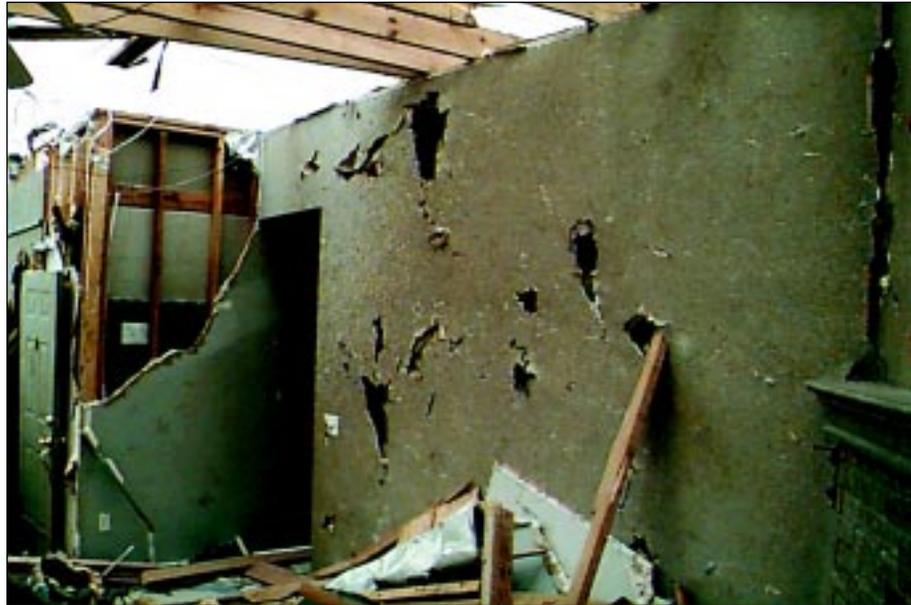
**FIGURE 3-30:** Several missiles struck and perforated the interior wall of this house in Moore, Oklahoma.

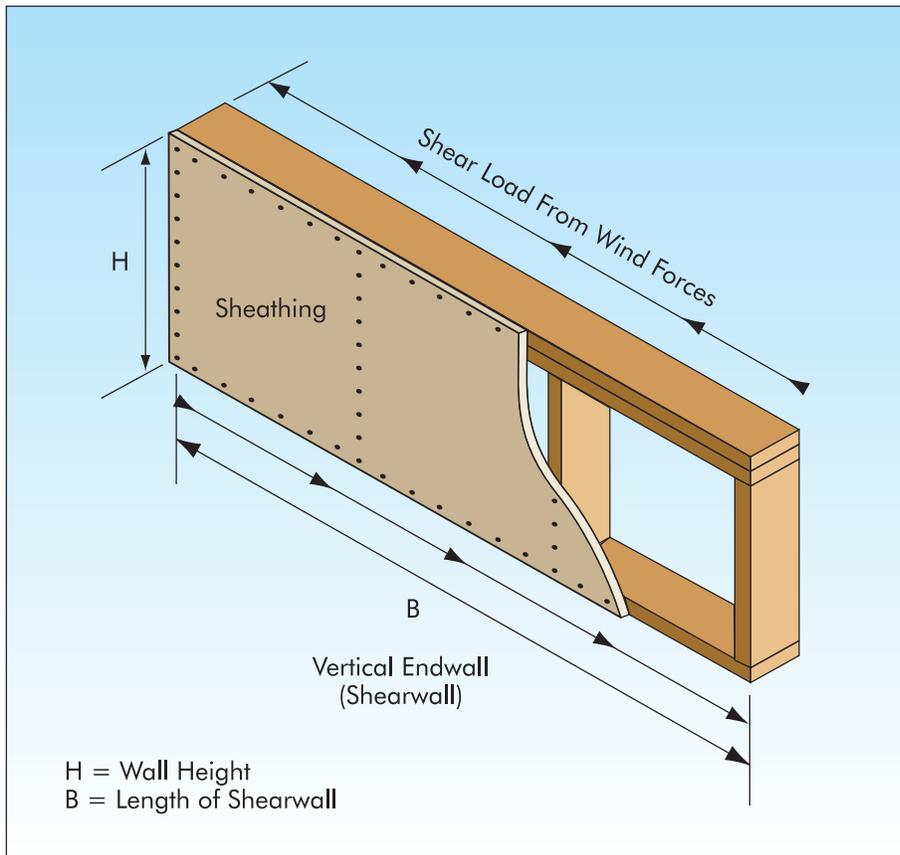
As wind induced loads reach the top of the walls, the shear has to be transferred to the top plate by some method of fastening. After the fasteners transfer the load from the roof system, there will be a force at the top of the supporting wall that is intended to be resisted by the shear wall. The wall sheathing and the connection to the wall framing (Figure 4-5) establish the capacity of a shear wall.

**FIGURE 4-5: Shear load carried by wall sheathing.**

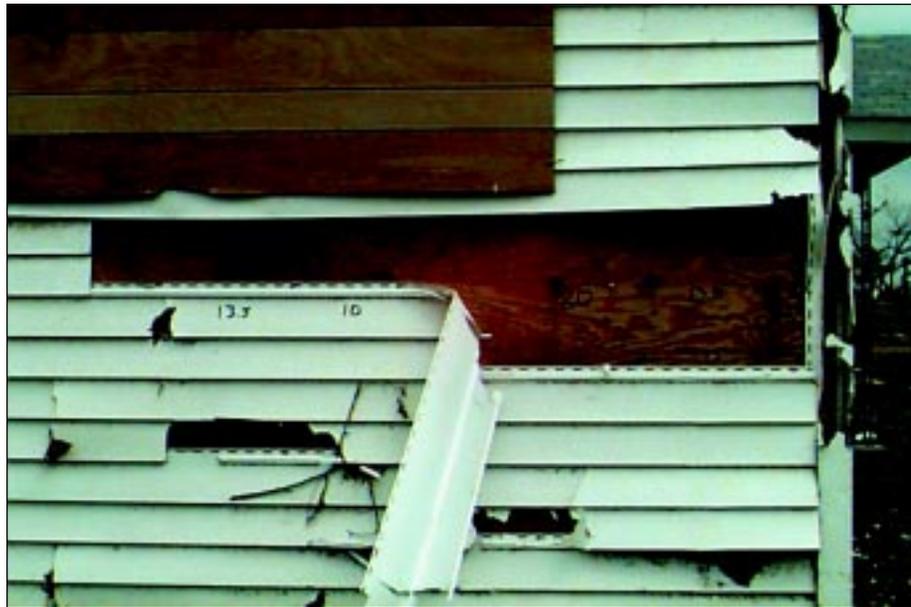
The siding of the home in Figure 4-16 was attached with roofing nails. In one area, the nails were 30-in and 21-in apart. The failure of the siding occurred when the vinyl pulled over the nailheads. Additionally, the home in Figure 4-16 suffered some asphalt shingle damage. Houses with vinyl siding that were closer to the vortex commonly had extensive missile damage (Figure 4-17). The siding on the home in Figure 4-17 was fastened with roofing nails placed at 13.5-in, 10-in, and 20-in along one length of siding. The vinyl pulled over the nailheads. Most of the siding failures observed were in areas that experienced straight inflow winds from the tornadoes that were likely at or slightly above the design wind speeds of the current building codes wind speeds (e.g., 70-80 mph, fastest mile or 90-mph 3-second peak gust).

**FIGURE 4-17:** *Some pieces of vinyl siding were blown off and in other areas the siding was torn away by missiles. The home was located along the periphery of a violent tornado in Mullhall, Oklahoma.*

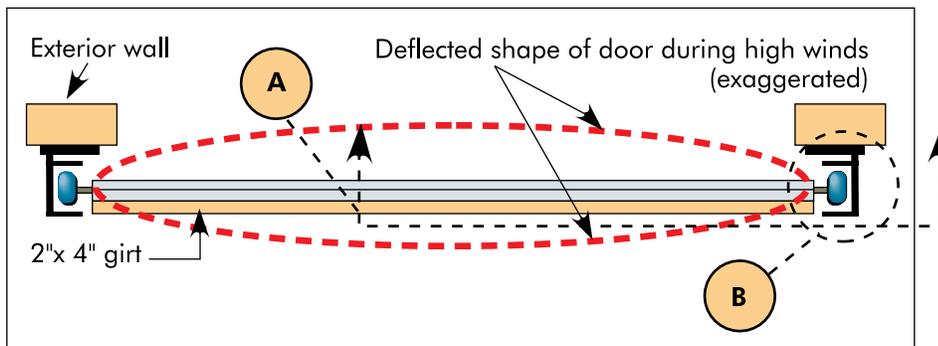
Most of the doors investigated were made of thin metal. Failures were typically caused by wind pressure, rather than by missiles. The most common failure mode observed was the door rollers disengaging from the door tracks, most likely caused by excessive door deformation (see Figures 4-19 and 4-20). Door failure resulted in increased load on the buildings.

**FIGURE 4-19:** Plan view of typical garage door shown in Figure 4-18.

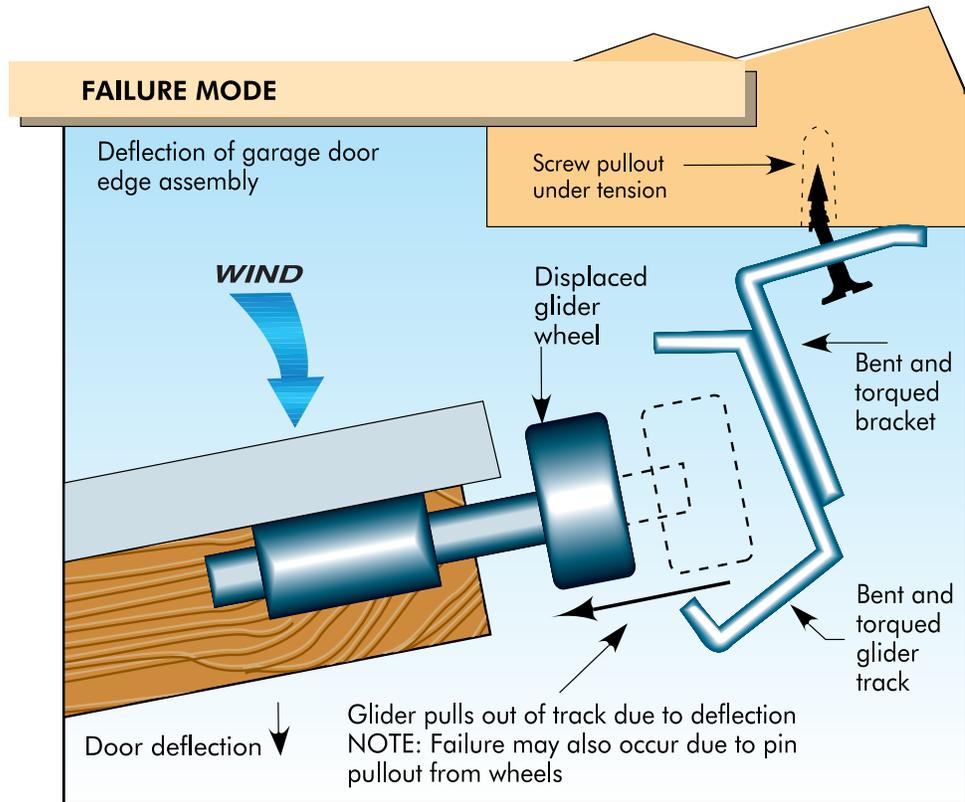
**FIGURE 4-20: Detail B from Figures 4-19. Garage door failure at track and recommend assembly improvements.**

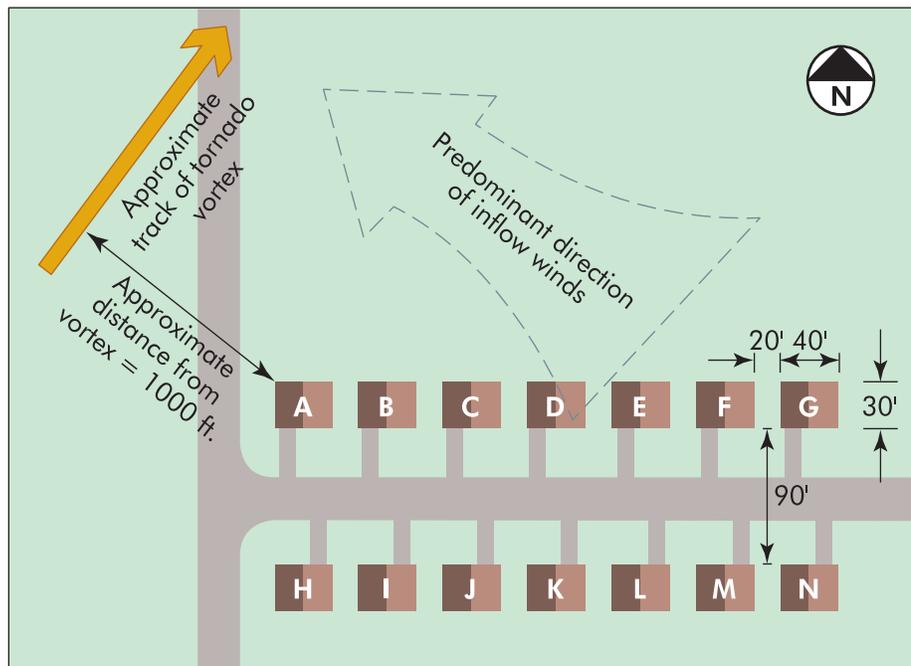
The BPAT conducted an extensive assessment of garage door performance at Greenbriar Eastlake Estates in Oklahoma City. A violent tornado directly struck this subdivision and destroyed many homes. The house in Figure 4-18 was located approximately 1200 feet away from the vortex of the tornado as it moved from the southwest to the northeast of this neighborhood. A partial schematic map of the Greenbriar Eastlake Estates is shown in Figure 4-21. The rectangles represent the average dimensions of homes surveyed with

house labels appearing within the rectangles. The homes surveyed in this subdivision are constructed of wood framing with brick veneer. The roofs on these homes were hip, gable, or a combination of the two. The majority of the homes were single-story, some with cathedral ceilings. Most house floor plan configurations are simple L, T, or rectangle shapes. Roof decking was observed to be mostly 1-in by 8-in board sheathing with some OSB and plywood sheathing. Roof rafter and wall top-plate connections were typically toe nailed with two 16d nails with no added straps or clips. Overall, material quality was observed to be typical for the Oklahoma City area. Windows were observed to be of average quality, as were front, back, and side entry doors. The large majority of the homes observed had single skin aluminum, non-insulated, and non-reinforced double width garage doors.

**FIGURE 4-21: Partial schematic map of an Oklahoma City subdivision that was affected by inflow winds from a violent tornado.**

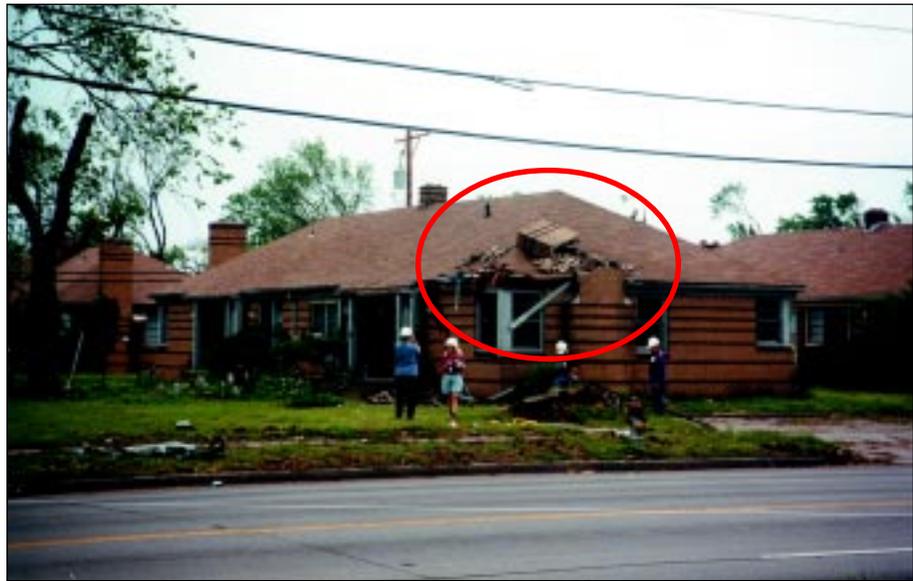
**FIGURE 4-43:** Chimney failure onto roof of single-family attached housing, Wichita, Kansas. This building was located along the periphery of a strong tornado.

was similar to the chimneys presented in Figures 4-43 and 4-44. These rectangular chimneys were calculated to have failed at wind speeds ranging from 75-85 mph (fastest mile). No reinforcing bars were observed in any of the chimneys in which calculations were performed.

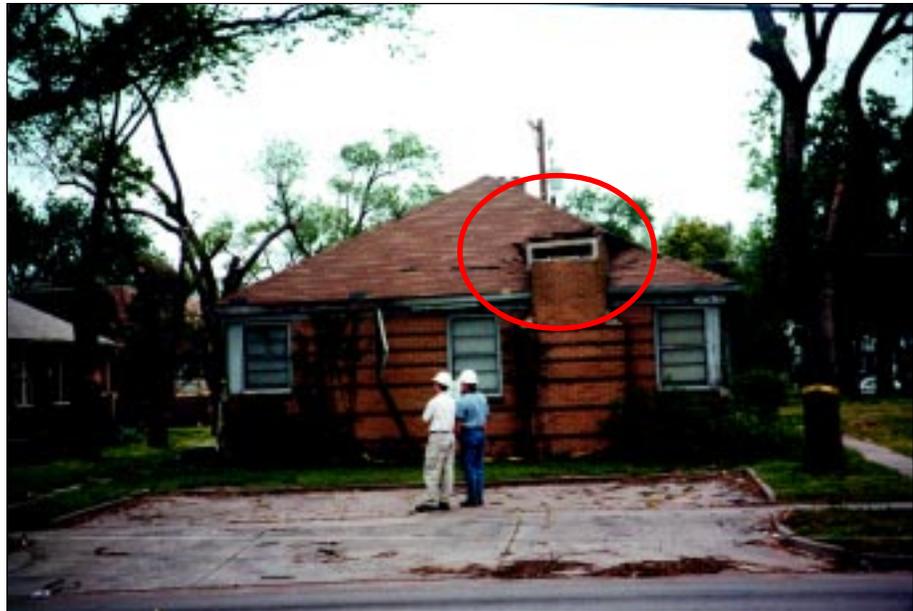
**FIGURE 4-44:** Chimney failure onto roof of single-family attached housing located along the periphery of a strong tornado, Wichita, Kansas.

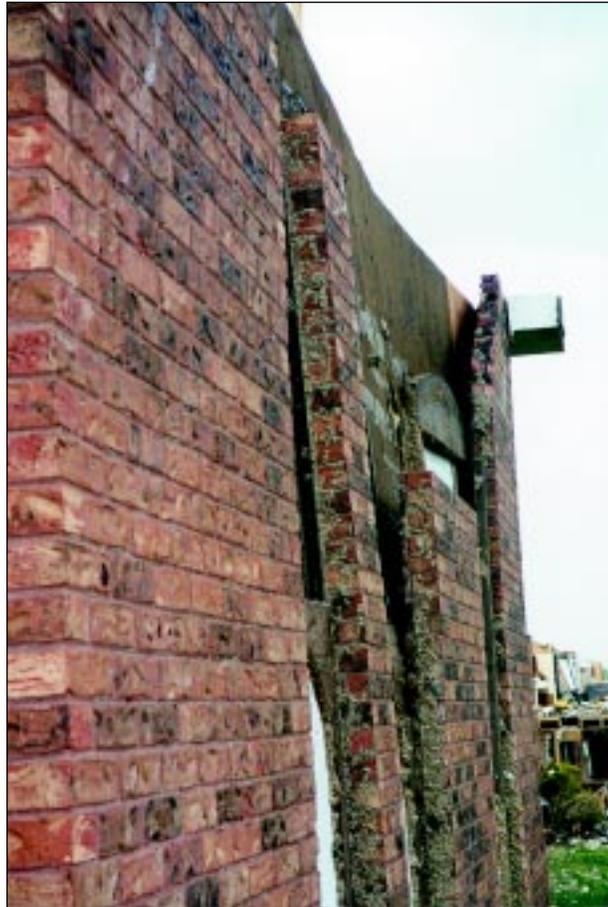
There were several two-story apartments in the Wichita, Kansas, area that also had extensive damage to roofs and brick veneer walls (Figures 4-45 and 4-46).

**FIGURE 4-46: Failure of brick veneer in multi-family housing located along the periphery of a strong tornado, Wichita, Kansas.**
