**BUILDING PERFORMANCE ASSESSMENT REPORT**

# *Midwest Tornadoes of May 3, 1999*

**OBSERVATIONS, RECOMMENDATIONS,  
AND TECHNICAL GUIDANCE**

**FEDERAL EMERGENCY MANAGEMENT AGENCY**

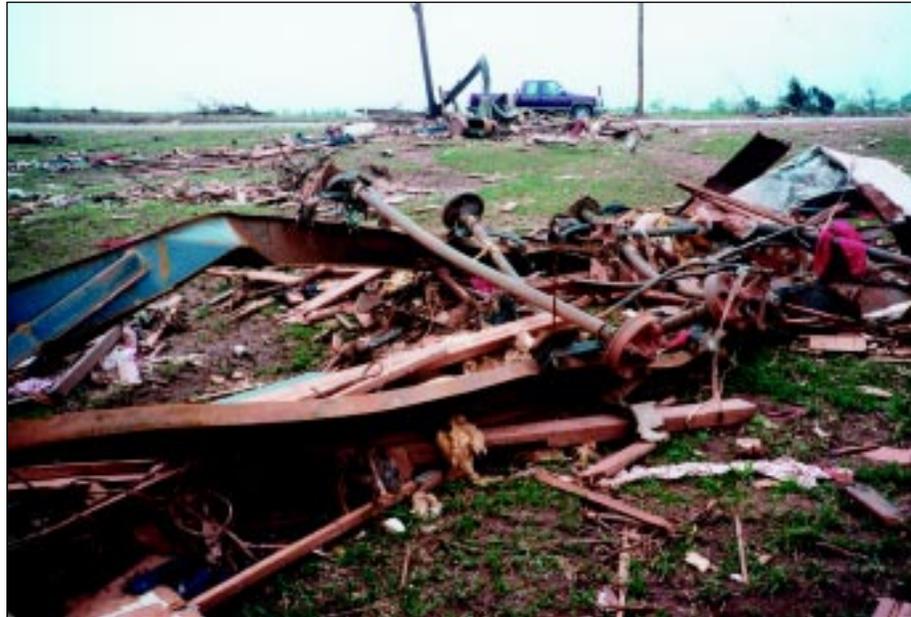
tornado vortex was approximately 300-400 ft away from this home. At the original site, vertical and diagonal straps remained attached to the ground anchor, but had failed about 2 to 3 ft from the anchors (Figure 4-48). The first anchors had been fastened about 12-ft from the east end. Both the number of anchor straps and tensile capacity of the straps were inadequate to resist wind uplift forces (Figure 4-49).

**FIGURE 4-49:** Strap anchoring failure most likely led to the displacement of this chassis, Bridge Creek, Oklahoma.

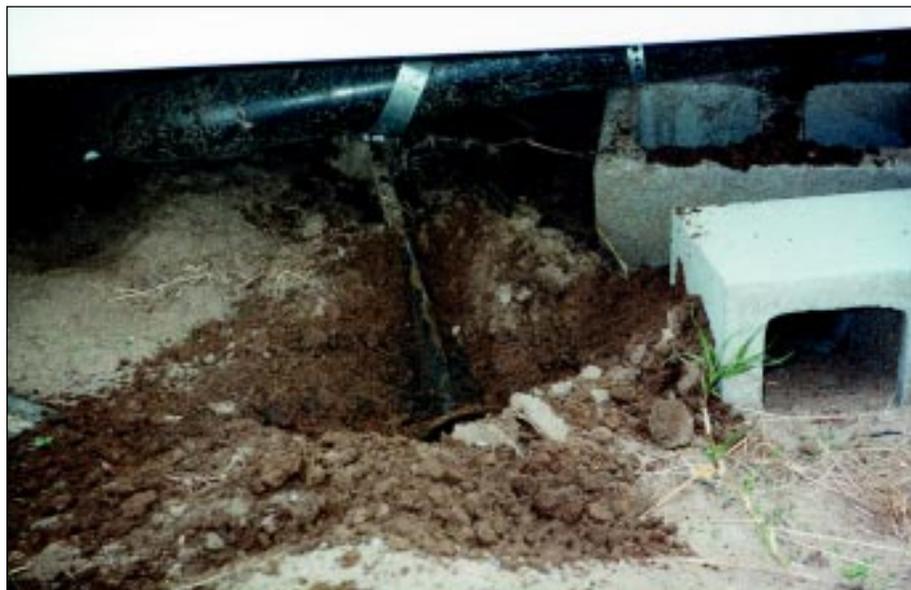
**FIGURE 4-50:** Ground anchor of manufactured home pulled from soil. This home in Wichita, Kansas, was located within the inflow area of a strong tornado.

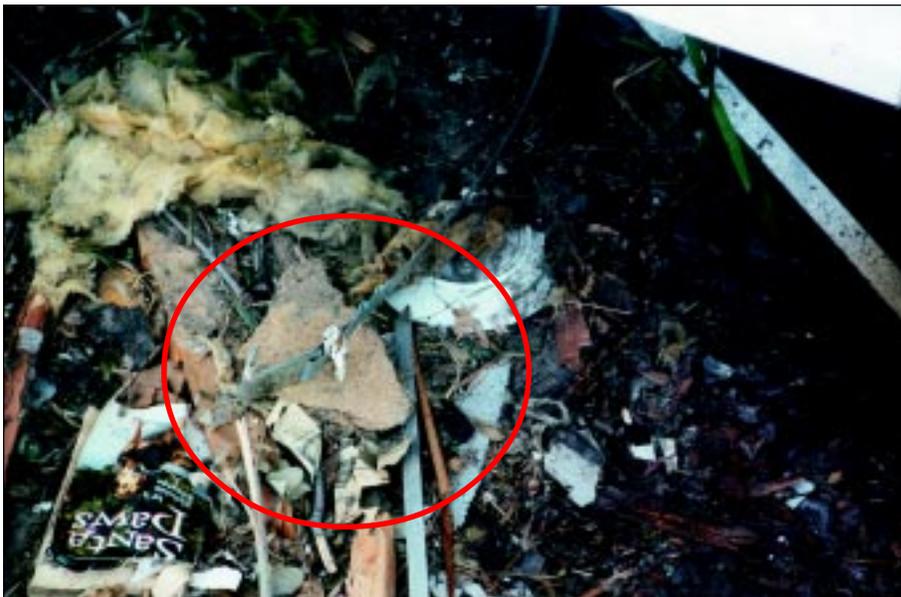
ment of the unit. Anchor depth into the loose sandy soil did not appear to be adequate to resist wind uplift and overturning forces (Figures 4-51 and 4-52) generated by a strong tornado whose vortex passed nearby, but did not directly strike the homes.

**FIGURE 4-52:** Strap torn off from chassis of manufactured home. This home in Wichita, Kansas, was located within the inflow area of a strong tornado.

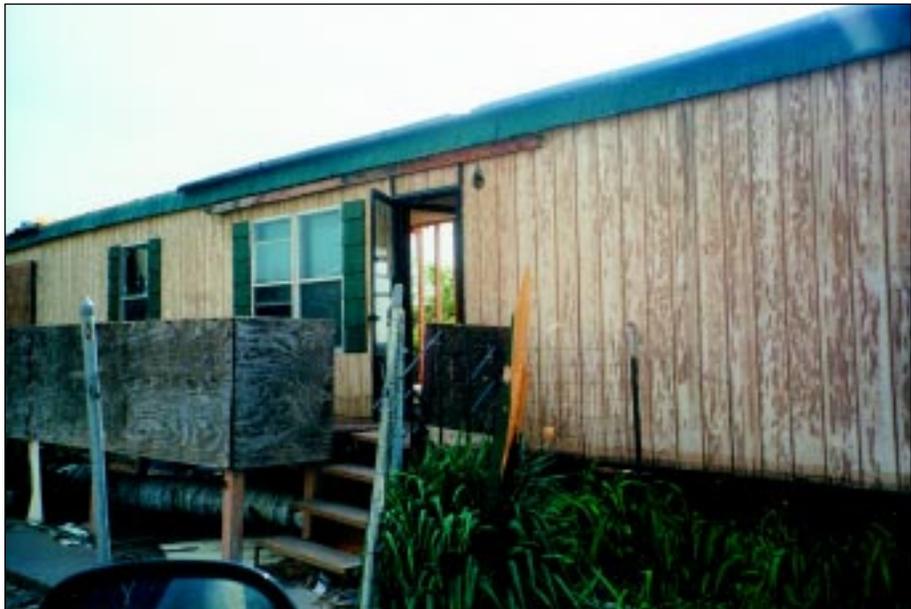
Several manufactured homes lost plywood roof sheathing and roof trusses, and some only lost asphalt roof shingles. Fastening of the roof sheathing and roofing materials was inadequate to resist wind uplift (Figures 4-53 and 4-54) from inflow winds of a strong tornado.

**FIGURE 4-54:** *Damage to a manufactured home located on the periphery of a strong tornado, Wichita, Kansas.*

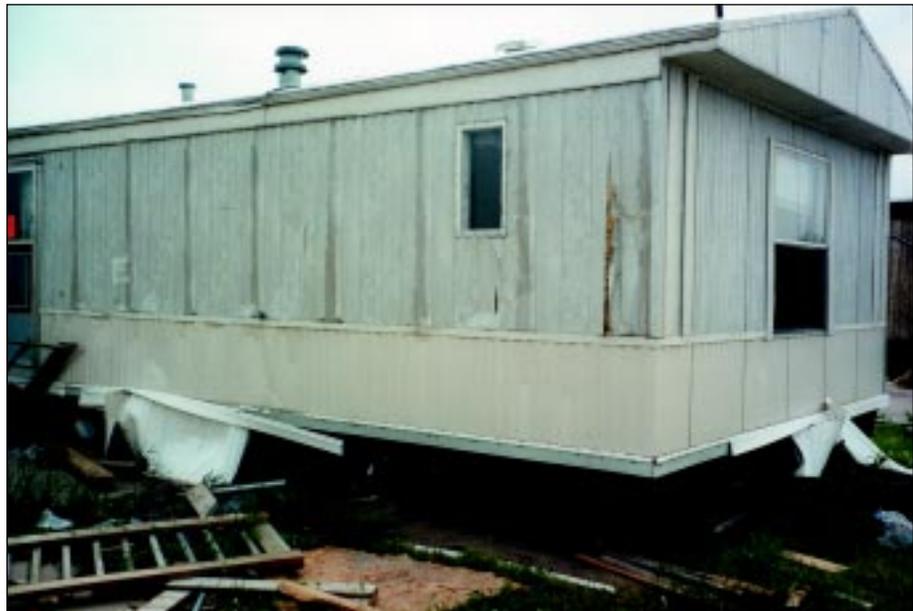
Several double-wide manufactured housing units in Haysville and Wichita, Kansas, partially survived high wind forces. However, ground anchors were pulled out of the soil, or they were bent over, loosening tie-down straps. Homes shifted laterally from wind forces and fell off un-reinforced and ungrouted CMU block piers. In some cases, tie-down straps with metal clips for attachment to chassis beams were loose and lying on the ground (Figures 4-57 through 4-60).

**FIGURE 4-57:** This manufactured home laterally shifted from wind force generated along the periphery of a violent tornado, Haysville, Kansas.

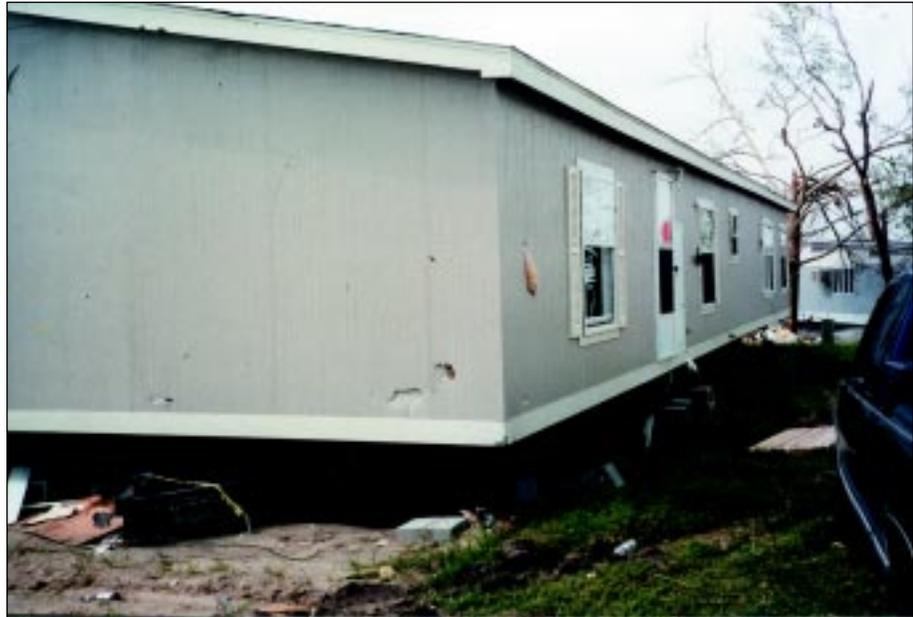
**FIGURE 4-60:** *Manufactured home laterally shifted off its dry-stacked masonry block foundation from wind force generated along the periphery of a violent tornado, Wichita, Kansas.*

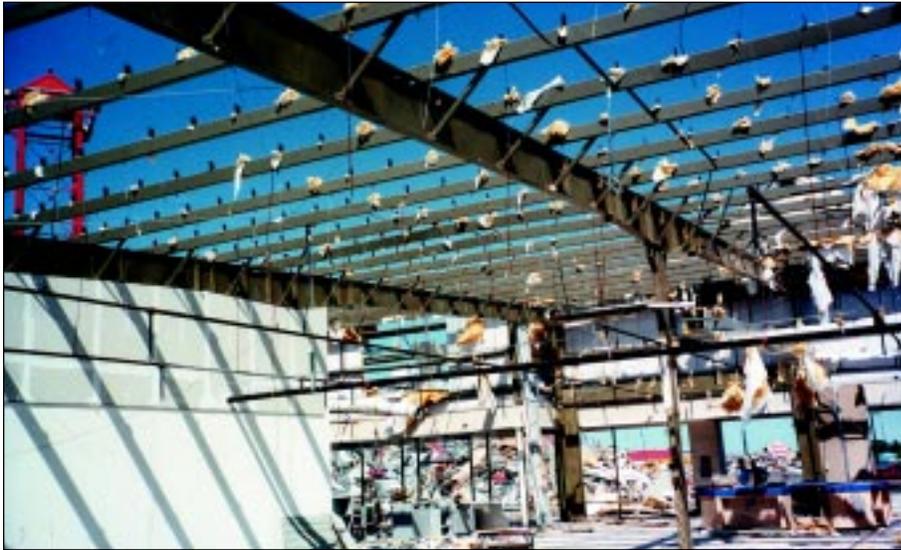
The BPAT visited a regional outlet mall in Stroud, Oklahoma, where most of the roof covering was blown away and significant damage to the building was evident. This mall was struck by a strong tornado that collapsed the central portion of the building's steel frame and damaged many of its masonry and steel frame walls. Figure 5-5 shows standing seam metal roof clips still attached to the purlins in one area of the mall that failed under the uplift loading. It was observed that metal wall panels attached with exposed fasteners performed better than the standing seam roof panels.

**FIGURE 5-5:** Metal roof deck (missing in photo) of regional outlet mall, Stroud, Oklahoma, was blown off when hit by a strong tornado vortex.

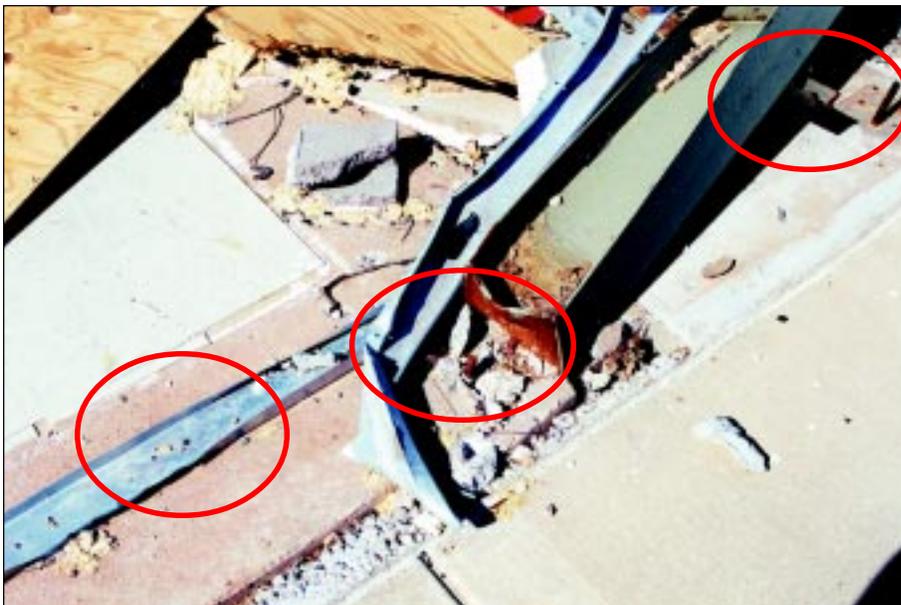
Figure 5-6 shows the attachment of columns to the foundation and attachment of the wall bottom plates to slab concrete. At the circle on the right in Figure 5-6, anchor bolts were provided, but the apparent lack of nuts on the anchor

**FIGURE 5-6:** Attachment of columns to foundation and attachment of wall bottom plates to concrete slab. Regional outlet mall, Stroud, Oklahoma, hit by a strong tornado vortex.

bolts permitted the column to lift off of the foundation. At the center circle, anchor bolts with properly attached nuts provided a high level of restraint to column uplift. The circle at the left shows a wall bottom plate that was attached to the concrete slab by powder-driven fasteners. Although the plate held at this location, lack of penetration by the nails into the concrete permitted the plate to pull out at many other locations. Additional fastener penetration would be needed to ensure consistent attachment of wall bottom plates to the slab.

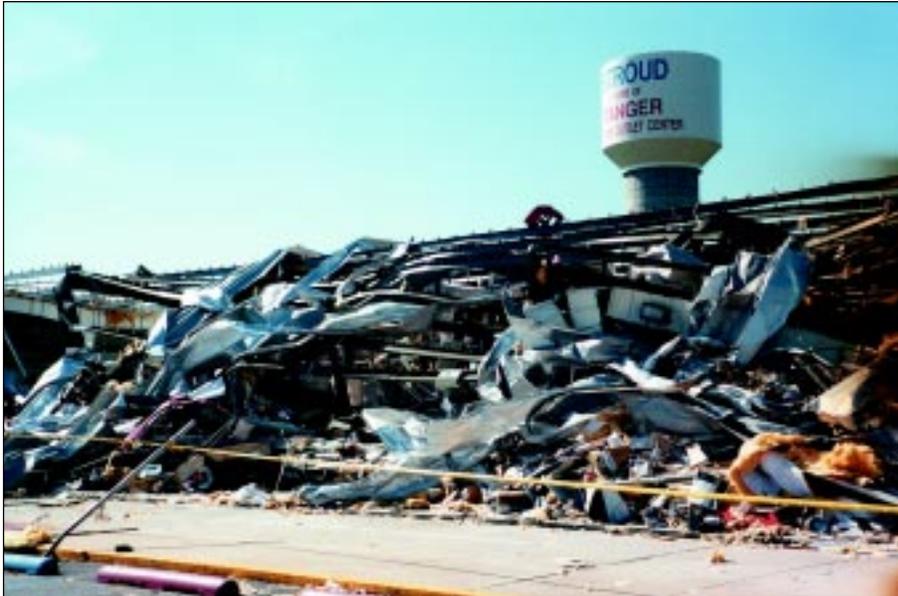
The BPAT investigated the regional outlet mall that was destroyed in Stroud, Oklahoma. Figure 5-9 shows damage to the outlet mall. In this structure, most of the metal roof panels were blown off by the tornado. In addition, most of the glass curtainwalls at the storefronts experienced failures.

**FIGURE 5-9:** *Stroud Regional Outlet Mall, Stroud, Oklahoma, was struck by the vortex of a weak tornado.*

In addition to the building failures at the regional outlet mall site in Stroud, numerous light poles failed. The BPAT documented the failures of these poles and calculated an approximate wind speed at this site from 180-210 mph (fastest mile wind).

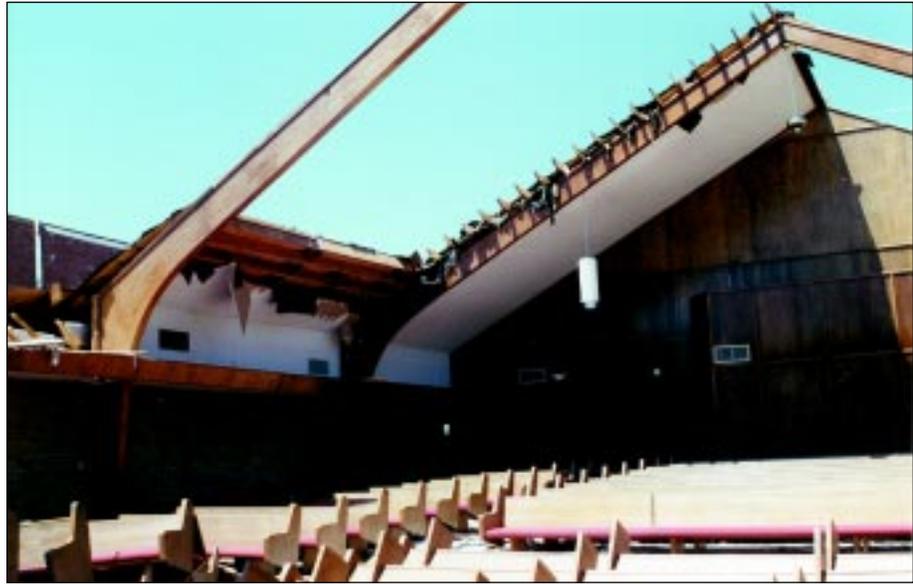
Lack of load path resulted in severe damage to the Regency Park Baptist Church in Moore, Oklahoma. This building was approximately one block north and across the street from Kelly Elementary School. The vortex of a violent tornado passed approximately a few hundred yards to the south. Figure 5-10 shows the rigid frames remaining after the roof had been removed by the tornado. Loss of load path between the rigid frames and the roof purlins resulted in severe damage to the facility.

**FIGURE 5-10:** *This church suffered loss of roof due to lack of load path between the rigid laminated wood arches and the roof purlins (missing in photo) that supported roof sheathing. Inflow area of a violent tornado, Moore, Oklahoma.*

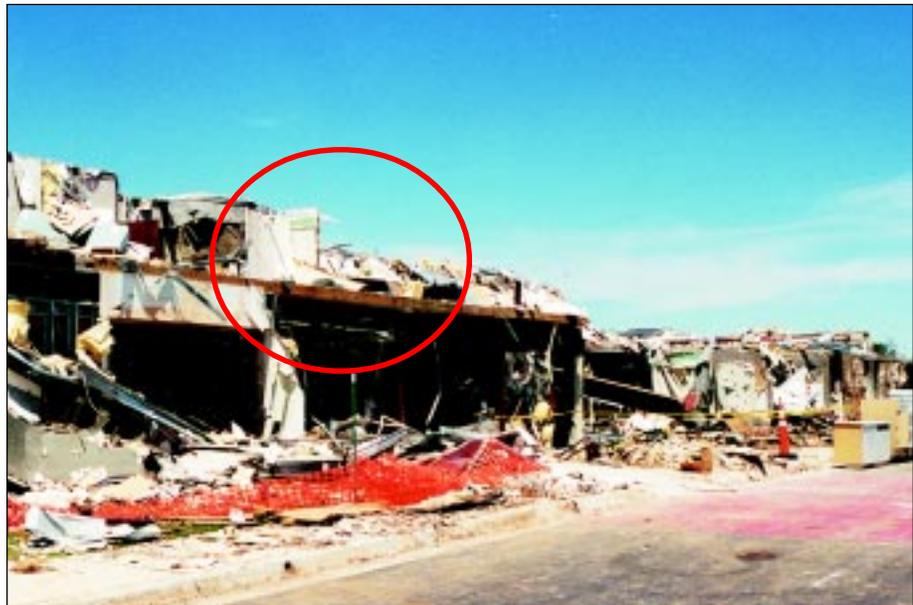
In several locations, combined effects of wind uplift and horizontal wind loads caused damage to structures. A continuous load path is often observed in this type of construction at the connection of the floor slabs to the walls. However, at many of the buildings of this type of construction, a continuous load path for uplift and lateral loads did not exist and roof failures and upper level floor failures were observed. Figure 5-11 shows the remains of a motel in Midwest City, Oklahoma, hit by a violent tornado vortex. The circle shows a steel beam

**FIGURE 5-11:** *Motel in Midwest City, Oklahoma that experienced major damage when struck by the vortex of a violent tornado.*

that had been deflected inward significantly when the floor slab was lifted during the tornado. There was no positive connection between the steel beam and the floor above.

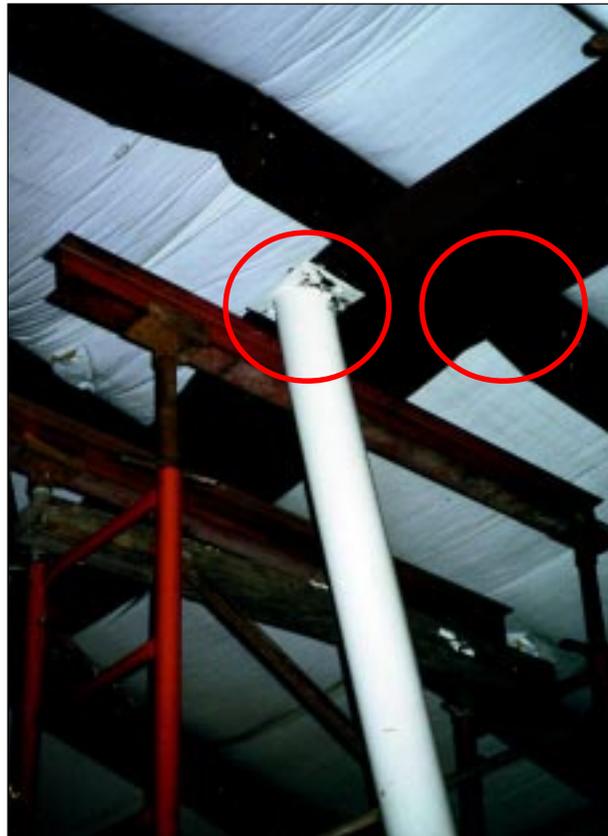
At a plastics manufacturing plant in Haysville, Kansas, a combination of uplift and horizontal wind caused out-of-plane buckling of the bottom flange of a main girder supporting the roof (Figure 5-12) when the plant site was struck by a strong tornado. One circle shows the column that supports the girder, while the other circle shows the bottom flange of the girder. It can be seen that the bottom flange has displaced significantly sideways in relation to the top flange of the girder. Inspection along the length of the girder indicated that the bottom flange was braced along its length at every purlin except at the location of the supporting column. This lack of bracing permitted buckling and out-of-plane displacement of the bottom flange. However, due to the light gravity loads left on the roof after the wind forces diminished, collapse did not occur.

**FIGURE 5-12: Out-of-plane buckling of the main girder supporting the roof created by a combination of uplift and horizontal wind loads. Plastics plant, Haysville, Kansas, hit by violent tornado. This building was in the inflow area of a strong tornado.**

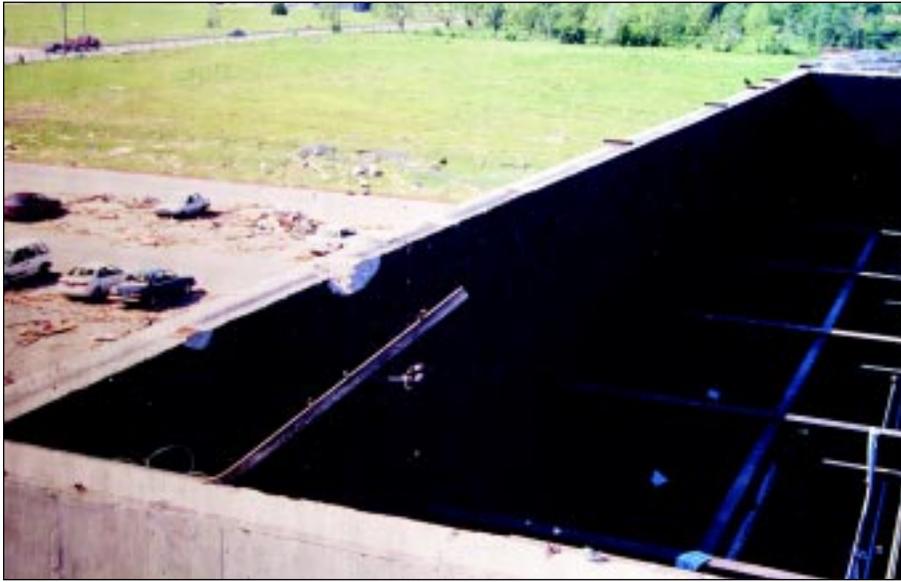
The Westmoore High School in Moore, Oklahoma, was a relatively new structure that was within 100 yards of the vortex of a violent tornado. A portion of the roof deck and supporting steel joists over the auditorium stage was blown off. Figure 5-14 shows the walls where the steel joists had been attached prior to the tornado. In all cases, welds failed between joist ends and embedments in the walls. This loss of continuous load path permitted the roof to be lifted up off of the reinforced concrete walls.

**FIGURE 5-14:** Roof blown off over top of auditorium at Westmoore High School, Moore, Oklahoma, hit by inflow winds of violent tornado.

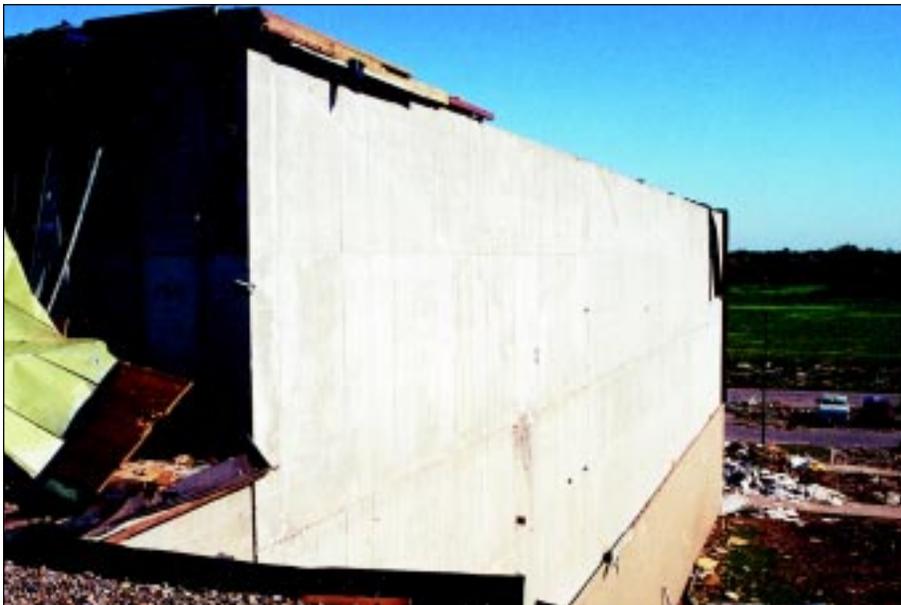
Figure 5-15 shows the exterior of the reinforced concrete wall at Westmoore High School following the tornado. This 12-in thick by approximately 35-ft-tall wall remained essentially undamaged, except for loss of the metal wall covering, even though the diaphragm action of the roof was lost. The construction of the stage area integrated an I-beam horizontal frame, shown in Figure 5-14, with the reinforced concrete walls. This frame helped to stabilize the walls. Prior to the tornado, the bare concrete had been covered with a decorative metal curtainwall. The entire curtainwall blew off during the tornado, while brick masonry veneer on the lower wall remained, with virtually no damage.

**FIGURE 5-15:** Exterior view of an undamaged reinforced concrete wall, Westmoore High School, Moore, Oklahoma, hit by inflow winds of a violent tornado. Note: decorative metal wall covering was peeled from this wall.

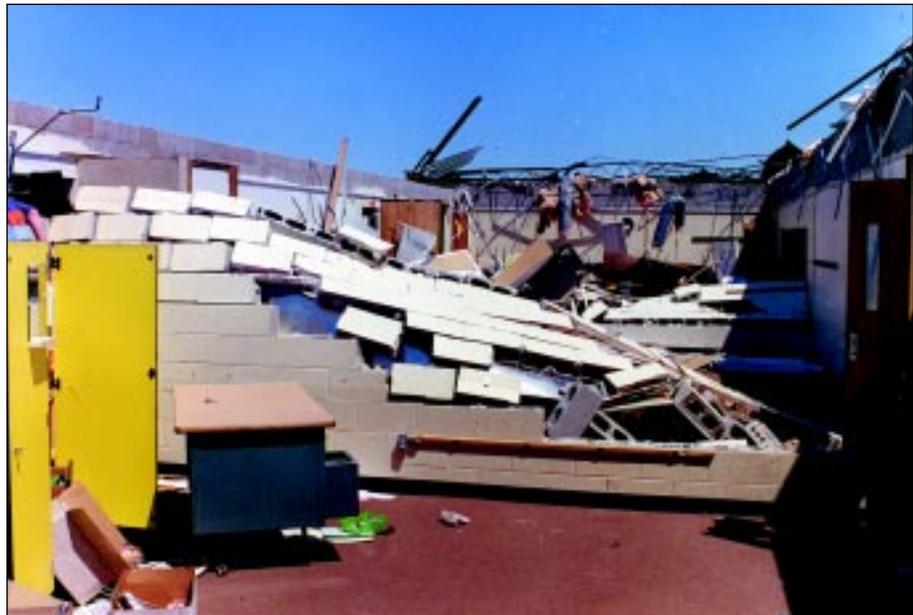
Figure 5-20 shows damage to both interior and exterior unreinforced masonry walls (URM) at Kelly Elementary in Moore, Oklahoma. Wind loads due to the vortex of a violent tornado lifted the roof system until the bond beam atop the URM wall failed. When this bond beam failed, the roof separated from the building and some interior walls failed.

**Figure 5-20: Damage to interior and exterior unreinforced masonry walls when bond beams failed at Kelly Elementary School in Moore, Oklahoma. The school was struck by the vortex of a violent tornado.**

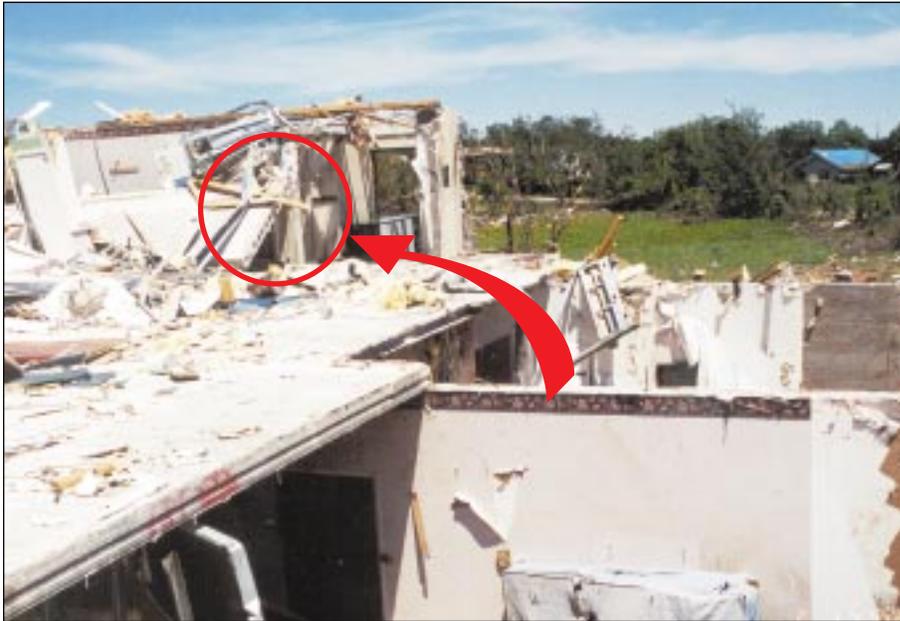
Figure 5-21 shows the location where hollow core planks had formed the second floor. The circle at the right shows a dowel from the masonry wall into grout between the ends of two hollow core panels. One of the panels that had been at the edge of the building was found up on the second level and across on the far side of the building as shown by the circle on the left of Figure 5-21. The wind uplift forces from the tornado were large enough to

**FIGURE 5-21: Hollow-core plank formed on second floor of a Midwest City, Oklahoma, hotel that was struck by the vortex of a strong tornado.**

overcome the tie-down force provided by the very short dowels. The hollow core planks were been lifted and blown across the width of the building.

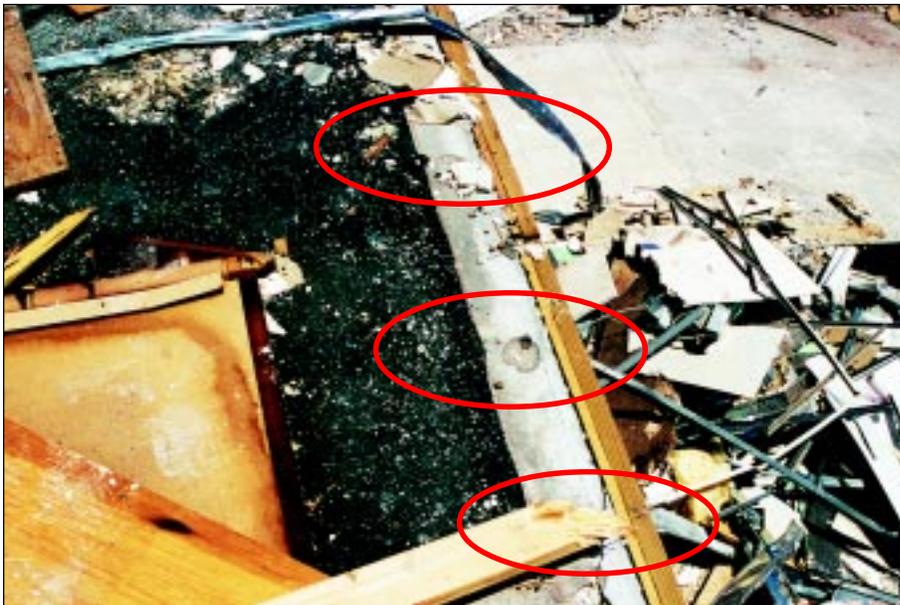
Elsewhere along the edge of the second floor of the motel, failure occurred between the hollow core planks and exterior walls of the building. As shown in Figure 5-22, lower plates for the walls had been attached to the hollow core planks using powder-driven anchors. As indicated by the circles, the powder-driven anchors pulled out during the tornado.

**FIGURE 5-22: Attachments of lower plates for wall to hollow core plank using powder driven anchors failed when required to carry loads generated by the winds of a strong tornado vortex. This motel was located in Midwest City, Oklahoma.**

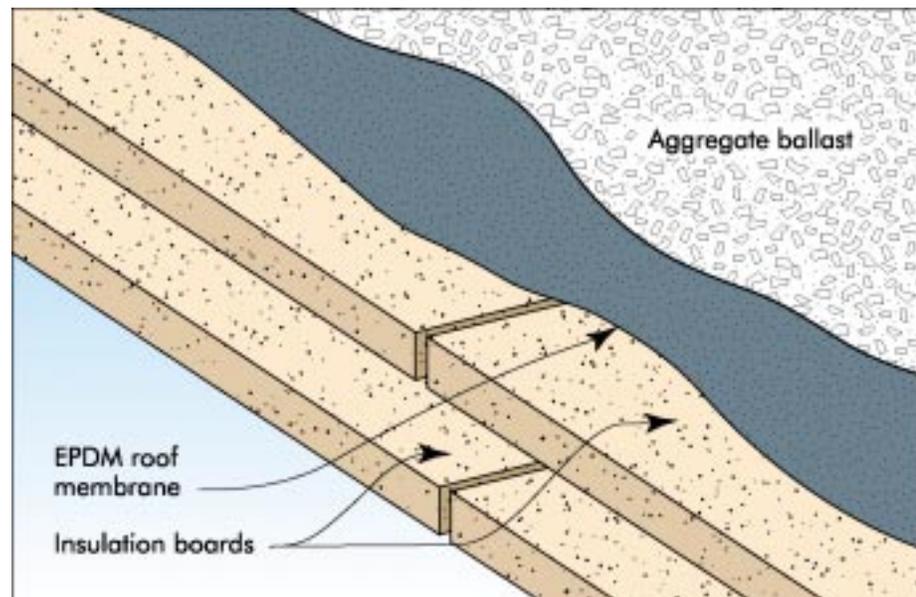
**FIGURE 5-23: EPDM with aggregate (stone) ballast roof covering.**

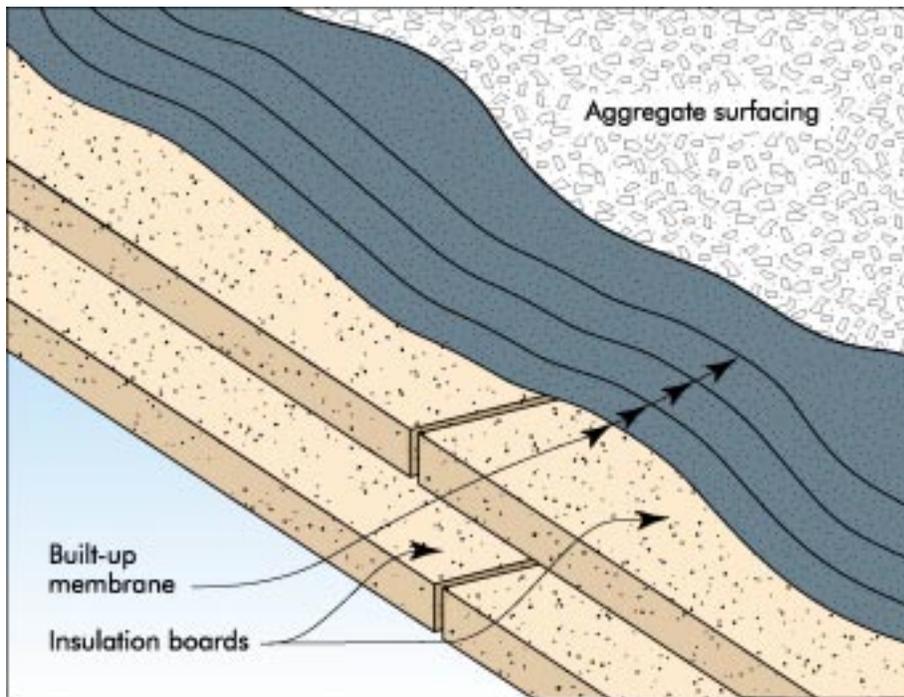
**FIGURE 5-24: Built-up (aggregate ballast surface and cap sheet) roof covering.**

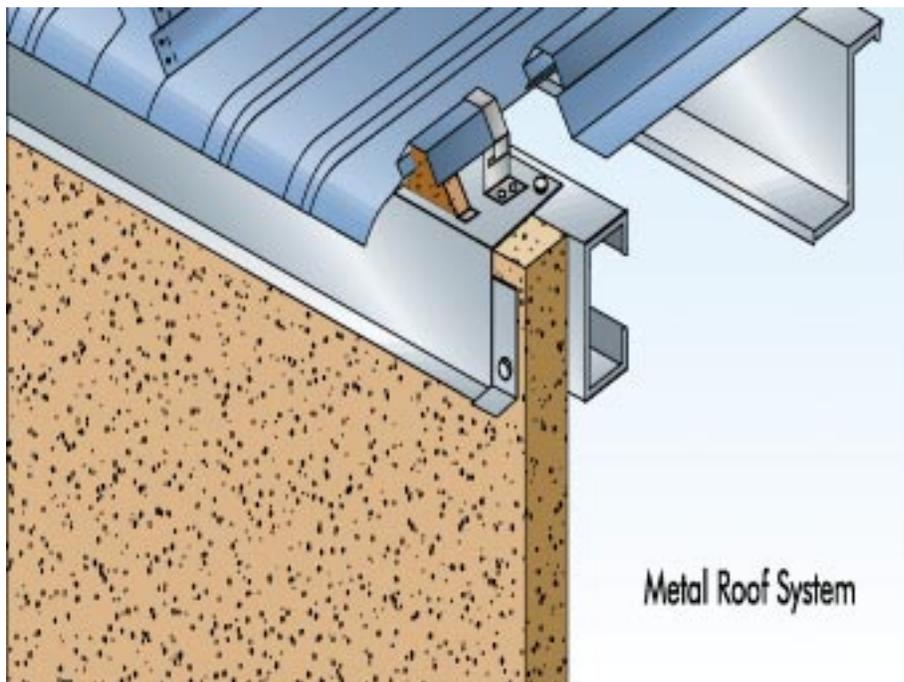
**FIGURE 5-25: Metal panel roof covering (architectural and structural), including standing seam.**

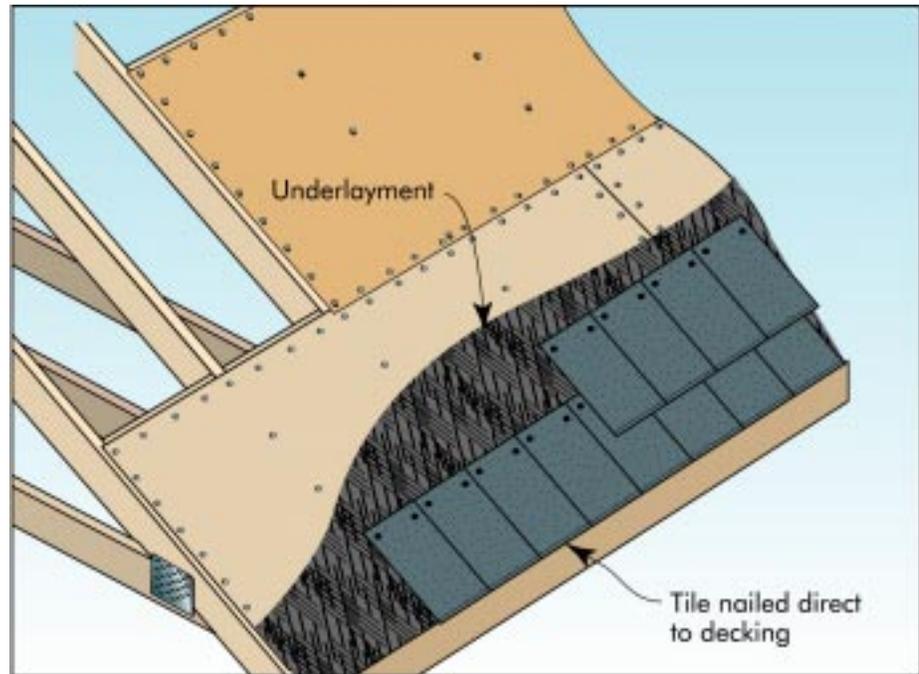
**FIGURE 5-26: Tile roof covering.**

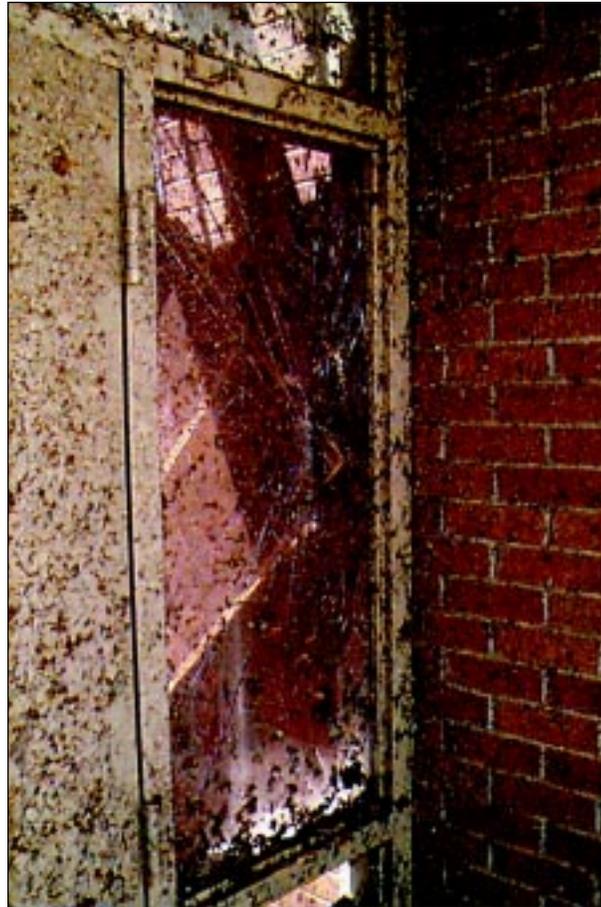
In a few instances, examples of laminated glass performance were observed. In some cases, the glass remained in the frame after missile impact (Figure 5-29). In another case, the glass was punched out of its frame. The school in Figure 5-29 is located adjacent to the Regency Park Baptist Church in Moore, Oklahoma, shown in Figure 5-10. The vortex of a violent tornado passed a few hundred yards south of this building.

**FIGURE 5-29:** *The corner of a table penetrated this laminated glass, but the glass remained in its frame. This school suffered major damage from inflow winds of a violent tornado in Moore, Oklahoma.*

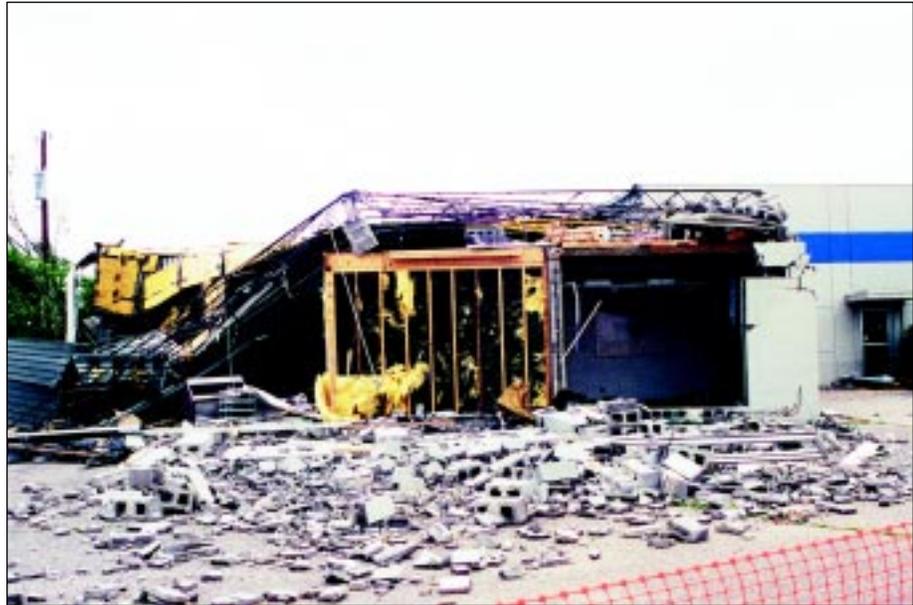
Figure 5-31 illustrates another condition in Wichita, Kansas, where breach of the building envelope contributed to additional structural damage. In this case, loss of showroom windows and a rollup door greatly increased loads in the showroom and on the wall at the left of the photograph. These increased loads caused the walls to fail and the roof to partially collapse, thereby greatly increasing structural damage.

**FIGURE 5-31:** *Additional structural damage caused by breach of envelope in Wichita, Kansas.*

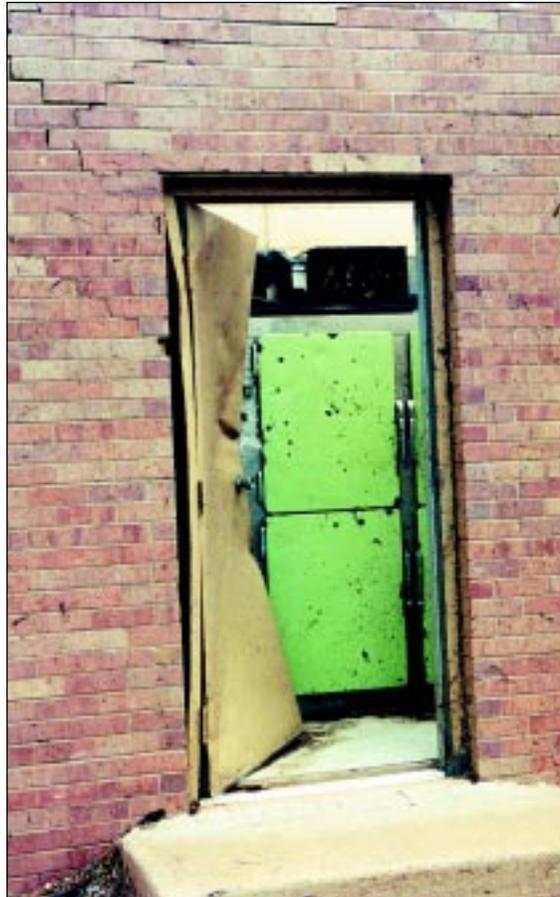
Figure 5-32 shows a steel door that appears to have been opened by impact of a heavy object. This door at Kelly Elementary School in Moore, Oklahoma, led into an area where the roof was completely missing. The breached door may have caused an increase in load that propagated damage to that part of the building envelope. A nearby door, which was also heavily impacted, but did not open, was located in an area of the school that saw less damage to the wall and roof of the building.

**FIGURE 5-32:** *Damaged door most likely opened by impact with heavy object. Kelly Elementary School, Moore, Oklahoma.*

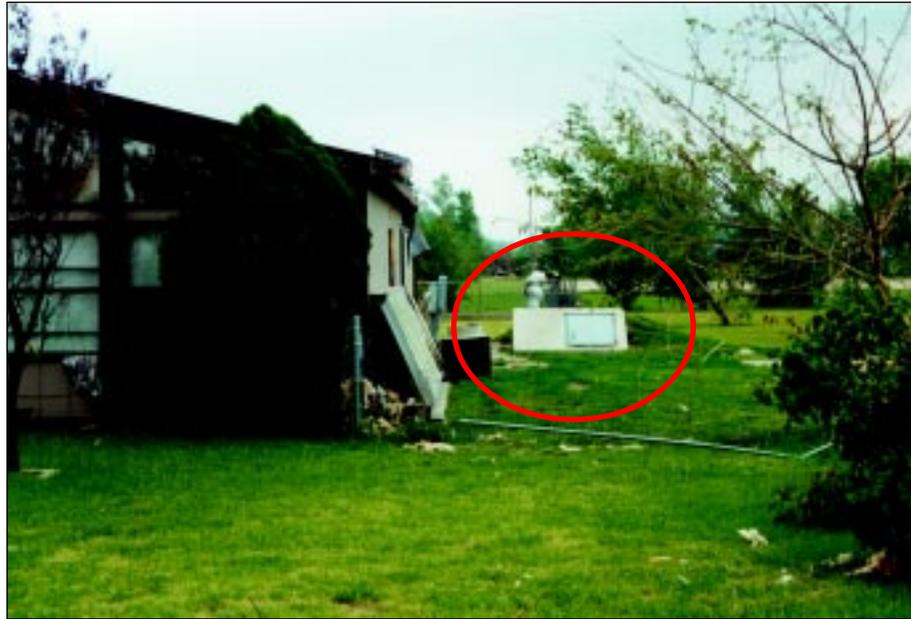
**FIGURE 6-4:** *This precast concrete storm cellar was located immediately behind a single-family residence in Sedgwick County, Kansas. This residence and shelter were on the periphery of a violent tornado path.*

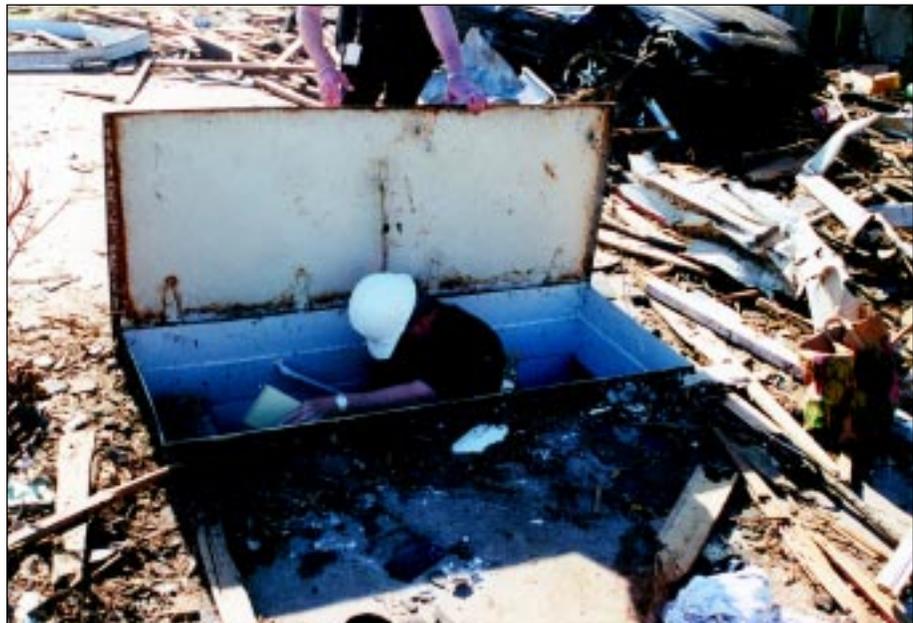
**FIGURE 6-5:** *Del City storm cellar constructed of welded steel sheets with a concrete roof slab. This area was directly struck by the vortex of a violent tornado.*

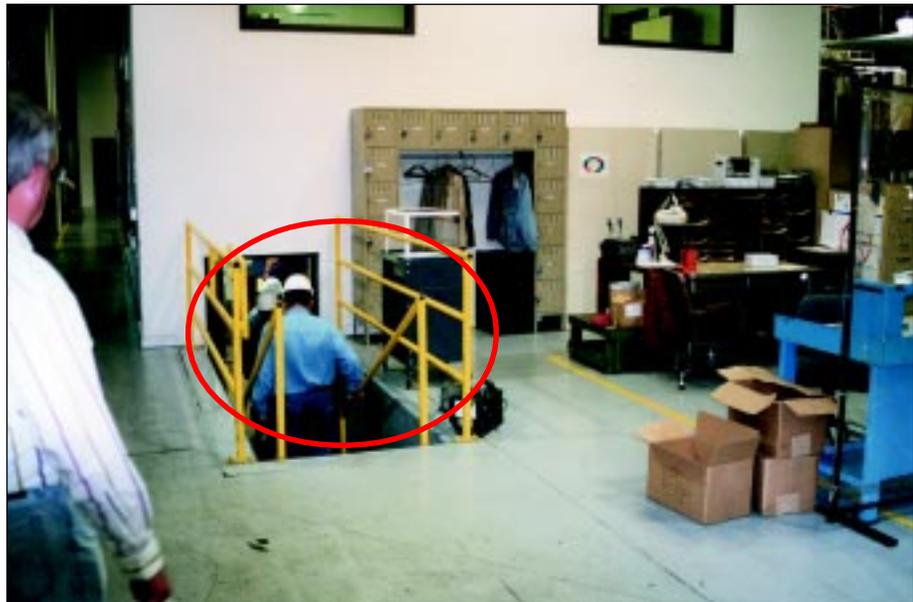
Deficiencies and vulnerabilities were observed in the group shelter presented in Figures 6-7 and 6-8. The shelters in both figures are only accessible by stairs and, depending upon the emergency plan, are possibly non-compliant by ADA requirements. The interior of the shelter in Figure 6-7 was also very damp, signifying a moisture problem that may be a problem for long duration stays within the shelter. The group shelter in Figure 6-8 has a vent on the top that is

**FIGURE 6-7:** Entrance to the plastics manufacturing plant group shelter in Haysville, Kansas.

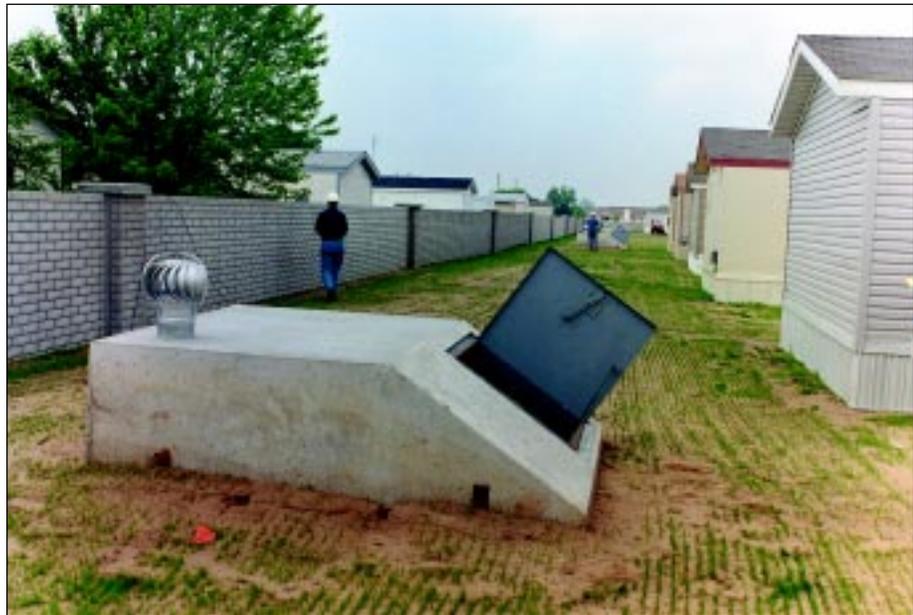
**FIGURE 6-8:** Group shelters at a manufactured home rental community in Wichita, Kansas.

very susceptible to damage and removal by wind and windborne debris. The door, specifically the latch mechanism, is vulnerable to windborne debris. Damage to either of these two elements would result in experiencing wind, windborne debris, and hail and rain from a storm event within the shelter.

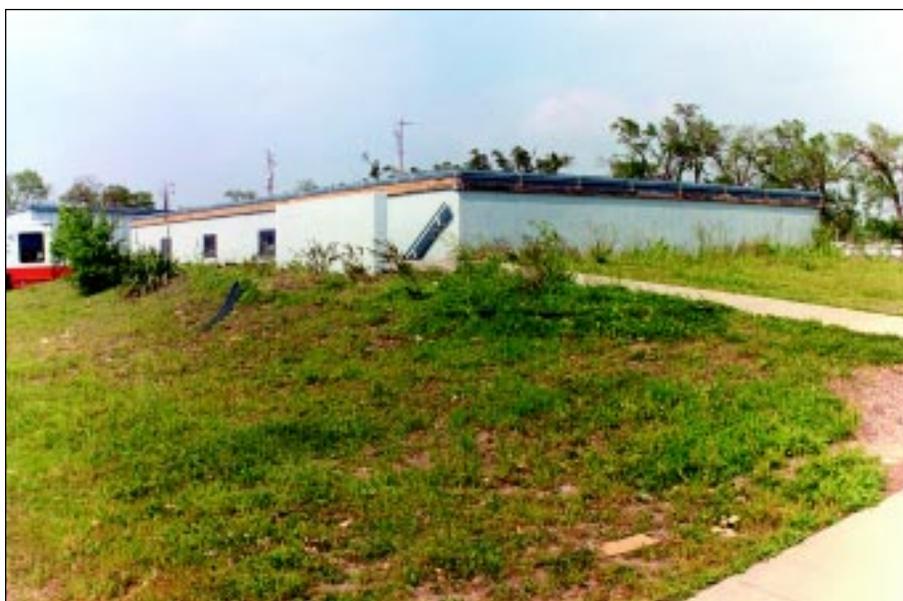
may often be located up to ½ mile from the individuals requiring use of the shelter. A manufactured home community shelter in Wichita, Kansas, was constructed partially underground and located at one end of the large development. The shelter was intended to house all residents of the development (Figure 6-9). Approximately 200 people reportedly sought shelter in this building during the May 3 tornadoes. Another community-sized shelter was located underground and under the concrete bleachers in the Midwest High School gymnasium in Midwest City, Oklahoma (Figure 6-10). Approximately 500 people sought shelter here during the May 3 tornadoes (the shelter has a capacity of 3,500). A similar shelter is located at Del City, Oklahoma High School in Del City. Members of the community are generally aware of the location of these shelters. Interviews with residents of the manufactured home community indicated that parking was a problem at the community shelter. In contrast to the shelter at the manufactured home community, ample parking is available near the high school gymnasiums for those seeking shelter.

**FIGURE 6-9: Partially belowground community shelter in a manufactured home park in Wichita, Kansas.**

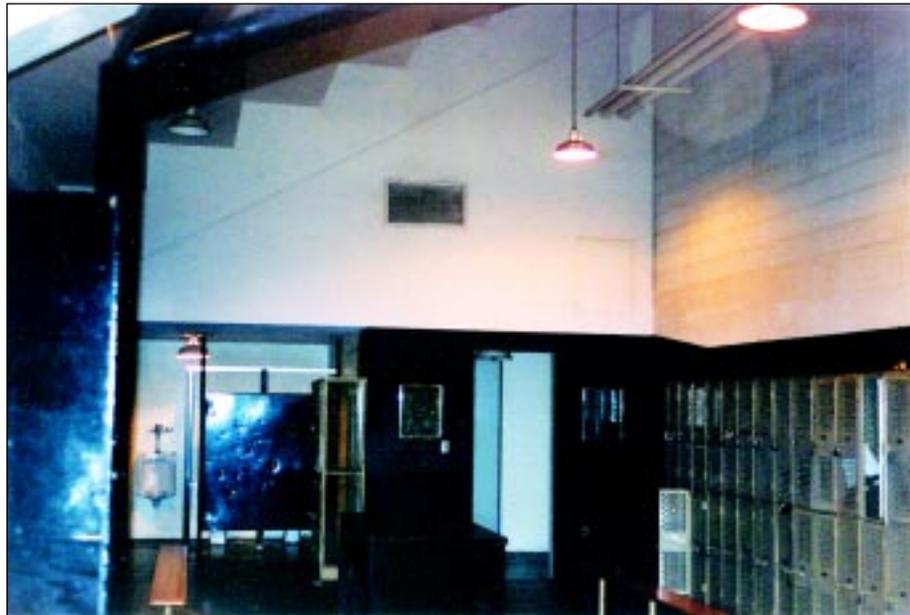
The shelter in Figure 6-10 had the following vulnerabilities. According to residents, the shelter was constructed in a flood-prone area that often causes access problems to the shelter and could result in the shelter being inundated by floodwaters. Residents also indicated that only a few people had keys to open the shelter and, during this event, other residents had to wait to gain access because they did not have keys. Similar to the shelters shown in Figures 6-7 and 6-8, access was limited to stairwells at each end of the shelter. Numerous windows along the sides of the building are vulnerable to damage. Finally, the roof covering of aggregate surfacing may become air-

**FIGURE 6-10:** *Community shelter, Midwest High School gymnasium in Midwest City, Oklahoma.*

borne during high-wind events and tornadoes. If this ballast becomes airborne, it could damage the windows of the facility and seriously injure individuals attempting to take refuge within the shelter.

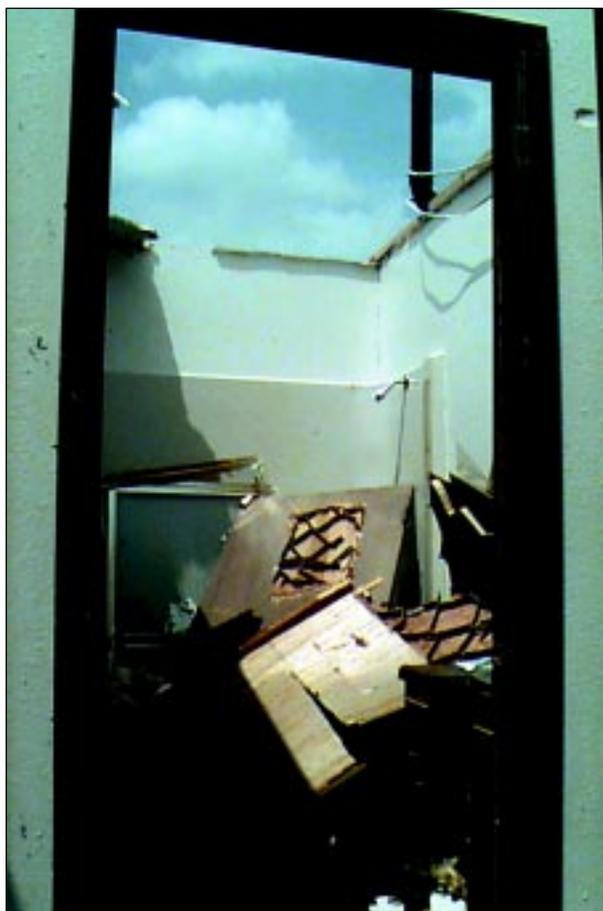
**FIGURE 6-21:** This apartment complex in Kansas was affected by inflow winds associated with a strong tornado. The roof and ceiling were blown off of the interior bathroom of this house, the door was blown into the bathroom, and the tub was full of debris. This bathroom would not have provided a safe place of refuge.

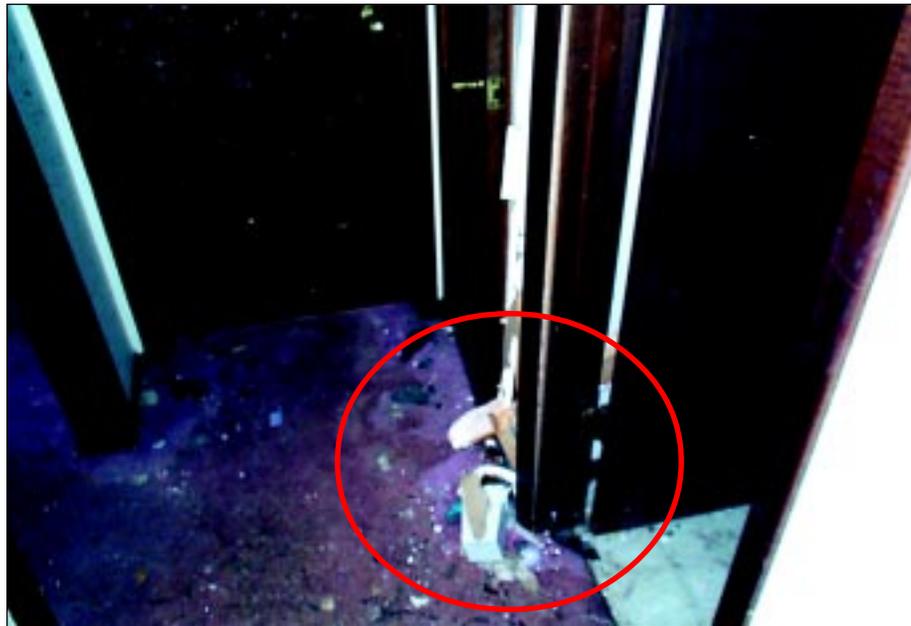
**FIGURE 6-24:** *This bathroom was on an exterior wall and had a window. It did not provide a safe place of refuge.*
