**BUILDING PERFORMANCE ASSESSMENT REPORT**

# *Midwest Tornadoes of May 3, 1999*

**OBSERVATIONS, RECOMMENDATIONS,  
AND TECHNICAL GUIDANCE**

**FEDERAL EMERGENCY MANAGEMENT AGENCY**

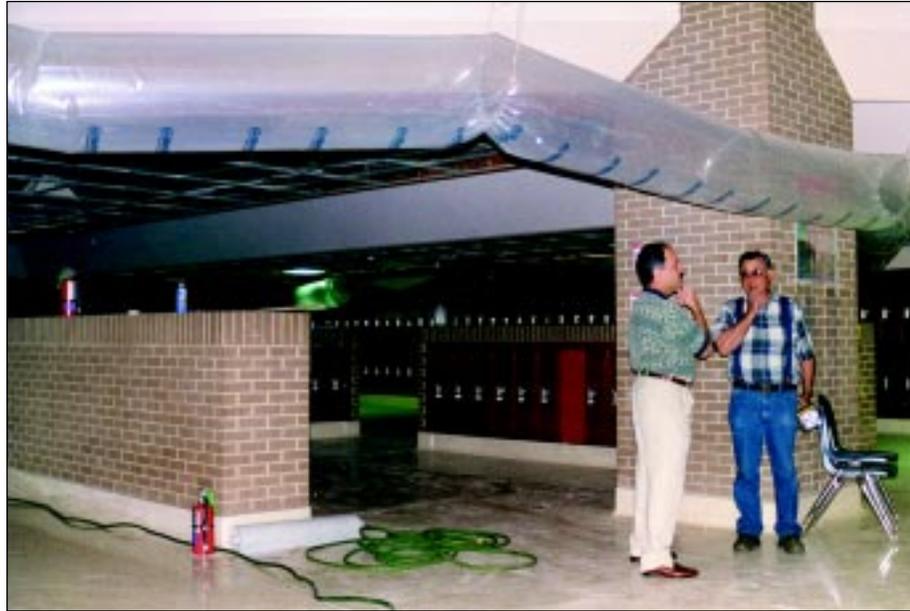
of the vortex of a violent tornado and received building envelope and roof structure damage. Just prior to the storm, several hundred students and parents occupied the auditorium. In accordance with the emergency plan, most of the students and parents were moved to a predetermined area in a central core of the building where they successfully took refuge (Figure 6-32). Other individuals reportedly took refuge in a reinforced concrete stairwell adjacent to the auditorium.

**FIGURE 6-32: Westmoore High School, Moore, Oklahoma, central locker core – a designated place of refuge.**

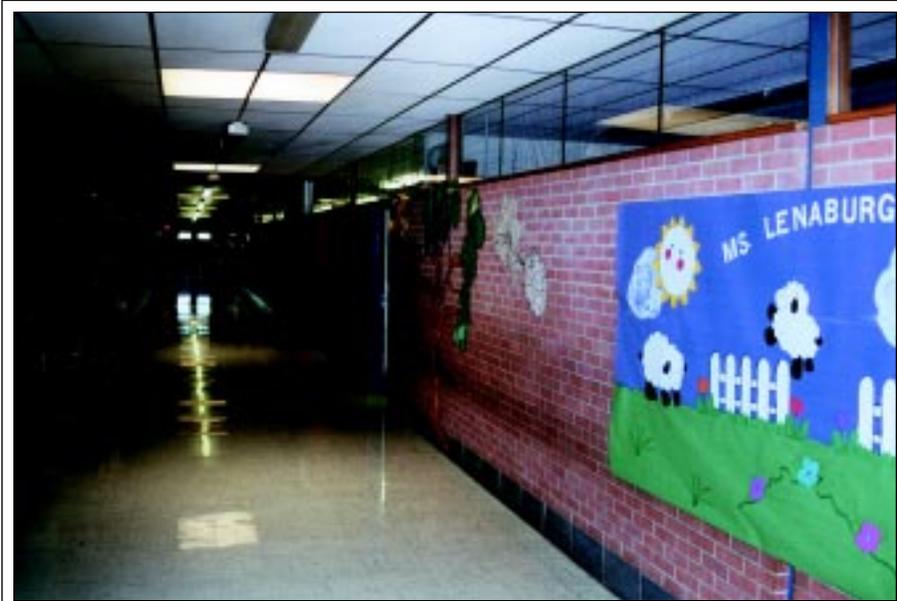
Figure 6-34 shows a central corridor of Northmoor that illustrates the corridor masonry walls topped with windows, called “clerestory”. These types of walls have limited capacity to resist lateral forces because of the windows located along the tops of the wall systems. Figure 6-35 shows a corridor in Kelly Elementary of nearly identical construction to the hallway in Figure 6-34. The inability of the corridor walls to withstand extreme loads due to lateral and uplift wind forces resulted in the collapse of this corridor. Many schools identify their central corridors as places of refuge in their tornado plans. Obviously, had these corridors been used for shelter during the tornado, numerous injuries or deaths would have occurred. Sooner Rose Elementary was a different construction type from the above, but contained similar windowed corridors (see Figure 6-36).

**FIGURE 6-34:** Northmoor Elementary place of refuge, Moore, Oklahoma – corridor with clerestory windows. This corridor offers little protection from tornadoes as shown in a school of similar design in Figure 6-35.

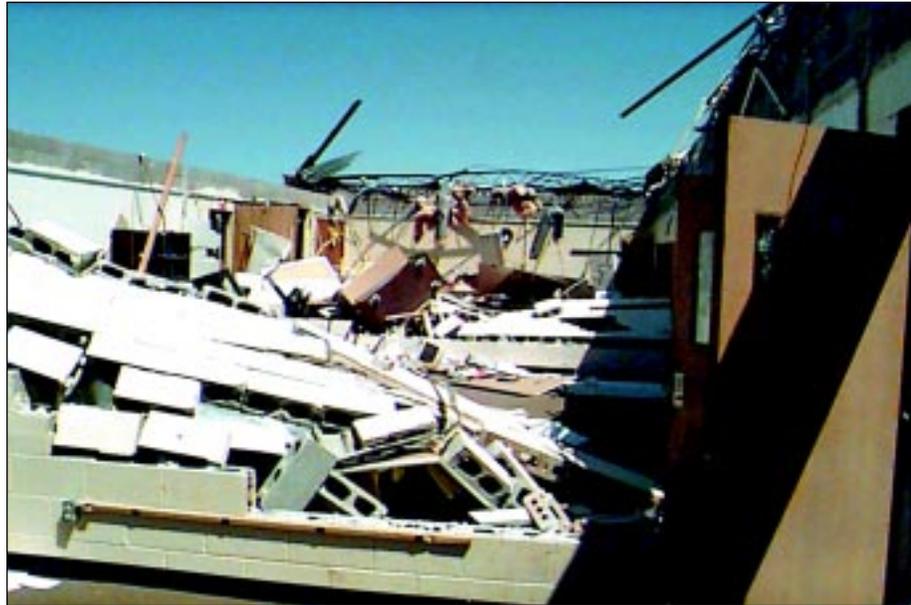
gypsum board that is supported by studs, and a layer of gypsum board on the interior side of the studs (Figure 6-37). Brick and CMU walls can also be deceiving. If they are adequately reinforced and braced, they can offer a significant level of protection. But if they are inadequately reinforced or braced, they can collapse, thereby trapping and crushing people (Figure 6-38).

**FIGURE 6-38:** *The non-reinforced interior CMU walls in this area of Kelly Elementary collapsed after the roof system was removed by vortex winds of a violent tornado.*
