4 *WTC 4, 5, and 6*

4.1 Design and Construction Features

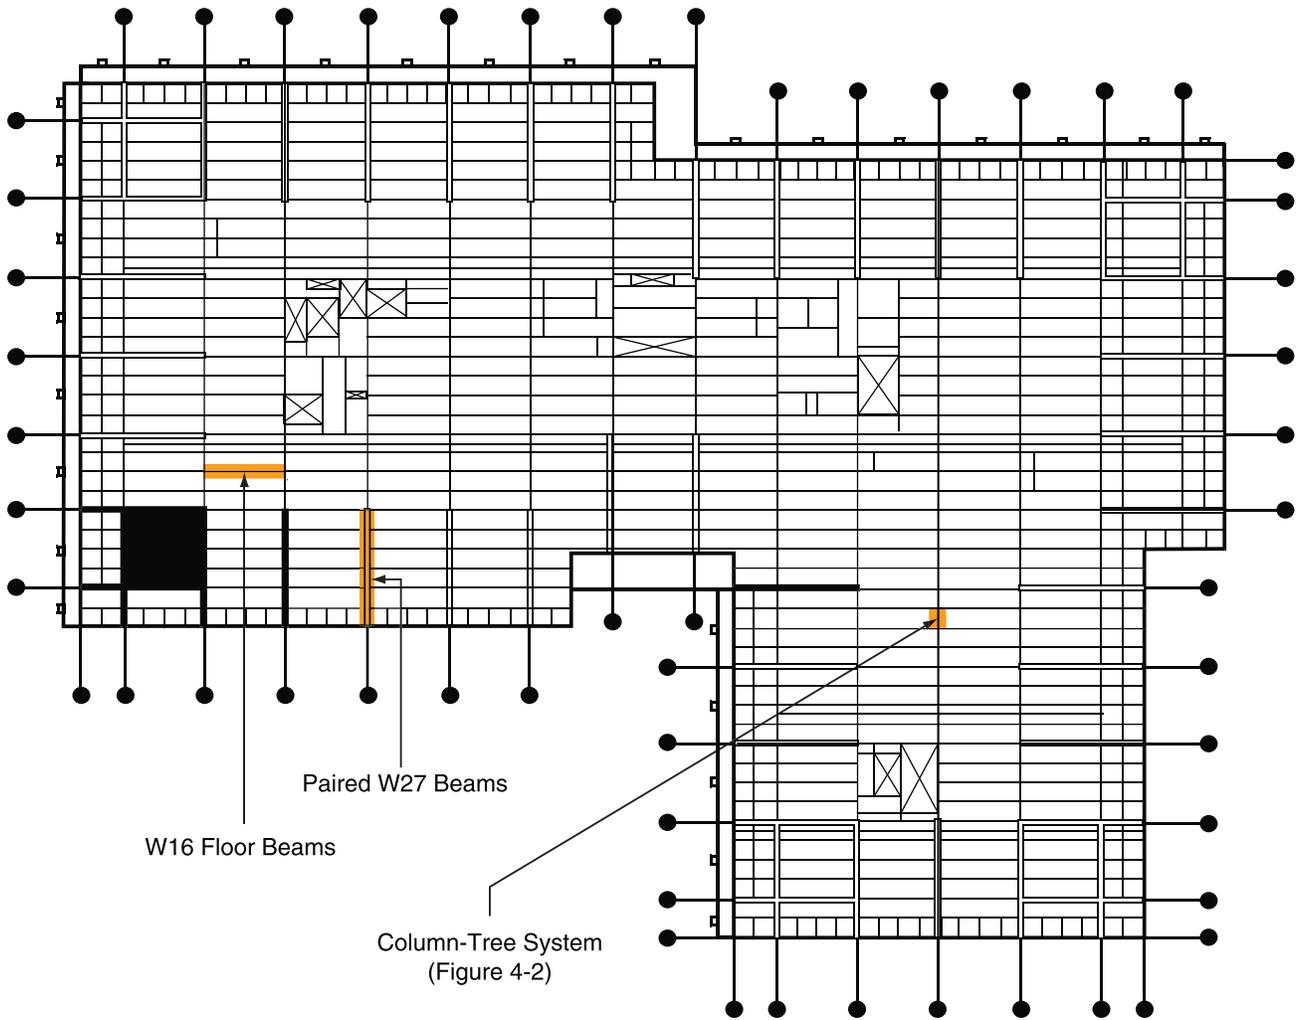
Figure 4-1 Typical floor plan for WTC 5 (Worthington, Skilling, Helle & Jackson 1968).

WTC 5 was located in the northeast corner of the WTC Plaza. The nine-story building was L-shaped in plan, with overall dimensions of 330 feet by 420 feet, providing approximately 120,000 square feet per floor (Figure 4-1). Floors were constructed of 4-inch-thick lightweight concrete fill on metal deck (with a combined thickness of 5-1/2 inches), supported by structural steel framing. The steel floor frame had shear studs welded to the top flange to create a composite floor system with the concrete deck. Wide-flange structural columns were placed on a regular 30-foot-square grid pattern. The floor plates cantilevered out 15 feet from the exterior column lines on all sides. To support this cantilever and provide the basic lateral resistance for the structure, a pair of W27 wide-flange beams were provided at each column line. These doubled wide-flange beams extended between the two outermost column lines, forming a moment-resisting frame, and cantilevered past the outer columns.

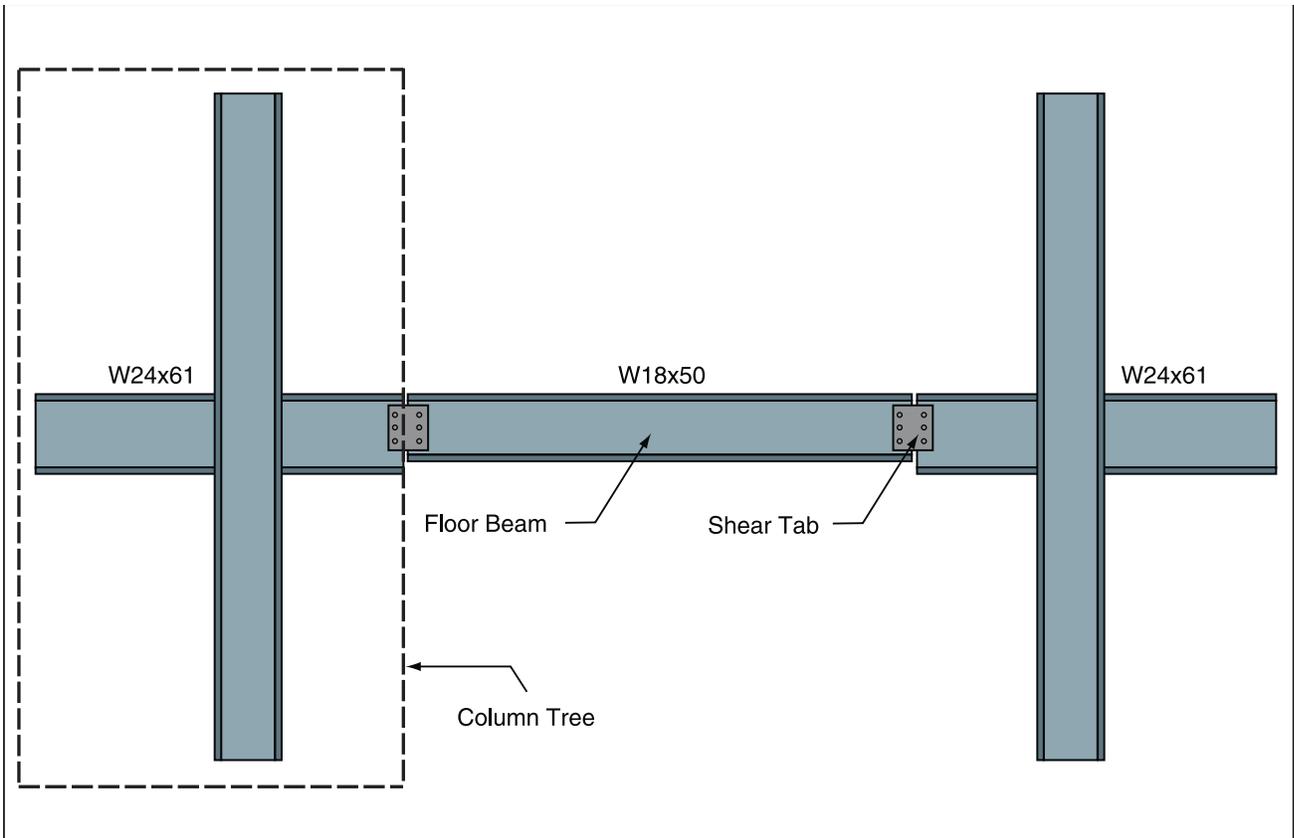
Figure 4-2 Typical column-tree system (not to scale).

Floor beams were typically W16 wide-flange members. At interior column lines, a column-tree system was used, in which a 4-foot-long stub was shop-welded to the column on each side, and the floor girder was

simply connected, with shear tabs, to the cantilevers (Figure 4-2). Floor 9 and roof level framing was conventional for steel-frame construction and did not include a column-tree system, as illustrated in Figure 4-3.

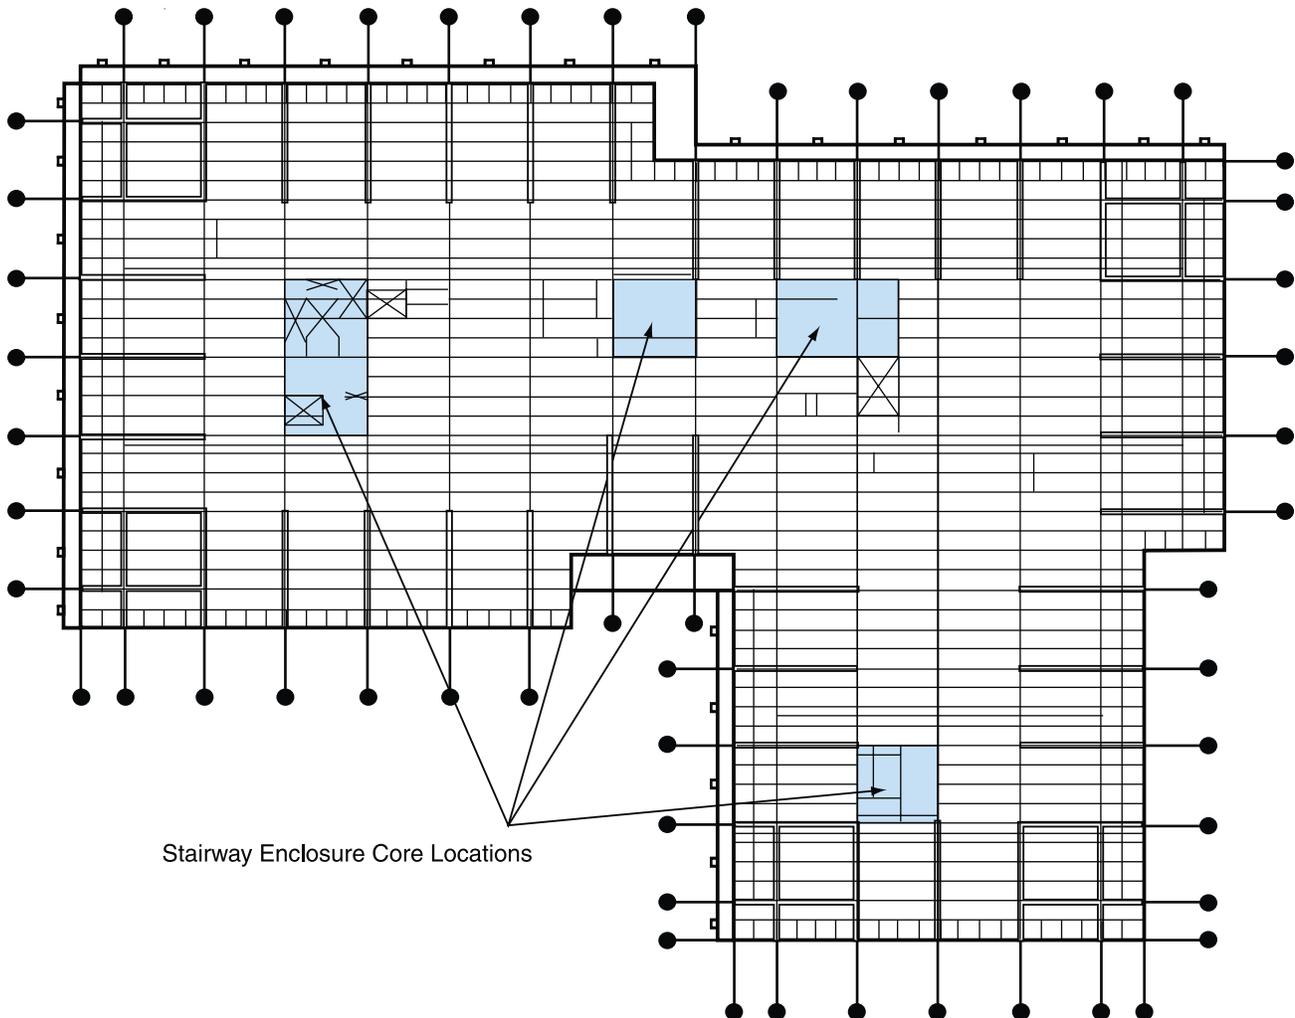
Figure 4-4 Stairway enclosure core locations in WTC 5.

The stairway enclosure core areas were constructed of two layers of 5/8-inch-thick Type-X (fire resistant) gypsum wallboard on both sides of steel studs. The elevator shafts were constructed of HT shaped steel studs and gypsum wallboard and coreboard, which provides a 2-hour fire resistance rating. This type of wall framing permits construction of elevator shafts from the office side of the wall. These core areas are illustrated in Figure 4-4.
