# Snow Study Summary Report

Observations of Snow Load Effects on Four School Buildings in New England

October 2016

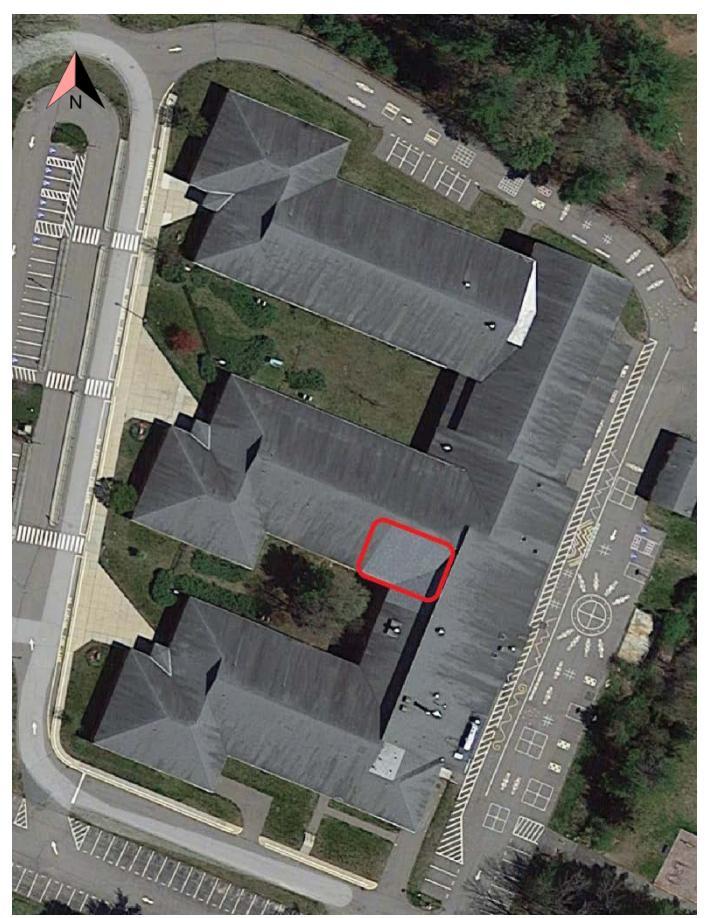
Figure 1 shows an aerial view of Mitchell Elementary School. The area where the roof collapsed is on the south side of the central wing gable roof (the ridge line is nominally east-west). In addition, there is an upper-level roof to the right (nominally east) of the damaged area. Since the wind directions were from the north and west, the roof was subject to over-the-ridge gable roof drifts due to the north wind, and windward roof step drifts due to the west wind (see Figures 2 and 3). Unfortunately, there is no current guidance on how to combine the over-the-ridge drifts with windward or leeward roof step drifts when both types of drifts occupy the same roof area.

Figure 1: Aerial photograph of Mitchell Elementary School (red outline shows damage location) (Source: Google Earth)

On Thursday, February 19, 2015, the roof above Classroom 218 collapsed due to snow loading. Fortunately, Massachusetts schools were on winter vacation that week, so the area was unoccupied. Classroom 218 is located on the southeastern end of the central wing indicated by the outline in Figure 1. As noted above, the roof failure appeared to have been triggered by loading from snow drifts that formed in a roof valley on the leeward side of the building's medium-sloped gable roof. The roof was demolished shortly after failure, but the collapsed roof prior to demolition is shown in Figures 4 and 5.

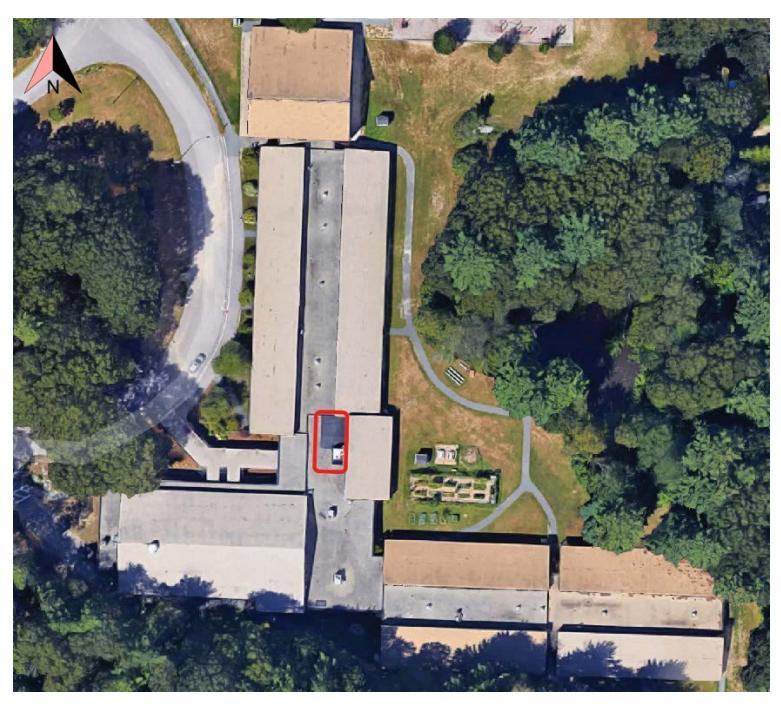
An aerial view of Plymouth River Elementary School is shown in Figure 15. The area of observed damage was on a flat roof adjacent to higher roofs to the north and east. As such, the area was subject to both a leeward roof step drift due to longer duration winds out of the north and a windward roof step drift due to shorter duration winds out of the west. In addition, the upwind fetch distances for wind out of the north were longer than those for wind out of the west. These conditions caused leeward drift loads to be larger than windward drift loads at the time of damage (as estimated by the assessment team<sup>3</sup>). ASCE 7-10 design loads reflect similar disparity for the same damaged area (see Table 2). These values are consistent with the observed drift (left side of Figure 16), which shows the largest drift at the north end of the damaged area.

Figure 15: Aerial photograph of Plymouth River Elementary School (red outline shows damage location) (Source: Google Earth)

On Thursday, February 19, 2015, a section of roof above the school library failed under snow loads. Fortunately, Massachusetts schools were on vacation that week, so the area was unoccupied. The school library is near the convergence of the three wings, as indicated by the red outline in Figure 15. As noted above, the damage appeared to have been triggered by loading from drifts that formed on a section of flat roof that abutted a clerestory roof. Figure 16 shows the damaged area before and after snow removal.

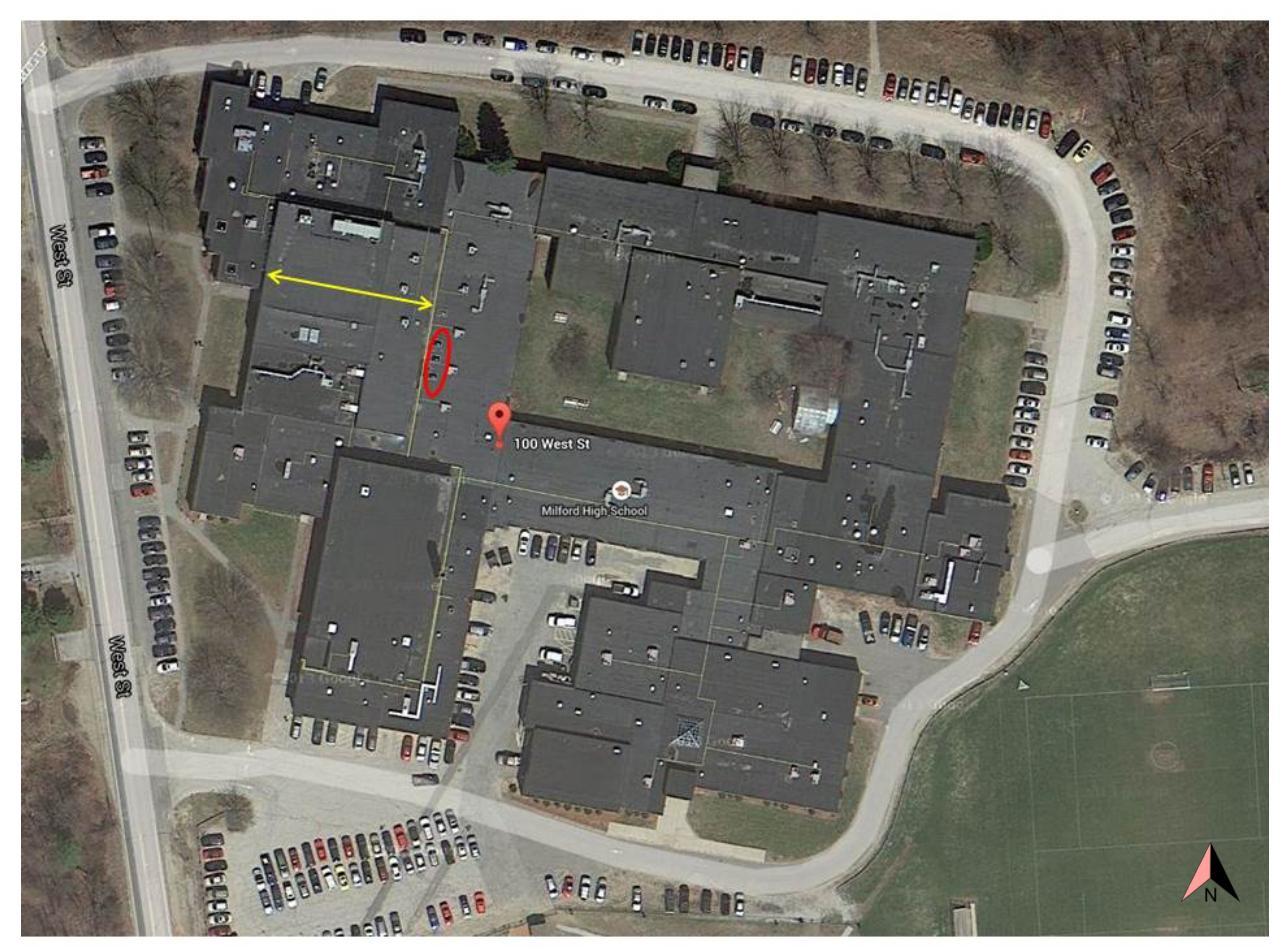
Figure 21 shows an aerial view of Milford High School. The damaged roof area is indicated by the red oval. It is a flat roof area with skylights. There are two higher roofs to the west of the damaged area; hence, the adjacent lower roof area is subject to leeward snow drifts due to wind from the west, as shown in Figure 22.

Figure 21: Aerial photograph of Milford High School (red oval shows damage location on lower flat roof, yellow double arrow indicates stepped higher flat roof)

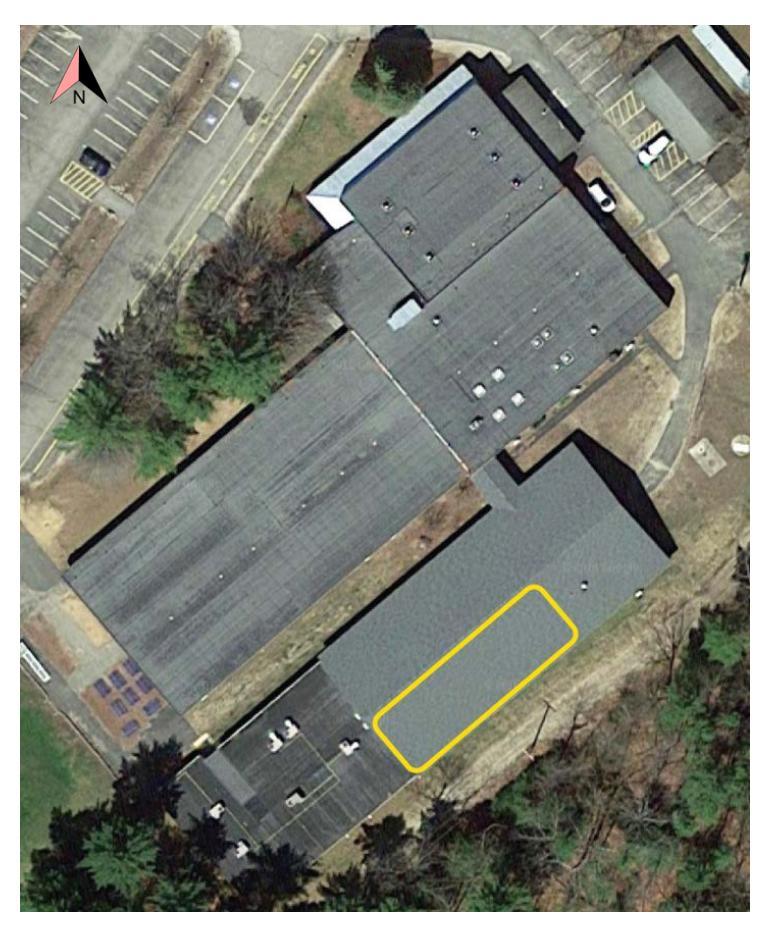
Figure 31 shows an aerial view of the Sanborn Middle School. The roof damage occurred on the southeast side of the gable roof (see yellow outline). The ridgeline runs nominally northeast-southwest; hence, the damaged area is subject to over-the-ridge drift loads (unbalanced loads) due to wind out of the northwest.

Figure 31: Aerial photograph of Sanborn Middle School (yellow outline shows damage location) (Source: Google Earth)
