Mitigation Assessment Team Report

Hurricane Michael in Florida

Building Performance Observations,
Recommendations, and Technical Guidance

FEMA P-2077 / February 2020

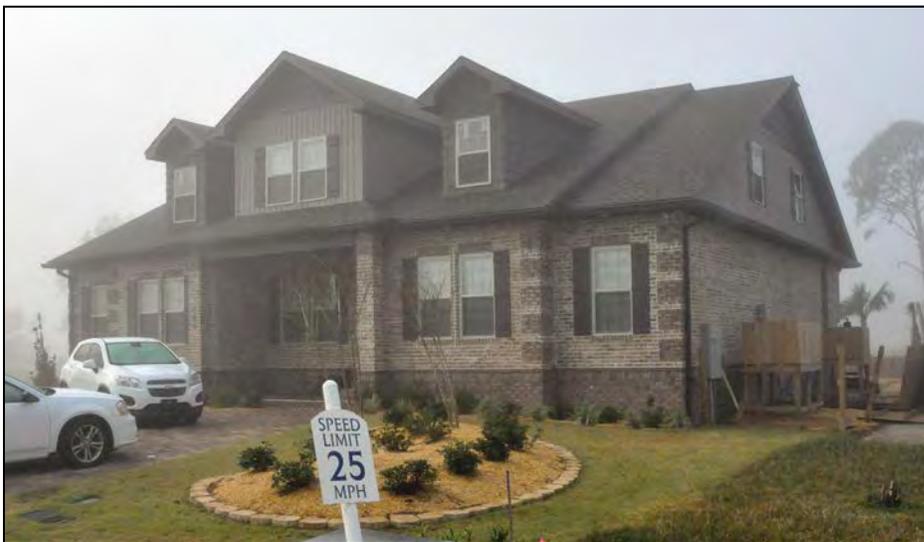
Panama City Beach. Figure 3-1 is an example of a single-family house built in 2018 elevated on a stem wall (backfilled) foundation that did not incur any flood damage. Based on floodplain management requirements at the time of construction and an Elevation Certificate for a recently constructed residence nearby, the house was elevated approximately 1 foot above the BFE. Houses built at grade in the surrounding neighborhood with a similar ground elevation, but not elevated, experienced 1 to 2 feet of flooding according to the homeowners. For example, one residential property built in 1972 located two parcels from the house in Figure 3-1 had approximately 1 foot of floodwater on the lowest floor. A nearby residence built at-grade had over \$75,000 of flood-related damages. Flood-related damages were determined using insurance payment data for Hurricane Michael.

Figure 3-1: No visible damage to elevated house constructed in 2018 (Panama City Beach; Zone AE)

This house was constructed in 2018 1 foot above BFE and had no damage. A nearby residence built at-grade had over \$75,000 of flood-related damage.

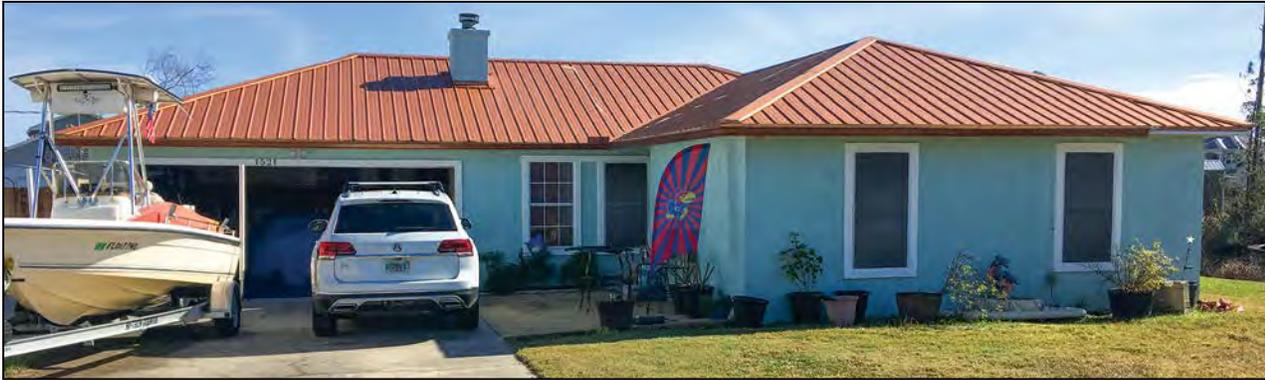
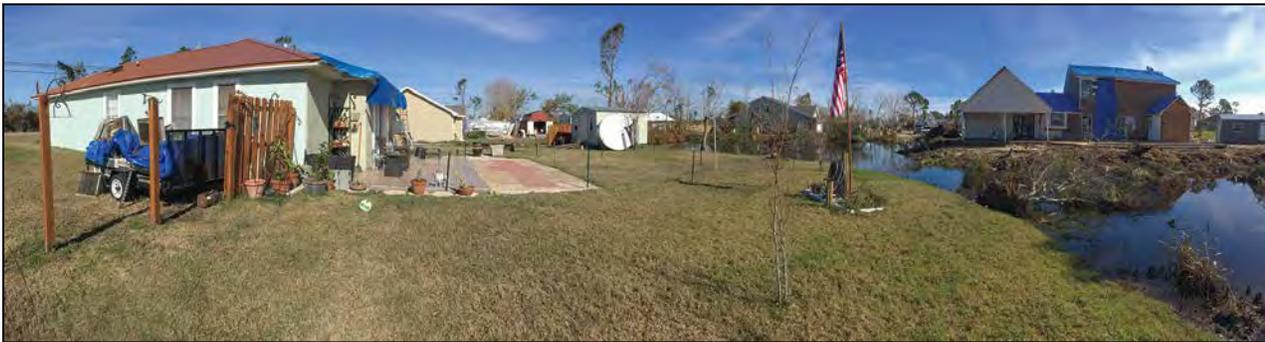
City of Callaway. Figure 3-2 is a representative single-family dwelling in the City of Callaway, built in 1997. The building is located in Zone AE; it had approximately 2 feet of flooding according to the homeowners, resulting in approximately \$60,000 in flood-related damages. Based on a homeowner interview, the flood insurance policy for the house was rated based on the house being built to the current BFE. An Elevation Certificate was not available for this house, nor did the flood insurance policy include a reported difference between the BFE and the lowest floor with which the MAT could deduce the elevation of the house.

This house was constructed in 1997 and at-grade. The bottom photograph shows its proximity to its flooding source.

Figure 3-2: Representative at-grade single-family house, constructed in 1997, was flooded with 2 feet of water (Callaway; Zone AE)

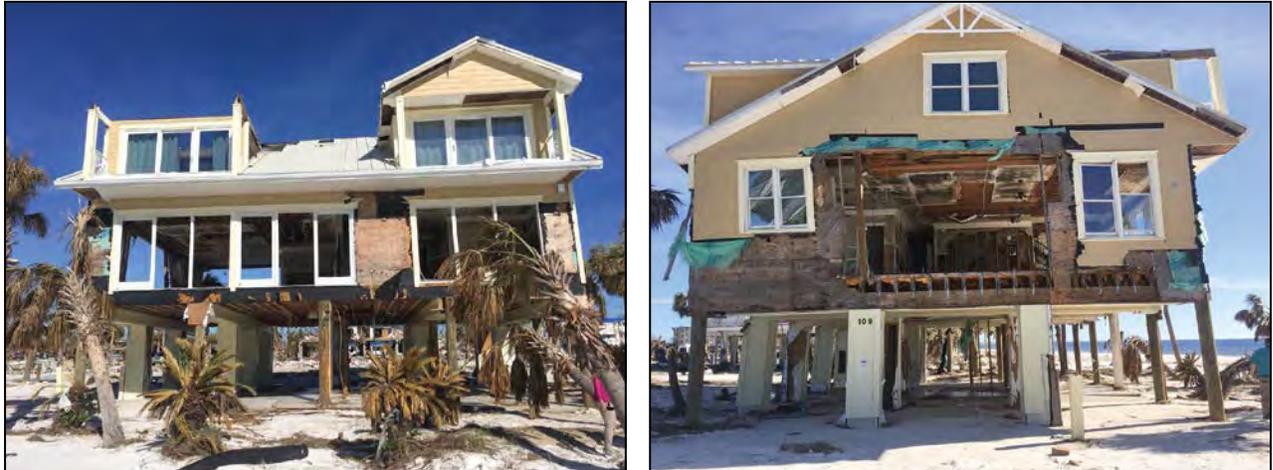
Figure 3-4 and Figure 3-5 are representative examples of elevated single-family houses that were not completely destroyed in Mexico Beach. Although the foundations and a majority of the structures survived the hurricane, the extensive flood damage made the houses uninhabitable while repairs and, in some cases, replacement were underway.

This house was built in 1997. The left photograph shows the side that faced the Gulf of Mexico. The right photograph shows the side facing the street.

Figure 3-4: Representative single-family house elevated on wood piles that remained after the hurricane (Mexico Beach; Zone AE)

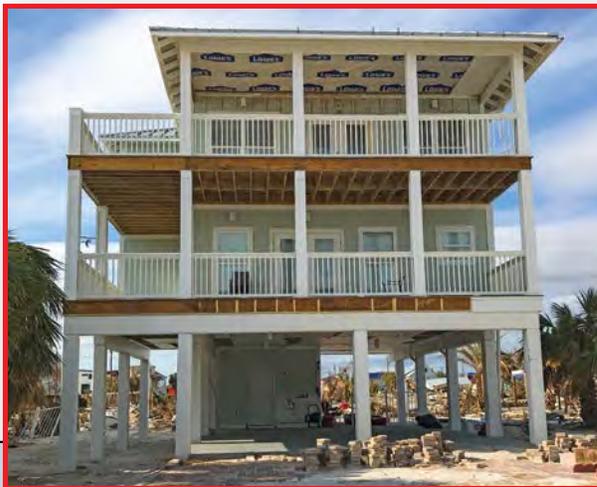
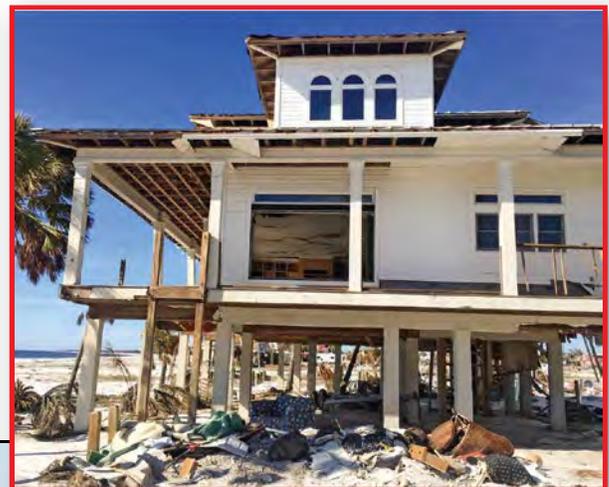
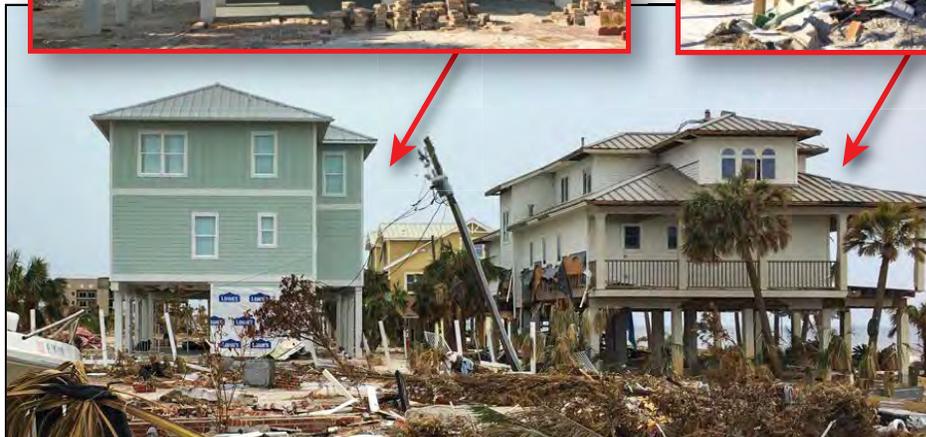
The structure on the left was built in 2016 and is located in Zone X. The structure on the right was built in 2002, also in Zone X, but is located closer to the ocean.

Figure 3-5: Representative adjacent single-family dwellings elevated on concrete piles that survived the hurricane (Mexico Beach; unshaded Zone X)

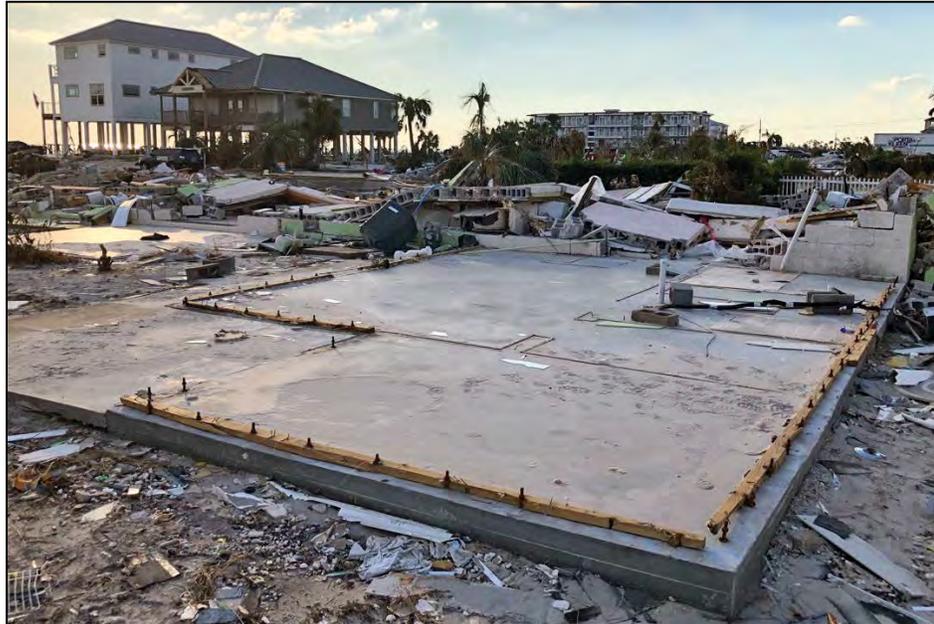
Figure 3-6:
Representative
damage along 36th
Street
(Mexico Beach;
unshaded Zone X)

Remnant of slab (foreground) compared to elevated structures (background). Photograph was taken through a clearing from the remaining slab of a non-elevated structure.

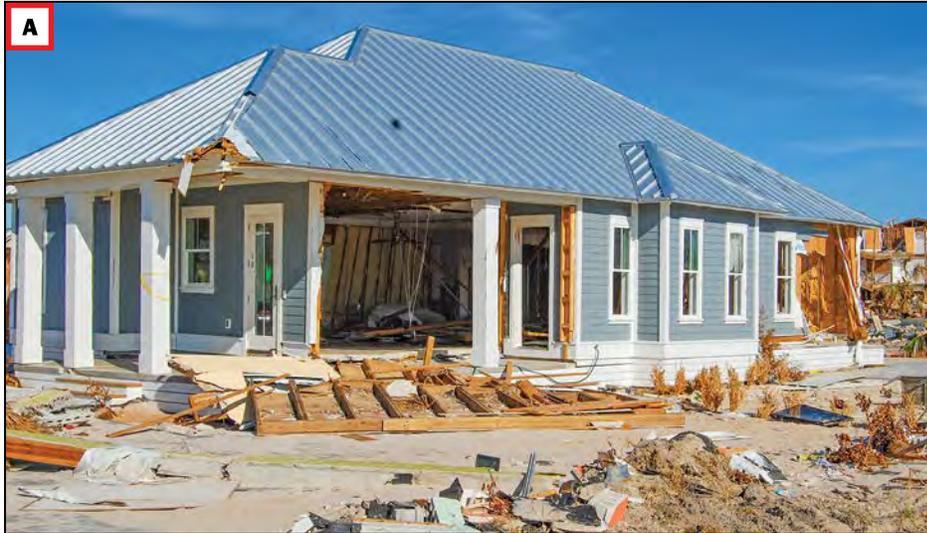
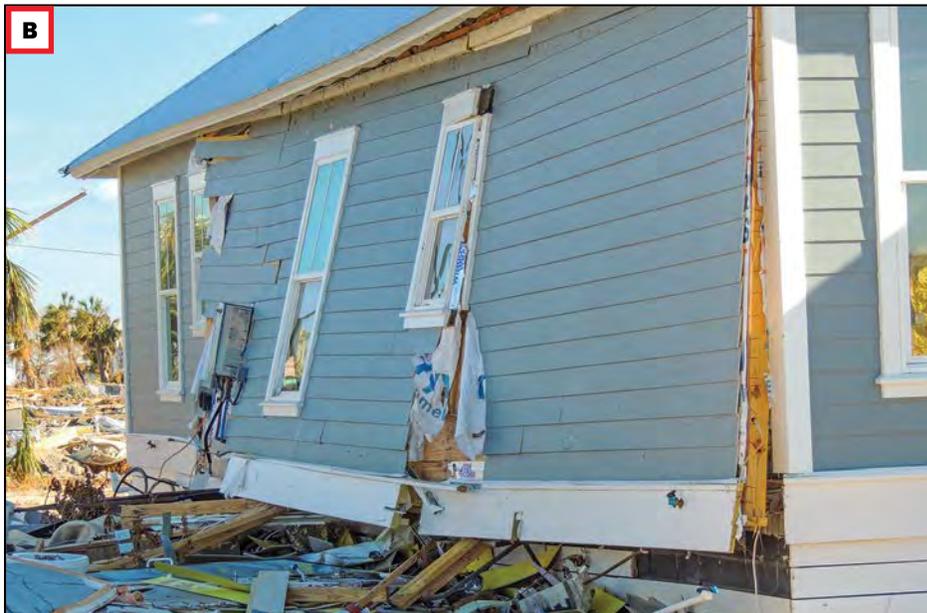
Figure 3-6 is representative of damage along 36th Street. Figure 3-7 is a slab-on-grade house, not commonly seen in this area, that was not completely destroyed by surge (most slab-on-grade houses could only be identified by their slab). However, the flood loads significantly damaged the single-story structure, and the uninhabitable house had to be demolished.

Figure 3-7: Slab-on-grade single-family dwelling along 33rd Street built in 2018 (Mexico Beach; unshaded Zone X)

The house was built in 2018. [A] shows the side that faced the Gulf of Mexico. [B] shows the impact of wave and water loads on the back wall of the house.

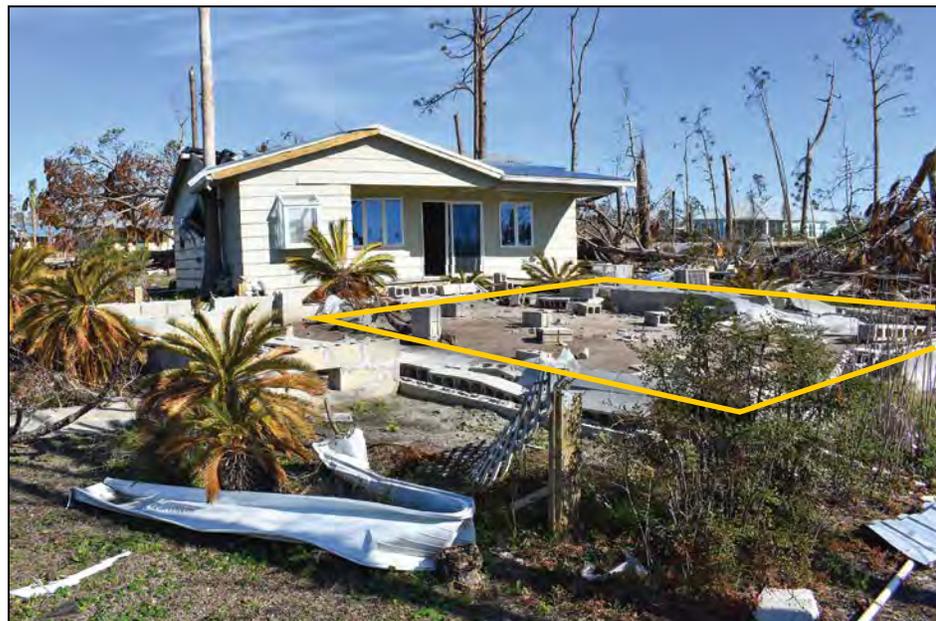
- At-grade structures were susceptible to impact from debris of adjacent structures. As such, even those at-grade structures that were constructed with adequate hydrostatic equalization measures were subject to failure due to debris impact from adjacent structures.
- Fasteners that connected structures to stem wall, pier, and, in some cases, pile foundations, were frequently inadequate and failed. Where foundation connections failed (or were non-existent), the structures broke free and floated a distance, at times striking a neighboring building or a tree (Figure 3-8). Most older construction lacked a load path through the foundation; although newer construction had a load path to resist uplift from wind, in some cases the connections were insufficient for buoyancy loads, which were likely not considered because the houses were outside the SFHA.

Figure 3-8: Single-family dwelling along Kim Kove that floated off its foundation (Mexico Beach; unshaded Zone X)

This house was built in 1976 with a crawlspace underneath. It detached from its foundation and floated approximately 40 feet before striking a tree. Standing concrete masonry unit (CMU) blocks visible in the photograph are located at the original footprint (yellow box).

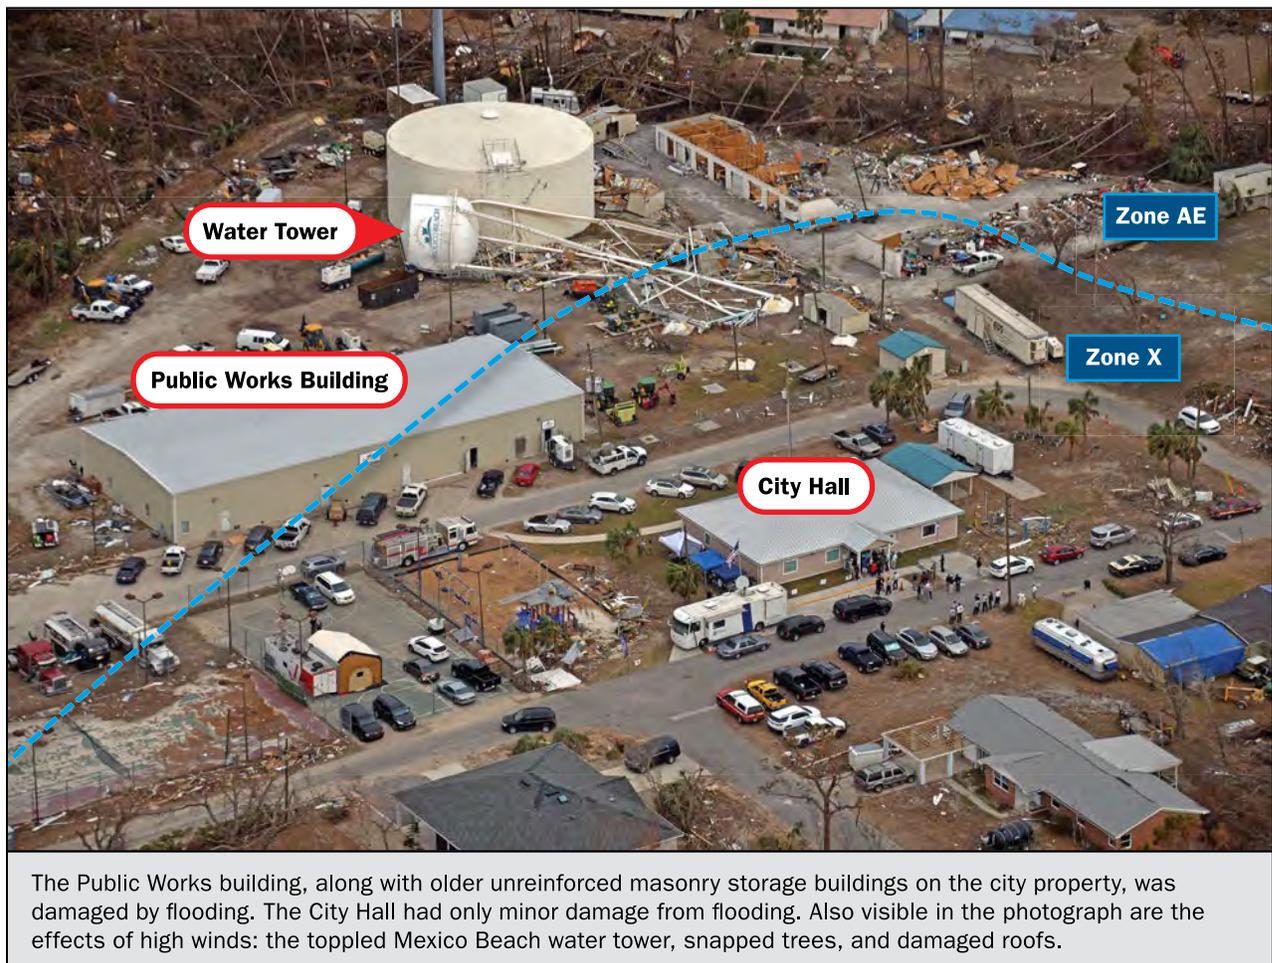
Mexico Beach Public Works Building and City Hall. The difference in damage to the Mexico Beach City Hall and the adjacent Public Works building (Figure 3-9) demonstrates the effect building elevation can have on building performance.

The Public Works building is located within the SFHA and approximately 100 feet from the nearest drainage ditch, which was a conveyance channel for floodwater. The building was damaged by approximately 18 inches of floodwater. The building was repaired by the time the MAT visited. The adjacent Mexico Beach City Hall and other structures on city property were slightly higher and not within the SFHA; while these structures still experienced flood damage during the event, it was less than the Public Works building. The City Hall, located 300 feet from the drainage ditch, experienced minor flood damage from approximately 6 inches of water. The City Hall building also had minimal interior water infiltration damage (wind-driven rain), primarily around windows and doors. The facility was in use when the MAT visited, and according to staff interviews, it remained opened after the hurricane while repairs were made.

Figure 3-9: Mexico Beach City Hall (unshaded Zone X) and Public Works Facility (Zone AE)

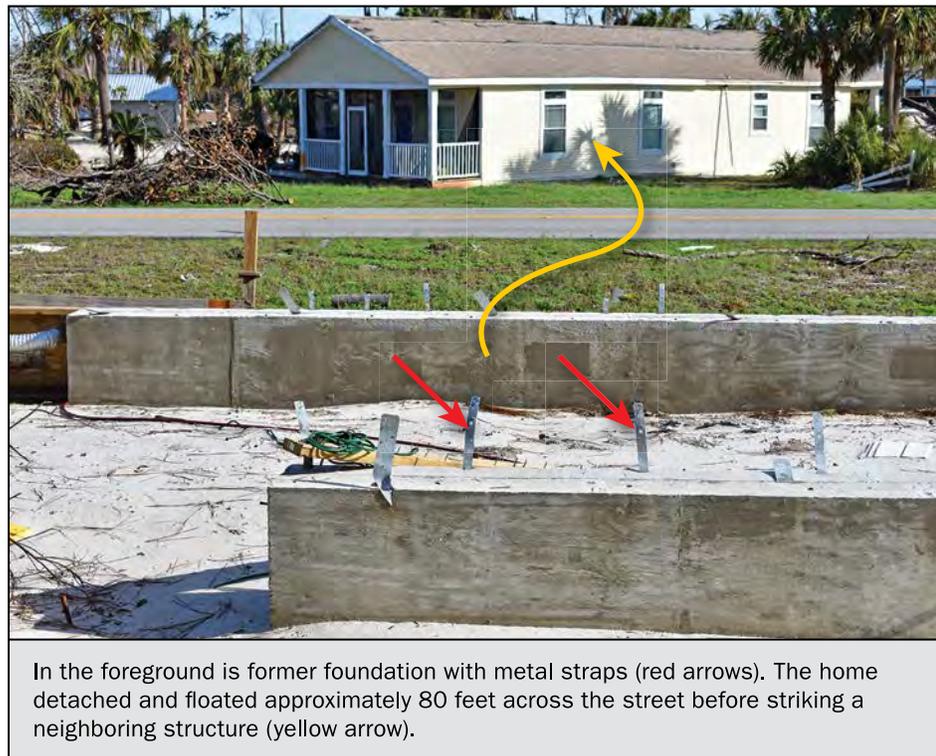
According to homeowners in the inland neighborhoods, water levels rose very rapidly. When the MAT visited this area, the recovery effort had progressed. Figure 3-12 is an example of a house that floated because the load path was insufficient to resist the flood loads. Nearby, a homeowner of a house of similar size and construction was in the process of elevating their building by approximately 10 feet and installing a foundation for pier supports (see Figure 3-13).

Figure 3-12: Single-family house (built in 2008) located inland of US Highway 98 that was washed off its foundation (Beacon Hill; shaded Zone X)

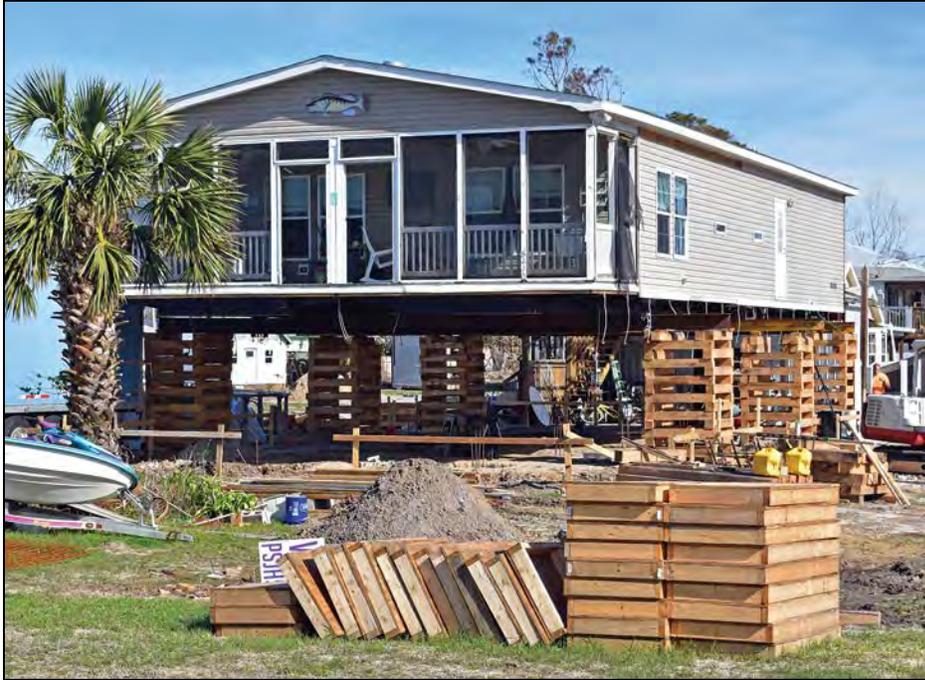
Figure 3-13: Single-family house located inland of US Highway 98 undergoing elevation during rebuilding (Beacon Hill; shaded Zone X)

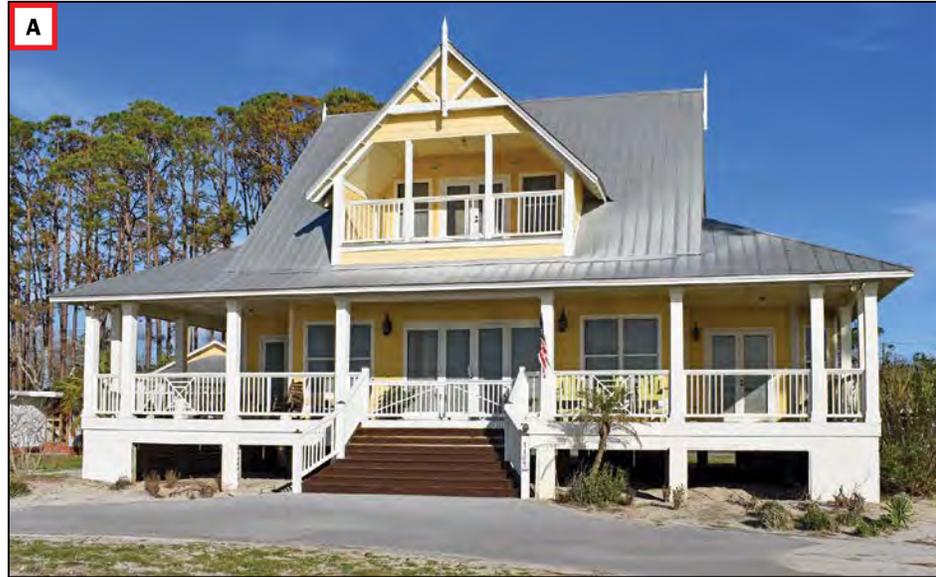
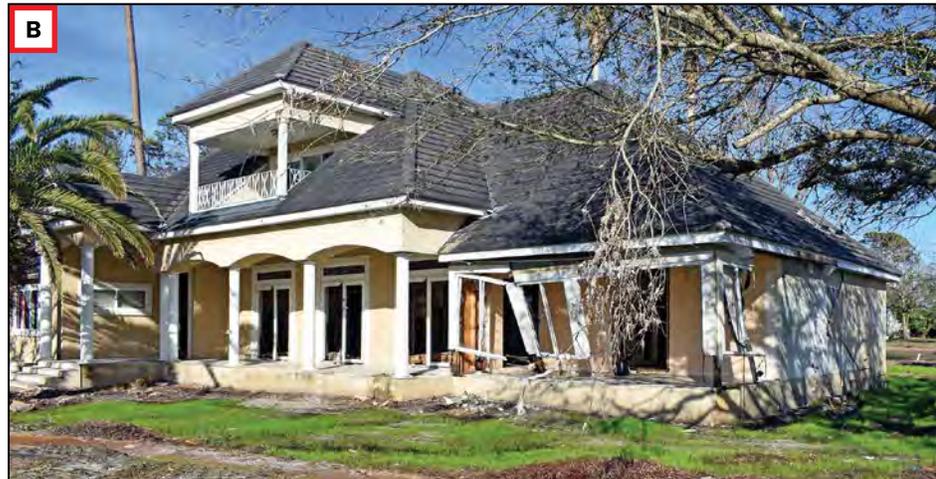
Along Constitution Drive, post-FIRM construction houses were elevated, and some had breakaway walls. While recovery and repairs were underway when the MAT visited, there was only limited or no damage evident in the elevated houses, but considerably more damage to those built at-grade. The MAT also observed structures that had experienced major flood damage that were either completely demolished by the time the MAT visited or had been left open to the elements, exacerbating the water infiltration and water intrusion. Newer construction built to higher elevation requirements (approximately 3 to 5 feet above grade in most cases) had considerably less damage than houses that were built at or closer to grade. Figure 3-14 shows a newer elevated house and an older construction non-elevated house approximately 600 feet apart on Constitution Drive.

Figure 3-14:
Comparison of houses
built 50 years apart
(Building A was built
in 2006 as an elevated
house and Building
B in 1956, renovated
in 2000) along
Constitution Drive
(Port St. Joe; Zone AE)

[A] Elevated single-family house with no apparent floodwater damage
[B] Non-elevated single-family house damaged during Hurricane Michael and left unprotected from subsequent rainfall

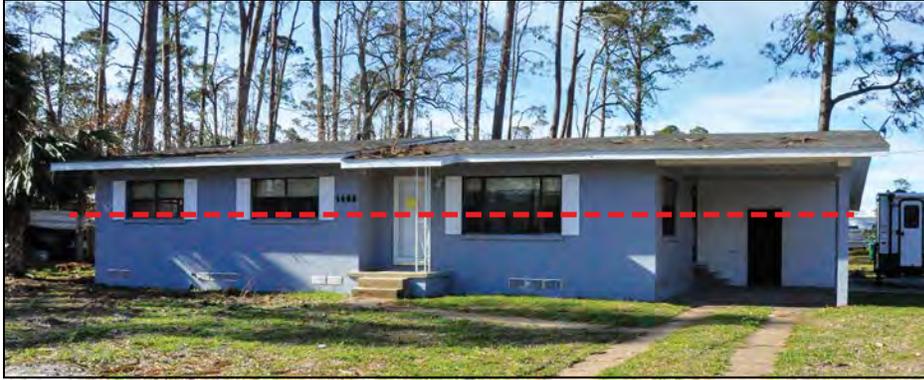
- Figure 3-15 is a representative at-grade, single-family house along Palm Boulevard built in 1977. Based on known elevations for existing adjacent houses, the first floor elevation was likely at the BFE (approximately 1 to 2 ft above grade) and had approximately \$150,000 in flood damages based on preliminary flood insurance claims data.

Figure 3-15: Representative single-family house (built in 1997) along Palm Boulevard with a high water mark (red dashed line) of 60 inches above grade (Port St. Joe; Zone AE)

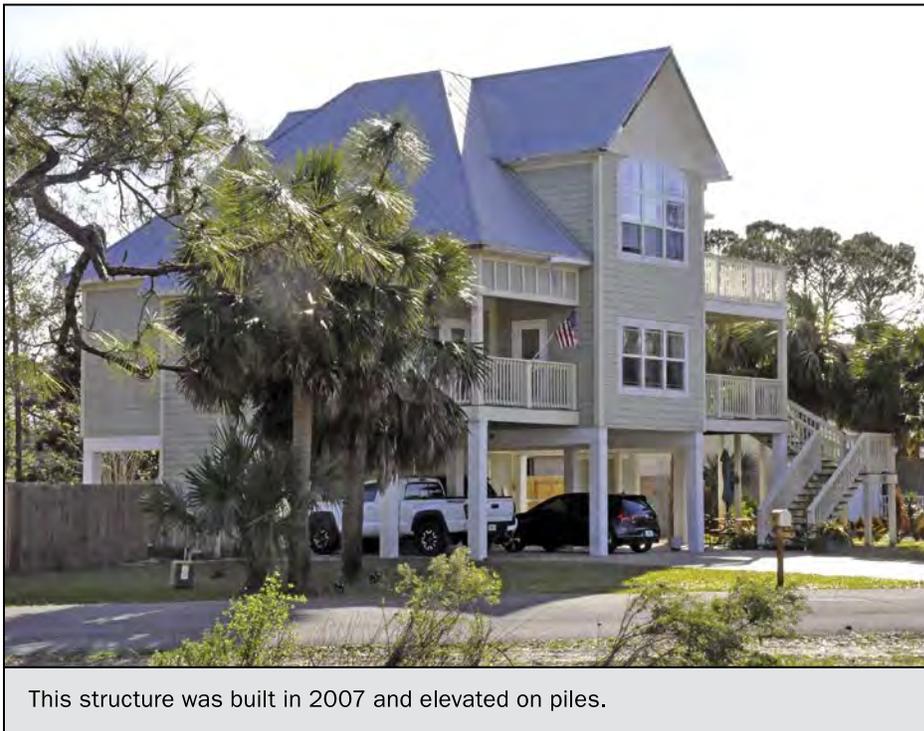
- Figure 3-16 is a rare (for this flood zone area) elevated single-family house built in 2007 in the vicinity of Palm Boulevard, with its lowest horizontal structural member of the lowest floor around 8 feet above grade. This house had less than \$10,000 in flood damages based on preliminary flood insurance claims data.

Figure 3-16: Newer single-family house in the vicinity of Palm Boulevard (Port St. Joe; Zone AE)

This structure was built in 2007 and elevated on piles.

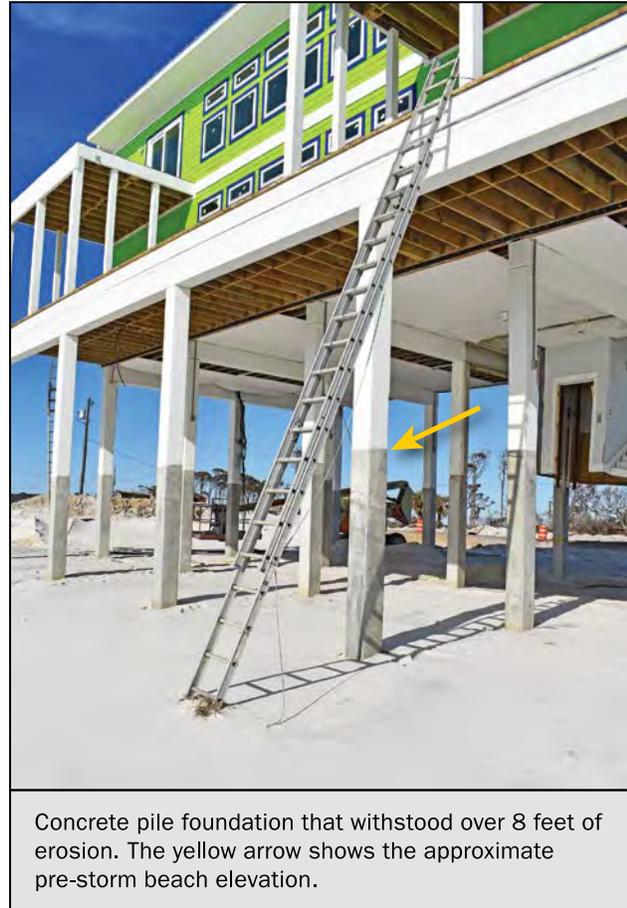
Many Cape San Blas houses on the ocean side of the barrier spit are elevated on open pile foundations and these houses experienced minimal damage from the hurricane. The western shore of Cape San Blas has the highest erosion rate on the Florida Gulf Coast (approximately 40 feet per year) (FDEP, 2019), and the MAT observed major beach and dune erosion along the peninsula. Erosion that occurred during Hurricane Michael caused approximately 8 feet of beach lowering at a recently constructed house along the western shore of Cape San Blas (Figure 3-17).

Figure 3-17: Newer (post-2017 construction) single-family house with significant erosion (more than 8 feet) at foundation (Cape San Blas; Zone VE)

Concrete pile foundation that withstood over 8 feet of erosion. The yellow arrow shows the approximate pre-storm beach elevation.

The Cape San Blas area of Franklin County sustained significant erosion (in excess of 8 feet in some areas) and wave attack, yet concrete piles and structures remained standing (see Figure 3-17). The pile performance is considered successful because the structure and piles were standing with no observed failure, displacement, or fracture.

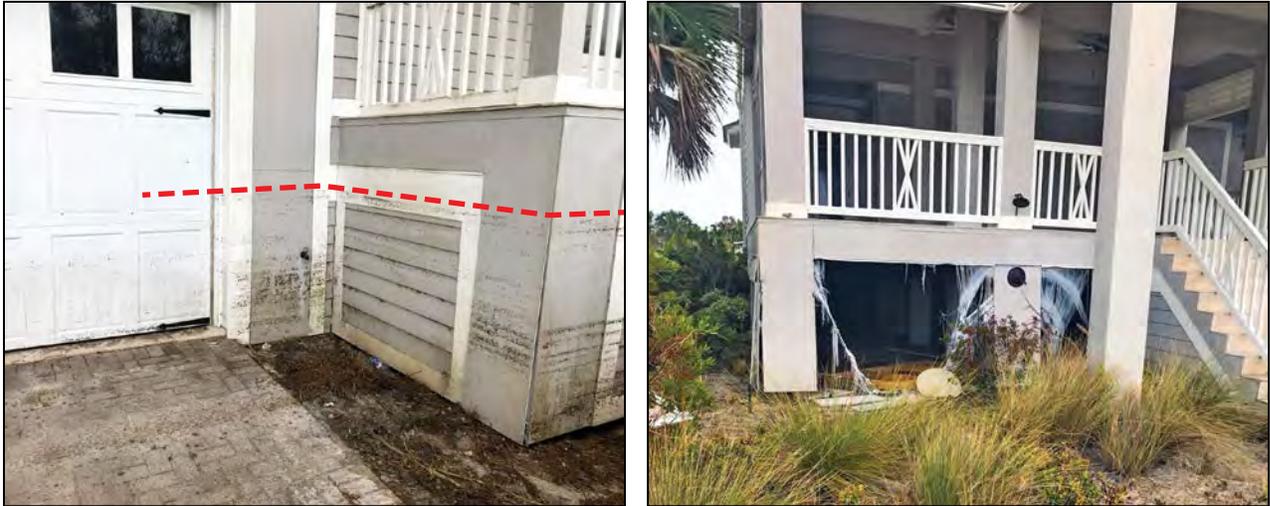
Based on pre-MAT observations, floodwater reached at least 3.5 feet above grade in Shell Point. The left image in Figure 3-19 shows an elevated residence where the highwater mark is visible on the garage.

The right image in Figure 3-19 shows a breakaway wall at the residence that was partially detached, leaving shredded building material. This breakaway wall may have been subjected to design flood depth conditions as it was partially detached, but evidence of moderate wave action that would have caused this type of force and damage on the breakaway wall was absent during the field assessment. Instead, evidence pointed to floodwater that rose and quickly receded. Thus, the breakaway wall did not perform as intended. From a design standpoint, the best practice of incorporating flood vents or openings would have allowed hydrostatic pressure on both sides of the wall to equalize. The 3.5 feet of water depth at the residence would have been enough to push the wall inward, but not fully detach.

The red dashed line shows a high water mark approximately 3.5 feet above ground (left image). Image on the right shows a partially detached breakaway wall.

Figure 3-19: Single-family house (built in 2008) that experienced minimal flooding. The building is elevated, and breakaway walls became partially detached during the event. (Shell Point; Zone VE)

To perform as intended, breakaway walls must break away cleanly so as to avoid damaging the elevated building when they break away. If the wall remains attached to the building instead of breaking cleanly via the building material, there is potential for continued damage from debris to the building and the foundation. In this instance, it is unclear whether the shredded building materials prevented the wall from detaching or was there for another reason.

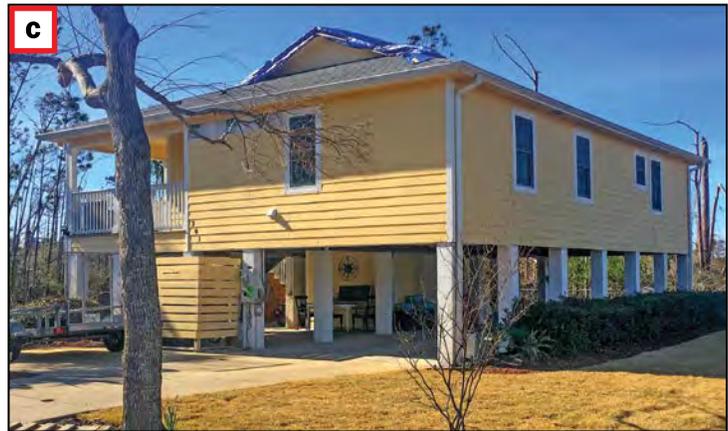
Figure 3-20: Examples of effects of elevation related to flood damage (Mexico Beach; unshaded Zone X)

The MAT visited eight structures built on a crawlspace foundation that did not resist the buoyant loads and floated off their foundations. Figure 3-20 illustrates the significance of elevation as it relates to flood damage. The three structures shown in the figure are located in an unshaded Zone X, so they were not required to be built to a regulated elevation, and are adjacent to an unnumbered Zone A. Building A floated off its foundation and into Building B, most likely due to an inadequate load path, while Building C (with the exception of a damaged enclosure) did not appear to have any flood-related damage, likely because the lowest floor was elevated above the flood elevation. Although there were high water mark stains visible in Building A, there was no reference line on Building C. Elevating Building C helped to avoid damage, while minor elevation without consideration for buoyancy loads resulted in flotation of Building A.

[B] Slab-on-grade house, built in 2003, is located just beyond Zone A and was significantly flooded. Inset shows interior of house. Red line shows the high water mark.

[C] This single-family house (built in 2003), located across the street from **[A]** and **[B]**, was proactively elevated multiple feet to accommodate storage and parking and to improve the resilience of this residence to future flooding. Observed flood damage was minimal.

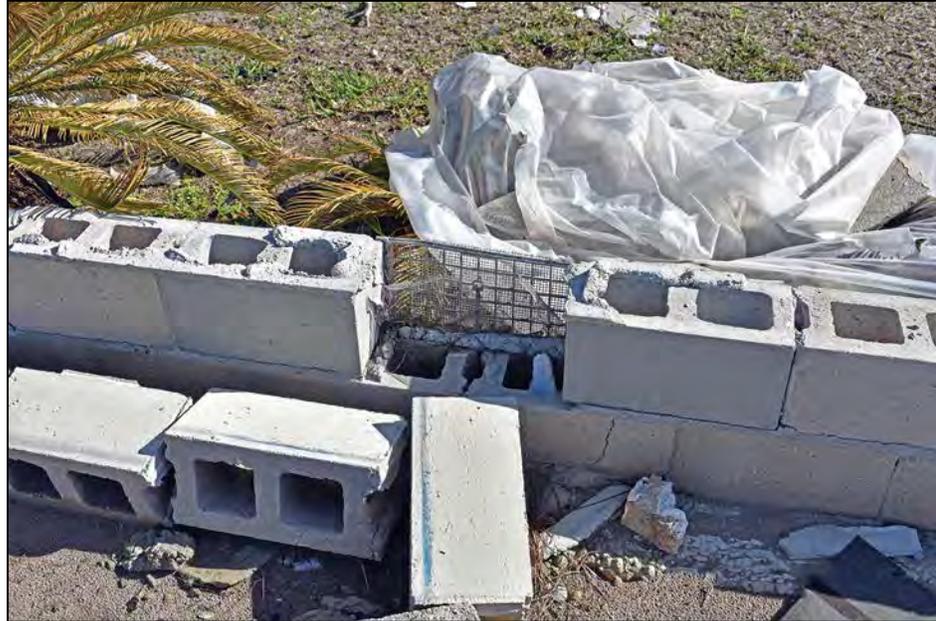
Figure 3-21:
Foundation of Building
A shown in Figure 3-20
(Mexico Beach;
unshaded Zone X)

Figure 3-21 is a close up of the foundation of Building A (as shown in Figure 3-20). The MAT noted several potential issues that may have led to the flotation:

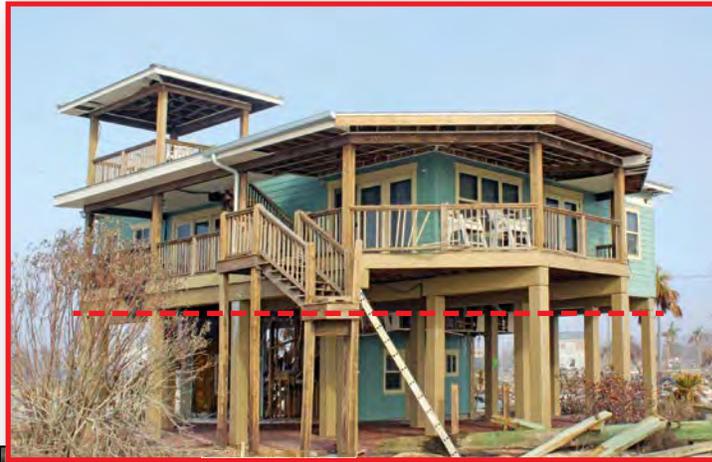
Figure 3-22: Post-storm aerial image of a beach front residential community in Mexico Beach that was heavily damaged by both wind and flood during Hurricane Michael (Mexico Beach; Zone VE, Zone AE, and unshaded Zone X)

Figure 3-22 shows post-storm aerial imagery of a beach front residential community in Mexico Beach that was heavily damaged during Hurricane Michael. The inset photograph shows an elevated house built in 2012 in an unshaded Zone X. This structure was the only residence for several blocks in each direction that survived the hurricane. The walls of the structure's at-grade first-floor enclosure suffered significant damage perpendicular to the flood path and erosion was observed around the piles and slab; otherwise, the house, with its lowest floor above the high water mark, withstood the flood loads experienced during Hurricane Michael. There was damage to the exterior on the second story (loss of soffits and other envelope damage) due to high winds that resulted in interior wind-driven rain damage. Other houses near the canal were standing when the MAT visited but had visible structural damage.

This single-family house (built in 2012) in Mexico Beach was elevated to approximately 11 feet above grade, or at the BFE (red dashed line), and was one of the few houses in this neighborhood that survived.

As shown in the post-storm aerial imagery, most of the other houses in the area (built in the 1960s to 1980s) were slab-on-grade construction or had one- to two-block concrete masonry foundations, and were destroyed by Hurricane Michael. The yellow outline shows houses that survived Hurricane Michael, but were damaged.

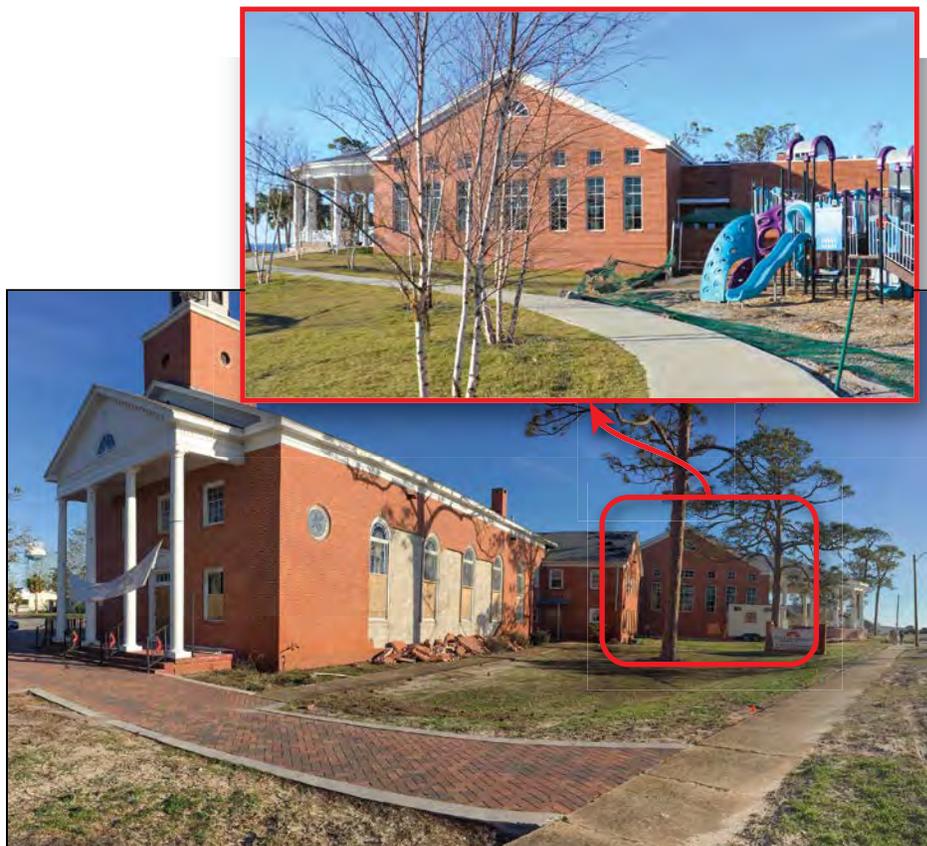
Figure 3-24: First United Methodist Church main building compared to the newer addition (Port St. Joe)

Figure 3-24 shows the First United Methodist Church in Port St. Joe, which is in a Zone AE10. The original church building experienced extensive inundation damage with more than 5 feet of water throughout as well as additional damage from sewage backup into the building because the outgoing pipe was missing a backflow prevention device (resulting in additional restoration costs and time). The addition at the back of the original pre-FIRM church building was built more than 5 feet higher than the original church building and experienced only minor flooding (less than 6 inches). When the MAT visited several months after Hurricane Michael, the addition was being used, but the original church facilities were still being repaired. An Elevation Certificate was not available for the addition; however, based on information gathered during the site visit interview, the addition may have been built 1 foot above the BFE. The church staff specifically recall having to navigate all the floodplain management requirements for the addition as it was considered new construction/Substantial Improvement. The staff seemed appreciative of the requirements based on how the new building performed and only wished they had built it even higher.

Before Hurricane Michael, the facility manager of this church in Port St. Joe had invested in a project to move the air conditioning units to the roof and to construct an addition (red square and inset) to be used as a community room. The floor of the addition was built more than 5 feet higher than the original church building. While the addition experienced some flooding (less than 6 inches), the damage was primarily limited to flooring. When the MAT visited, the addition was being used for most community functions, while the original church facilities were in the process of being repaired.

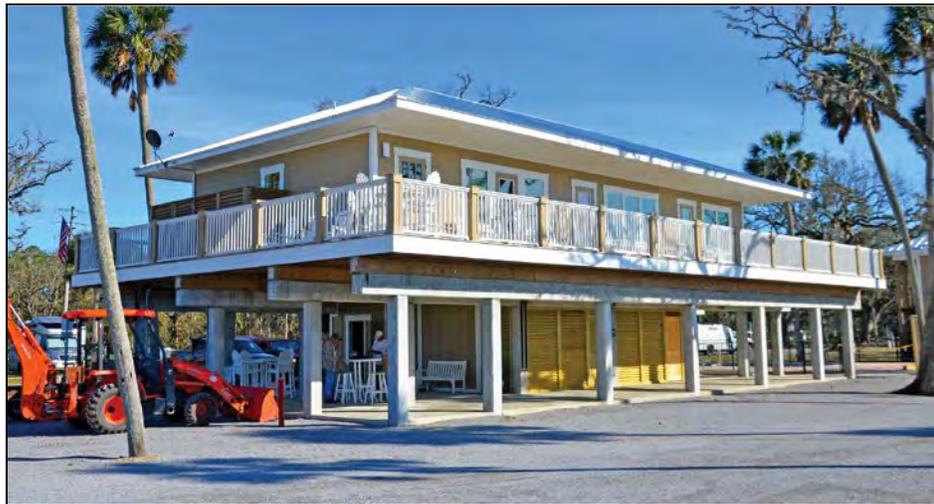
Figure 3-25:
Administrative building
elevated on a concrete
pile foundation
(Port St. Joe; Zone VE)

Figure 3-25 shows the administrative building for a recreational vehicle (RV) resort along State Route 30 in Port St. Joe. This elevated, non-residential building has an open concrete foundation with an enclosure consisting of breakaway walls. The administrative building had minimal flood damage as the flood inundation levels reached the bottom of the lowest horizontal structural member, it experienced very limited to no water infiltration through the window and doors, and the breakaway walls in the enclosure performed as intended. About 50 to 75 campers are typically onsite, and all but one were evacuated (the one camper was destroyed). The administrative building was back in operation by mid-December, with power restoration being a critical factor in the building being fully operational.

This elevated, non-residential building built in 2016 with an open concrete pile foundation and breakaway walls had minimal flood damage. During an interview with the property owners, the MAT learned that the breakaway walls broke away as intended, and floodwater reached the beam supporting the administrative building/clubhouse but did not enter the first floor. The enclosures were used for storage and restrooms. The damage to the enclosure did not cause any damage to the first floor (NOTE: Restrooms below the BFE are not compliant with the NFIP for new construction).

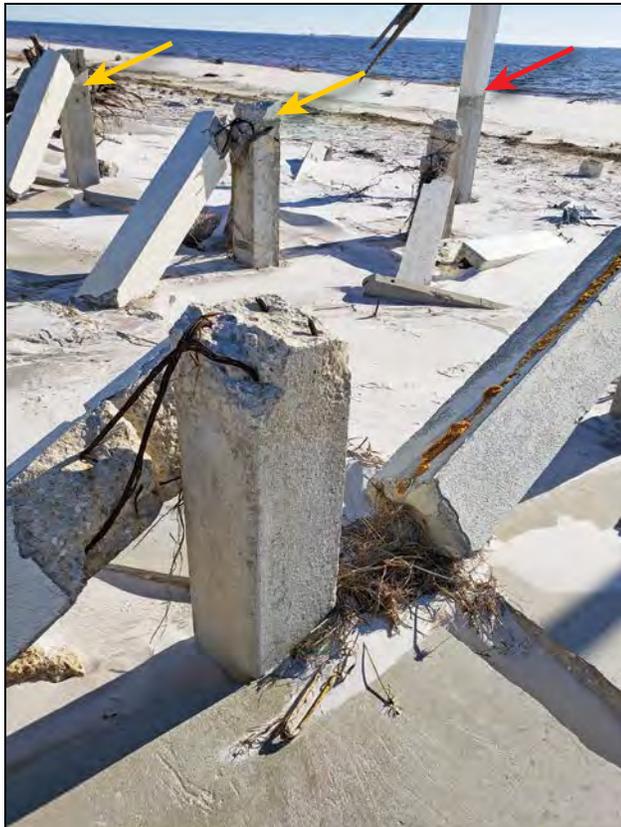
The MAT observed instances of concrete piles that failed and some that survived. In Mexico Beach along US Highway 98, the concrete piles of many structures failed completely. Figure 3-26 shows two examples of failed piles. The majority of the residences with failed piles were located on Gulf-front property, seaward of US Highway 98. Although the structures, which were located in Zone X, need not adhere to stricter codes, the designers could have considered the proximity to the ocean and eroding dunes and built to a higher standard.

Based on the paint line visible on the remnant concrete piles shown in the left photograph of Figure 3-26, the failure appears to have likely occurred at the connection to the concrete slab. The right photograph in Figure 3-26 shows a building located two lots west of the building in the left photograph. The MAT observed stress fractures in these piles from lateral loads, possibly from surge, wave, wind or debris loads. In both cases shown in Figure 3-26, the buildings may have rotated landward, thereby stressing the piles. Both cases show a final failure location that occurred at approximately the elevation of the concrete slab, which itself was undermined by flood effects and failed.

The two broken columns in the background failed along the paint line (yellow arrows) that was most likely associated with the location of a concrete slab. The pile closest to the water did not fail (red arrow).

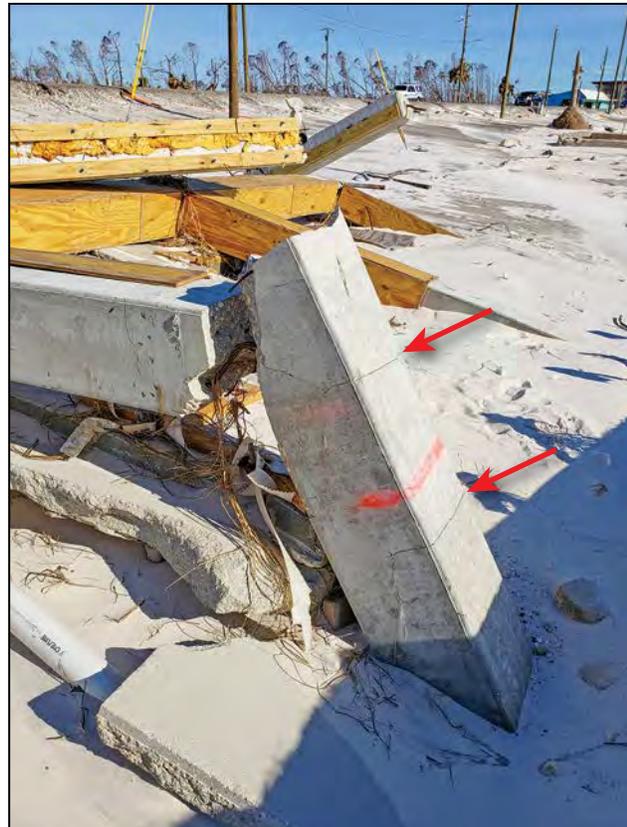
Red arrows indicate lateral cracks (stress fractures) on the gulf-fronting pile, possibly from surge or waves.

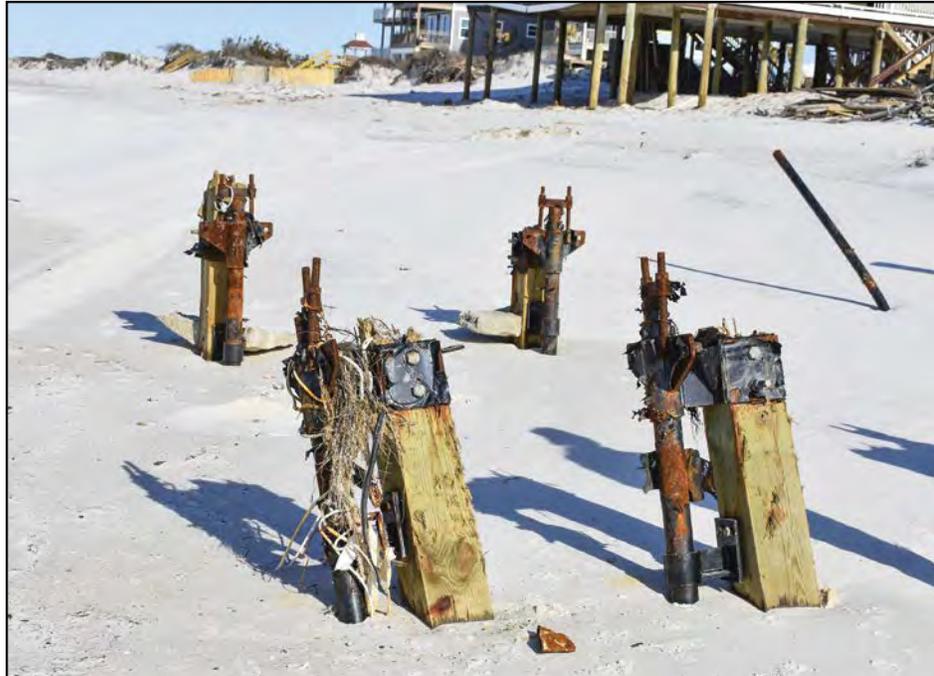
Figure 3-28: Fractured wooden pile attached to retrofitted steel pipe foundation connection (Cape San Blas; Zone VE)

In Cape San Blas, the MAT team visited a site of 16 condominium units across four structures built in 1986 on wooden piles. The condominium complexes were located in a Zone VE. The wooden piles failed during the event, resulting in structural damage and eventual demolition of the entire condominium building (Figure 3-28). At some point prior to Hurricane Michael, the foundation system had been modified and retrofitted to extend the depth of embedment of the piles; as shown in Figure 3-28, a round steel pipe was driven alongside the existing wooden piles and attached via a connection system. The MAT observed a contractor clearing debris from the remaining structure from the beach. Many factors could have contributed to the failure of the wooden piles, as outlined in the textbox “Possible Failure Mechanisms for Piles.”

A 16-unit condominium structure had to be demolished when these retrofitted wooden piles failed during Hurricane Michael. Based on discussions with private owners of neighboring structures, previous erosion events had resulted in the need to reinforce and extend the embedment depth of the piles. Instead of installing or developing a new open foundation, the existing foundation system was retrofitted by driving round steel pipes next to the existing wooden piles and then connecting them to the piles.
