Mitigation Assessment Team Report

Hurricane Michael in Florida

Building Performance Observations,
Recommendations, and Technical Guidance

FEMA P-2077 / February 2020

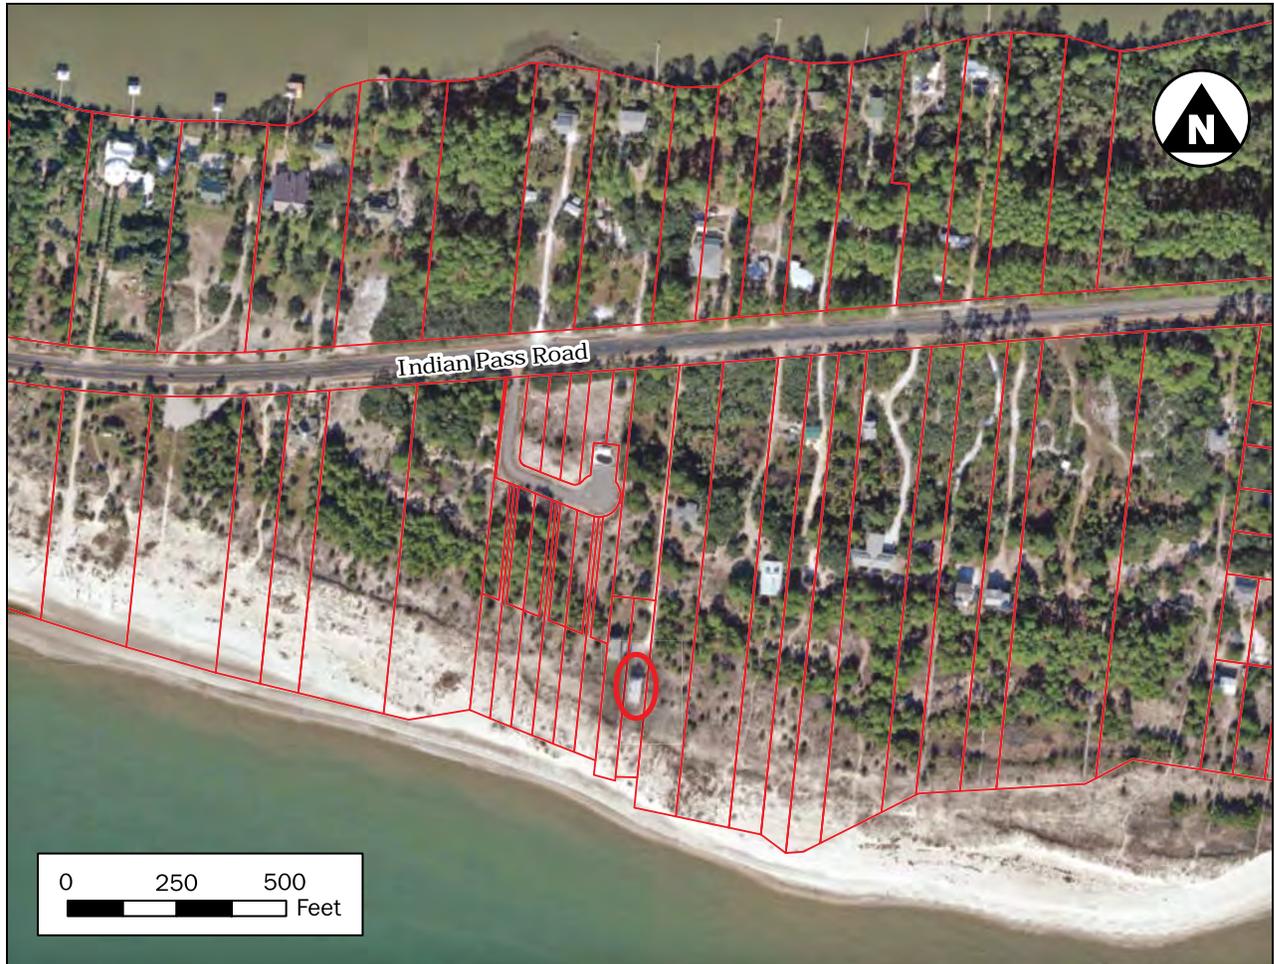
Figure 3-29: Parcel outlines along Indian Pass Road showing the location of the structure relative to the parcel extent. The red circle indicates the approximate location of a building (Indian Peninsula).

The importance of the location of the building within a building lot and relative to the shoreline is illustrated in a case study of a building along the shoreline in Port St. Joe (Indian Peninsula). Figure 3-29 shows a structure (green circle) sited too close to the shoreline. Note the relatively narrow parcel boundaries, which typically evolve over time with land acquisition, real estate transactions, and eventually development, and the division of parcels along Indian Pass Road. The case study structure is located at the midpoint of the parcel and is in front of the vegetated dune area. Other structures are set back farther on their respective parcels.

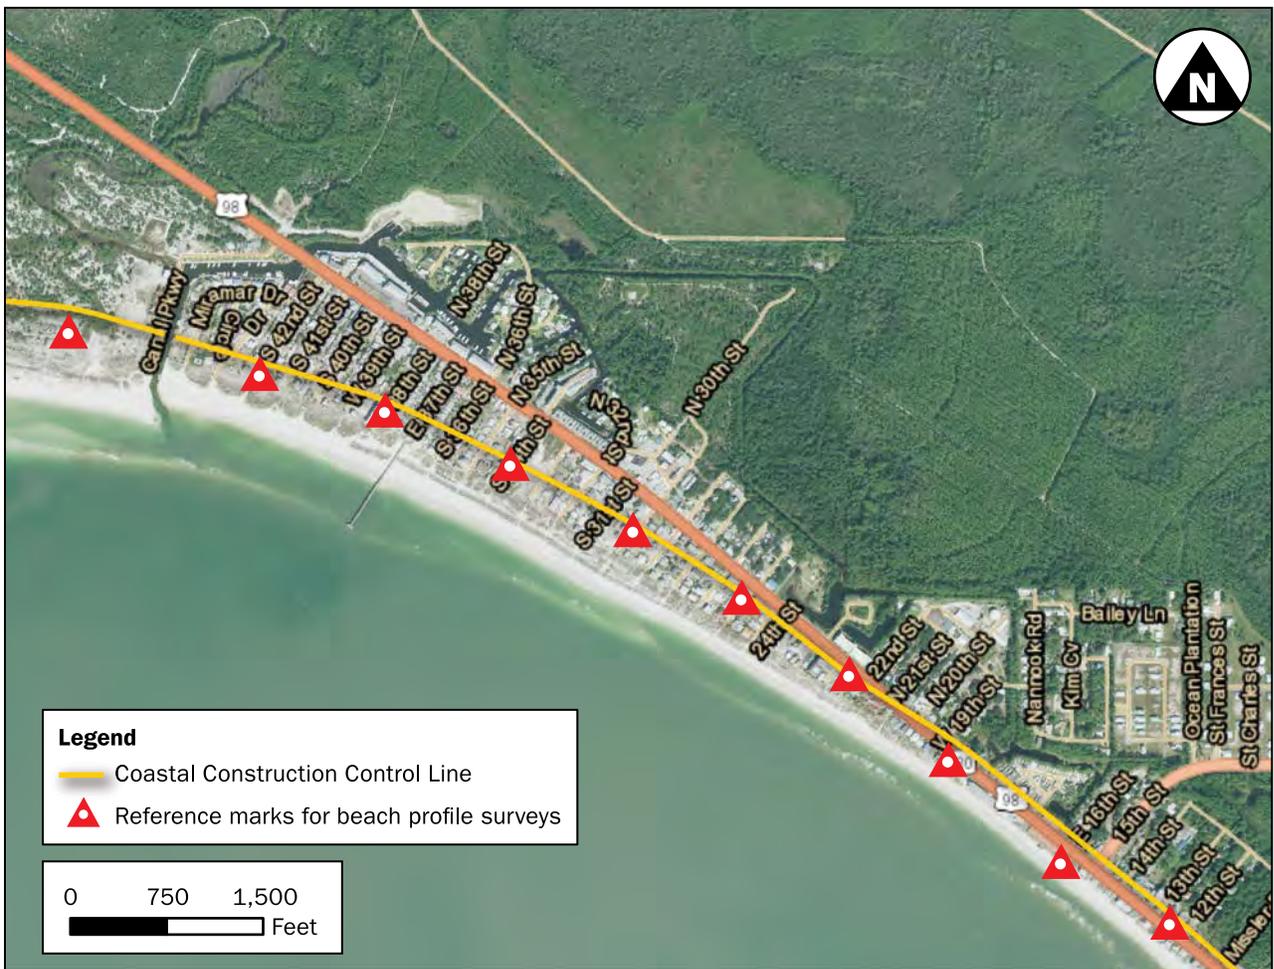
Figure 3-31: Aerial imagery showing CCCL in Mexico Beach before Hurricane Michael

Mexico Beach. Figure 3-31 shows the location of the CCCL in Mexico Beach before Hurricane Michael. The CCCL was established in Bay County in 1974 and updated in 1995 after Hurricane Opal and revised again in 1997. One-third of the residential structures seaward of the 1997 CCCL in Figure 3-31 were constructed prior to the establishment of the CCCL in Bay County.

Damage to Mexico Beach was extensive and is described in Section 3.1.1.2. Structures were sited too close to the shoreline and long-term erosion trends were not accounted for. Many pre-FIRM structures and infrastructure were built close to the shoreline and were destroyed by Hurricane Michael. This area is highly susceptible to future damage. Prudent decisions about rebuilding more resiliently should be made.

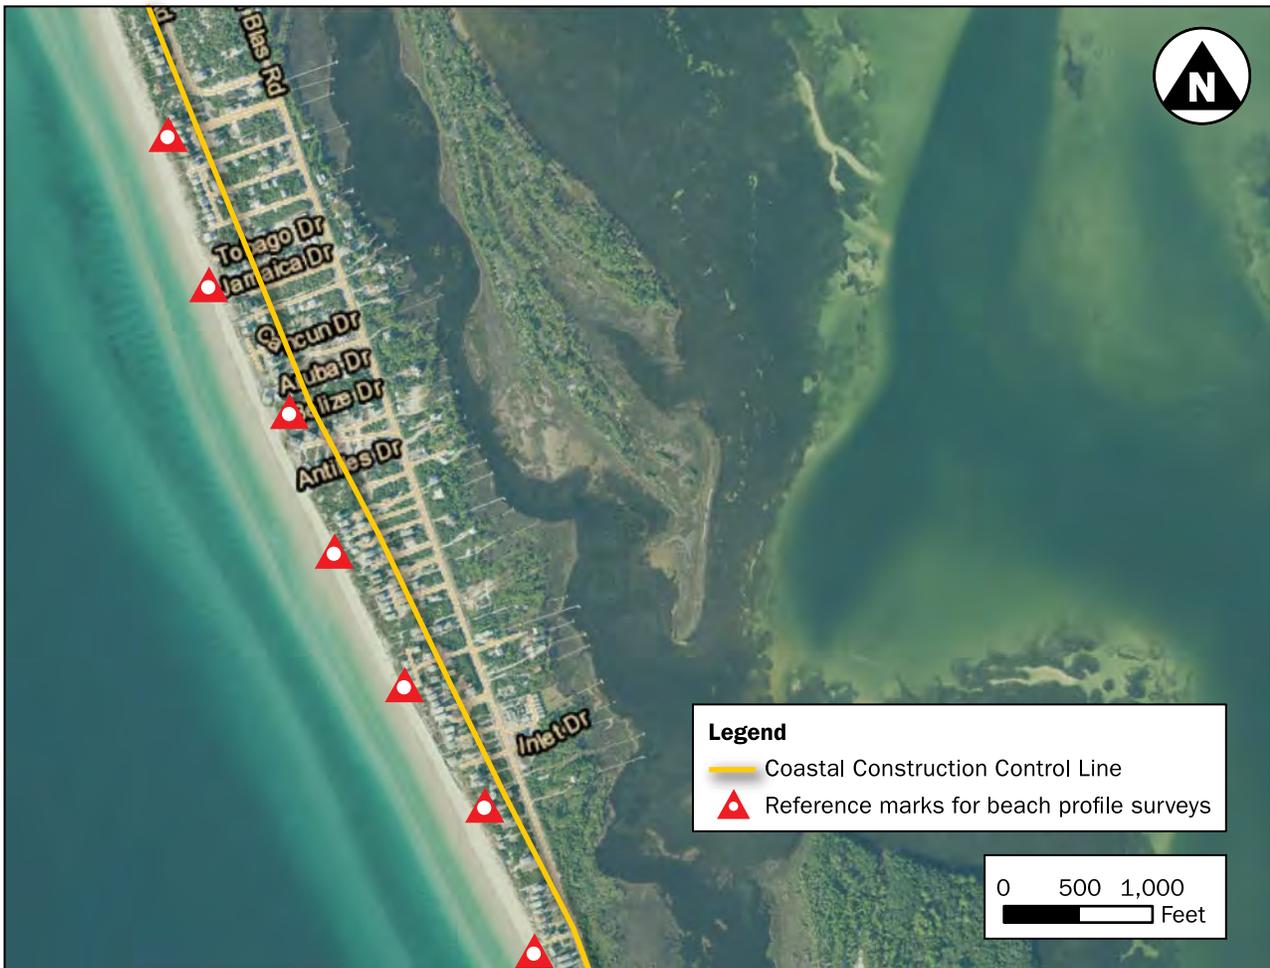
Figure 3-32: Aerial imagery showing CCCL in Cape San Blas before Hurricane Michael

Cape San Blas. Figure 3-32 shows the location of the CCCL in the Cape San Blas area before Hurricane Michael. Similar to Mexico Beach and clearly visible in the aerial image, much development was present between the CCCL and the shoreline before the storm. The CCCL was first established in Gulf County in 1975 and re-established in 1986 and 2010. A dozen

residential structures seaward of the CCCL were constructed prior to the establishment of the 2010 CCCL in Bay County (post-1974) (see Figure 3-32).

Community governments, in conjunction with private landowners, should determine the suitability of redevelopment in highly vulnerable areas given the high winds, storm surge, and waves that occurred during Hurricane Michael. Using the CCCL as a guideline, communities should consider rezoning to limit development, and developers should consider exceeding siting requirements and incorporating best practices.

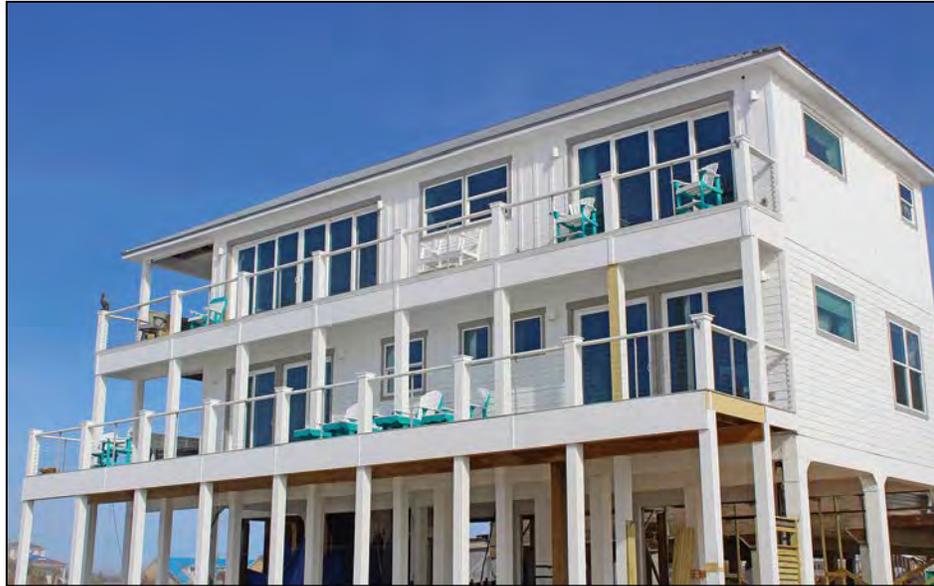
Figure 4-3:
Post-FBC house (built in 2017) with minimal damage
(EWS = 150 mph, DWS = 130 mph)
(Mexico Beach)

Example 1 – Mexico Beach: The contrast in building performance is illustrated by four houses located near each other, as indicated on an aerial photograph (Figure 4-1). Examples of post-FBC performance are shown in Figure 4-2 and Figure 4-3. Figure 4-2 shows an elevated post-FBC house that had severe envelope damage, but did not appear to have any damage to its MWFRS even though the building was subjected to wind speeds that exceeded the design wind speed. Similarly, Figure 4-3 shows another elevated post-FBC building (built in 2017) that had little structural damage (likely due to surge) and very little envelope damage.

This house had only a small amount of damage, which was most likely due to coastal storm surge, and very little envelope damage.

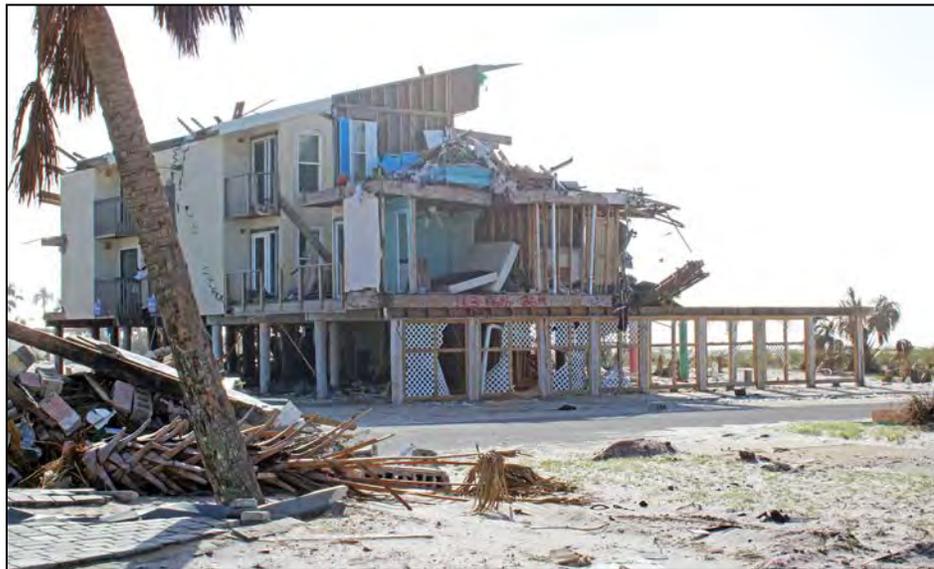
Figure 4-4:
Pre-FBC house (built in 1984) with severe structural damage
(Mexico Beach)

In contrast, an adjacent house constructed pre-FBC suffered significantly more structural damage (Figure 4-4). Figure 4-5 shows a nearby post-FBC house (built in 2017) with some wall covering and soffit damage, but no apparent structural damage.

The damage to this building was likely due to a combination of wind and coastal storm surge.

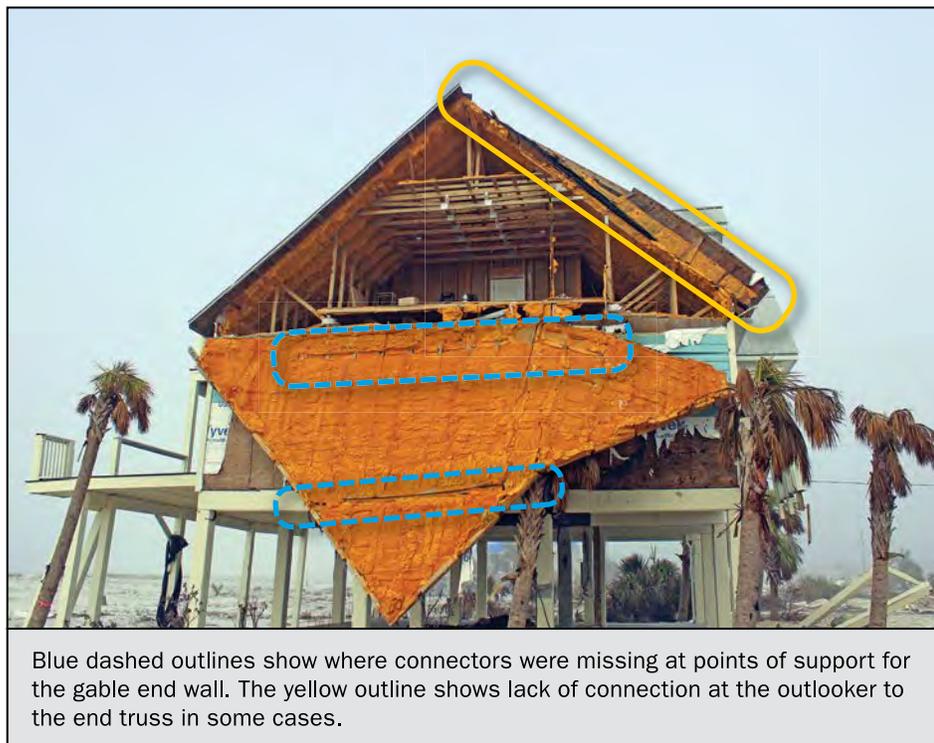
Figure 4-8:
Post-FBC house
(built in 2016) with
significant gable end
failure
(EWS = 150 mph,
DWS = 130 mph)
(Mexico Beach)

Example 4 – Mexico Beach: The house shown in Figure 4-8 sustained a significant gable failure. Given its location (Exposure D) and unique roof framing, this building could not have been built to any of the prescriptive high-wind standards referenced in the FBC. It would have been required to be designed by a registered design professional.

Although the MAT could not determine the exact cause of failure, a couple of issues likely contributed to the failure of this gable end wall. The gable end wall was particularly tall and likely needed bracing in locations other than at the interface with the wall below. The blue dashed rectangles in the figure show where additional support was likely intended. However, there was no evidence of any metal straps/clips at these points to resist the outward or suction forces on the gable end wall. The end wall framing was turned flatwise, which is a weaker orientation for the framing. Additionally, the outlookers appeared to not have been adequately connected to the end truss. Where the outlookers are still attached to the roof decking, two or three nails through the outlookers are visible. However, several of the notches in the end truss/framing on the right side of the gable showed no sign of fastener penetration, indicating that there was no connection at that joint (yellow rectangle). The lack of a connection at the outlooker would make the gable end wall susceptible to failure at that location.

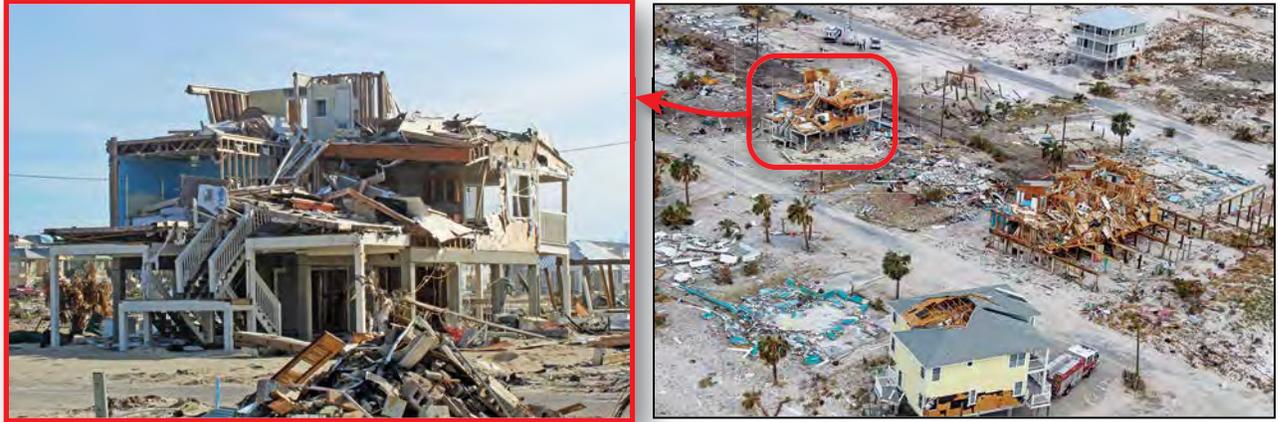
Figure 4-9: Post-FBC house (built in 2012) with significant structural damage (EWS = 150 mph, DWS = 130 mph) (Mexico Beach)

Example 5 – Mexico Beach: The Mexico Beach house shown in Figure 4-9 had severe structural damage. The damage to this building was too severe to draw any conclusions about what caused the structural failures. This house is approximately 325 feet from the Gulf of Mexico in open terrain with limited obstructions.

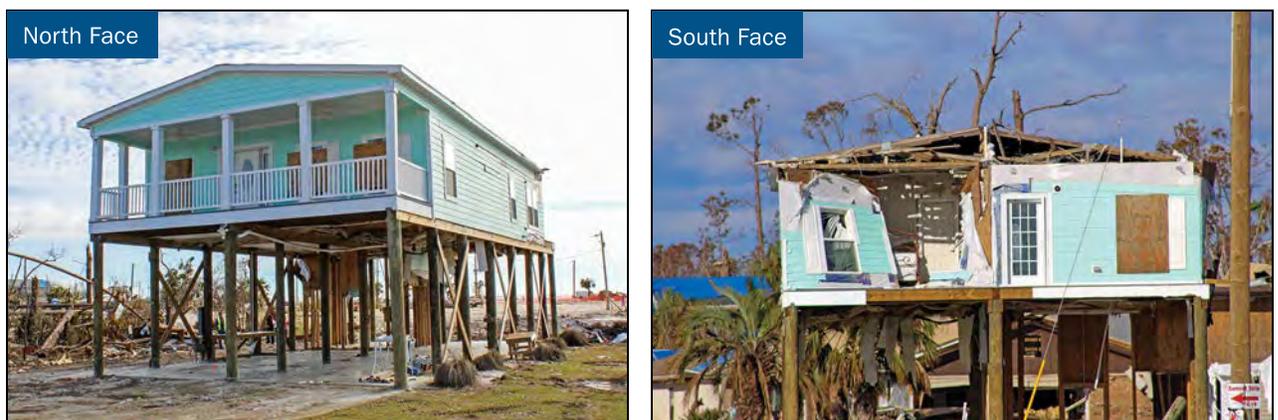
Figure 4-10: Post-FBC house (built in 2012) with significant structural damage (EWS = 150 mph, DWS = 130 mph) (Mexico Beach)

Example 6 – Mexico Beach: The house shown in Figure 4-10 was built in 2017. The south face of this particular building suffered severe damage to the roof and walls. Based on the MAT's observations, the south face of the building likely had an overhanging porch, as shown in the picture of the north face of the building (which was not severely damaged). The south porch, being the windward face and exposed to a combination of wind loads on the roof and underneath the porch overhang (in addition to possible wind-borne debris), is likely where failure initiated. The failure of the porch may have created a breach in the envelope, allowing wind to enter the interior of the building, resulting in high internal pressures and significant structural damage to the south end of the building.

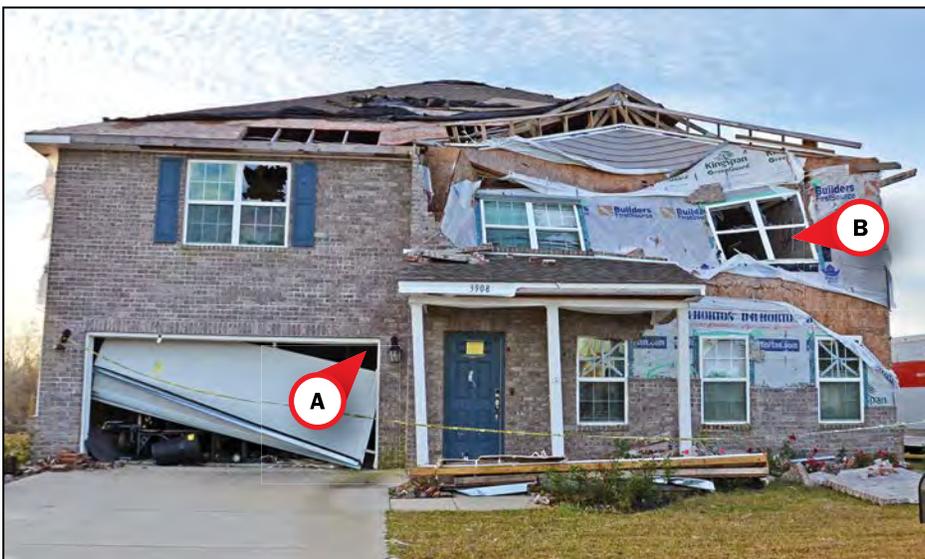
Figure 4-11:
Post-FBC house
(built in 2016) with
significant structural
damage
(EWS = 127 mph,
DWS = 133 mph)
(Panama City)

Example 7 – Panama City: The house shown in Figure 4-11 was one of a few post-FBC houses assessed in the Panama City area that suffered significant structural damage. It was built in 2016, and the homeowners were home during the storm. The homeowner described the series of events that unfolded, which included the failure of gypsum board on the wall adjacent to the garage, failure of the sectional (garage) door, failure of a window on the first floor, and failure of the gable end area on the second floor (not necessarily in chronological order). The MAT was not able to make a definitive determination about the initial or primary cause of failure, but it likely was a combination of failure of the sectional (garage) door and breaching of the first- and/or second-story window. These events enabled wind to enter the interior of the house, creating high internal pressures, which contributed to the failure of the second-story gable end wall. The back door also blew out.

The vertical framing supporting the sectional (garage) door track failed as shown in Figure 4-11. While it was difficult to make a definitive determination about the gable end given the degree of destruction, the MAT could not find evidence of appropriate bracing of the gable end wall that failed. As previously indicated, numerous glazed openings were also breached. Although the glazed openings did not appear to be impact-resistant, this house is not located in a WBDR (see Section 2.3.1 of this report for a discussion on the WBDR).

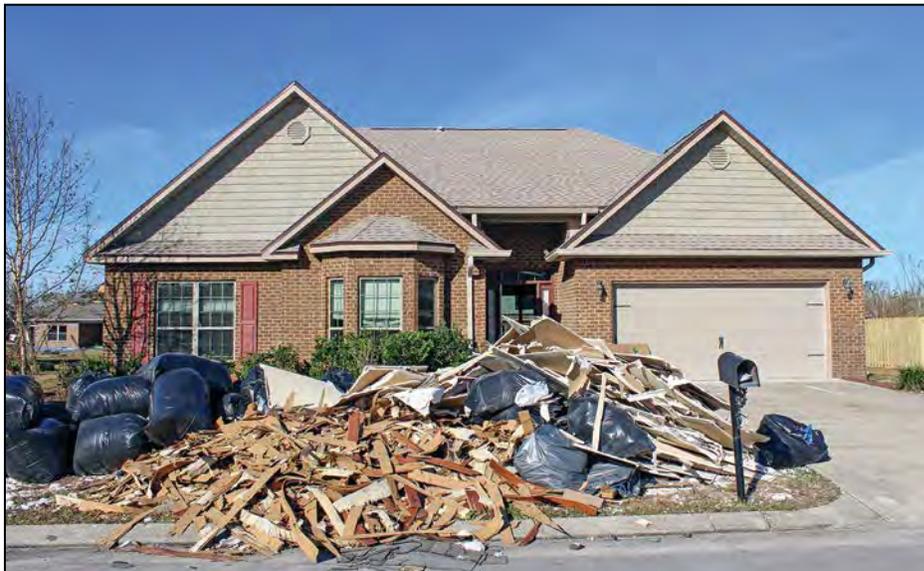
Figure 4-12:
Post-FBC house
(built in 2016) that
experienced water
intrusion
(EWS = 127 mph,
DWS = 133 mph)
(Panama City)

When the MAT visited this house, it appeared to have recently had a new roof installed. NOAA post-storm imagery indicates that this area suffered significant roof covering loss. Clearly, this house suffered severe water intrusion as evidenced by the debris pile at the curb. Although the MAT could not be certain of the source of the water intrusion, the loss of the asphalt shingle roof covering was likely a contributor to the interior damage.

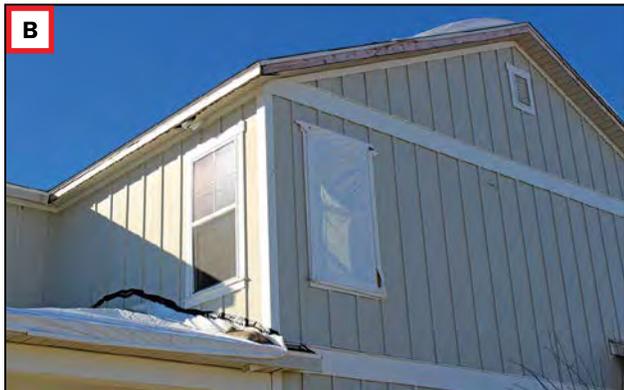
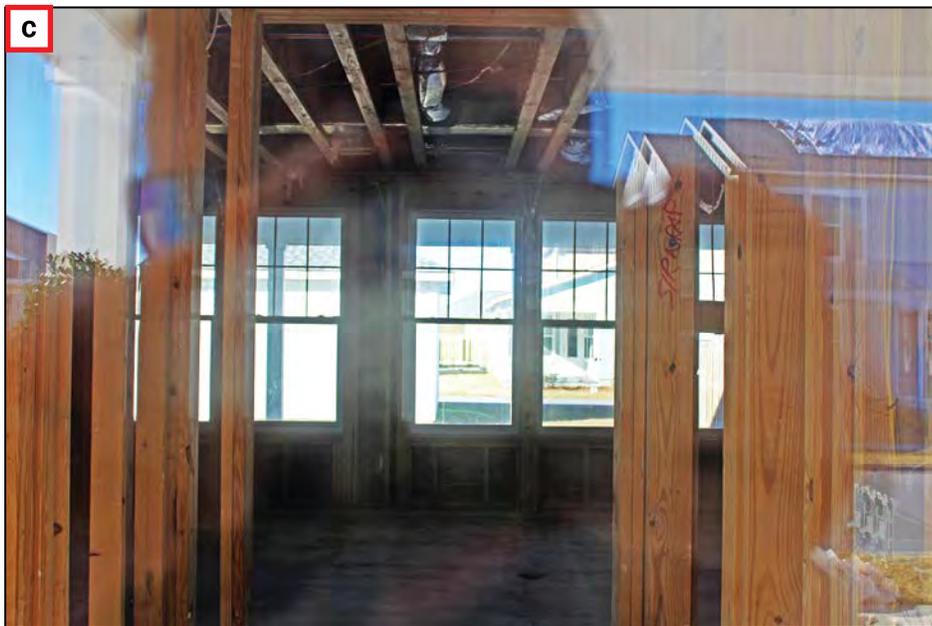
Figure 4-13:
Post-FBC house
(built after 2017)
with significant
water intrusion
(EWS = 125 mph,
DWS = 134 mph)
(Panama City)

The MAT observed many instances where it was clear that houses had experienced water intrusion and resulting interior damage, as evidenced by water-damaged interior components piled outside the house. Such debris piles were common, particularly throughout the Panama City area, even when the houses appeared to have suffered only minor exterior damage from the storm. One such example is shown in Figure 4-12. Another example that demonstrates the importance of building envelope components is illustrated by the house in Figure 4-13, which had so much water intrusion damage that the building was declared unsafe.

While this relatively new house shown in [A] appeared from the road to have performed relatively successfully, it suffered significant water intrusion. The house suffered roof covering loss near the ridge, some soffit damage, and damage to one glazed opening [B]. The MAT could not determine whether the damage was due to wind-borne debris or wind pressure. The interior finishes and furnishings were mostly removed [C], and the building was declared unsafe.

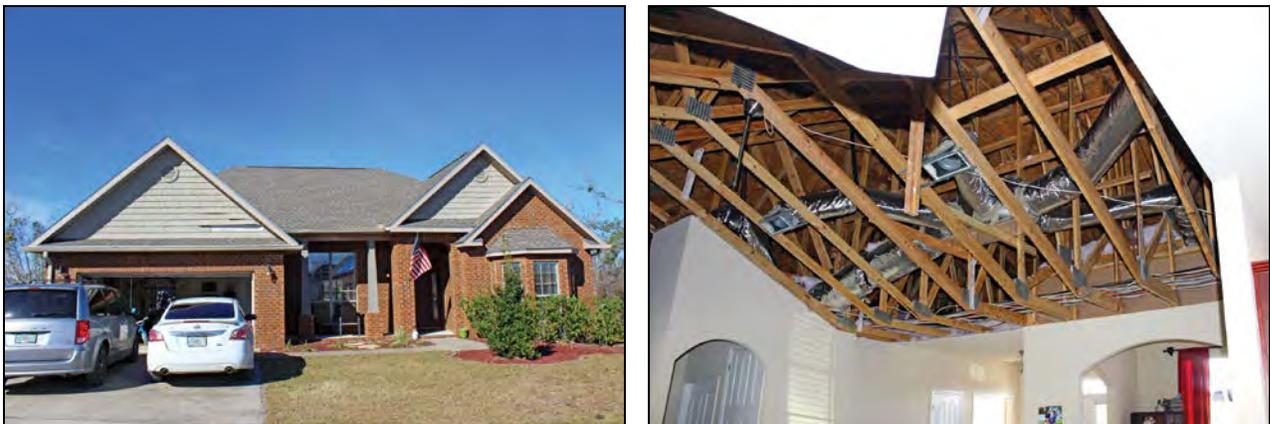
Figure 4-16: Post-FBC house (built in 2012) with interior damage due to loss of ridge shingles and ridge vent (EWS = 128 mph, DWS = 133 mph) (Panama City)

Hip and ridge shingle performance. Failure of hip and ridge shingles was prevalent. Failure of ridge shingles often included failure of ridge vents, which resulted in significant water intrusion according to homeowners. A new roof covering had recently been installed on the house in Figure 4-16. The homeowner said the roof covering mostly stayed intact except for the shingles at the ridge and the ridge vent. No other envelope components were observed to have failed. Observations from the road would indicate that the house fared reasonably well during the storm. However, according to

the homeowner, significant water intrusion occurred, causing the collapse of ceilings in multiple rooms.

The MAT was given the opportunity go inside and document the interior water intrusion in the house shown in Figure 4-16. This house had recently had the roof replaced and a new ridge vent installed. The MAT observed the ridge vent and sheathing from the inside of the house and could not find definitive evidence that the ridge vent fasteners adequately penetrated the roof sheathing.

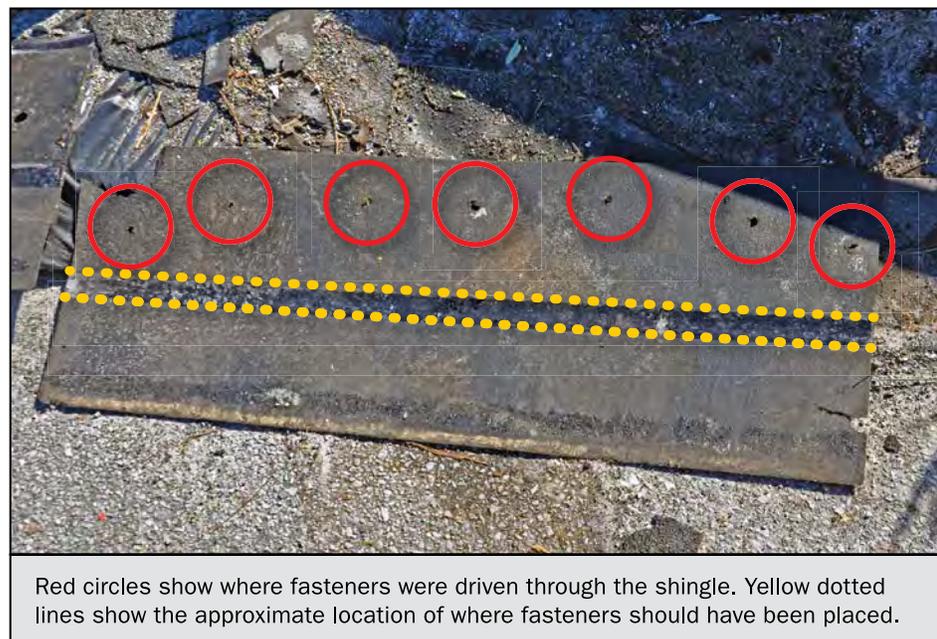
Figure 4-17:
Incorrect location of fasteners in asphalt shingle

First, the Michael MAT noted, as did the Hurricane Irma in Florida MAT report, incorrect location of fasteners in asphalt shingles was commonly observed either on damaged roofs or asphalt shingles in debris piles. Figure 4-17 depicts an asphalt shingle retrieved from a debris pile indicating fasteners were installed well above the recommended location.

Asphalt shingle fasteners should be installed on the nail line or in the nail zone, as specified by the manufacturer. If the shingle does not have a nail line or nail zones, nails should be installed such that they also secure the shingle underneath as shown in the image below.

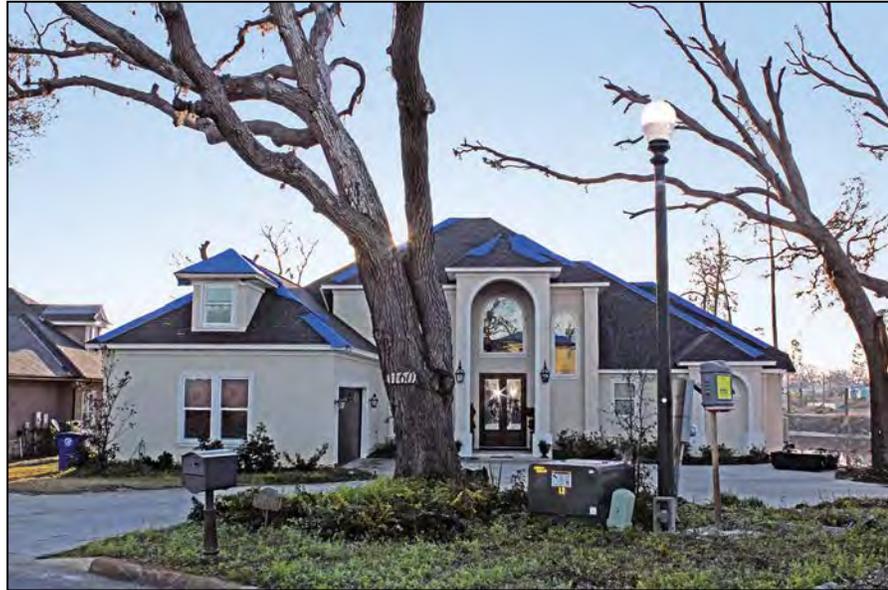
Figure 4-18:
Post-FBC (2015) house
with hip and ridge asphalt
shingle damage
(EWS = 132 mph,
DWS = 134 mph)
(Panama City)

The second trend observed from evaluating debris piles is related to hip and ridge shingles. Most hip and ridge shingles that were observed in debris piles lacked evidence of roofing cement. Figure 4-18 shows a residential building in Panama City with mostly hip and ridge asphalt shingle damage.

Although the use of roofing cement on hip and ridge shingles is not required in the FBC unless required by the Product Approval, FEMA P-499, *Home Builder's Guide to Coastal Construction* (2010e), and FEMA P-55, *Costal Construction Manual* (2011), both recommend the use of roofing cement when installing hip and ridge shingles. (Refer to Technical Fact Sheet No. 7.3, "Asphalt Shingle Roofing for High-Wind Regions" [in FEMA P-499, 2010a], and Section 11.5.1 in FEMA P-55.)

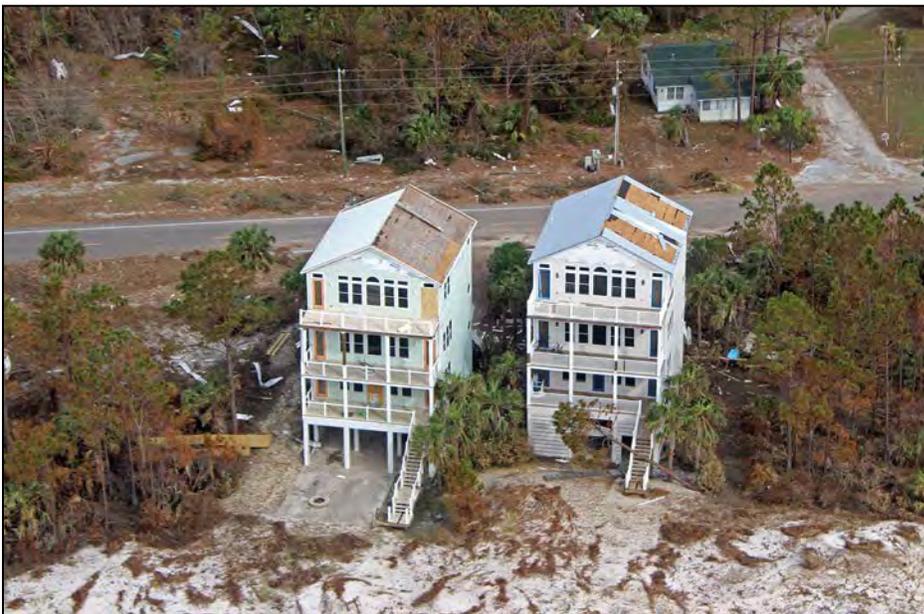
Figure 4-20:
Post-FBC house (built
in 2006) with metal
roof panel damage
(EWS = 138 mph,
DWS = 130 mph)
(Port St. Joe)

Metal panel roof systems on post-FBC houses performed reasonably well overall in the areas visited by the MAT. There were some instances of damage to metal panel roof systems observed. Figure 4-20 and Figure 4-21 show post-FBC houses (both built in 2006) with metal roof panel damage. It is worth noting that most of the metal panel roof damage observed was in areas where the estimated wind speeds were above the design level wind speed.

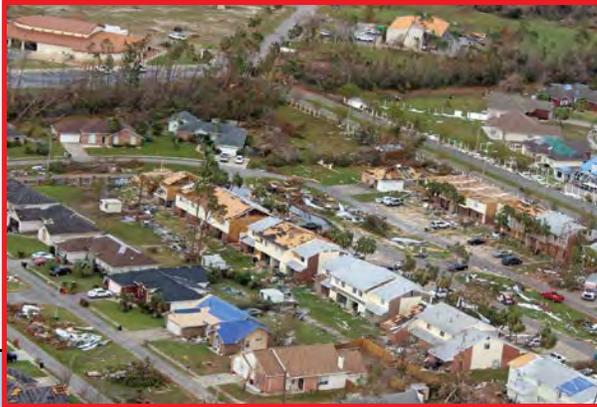
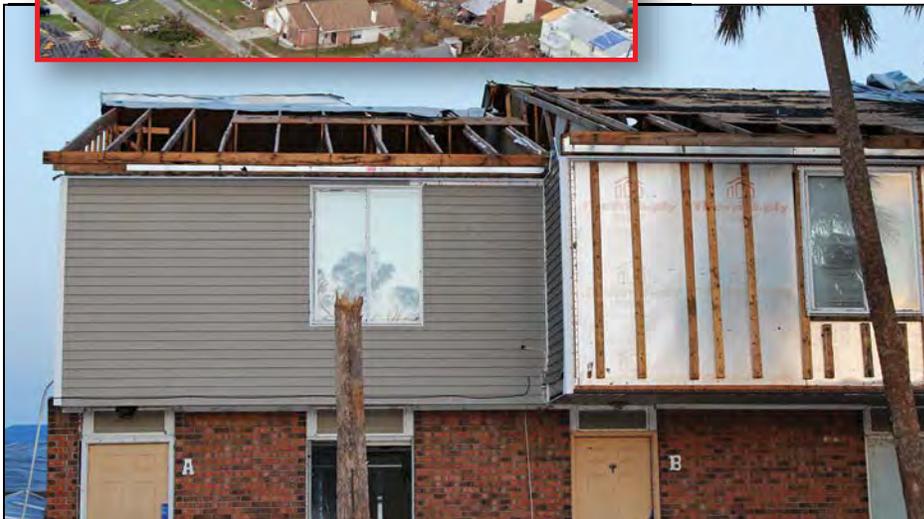
Figure 4-22:
Pre-FBC multi-family house (built in 1987) with asphalt shingle roofs re-covered with metal roof panels; aerial view shows the scope of damage in the vicinity of the house (EWS = 134 mph, DWS = 133 mph) (Panama City)

Although observing the performance of roof re-covers was not a primary objective, the MAT did observe a couple of severe roof sheathing failures where pre-FBC buildings with asphalt shingles were re-covered with metal roof panels. As previously mentioned, the FBC does not require re-nailing of the roof deck where metal roof panels are installed over an existing asphalt shingle roof. However, if the asphalt shingles are removed, the roof sheathing nailing has to be evaluated and re-nailed if found to be deficient.

Figure 4-22 shows a pre-FBC multi-family complex where asphalt shingle roofs were re-covered with metal roof panels. Figure 4-23 shows a pre-FBC single-family dwelling where an asphalt shingle roof was re-covered with metal roof panels. It is possible that these houses would have performed better if the roof sheathing had been re-nailed.

Note that the actual design wind speed for the buildings in Figure 4-22 and Figure 4-23 is unknown as they were built in 1987 and 1975, respectively. The design wind speed from the current FBC and ASCE 7 is provided to give a general perspective of the design criteria in this area.

When a roof covering on a site-built, pre-FBC single-family dwelling is removed and replaced, the FBC requires certain mitigation techniques be performed. Most notably, if the existing roof sheathing nailing does not meet certain criteria, the FBC requires roof sheathing to be re-nailed. These provisions are addressed in detail in Hurricane Irma in Florida Recovery Advisory 3, *Mitigation Triggers for Roof Repair and Replacement in the 6th Edition (2017) Florida Building Code (2018f)*. However, this mitigation criterion does not apply to roof re-covers (a roof re-cover is the process of installing a new roof covering over an existing roof covering and is often referred to as a “roof-over”).

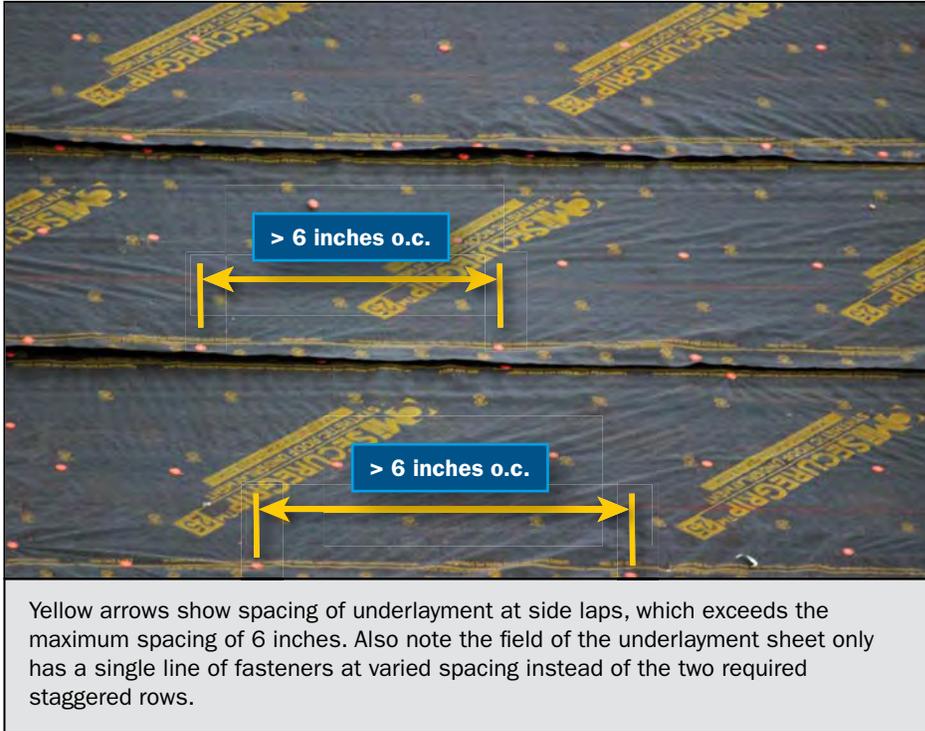
Figure 4-24:
Pre-FBC house
(built in 1986)
roof replacement
using synthetic
underlayment
(EWS = 123 mph,
DWS = 134 mph)
(Lynn Haven)

The MAT observed many buildings undergoing roof replacement during their assessment. At many of the job sites visited, new underlayment installation was not being fastened as required by code. Roof underlayment can be used as a secondary method for preventing water infiltration where the primary roof covering fails due to wind; studies and tests have validated the effectiveness of certain underlayment installations. As a result, the FBC requires enhanced attachment of traditional underlayment products such as felt, and also recognizes more robust underlayment such as the self-adhered modified bitumen products (in the IBC and IRC, enhanced underlayment is required only where the design wind speed is 140 mph and greater). Refer to the textbox for additional information on underlayment requirements. A couple of examples of improper attachment of underlayment observed by the MAT are shown in Figure 4-24 and Figure 4-25.

For roof slopes of 4:12 and greater, the FBC requires that felt used as an underlayment to be in accordance with ASTM D226 Type II or ASTM D4869 Types III or IV. The felt underlayment must be fastened with cap nails at 6 inches on center (o.c.) at side laps and have two staggered rows at 12 inches o.c. in the field of the sheet. Synthetic underlayment is permitted if it is approved as an alternate to ASTM D226 Type II and is fastened as required for felt underlayment. The specific installation requirements for this method are shown below.

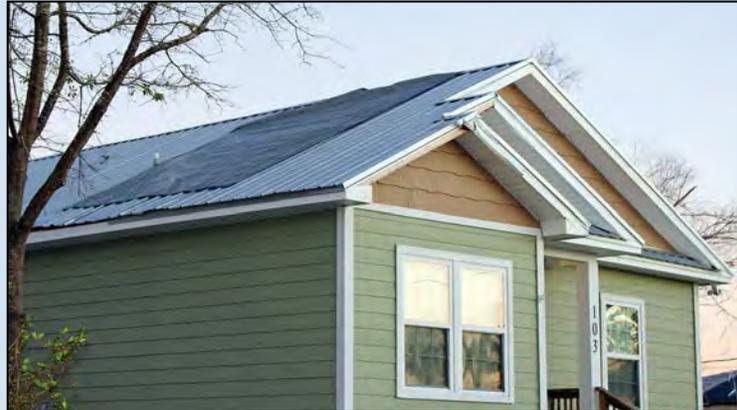
This house was successfully protected by a sealed roof deck during Hurricane Michael after wind-borne debris punctured the metal roof covering.

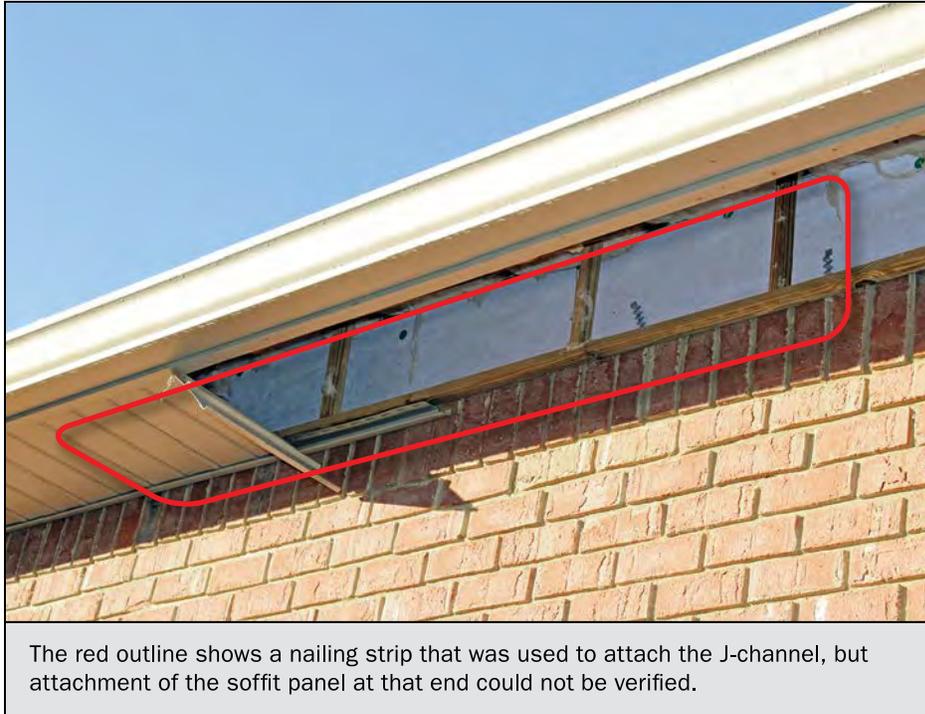
Figure 4-28:
Post-FBC house
(built in 2006) with
vinyl soffit damage
(EWS = 131 mph,
DWS = 134 mph)
(Panama City)

Soffit attachment issues. At some sites, the MAT was able to document the presence of nailing strips or framing at the wall where soffit assemblies failed. However, whether the soffit was attached at the end adjacent to the wall could not be verified. Figure 4-28 is one example of several observations of soffit assembly failure where a nailing strip could be seen at the adjacent wall, but evidence of attachment of the end of the soffit panel to the nailing strip could not be verified.

In high-wind areas, vinyl soffit panels have to be fastened at both ends to framing, the fascia board, and/or a nailing strip to meet the required design wind pressures in these areas. Fastening the vinyl soffit panel at both ends, as shown in Figure 4-26, is one of the key installation criteria for successful performance under wind loading. While soffit framing methods may differ from those shown in Figure 4-26, the soffit panel should be fastened at both ends and the span of the soffit panel should not exceed 12 inches. Where the span of the eave or rake exceeds 12 inches, additional nailing strips should be provided. The maximum span of 12 inches is recommended by the Vinyl Siding Institute (VSI) and IBHS, and is also a requirement in a code change currently moving through development of the IRC and the FBC.

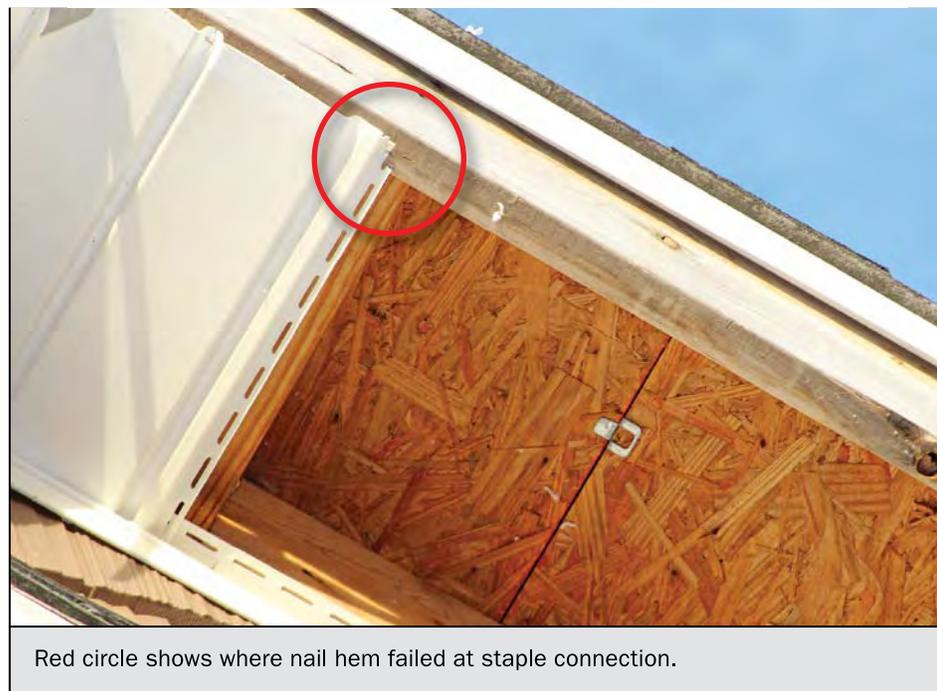
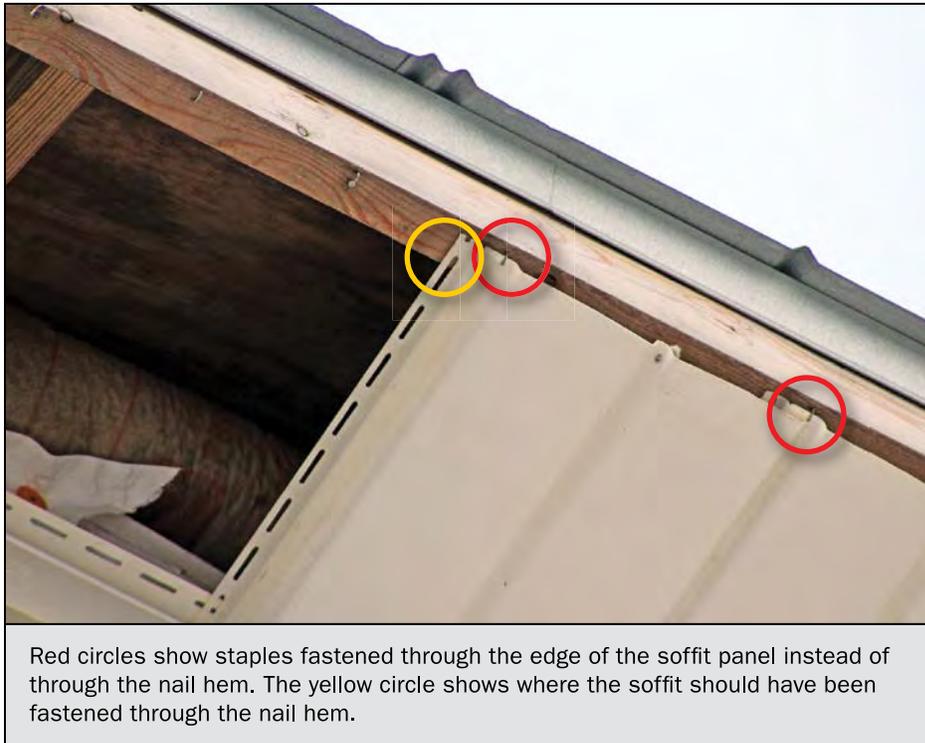
Figure 4-31:
Post-FBC house (built
after 2017) with vinyl
soffit damage
(EWS = 150 mph,
DWS = 130 mph)
(Mexico Beach)

Fastening of soffit panels varied as well. The MAT observed some soffit panels that were attached with staples. While the FBCR has eliminated the use of staples as an approved fastener, many of the Product Approvals for vinyl soffit panels permit the use of staples. The *Vinyl Siding Installation Manual* (VSI, 2017), as well as Florida's Product Approvals, require soffit panels to be fastened through the nail hem. Figure 4-29, Figure 4-30, and Figure 4-31 show vinyl soffits that were not installed properly.

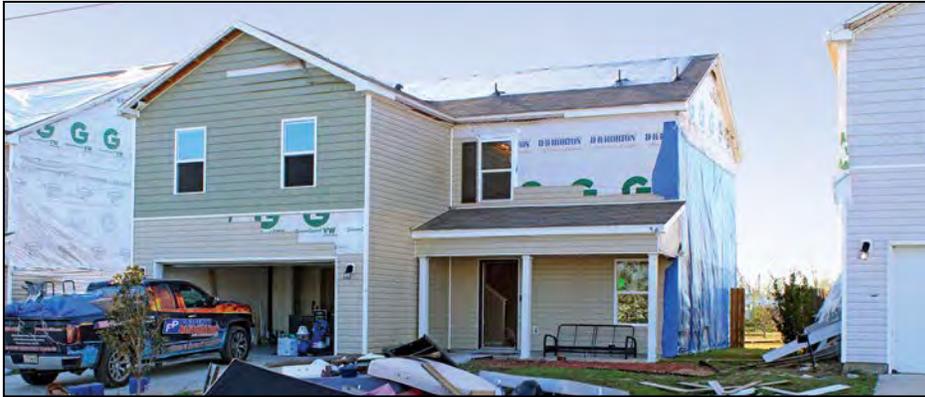
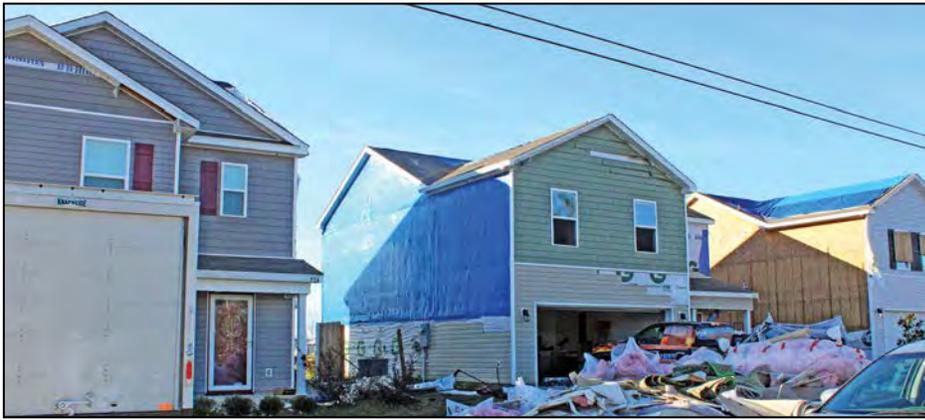
Figure 4-32: Post-FBC house (built in 2015) with vinyl siding damage (EWS = 135 mph, DWS = 134 mph) (Panama City)

performance to wind loading. The location of vinyl siding failures on houses observed by the MAT after Hurricane Michael varied, but was particularly prevalent on walls between closely spaced houses in dense developments (possibly due to a channeling effect between buildings that increased wind speed). An example is shown in Figure 4-32.

The vinyl siding between these closely spaced houses was damaged, possibly due to increased wind speeds being channeled between the buildings.

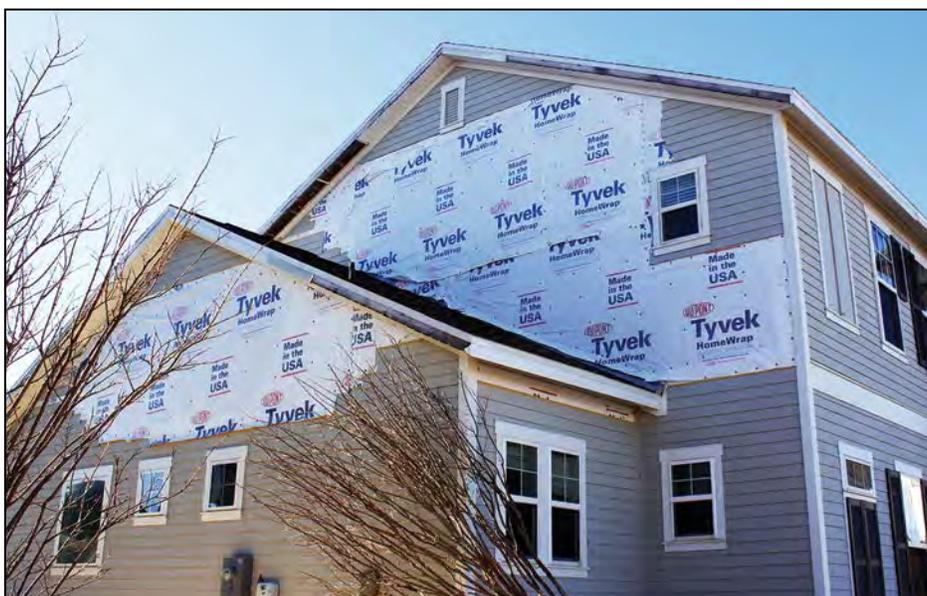
Figure 4-35:
 Post-FBC house
 (built after 2017)
 with fiber-cement
 siding damage
 (EWS = 125 mph,
 DWS = 134 mph)
 (Panama City)

- Figure 4-35 is an example of a residential building in Panama City that suffered extensive fiber-cement siding failure. Fiber-cement siding failure in this development was common, and the MAT noted ongoing repair work on buildings in this area. While the estimated wind speed for this site was less than the design wind speed, these houses were adjacent to a very large area of open terrain with scattered obstructions (Exposure C condition).

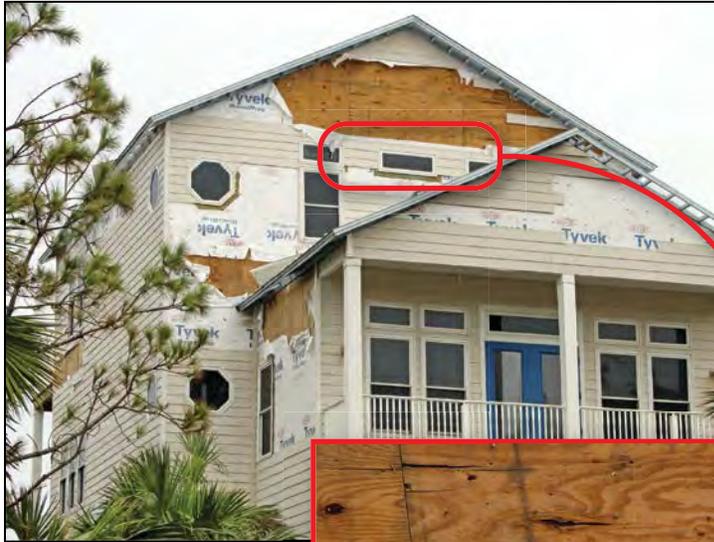
Figure 4-36:
Post-FBC house (built in 2006) with
fiber-cement siding damage
(EWS = 138 mph, DWS = 130 mph)
(Port St. Joe)

- The house in Figure 4-36 experienced significant fiber-cement siding damage, particularly in the gable wall area. The inset shows the location of the fasteners. Although the siding appears to be well fastened into plywood wall sheathing, some of the fasteners appear to have missed the wall stud framing as the joints in the plywood sheathing indicate where wall studs are located. This poor installation could have contributed to the poor performance of the siding.

Red circles show
 where some
 fasteners likely
 missed stud framing.
