Mitigation Assessment Team Report

Hurricane Michael in Florida

Building Performance Observations,
Recommendations, and Technical Guidance

FEMA P-2077 / February 2020

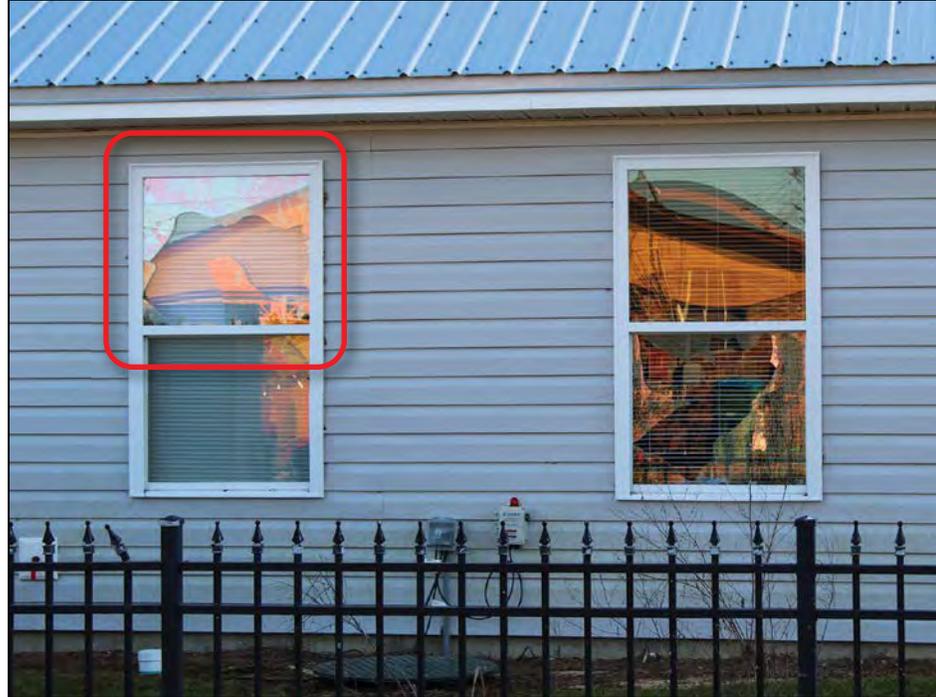
Figure 4-42:
Post-FBC house
(built in 2012) with
glazed opening
damage
(EWS = 150 mph,
DWS = 126 mph)
(Panama City)

Panama City. Typical damage to glazed openings observed by the MAT in the Panama City area is shown in Figure 4-40 through Figure 4-42. Similar to other areas visited by the MAT, damage to glazed openings was generally scattered and limited to one or two glazed openings.

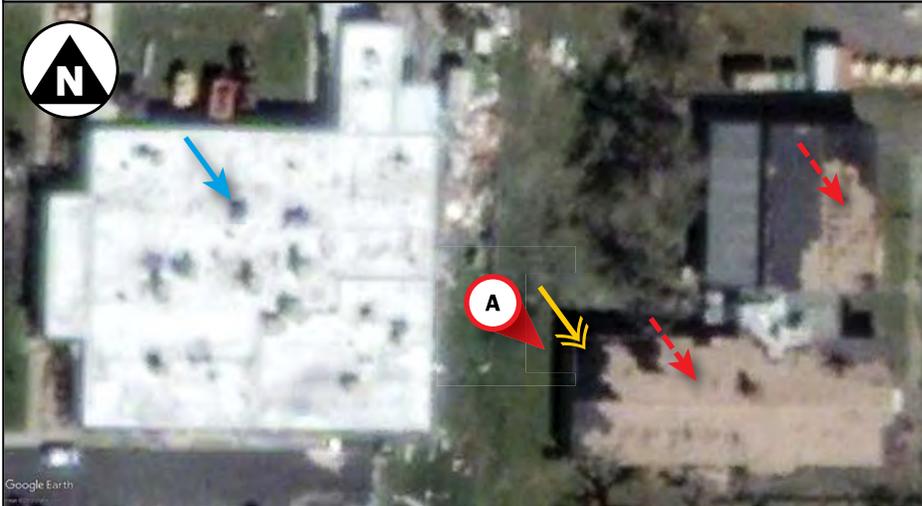
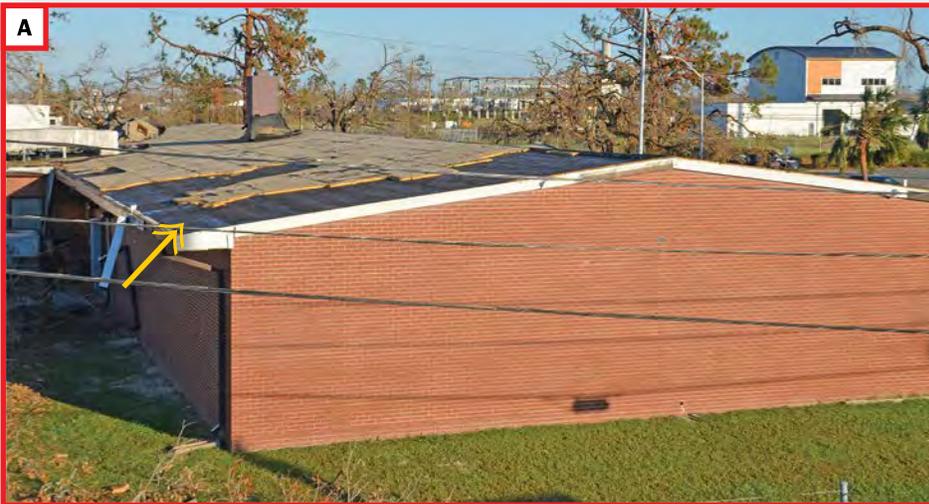
Figure 5-3: Aerial view of the Panama City Police Department (blue arrow) and adjacent U.S. Army Reserve Building (Panama City, FL)

Wind Damage Observations. The pre-MAT visited the facility 14 days after hurricane landfall. Figure 5-3 is an aerial view of the Panama City police facility shortly after Hurricane Michael.

The blue arrow indicates one of the 13 HVAC units. The inset [A] indicates the adjacent U.S. Army Reserve building. The yellow double arrows indicate where the insulation boards debonded from the mopping asphalt and initiated roof membrane lifting and peeling. Board debonding from mopping asphalt is indicative of a workmanship deficiency. The red dashed arrows indicate progressive failure, wherein the roof membrane peeled from the insulation boards. The primary wind direction was from the west.

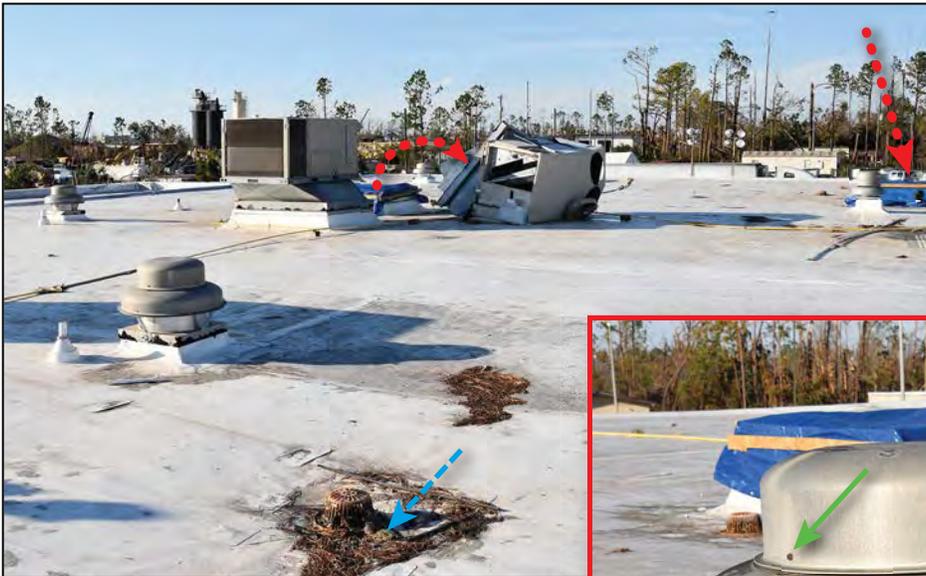
Figure 5-4: A portion of the roof of the Panama City police facility (Panama City, FL)

Other damage observations. Other damage, unrelated to the retrofit project, was also observed by the MAT. There was significant wind damage to the rooftop equipment. Some of the HVAC units blew off their curbs (Figure 5-4 and Figure 5-5), which resulted in extensive water entry (Figure 5-6) and rupture of gas lines serving the units. The roof membrane was punctured in several areas by wind-blown debris, and water that got underneath the roof membrane adversely affected the integrity of the membrane’s attachment. Much of the debris was likely from failed HVAC units, blown-off HVAC unit access panels, and condensate drain lines. A walkway canopy was also blown off (Figure 5-7). Roof drains were clogged by debris.

Hurricanes Irma and Maria in the U.S. Virgin Islands Recovery Advisory 2, *Attachment of Rooftop Equipment in High-Wind Regions* (2018c) provides recommendations for attaching various types of rooftop equipment. The recommendations address buildings in the planning stage, existing rooftop equipment, preparations prior to hurricane landfall, and post-hurricane landfall assessment.

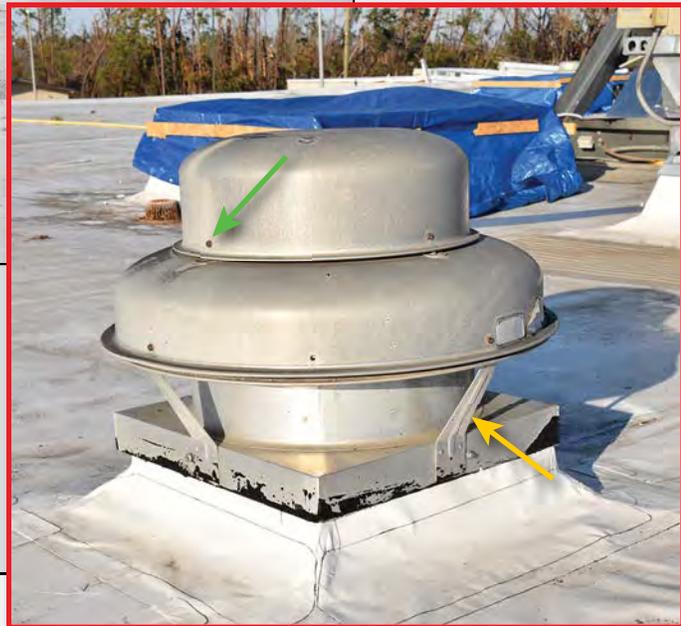
The red dotted arrows indicate blown-off HVAC units. The blue dashed arrow indicates vegetation debris at a roof drain. The debris was likely deposited on the roof during the storm. The inset shows one of the exhaust fans. The yellow arrow shows the brackets that attach the lower portion of the cowling to the fan base. Screws and clips, which attach the upper cowling to the lower cowling, are indicated by the green arrow.

Although exhaust fans or fan cowlings are often blown off, that did not occur at this facility even though far fewer screws were used to attach the fan to the curb than recommended in FEMA 543, *Design Guide for Improving Critical Facility Safety from Flooding and High Winds: Providing Protection to People and Buildings* (2007a). The fans at this facility had brackets that attached the lower portion of the cowling to the fan base (yellow arrow on the inset of Figure 5-4). Screws and clips attached the upper cowling to the lower cowling (green arrow).

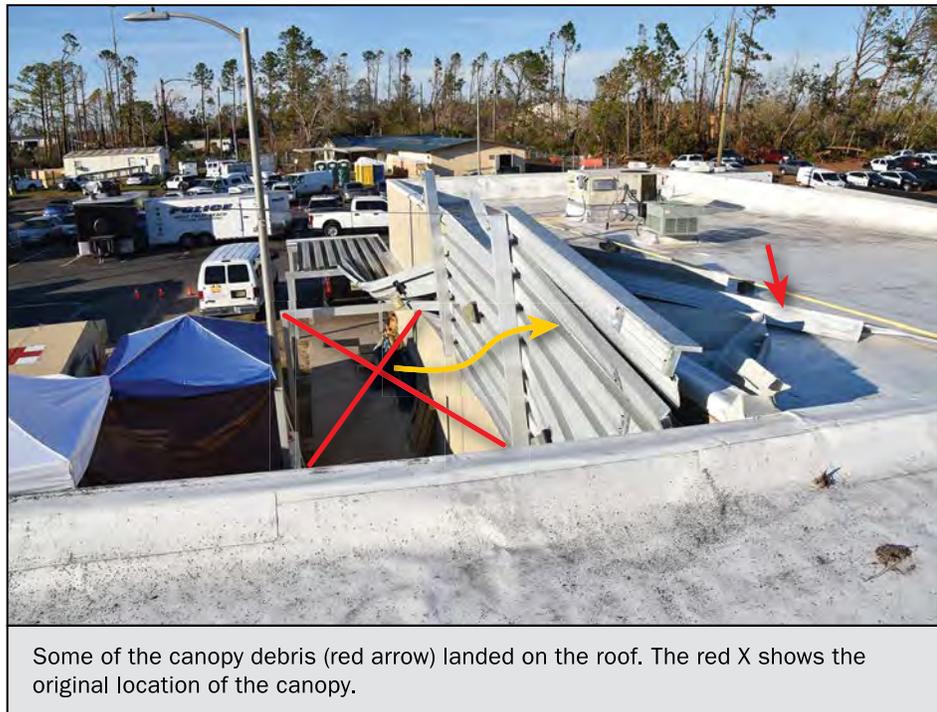
Figure 5-7: Damaged walkway canopy (Panama City, FL)

Some of the canopy debris (red arrow) landed on the roof. The red X shows the original location of the canopy.

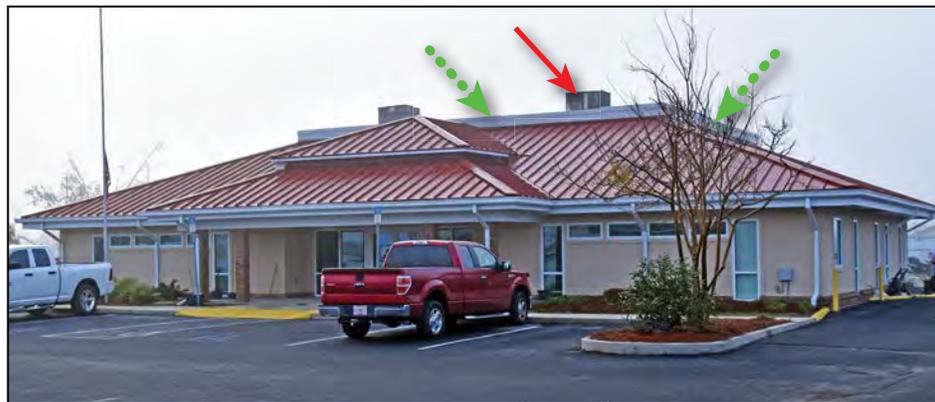
Figure 5-9: Front of the University of Florida IFAS facility (Panama City, FL)

One of the HVAC units blew off its curb (red arrow), allowing rain to enter the building.

The red arrow indicates the HVAC unit that blew off the curb (the unit had been placed back onto the curb). The coping was blown off the front and part of two sides (green dotted arrows).

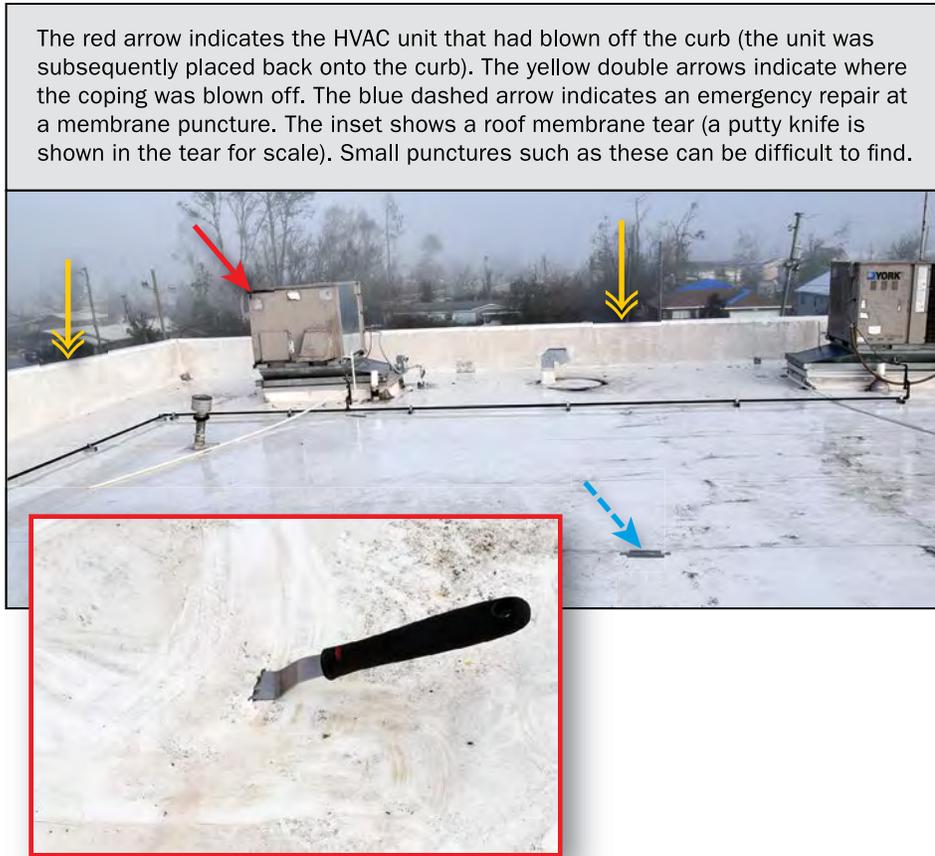
Figure 5-11: Low-slope roof of the IFAS facility (Panama City, FL)

An HVAC unit was blown off (Figure 5-11) and the roof membrane was punctured. The roof membrane punctures were likely caused by the HVAC unit and coping blowing off. At the time of the MAT visit, some of the punctures had been repaired, but at least one puncture was still open (inset at Figure 5-11). Water entry at the open curb and membrane punctures wetted and collapsed the gypsum board ceiling below the low-slope roof (Figure 5-12).

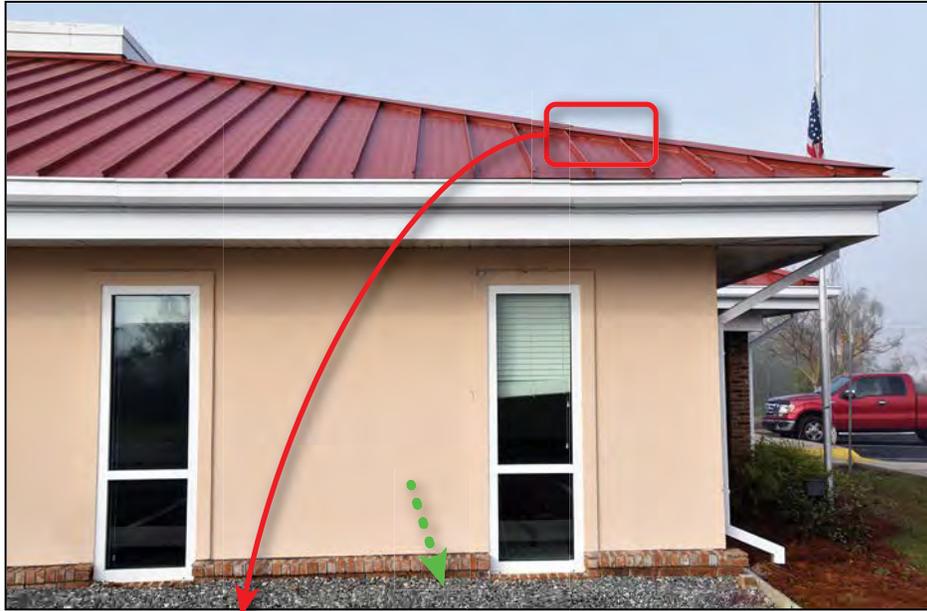
Figure 5-14: The gypsum board ceiling at this corner office was wetted and collapsed, as shown in Figure 5-15 (Panama City, FL)

Interior Water Intrusion. Water leakage wetted and collapsed the gypsum board ceiling below a portion of the sloped roof (Figure 5-14 and Figure 5-15). Based on the MAT observations, the source of the leakage was judged to have been wind-driven rain that entered the building at the hip because the closure was ineffective (see figure in textbox titled “Recommended Roof Hip and Ridge Closure” for an enhanced closure detail).

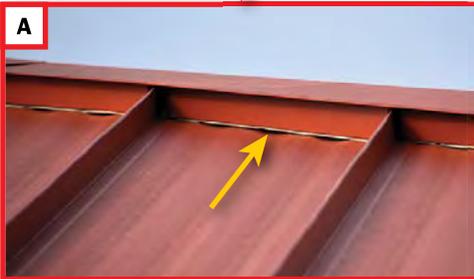
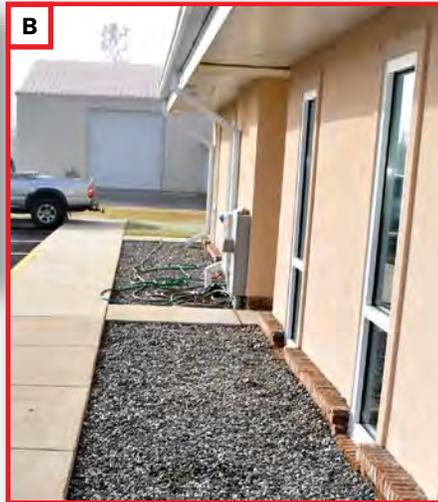
Wind-driven rain could drive through the gaps between the closure and roof panel pan (yellow arrow) [A]. Without a secondary closure, rain driving past this closure could leak into the building. The green dotted arrow indicates a strip of gravel adjacent to the wall [B]. When coupled with a perforated drainage pipe, this can effectively control rain that spills over a gutter during deluge or wind-driven rains.

In high-wind regions, it is important to use at least two rows of closures at hips and ridges to prevent entry of wind-driven rain. All edges of the inner closure should be set in sealant or sealant tape. At the outer closure, sealant should be at the top and edges of the closure. The juncture between this closure and the pan of the roof panel is left unsealed to allow water that may be blown past the outer closure at sealant discontinuities to drain.

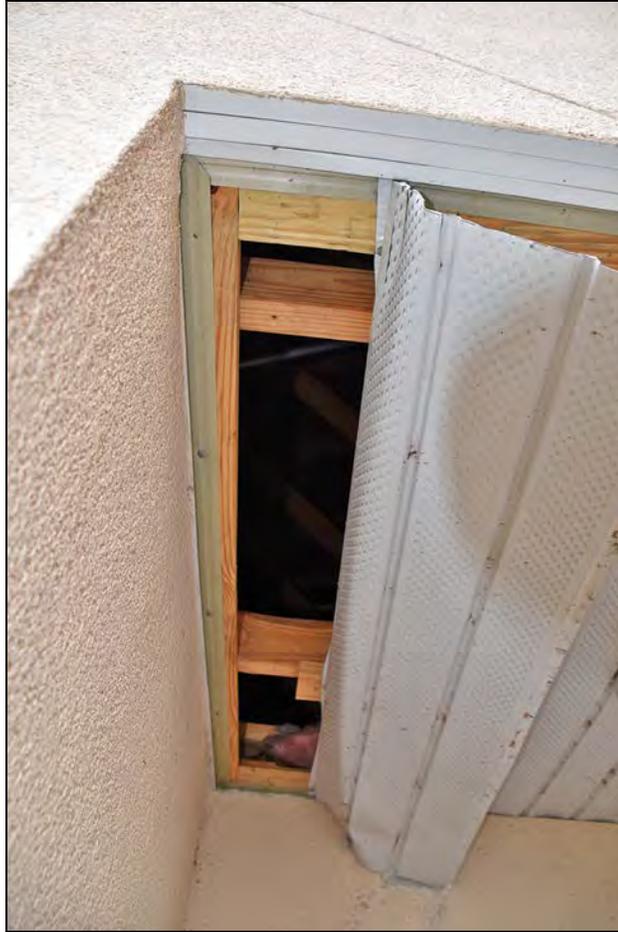
Figure 5-16: One of the damaged soffit panels (Panama City, FL)

Soffit Blow-Off. Several soffit panels were also blown away (Figure 5-16), thereby exposing the attic space to entrance of wind-driven rain.

Refer to FEMA Fact Sheet 7.5, *Minimizing Water Intrusion Through Roof Vents in High-Wind Regions* (in FEMA P-499, 2010f).

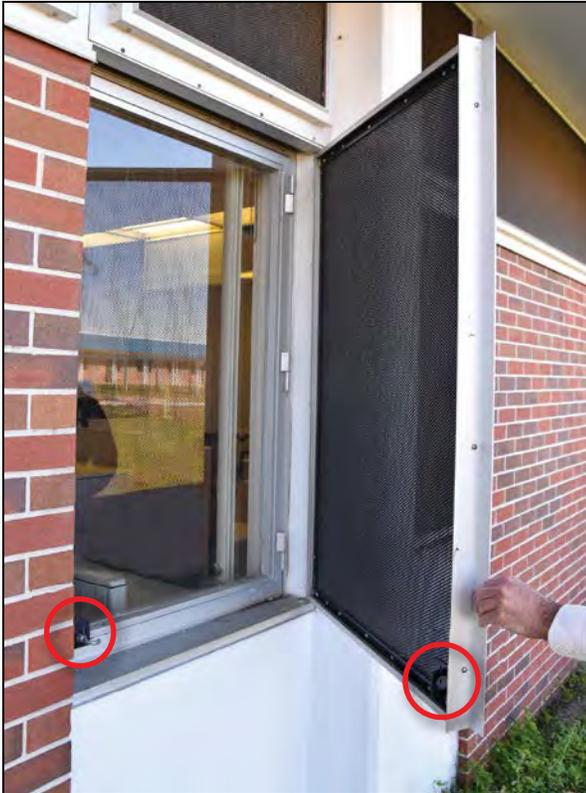
Figure 5-18: The campus (Panama City, FL)

The red arrows indicate the steep-slope conversion. The green dotted arrows indicate where standing seams opened up (Figure 5-23). The yellow double arrows indicate a blown-off gutter, broken glazing, and a damaged screen shutter frame.

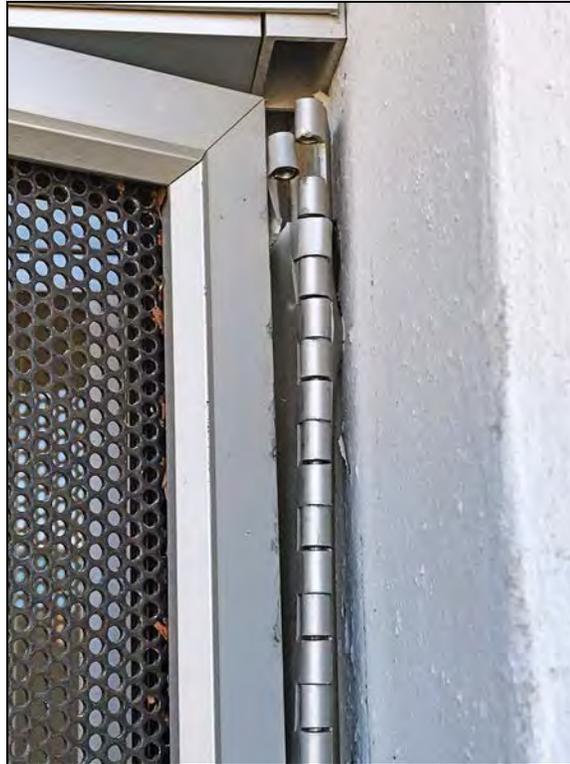
Figure 5-19: A shutter in the unlatched position (Panama City, FL)

In addition to the window assembly failure, several shutters unlatched during the hurricane. The shutters were hinged to allow them to be opened to clean the windows (Figure 5-19).

Red circles indicate the latching mechanism.

This damage likely occurred when the shutter unlatched during the storm.

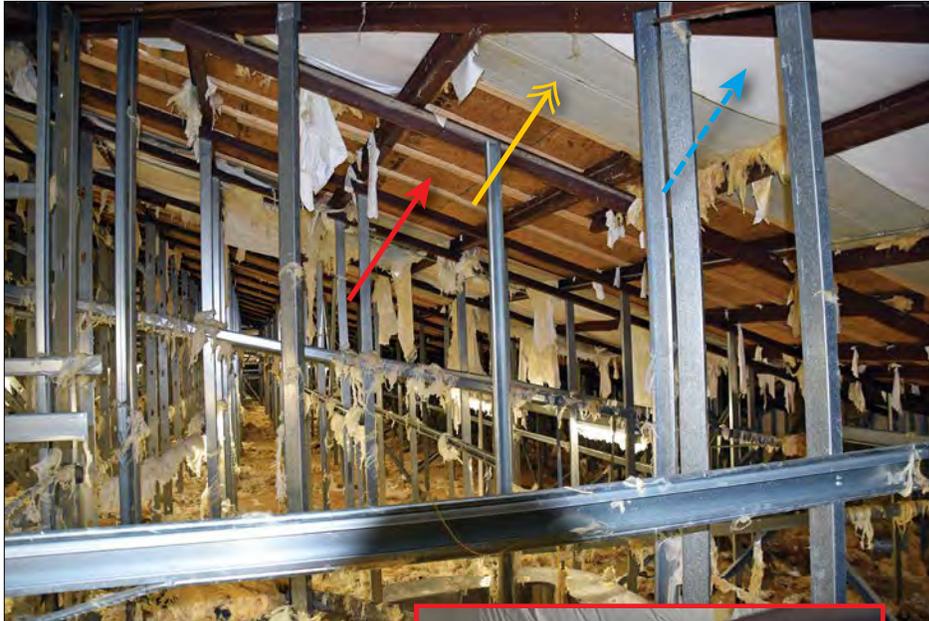
Figure 5-21: East elevation of the main building (Panama City, FL)

- There was widespread significant roof covering damage (see Figure 5-17). Several of the steep-slope conversion roof panels blew off the east side of the main building (Figure 5-21). Figure 5-22 is a view of the attic space below the area where the roof panels were blown off. Metal framing was installed over the previous low-slope roof, and the old roof

The black area (red arrows) is where emergency roof repairs were made. The yellow double arrow indicates a tarped area. The yellow outlined area indicates where stucco blew off.

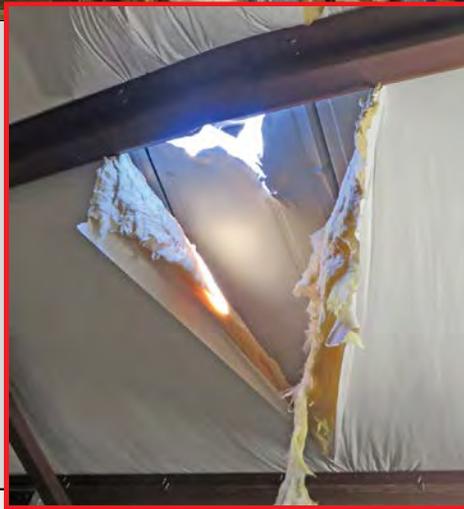
Figure 5-22: Attic space below the damaged area shown in Figure 5-21 (Panama City, FL)

The red arrow indicates OSB and 2x4s that were installed over the purlins to provide a substrate for the emergency roof covering. The yellow double arrow indicates metal panels. The blue dashed arrow indicates a vapor retarder that was underneath fiberglass insulation. Wet fiberglass insulation was hanging from the framing and lying on the old roof. The inset shows a hole through a roof panel; the roof was still taking on rainwater 92 days after the storm.

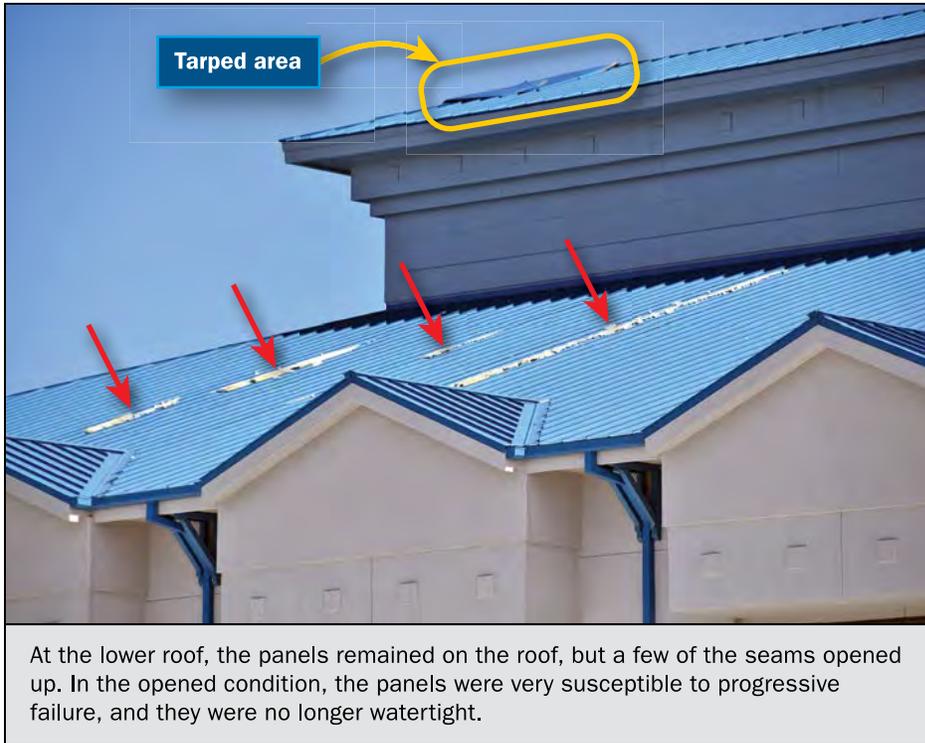
Figure 5-23: Open roof panel seams (red arrows) (Panama City, FL)

membrane served as a secondary membrane after the panels blew off. Some water leaked into the second floor, but much of the rain was intercepted by the old roof. The MAT observed a few other buildings that experienced blow-offs of structural standing seam metal roofs that were attached to framing. Figure 5-23 shows a portion of the west elevation of the main building where roof panel seams opened up.

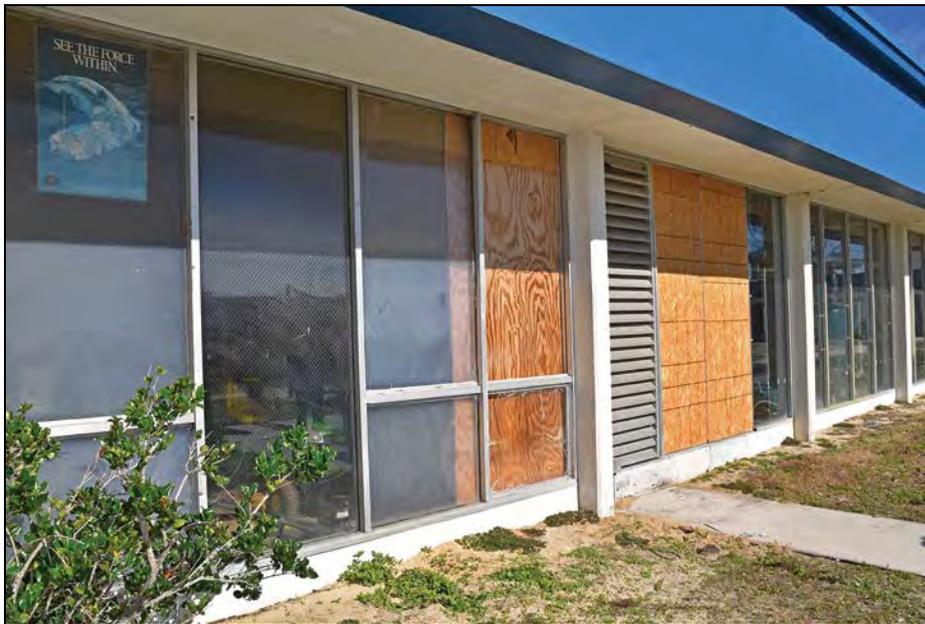
Figure 5-24: Broken unprotected glazing (Panama City, FL)

- Rooftop equipment (including the lightning protection system [LPS] conductors) was blown off at areas where the roof membrane was not damaged.
- Gutters, downspouts, and exterior wall coverings were damaged.
- It was reported that wind-driven rain infiltrated about 25 windows that were protected by shutters (see textbox). Most of the leakage occurred at operable windows, but some fixed glazing units also leaked.
- Glazing was damaged where not retrofitted with shutters (Figure 5-24).
- Wind-driven water entered the main building at the main entry doors.

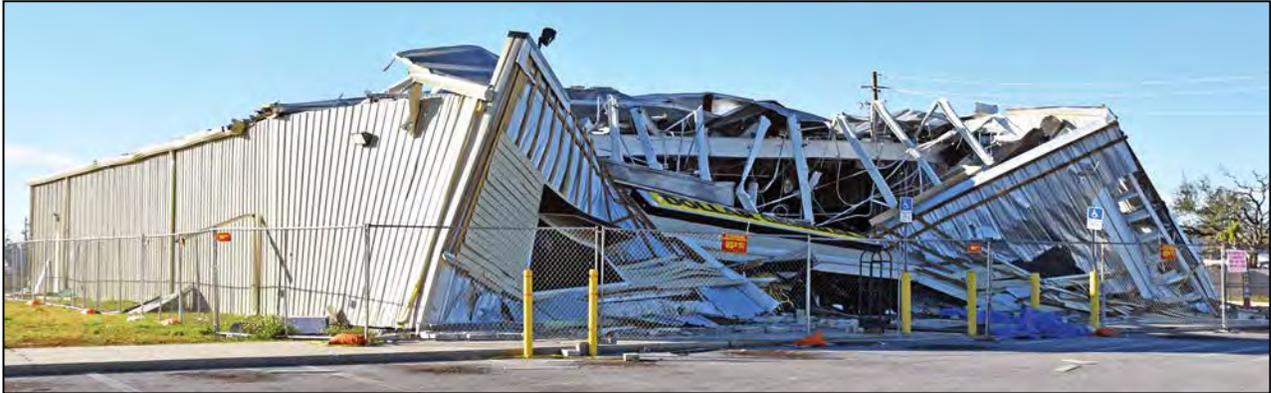
Wind Damage Observations. The MAT visited the Dollar General building on January 7, 2019 (91 days after hurricane landfall) (see Figure 5-25). The building experienced a partial collapse. The failure was predominantly in the first windward bay. The end wall main frame collapsed, and the purlins in the first bay buckled, which resulted in roof panel blow-off. This type of metal panel roof system does not provide any significant resistance to lateral loads (i.e., it is not a diaphragm).

Figure 5-25: North end wall and the east side wall of the Dollar General building (Panama City, FL)

This structural failure is noteworthy because the basic wind speed and exposure parameters given in the contract drawings are more conservative than the criteria given in the 2016 edition of ASCE 7. It is apparent that the collapse was due to a significant MBS design or installation error. Without the drawings for the MBS, the MAT was unable to evaluate the adequacy of the design. A glass storefront system was in the wall that collapsed. A security fence prohibited the MAT from getting close enough to the storefront to determine whether it failed before or after the main frame began to fail. If the storefront failed first, partially enclosed conditions would have occurred, which would have resulted in increased pressures on the MWFRS. However, such a load increase should not have resulted in failure of a properly designed and constructed MBS because of the load factor, especially considering the conservative basic wind speed and exposure that was specified on the contract drawings.

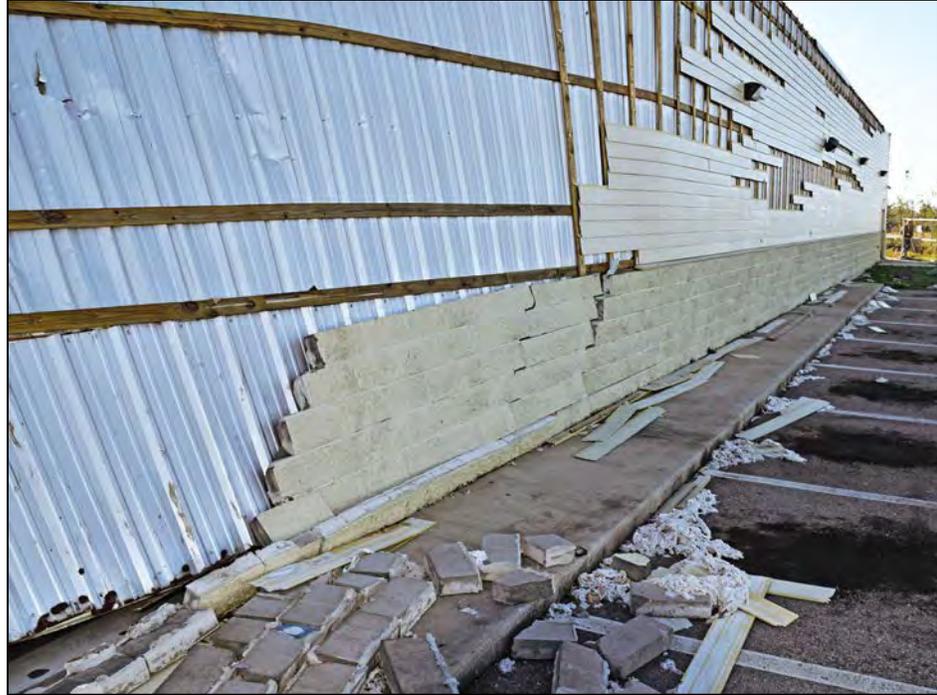
Much of the fiber cement siding blew off (Figure 5-26 and Figure 5-27). The siding was inadequately attached; however, blow-off was likely initiated by the frame collapse. A portion of the masonry veneer collapsed, likely also initiated by the frame collapse. Most of the fasteners that attached the masonry ties to the building pulled out of the masonry.

Figure 5-26: Siding and masonry veneer failure of the Dollar General building (Panama City, FL)

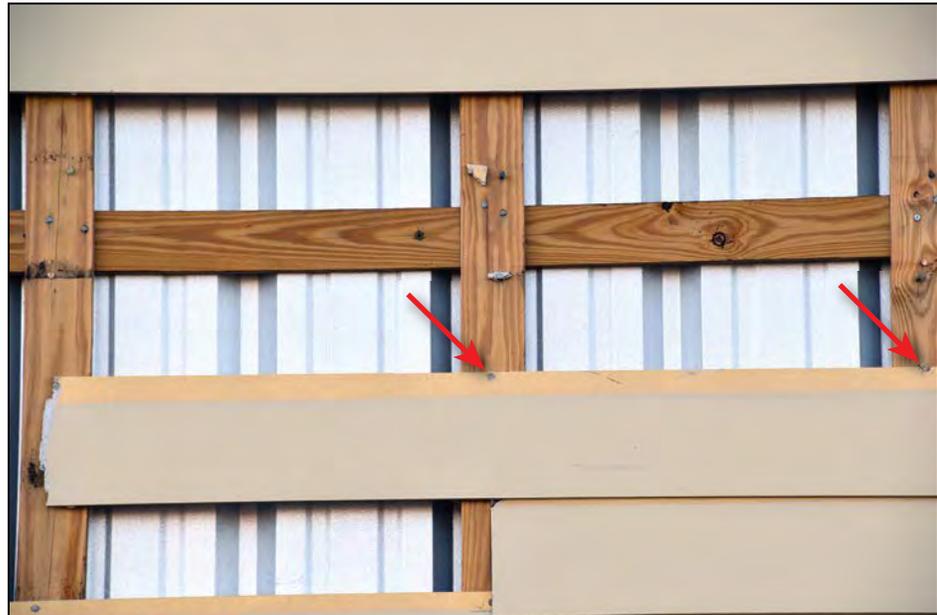
Figure 5-27: Close-up of the siding attachment for the Dollar General building (Panama City, FL)

The siding was blind nailed at 24 inches on center; several nails were too close to the edge of the siding (red arrows). Fact Sheet 5.3, *Siding Installation in High-Wind Regions* (in FEMA P-499, 2010) recommends face nailing instead of blind nailing where the allowable stress design wind speed is 100 mph or greater (this equates to an ultimate speed of 126 mph).

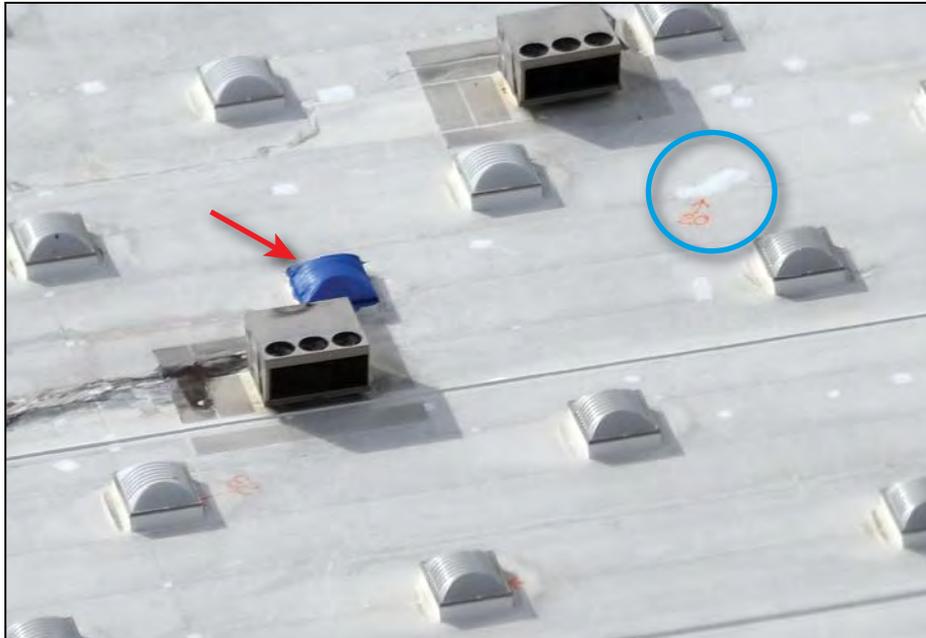
Figure 5-29: Close-up of the single-ply membrane roof of the shopping center shown in Figure 5-28 (Panama City, FL)

The blue area is a tarped skylight (red arrow). Repairs appear to have been made to roof membrane punctures (circled in blue).

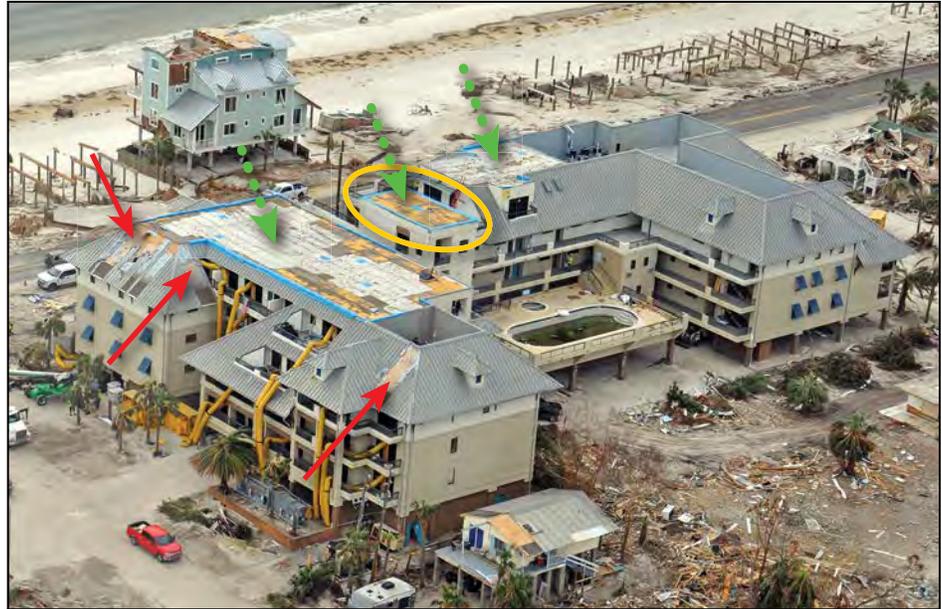
At one of the low-slope roofs shown in Figure 5-30, the primary failure plane was separation of the facer from the polyisocyanurate roof insulation as a result of roof membrane lifting and peeling. The coping all around this roof area was blown off; failure of the coping likely initiated the membrane blow-off.

Figure 5-30:
Condominium roof
covering damage
(Mexico Beach, FL)

The red arrows indicate exposed roof sheathing, where the synthetic underlayment and architectural metal roof panels blew off. The panels were attached with concealed clips. The green dotted arrows indicate where the adhered single-ply membrane blew off. The yellow oval indicates the area where the primary failure plane was the separation of the facer from the polyisocyanurate roof insulation as a result of roof membrane lifting and peeling. The coping all around this roof area was blown off; this failure likely initiated the membrane blow-off.

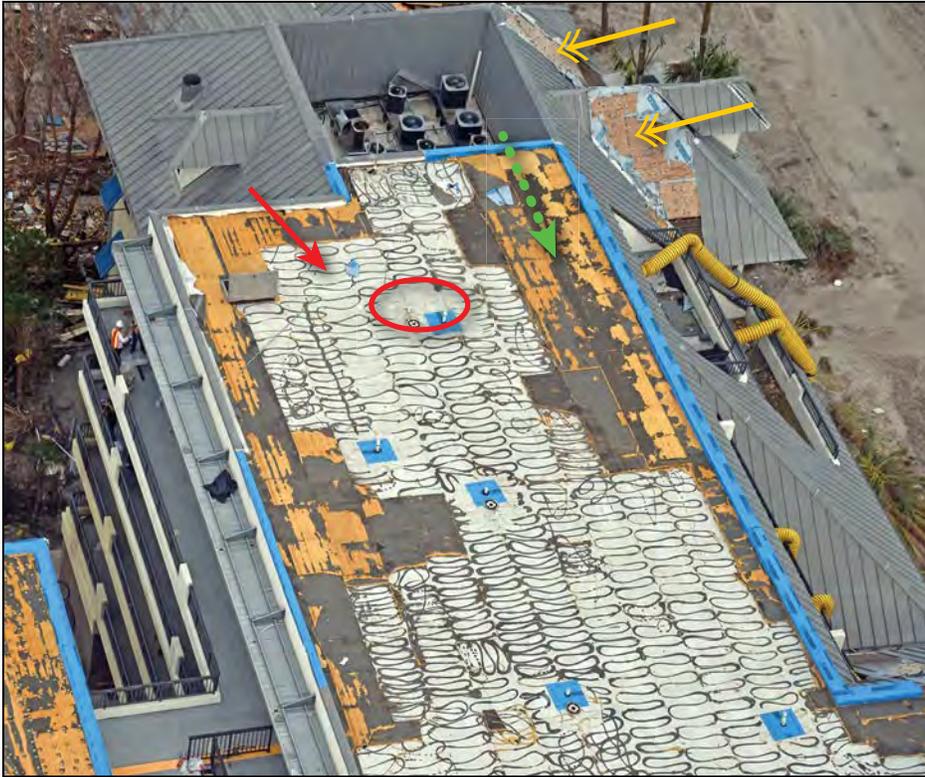
At the other two low-slope roofs, the primary failure plane was between the foam ribbon adhesive and the top insulation board (Figure 5-31). While the copings also blew off of these areas, the roof membrane failures were likely initiated by lifting of the top insulation board because of inadequate adhesion.

Figure 5-31: Close-up of the largest low-slope roof shown in Figure 5-30 (Mexico Beach, FL)

The black serpentine lines (red arrow) indicate the foam ribbon adhesive. The ribbons at the perimeter uplift zone are too far apart. The red circled area is where the adhesive had a poor bond to its substrate. The green dotted arrow indicates top insulation boards that remained attached to the adhesive. The blue material around the edges of the roof is emergency protection where the coping blew off. The yellow double arrows indicate exposed roof sheathing where the underlayment and metal panels blew off.

Discussion. Foam ribbon adhesive has been the predominant method to adhere insulation boards for several years. It can be an effective attachment method, but damage investigations by others have shown inadequate adhesion in many cases. Attachment problems can be related to adhesive material deficiencies; however, application deficiencies are typically the root cause of inadequate adhesion. To ensure adequate adhesion is achieved, test cuts must be taken or field uplift testing must be performed.

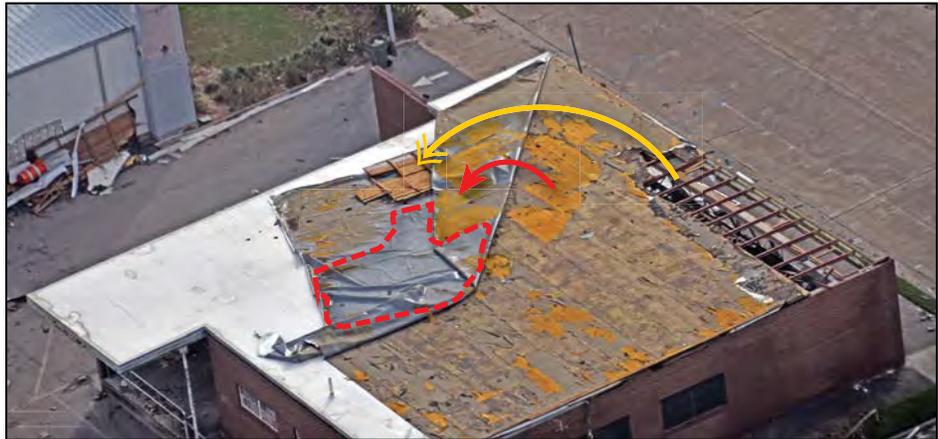
Wind Damage Observations. The Bay County Tax Collector’s office, an example of an older commercial building, experienced significant interior water damage due to roof membrane blow-off. The building had been reroofed with an adhered single-ply membrane over polyisocyanurate roof insulation that was mechanically attached to a wood plank deck. The failure was initiated by lifting of the roof deck. Figure 5-32 shows the roof of the building 12 days after hurricane landfall.

Figure 5-32: Roof damage initiated by lifting of the roof deck at the Bay County Tax Collector office building (Lynn Haven, FL)

The yellow arrow indicates the blown-off roof deck. The red arrow indicates where the membrane was well adhered to the insulation facer (the facer separated from the insulation). The grey area in the vicinity of the red dashed outline is the underside of the roof membrane; the membrane was superficially adhered in this area.

Discussion. This blow-off demonstrates the importance of evaluating the adequacy of roof deck attachment as part of a reroofing project. Portions of the roof membrane were poorly adhered; this failure highlights the importance of quality control and quality assurance during roof system application.

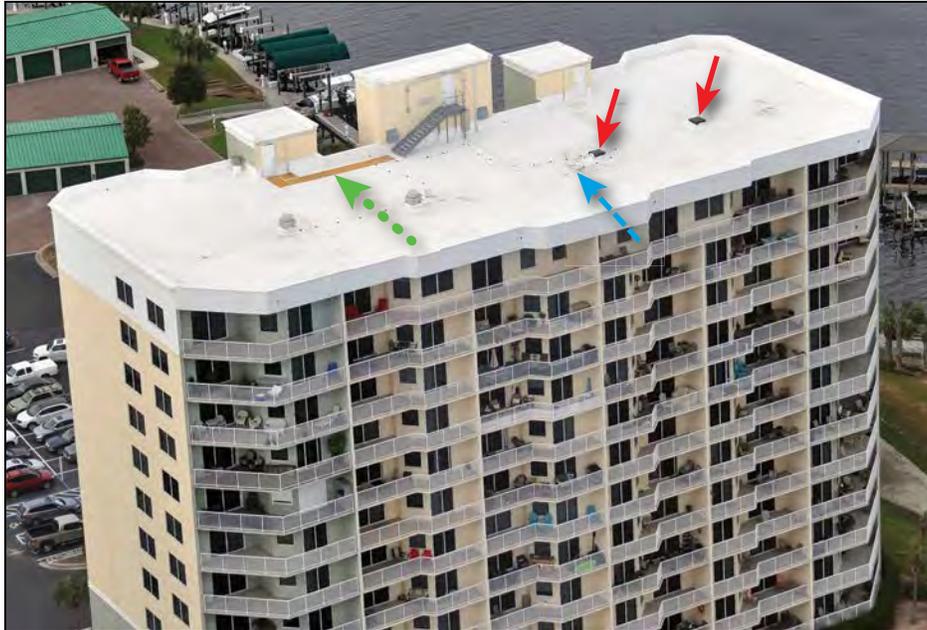
Wind Damage Observations. Condominium No. 2, constructed in 2005, experienced damage to rooftop equipment when two of the four exhaust fans blew off their curbs, causing the LPS conductor to detach from the roof membrane. However, there was no apparent roof membrane damage, though the roof membrane may have been punctured by the detached LPS. Figure 5-33 shows the condominium 12 days after hurricane landfall.

Figure 5-33:
Successful wind uplift
resistance of a single-
ply membrane for a
condominium building
(Panama City, FL)

Two rooftop exhaust fans blew off (red arrows). The blue dashed arrow indicates a detached LPS conductor. The green dotted arrow indicates walkway pads. Pads are often blown off, but these pads stayed in place. An adjacent twin building did not have any apparent wind damage.

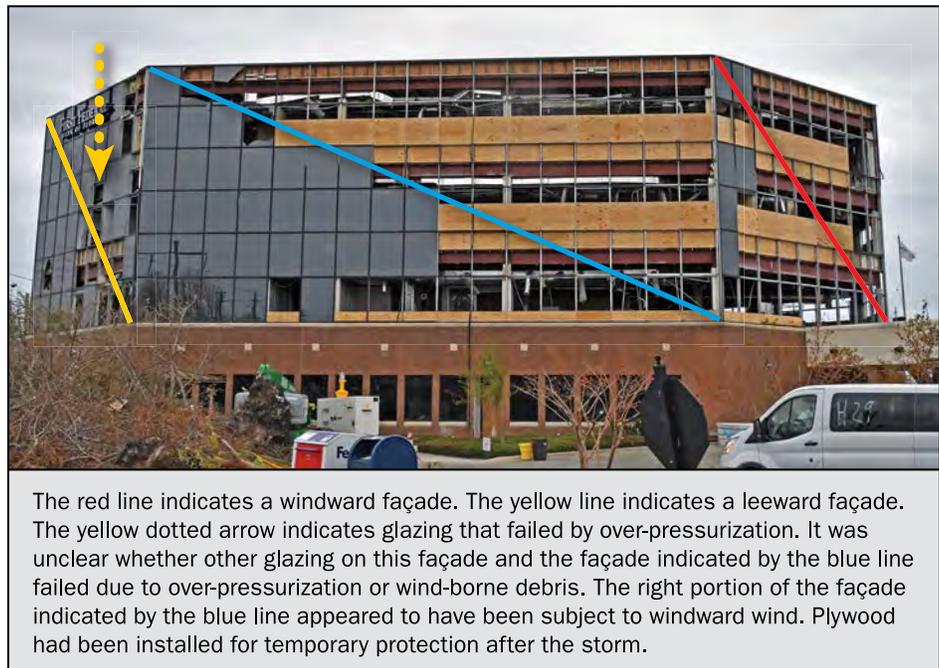
Wind Damage Observations. This bank building, constructed in 1989, has eight sides, five of which were exposed to windward winds. Figure 5-34 is a view of a bank shortly after the hurricane. The building did not have protected glazing. Most of the windows and spandrel glazing were broken on the windward facades (Figure 5-35). Based on MAT observations, the damage was judged to have been primarily initiated by wind-borne debris from nearby residential buildings.

Figure 5-35: Broken glazing on the bank shown in Figure 5-34 (photograph taken 15 days after hurricane landfall) (Panama City, FL)

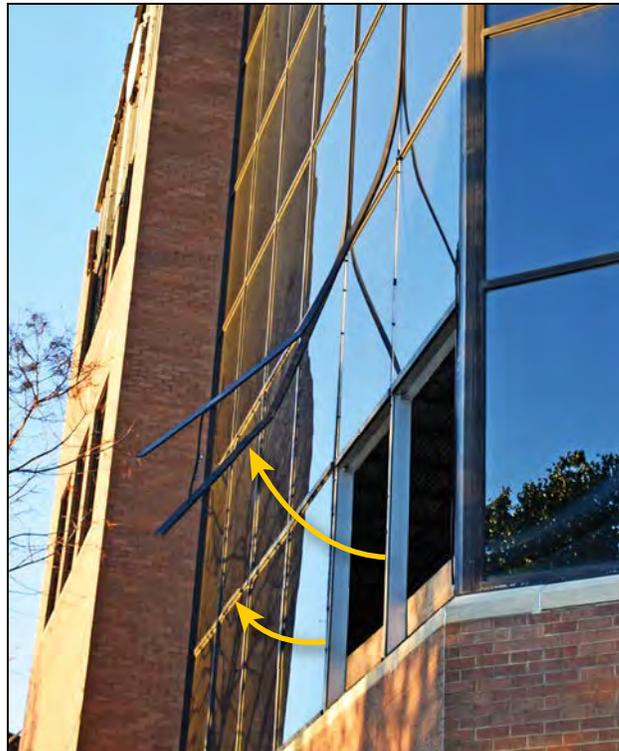
Some glazing was also broken on the leeward sides of the building (Figure 5-35 and Figure 5-36). Some of the leeward damage was caused by air pressure that exceeded the resistance of the window assembly. Other leeward damage appeared to have been caused by wind-borne debris striking the interior side of the glazing after the windward glazing was breached.

The yellow arrows indicate pressure plates that detached from the mullions, thereby allowing the glazing to blow away.

Figure 5-36: Two windows on a leeward facade of the bank shown in Figure 5-34 that failed due to over-pressurization (photograph taken 93 days after hurricane landfall) (Panama City, FL)

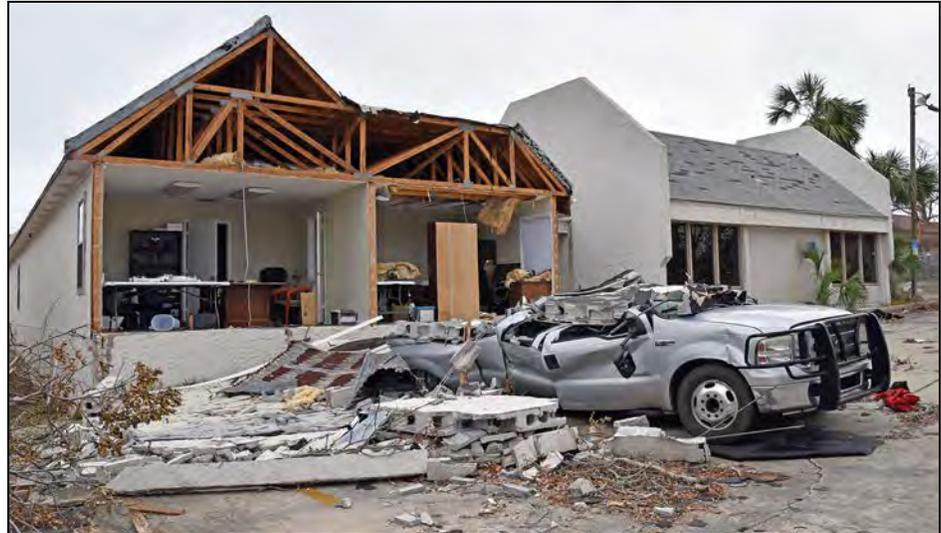
Wind Damage Observations. The office shown in Figure 5-37 had stucco-surfaced, unreinforced CMU exterior walls that collapsed during Hurricane Michael. Figure 5-37 was taken 15 days after hurricane landfall.

Figure 5-37: Collapsed unreinforced CMU walls at an office building (Panama City, FL)

An unreinforced CMU wall toppled into the parking area. Previous MATs have observed unreinforced CMU walls that have fallen inward.

Discussion. Exposed CMU and stucco-surfaced CMU walls may be perceived as having high wind resistance. However, when unreinforced, this type of wall can topple and present a significant life-safety risk. For buildings that will be occupied during a hurricane, it is important to predetermine if there are unreinforced walls that could topple onto occupants or if toppled walls could result in roof collapse in occupied areas. If either condition exists, the vulnerability should be mitigated, or the area should not be occupied during a hurricane.

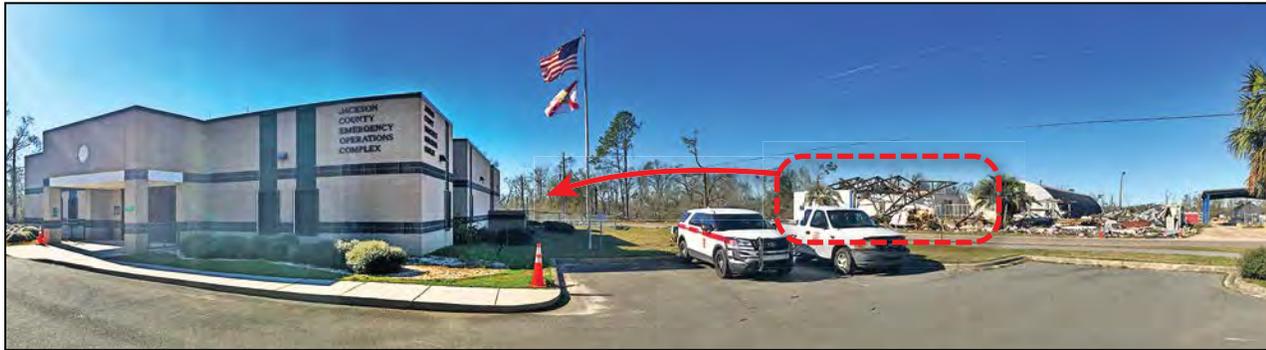
The red arrow indicates the debris flight path.

Figure 5-42: The EOC (left) and the building that generated the wind-borne debris (red dotted outline) (Marianna, FL)

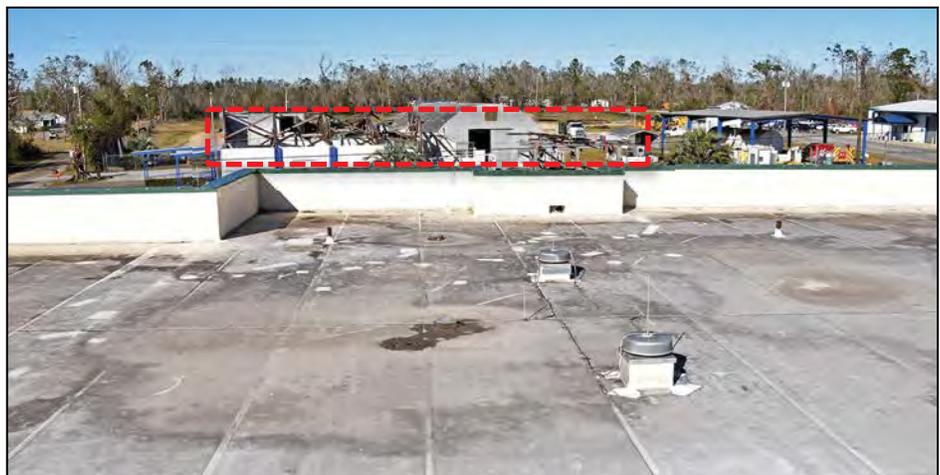
Debris also punctured the single-ply membrane in several locations resulting in minor interior water leakage. Apparently, the roof system had a secondary membrane (which is recommended in FEMA 543), or the roof deck acted as secondary membrane. Water leakage also occurred at windows. The MAT was unable to obtain the contract documents, specifications, and submittals needed to evaluate the building's wind and wind-driven rain resistance.

Figure 5-44: Jackson County EOC roof (Marianna, FL)

The bright white spots are patches that were made where the roof membrane was punctured by wind-borne debris. The red dashed outline indicates the building that shed the debris.

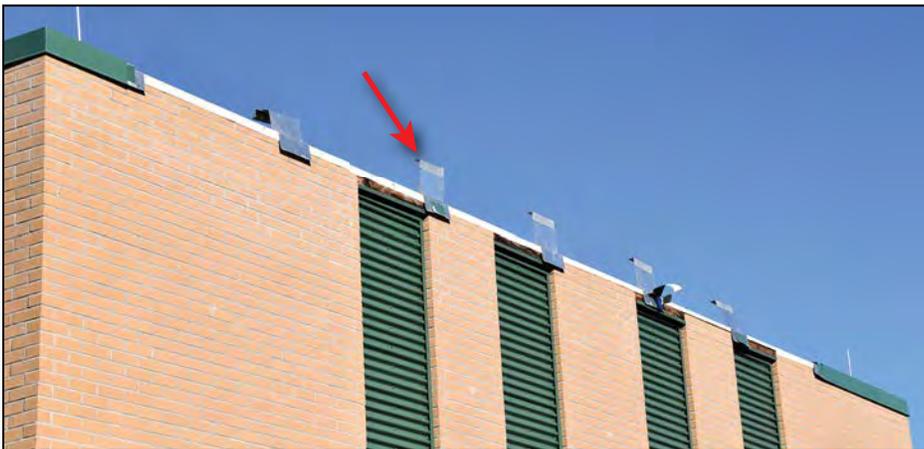
The coping blew off a portion of the south parapet (see Figure 5-45 for location and Figure 5-46 for a close-up). The blow-off was caused by a significant workmanship error. Screws were not installed at the inner leg of the coping clips.

Figure 5-45: Where the coping blew off the Jackson County EOC roof (Marianna, FL)

The coping blew off because the inner legs of the coping clips (red arrow) were not attached.

Discussion/Guidance. The workmanship error illustrates the importance of diligent quality control and the need for quality assurance during roof application. It is important for coping to remain intact because coping blow-off often results in roof membrane lifting and peeling. Also, coping that becomes wind-borne debris can puncture roof membranes and cause other types of damage. A wind vulnerability assessment has the potential of detecting inadequately attached copings (such as those shown at Figure 5-45 and Figure 5-46) and edge flashings. By detecting vulnerable building components/systems, corrective action can be taken before they are damaged by a storm. Refer to FEMA P-2062, *Guidelines for Wind Vulnerability Assessments of Existing Critical Facilities* (2019c).

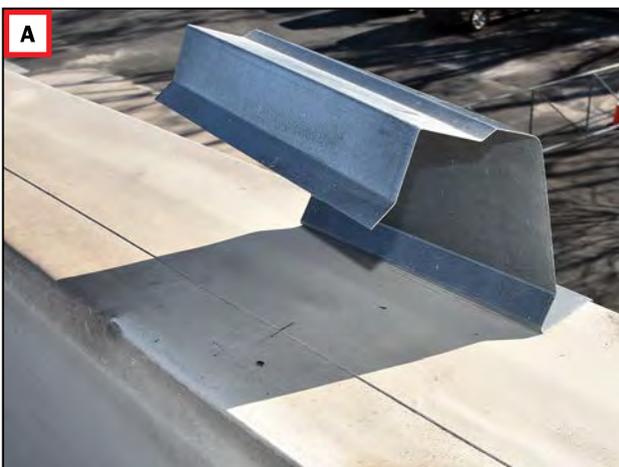
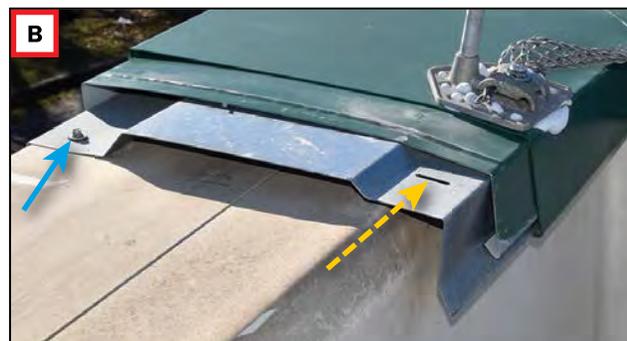
Figure 5-46: One of the lifted coping clips at the Jackson County EOC roof (Marianna, FL)

The clips were intended to be attached with four screws, two at each leg.

[A] Screws were not installed at the inner leg.
