Mitigation Assessment Team Report

Hurricane Michael in Florida

Building Performance Observations,
Recommendations, and Technical Guidance

FEMA P-2077 / February 2020

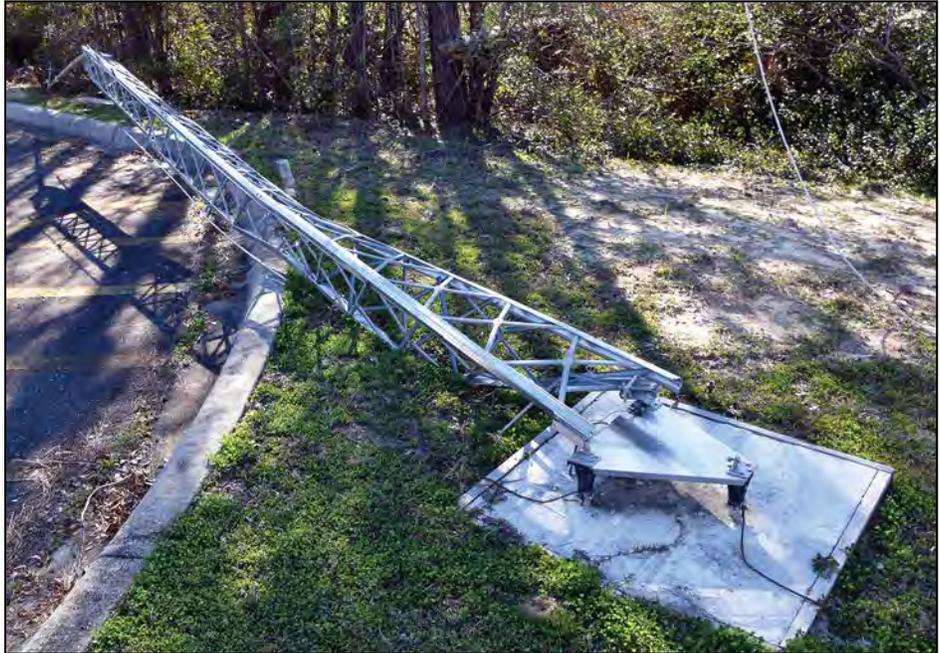
The communications antenna, which had a hinged base, was placed on the ground prior to the storm to avoid it being struck by wind-borne debris (see Figure 5-47). The antenna was damaged by a falling tree during the storm.

Figure 5-47: The lowered antenna that was struck by a falling tree (Marianna, FL)

Discussion/Guidance. To avoid tree-fall damage, FEMA 543 recommends that trees with trunks larger than 6 inches in diameter not be within laydown distance of a critical facility. Similar laydown guidance is applicable to communications towers.

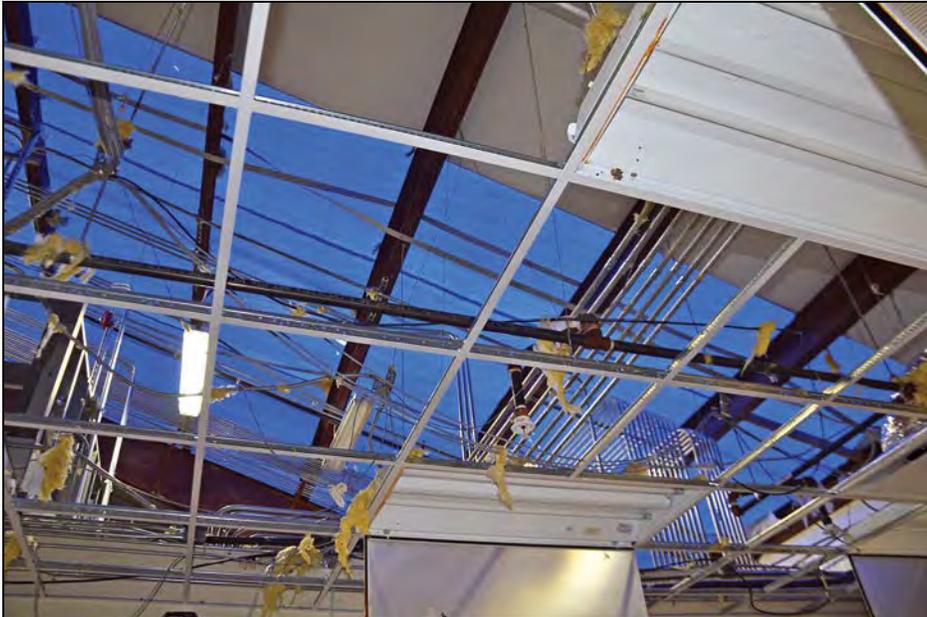
- Blown-off roof panels on Building No. 7. Negative pressure (uplift) from high winds during the storm caused roof panel to structural framing member connections to fail. With no roof deck between the roof panels and the framing members, rain and debris freely entered the building (see Figure 5-49).
- Infiltration at ridge/roof panel interface. Fiberglass insulation was visible along several of the roof ridges (see Figure 5-50). Both HESs and non-HES buildings were affected. Suction from high winds pulled the insulation from underneath the panels, indicating that ridge closures had not been sealed to the roof panels. The breach created between the ridge flashing and roof panels allowed wind-driven rain to drive past the closures and wet the insulation.

Figure 5-49: Building No. 7 area designated as a HES, and constructed to meet EHPA provisions, was damaged during Hurricane Michael; the building was not occupied during the event (Blountstown, FL)

The roof panels blew off this building, exposing would-be occupants to the elements and allowing the ceiling boards to become wetted and collapse. A blue tarp is visible placed over the damaged roof.

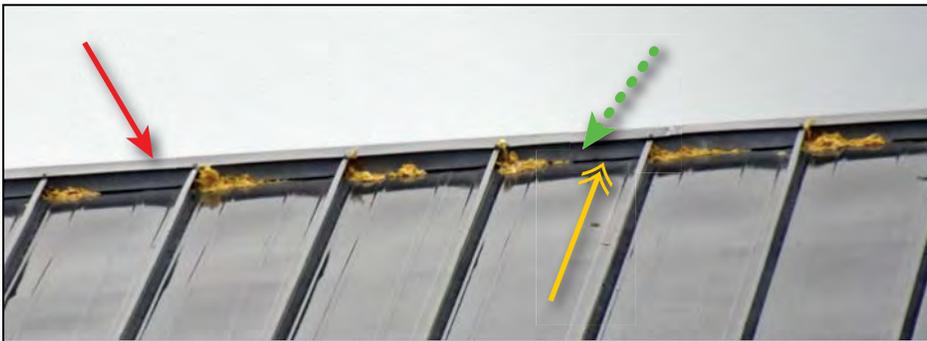
Figure 5-50: Roof of Building No. 3, while not designated as HES, similar damage was evident along ridges of HESs including Building No. 2. Pulled-out fiberglass insulation can be seen coming through the unsealed gap between the closure and metal roof panel. (Blountstown, FL)

Wind-driven rain infiltrated the building where breaches developed between the ridge flashing and roof panels. The red arrow indicates the ridge flashing. The green dotted arrow indicates a closure. The yellow double arrow indicates an unsealed gap between the closure and metal roof panel.

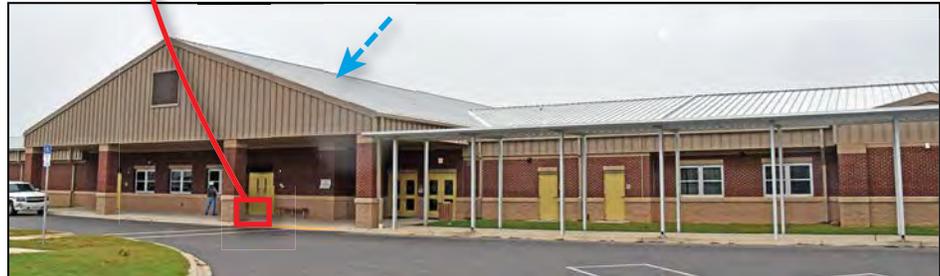
Figure 5-53: Portion of the Altha public school that was used as a shelter (Altha, FL)

amount of wind-driven rain entered at the exterior doors and some of the windows also leaked (Figure 5-53).

The blue dashed arrow indicates the dining hall and multipurpose room. The inset shows that the pair of doors had a sweep, rather than an automatic door bottom. Note the absence of an astragal (weatherstripping) at the meeting stile.

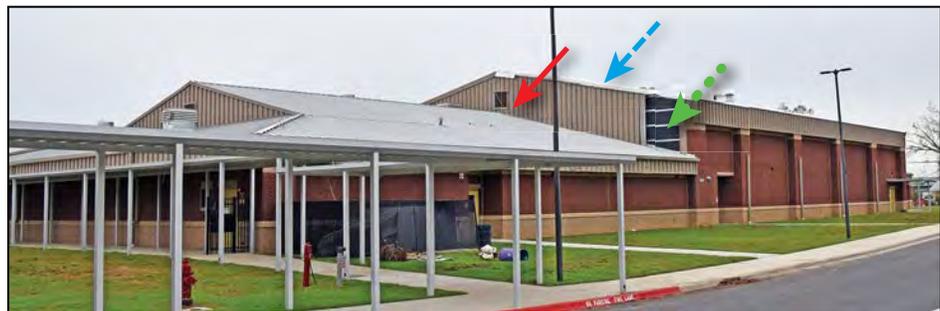
Figure 5-54: Altha Public School gym (Altha, FL)

At the gym, portions of the metal roof and wall panels, LPS conductors, and rooftop mechanical equipment were blown off (Figure 5-54), resulting in interior water intrusion.

The red arrow indicates a displaced LPS conductor. The blue dashed arrow indicates emergency roof repairs. The green dotted arrow indicates where metal wall panels blew off. The panels were attached with concealed clips, rather than the more reliable exposed fasteners.

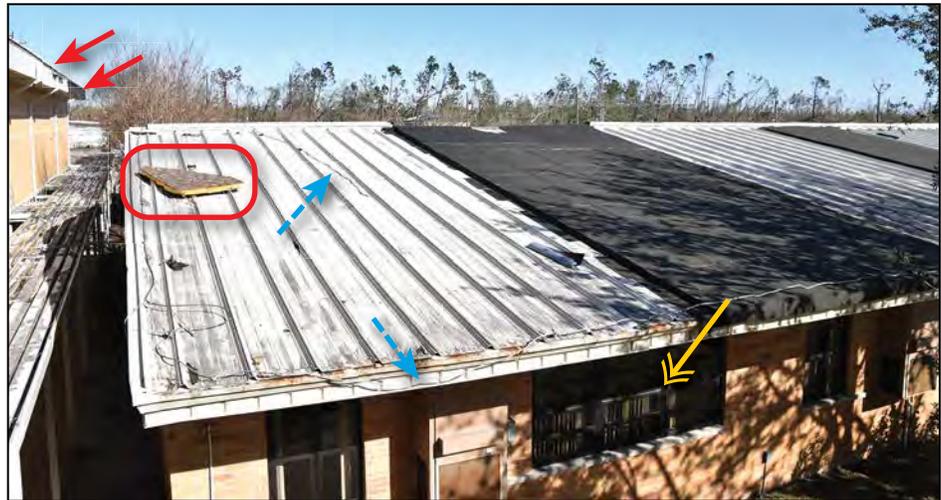
Figure 5-56: Roof damage at Building No. 4 (Panama City, FL)

the first floor areas below as shown in the textbox photograph above, which was taken immediately after the storm. Wind-borne roof deck and/or metal roof panels from this building struck Building No. 4 (Figure 5-56).

The red arrows indicate fascia and gutter damage at Building No. 2. The red outline indicates a composite roof insulation board (OSB/polyisocyanurate) that was blown from Building No. 2. The metal roof panel clips were attached to the OSB. The blue dashed arrows indicate detached LPS conductors. The black areas are emergency roof patches; some or all of the Building No. 4 roof damage was likely caused by wind-borne debris from Building No. 2. The yellow double arrow indicates the retrofitted screen shutters.

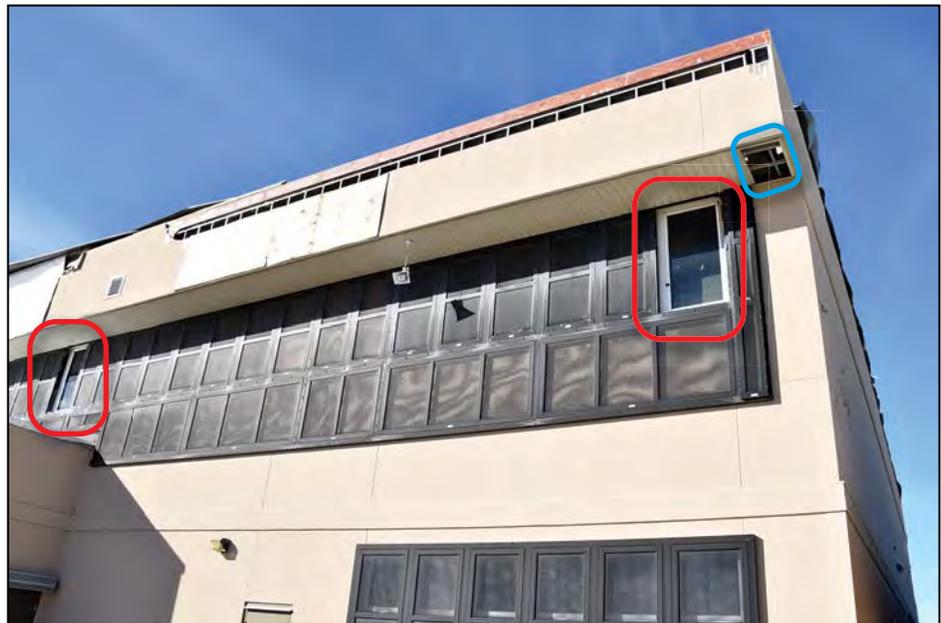
Figure 5-57: Missing soffit panel (inside blue outline) and screen shutters (inside red outlines) on floor 2 of Building No. 13 (a designated HES) (Panama City, FL)

- Building No. 13 suffered roof covering damage (Figure 5-57) that allowed a significant amount of rain to enter the building. Water reportedly reached the first floor.

Although not every shutter onsite was checked, the MAT did not observe evidence of damage by wind-borne debris on any screen shutters that were still in place. However, the MAT noted two missing screen shutters on the second floor of Building No. 13 as shown in Figure 5-57. Staff stated that the screens were in place prior to the storm; they suspect the screens were damaged during the event by building cladding (see wall section above windows in Figure 5-59) that peeled off multiple buildings and damaged campus building envelopes as shown in Figure 5-57.

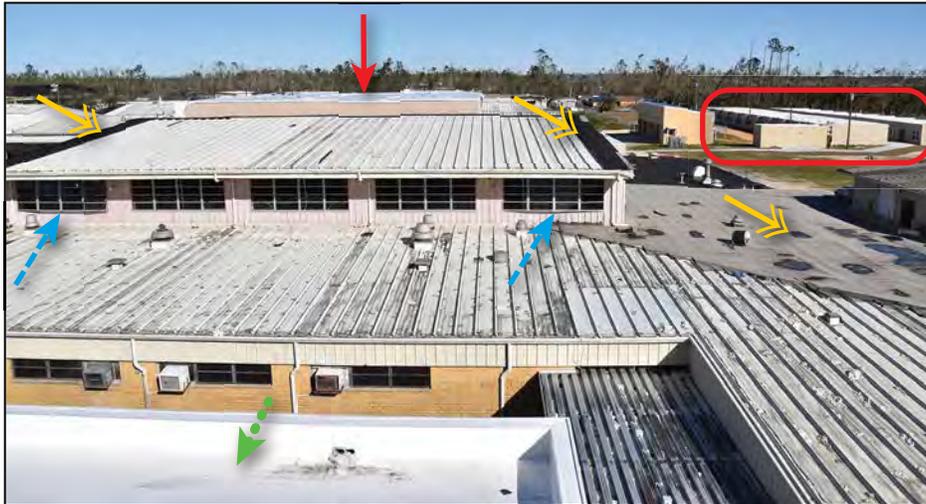
Figure 5-58: Building Nos. 13, 14, and 17 (looking north) (Panama City, FL)

Figure 5-58 is a view of a portion of the school campus showing damage at three large roof areas. Elsewhere on campus, rooftop fan cowlings and other rooftop equipment (including LPS conductors) were blown off along with gutters, soffits, fascia, and ridge flashings.

The red arrow indicates a single-ply membrane at Building No. 13; it replaced the single-ply membrane that was blown off. The yellow double arrows indicate emergency roof patches at damaged metal roof panels at Building No. 14. The blue dashed arrows indicate suction-induced window frame failures at the corner zones. The green dotted arrow indicates a new single-ply membrane on the lower roof of Building No. 17; it was part of the reroofing work that replaced the single-ply membrane that was blown off the upper roof. The red outline indicates portable classroom buildings that were brought in after the storm.

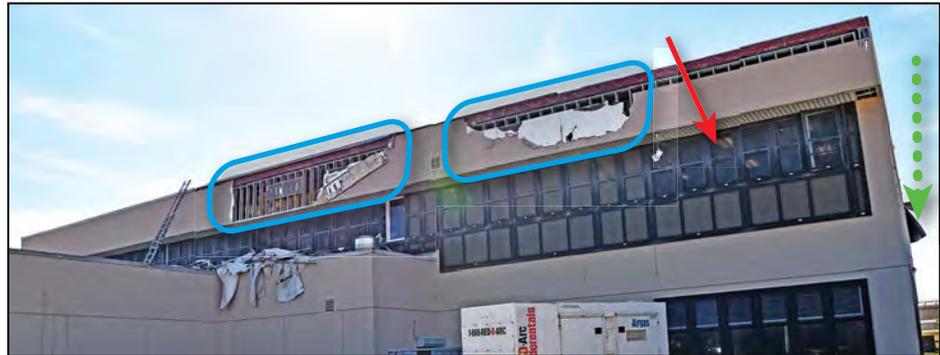
Figure 5-59:
Damage at Building
No. 13
(Panama City, FL)

The red arrow indicates the retrofitted screen shutters. The green dotted arrow indicates blown-off roof membrane. The blue outlines indicate damaged EIFS. Typically, the gypsum board detached from the studs. At the white area in the right outlined area, the synthetic stucco detached from the molded expanded polystyrene insulation.

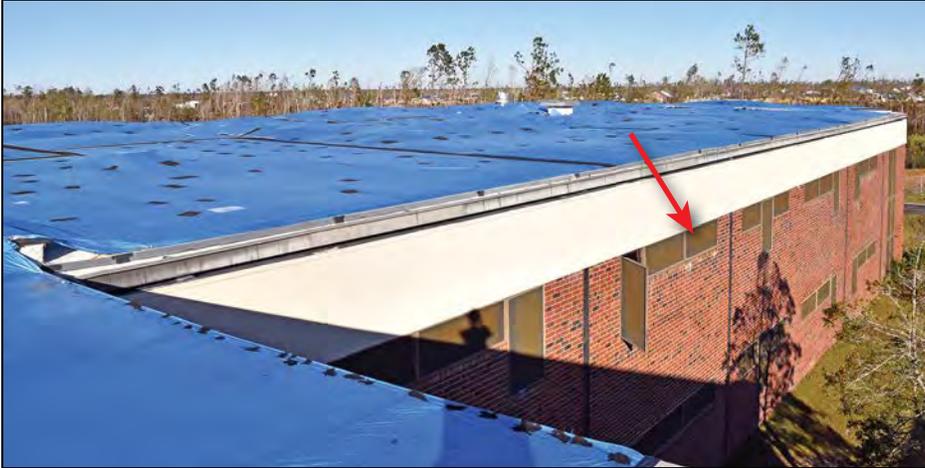
Figure 5-61: Roof and side of Building No. 4 (designated HES) (Panama City, FL)

The windows were protected by screen shutters (red arrow). The blue area is a temporary tarp.

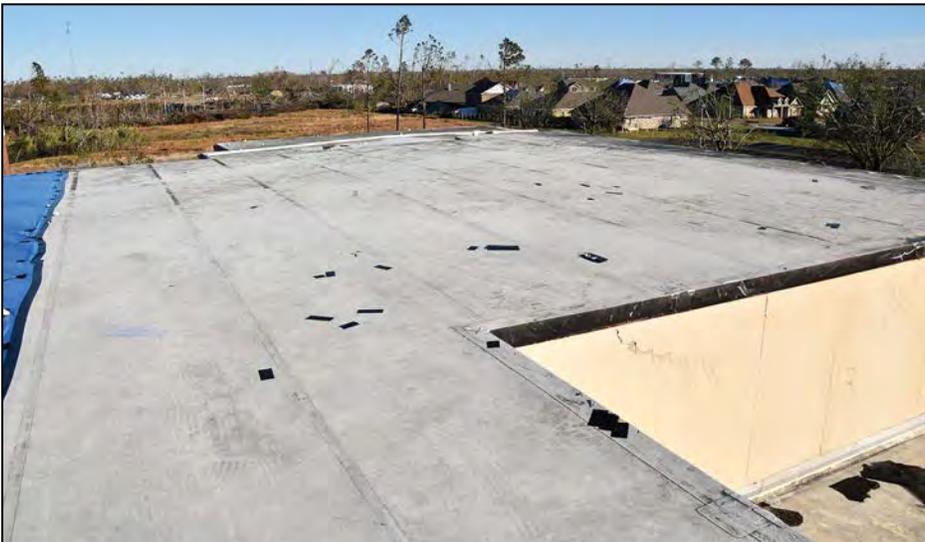
Figure 5-62: Wind-borne debris damage, looking east (Panama City, FL)

As shown in Figure 5-60, the steel roof deck blew off at least four different buildings and there was widespread roof membrane blow-off. Remaining roof membranes showed evidence of puncture by wind-borne debris (Figure 5-62). These failures resulted in extensive interior water damage (Figure 5-63). Gutters were also blown off.

The small black areas are emergency patches at roof membrane punctures. Because this membrane was mechanically attached, water could readily spread laterally until it reached an insulation board joint, where it could then migrate toward the building's interior unless intercepted by a secondary roof membrane. When the membrane is adhered, if a puncture or tear occurs somewhere other than at a board joint (which is likely), water is inhibited from migrating towards the interior.

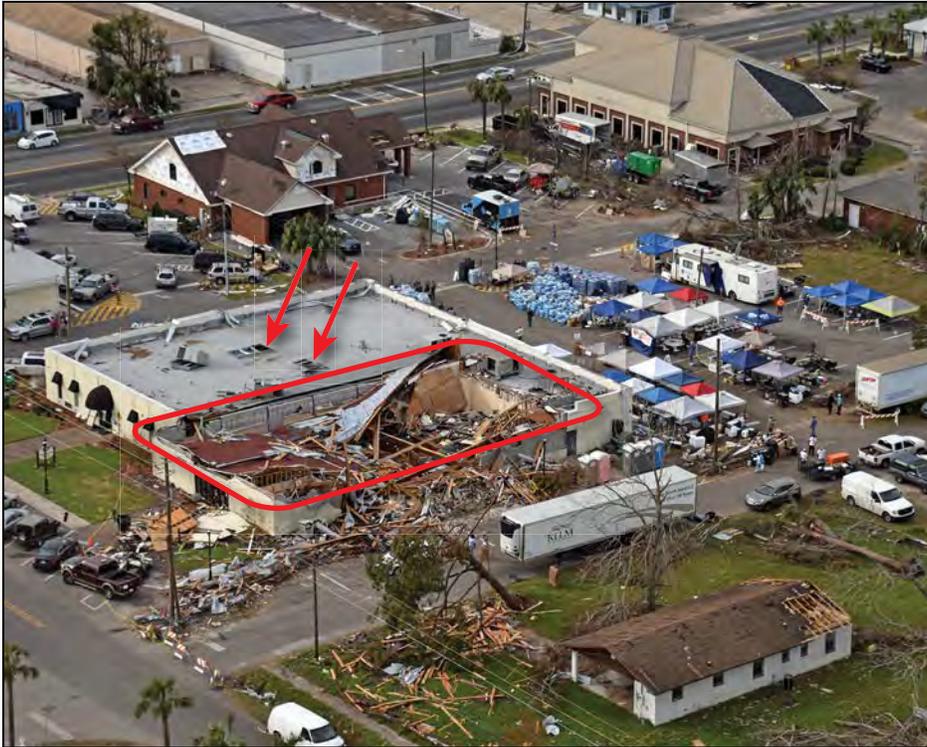
Figure 5-64: Aerial view of the Lynn Haven Police Administration building (Lynn Haven, FL)

Wind Damage Observations. The portion of the building that was an A-frame collapsed during Hurricane Michael. Prior to its collapse, HVAC units on the adjacent low-slope roof blew off and windows were broken. Figure 5-64 is an aerial view of the facility at the time of the pre-MAT on October 22, 2018 (12 days after hurricane landfall). Figure 5-65 is a close-up of the building.

The red arrows indicate where HVAC units blew off the building with the low-slope roof. The red rectangle indicates the collapsed A-frame.

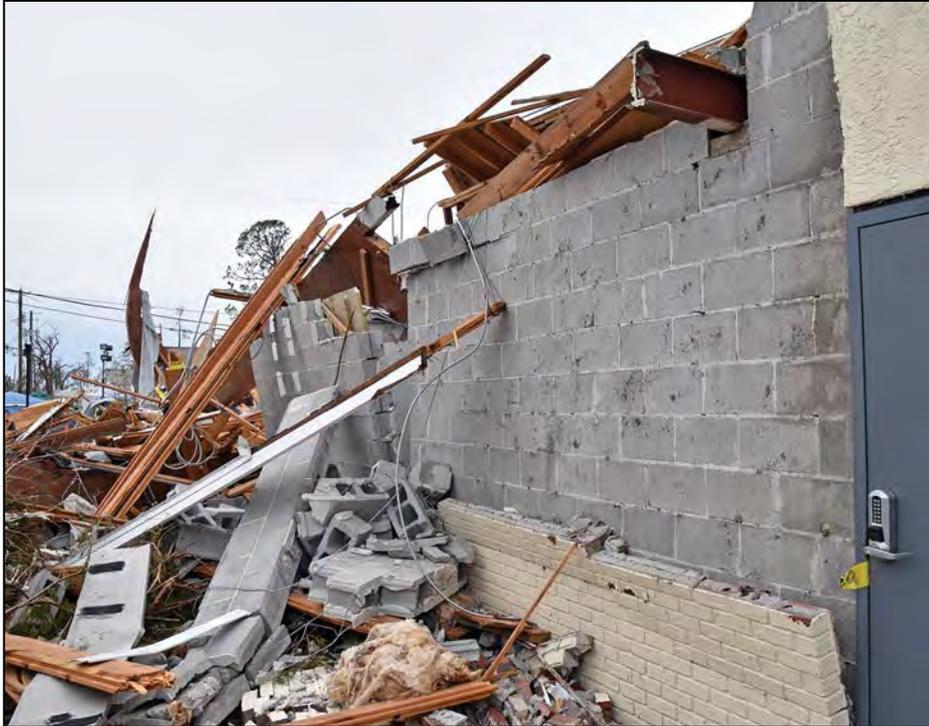
Figure 5-66: Collapsed brick veneer, CMU, and roof structure (Lynn Haven, FL)

Figure 5-66 and Figure 5-67 illustrate brick veneer attachment problems.

Discussion/Guidance. Performing a wind vulnerability assessment of brick veneer can be important at facilities where bricks could collapse on people seeking shelter during a storm. FEMA Fact Sheet 5.4, *Attachment of Brick Veneer in High-Wind Regions* (in FEMA P-499, 2010b) provides brick veneer attachment design and construction guidance.

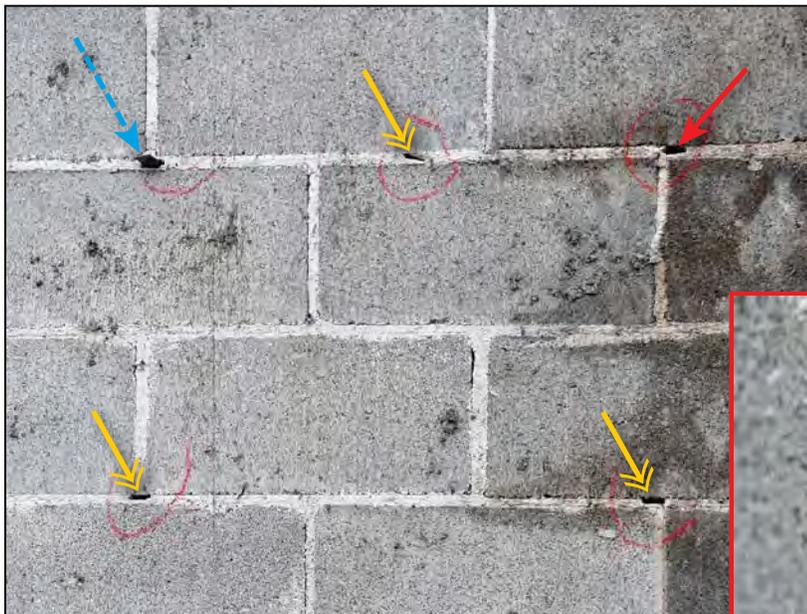
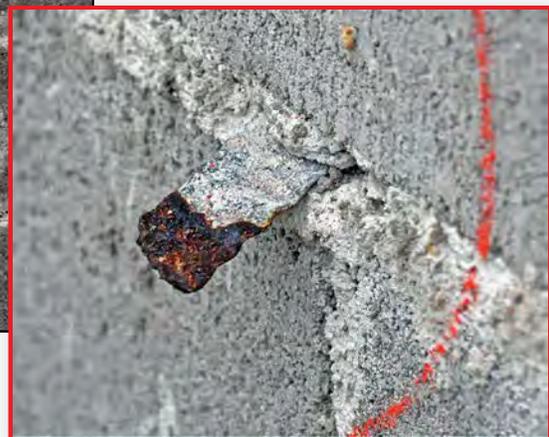
Figure 5-67: Tie deficiencies resulted in brick collapse (Lynn Haven, FL)

The inset and red arrow indicate two different ties that failed due to severe corrosion. The yellow double arrows indicate ties that pulled out of the mortar joint. The blue dashed arrow indicates a tie that failed in tension (the tie was well embedded in the CMU and brick mortar joints). Note the significant difference in tie failure modes within a small area of the wall.

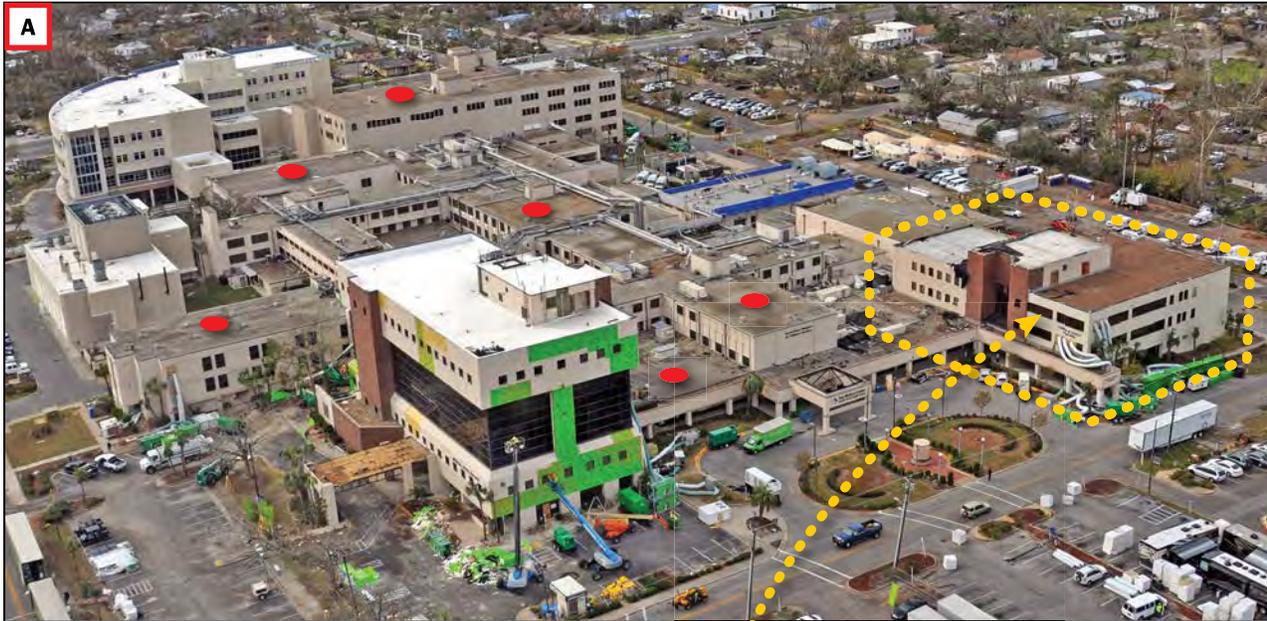
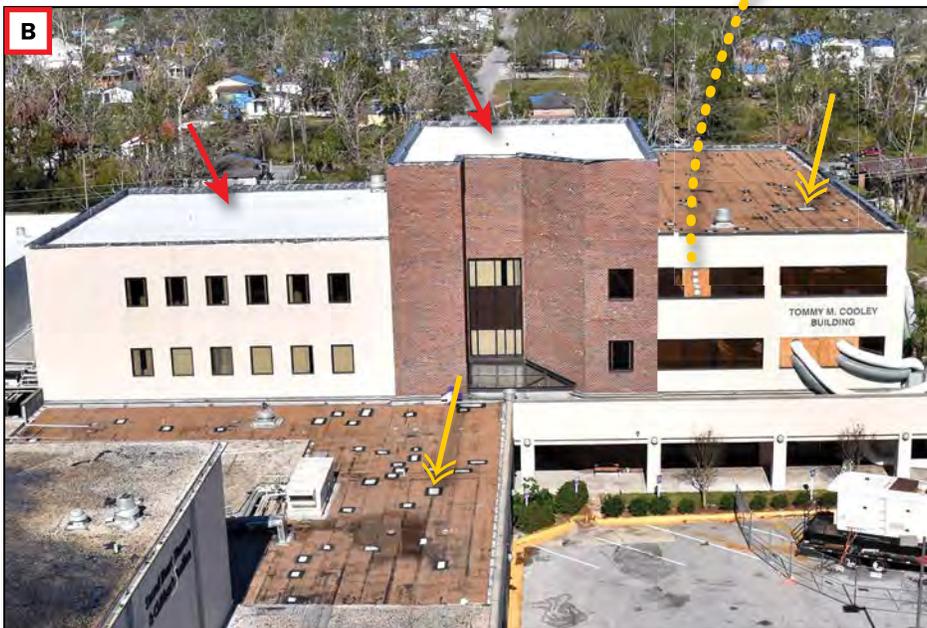
Figure 5-70: Overview of wind damage at the Bay Medical Sacred Heart campus (Panama City, FL)

[A] The red dots indicate aggregate surface built-up roofs (BURs), which were a major source of wind-borne debris. The yellow outline indicates the Administration Building No. 8, which is shown in photo B.

[B] The red arrows indicate where roof membranes blew off. The yellow double arrows point to white temporary patches where the roofs were punctured by wind-borne debris. The roof coverings that blew off and those that were patched were bituminous cap sheet membranes. The base sheet of coverings that blew off were mechanically attached to lightweight insulating concrete.

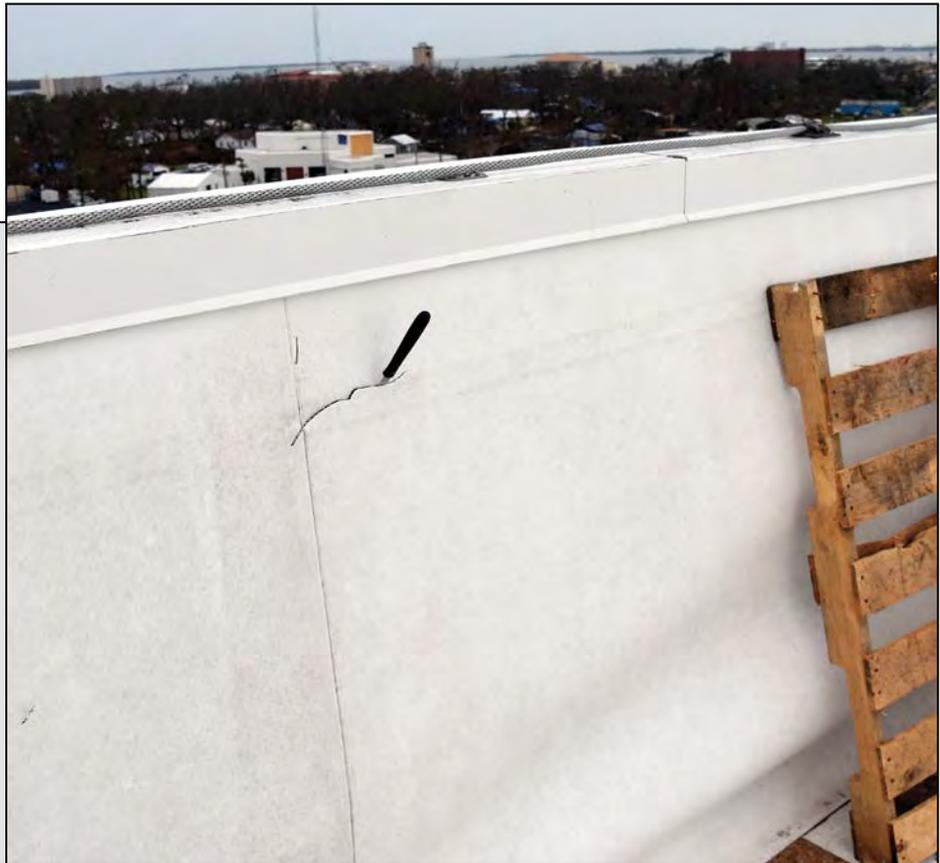
Figure 5-71: Damaged base flashing, Building No. 1, Patient Care Tower (2010) (Panama City, FL)

The base flashing blew off the parapet in the area where the roof membrane blew off. The portion of the parapet shown above was in an area where the membrane did not blow off. The base flashing had detached from the substrate. The base flashing was also torn by wind-borne debris (a putty knife is shown in the tear for scale). FEMA 577 recommends and provides design guidance for placing metal panels on furring strips over the base flashing to protect it from wind-borne debris and subsequent leakage.

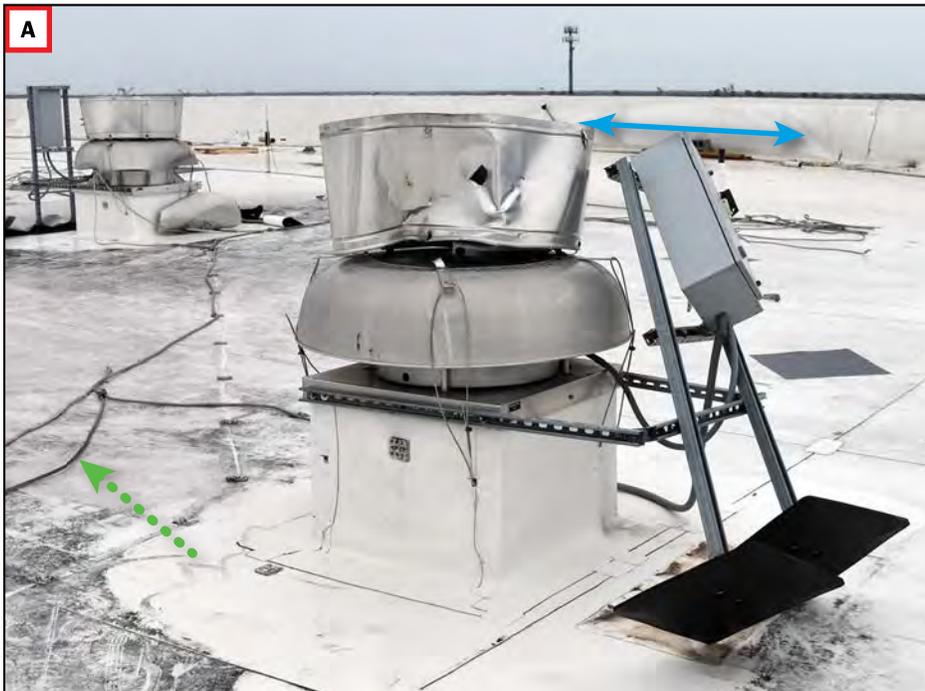
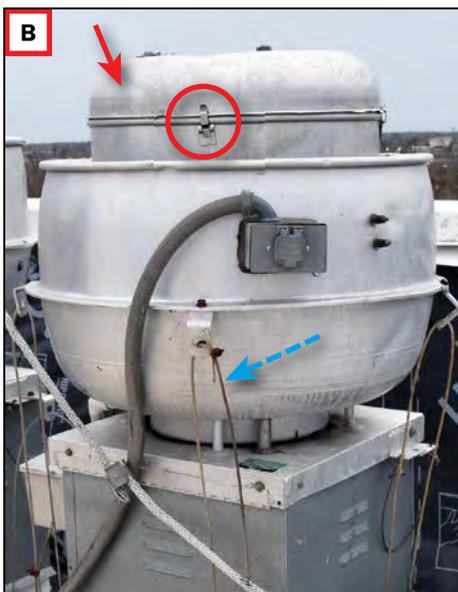
Figure 5-72: A portion of the roof that was not blown off Building No. 1, Patient Care Tower, showing damage to rooftop equipment (2010) (Panama City, FL)

[A] The fan in the foreground was struck by wind-borne debris. The top portion of the cowling on this fan and the one beyond were blown off. The top cowlings were attached to the lower portion of the cowling (see B, red circle) with a snap clip. Loss of the cowling in the foreground was likely caused by debris impact. However, loss of the cowling beyond was likely caused by the clip unlatching. The blue arrow indicates detached base flashing. The fan's disconnect switch bracket was not anchored to the roof deck. The green dotted arrow indicates a detached LPS conductor.

[B] A fan with the top cowling (red arrow) in place. The blue dashed arrow indicates a cable that anchored the outer cowling to the curb (similar to a connection shown in FEMA 577).

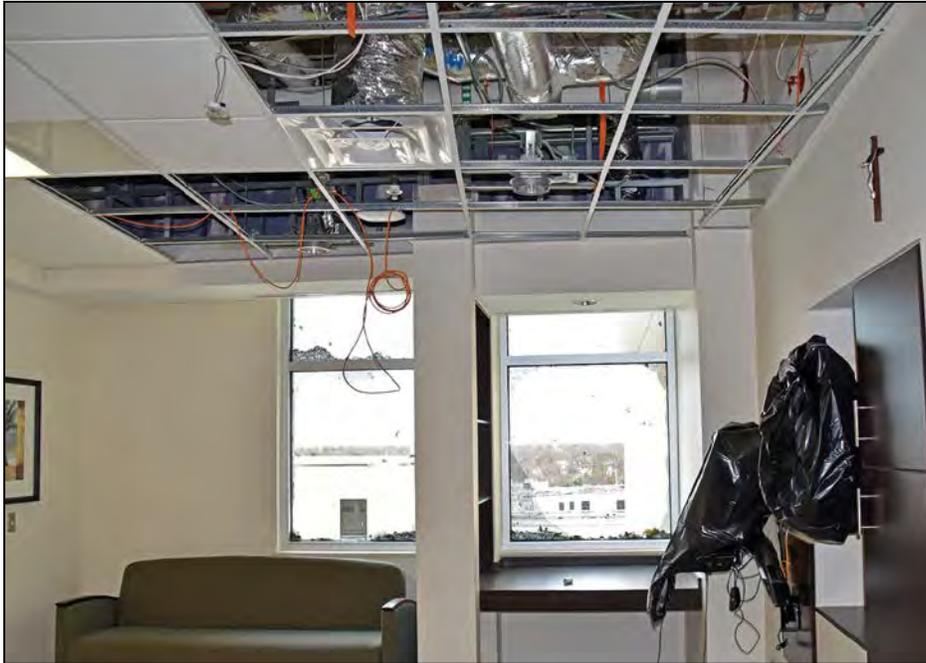
Figure 5-75: View within a fifth floor patient room in Building No. 1, Patient Care Tower (2010) (Panama City, FL)

All four of the tempered glass outer panes in this room were broken by wind-borne roof aggregate. The inner laminated glass panes were not broken; these panes prevented the entry of wind and wind-driven rain, although some window leakage was reported. Wetted ceiling boards had collapsed.

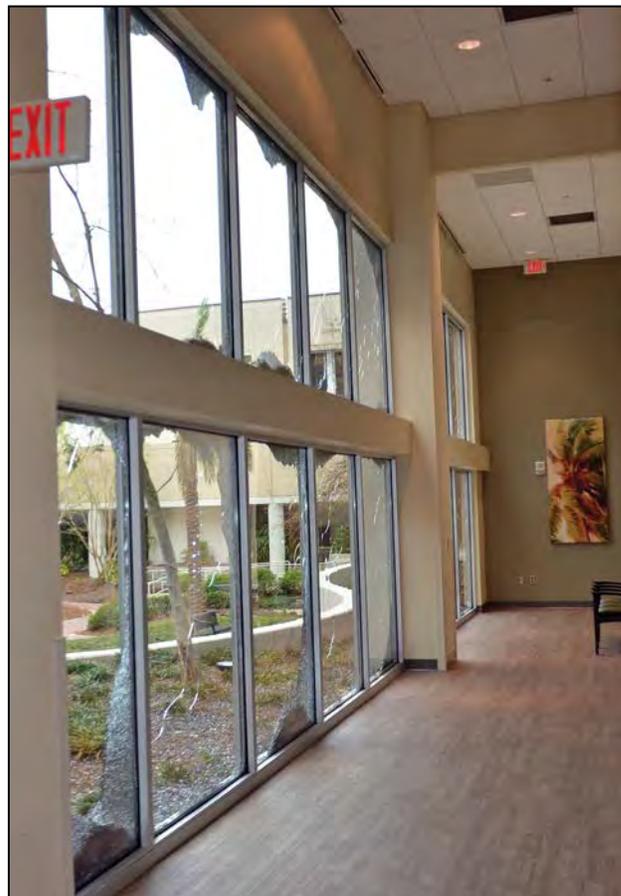
Figure 5-76: Damaged lobby widows in Building No. 1, Patient Care Tower (2010) (Panama City, FL)

All of the outer tempered glass panes shown in this figure were broken by wind-borne aggregate from one of the roofs shown in Figure 5-74. Several of the laminated glass inner panes were also broken, but the polymer interlayer prevented the entry of wind and wind-driven rain.

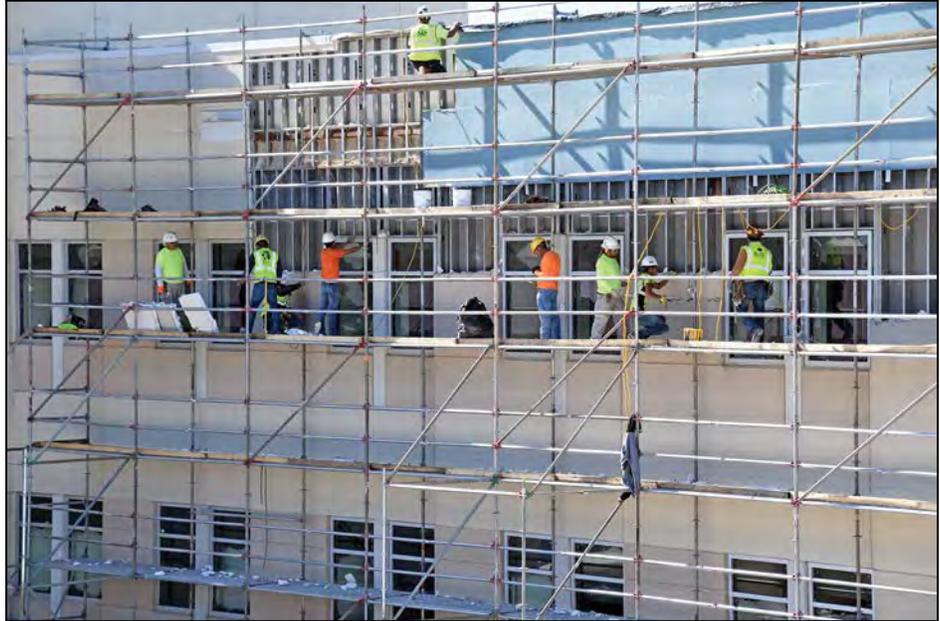
Figure 5-77: Repairing the damaged EIFS shown in Figure 5-74, Building No. 1, Patient Care Tower (2010) (Panama City, FL)

The Patient Care Tower's wall assembly consisted of synthetic stucco, rigid insulation, metal studs, and gypsum board (one layer over the exterior face of the metal studs and another layer on the inner face of the metal studs). This type of wall assembly is insufficient to resist wind-borne debris that has high momentum, and numerous wind damage investigations have documented poor wind performance. FEMA 577 does not recommend this type of wall assembly for hospitals located in hurricane-prone regions.

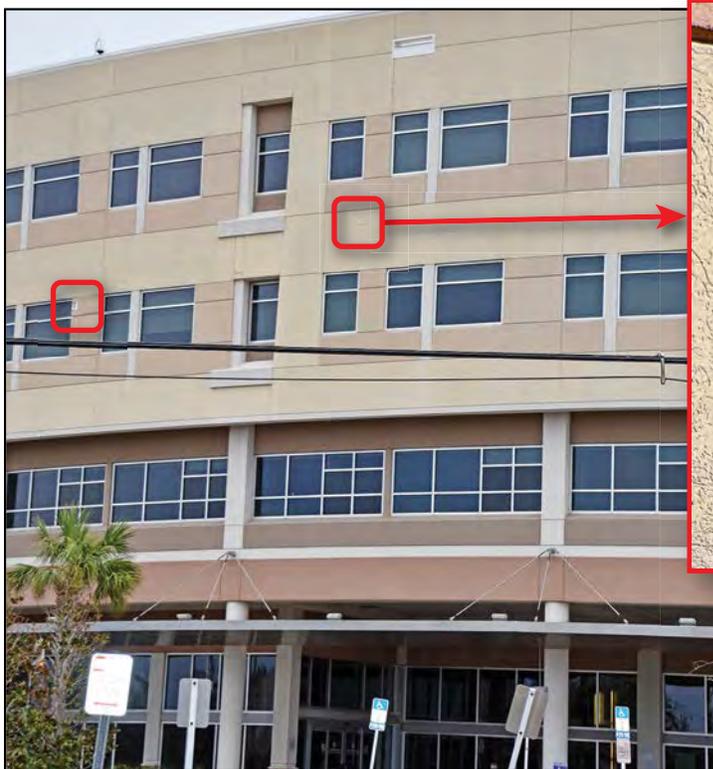
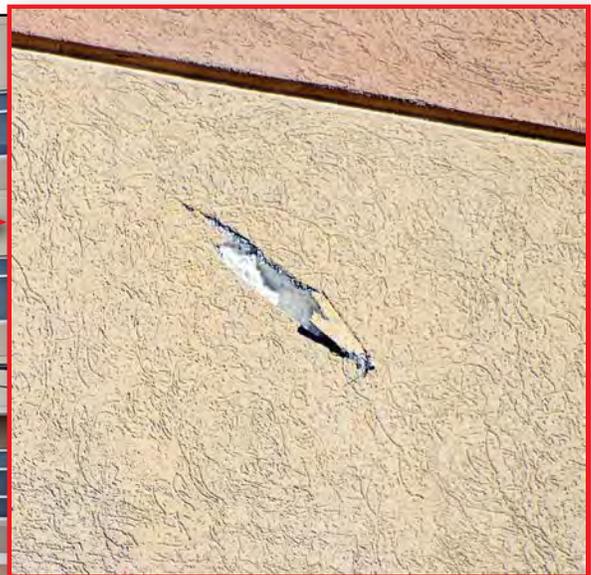
Figure 5-78: Wind-borne debris wall damage at Building No. 1, Patient Care Tower (2010) (Panama City, FL)

The red boxes indicate where wind-borne debris damaged the EIFS. These impacts were on the leeward side of the tower. They illustrate that debris can strike multiple stories above grade.

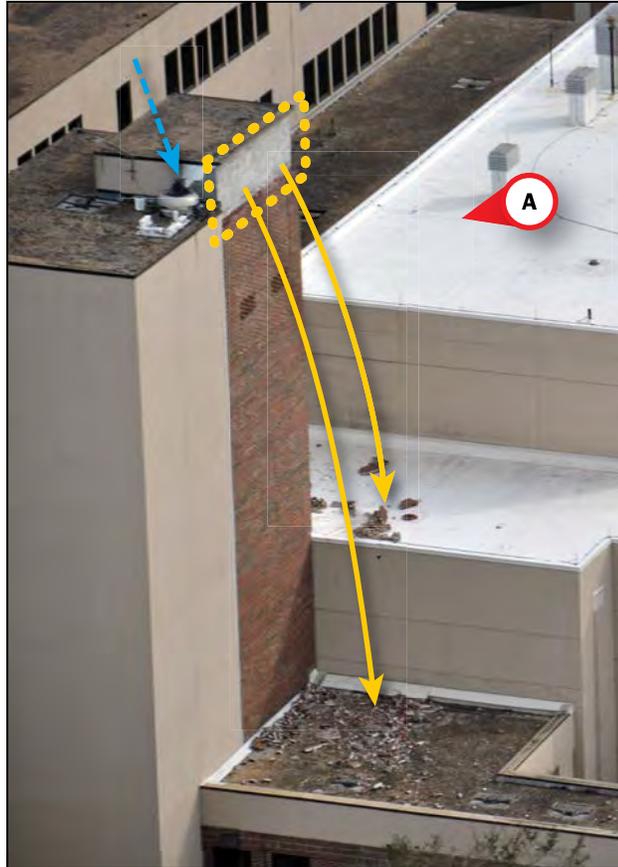
Figure 5-80: Brick veneer blow-off.
 See Figure 5-74 for location.
 (Panama City, FL)

The yellow dotted outlines indicate where brick veneer failed due to tie corrosion and excessive tie spacing. Brick debris fell onto lower roofs. The blue dashed arrow indicates where a fan cowling was blown off.

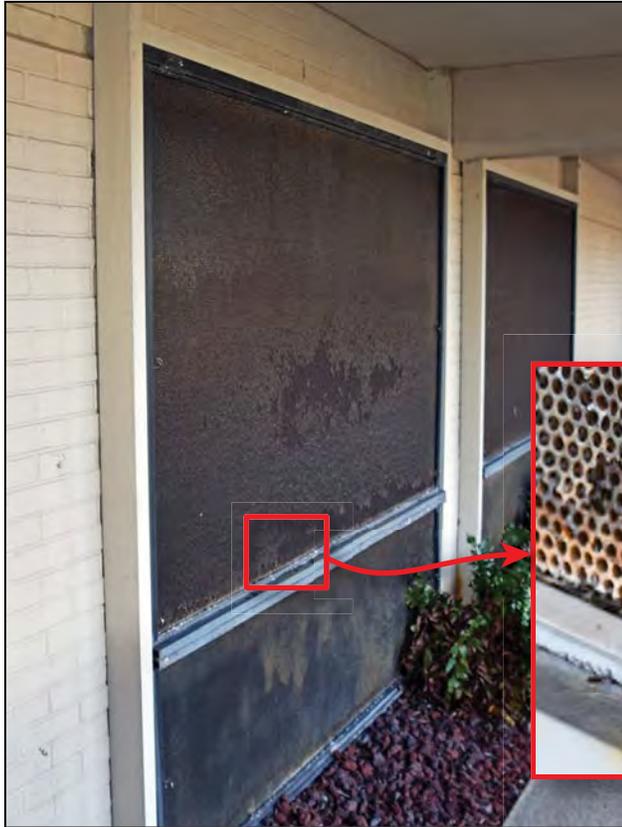
Figure 5-83: Permanently mounted screen shutters at Building No. 9, Women’s and Children’s Pavilion (Panama City, FL)

A portion of a screen was severely corroded; it was no longer capable of protecting the glazing.

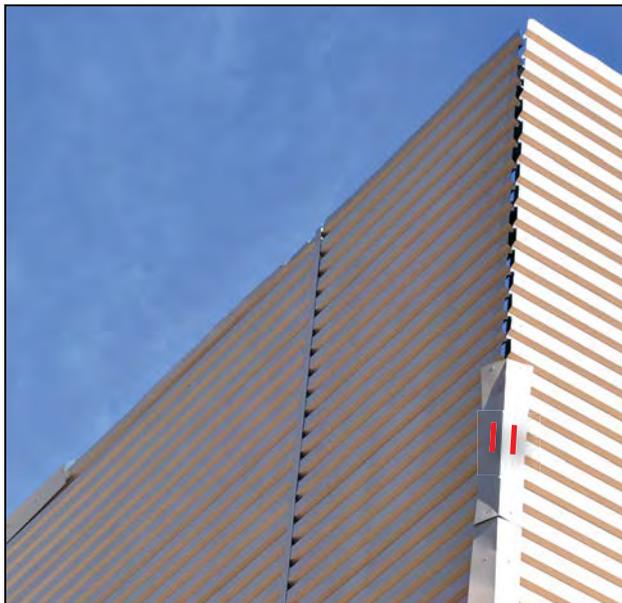
Figure 5-84: Coping and corner flashing blow-off at a metal screen wall (Panama City, FL)

The corner flashing was attached with a single row of screws on each flange (red lines). The screws were near the center of the flanges, which allowed the edge of the flashing to lift. Wind-borne copings and flashings can puncture roof membranes and may injure people coming to a hospital during a storm.

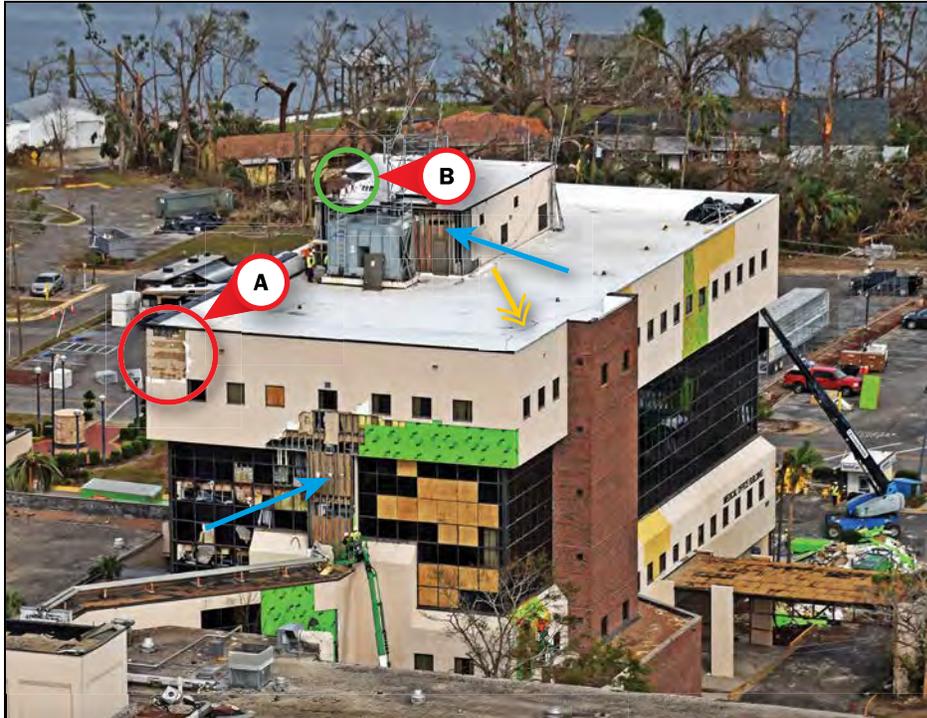
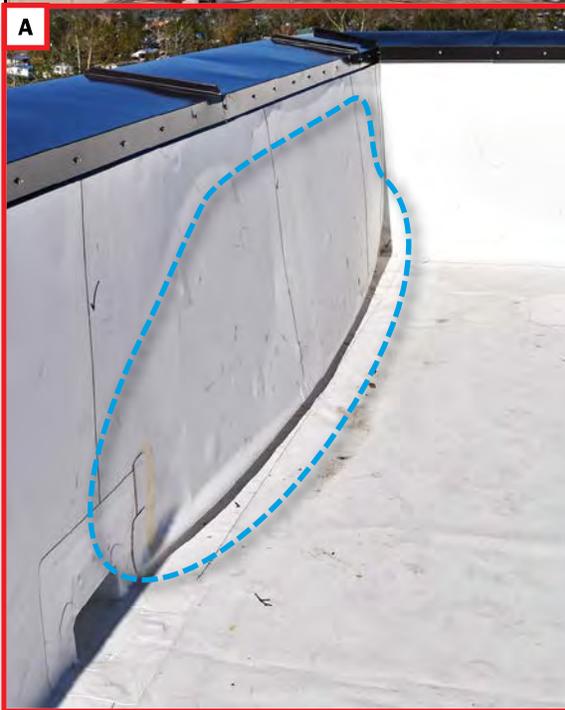
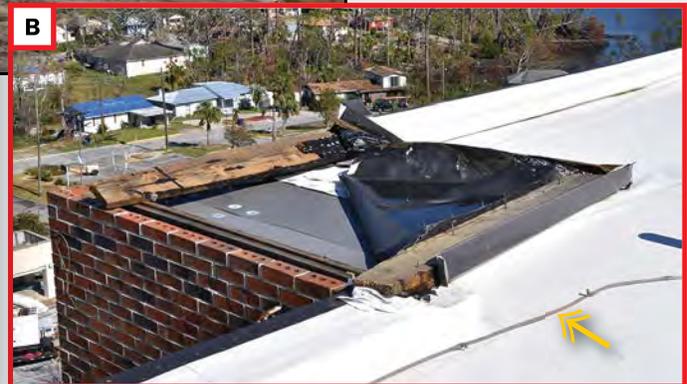
Figure 5-85: Damage at the roof, west and south facades of Building No. 9, Medical Office Building (Panama City, FL)

[A] At the red circle, EIFS insulation and some gypsum board adjacent to the coping blew off. The inset shows the back side of the parapet in this area. The base flashing remained adhered to the sheathing, but the sheathing detached from the metal studs (blue dashed outline). The blue arrows indicate other areas where EIFS gypsum board blew off. The green and yellow patches are where EIFS repairs are underway.

[B] At the green circle, the nailer lifted and caused progressive lifting and peeling of the roof membrane. The nailer was part of the original construction but its attachment was apparently not checked when the building was reroofed.

Several windows on the west facade were broken; likely by wind-borne roof aggregate. The yellow double arrow indicates a detached LPS conductor.

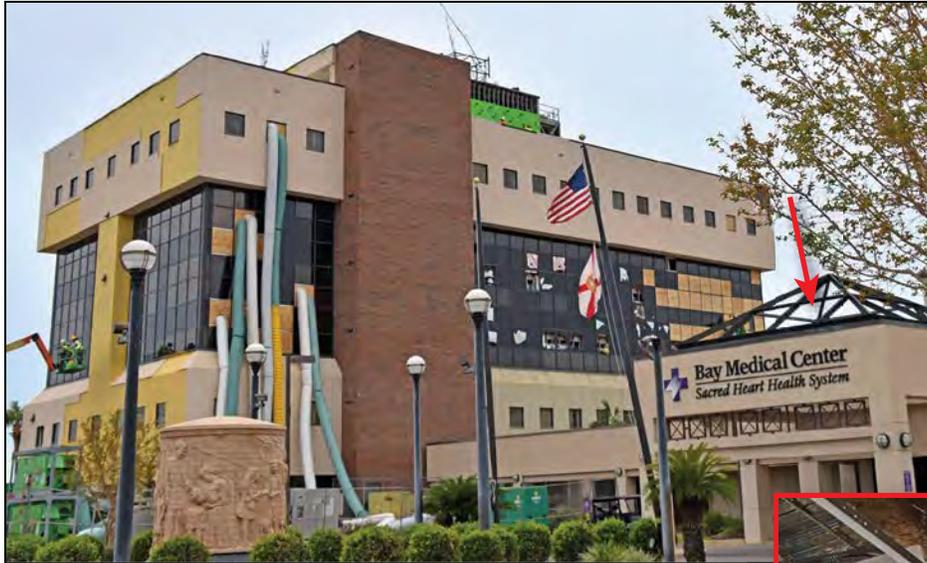
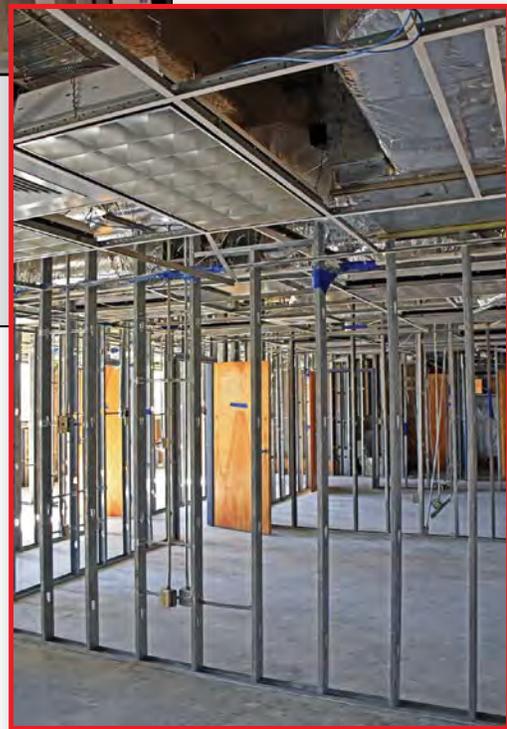
Figure 5-86: Damage at the north and east facades of Building No. 9, Medical Office Building (Panama City, FL)

Several windows on the north façade were broken, likely by wind-borne roof aggregate. The green and yellow areas are where EIFS repairs are underway. The inset shows one of the upper floors of this building after water-damaged ceiling boards and gypsum wall board were removed.

The red arrow indicates broken skylight glazing likely caused by wind-borne BUR debris from Building No. 8, Administration.

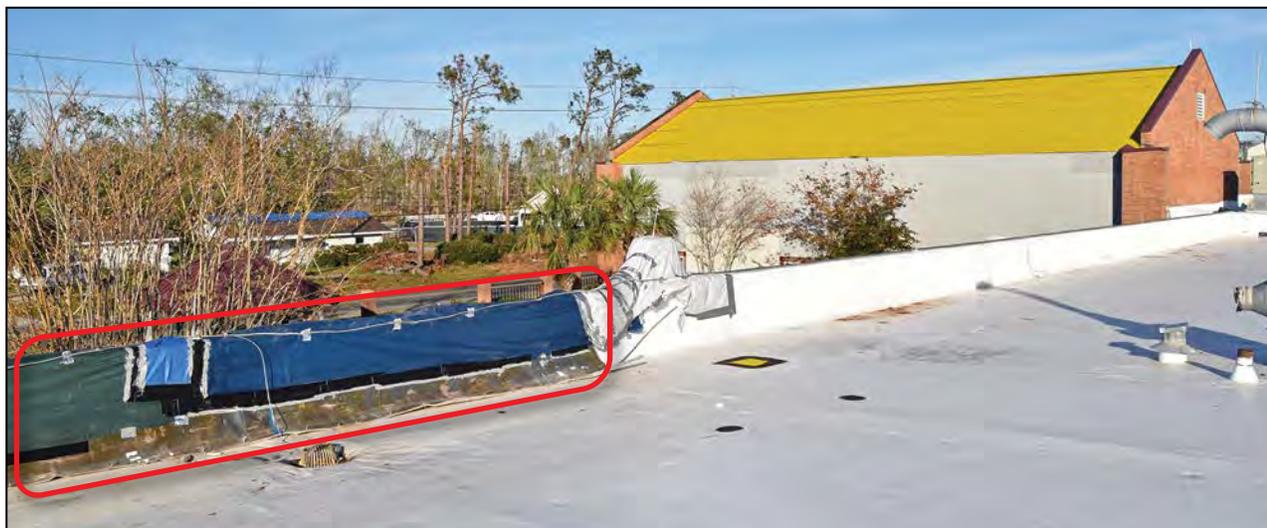
Figure 5-88: Roof damage at the Encompass Health Rehabilitation Hospital (Panama City, FL)

The yellow area is an emergency roof repair over the gym. The red outline indicates emergency repair at damaged parapet base flashing. The black areas are emergency repairs at roof membrane punctures.

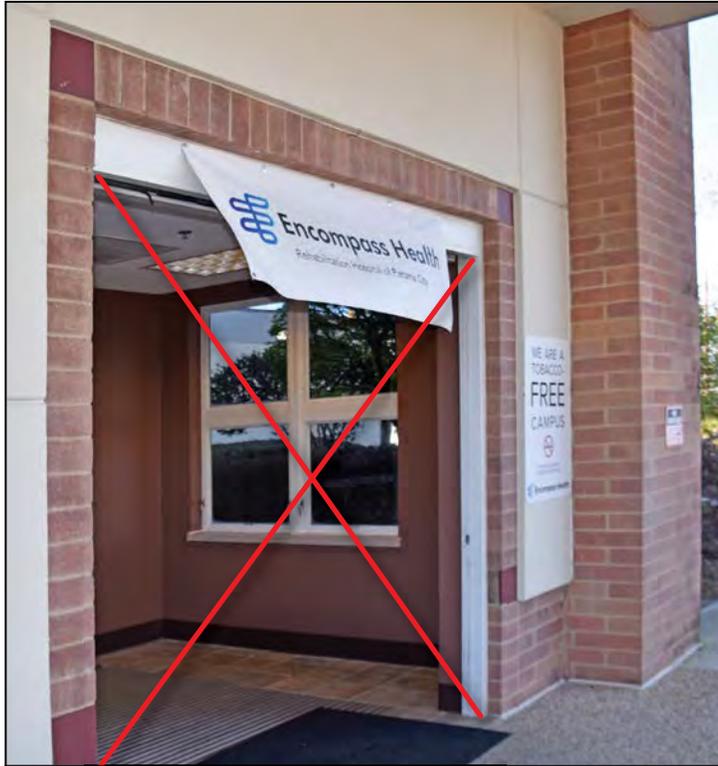
Figure 5-90: East (main) entry door failure (Panama City, FL)

As at the west entry, the exterior glass sliding automatic door and sidelite at the east entry were blown away (red X). The interior door and sidelite remained in place and prevented free entry of wind and rain into the interior of the hospital. Although the interior walls of the lobby were exposed to increased air pressure after the door failure, they apparently were not over-stressed.

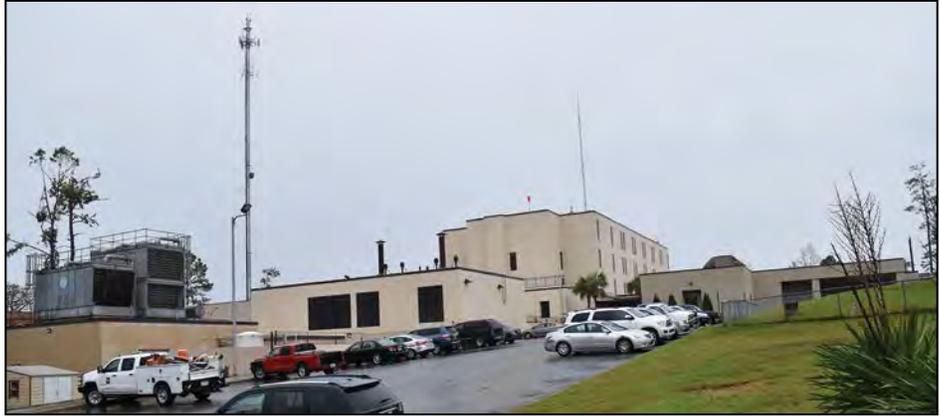
Figure 5-92: Rooftop equipment damage at the tower roof (Marianna, FL)

The cowling at the left fan lifted, but did not blow off. The adjacent fan blew away.
