Mitigation Assessment Team Report

Hurricane Michael in Florida

Building Performance Observations,
Recommendations, and Technical Guidance

FEMA P-2077 / February 2020

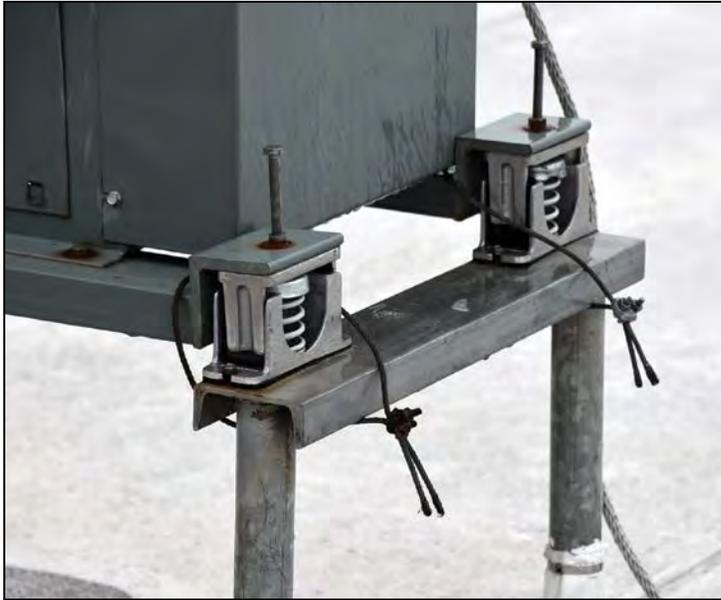
Figure 5-94: Cable tie-down for equipment mounted on vibration isolators (Marianna, FL)

The vibration isolators provided lateral resistance but no uplift resistance. Cable tie-downs had been installed to provide uplift resistance beyond that provided by the dead load of the equipment. FEMA 577 recommends such an attachment enhancement.

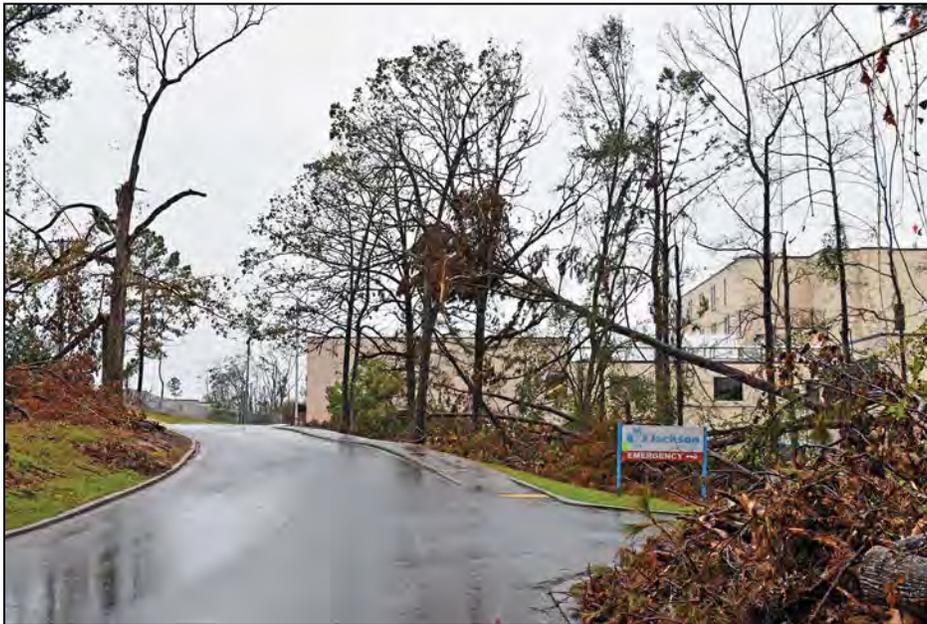
Figure 5-95: Downed trees along a Jackson Hospital campus road (Marianna, FL)

Several large trees were within lay-down distance of the roads on the hospital campus (Figure 5-95). Many trees fell during the hurricane, but most of them did not fall onto the road.

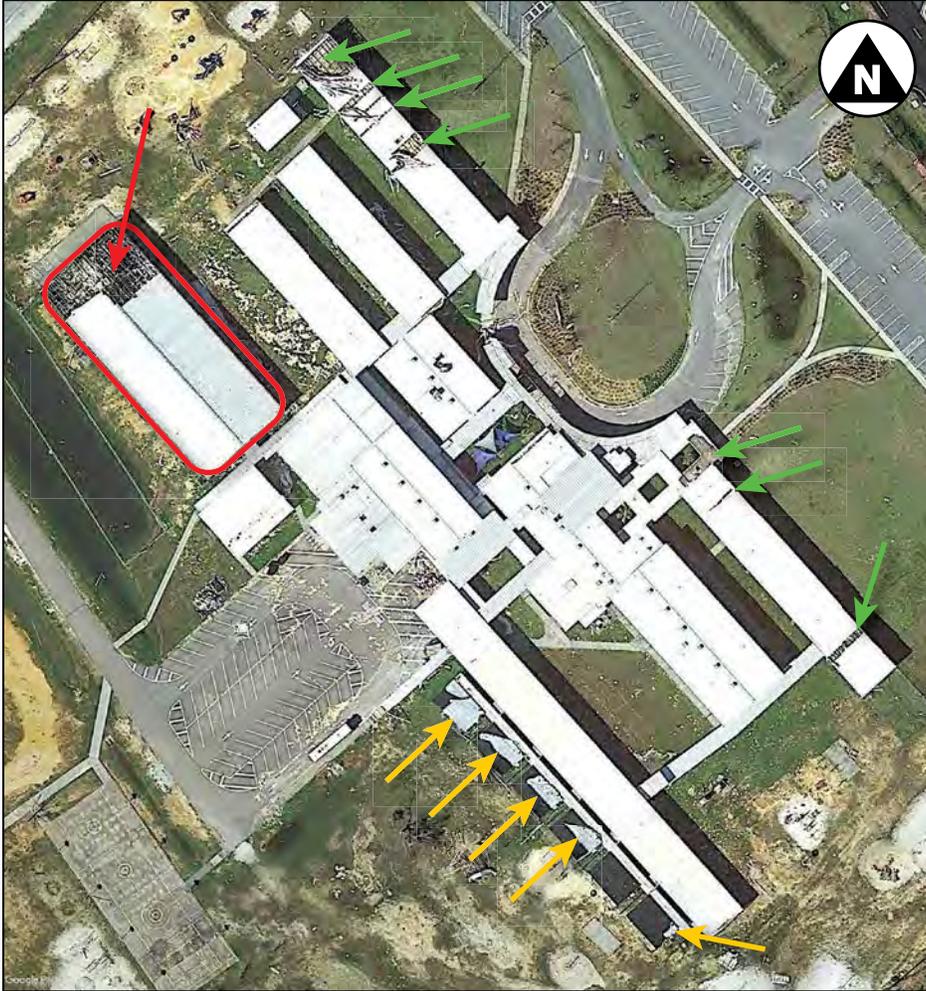
Figure 5-96: Aerial view of Tyndall Elementary School Building No. 8 (Panama City, FL)

Aerial view of Tyndall Elementary School shortly after Hurricane Michael. The MBS with the roof and end wall failure (red arrow) is indicated by the red box. The green arrows indicate roof covering blow-off. The yellow arrows indicate roof covering blow-off at portable classroom buildings.

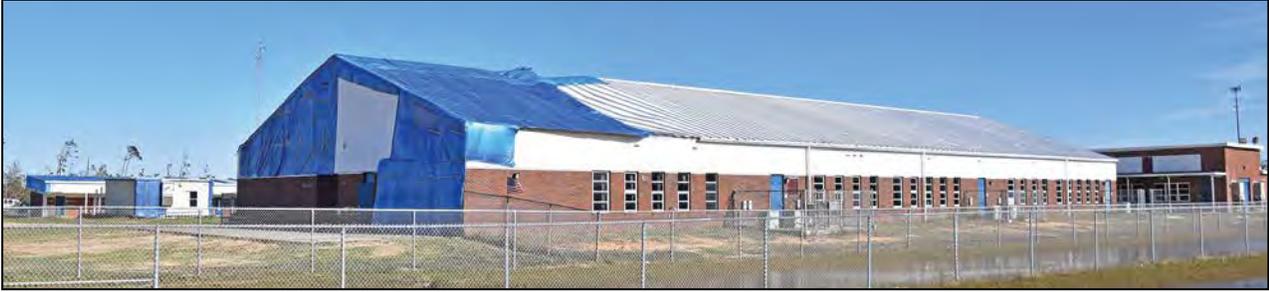
Figure 5-98: Blue tarps cover portions of the failed end wall and damaged roof areas of Building No. 8 (Panama City, FL)

Building No. 8 had a failed end wall and several structural standing seam trapezoidal metal roof panels were blown off (Figure 5-98). This type of metal panel system does not provide any significant resistance to lateral loads (i.e., it is not a diaphragm). To resist lateral loads parallel to the ridge, cable x-bracing was provided (Figure 5-99). The roof panels between the failed end wall and first main frame were blown off, as were the panels between the first and second main frames. At the time of the MAT visit, missing metal panels had been temporarily replaced with plywood, as indicated in Figure 5-100 and Figure 5-101. Some metal wall panels on the end wall were also blown off.

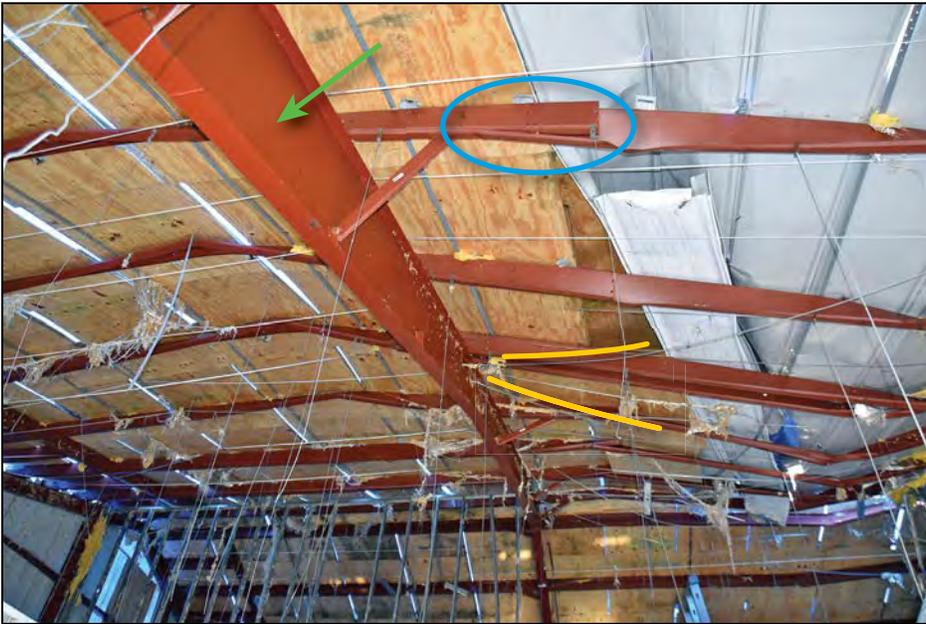
Figure 5-99: Structural roof damage at Building No. 8 (Panama City, FL)

Figure 5-99 illustrates structural roof damage on either side of the first main frame where purlins buckled.

The northwest end bay is to the left of the main frame indicated by the green arrow. The yellow lines indicate cable x-bracing. The purlin overlap (blue oval) may not have been installed with the proper number of bolts.

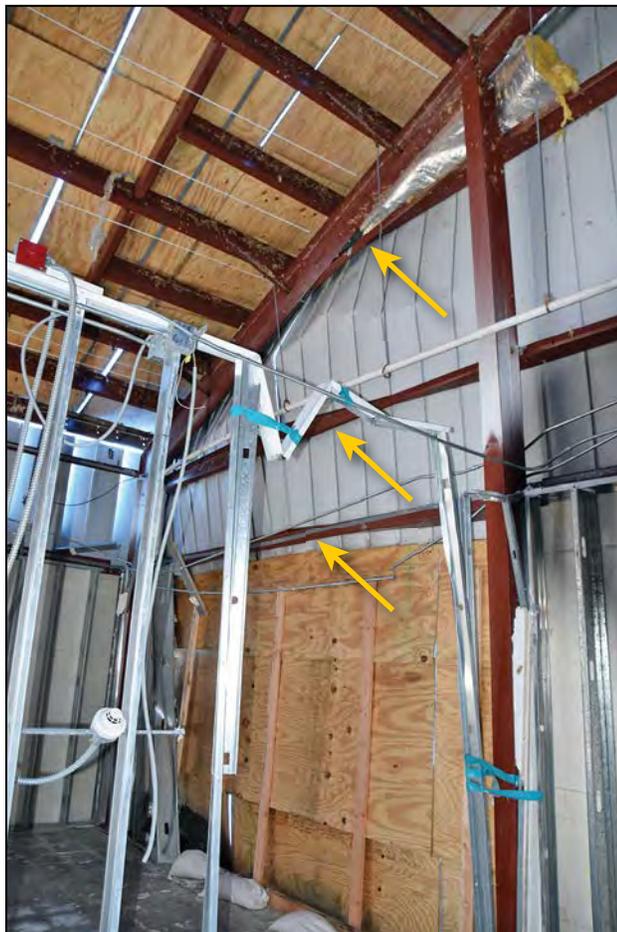
Figure 5-101: Interior view of damaged end wall of Building No. 8 (Panama City, FL)

Figure 5-100 and Figure 5-101 are interior views of the damaged end wall, which was observed to be out of plumb.

Yellow arrows indicate twisted end wall girts between columns. The metal cladding between girts has deformed under pressure.

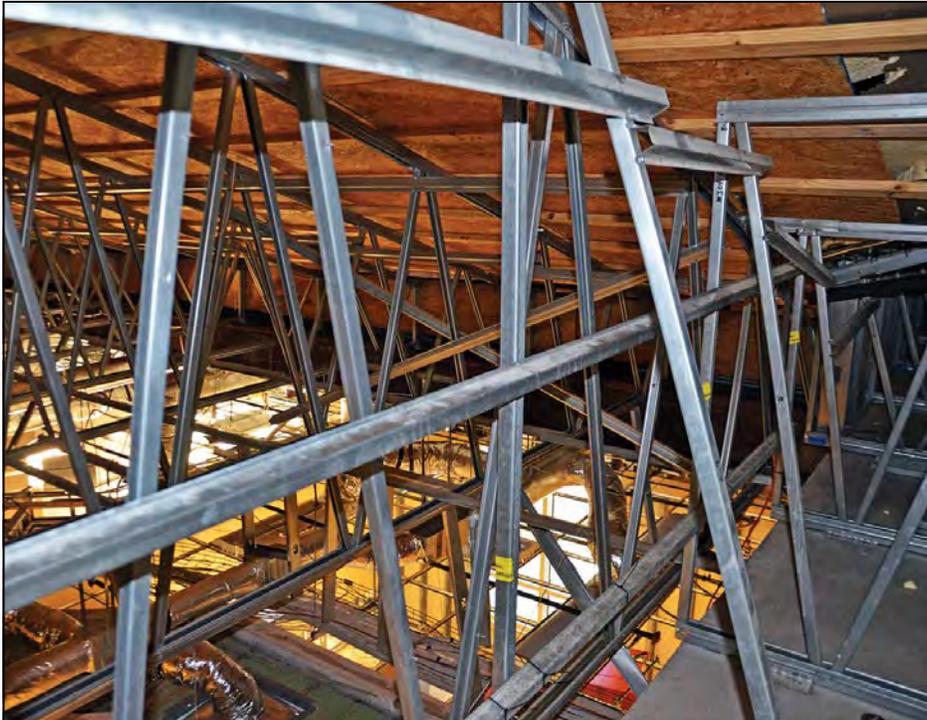
Figure 5-104: Attic space where the roof deck blew off (Panama City, FL)

A portion of the steel roof deck blew off during the hurricane, which allowed rain and debris to freely enter the building. Figure 5-104 is a view of the attic space after an emergency roof had been installed. The deck was screwed to cold-formed steel roof trusses. In some undamaged and damaged areas, the deck was screwed to the truss at each bottom flange (Figure 5-105 and Figure 5-106). However, along one of the trusses in the damaged area, several screws had not been installed (Figure 5-107). Based on these observations, it appeared the lack of several contiguous fasteners in one or more localized areas caused the deck blow-off. The deck blow-off did not damage the trusses that were observed by the MAT.

OSB was placed over the trusses after the storm to support an emergency roof covering. Prior to placing the OSB, the offices below were open to the sky.

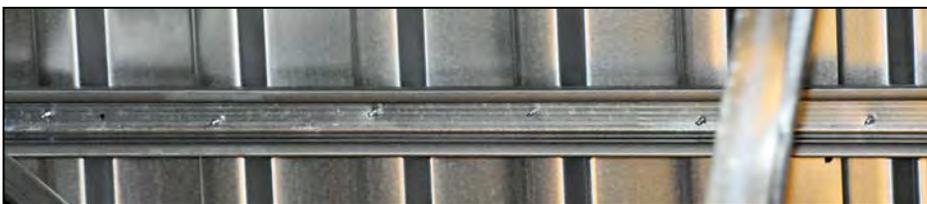
Figure 5-105: An area near the deck blow-off (Panama City, FL)

In this area, each bottom flange (rib) of the deck was screwed to the truss.

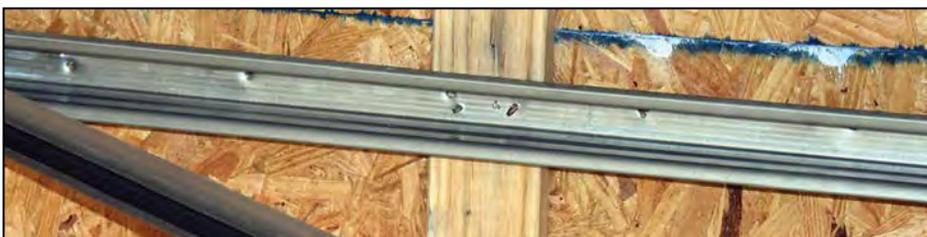
Figure 5-106: An area where the deck blew off (Panama City, FL)

In this area, it was apparent that the deck screws pulled out of the truss. Each bottom flange was screwed to the truss in this area. Pull-out of these screws was likely a progressive failure, with failure beginning at an area with insufficient deck attachment, such as shown at Figure 5-107.

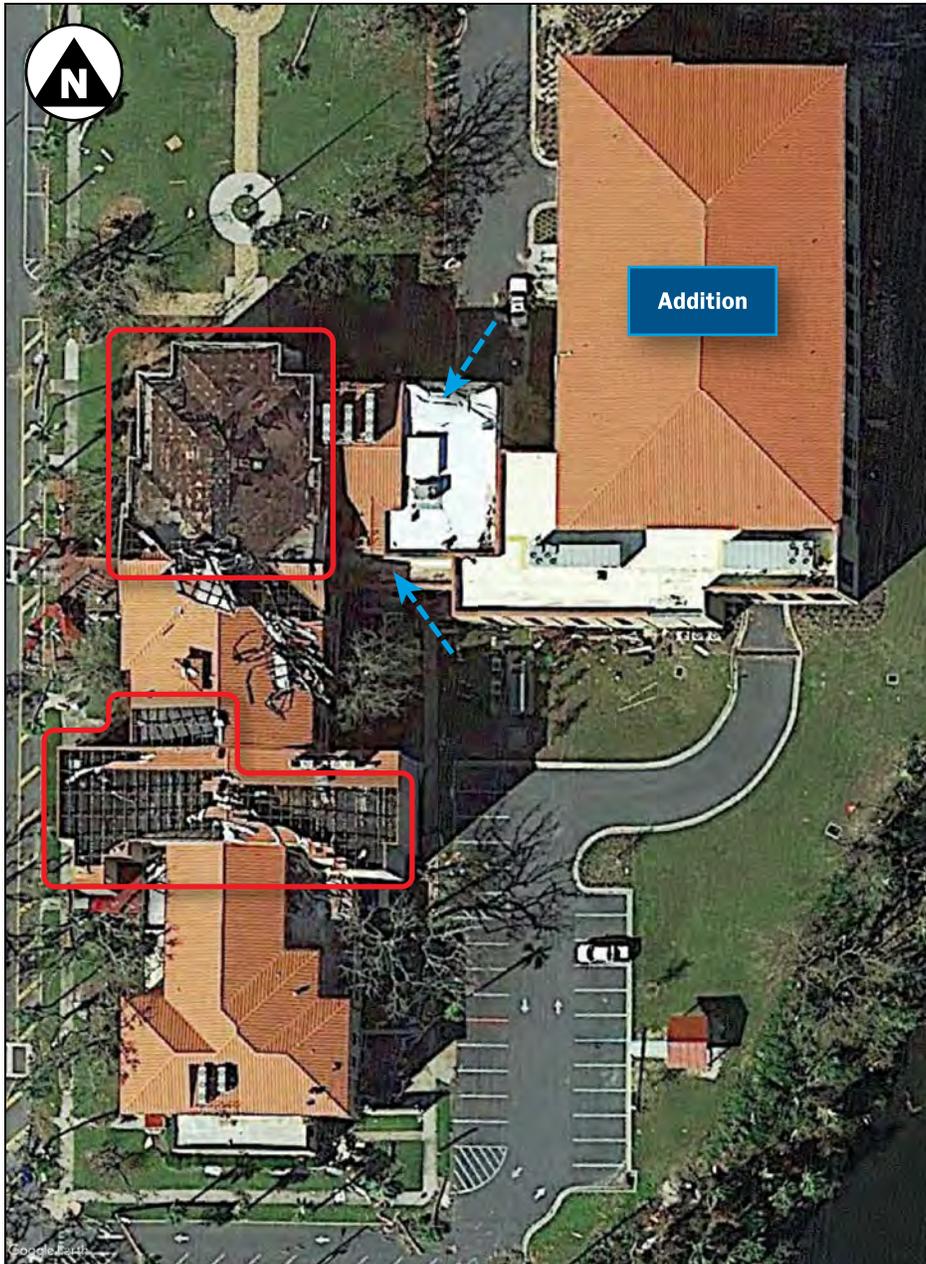
Figure 5-108: Aerial view of the Bay County Courthouse (Panama City, FL)

The red outlines indicate areas where the structural standing seam roof panels blew off the historic building. The blue dotted arrows indicate roof membrane damage (refer also to Figures 5-113 and 5-115).

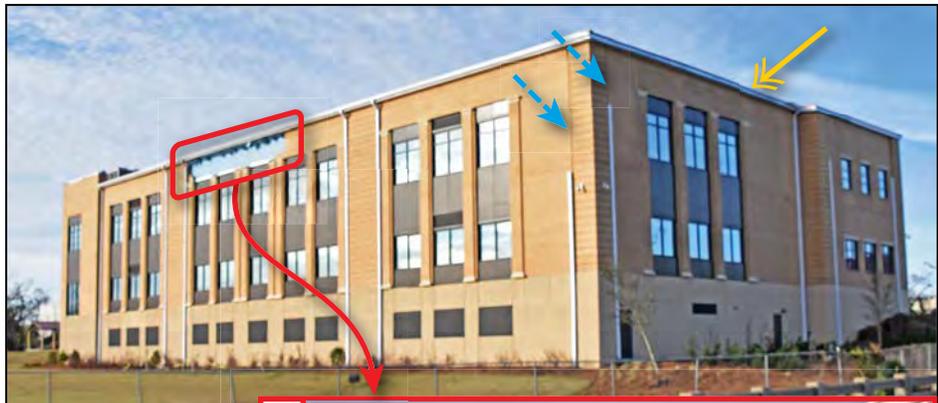
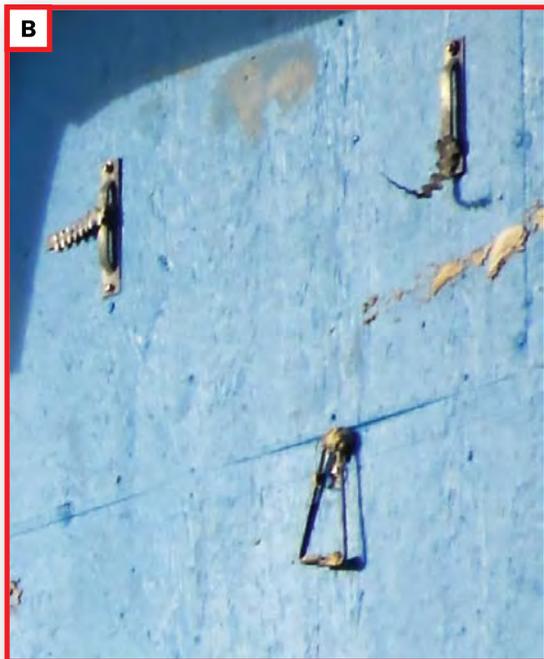
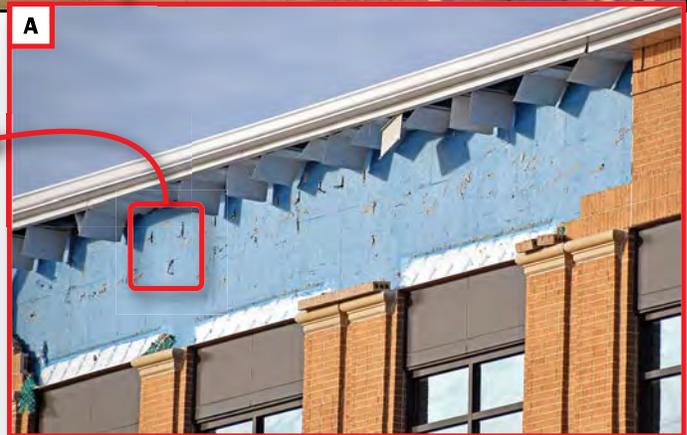
Figure 5-110: Bay County Courthouse addition (Panama City, FL)

[A] shows soffit damage and where the brick veneer blew off. There were an inadequate number of ties where the brick failed.

[B] shows that two different types of ties were used. The design of the top two ties allowed adjustment of the tie to suit the location of the mortar joint. It appeared that these two ties had not been embedded into the mortar. The yellow double arrow indicates where a portion of the gutter blew off. The blue dashed arrows indicate where portions of the downspout blew off.

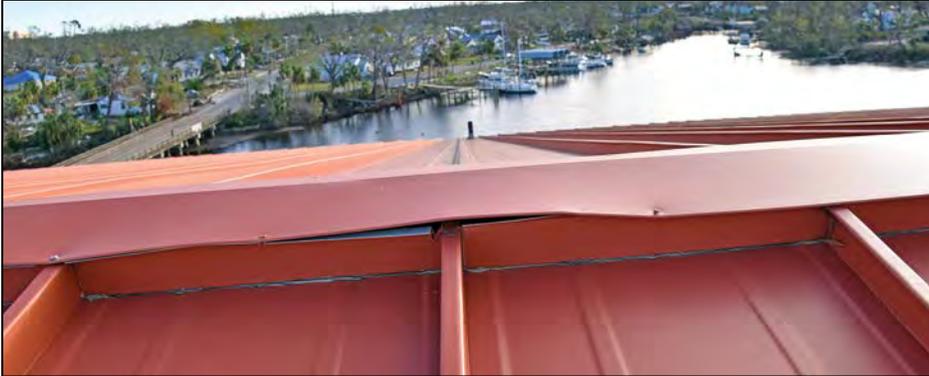
Figure 5-111: Ridge flashing at the Bay County Courthouse addition (Panama City, FL)

The ridge flashing was inadequately attached. There was only a single row of rivets on either side of the ridgeline. The rivets were 16 inches apart where the ridge flashing lifted. The spacing is too far apart. Screws provide more reliable flashing attachment. The lifted flashing was no longer able to prevent entrance of wind-driven rain.

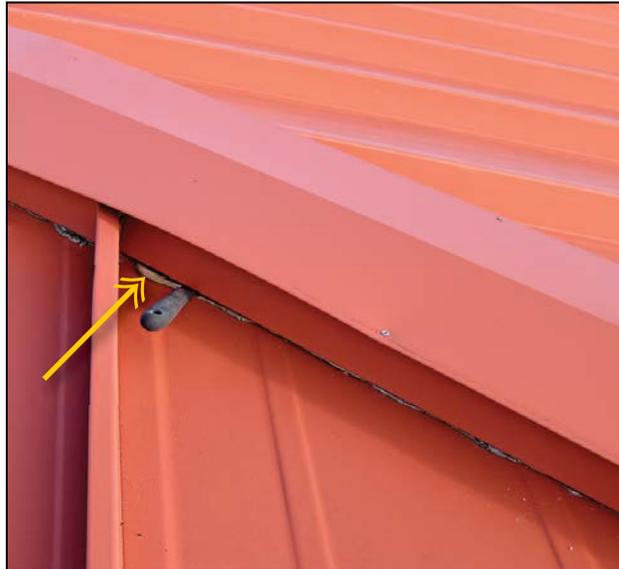
Figure 5-112: Hip flashing at the Bay County Courthouse addition (Panama City, FL)

It appeared that only one foam closure was installed on either side of the hipline. Sealant was placed between the metal panel and foam closure (yellow double arrow). However, as shown by the putty knife, the sealant did not provide a continuous barrier to wind-driven rain, which is important if only one closure is installed. In a high-wind region, it is prudent to install two closures (see figure in textbox titled “Recommended Roof Hip and Ridge Closure” in Section 5.1.2).

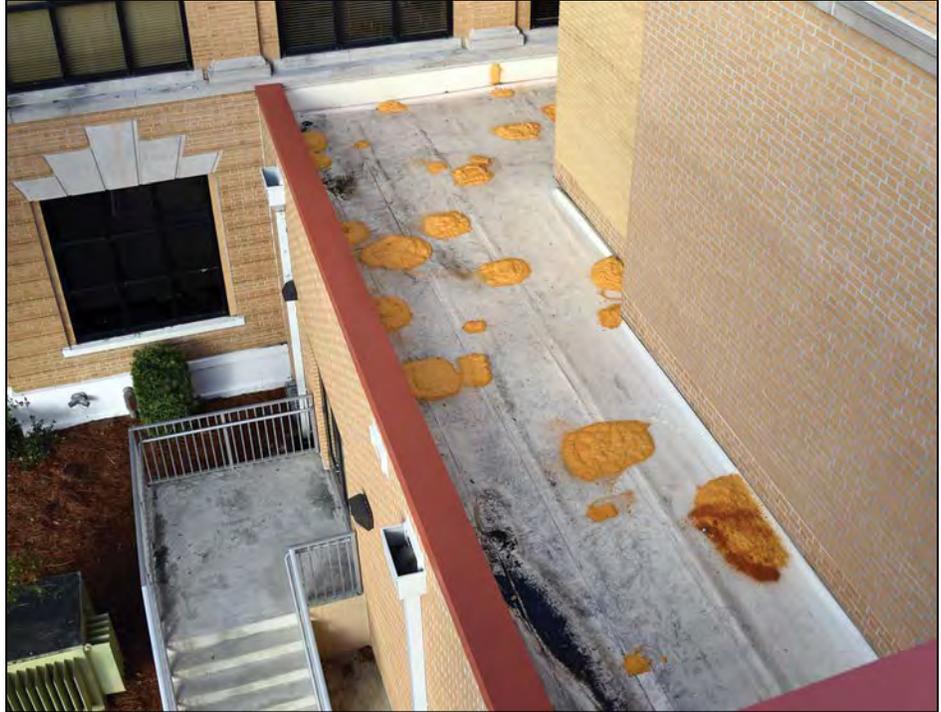
Figure 5-113: Roof membrane punctured by wind-borne debris at the Bay County Courthouse addition (Panama City, FL)

This mechanically attached single-ply membrane was punctured by wind-borne debris. Emergency repairs were performed with sprayed polyurethane foam (SPF). SPF is a fast, effective way to perform emergency repairs. This illustrates the amount of debris that can be generated during a hurricane. It appeared that the debris source was the metal roof panels from the historic building (see Figure 5-108).

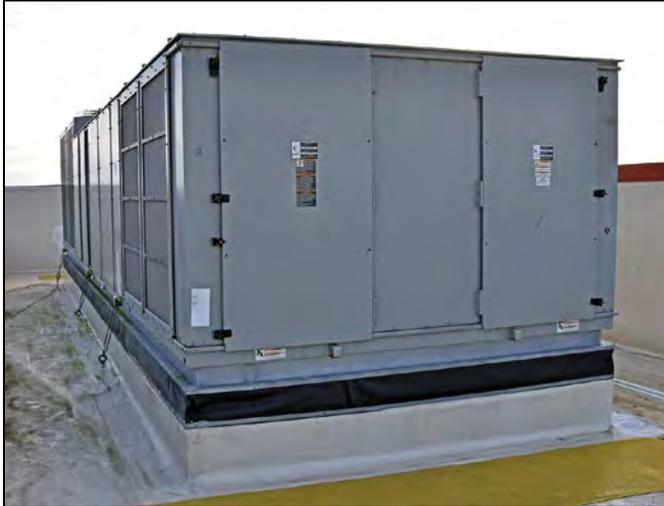
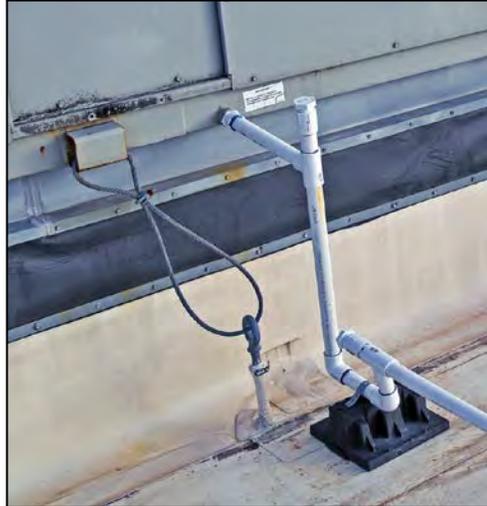
Figure 5-116: Attachment of an HVAC unit on the Bay County Courthouse addition

While the large rooftop HVAC unit shown in Figure 5-116 did not fail, the MAT observed attachment concerns.

This unit had three cable tie-downs on each side. The three tie-downs on the left side of the unit were taut and the unit did not shift.

The tie-downs on the right side were not taut. When tie-downs are not taut, units can lift and shift off of their curb.
