Coastal Flood and Wind Event Summaries

COASTAL FLOOD AND WIND EVENT SUMMARIES

This resource supplements Chapter 2 of *Coastal Construction Manual*. It summarizes coastal flood and wind events that have affected the continental United States, Alaska, Hawaii, and U.S. Territories since the beginning of this century.

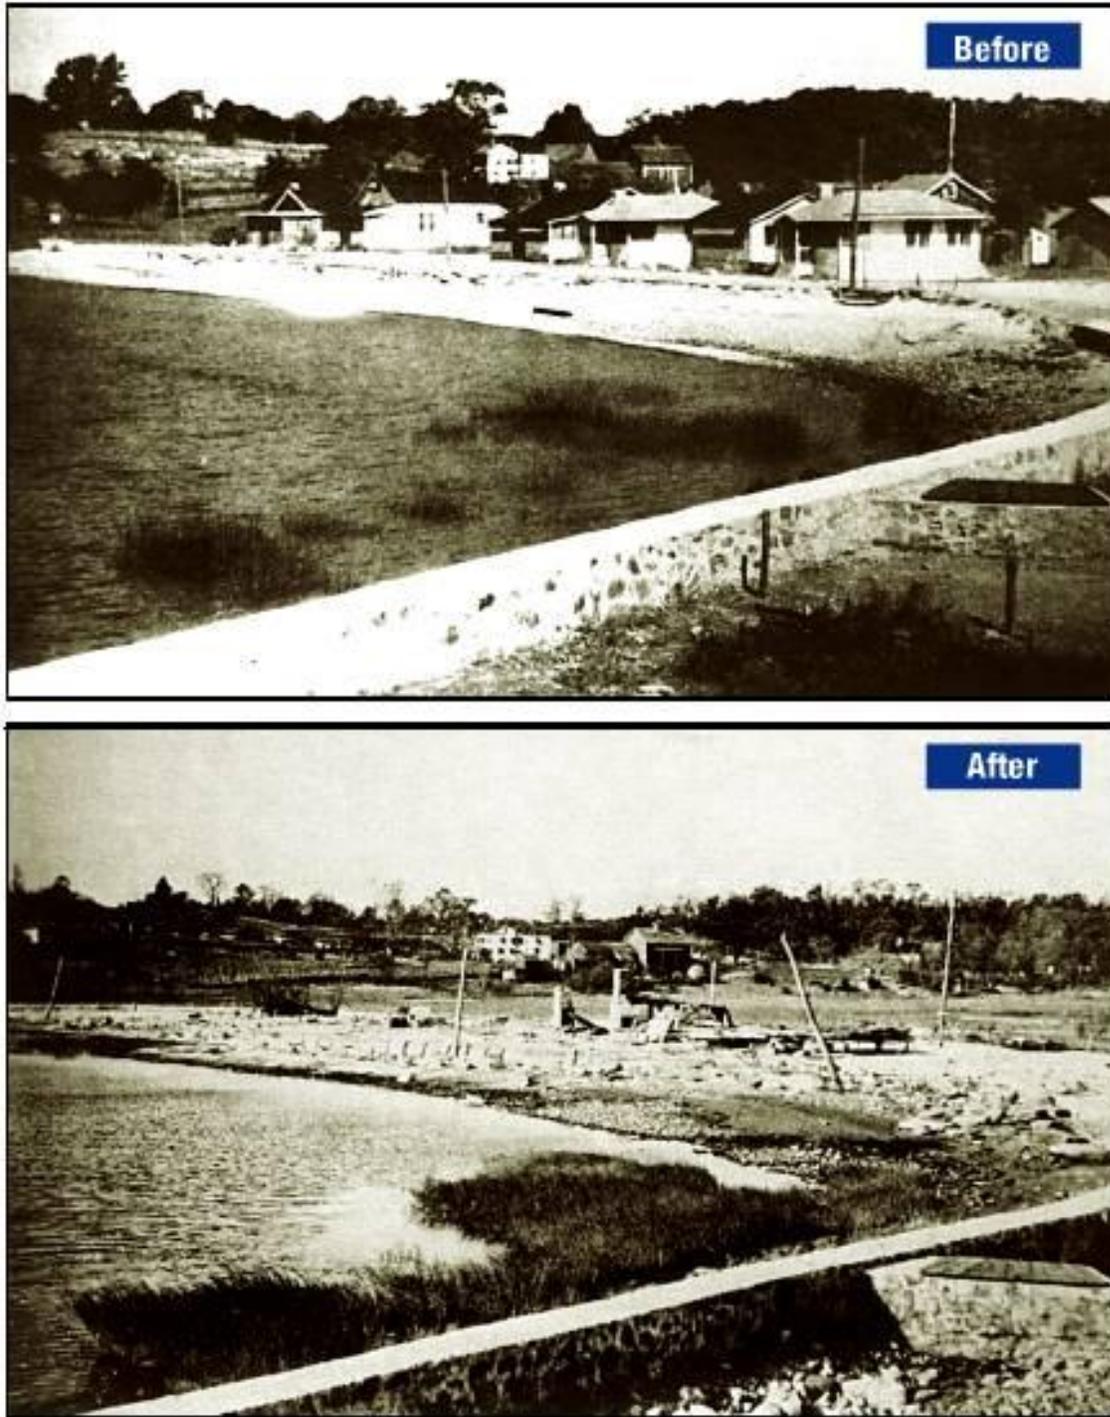
Figure 1. “Long Island Express” Hurricane. Schell Beach, Guilford, CT, before and after the storm. Non-elevated houses at the shoreline were destroyed.

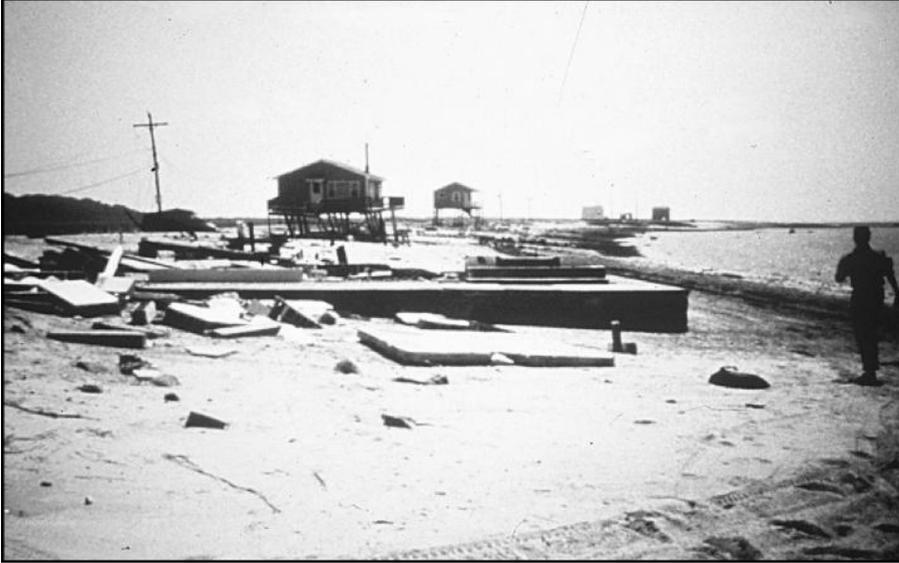
- Buildings that were constructed before the date of the Flood Insurance Rate Map (FIRM) for their community and that had not been elevated, or were not elevated sufficiently, suffered major damage or complete destruction; some destroyed buildings appeared to have had insufficient foundation embedment.

Figure 2. Hurricane Bob (1991) destroyed 29 homes along this reach of Mattapoisett, MA.

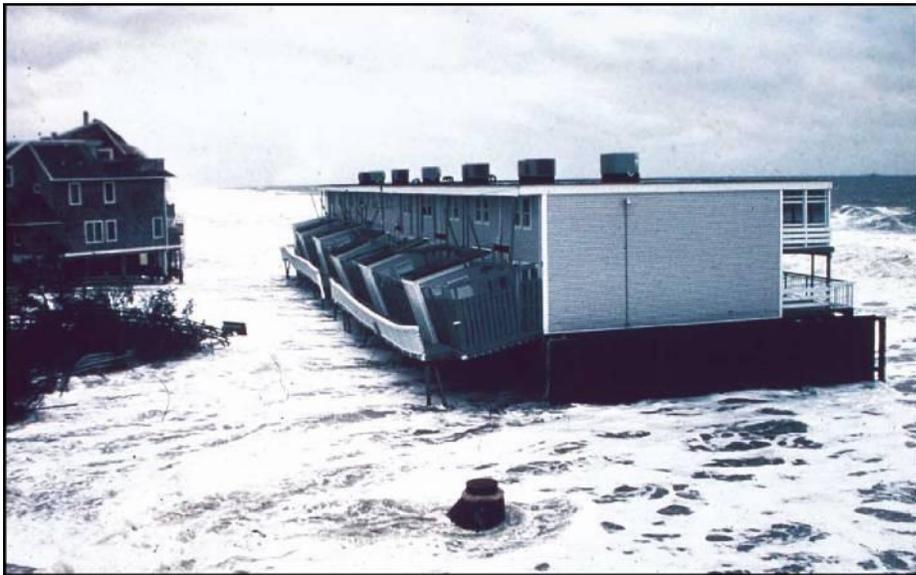
- Some buildings had poorly located or fastened utility lines. For example, some sewer stacks and sewer laterals failed as a result of erosion and flood forces. The report provides guidance on locating and fastening sewer connections to minimize vulnerability.
- Many pile-supported buildings were observed to have sustained damage to at-grade or inadequately elevated mechanical equipment, including air conditioning compressors, heat pumps, furnaces, ductwork, and hot water heaters. The report provides guidance on proper elevation of these units.

Figure 9. 1992 storm impacts at Dewey Beach, DE. Note collapse of deck on landward side of building.

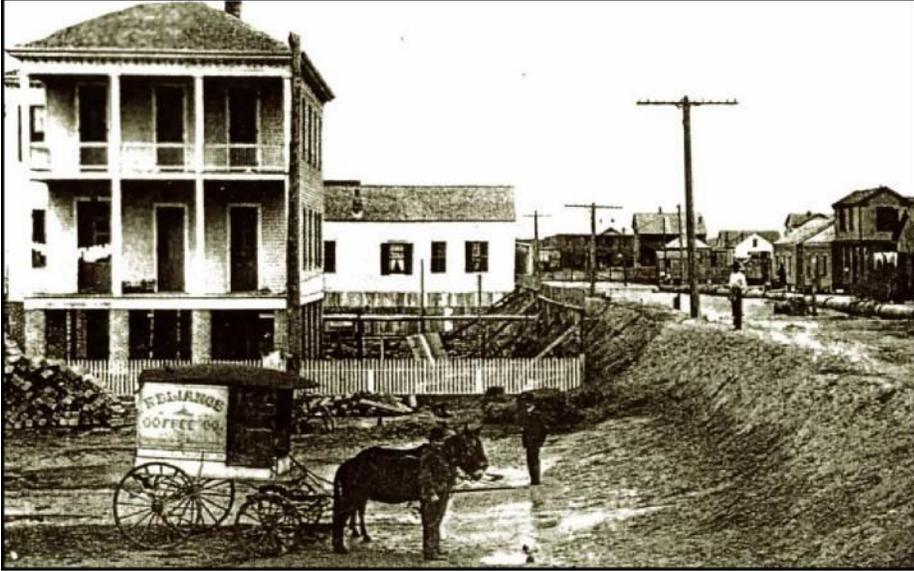
1900, September 8 – Galveston, TX. This Category 4 hurricane was responsible for over 8,000 deaths. The storm caused widespread destruction of much of the development on Galveston Island and pointed out the benefits of siting construction away from the shoreline. As a result, the city completed the first, large-scale retrofitting project (see Figure 19): roads and hundreds of buildings were elevated, ground levels in the city were raised several feet with sand fill, and the Galveston seawall was built (Walden 1990).

Figure 16. Galveston on two levels—the area at the right has already been raised; on the left, houses have been lifted, but the land is still low.

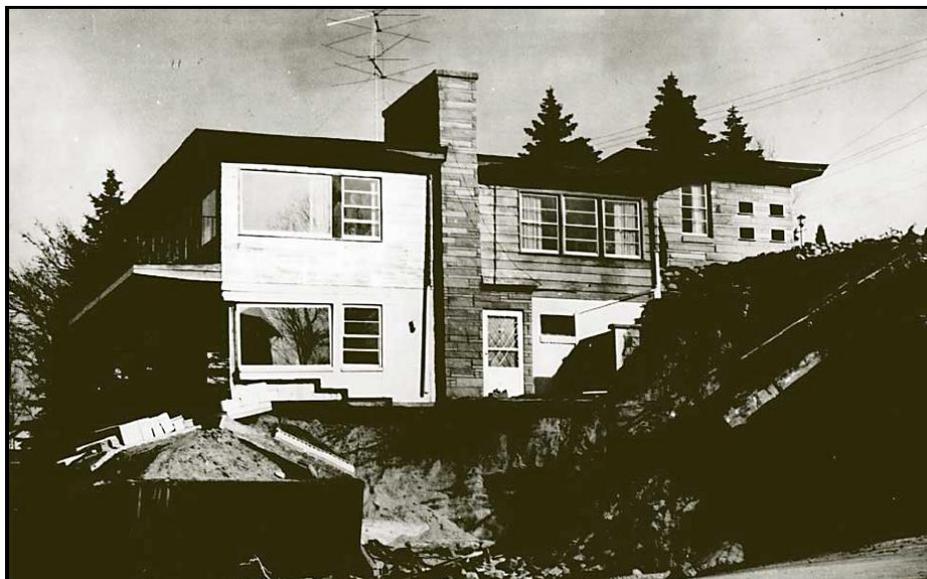
1951, November 7 – Storm on Lake Michigan. After 20 years of lower than-average levels, the water level on Lake Michigan in November 1951 was slightly above average. The November 7 storm caused extensive erosion along the southeast shore of the lake, undermining houses and roads (see Figure 32). Damage observed as a result of this storm is consistent with the concept of Great Lakes shoreline erosion as a slow, cumulative process, driven by lakebed erosion, high water levels, and storms.

Figure 25. House on southeastern shoreline of Lake Michigan undermined by erosion during storm of November 1951.

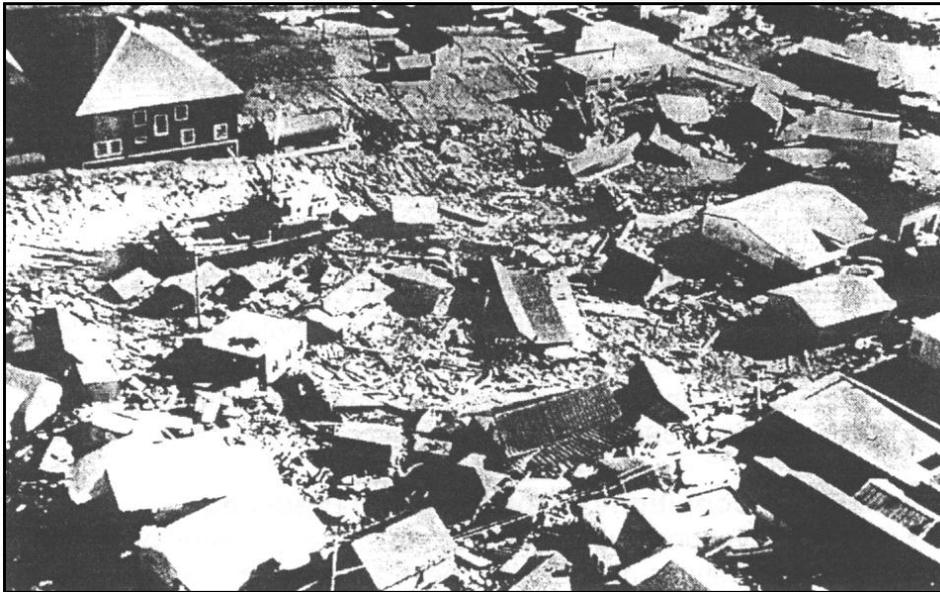
1964, March 27 – Alaska Tsunami. This tsunami, generated by the 1964 Good Friday earthquake, affected parts of Washington, Oregon, California, and Hawaii; however, the most severe effects were near the earthquake epicenter in Prince William Sound, southeast of Anchorage, Alaska (Wilson and Tørum 1968). The tsunami flooded entire towns and caused extensive damage to waterfront and upland buildings (see Figure 25). Tsunami runup reached approximately 20 feet above sea level in places, despite the fact that the main tsunami struck near the time of low tide. Also, liquefaction of coastal bluffs in Anchorage resulted in the loss of buildings.

Figure 26. 1964 Good Friday earthquake. Damage in Kodiak City, AK, caused by the tsunami of the 1964 Alaskan earthquake.

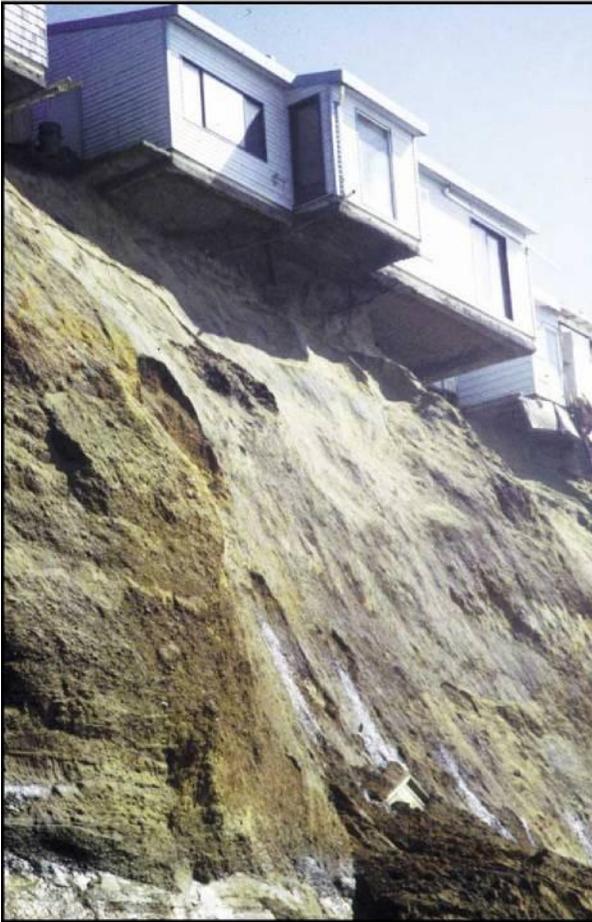
1997-98 – Winter Coastal Storms, California and Oregon. Another series of severe El Niño-driven coastal storms battered the Pacific coast. The distinguishing feature of the 1997-98 event was rainfall. The California Coastal Commission (1998) reported widespread soil saturation, which resulted in thousands of incidents of debris flows, landslides, and bluff collapse (see Figure 26).

Figure 27. Winter coastal storms, California and Oregon (1997– 1998). House in Pacifica, CA, undermined by bluff erosion.

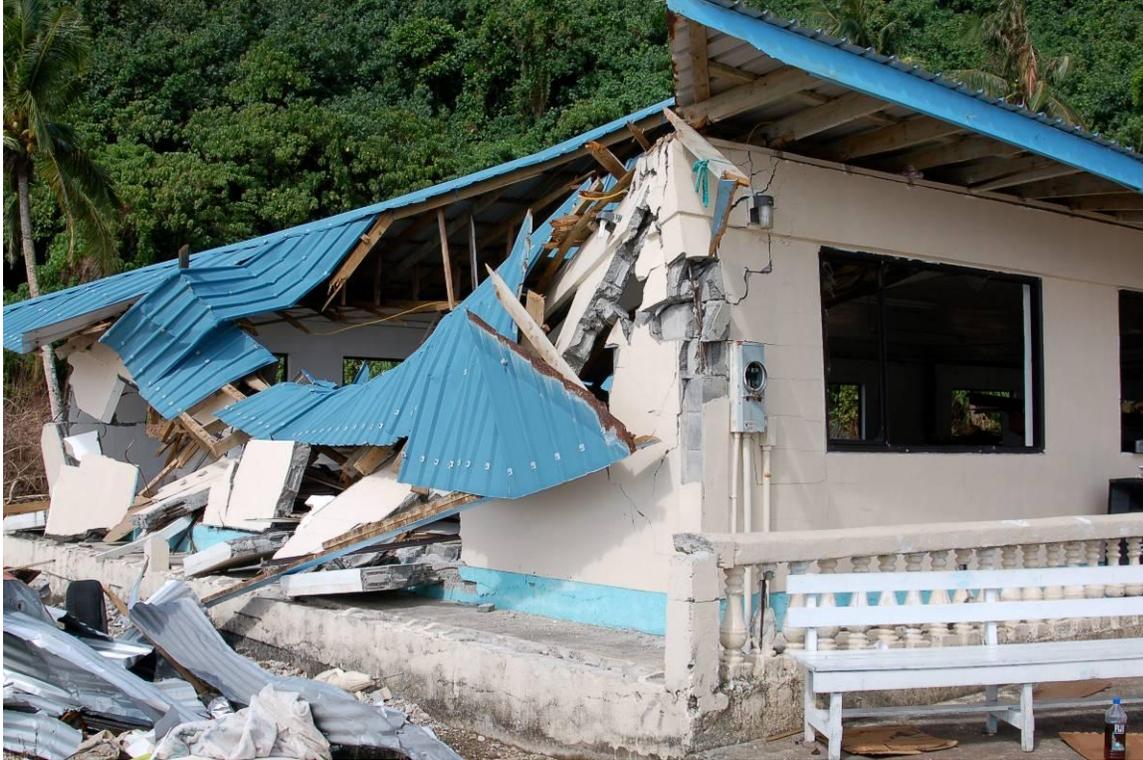
15 to 40 feet above sea level. At least 275 residences were destroyed by the tsunami and several hundred others were damaged (Figure 31). Damage to commercial buildings, churches, schools and other buildings was also widespread. Elevated buildings and buildings farther inland generally performed better. Thirty four people were killed by the tsunami.

Figure 32. Tsunami damage at Poloa, American Samoa.
