South Carolina Dam Failure Assessment and Advisement

DR-SC-4241

FEMA P-1801 / December 2016

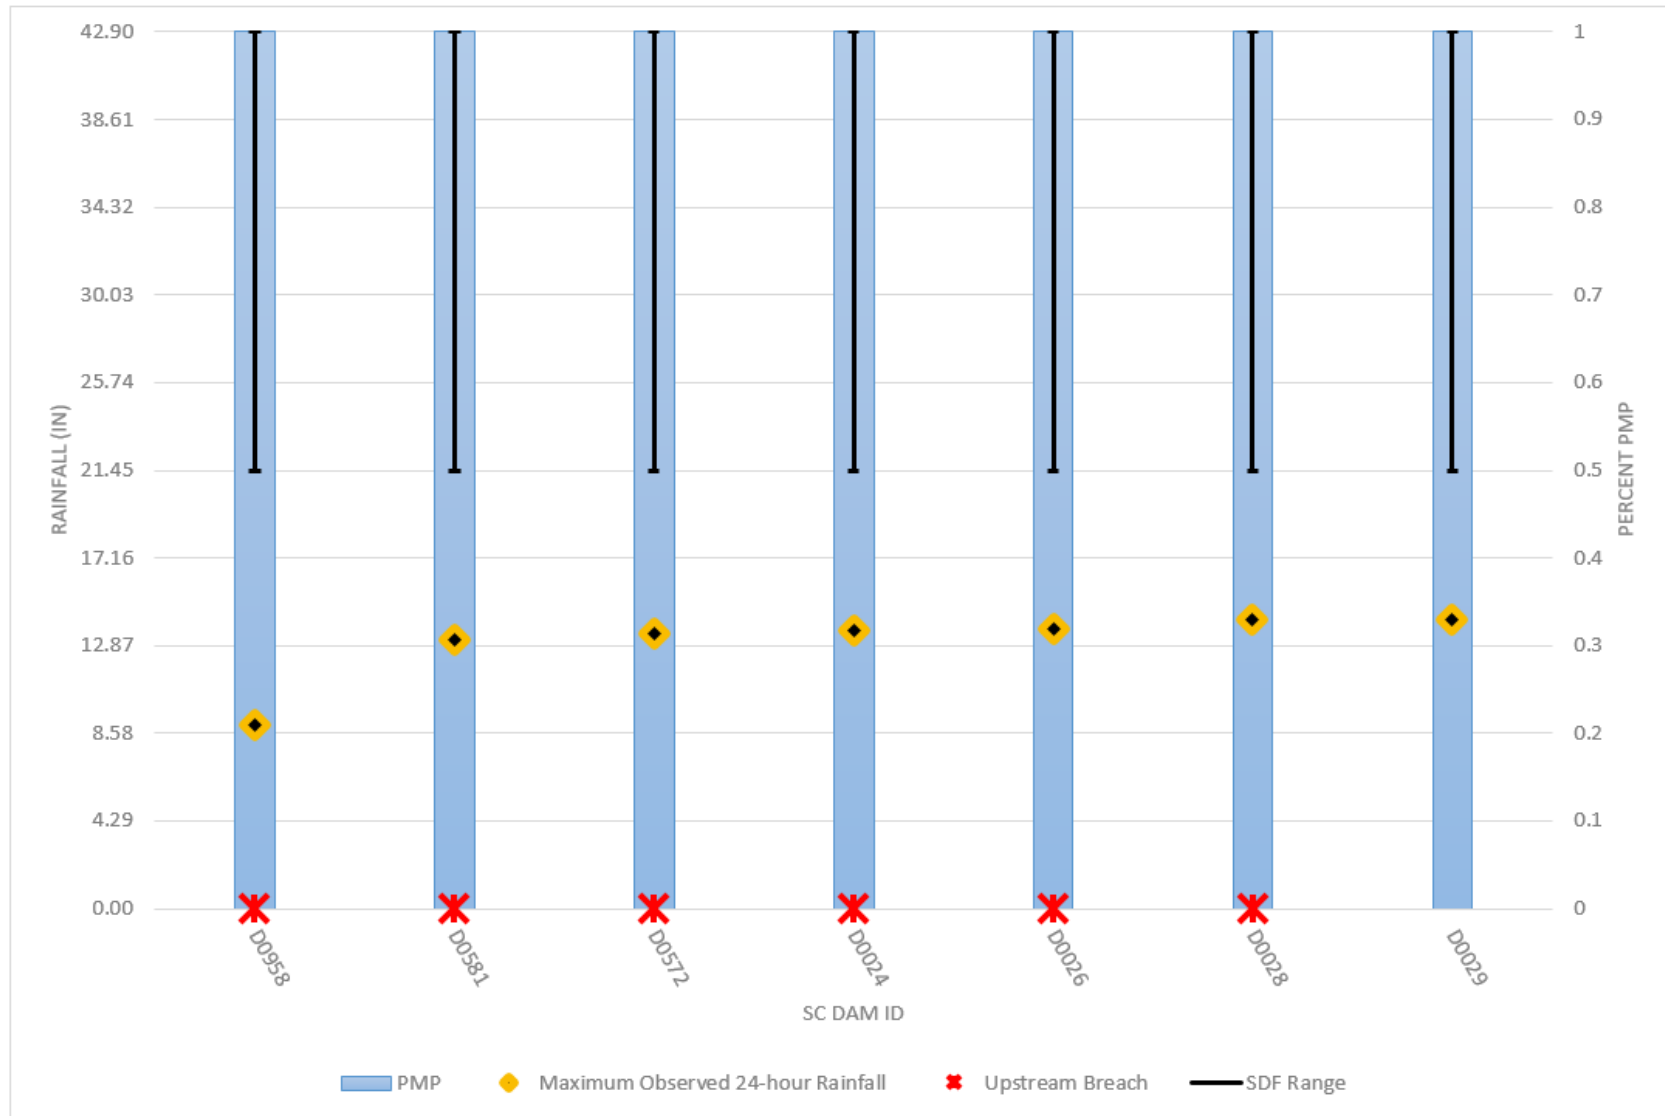
Figure 9: Rainfall Analysis for High Hazard Potential Dams Compared to SC DHEC SDF Design Criteria (Assumes that a 24-hour PMP results in a PMF)

- None of the High Hazard potential dams in Figure 9 received a rainfall loading greater than the minimum or maximum SDF design criteria.
 - However, 6 of 7 High Hazard potential dams experienced an upstream breach which may have potentially resulted in increased volumes entering the impoundments and contributing to their failure. Therefore it is possible that peak inflows were higher than what would be expected from the natural flood event and potentially exceeded the state SDF requirements. All dams were constructed prior to the enactment of the Dams and Reservoirs Safety Act, however, dams D0571 and D0026 are known by SC DHEC to have been modified in 1994 and 1988 respectively.

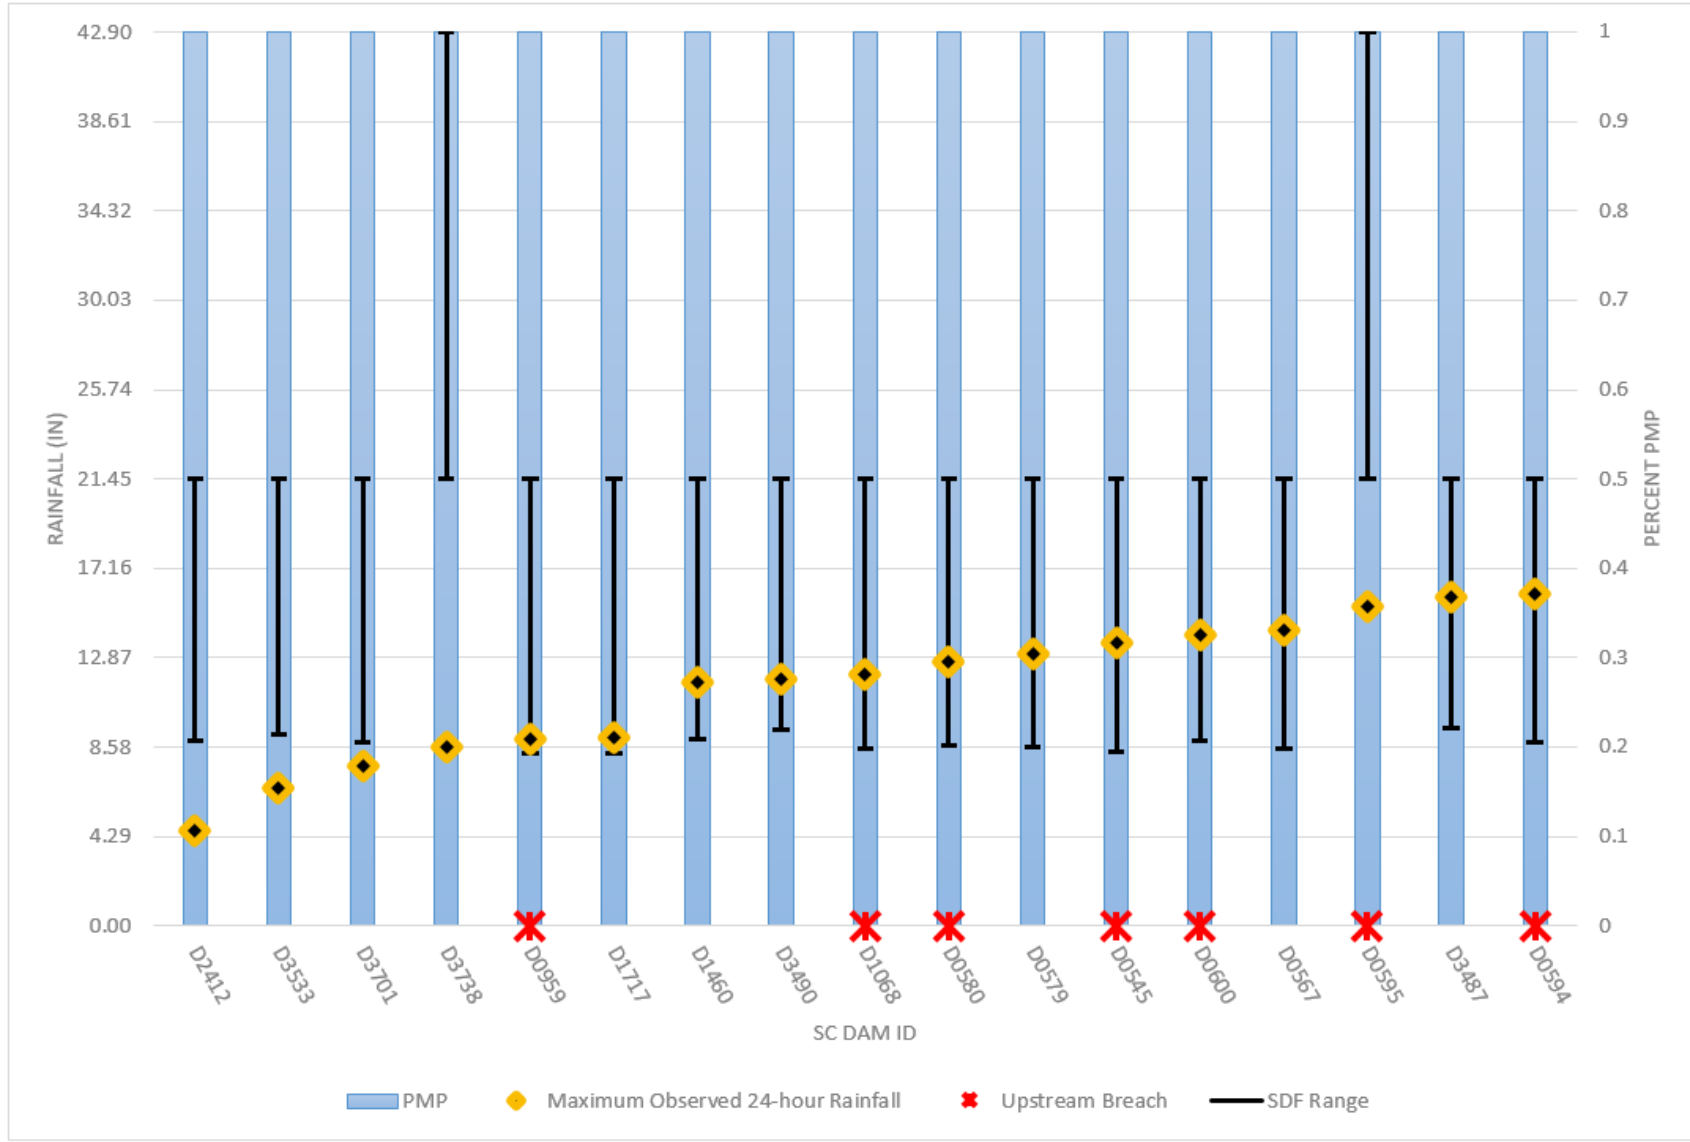
Figure 10: Rainfall Analysis for Significant Hazard Potential Dams Compared to SC DHEC SDF Design Criteria (Assumes that a 24-hour PMP results in a PMF)

- The majority of the Significant Hazard potential dams (12 of 17) in Figure 10 received a rainfall loading greater than the minimum SDF amount, but less than the maximum SDF amount.

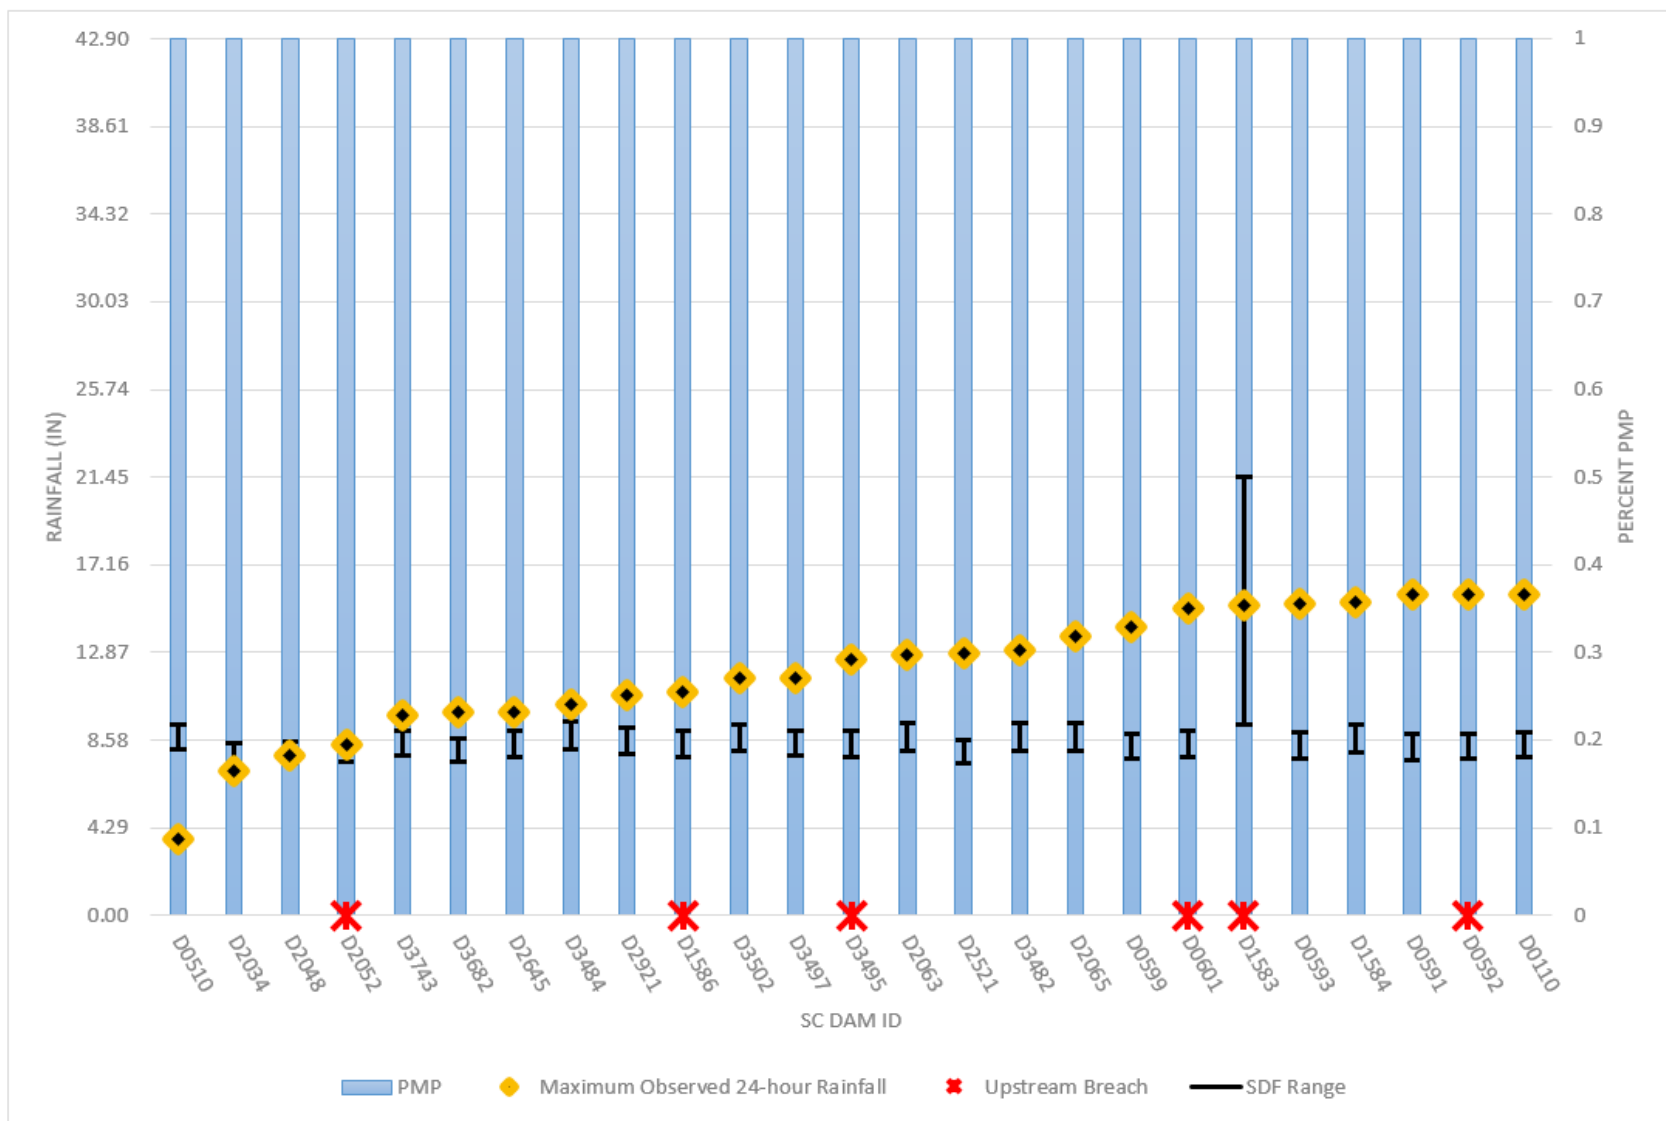
Figure 11: Rainfall Analysis for Low Hazard Potential Dams Compared to SC DHEC SDF Design Criteria (Assumes that a 24-hour PMP results in a PMF)

- The majority of Low Hazard potential dams in Figure 11 received a rainfall loading greater than the minimum SDF and the maximum SDF amount.
 - Six dams that experienced an upstream breach which may have potentially contributed to their failure. These failed dams' potentially experienced volumes more than what was required by regulations. All dams were constructed prior to the enactment of the Dams and Reservoirs Safety Act.

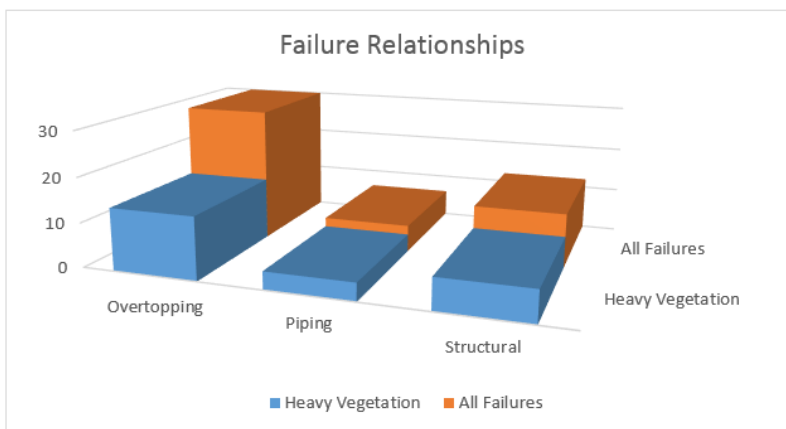
Figure 19: Failed Dams Having Heavy Woody Vegetation

This data was broken down further to determine the number of dams exhibiting heavy woody vegetation which can potentially contribute to failure as illustrated in Figure 19. Woody vegetation penetrations of earthen dams is all too often believed to be a routine maintenance situation, but penetrations of earthen dams and their appurtenances have been demonstrated to be causes of serious structural deterioration and distress that can result in failure of earthen dams. This data was further broken down by failure modes to illustrate the frequency of heavy vegetation on dams. Heavy vegetation was observed at 14 of 30 dams with a probable failure mode determined to be by overtopping, 4 of 6 dams with a probable failure mode determined to be by piping, and 7 of 12 dams with a probable failure mode determined to be structural failures.

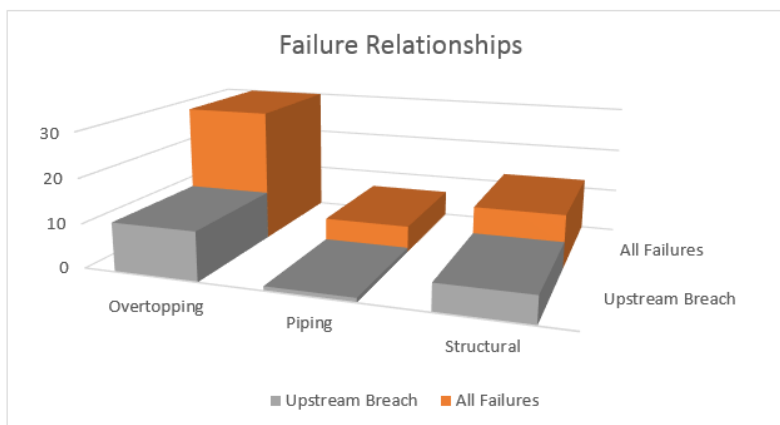
Figure 20: Failed Dams Where Upstream Breach Occurred

satellites. It is important to note that this data should not be used to say whether or not an upstream breach contributed to the downstream dam failure. In many cases, this is quite possible. However, in other cases the upstream dam may have breached after the downstream dam, thus not contributing to the downstream dam's failure. This indicated that a large number of dams that most likely failed due to overtopping and structural failures were located downstream of another breached dam (Figure 20).
