# **BUILDING PERFORMANCE: HURRICANE ANDREW IN FLORIDA**

OBSERVATIONS, RECOMMENDATIONS,  
AND TECHNICAL GUIDANCE

FEDERAL EMERGENCY MANAGEMENT AGENCY  
FEDERAL INSURANCE ADMINISTRATION

**DECEMBER 21, 1992**

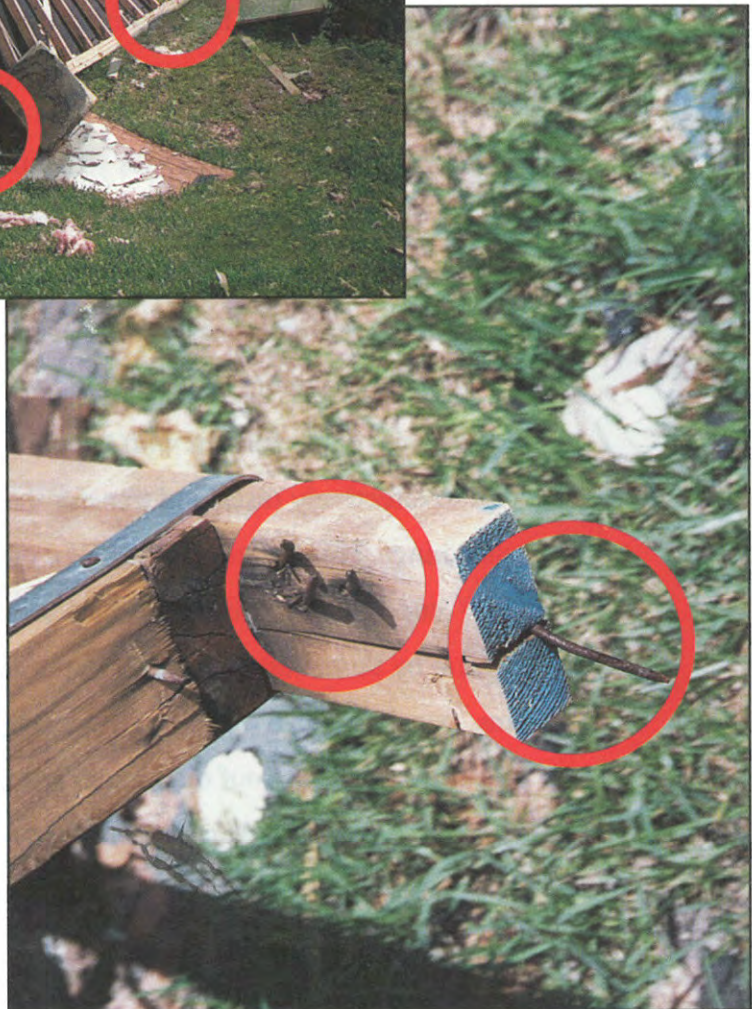
An absence of or improper installation of framing connections, load transfer straps, or bracing from non-loadbearing walls to connecting wall and roof components was noted. This condition contributed significantly to the primary failure of the framing system (SEE FIGURES 4 AND 5).

FIGURE 5.  
*End of exterior non-  
loadbearing wall top  
plate. Transfer of  
forces on entire wall  
depended on a limited  
number of nails.*

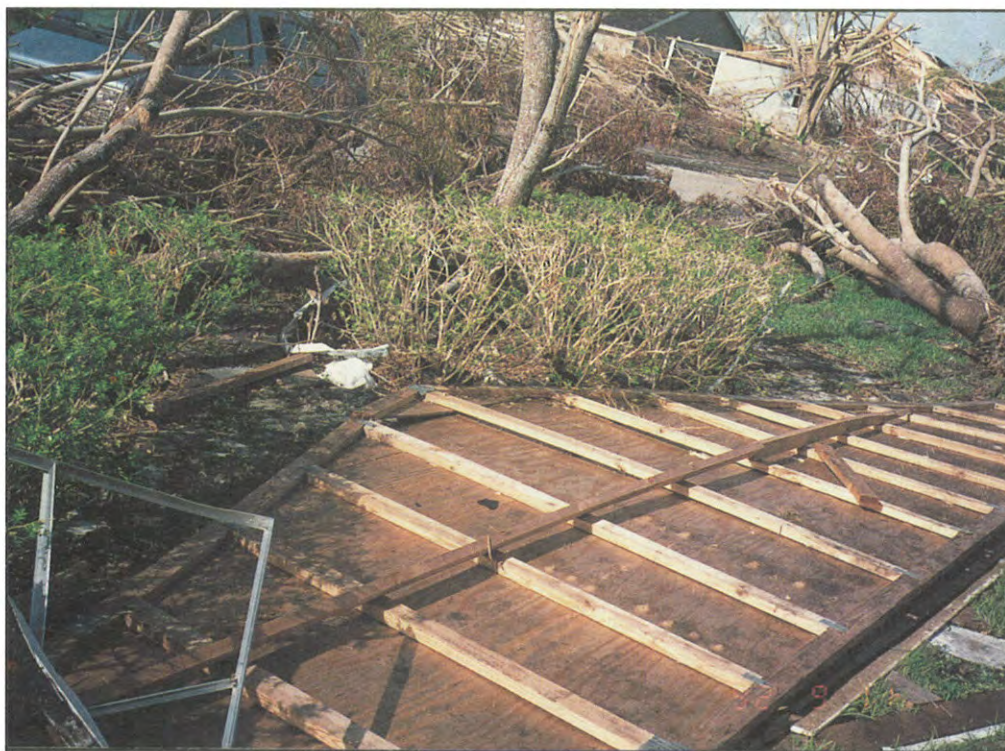
The wood-frame gable ends of roof structures were found to be especially failure-prone. Wood-frame gable ends are effectively a vertical continuation of windward/leeward wall systems and require bracing from within the roof structure for lateral force resistance. A lack of an adequately defined load transfer path for the gable ends was evident. Bracing of the wood-frame gable ends was not performed with the consistency and completeness required to effectively resist and transfer the wind loads in the absence of roof sheathing. This indicates a lack of a clear understanding of the gable sections’ importance to the integrity of the overall structural system during a wind storm by those responsible for the design and construction of such systems. (SEE FIGURES 6 AND 7). The reliance on plywood sheathing to act as the sole stiffener of the roof diaphragm left buildings susceptible to structural damage from roof truss collapse when sheathing separated from the roof trusses.

FIGURE 6. *Entire wood gable separation. Bracing connection, if completed, may have prevented this from occurring.*

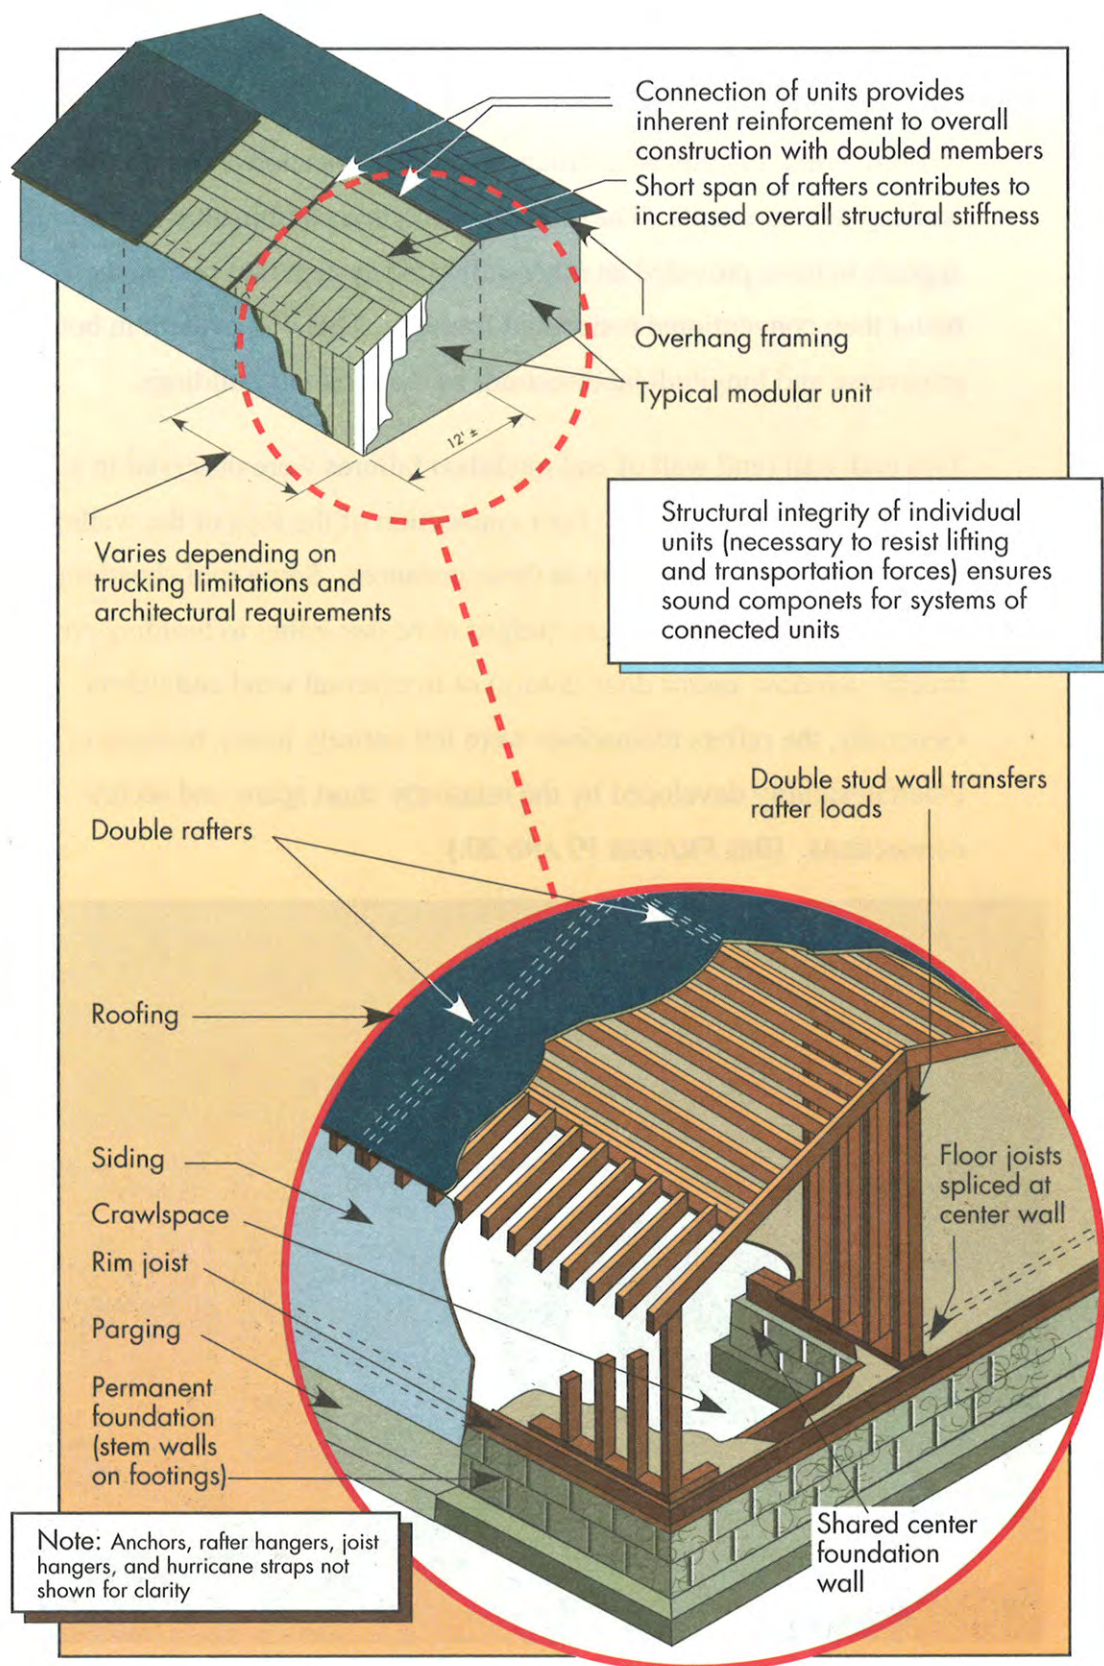
Two end-wall (end wall of end modules) failures were observed in a modular home subdivision. Poor connection of the tops of the walls to the roof diaphragms was evident in these instances. Some roof sheathing was observed missing from rafters, judged to be due either to building envelope breach (window and/or door failure) or to external wind and debris. Generally, the rafters themselves were left entirely intact, because of the inherent rigidity developed by the relatively short spans and secure connections. (SEE FIGURES 19 AND 20.)

FIGURE 20. *Inherent structural strength of modular construction.*

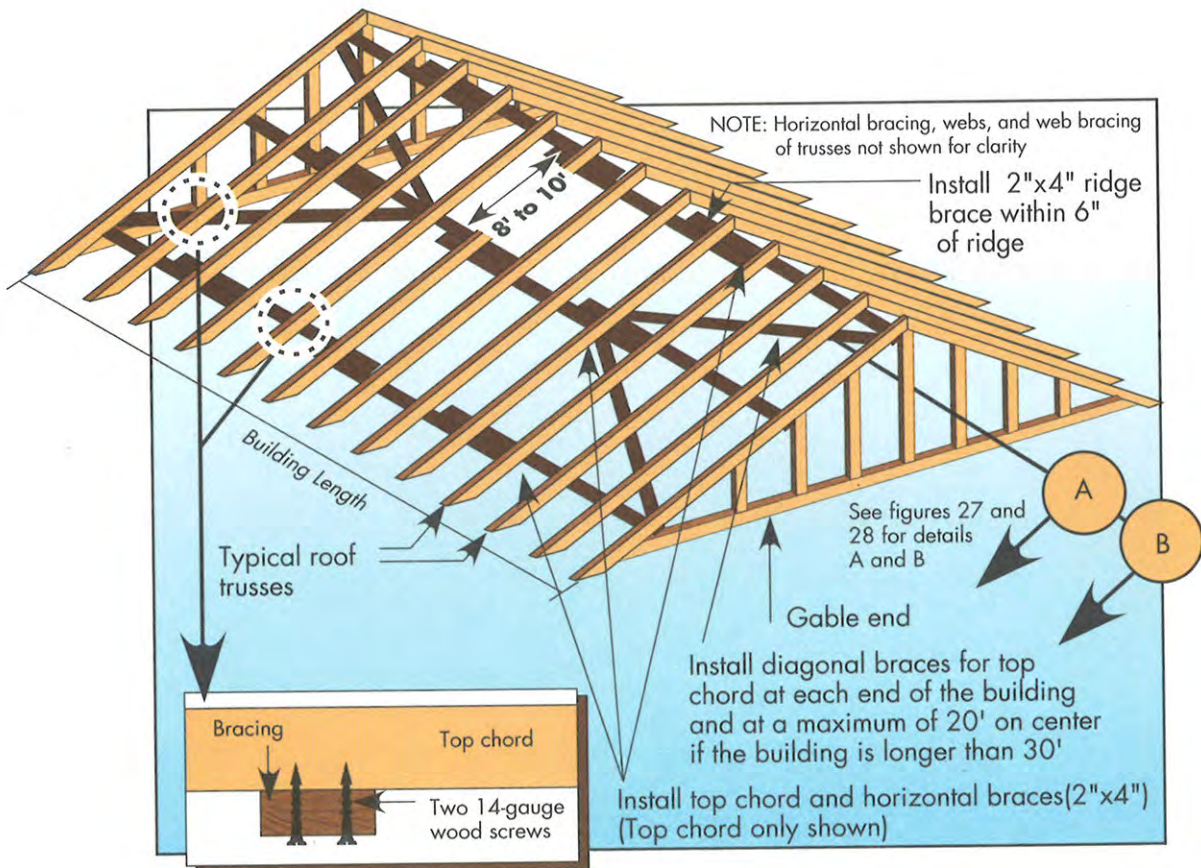
FIGURE 26. Typical roof truss top chord bracing.

1. In addition to the existing program of systematic framing inspections, a specific roof bracing and sheathing inspection should be required prior to installation of roof underlayment (SEE FIGURES 26-29). Note the extra bracing recommended for gable ends in particular.

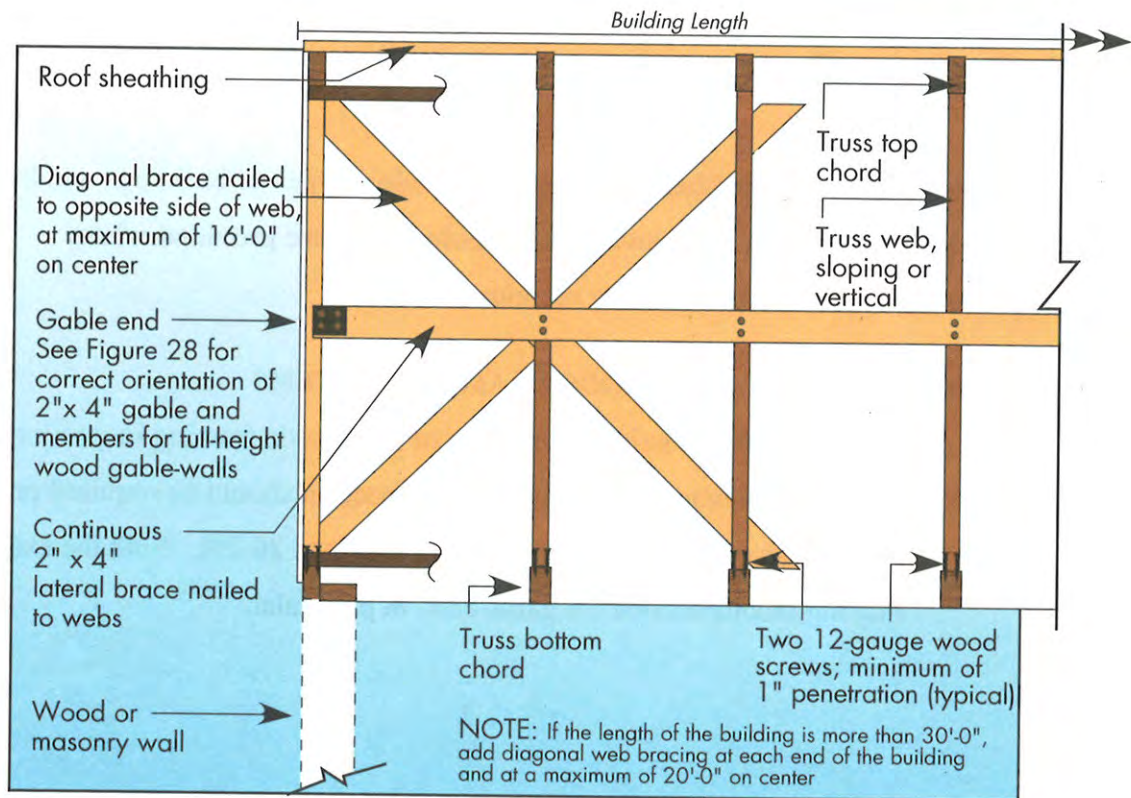
FIGURE 27. Detail A — Typical truss web bracing. Diagonal web bracing as shown, at each gable end of building.

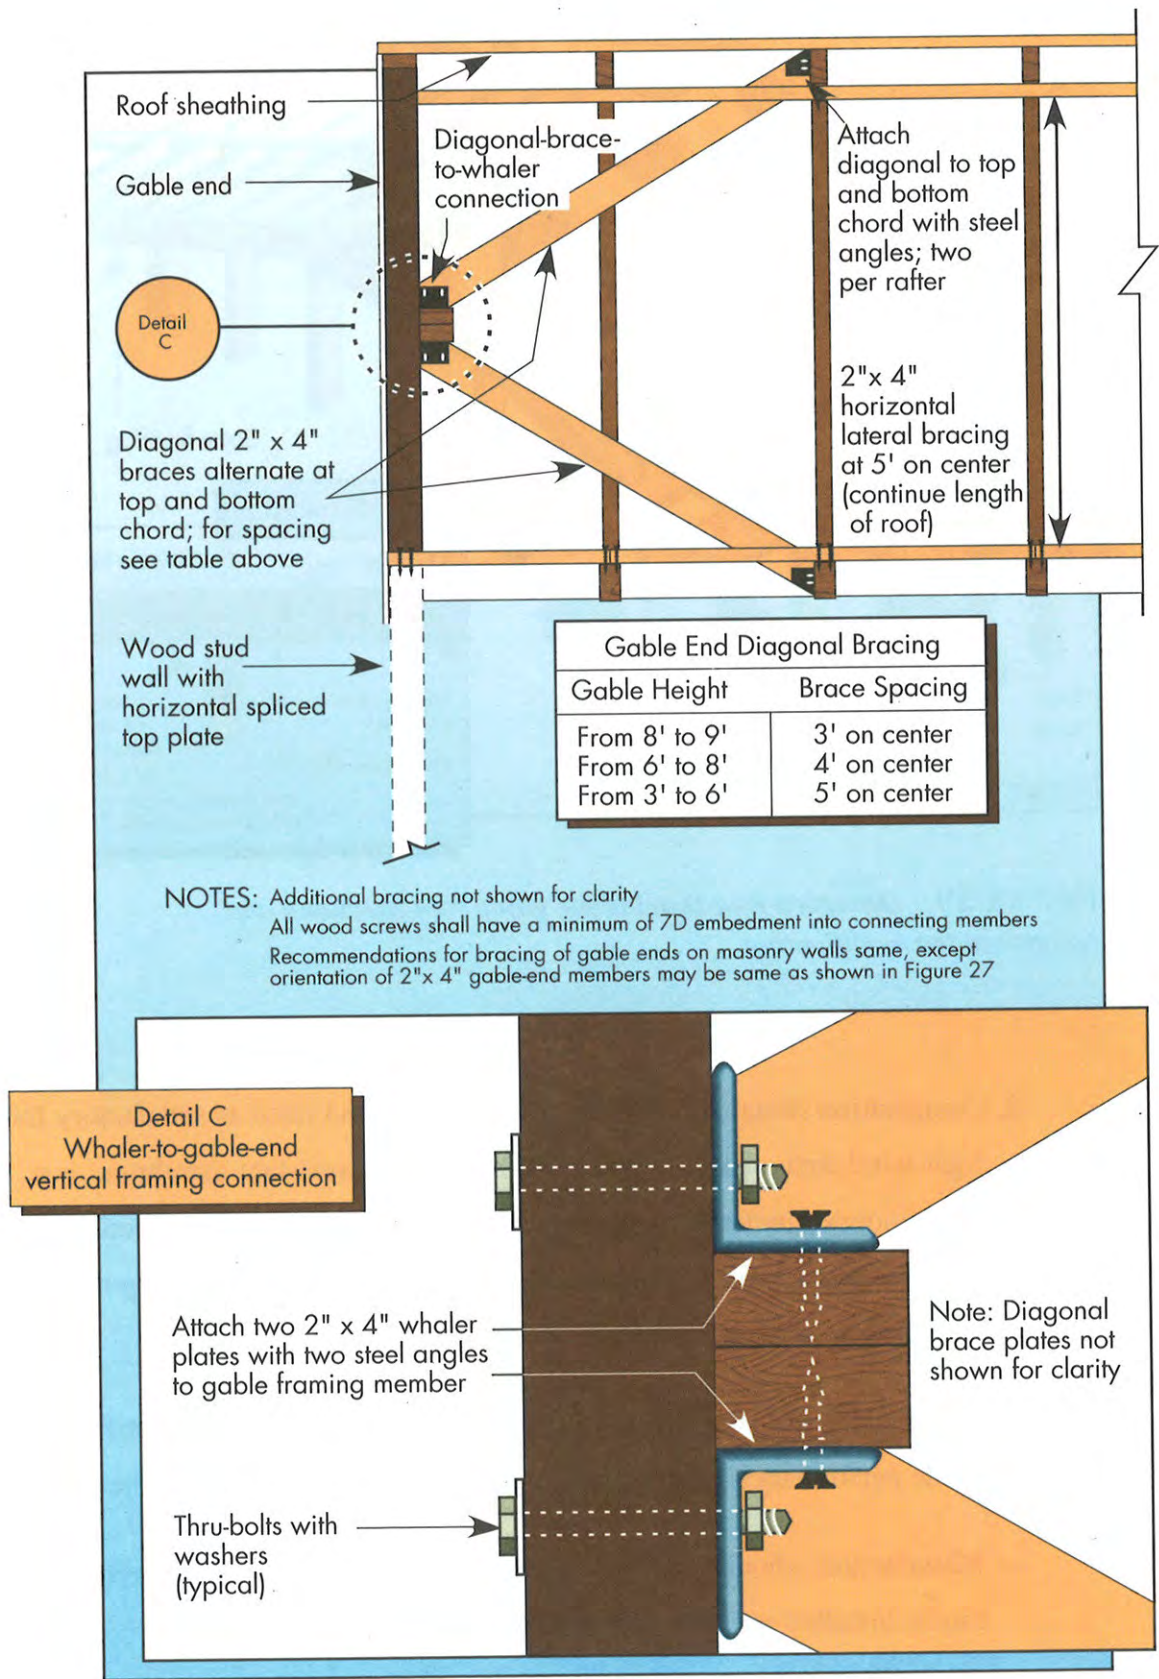
FIGURE 28. *Detail B — Typical wood gable-wall bracing.*

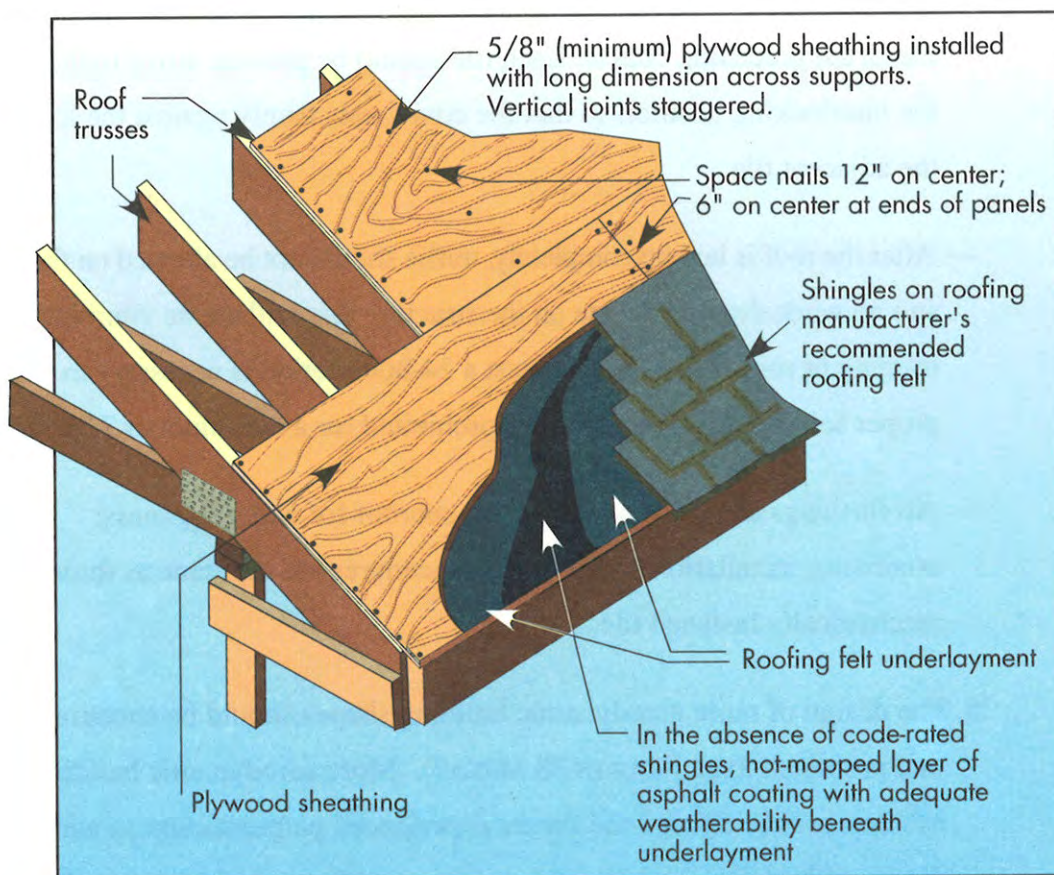
FIGURE 31. *Composition shingle roofing system showing sheathing and hot-mopped underlayment.*

2. Composition shingles should be manufactured and rated as satisfactory for high-wind areas. In the absence of this, a water-resistant membrane, e.g., a hot-mopped underlayment, should be installed to provide protection from the water infiltration that may result from the loss of roofing material during high-wind storms (SEE FIGURES 30 AND 31).
  3. Manufacturers of roof tile products should provide testing and verification of tile performances under realistic conditions (as addressed by the Code).
- Manufactures should verify that mortar used with extruded concrete tiles can be installed to Code requirements.

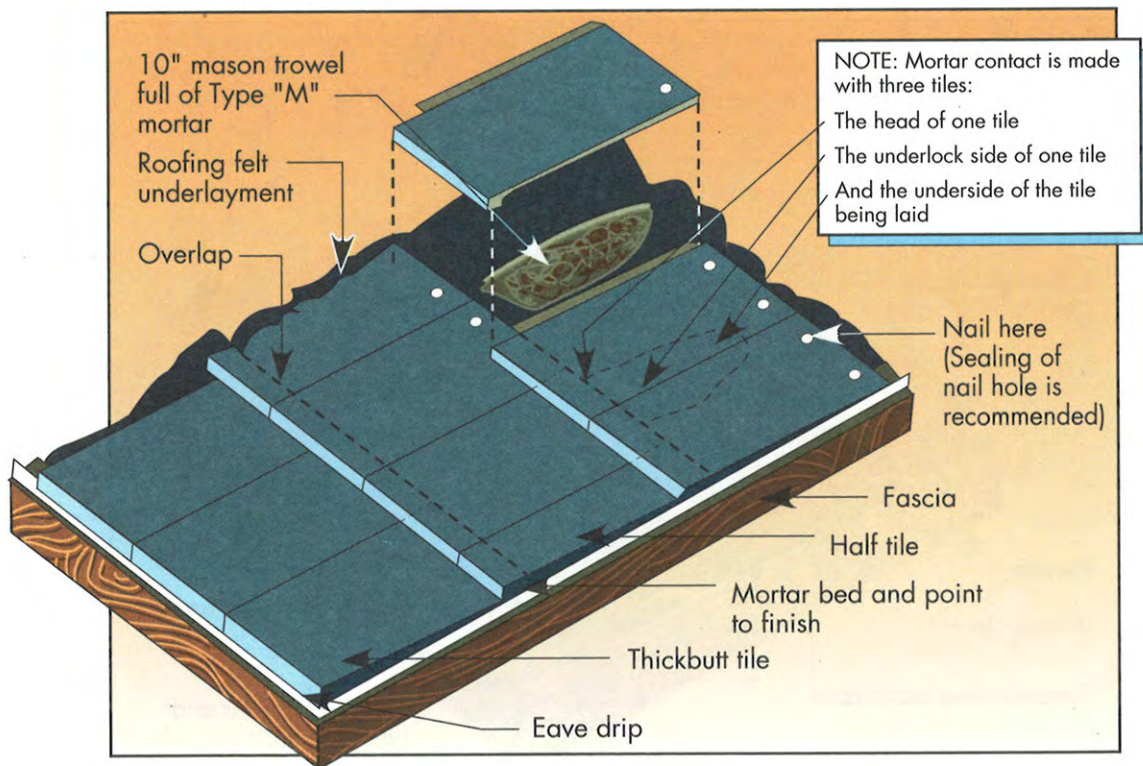
FIGURE 33. *Recommended tile and mortar placement for extruded concrete flat tile roofing system.*

4. Quality control of roof tile installation should be improved by ensuring both consistent mortar pad placements and installation in accordance with manufacturers' requirements, as specified by the Code. (SEE FIGURES 32-37). Though this would improve the survivability of roof tile systems, continued debris impact will result in damage occurring from future wind storms.

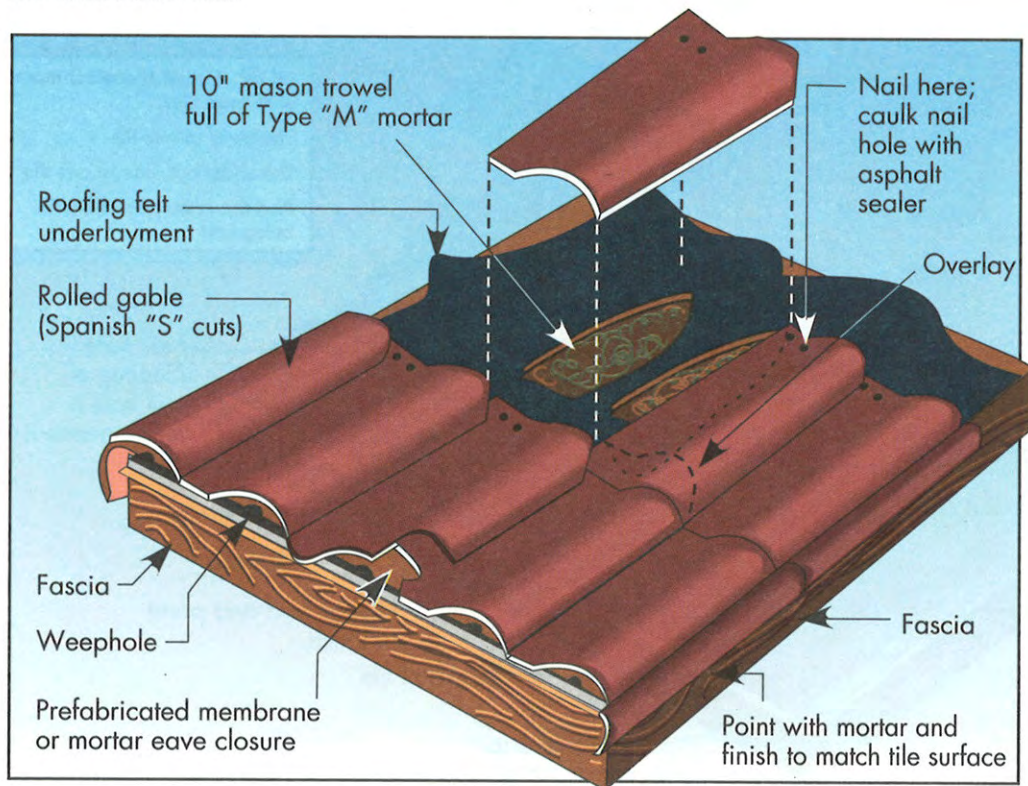
FIGURE 35. *Recommended tile and mortar placement for "S" tile roofing system.*

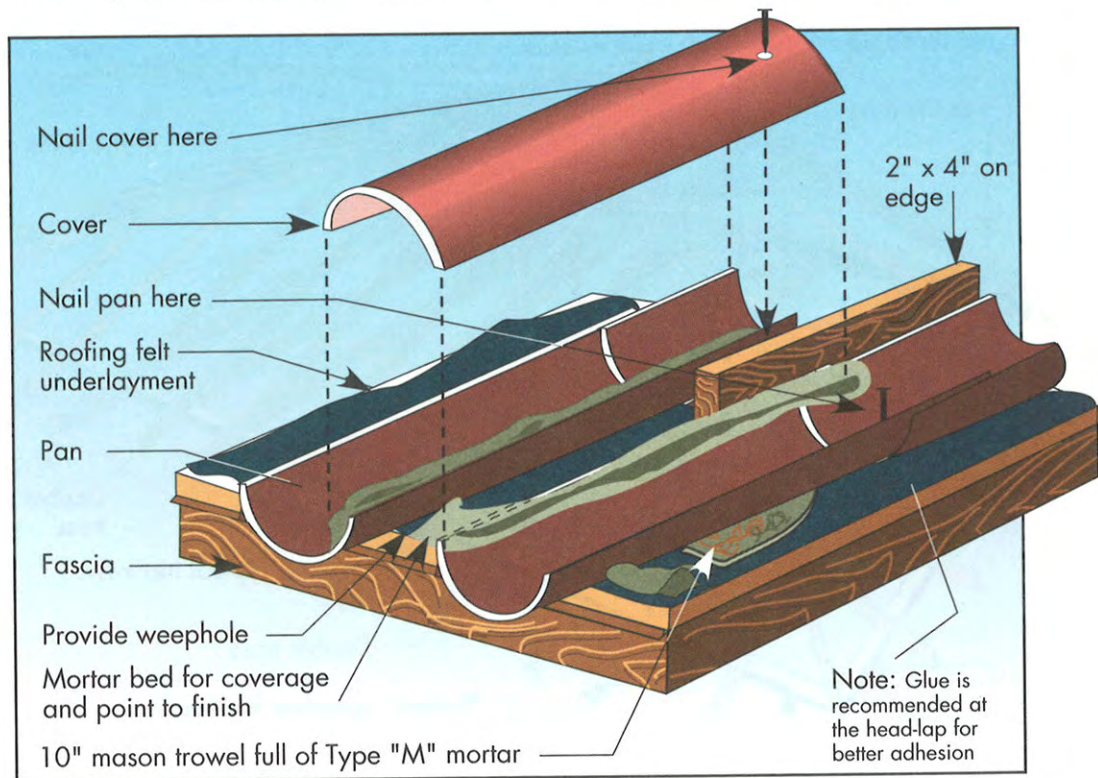
FIGURE 37. *Recommended tile and mortar placement for barrel tile roofing system.*

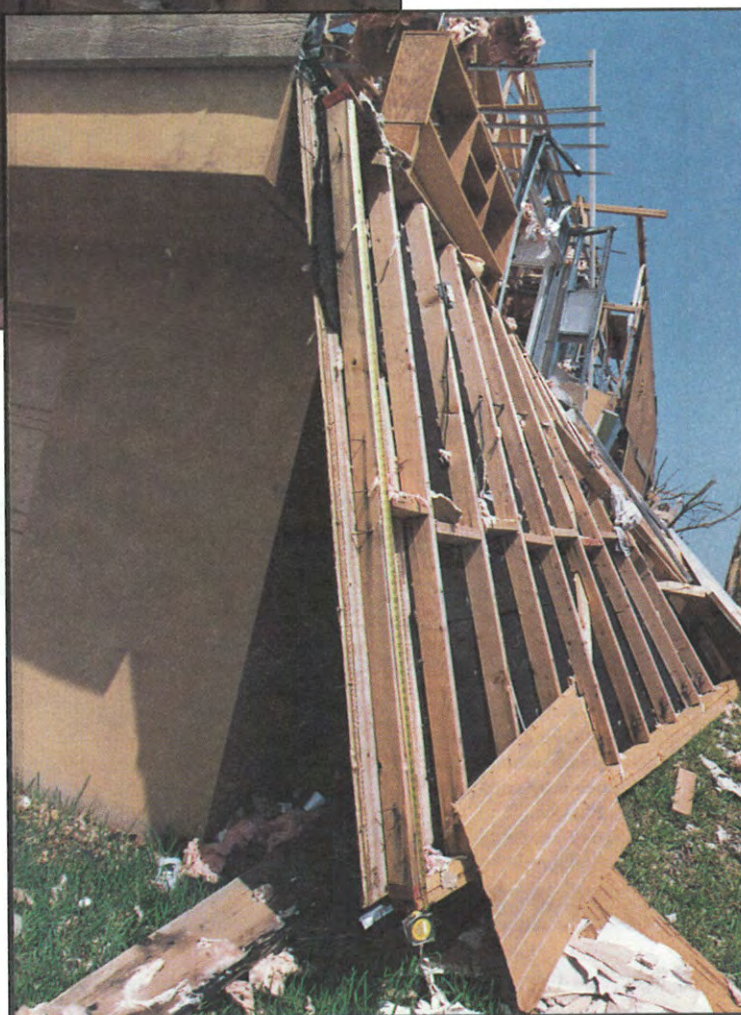
FIGURE 60.  
*Side wall failure. Side  
wall has no lateral load  
transfer capacity due to  
inadequately built-up  
corner post.*

1. Designers and plan reviewers should pay greater attention to lateral load transfer mechanisms because of high lateral loads generated by hurricane winds (SEE FIGURES 9, 10, AND 54-58).
  2. At the construction stage, greater attention must be paid to the proper installation of all lateral load transfer mechanisms inherent in conventional building framing, especially hurricane straps and clips (SEE FIGURES 59-62).
- Manufacturers of metal connectors for wood framing currently provide on-site demonstrations and workshops for training purposes. These workshops should be structured to provide certificates of participation to builders and should be encouraged by the home-buying community.

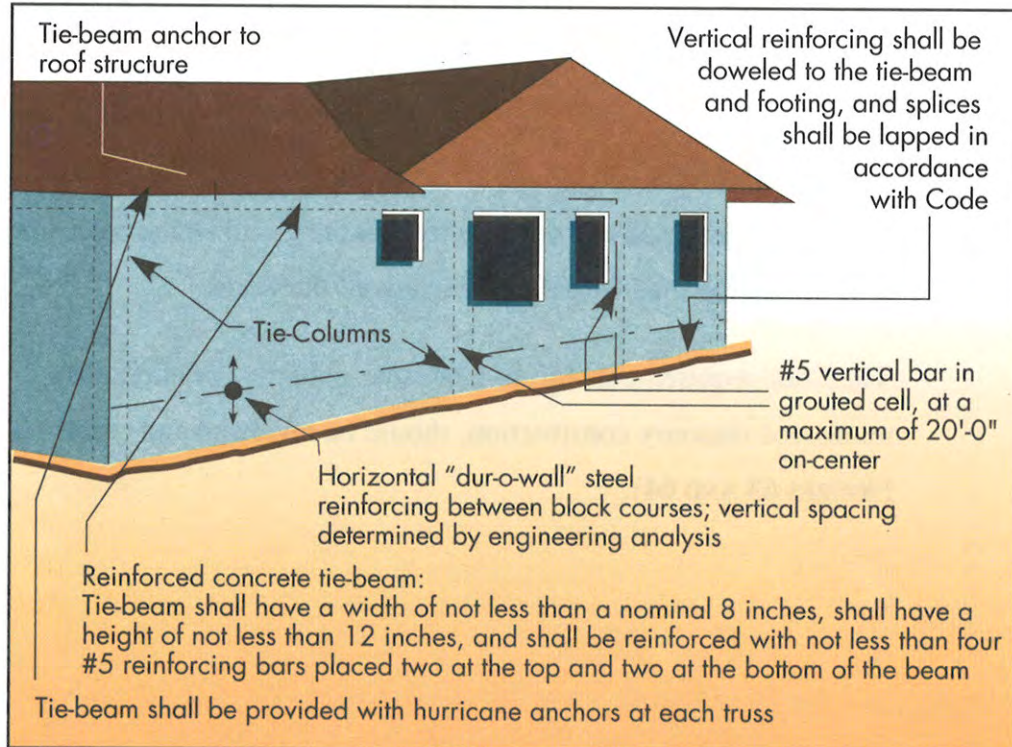
FIGURE 64. *Adequately designed and constructed tie-beam/tie-column masonry wall.*

— The Code requirements for tie-beams/tie-columns, or alternative reinforced masonry construction, should be reviewed and enforced (SEE FIGURES 63 AND 64).

- A tie-beam of reinforced concrete should be placed in all walls of unit masonry, at each floor or roof level, and at such intermediate levels as may be required to limit the vertical heights of the masonry units to 16 feet.

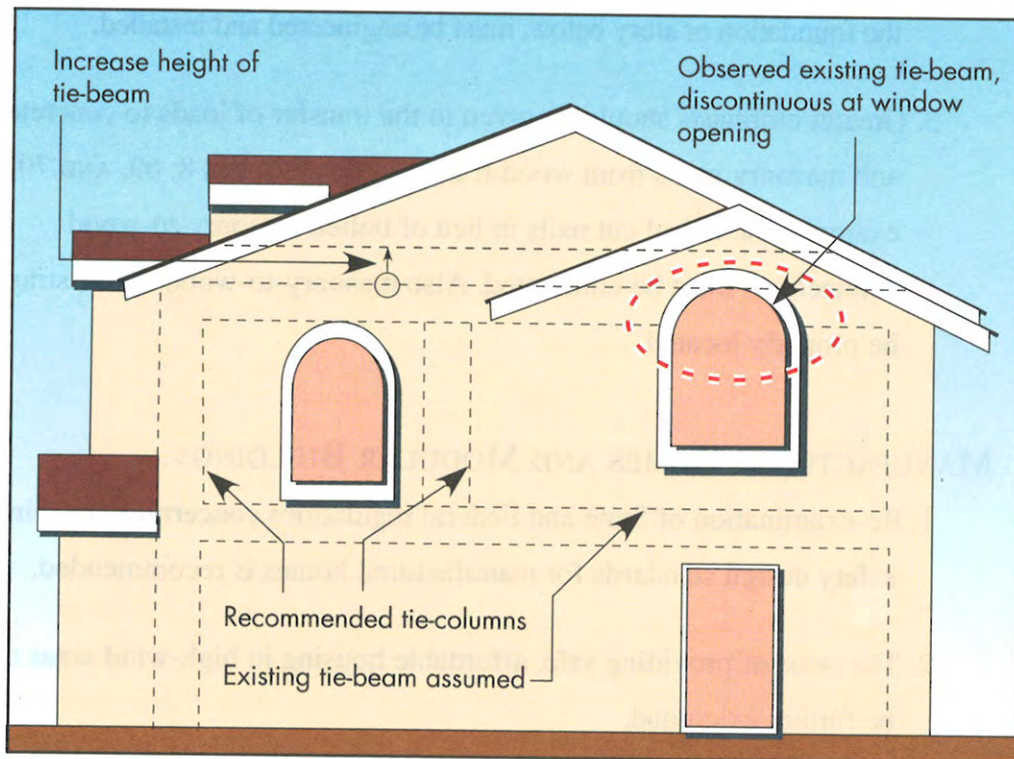
FIGURE 66. *Individualized architectural systems require designs for structural support.*

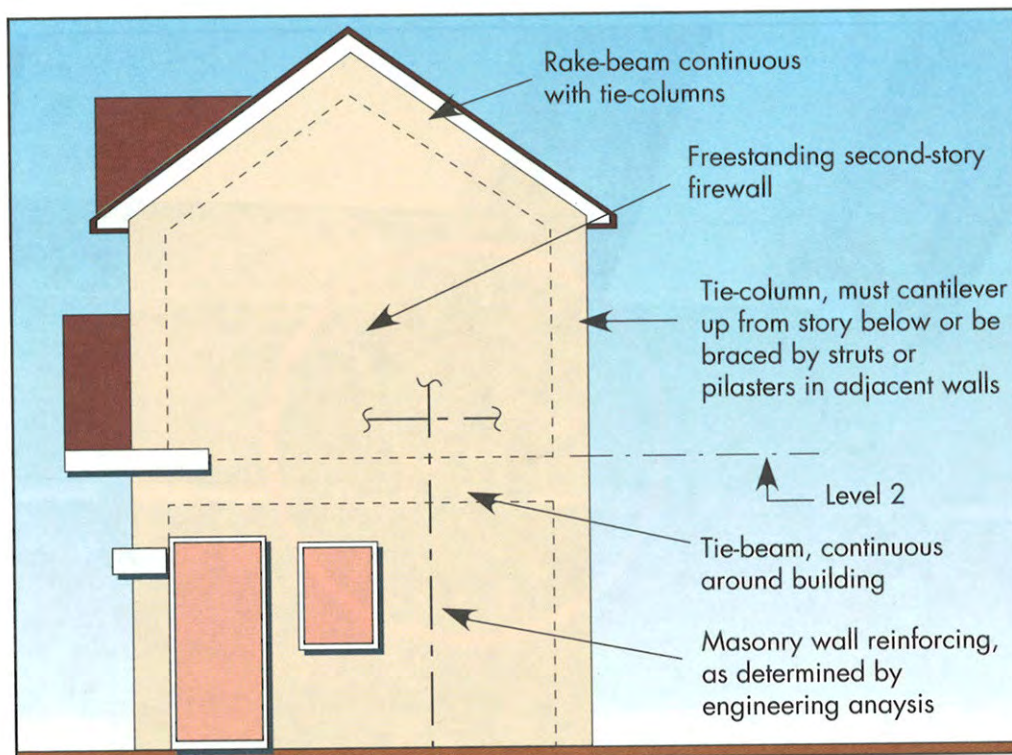
FIGURE 68. *Adequately designed and constructed freestanding cantilevered wall system.*

- Bracing with struts or pilaster columns in walls perpendicular to the free-standing walls, or adequate reinforcing in the walls sufficiently anchored in the foundation or story below, must be engineered and installed.

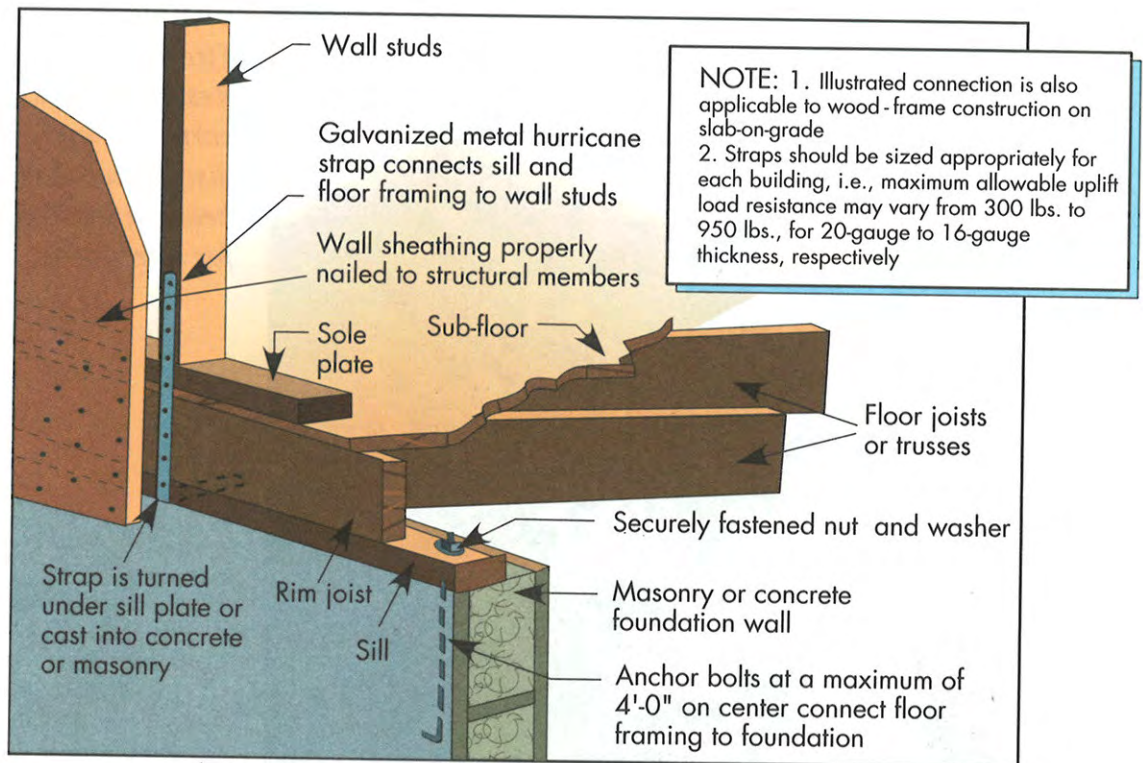
FIGURE 69. Lower-story wall anchorage to masonry (or concrete) base. Straps properly nailed at wall studs.
