BUILDING PERFORMANCE: HURRICANE INIKI IN HAWAII

OBSERVATIONS, RECOMMENDATIONS,
AND TECHNICAL GUIDANCE

FEDERAL EMERGENCY MANAGEMENT AGENCY
FEDERAL INSURANCE ADMINISTRATION

JANUARY 29, 1993

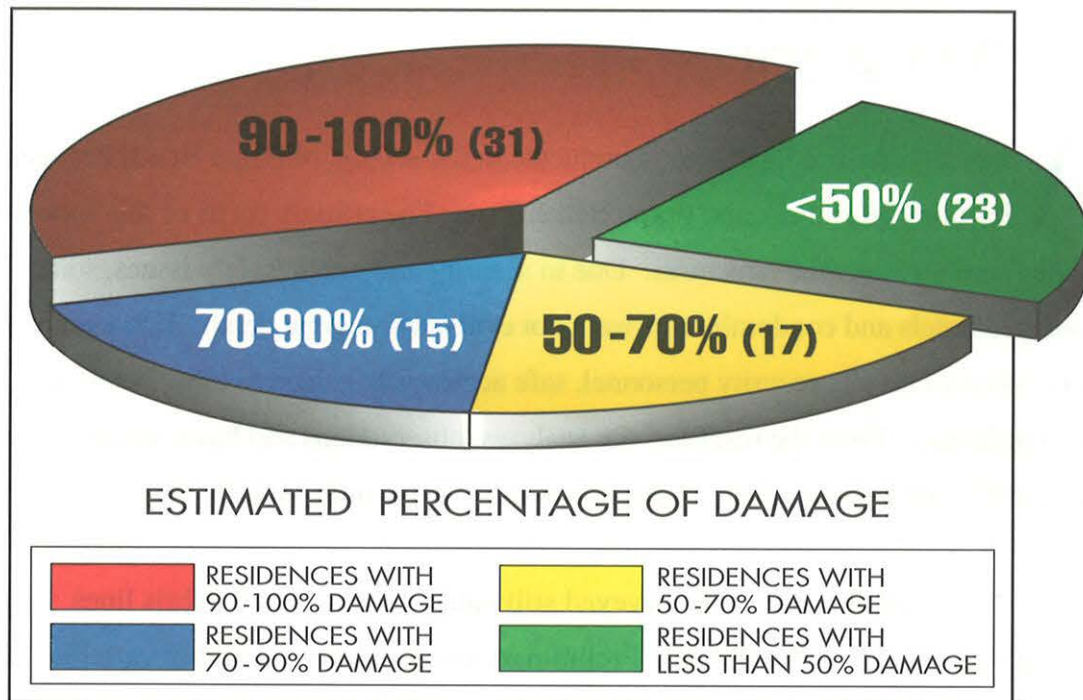
Coastal flooding in the section from Spouting Horn Park to Poipu Beach Park was severe and widespread, resulting in substantial damage to an estimated 60 or more single-family, detached residences (FIGURE 6). Several condominiums and hotels fronting the ocean also sustained significant flood damage to their lowest (ground level) units. Table 1 provides a preliminary inventory of damaged buildings for particular segments. The damage was caused by direct wave impact on buildings that were constructed without adequate consideration of the potential flood hazard. Additional damage was caused by debris impact. This debris included lava rocks, trees, detached pieces of buildings, and in some cases entire buildings that rammed adjacent structures (FIGURE 7).

FIGURE 6. Results of preliminary field inventory of damaged residential buildings — Poipu Beach Park to Spouting Horn Park. Numbers in parentheses are building counts.

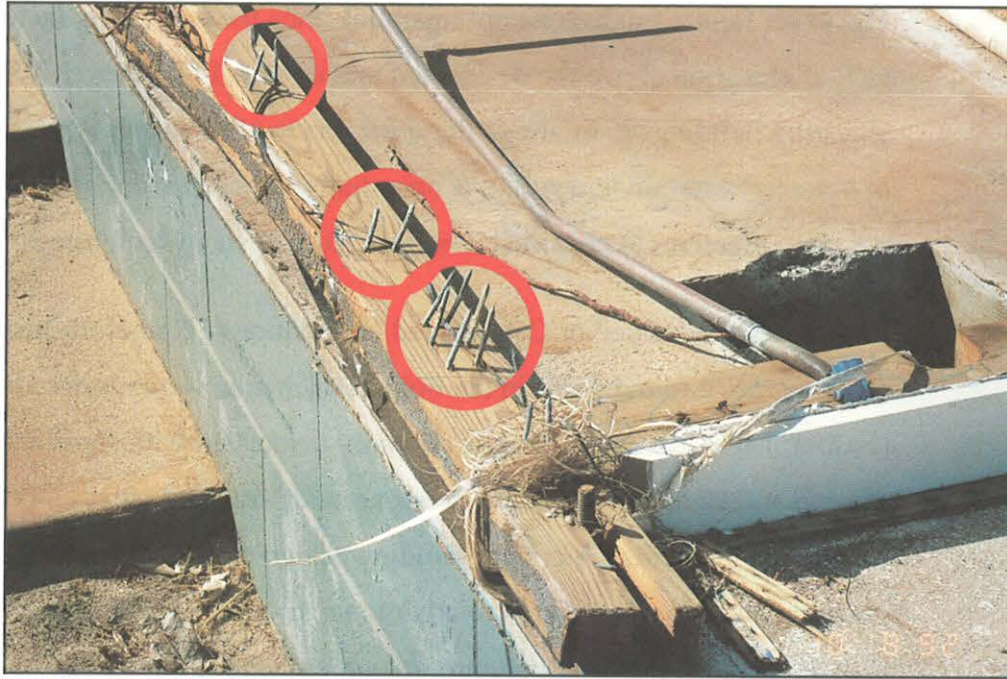
- In most instances where the bottom sill plate was fastened to the grade slab, the building was partially or entirely dislodged from its foundation. Either the wooden sill plate failed at the anchor bolts (FIGURE 12) or the vertical members (studs) were dislodged from the sill plate (FIGURE 13).
- Where the vertical members were not torn from the foundation, the walls were dislocated and the building's interior destroyed (FIGURE 14).

FIGURE 13. *Non-elevated building at Poipu Beach destroyed by coastal flooding. Vertical members ripped from sill plate.*

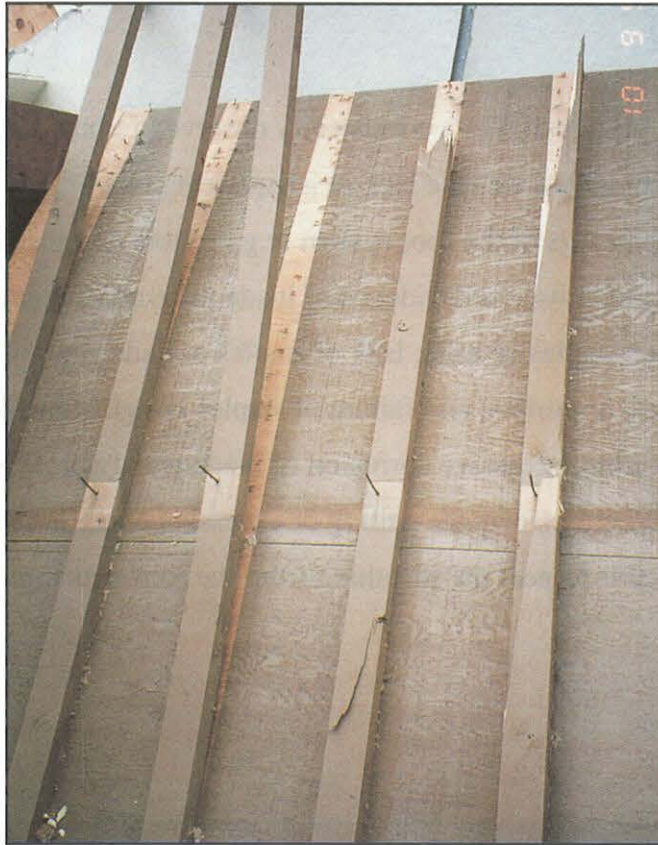
FIGURE 39.
Improper nailing design and schedule for purlin-to-rafter attachment. Note infrequency of nails for large surface area. Nowhere is the plywood sheathing directly nailed to the rafter system.

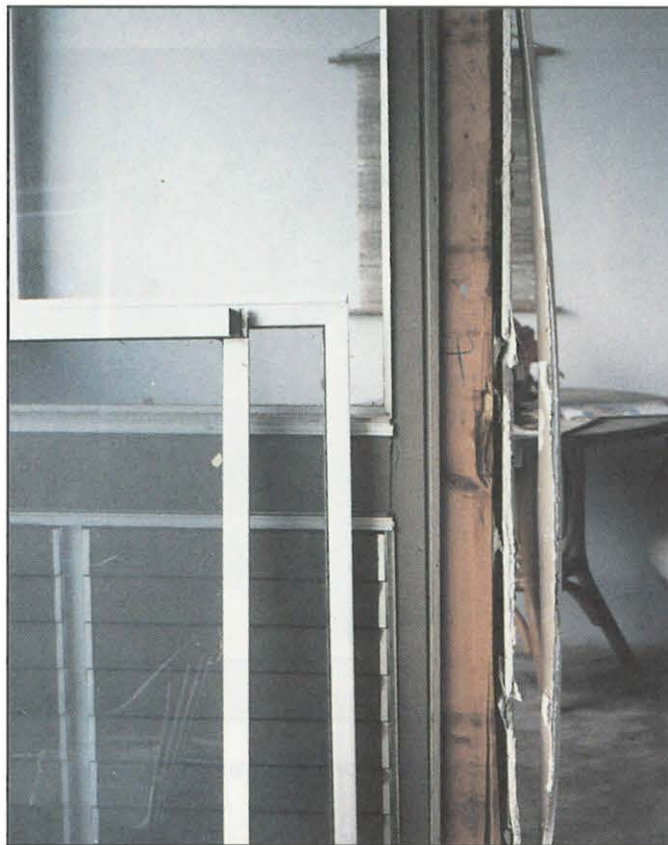
Failure of exterior wall openings occurred in two ways: 1) shattering of glazing from projectile impact (FIGURE 47) and 2) implosion or explosion of glazing due to the combination of wind pressure and improper installation (FIGURE 49).

FIGURE 49. *Implosion of transparent shatter-resistant sliding door. Failure of door frame due to improper attachment to structural elements.*

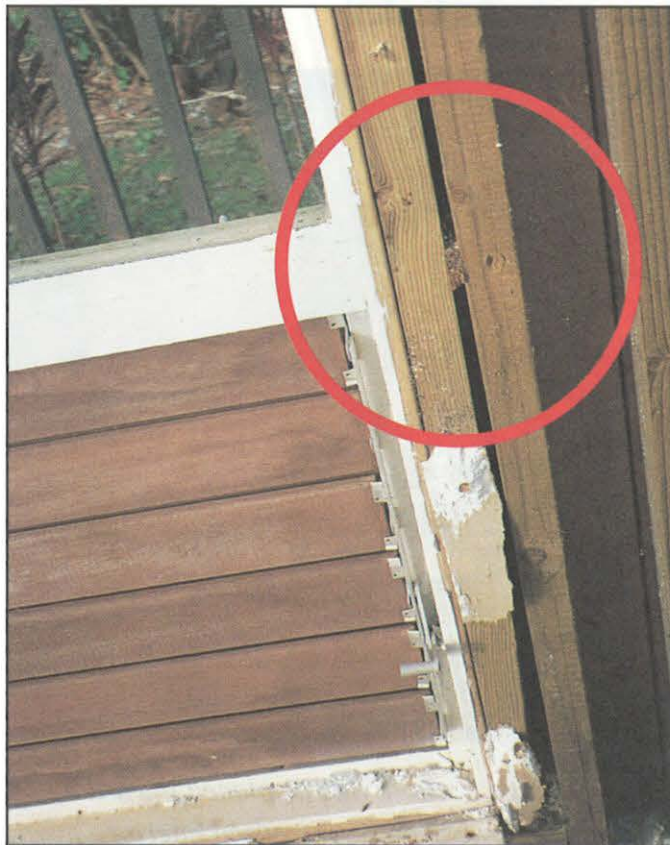
Improper installation, for example, inappropriate attachment of window frames to the structural elements of the wall (FIGURE 50), and weak connections of expansive sliding doors (FIGURE 51), were consistently observed causes of the failure of glazing units. Where shatter-resistant material was used, failure was frequently observed where the material remained intact, but the unit, as a whole, was displaced inward by wind pressure (FIGURE 52) due to bowing and subsequent failure at the perimeter connections.

FIGURE 50.
Improper attachment of window unit. Note only one connection (nailing) point between unit and wall structure at the single shim.

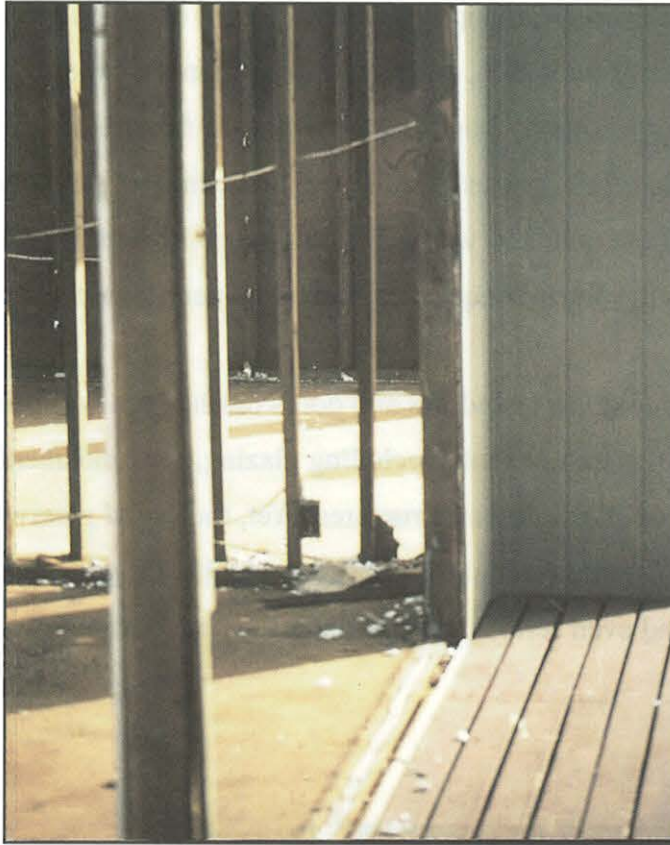
FIGURE 51.
Improper connection of sliding glass door. Track attached with only three screws in vertical member. Sliding track on floor attached with caulk only.

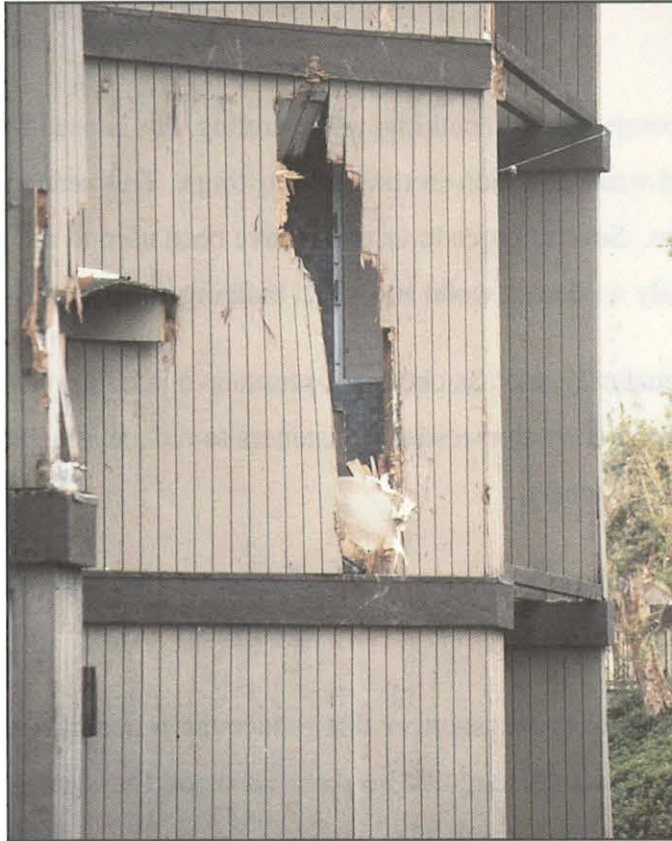
FIGURE 55.
*Windborne debris impact
can puncture building and
allow buildup of internal
wind pressure.*

the potential for compromise of windows and doors and failure of neighboring buildings; this in turn further increased the number of windborne projectiles.
