BUILDING PERFORMANCE ASSESSMENT:

Hurricane Fran in North Carolina

OBSERVATIONS, RECOMMENDATIONS,
AND TECHNICAL GUIDANCE

FEDERAL EMERGENCY MANAGEMENT AGENCY
MITIGATION DIRECTORATE

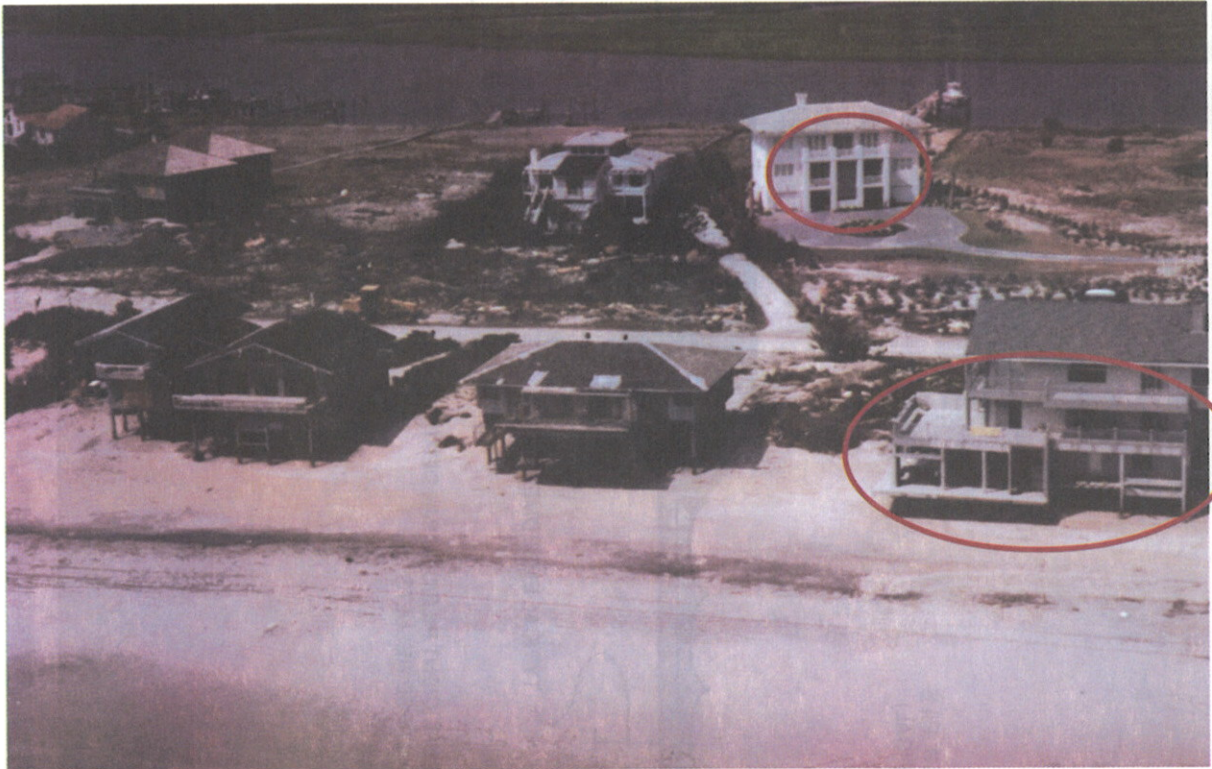
Figure 2-15 As shown by this post-Fran photograph taken at Figure Eight Island, North Carolina, a current architectural trend is the construction of multistory decks supporting roof overhangs.

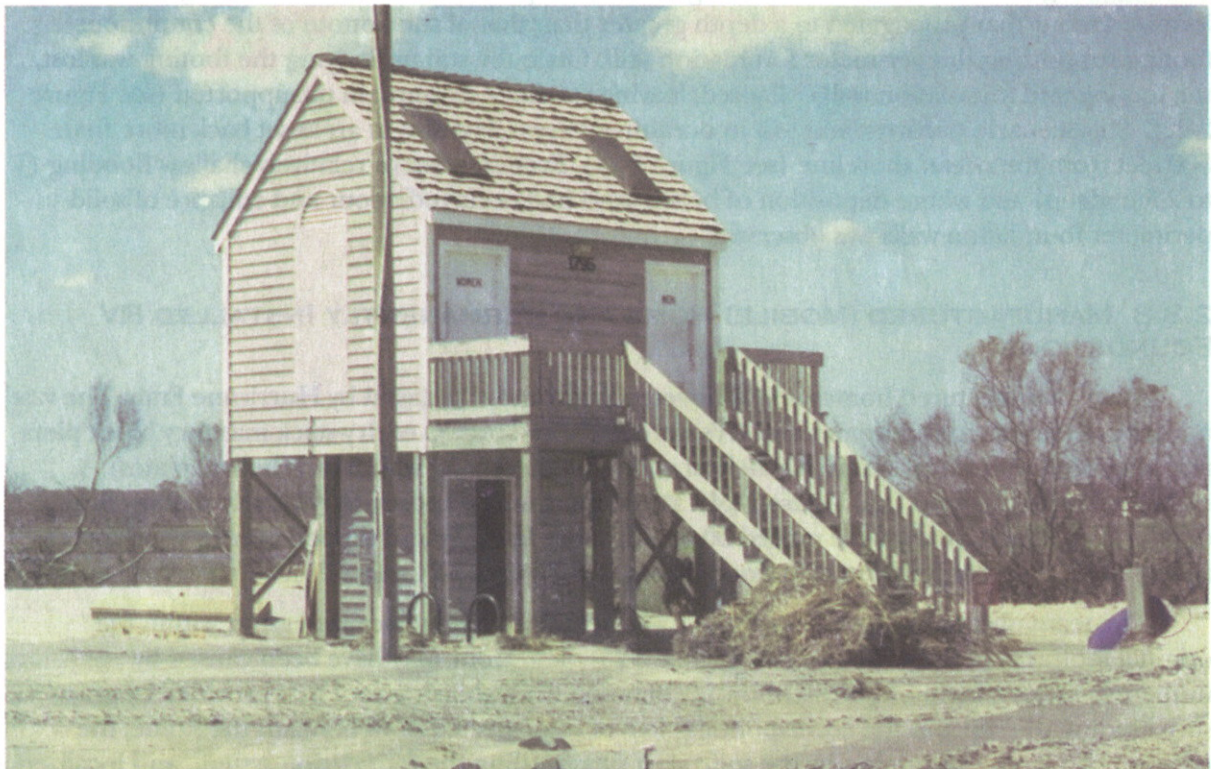
NFIP regulations require that structures in Coastal High Hazard Areas (V zones) be elevated so that the lowest horizontal structural member of the lowest floor is at or above the BFE shown on the FIRM in effect at the time of construction. In the areas visited by the BPAT, structures in V zones appeared to have been built in compliance with this requirement. For structures in A zones, the NFIP regulations require that the lowest floor be elevated to or above the BFE; no requirements are imposed for structures in B, C, and X zones. Although elevating on open foundations with lowest horizontal structural members at or above the BFE is not required outside of V zones, this practice was widely observed in A, B, C, and X zones on the barrier islands within the study area (see Figure 2-21).

Figure 2-21 Survival of this properly elevated North Carolina State Park public rest room demonstrates the State's commitment to proper construction in coastal areas.

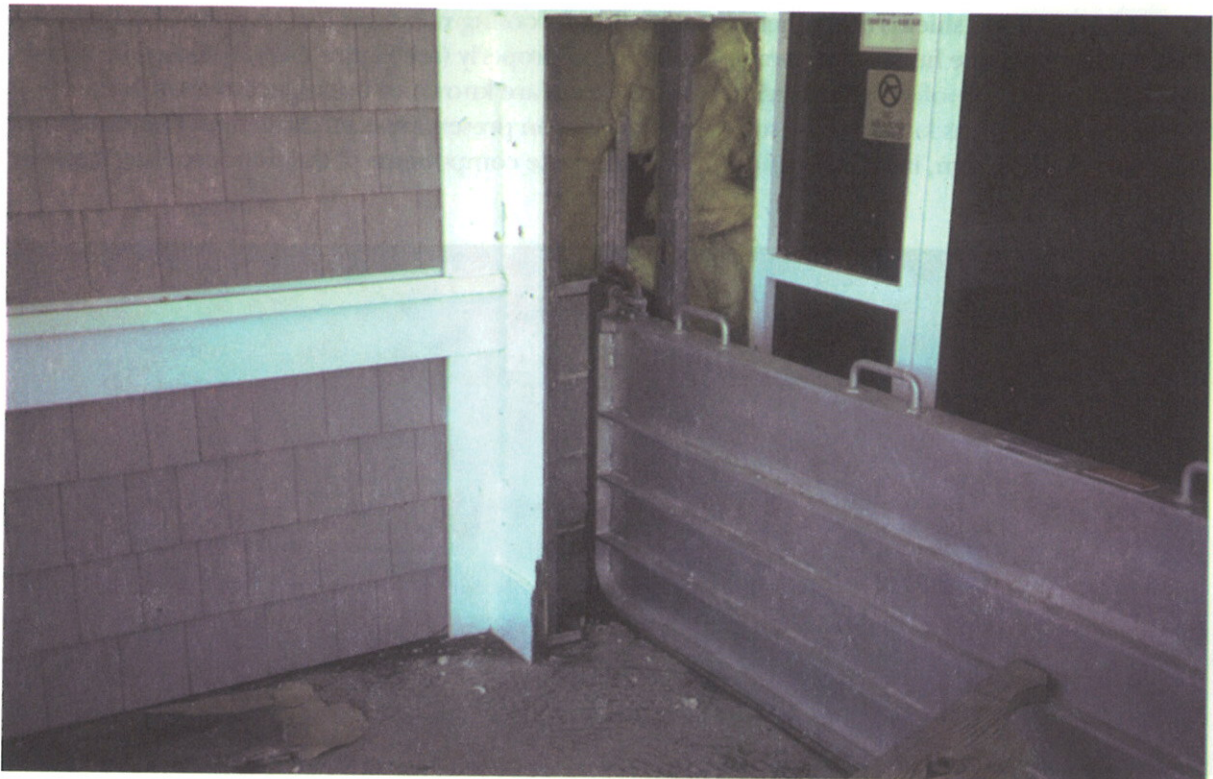
The BPAT interviewed the hotel manager and engineer during the site investigation. Both were directly involved in the renovation of the hotel. Both said that the floodproofing was worth the effort but that they wished the shields had been 1 foot higher. While the shields prevented the storm surge from entering the protected area, some water splashed over the tops of the shields. The water that passed over the top flooded the conference rooms to a depth of 4 inches. It damaged the carpeting and mildewed the wall paper. However, in the remaining portions of the hotel, which were not floodproofed, the depths of flood waters reached 18 inches. In these areas, the water damaged the sheetrock and left over 2 inches of sand on the floor. Both the manager and the engineer stated that keeping sand out of the conference area was, in itself, justification for the expense of the floodproofing.

Figure 2-40 Engineered flood shield installed over opening to large dry floodproofed commercial building.

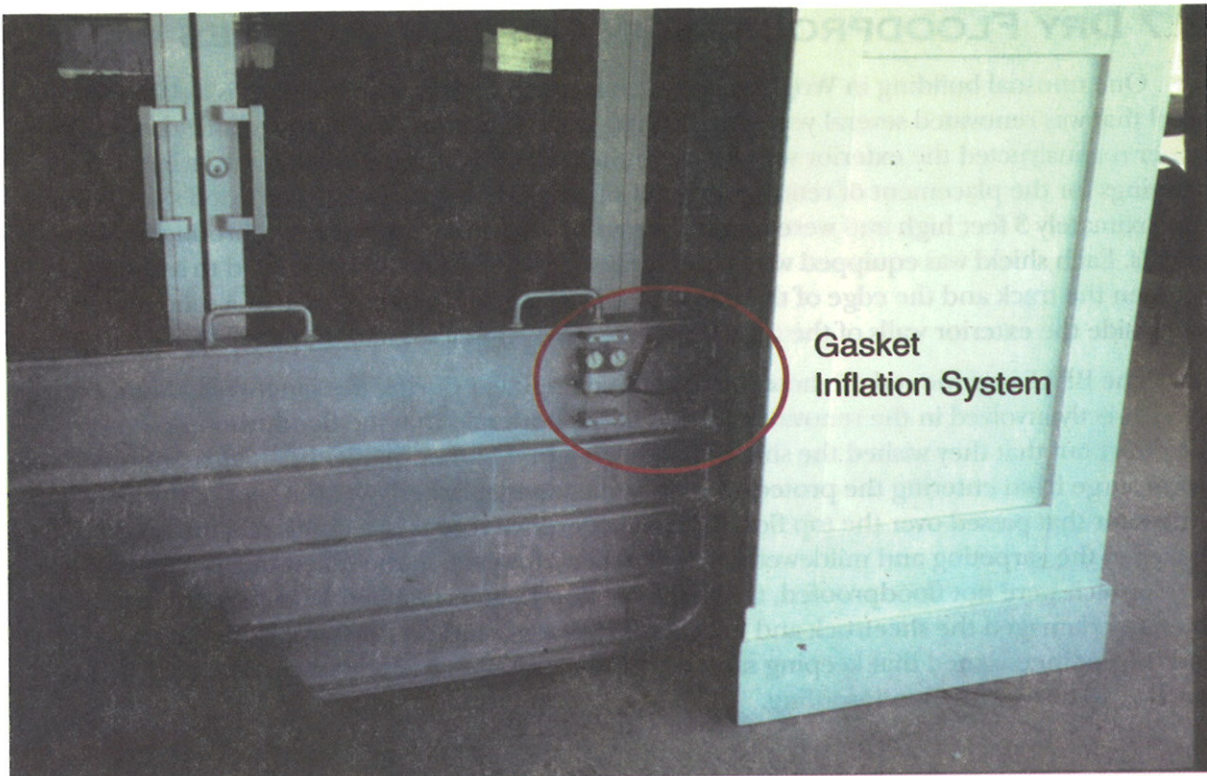
Figure 2-41 *Buildings that are floodproofed require extensive engineering detailing. Note that this flood shield is sealed with a pneumatic gasket.*

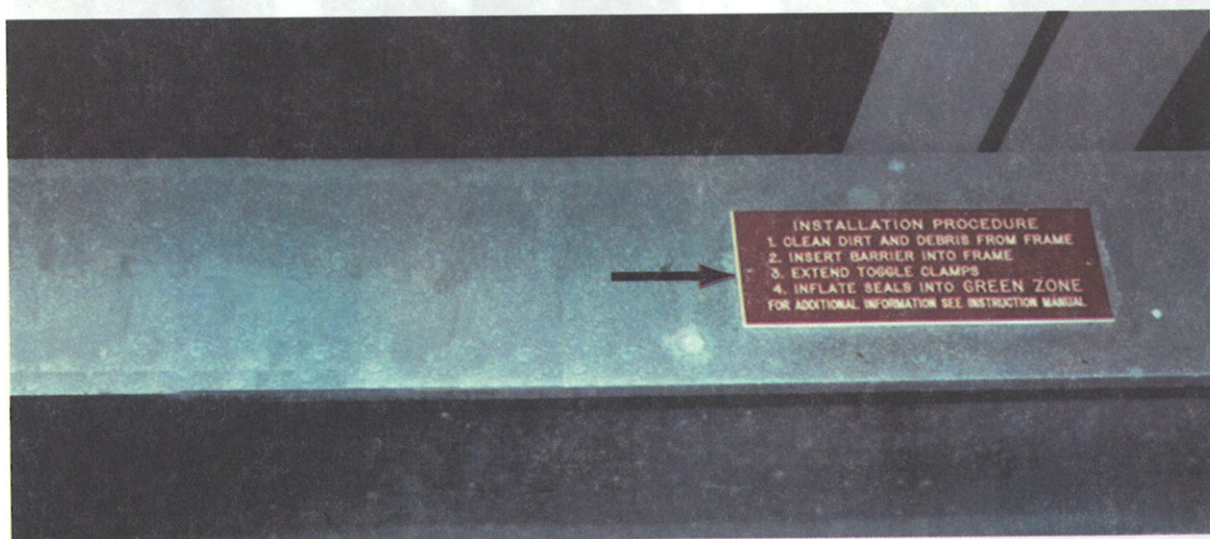
Although flood shields and other elaborate floodproofing measures can be quite effective, they often require extensive human intervention to function properly (see Figure 2-42). It should be noted that very few floodproofed buildings in coastal A zones are known to be subject to wave action. Floodproofing in areas known to be subject to wave action presents special challenges that must be addressed in the design, installation, and operation of the components of the floodproofing system.

Figure 2-42. *Dry floodproofing often requires extensive human intervention. Note the detailed instructions affixed to this flood shield.*

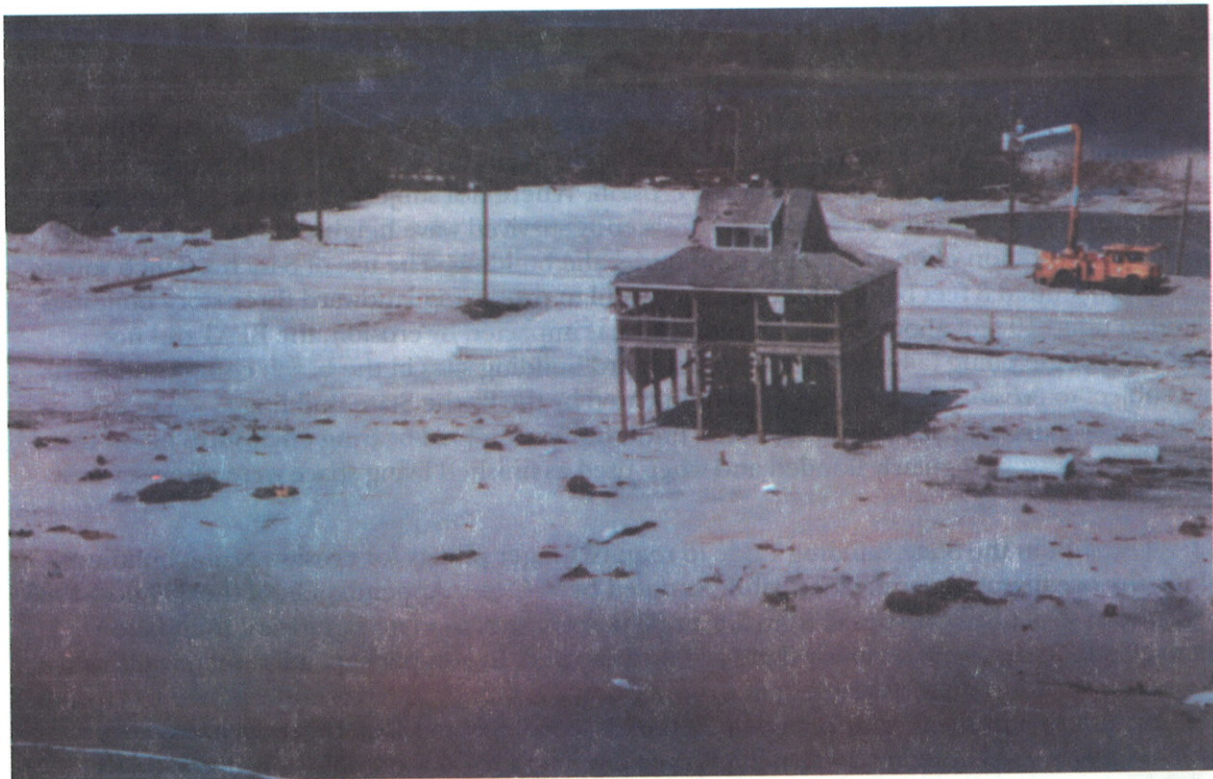
Figure 2-46 While this house experienced 6 feet or more of vertical erosion and scour, as well as the loss of breakaway wall panels, the foundation and superstructure performed as designed.

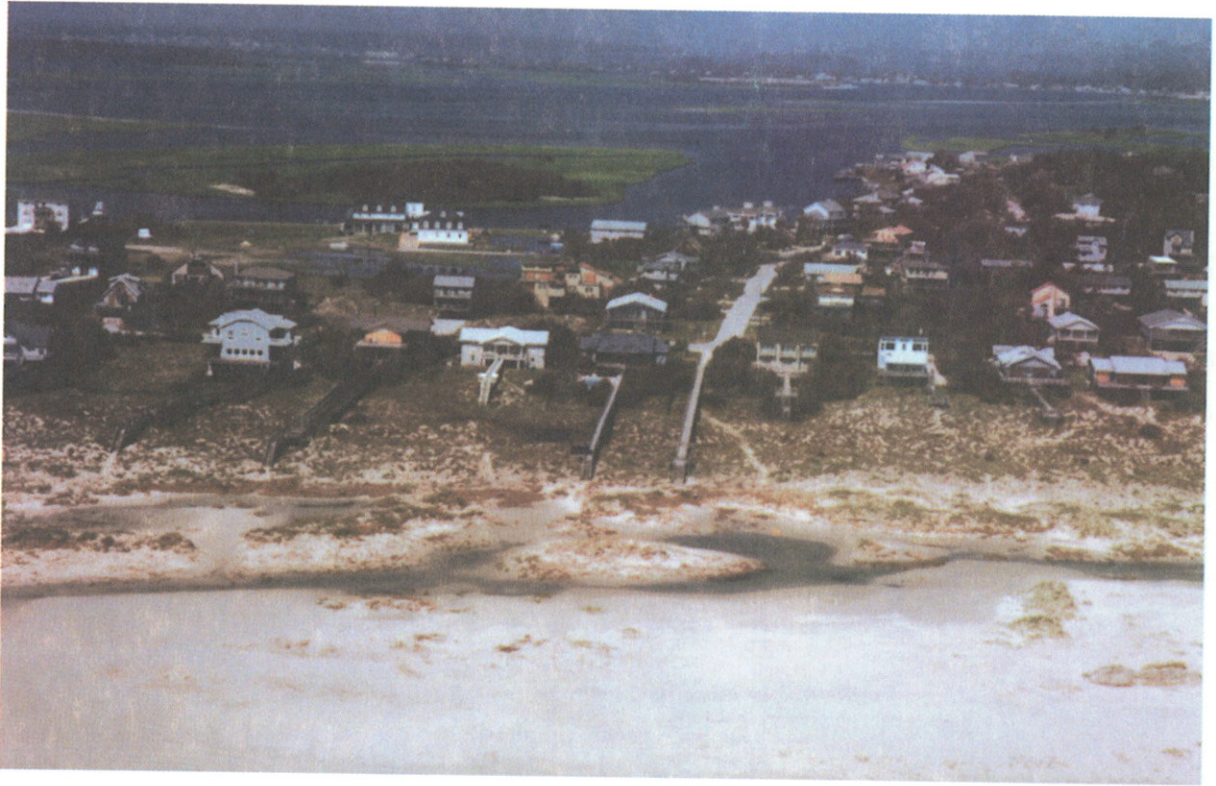
Figure 2-47 As shown by this post-Fran photograph taken at Emerald Isle, North Carolina, proper elevation and setback from the oceanfront in conjunction with substantial protection afforded by dunes resulted in little or no flood damage to the oceanfront row of buildings.

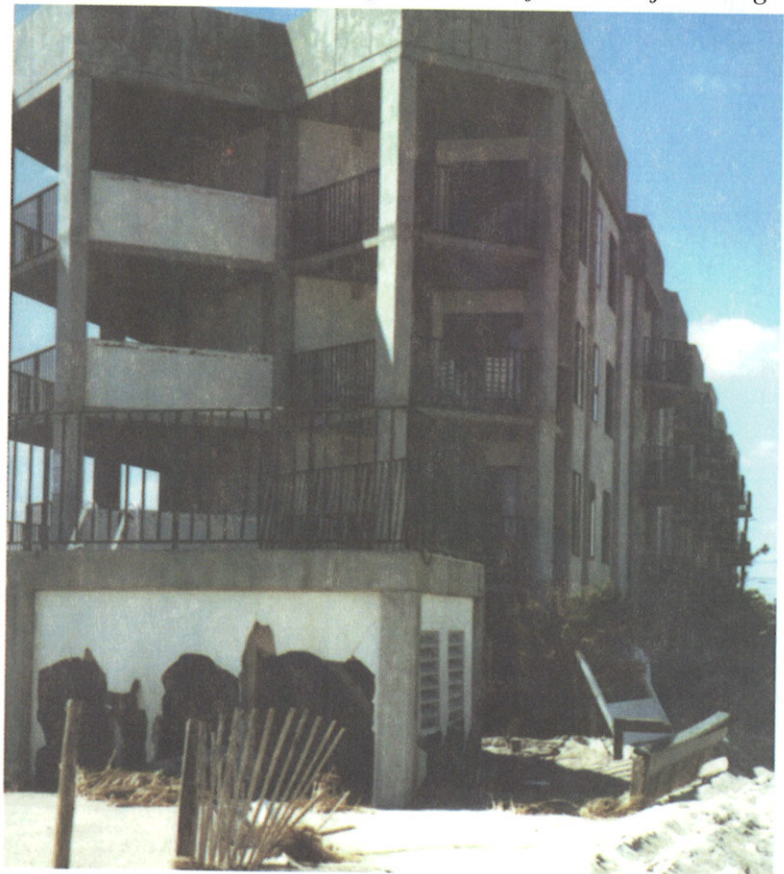
Figure 2-48 This large, engineered oceanfront structure performed as designed.
