## 4. Structural Systems Performance

*The dominant causes of structural failure observed by the MAT included storm surge, waves, floodborne debris, and wind. Structural damage due to erosion was also common on the barrier islands. Damage occurred to residential buildings (single- and multi-family housing), commercial buildings, and critical and essential facilities.*

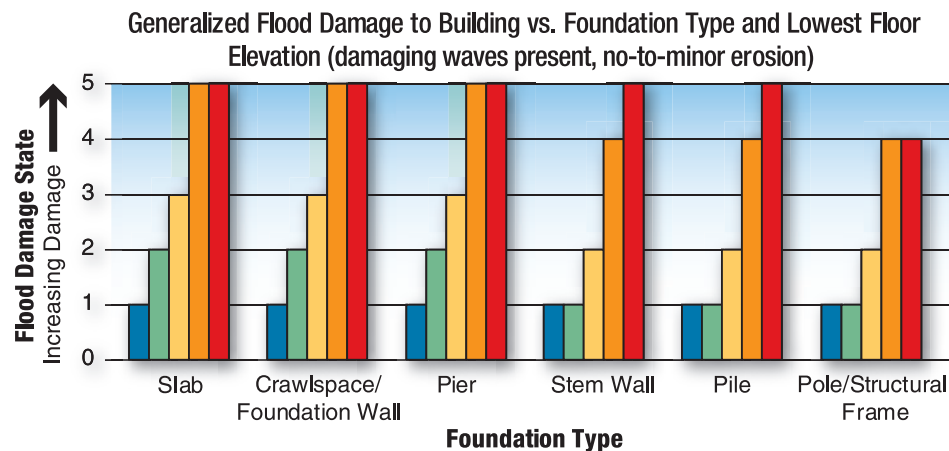
Figure 4-1 (a).

Flood damage vs. foundation type and floor elevation (no waves or erosion)

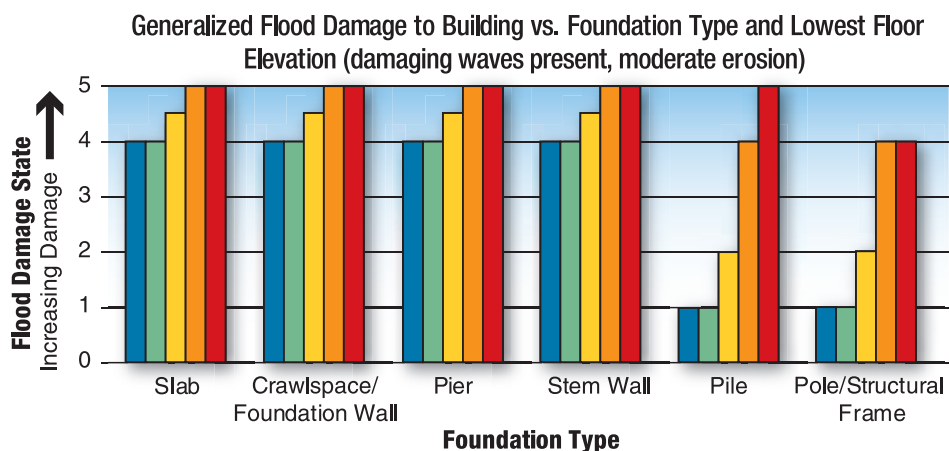
Figure 4-1 (b).

Flood damage vs. foundation type and floor elevation (waves present)

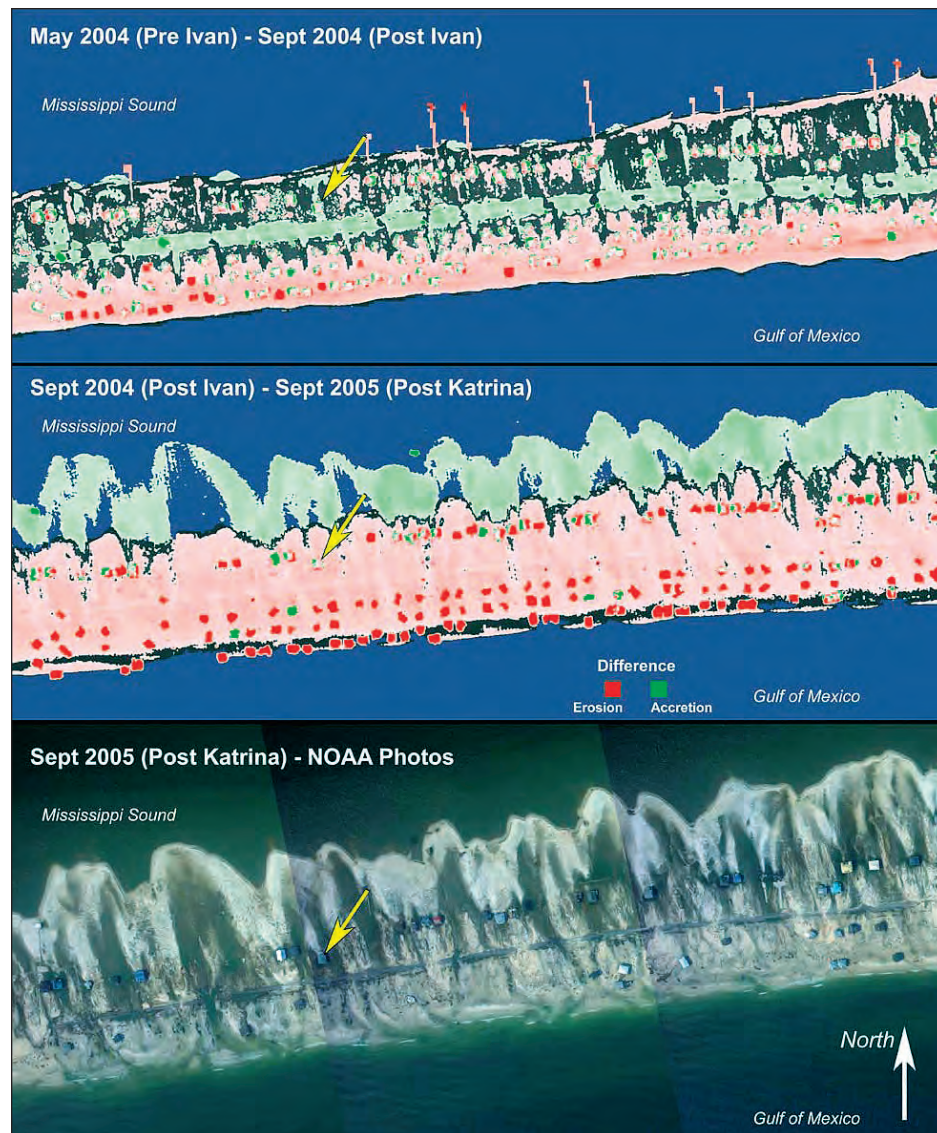
Island, Alabama, more pile-supported houses were destroyed by Katrina (108) than by Hurricane Ivan (17). Two-thirds of the 150 houses on the far west side of the island were totally destroyed and many of the remaining houses were significantly damaged. Many of these homes were not flooded to the first floor level. The failure of the pile systems was likely due to erosion and loss of foundation support from successive storms (Hurricanes Ivan, Dennis, and Katrina) that made the buildings more susceptible to pile failure.

**Figure 4-2.**  
Comparison of erosion  
patterns and building  
losses on Dauphin  
Island, Alabama, due to  
Hurricanes Ivan (2004) and  
Katrina (2005)

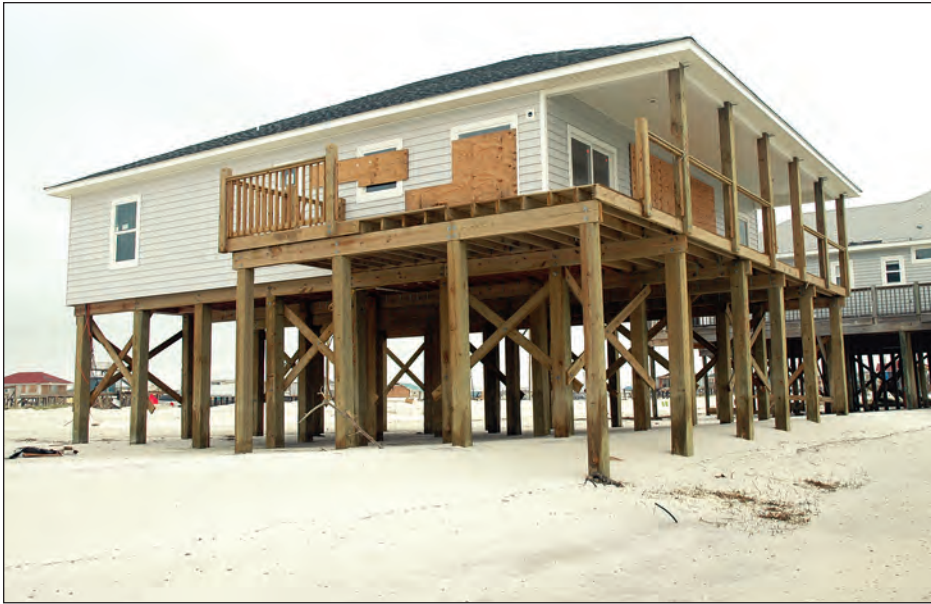
When pile foundations elevated single-family houses above the storm surge/waves and the piles were adequately embedded to tolerate the erosion, they performed well, as shown in Figures 4-3 and 4-4.

Figure 4-3.  
Successful example  
of well-elevated and  
embedded pile foundation  
following Katrina  
(Dauphin Island, Alabama)

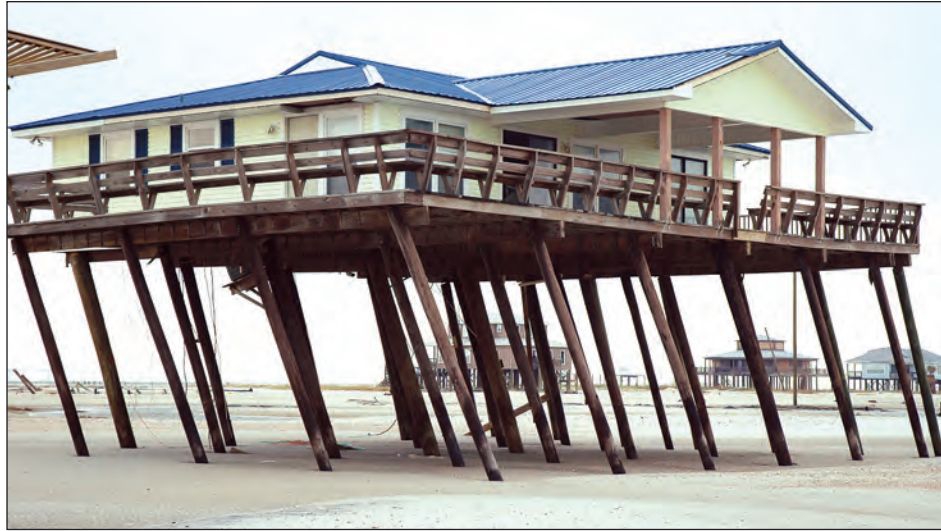
Damage and failures caused by inadequate pile embedment are shown in Figures 4-5 and 4-6. Wave damage to elevated buildings is shown in Figures 4-7 and 4-8. Once the storm surge and wave heights rose above the bottom of the floor beams and joists, either on stable foundations or when the foundation was undermined, the buildings were quickly destroyed by the waves, leaving little debris on the island.

Figure 4-6.  
Leaning piles indicate  
building failures due  
to shallow embedment  
(Dauphin Island,  
Alabama).

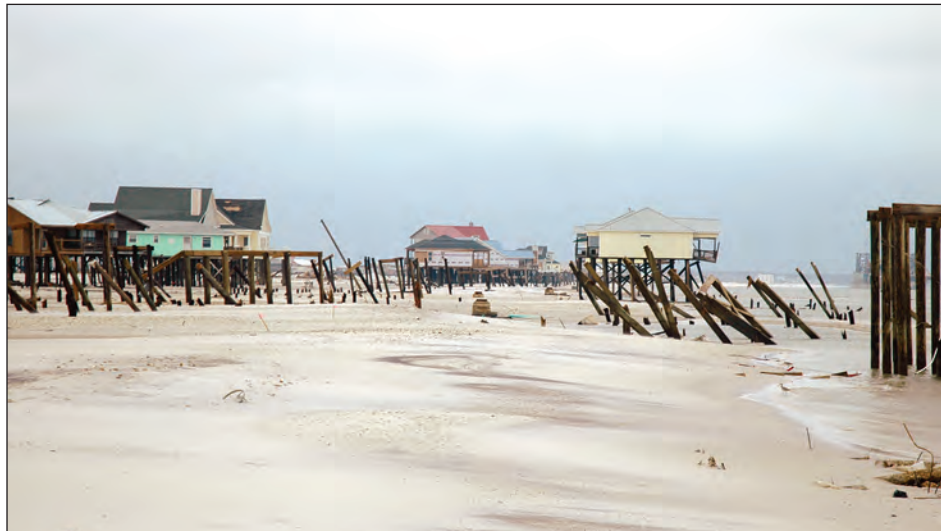
Figure 4-7.  
Partial wave damage  
after wave heights  
exceeded the floor  
elevations (Dauphin  
Island, Alabama)

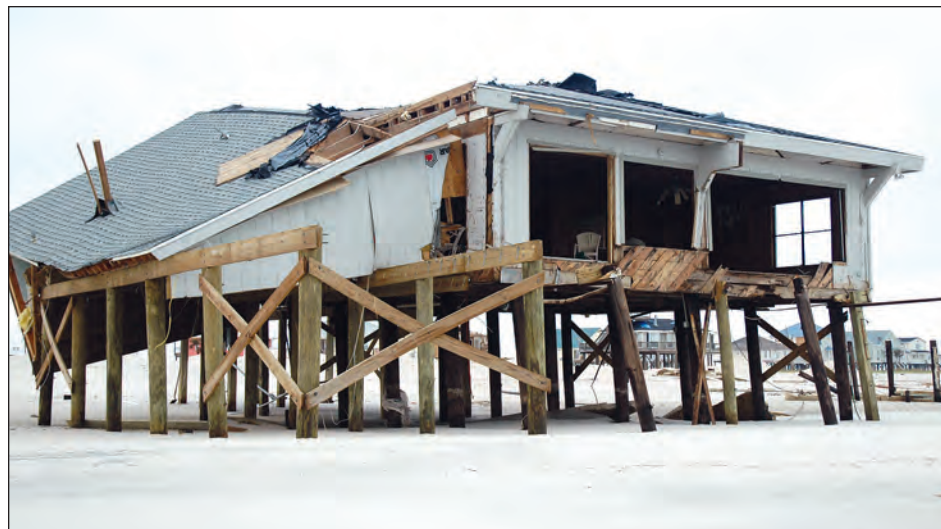
Figure 4-8.  
Total wave damage after  
wave heights exceeded  
the floor elevations  
(Dauphin Island, Alabama)

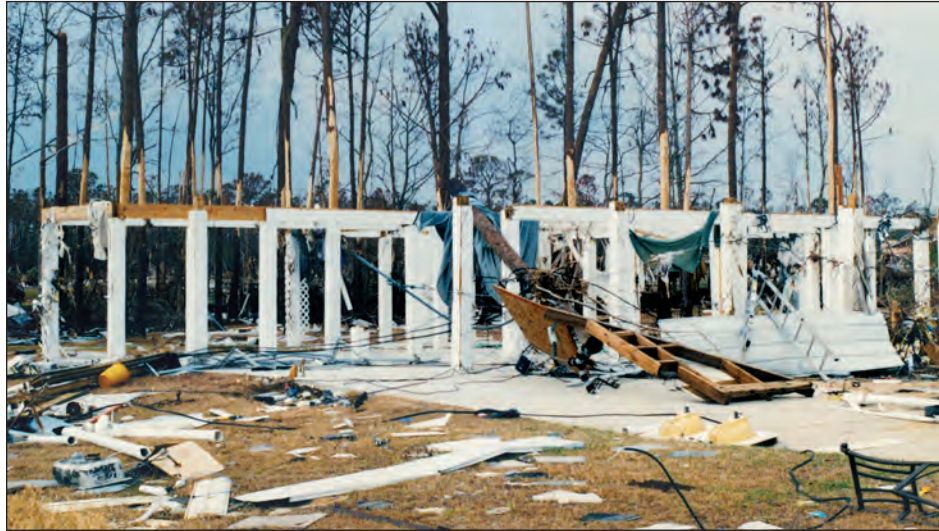
(see Figure 4-10) and on the north-facing bay shoreline in Bay St. Louis (see Figure 4-11). In most cases, the waves destroyed the floor beams, joists and above, but left the piles in place where erosion was not a significant factor.

**Figure 4-11.**  
Pile and connection failure  
(Bay St. Louis, Mississippi)

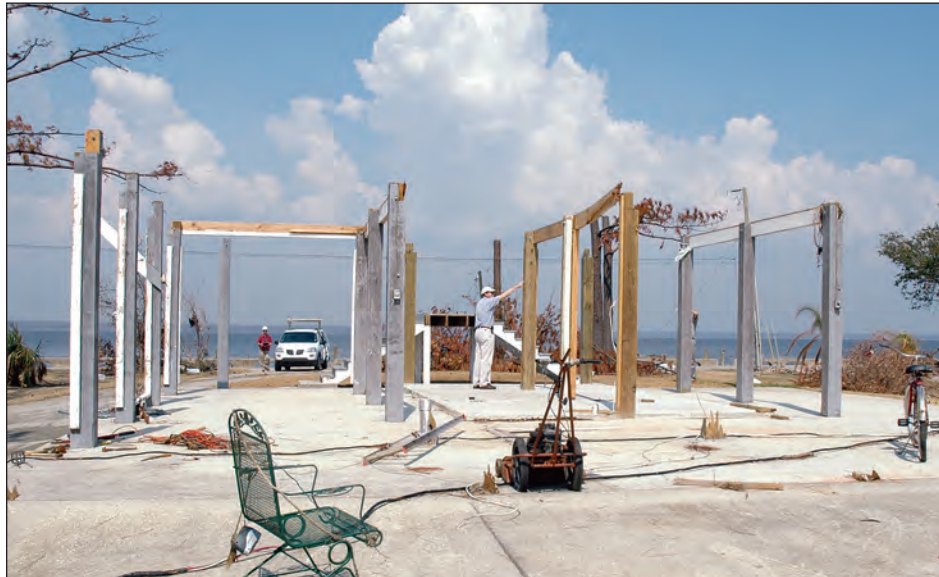
**Figure 4-10.**  
Failure at connections  
between pile foundations  
and buildings (Pass  
Christian, Mississippi)

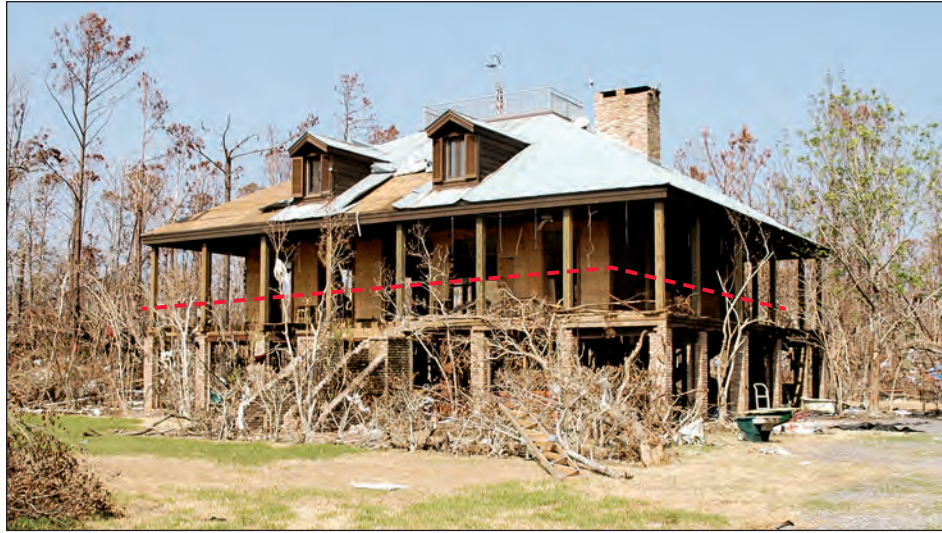
Figures 4-12 through Figure 4-14 show an example of a house with timber pole-type construction. Wave heights exceeded the elevated floor level by approximately 4 feet, lateral wave forces destroyed many of the exterior and interior walls, and wave uplift damaged the floor (Figure 4-14) and interior floors. However, the upper portion of the structure and the roof remained stable due to the nature of the foundation and structural frame.

**Figure 4-14.**  
Wave damage to floors and walls, but pole construction left a repairable, surviving building (Waveland, Mississippi)

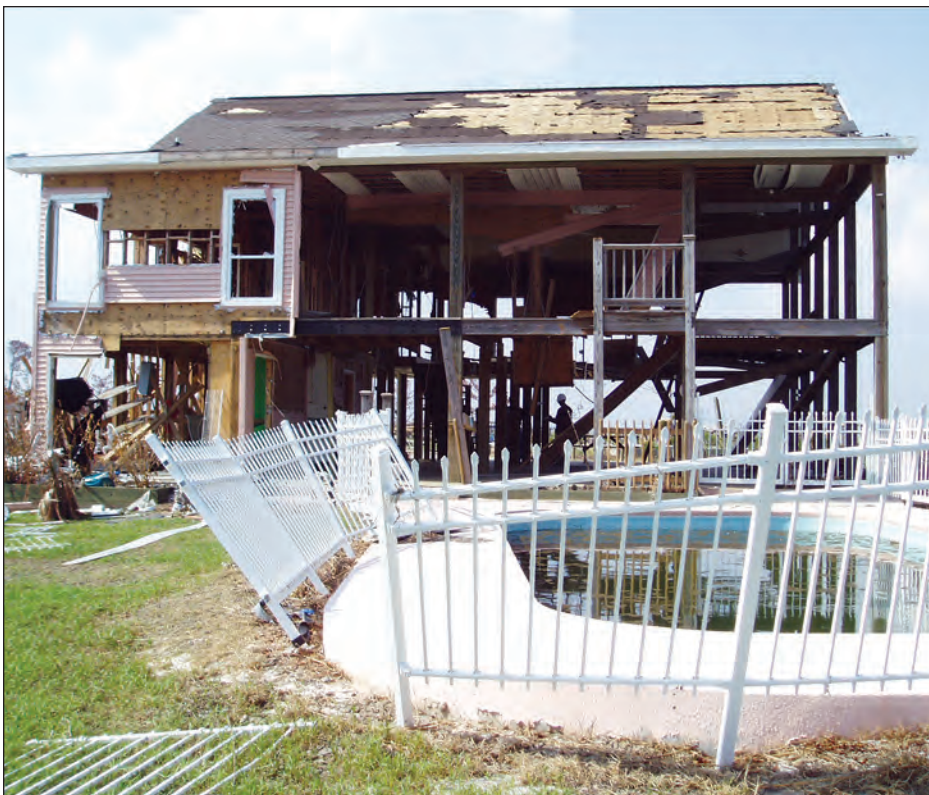
Figure 4-16.  
Wood-framed survivor  
exposed to storm surge  
and waves (Jourdan  
River shoreline of Bay St.  
Louis, Mississippi)

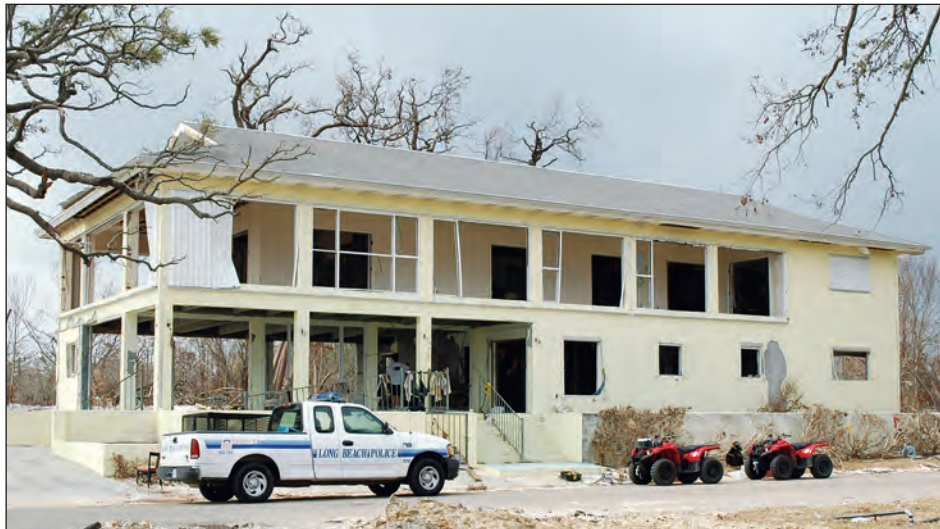
**Figure 4-19.**  
Another surviving house constructed with a reinforced concrete frame. The wave elevation was approximately 2 to 3 feet above the elevated floor (Long Beach, Mississippi).

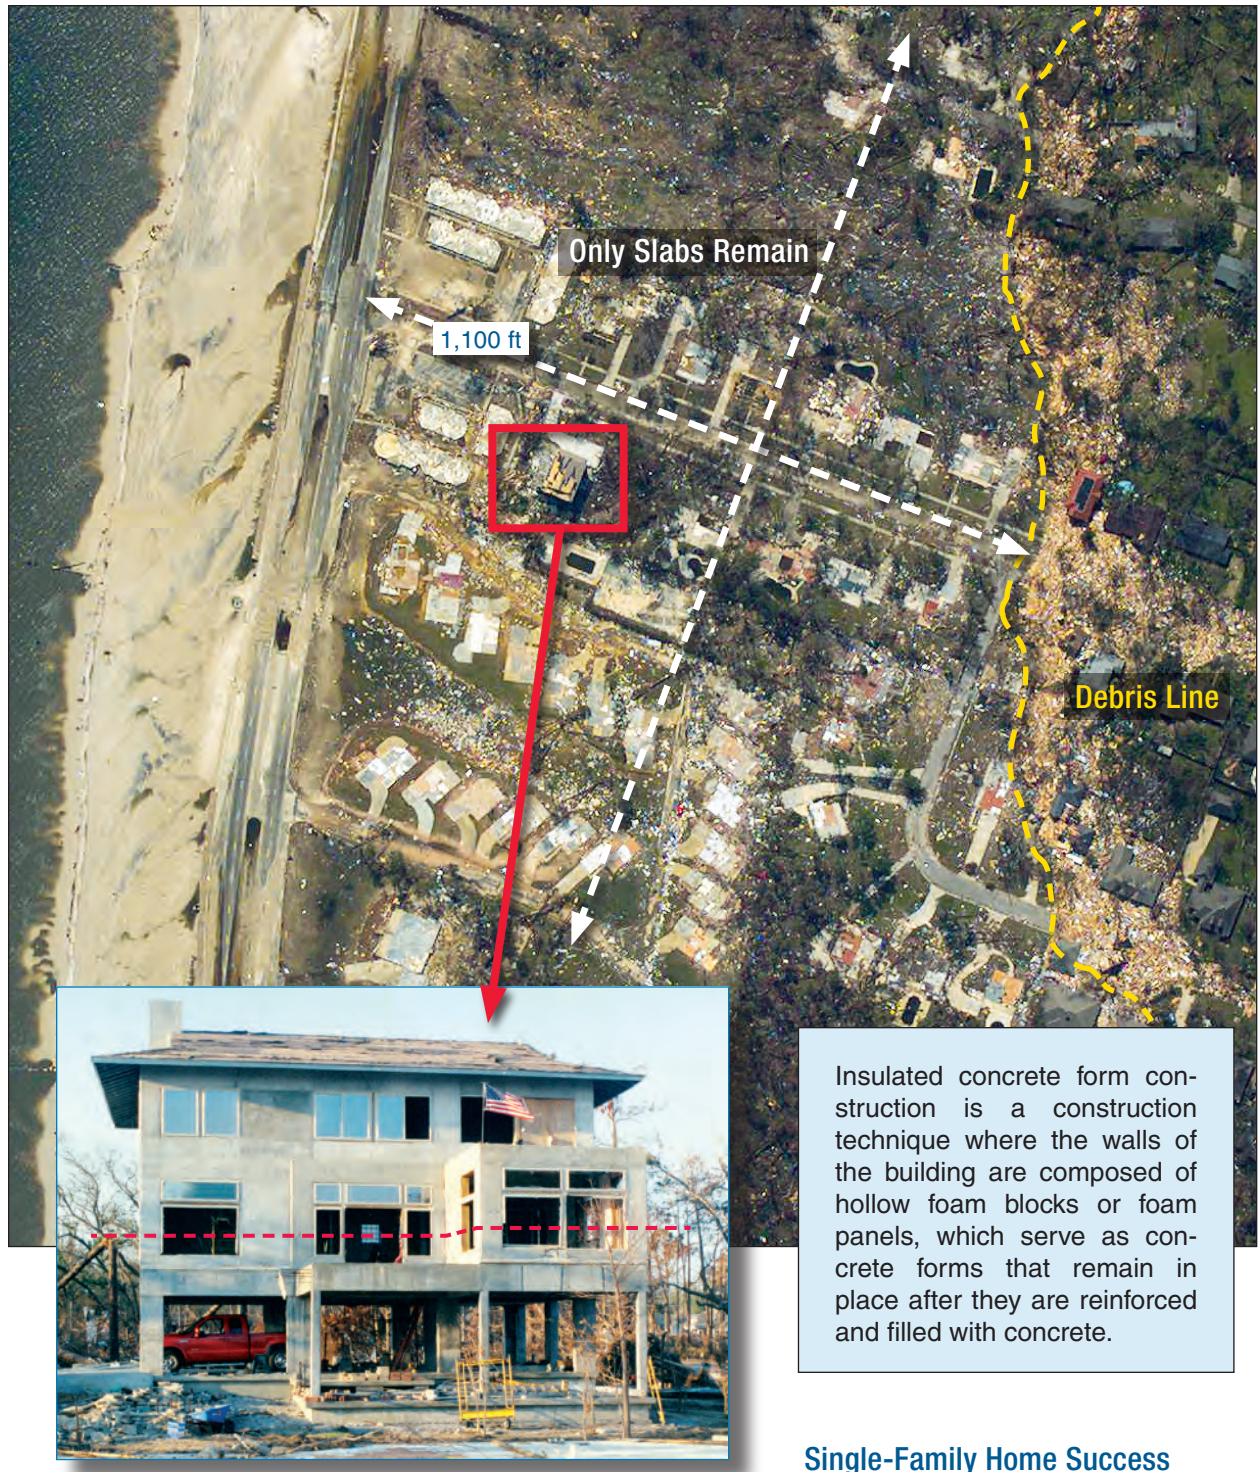
Figure 4-20.

Success amidst dozens of destroyed homes; the house was constructed with a reinforced concrete frame and insulated concrete form walls. Waves during Katrina washed through the elevated portion of the house (white dashed lines on aerial indicate total destruction of all houses except the one in the insert; red line on house indicates flood level) (Pass Christian, Mississippi).

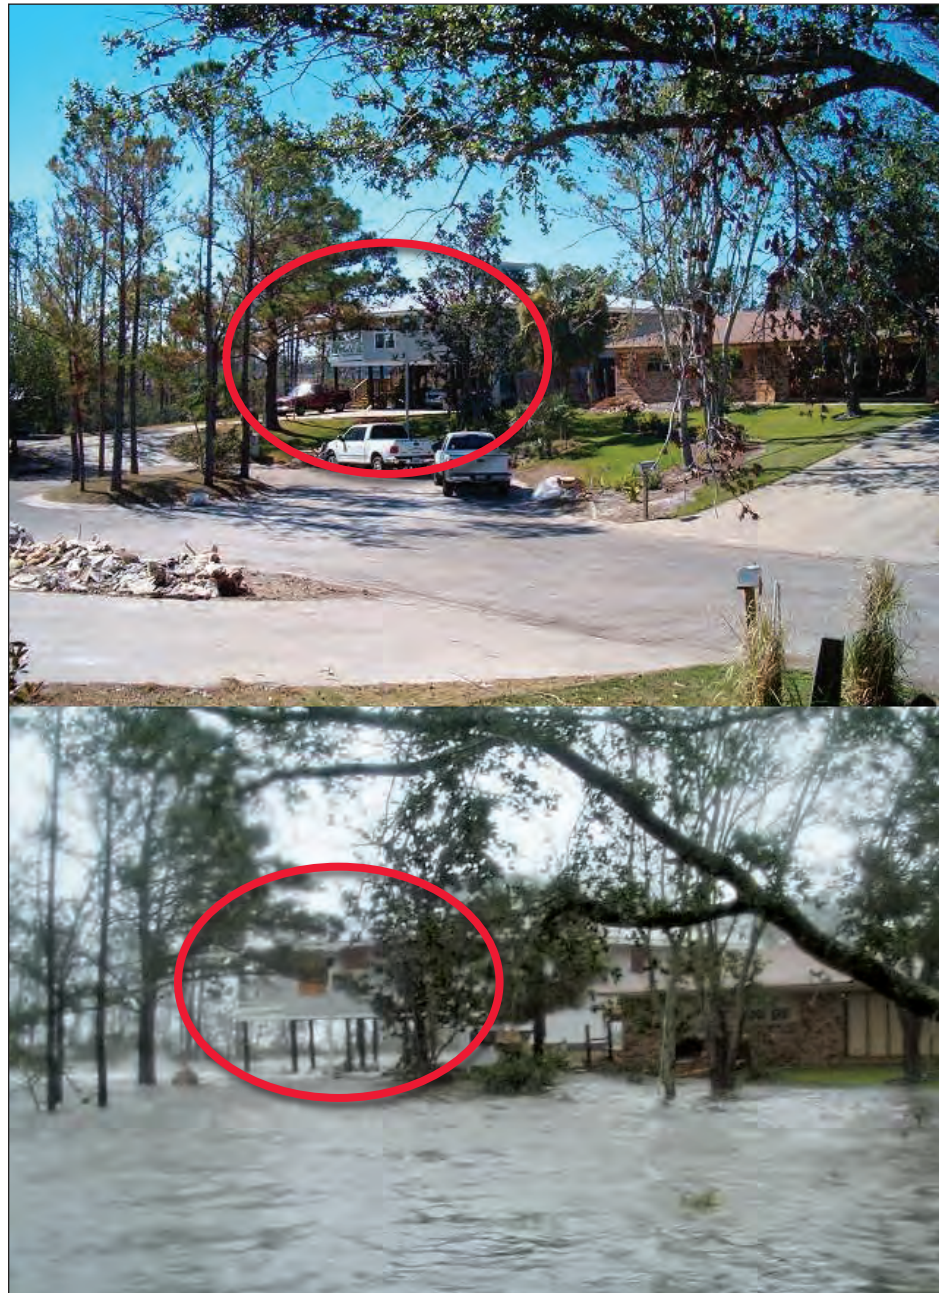
**Figure 4-21.**  
Successful pole construction home (background) near Old Fort Bayou. The top photo was taken approximately 3 weeks after Hurricane Katrina. The lower photo was taken during Katrina (the water level had dropped approximately 6 feet from its peak when the photo was taken) (Ocean Springs, Mississippi).

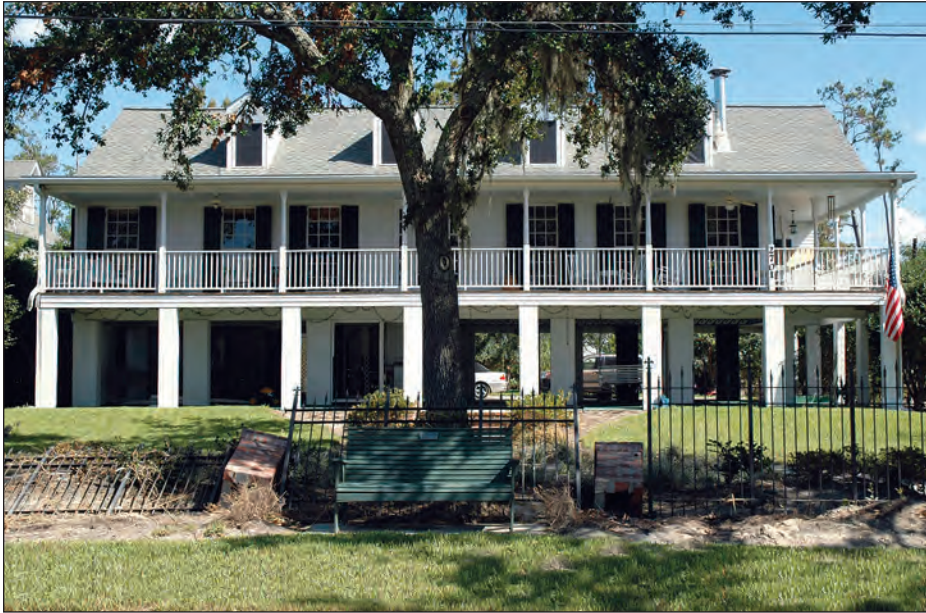
When properly designed and constructed, piers were effective foundations as long as storm surge and waves remained below the floor beam and floor system components, and erosion and scour did not undermine the foundations. In Mandeville, Louisiana (see Figures 4-22 and 4-23), on the north shoreline of Lake Pontchartrain, storm surge in the lake was close to the predicted BFEs. Many buildings along the lakefront experienced storm surge and waves ranging from 2 to 6 feet above existing grade; however, buildings were adequately set back from the shoreline such that erosion was not a threat around most building locations.

Figure 4-22.  
Pier-supported house  
with minimal flood  
damage (Mandeville,  
Louisiana)

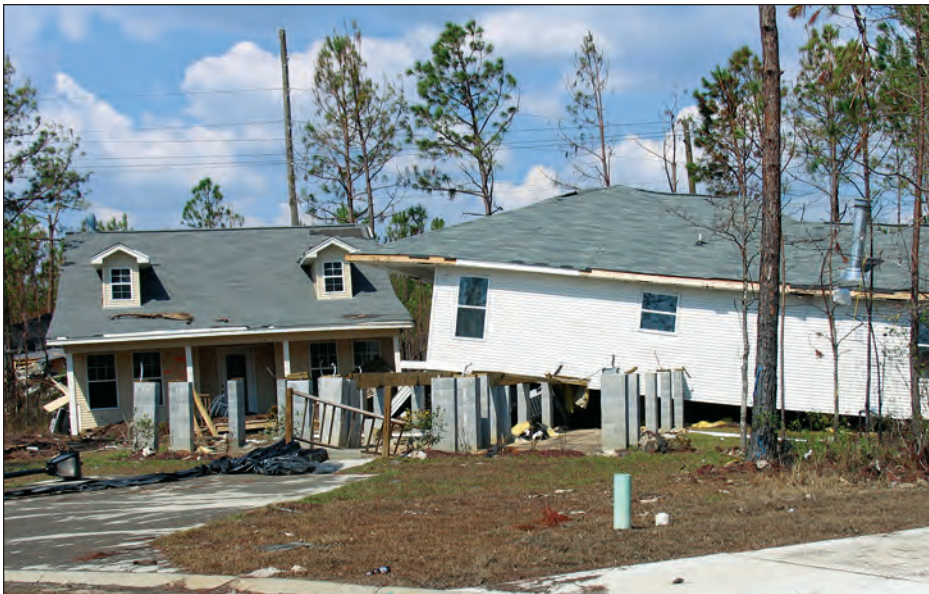
Each of the failures noted points out the importance of a continuous load path, from the top of the building, through the foundation, and into the ground. A continuous load path would have reduced flood damage to many buildings subject to storm surge only (no damaging waves), such as those shown in Figure 4-32, and would have had a mitigating effect on some of the buildings subject to wave forces (turning some failures into survivors).

Figure 4-32.  
Buildings floated off of pier foundations (Pass Christian, Mississippi)

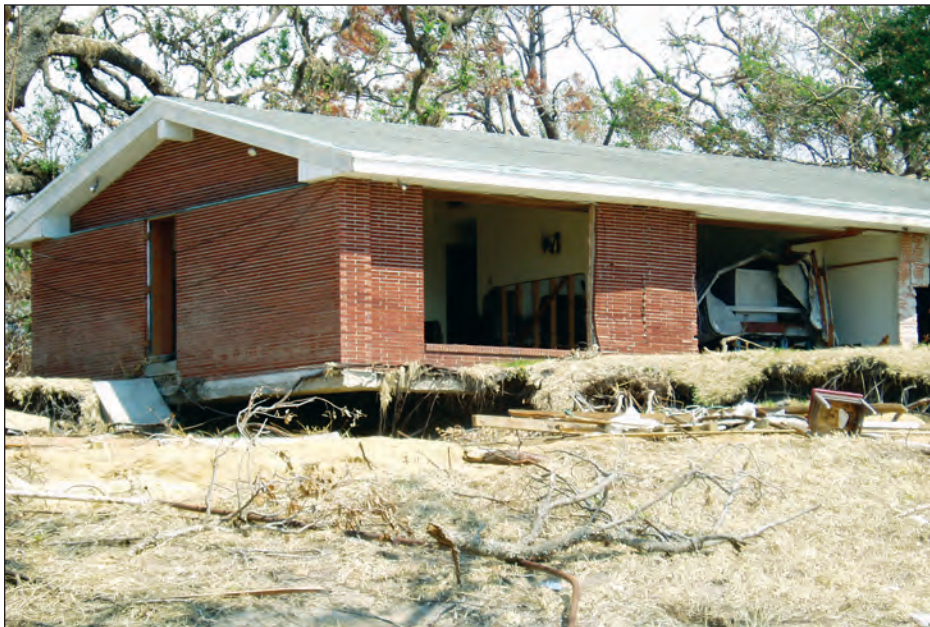
Figure 4-35.  
Slab-on-grade  
undermining (Ocean  
Springs, Mississippi)

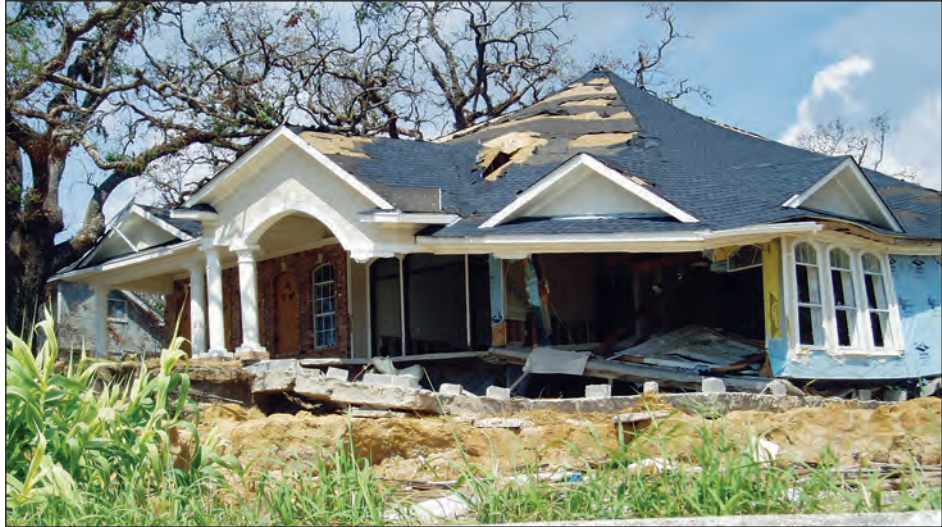
undermining due to erosion or localized scour. If undermined, the contained fill can be lost, removing support for the slab floor, as shown in Figure 4-39. Similar to buildings with slab-on-grade foundations, buildings with stem wall foundations experienced severe damage when flood levels and wave heights far exceeded the top of the slab (see Figure 4-40).

**Figure 4-40.**  
Stem wall foundation survived intact, but waves and surge above the floor destroyed the house, sweeping it off the foundation (Waveland, Mississippi).

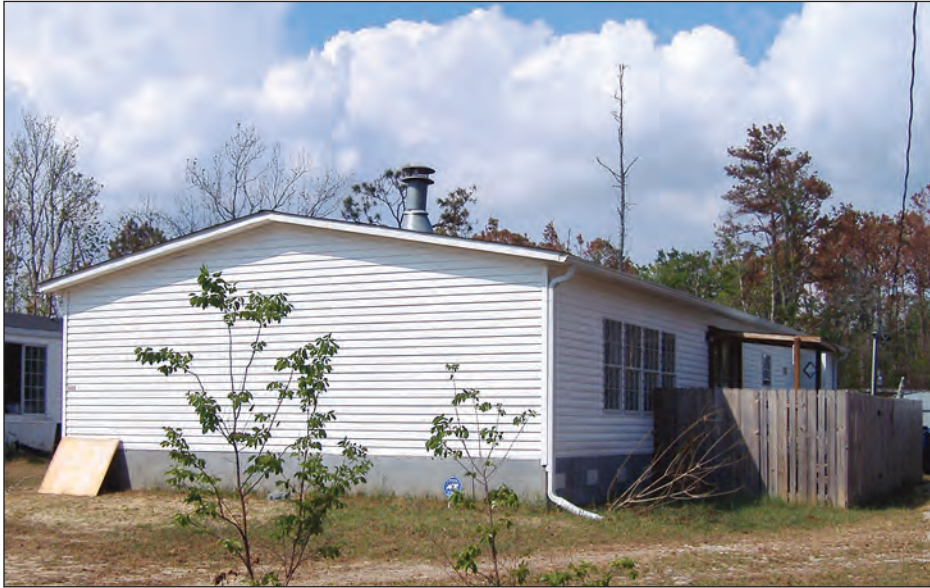
**Figure 4-43.** Manufactured home placed on and secured to poured concrete strip footing had floodwaters 6 feet above its floor, but was not moved from its foundation. Although this indicates good foundation performance, the cost of repairing may exceed the value of the residence because of the significant inundation damage (Ocean Springs, Mississippi).

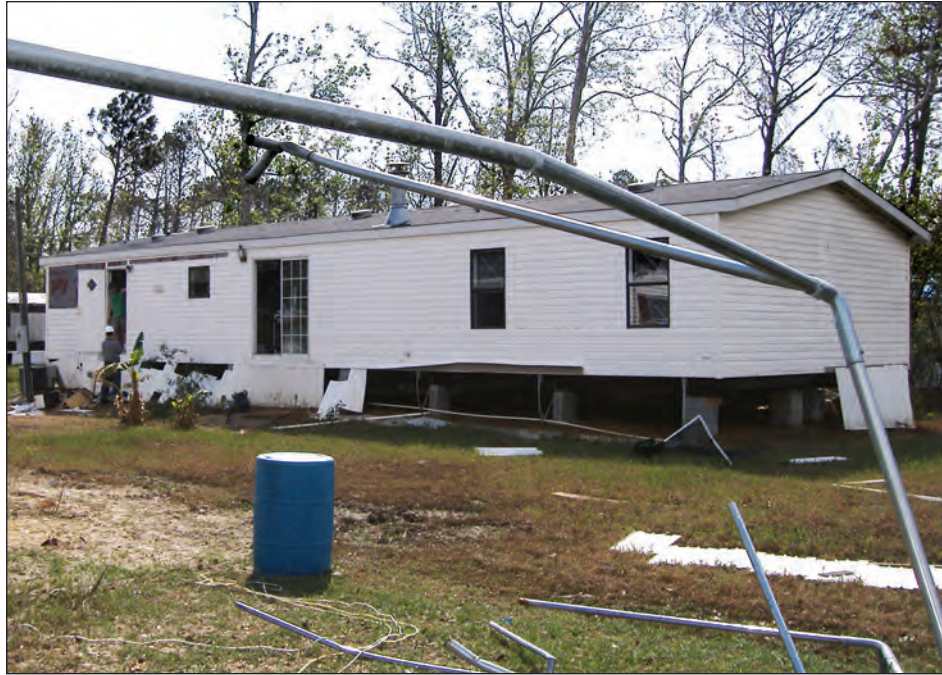
**Figure 4-45.**

A manufactured home near the home shown in Figure 4-43, but placed using a “standard set” installation of ground anchors and dry-stacked masonry piers (Ocean Springs, Mississippi).

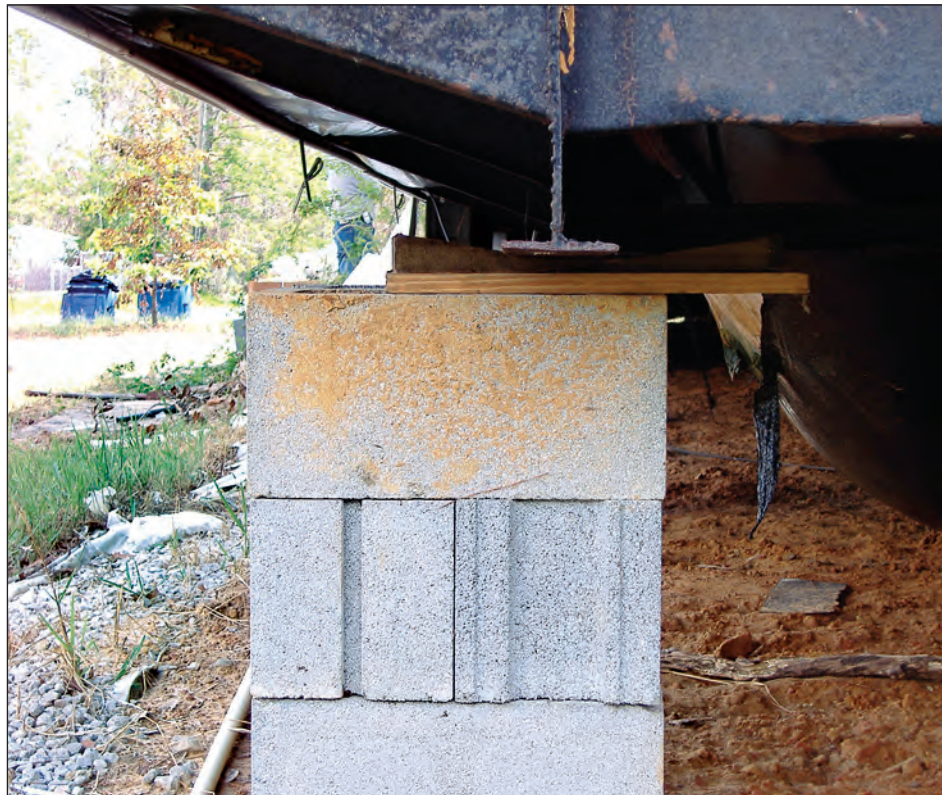
**Figure 4-46.**

Foundation of manufactured home in Figure 4-45. Although the home did not collapse, the ground anchors were partially pulled out of the ground (probably by flotation and lateral flood forces on the home under saturated soil conditions) and it shifted laterally on its piers (Ocean Springs, Mississippi).

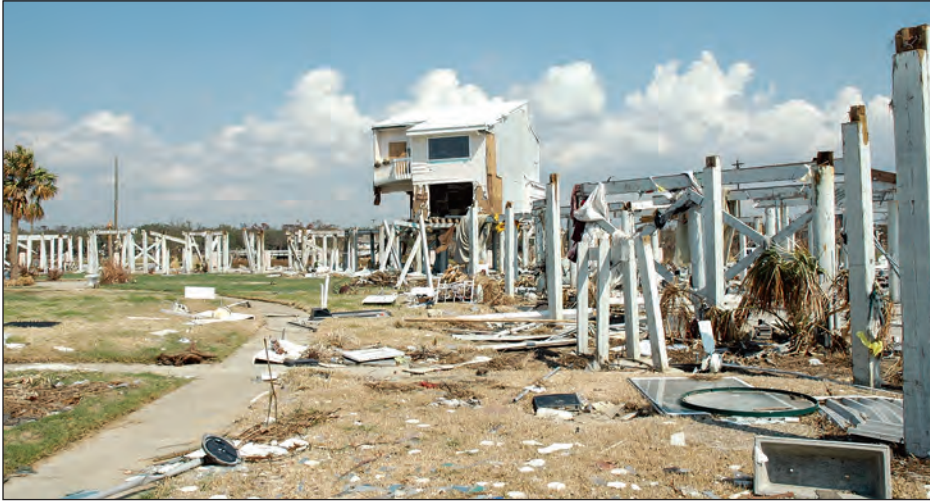
Figure 4-50.  
Another view of the  
severely damaged  
condominium unit  
shown in Figure 4-49  
(Pascagoula, Mississippi)

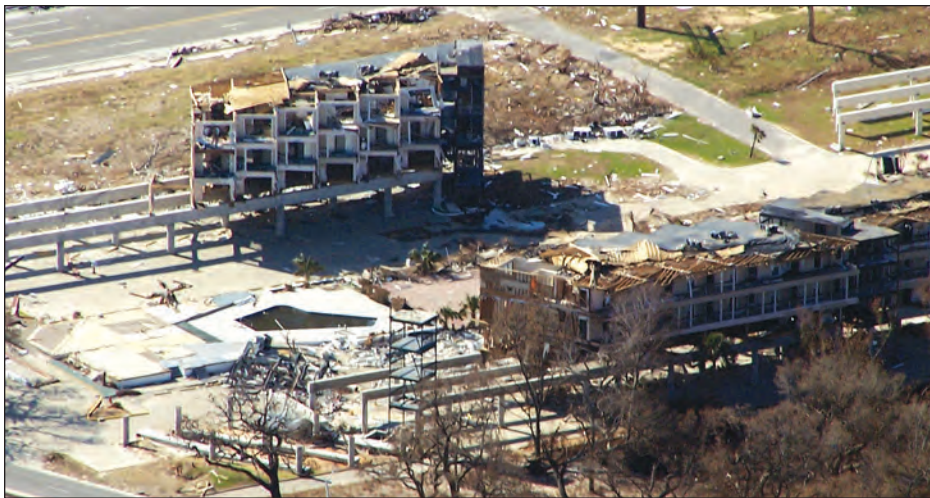
Figure 4-51.  
Condominium on heavy  
concrete foundation  
severely damaged  
when wave elevations  
exceeded lower floor  
elevations (Gulfport,  
Mississippi)

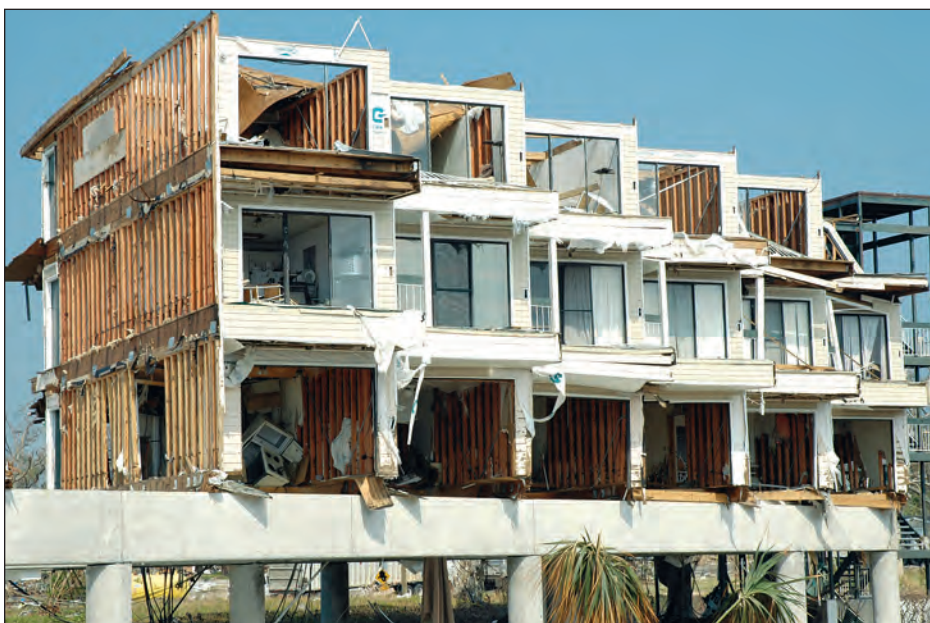
Figure 4-52  
Another view of the  
condominium shown in  
Figure 4-51 (Gulfport,  
Mississippi)

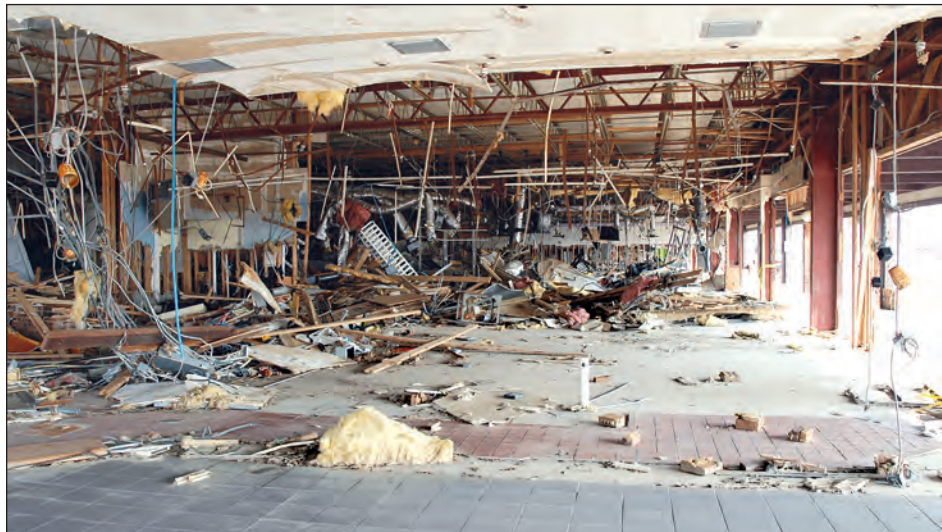
**Figure 4-57.**  
Steel-framed church that  
was gutted by waves, but  
the roof remained in place  
(Biloxi, Mississippi)

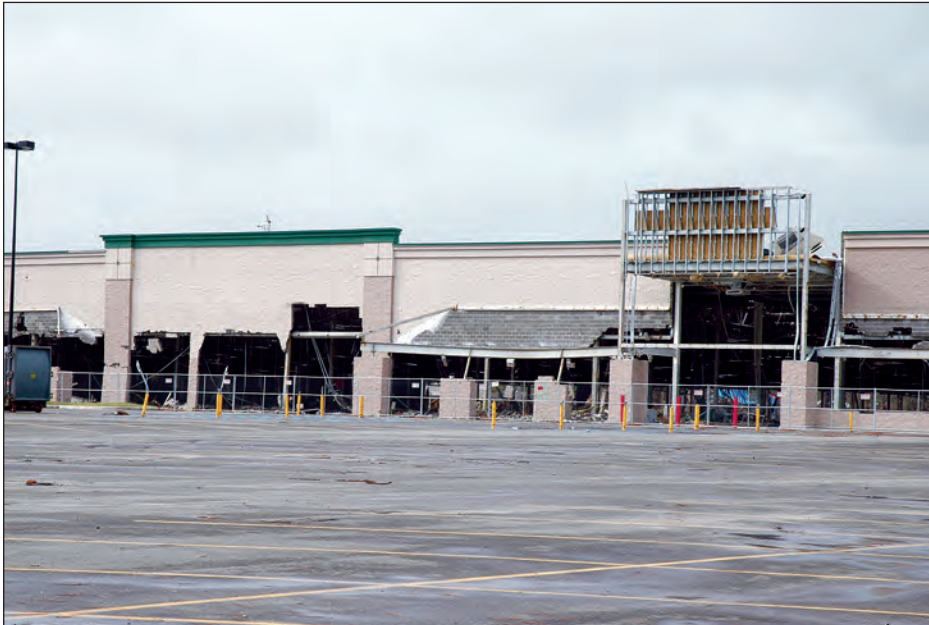
Figure 4-58.  
Large retail store that  
was gutted by waves,  
but most of the roof  
remained in place (Pass  
Christian, Mississippi)

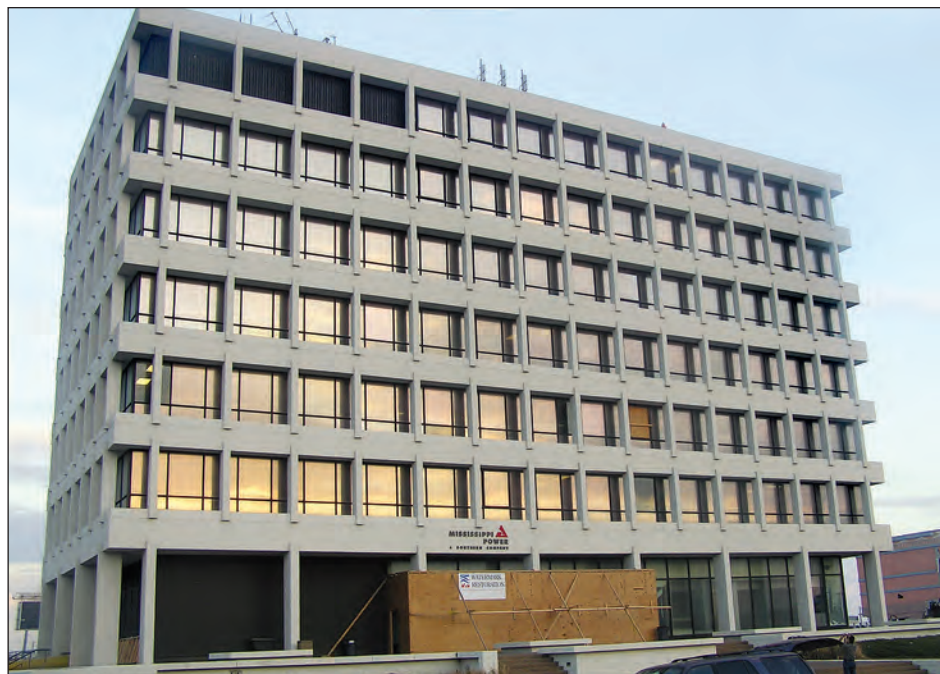
**Figure 4-60.**  
Concrete-framed building  
sustained non-structural  
damage to lower portions  
from storm surge  
(Gulfport, Mississippi)

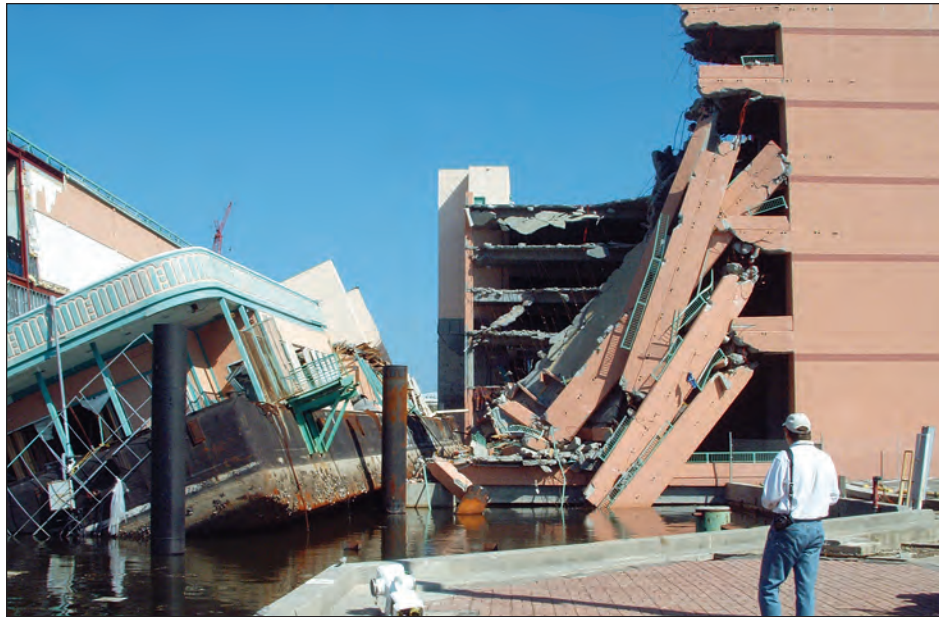
barges from their moorings to become massive floating debris. An example of barge damage to a hotel parking deck in Biloxi is shown in Figure 4-66. The consequences of other barge impacts is described in Chapters 3 and 6.

**Figure 4-66.**  
Parking deck collapse due  
to impact by casino barge,  
on left (Biloxi, Mississippi)

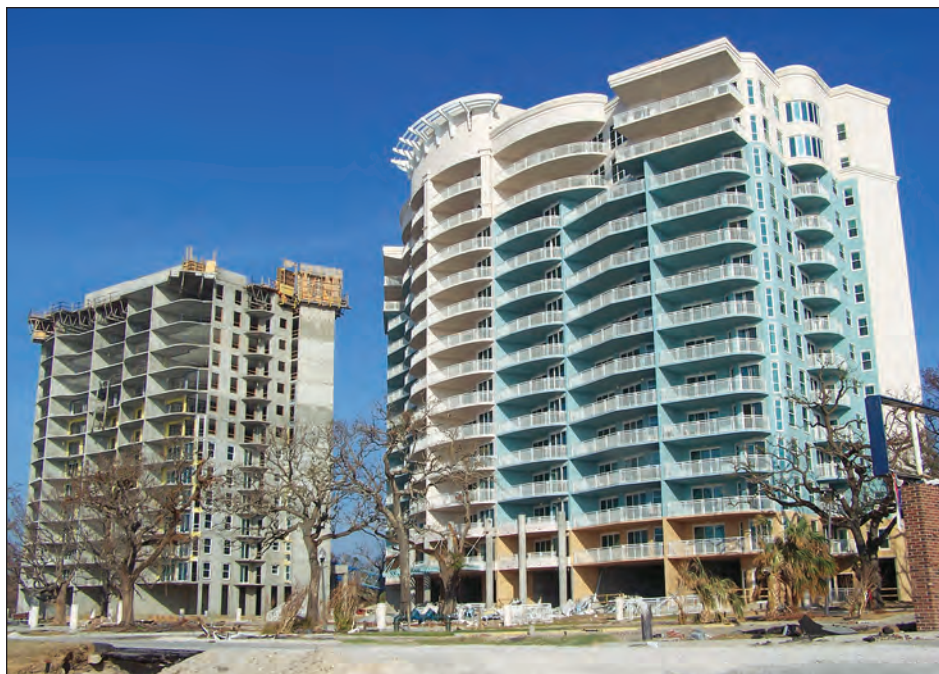
The MAT observed generally good structural performance of high-rise buildings located near the Gulf shoreline. The buildings observed included casinos/hotels, office buildings, and condominiums. High-rise foundation systems were generally not impacted by storm surge and wave impacts due to their location on high ground and building elevations. As an example, a high-rise building in Gulfport was sited on higher ground with a lower level office floor at elevation 20 feet NGVD (see Figures 4-67 and 4-68). One building was almost complete and the second tower was nearing completion. The cast-in-place concrete shear walls, aligned perpendicular to the shoreline, allowed waves to pass through the lower level, damaging only the office and other non-structural walls on the ground floor. The higher floors were undamaged.

**Figure 4-67.**  
High-rise building along  
Beach Boulevard received  
non-structural flood  
damage to lower floors,  
but no apparent flood or  
wind damage to higher  
residential floors (Gulfport,  
Mississippi)

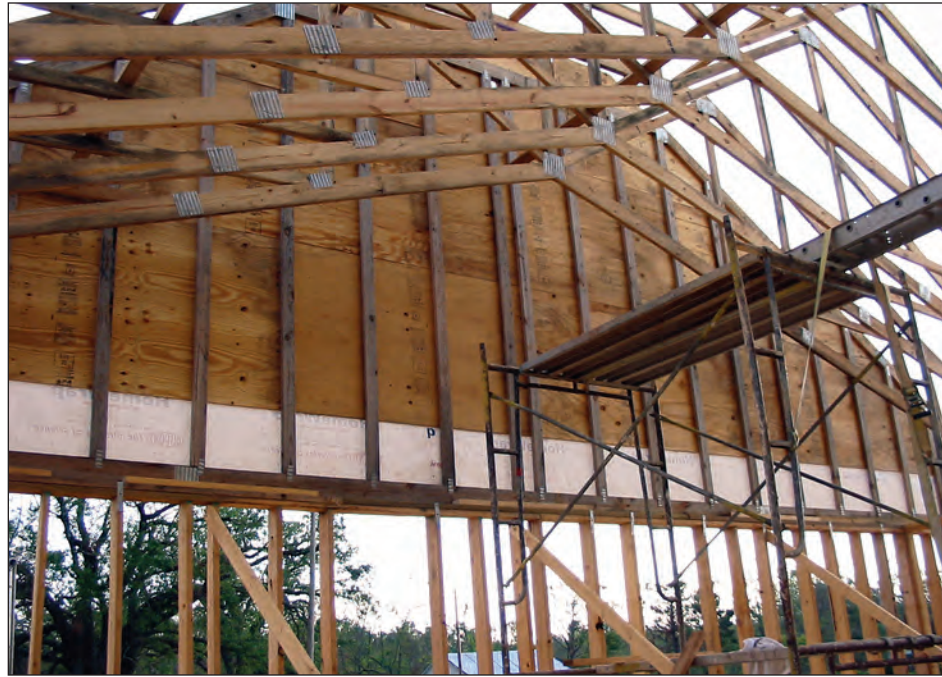
Figure 4-71

Observations of hurricane damage during the past few decades have revealed that a common failure point was wood-framed gable end walls. These were commonly under designed, improperly constructed, and unbraced. Often, a typical roof truss is the only support element behind the wall covering of the gable, as shown in Figure 4-70. Properly designed, fabricated, and installed trusses are usually designed to carry gravity loads across their strong axis. However, when a truss is used alone as the wall framing for the gable end wall, the truss members must resist the wall's wind forces along its weak axis. In many cases, the gable end may be as tall as a story high and, even if wall studs are added to the truss, the truss may still be inadequate to carry the shear and bending forces produced by the lateral wind load. Lateral bracing must also be considered in buildings using scissor trusses. Scissor trusses have sloped bottom chords that create vaulted ceilings. If the wall framing below the gable assembly is not continuous, a hinge can form and the wall framing can fail under lateral loads. The MAT observed new construction where inadequate wall framing was being provided (see Figure 4-71).

Inadequately braced gable on a building under construction (the building was not in place during Katrina). The trusses have sloped bottom chords (scissor style trusses) to create a cathedral vaulted ceiling. While the gable truss has a flat bottom chord, the wall studs below the bottom of the gable assembly are interrupted, which creates a weak hinge that will not adequately brace the top of the wall or the bottom of the gable truss above (estimated wind speed: 130 mph. Long Beach, Mississippi).

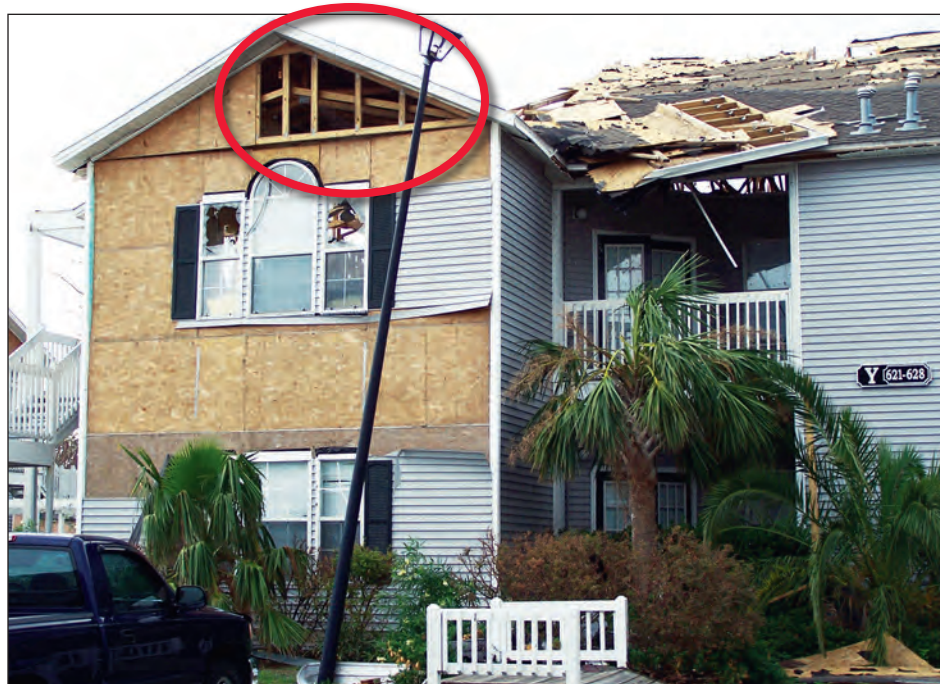
In cases where adequate wall stud framing is present in the gables, the problem is typically the absence of adequate bracing of the gable end wall, which sits on top of the wall below, as shown in Figure 4-72. Without adequate bracing, a hinge is produced between the bottom of the truss and the top of the wall, as seen in Figure 4-73. In most cases, the only bracing is the roof diaphragm, and when removed by the wind, total collapse of the roof and wall occurs as shown in Figure 4-74.

Apartment with typical gable end wall truss with stud infill. Note the loss of gable sheathing and the lateral displacement of the bottom chord of the truss (circle) (estimated wind speed: 120 mph.<sup>6</sup> Ocean Springs, Mississippi).
