## 4. Structural Systems Performance

*The dominant causes of structural failure observed by the MAT included storm surge, waves, floodborne debris, and wind. Structural damage due to erosion was also common on the barrier islands. Damage occurred to residential buildings (single- and multi-family housing), commercial buildings, and critical and essential facilities.*

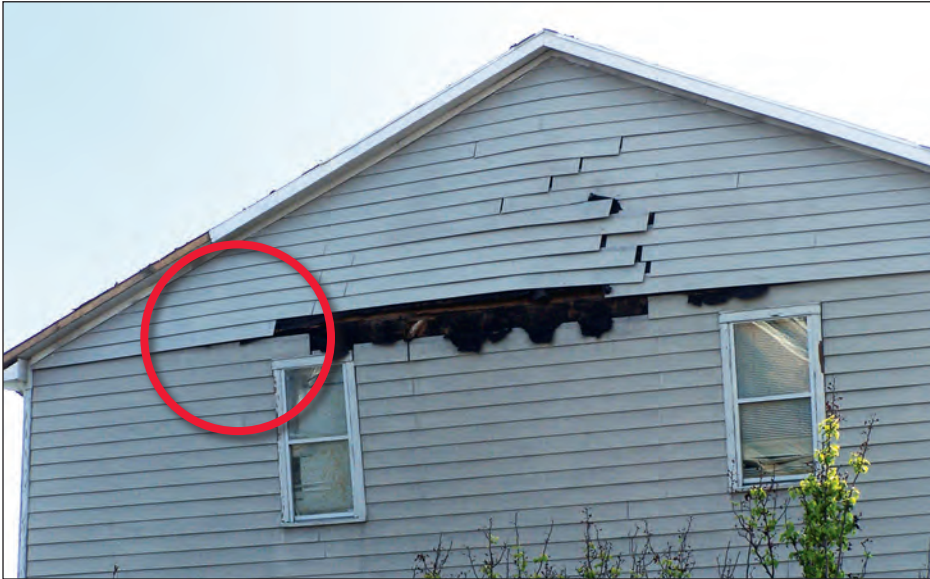
**Figure 4-73.**  
Hinge formed between  
gable end and top of wall  
(hinge circled)  
(estimated wind speed:  
120 mph. Ocean Springs,  
Mississippi)

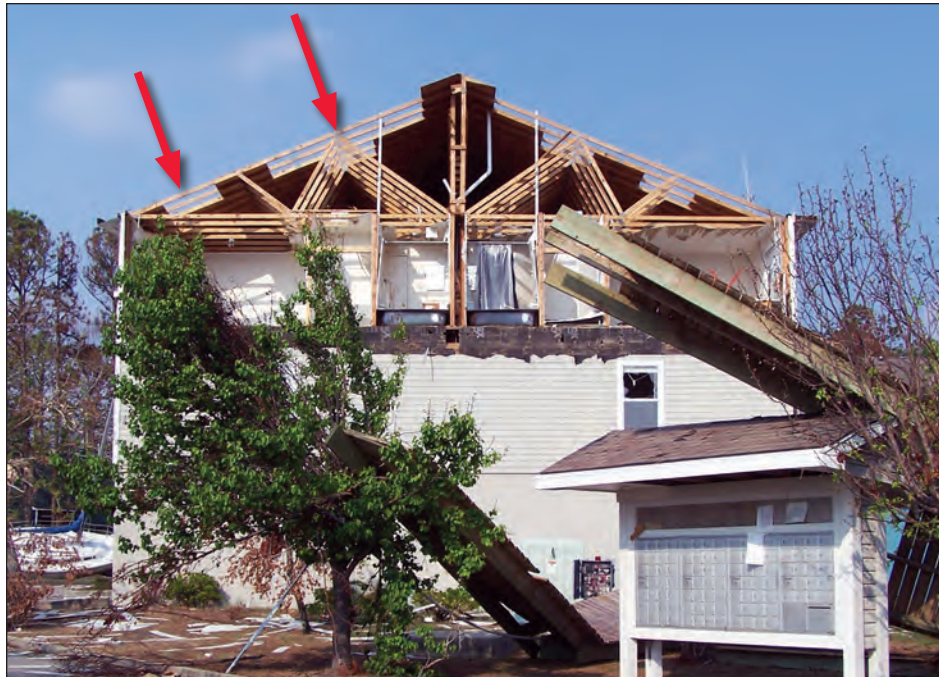
The most common wind-related structural failures observed in light-framed construction were roof framing failures. Failures were observed in both new and old construction. Insufficient attachment of roof sheathing panels to the supporting framing was the most common problem. Before the 1982 SBC, the code did not account for higher uplift pressures that occur at roof perimeters and corners. Much closer nail spacing was required after implementation of the 1982 SBC criteria. Once the sheathing attachments fail, a variety of other failure modes can occur. Attics that have been breached can become pressurized and other structural elements may then become overstressed. This can lead to an “unzipping” effect of progressive failure where one failure leads to a series of subsequent failures, as seen in Figure 4-75.

**Figure 4-75.**  
Failure of the gable end wall of this apartment building led to pressurization of the attic and the release of sheets of plywood sheathing. Note the plywood roof sheathing “unzipped” by wind pressures (arrows) (estimated wind speed: 120 mph. Ocean Springs, Mississippi).

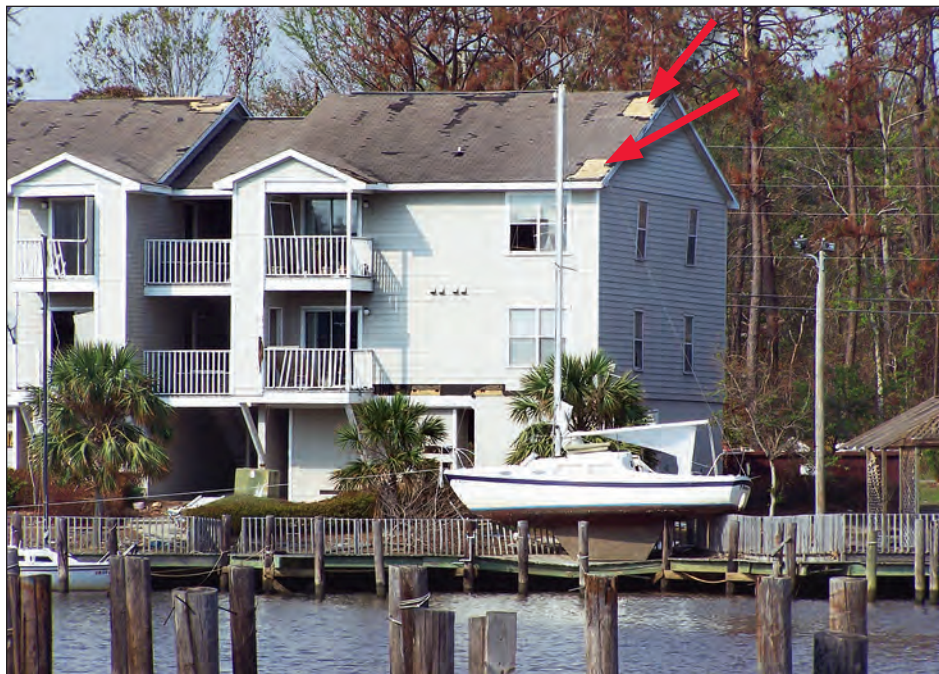
Zones of increased wind pressure occur at wall and roof corners, roof edges, roof ridges, hips, and overhangs. Failures of building structural and/or envelope components usually begin in these zones. Breaches of the building envelope (such as door or window failure) can result in increased internal pressure, which can damage interior partitions and ceilings and increase the wind load on structural and envelope components. Increased pressure can cause failure if the structure and envelope possess inadequate wind resistance. Figures 4-76 and 4-77 are illustrative of these zones of high pressure.

**Figure 4-76.**  
Roof corners, edges, and ridges are zones of increased wind pressures (arrows), as seen in this apartment complex (estimated wind speed: 120 mph. Ocean Springs, Mississippi).

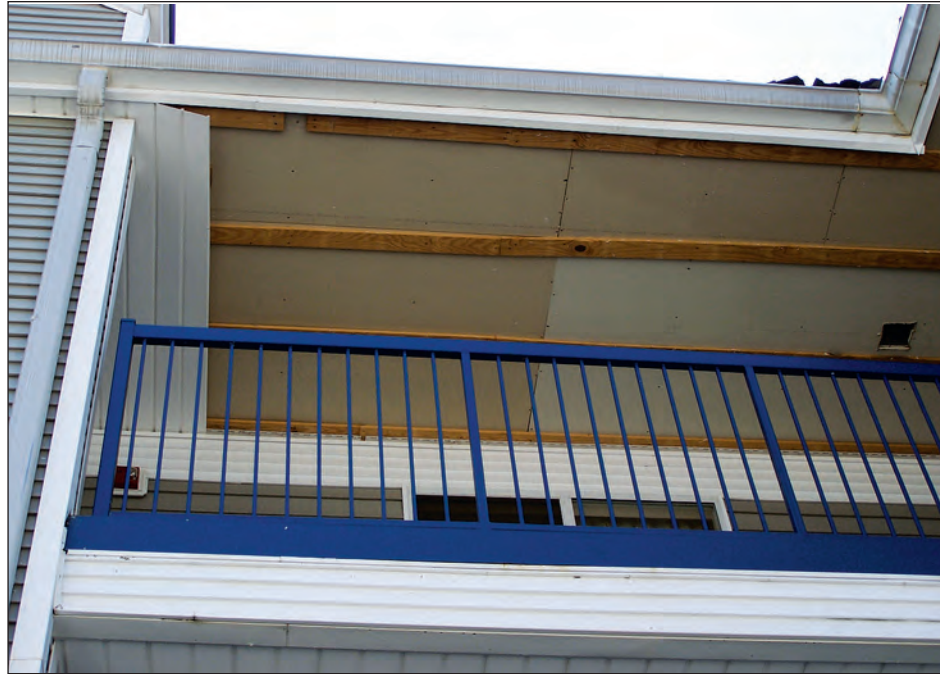
The MAT observed numerous examples of failures of building soffits that led to attic internal pressurization and subsequent loss of decking and roof framing members, as seen in Figure 4-78. Soffits supported by solid substrate, seen in Figure 4-79, often prevented significant air pressure from entering inside the building envelope.

**Figure 4-79.**  
Properly attached  
gypsum board  
substrate avoided attic  
pressurization and  
entrance of wind-driven  
rain when the finish  
soffit material was lost  
(estimated wind speed:  
120 mph. Ocean Springs,  
Mississippi).

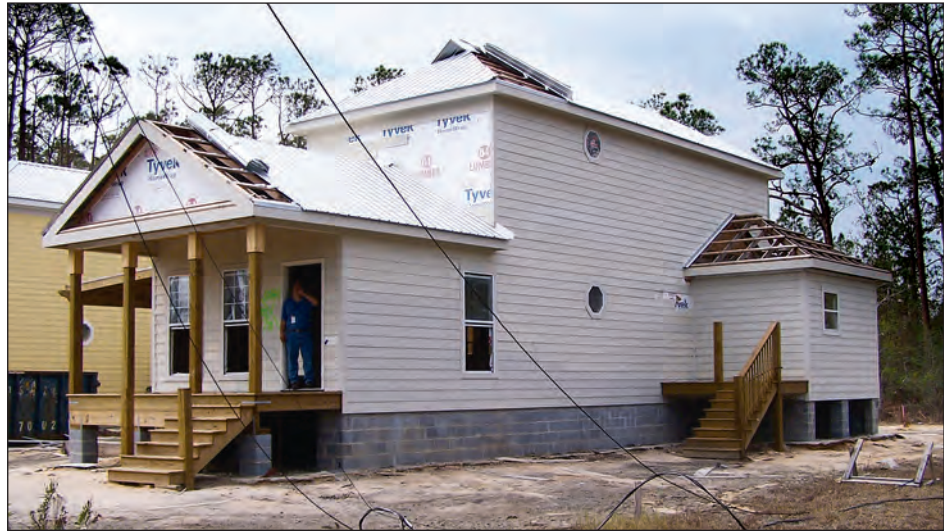
Figure 4-82.  
Home under construction  
subjected to flood and  
wind damage (estimated  
wind speed: 130 mph. Pass  
Christian, Mississippi)

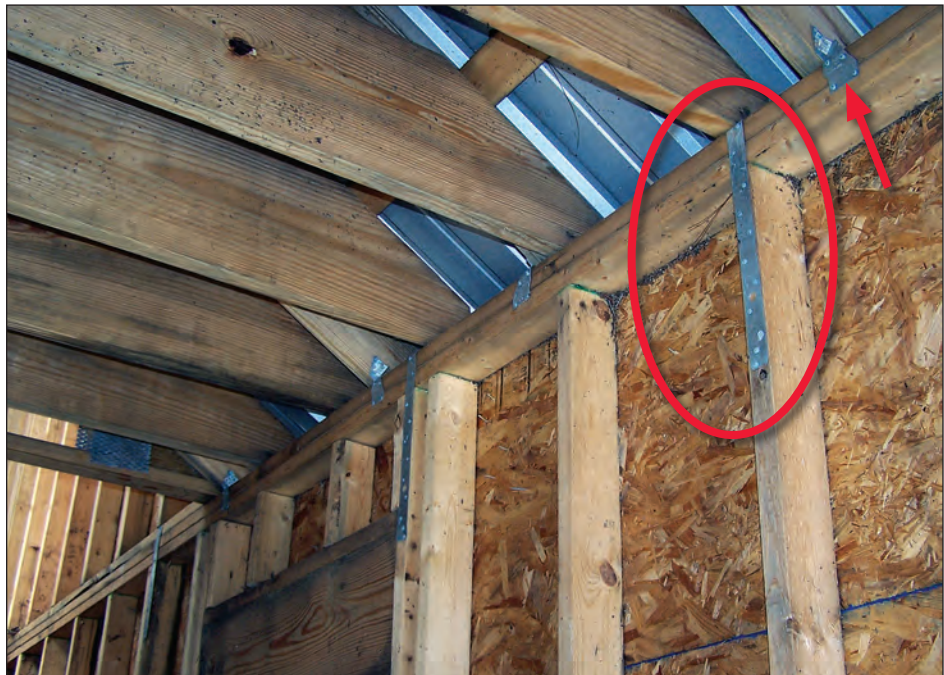
Figure 4-83.  
Home located in Exposure  
C with rafter-wall  
connectors and top plate-  
stud connectors. Note the  
rafter-top plate connector  
(arrow) is more effective  
to install on opposite side  
of wall, and the top plate  
stud connector (circle)  
(estimated wind speed:  
130 mph. Pass Christian,  
Mississippi).

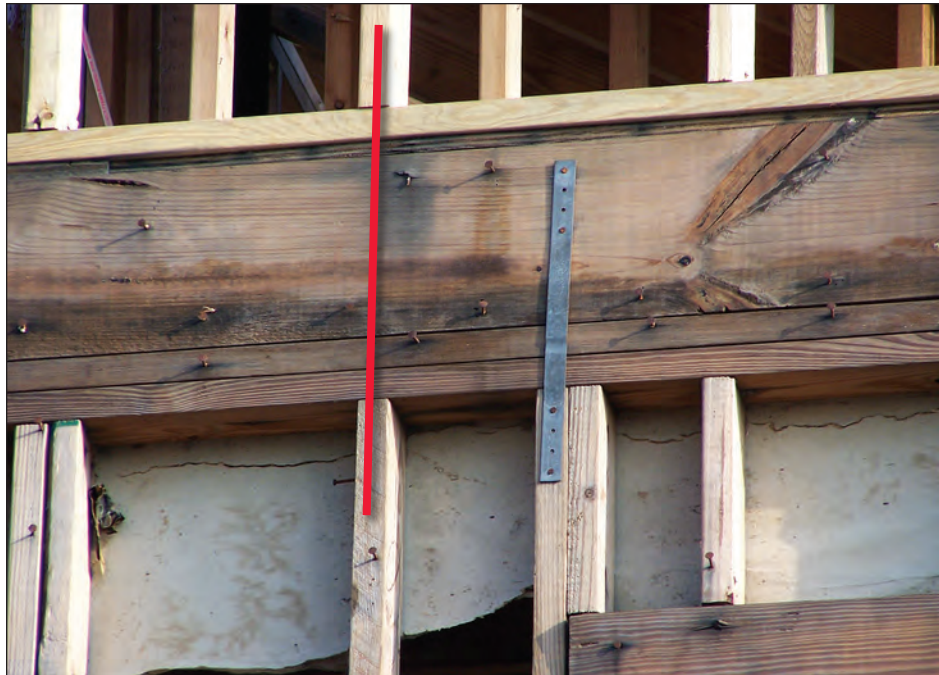
Figure 4-86.

Floor-to-floor straps are intended to keep the load path connected (proper strap location in red). The strap installed in this Biloxi office condominium does not extend to the upper wall system and is insufficiently nailed (estimated wind speed: 120 mph. Biloxi, Mississippi).

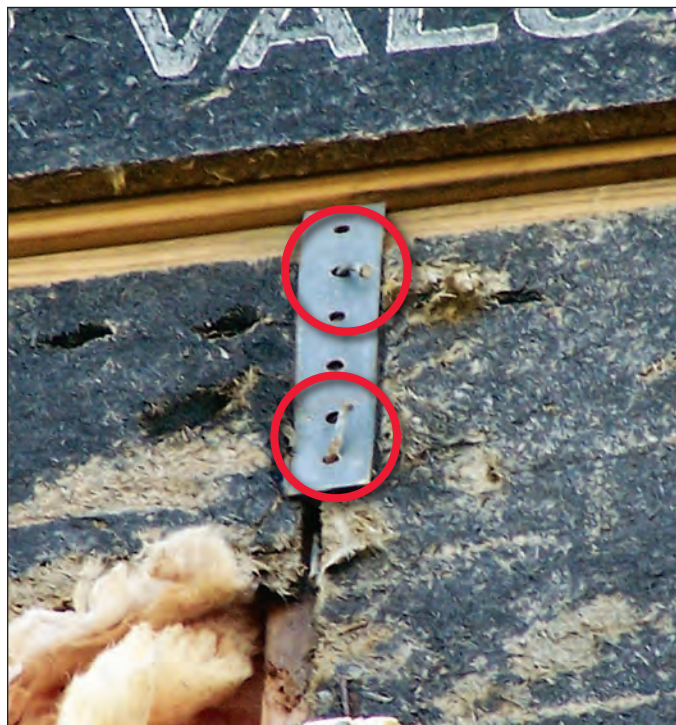
Figure 4-87.

Stud strap connected to top plate with improperly sized nails with bent heads (circles). The strap did not extend far enough down the stud and several fasteners were missing (estimated wind speed: 120 mph. Ocean Springs, Mississippi).

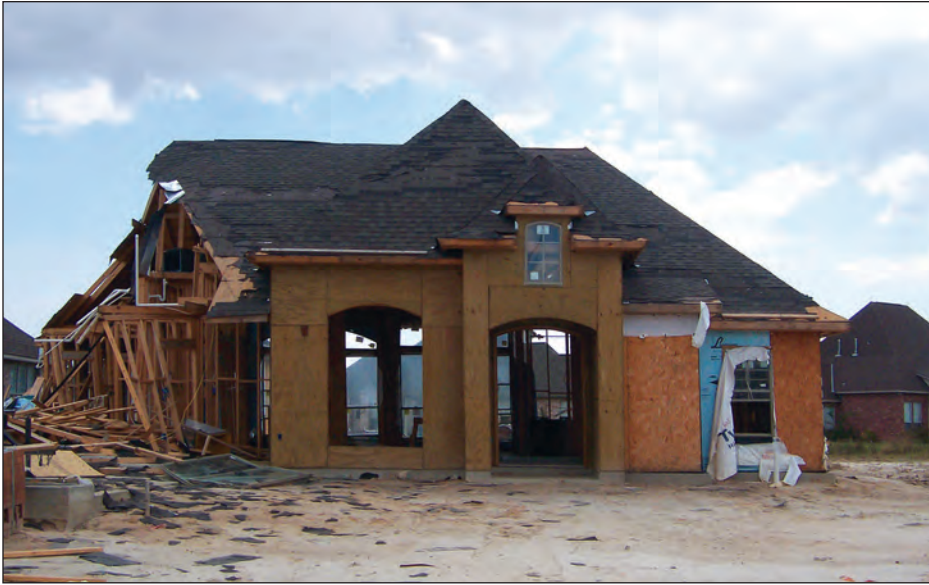
Some homes under construction were severely damaged or destroyed by Katrina's winds even though wind speeds were well below current design levels. Figure 4-88 shows a home in St. Tammany Parish with failed shear walls and a collapsed garage. The complete destruction of the garage prevented the MAT from determining the mode of failure, but the failure of the home could be attributed to inadequate shear wall nailing. The home had shear walls that were only stapled and the staples were widely spaced. Several staples missed the wall framing.

Figure 4-88.  
Home under construction whose garage collapsed and that racked laterally approximately 1 foot. Sheathing in the shear walls in the front of the home were found to be inadequately fastened to the wall framing (estimated wind speed: 120 mph. St. Tammany Parish, Louisiana).

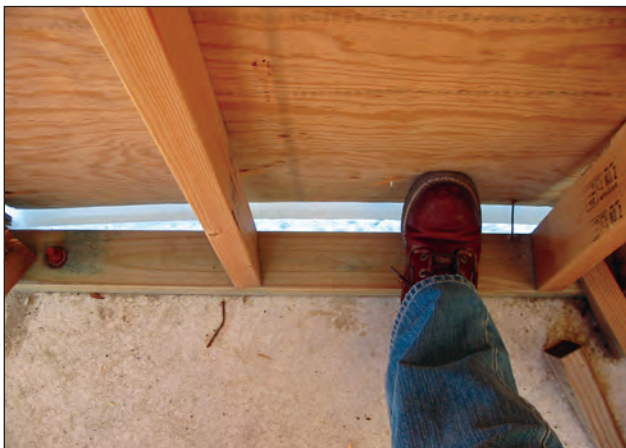
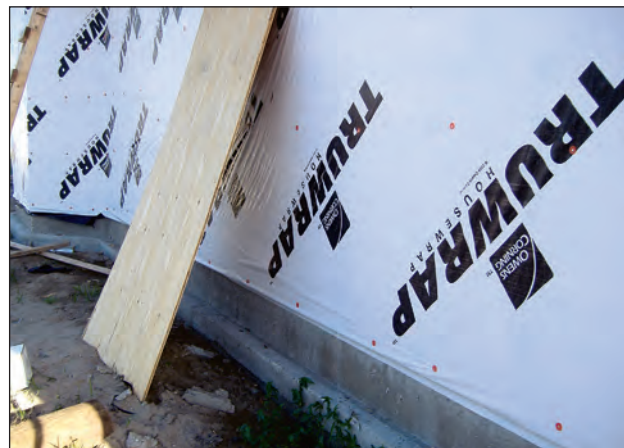
Figures 4-91 (a) and 4-91 (b) show a home in St Bernard Parish, Louisiana, that did not experience significant damage during Katrina (it is possible that the home was constructed after Katrina), but was indicative of improper construction methods found in several new homes the MAT visited. Wall sheathing in the home was fastened to the bottom wall plate at 32 inches on center while prescriptive codes would require nailing at 6 to 8 inches. The presence of building wrap on the outside walls indicates that no additional nailing was to be installed.

**Figure 4-91 (a) and 4-91 (b).**  
Wall framing was inadequately secured to the bottom plate with fasteners spaced over 32 inches on center. The presence of building wrap shows that no additional nailing was planned (estimated wind speed: 130 mph. St. Bernard Parish, Louisiana).

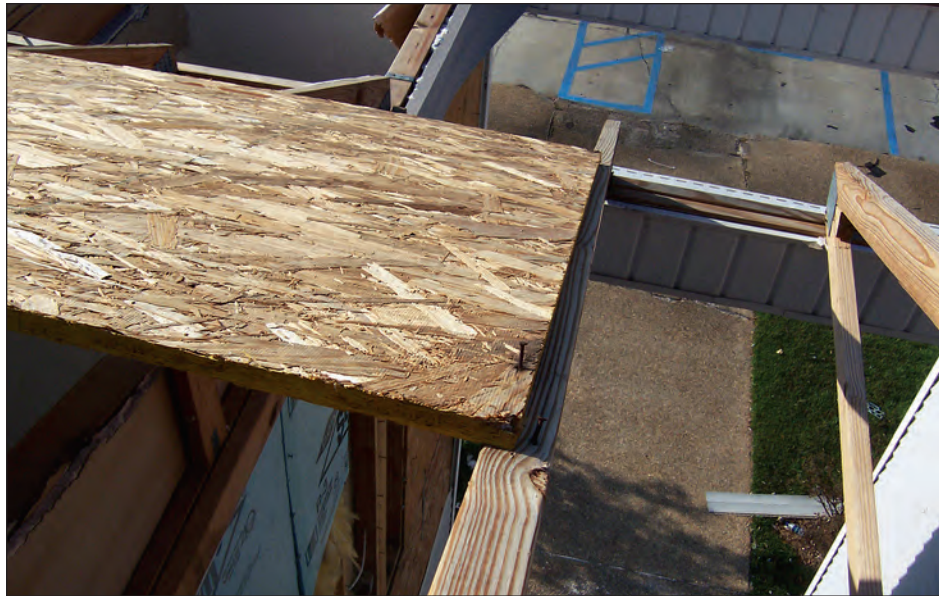
**Figure 4-94.**  
Roof sheathing attachment was inadequate. Several staples were missing, some staples missed framing, and inland the sheathing pulled over the staples (estimated wind speed: 130 mph. Long Beach, Mississippi).

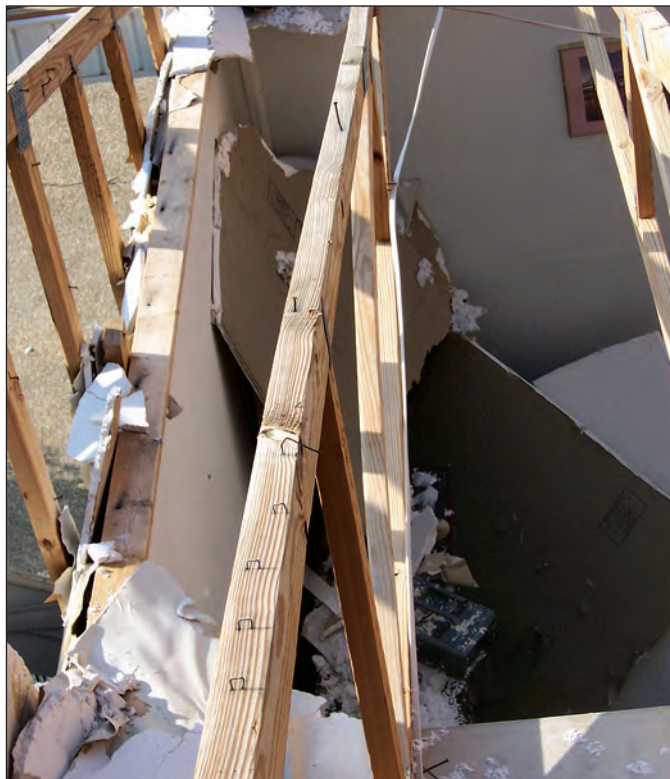
Metal connectors were frequently left out, or were installed improperly. In a Long Beach apartment complex, connectors were used to anchor the main trusses to the bearing walls, but none were used on the gable trusses above the entrances and porches (see Figures 4-95 through 4-98). In those areas, the wide eaves and open breezeways were subjected to uplift forces on the trusses on several buildings in the complex. Connections failed and entire roof structures above the entrances and porches blew off of the buildings.

**Figure 4-95.**  
Metal connectors (arrow) were used on main trusses (estimated wind speed: 130 mph. inland Long Beach, Mississippi).

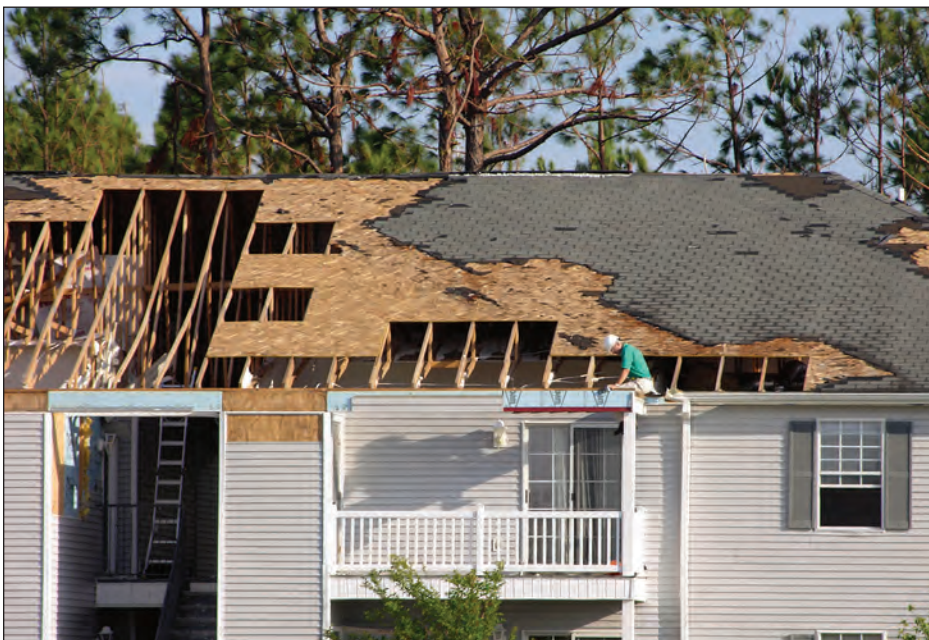
Gable end walls were often constructed with vinyl siding over rigid insulation sheathing, which is vulnerable to damage from wind and windborne debris. If the gable walls are penetrated, internal pressurization occurs and uplift forces on the trusses increase. Properly fastened plywood sheathing on the gable walls would have improved performance and may have prevented failure.

**Figure 4-96.**  
Metal connectors were lacking on the gabled roofs over the porches and entrances. Several roof structures were blown off (estimated wind speed: 130 mph. Long Beach, Mississippi).

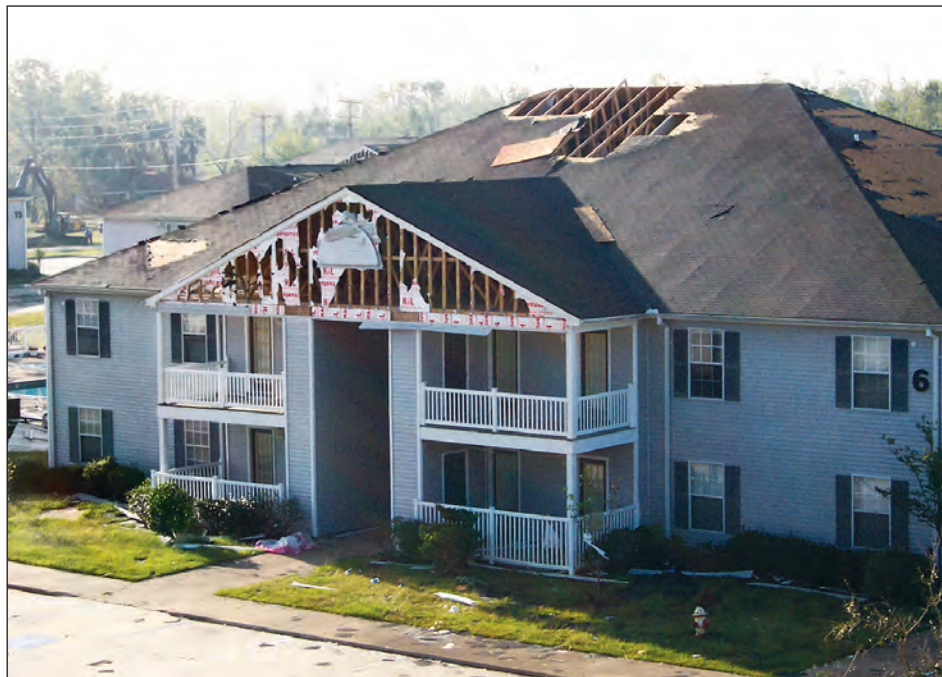
**Figure 4-98.**  
Apartment building's gable walls sheathed with insulation failed during Katrina (estimated wind speed: 130 mph. inland Long Beach, Mississippi)

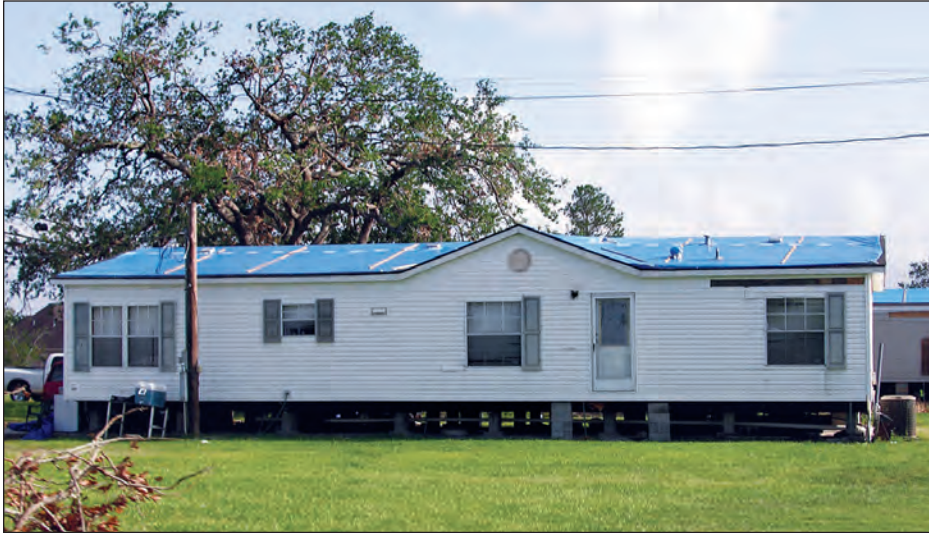
Figure 4-103.  
Newer manufactured home located in Exposure C with roof covering damage (estimated wind speed: 110 mph. Plaquemines Parish, Louisiana)

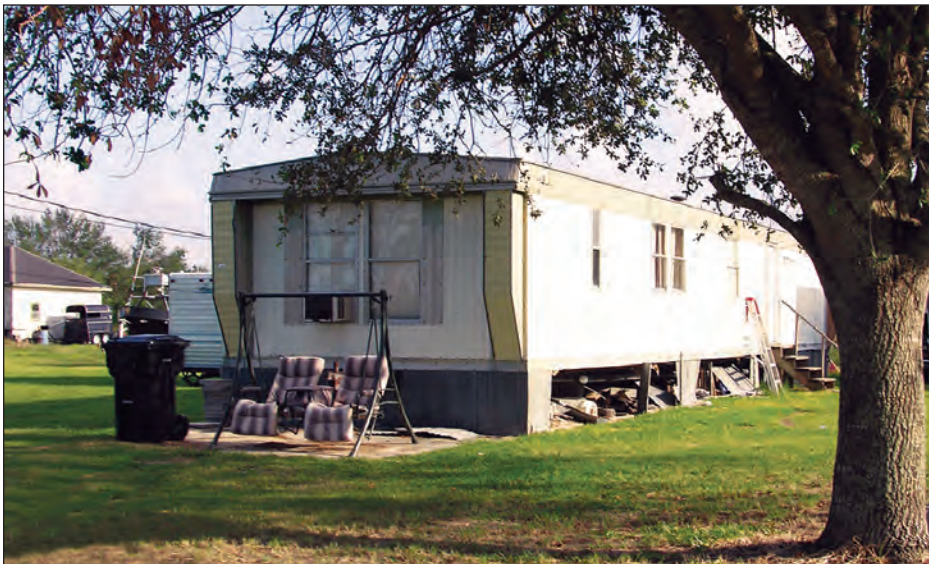
The styles of manufactured home installations impacted performance during Hurricane Katrina. When properly anchored, manufactured home damage under wind loads was less significant. Unanchored or improperly anchored homes or homes with damaged anchors were prone to wind-related damage. The home in Figure 4-104 was installed with ground anchors. The heads of the ground anchors extended several inches above the ground (see Figure 4-105). The straps that connect the ground anchors to the frame were loose and would allow the home to move several inches before the ground anchors would begin to resist wind loads.

Figure 4-104.  
Manufactured home located in Exposure C installed with ground anchors (estimated wind speed: 110 mph. Plaquemines Parish, Louisiana)

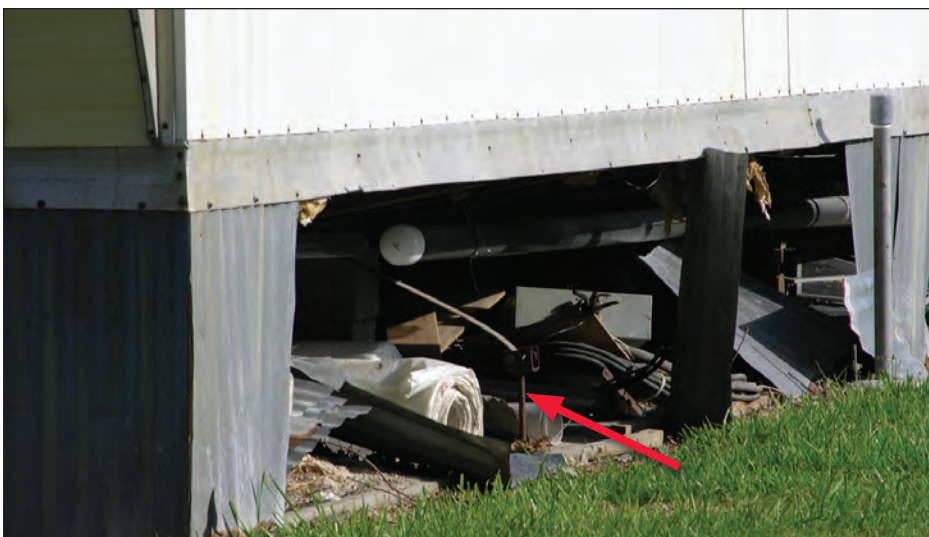
Figure 4-105.  
Ground anchors at manufactured home located in Exposure C (estimated wind speed: 110 mph. Plaquemines Parish, Louisiana)

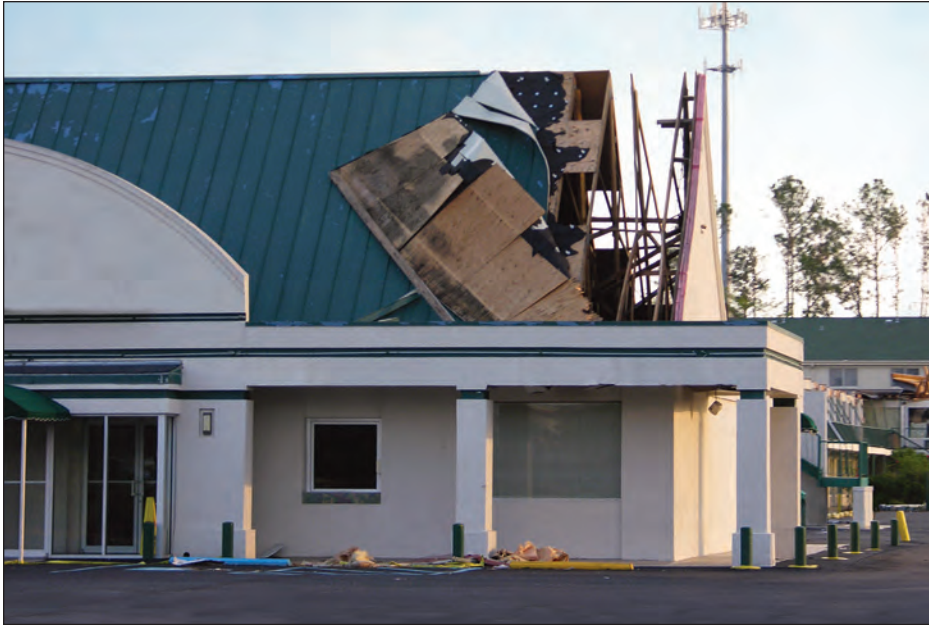
Wood-framed commercial buildings failed similarly to wood-framed residential buildings. Roof structure uplift failures and gable wall end failures like the ones shown in Figures 4-107 through 4-109 were observed. In Figure 4-109, the bottom chords of the roof trusses appear to have buckled under uplift forces. Insufficient truss bracing is suspected.

Figure 4-108.  
Roof uplift failure  
in wood-framed  
commercial building  
(estimated wind speed:  
115 mph. Slidell,  
Louisiana)

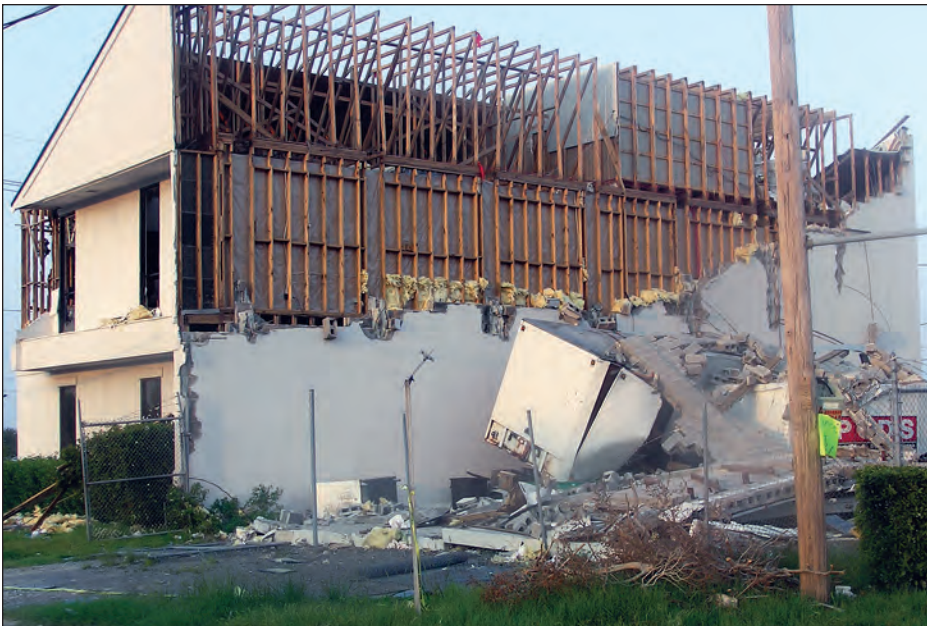
Figure 4-109.  
Three-story wood-framed  
commercial building lost  
roof sheathing and the  
exterior wall collapsed  
(estimated wind speed:  
105 mph. New Orleans,  
Louisiana)

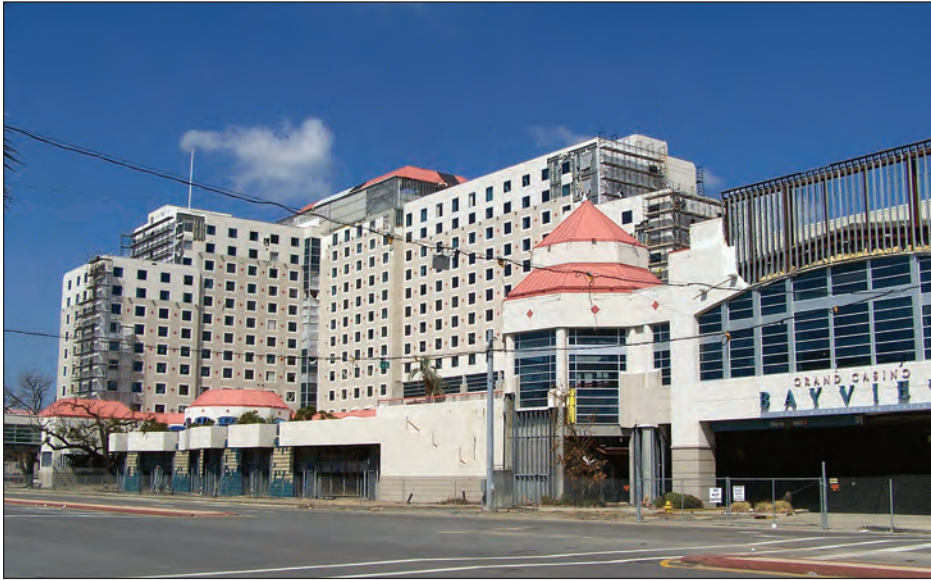
but were inundated with water and experienced envelope failures (see Figure 4-110). Though reinforced concrete buildings are normally quite expensive to construct, new methods have been developed to facilitate the ease of forming, reduce the sizes of members, and reduce the amount of labor required.

**Figure 4-110.**  
This casino located in Exposure C suffered water inundation and wind damage to wall finishes (estimated wind speed: 120 mph. Biloxi, Mississippi).

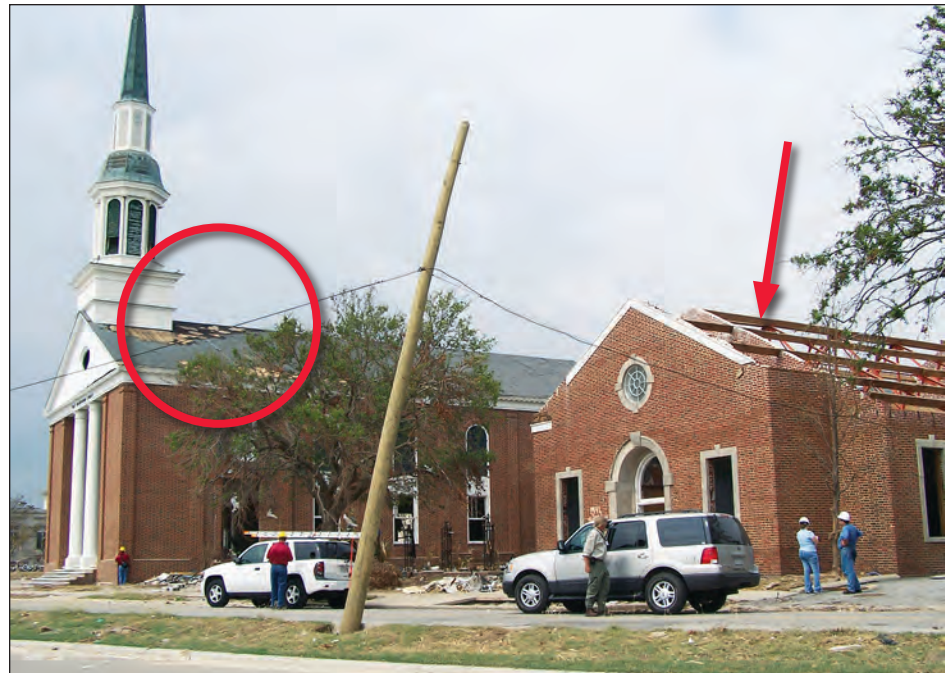
awning. The First Presbyterian Church of Gulfport, Mississippi (see Figures 4-117 and 4-118) was constructed of grouted multi-wythe brick masonry. Though the chapel lost its roof covering and decking, the heavy timber purlins and steel trusses remained firmly attached to the load-bearing masonry walls.

Figure 4-117.  
Gulfport First  
Presbyterian Church with  
wind damaged roofs.  
Note the wind damaged  
roof covering (circle) and  
the missing roof decking  
(arrow) (estimated wind  
speed: 130 mph. Gulfport,  
Mississippi).

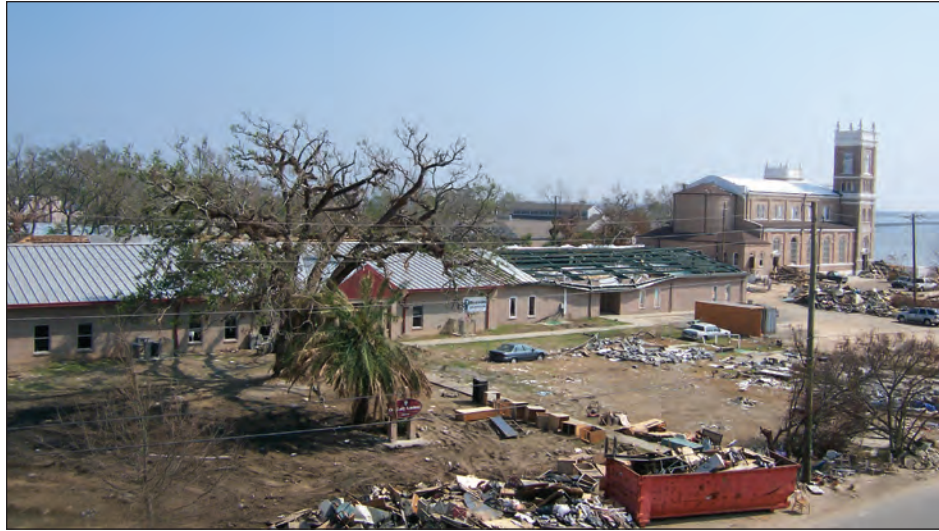
**Figure 4-120.**  
Undamaged newer PEMB constructed in 2001 (estimated wind speed: 130 mph. Pass Christian, Mississippi)

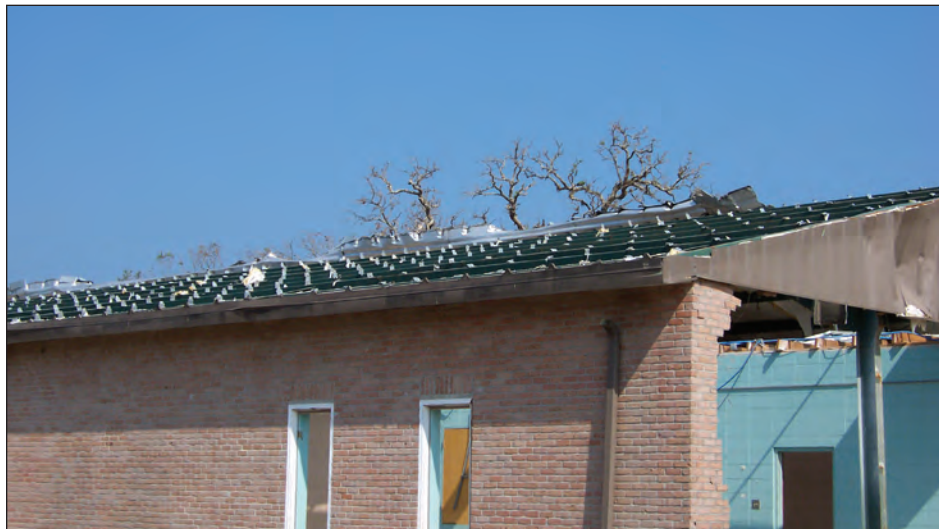
Most failures either involved connections between the metal roof panels and their supporting purlins, or between the purlins and the steel moment frames, as shown in Figures 4-122 through 4-125. Connection failures between the base of the moment frames and supporting footings were observed, but were much less common than connection failures higher up in the structure (Figure 4-124).

**Figure 4-122.**  
Failure of older (1974)  
pre-engineered metal  
building (estimated wind  
speed: 130 mph. Gulfport,  
Mississippi)

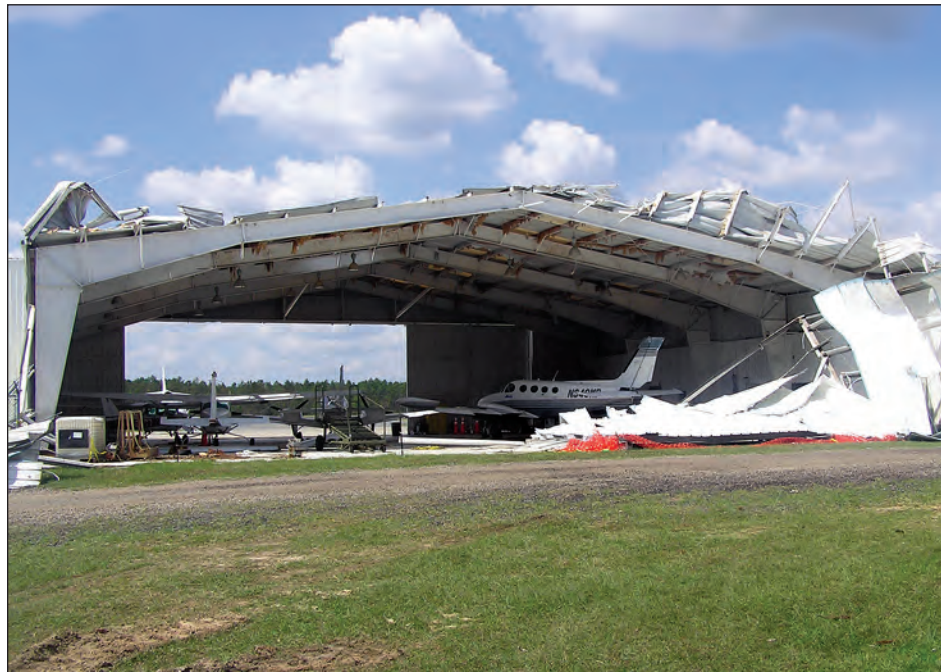
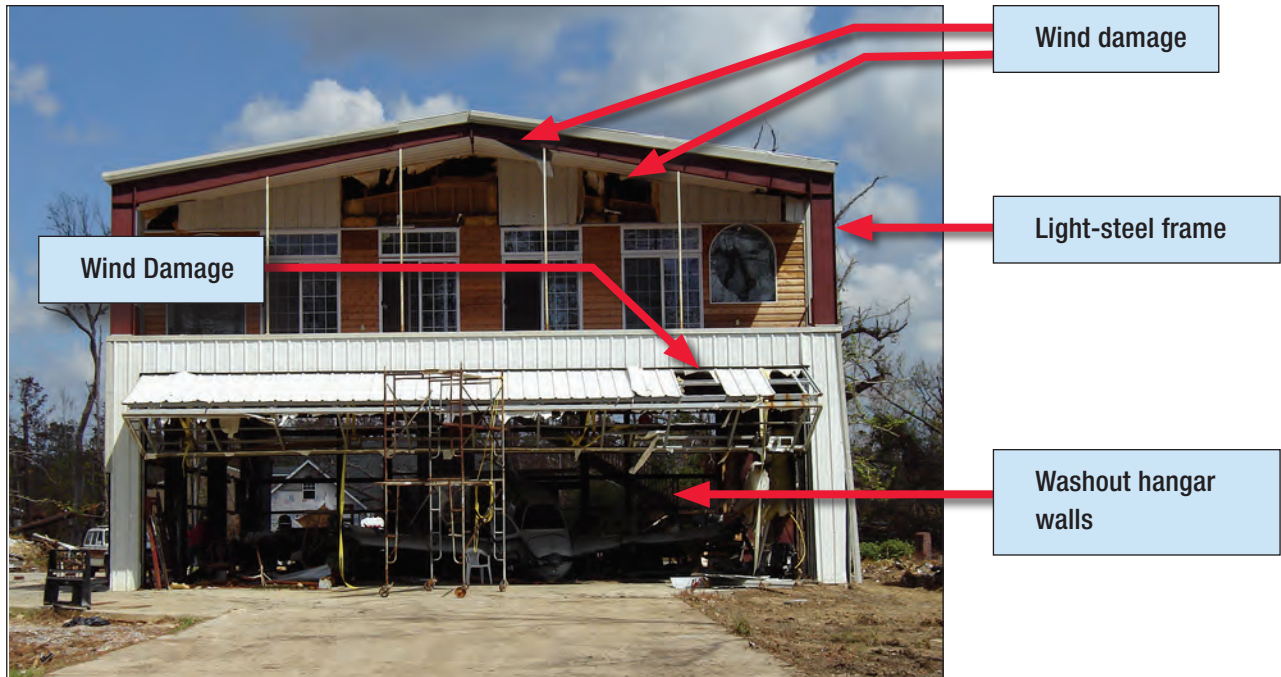
Figure 4-126.

Though not a commercial-use structure, the airplane hangar with a second floor residence was constructed of a light steel pre-engineered frame (see Figure 4-126). This home/hangar, along with others in the Diamondhead, Mississippi, fly-in residential community, was devastated by wind and water.

Residence/hangar constructed of a light-steel pre-engineered frame (estimated wind speed: 120 mph.  
Diamondhead, Mississippi)
