Performance of Residential Buildings

Mitigation Assessment Team Summary Report and
Recommendations
State of Hawai'i
Maui Wildfires

February 2025

DR-4724

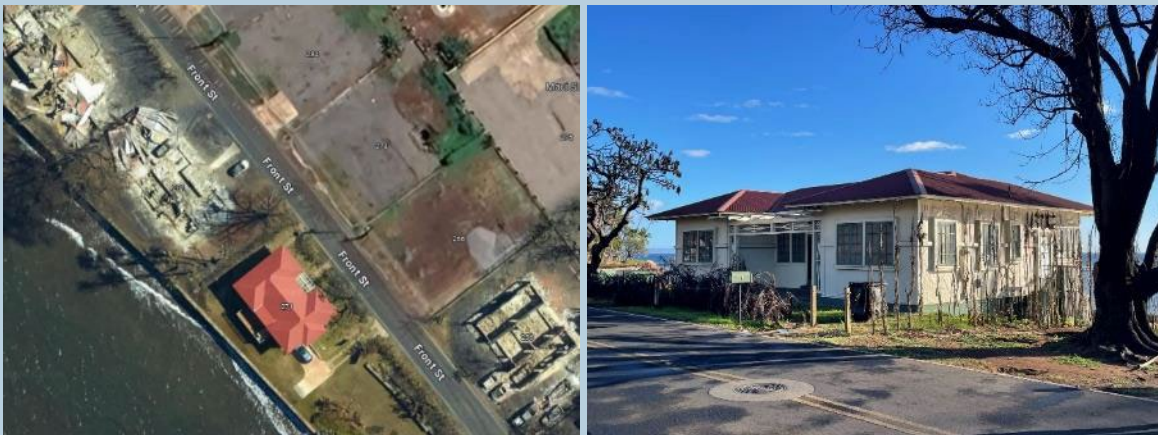
Shortly after the Maui wildfires, local and national news media outlets dubbed one house along the Lahaina coast as the “miracle house.” The historic building survived the devastating Lahaina Fire, while its surrounding neighbors did not. While it cannot be determined precisely why this house survived when many others didn’t, a combination of features likely contributed to its wildfire resilience (Figure 5). According to news articles from Honolulu Civil Beat and National Public Radio, the “miracle house” roof had undergone a detailed renovation that included replacement of the existing wood roof with a commercial grade metal roof.^{14,15} Metal roofs are more resistant to ember and firebrand penetration than a wood roof. Additionally, a 3-foot perimeter of wood mulch and other vegetation immediately surrounding the building was removed and replaced with river stones. Although the stone was intended to reduce the risk of termite damage and improve water drainage, it also helped provide defensible space (hardscaping) to resist fire spread toward the home. The news articles and the MAT concluded that the combination of structural hardening and defensible space, combined with a considerable amount of luck, allowed the “miracle house” to earn its name.

Figure 5. Aerial image of the “miracle house” (left) and a street view of the house with a metal roof that provided structural hardening and minimal landscaping that provided defensible space (right).

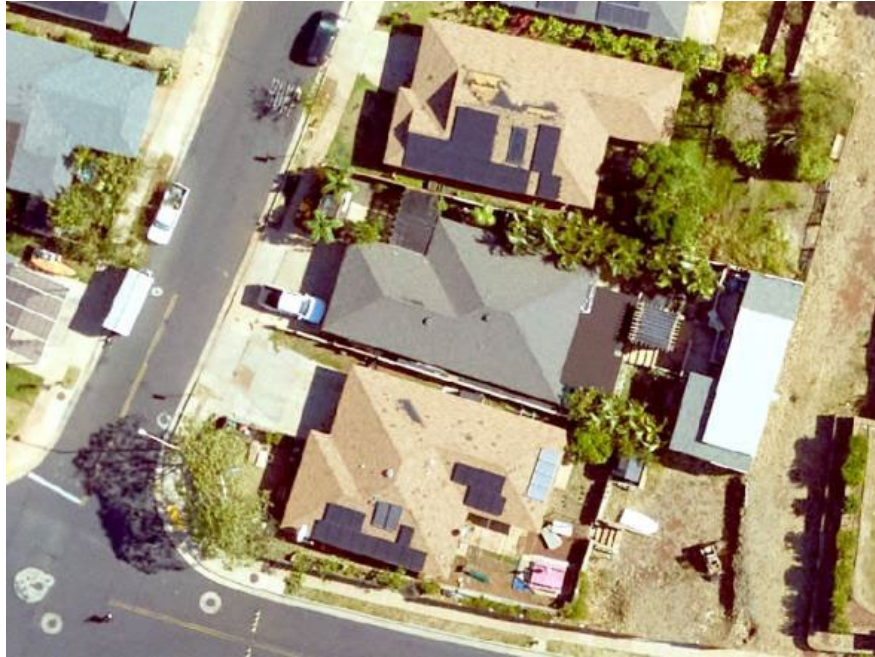
Small parcel sizes observed throughout the impacted and unimpacted neighborhoods of Lahaina and Kula limited homeowners from incorporating defensible space best practices on their own property. This resulted in residences proximate (e.g., within five to 30 feet) to their property line or

their neighbor's home with insufficient defensible space, compounded by a lack of fuel treatments or other forms of defensible space on the adjacent neighbor's property (Figure 26). Many of the neighborhoods impacted by the Lahaina fire featured densely spaced buildings with limited fire separation distances (i.e., less than 10 feet of separation) (Figure 27). At the time of the fire, local planning, building and fire codes did not incorporate wildfire hazard and risk assessments as part of the planning or development process. *Maui Wildfires MAT Recovery Advisory #2 (RA-2) Reducing Wildfire Risk to Your Home* provides guidance and best practices for defensible space considerations on Maui.³²

Figure 26. Aerial imagery showing limited distances between residential buildings in Lahaina.

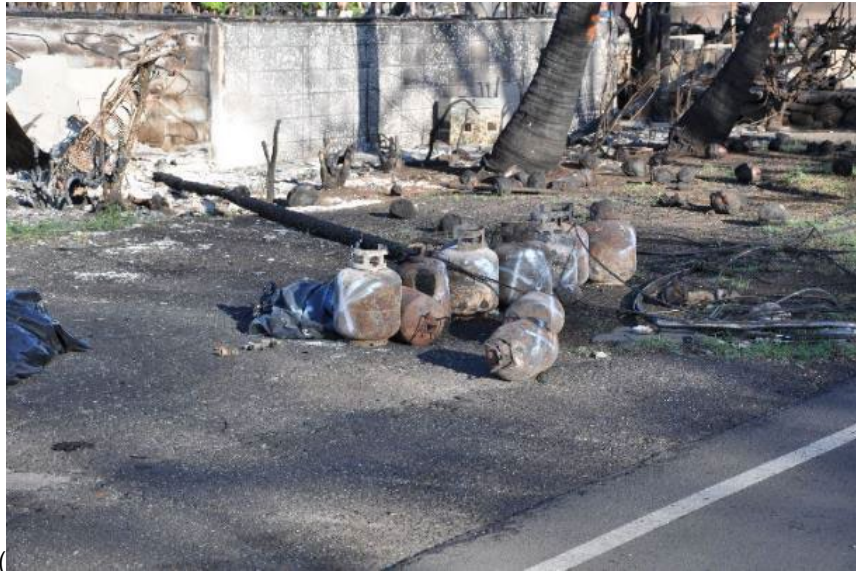
The MAT noted that many homes stored combustible materials, including fixed and portable propane

tanks, close to dwellings (

Figure 29. Propane tanks are commonly used in and around residential buildings.

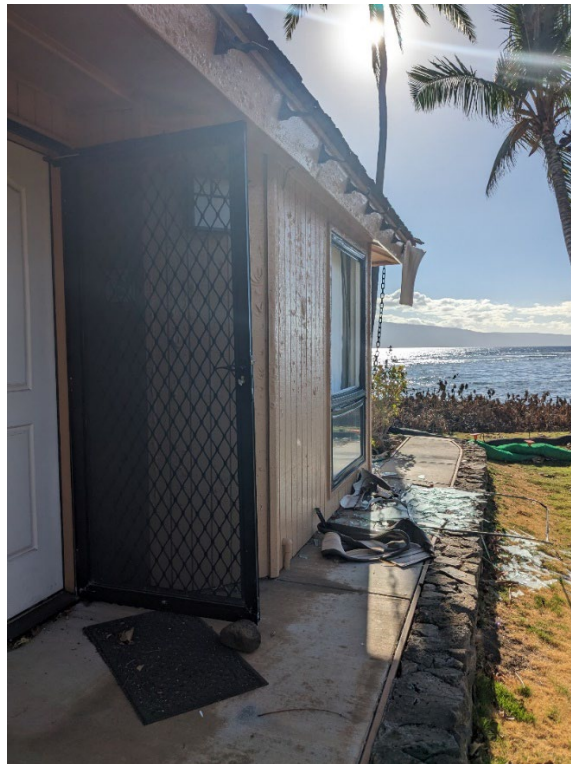
Figure 33. Concrete and stone hardscape creates a non-flammable ground cover around the perimeter of the home.
