# A.V. Watkins Dam Backward Erosion Piping Incident Update

National Dam Safety Program Technical Seminar | 2023

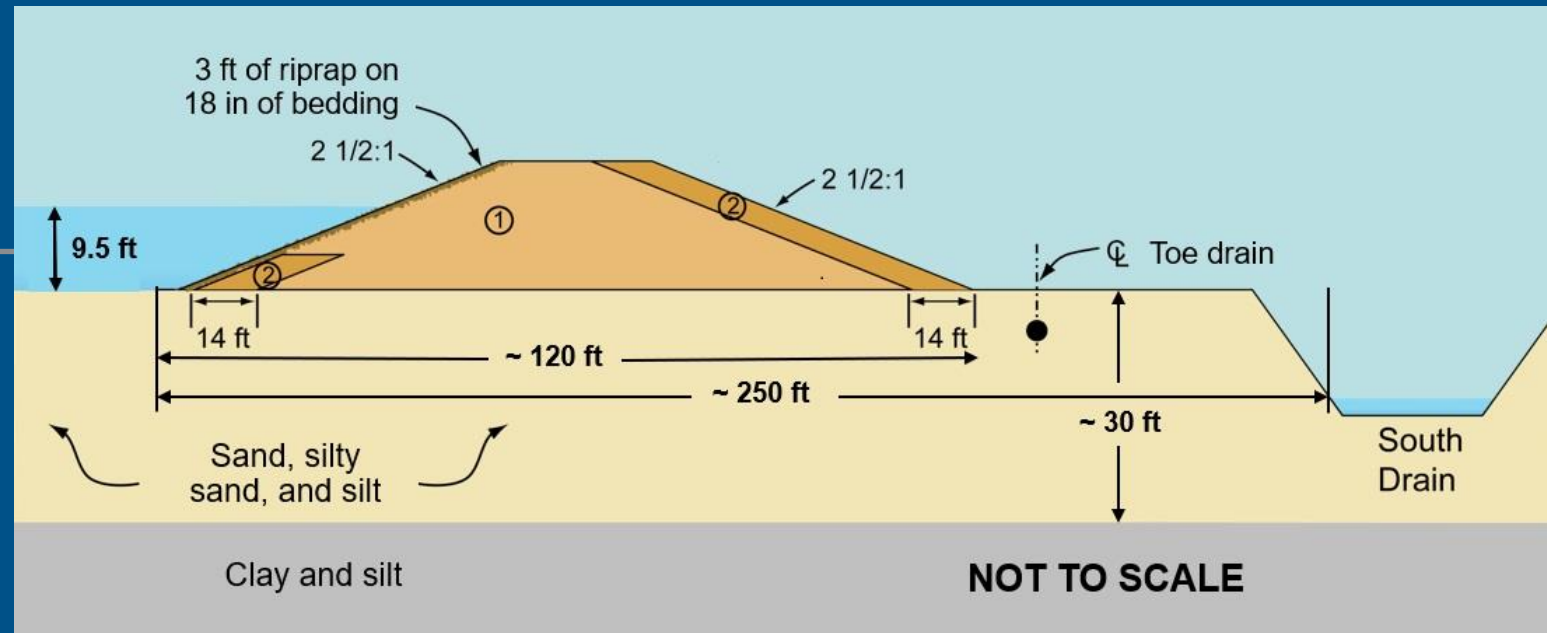
### Typical section in area of incident

- Zone 1 is a sandy to silty clay (~70% fines content)
- Zone 2 was finer than intended by the design in the incident area with essentially no gravel and 20% to 50% fines content
- Foundation consists of ~30 ft of sand, silty sand, and silt overlying very soft lacustrine clay and silt that is hundreds to thousands of feet deep
- Hardpan was encountered during construction of portions of the South Drain

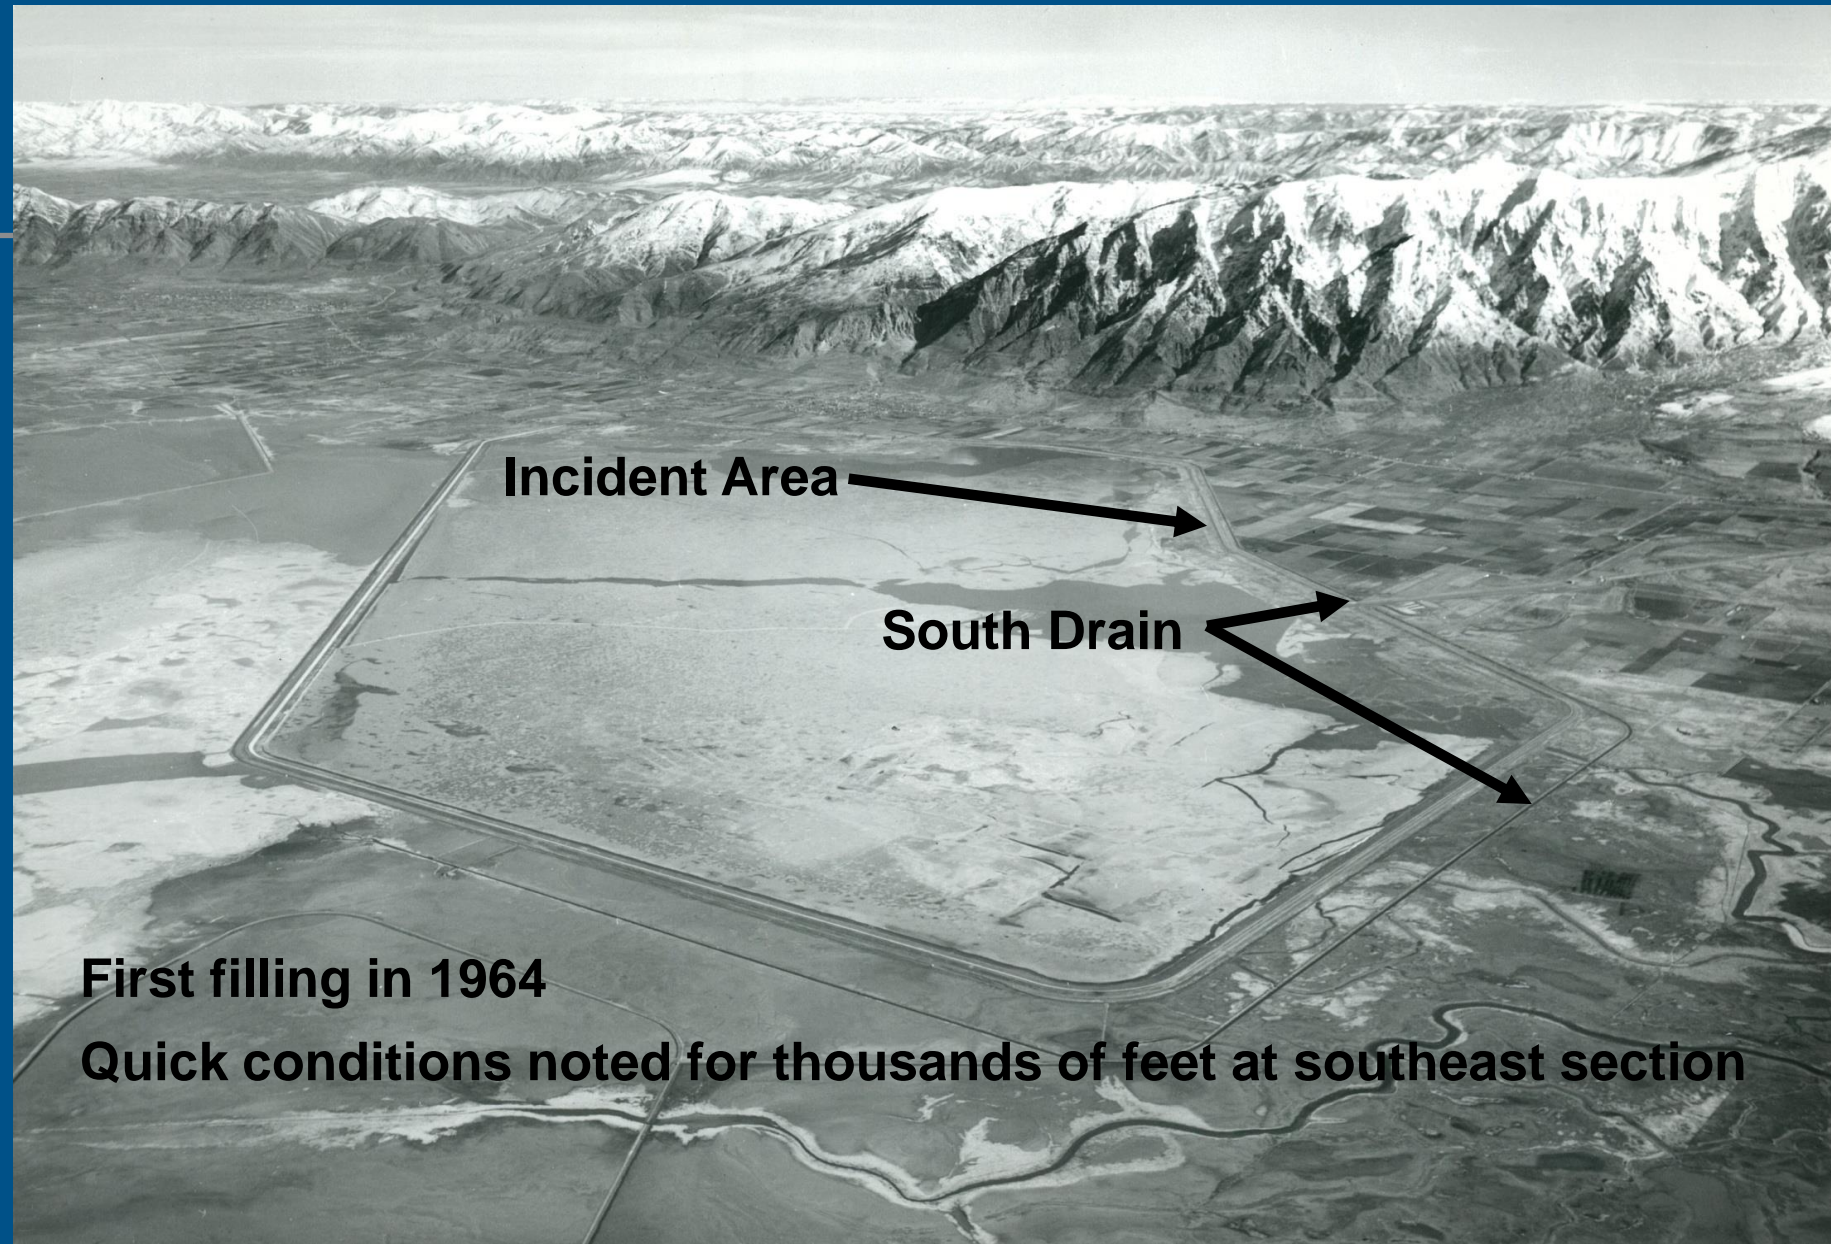
**First filling in 1964**

**Quick conditions noted for thousands of feet at southeast section**

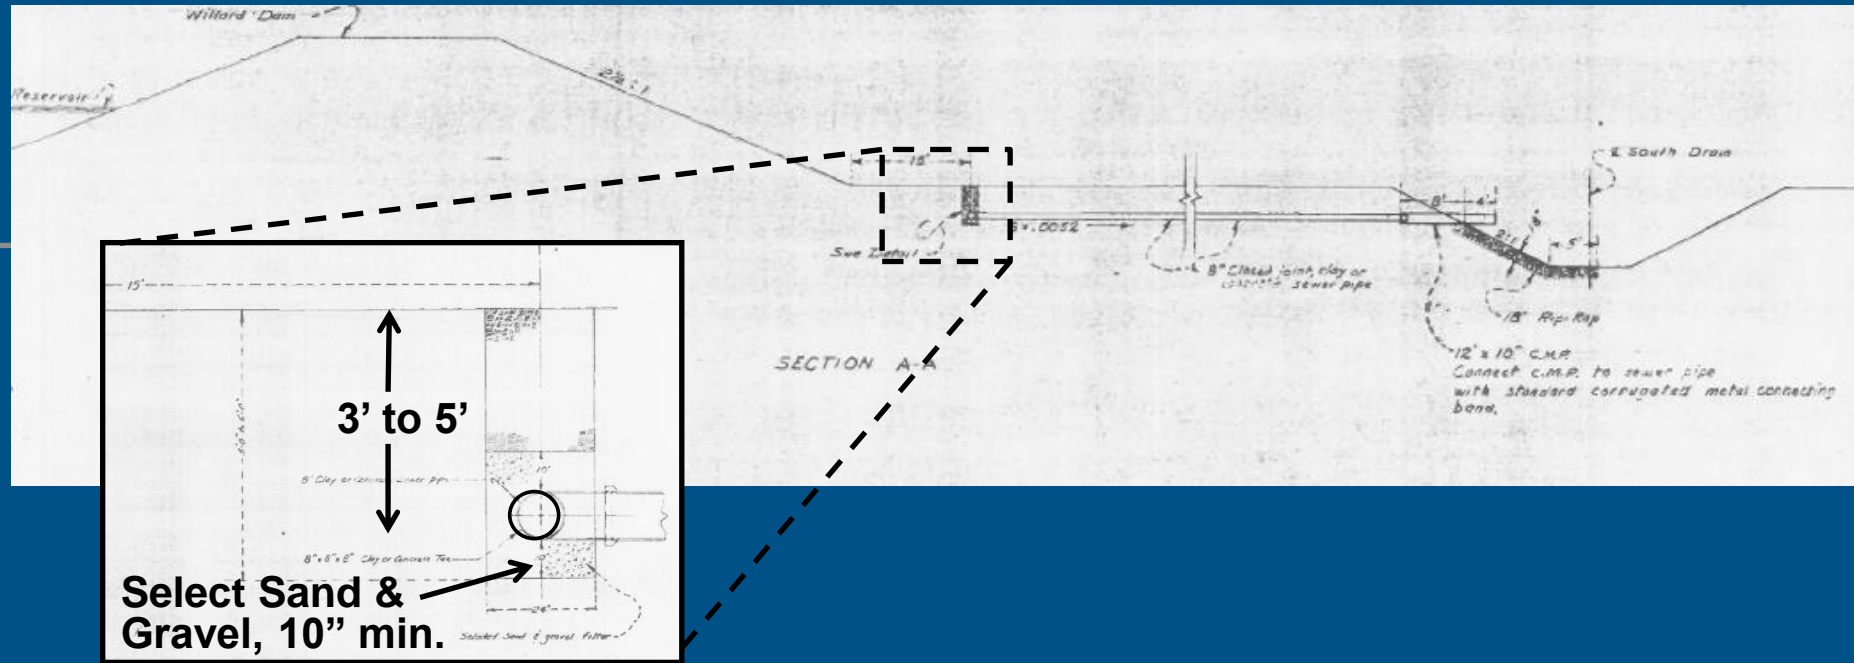
- “Quick conditions” occurred at RWS El. 5224.5 feet
- Decision made to install toe drain along approximately 4 miles
- 8” diameter open joint concrete pipe along dam toe
- 15’ downstream and pipe is 3 to 5 ft deep
- Outfalls at 1,000 ft intervals into the South Drain
- Toe drain sloped at 0.13%; outfalls sloped at 0.52%
- Dam filled successfully in 1965

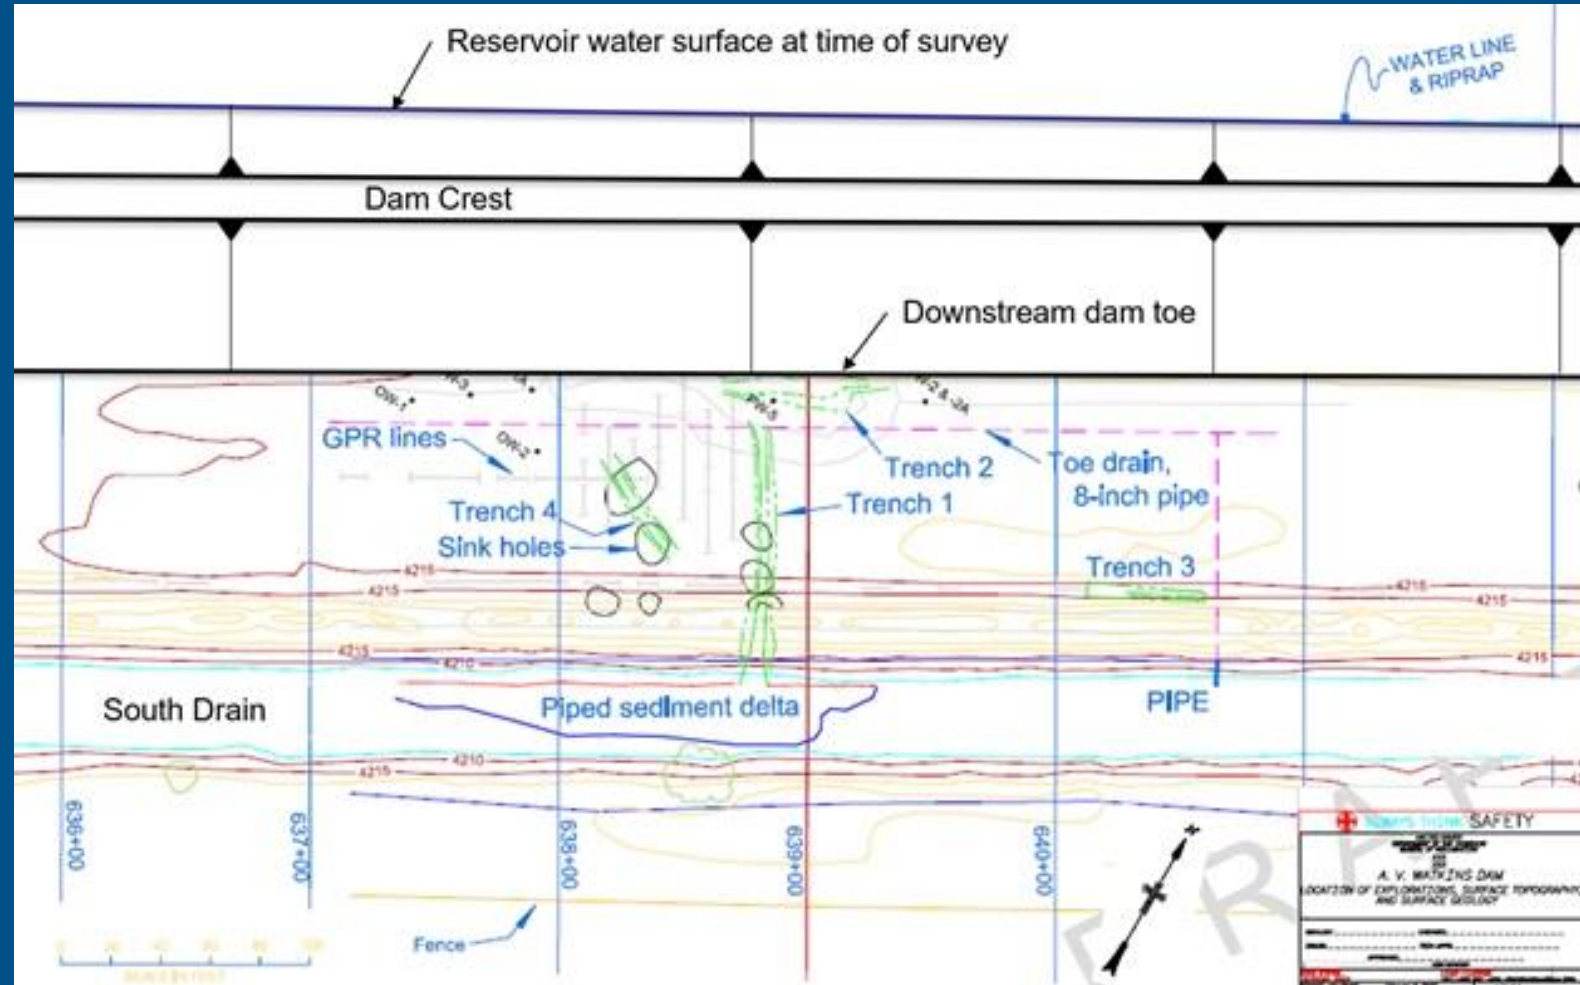
## Plan of Incident Area

- Locations of Explorations
- Sinkholes
- Survey including sediments in South Drain

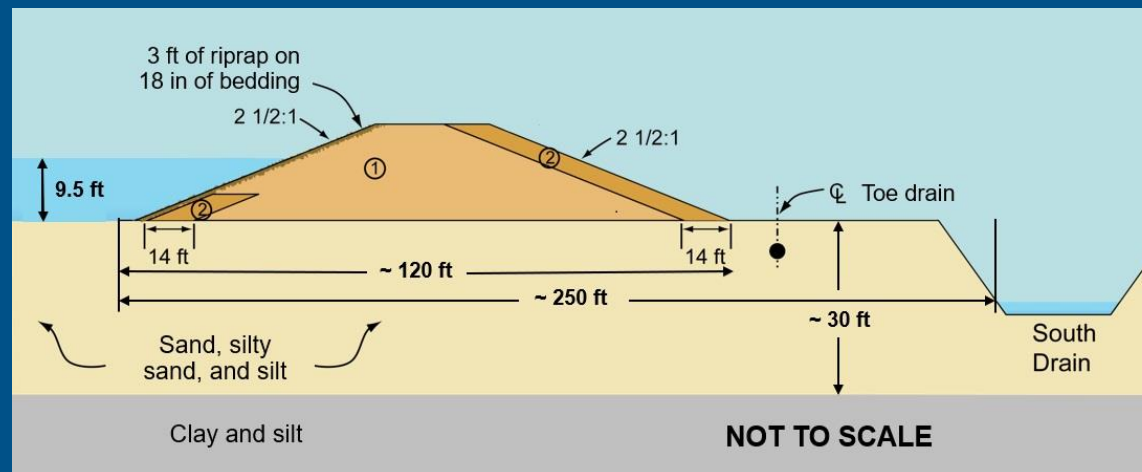
## Adverse Site Conditions Existed Since Original Construction (although not fully recognized)

- Highly erodible foundation materials
- Unfiltered horizontal seepage exit into the South Drain
- Continuous hardpan layer that acted as a roof over the developing pipe
- Filled to top of active conservation El. 4226 many times without any problems

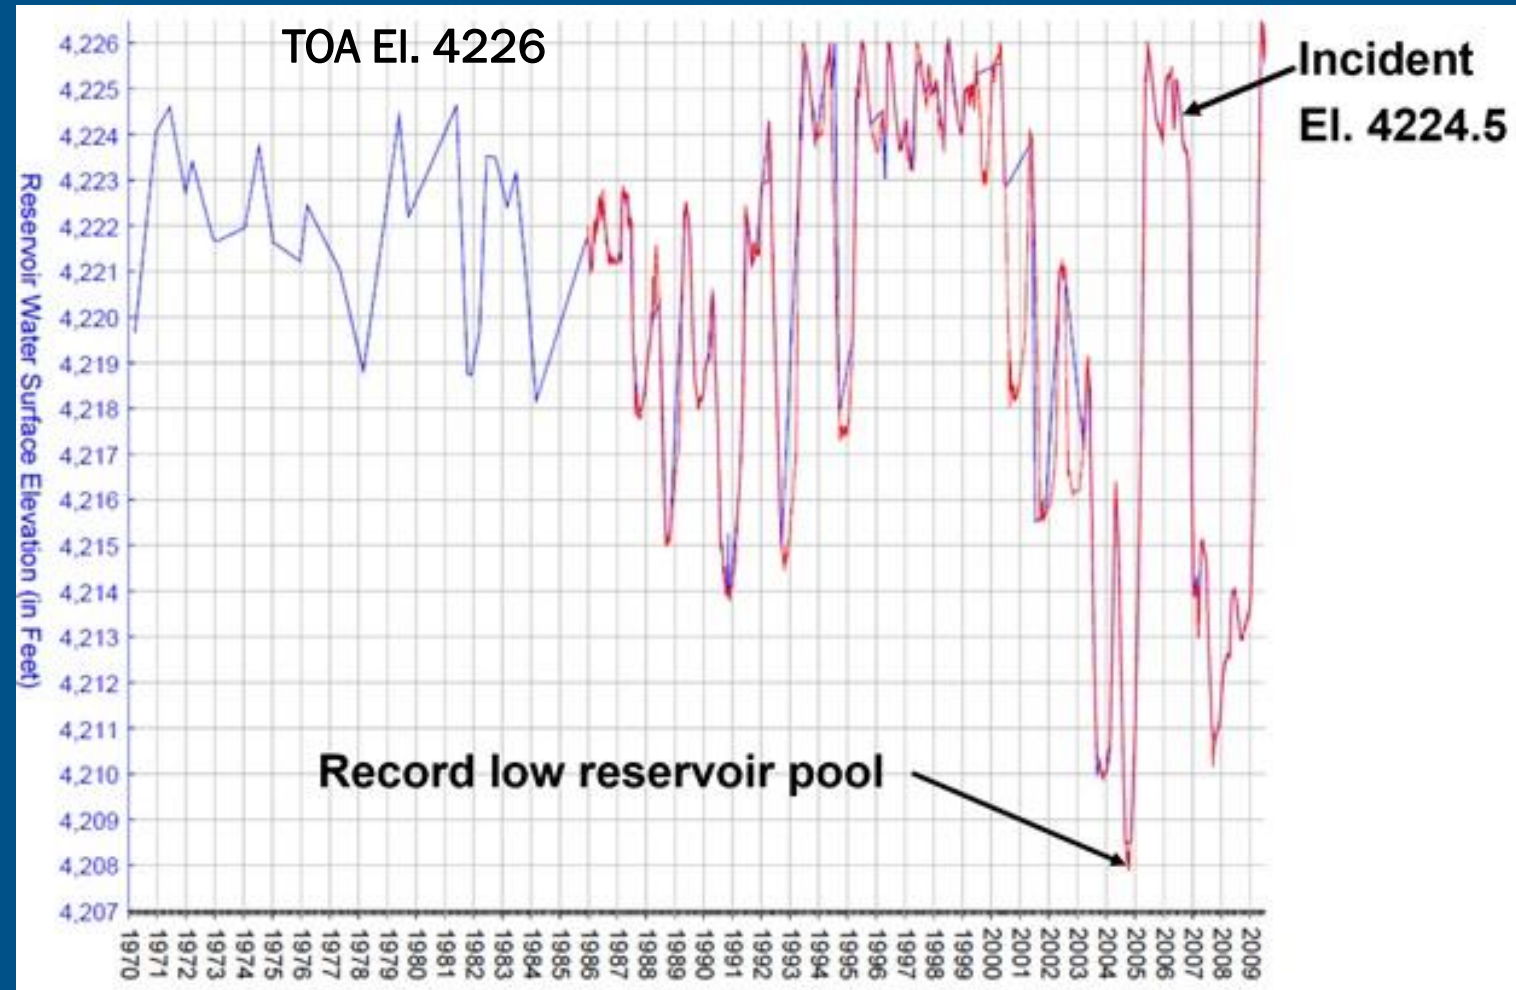
## Factors that were Different at Time of Incident (i.e. Triggering Event)

- Increased gradient
  - Drought conditions
  - Reduced toe drain capacity (plugged)
  - Possible presence of animal burrows beneath the hardpan
- Stress changes during drought in the years prior to 2005 could have altered foundation conditions and seepage behavior upon refilling of the reservoir

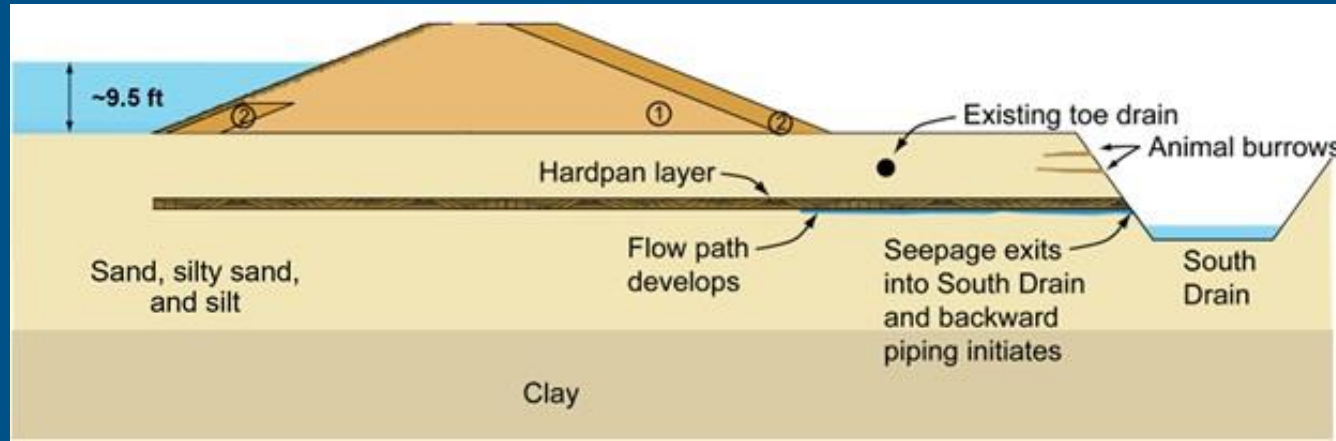
## Average (Global) Gradient Calculations at Time of Incident

- Average gradient from upstream toe to exit at South Drain = 0.06
- Average gradient from upstream toe to downstream toe = 0.08
- Functioning toe drain: average gradient from toe drain to South Drain = 0.04
- Plugged toe drain: average gradient from toe drain to South Drain = 0.06
- Postulated average gradient from upstream dam toe if the unfiltered exit occurred into an animal burrow that extended 20 ft upstream of South Drain = 0.08

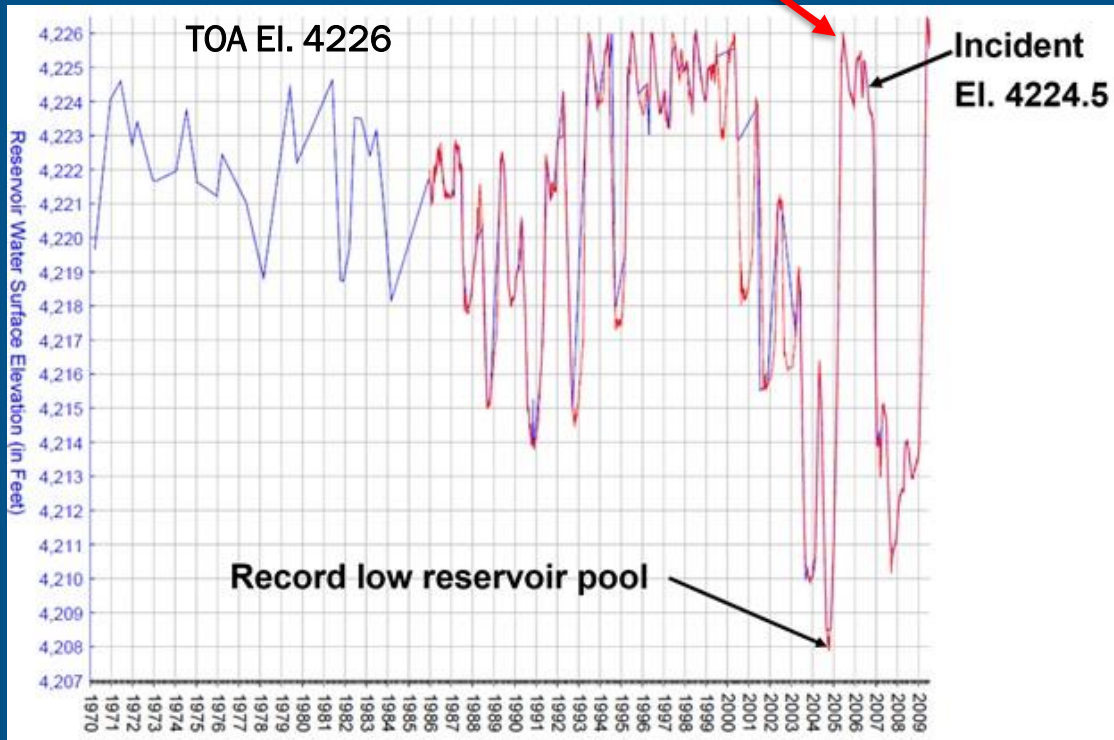
## Record low reservoir pool in 2004 and refilling of reservoir

- During multi-year drought and record low pool, tailwater in the South Drain was likely at its lowest historic level
  - Upon refilling, highest historic avg. gradient likely occurred
- Filled to El. 4226 in 2005 but no incident detected
- A partial pipe may have been created in 2005
  - Avg. gradient to South Drain was 0.07 (vs 0.06 at time of incident)
  - Undetected erosion could have occurred in 2005, but stopped when pool was lowered, or self-healing occurred
  - Shorten seepage path to the pipehead in a partial pipe would increase the avg. gradient calculation upon filling in 2006, and may explain why piping initiated at 1.5 ft lower pool
