RESIDENTIAL CHIMNEY

ENGINEERING REQUIRED

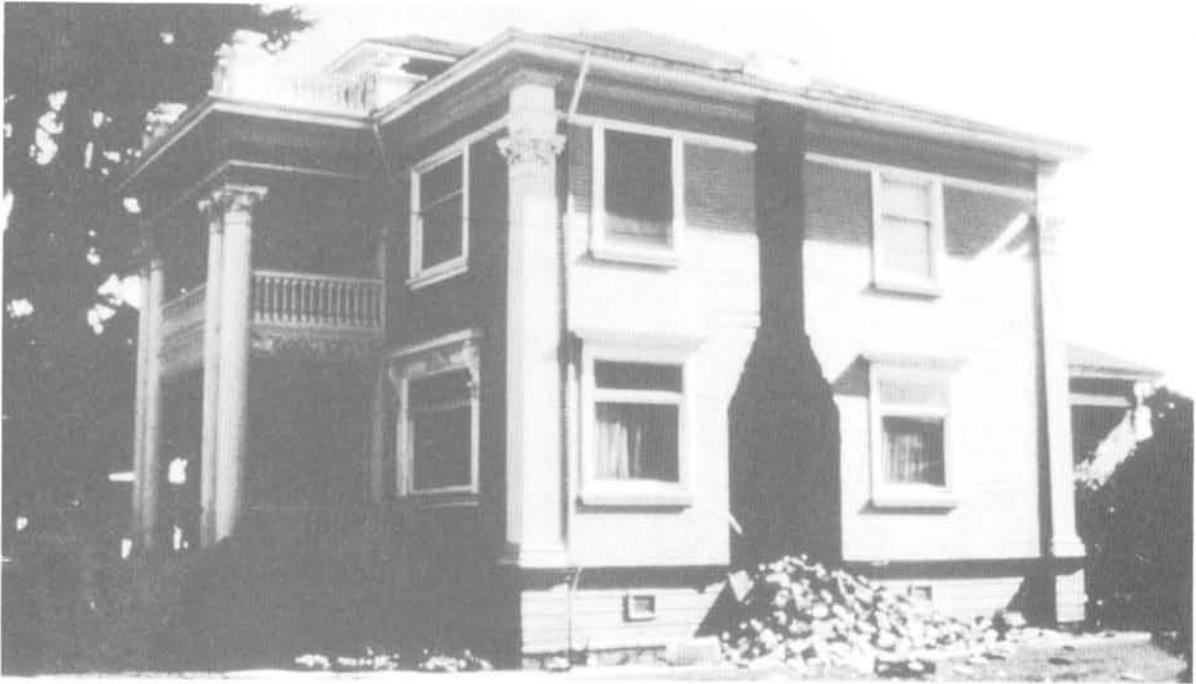
Earthquake Damage: 1989, Loma Prieta, California
Photo Credit: California Office of Emergency Services, Earthquake Program

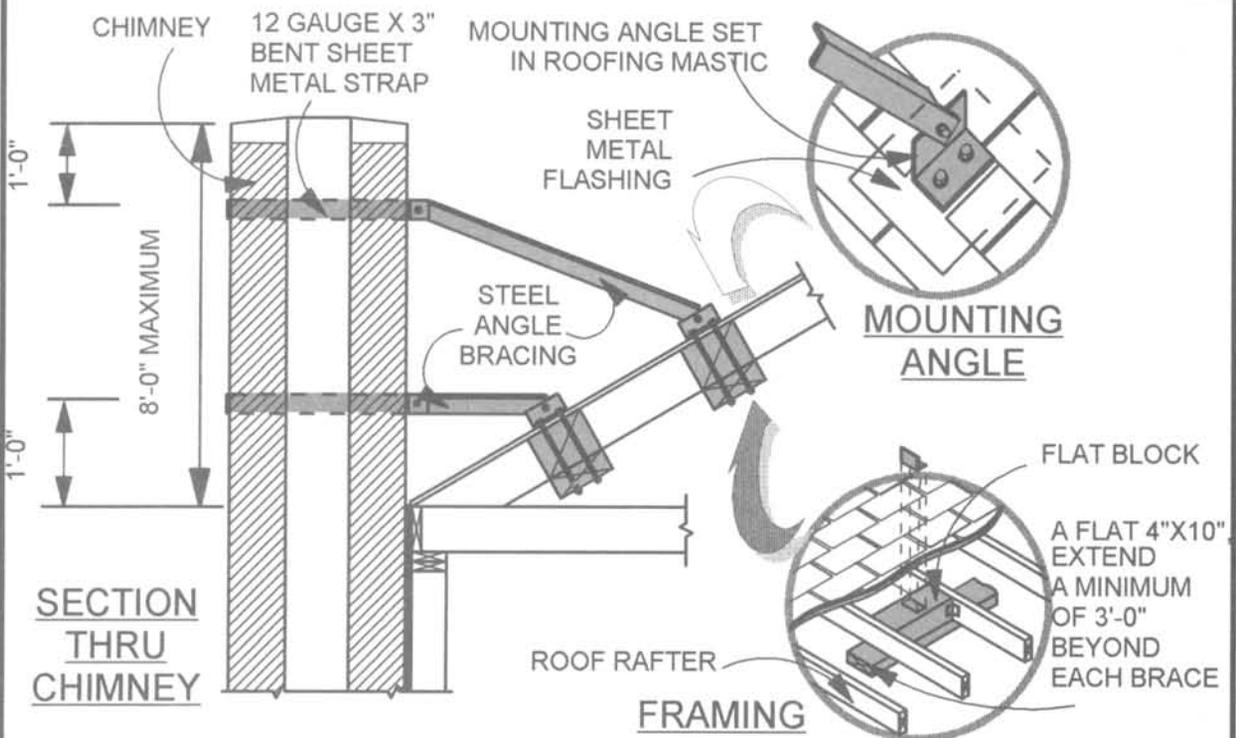
Upgrade Detail U38 (Recommended only for areas of low to moderate seismicity).
Approximate Cost: \$1,000

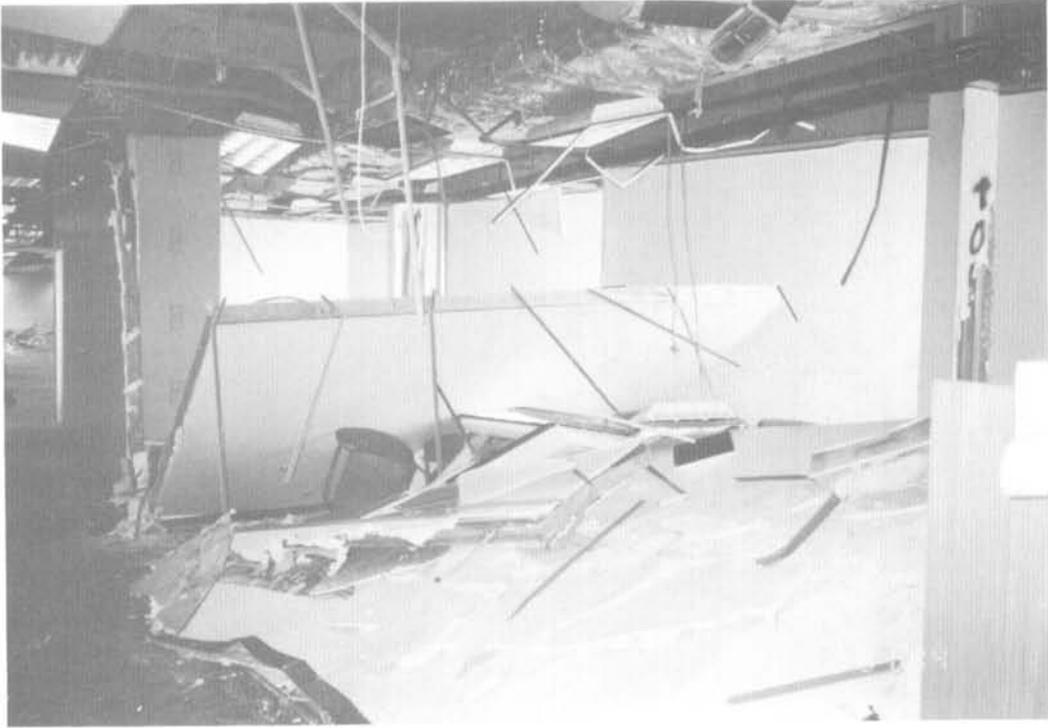
Earthquake Damage: 1994, Northridge, California
Photo Credit: Wiss, Janney, Elstner Associates, Inc.

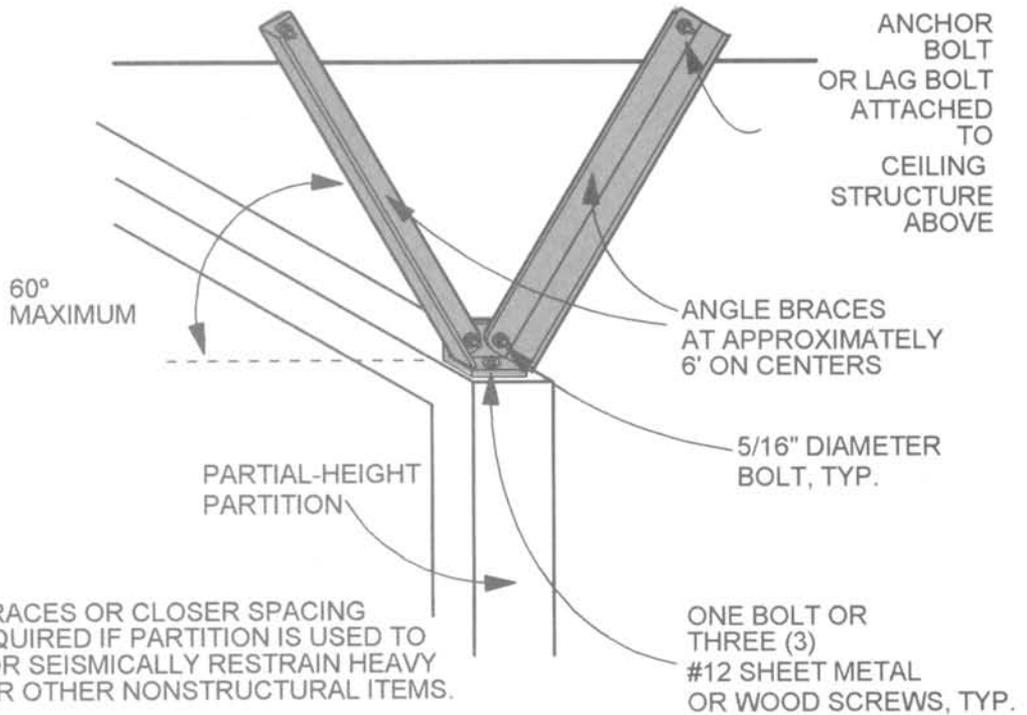
Schematic Upgrade Detail A2a

Approximate Cost: Varies - \$20 - \$40 per lineal foot

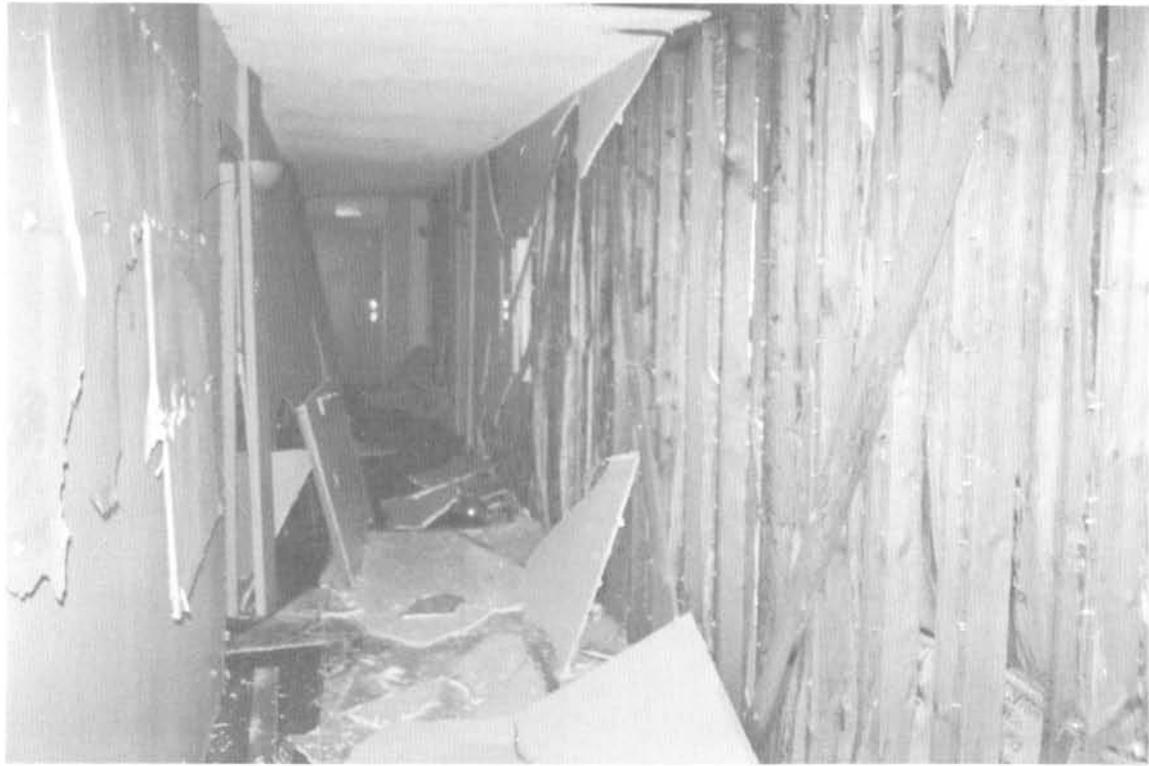
Earthquake Damage: 1994, Northridge, California
Photo Credit: Wiss, Janney, Elstner Associates, Inc.

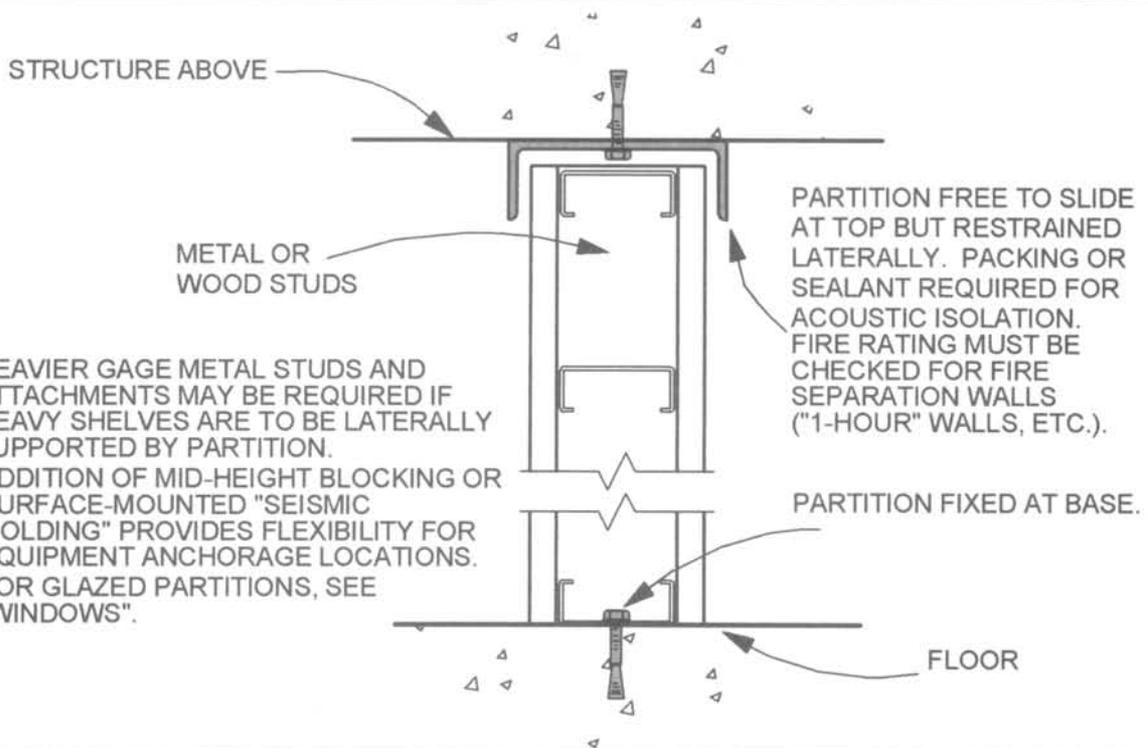
Schematic Upgrade Detail A2b

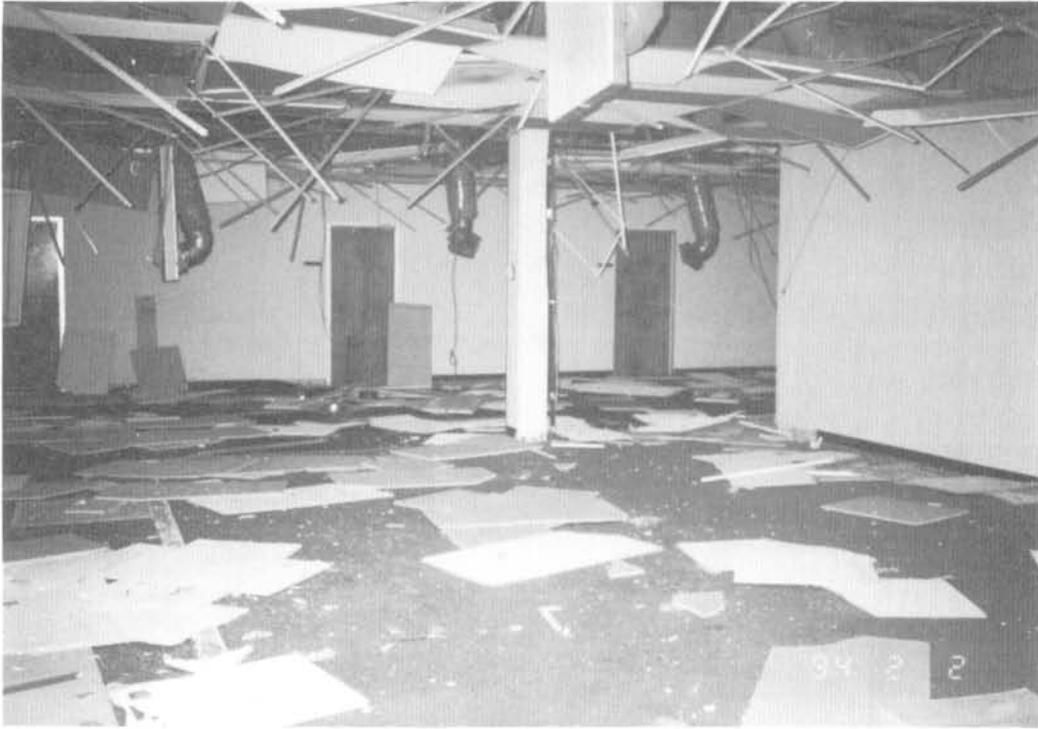
Earthquake Damage: 1994, Northridge, California
Photo Credit: Wiss, Janney, Elstner Associates, Inc.

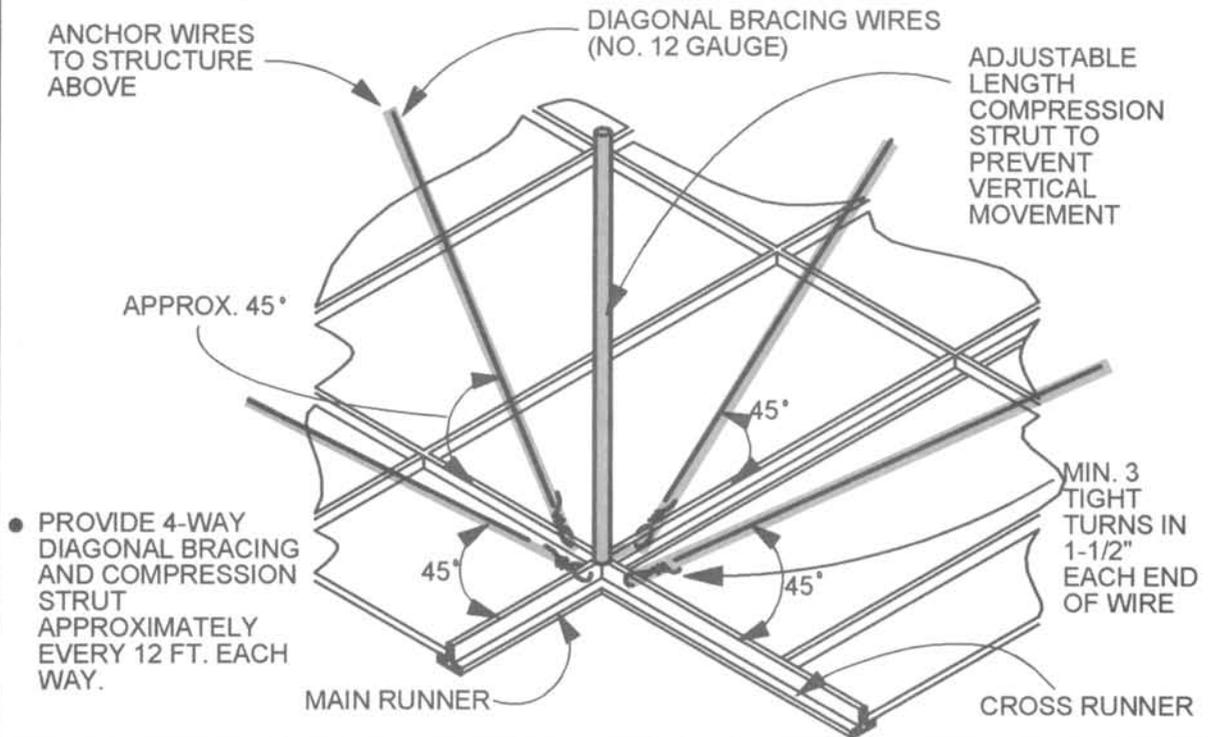
Schematic Upgrade Detail A3
Approximate Cost: \$50 per brace

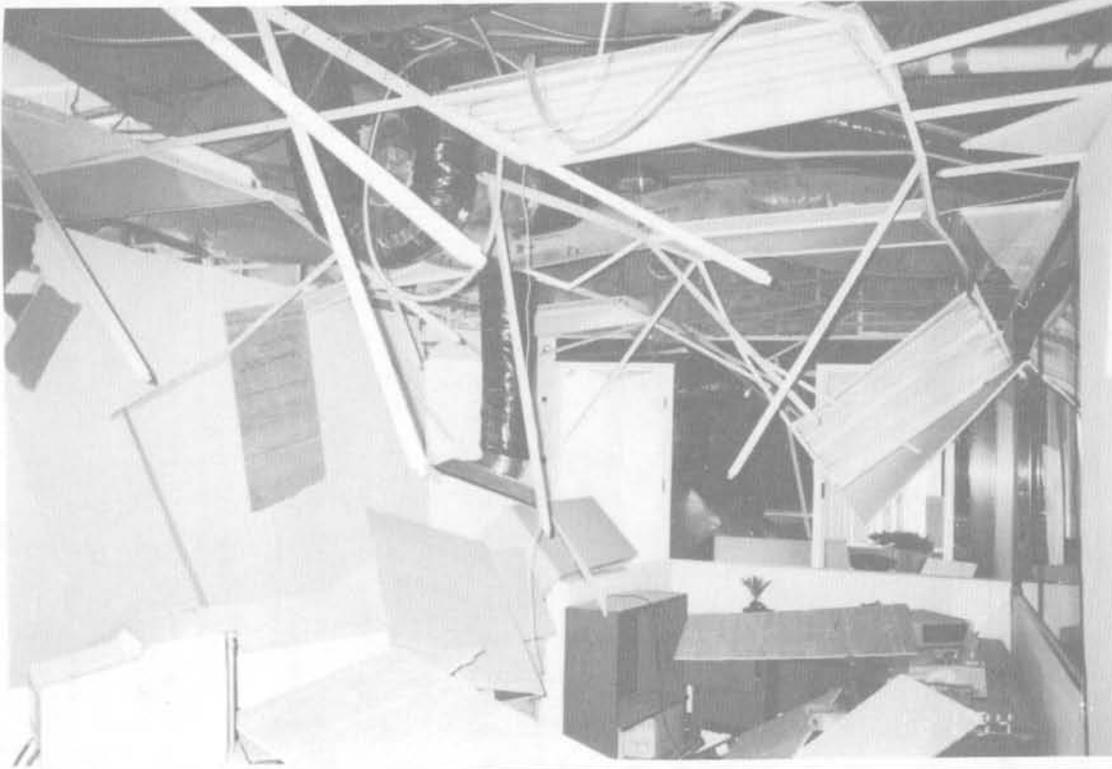
Earthquake Damage: 1994, Northridge, California
Photo Credit: Wiss, Janney, Elstner Associates, Inc.

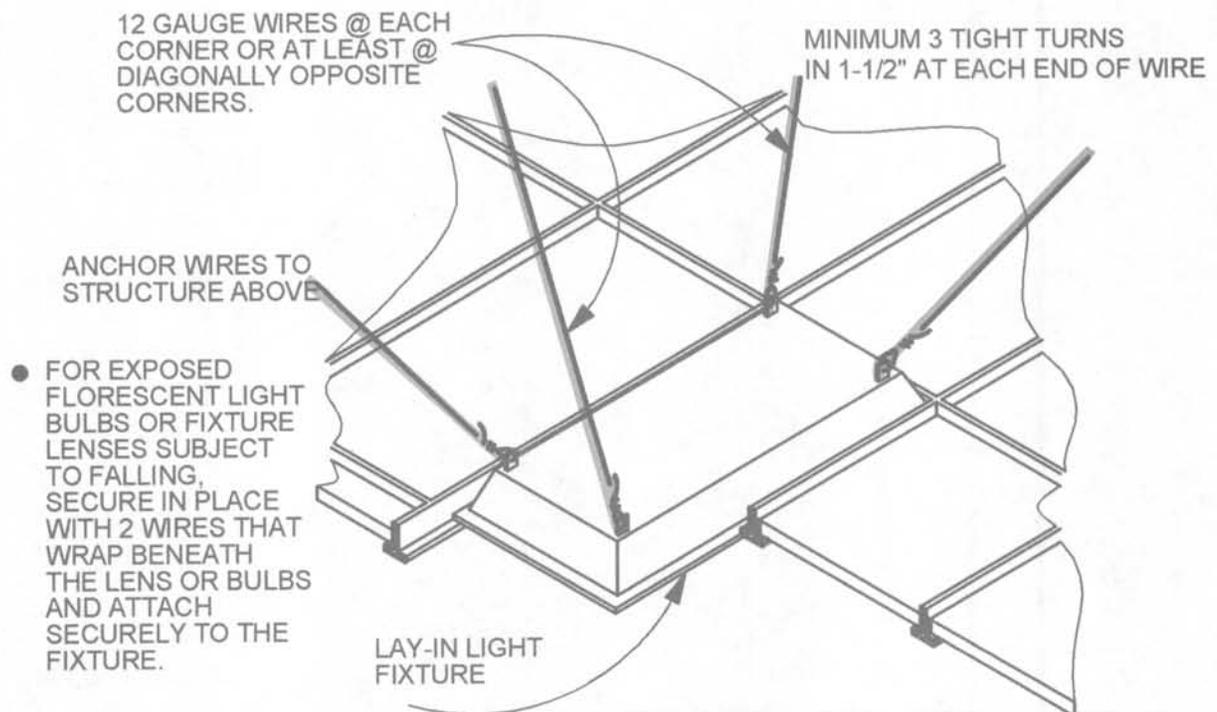
A5a

Upgrade Detail U5a

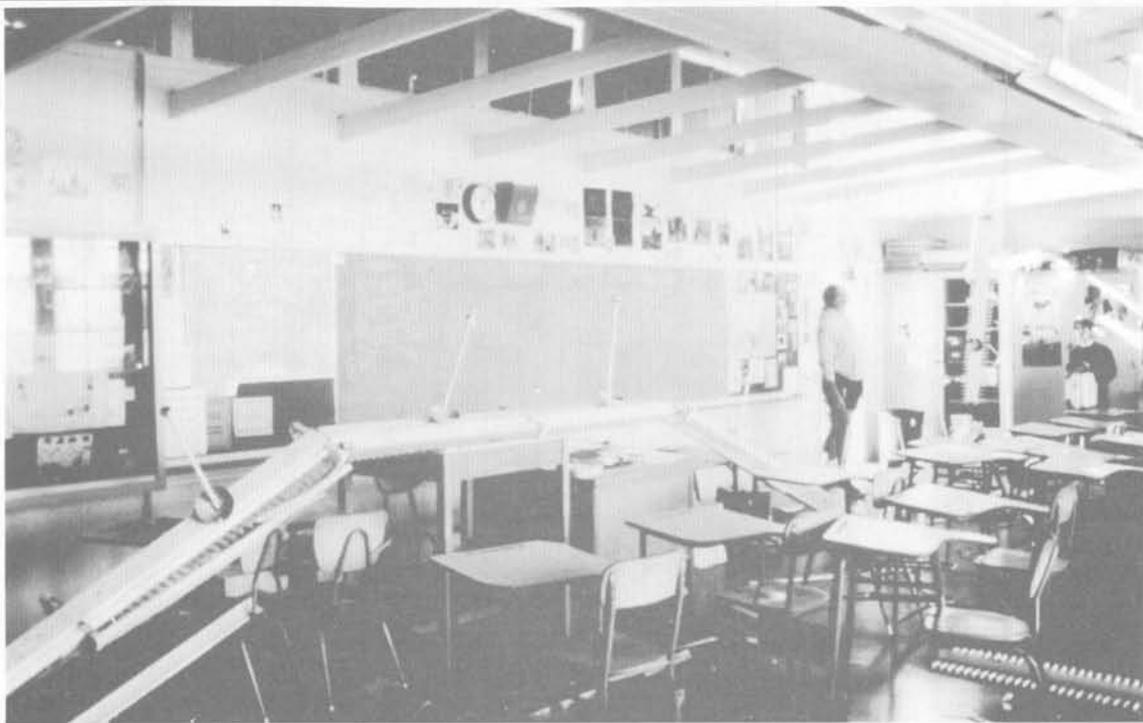
Failure of light fixtures at Northridge Junior High School
Earthquake Damage: 1994, Northridge, California
Photo Credit: Earthquake Engineering Research Institute, Gary L. McGavin

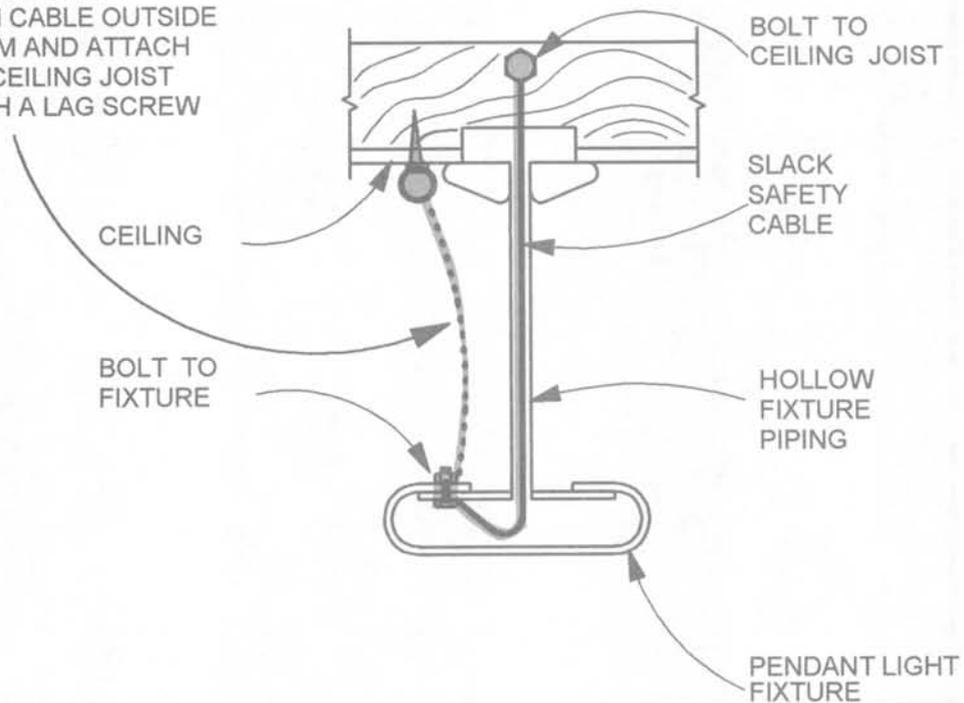
ALTERNATE:
RUN CABLE OUTSIDE
STEM AND ATTACH
TO CEILING JOIST
WITH A LAG SCREW

Upgrade Detail A5b
Approximate Cost: \$80

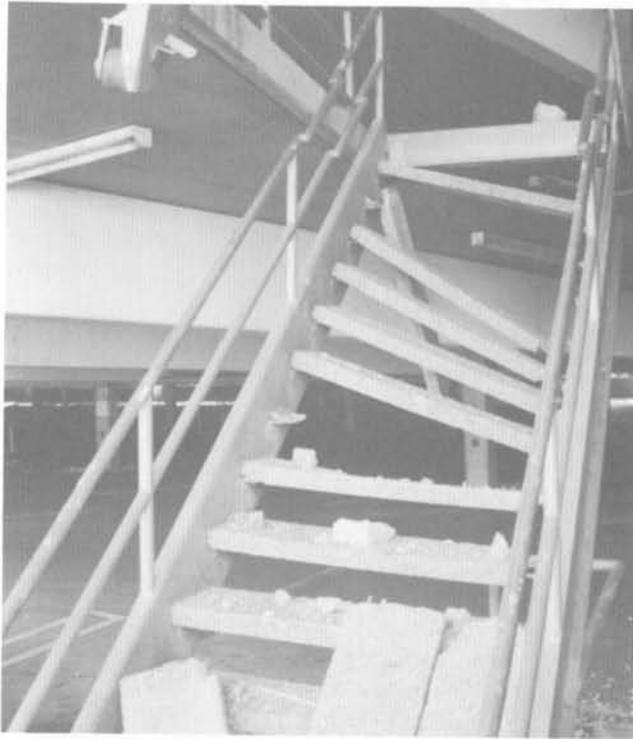
Earthquake Damage: 1994, Northridge, California
Photo Credit: Wiss, Janney, Elstner Associates, Inc.

- TO PREVENT DAMAGE TO STAIRS THEY SHOULD BE MODIFIED TO ALLOW THEM TO SLIDE AT LANDINGS WITH "GANG PLANK" DETAILS; THIS IS DESIRABLE FOR FLEXIBLE FRAME BUILDINGS.
- IF STAIR ENCLOSURES ARE CONSTRUCTED USING BRITTLE MATERIALS, SUCH AS, HOLLOW CLAY TILE, GLASS BLOCK PARTITIONS, OR SKYLIGHTS, IT IS RECOMMENDED THAT THEY BE ENCAPSULATED OR REPLACED TO PREVENT FALLING HAZARDS AND DEBRIS IN THE STAIRWELL.
- PROVIDE ANCHORAGE FOR PIPES, LIGHTING OR DUCTS IN STAIRWELLS TO PREVENT FALLING HAZARDS AND DEBRIS.

Schematic Upgrade Detail A9

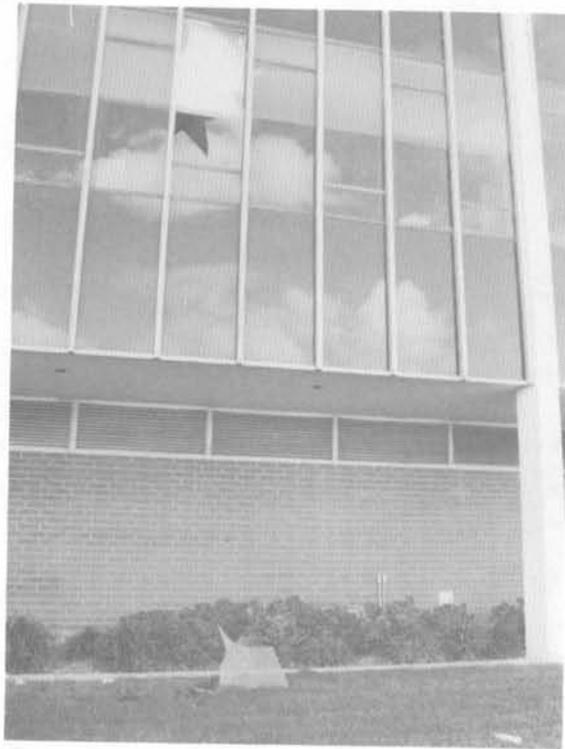
Earthquake Damage: 1994, Northridge, California
Photo Credit: Wiss, Janney, Elstner Associates, Inc.

- USE OF TEMPERED GLASS WILL GREATLY REDUCE THE SEISMIC HAZARD. TEMPERED GLASS MAY STILL BREAK, BUT WILL BREAK INTO SMALL DULL FRAGMENTS INSTEAD OF LARGE DANGEROUS SHARDS.
- POLYESTER SHATTER RESISTANT FILMS ARE AVAILABLE THAT HELP HOLD TOGETHER FRAGMENTS OF ANY PANES THAT CRACK IN AN EARTHQUAKE. (TYPICAL SOLAR FILM MAY NOT BE ADEQUATE FOR THIS PURPOSE).
- USE OF LAMINATED GLASS FOR STOREFRONTS REDUCES SEISMIC RISK AND ALSO INCREASES PROTECTION FROM BURGLARY OR VANDALISM.
- SMALLER, OPERABLE, AND WOODEN FRAMED WINDOWS TOLERATE MORE LATERAL DRIFT.
- FOR NEW CONSTRUCTION, STIFFER BUILDINGS AND GLAZING WITH MORE THAN THE STANDARD EDGE CLEARANCES MAY BE DESIRABLE. CHECK WHETHER OR NOT THE BUILDING'S CALCULATED SEISMIC DRIFT HAS BEEN CONSIDERED IN THE DESIGN OF THE GLAZING.

Schematic Upgrade Detail A12

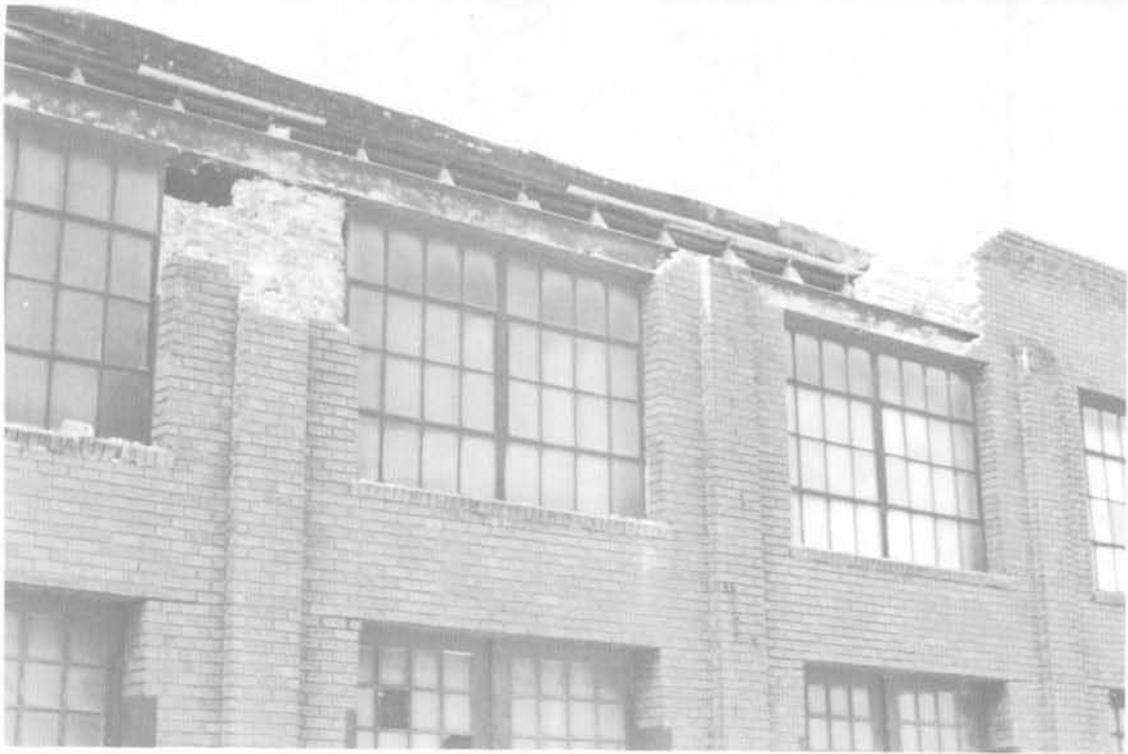
Earthquake Damage: 1989, Loma Prieta, California
Photo Credit: Wiss, Janney, Elstner Associates, Inc.

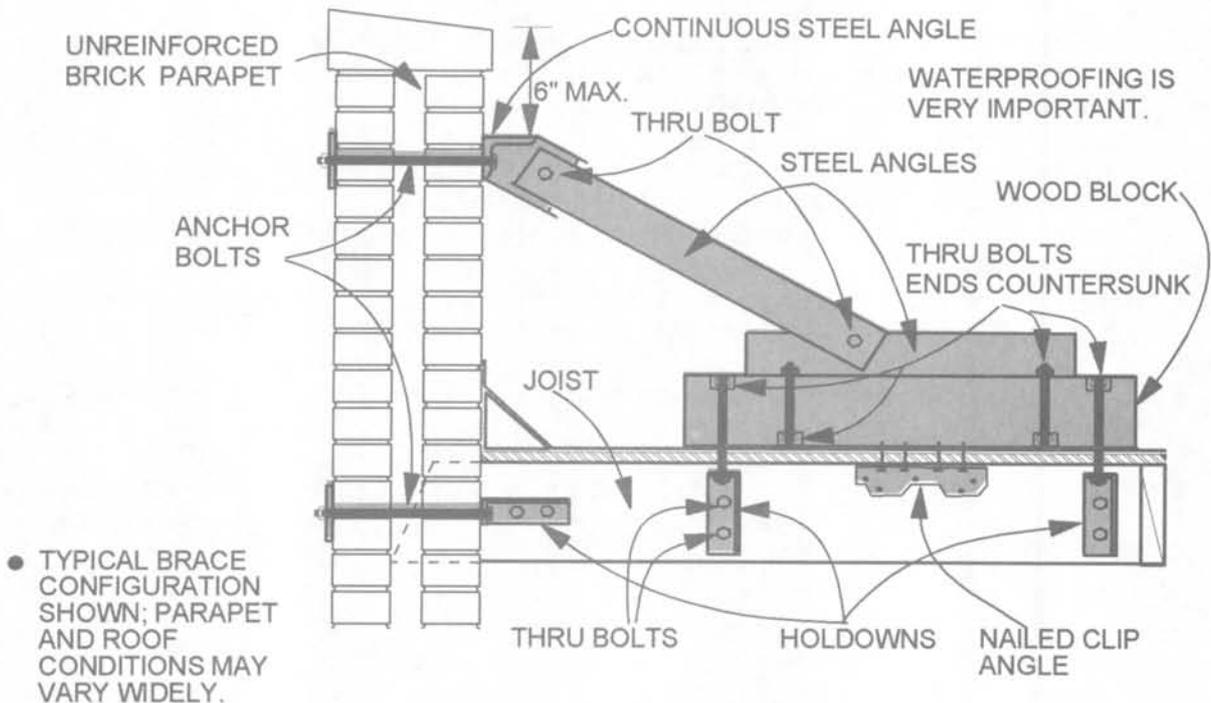
Schematic Upgrade Detail A15a
Approximate Cost: \$50 per foot

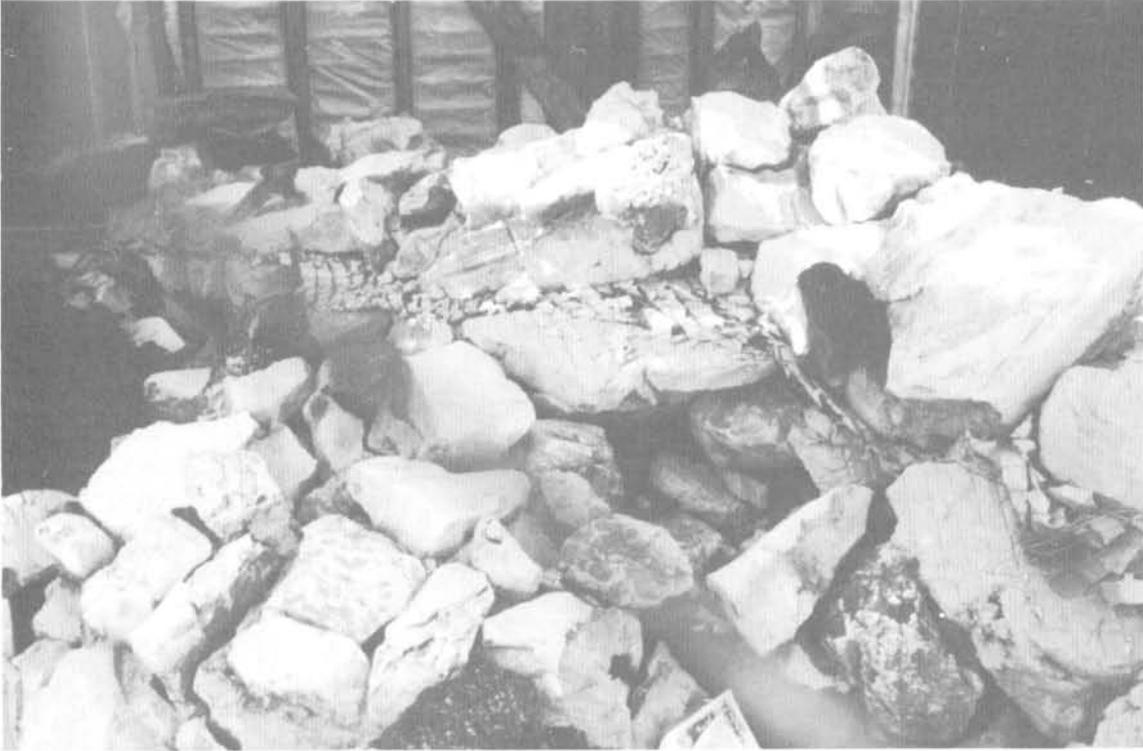
Earthquake Damage: 1994, Northridge, California
Photo Credit: Robert Reitherman

- SEE APPLICABLE BUILDING CODE REQUIREMENTS FOR LIMITATIONS REGARDING THE HEIGHT, AREA, UNIT SIZE, AND UNIT WEIGHT OF EITHER ADHERED OR ANCHORED VENEER SYSTEMS. REFER TO THE CODE SECTIONS FOR SPECIFIC REQUIREMENTS FOR BACKING, TIES, AND REINFORCEMENT. (FOR EXAMPLE, SECTION 1403 OF THE 1994 UBC).
- VENEER SYSTEMS MUST ALSO AT LEAST MEET THE MINIMUM LATERAL FORCE REQUIREMENTS FOR NONSTRUCTURAL COMPONENTS. (FOR EXAMPLE, THE REQUIREMENTS FOR EXTERIOR AND INTERIOR ORNAMENTATION AND APPENDAGES IN CHAPTER 16 OF THE 1994 UBC).
- REMOVAL OF VENEER MOUNTED OVER ENTRANCES OR OTHER POTENTIALLY CROWDED LOCATIONS IS THE MOST RELIABLE UPGRADE SOLUTION.

Schematic Upgrade Detail A15b
Approximate Cost: Varies

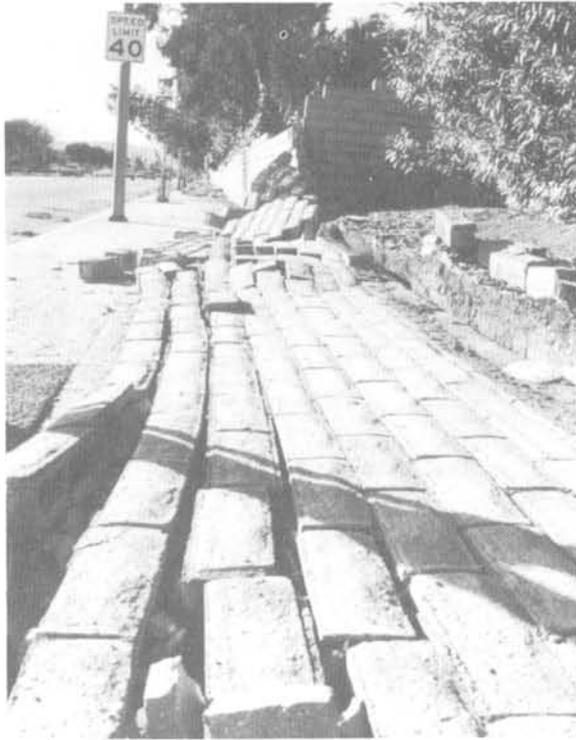
Earthquake Damage: 1994, Northridge, California
Photo Credit: Robert Reitherman

- MANY MILES OF POORLY CONSTRUCTED CONCRETE MASONRY UNIT (CMU) FENCES WERE DAMAGED DURING THE 1994 NORTHRIDGE EARTHQUAKE. COLLAPSE OF WALLS WITH INADEQUATE OR ABSENT REINFORCING AND/OR FOUNDATIONS WAS COMMON IN NORTHRIDGE AND SYLMAR. IN MANY CASES, MOST OF THE SIDEWALK WAS COVERED WITH DEBRIS, AS SHOWN ABOVE.
- FREESTANDING WALLS OR FENCES BUILT OF CMU, BRICK, OR STONE NEED TO BE ENGINEERED AND CONSTRUCTED WITH APPROPRIATE FOUNDATIONS, ADEQUATE REINFORCEMENT, AND GOOD QUALITY MORTAR.
- STANDARD DETAILS FOR LOW FENCES OR SHORT RETAINING WALLS MAY BE AVAILABLE FROM THE LOCAL BUILDING DEPARTMENT.

Schematic Upgrade Detail A16

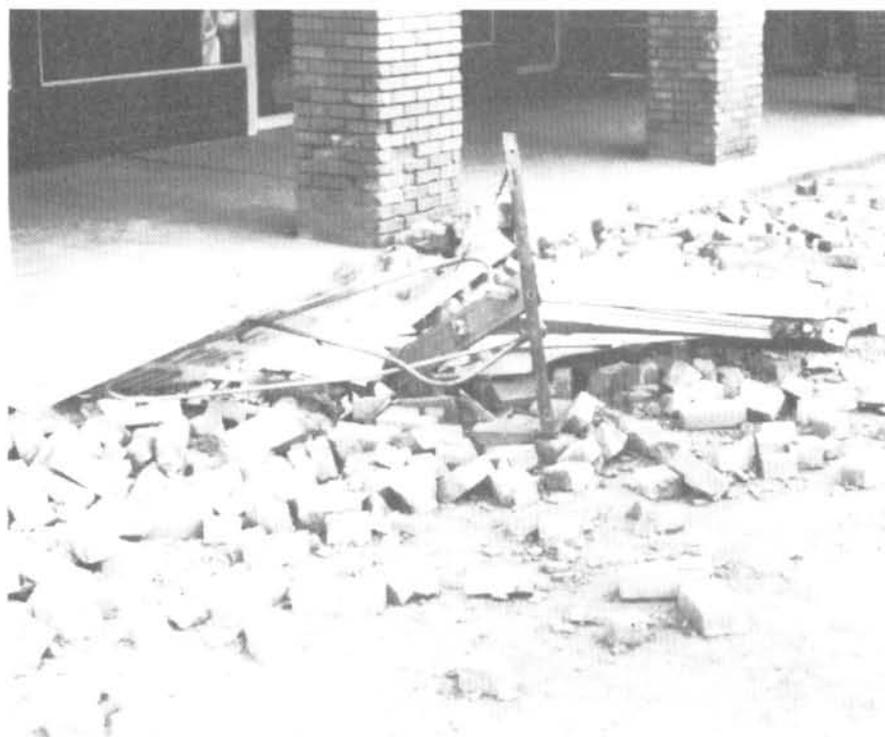
Earthquake Damage: 1979, Imperial Valley, California
Photo Credit: Robert Reitherman/BSD, Inc.

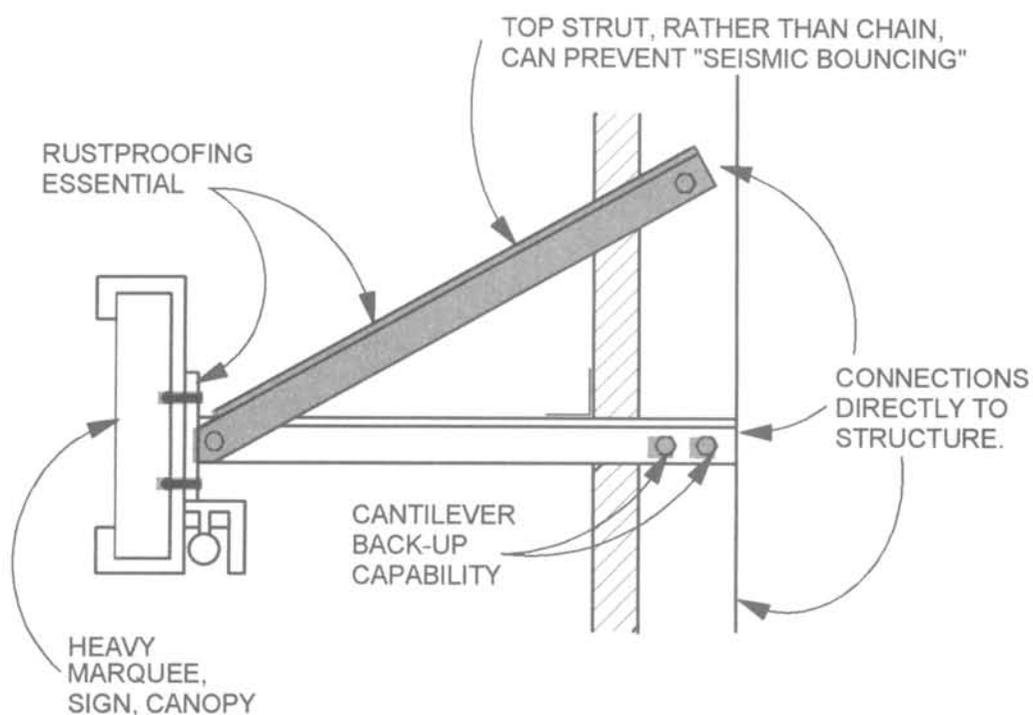
Schematic Upgrade Detail A21
Approximate Cost: \$500 - \$800

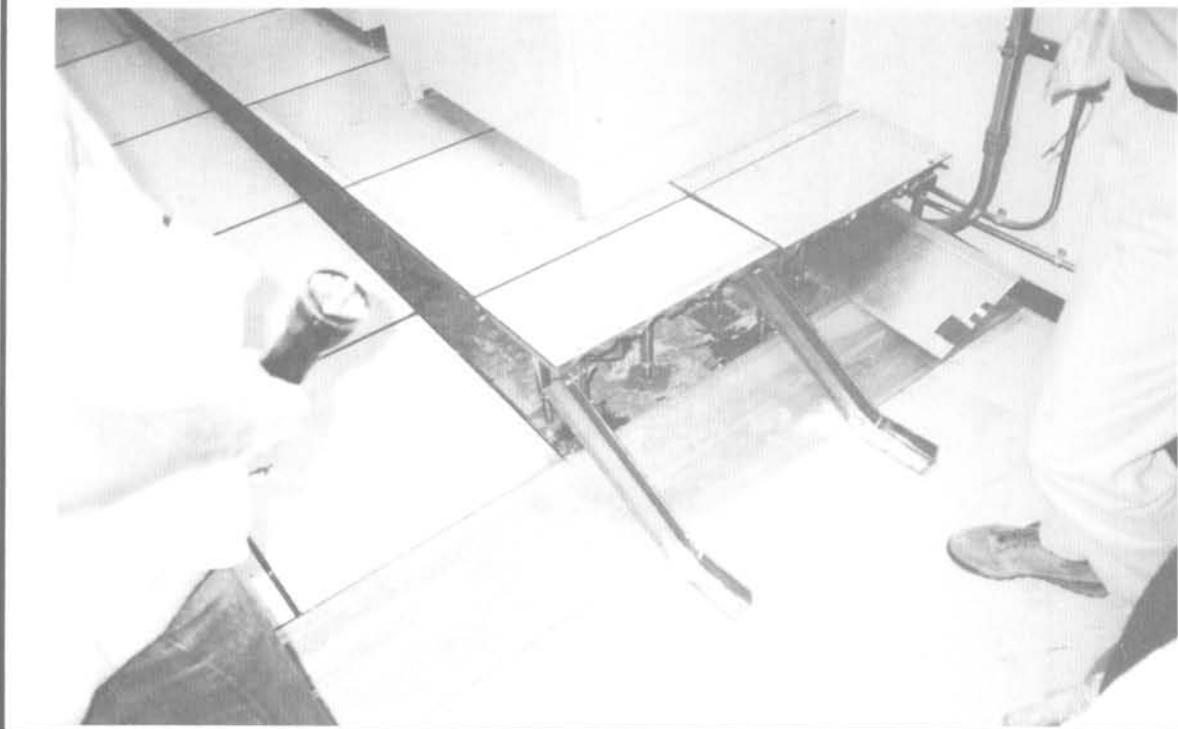
Temporary bracing for collapsed access floor
Earthquake Damage: 1994, Northridge, California
Photo Credit: Wiss, Janney, Elstner Associates, Inc.

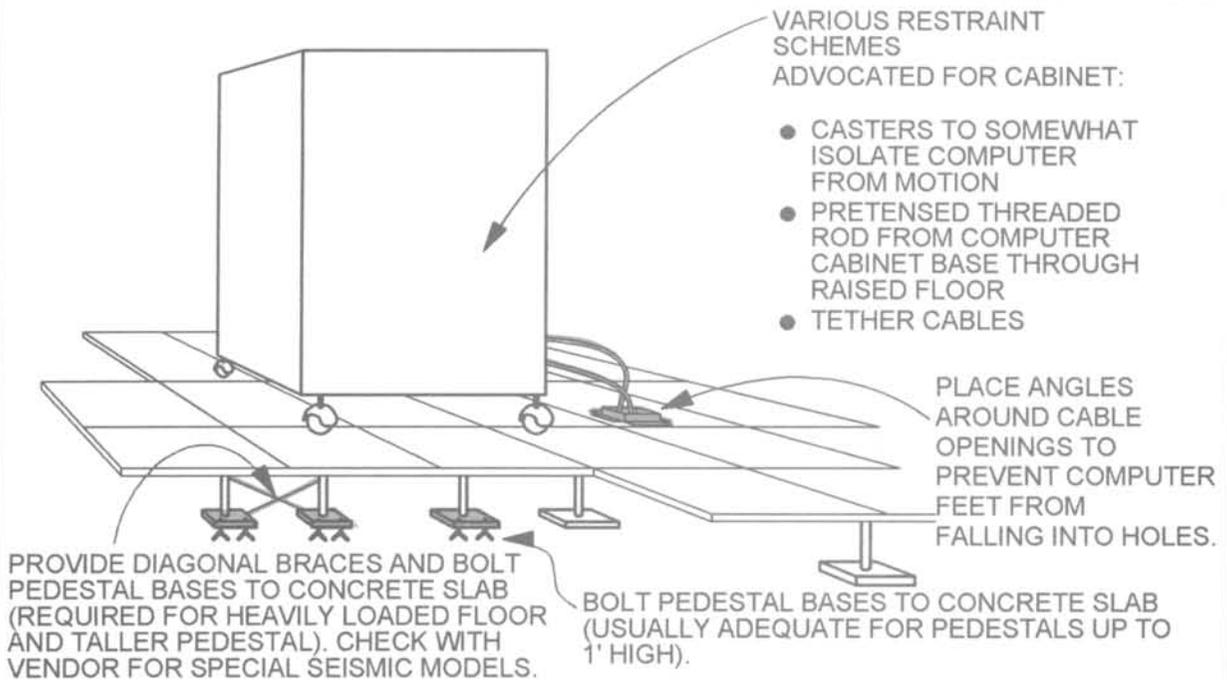
Schematic Upgrade Detail C8

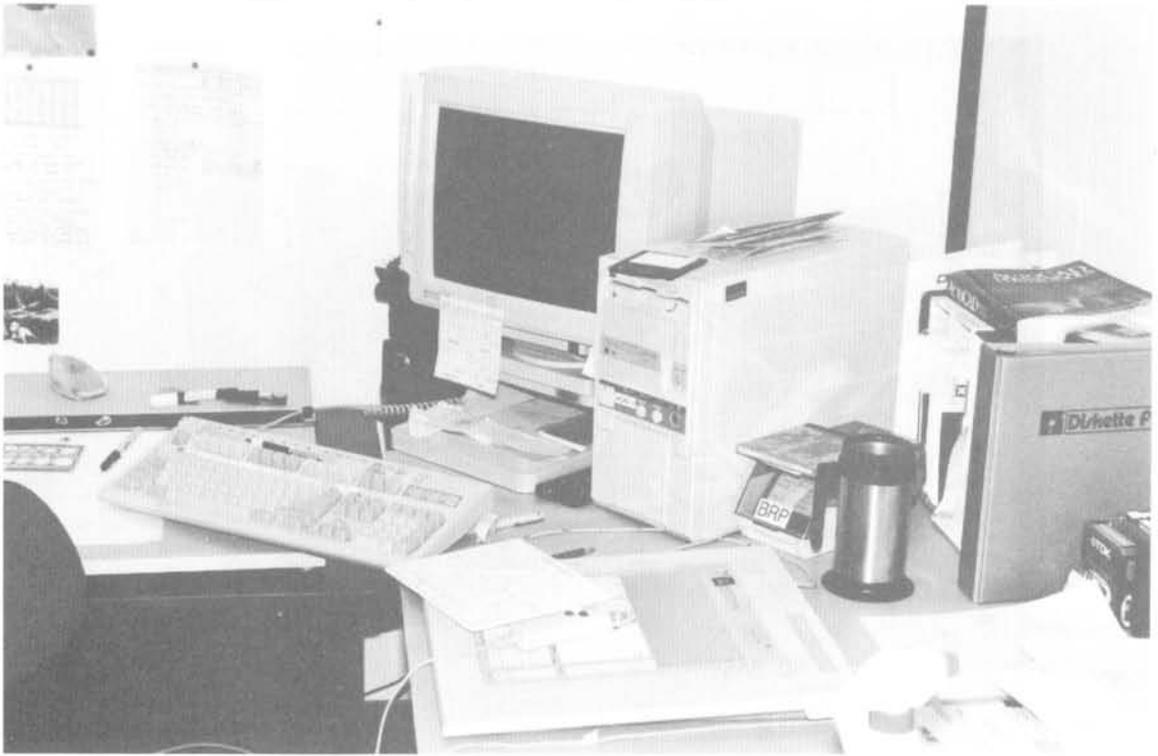
Unsecured computers may fall and suffer damage
Photo Credit: Wiss, Janney, Elstner Associates, Inc.

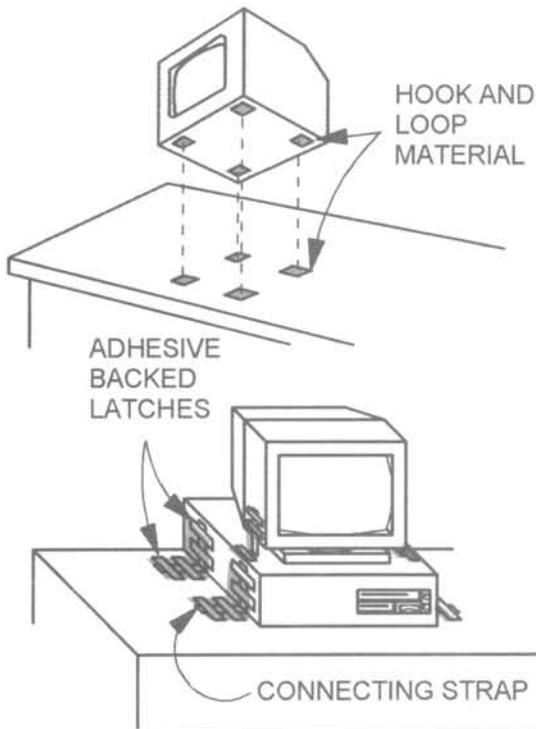
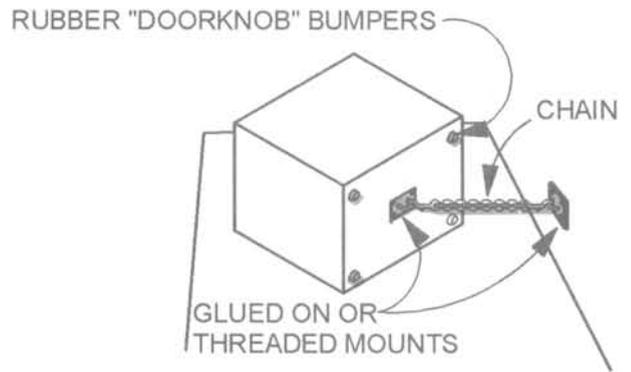
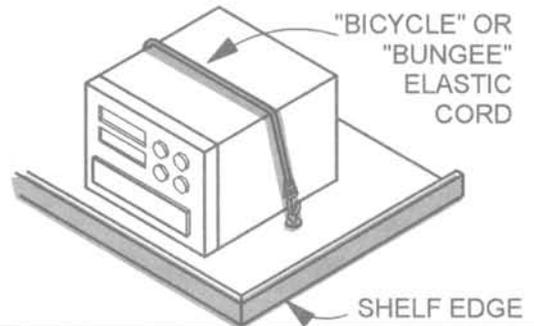
Upgrade Detail C10
Approximate Cost: \$50 per computer

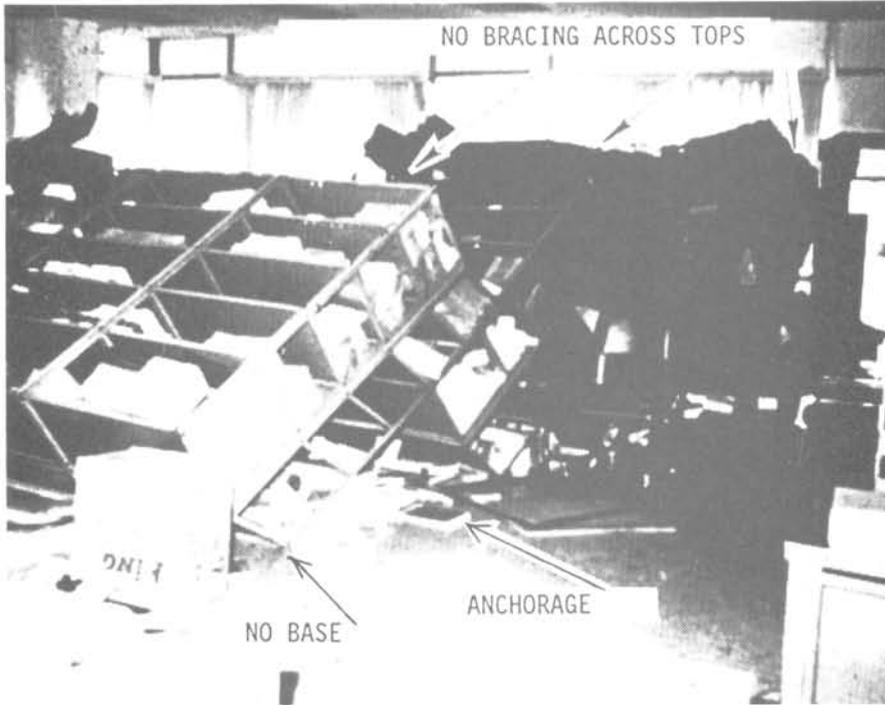
Earthquake Damage: 1972, Managua, Nicaragua
Photo Credit: John F. Meehan

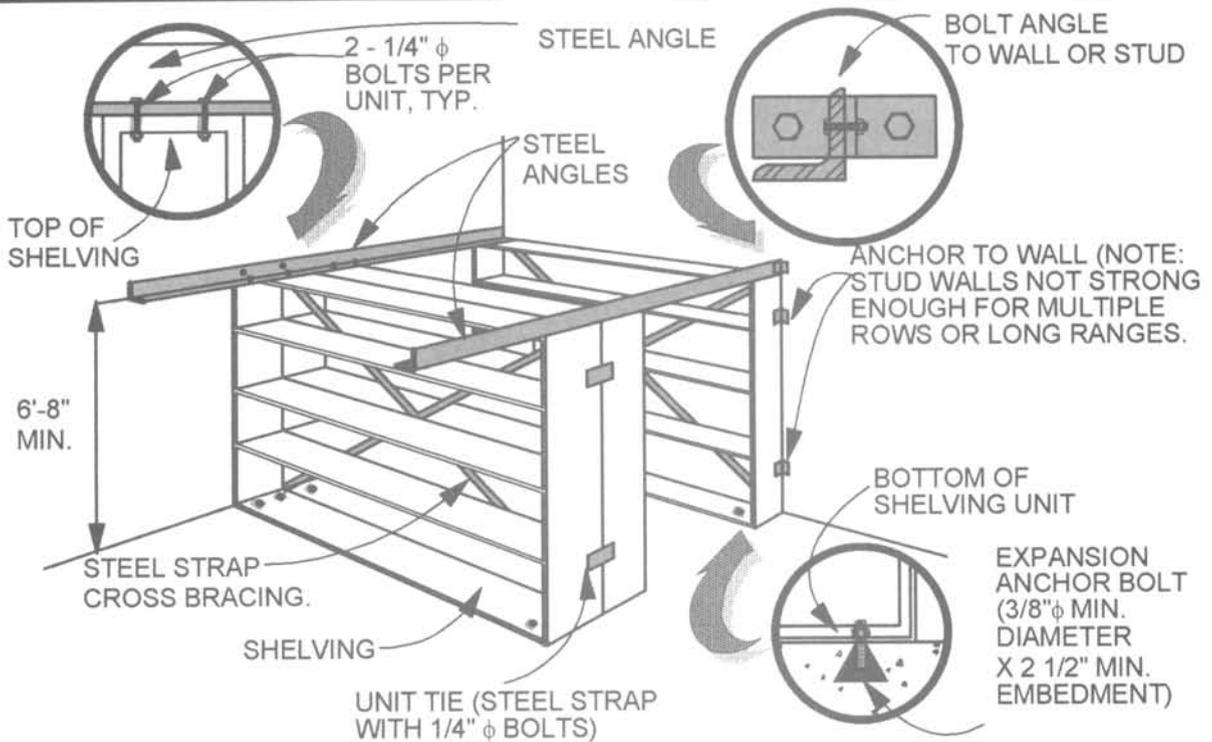
Schematic Upgrade Detail C12a

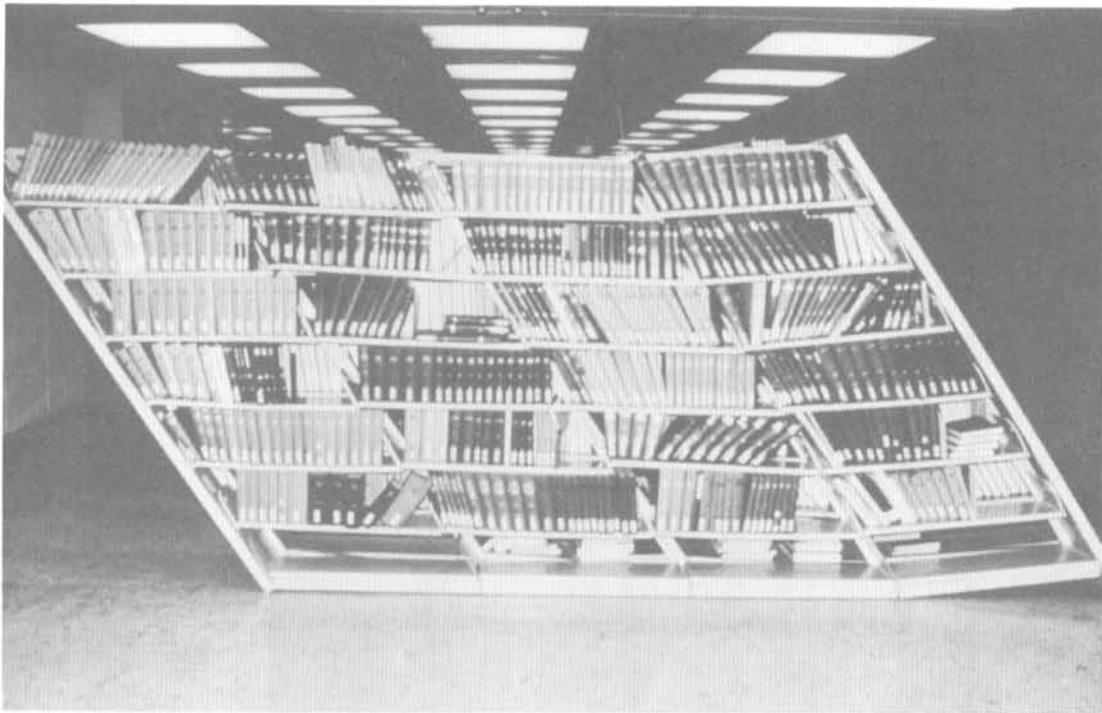
Failure of library shelving

Earthquake Damage: 1987, Whittier Narrows, California

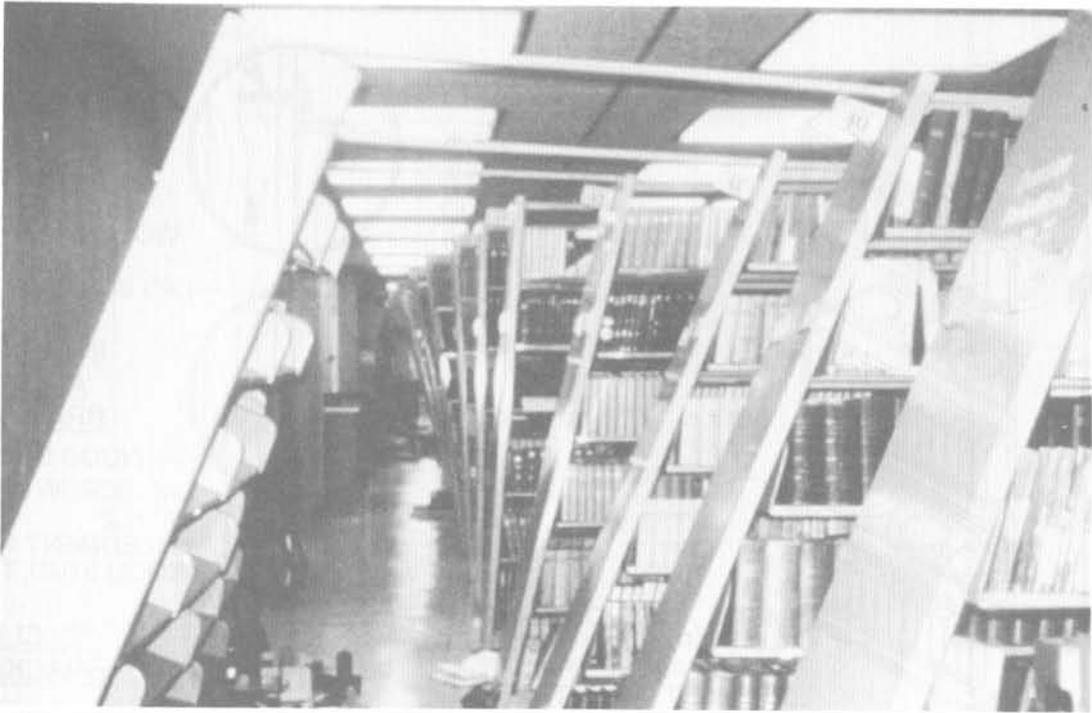
Failure of inadequately upgraded library shelving

Earthquake Damage: 1987, Whittier Narrows, California
