RESIDENTIAL CHIMNEY

ENGINEERING REQUIRED

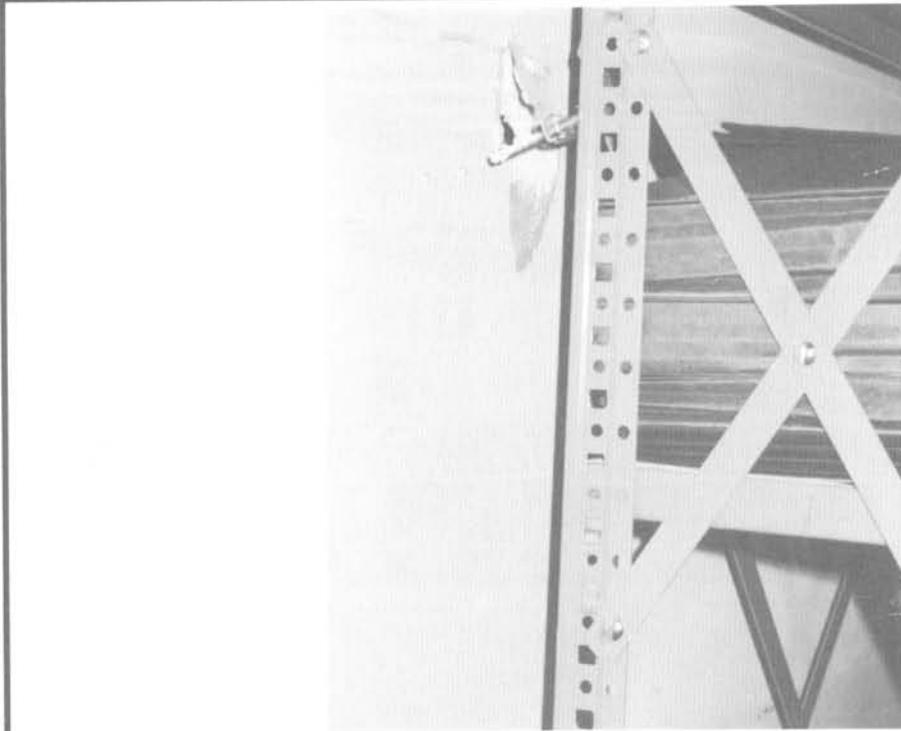
Failure of inadequately upgraded shelving; toggle bolt pulled out of gypsum board.
Earthquake Damage: 1994, Northridge, California
Photo Credit: Wiss, Janney, Elstner Associates, Inc.

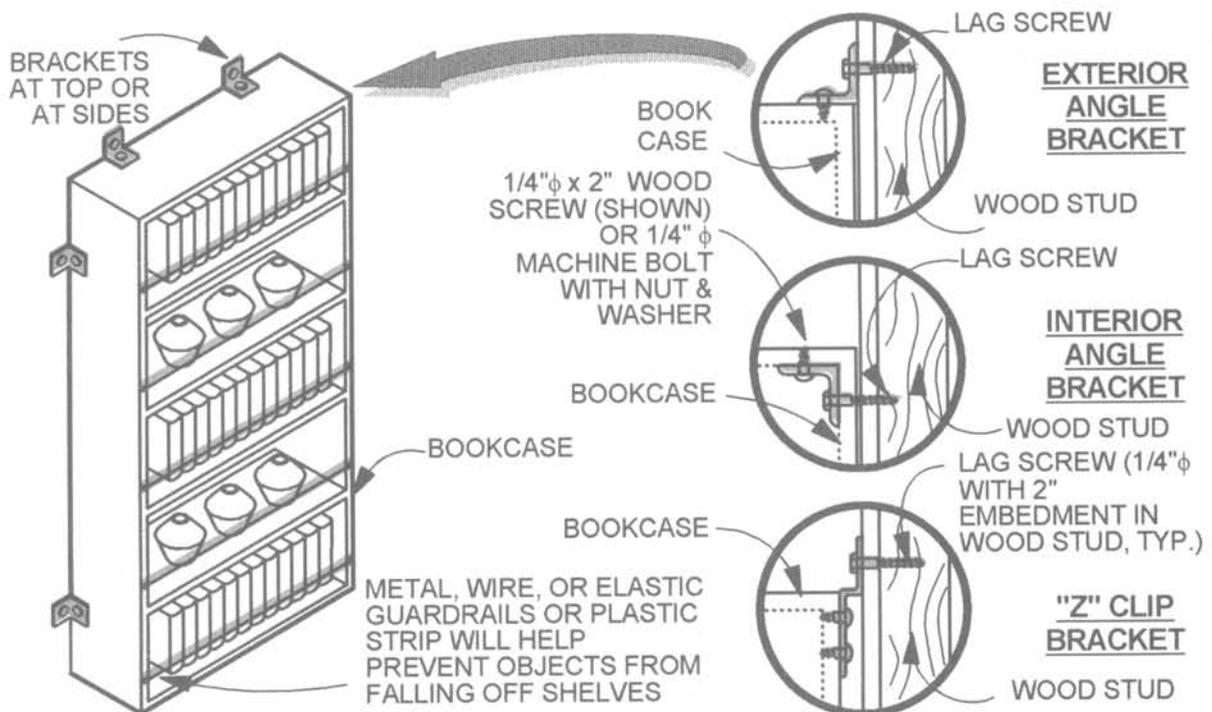
Upgrade Detail C12c

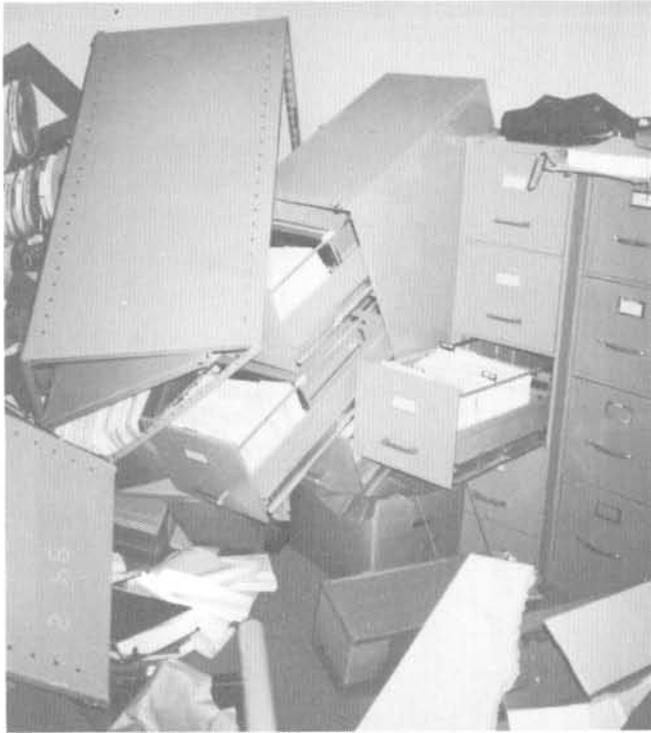
Earthquake Damage: 1994, Northridge, California
Photo Credit: Wiss, Janney, Elstner Associates, Inc.

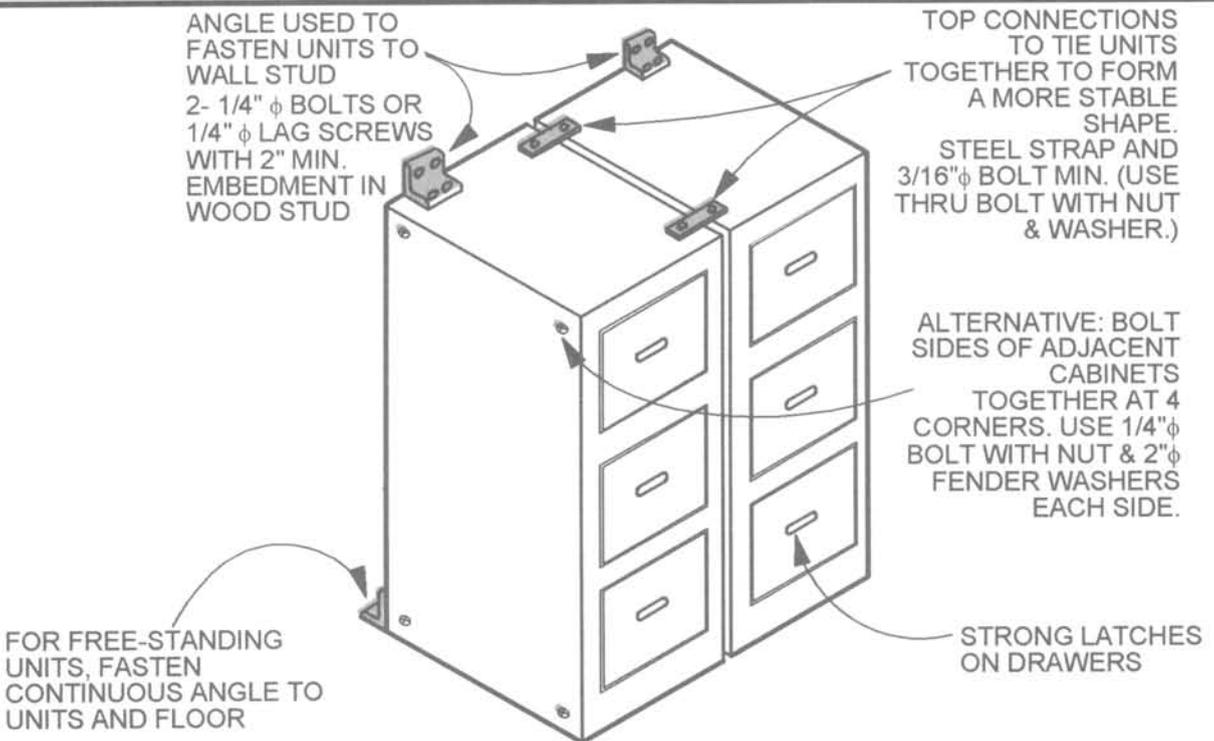
Upgrade Detail C13
Approximate Cost: \$20 per lineal foot

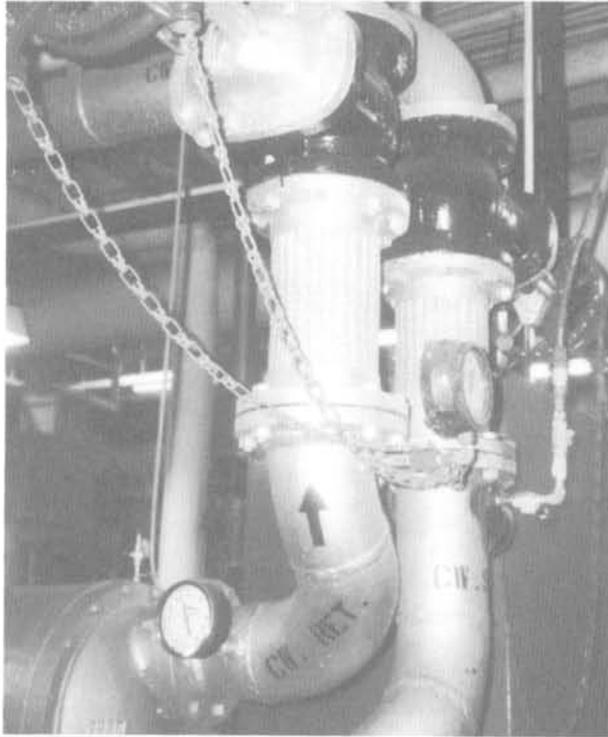
Flexible connection at pipe attachment to tank
Photo Credit: Wiss, Janney, Elstner Associates, Inc.

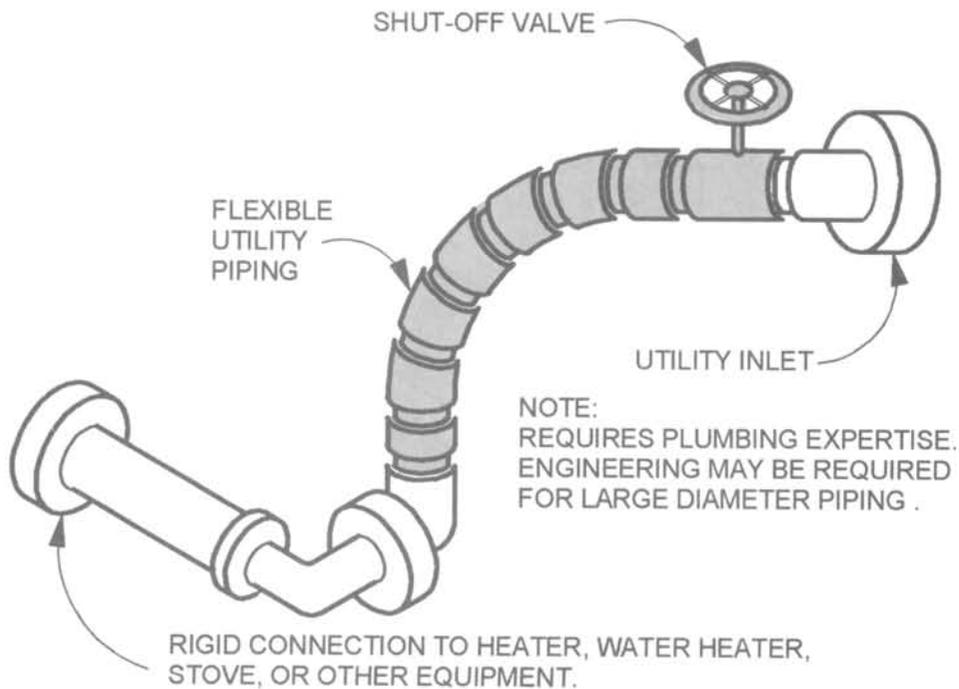
Upgrade Detail C18

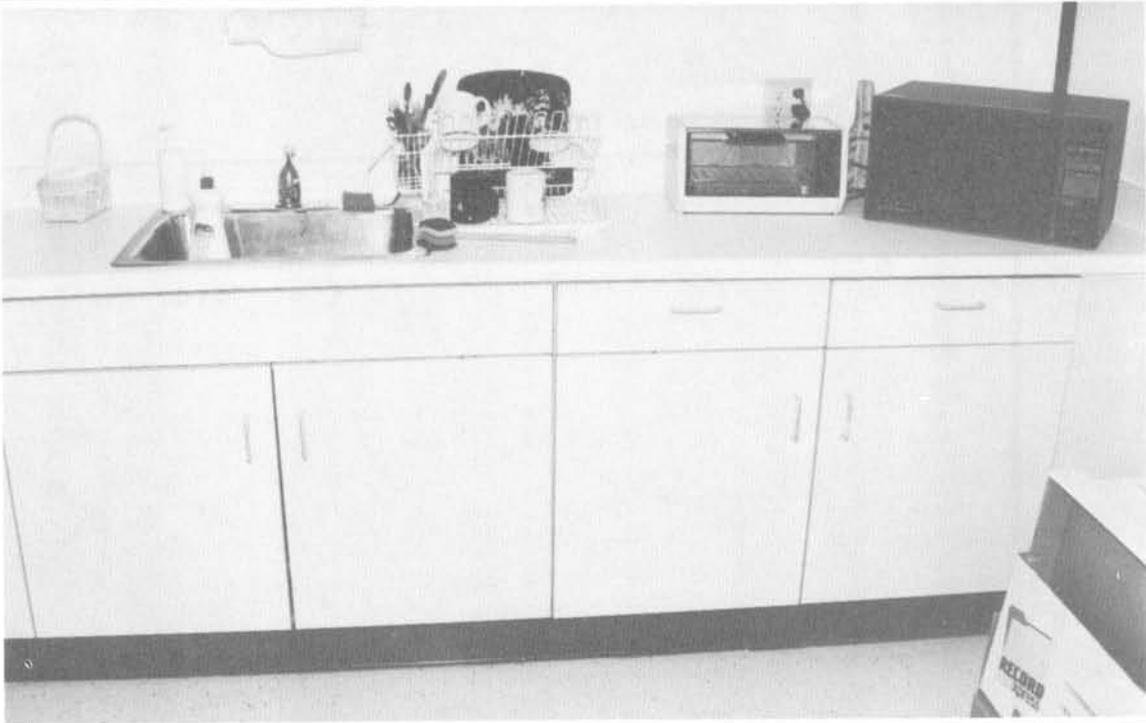
Unrestrained drawers and cabinets

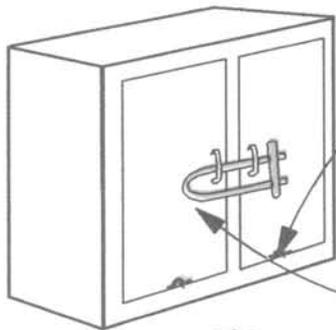
INSTALL STRONG MECHANICAL CABINET CATCHES (SAFETY HASP, SLIDE BOLT, TOUCH-DOOR CABINET CATCH, CLIP-ROLLER OR SNAP-ACTION CABINET CATCH, ETC.)

ALTERNATIVE: PROVIDE BABY-PROOF CLOSURE

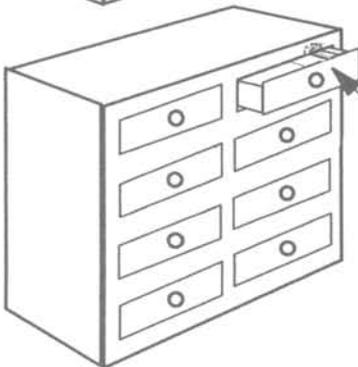
INSTALL MECHANICAL DRAWER CLOSURE (BABY-PROOF LATCHES, DRAWER LOCKS, OR OTHER SPECIALTY LATCHES)

Upgrade Detail C19

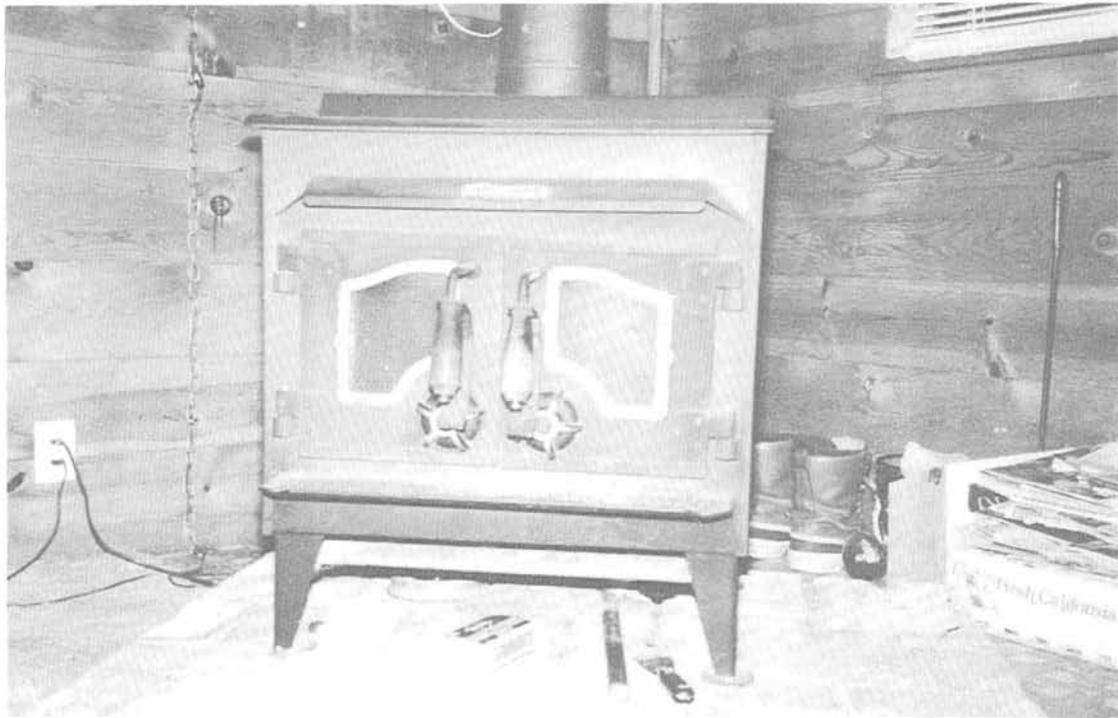
Unrestrained wood burning stove
Photo Credit: Wiss, Janney, Elstner Associates, Inc.

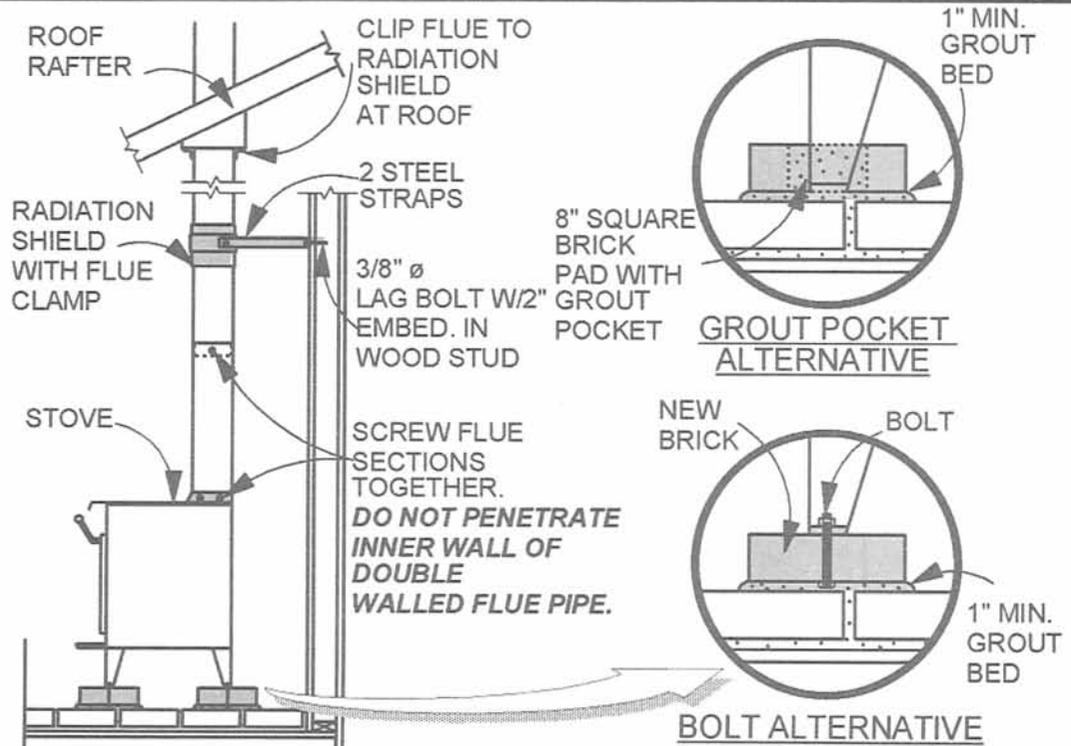
Upgrade Detail C20
Approximate Cost: \$500

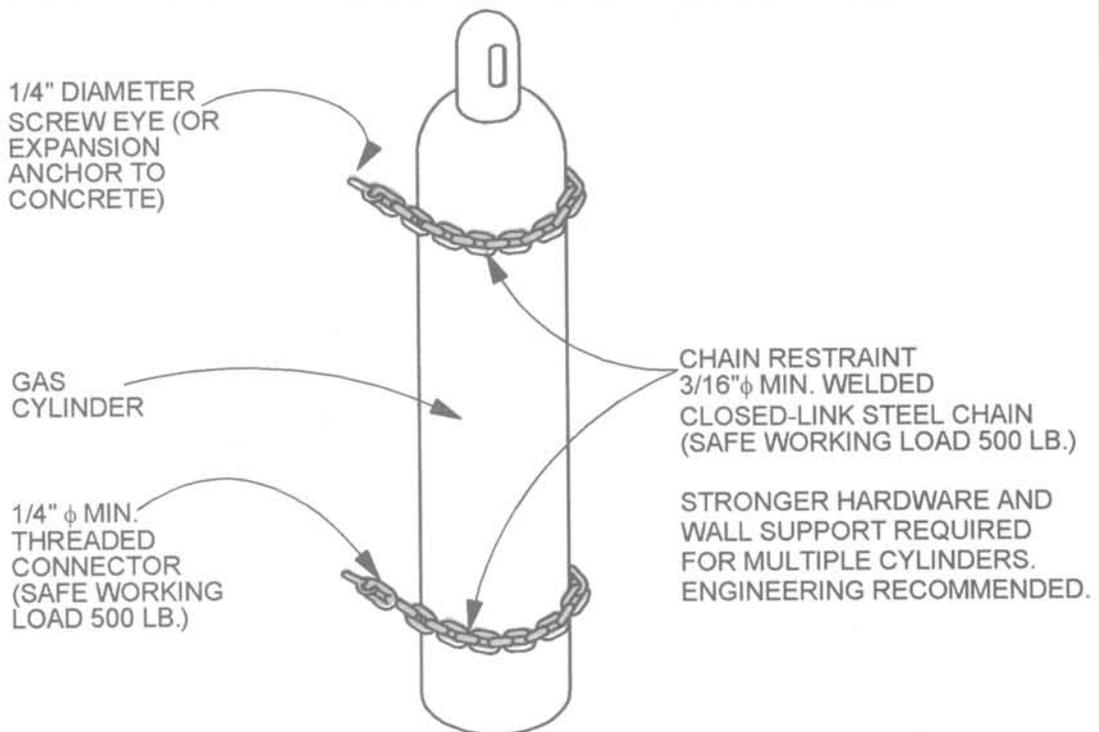
Upgrade Detail C21

Approximate Cost: \$30 per lineal foot; \$50 for single units

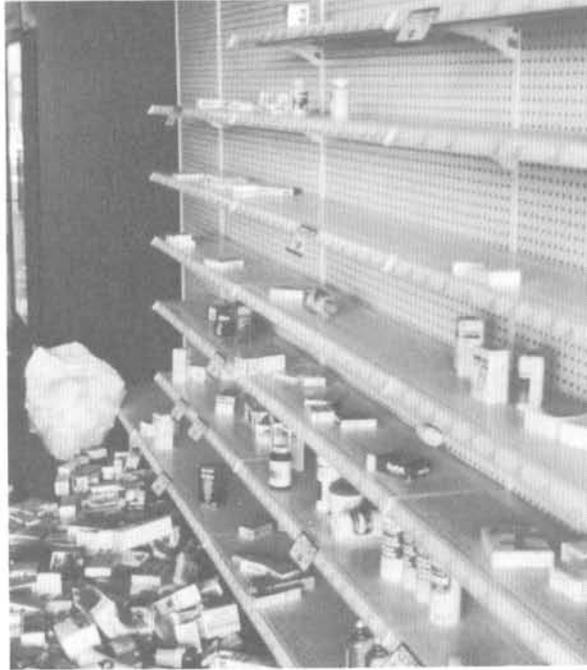
Spilled pharmaceutical and medical supplies.
Earthquake Damage: 1994, Northridge, California
Photo Credit: Robert Reitherman

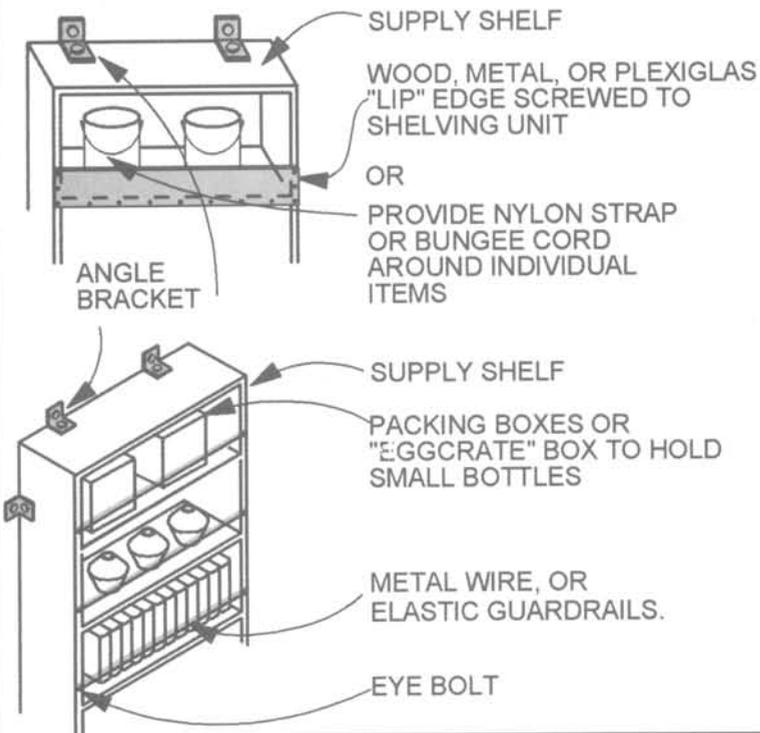
- ANCHOR STORAGE SHELVES
- PROVIDE SAFETY LIP OR SHELF EDGE
- PROVIDE MECHANICAL LATCHES FOR CABINETS AND DRAWERS
- STORE SMALL OR BREAKABLE ITEMS IN ORIGINAL PACKING OR EGGCRATE BOXES, NOT LOOSE ON SHELF OR IN DRAWER
- STORE INCOMPATIBLE MATERIALS AT A SAFE DISTANCE TO AVOID MIXING IF THE CONTAINERS FALL
- ORDER HAZARDOUS LAB CHEMICALS IN UNBREAKABLE PLASTIC BOTTLES OR IN GLASS BOTTLES WITH AN EXTERIOR PLASTIC SAFETY COATING

Schematic Upgrade Detail C22
Approximate Cost: Varies

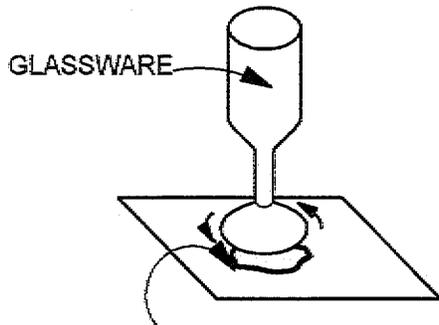
BEE'S WAX OR DENTAL WAX CAN RESTRAIN SMALL LIGHTWEIGHT OBJECTS. (REMOVE WITH CARE - WAX MAY LEAVE SMALL STAIN ON BASE OF OBJECT). ALTERNATIVE: USE PATCHES OF HOOK AND LOOP MATERIAL. [CAUTION - GLUE MAY AFFECT FINISH ON BASE OF OBJECT].

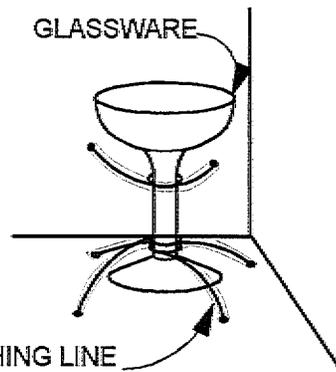
MONO-FILAMENT FISHING LINE USED FOR GUY WIRES

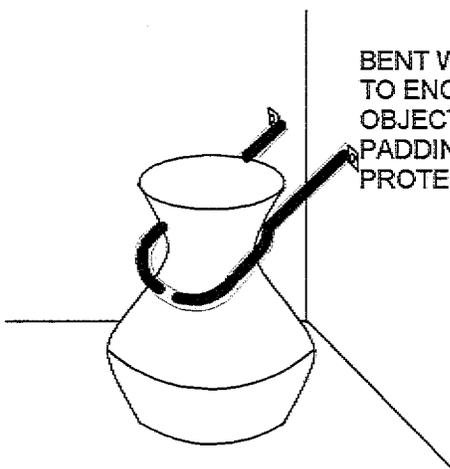
BENT WIRE ARMS TO ENCIRCLE THE OBJECT. PROVIDE PADDING TO PROTECT ARTWORK.

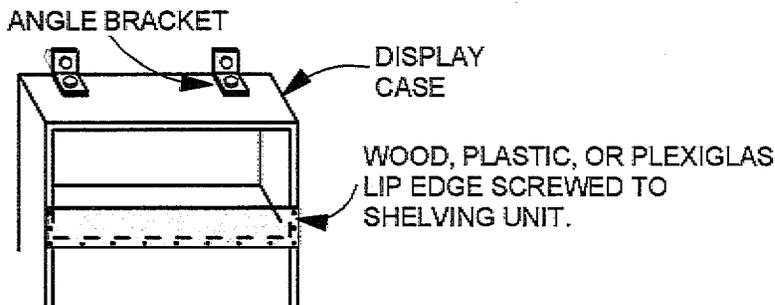
PLACE OBJECT IN CLOSE-FITTING GLASS OR PLEXIGLASS DISPLAY CASE. PEDESTAL MUST BE ANCHORED.

Upgrade Detail C26
Approximate Cost: Varies
