1.0 INTRODUCTION

1.1 PURPOSE

The purpose of this report is to provide guidance and recommendations for reducing hurricane and flood damage in the future. This purpose is best achieved through learning from successes and failures of building performance. Therefore, this report includes observations of both successes and failures of various building types.

In the afternoon of September 11, 1992, Hurricane Iniki struck the Island of Kauai, Hawaii, generating high winds and storm surge over a vast area of the island (FIGURE 1). With wind speeds exceeding those of Hurricanes Iwa (1982) and Dot (1959), Iniki was the strongest and most destructive hurricane to strike the Hawaiian Islands in recent memory.

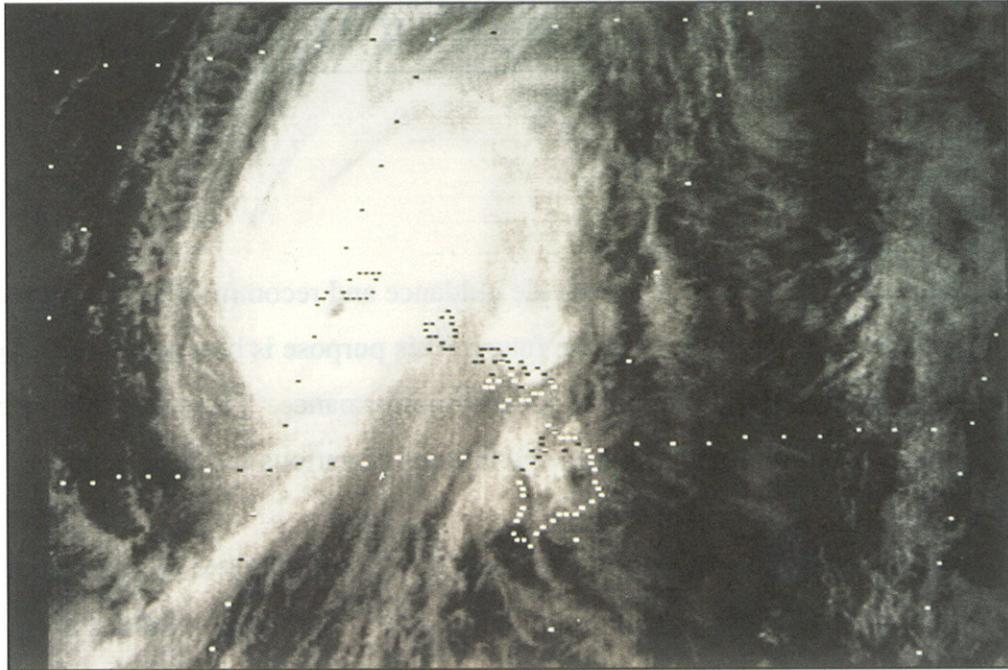
FIGURE 1. *The eye of Hurricane Iniki crossed the Kauai coast just west of Port Allen near Kaumakani just before 4:00p.m. Hawaiian Standard Time on September 11, 1992.*

Hurricane Iniki was a small but intense hurricane as it moved northward across the Island of Kauai during the late afternoon hours of September 11, 1992. The eye of Iniki crossed the Kauai coast just west of Port Allen near Kaumakani just before 4:00 p.m. Hawaiian Standard Time (HST). Iniki left behind a path of destruction, with property damage expected to approach 1.8 billion dollars. On Kauai alone, Iniki destroyed or damaged 14,350 homes. Of that total, 1,421 were destroyed and another 5,152 suffered major damage. Damage on Kauai was widespread, with the most severe damage occurring on the south, east, and north ends of the island. Even with such widespread and severe damage, only three deaths were attributed directly to the storm. The low loss of life can be attributed to ample warning time, an excellent response by the State of Hawaii Office Civil Defense System, the evacuation of all coastal areas, and the high level of awareness created by previous press coverage of Hurricane Andrew in Florida and Typhoon Omar in Guam.

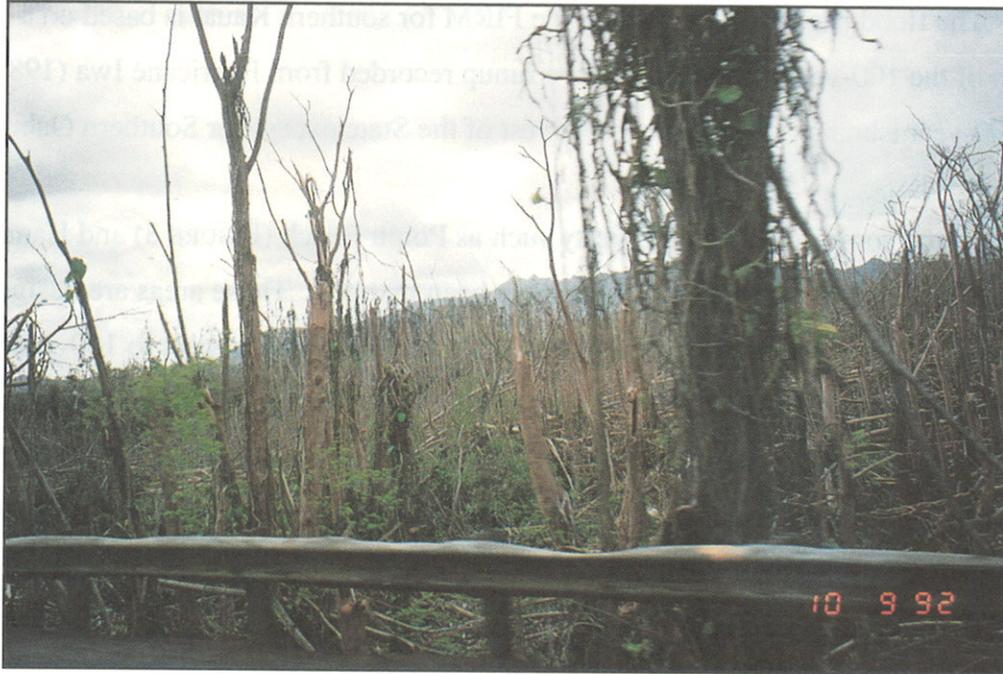
FIGURE 2. *Hurricane Iniki produced substantial wind speeds at low altitudes in excess of the 80-mph base condition.*

On October 8, 1992, members of the team met with various experts involved in the assessment of the winds generated by Iniki. The team learned that the sustained wind speeds at low altitude were recorded in excess of the 80-mph basic code design (FIGURE 2). However, it is important to understand that the basic wind speed of Hurricane Iniki was not beyond that which a building can be designed for with reasonable likelihood of successful performance.

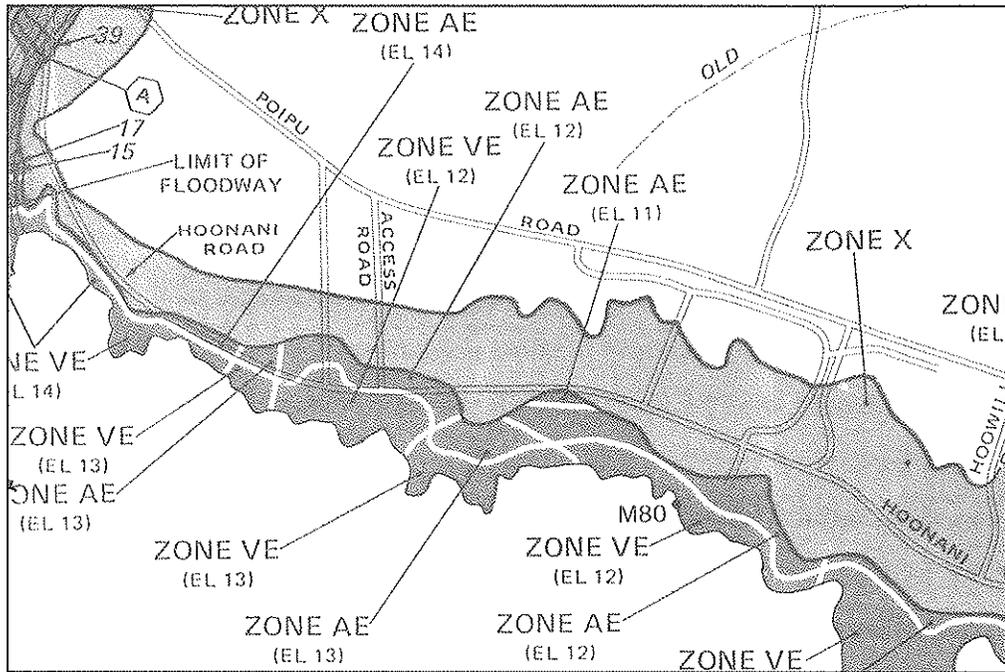
FIGURE 3. Portion of Flood Insurance Rate Map (FIRM) for Kauai County covering the Poipu Beach area. Note predicted 100-year flood heights of 12 to 14 feet above mean sea level.

Along some oceanfront property such as Poipu Beach (FIGURE 3) and Hanalei (FIGURE 4), Coastal High Hazard Areas have been mapped. These areas are designated as V zones (velocity zones) on the FIRM. A V zone is an area subject to 100-year coastal flooding with waves 3 feet or greater in height. Consequently, additional design considerations are necessary for construction in V zones. Such considerations include use of pile and column foundations, leaving the area under the elevated building open to allow for free passage of velocity flood waters, and ensuring that foundation embedment is sufficient to withstand erosion and localized scour.

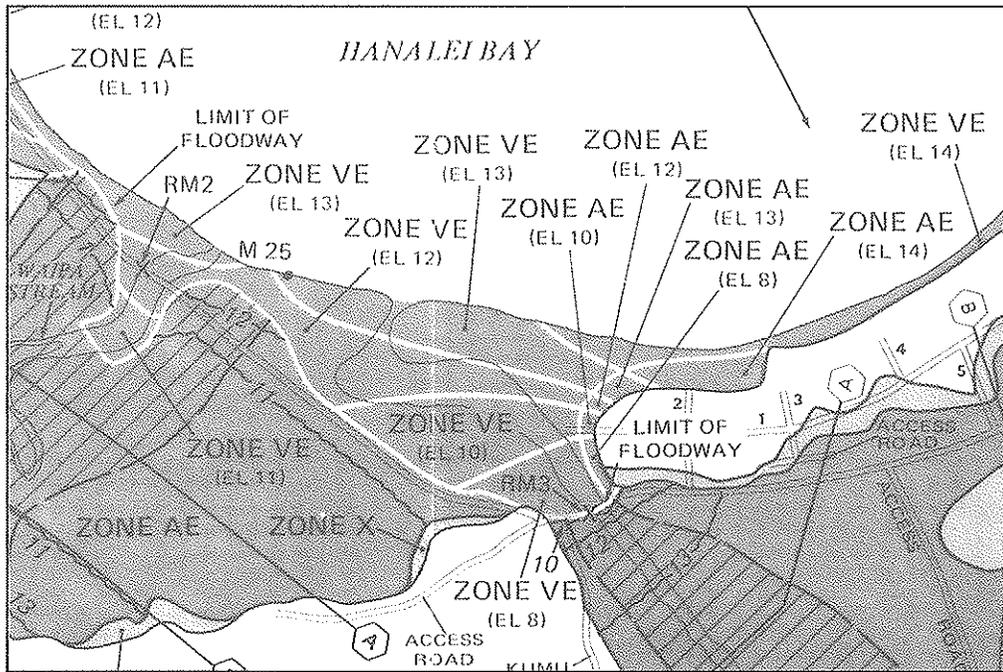
FIGURE 4. Various flood hazard zones, including velocity (V) Coastal High Hazard zones, on the Kauai County FIRM (Hanalei example).
